March 12, 2013

Project No: NIRB No.: 04DN001 2011 Annual Report

Regarding: DYE-M, Cape Dyer DEW Line Site

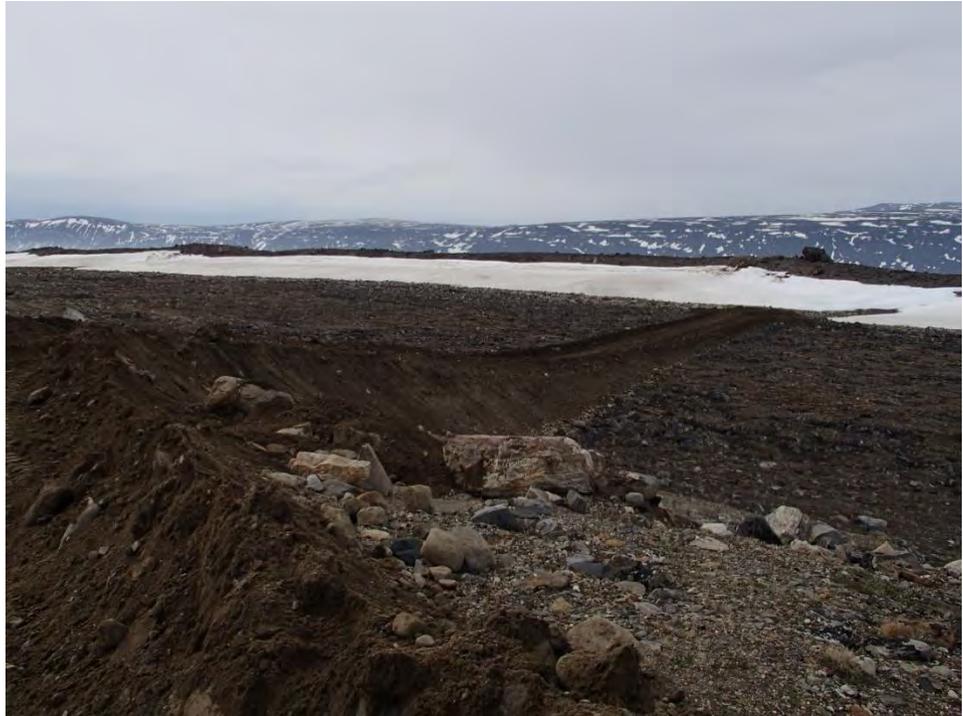
Photo No.
3

Borrow Area 4 –
Access roadway
construction.

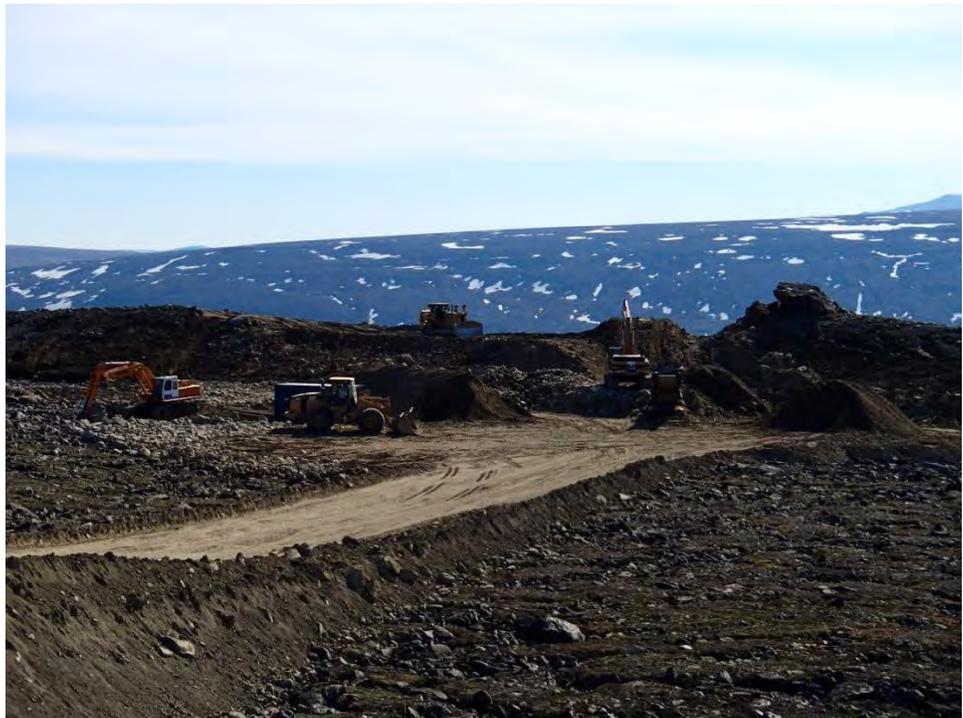
Photo No.
5

Borrow Area 4 –
Screening Type 2
Granular Fill.

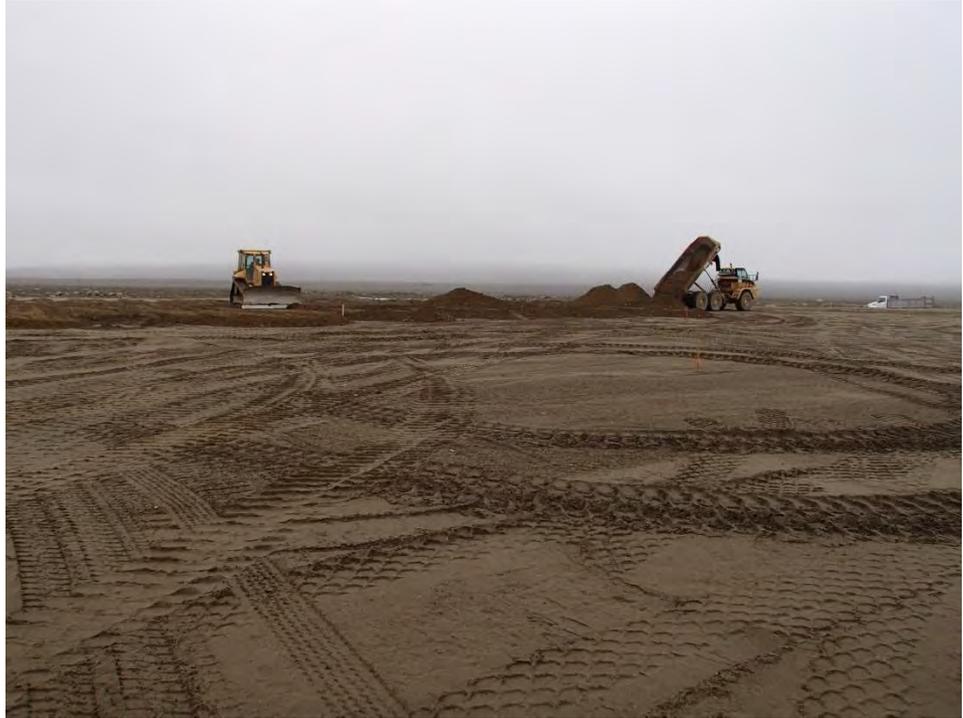
Photo No.
7

Lower Site NHWL –
Construction of Type 2
Granular Cover Layer.

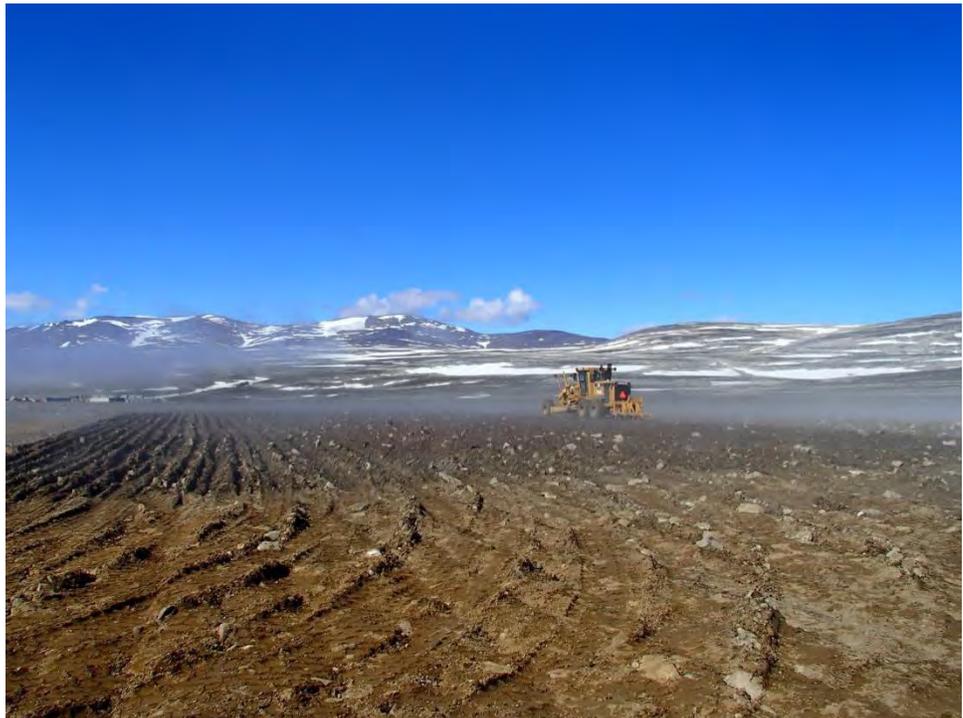
Photo No.
8

Landfarm – Tilling Event.

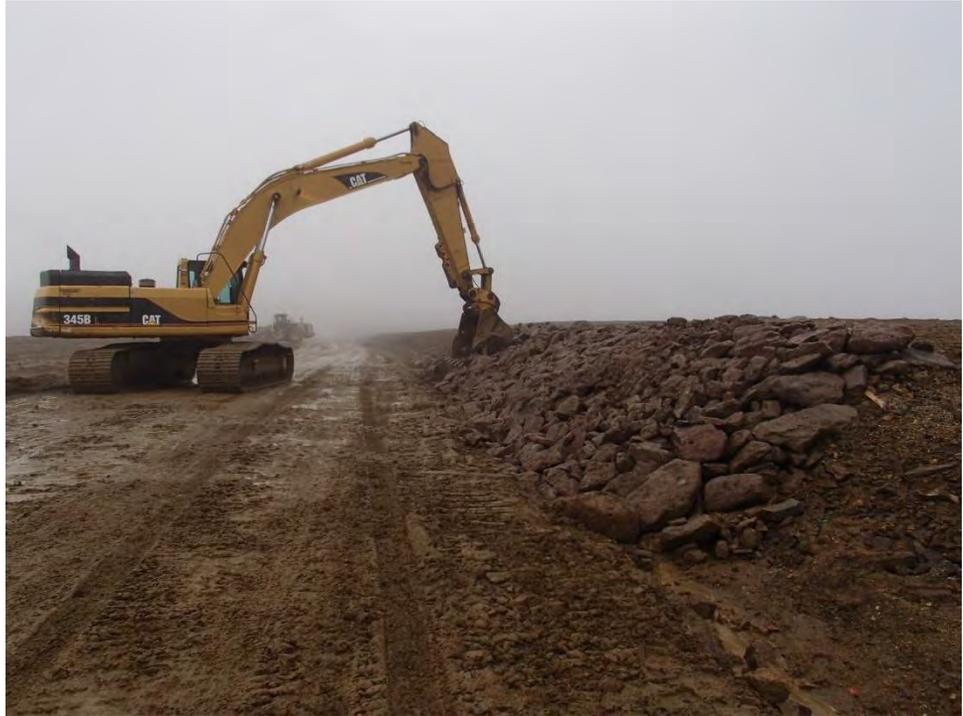
Photo No.
9

Pallet Line Landfill – Type
1 Granular Fill Placement.

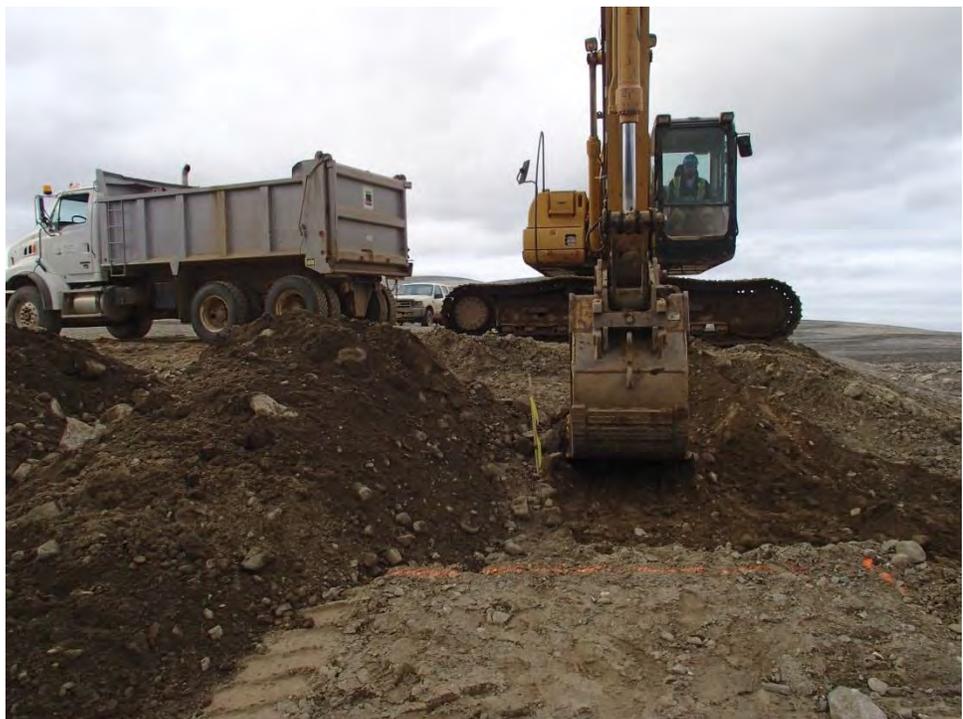
Photo No.
10

Lower Site Tier II DF –
Removal of Spilled Soils.

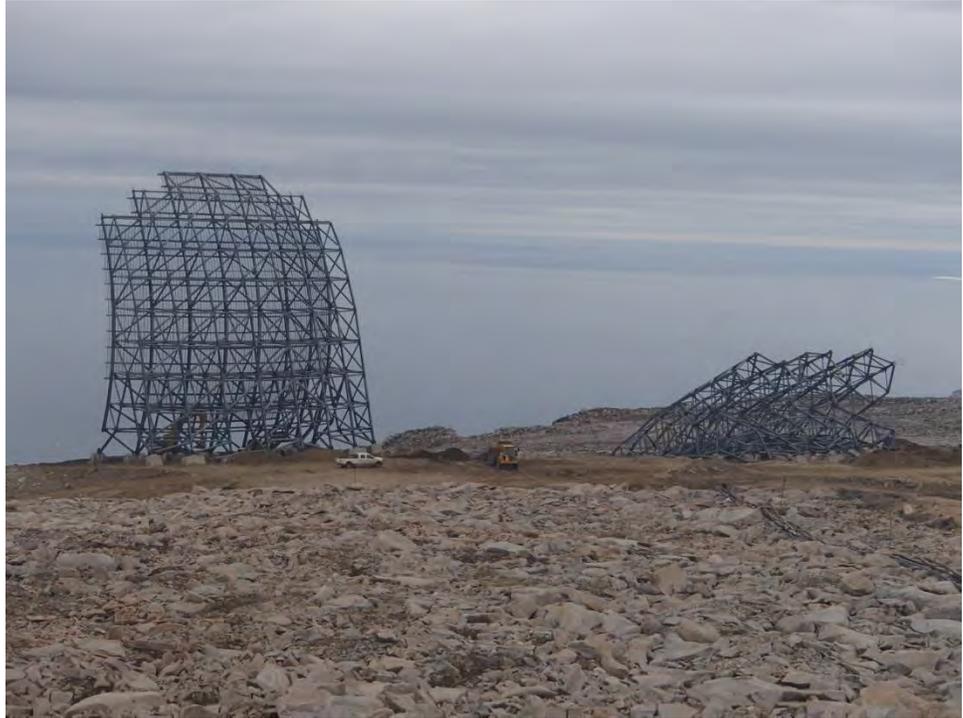
Photo No.
11

DEW Drop Area – Large
Billboard Demolition.

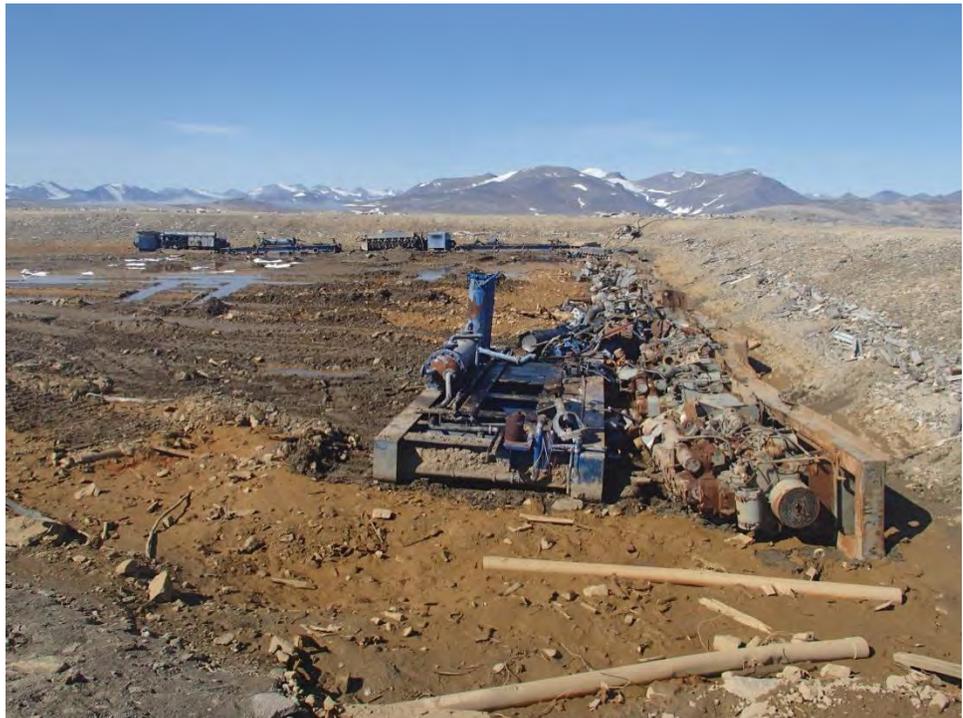
Photo No.
12

Upper Site NHWL –
Segmentation of Large
Generators.

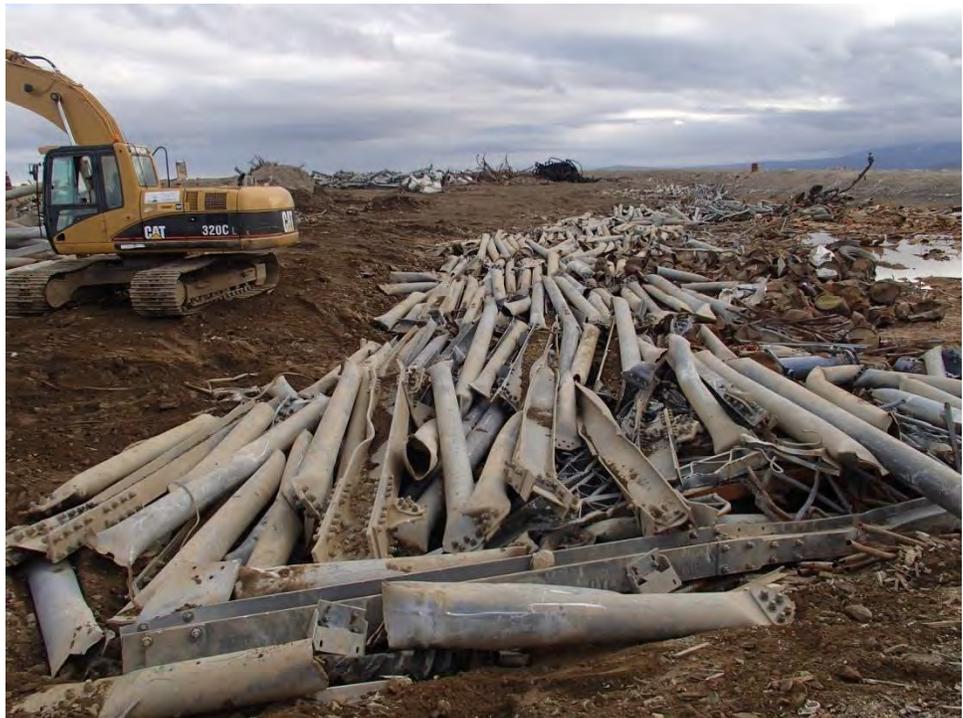
Photo No.
14

Upper Site NHWL –
Landfilling of Large
Billboard.

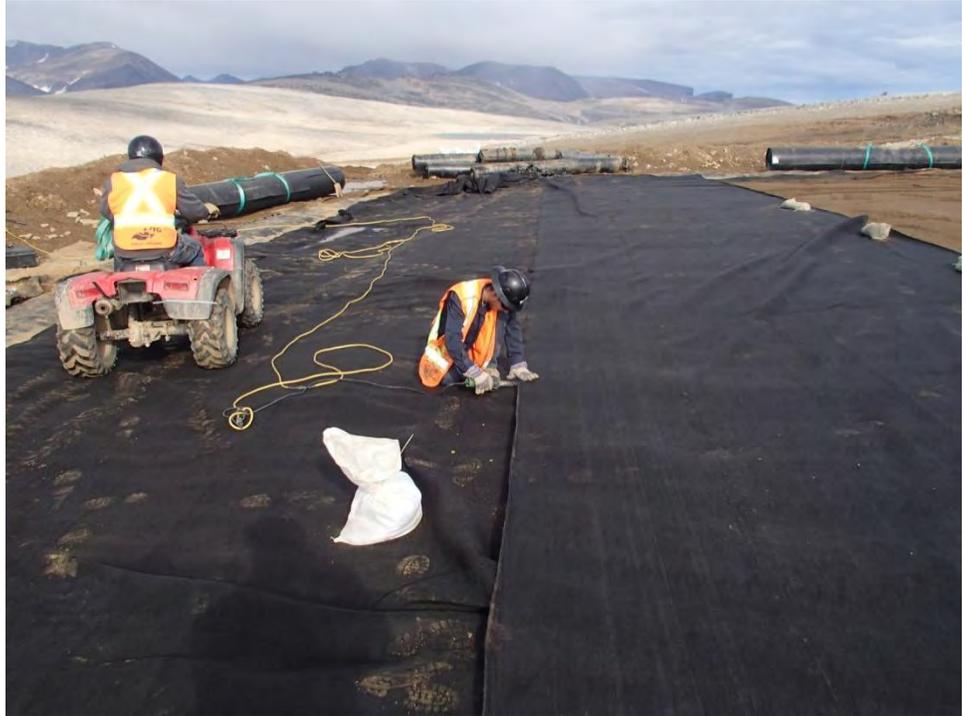
Photo No.
15

Upper Site Tier II DF –
Installation of Geotextile.

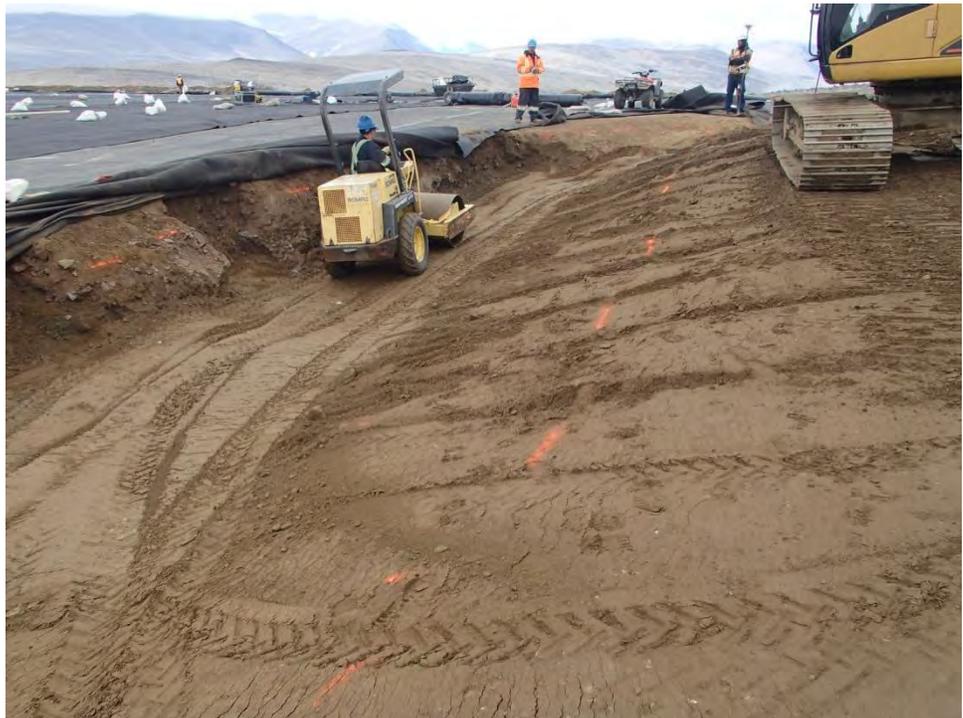
Photo No.
16

Upper Site Tier II DF –
Backfilling Ramp Area.

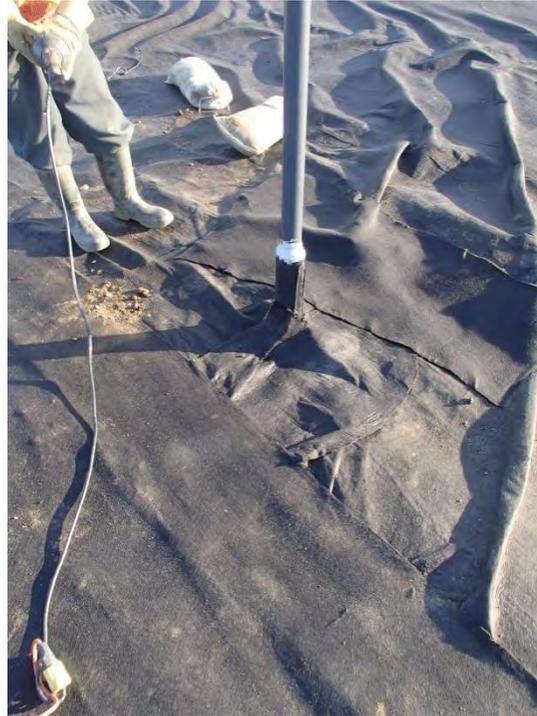
Photo No.
17

Upper Site Tier II DF –
Installation of
Geomembrane Boot on
VT-10..

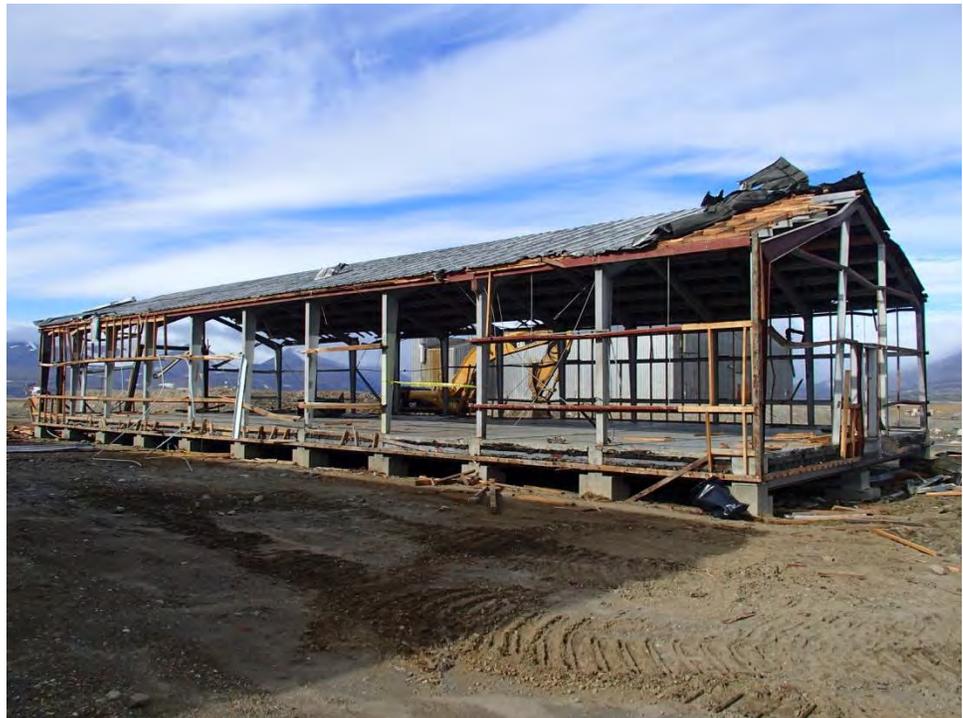
Photo No.
18

Lower Site Station Area –
Demolition of Warehouse
B13F.

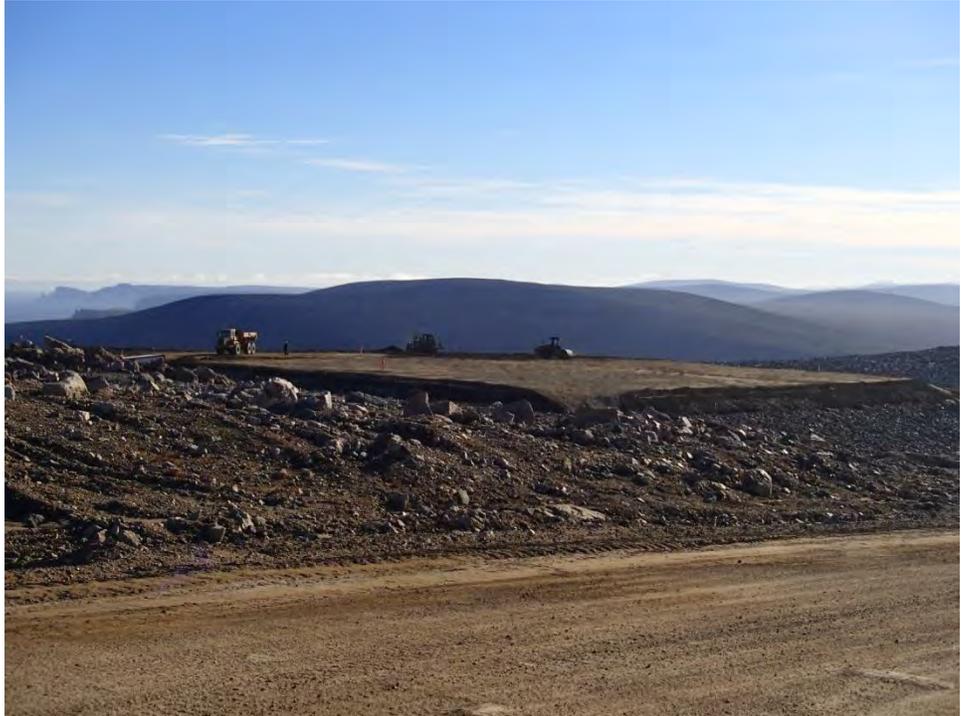
Photo No.
19

Upper Site Tier II DF –
Construction of Type 2
Granular Cover Layer.

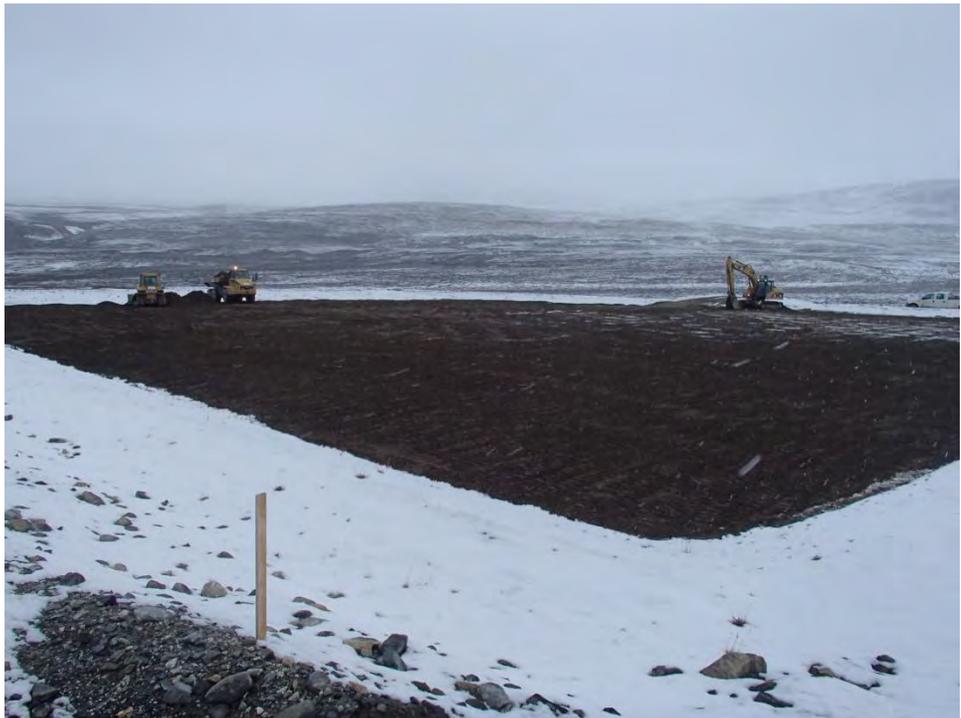
Photo No.
20

Lower Site Tier II DF –
Placement of Winter
Cover Layer on Cell 2.
