**Project No: NIRB No.: 04DN001**

**Regarding: DYE-M, Cape Dyer DEW Line Site**

**DYE-M DEW Line Clean Up Project**  
**Cape Dyer, Nunavut**

WATER USE INSPECTION REPORT

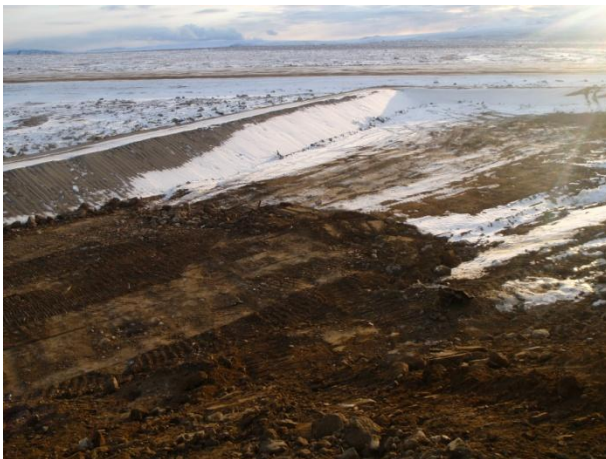
**Photograph 3 ↑**  
Lower Site Non-Hazardous Waste Landfill

**Lower Site Non-Hazardous Waste Landfill:** Construction of the berms for the expansion were completed.

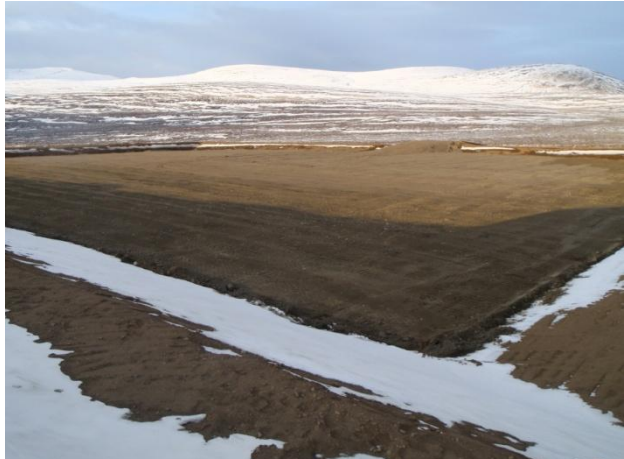
**Photograph 4 ↑**  
Lower Site Tier II Facility

**Lower Site Tier II Disposal Facility:** Completed construction of the second cell. The first cell was closed at the end of the season, including placement of the geomembrane and final shaping.
