March 12, 2012

**Project No: NIRB No.: 04DN001 2011 Annual Report**

**Regarding: DYE-M, Cape Dyer DEW Line Site**

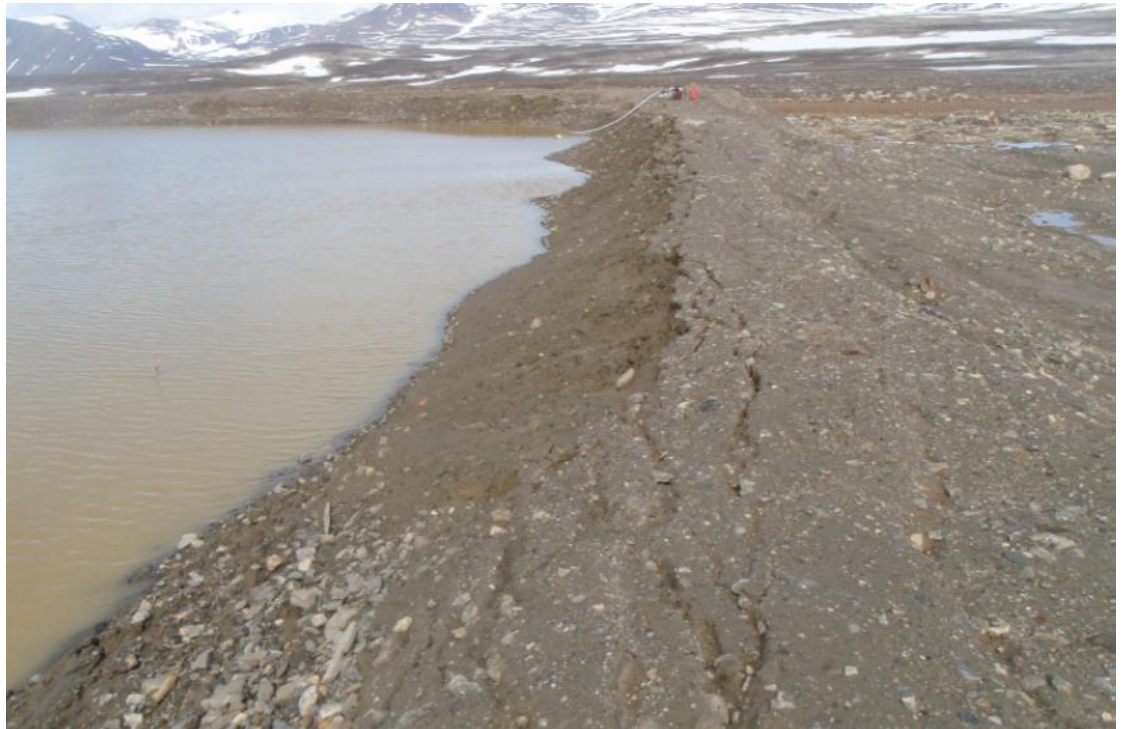
**Photo No.**  
1

Landfarm at the start of  
the season.

- The two Atwell Dormitories, two small billboards, the Abandoned Powerhouse, the Power and Equipment Building, and the Switch House were demolished.
- Activities at the landfarm consisted of landfarming the hydrocarbon-contaminated soils and repairs to the berm.
  - Landfarming included weekly tilling of the soils and collection of samples for moisture content determination. No moisture conditioning was required in 2011.
  - The berm repairs were completed in the middle of August. The work included the placement of additional Type 3 granular material in the sloughed section. Type 3 granular fill was added to the buttress top along an approximately 50 m stretch outside of the east berm and compacted with a steel drum compactor. A total length of 200 m was scarified along the top horizontal surface and re-compacted with a steel drum compactor to fill in the cracks.

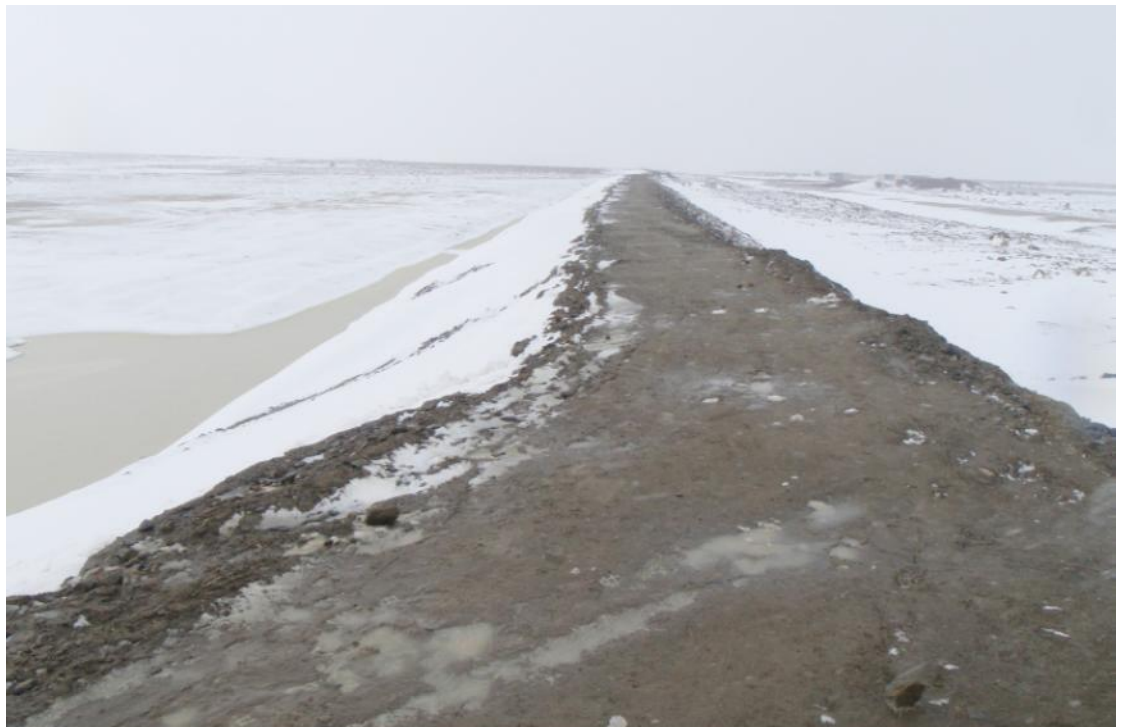
**Photo No.**  
2

Landfarm at the end of the  
season

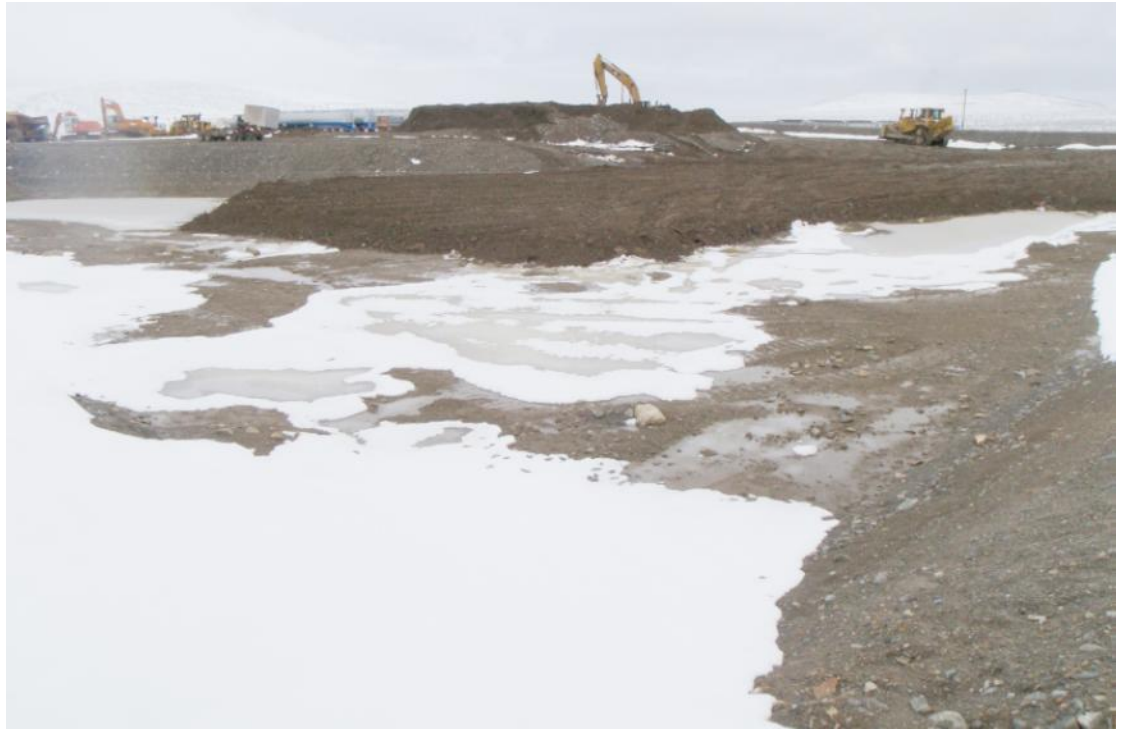
**Photo No.**  
3

- Activities at the Lower Site Non-Hazardous Waste Landfill (NHWL) consisted of placing debris and soil in the landfill cell and minor ditching outside the landfill. No work was carried out on the capped cell of the landfill.

- Landfilling was carried out in early to mid-September. Only one lift was placed in the cell, which was covered with intermediate fill for the winter.

- The debris contained galbestos from the Abandoned Powerhouse demolition and other demolition debris from the Atwell Dormitories.
  - Once the debris was placed it was covered with intermediate fill.

Lower Site Non-Hazardous Waste Landfill at the end of the construction season.

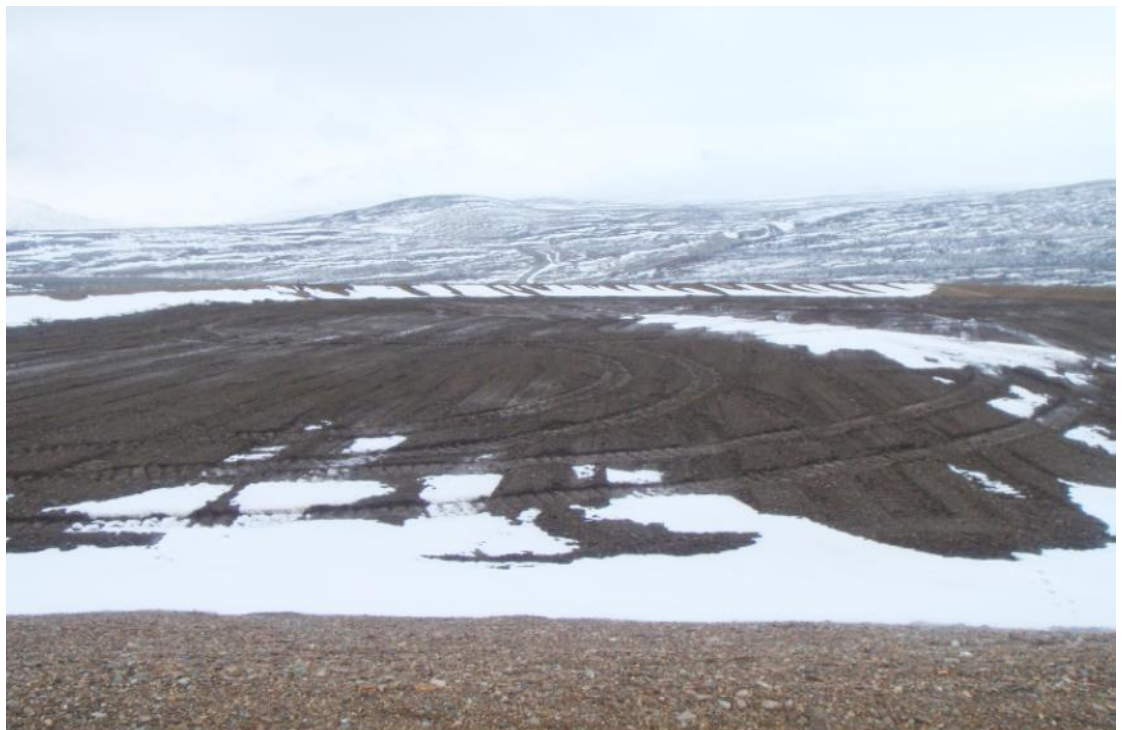
**Photo No.**  
4

- Activities at the Lower Site Tier II Disposal Facility consisted of placing small amounts of Tier II soil in the landfill. No work was carried out on the closed cell of the facility.

- Only one lift was placed in the facility. This lift was capped for the winter as the season's end.
- Activities at the Upper Site NHWL consisted of removed ponded water and landfilling with debris and intermediate fill soils.

Lower Site Tier II Disposal Facility at the end of the construction season.

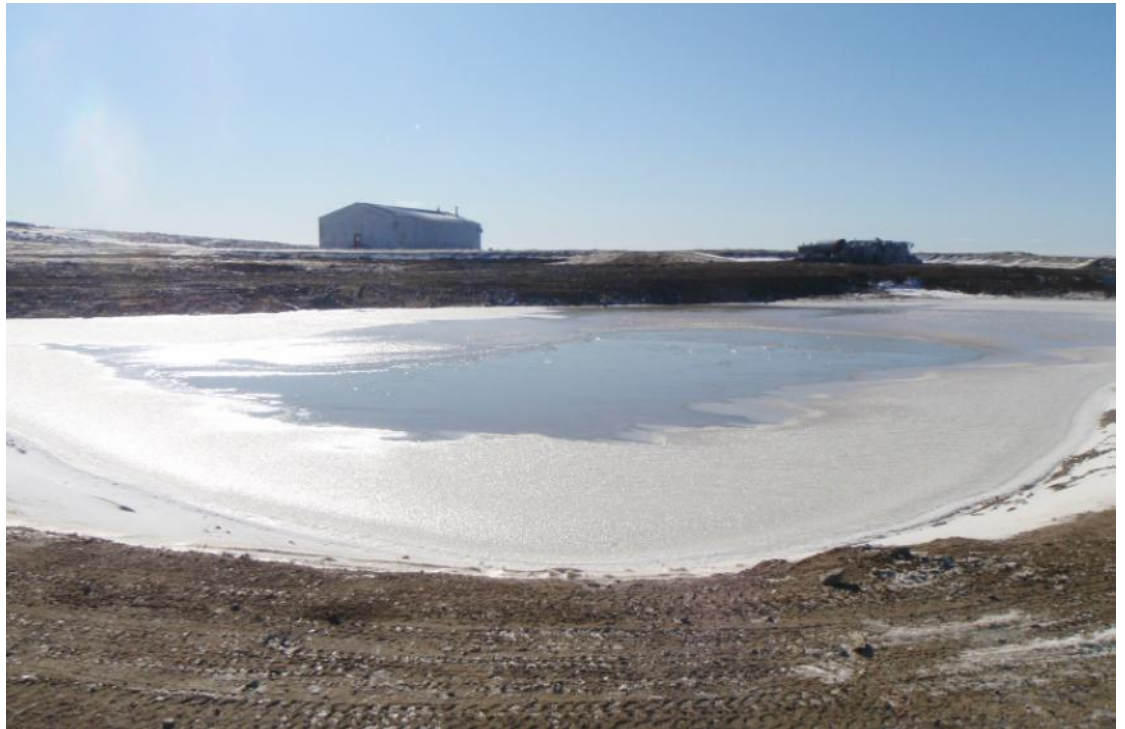
**Photo No.**  
5

- Snowmelt and precipitation water were present in the landfill at the start of the season. This water did not meet the discharge criteria set out in the water use license and was treated. Treatment occurred from July 30 to August 13, at which time it was tested and found to meet the discharge criteria. This water was then discharged. Heavy precipitation on Aug. 24-25 filled the landfill up again. This water was not discharged at the end of the season as it did not meet the criteria.

- The debris originated from demolition activities at the Upper Site including demolition of the Power and Equipment building at the DEW Drop, Abandoned Powerhouse and the small billboards.

**Description:**  
Upper Site Non-  
Hazardous Waste Landfill  
at the end of the  
construction season.

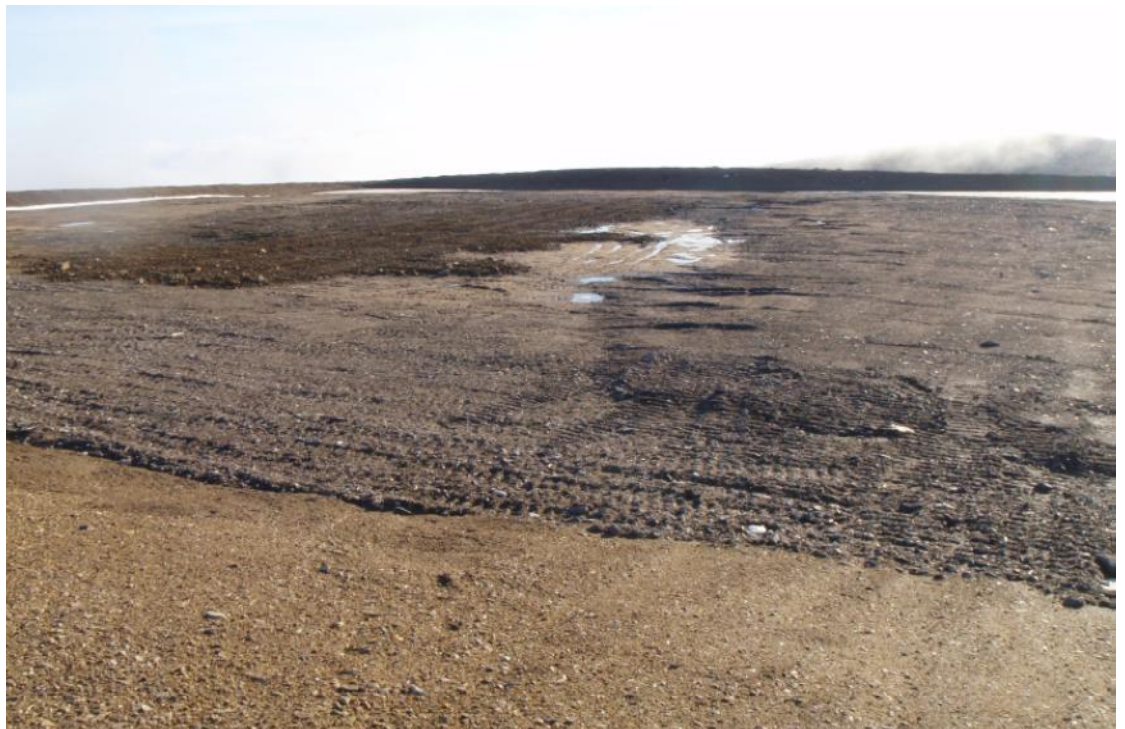
**Photo No.**  
6

- The debris was covered with intermediate fill at the end of the season.
- Activities at the Upper Site Tier II Disposal Facility consisted of dewatering the facility and placement of a small amount of Tier II soil.

- Snowmelt and precipitation water present in the landfill at the start of the season met discharge criteria and was discharged.
  - Tier II soils were placed near the centre of the facility.

**Description:**  
Upper Site Tier II  
Disposal Facility at the  
end of the construction  
season.

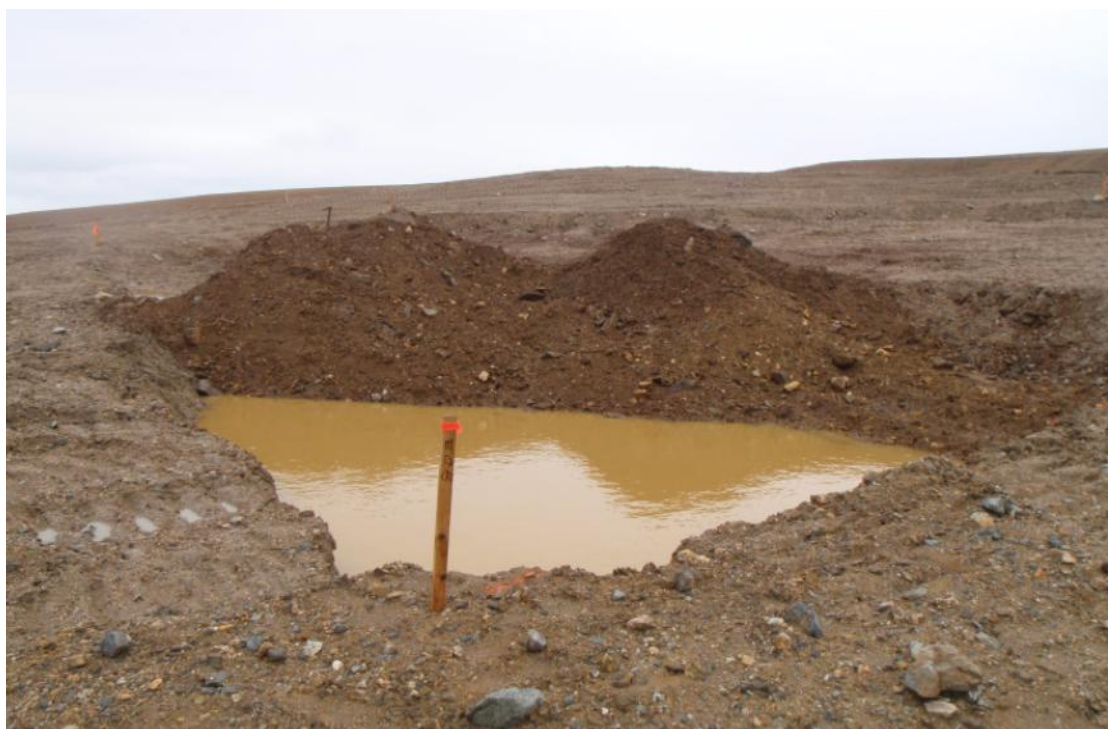
**Photo No.**  
7

Excavated area at the  
West Landfill prior to  
backfilling.

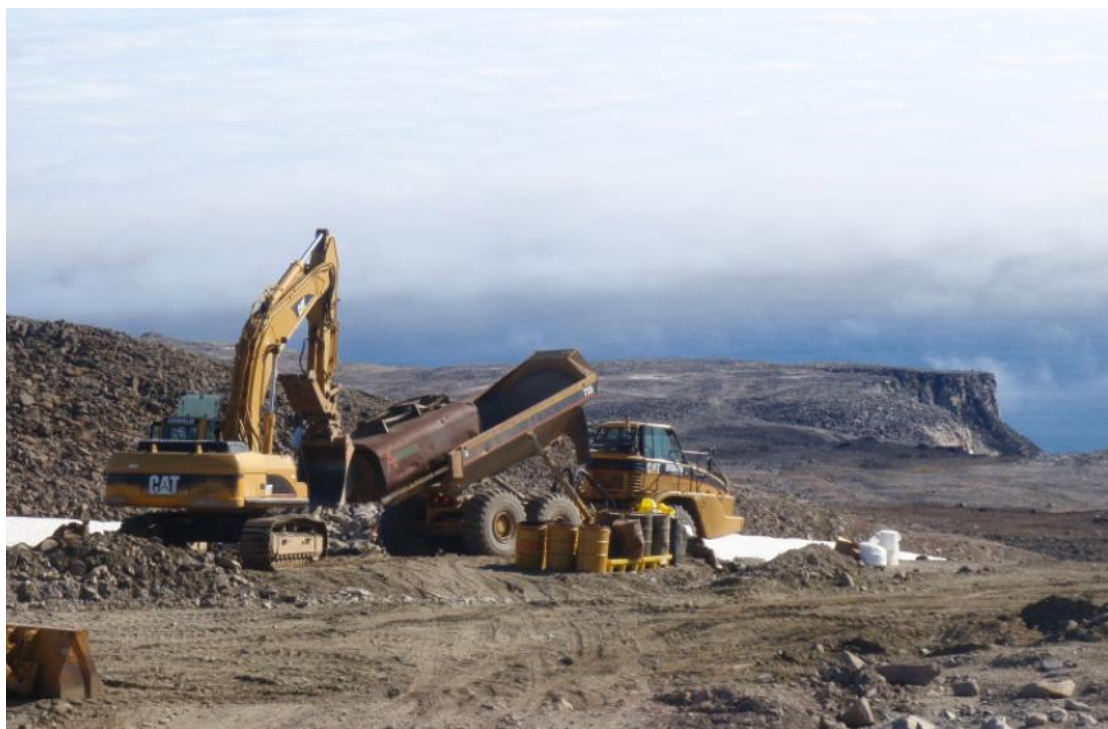
**Photo No.**  
8

Removal of large tanks at  
the Buried Debris  
Excavation (South Landfill  
Area).
