**Project No: NIRB No.: 04DN001 2013 Annual Report**

**Regarding: DYE-M, Cape Dyer DEW Line Site**

AECOM Canada Ltd. is providing the following information as per the requirements listed for the annual report. The information is being provided on behalf of Defence Construction Canada and the Department of National Defence.

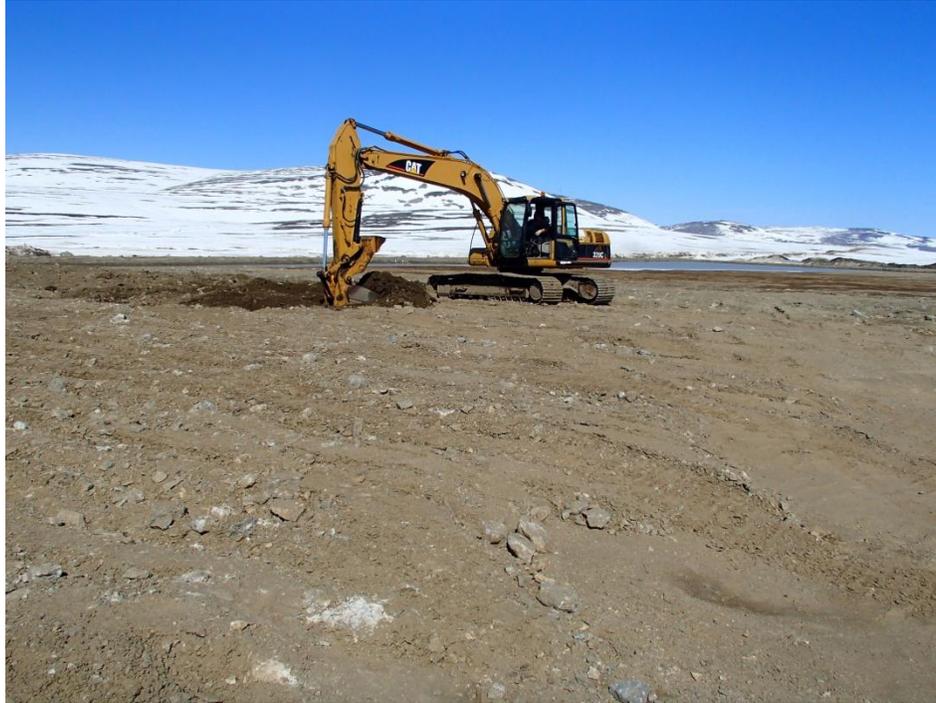
**Photograph 1. Landfarm – Turning Treatment Soil. June 17, 2013 (West)↑**

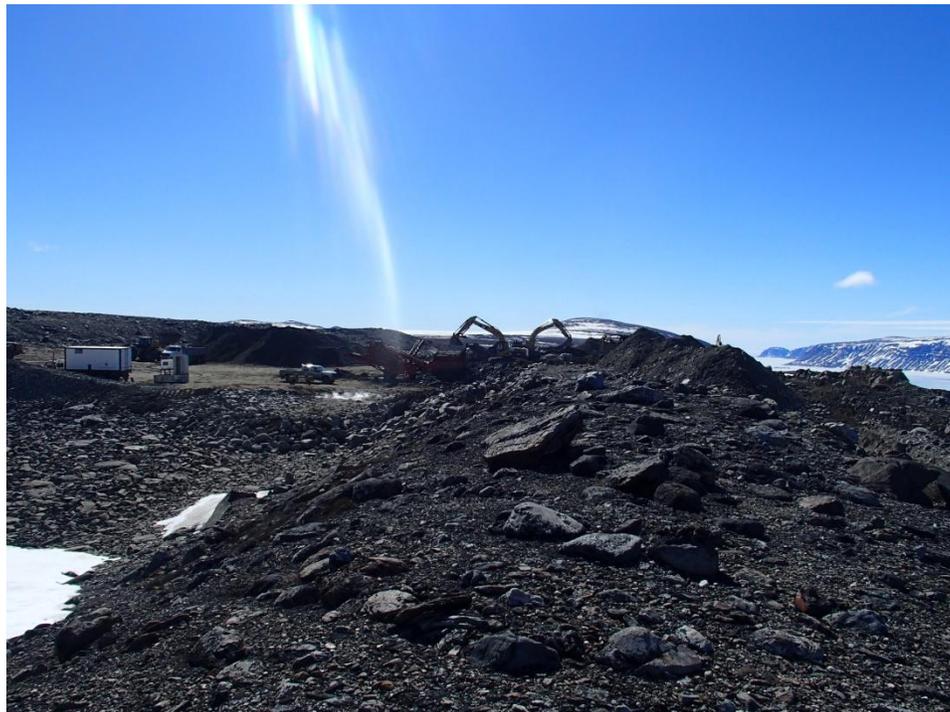
**Photograph 2. Borrow Area #4 – Type 5 and Type 2 Granular Production. June 22, 2013 (South)↑**

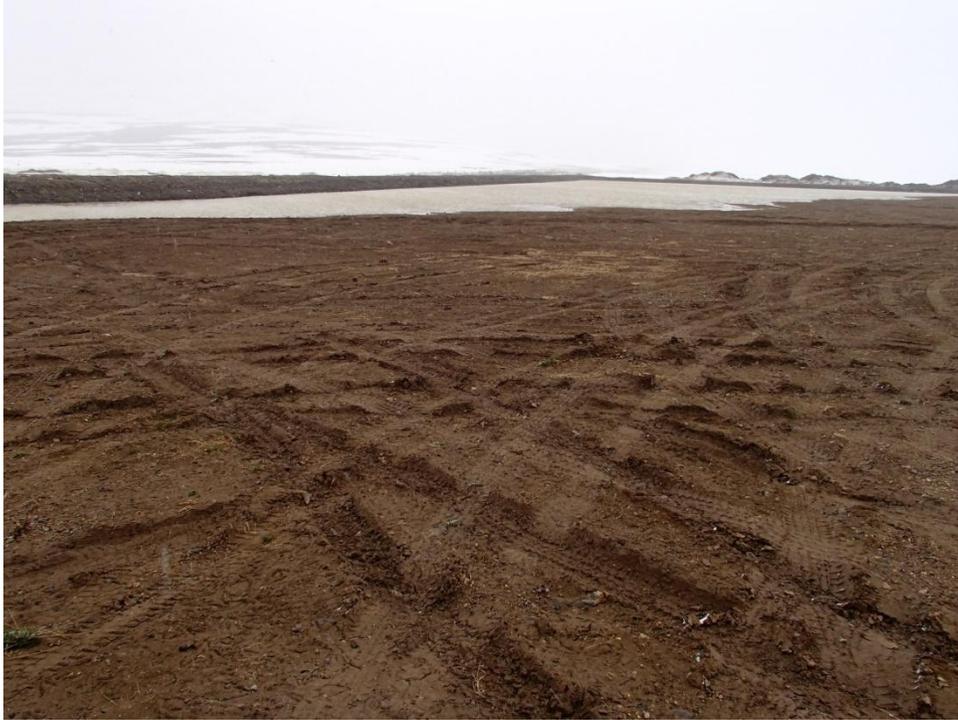
**Photograph 3. Landfarm – Spring Meltwater. June 23, 2013 (North)↑**

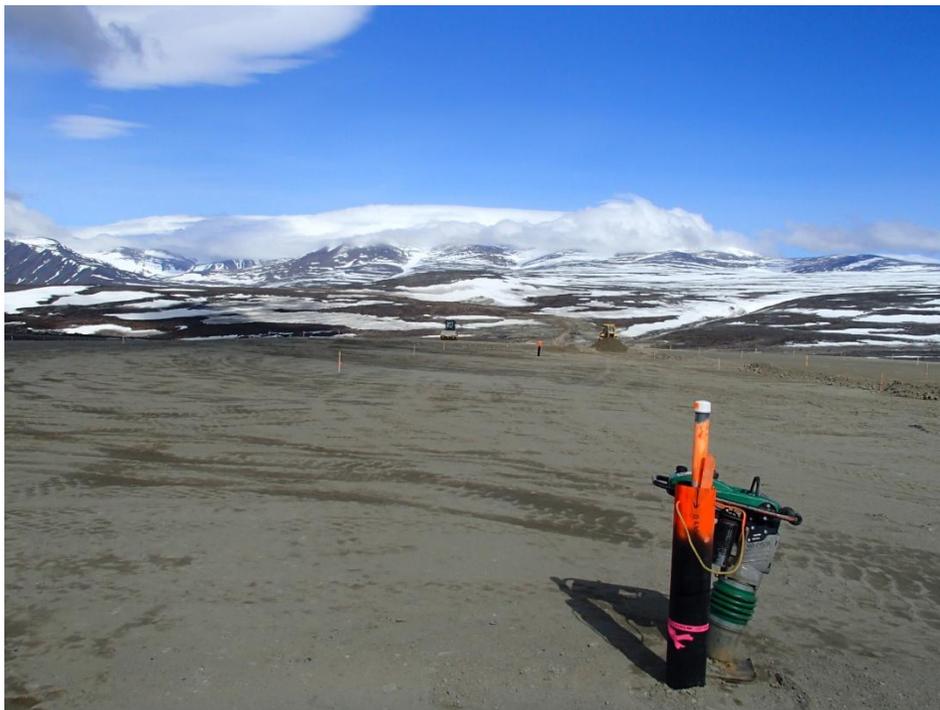
**Photograph 4. LS Tier II DF – Type 2 Granular Fill Placement (Cell #1). June 24, 2013 (North)↑**

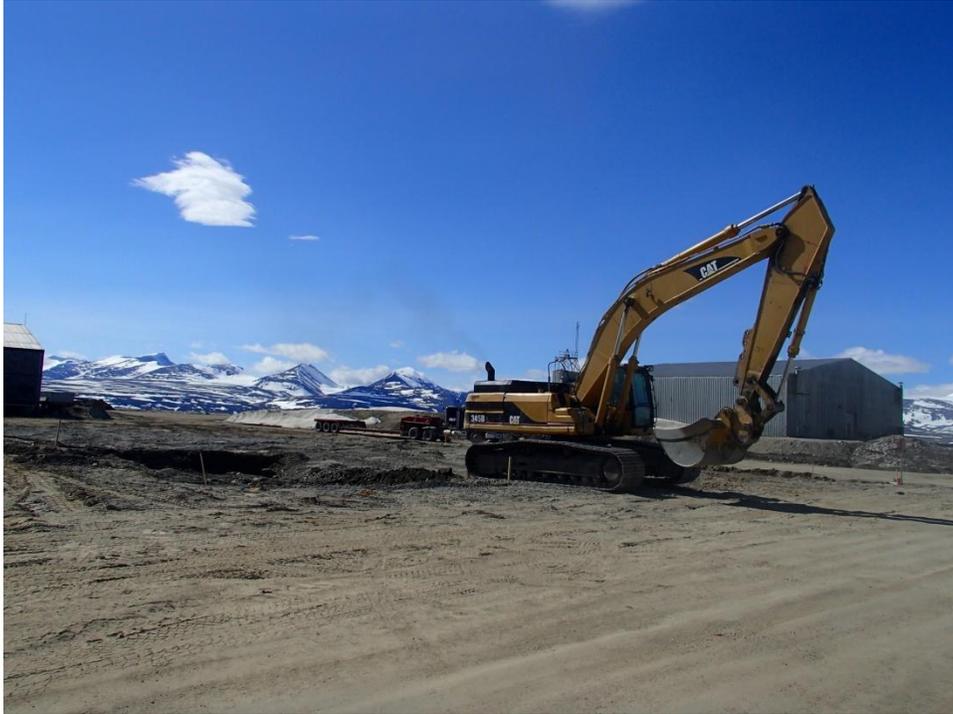
**Photograph 5. Lower Site – Contaminated Soil Excavation. June 25, 2013 (West)↑**

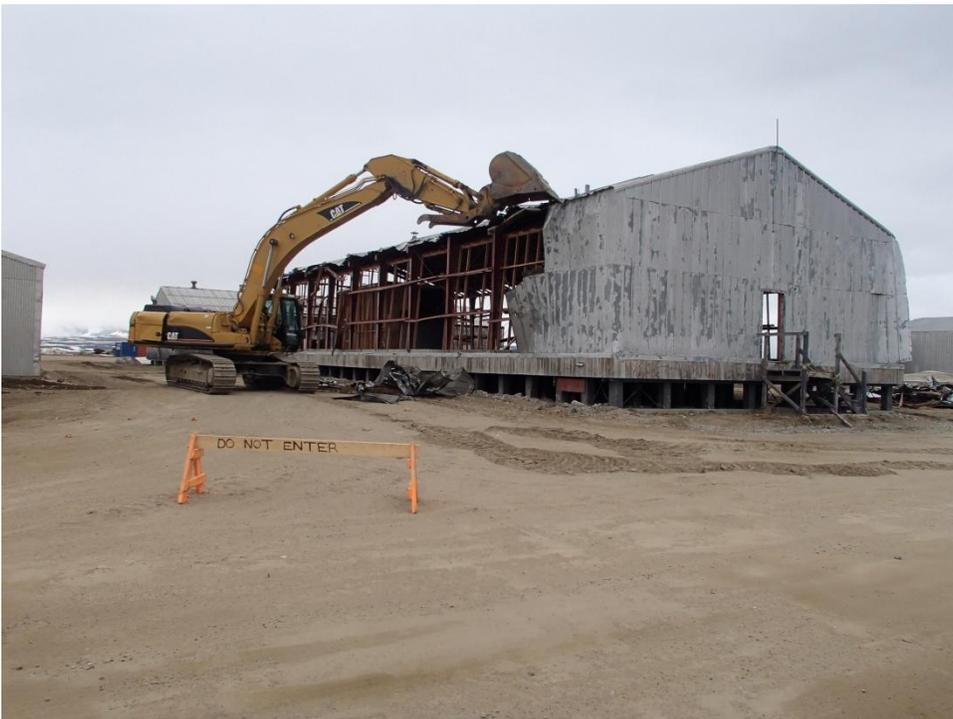
**Photograph 6. Lower Site – Warehouse B13A Demolition. June 27, 2012 (West)↑**

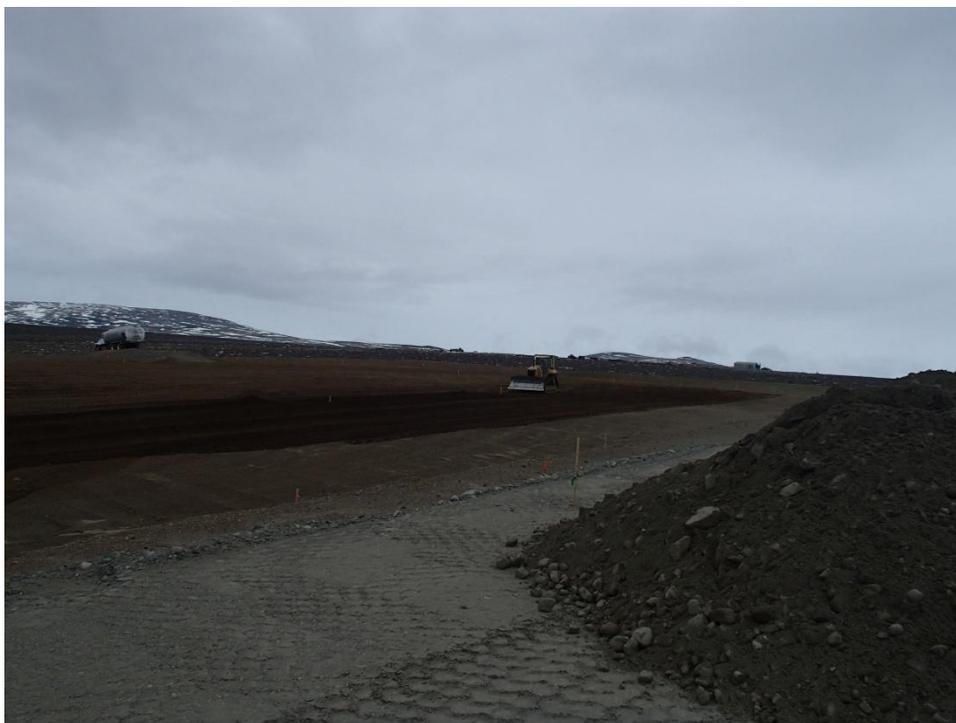
**Photograph 7. LS Tier II DF – Grading Tier II Soils (Cell #2). June 27, 2013 (East)↑**

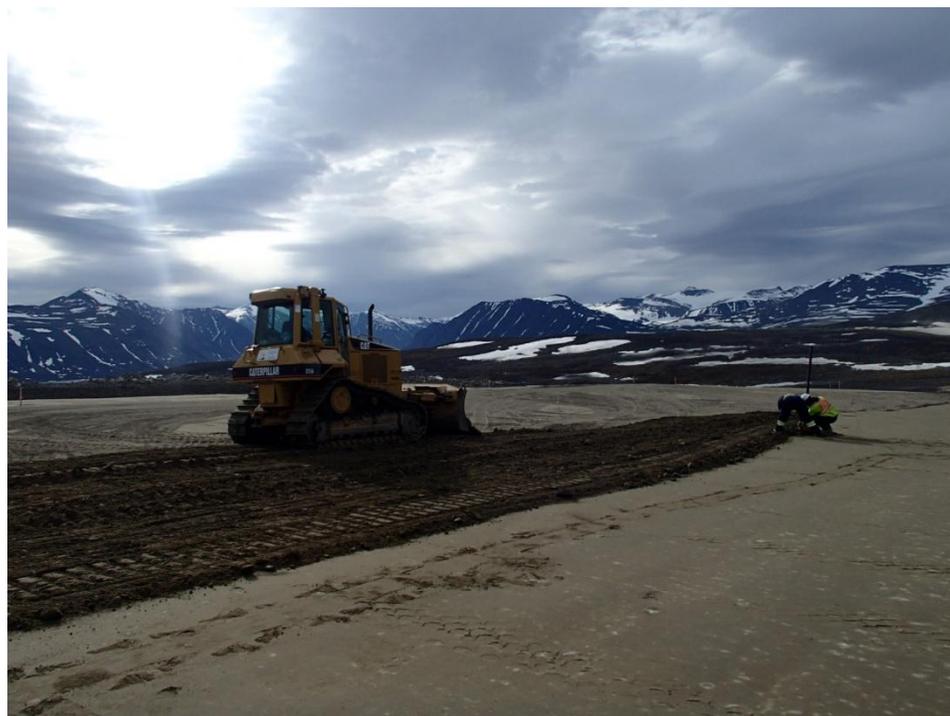
**Photograph 8. LS Tier II DF – Placing Type 2 Granular Fill (Cell #1). July 6, 2013 (West)↑**

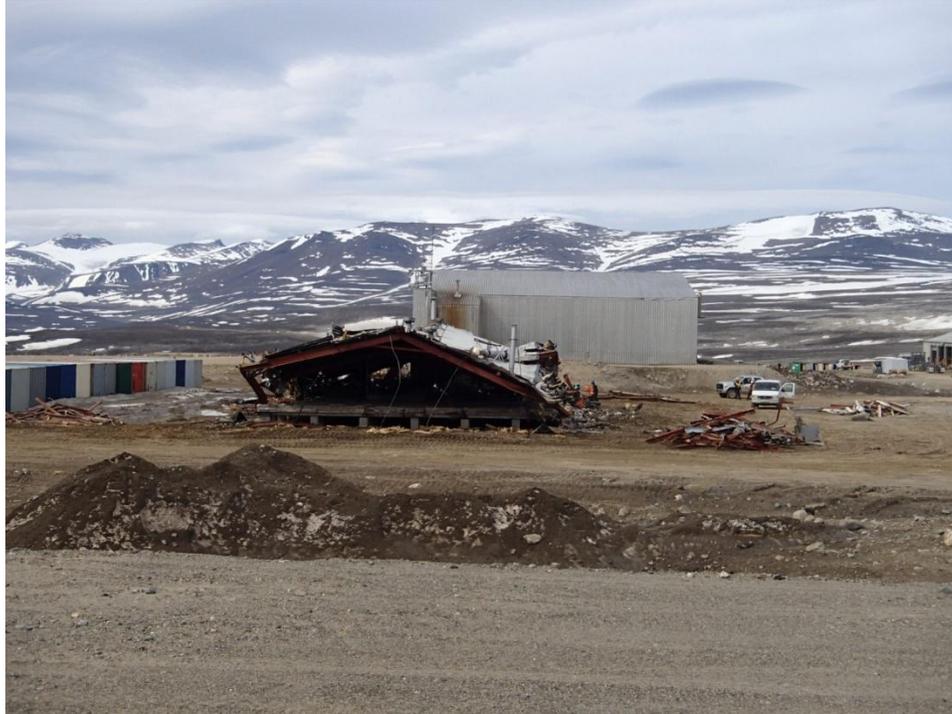
**Photograph 9. Lower Site – Air Terminal Building Demolition. July 11, 2013 (North West)↑**

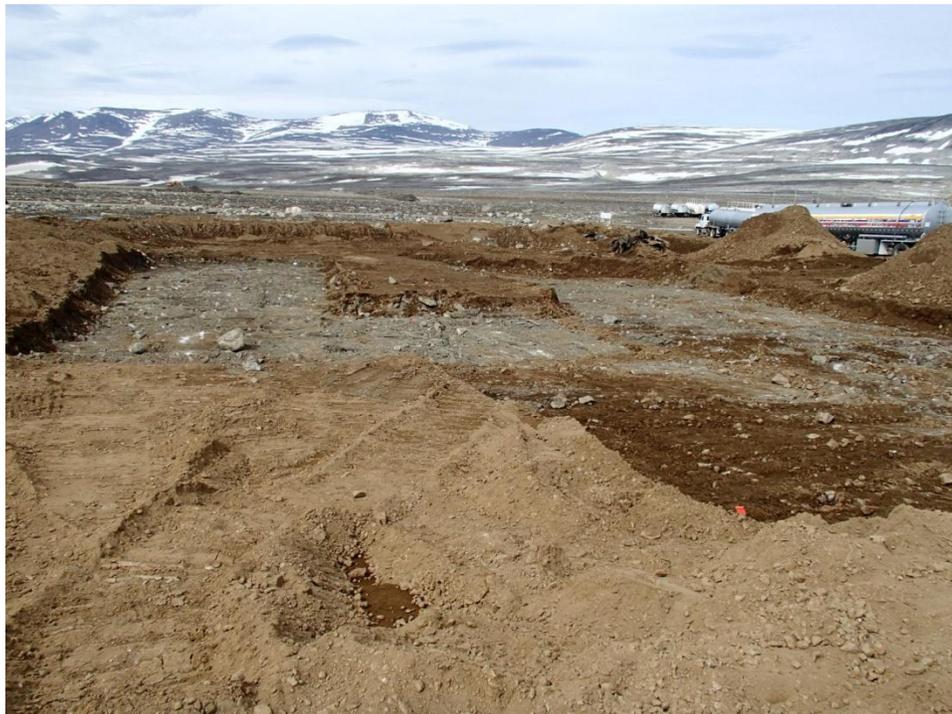
**Photograph 10. Lower Site - POL Storage area – Contaminated Soil Excavation (below liner). July 11, 2013 (East)↑**

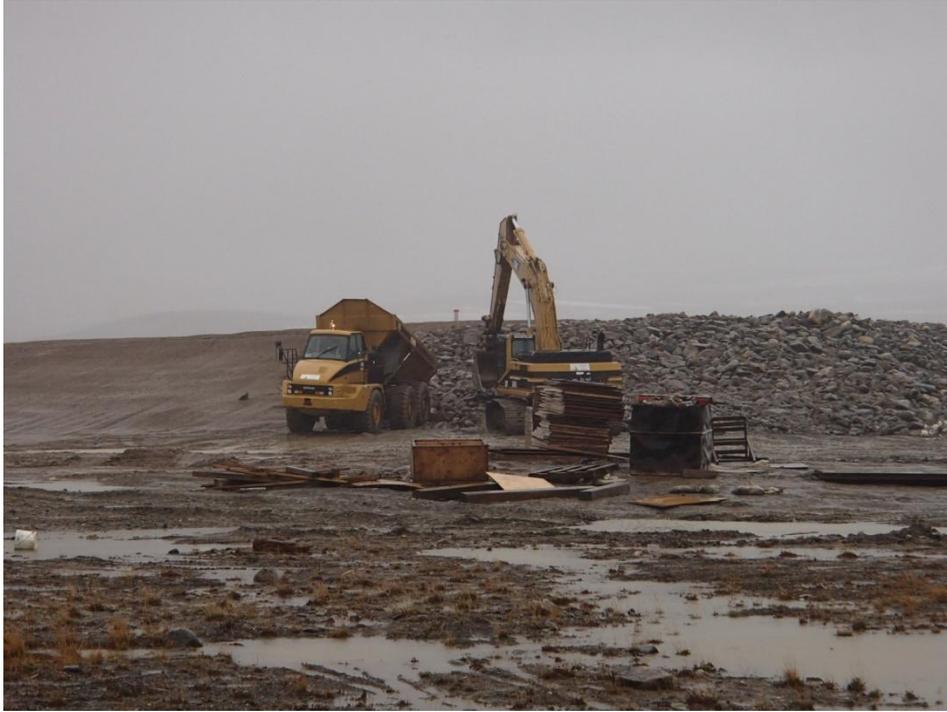
Photograph 11. LS Powerhouse Landfill – Type 1 Granular Fill Placement. July 12, 2013 (North East)↑

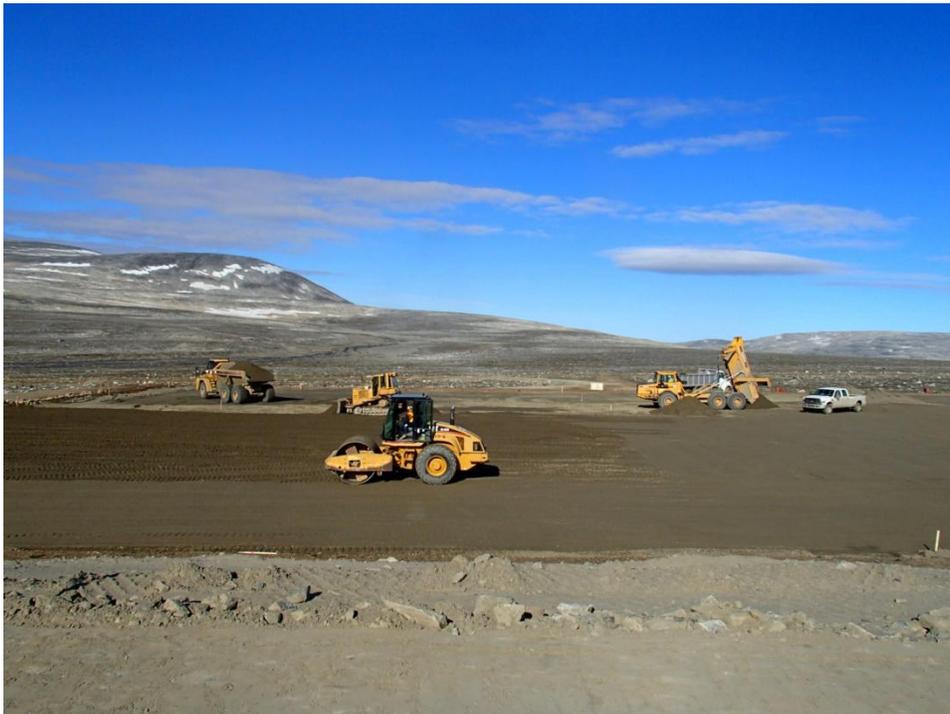
Photograph 12. LS Tier II DF – Placing Type 5 Granular Fill (Cell #2). July 15, 2013 (North East) ↑

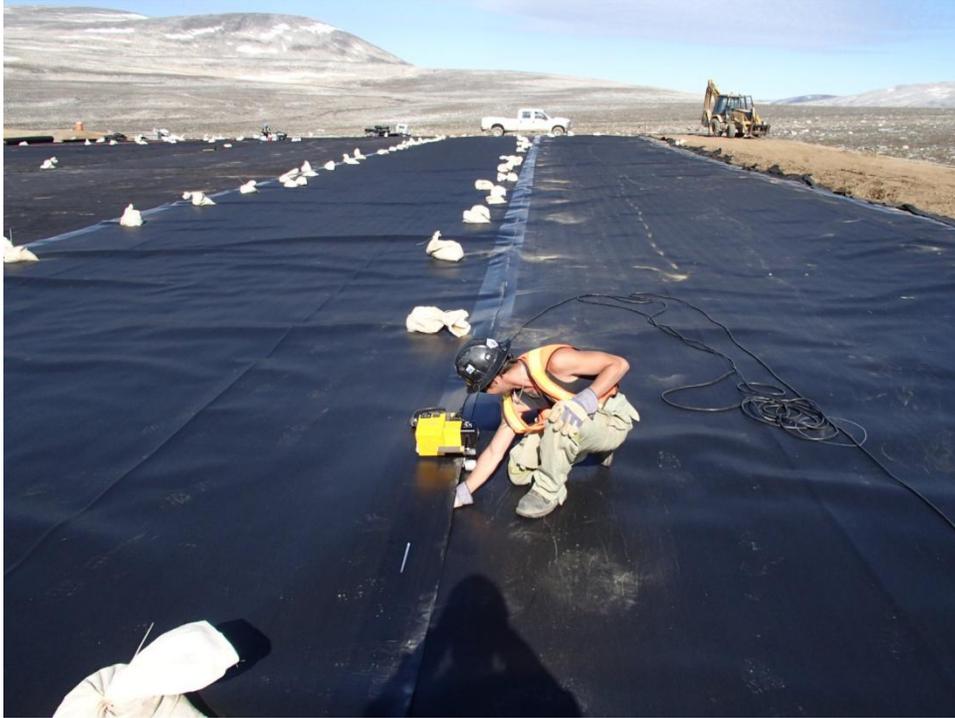
**Photograph 13. LS Tier II DF – Geomembrane Installation (Cell #2). July 17, 2013 (North East) ↑**

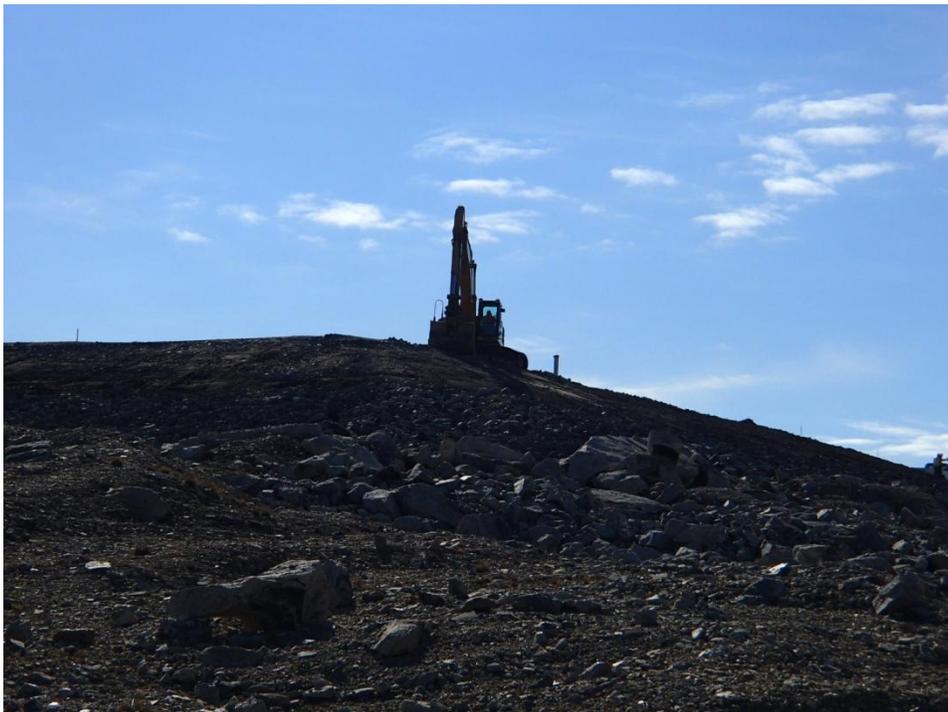
**Photograph 14. US Tier II DF – Reshaping Side Slopes. July 19, 2013 (South) ↑**

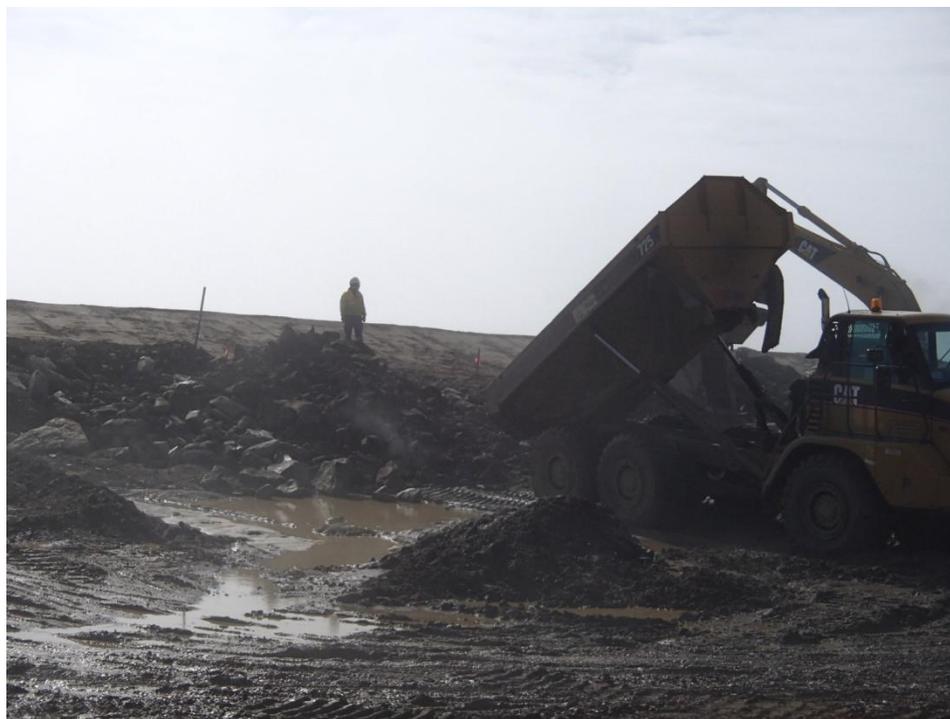
**Photograph 15. US Tier II DF – Type 1 Granular Fill Placement. July 21, 2013 (North)↑**

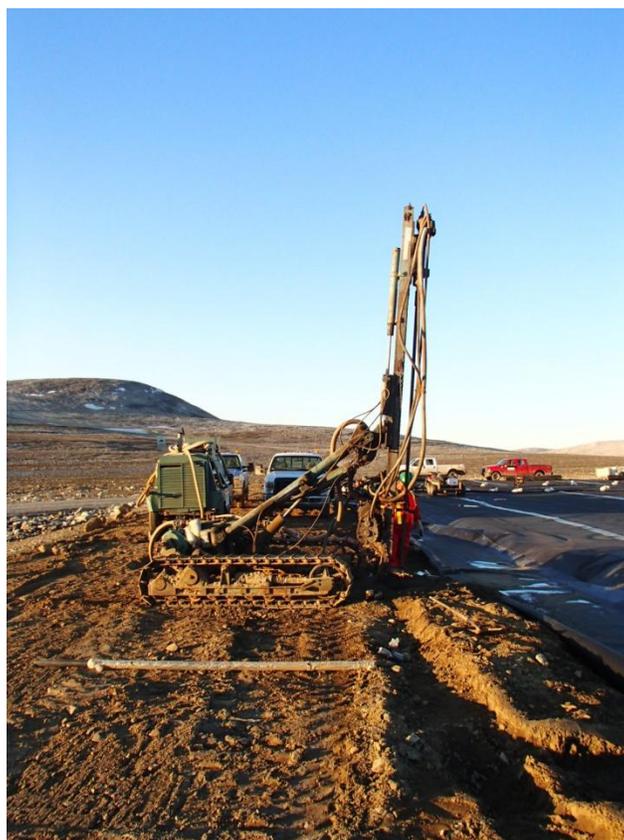
**Photograph 16. LS Tier II DF – Drilling Thermistor VT-1. July 22, 2013 (North East)↑**

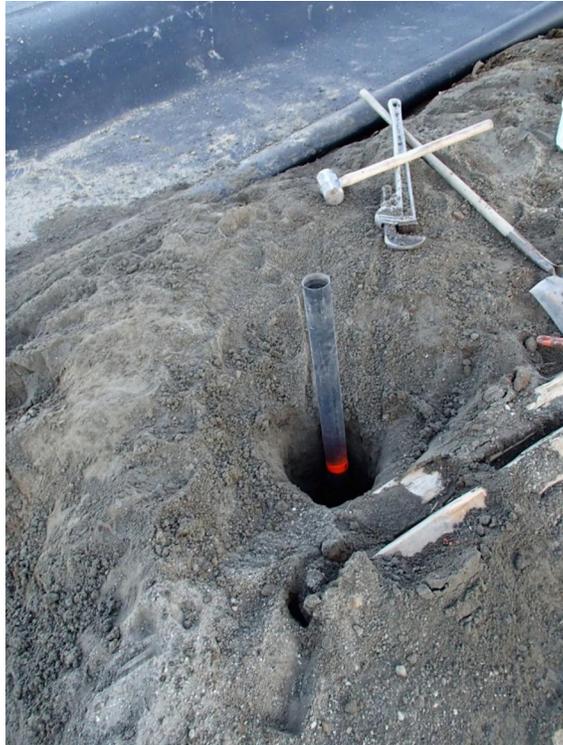
**Photograph 17. LS Tier II DF – Installation of PVC Casing for VT-1. July 22, 2013 (N/A)↑**

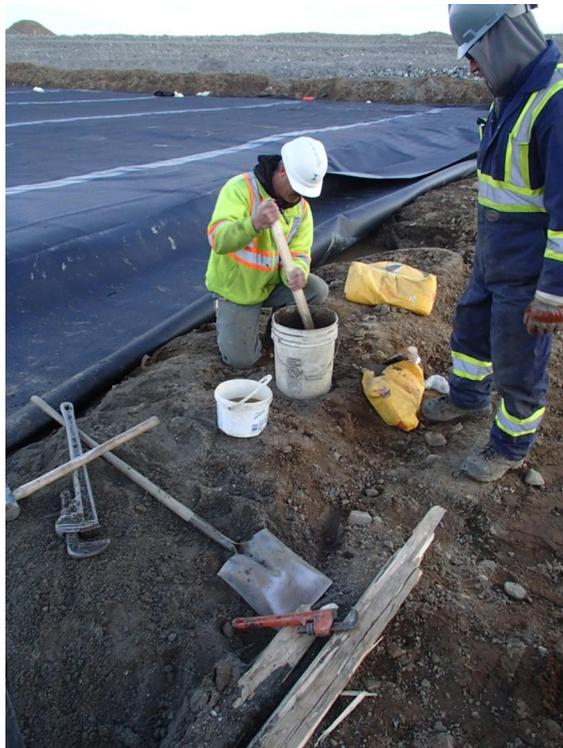
**Photograph 18. LS Tier II DF – Installation of Casing for VT-1. July 22, 2013 (N/A)↑**

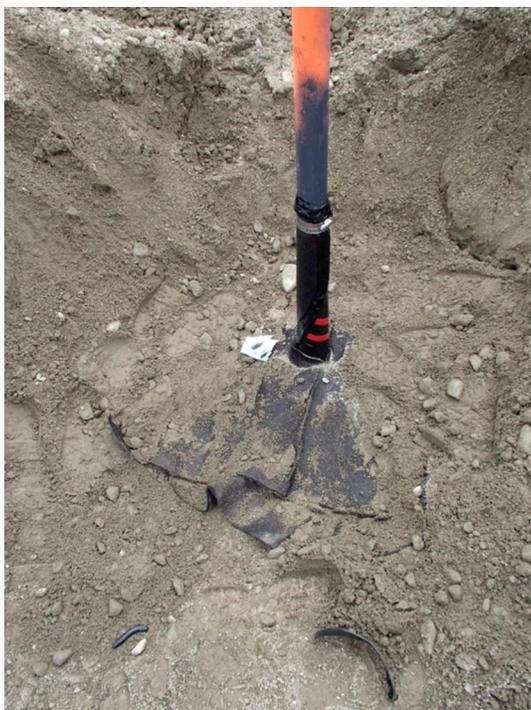
**Photograph 19. LS Tier II DF – Installation of Neoprene Boot for VT-3. July 23, 2013 (N/A)↑**

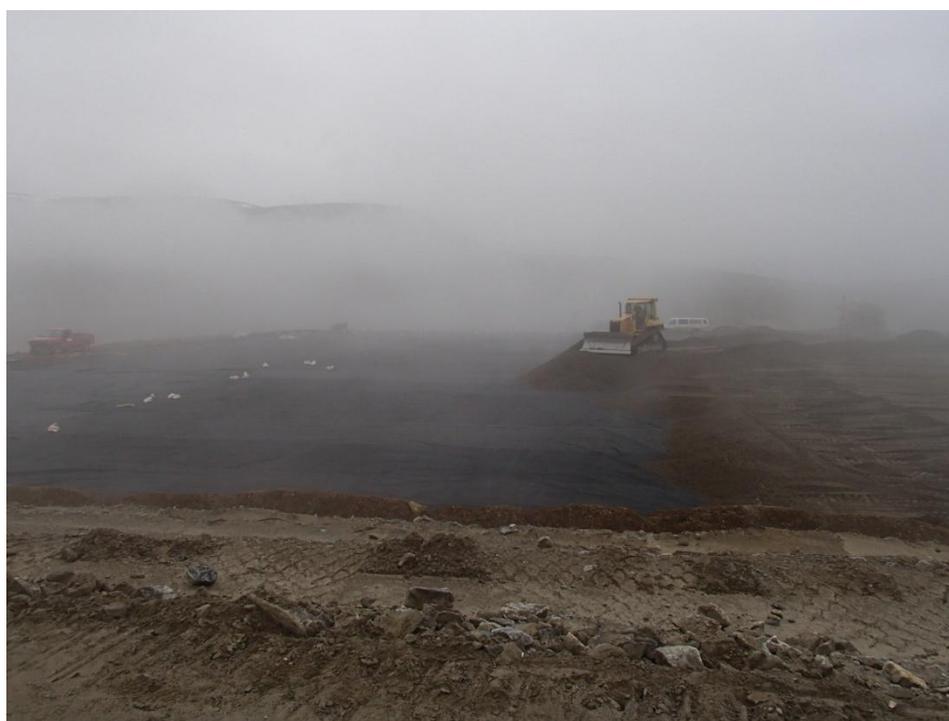
**Photograph 20. LS Tier II DF (Cell #2) – Type 5 Granular Fill Placement. July 24, 2013 (North East) ↑**

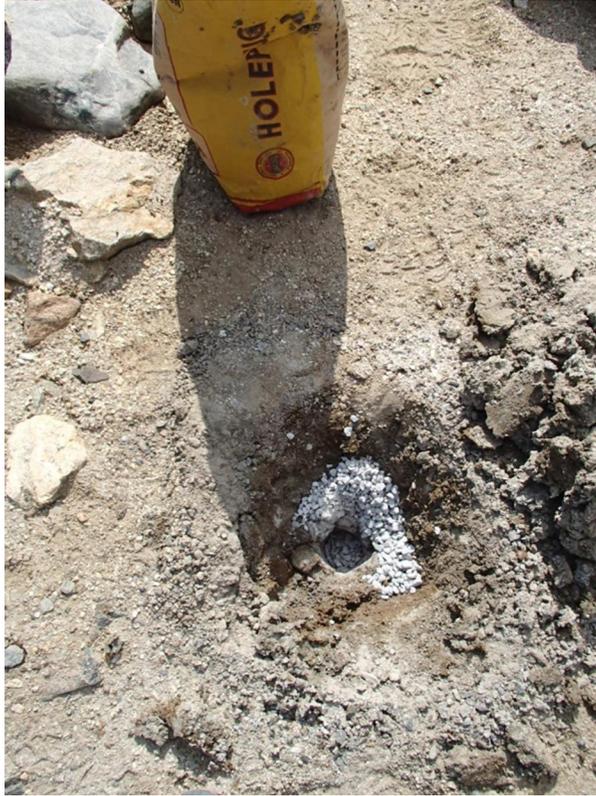
Photograph 21. US Tier II DF – Temporary Monitoring Well MW09-22A Decommissioning. July 29, 2013↑

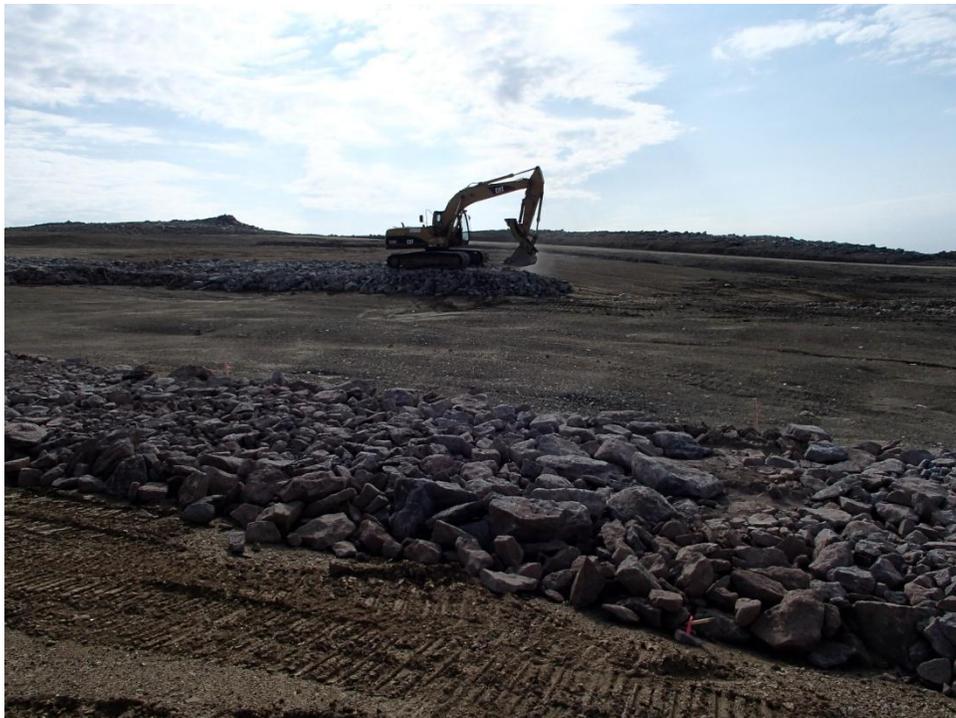
Photograph 22. US West Landfill – Type 1 Placement at West End. August 13, 2013 (South)↑

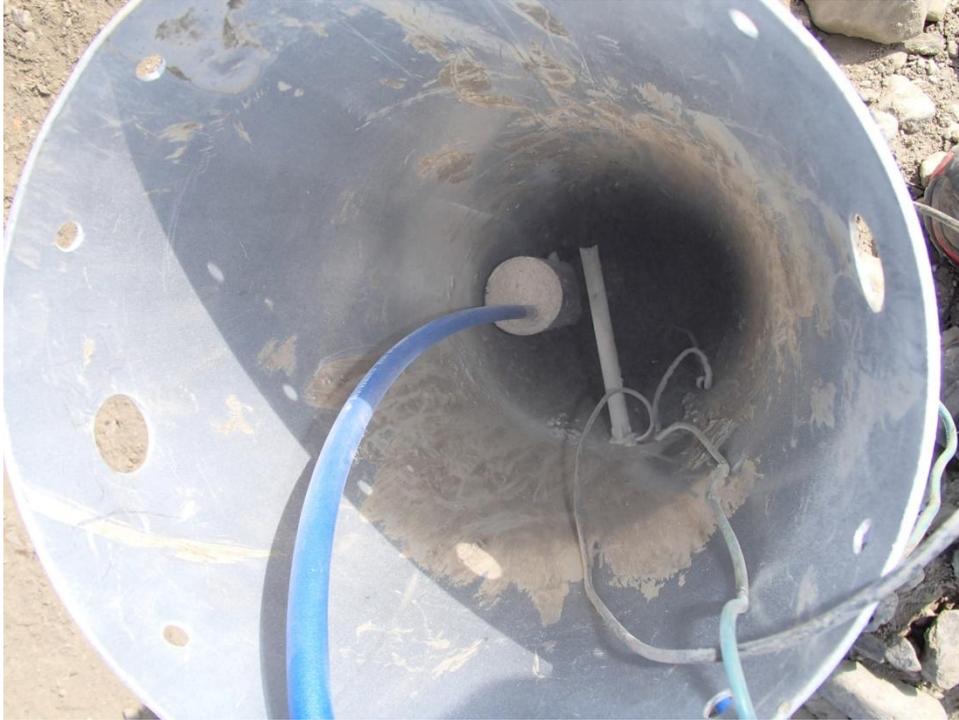
**Photograph 23. LS Tier II DF – Typical Installation of Thermistor Cable. August 14, 2013 ↑**

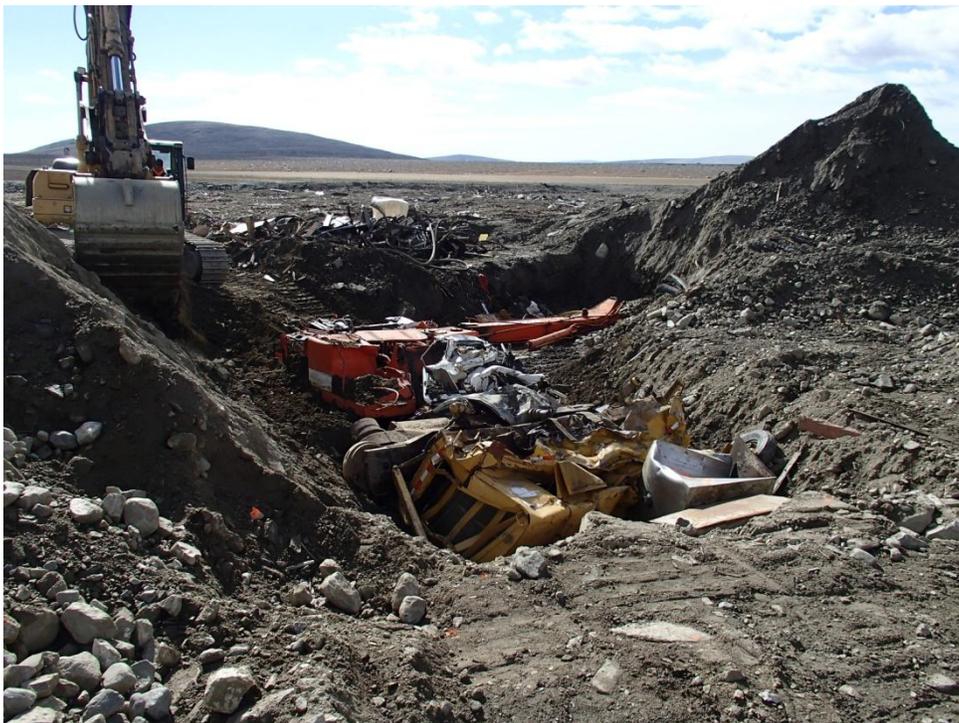
**Photograph 24. LS NHWL – Landfilling Large Equipment. August 17, 2013 (North)↑**

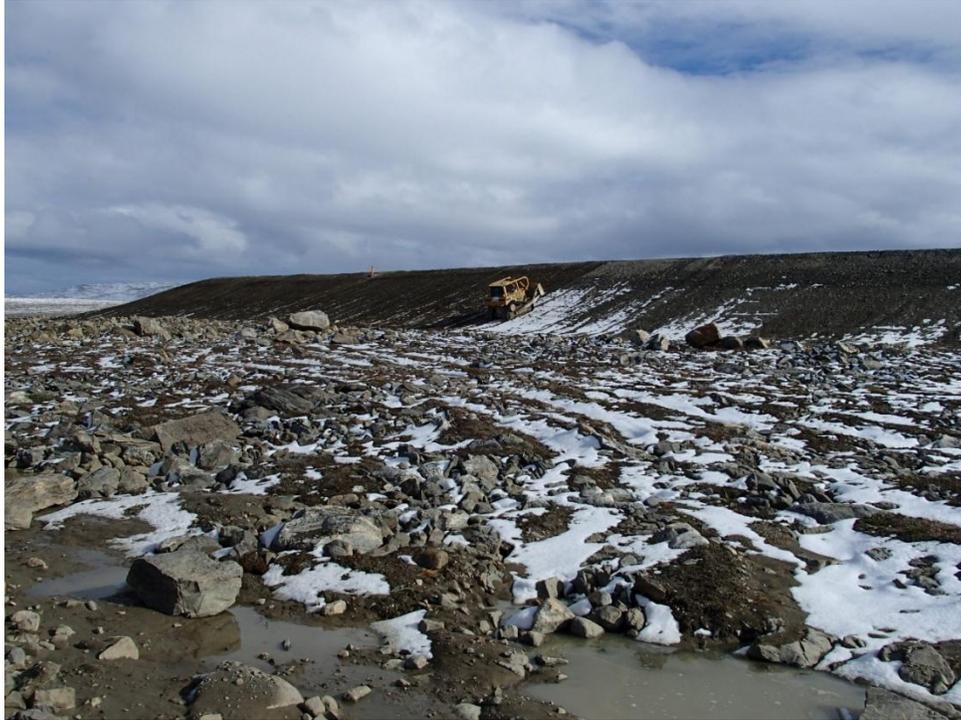
**Photograph 25. LS Tier II DF – Track Packing Side Slopes. September 1, 2013 (East) ↑**

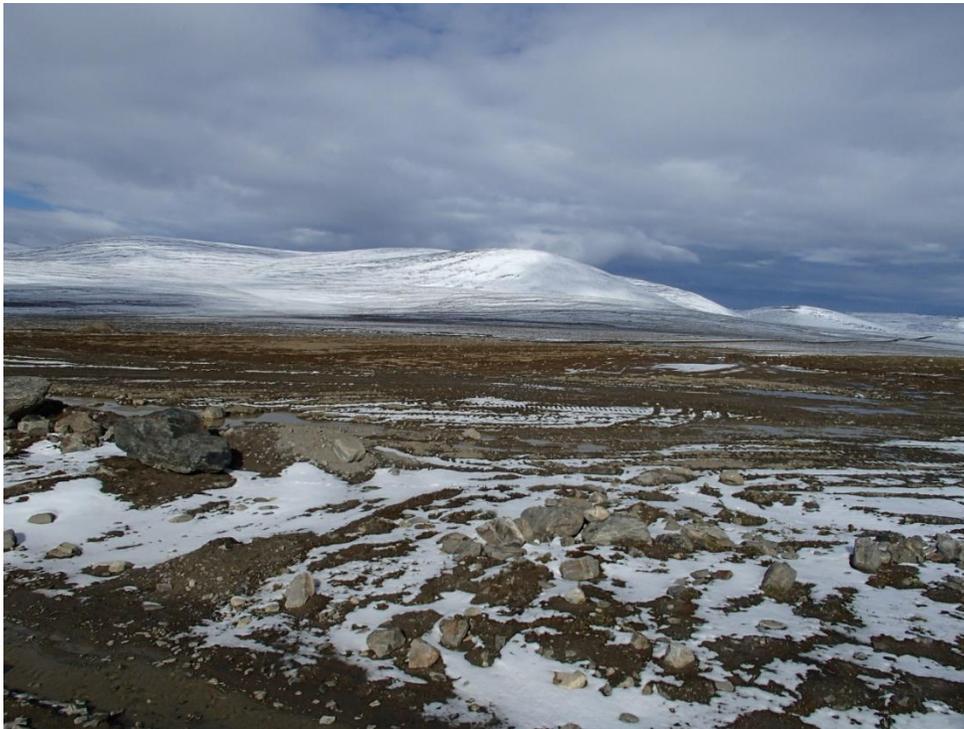
**Photograph 26. Landfarm – Closure of Facility. September 1, 2013 (North) ↑**

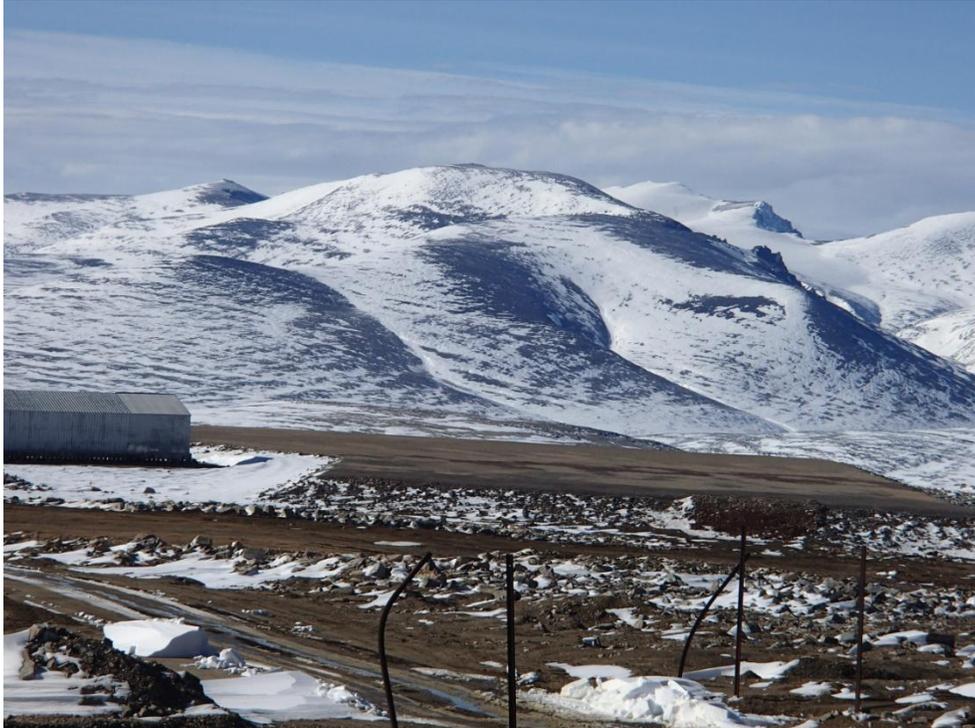
**Photograph 27. US NHWL – Completed Facility. September 2, 2013 (West) ↑**

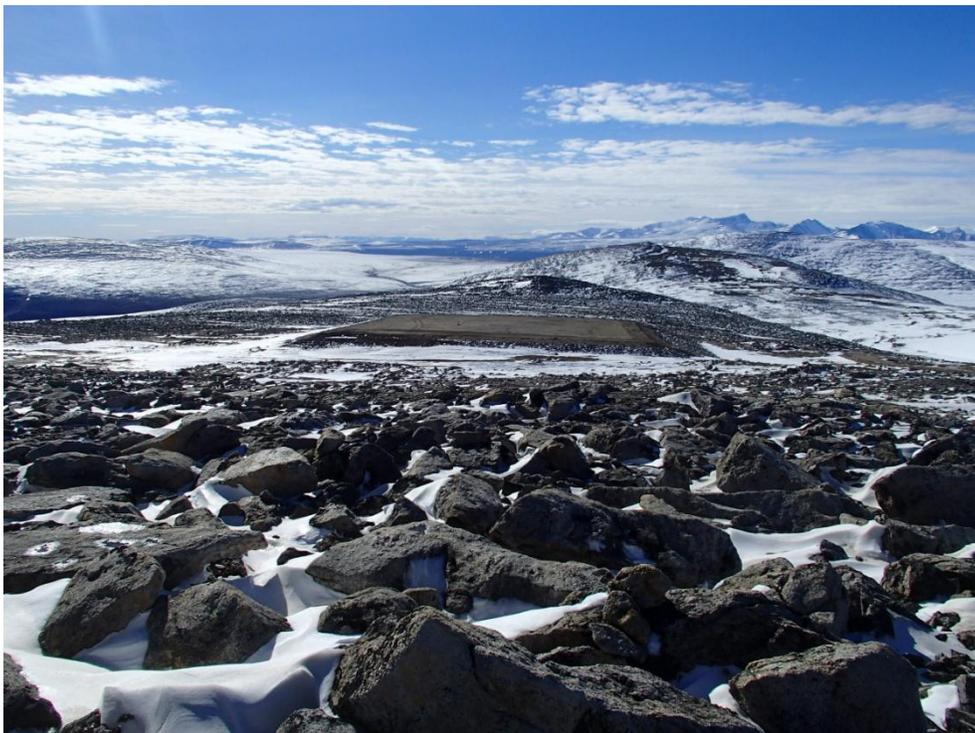
**Photograph 28. US Tier II DF – Completed Facility. September 2, 2013 (South West) ↑**

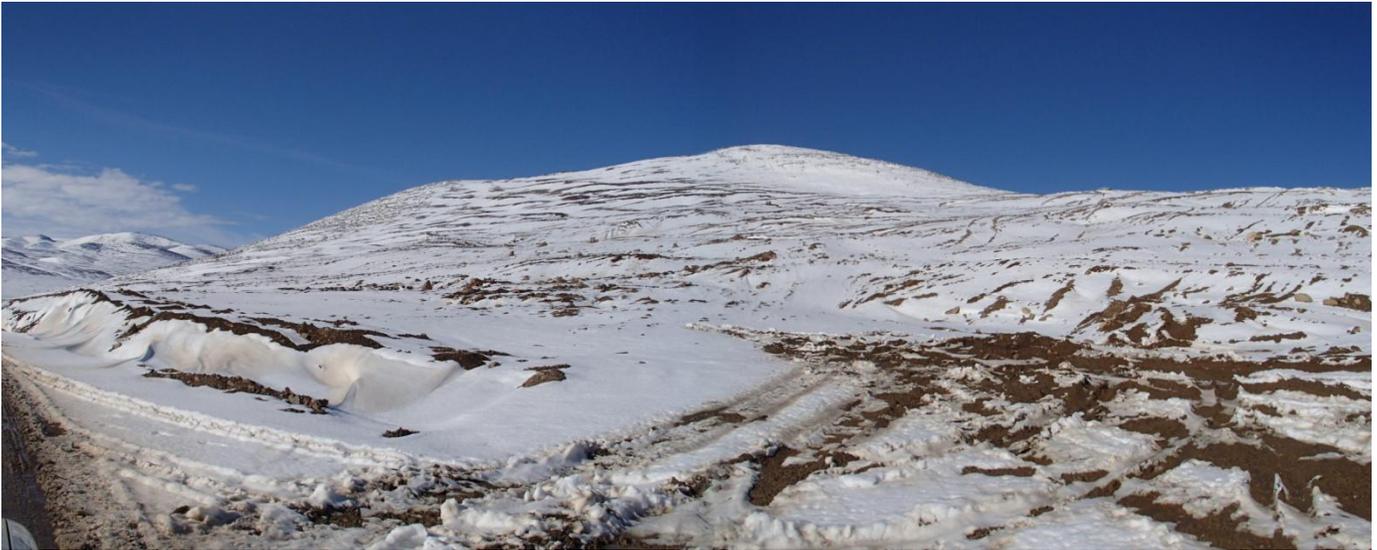
**Photograph 29. Borrow Area #3 – Borrow Area Reclamation. September 2, 2013 (North) ↑**

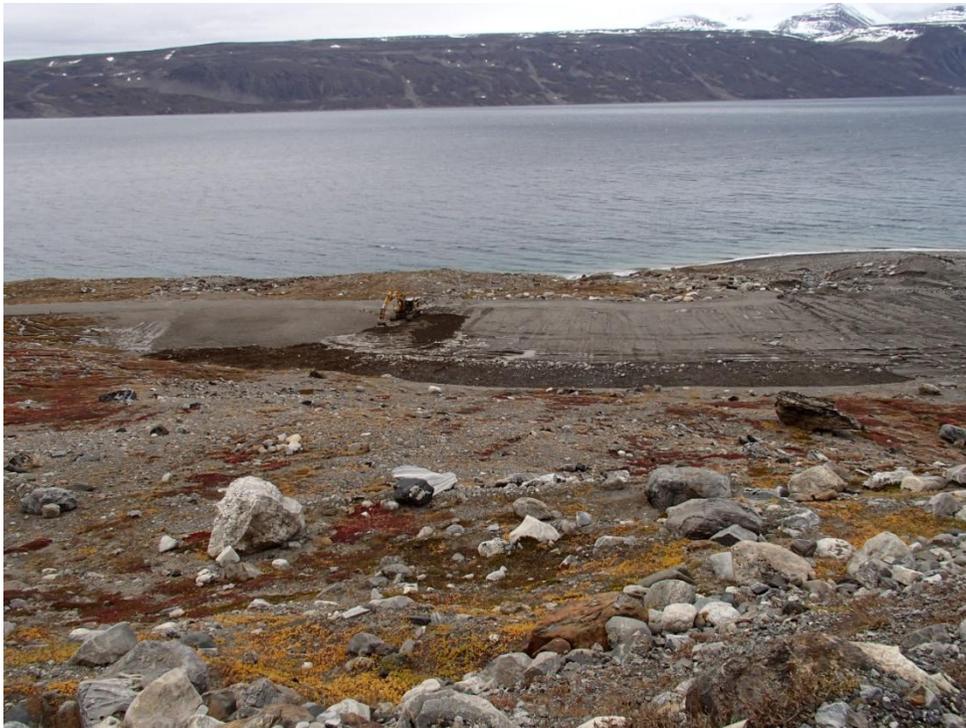
**Photograph 30. Beach Area – Reshaping To Fill Drainage Ditch. September 5, 2013 (South West) ↑**

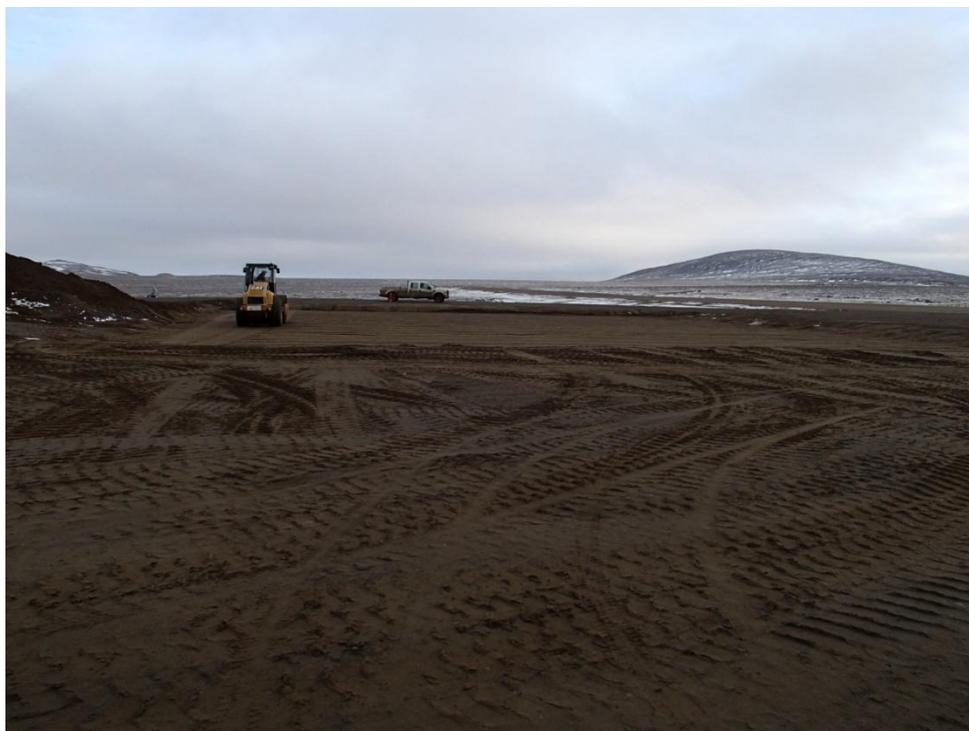
**Photograph 31. LS NHWL – Construction of Type 2 Granular Cover Layer (Cell #2). September 13, 2013 (South)↑**

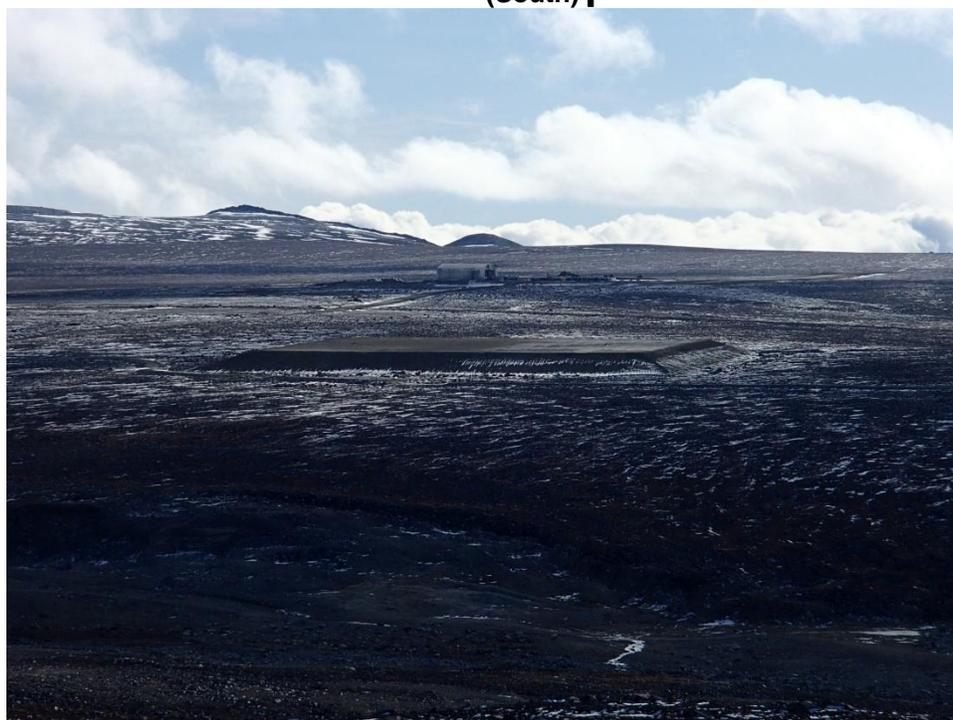
**Photograph 32. LS Tier II DF – Completed Facility. September 14, 2013 (South East) ↑**
