Nunavut Impact Review Board

2024 Site Visit Report for

Doris North Gold Mine and Phase 2 Hope Bay Belt Projects

January 2025

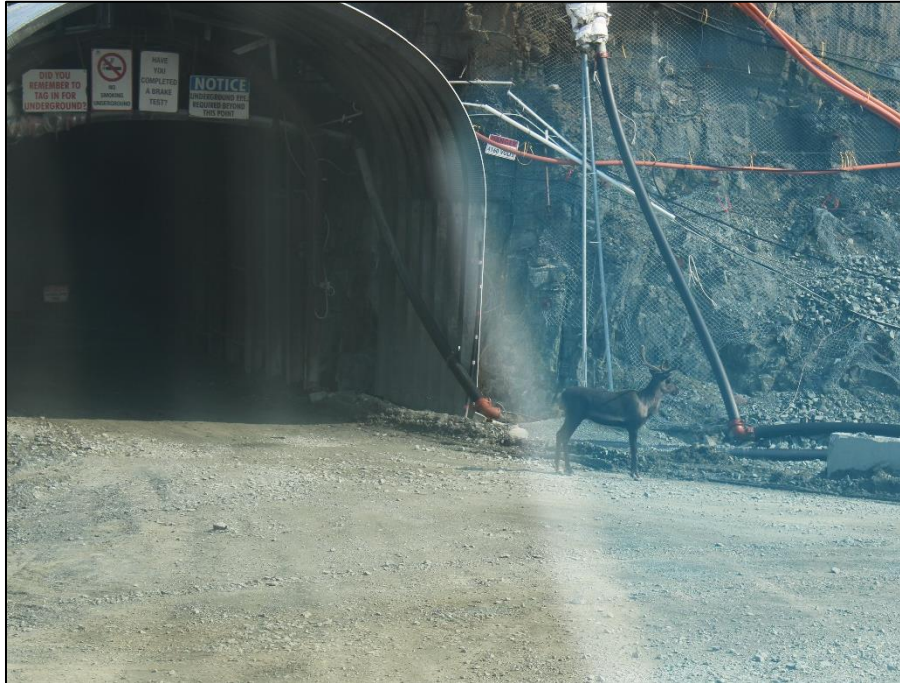
Photo 1: Doris North Main Portal (closed).

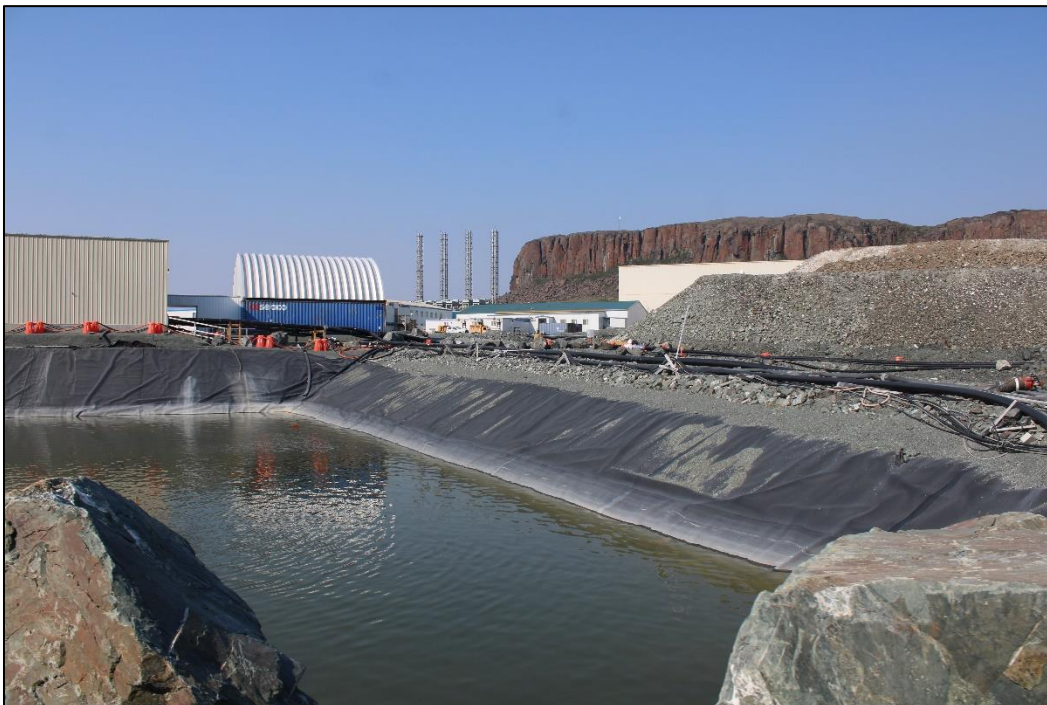
Photo 2: Contact Water Storage Pond.

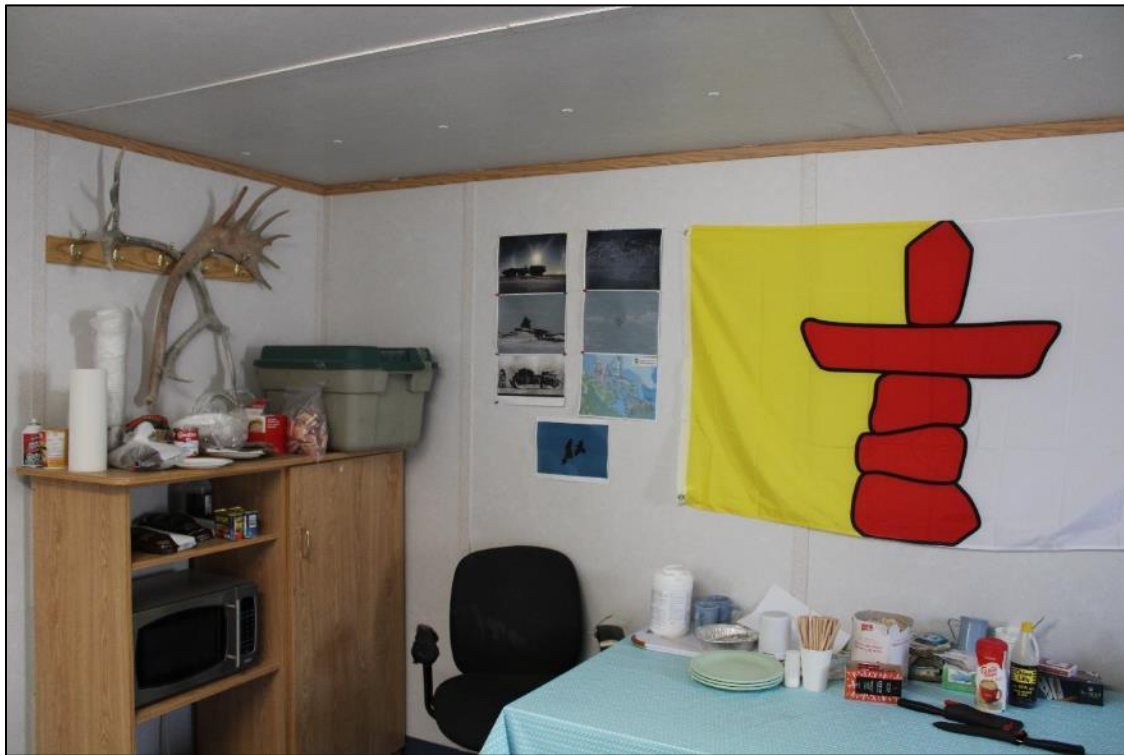
Photo 3: The Inuit Cultural Centre.

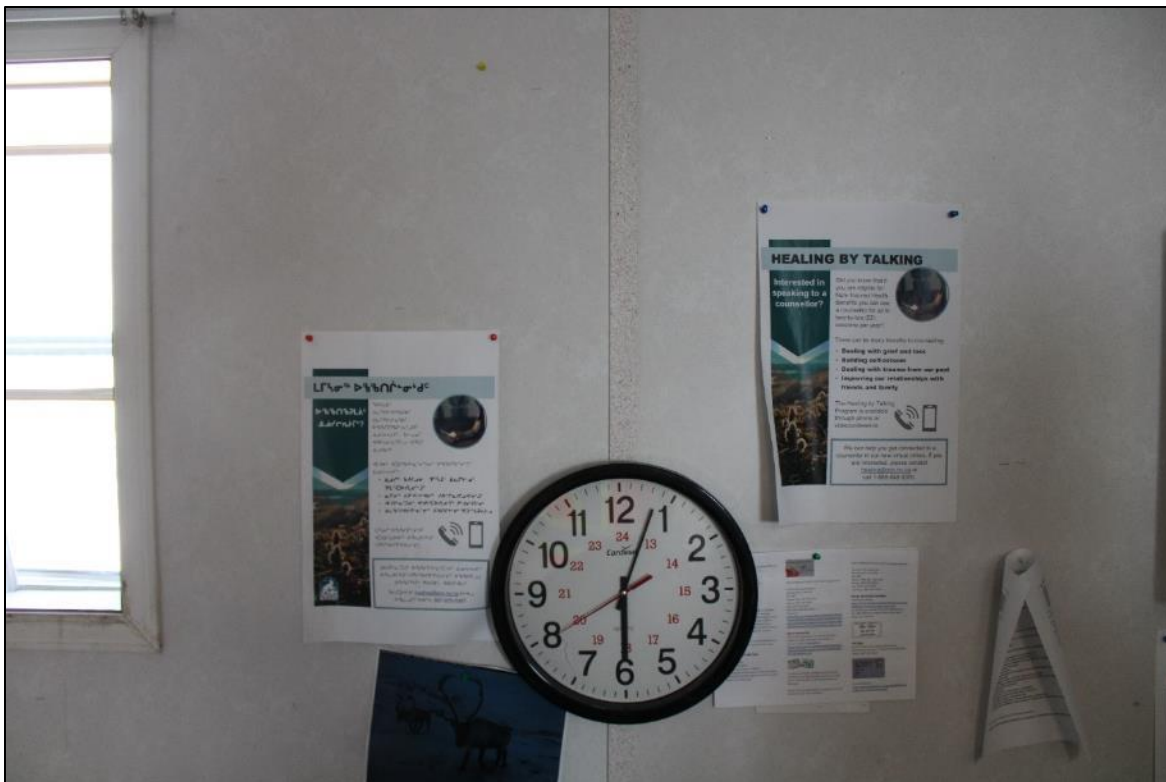
Photo 4: Counselor Information Poster at Doris Camp.

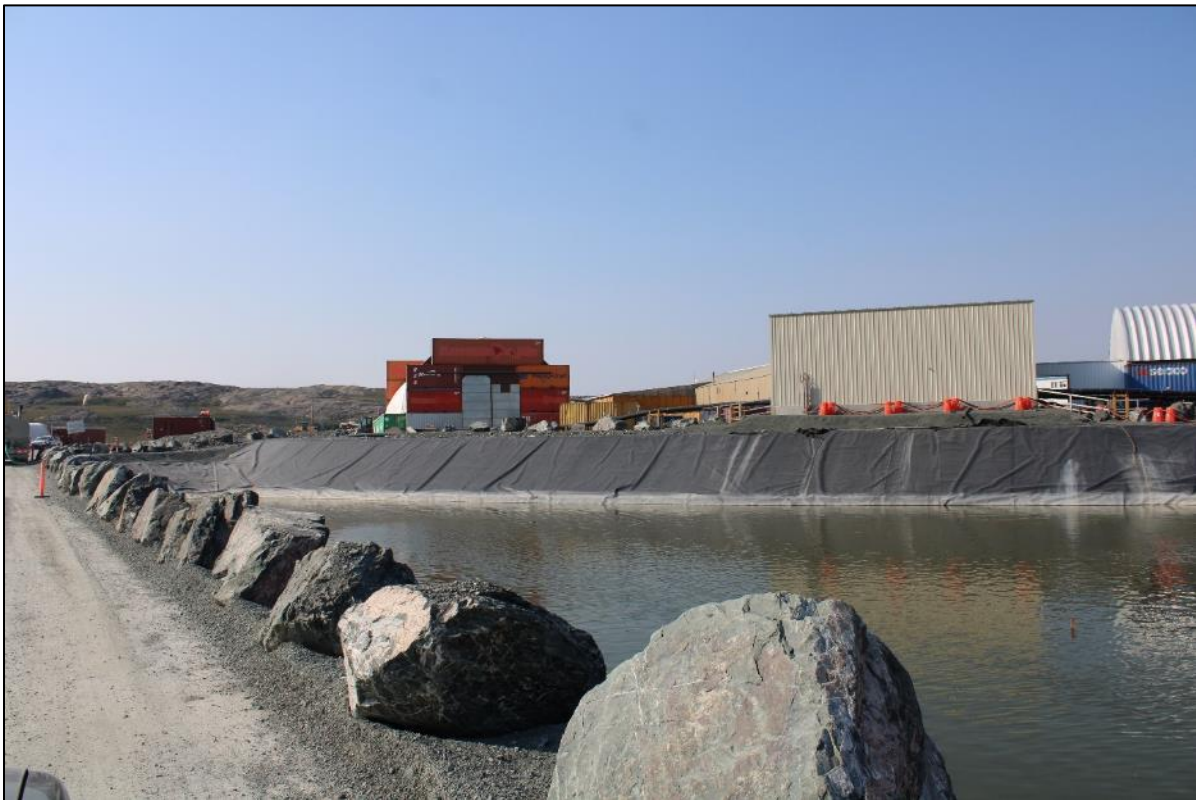
Photo 5: Sedimentation Pond at Doris North which collects Runoff Water.

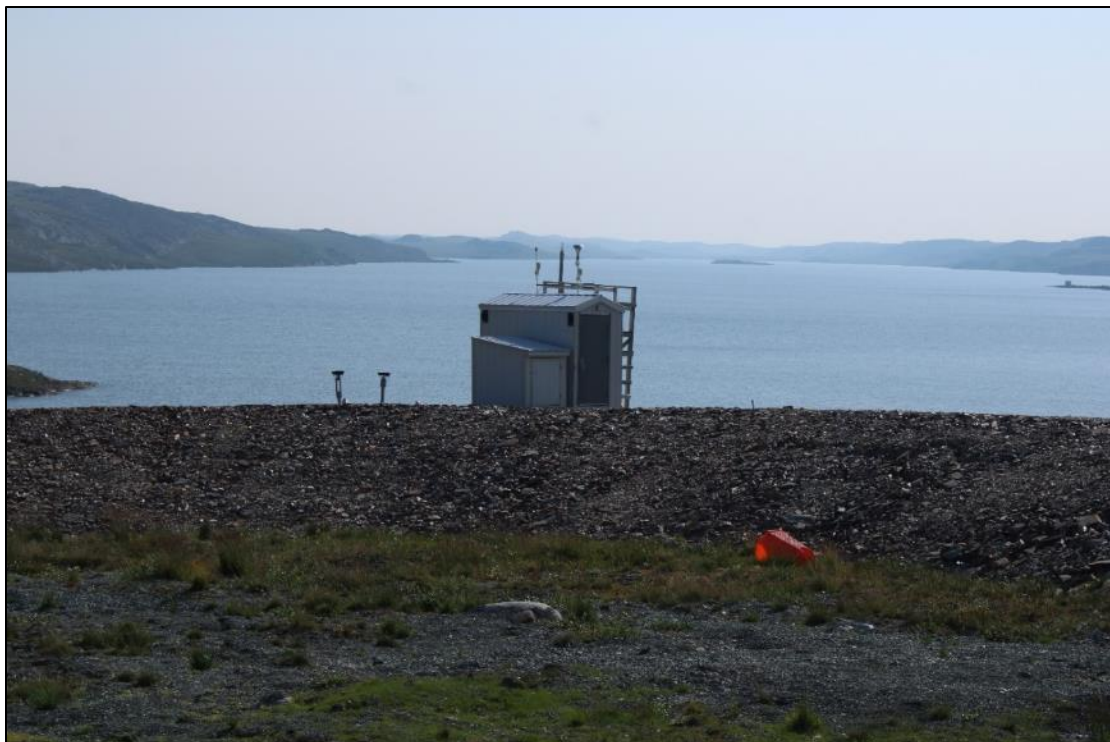
Photo 6: Continuous Air Quality Monitoring Station, next to Doris Lake.

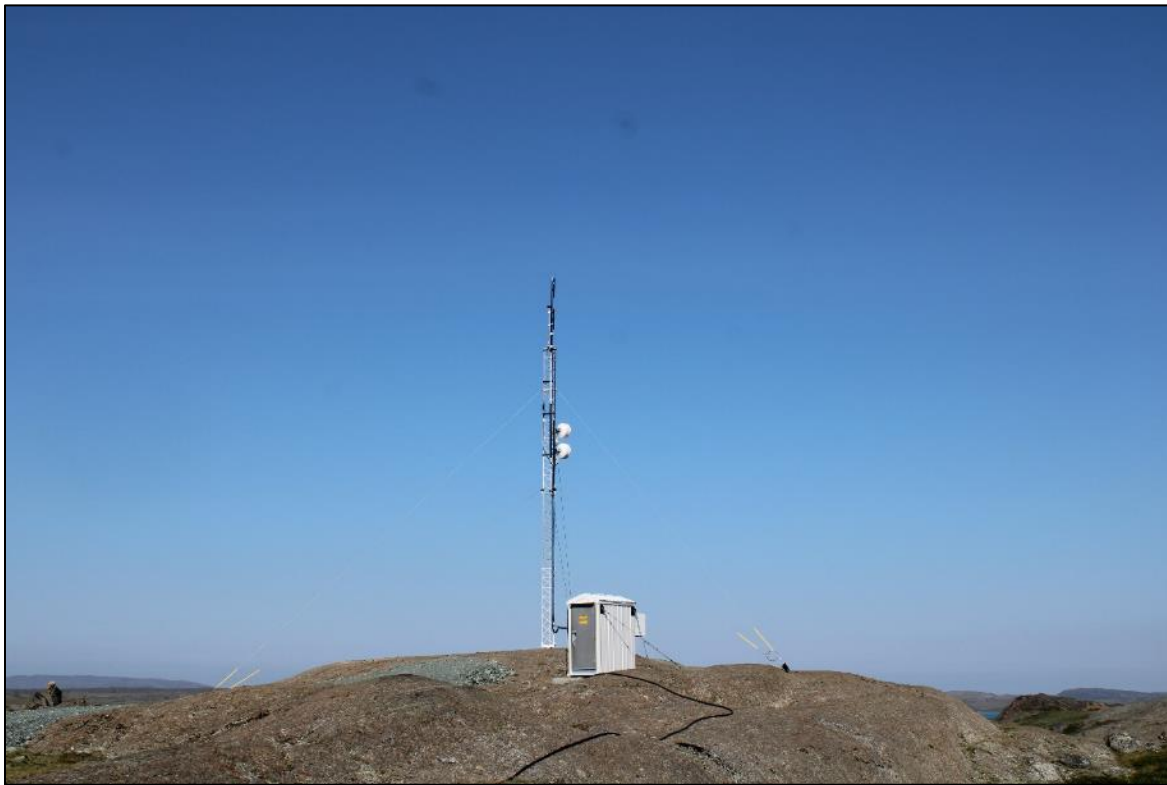
Photo 7: Weather Monitoring Station at Doris North.

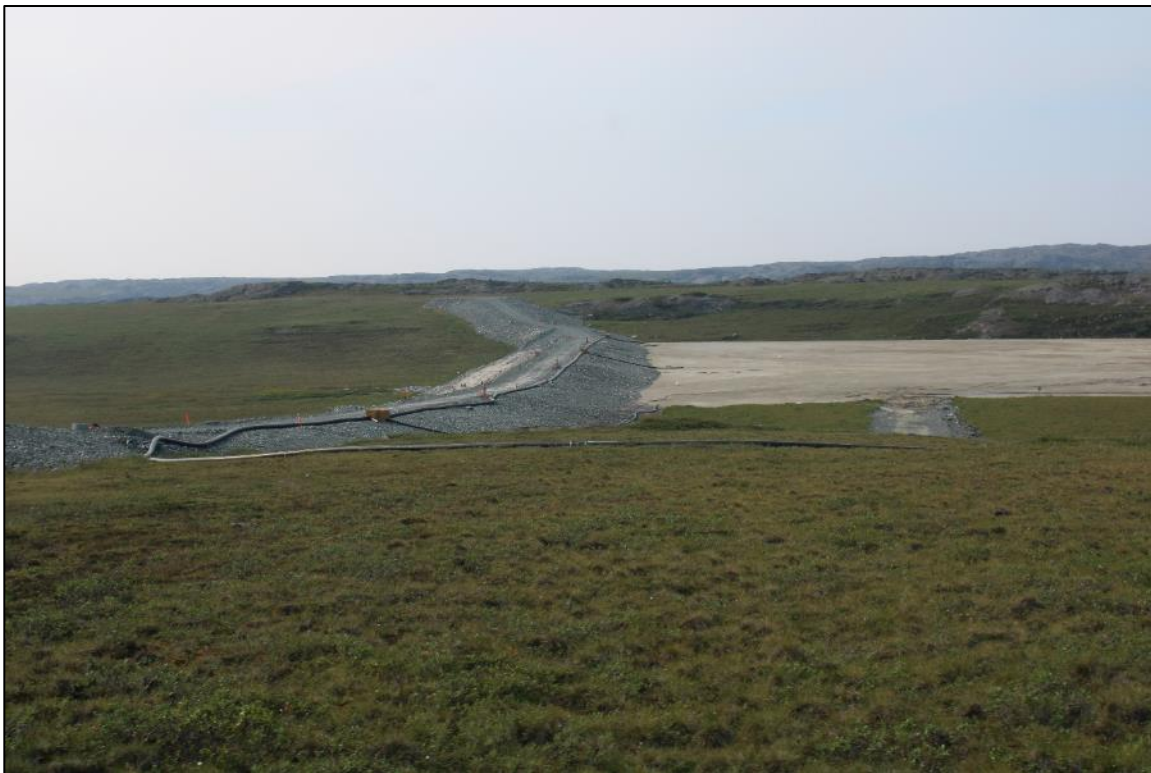
Photo 8: South Dam at the Tailings Impoundment Area.

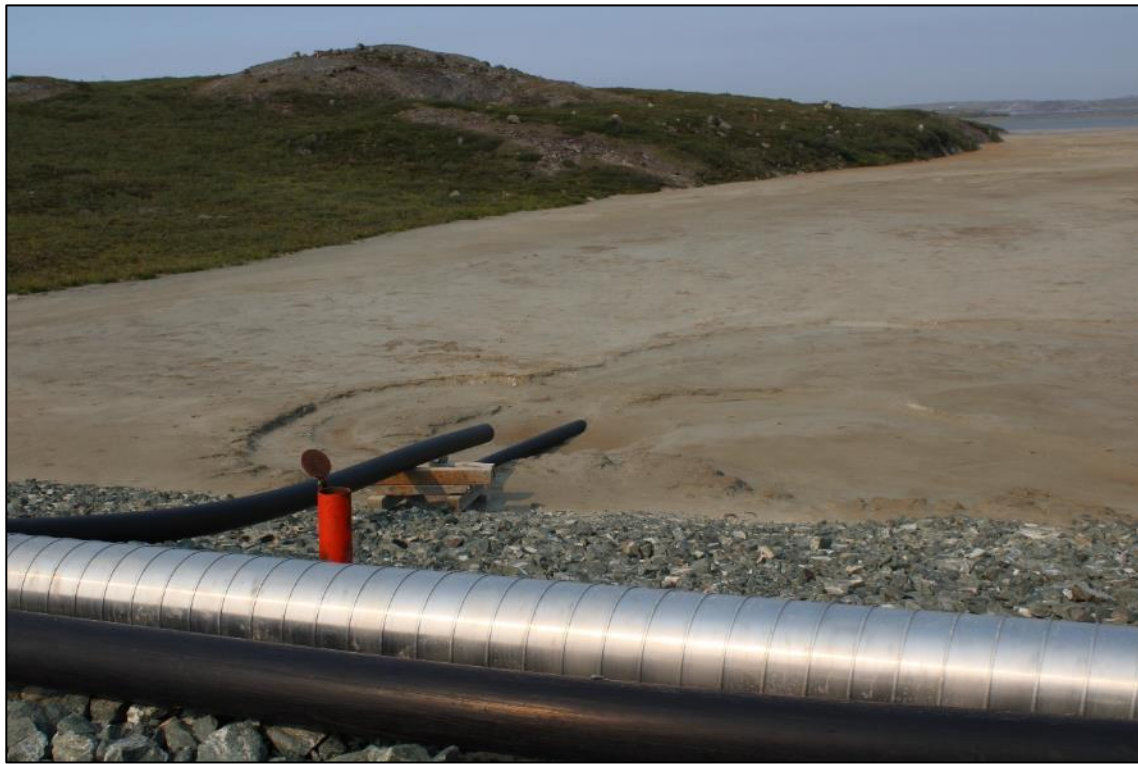
Photo 9: Discharge Point and Monitors at the South Dam.

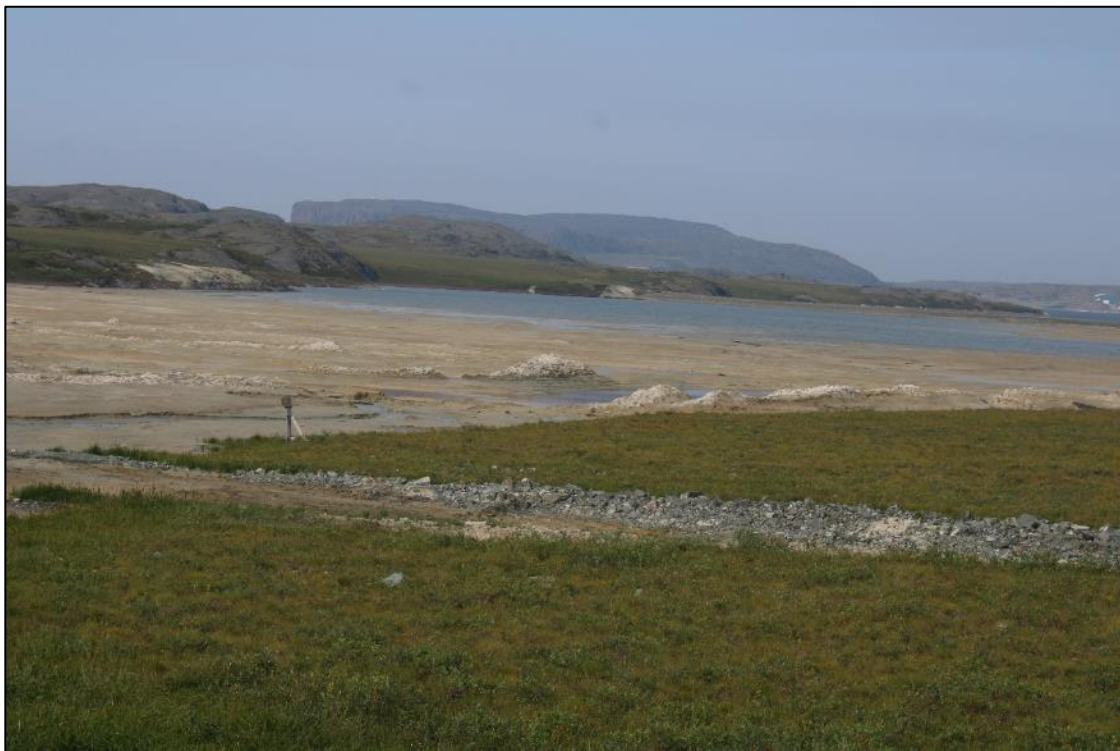
Photo 10: Wildlife Camera at the Tailings Impoundment Area.

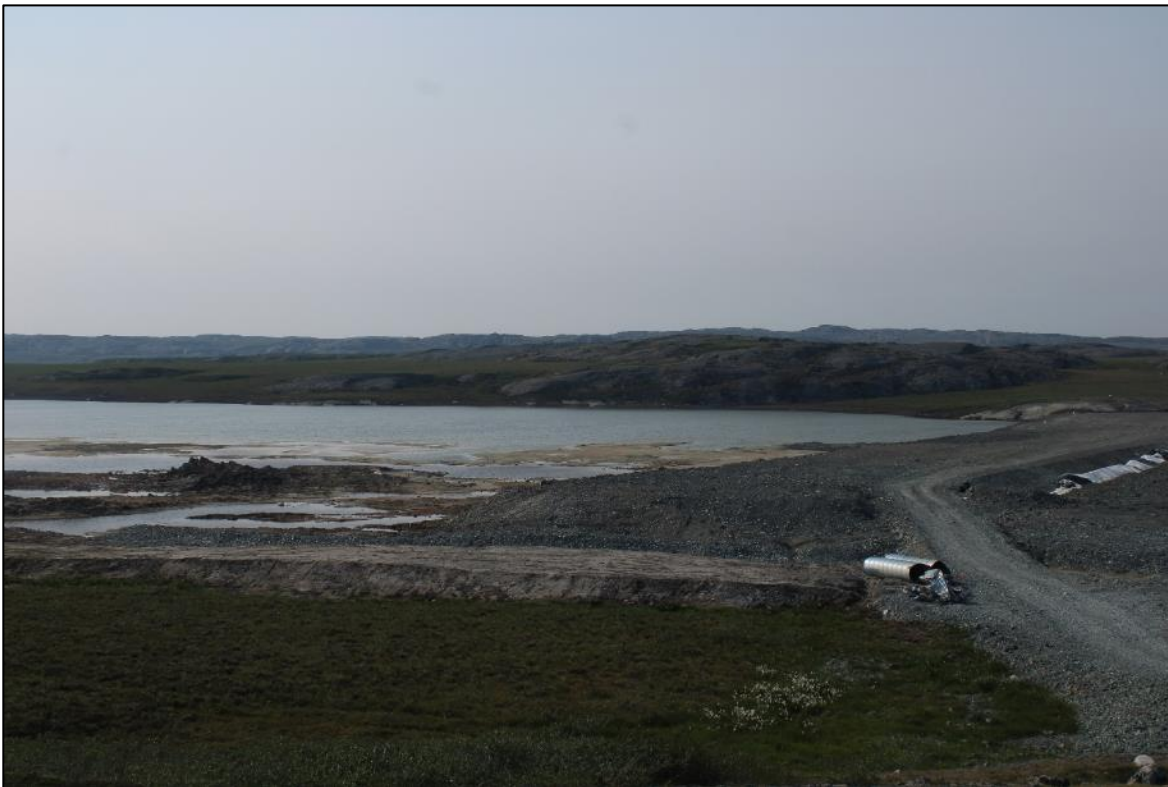
Photo 11: Aqua Dam, measures in place to be compliant with the new *Metal and Diamond Mining Effluent Discharge Regulations*.

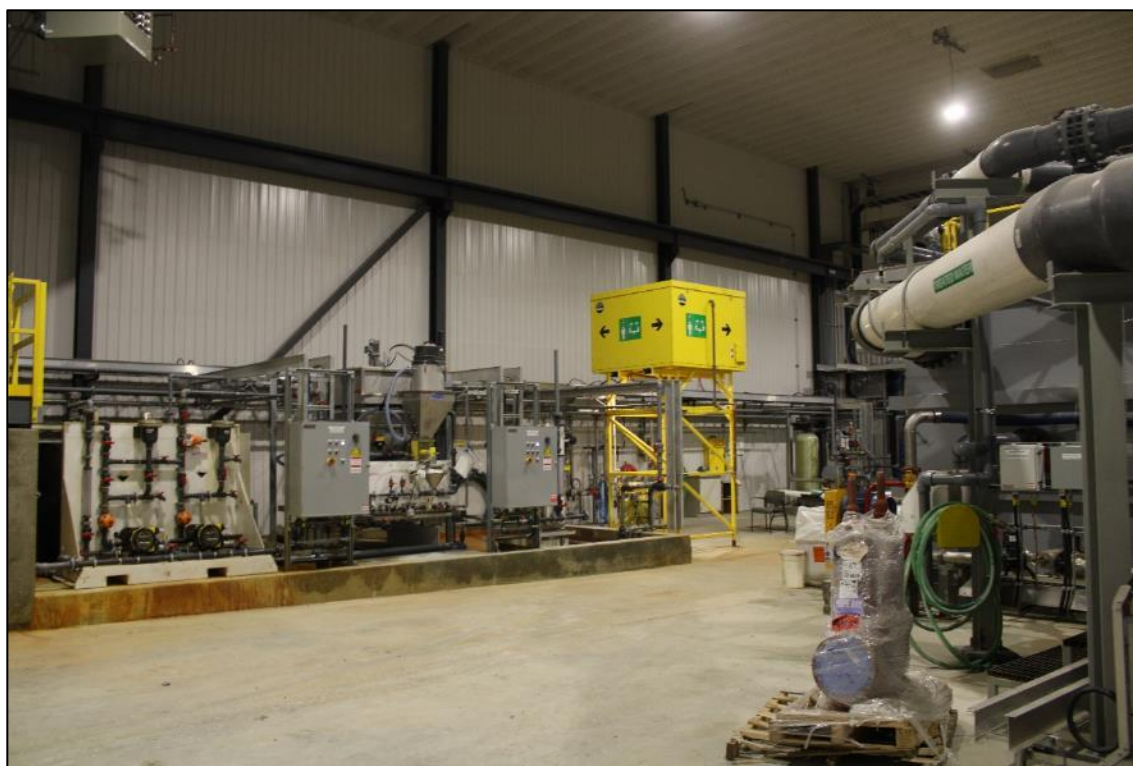
Photo 12: Inside of Effluent Water Treatment Plant.

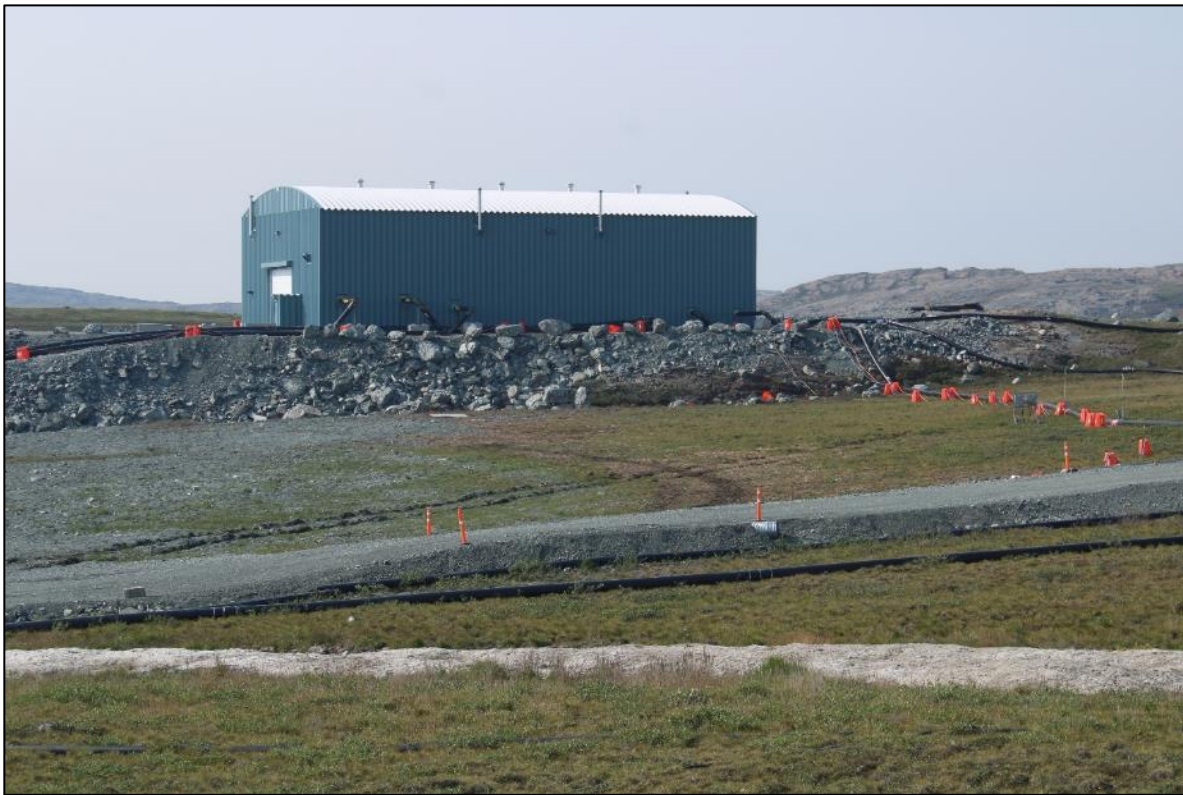
Photo 13: Outside View of Effluent Water Treatment Plant.

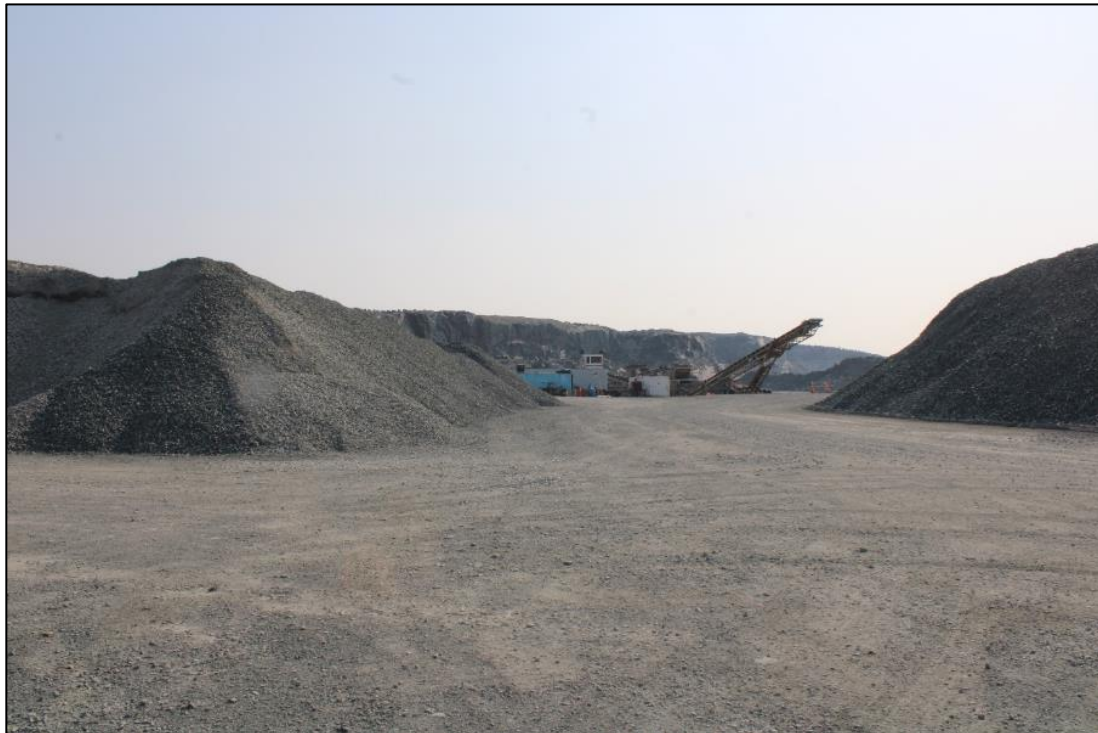
Photo 14: Active Quarry 2.

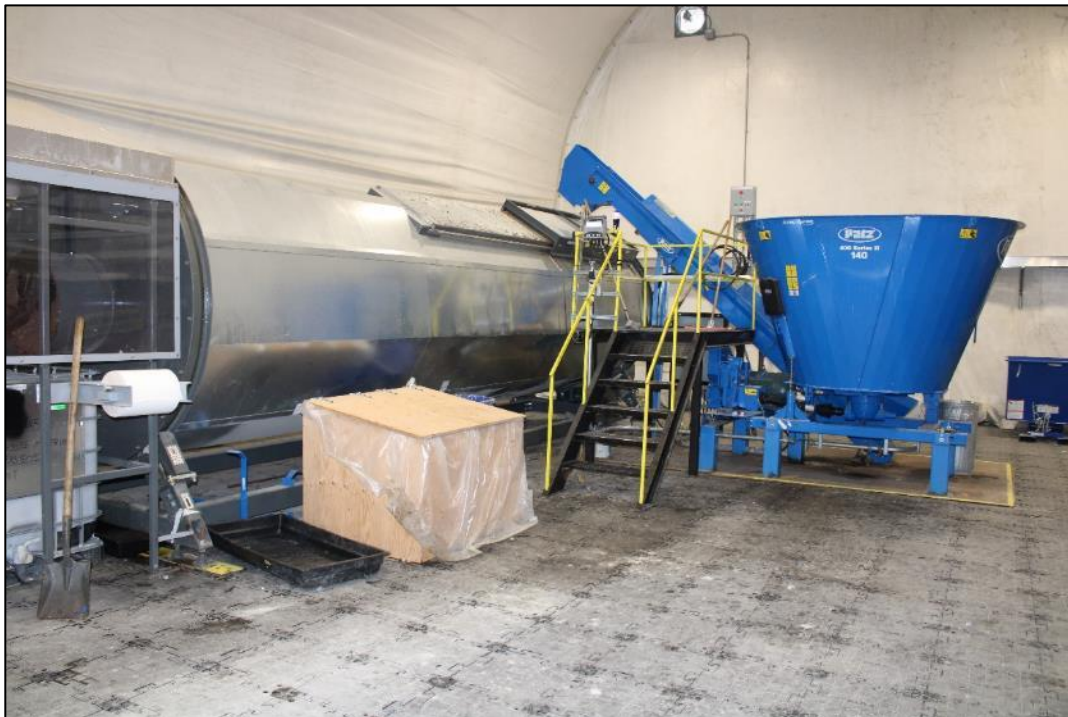
Photo 15: Industrial Composter Installed at the Incinerator Facility.

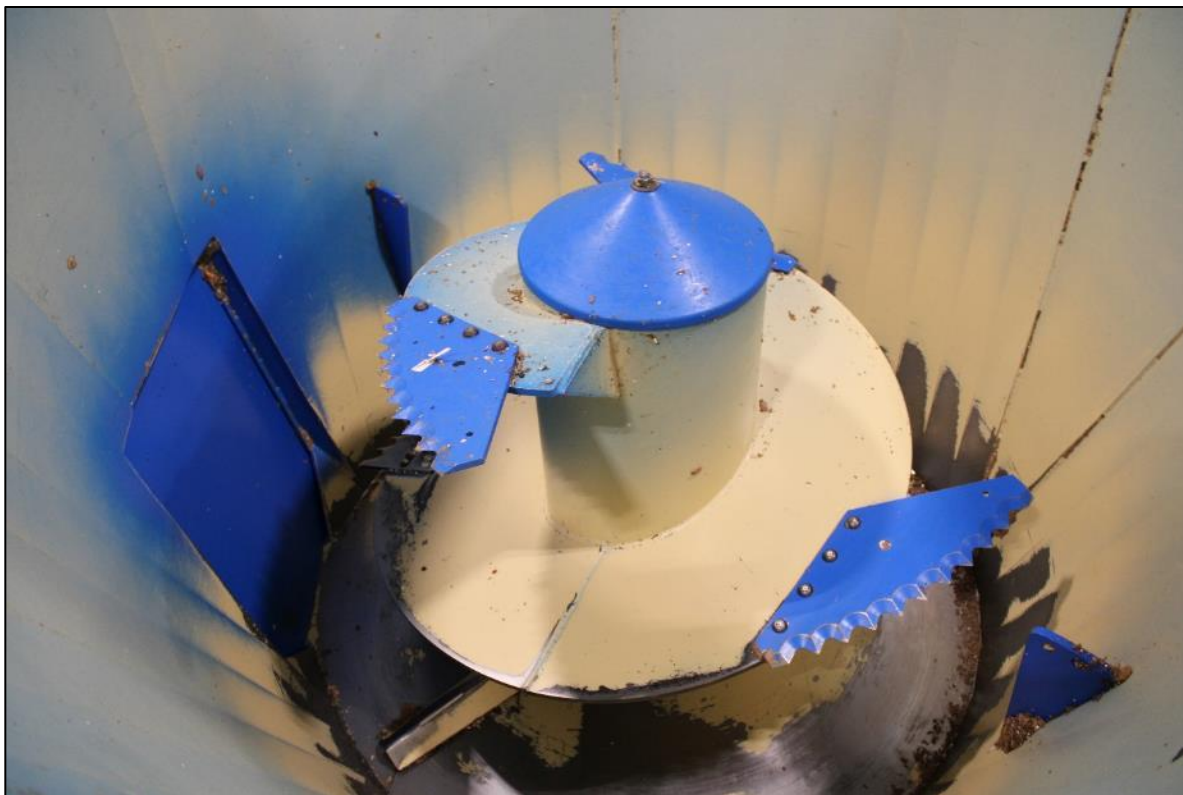
Photo 16: Hopper for Organic Waste to be Loaded.

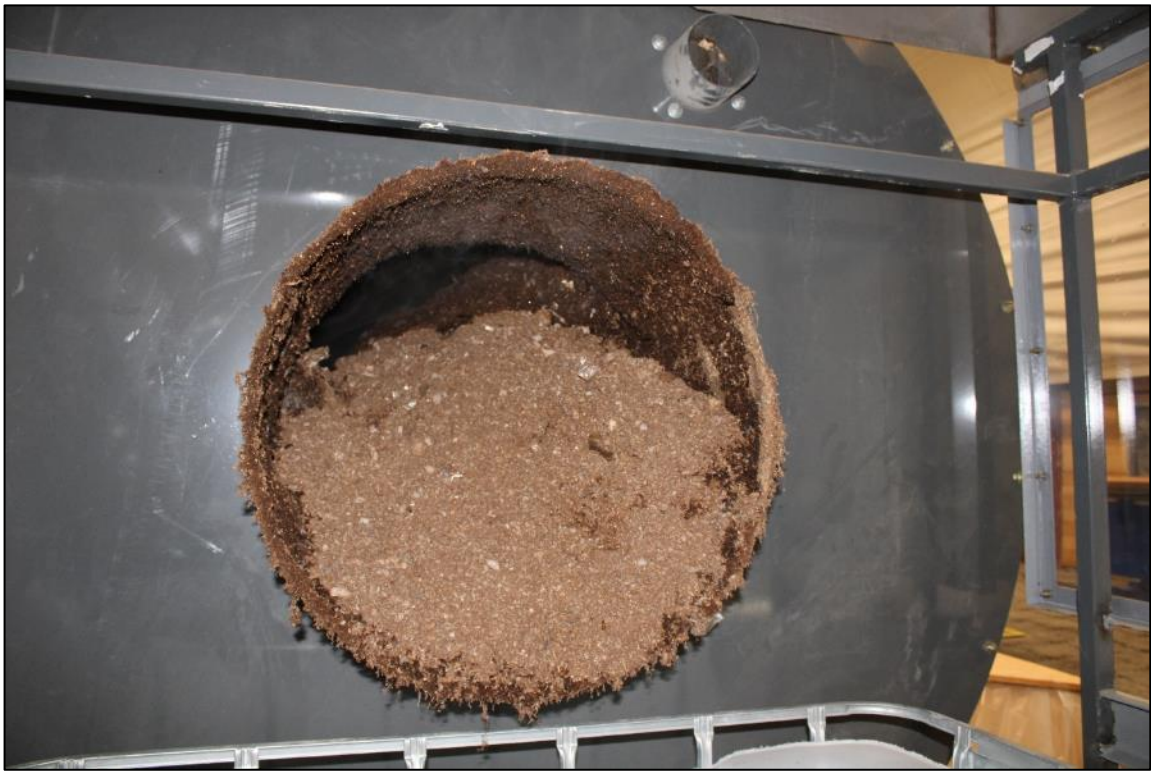
Photo 17: Soil from Industrial Composter.

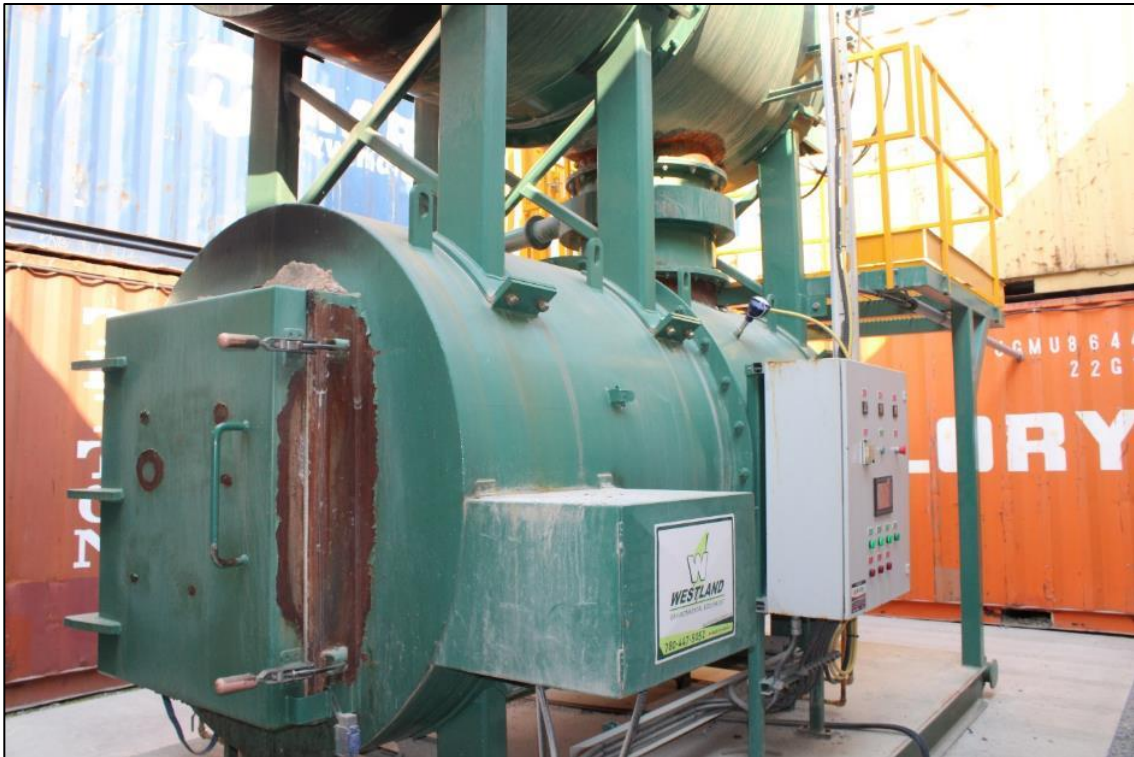
Photo 18: Incinerator Facility.

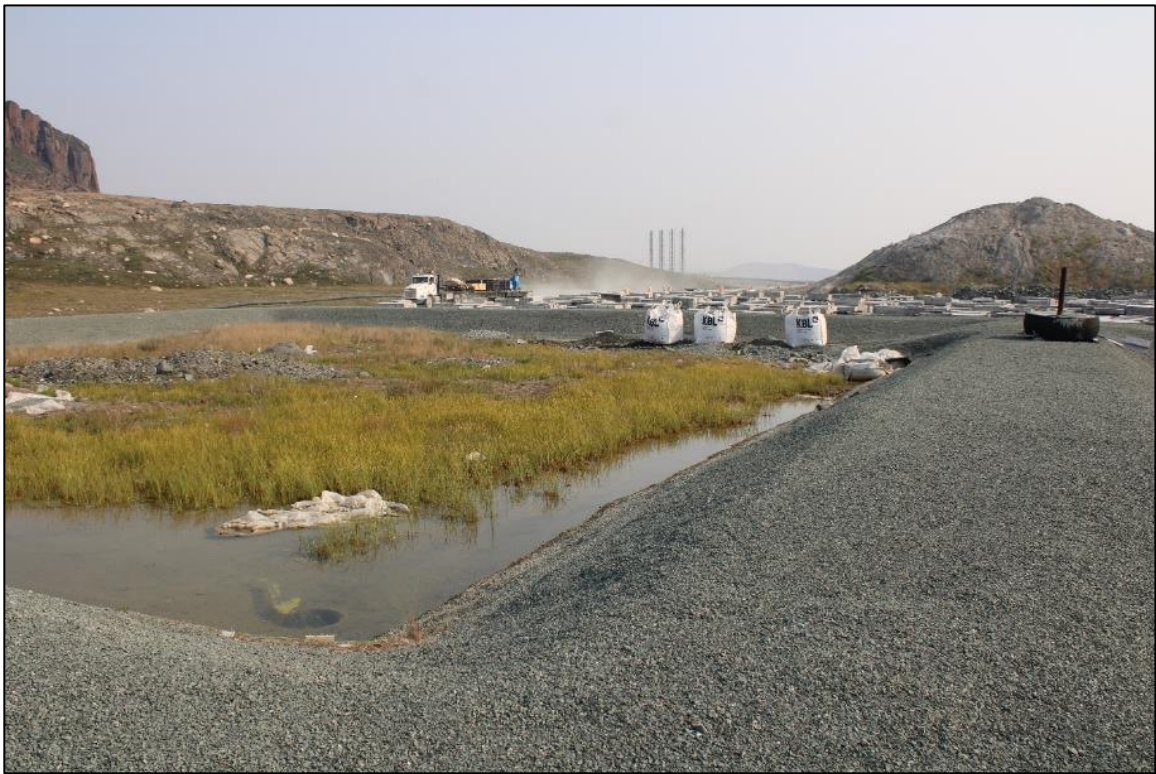
Photo 19: Landfarm Facility.

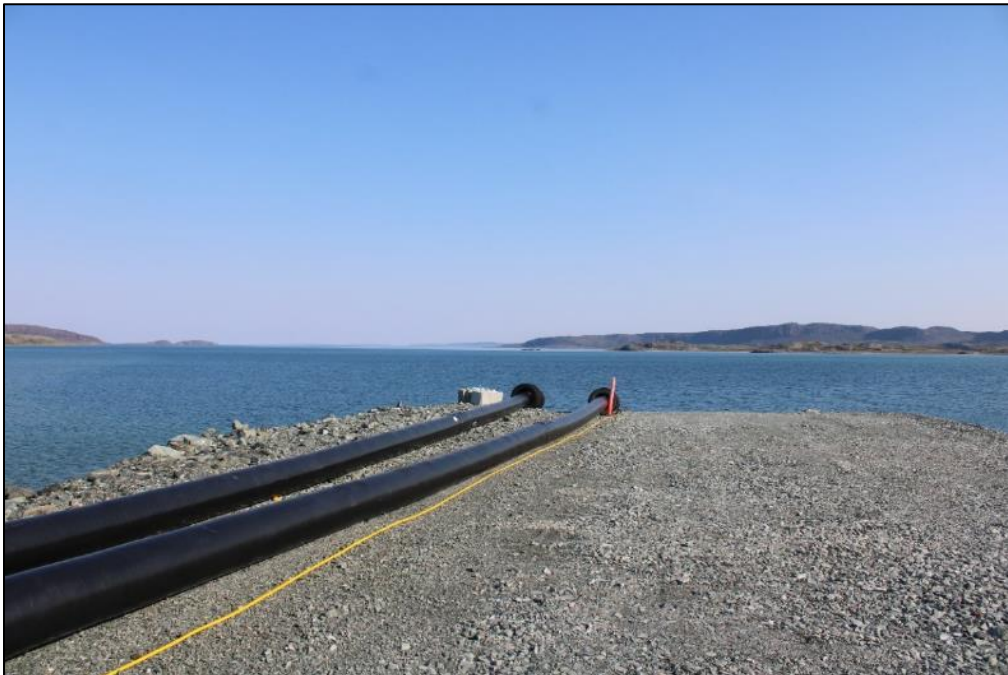
Photo 20: Saline Discharge and Water Recirculation Lines along the Roberts Bay Jetty.

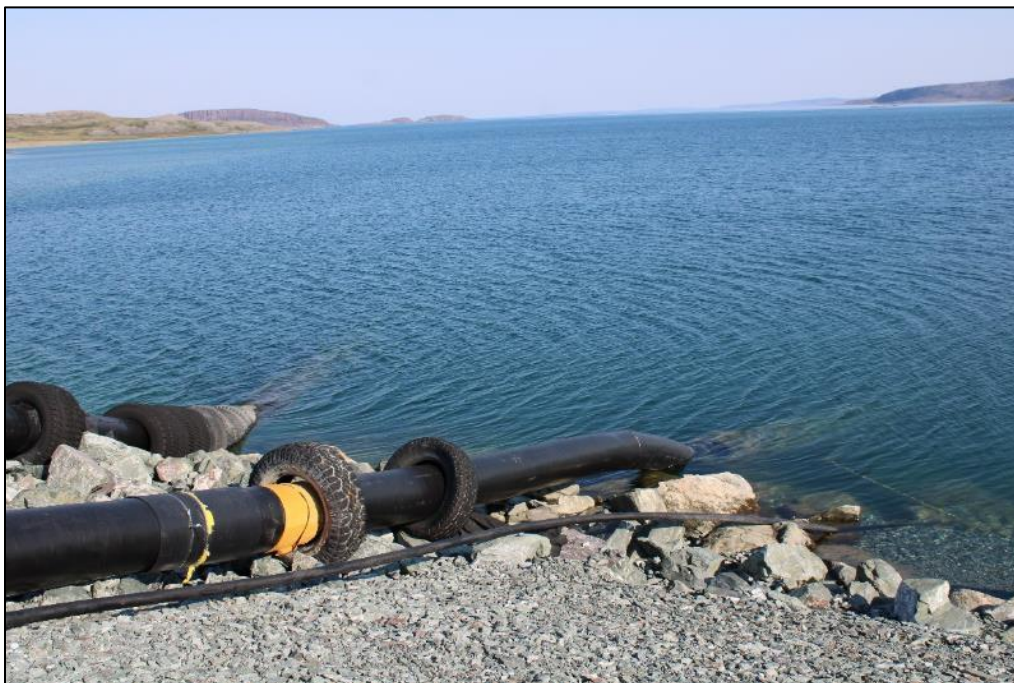
Photo 21: Saline Discharge and Water Recirculation lines.

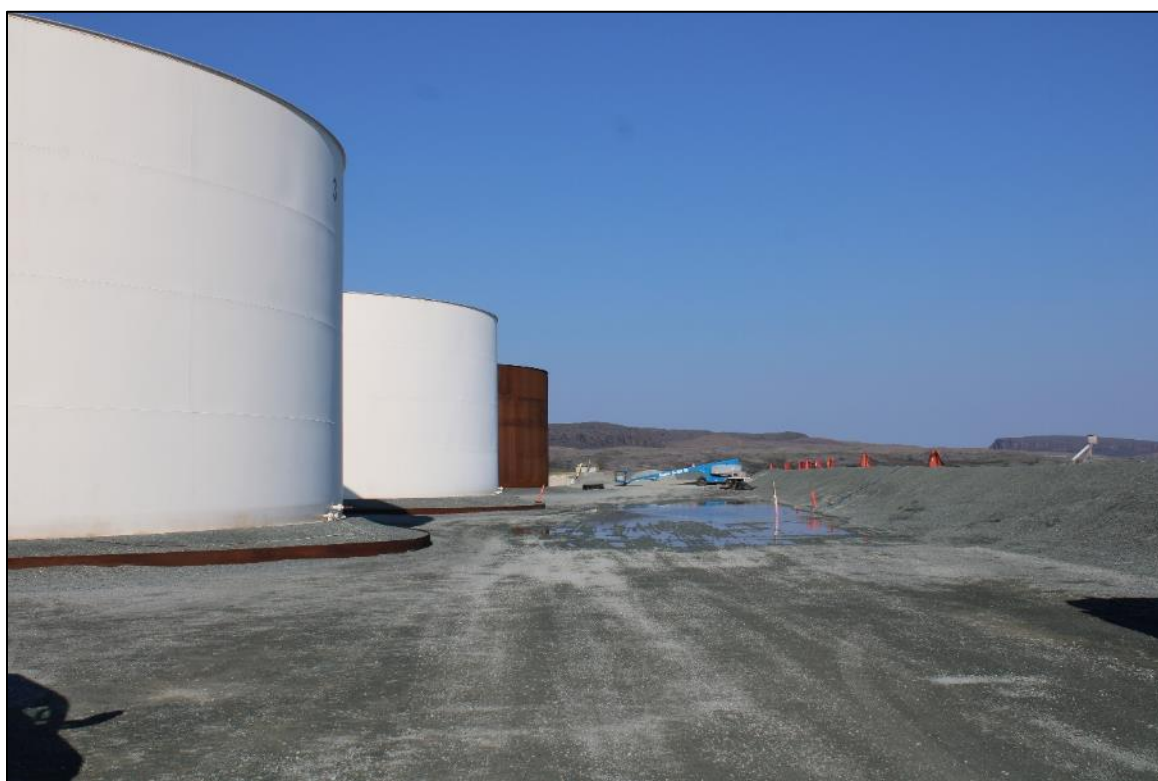
Photo 22: Roberts Bay Tank Farm and Fuel Storage.

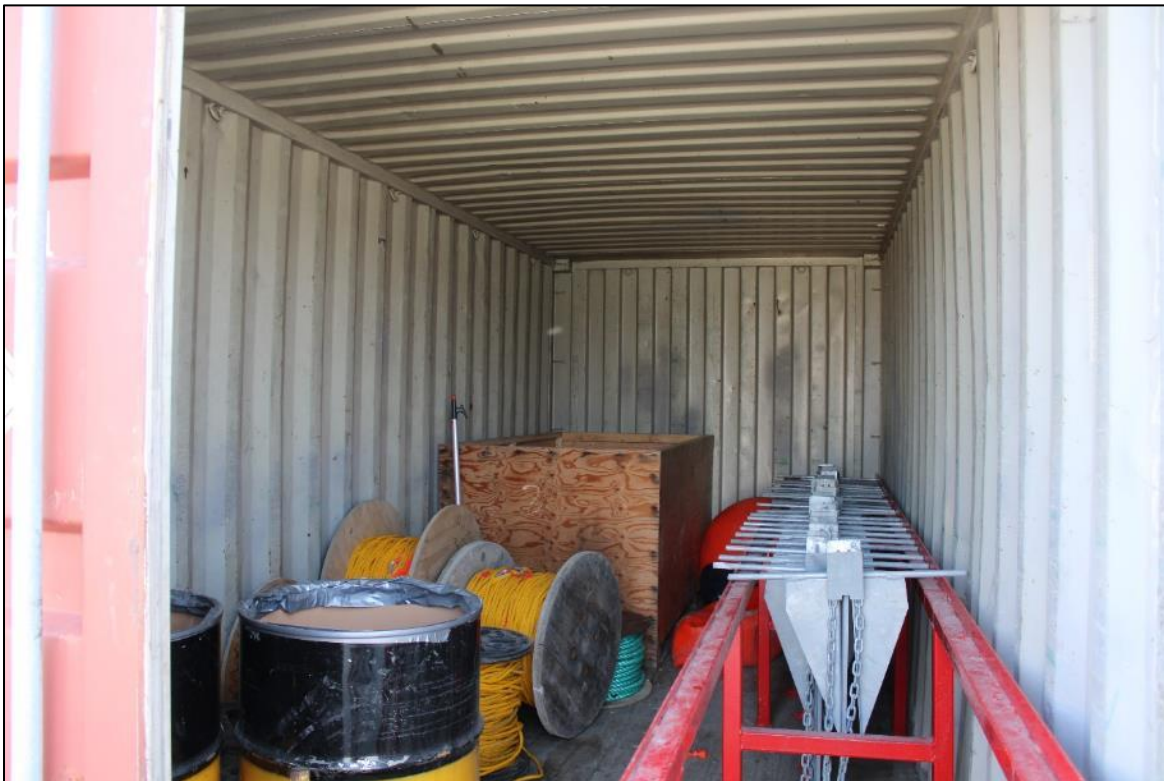
Photo 23: Spill Equipment in seacans next to the Robert's Bay Jetty.

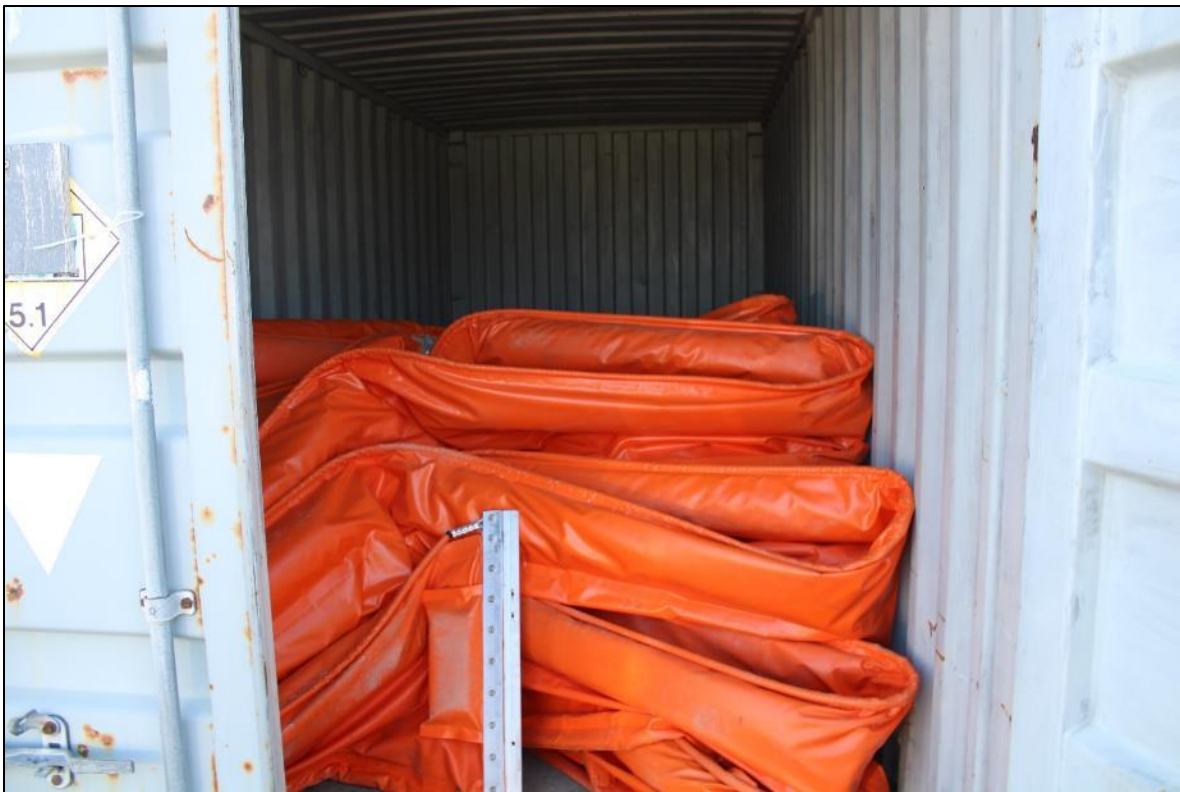
Photo 24: Floating Booms in seacans at Roberts Bay.

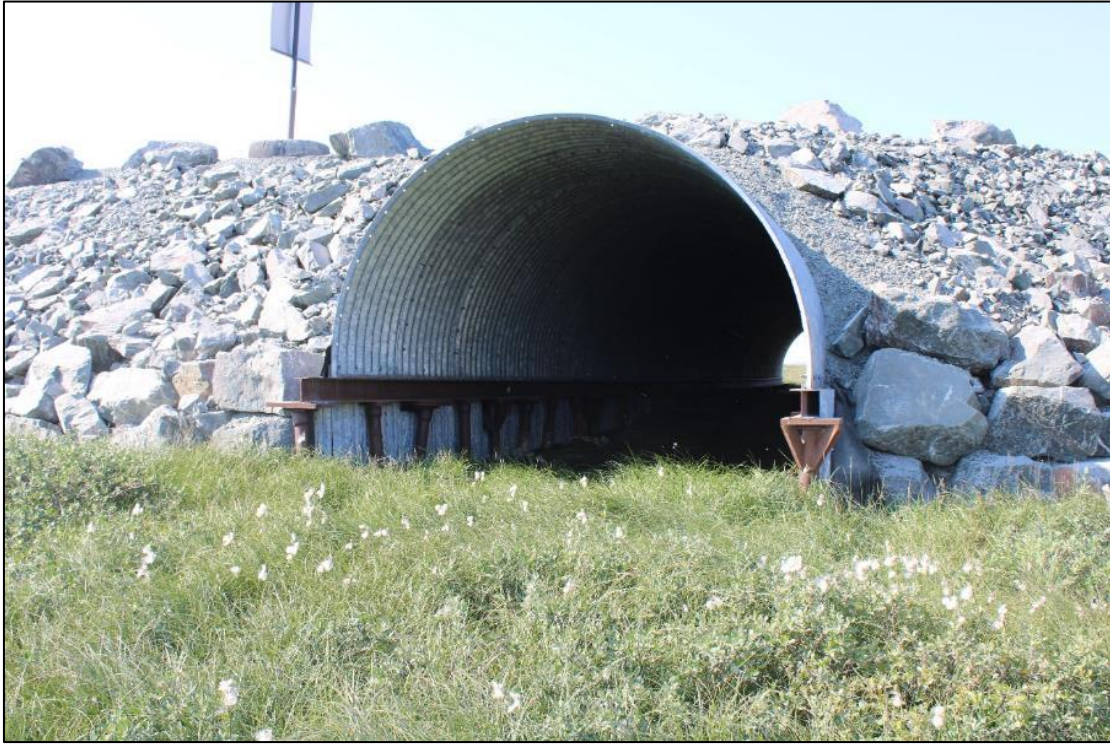
Photo 25: Wildlife Passage under the Windy Road going to Madrid.

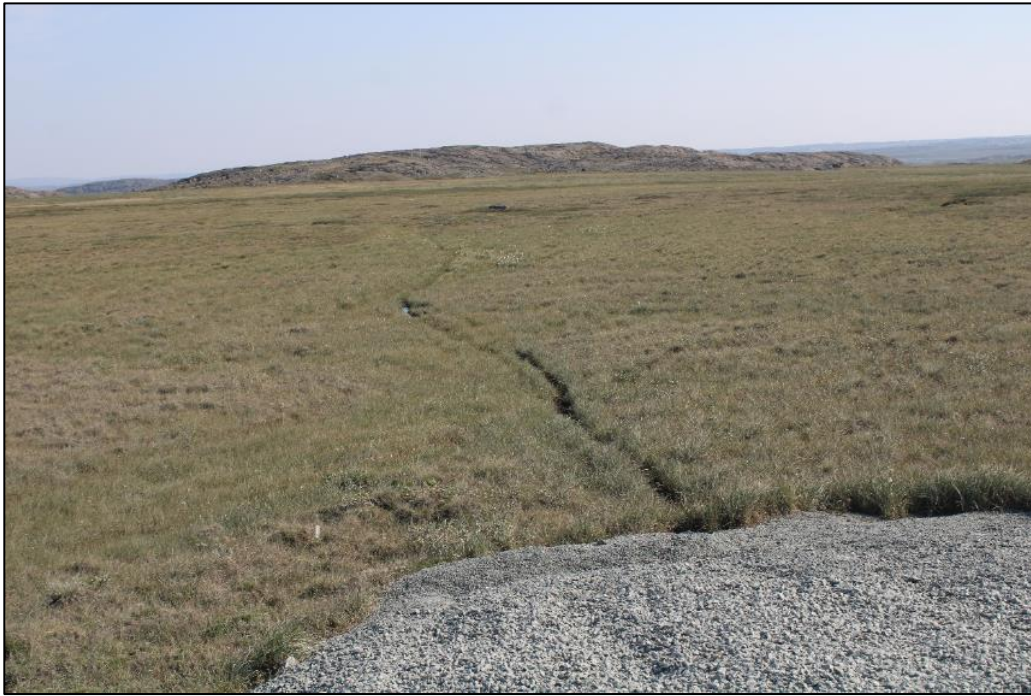
Photo 26: Caribou Trail Leading to Wildlife Passage.

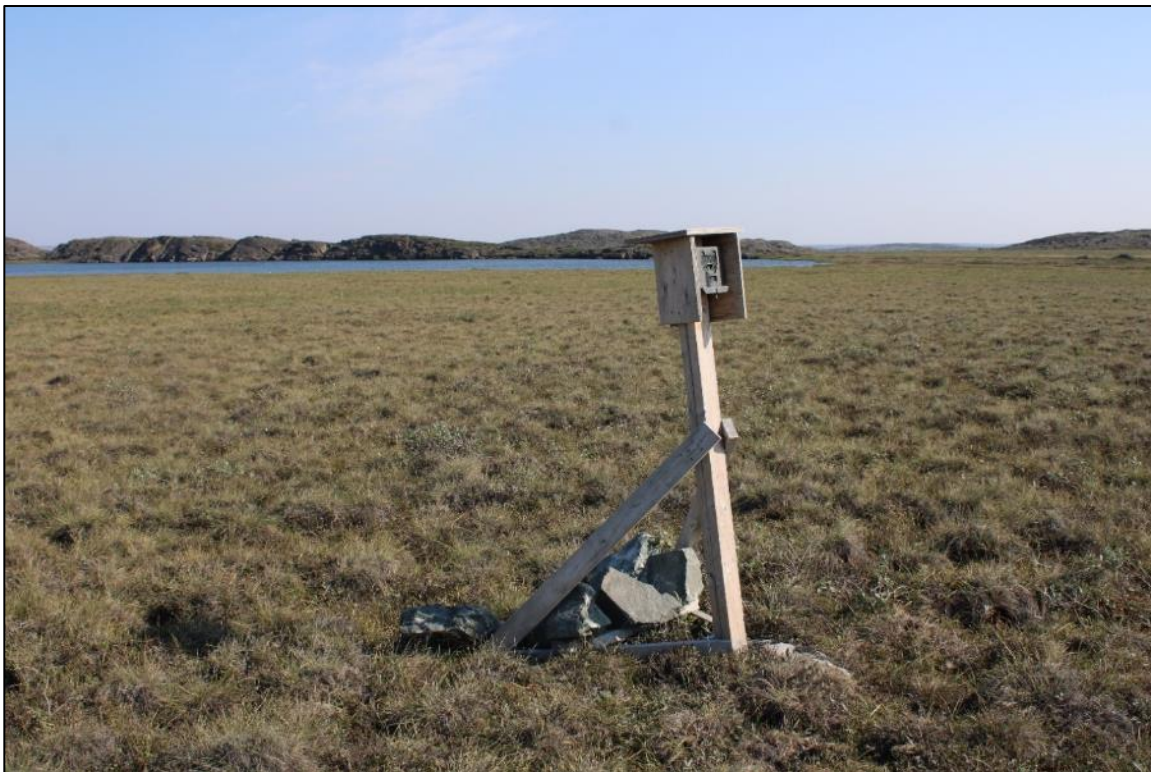
Photo 27: Wildlife Camera at Wildlife Passage.
