Nunavut Impact Review Board

2024 Site Visit Report for

Doris North Gold Mine and Phase 2 Hope Bay Belt Projects

January 2025

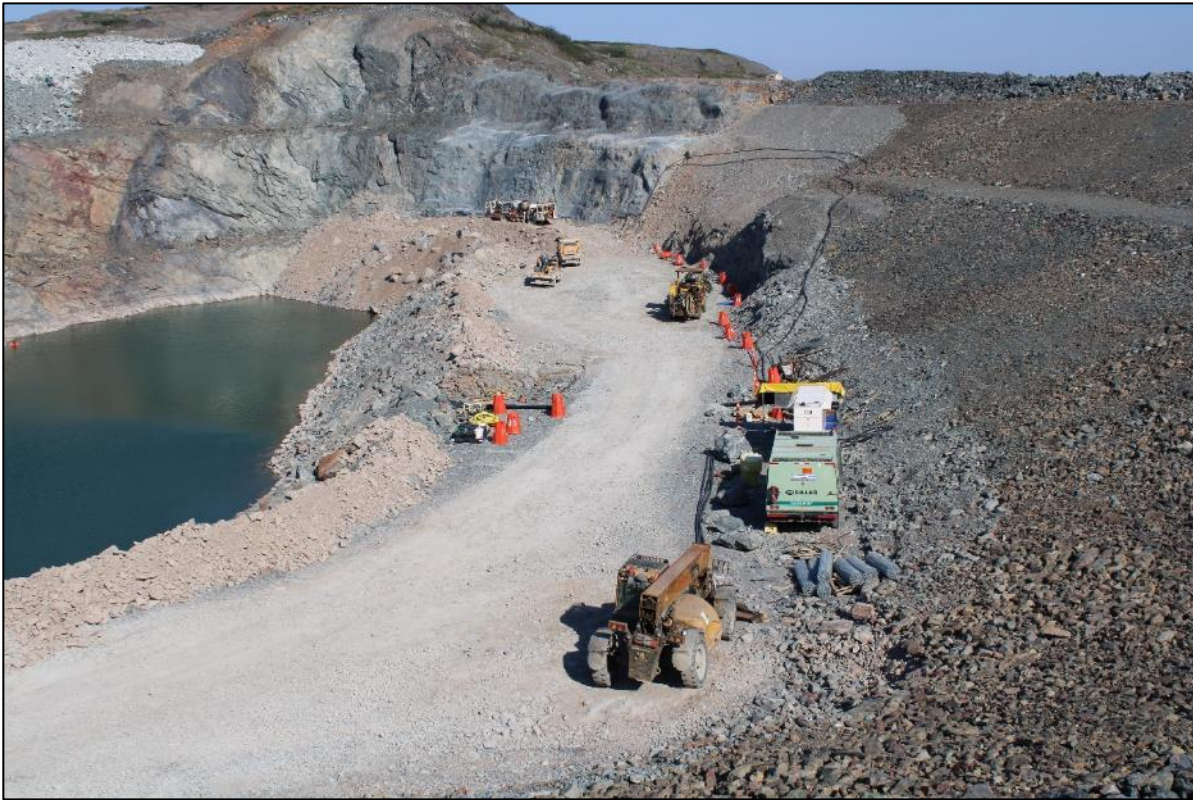
Photo 28: Naartok East Crown Pillar Pit Construction.

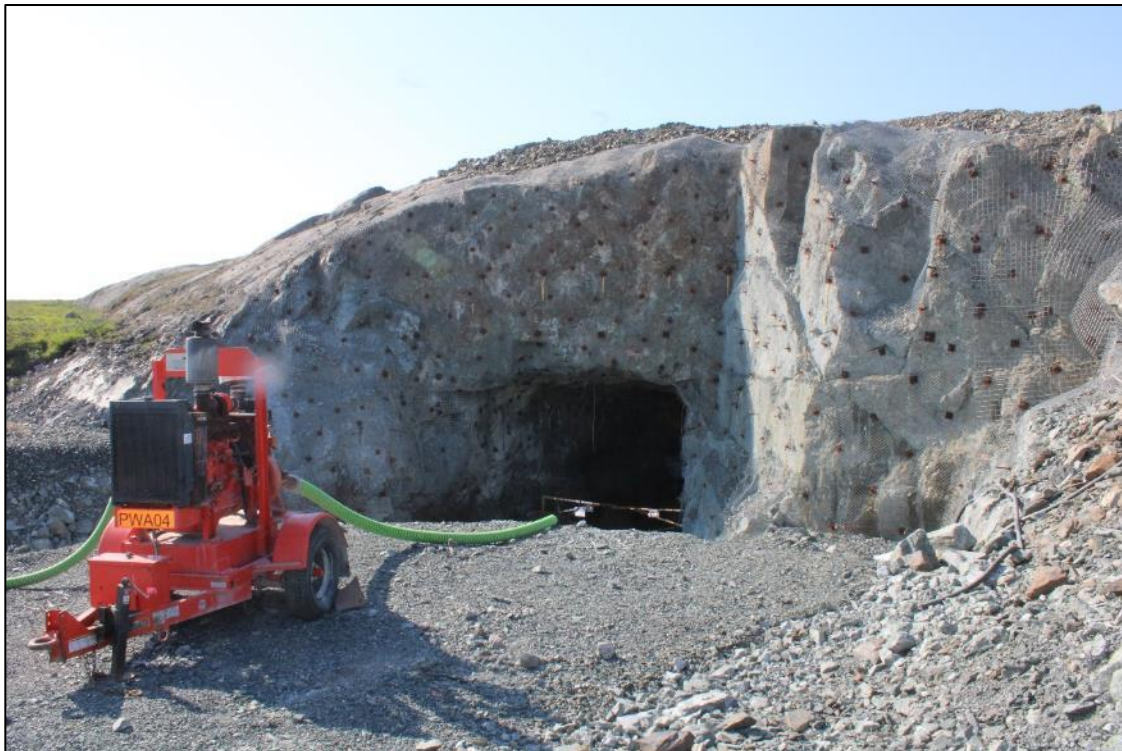
Photo 29: Closed Former Madrid Portal.

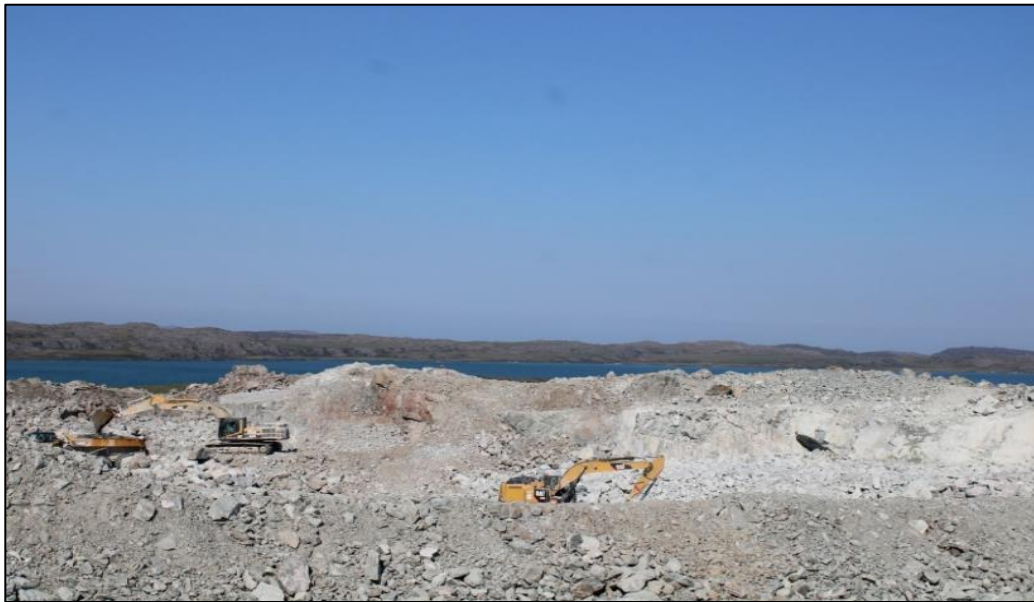
Located next to the Madrid Portal, the Potential Acid Generating (PAG) Waste Rock Storage pile was constructed. This area is monitored with several water monitoring stations and all the water in contact with the PAG waste rock is collected in the waste rock pond.

Photo 30: PAG Rock Storage Area.

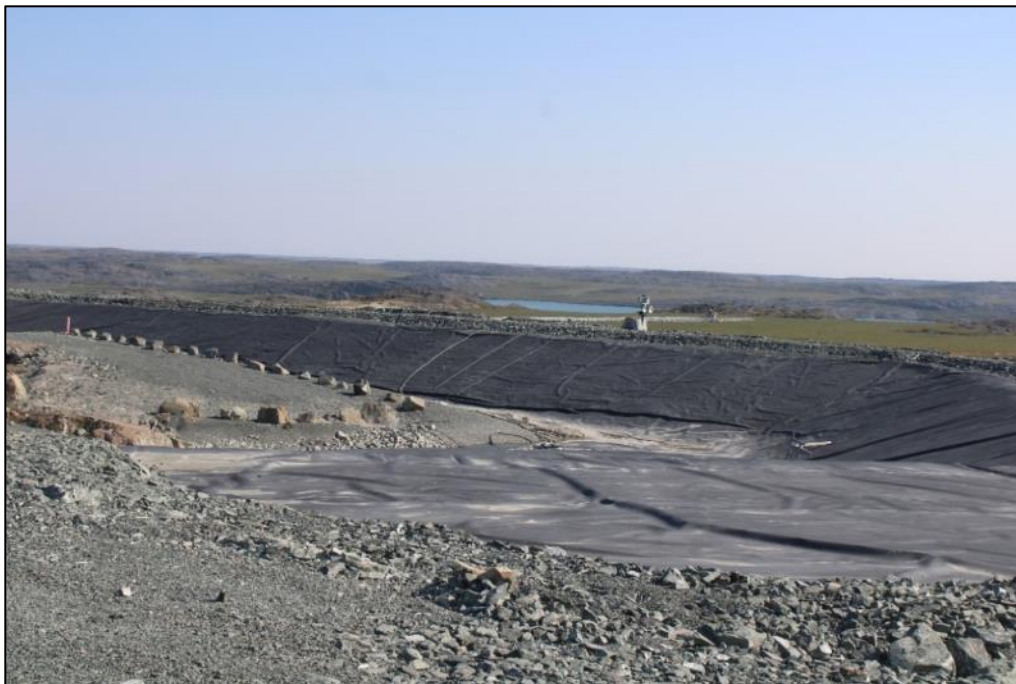
Photo 31: PAG Rock Storage Area Sedimentation Pond.

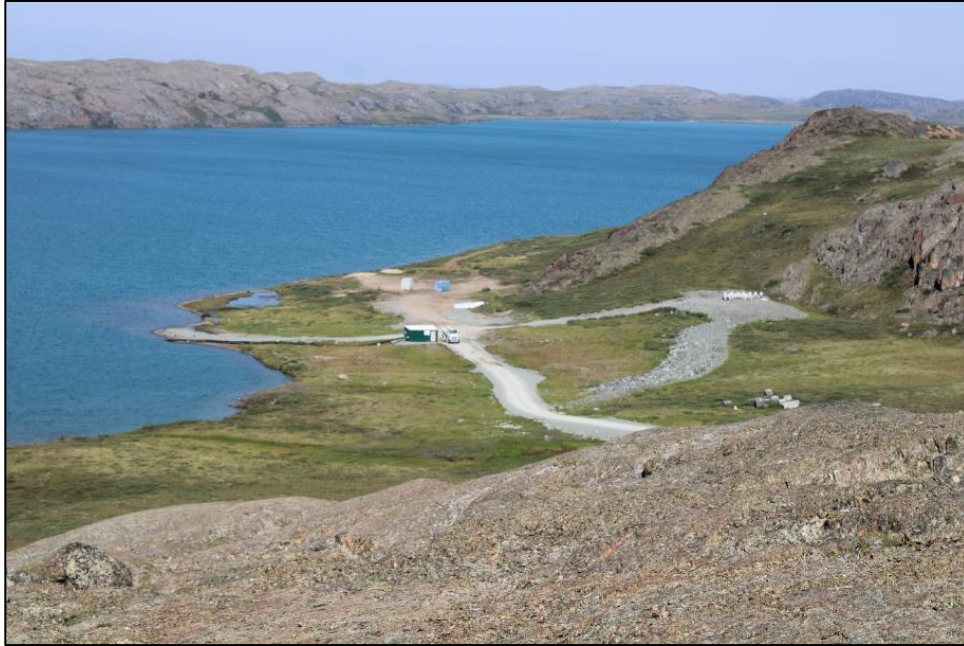
Windy Camp has largely been decommissioned with only a few seacans and storage items left to be moved. Windy Lake remains the main source of potable water for the Doris North Camp and some infrastructure will remain in place to facilitate water withdrawal for the approved mine.

Photo 32: Windy Camp.
