Nunavut Impact Review Board

2025 Site Visit Report

Doris North and Phase 2 Hope Bay
Projects

Project Certificates 003 and 009

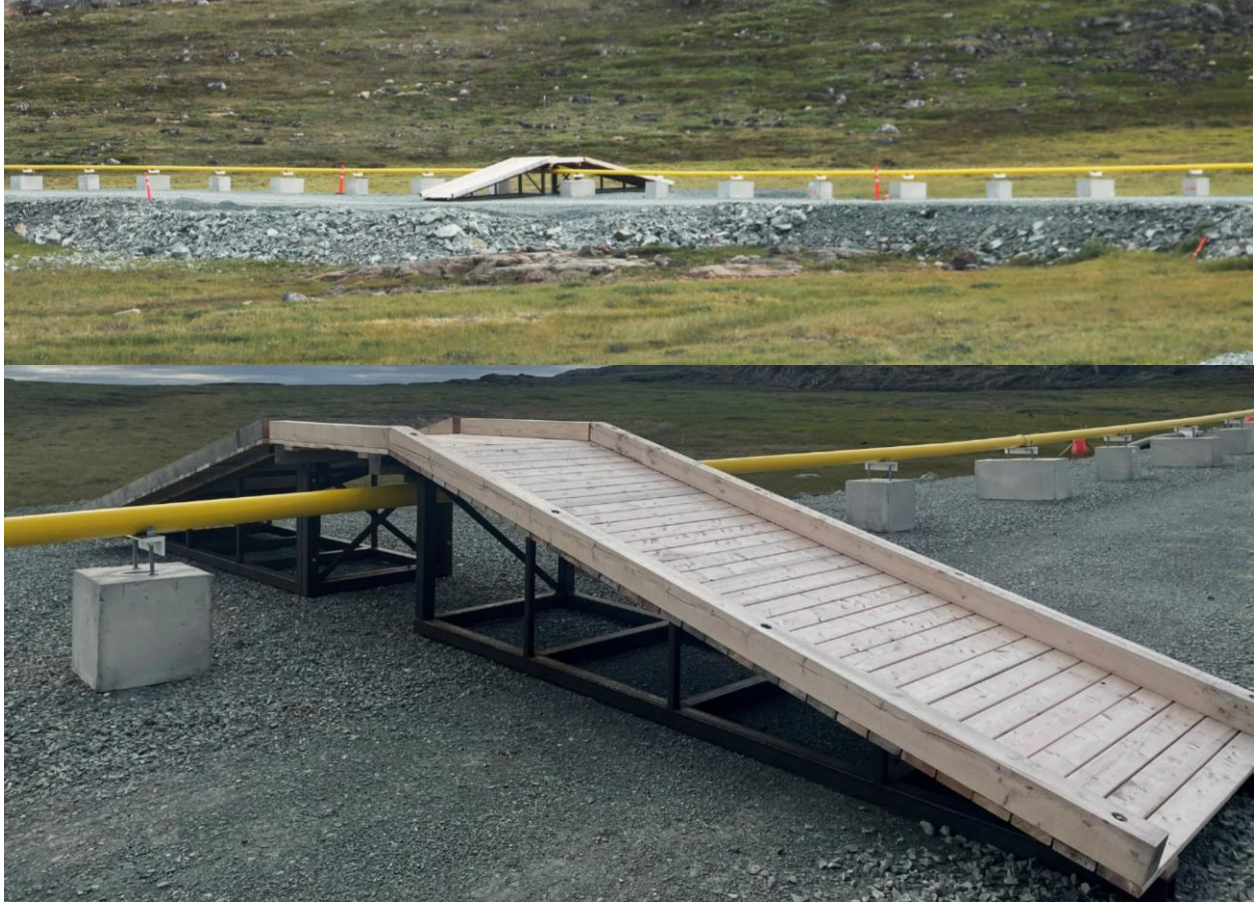
Photo 7: Snowmobile Crossing Ramp with unsafe drop - requires design modification¹

¹The snowmobile crossing is deemed unacceptable, as the slope is steep when approaching from the south, and the drop-off is too abrupt for safe use. Agnico Eagle is aware of this issue, and the crossing will be redesigned.

- There is no obvious dust control used on roads, with vehicles raising dust clouds.
- The ramp at Roberts Bay intended to allow snowmobiles to pass the fixed fuel line is unacceptably designed and built to allow safe usage. The staff at Hope Bay are aware of the issue and plans to replace it are underway.

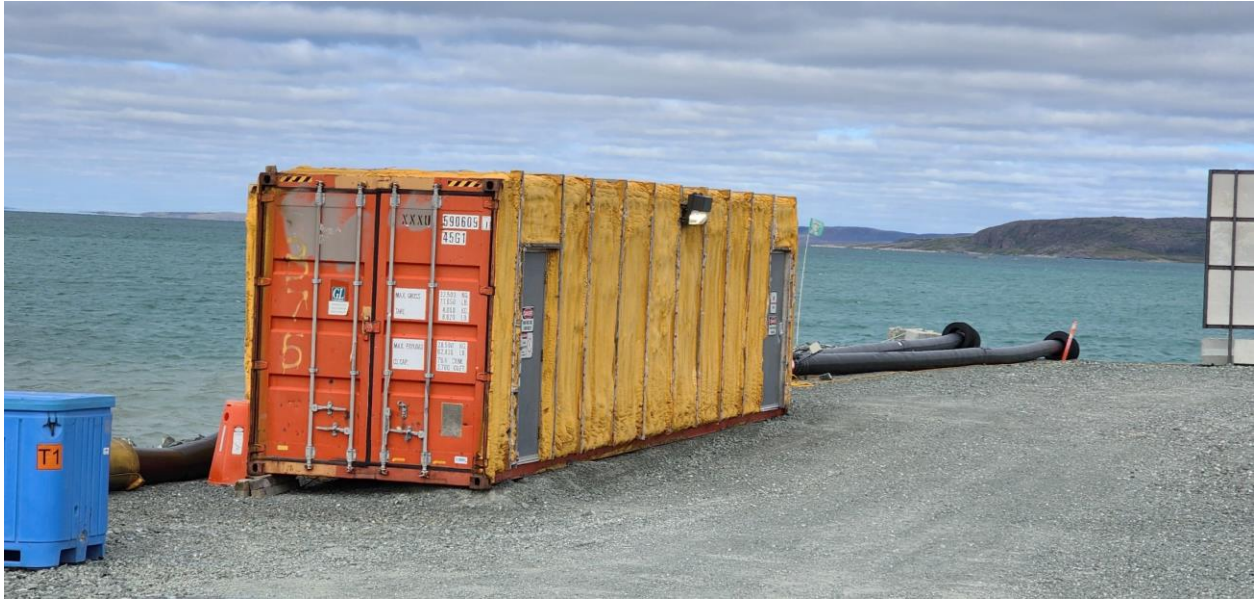
Photo 9: Treated Effluent Discharge Pipeline and Pumphouse – Weight Addition and Diffuser Reattachment Completed in 2024

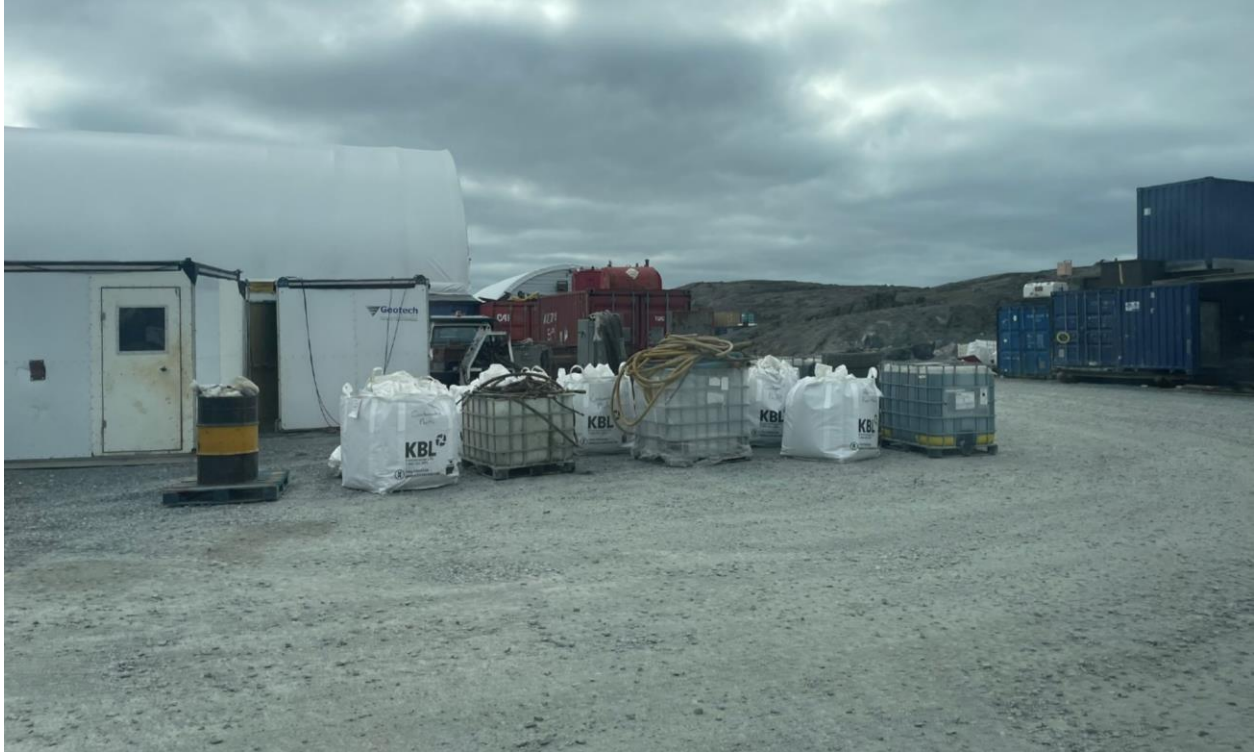
Photo 15: Hazardous Material, mostly contaminated plastic, outside secondary containment at the South Apron

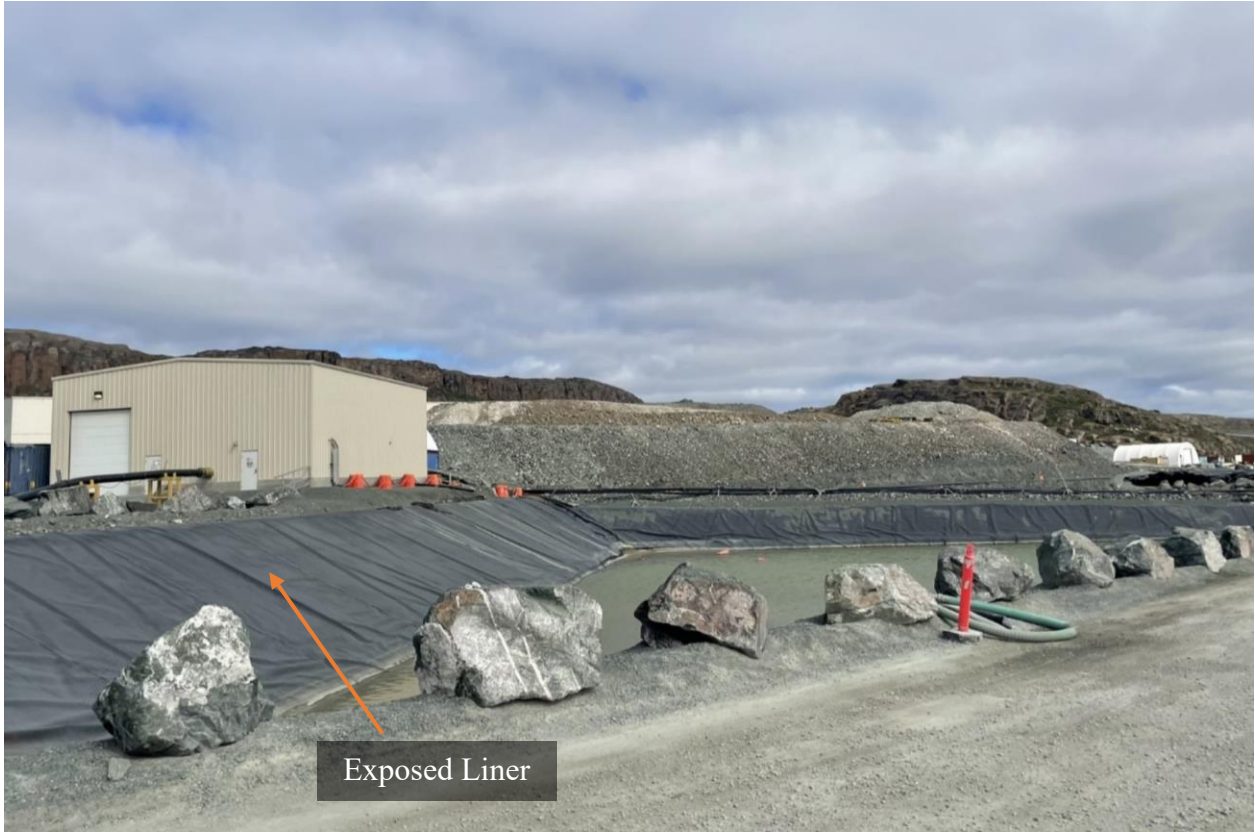
Exposed Liner

Photo 21: Contact Water Storage Pond

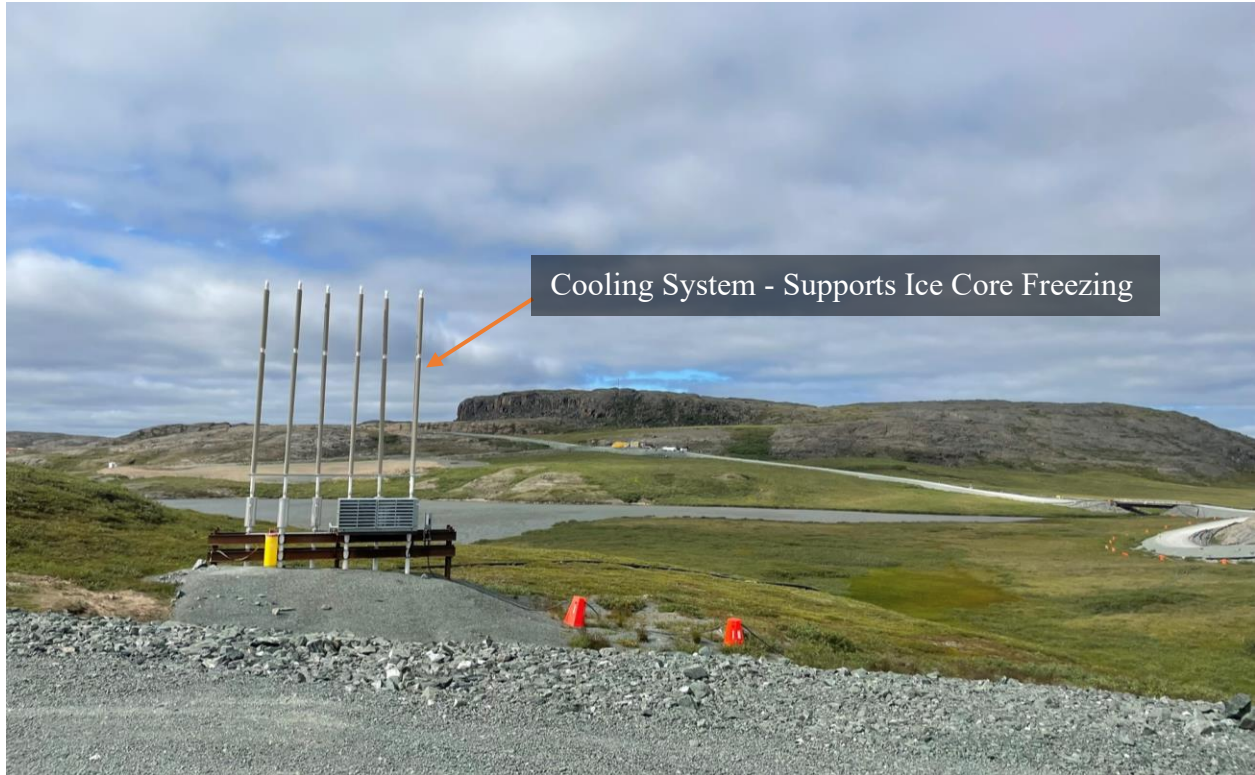
Cooling System - Supports Ice Core Freezing

Photo 34: Thermosyphon Cooling System at the North Dam

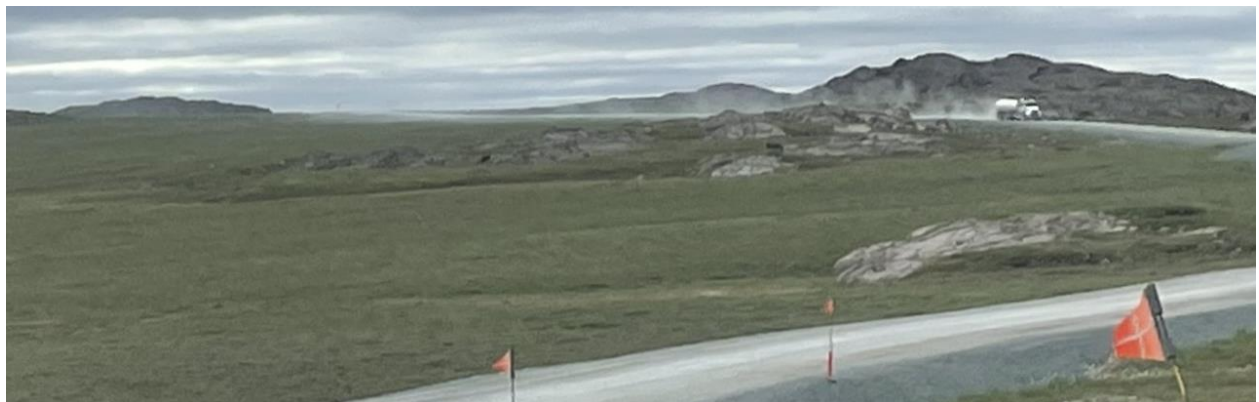
Photo 40: Doris-Windy All-Weather Road: Northbound Tanker Trailing Dust

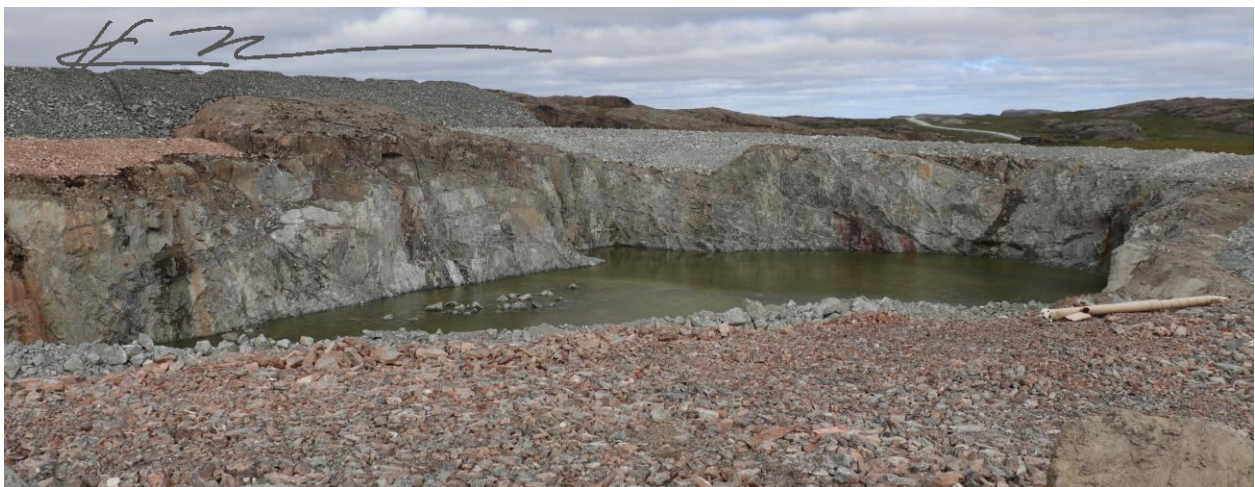
Photo 55: CWP2 Sump - used for collecting leakage from CWP2
