Rascal Stream West Culvert Installation Construction Monitoring Report

B2Gold Back River Project

22567626

December 12, 2023

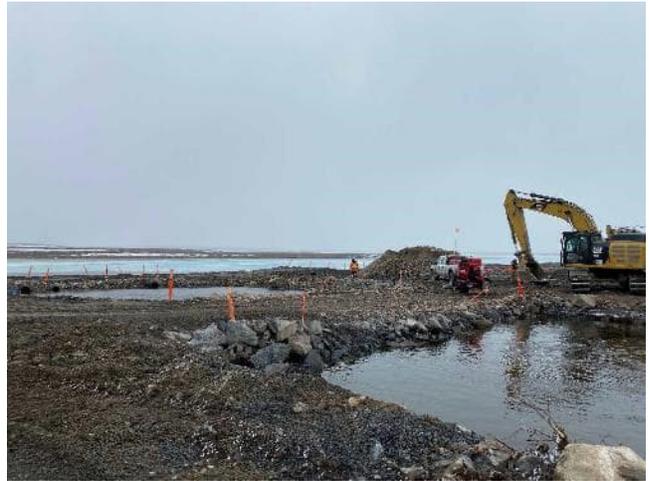
Photo 2: Lower pond seeping into twin multiplate excavation through temporary road, 10 May 2023.

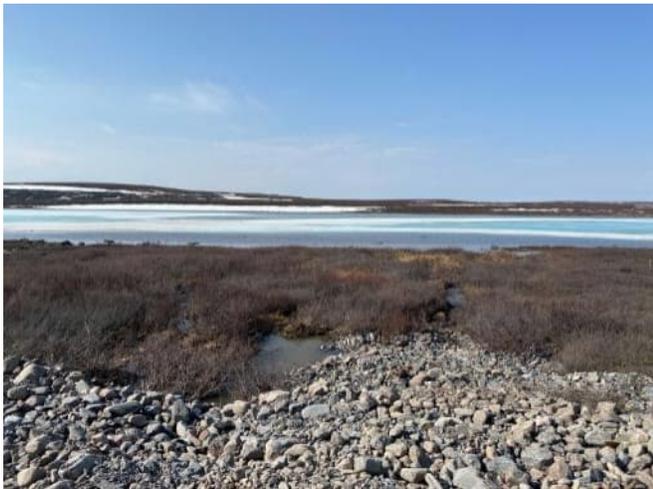
Photo 9: View of seepage under the road, facing Goose Lake, 12 May 2023.

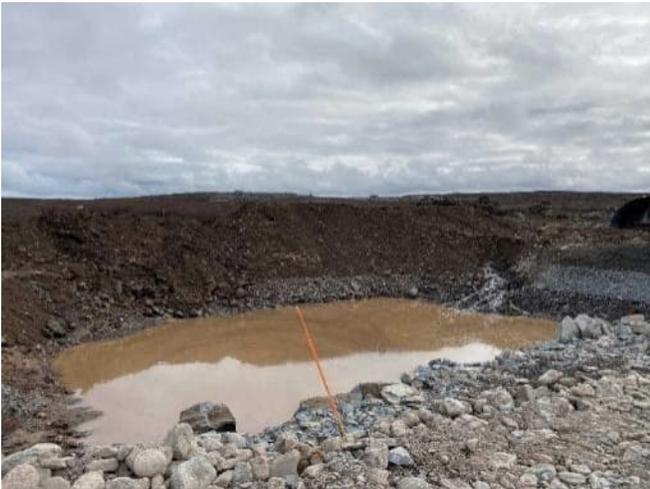
Photo 15: View of the downstream side of the diversion berm, facing upstream, 15 May 2023.

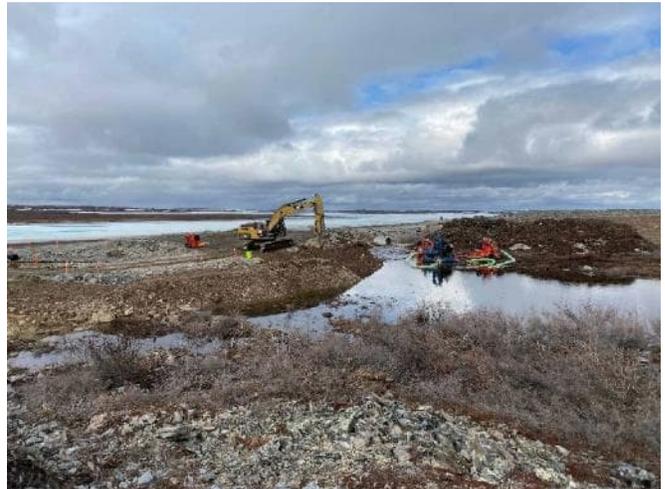
Photo 16: View of the diversion dam and diversion channel, facing downstream, 15 May 2023.

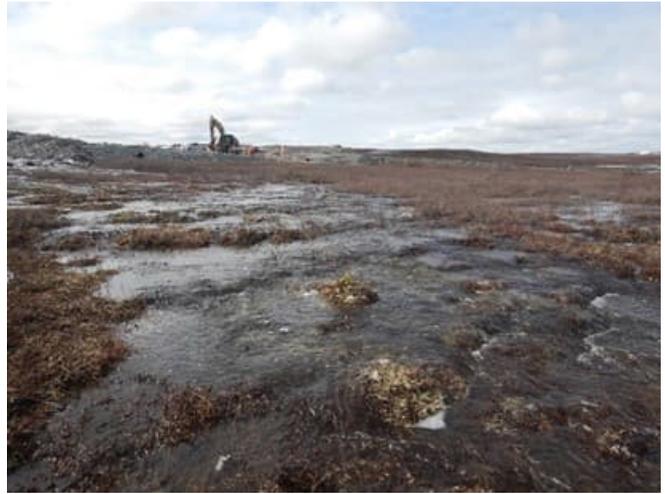
Photo 18: View of the RSW secondary channel showing flooding on tundra, facing upstream, 16 May 2023.

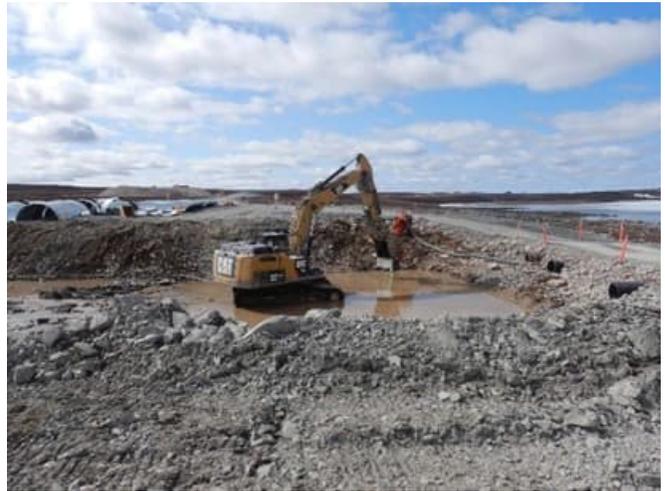
Photo 20: Excavator working in excavation pond, 16 May 2023.

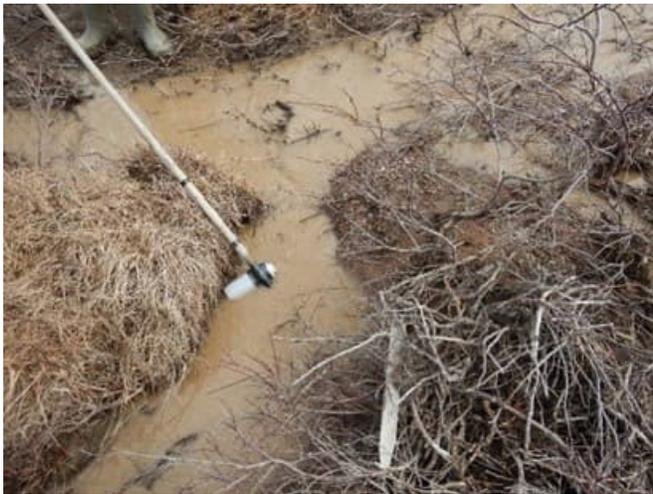
Photo 21: Very turbid water at monitoring station DS2.2, 16 May 2023.

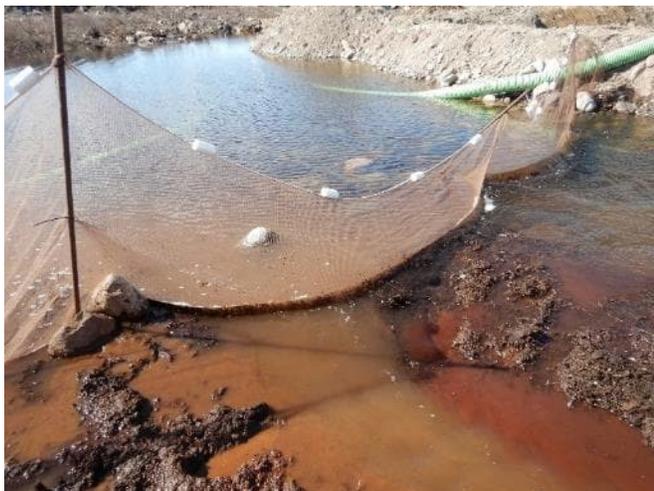
Photo 25: Block net filling with debris, facing upstream, 17 May 2023.

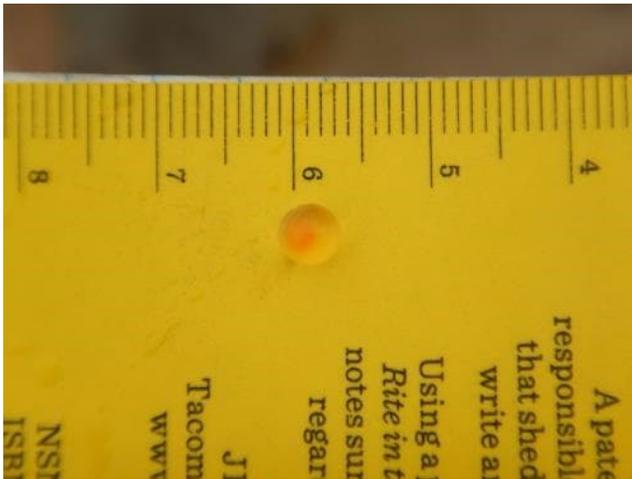
Kick net surveys were conducted at all potential Arctic Grayling spawning habitat identified between Goose Lake and Gander Pond (Table 3-5). Arctic Grayling eggs were captured in the secondary and diversion channel (Table 3-5; Appendix A, Photo 37). No Arctic Grayling eggs were observed in the primary channel.

Photo 37: Arctic Grayling egg captured from Rascal Stream West during kick net surveys, 24 May 2023.
