2023 Annual Geotechnical Inspection		
		Gander Crossing		
Job No: CAPR003105 Filename: BackRiver_Goose_2023AGI_PhotoLog.pdf	Back River Project	Date: 2024-02-28	Approved: JBK	Figure: A.1-39

Back River Project

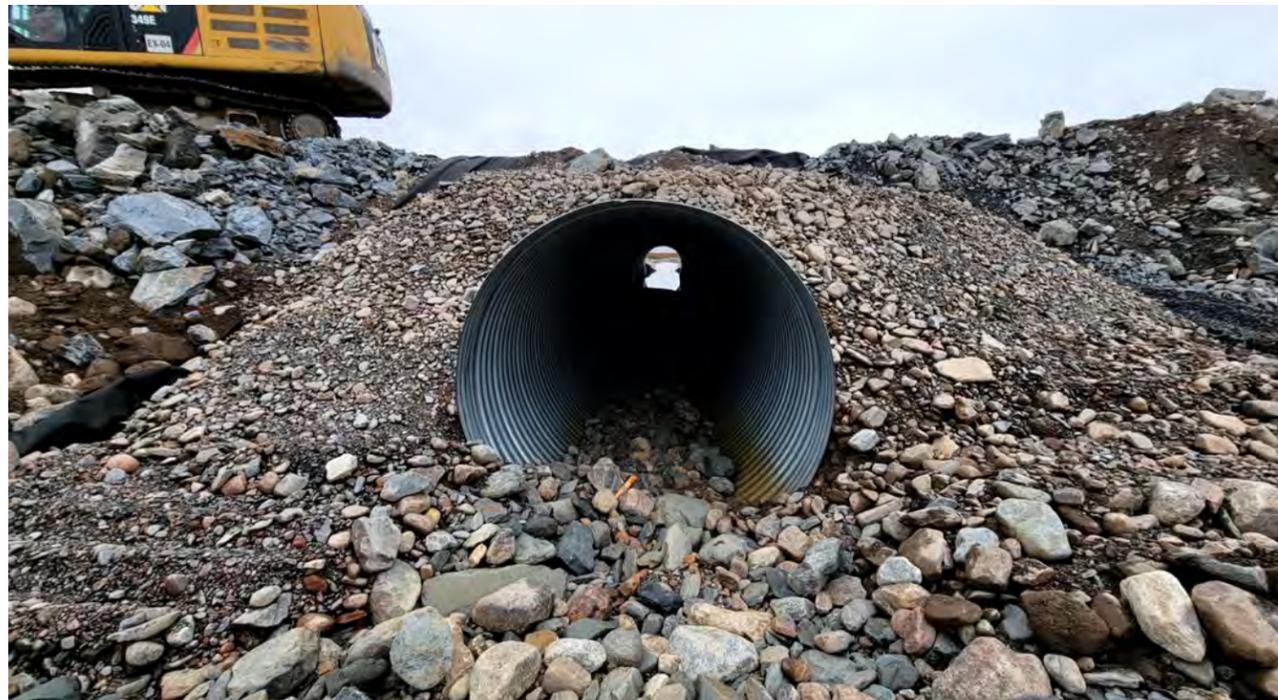
G-101. Culvert #3: Outlet

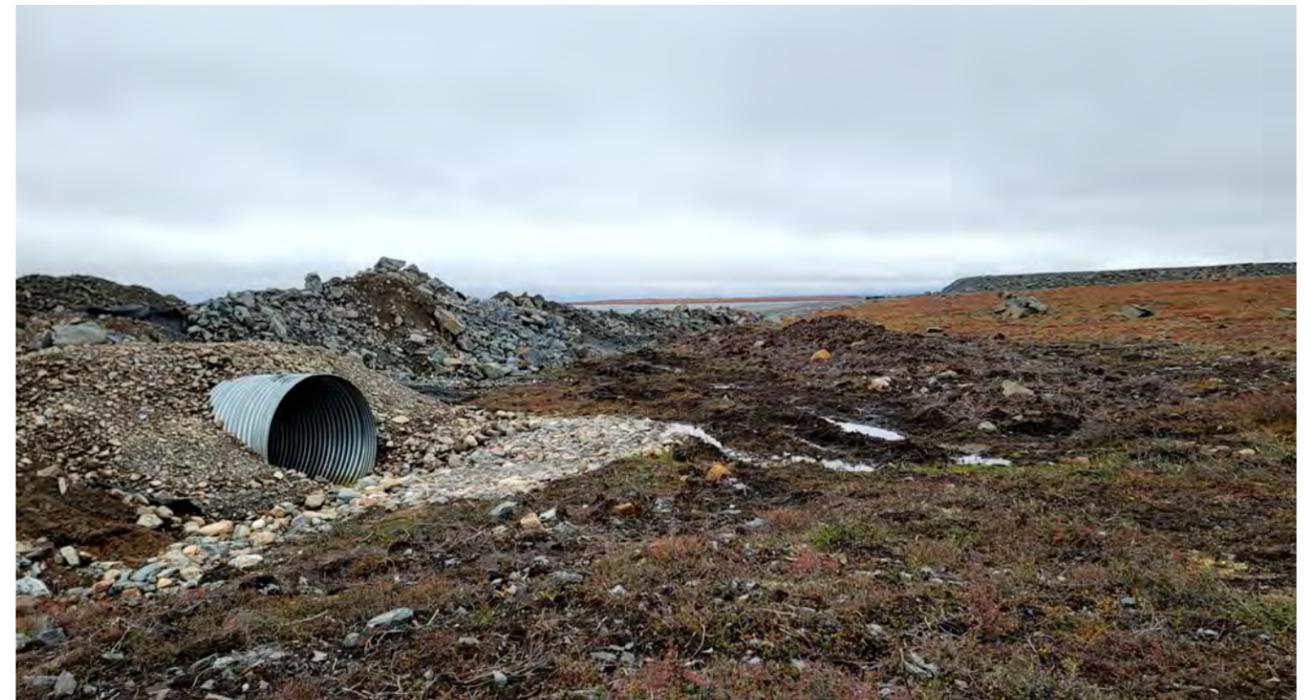
G-102. Culvert #3: Outlet. Note the tundra degradation around the outlet

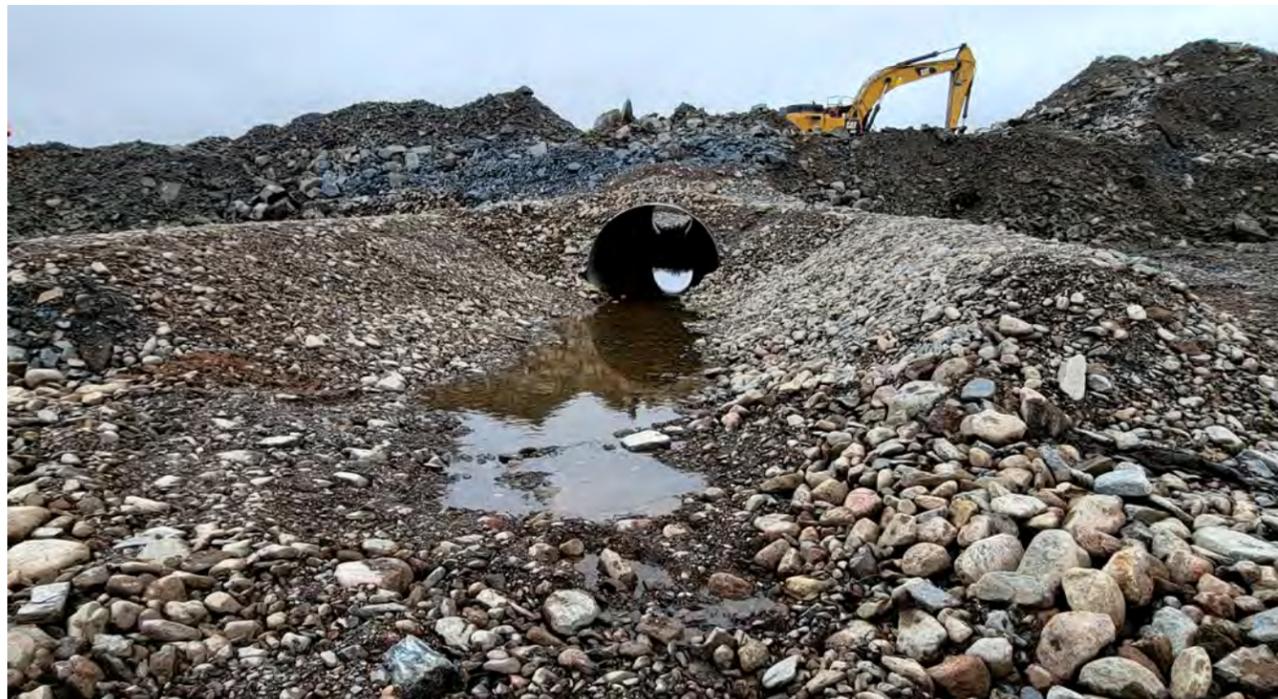
G-103. Culvert #3: Inlet

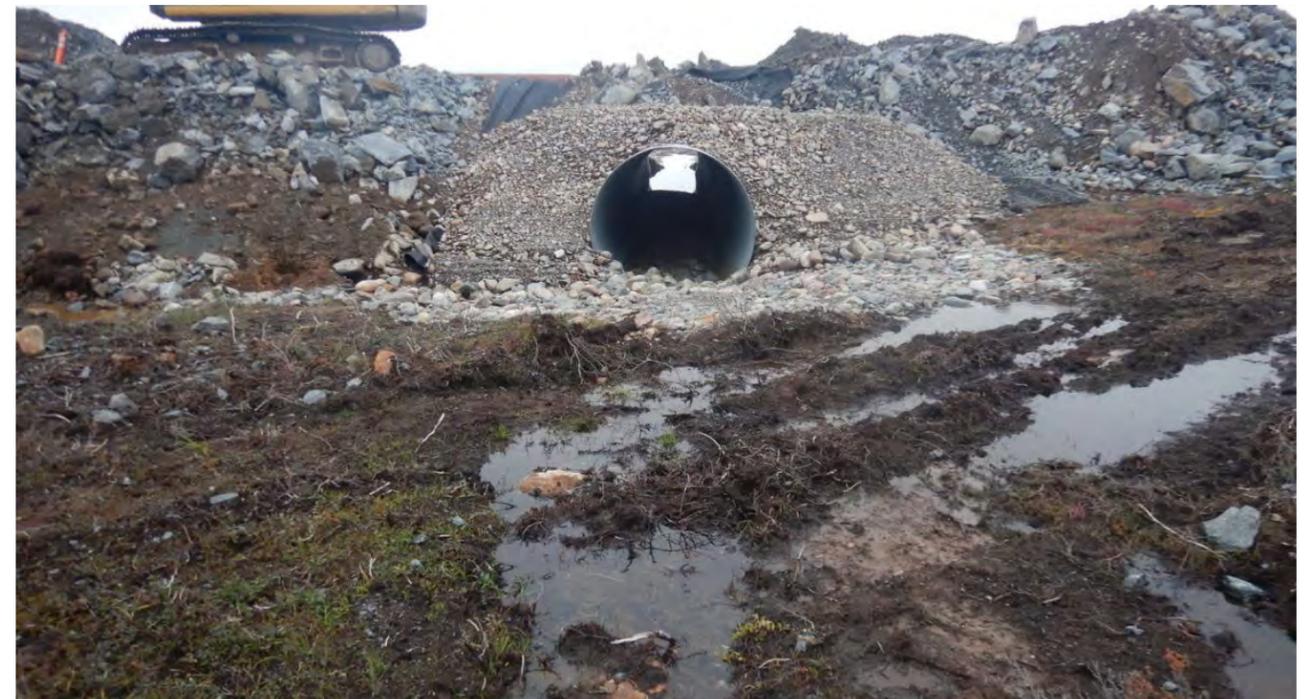
G-104. Culvert #3: Outlet. Note the thickness of the overculvert fill

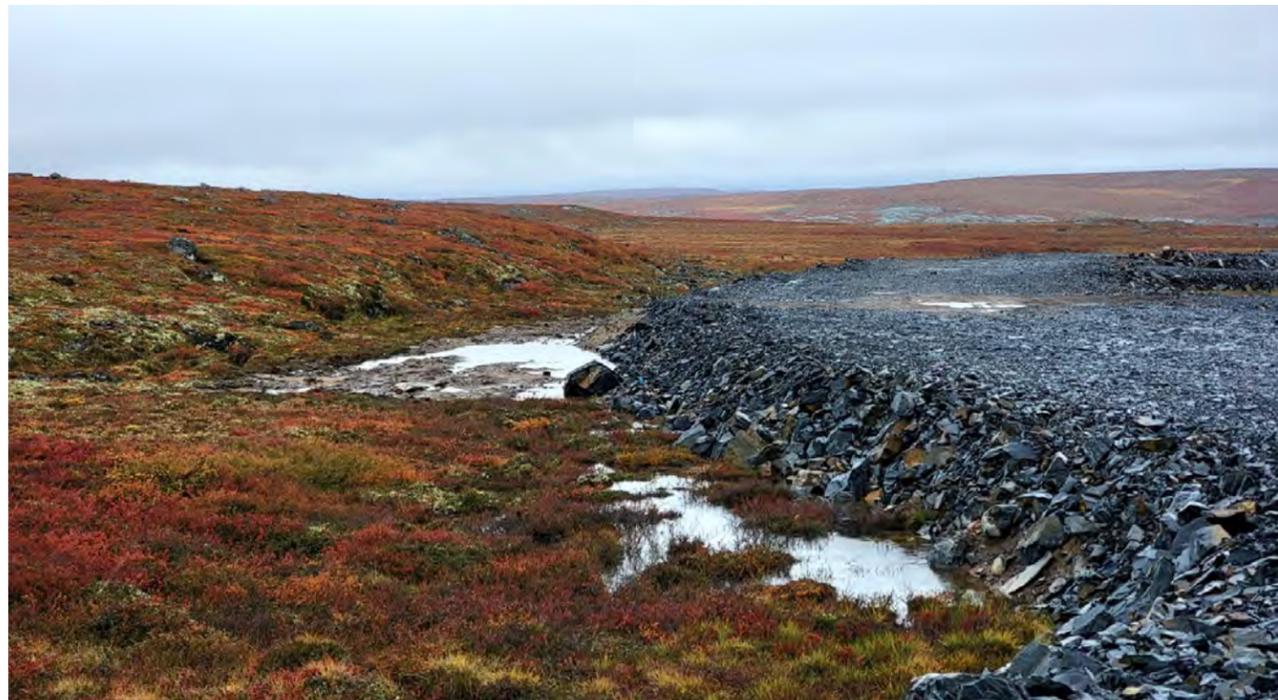
G-105. - Echo Diversion berm, looking NE. Note the thickness of the pad

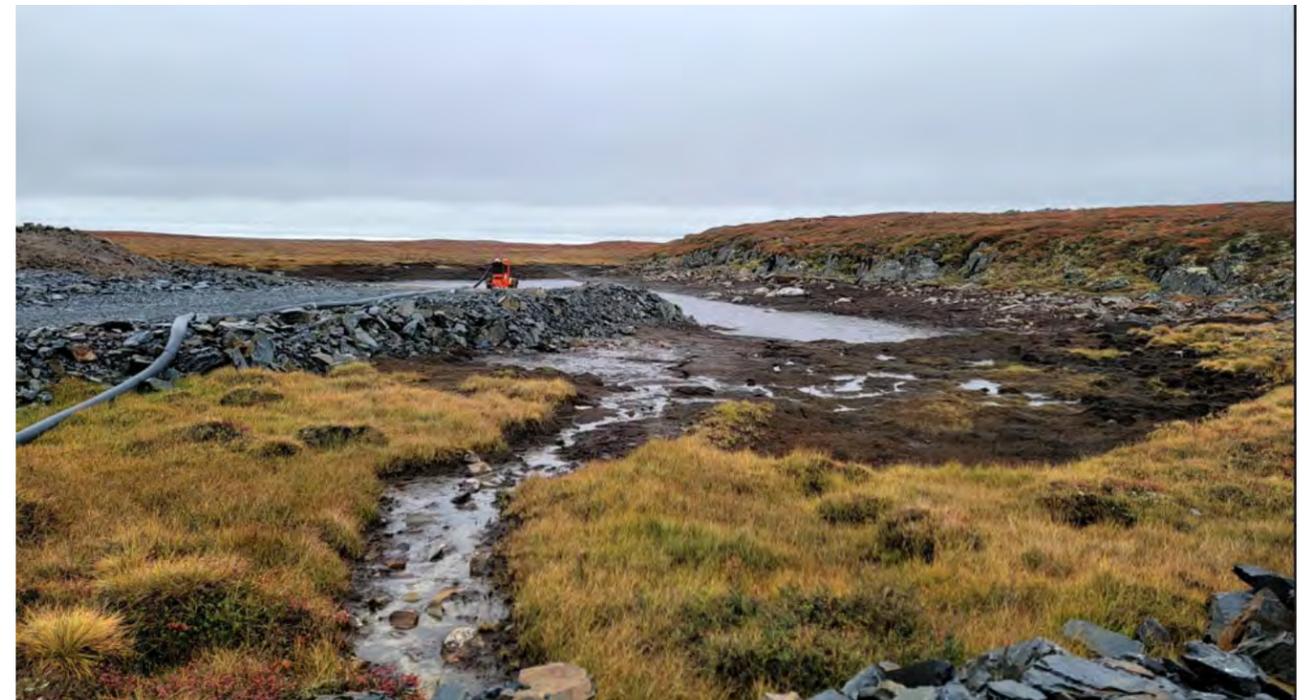
G-106. – A pond at the toe of the diversion berm and discharge point of the drainage water form Echo Pit

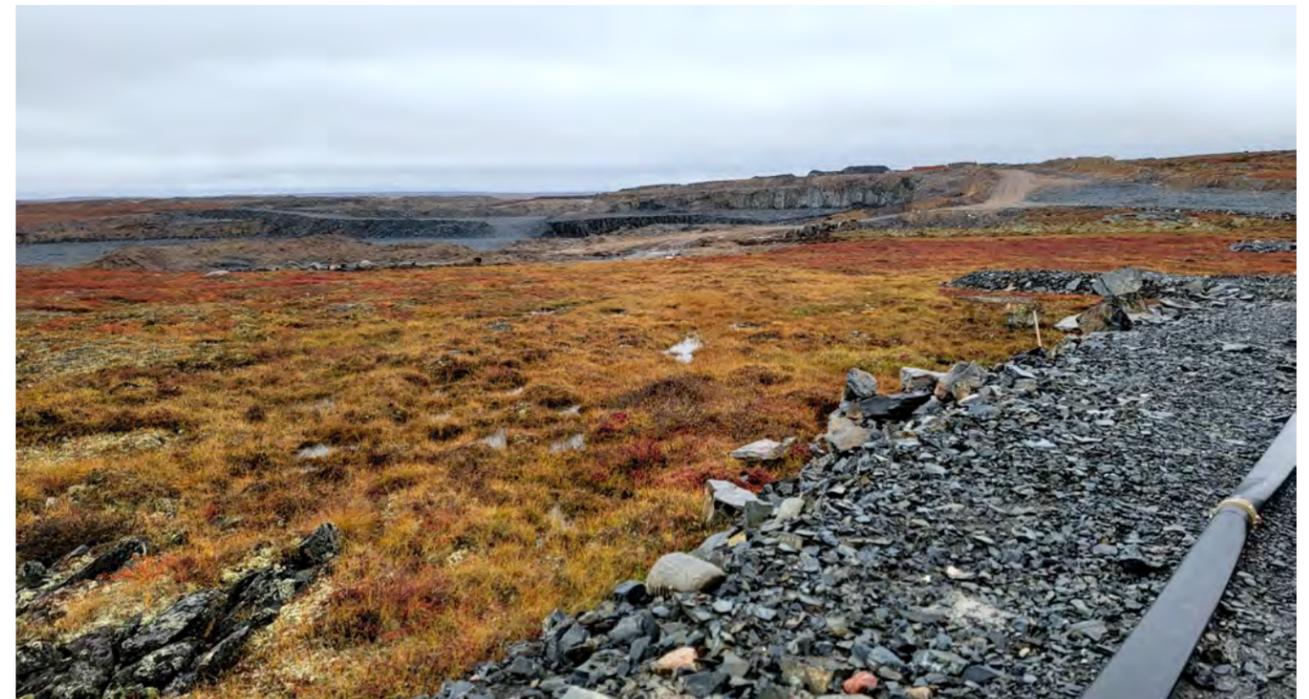
G-108. Echo Diversion berm, looking north. Note the thickness of the pad

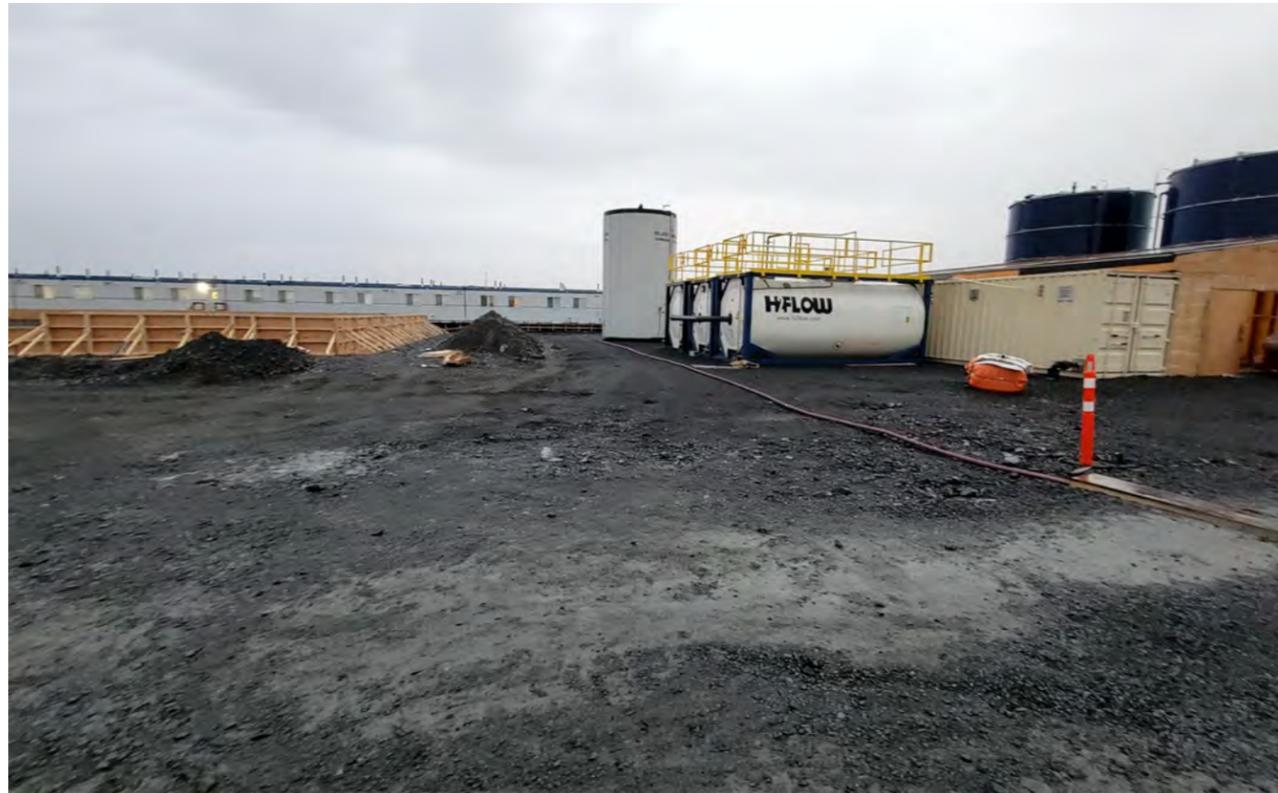
G-109. – Warehouse construction is in progress. Example of the fill material used in the pad construction

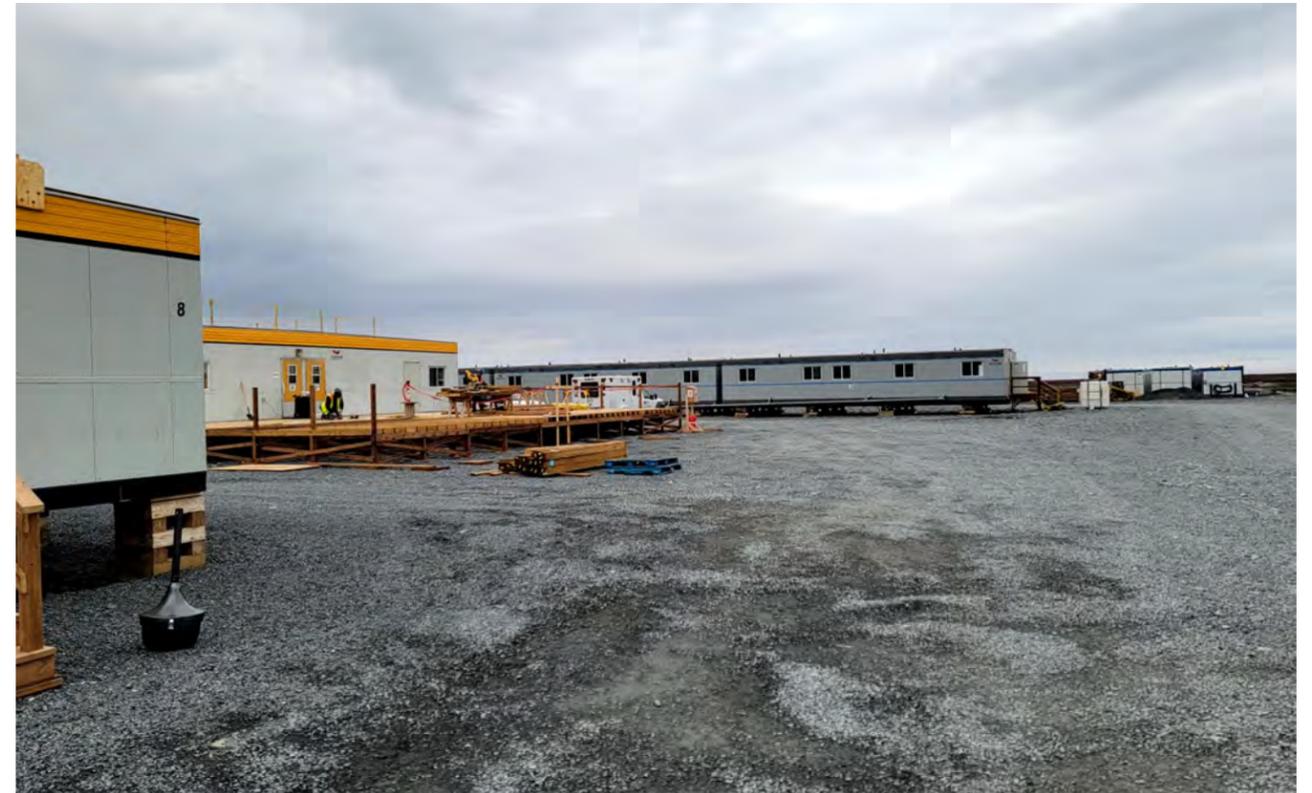
G-110. – Example of the fill material used in the pad construction

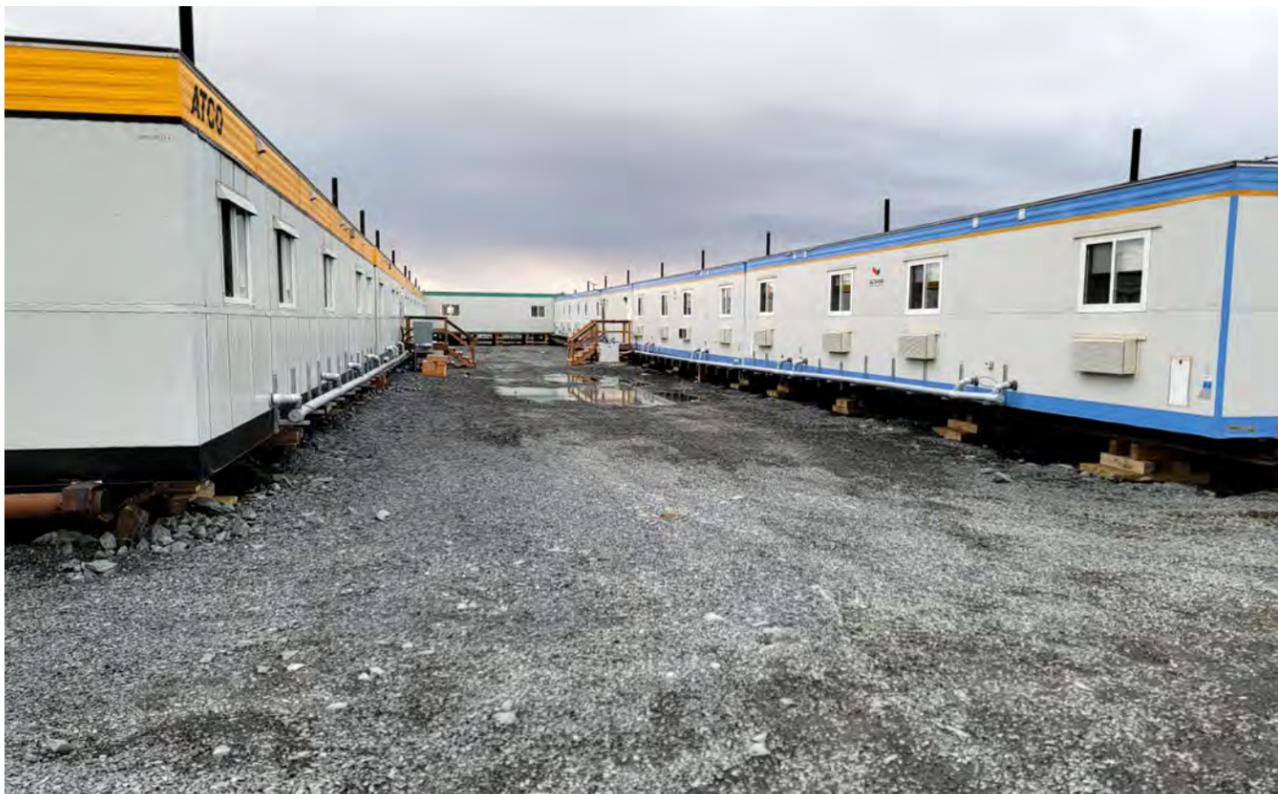
G-111. – All dormers have been mounted onto the wooden foundation to allow airflow below the buildings

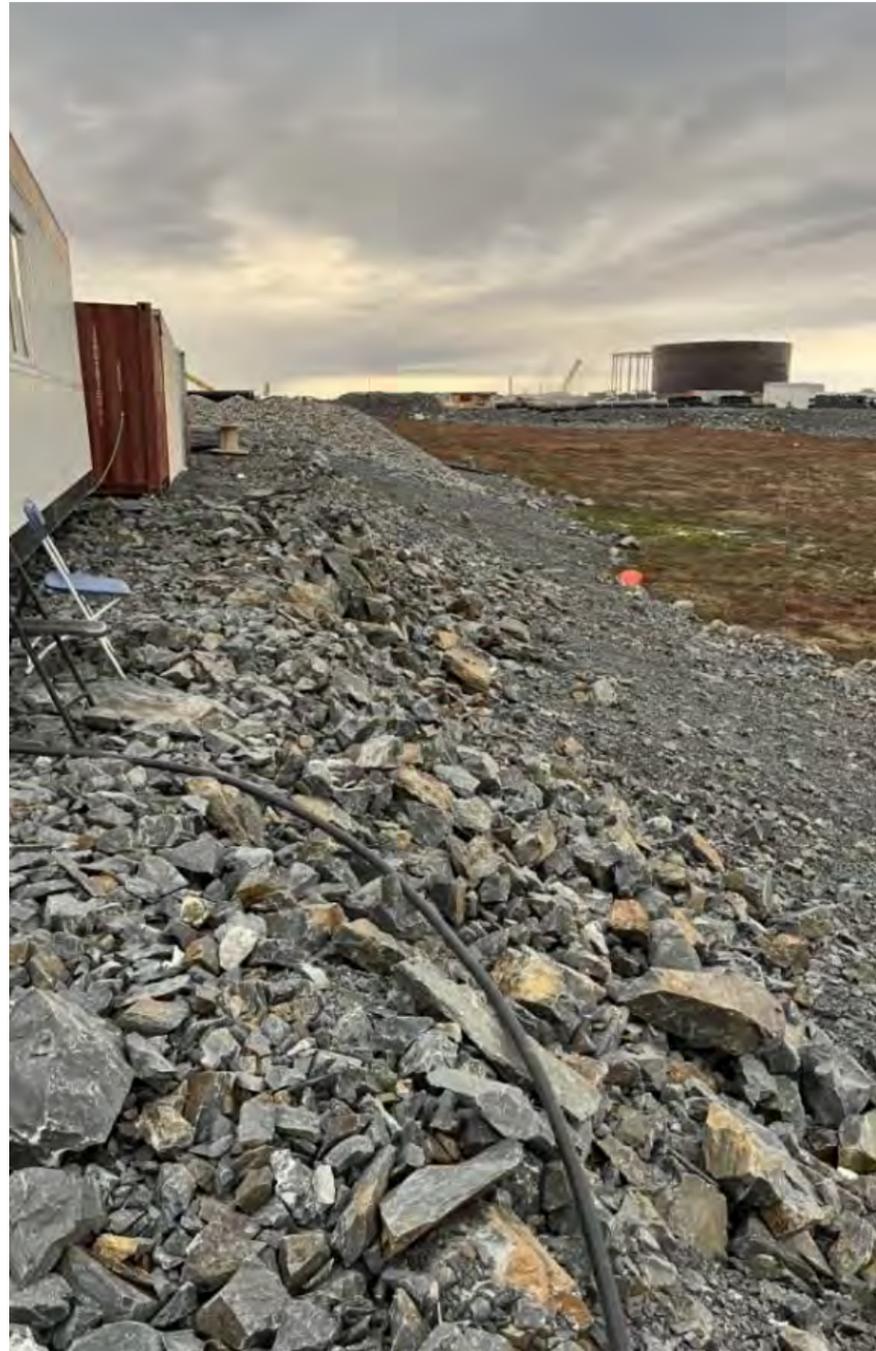
G-112. – Southern slope of the Camp Pad. Photo was taken looking east

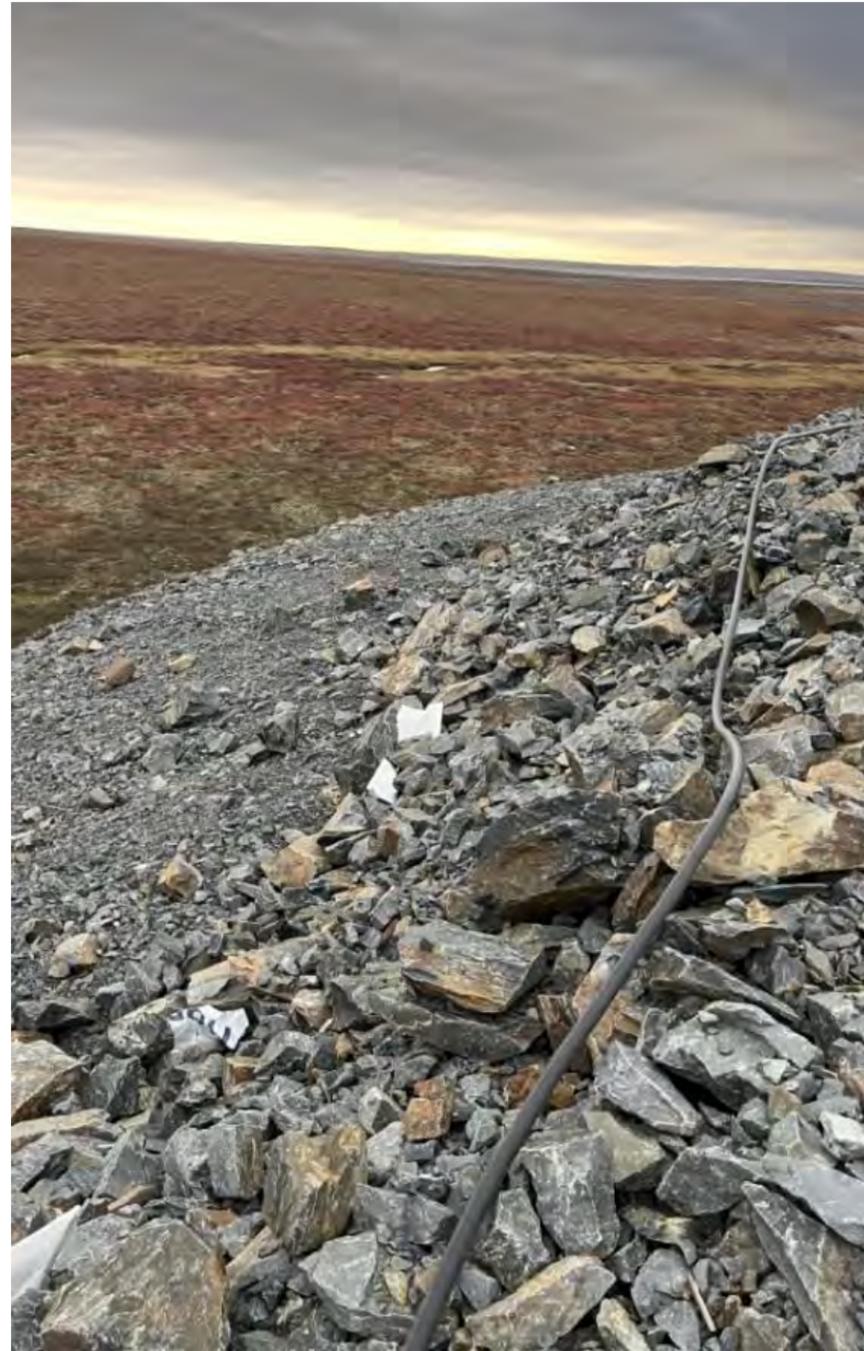
G-113. – Western slope of the Camp Pad. Photo was taken looking NW

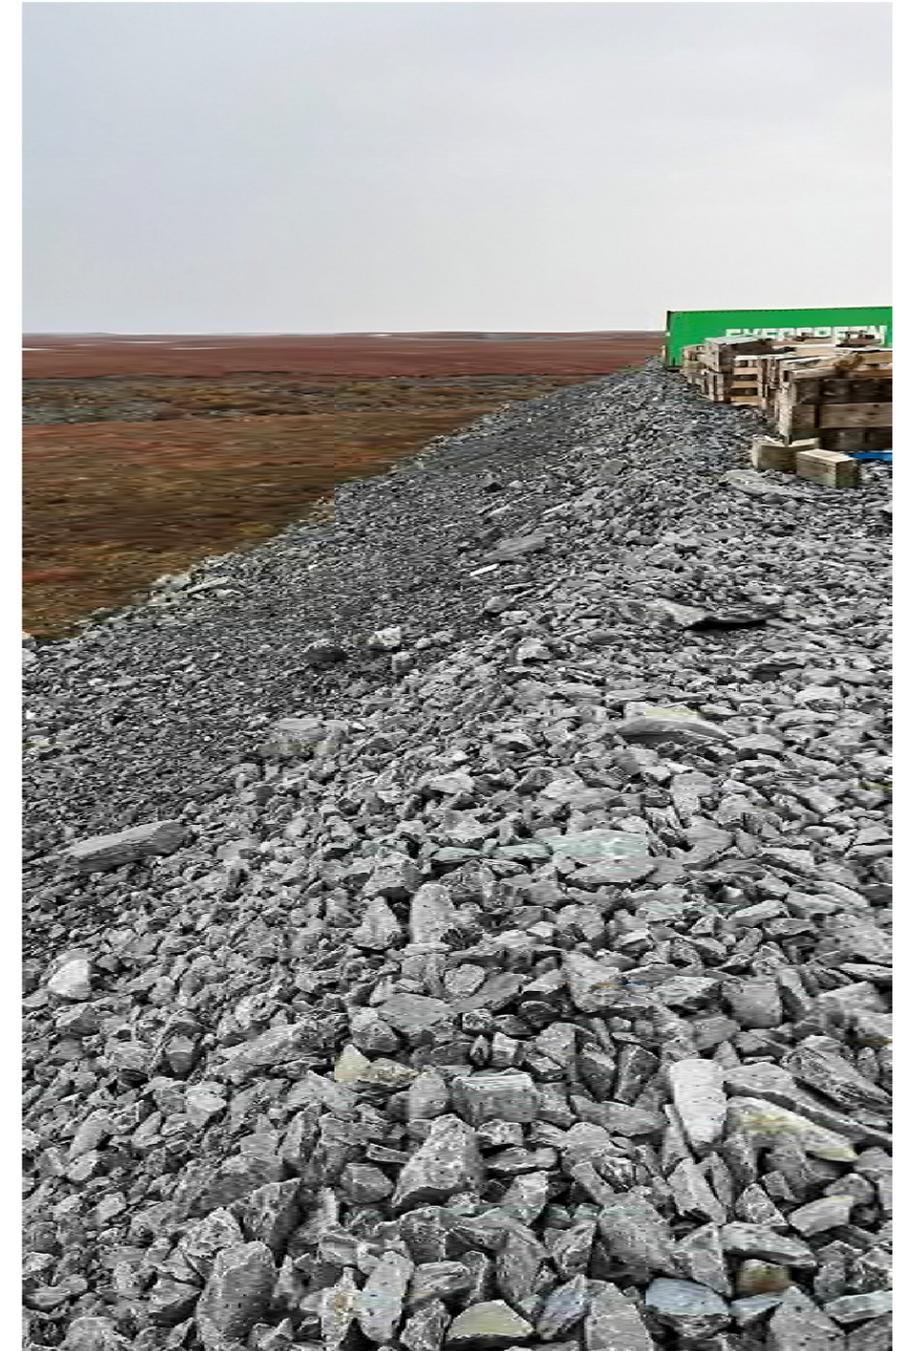
G-114. – Northwestern corner of the Camp Pad. Photo was taken looking NWt

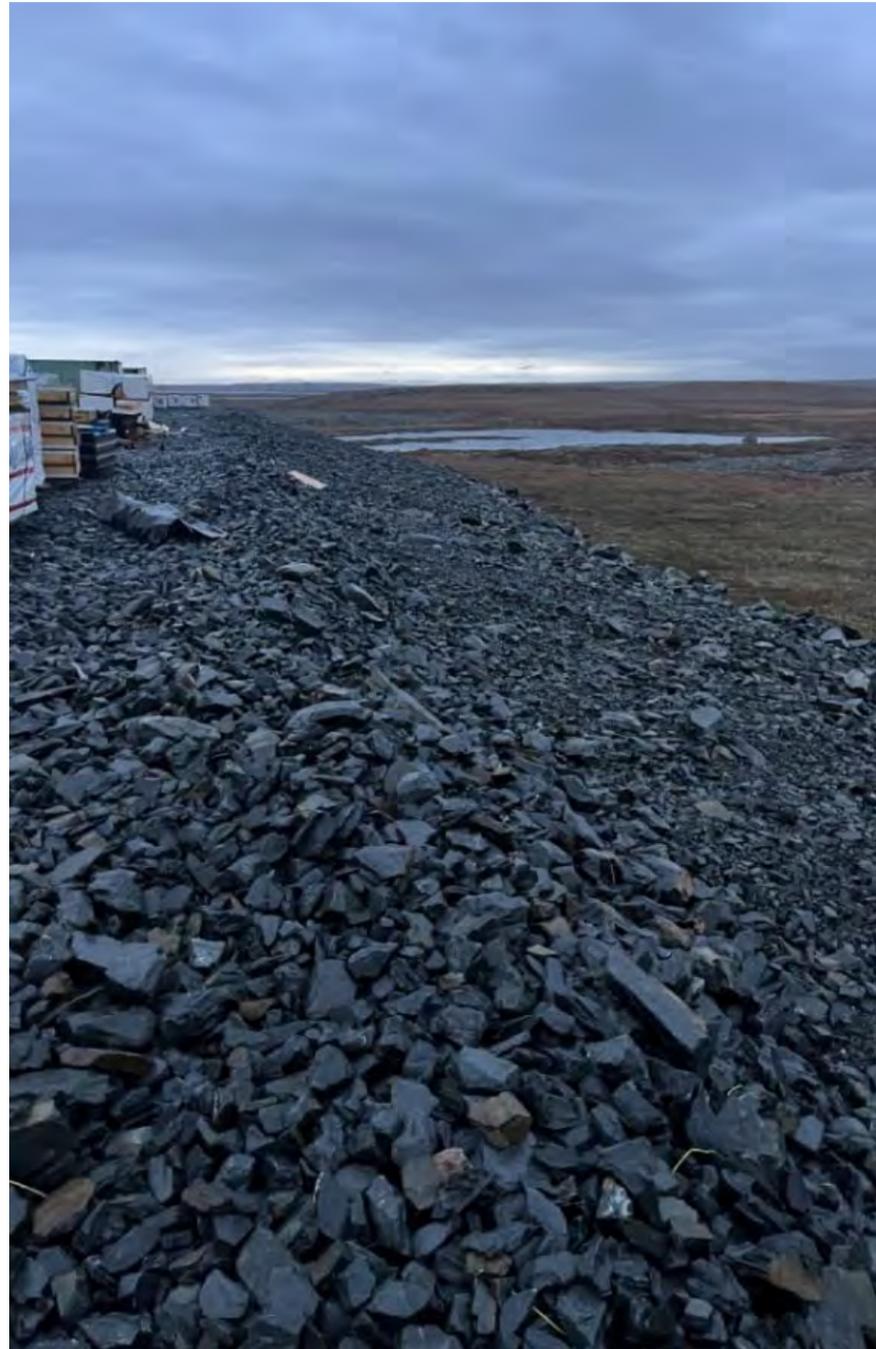
G-115. – Northern slope of the Camp Pad. Photo was taken looking west

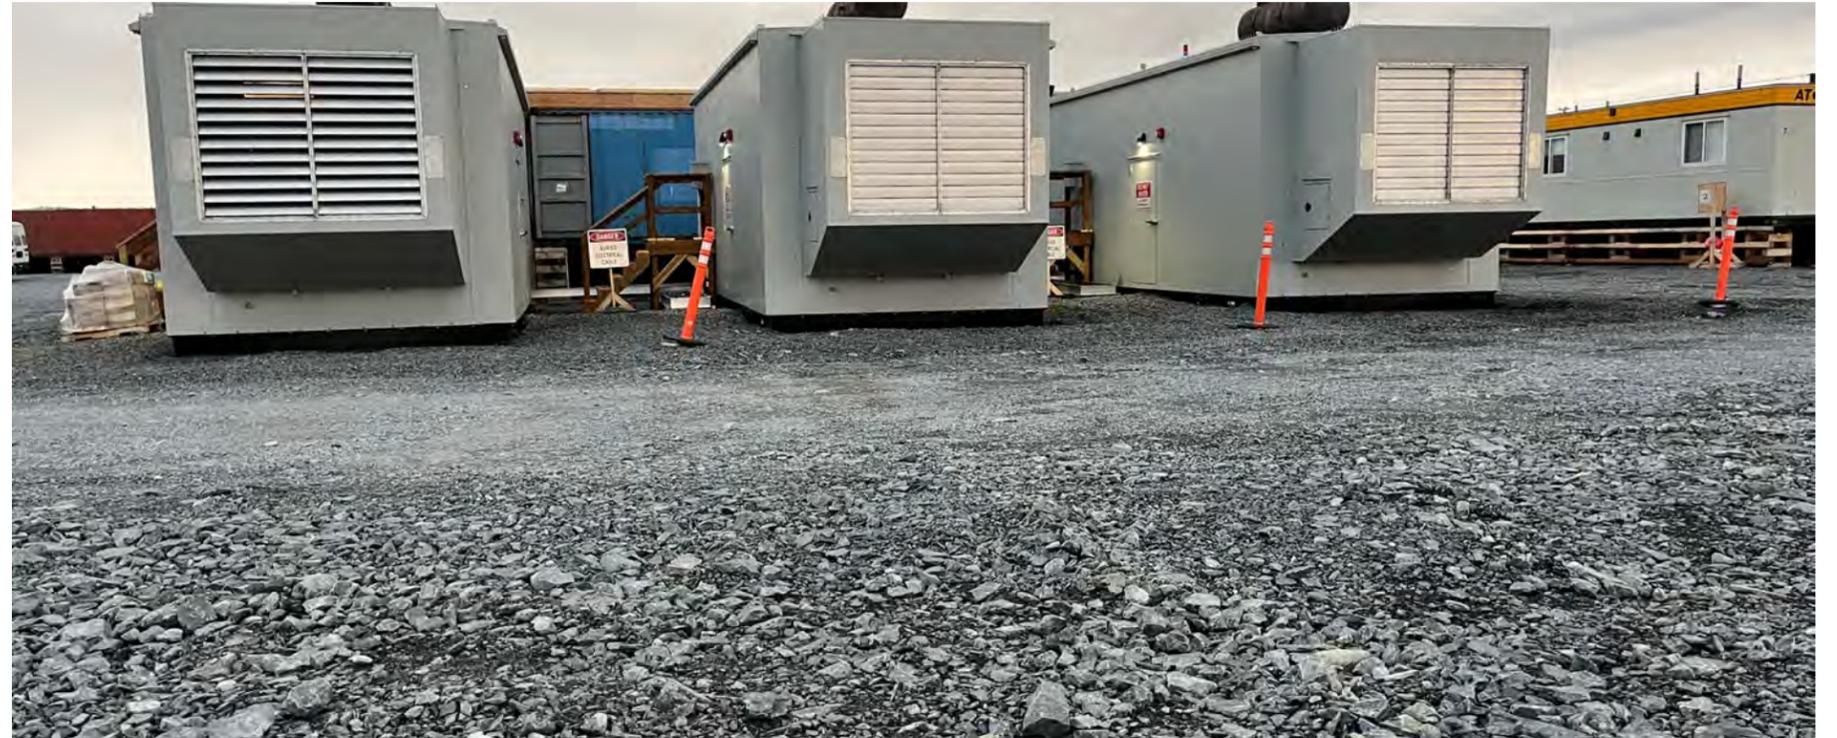
G-116. – Example of the fill materials used for the camp pad construction

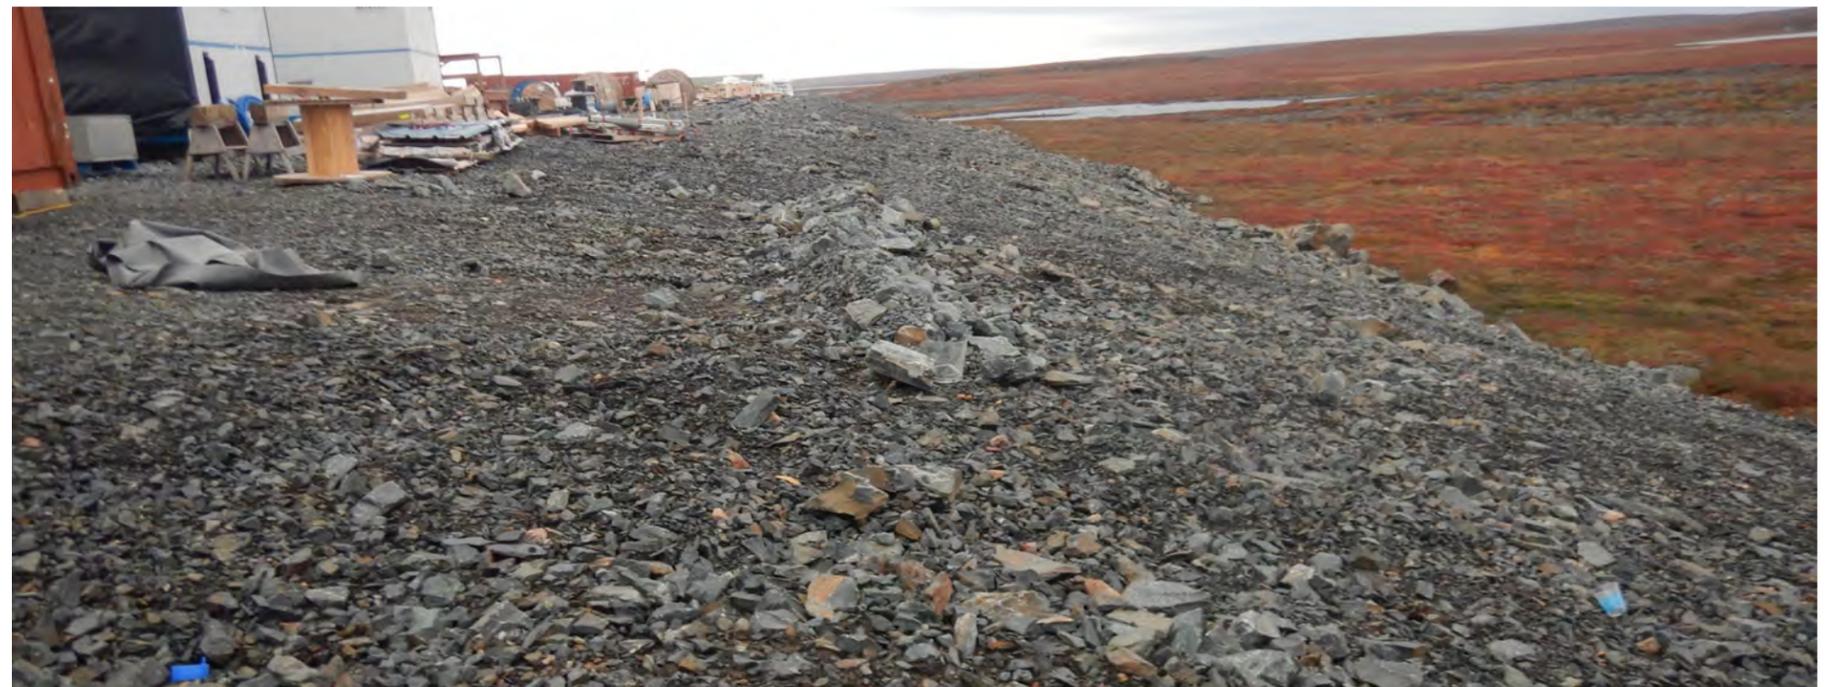
G-117. – Northern Slope of the Camp Pad. Photo was taken from the northeast corner of the pad looking west

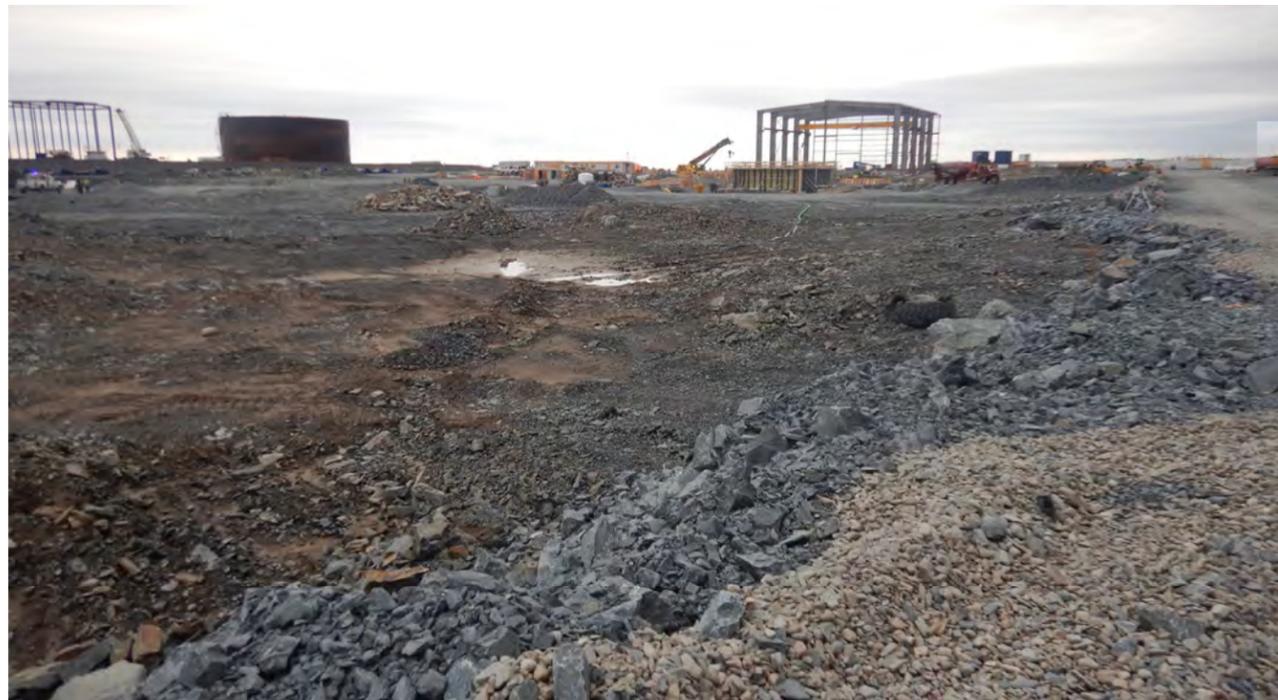
G-118. – Northern side of the Processing Plant pad, looking SW

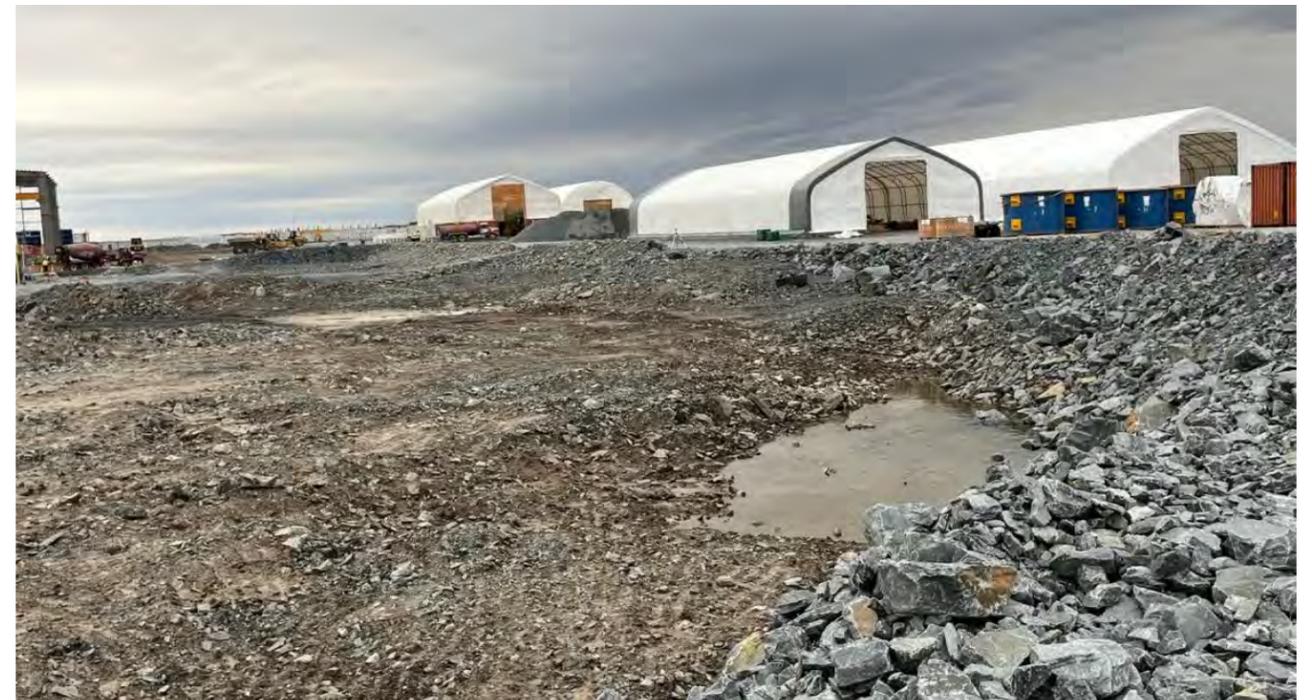
G-119. – NE corner of the Processing Plant pad, looking NW

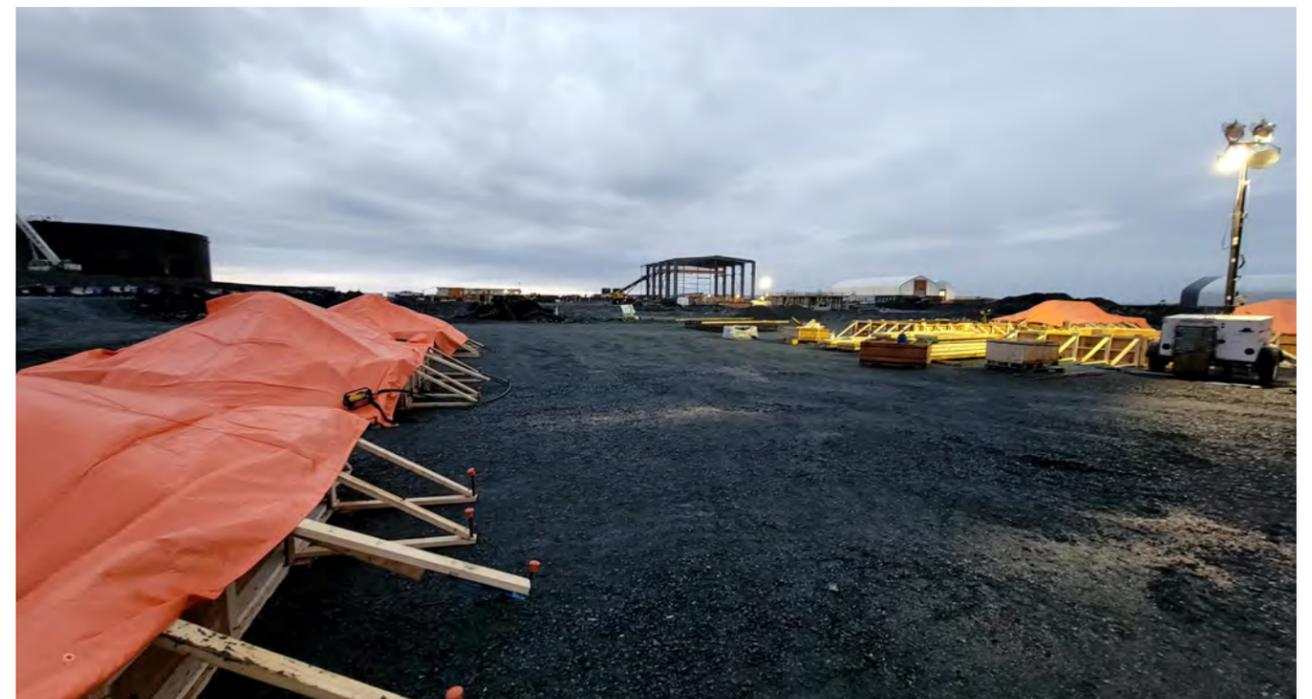
G-121. – Central part of the Processing Plant Pad: Power Plant foundation

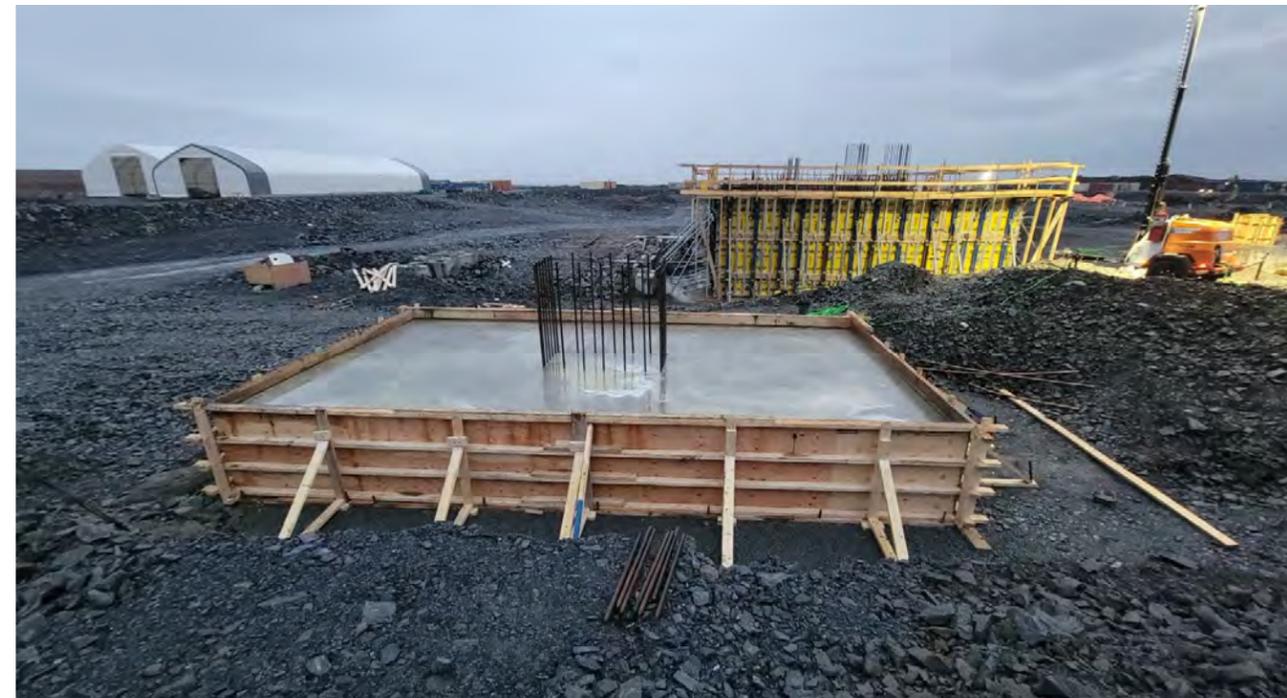
G-123. – Processing Plant: construction of the footings

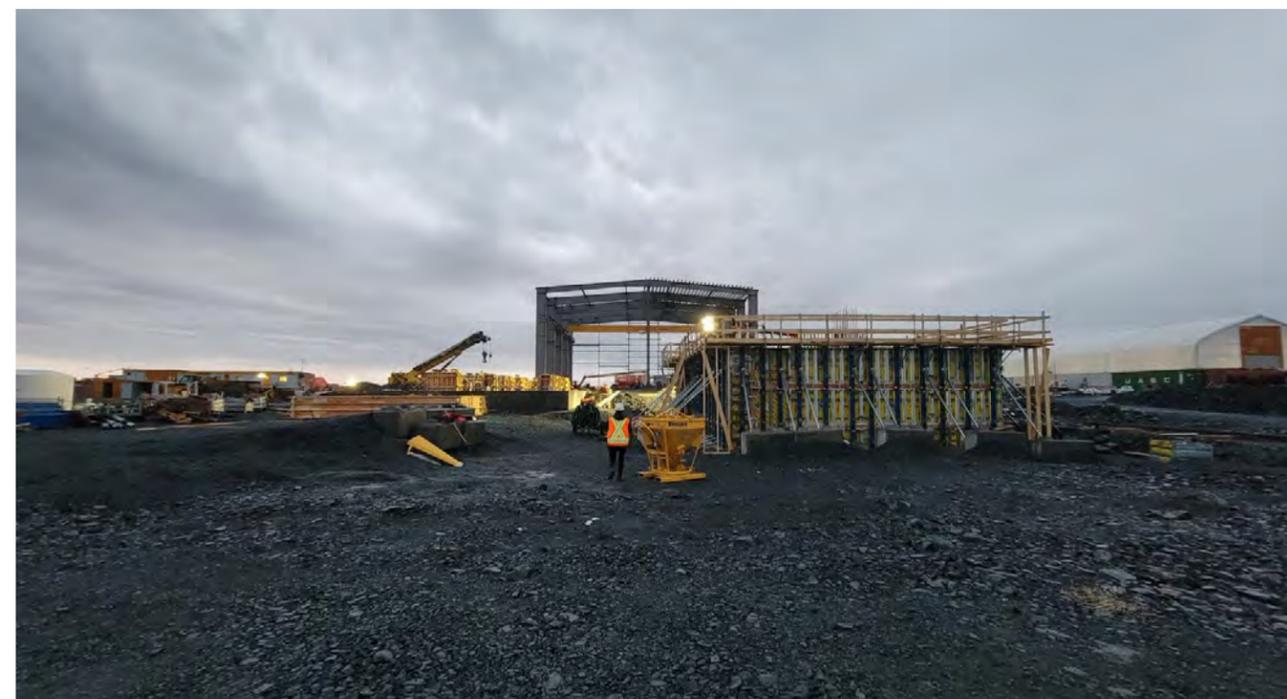
G-125. – Processing Plant: construction of the footings

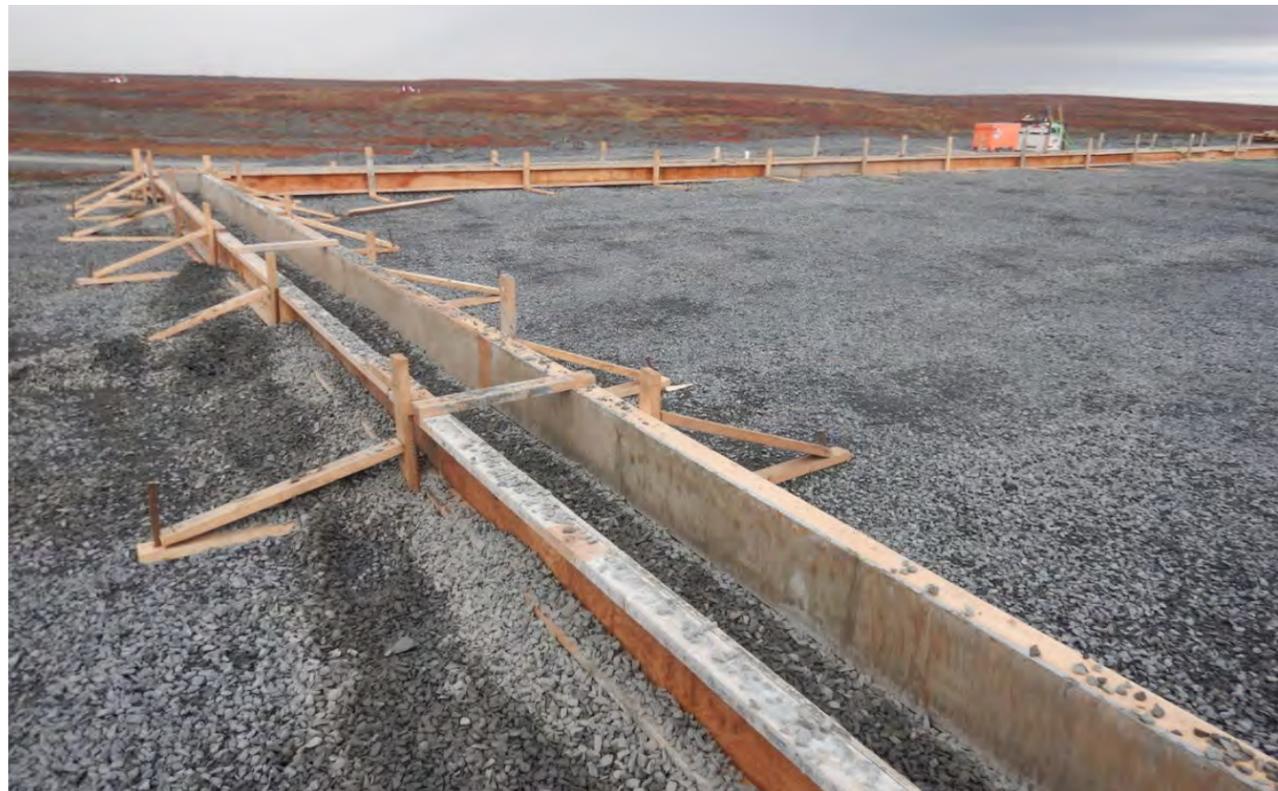
G-126. – Construction of the tent foundation
