2023 Annual Geotechnical Inspection		
		Gander Crossing		
Job No: CAPR003105 Filename: BackRiver_Goose_2023AGI_PhotoLog.pdf	Back River Project	Date: 2024-02-28	Approved: JBK	Figure: A.1-39

Back River Project

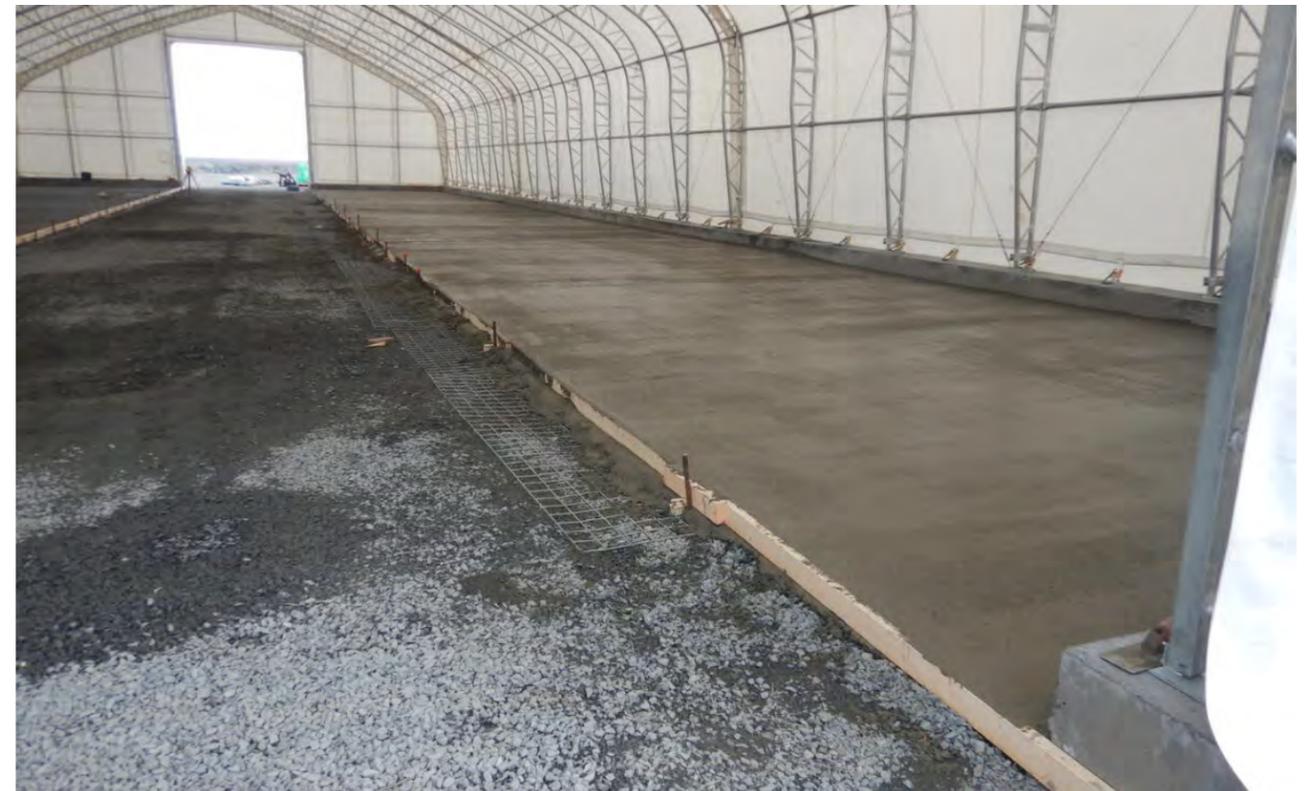
G-127. – Base of the tent: pored concrete

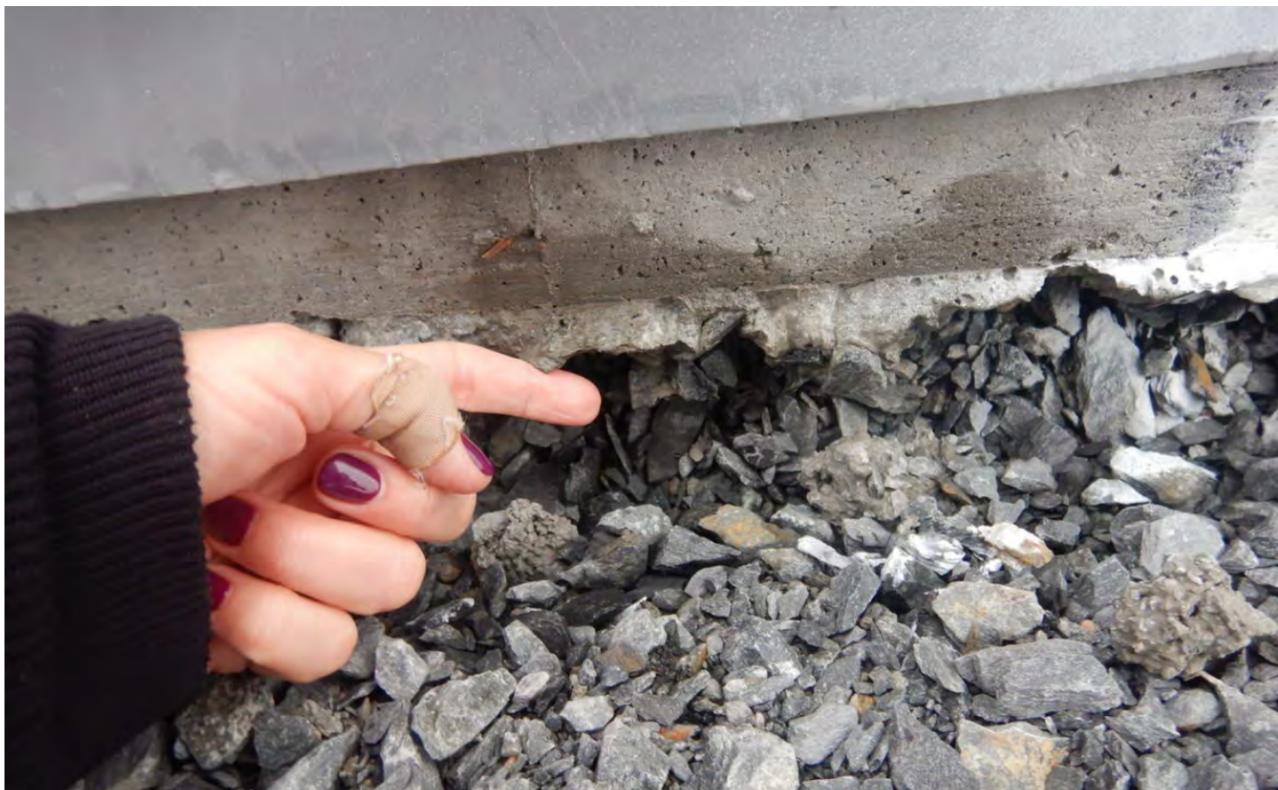
G-128. - Some voids observed between the footing and the fill material

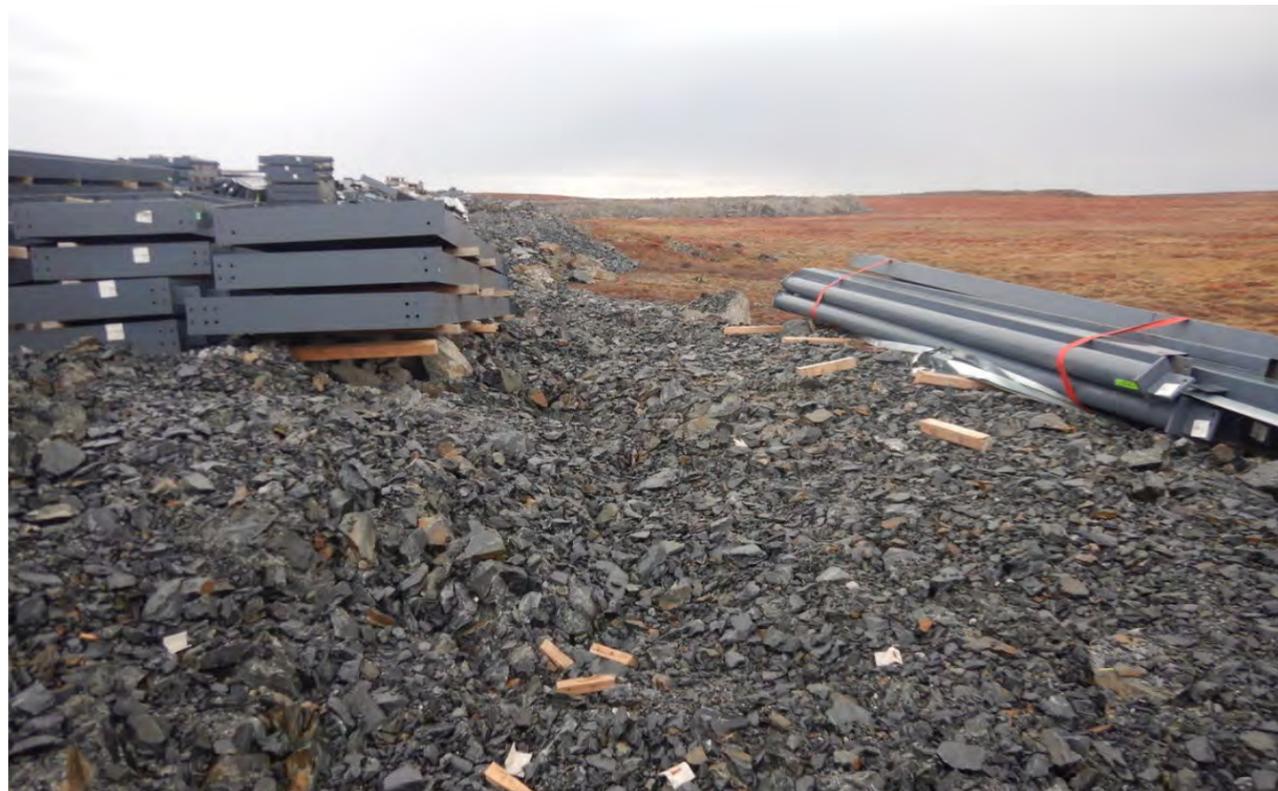
G-129. – Southern slope of the Plant Site Pad, looking east. Note that stored materials are placed too close to the edge of the pa

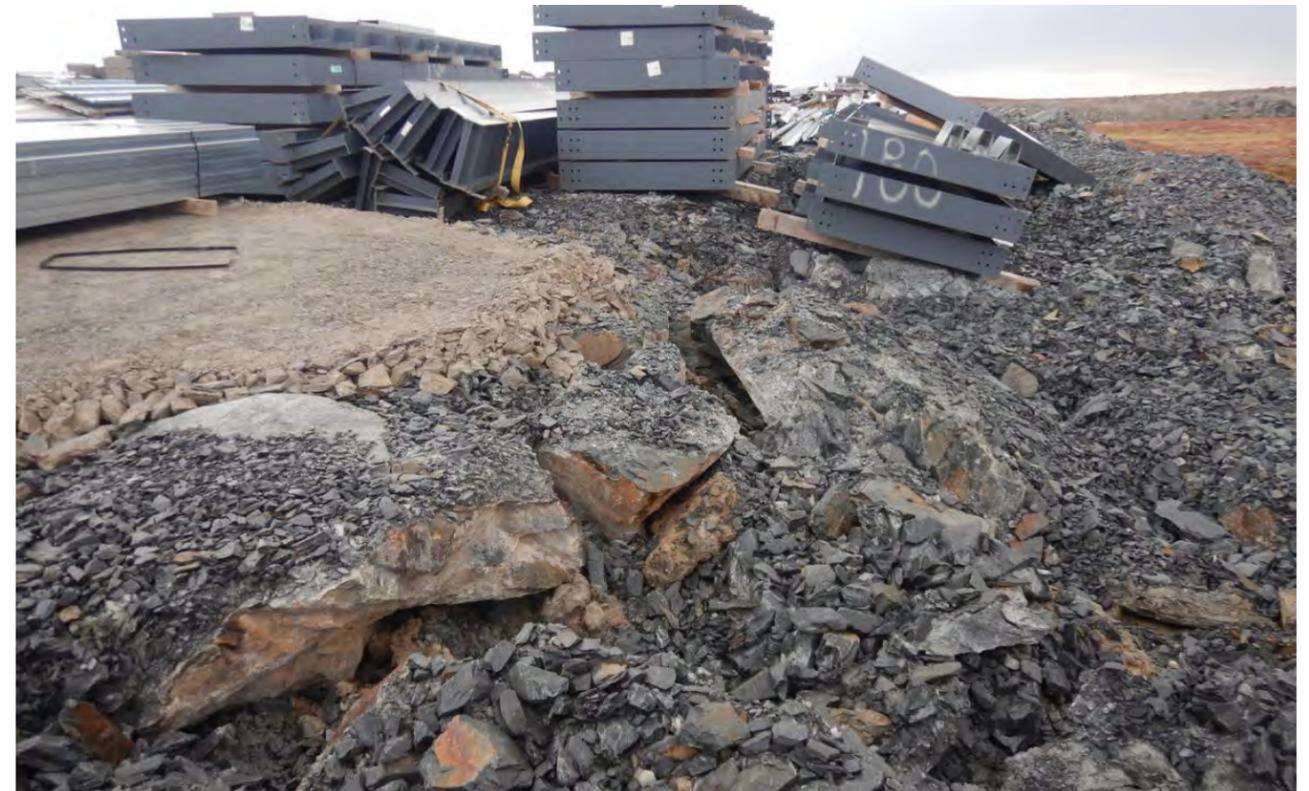
G-130. – Southern slope of the Plant Site Pad, looking east.

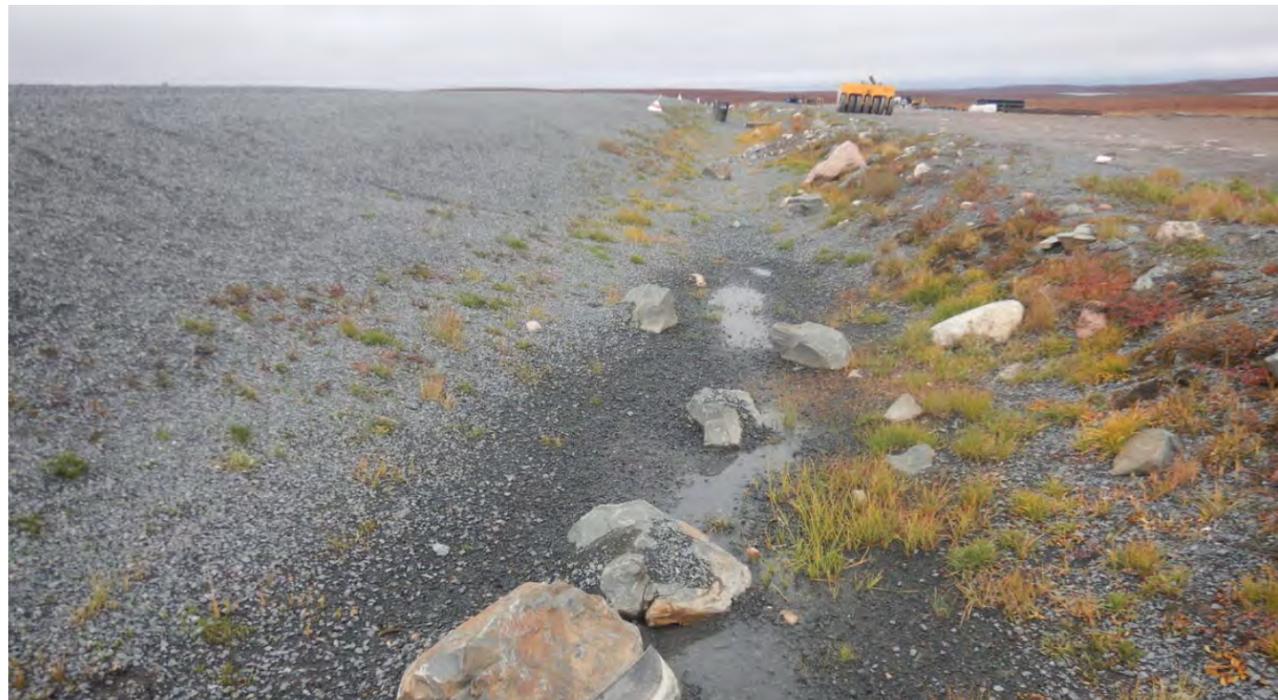
G-136 –A trench at the laydown area on the eastern side of the airstrip, looking NW

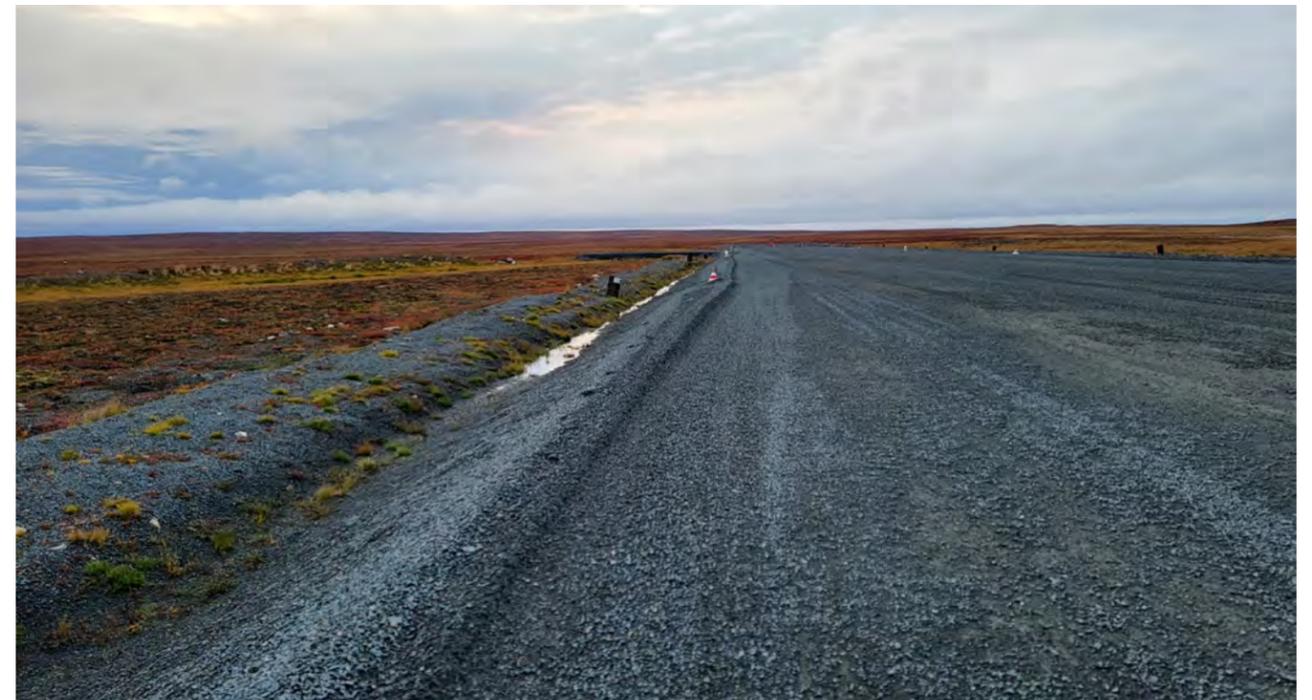
G-137. – A trench along the Eastern edge of the airstrip, looking SE

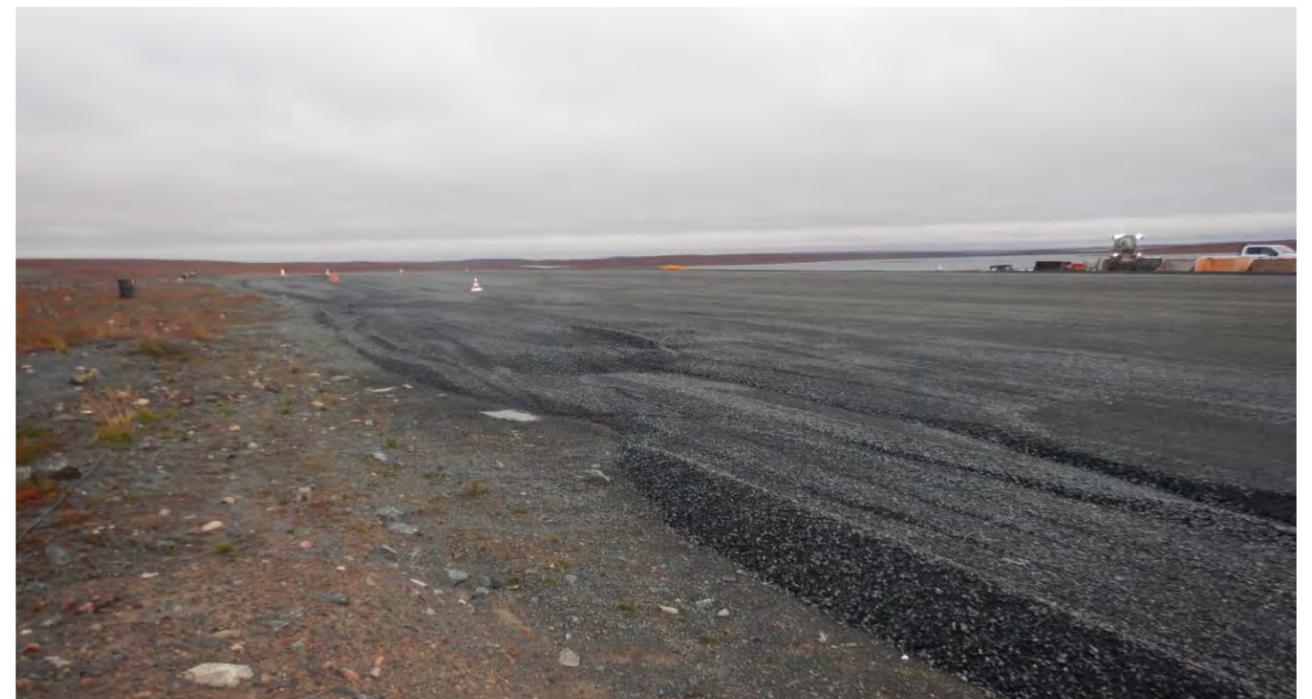
G-139. – Western side of the pad, looking north, note the thickness of the pad

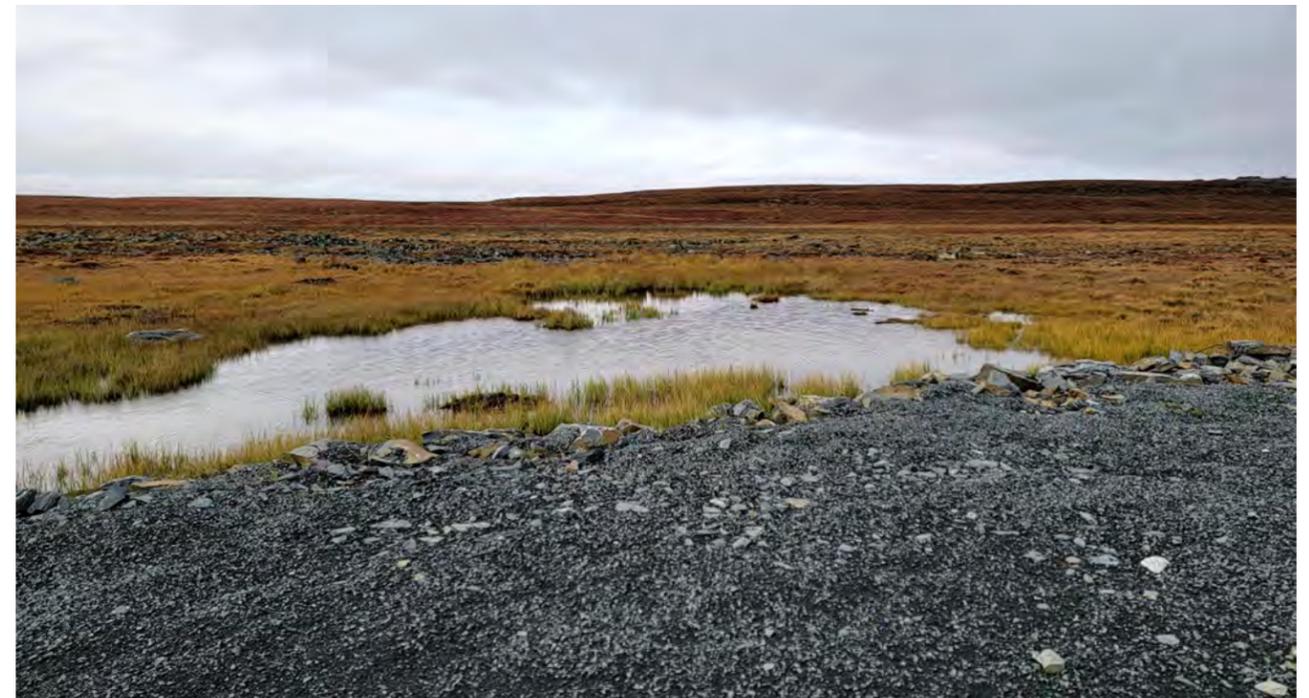
G-141.- Ponding waters at the SE end of the airstrip, looking SE

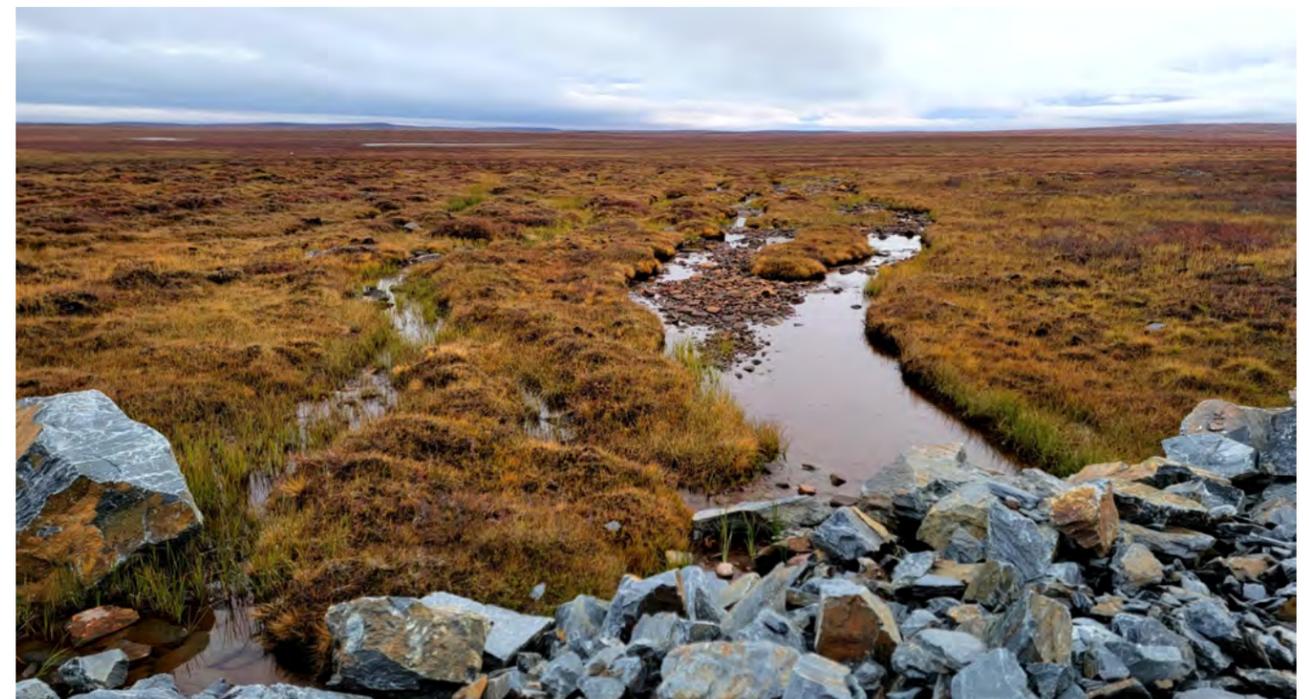
G-144 .- Ponding waters at the SE end of the airstrip, looking east

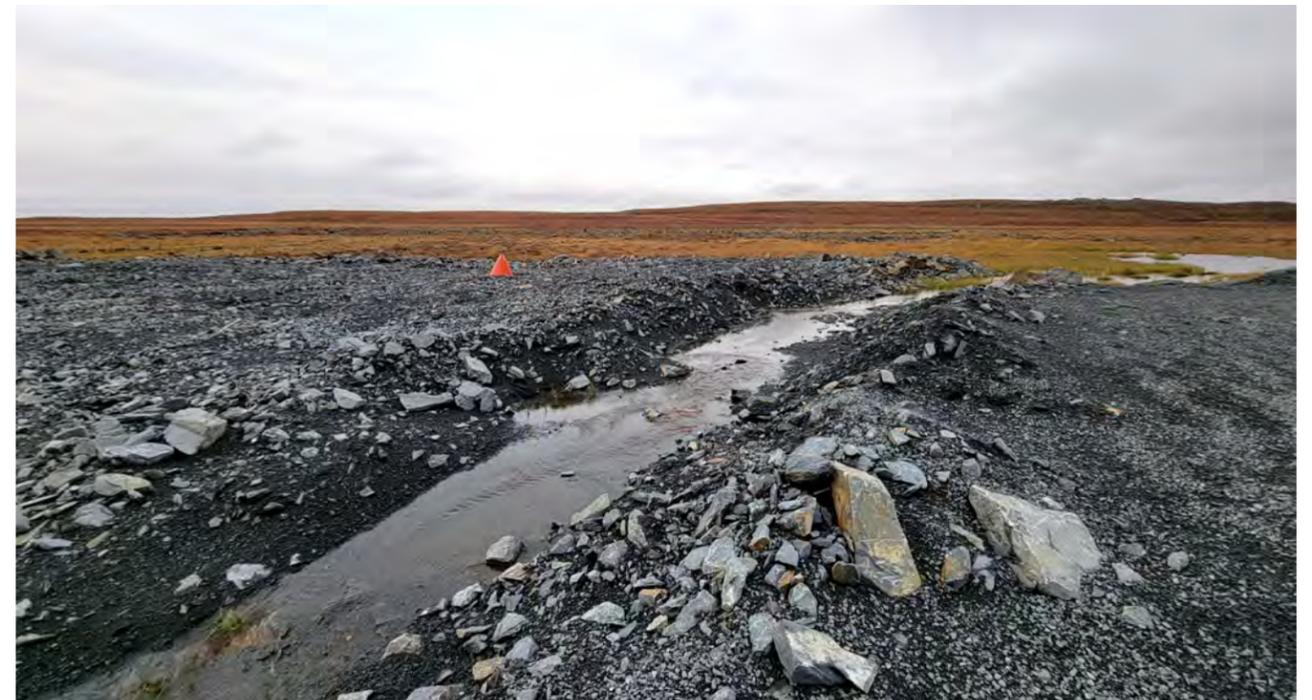
G-146. A creek crossing the SE extension of the pad

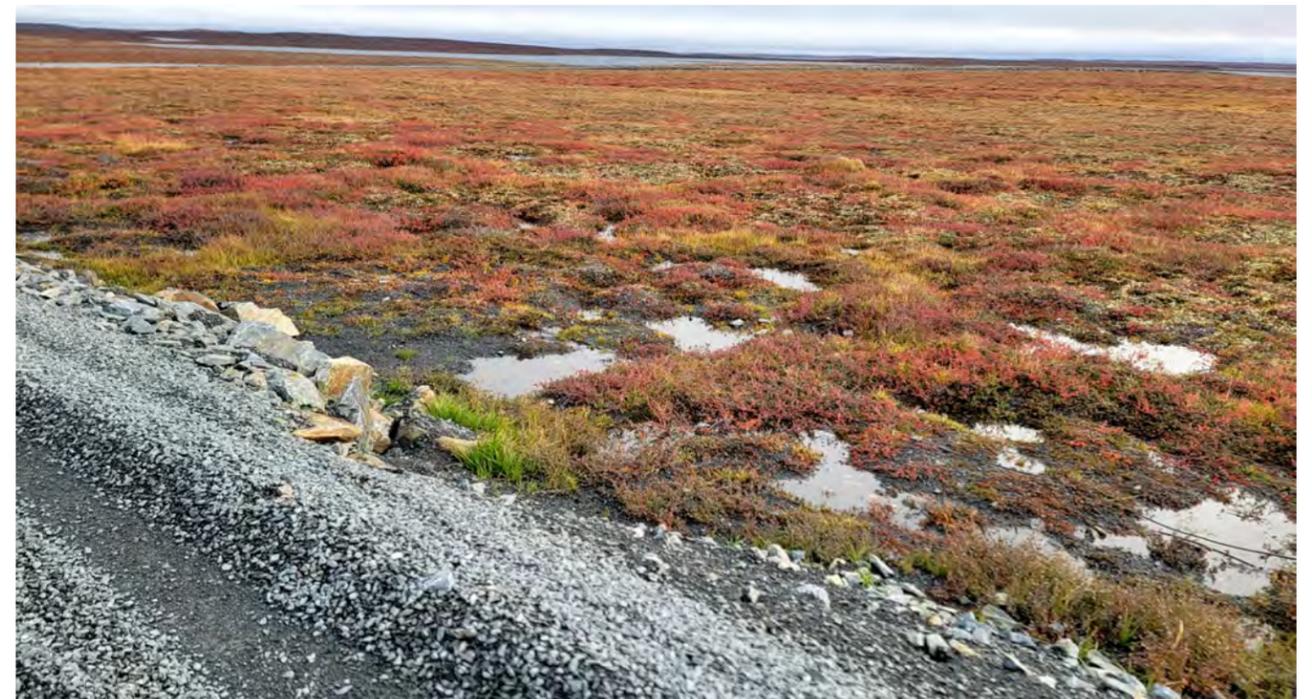
G-148. – Ponding waters on the east side of the pad, looking east

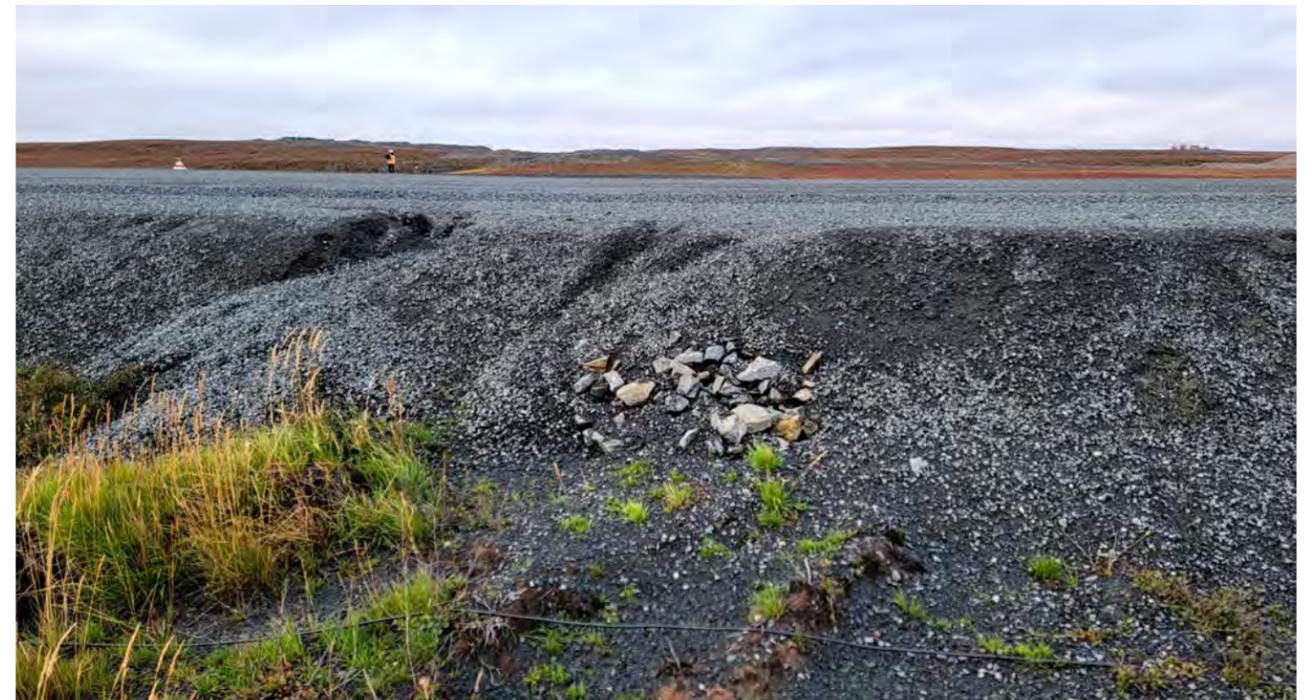
G-150. – Erosion gullies on the eastern side of the pad, looking south

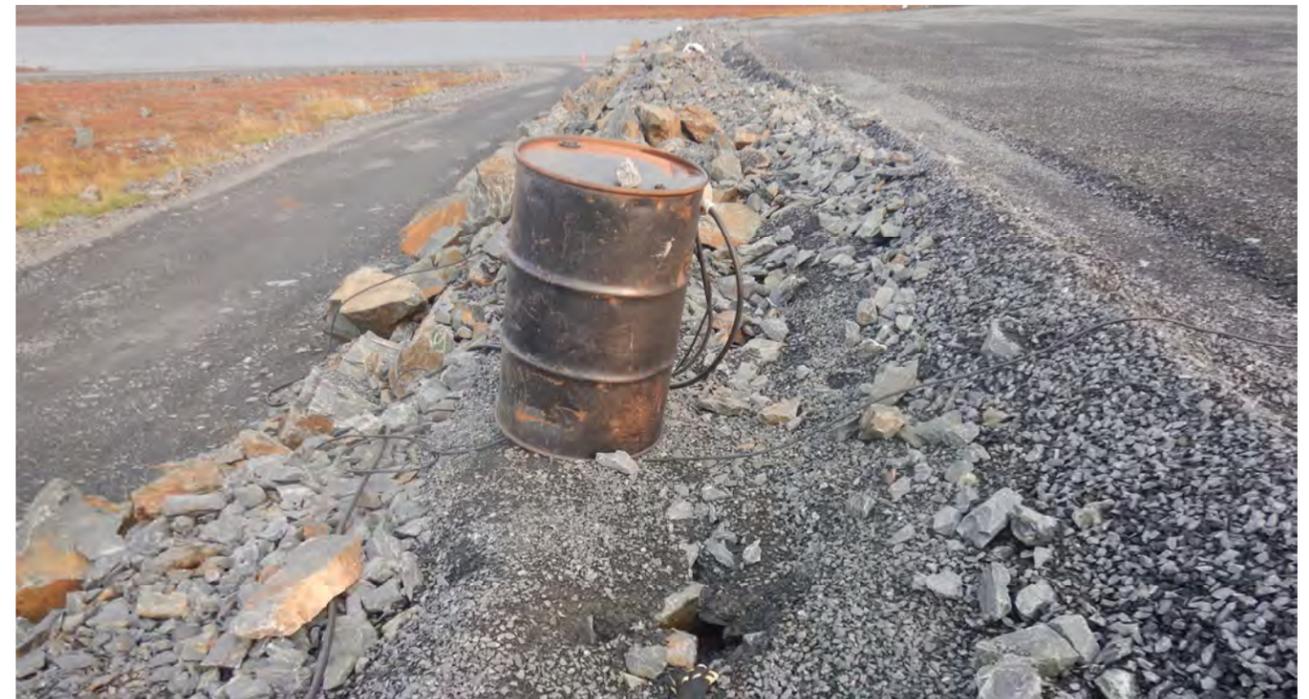
G-152. – Western side of the pad, looking SW.

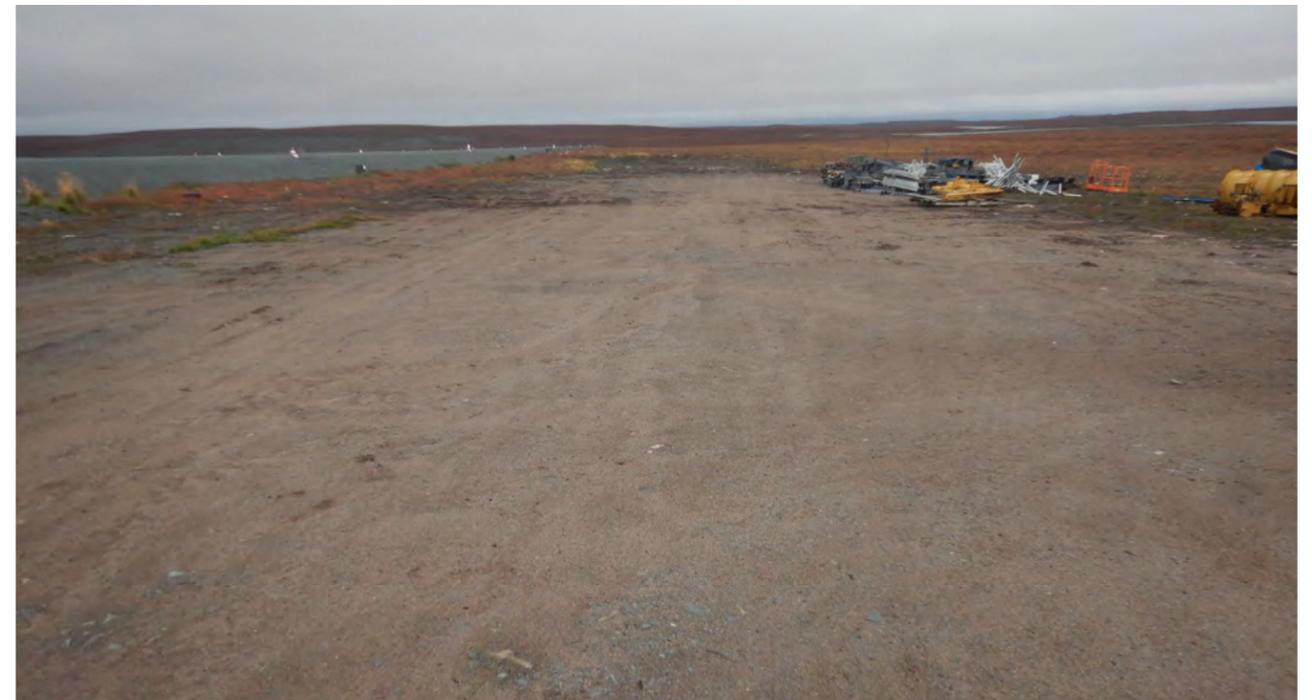
G-154. – Laydown area along the eastern side of the airstrip, looking SE

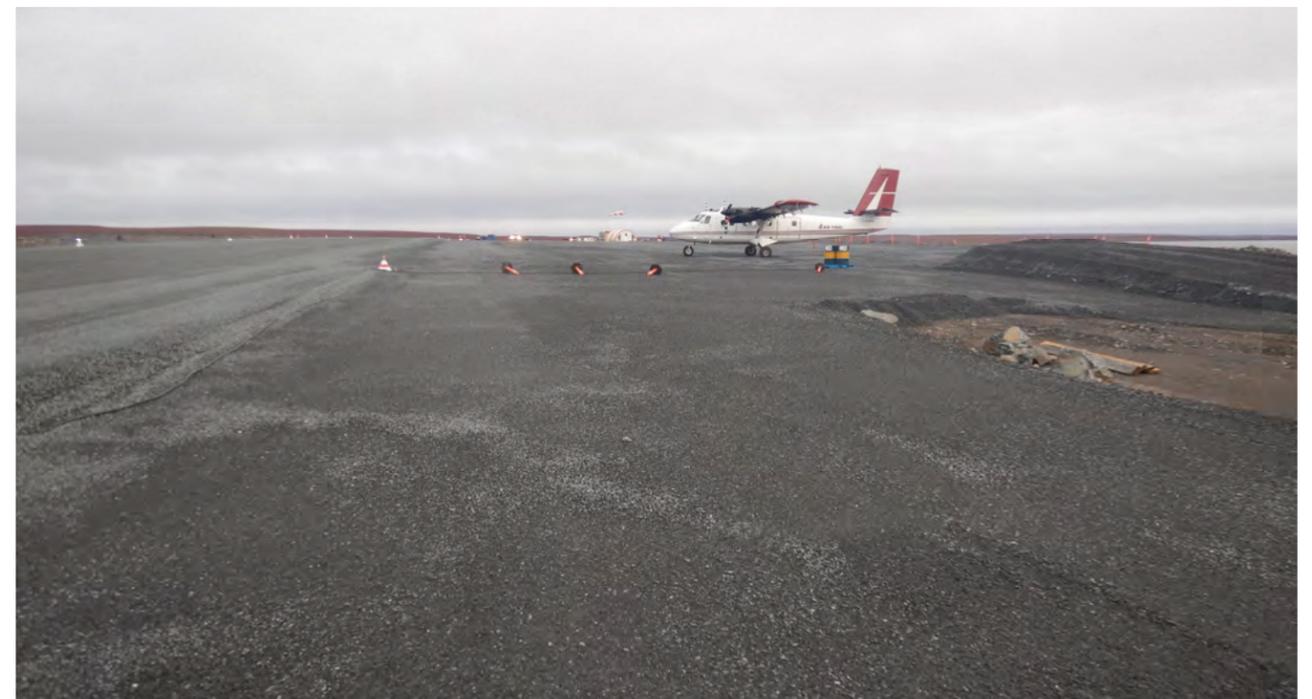
G-156.- Plane parking area, looking NE

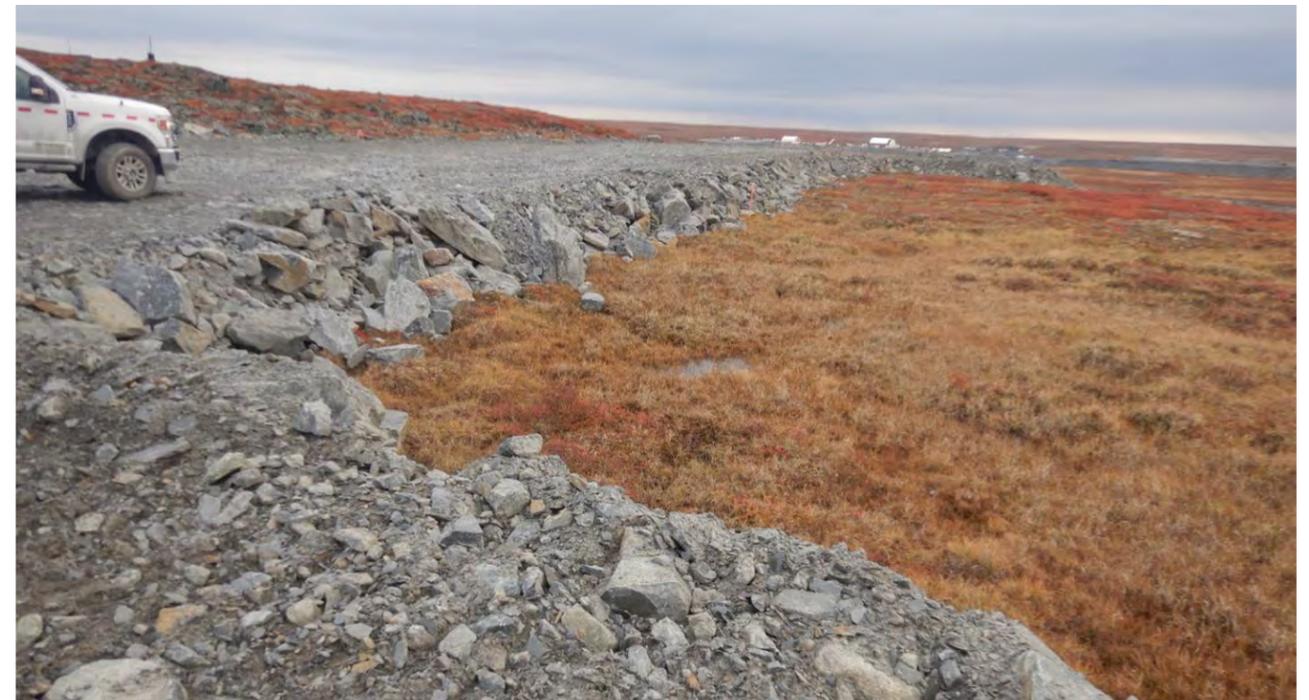
G-158. - Northern end of the road. Note the thickness and the slope of the embankment.

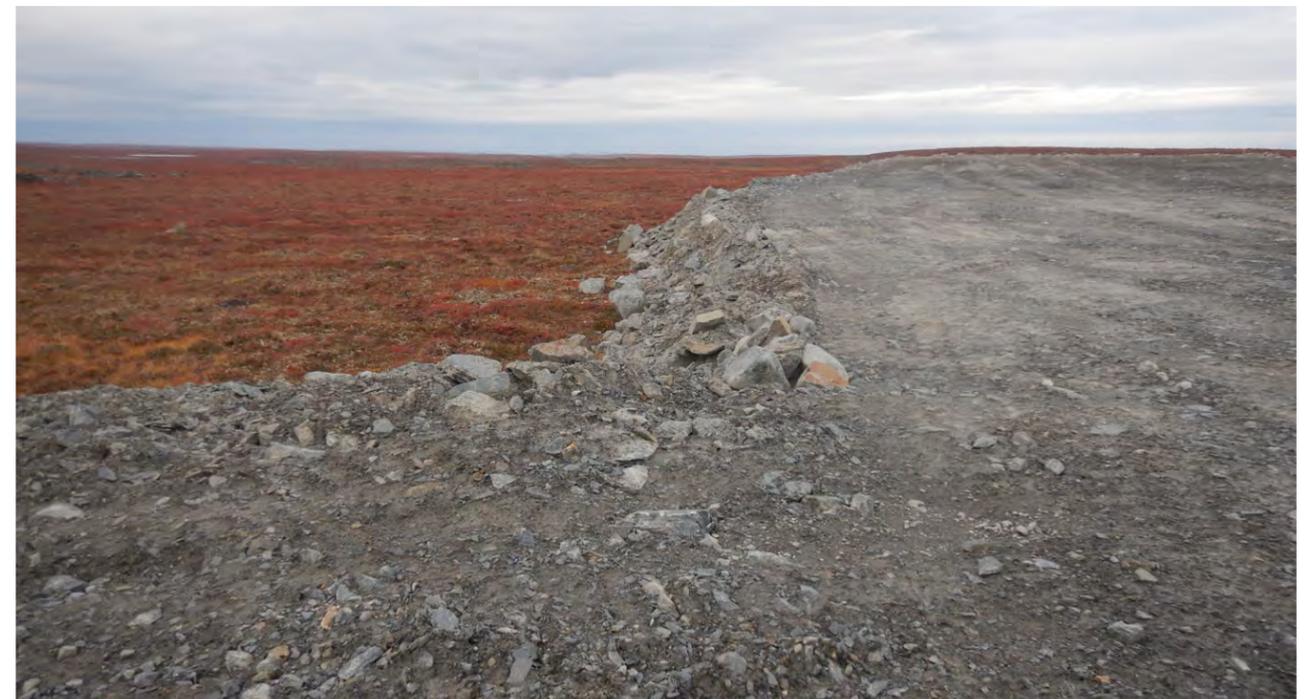
G-160. - Example of the fill material used for road construction. The photo was taken looking south

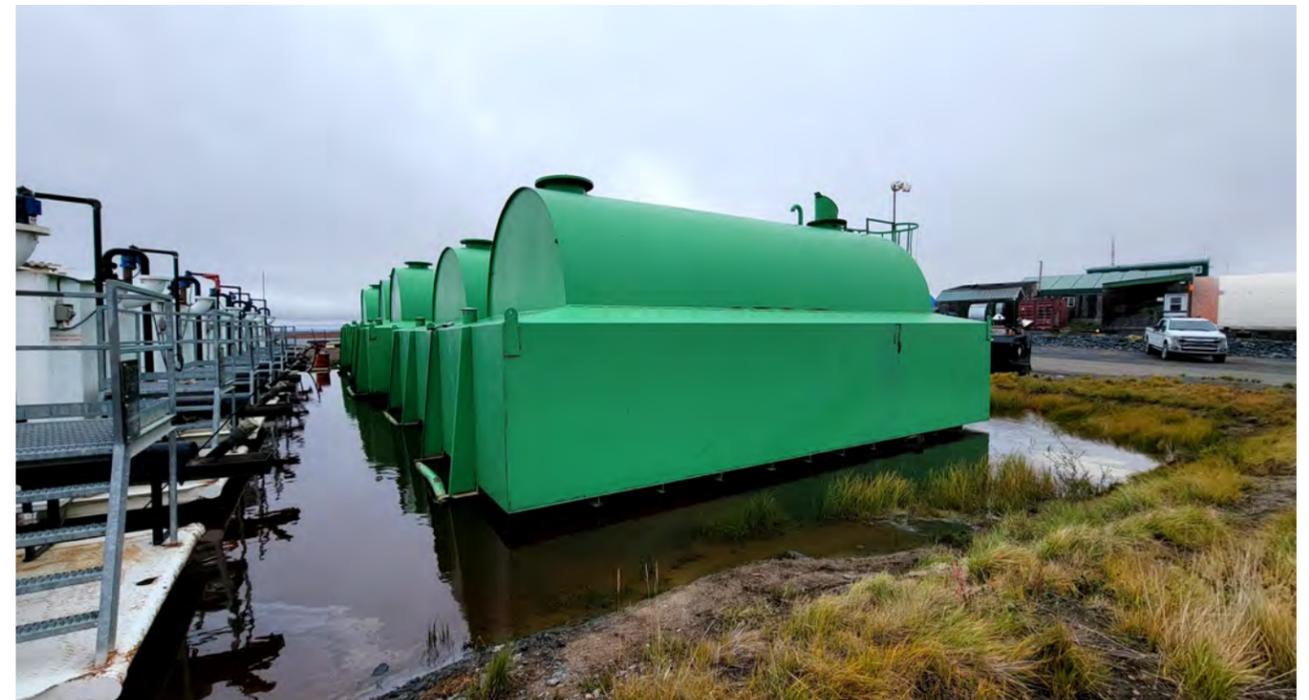
G-162. – Temporary Fuel Storage Facility

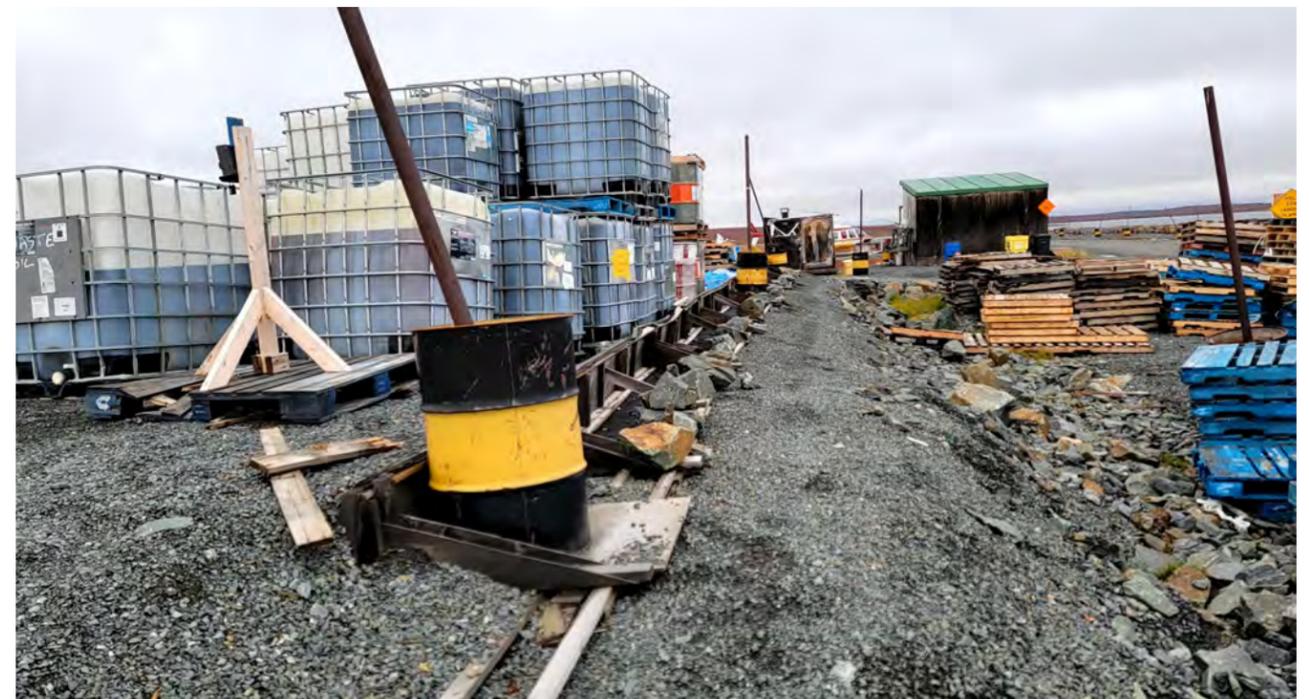
G-164 - Temporary Fuel Storage Facility

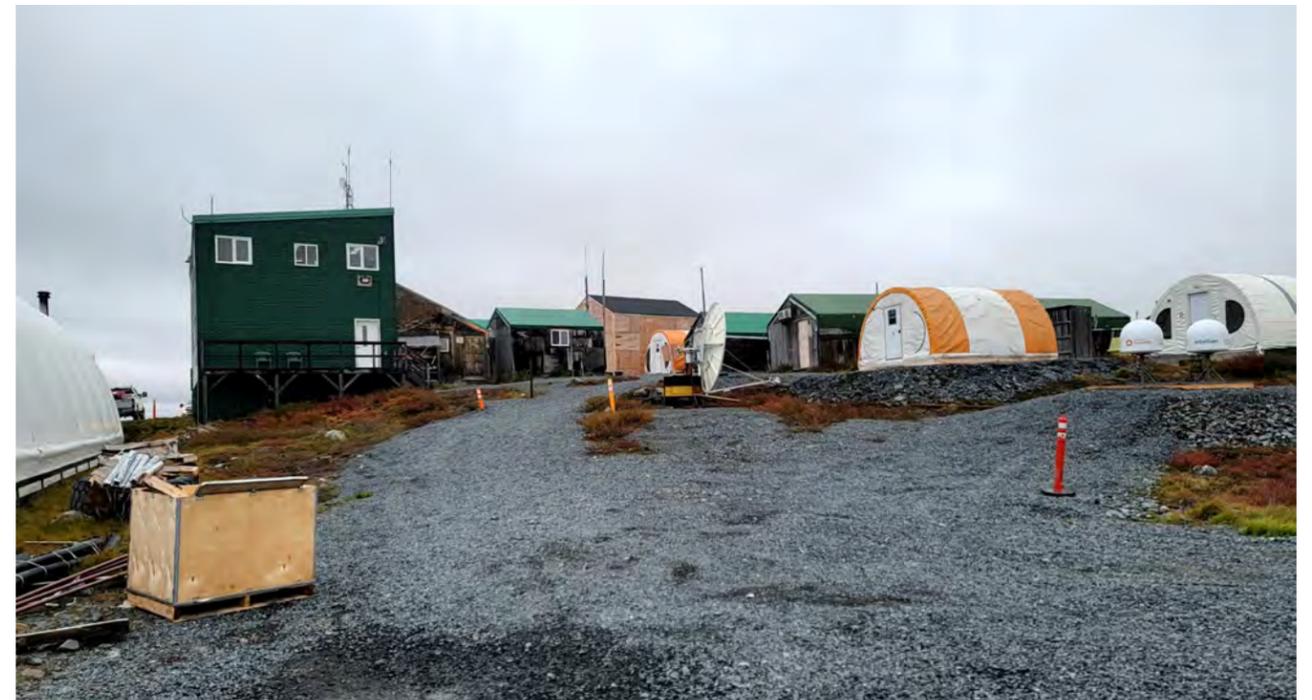
G-166 – NW side of the Camp Pad, looking NE

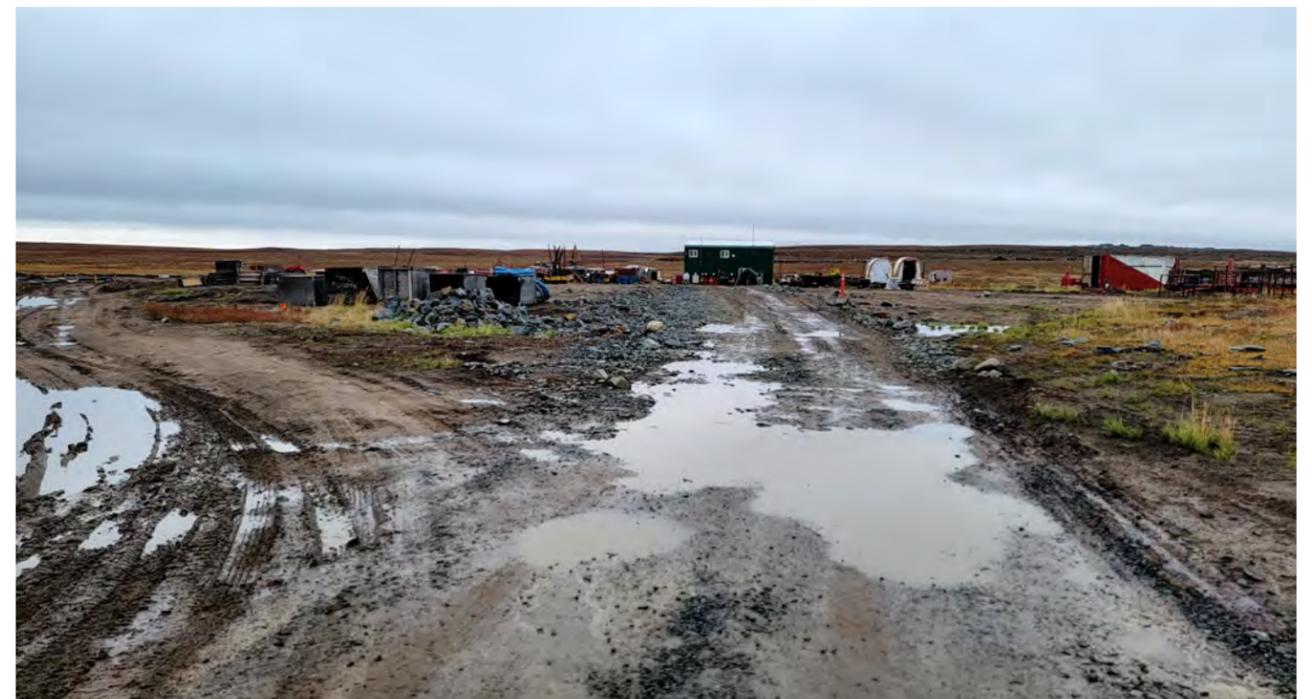
G-168. –Tundra degradation at the SE of the Exploration Camp

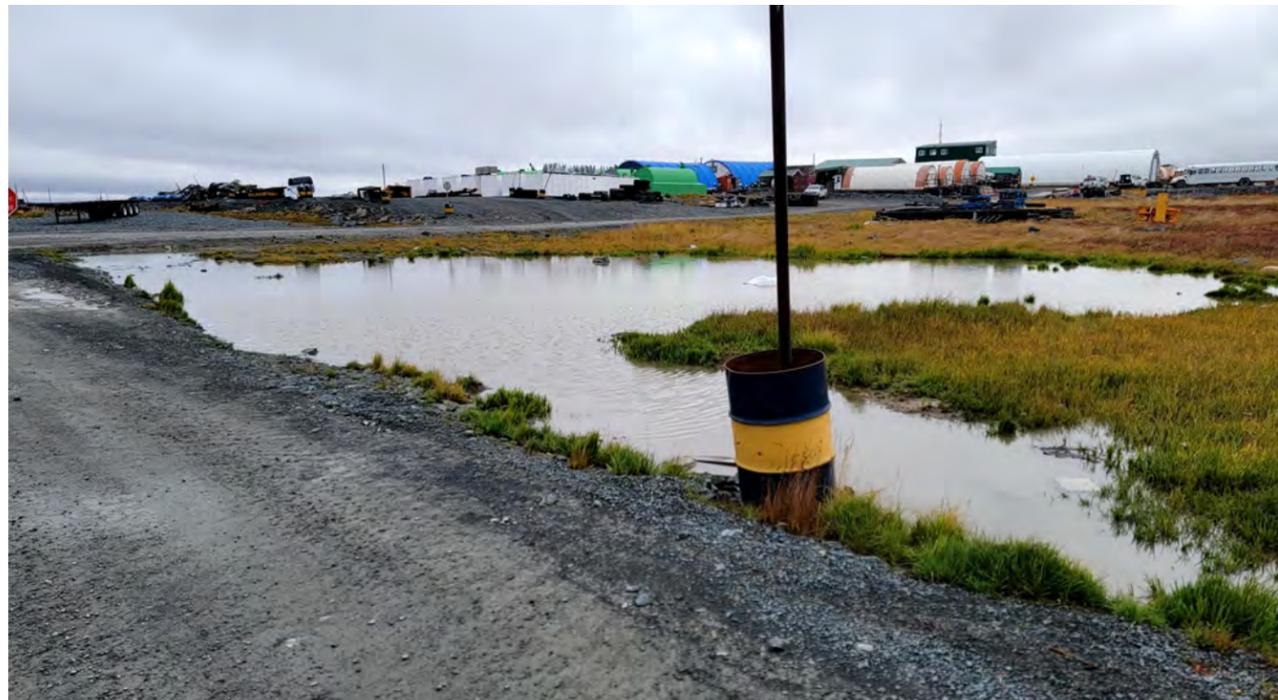
G-169. – Ponding waters were observed at the SE side if the access road

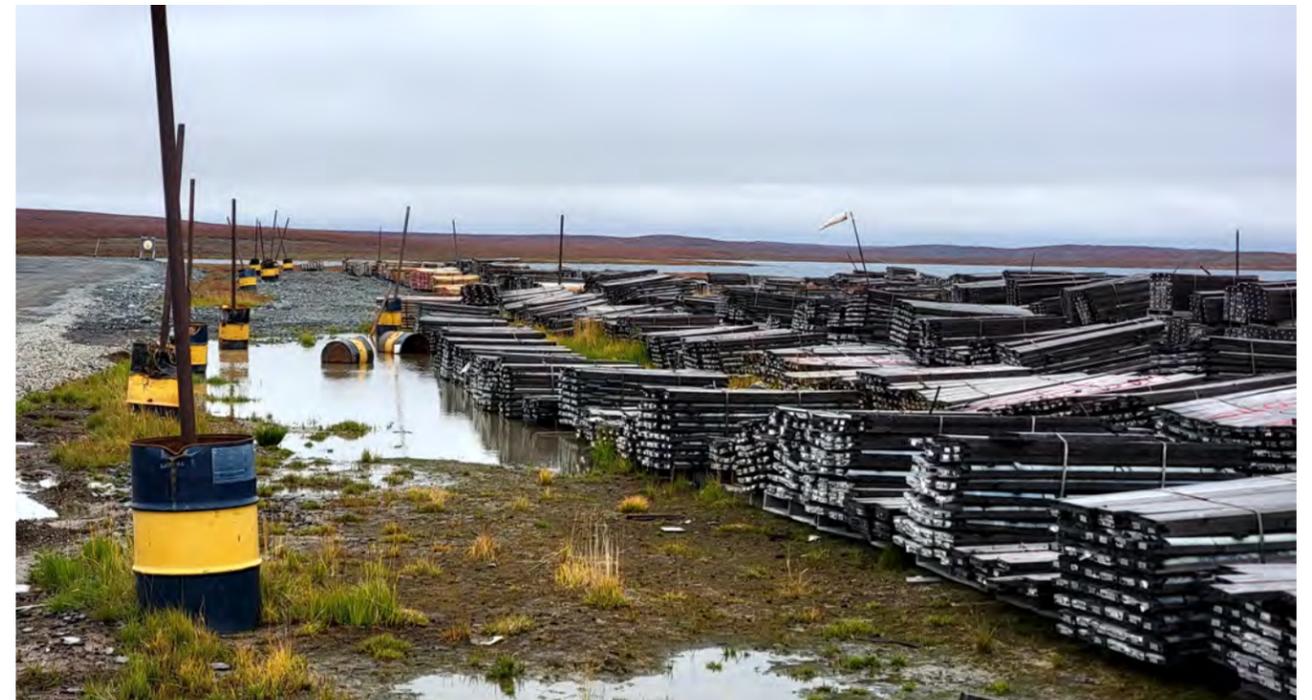
G-170. – Core Storage Facility

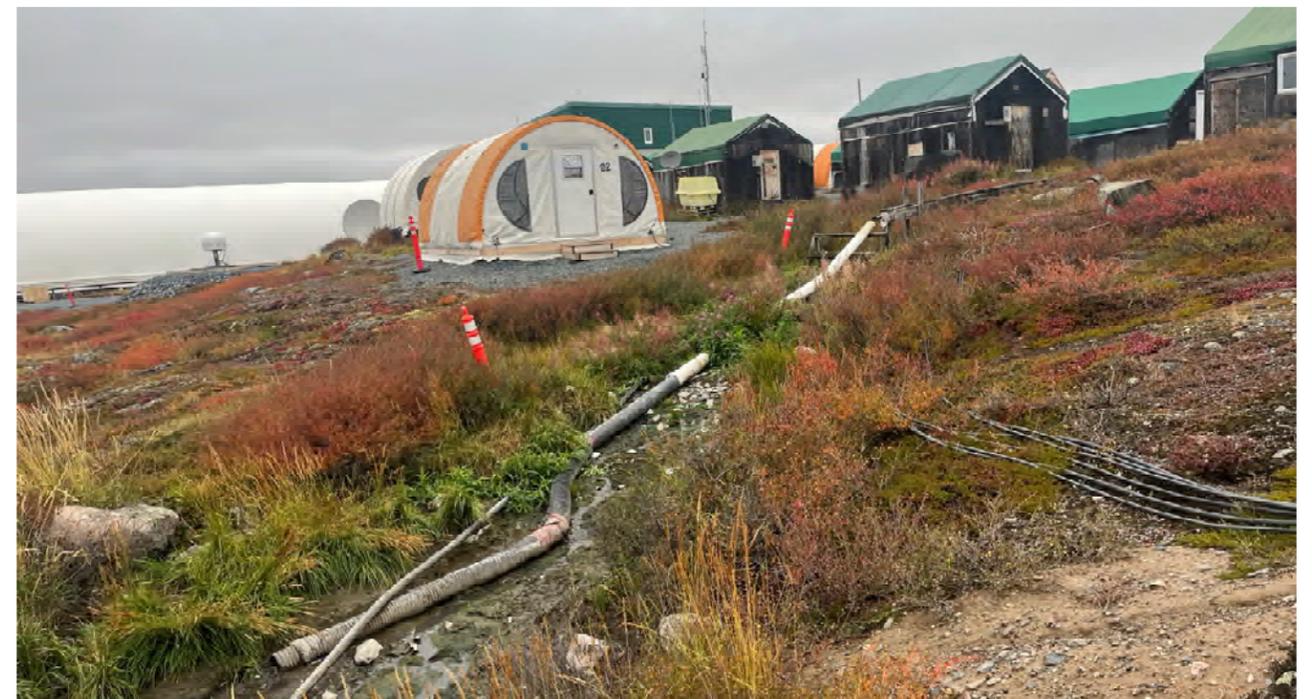
G-172. – Discharge point at the SW side of the exploration camp
