2023 Annual Geotechnical Inspection		
		Gander Crossing		
Job No: CAPR003105 Filename: BackRiver_Goose_2023AGI_PhotoLog.pdf	Back River Project	Date: 2024-02-28	Approved: JBK	Figure: A.1-39

Back River Project

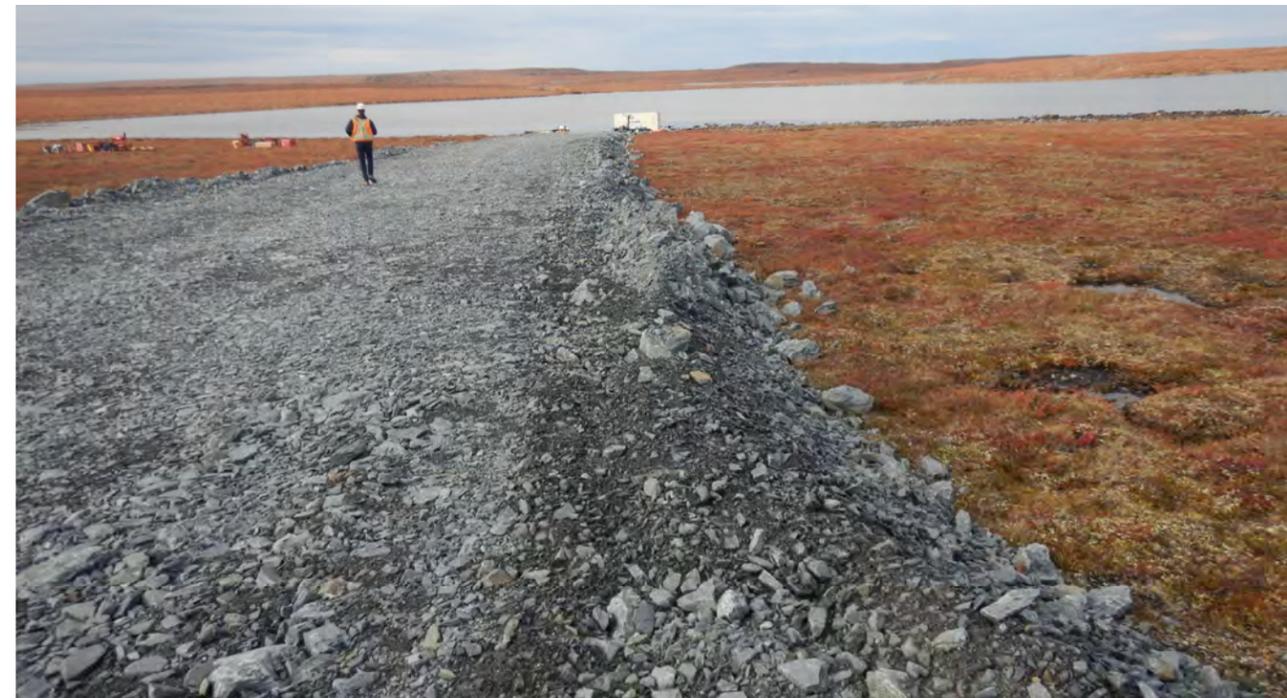
G-178. – Temporary Road access to Llama Lake: northern side, looking west

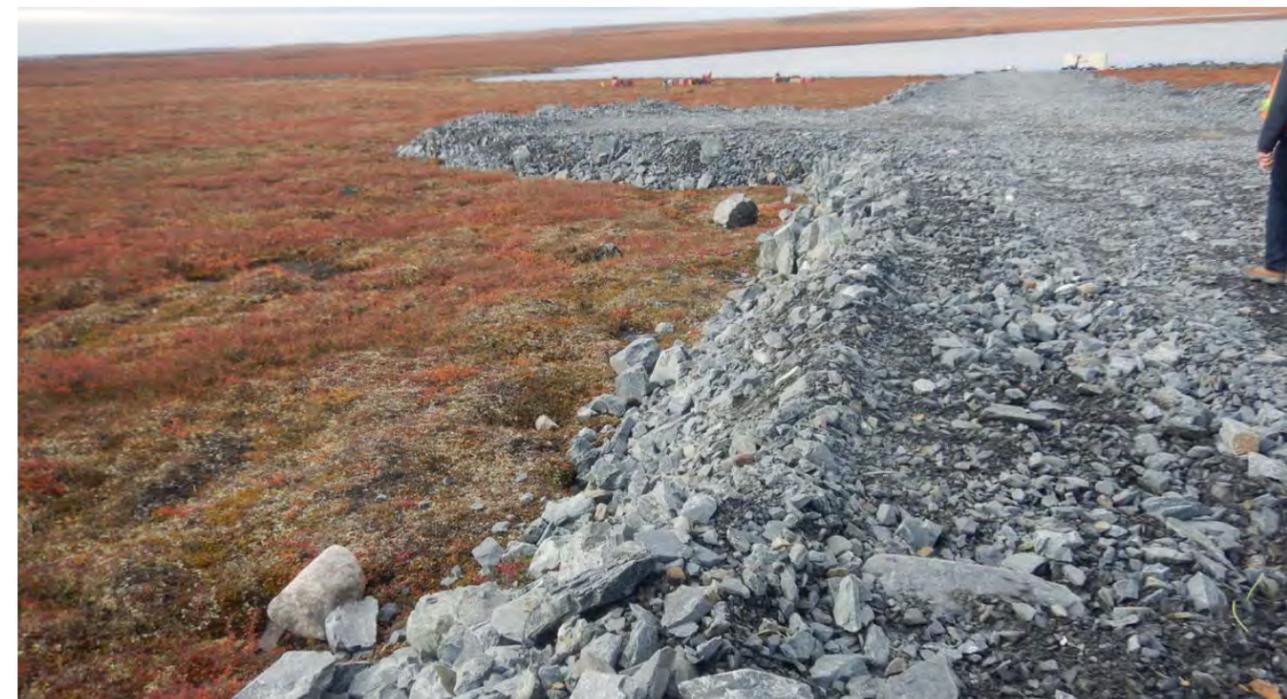
G-180. – Temporary road access: southern side, looking east

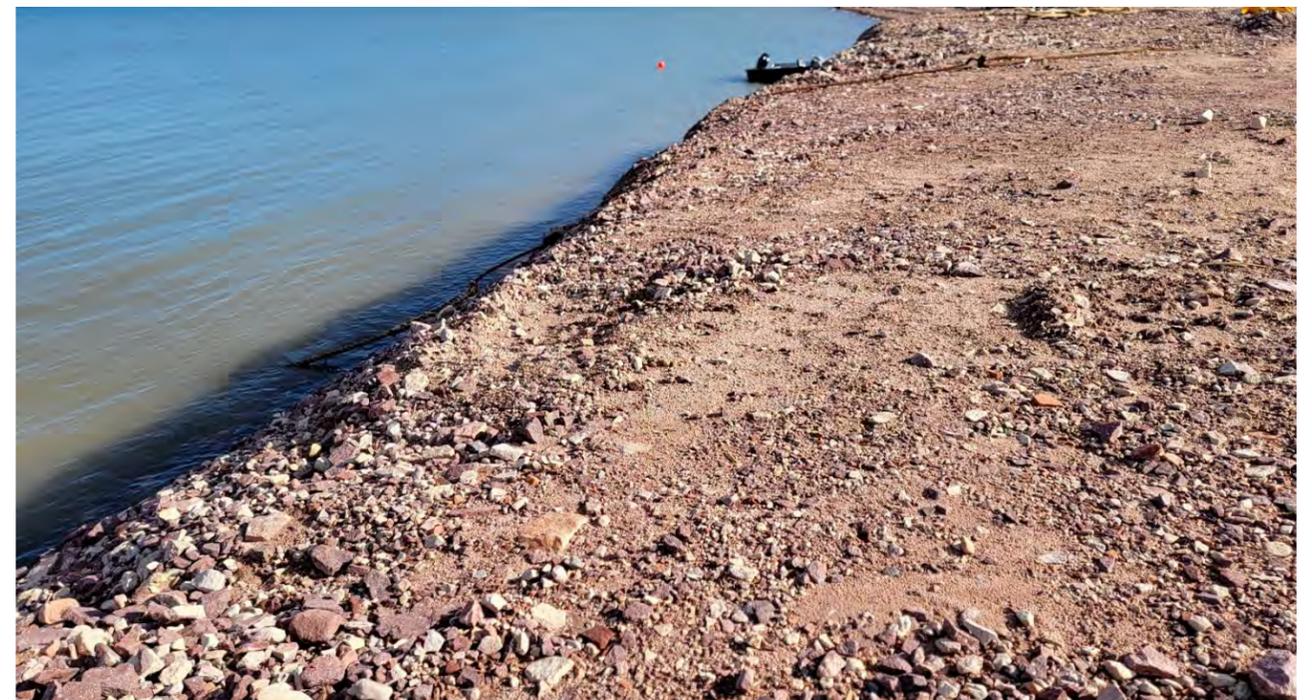
M-5. – Eastern side of Shoreline Pad, looking east

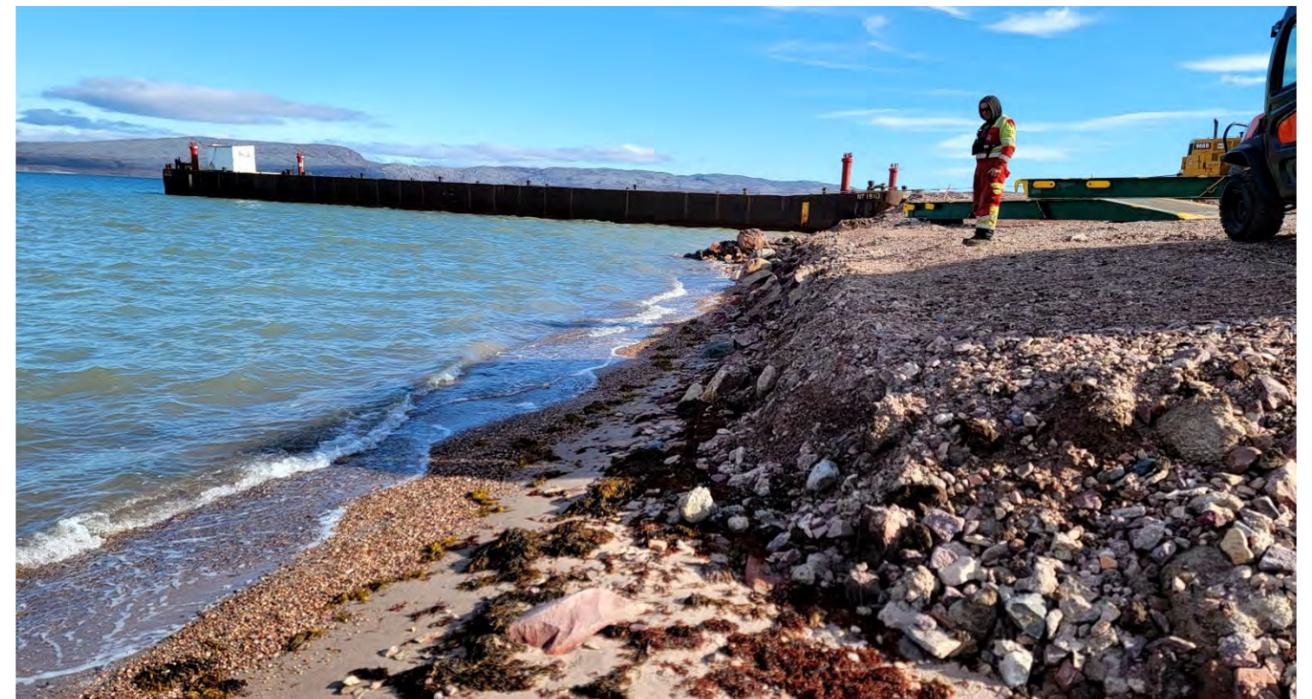
M-7. – Western side of Shoreline Pad, looking east

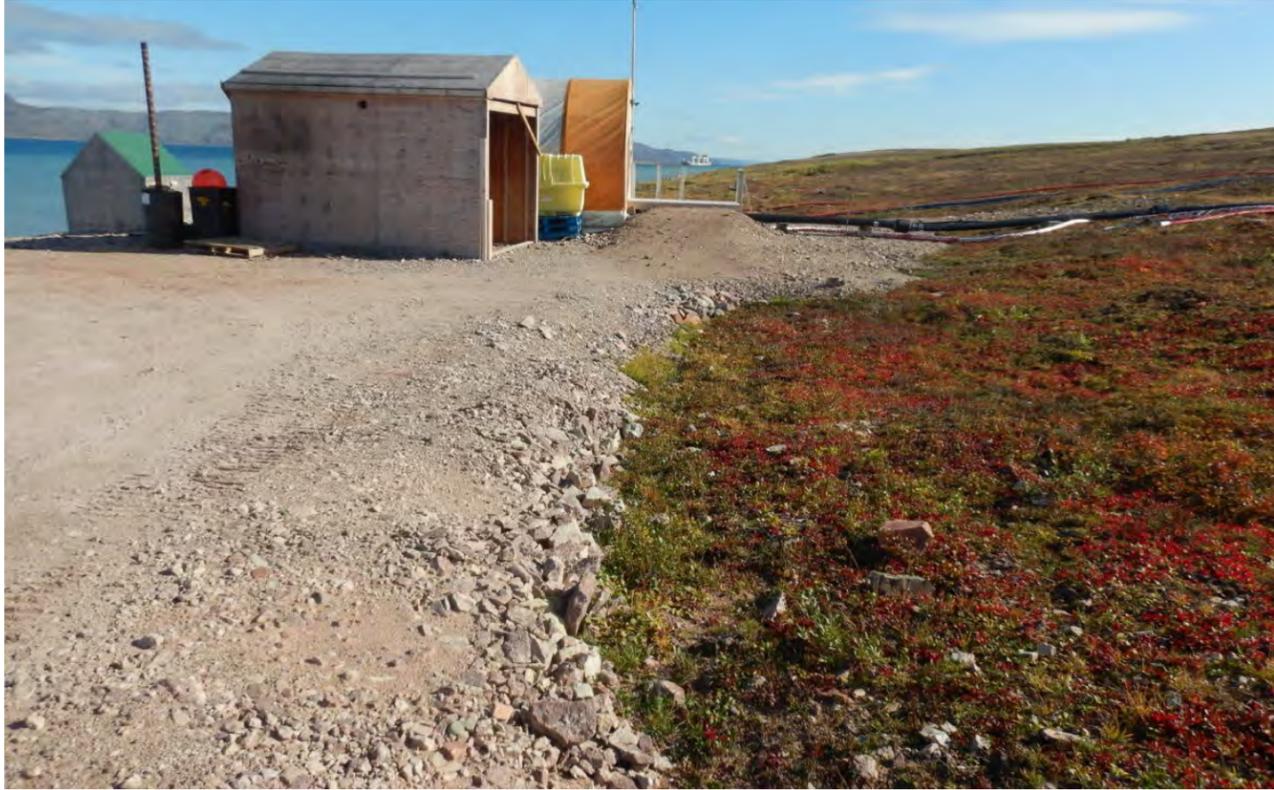
M-8 Southern side of the Shoreline pad looking southeast. Note the thickness of the fill material

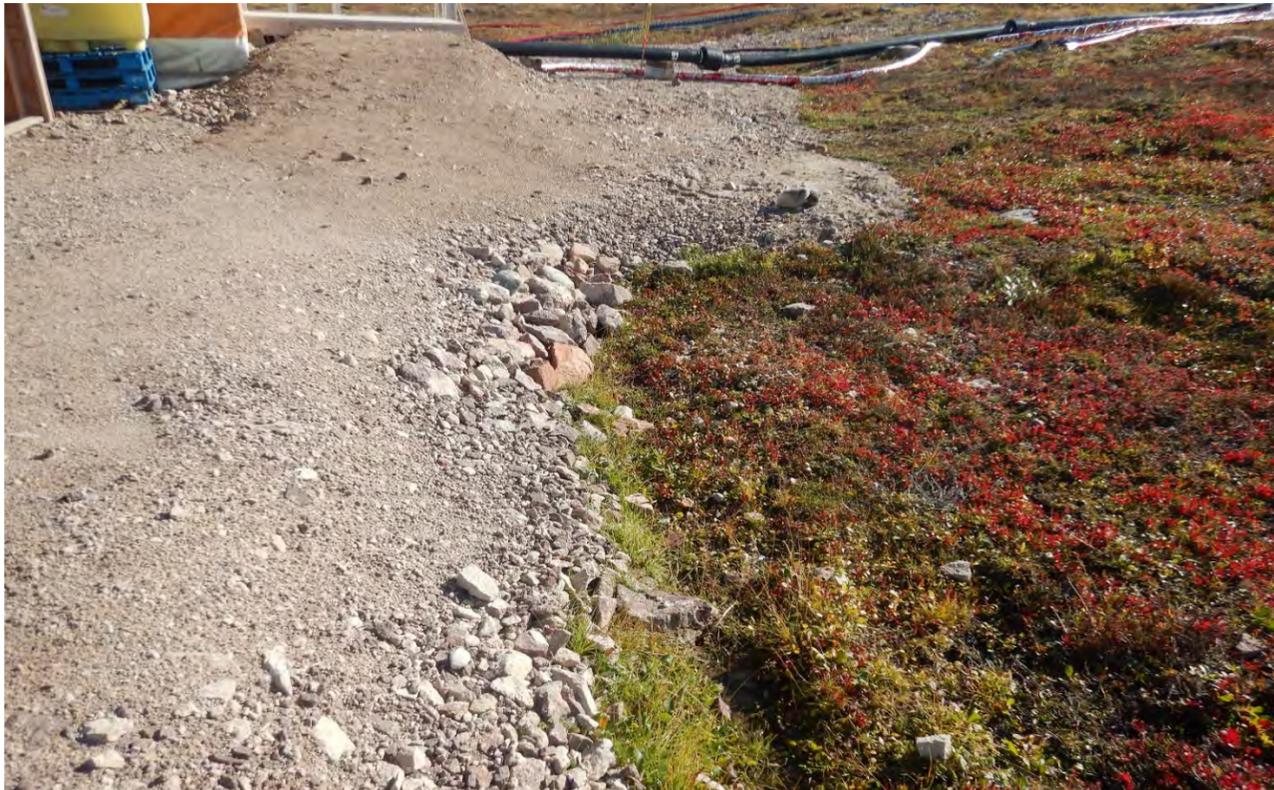
M-11 Southern side of the Shoreline pad looking southeast. Note the thickness of the fill material is less than 0.5m

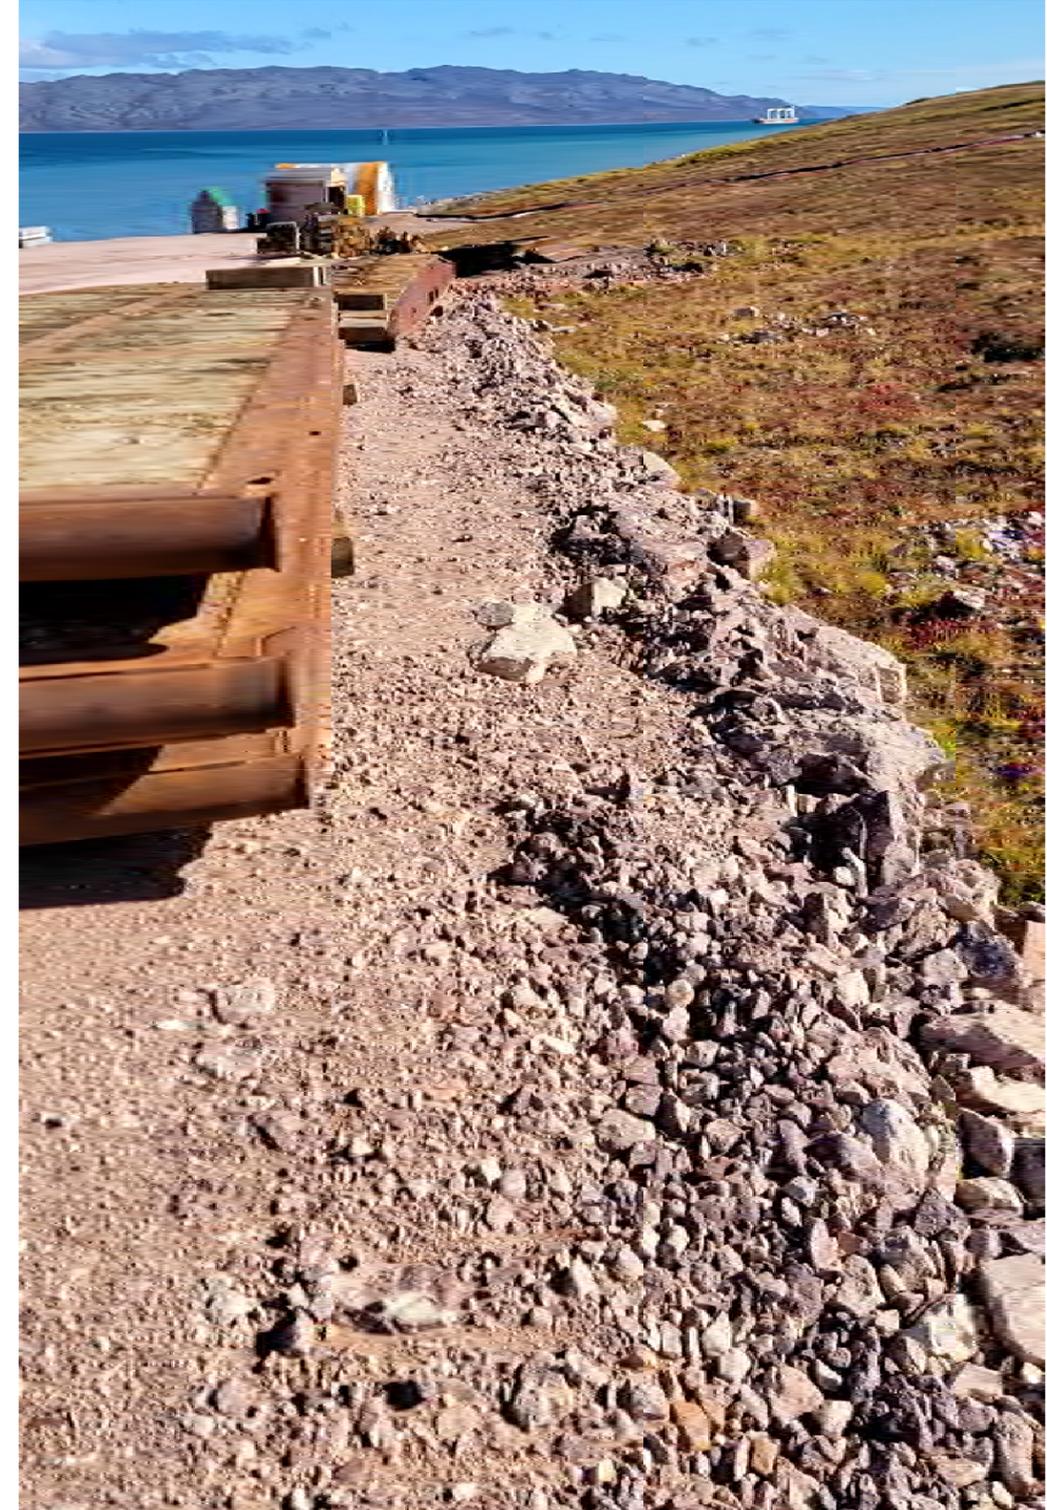
M-10 Southern side of the Shoreline pad looking northeast. Note the thickness of the fill material

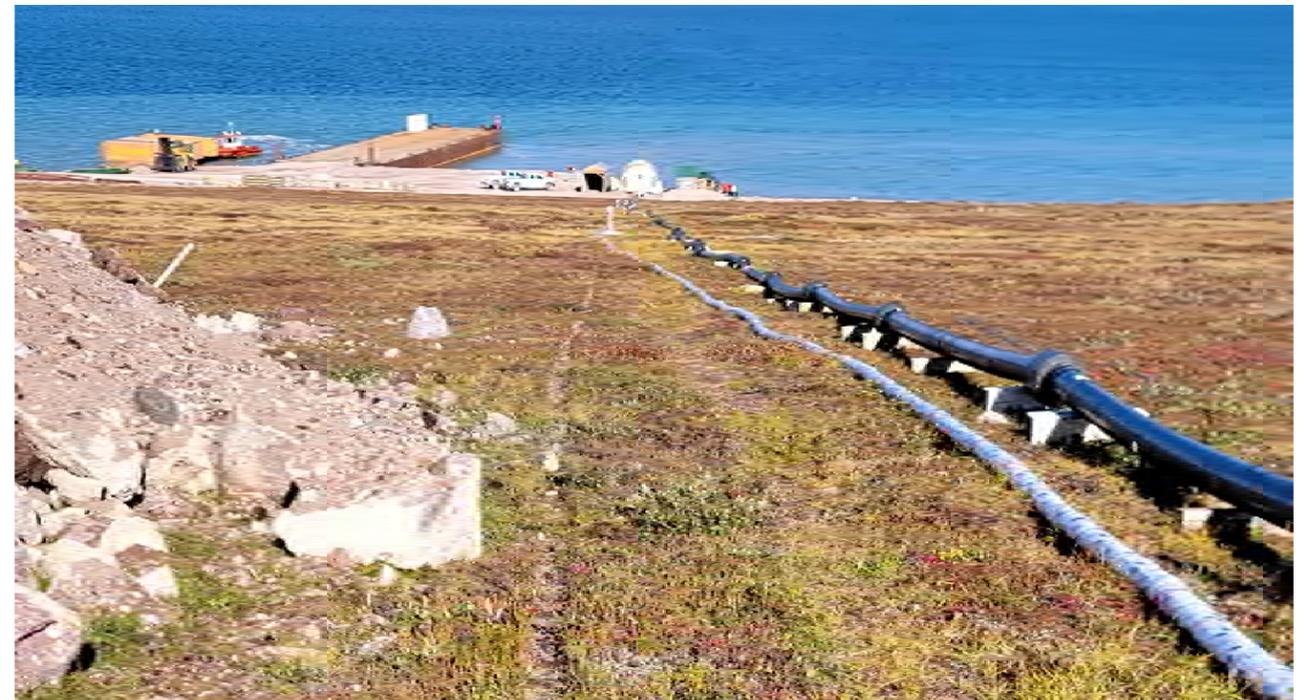
M-12. – Pipelines go from the Camp area to the Shoreline Pad. Note that the pipe connections are in between wooden blocks

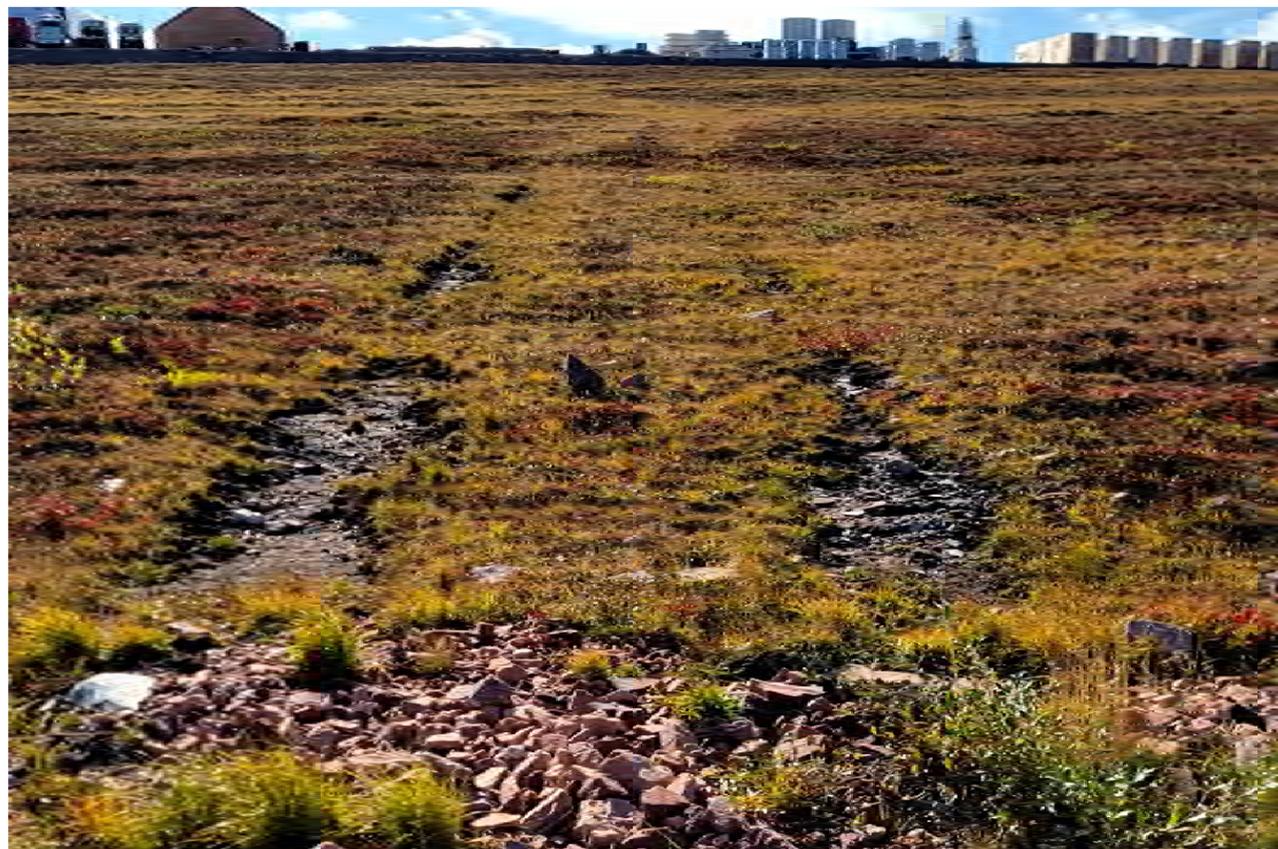
M-13. – Tundra degradation. Note the remain equipment trucks

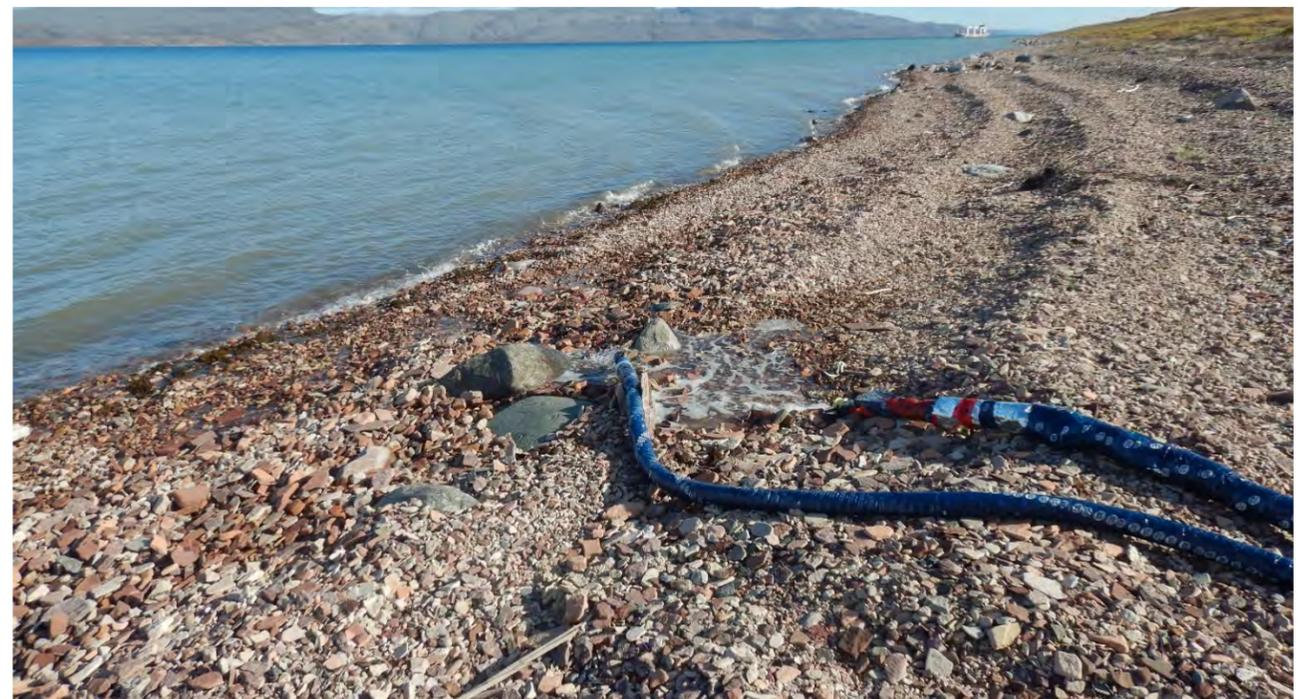
M-14. – Discharge point

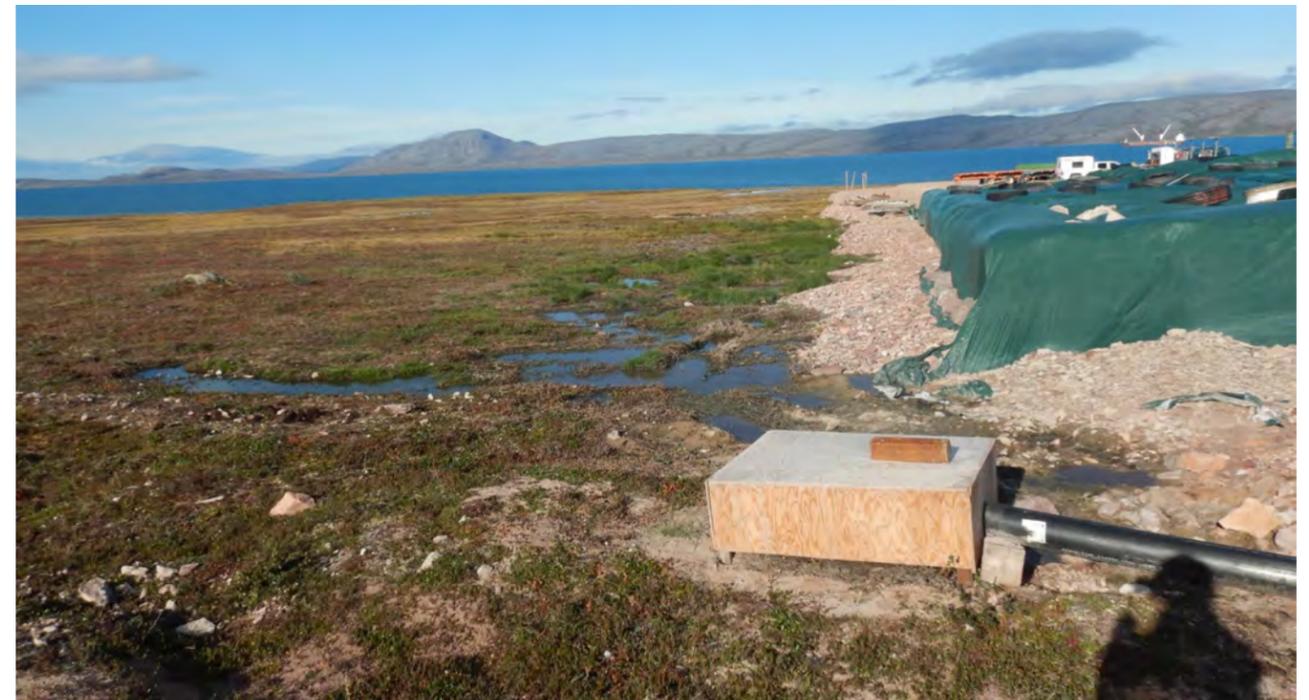
M-16. – Discharge point at the eastern corner of the Freight Storage Pad. Note ponding waters along the east side of the Pad

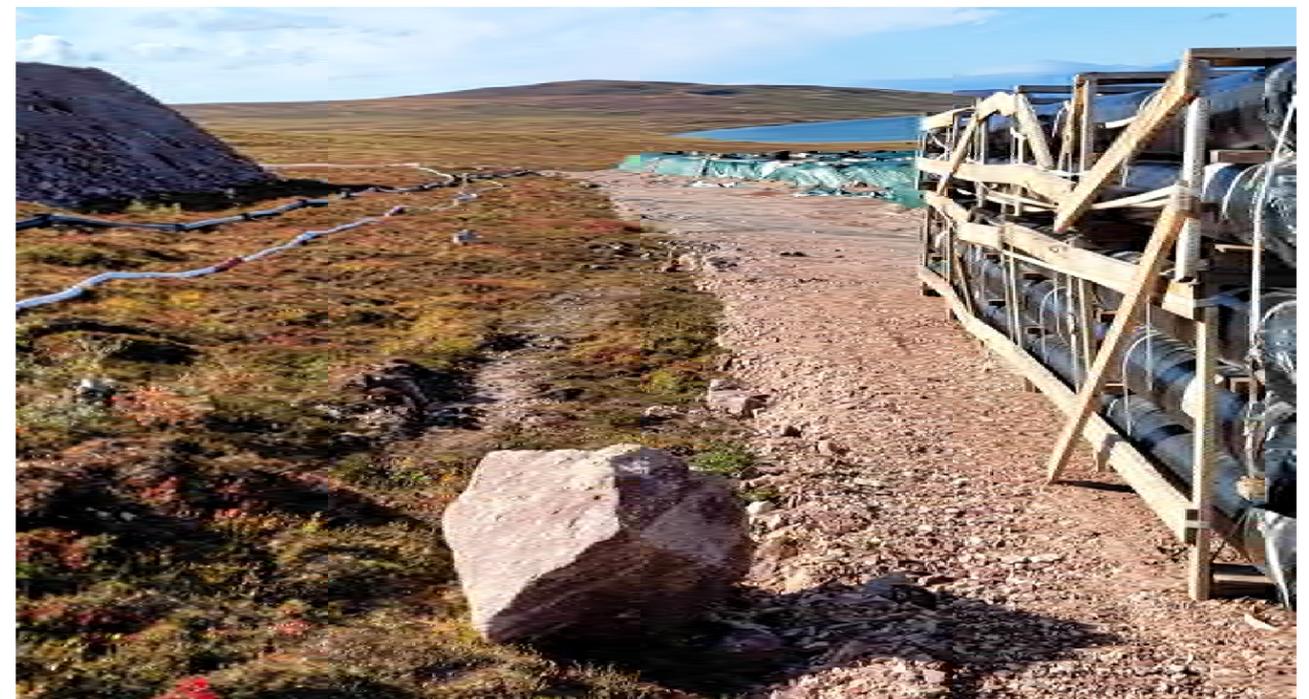
M-18. – Northeast side of the Freight Storage Pad. Note that the fill thickness is less than 0.15m
