2023 Annual Geotechnical Inspection		
		Freight Storage Pad		
Job No: CAPR003105 Filename: BackRiver_MLA_2023AGI_Photos.pdf	Back River Project	Date: 2024-02-28	Approved: JBK	Figure: A.2 -8

Back River Project

2023 Annual Geotechnical Inspection

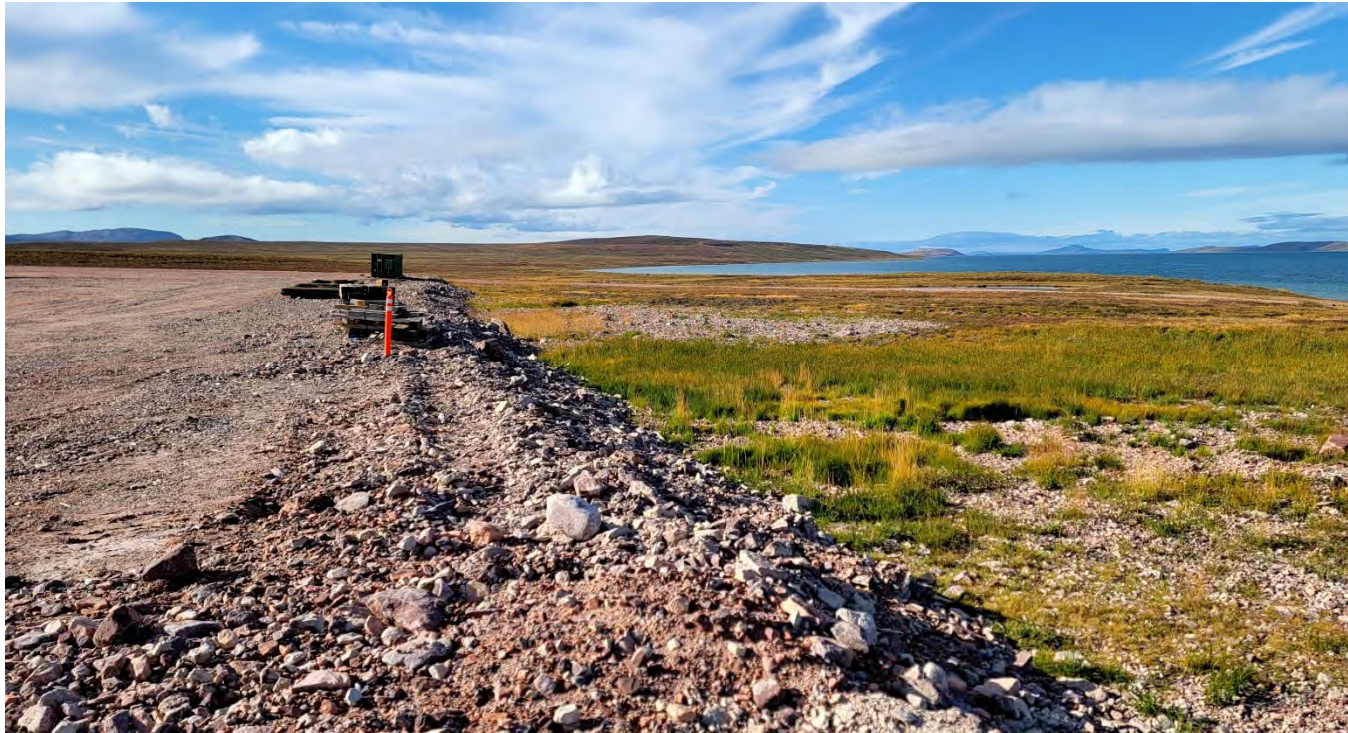
M-19. - Northern side of the Freight Storage Pad

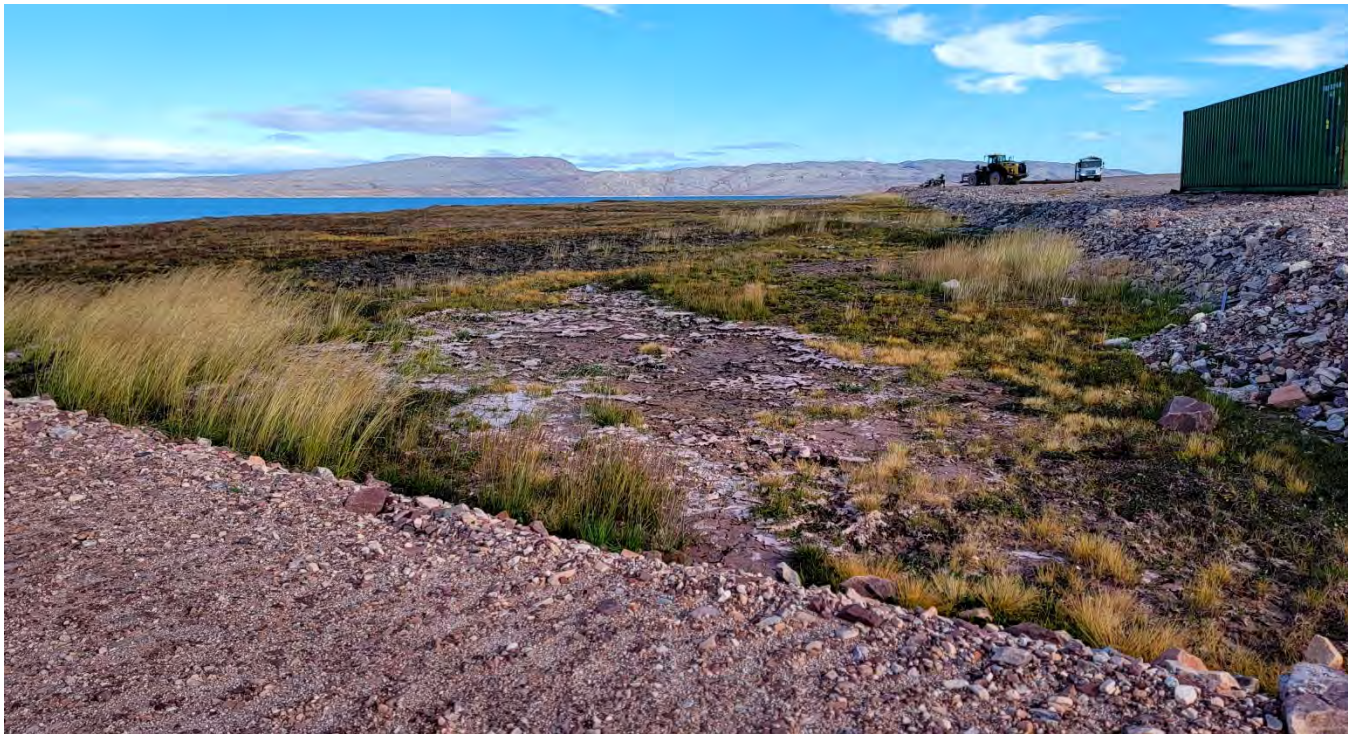
M-21. – Northern corner of the Freight Storage Pad. Note some ponding water signs at the lower points between access road and the pad

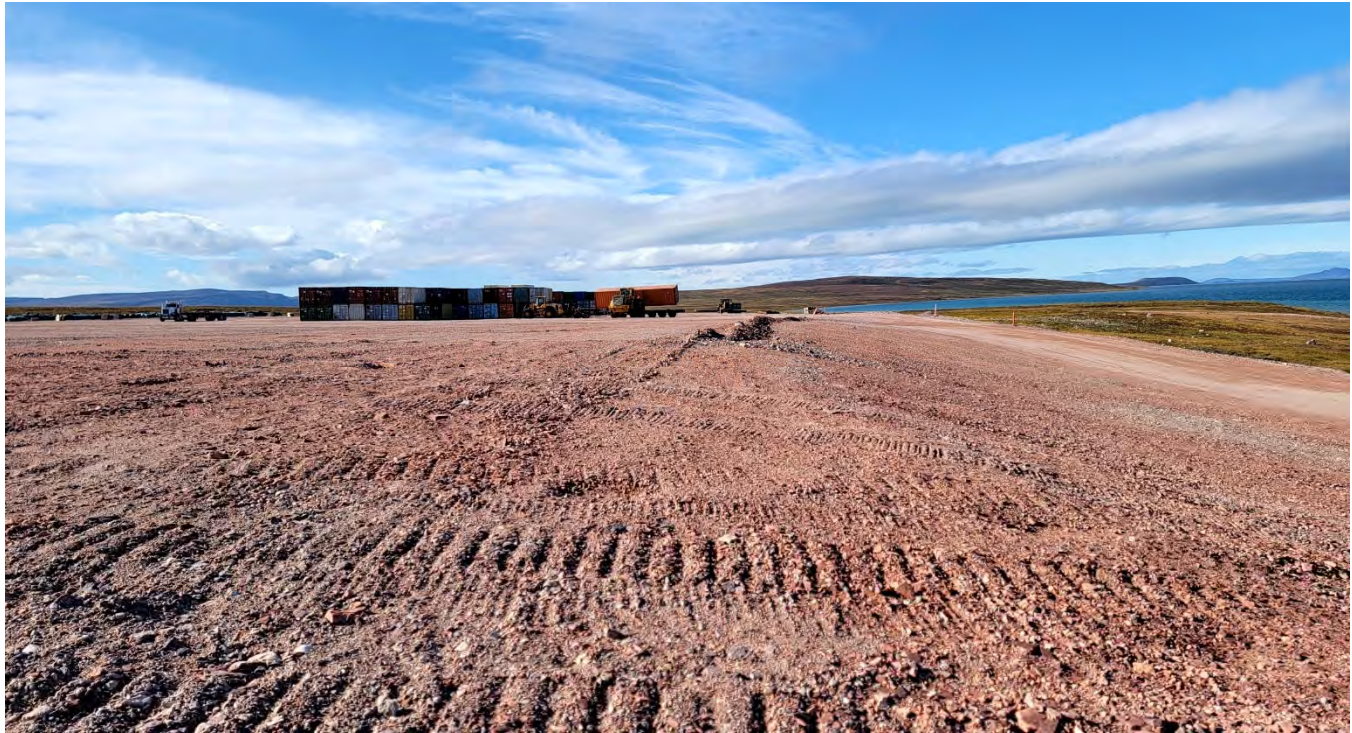
M-23. – Fill material used for the Freight Storage Pad construction.

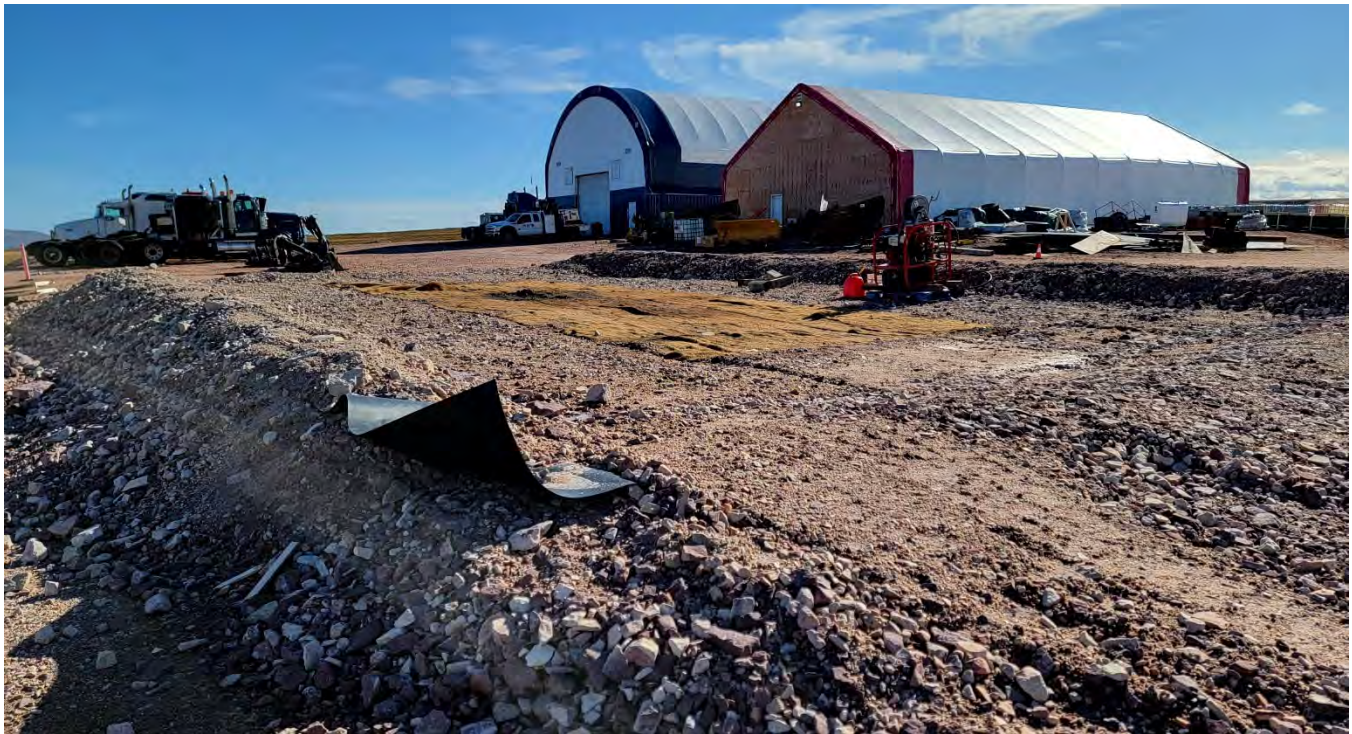
M-25. – Spill mat at the eastern side of the Freight Storage pad.

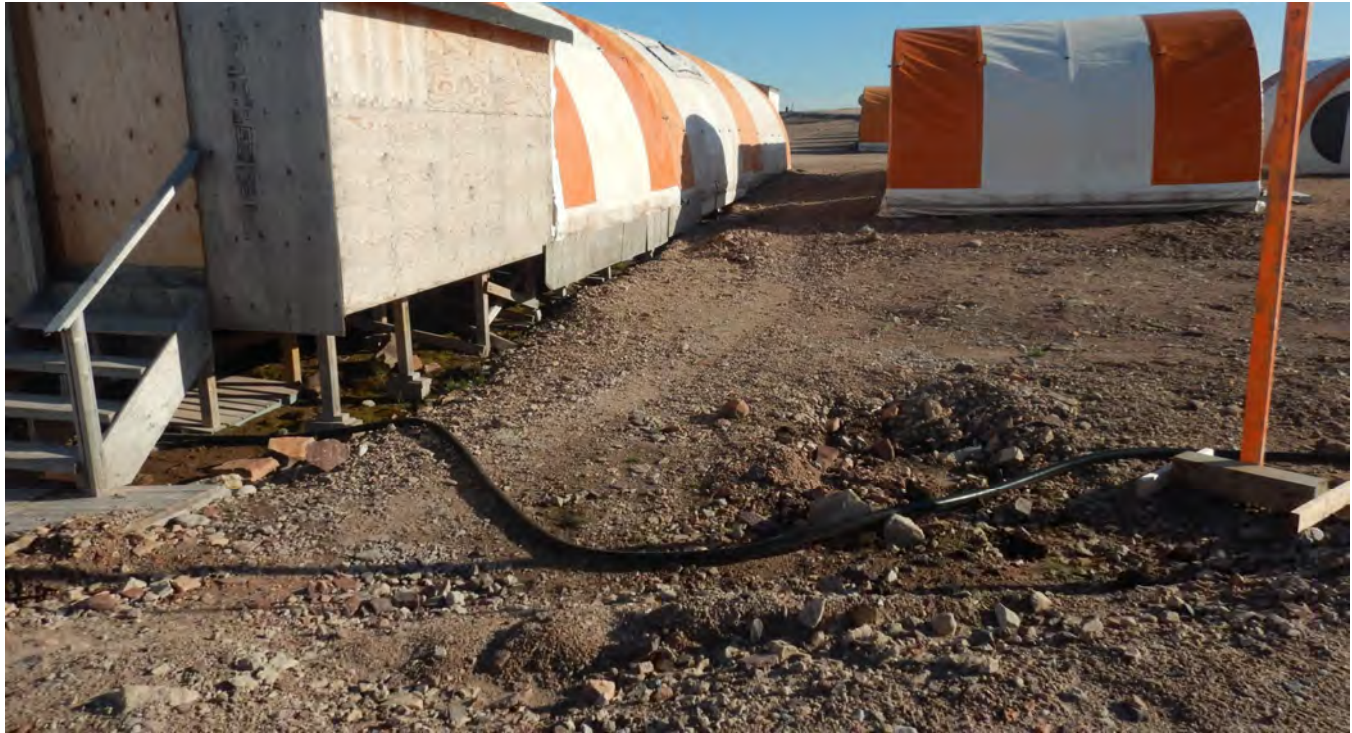
M-27. – Surface undulation at the Camp Pad.

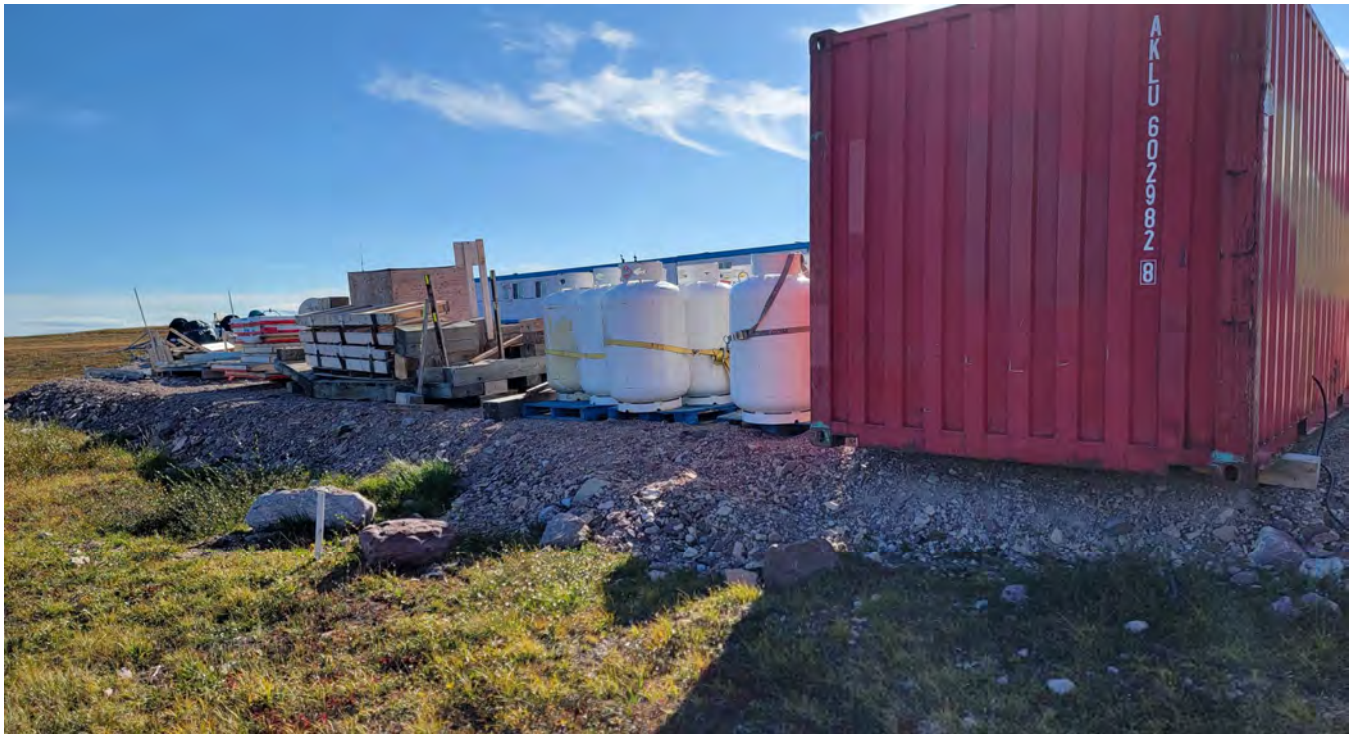
M-29. – Materials and seacans are placed at the crest of the pad.

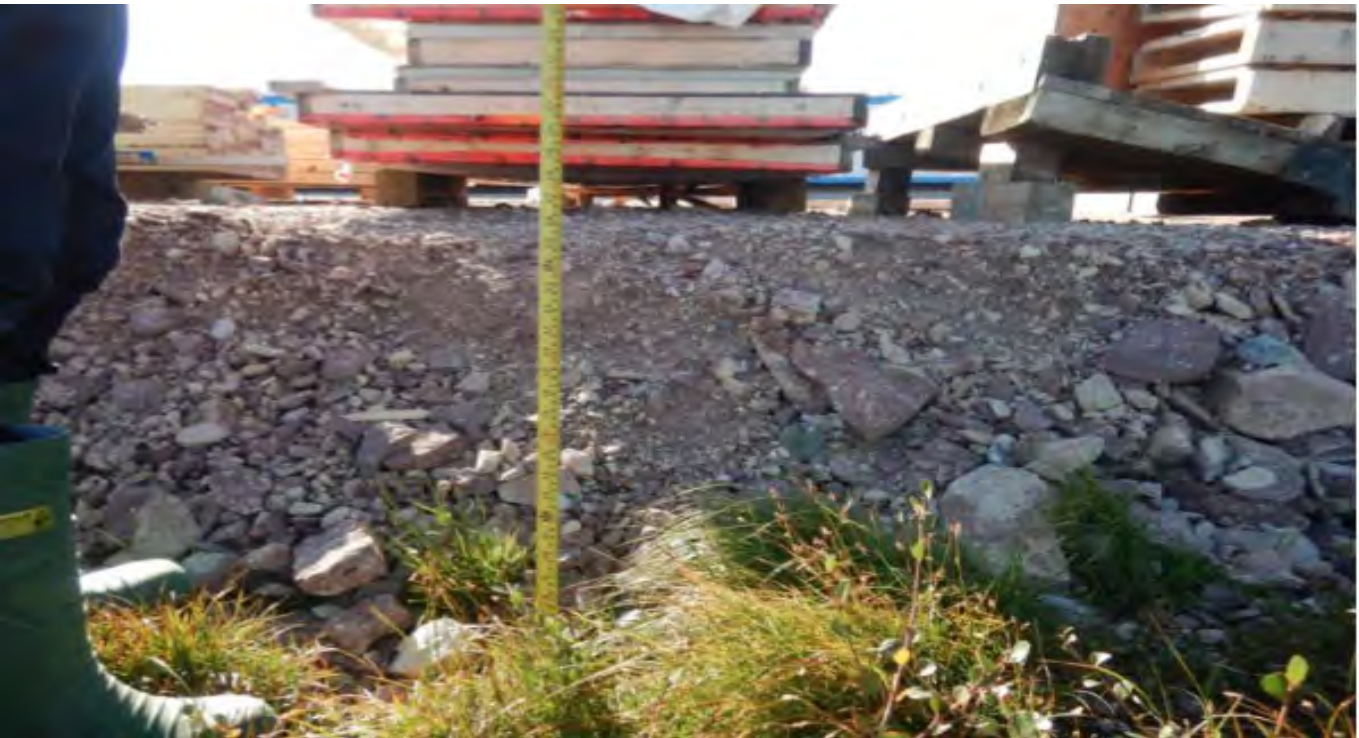
M-30. – Thickness of the Camp Pad.

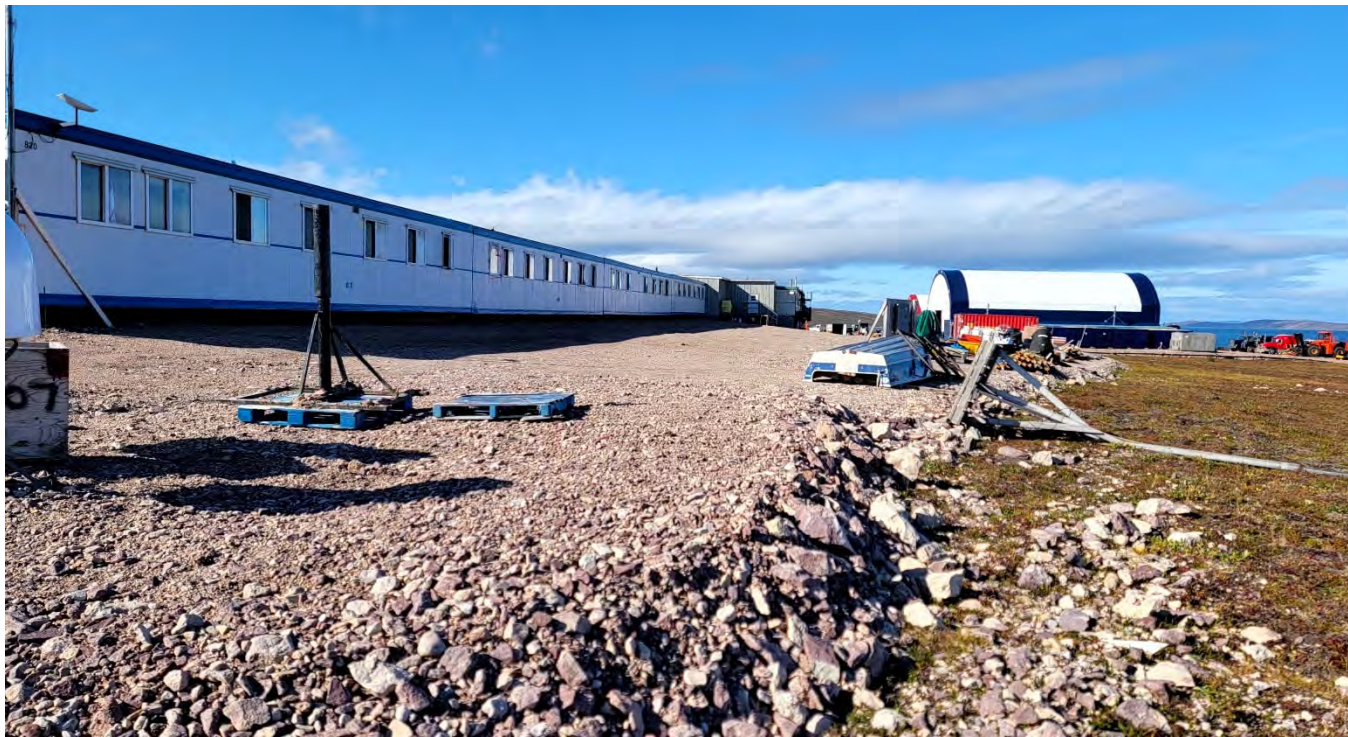
M-31. – East corner of the Cap Pad looking NW. Note camp pad thickness

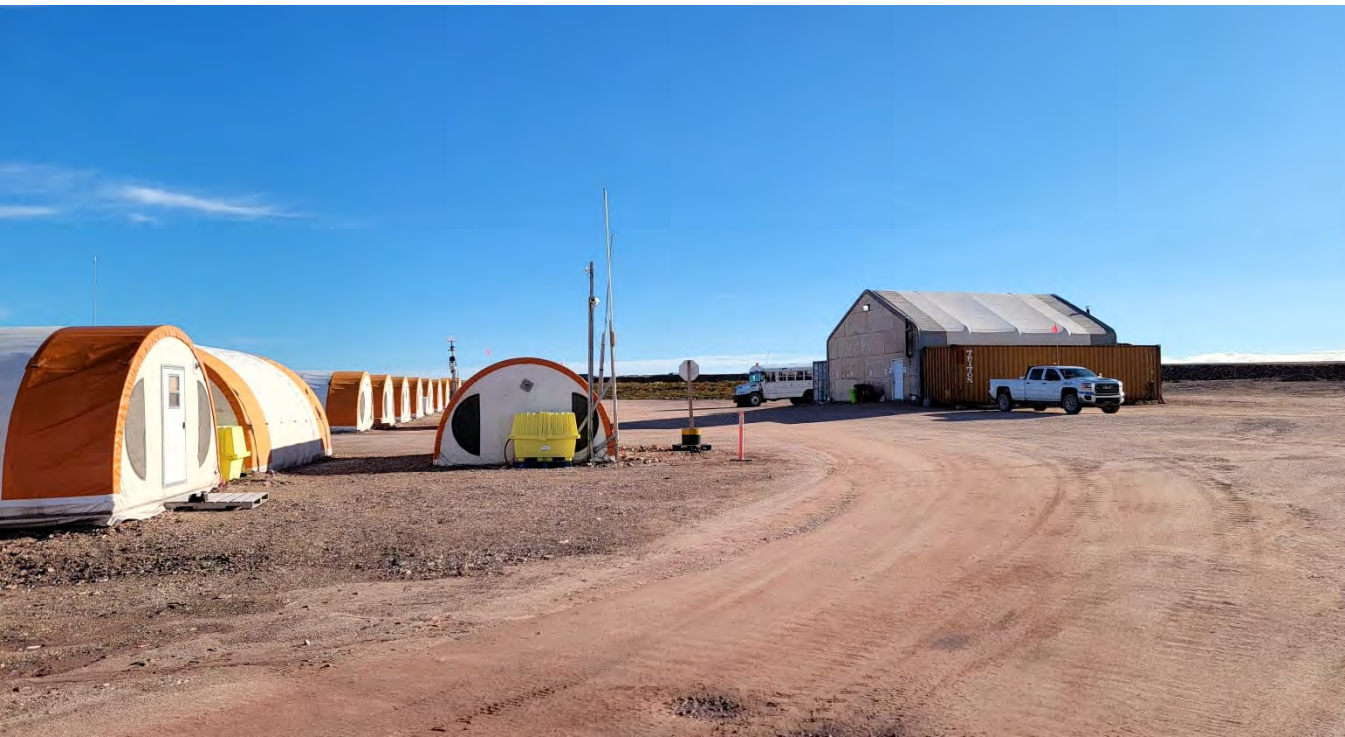
M-32. – Western side of the Cam Pad looking SE.

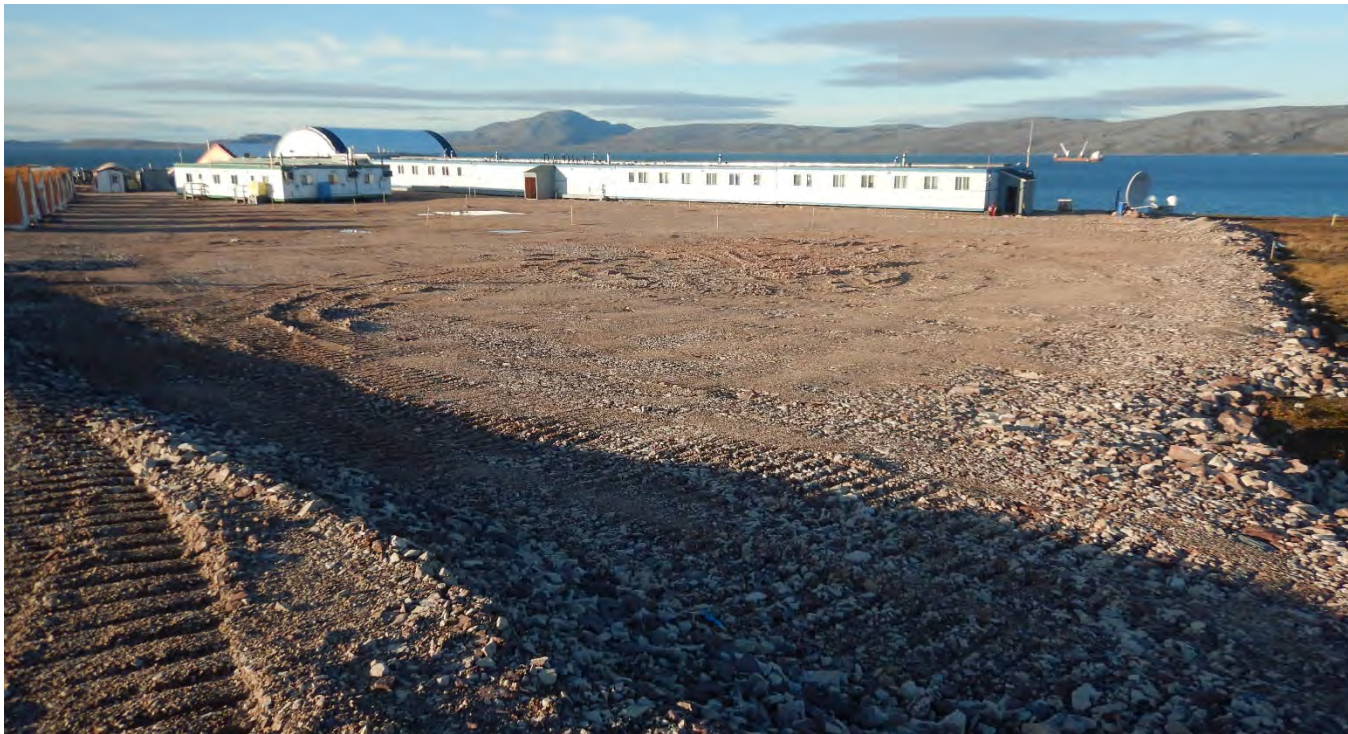
M-33. – Southern extension of the Camp Pad looking north. Note the uncompact material and thickness of the pad.

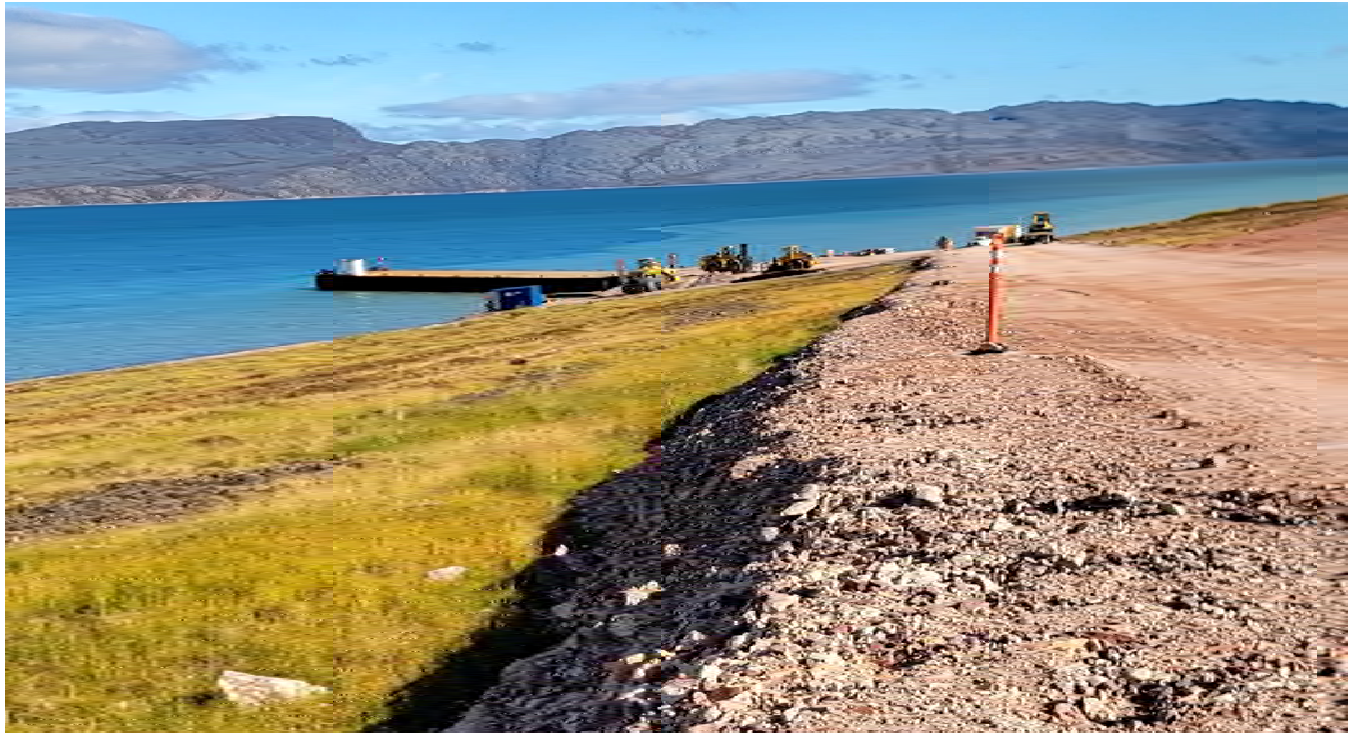
M-34. – Access road to the Shoreline Pad looking west

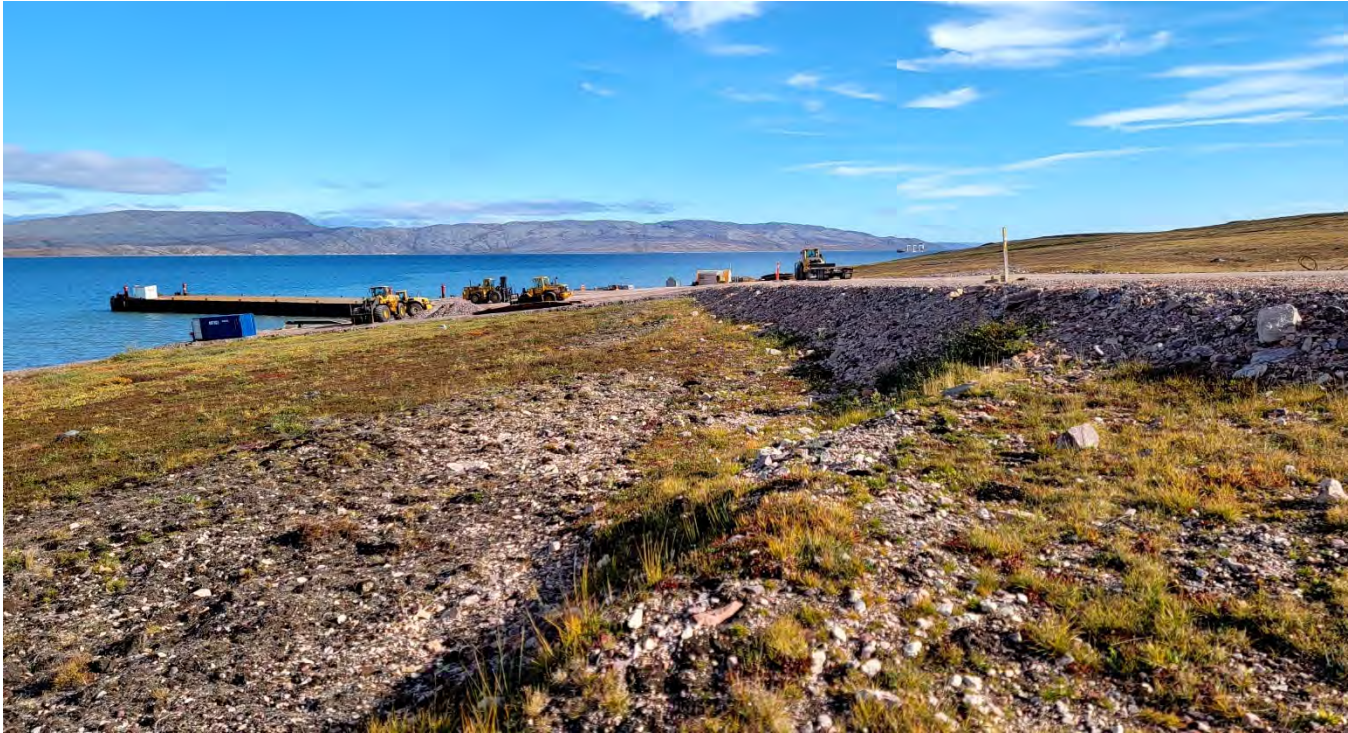
M-35. – Access road to the Shoreline Pad looking west, note thickness of the embankment

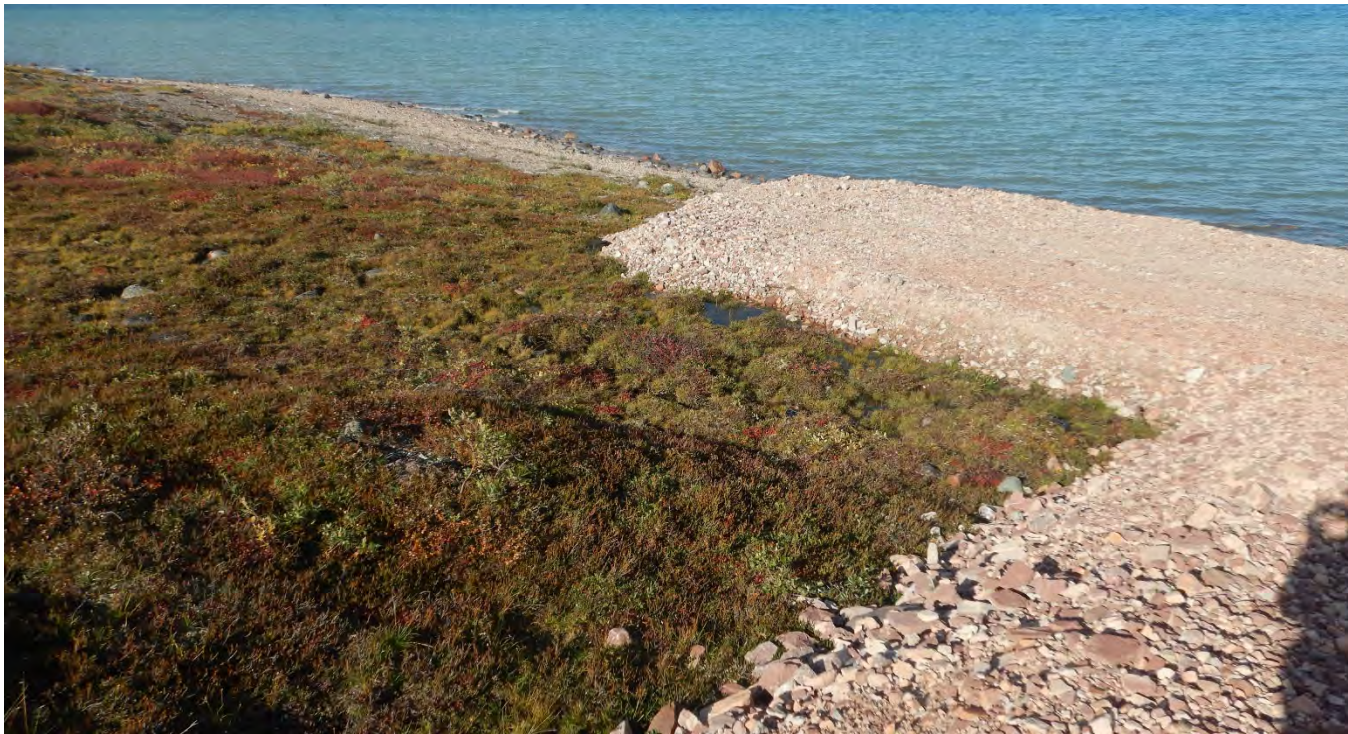
M-36. – Access road and pad at the norther side of the Fright Storage Pad

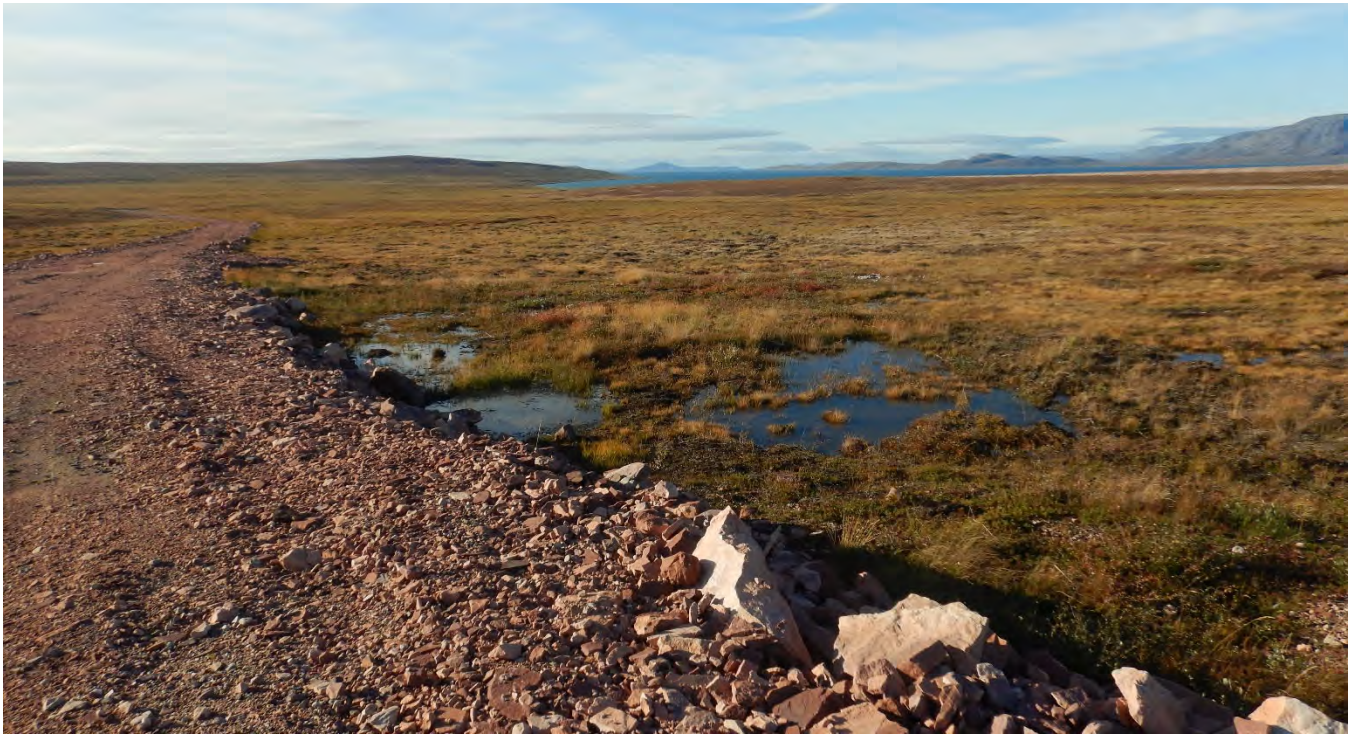
M-37. – Former Explosives Storage Berm. Note ponding waters along the toe of the embankment

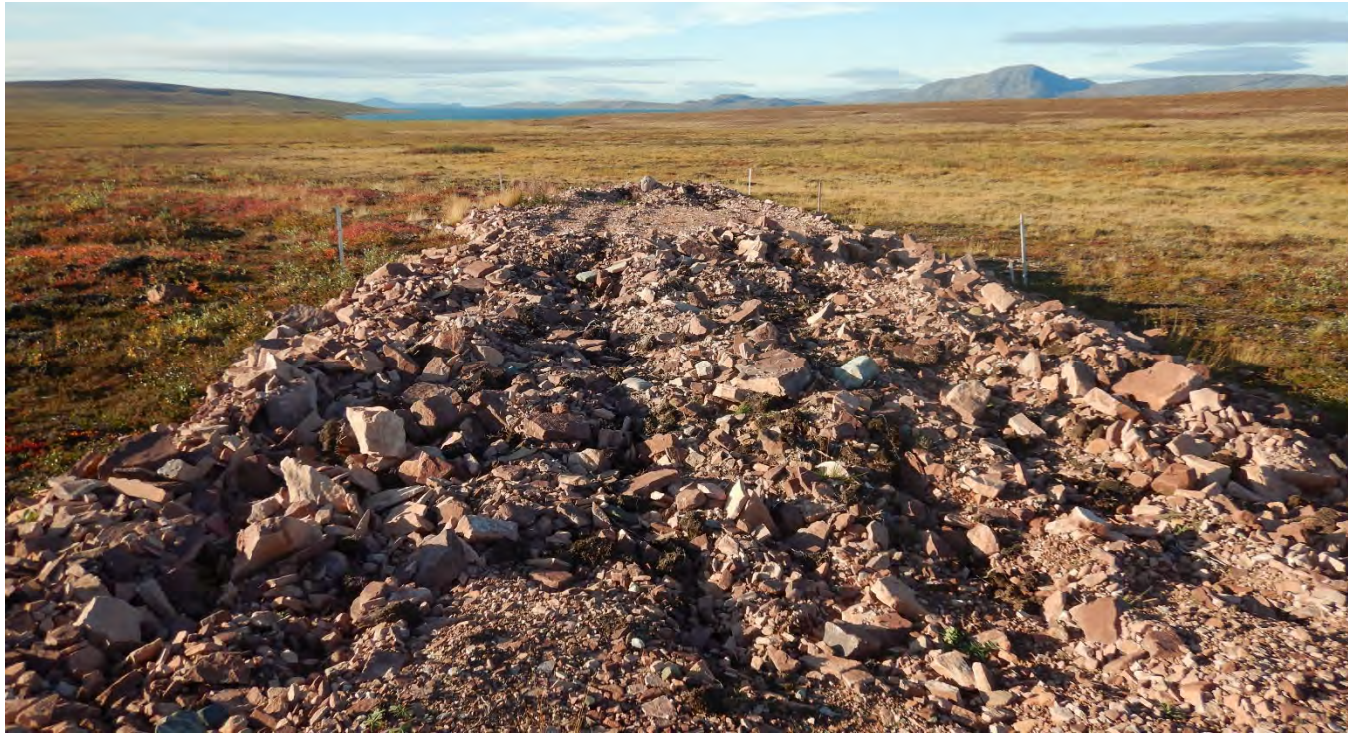
M-38. – Former Explosives Storage Berm.

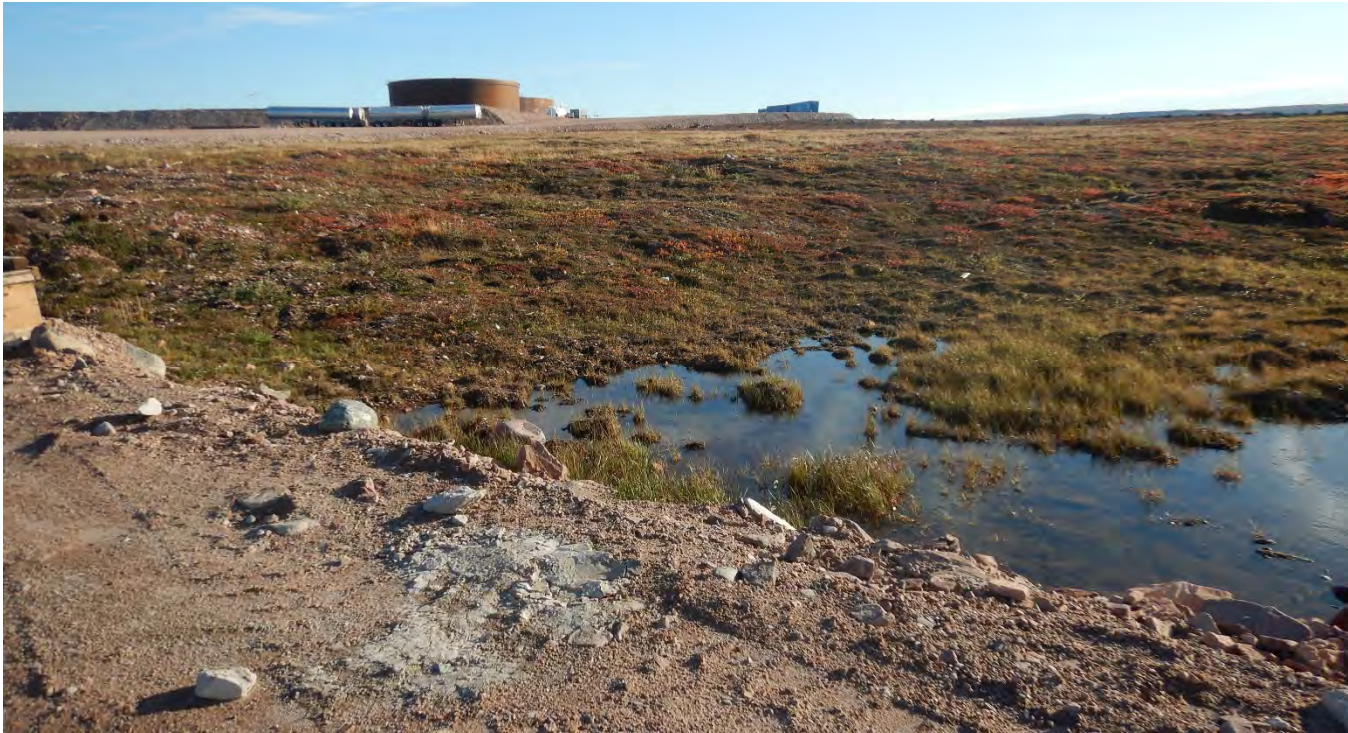
M-39 Former Explosives Storage Berm. Note ponding waters along the toe of the embankment

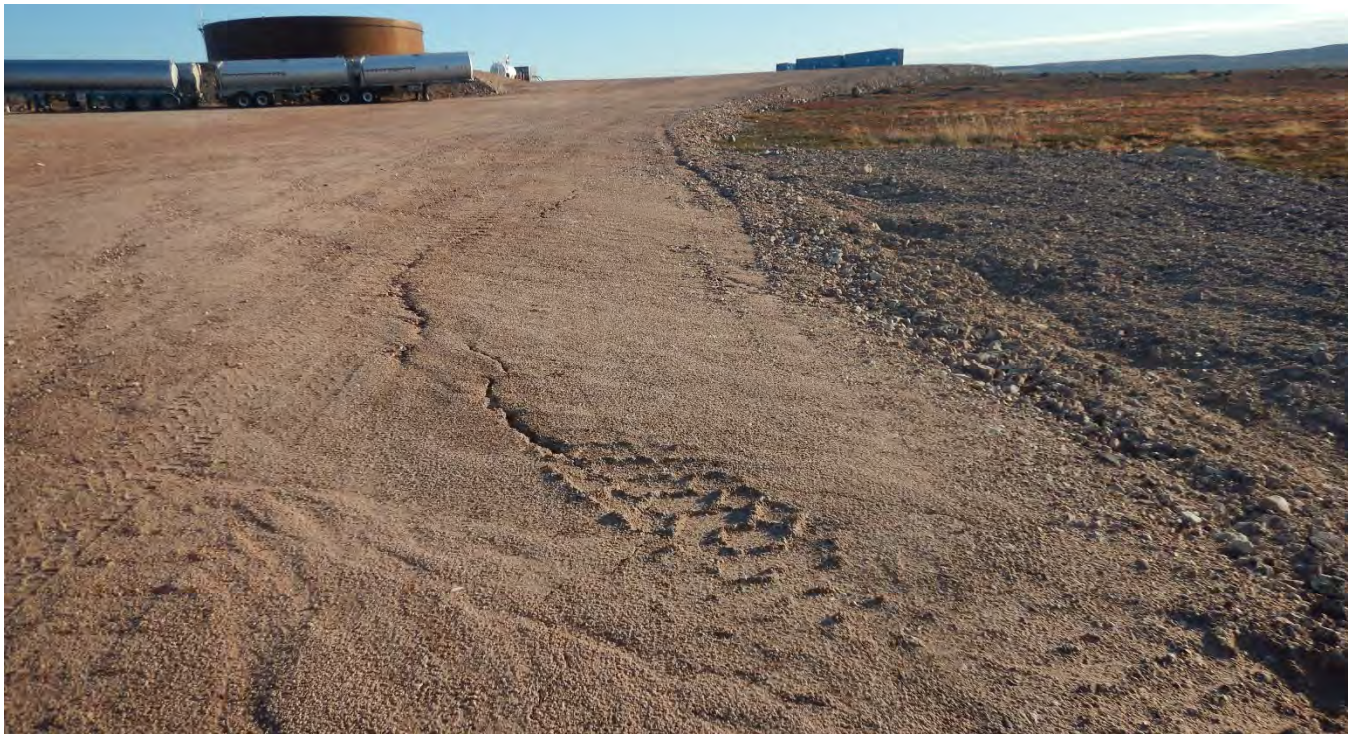
M-40. – Former Explosives Storage Berm. Note cracks along the road edge.

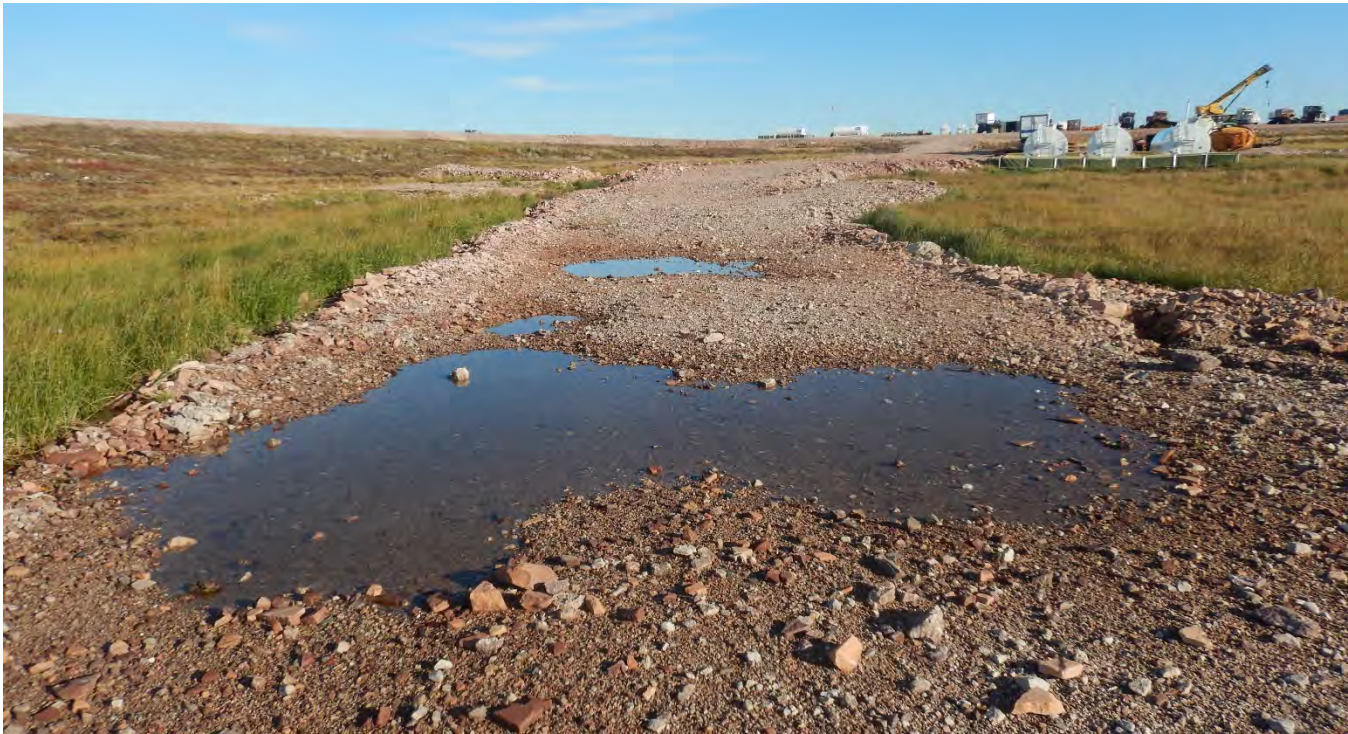
M-41. – Former Temporary Fuel Containment access road.

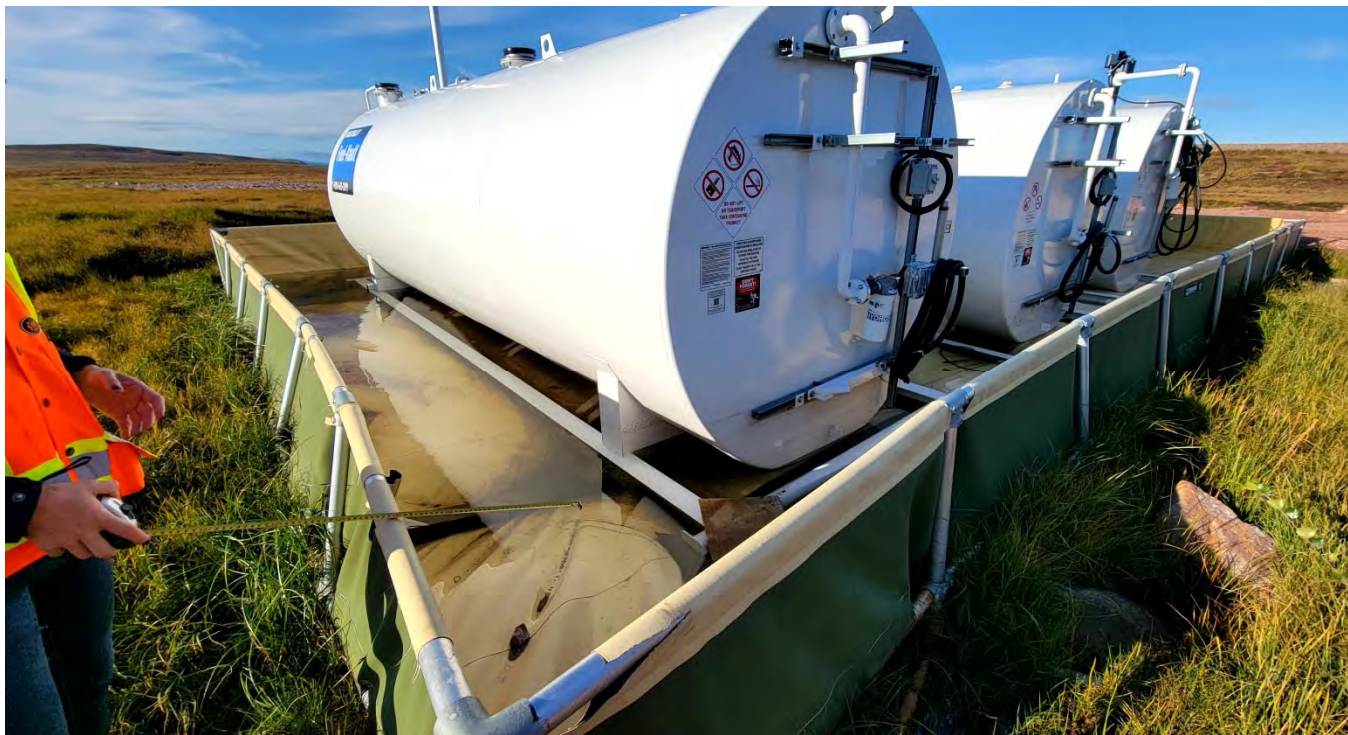
M-42. – Insta Berm with three empty fuel tanks. Note ponding water at the base of the containment area

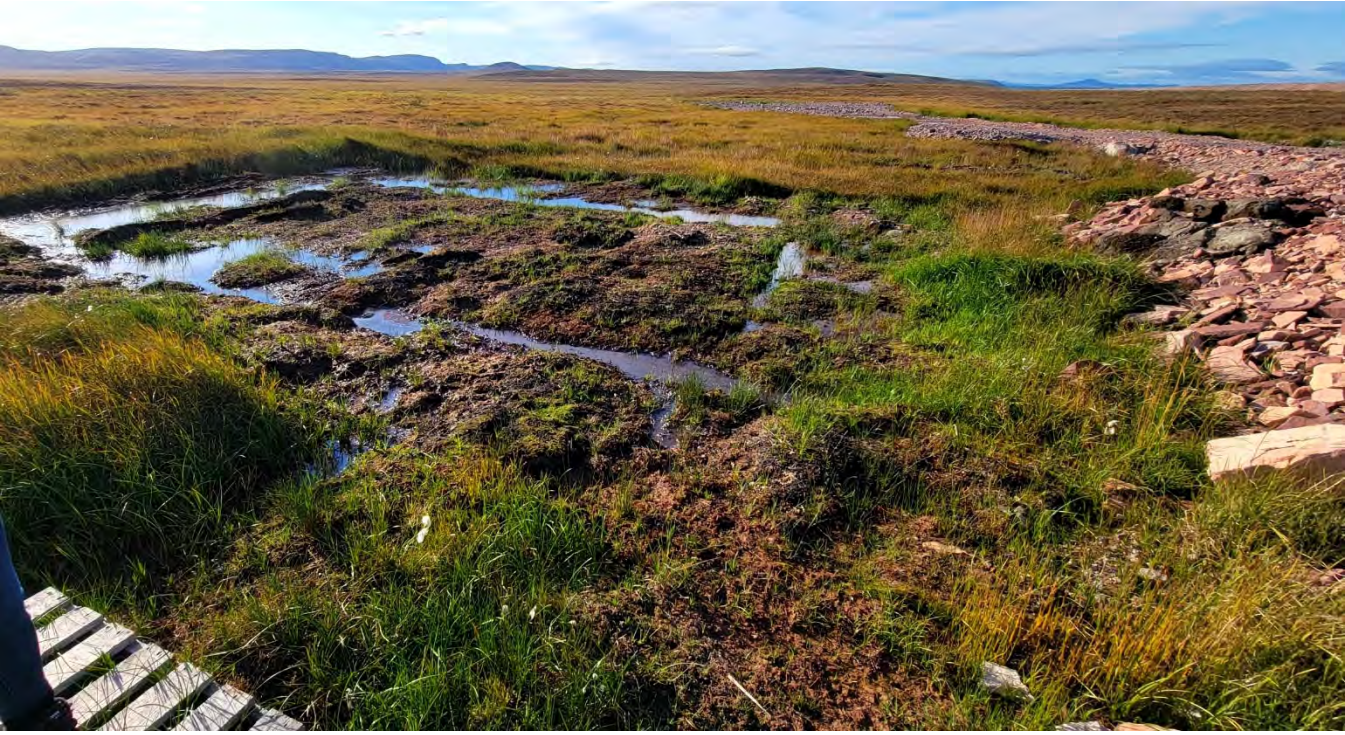
M-43. – Degradation of the tundra after replacement of the containment berm. Oil was noted at the surface of the ponding water

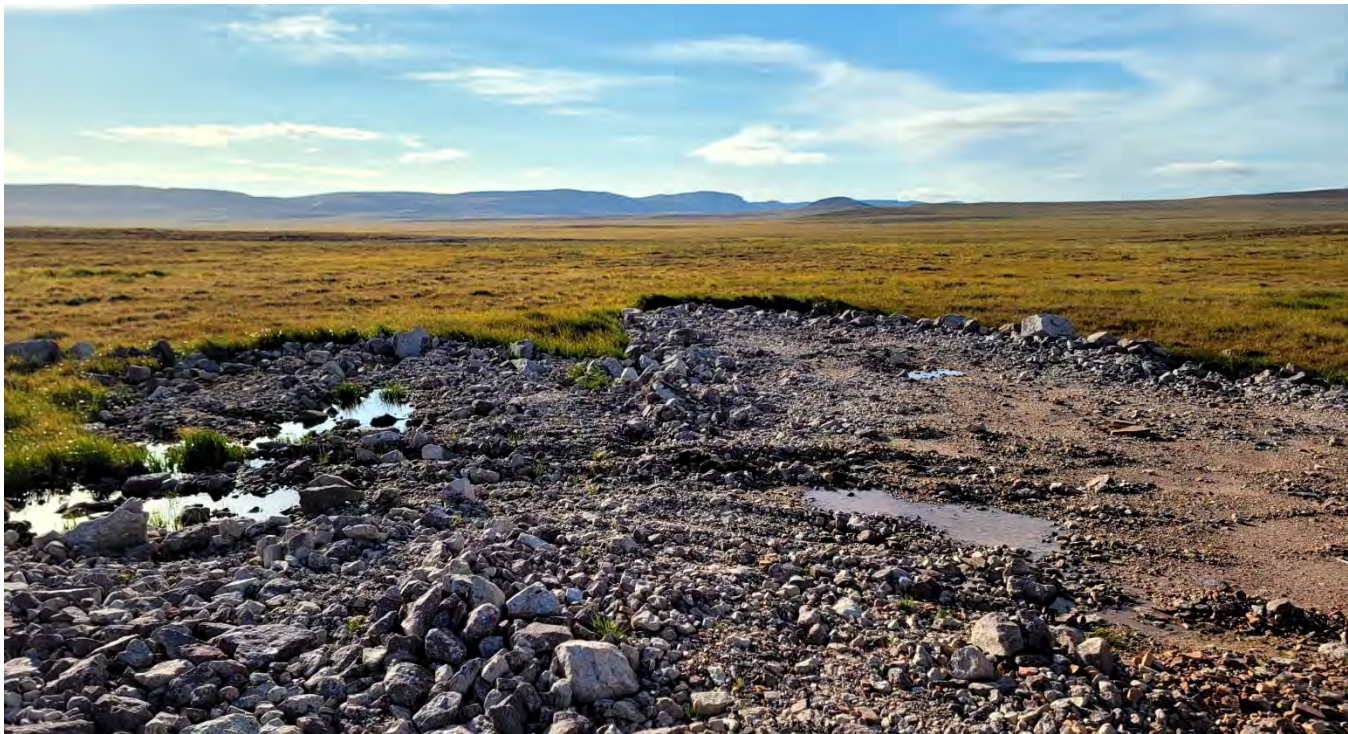
M-44. – Fill material is spreading on the tundra southeast to the Former Temporary Fuel Containment Area

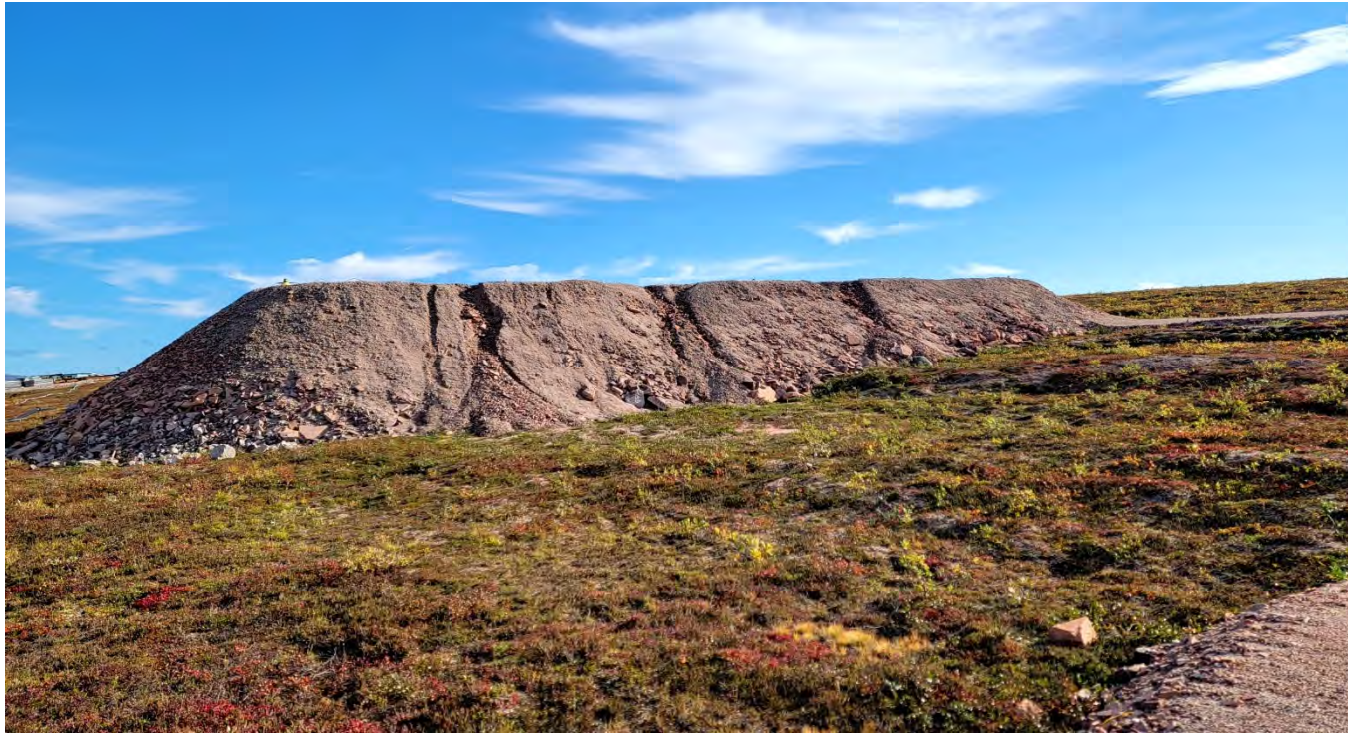
M-46. – Set of deep erosion gullies at the NW end of the airstrip

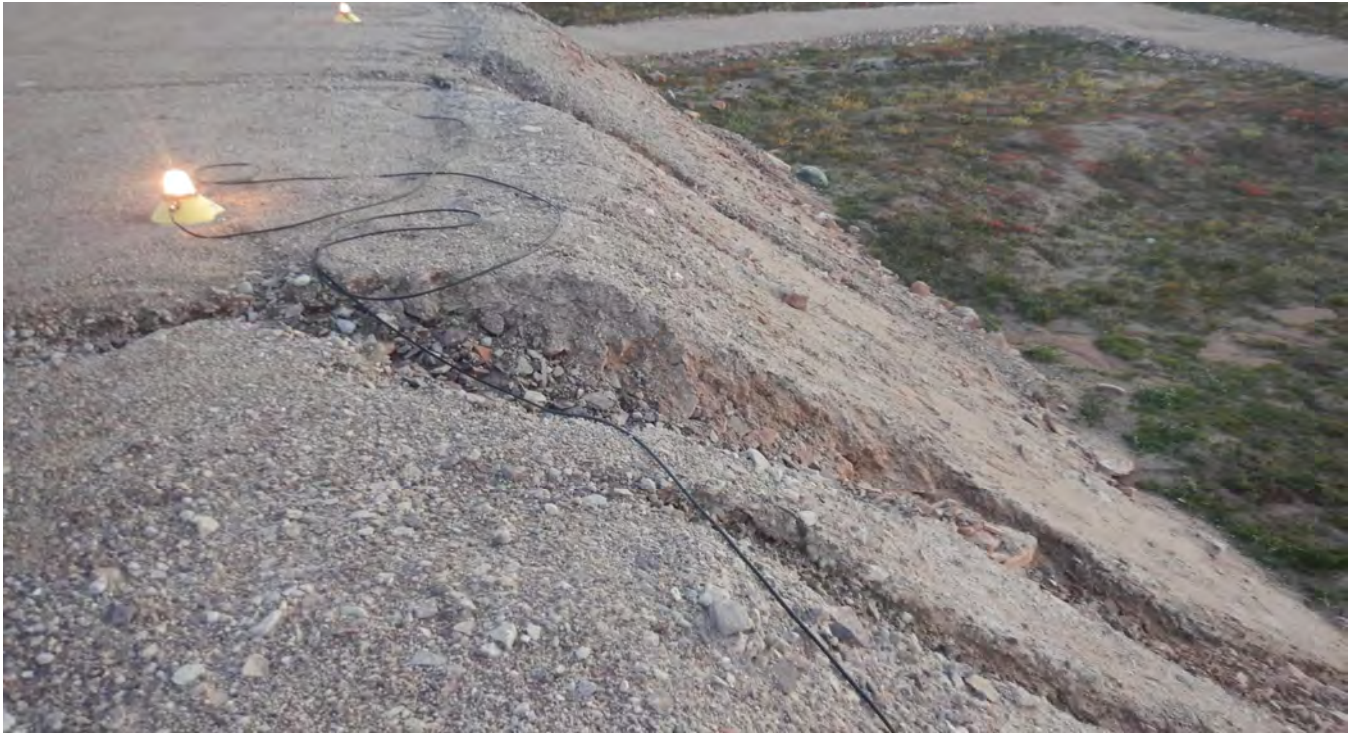
M-46a. – Erosion gullies at the NW end of the airstrip
