2023 Annual Geotechnical Inspection		
		Freight Storage Pad		
Job No: CAPR003105 Filename: BackRiver_MLA_2023AGI_Photos.pdf	Back River Project	Date: 2024-02-28	Approved: JBK	Figure: A.2 -8

Back River Project

2023 Annual Geotechnical Inspection

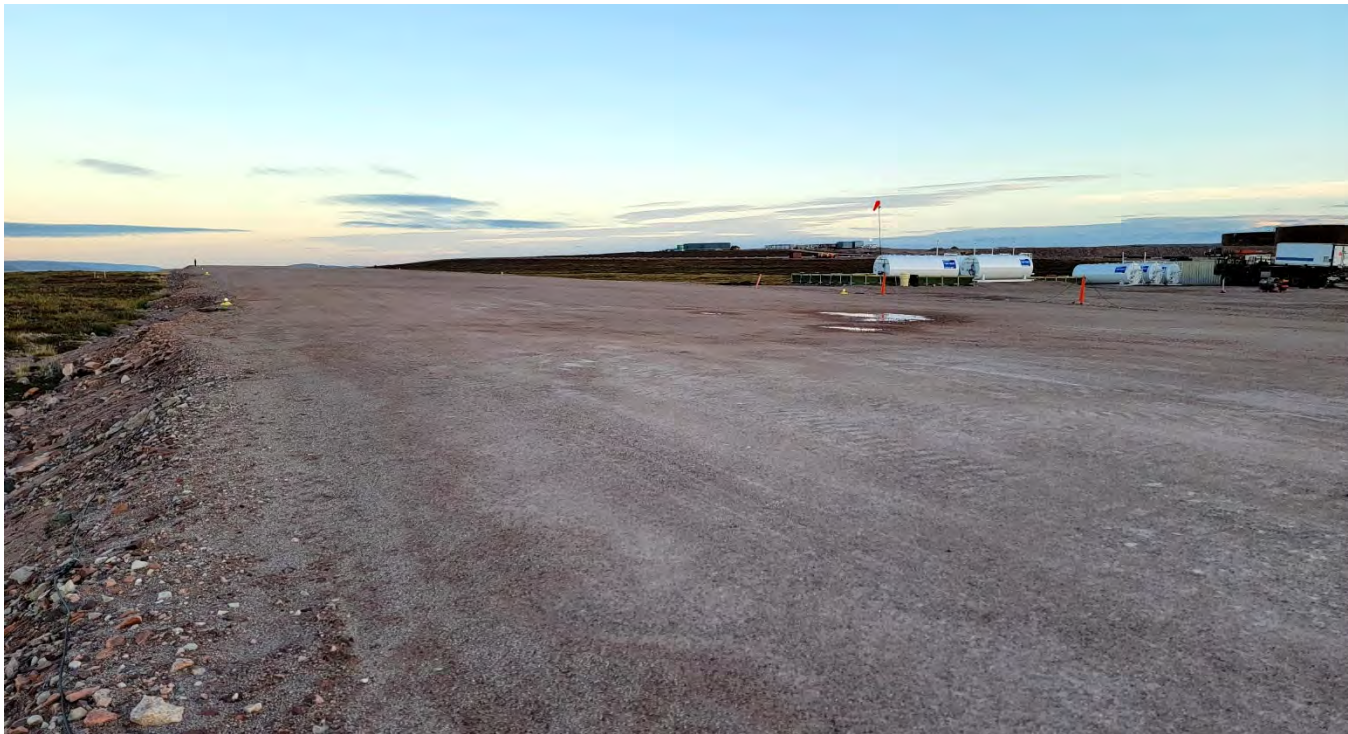
M-47. – Overview of the Airstrip surface looking SE

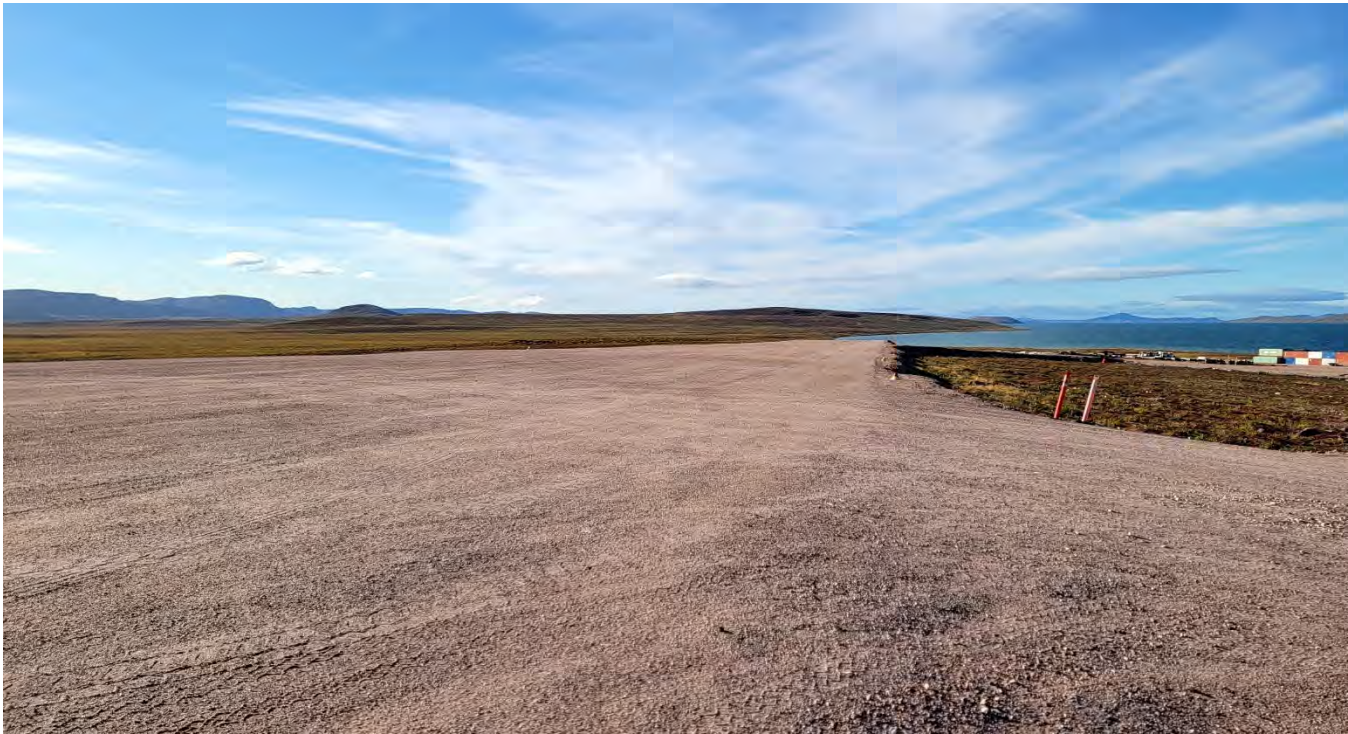
M-48. – Overview of the Airstrip surface looking NW

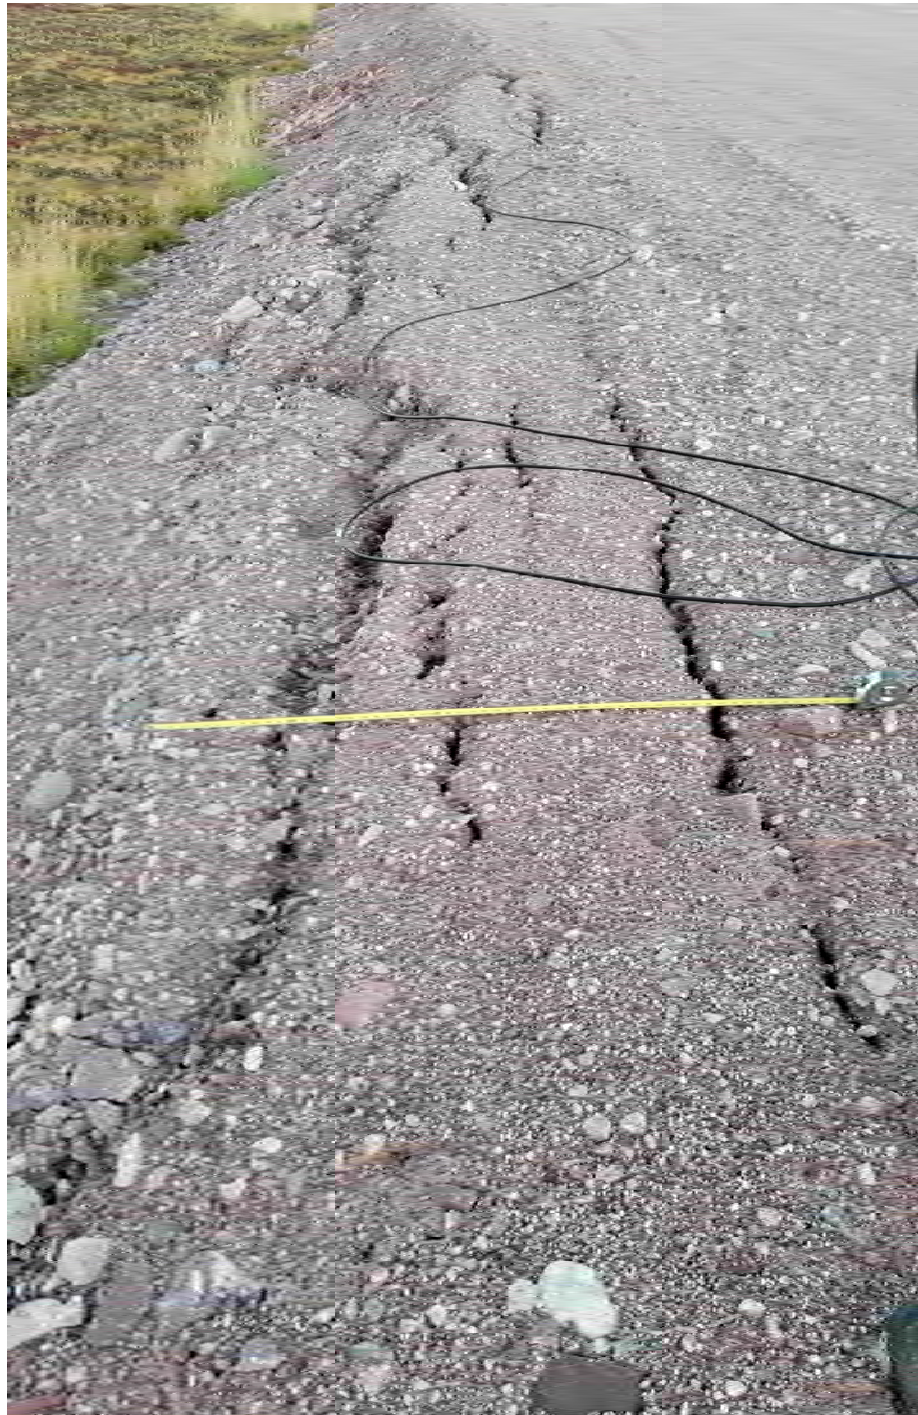
M-50. – SE end of the airstrip. Note a series of elongated cracks at the embankment crest.

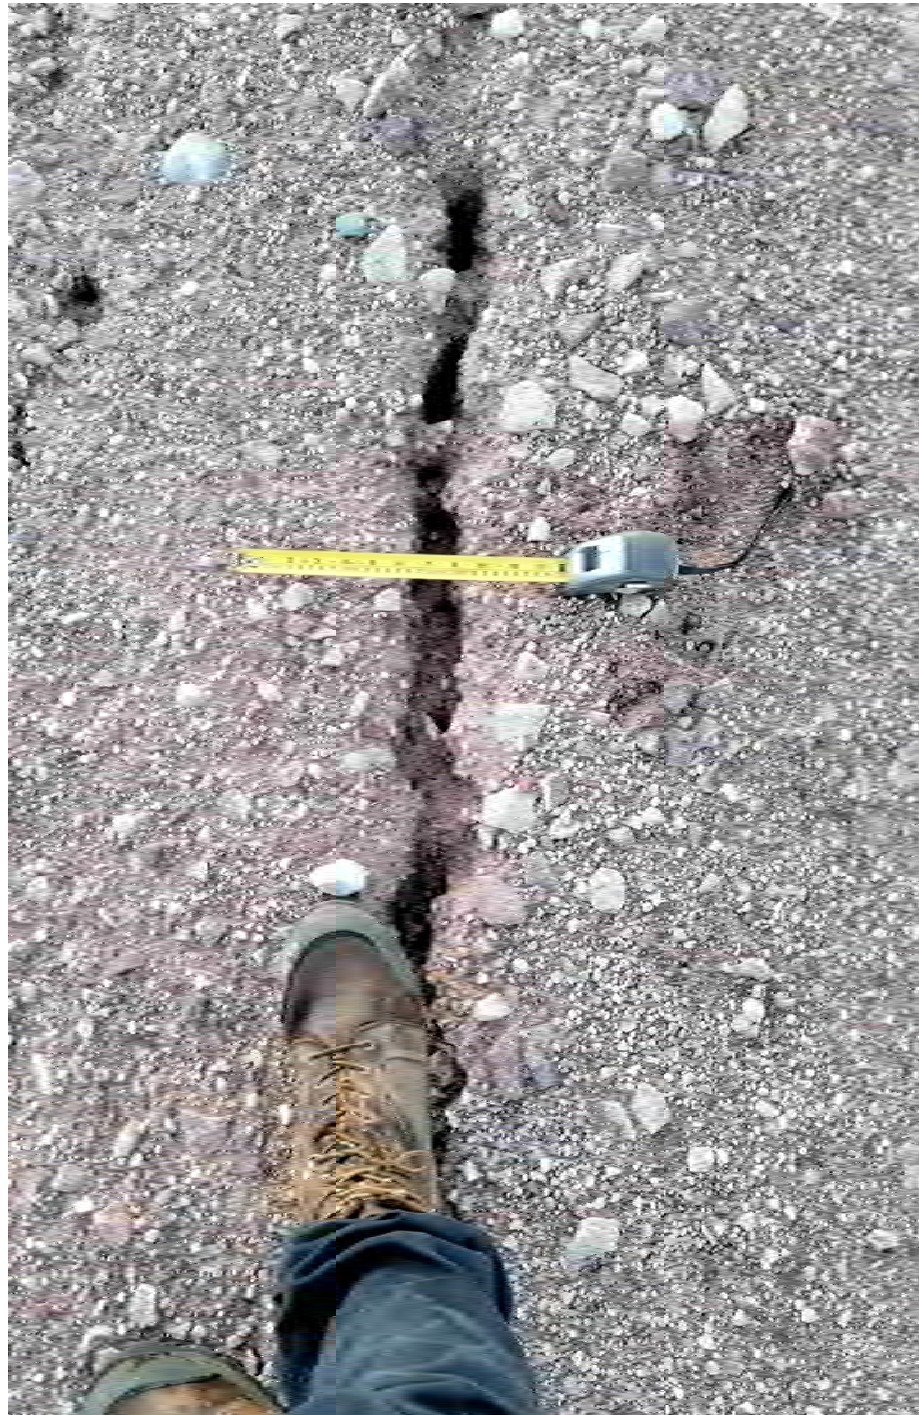
M-50a. – SE End of the airstrip. Note that the crack width is 2-2.5 inch

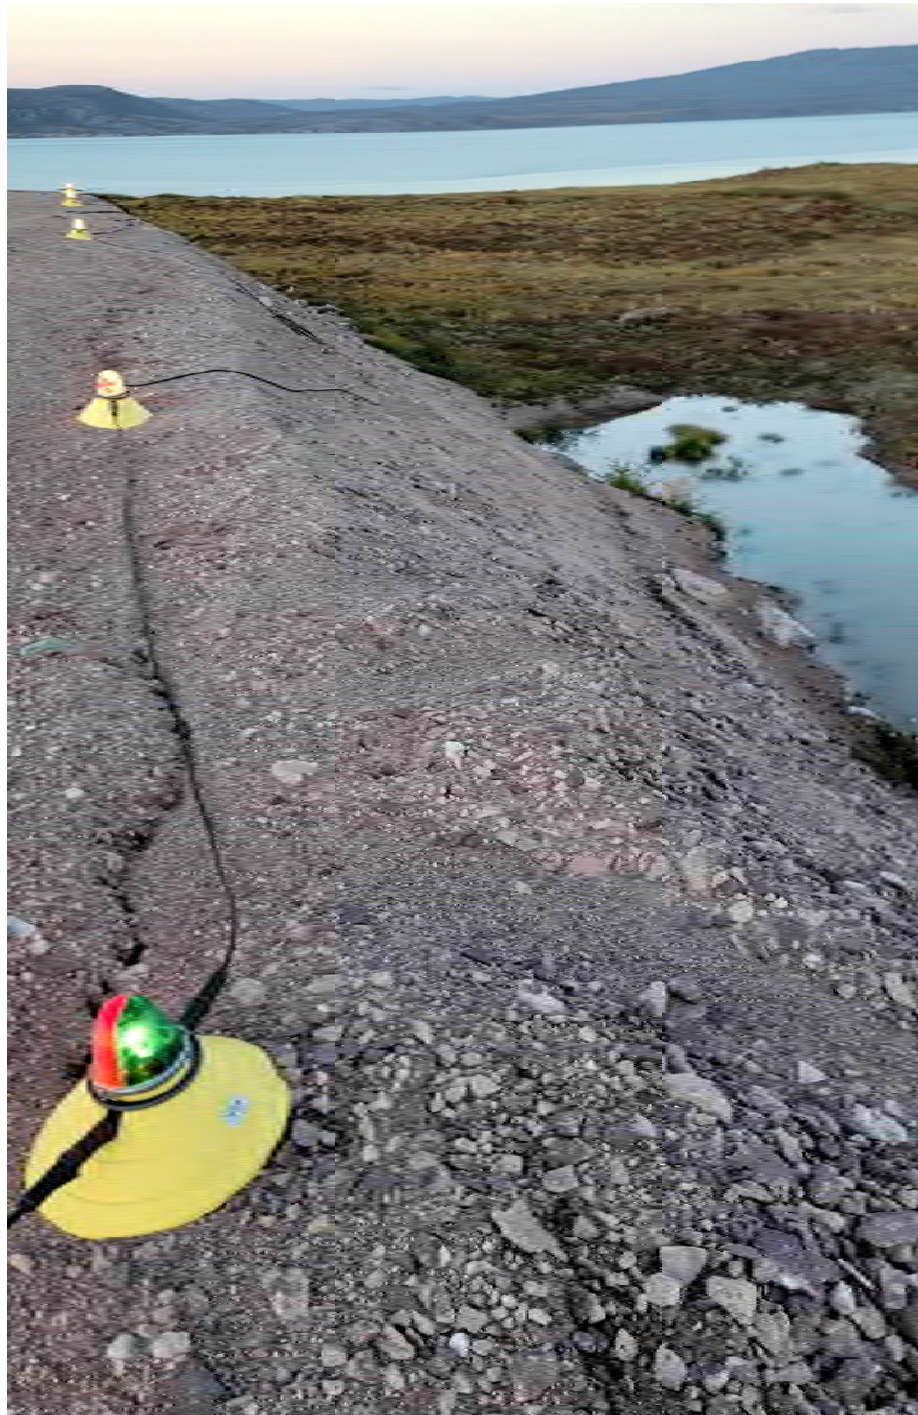
M-51. – SE end of the airstrip. Note ponding waters at the toe of the embankment and crack at the crest.

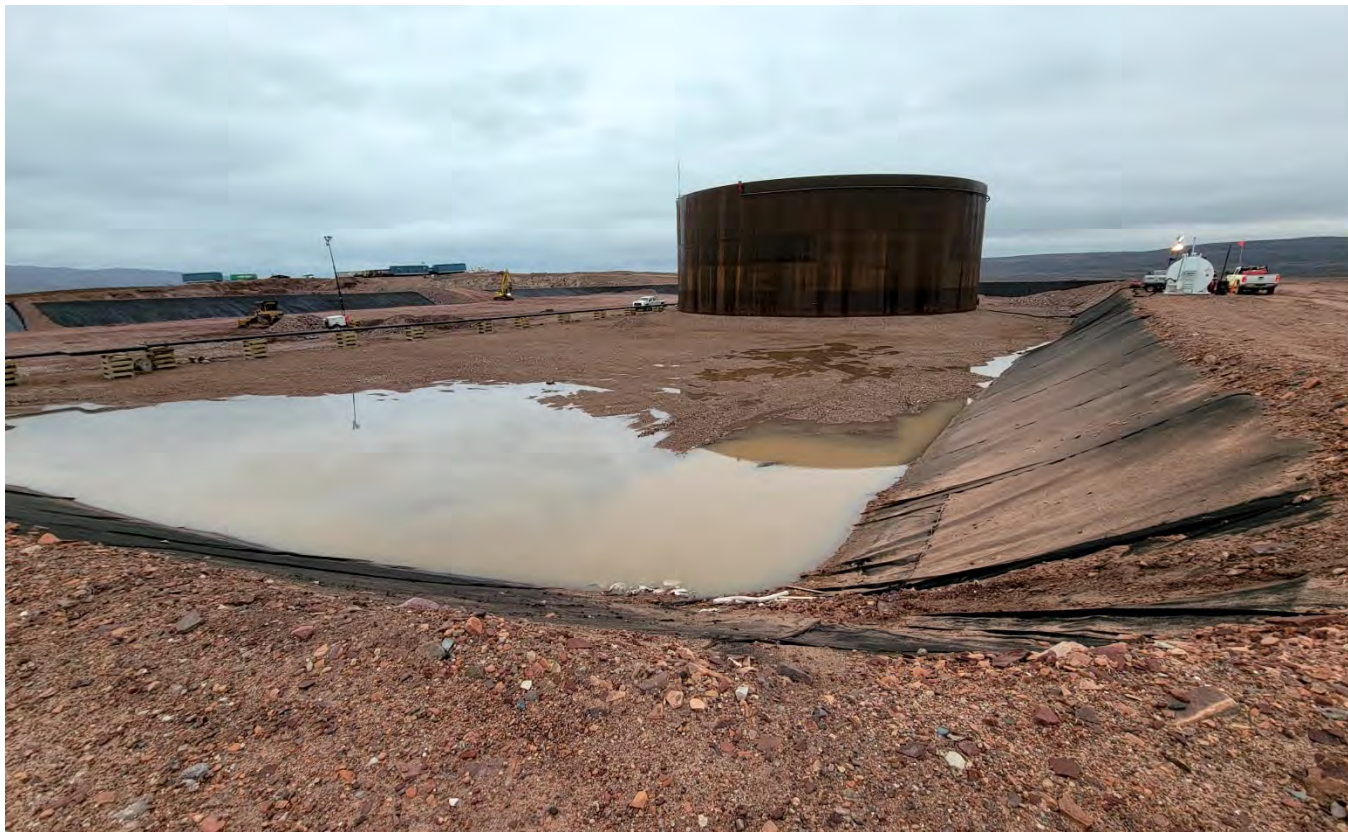
M-56. – Ponding water at the base of the NW corner of the containment area, looking south.

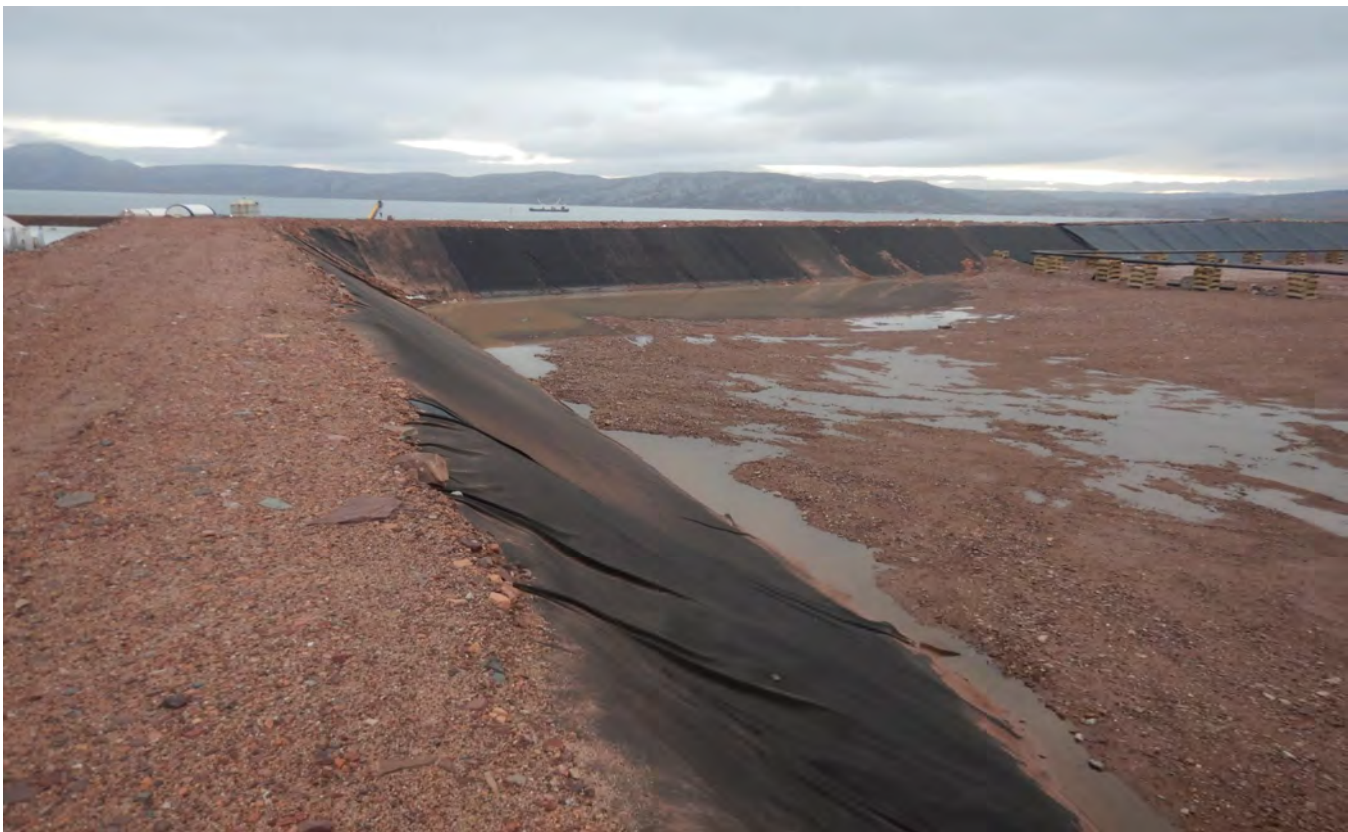
M-57. – Ponding water at the base of the NW corner and along the toe of the western berm of the containment area, looking NE.

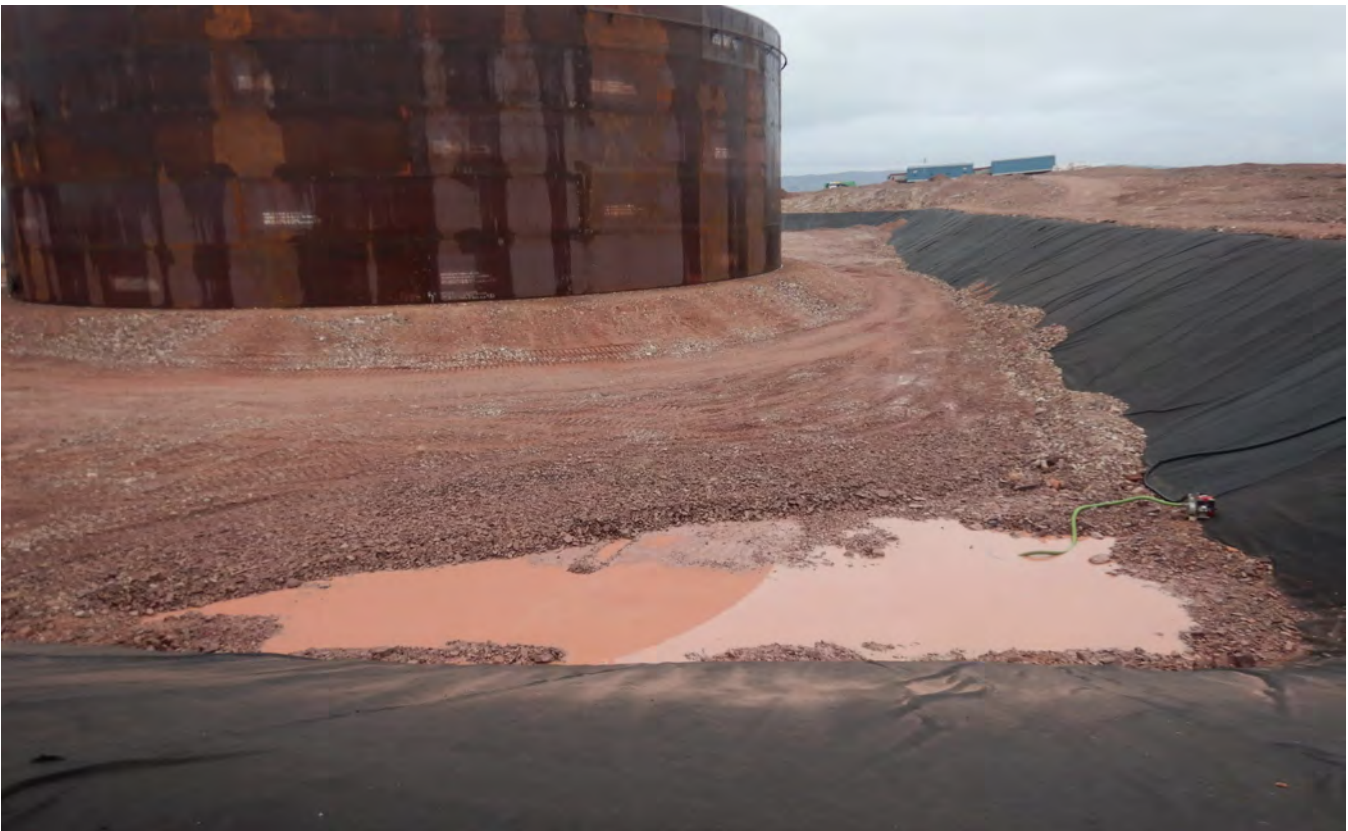
M-58. - Ponding water at the base of the SW corner of the containment area, looking NW.

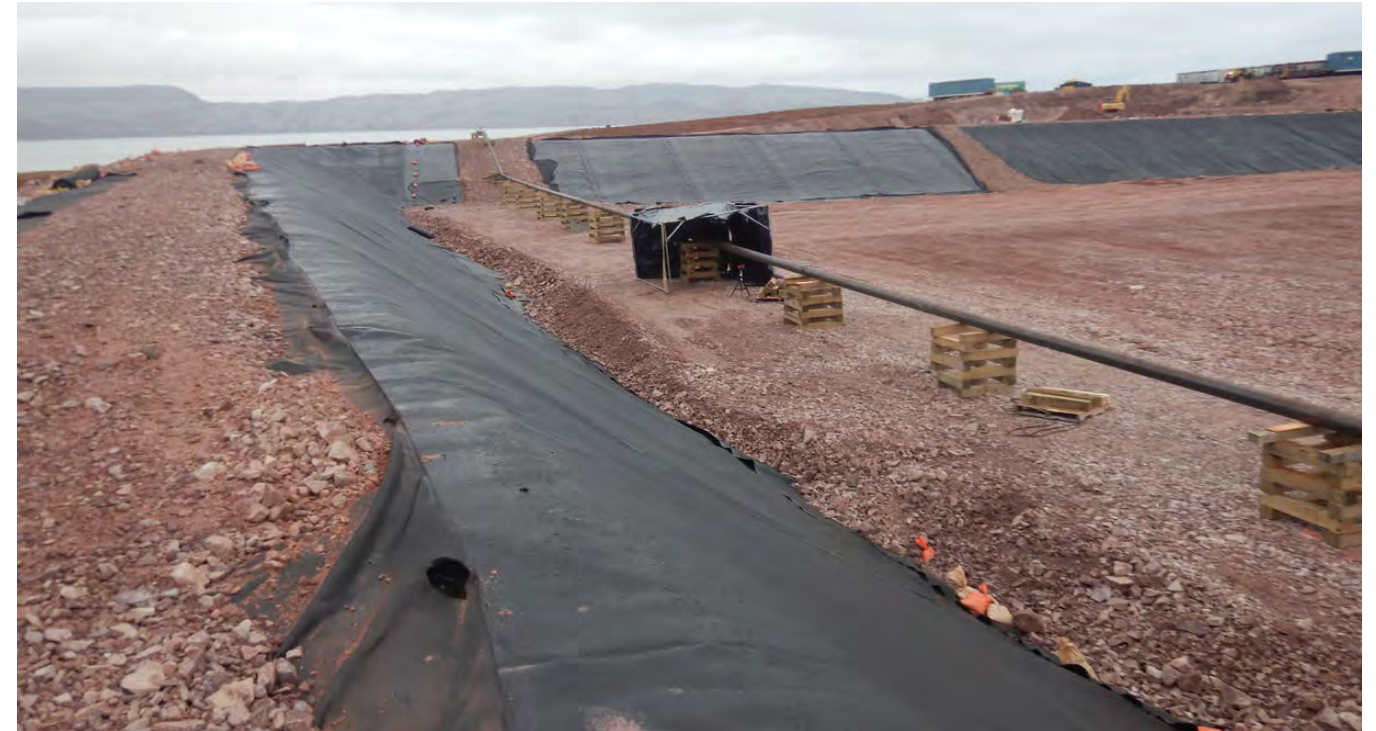
M-61. – Northern and western inner slopes. Note that the slopes are oversteepened (approx. 1.5H:1V) and not covered with the fill material.

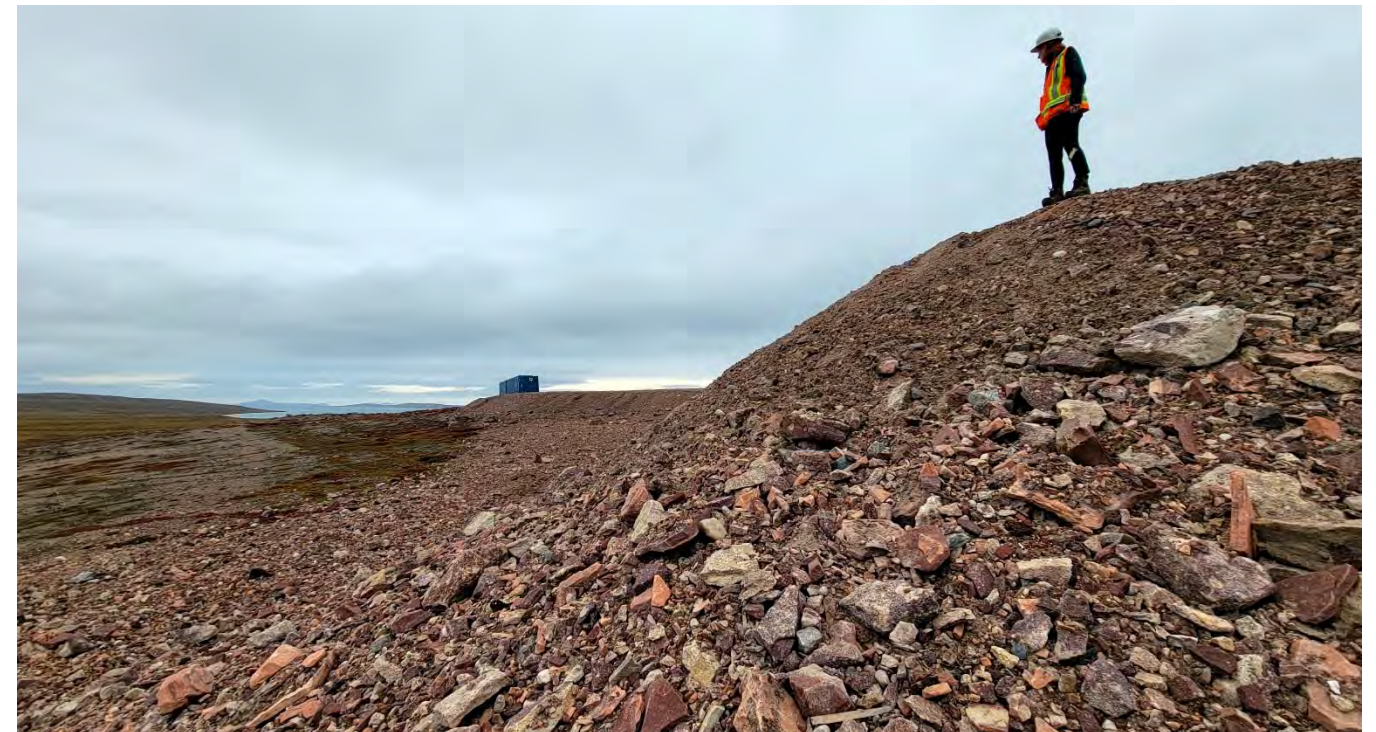
M-63. – Outer slope of the SW corner of the containment area. Note that the slope is oversteepened and has a height about 4 m

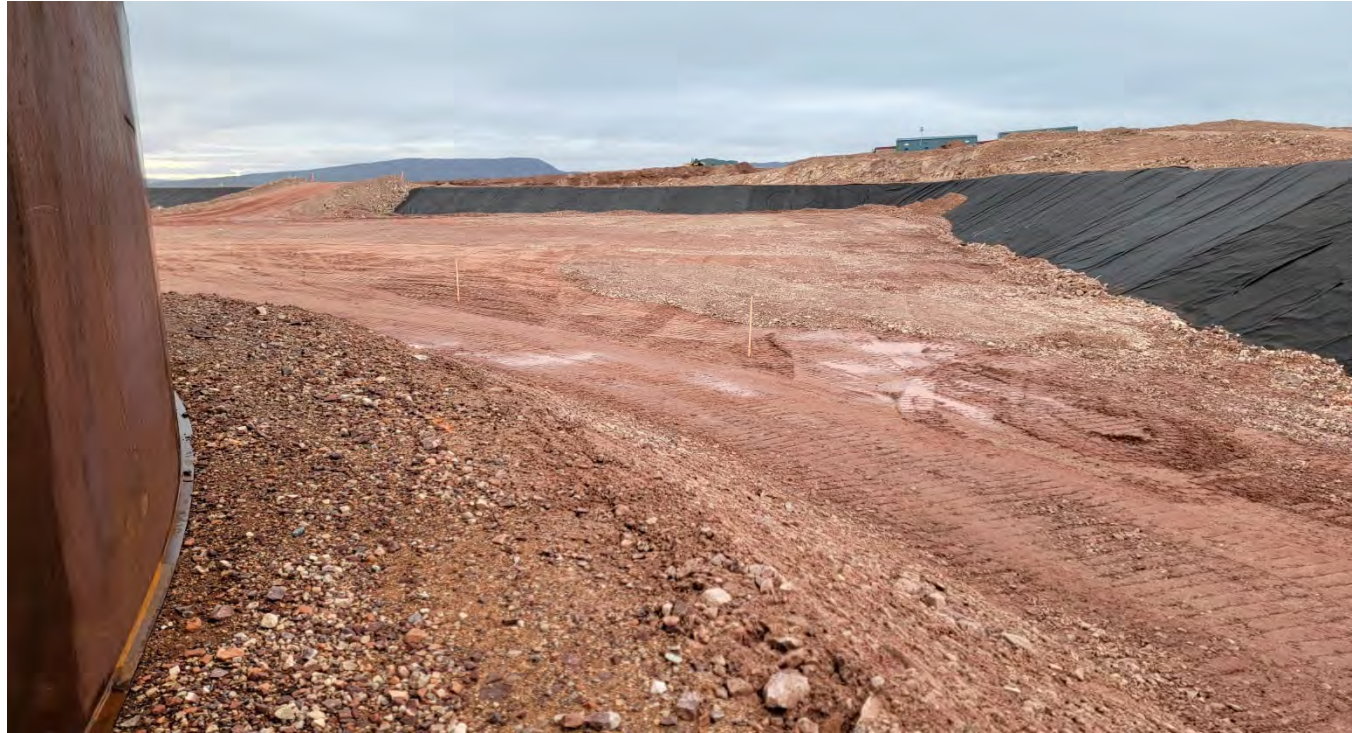
M-65. – Tank #2 pedestal. Southern slope and berm, looking NE. Note some cracks at the crest.

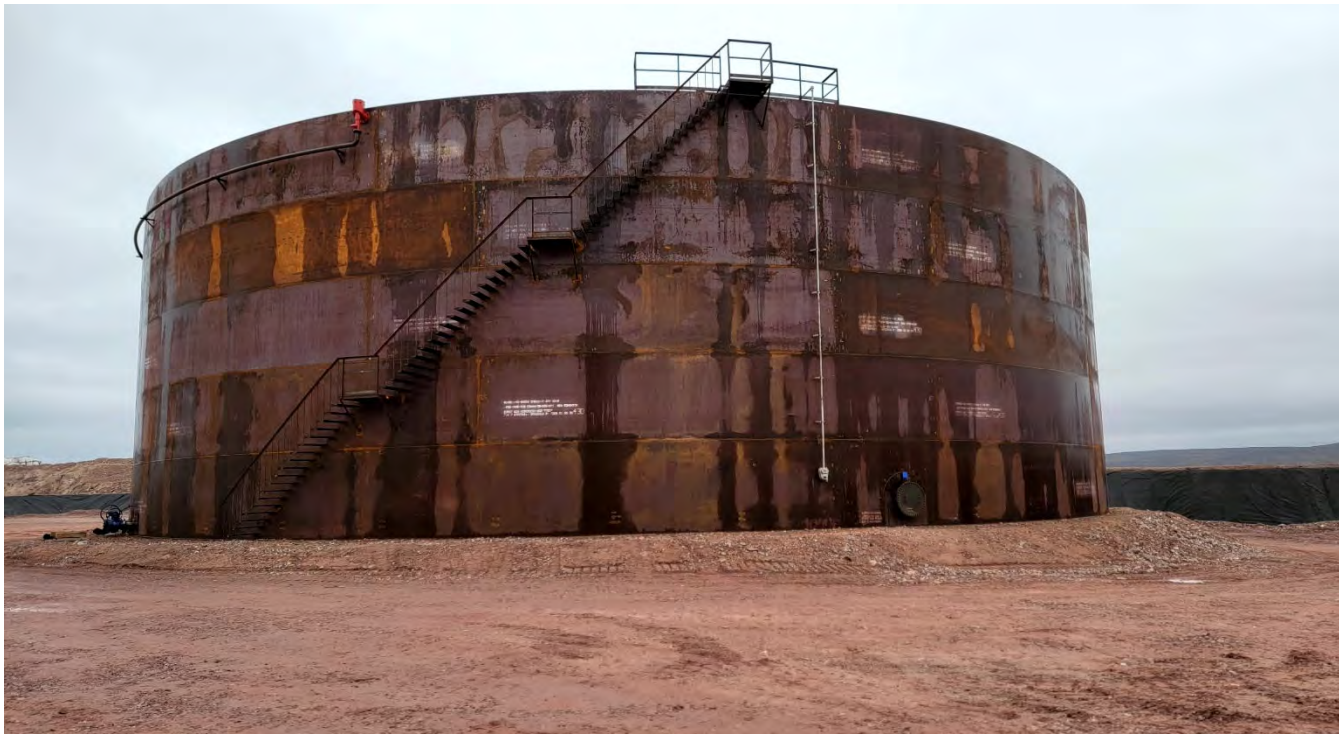
M-66. – Tank #2 pedestal. Northern slope, looking south

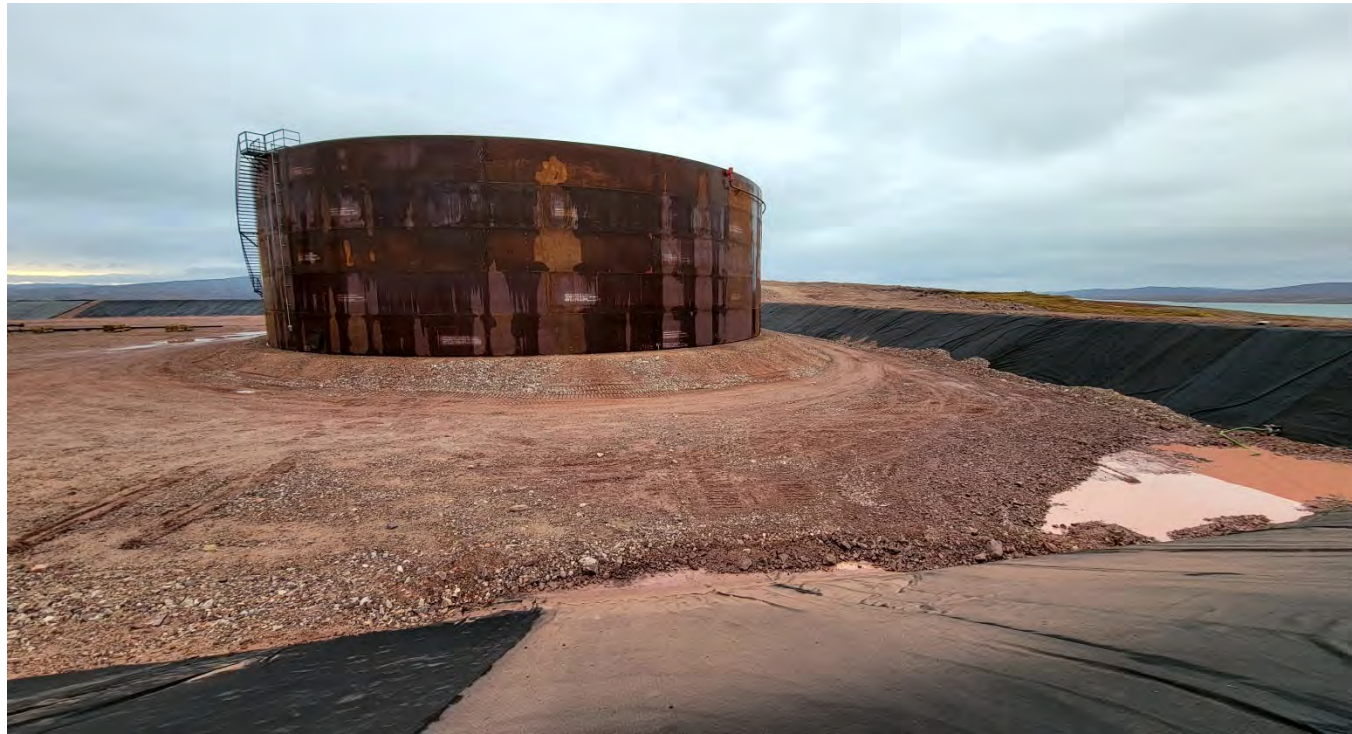
M-67. – Overview of the SW corner of the containment area and Tank #2, looking SE

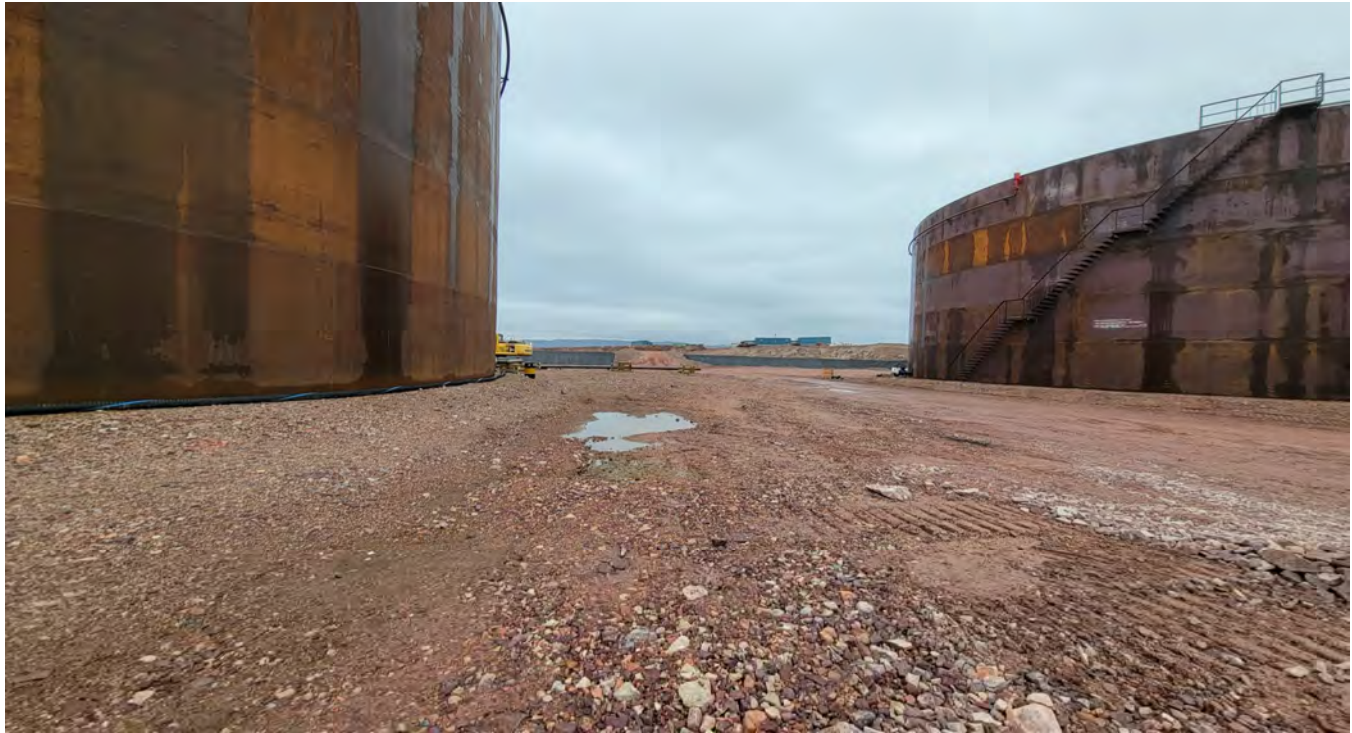
M-68. – Pedestal of Tank #1. Southern slope, looking east

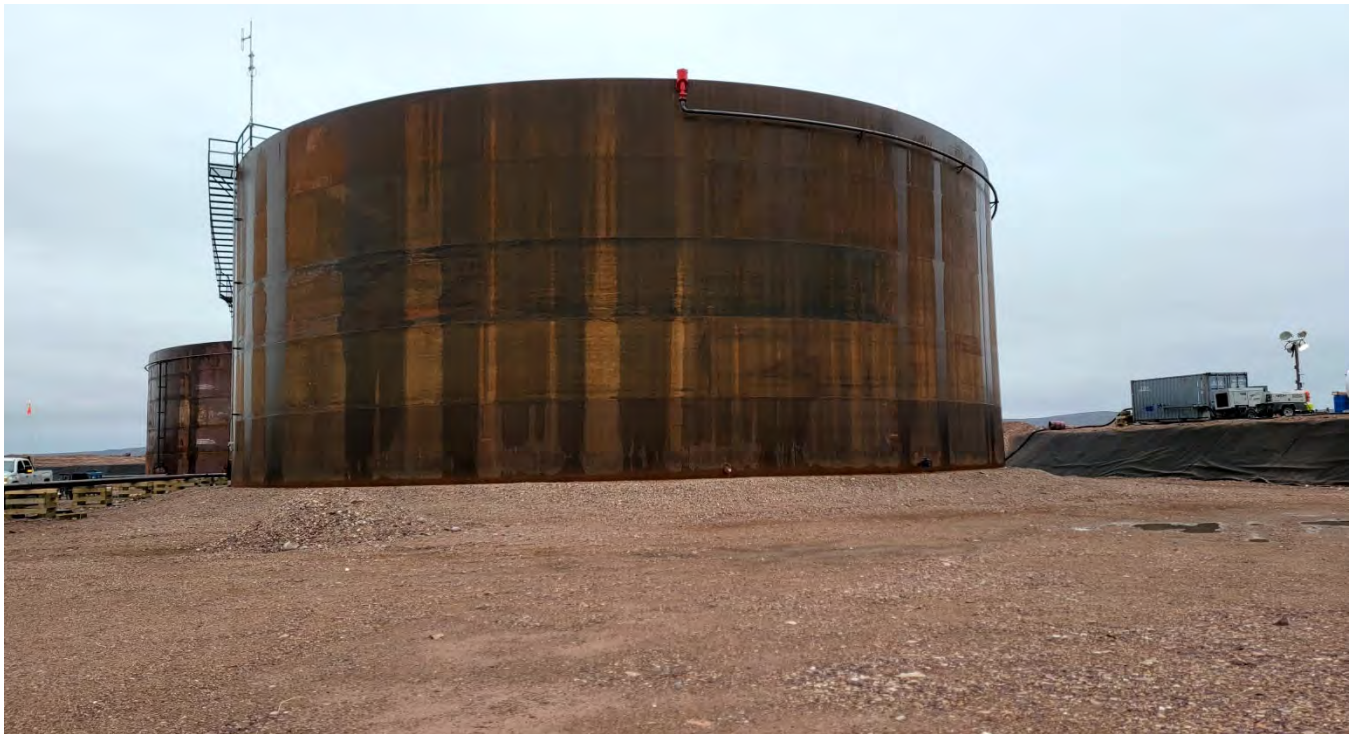
M-70. – Pedestal of Tank #1. Northern slope, looking south

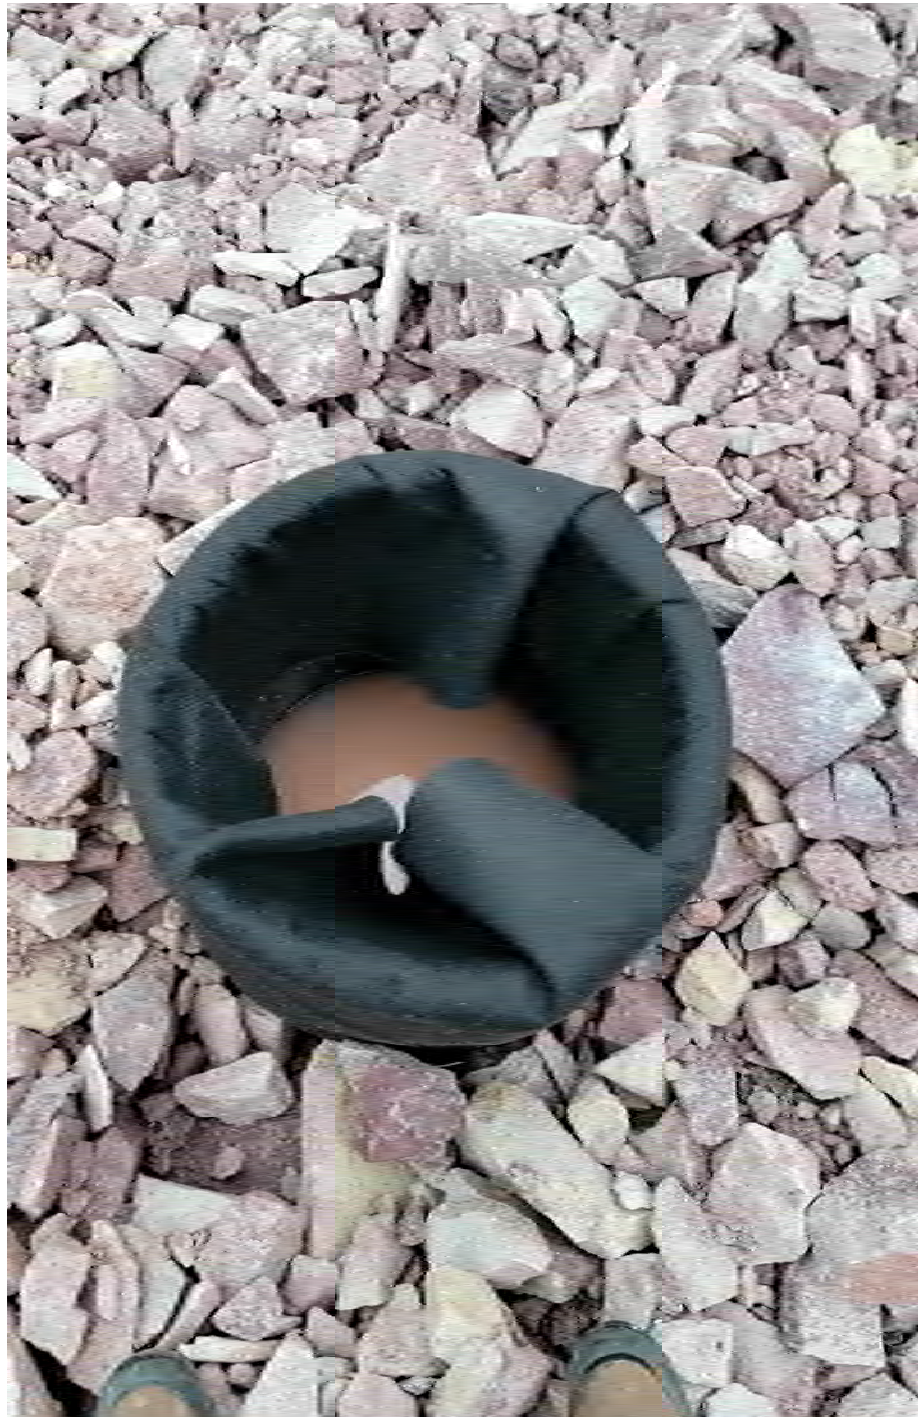
M-71. – A drainage at the NE corner of the containment area

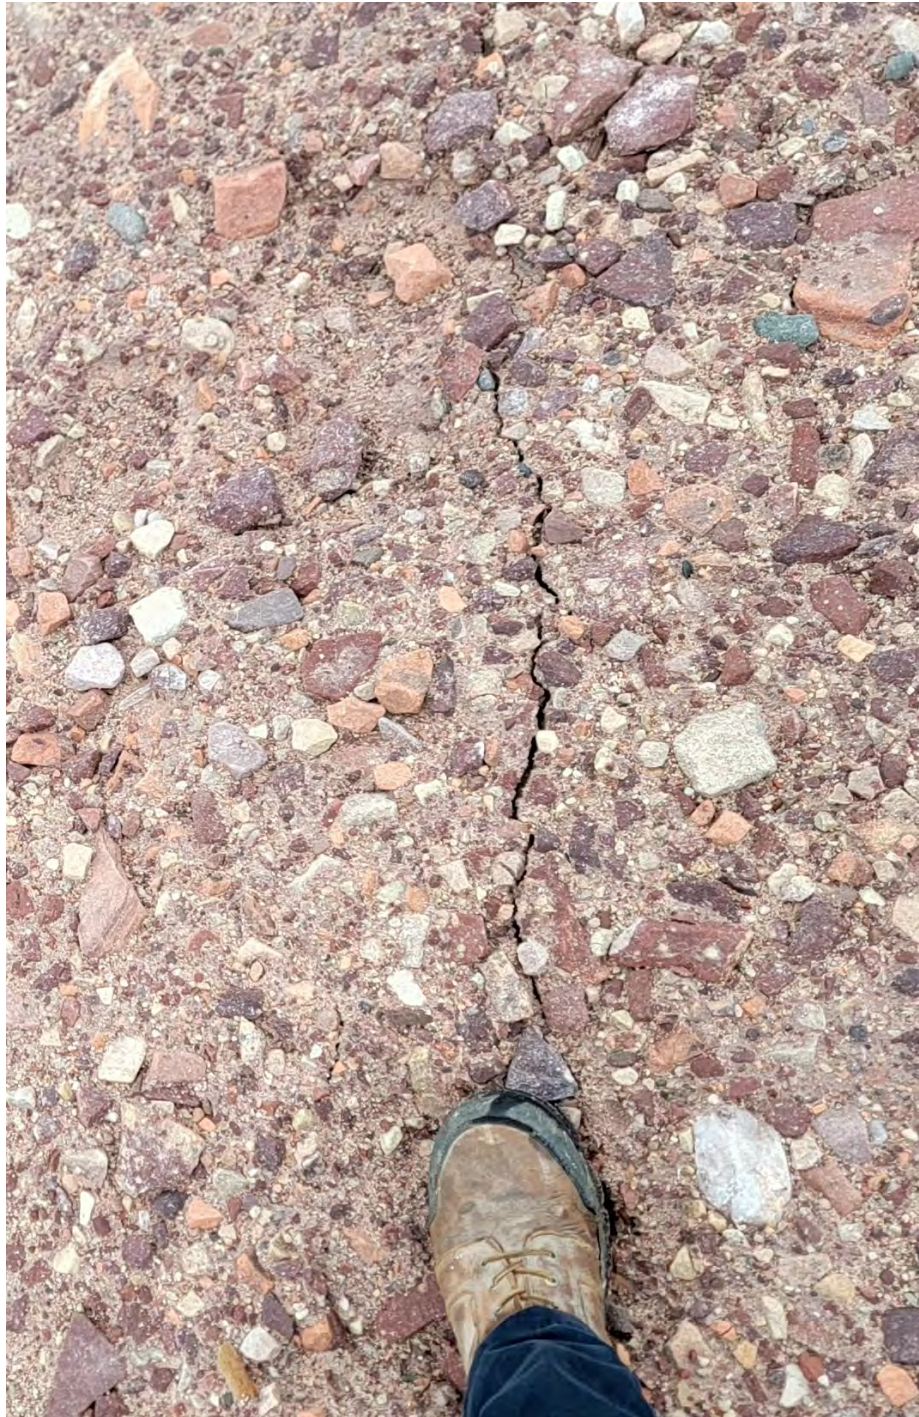
M-72. – Southeast berm of the containment area. Note that the fill material cracking at the crest.

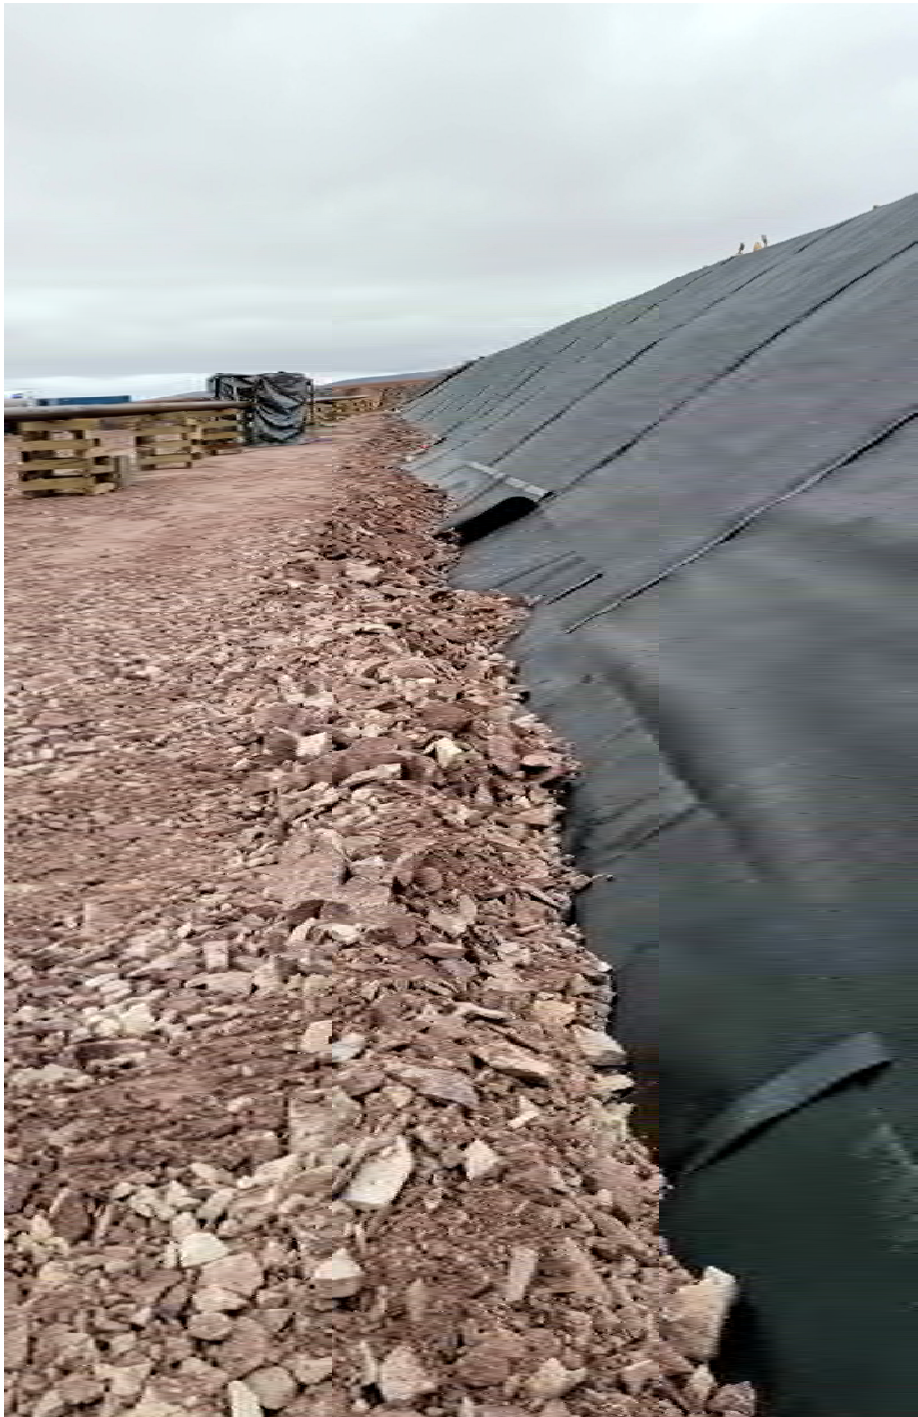
M-73. – Northern berm of the containment area. Note unwelded and unprotected HDPE liner panels at the toe

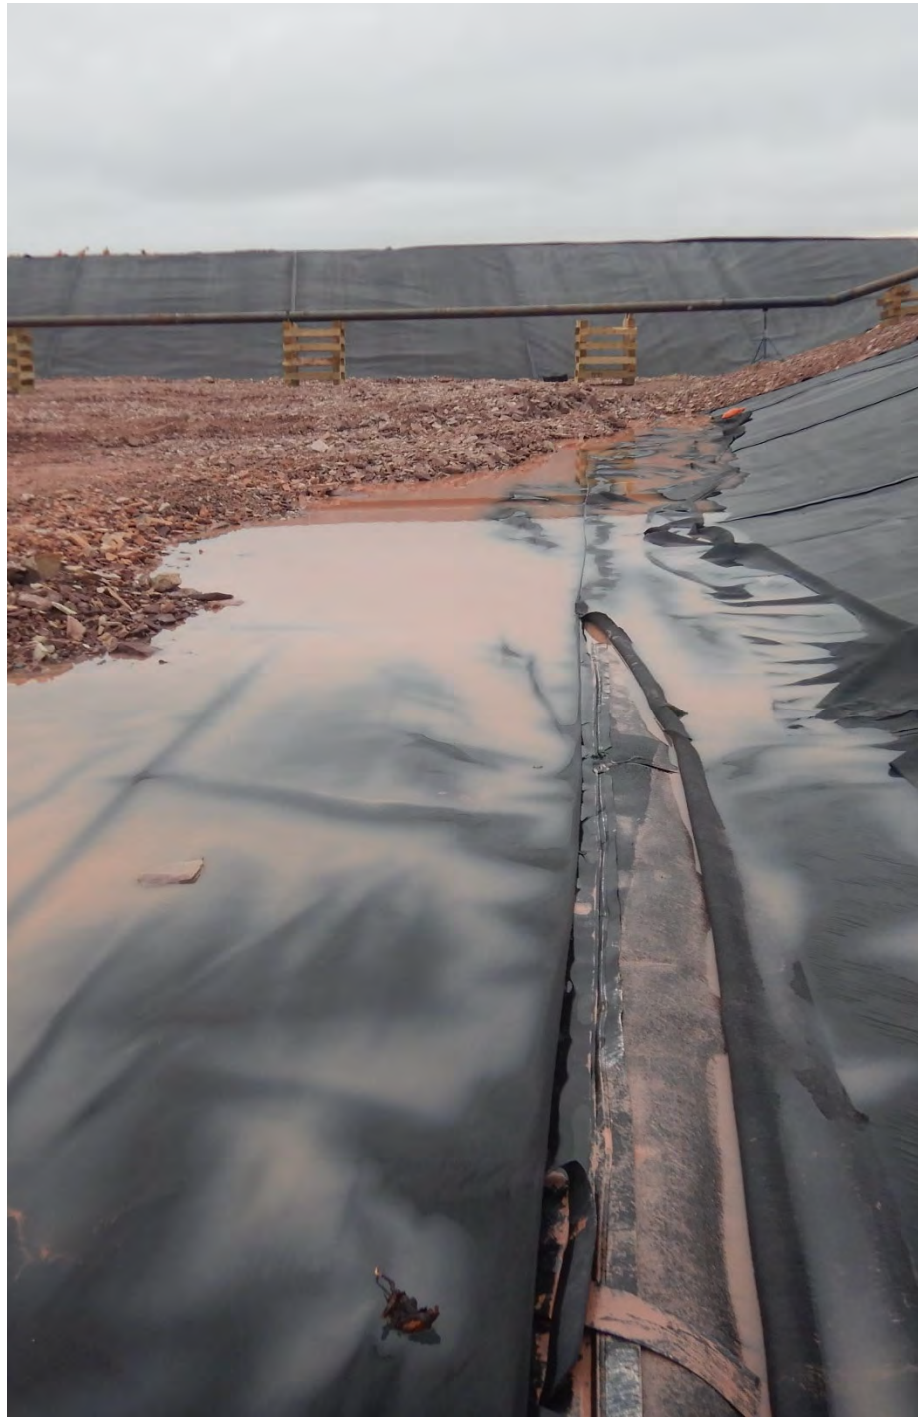
M-74. – exposed liner at the toe of the eastern berm

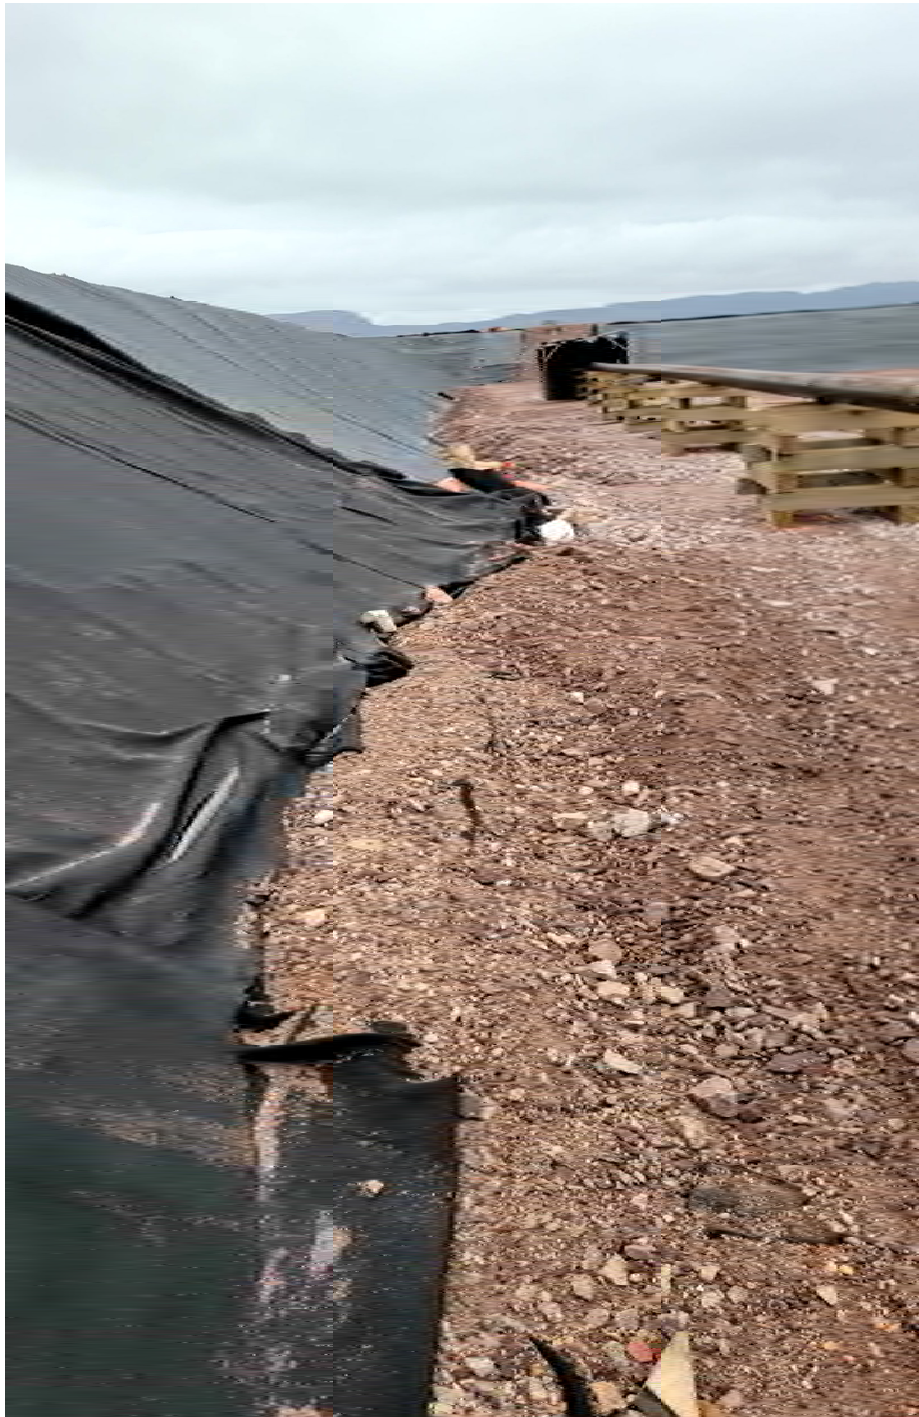
M-75. – Toe of the northern berm of the containment area
