2023 Annual Geotechnical Inspection		
		Freight Storage Pad		
Job No: CAPR003105 Filename: BackRiver_MLA_2023AGI_Photos.pdf	Back River Project	Date: 2024-02-28	Approved: JBK	Figure: A.2 -8

Back River Project

2023 Annual Geotechnical Inspection

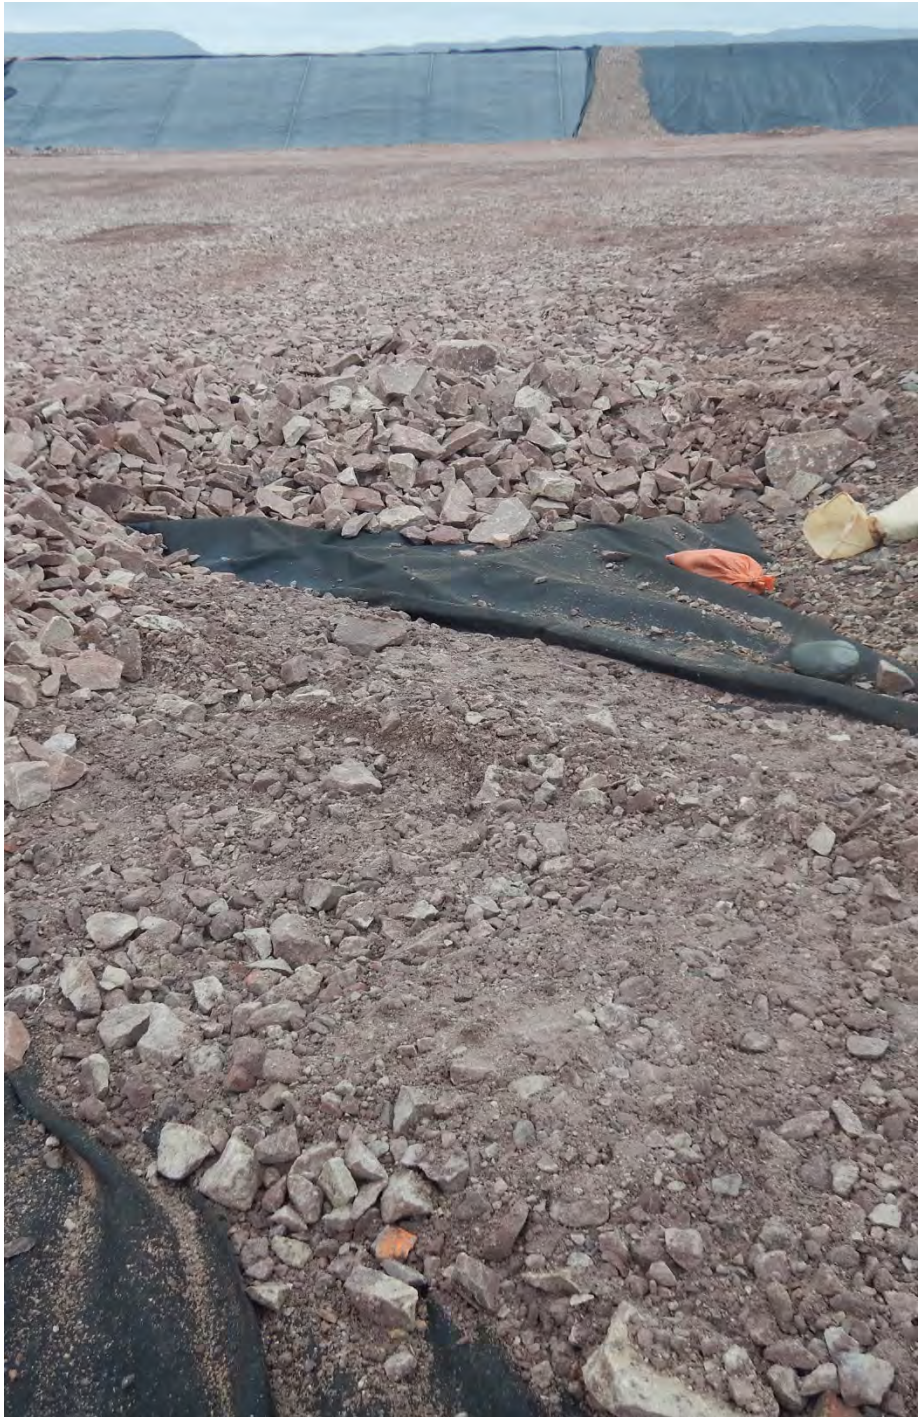
M-76. – Exposed Geotextile and HDPE liner at the base of the containment area.

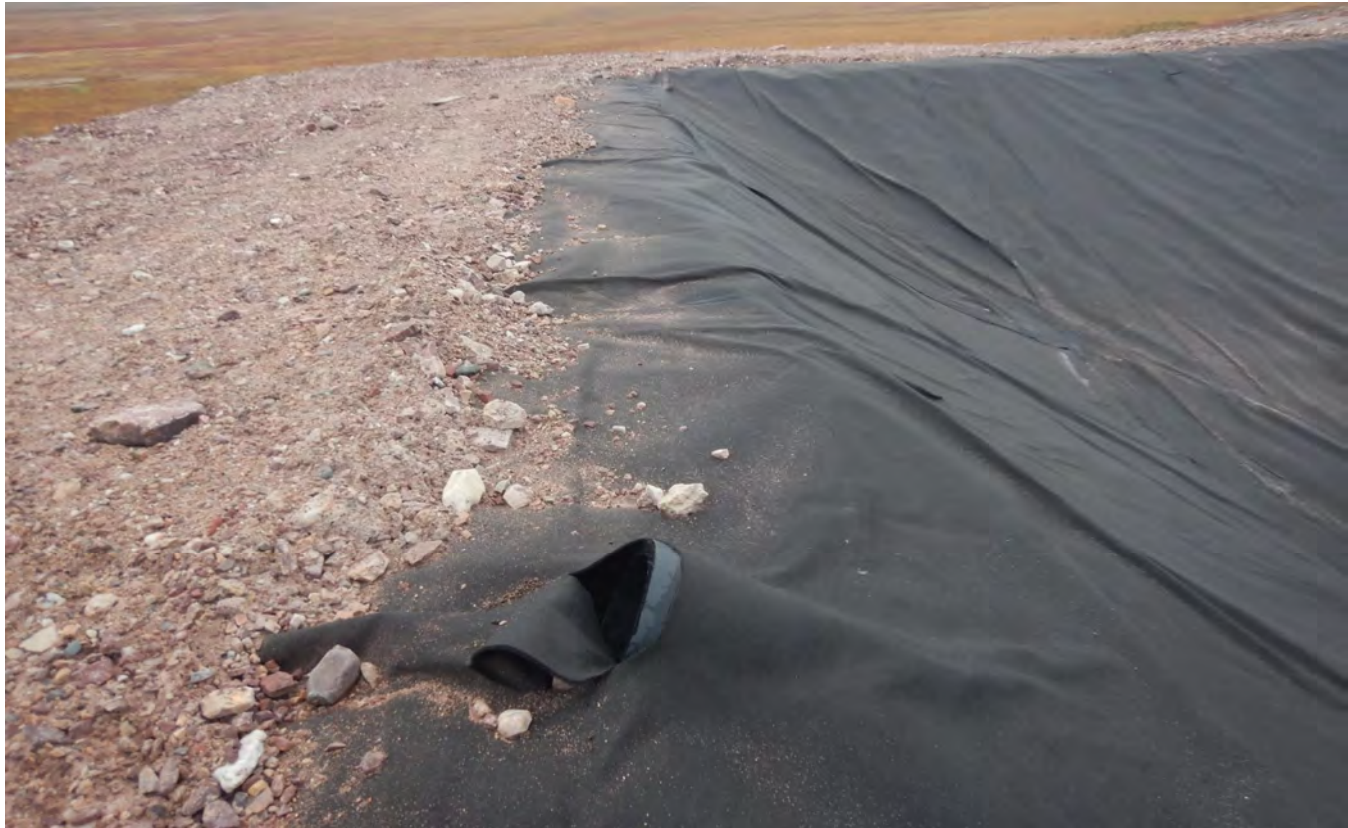
M-77. – Note there is no cap

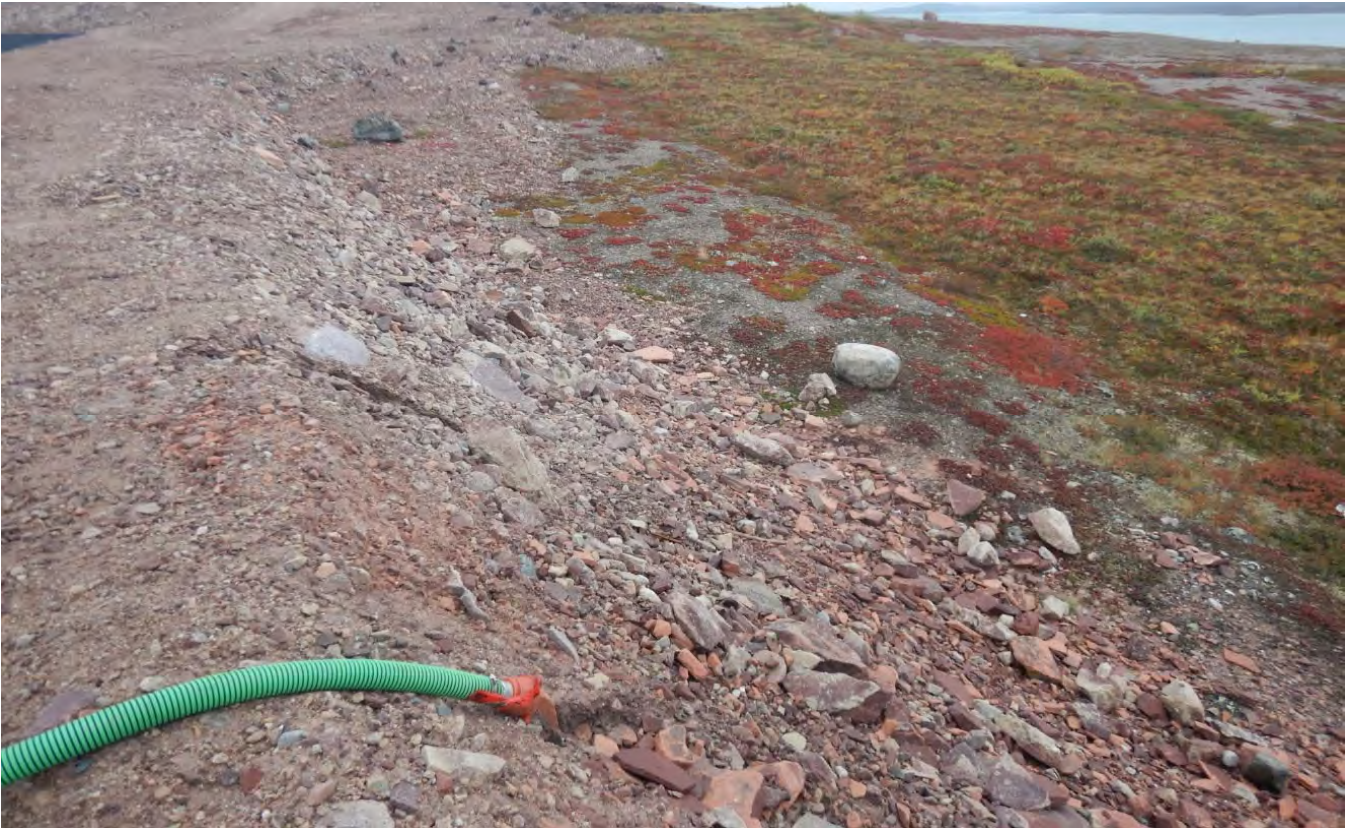
M-78. – Water discharge point at the NW corner of the berm.

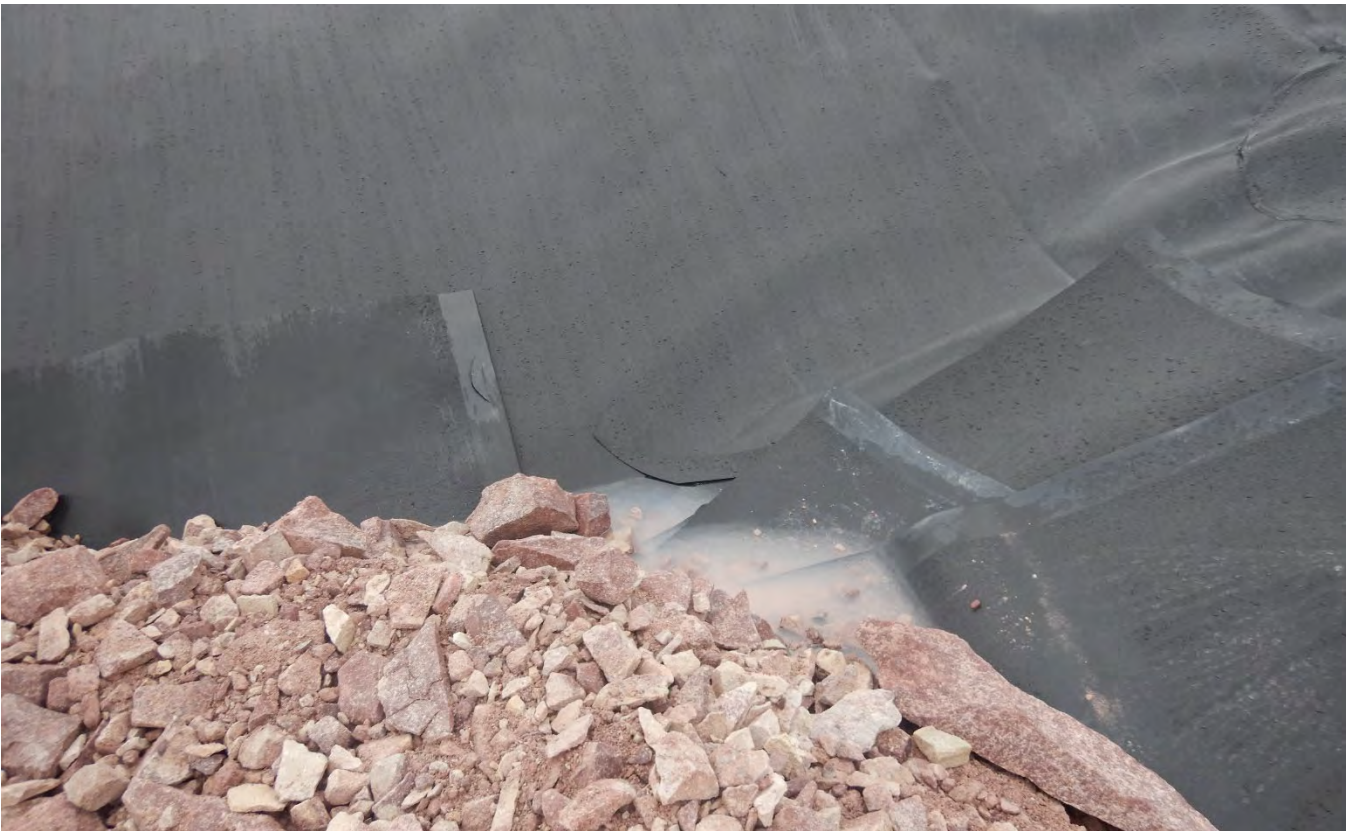
M-79. – NE corner of the containment area. Note unwelded and unprotected HDPE liner panels at the toe.

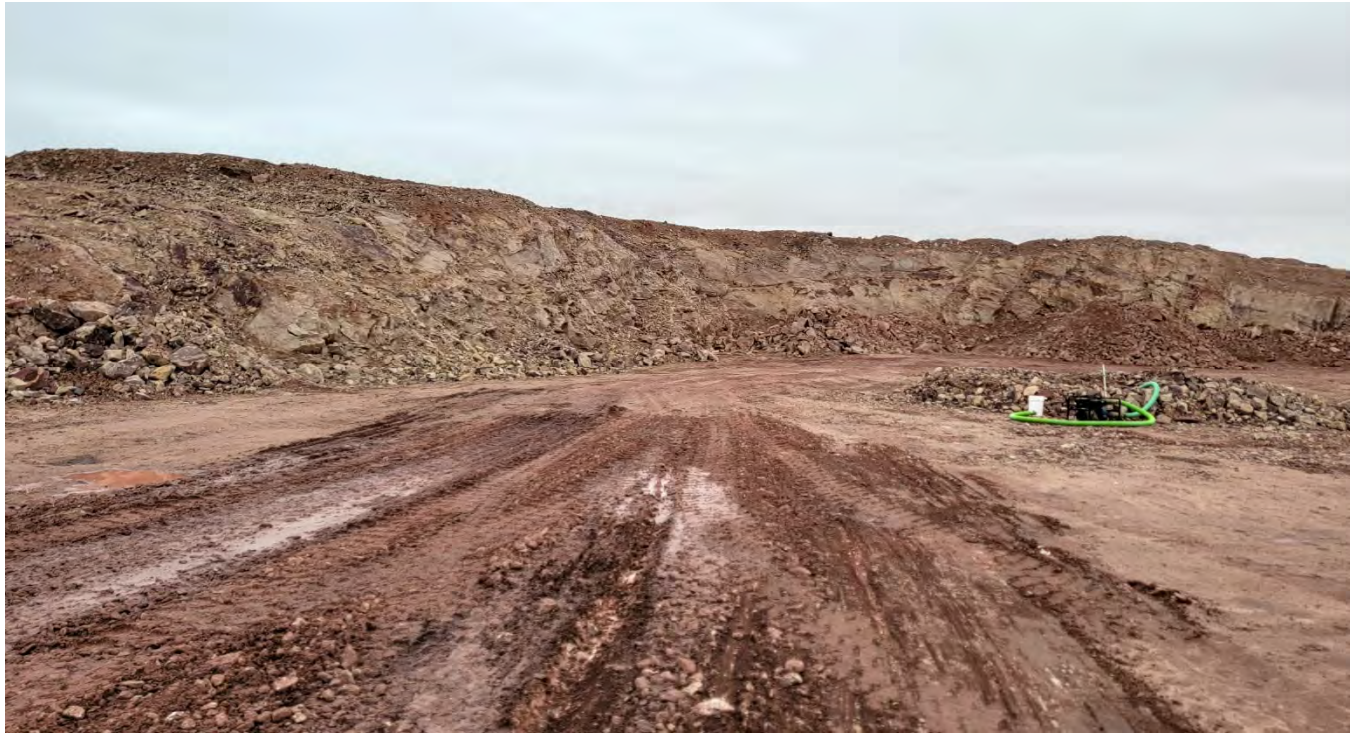
M-80. – Quarry. Southern wall, looking south.

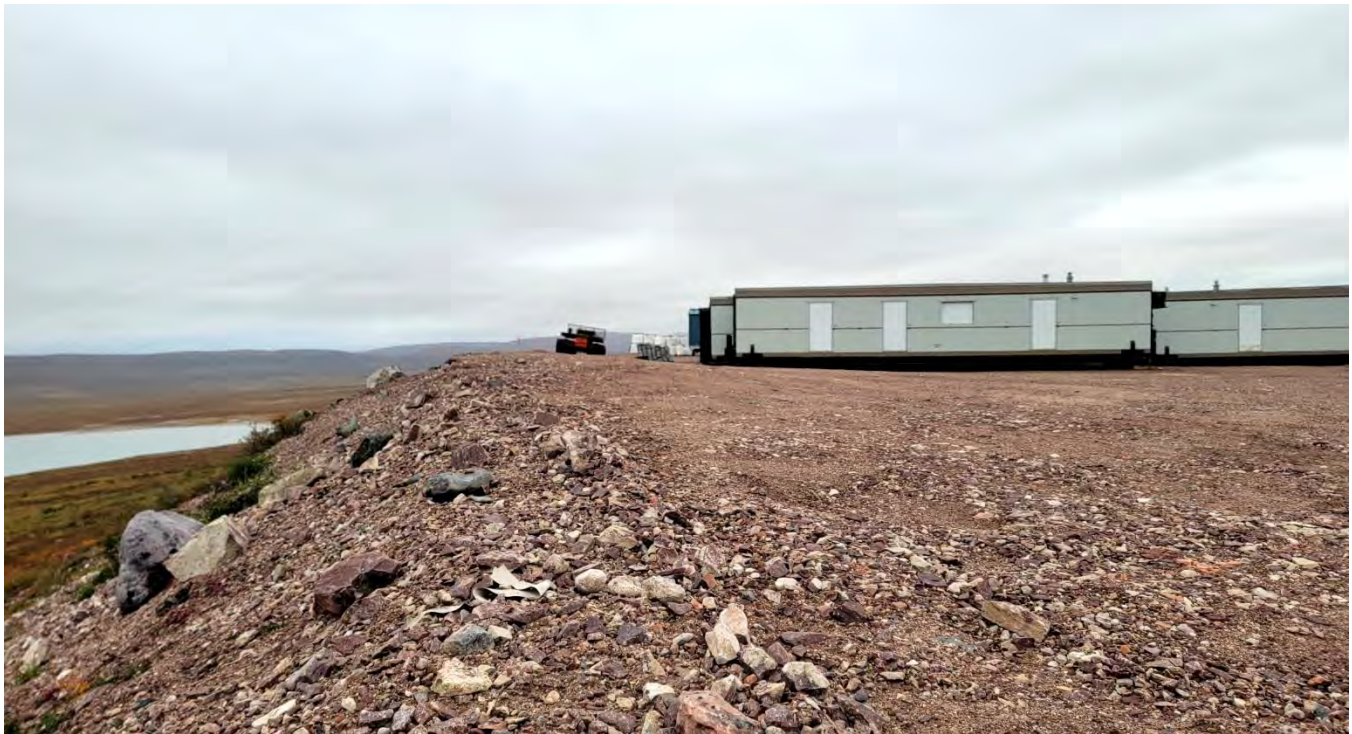
M-82. – SE corner of the Upper Laydown Area adjacent to the SE side of the MLA Tank Farm, looking west.

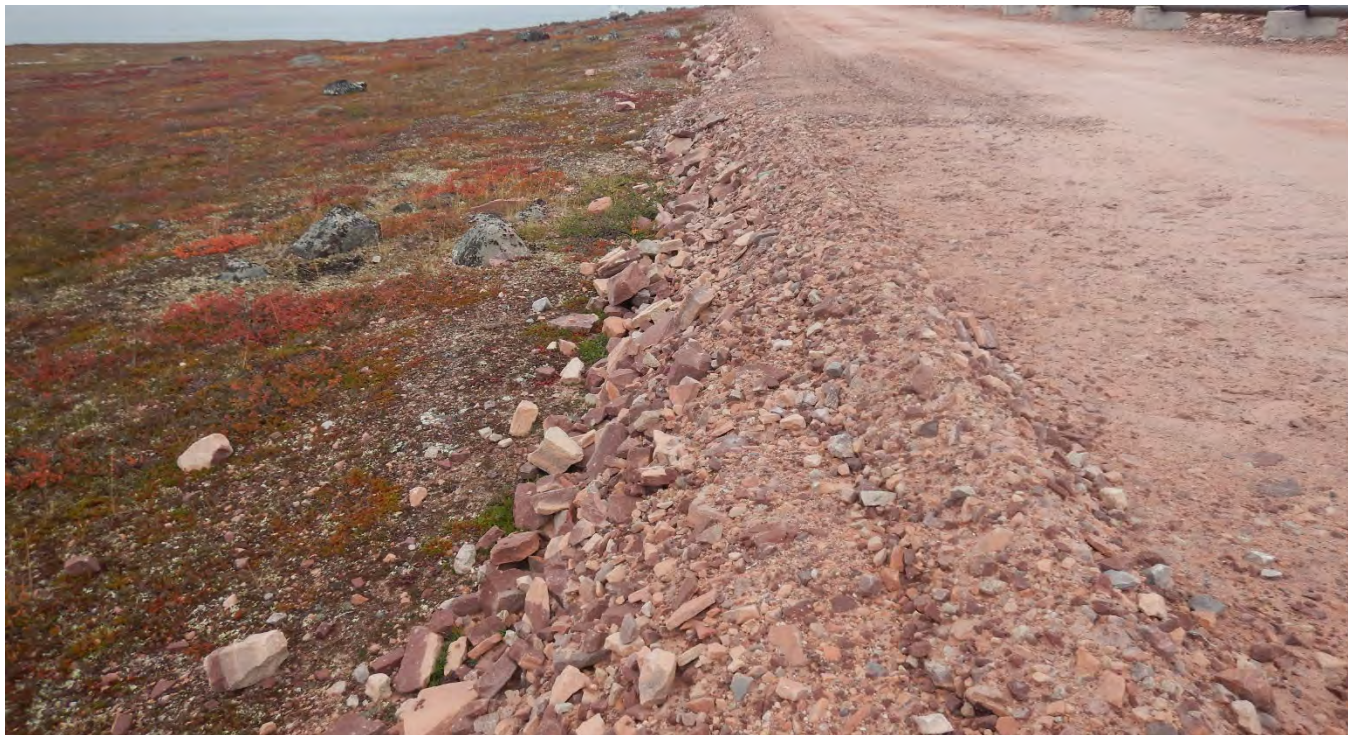
M-84. – Fuel Offload Access road. Note the thickness of the embankment

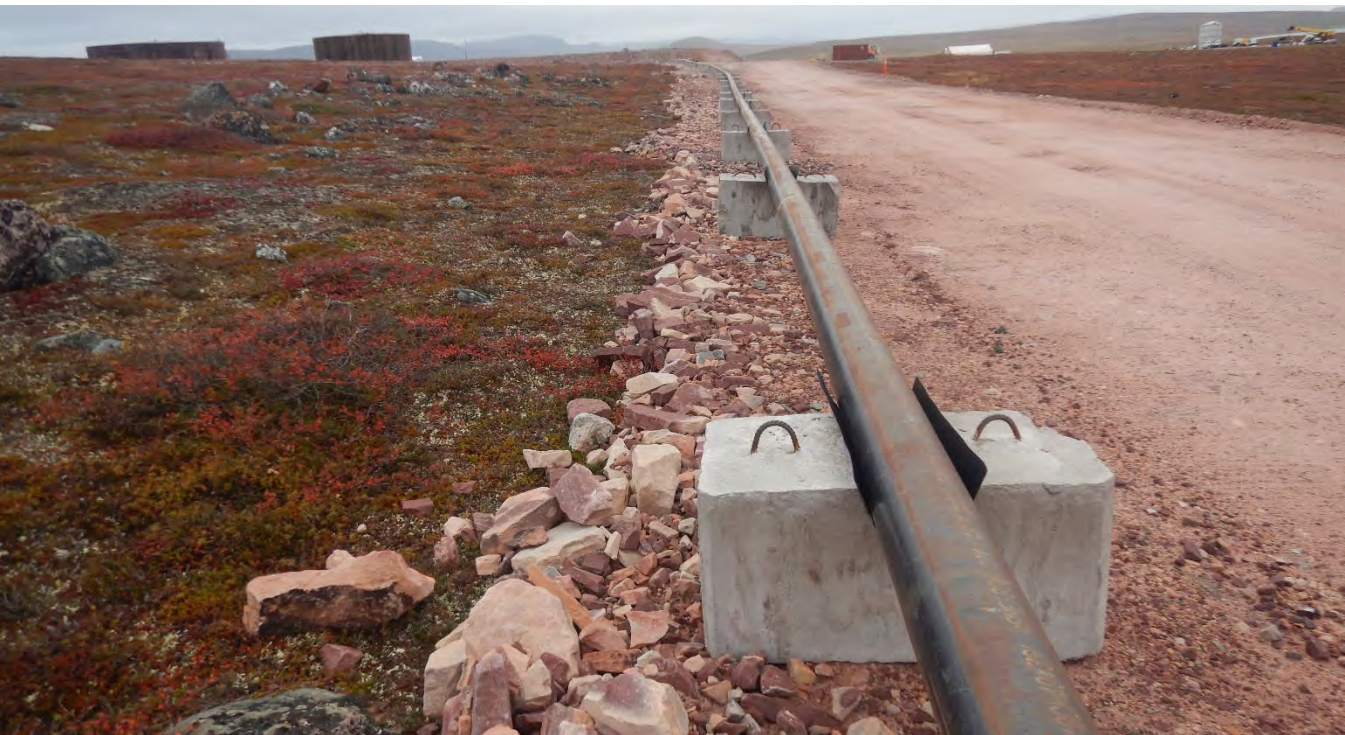
M-85. - Fuel Offload Access road. Note the thickness of the embankment

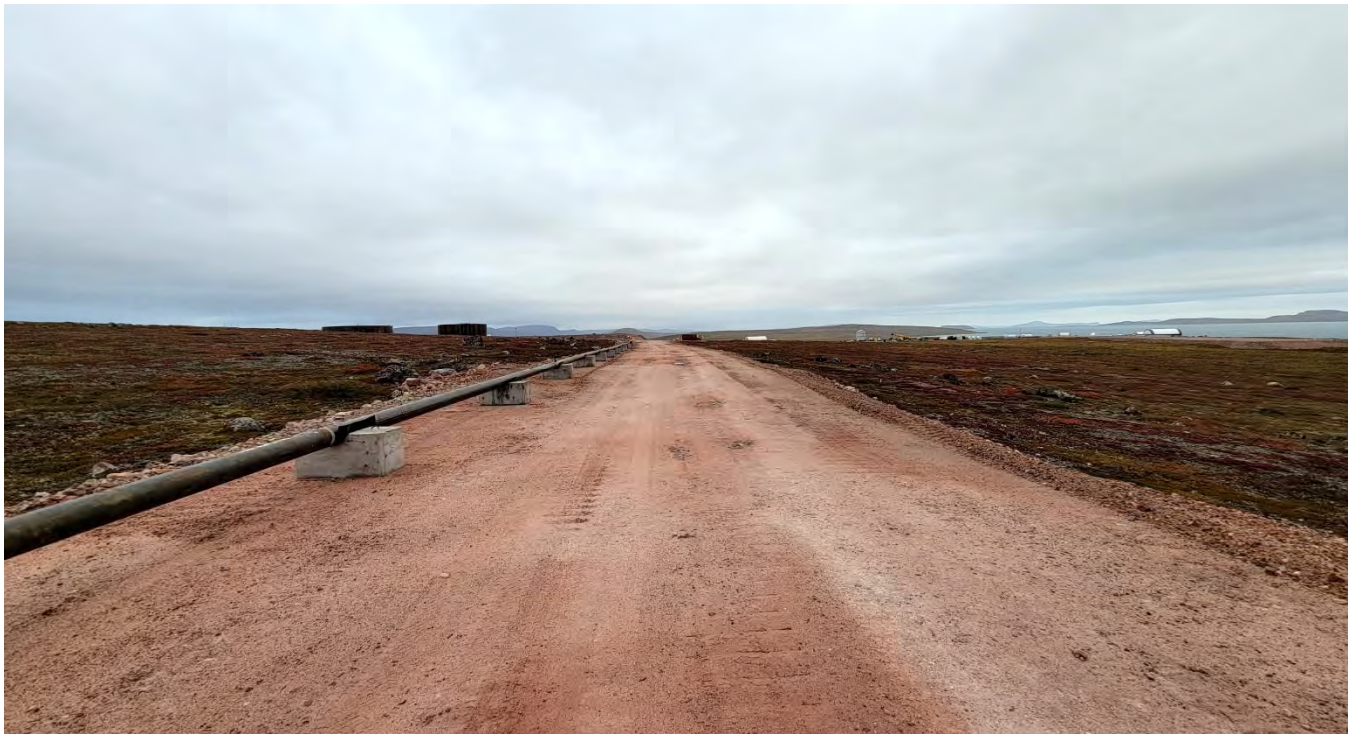
M-86. – Fuel Offload Access road.

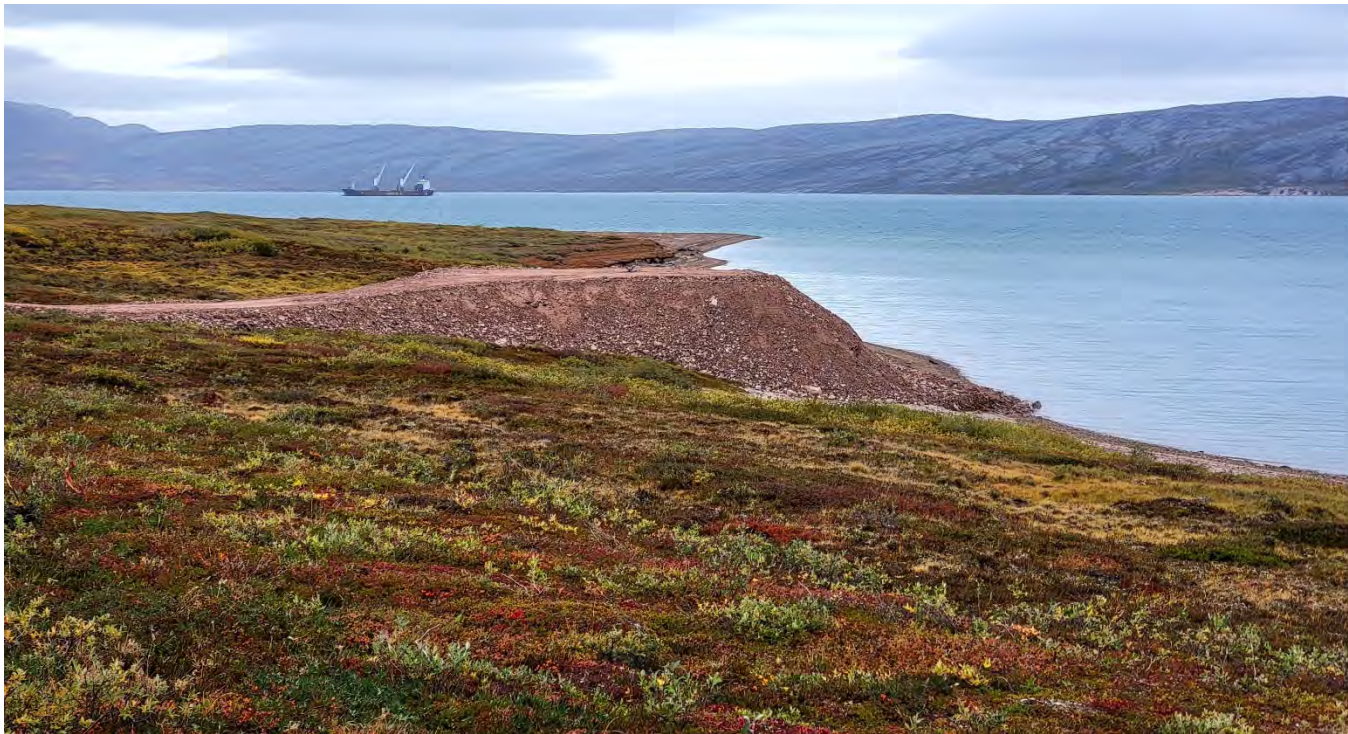
M-90. – Offload Pad, looking NE. Note that the eastern slope of the pad is oversteepened and the thickness of the access road is less than 0.5m

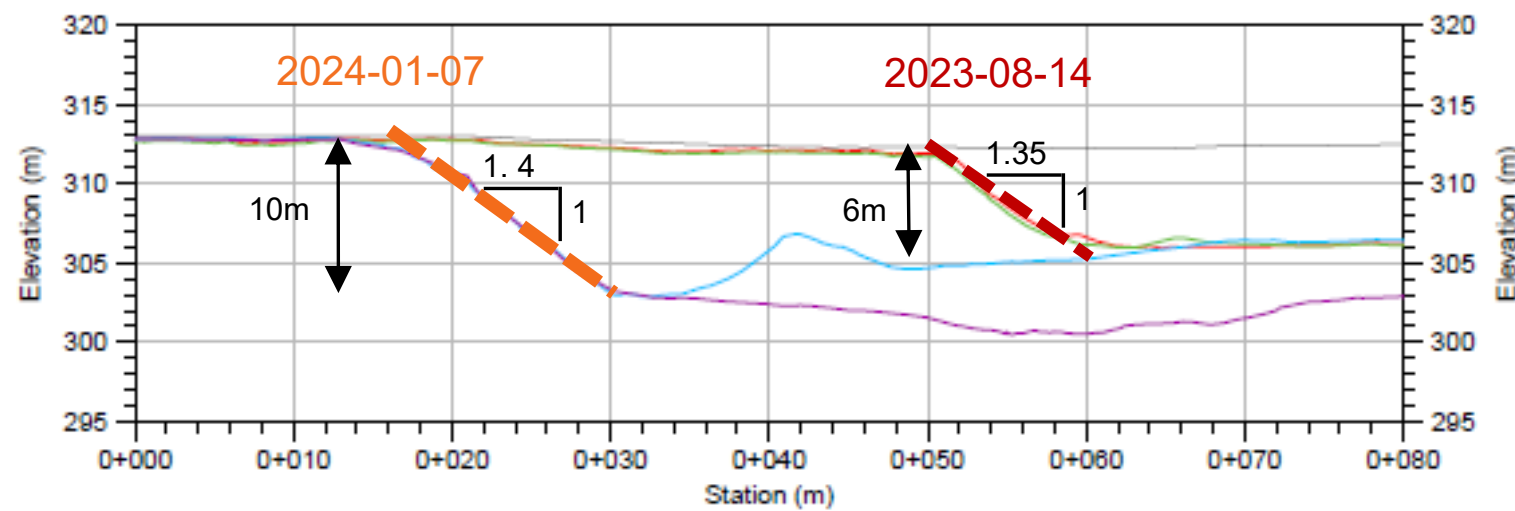
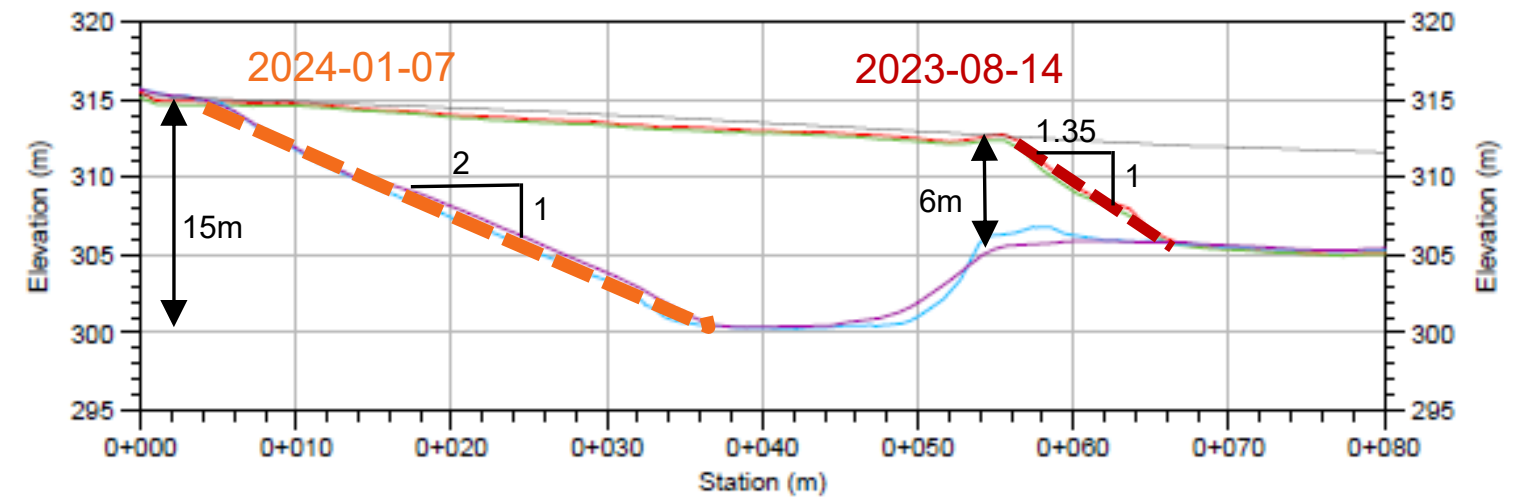
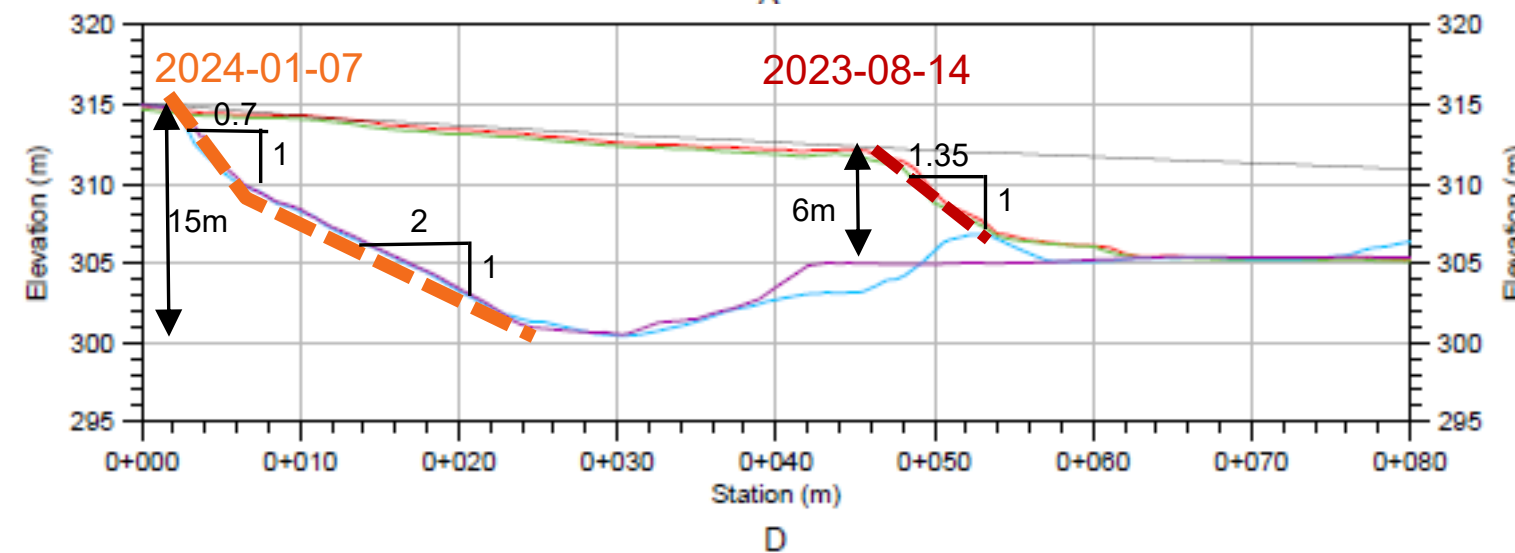
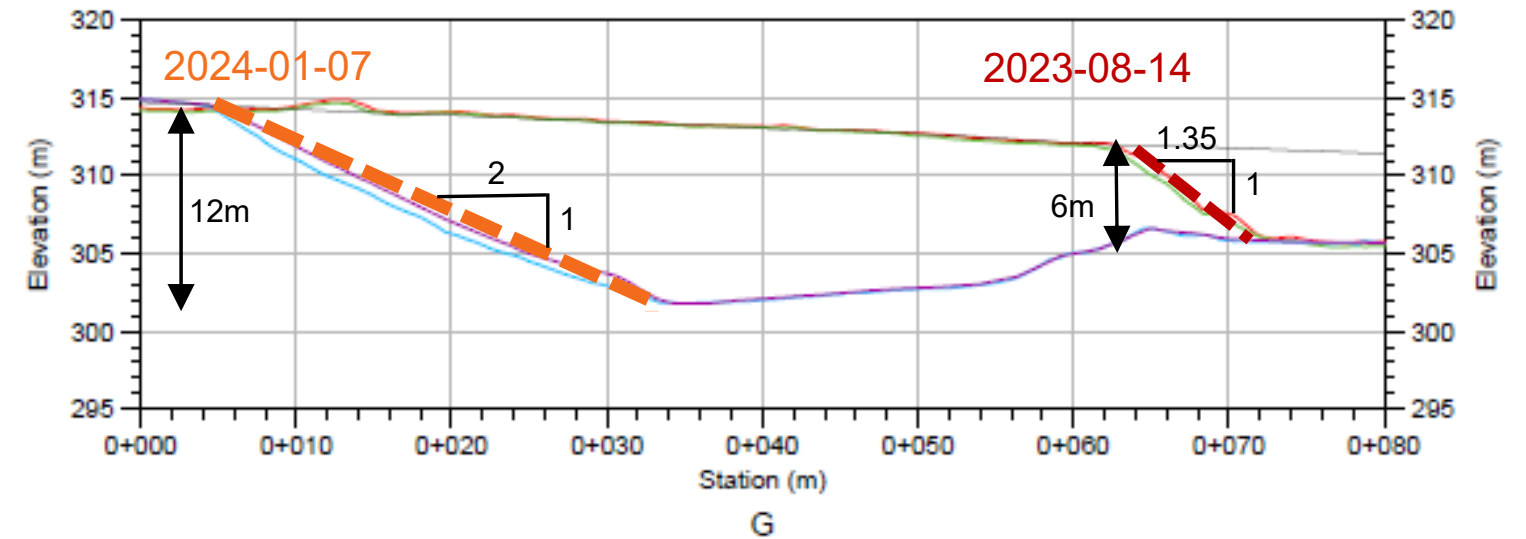
Re-Sloping of the SSW wall

- The slopes of the SSW wall vary from 1.4H:1V to 2H:1V.
- The top 6 m of the southern wall is observed to be too steep: slope 0.7H:1V (55°) .
