APPENDIX F RASCAL STREAM WEST CROSSING CONSTRUCTION SUMMARY REPORT

Rascal Stream West Crossing Construction Summary Report

Back River Project (B2Gold Back River Corp.)

22567626-163-R-Rev0-8000

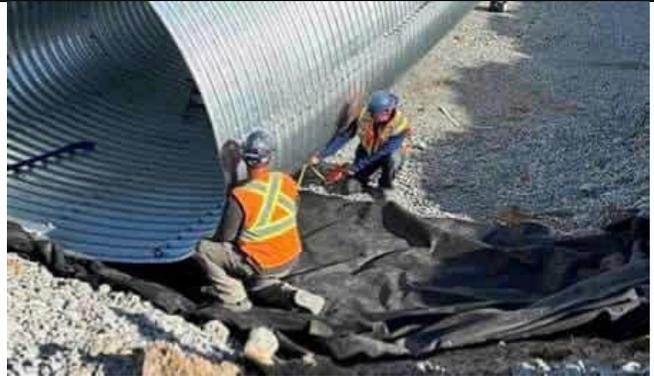
Photo 2: Non-woven geotextile extends 2 m beneath culvert

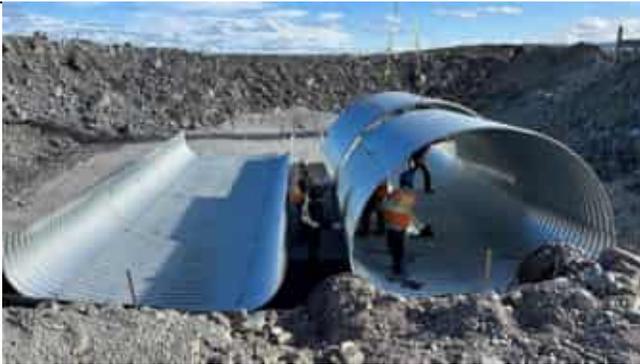
Photo 3: Top plate assembly began prior to placement of embankment material and boulder cluster

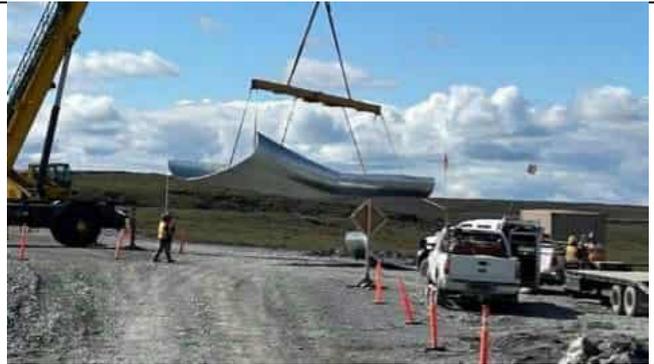
Photo 4: Culvert bottom plate of the downstream segment on the east side (right downstream) was deformed when being lifted

- Armtec's designer, S.J. Macrae, who provided the culvert structural design (Armtec drawing reference:19-463-B) should be notified about the culvert bottom plate deformation when being lifted to confirm structural integrity of the arch culverts under the haul road. Assessment, recommendations and potential remedial actions to be completed by Armtec.

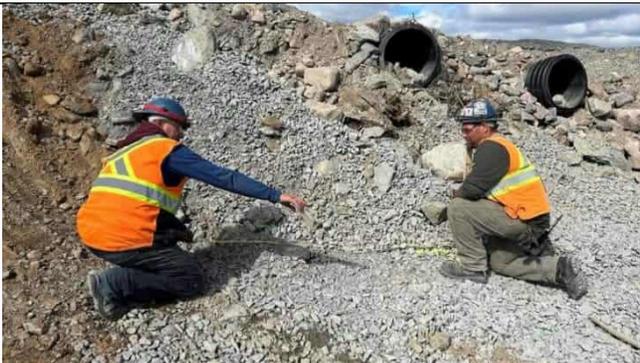
Photo 5: The excavated area extends 2.7 m from edge of the culvert on the west side

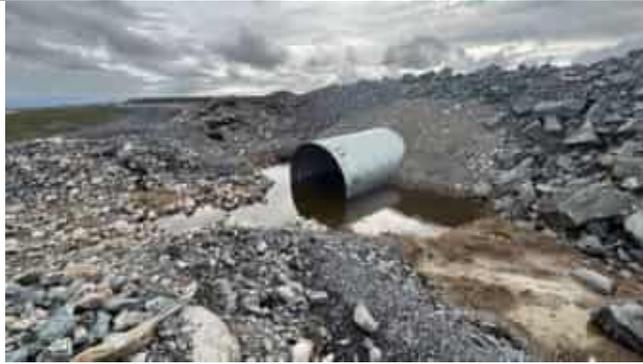
- No channel substrate was identified inside the secondary culvert.
- No geotextile was identified underneath riprap apron of the secondary culvert.
- Outlet of the secondary culvert was partially submerged under low flows with backwater effects observed at the outlet.

Photo 7: Outlet of the secondary culvert was partially submerged under low-flow condition

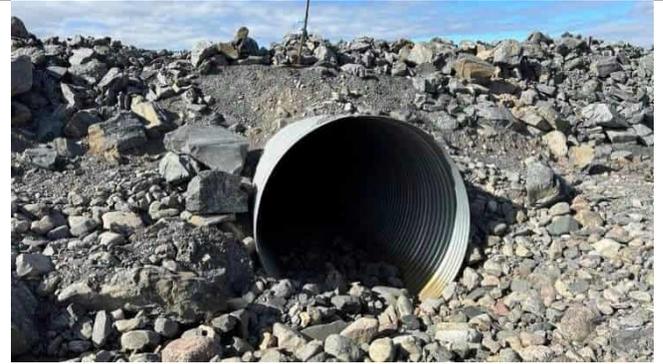
WSP did not observe or document the placement of the geotextile for the secondary channel culvert during the installation of the secondary culvert and B2Gold Nunavut did not provide documentation supporting the installation of the geotextile. Therefore, the geotextile installation was not confirmed and is considered a potential deficiency. WSP recommends monitoring the secondary channel culvert inlet, outlet, and aprons for channel migration and erosion and completing repairs as required with material that meets the design specifications or has been approved by WSP.

Photo 8: No non-woven geotextile was identified at the inlet and the outlet secondary culvert

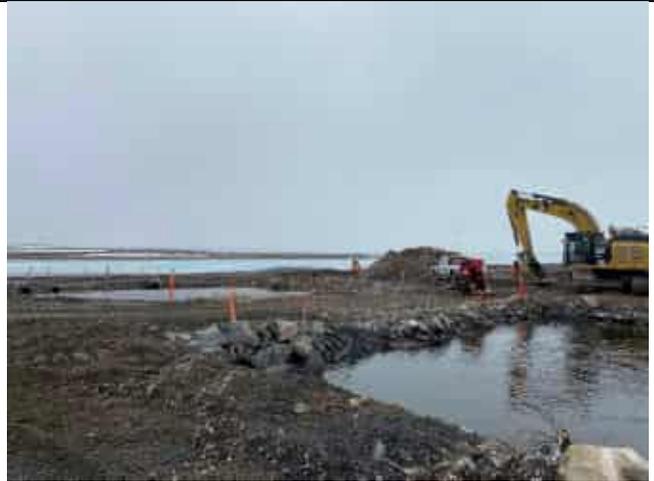
Photo 2: Lower pond seeping into twin multiplate excavation through temporary road.

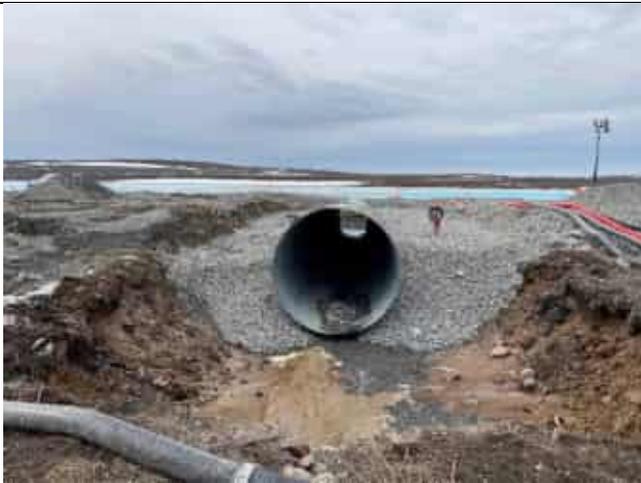
Photo 3: Secondary culvert inlet section raised without bedding underneath looking downstream at 16:52.

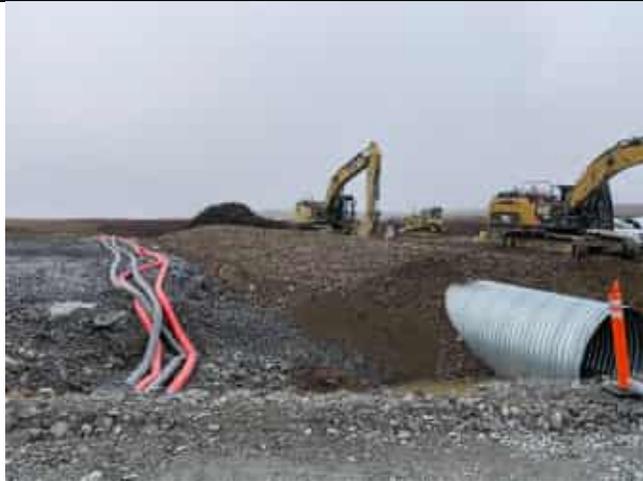
Photo 1: Secondary culvert raw esker backfill 0.3 m above culvert crest looking upstream at 8:59.

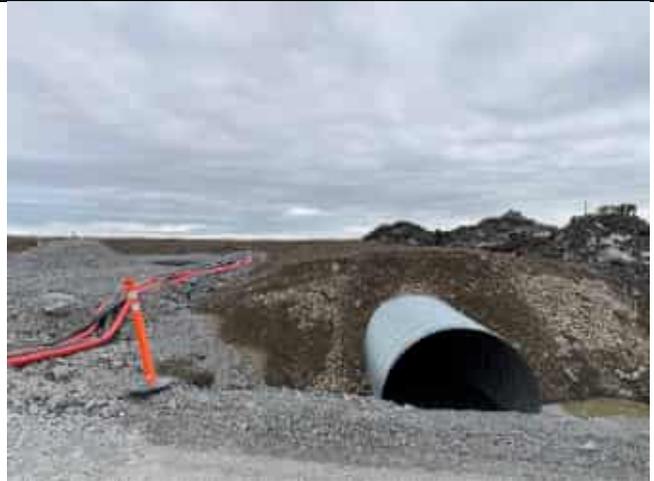
Photo 2: Secondary culvert raw esker backfill 0.6 m above culvert crest looking upstream at 14:38.

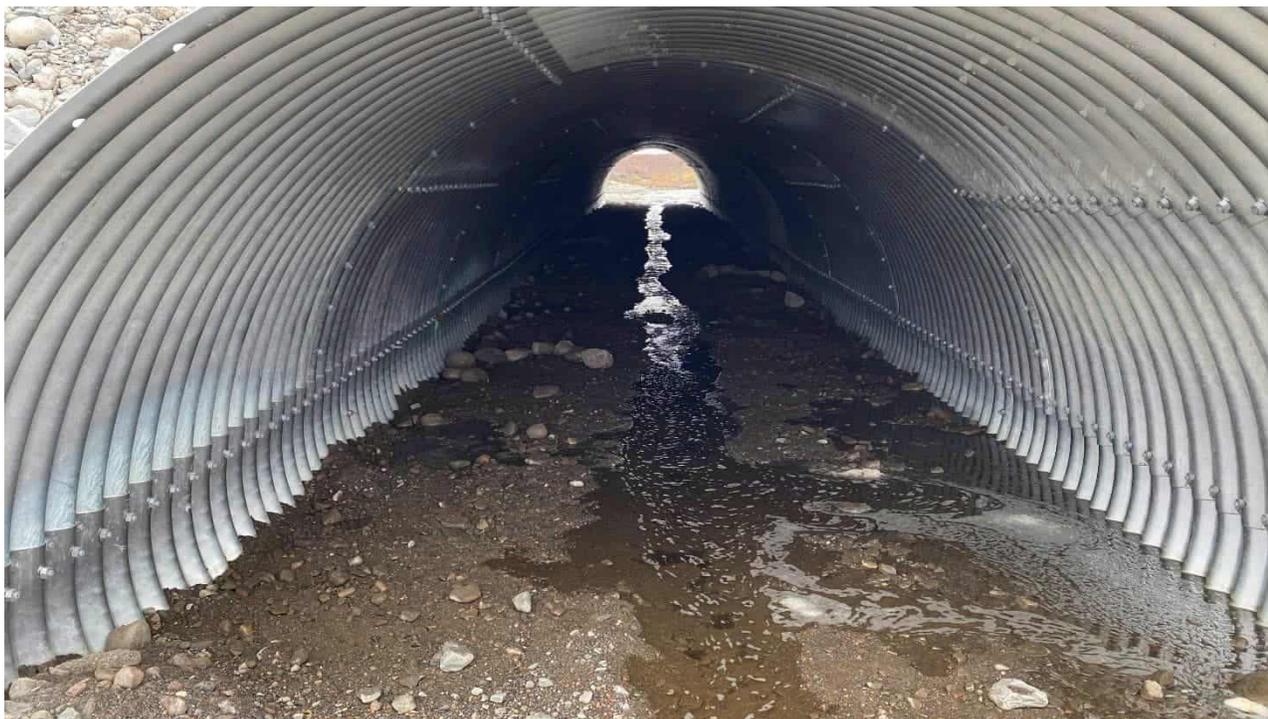
The channel embedment depth for the main channel culverts was specified to be 890 mm with shallow V-swale depth of 250 mm. The constructed embedment depth was observed to be approximately 500 mm with V-swale depth less than specified on September 17, 2023, and is a modification from the design specifications. This is not anticipated to adversely affect the conveyance capacity of the main channel culverts and concentrated flow was observed along the centerline. However, the shallow V-swale depth may adversely affect fish migration through the culverts during low-flow conditions. WSP recommends fisheries monitoring and monitoring the channel substrate for channel migration and erosion within the culverts and completing repairs as required.

Channel substrate for the main channel culverts and secondary channel culvert was specified to be excavated native channel substrate. The excavated channel substrate was deemed unsuitable for the culvert channel substrate due to high saturation and esker material was substituted. The esker material placed was observed to be undersized gravelly cobbles with an approximate D_{50} of 75 mm and is a modification from the design specifications. WSP recommends monitoring the channel substrate for channel migration and erosion within the main channel culverts and secondary channel culvert and completing repairs as required.

Photograph 15: Main Channel East Barrel Channel Substrate Looking Upstream from Culvert Outlet, Taken September 17, 2023

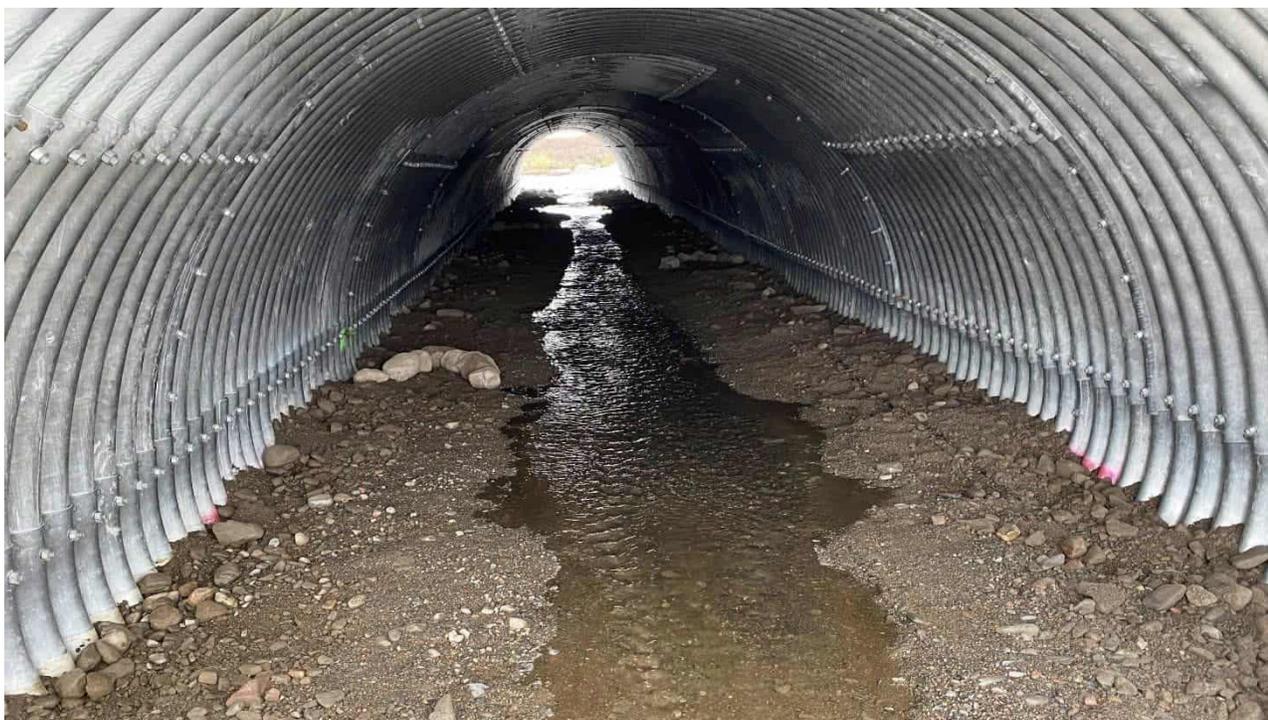
Photograph 16: Main Channel West Barrel Channel Substrate Looking Upstream from Culvert Outlet, Taken September 17, 2023

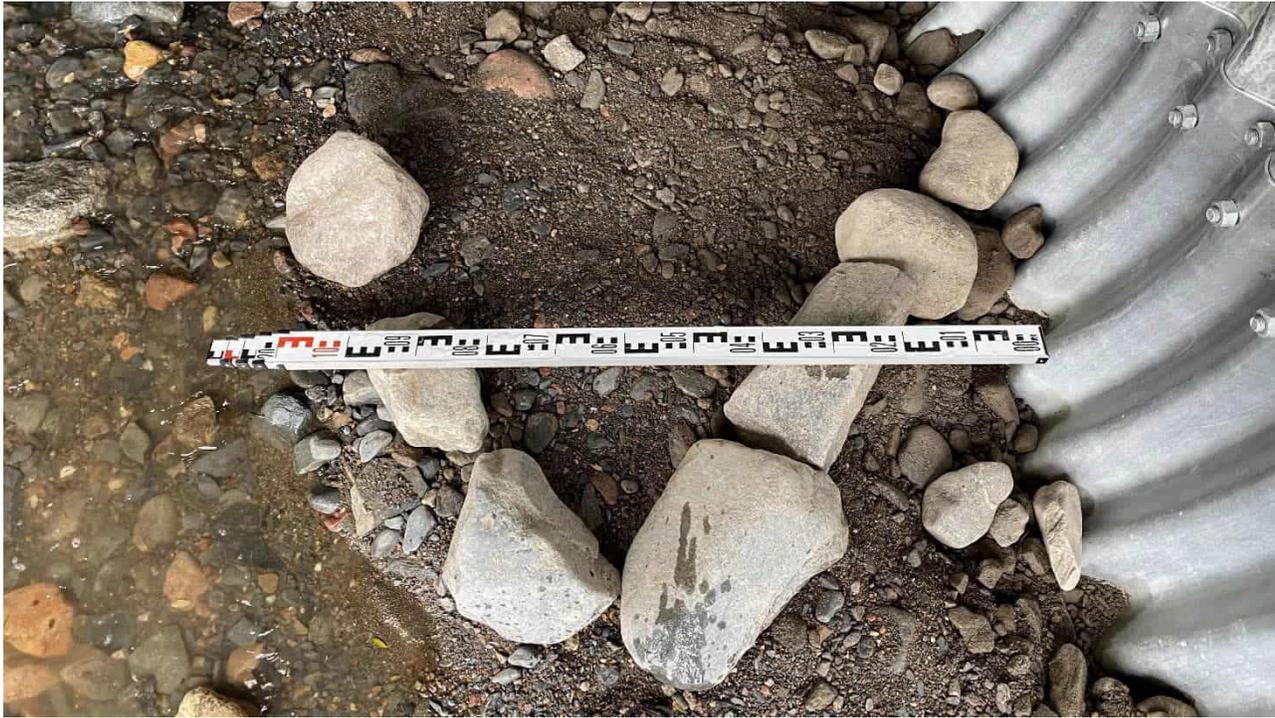
The boulder clusters for the main channel culverts were specified to be composed of rock sizes from 250 mm to 300 mm. The boulder clusters placed were observed to be undersized with an approximate D_{50} of 150 mm and is a modification from the design specifications. WSP recommends monitoring the boulder clusters for particle migration and completing repairs as required with rock sizes of 250 to 300 mm.

Photograph 17: Main Channel Culverts Typical Boulder Cluster and 1 m Scale Bar, Taken September 17, 2023

-
- Shallow V-swale cross-sectional shape for main channel culverts remains for improved fish passage under low-flow conditions.
 - Inspect boulder clusters after freshet and replace displaced boulders as required.
 - Embankment, inlet and outlet riprap erosion, as well as bed and banks erosion near the culverts.
 - Debris accumulation:
 - Remove debris as required to maintain designed culvert capacity.
 - Structural monitoring of the culverts (deformation) and haul road subsidence inspection.

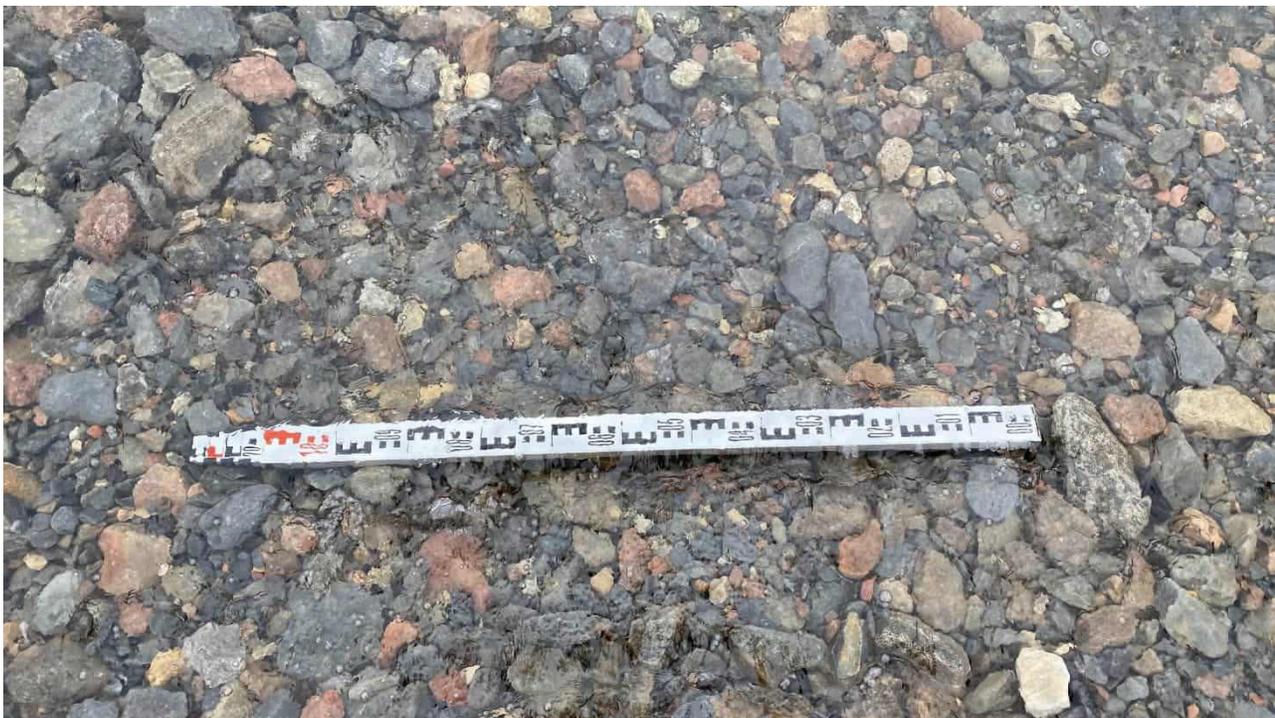
The material used for the construction of the main channel culverts and secondary channel culvert riprap aprons was esker material and is a modification from the design specifications. Based on visual observations, the esker material placed for the culvert aprons is undersized gravelly cobbles with an approximate D_{50} of 75 mm. Gradation of the esker material placed within the culvert aprons was not provided. There is potential for erosion of the embankments and at the culverts inlet and outlet due to undersized riprap material. WSP recommends riprap aprons be included in a monitoring program.

Photograph 18: Main Channel Apron Material and 1 m Scale Bar, Taken September 17, 2023

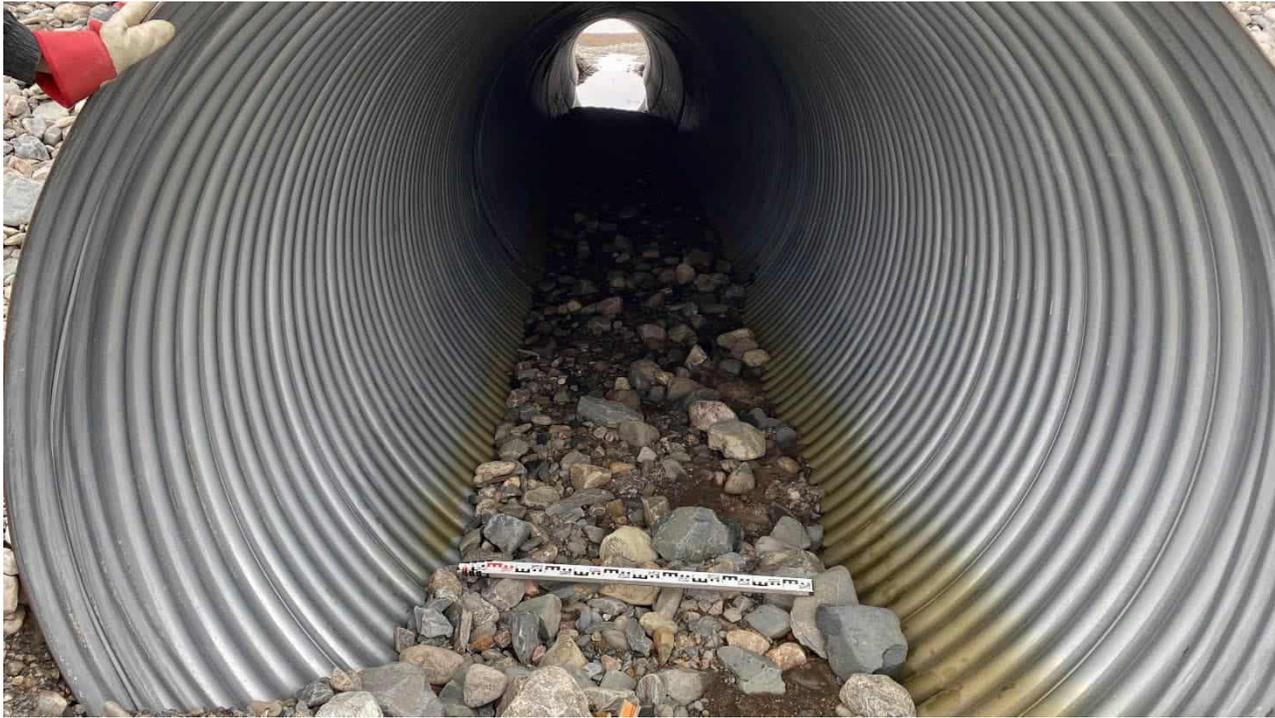
The channel embedment depth for the secondary channel culvert was specified to be 960 mm. The constructed embedment depth was observed to be approximately 310 mm on September 17, 2023 and is a modification from the design specifications. This is not anticipated to adversely affect the conveyance capacity of the secondary channel culvert. However, WSP recommends including the secondary channel culvert in future fish monitoring programs.

Photograph 25: Secondary Channel Culvert Substrate and Embedment Material Looking Downstream from Culvert Inlet, Taken September 17, 2023

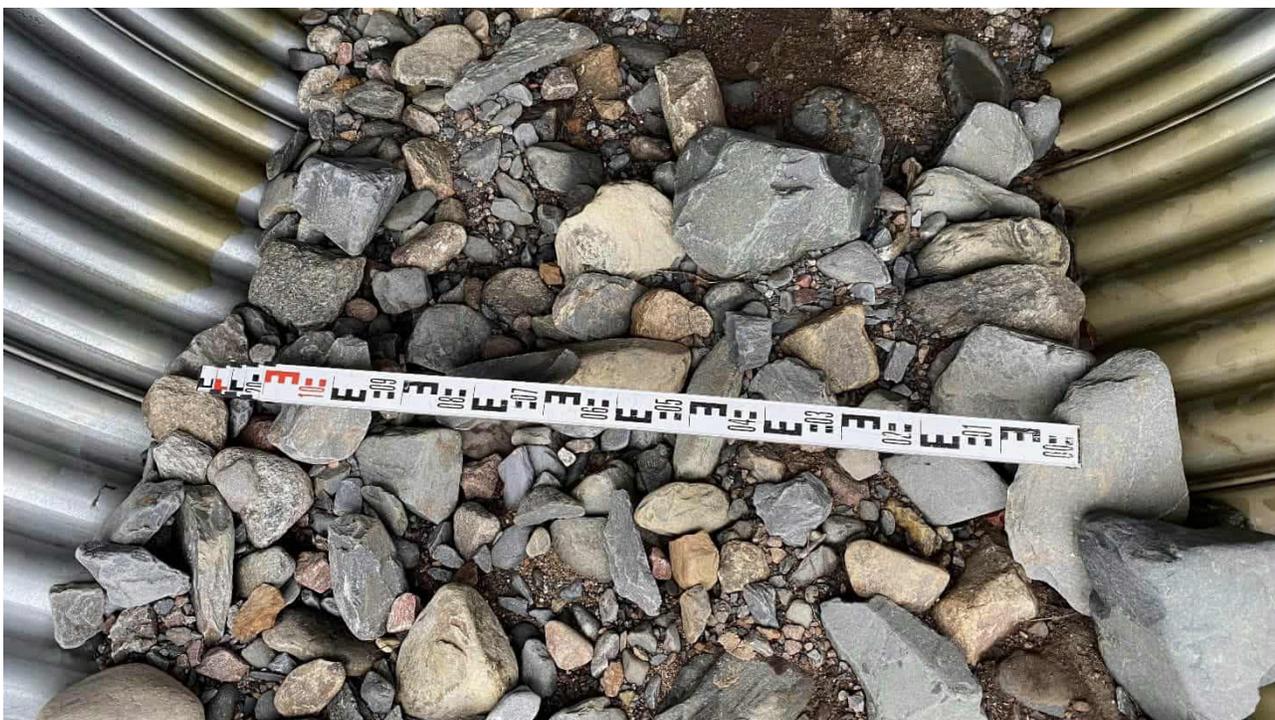
Photograph 26: Secondary Channel Culvert Substrate and 1 m Scale Bar at Inlet, Taken September 17, 2023
