NOVEMBER 2017 GEOTECHNICAL INSPECTION REPORT

BAFFINLAND IRON MINES CORPORATION

ANNUAL GEOTECHNICAL INSPECTIONS

MARY RIVER PROJECT

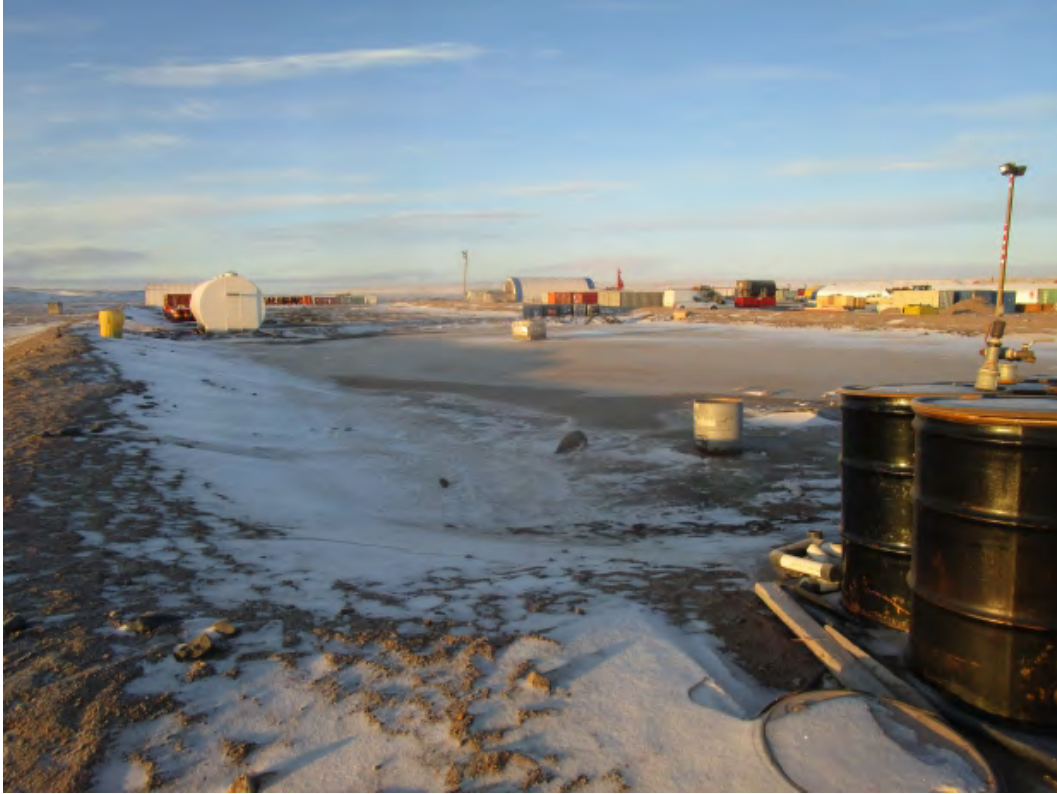
1. Bulk Fuel Storage Facility. (MS-HWB-7)

At the time of this second review, some water remained from the treatment that occurred in the summer. A significant amount of water was treated from MS-HWB-7 this year. Water was ponding above the level of the gravel within the bottom of the containment at the north end of the facility. This water is just beginning to freeze.

At the load-out end of the facility there was water ponding within the dykes. At the former fuel unloading area at the south end there is water ponding within the dykes.

The soil structure is considered stable in the present condition and is in conformance with the design basis for the facility.

The presence of ice and water within the structure and at the load-out area is an indication of the integrity of the liner.

We have no recommendations with respect to this containment structure.

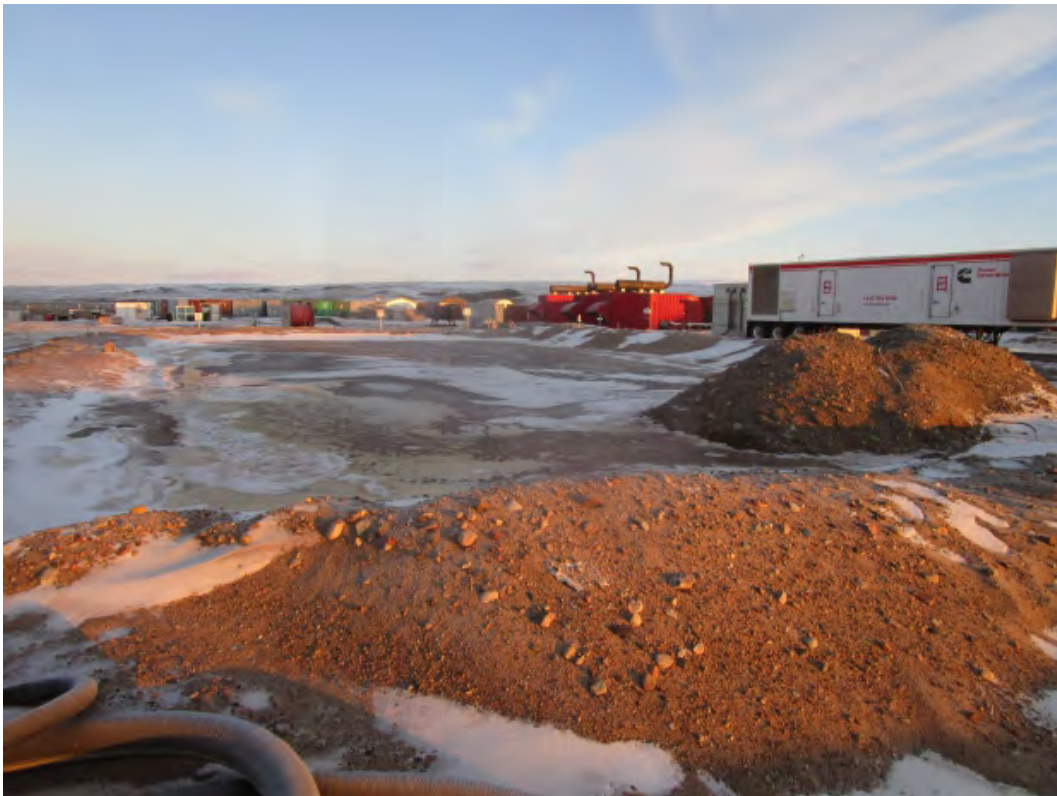
2. Generator Fuel Containment.

This particular containment structure is planned to be decommissioned. The fuel bladder that was contained within the dyke has been removed.

There is no indication that the liner is compromised and decommissioning should proceed when the ponding water has been removed and the granular cover is either moved to a land farm or other containment. There is water ponding within the structure confirming the integrity of the containment.

The granular fill over the geotextile and liner shall require landfarming with the material from the bulk fuel storage facility.

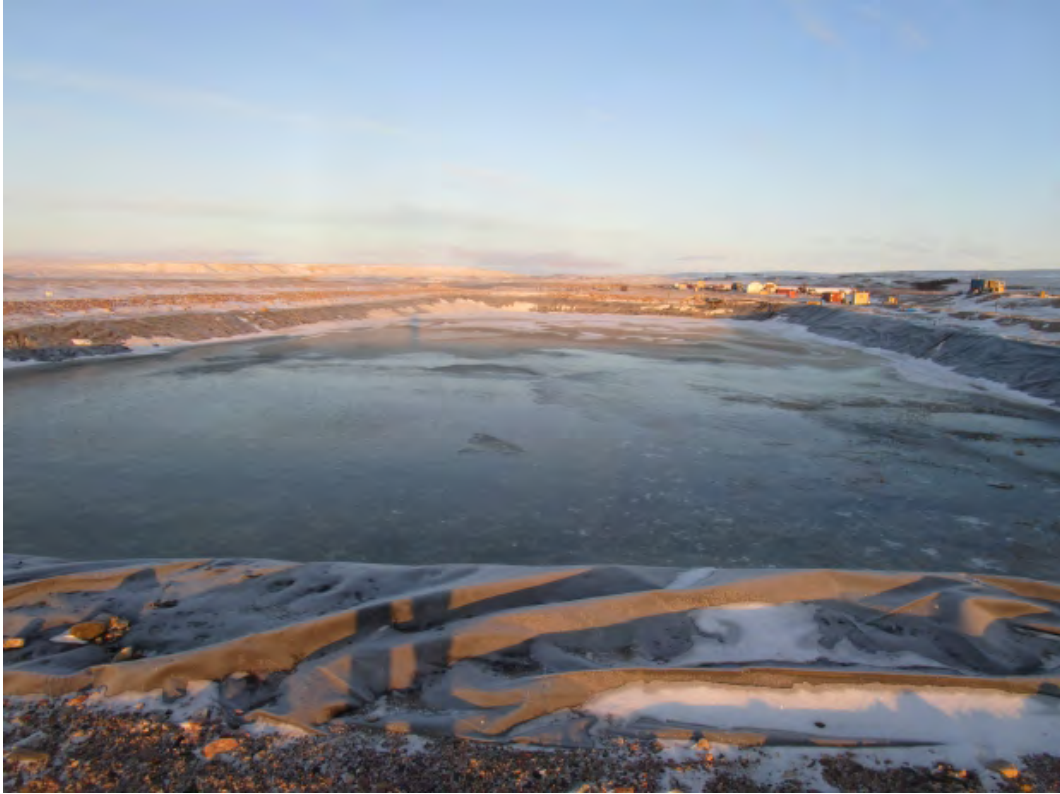
3. PWSP 1

At the time of our visit there was approximately fifty percent of capacity to accommodate further sewage and the structure readily conforms to its design intent.

Our review of this area around the pond at the base of the slopes showed no sign of seepage and hence we conclude that the liner has been effective in containing sewage and there are no tears or ruptures in the membrane, excepting some minor tears from past activity at the top of the dyke well above the allowable effluent level in the structure in the horizontal portion of the membrane.

A review of the top of the dyke showed no indication of cracking or settlement which would indicate stresses within the structure.

Many of the tears that had occurred in the liner on the top of the dyke have been patched during the period between reviews in 2008 and 2009 and are holding well. As well, there are no signs of weather related deterioration of the liner where it is exposed.

We have no recommendations with respect to this containment facility.

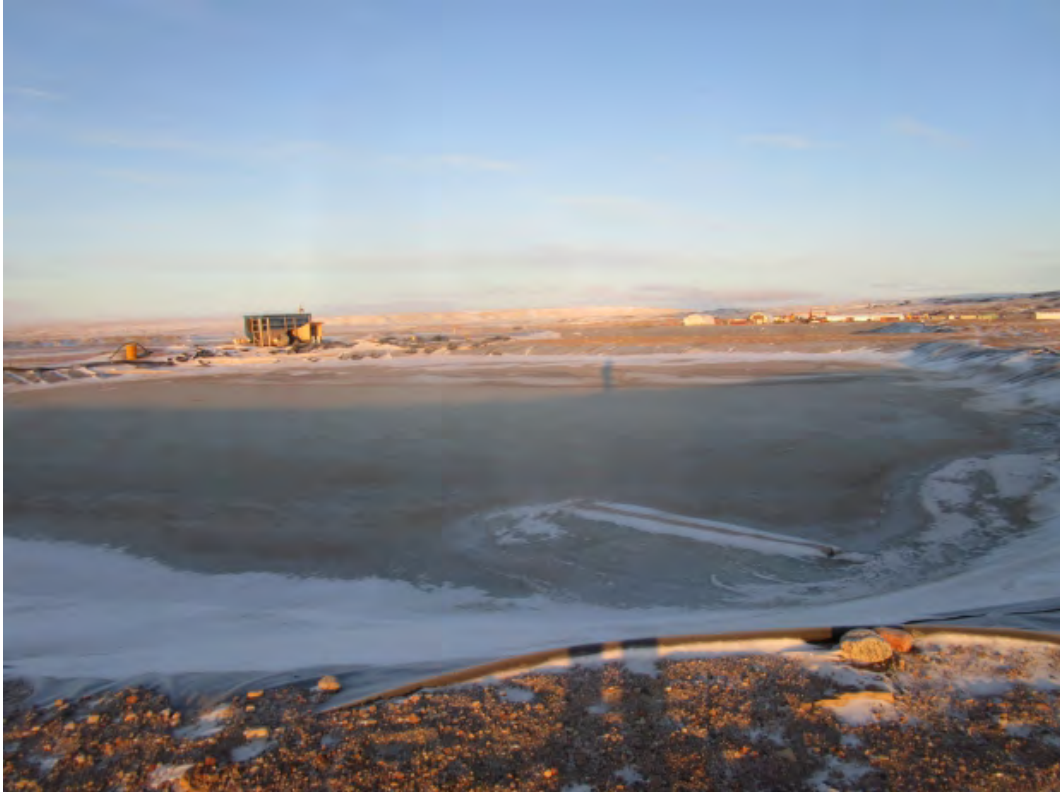
4. PWSP 2

structure readily conforms to its design intent. One cell was almost empty and contained less than one foot of liquid. The second cell was operating at 50% of capacity. The empty cell has not been utilized since 2016.

Our review of the area around the pond at the base of the slopes showed no sign of seepage and hence we conclude that the liner has been effective in containing the sewage and there are no tears or ruptures in the membrane.

The small bubbles that were observed under the liner at the time of the last year's first inspection have returned.

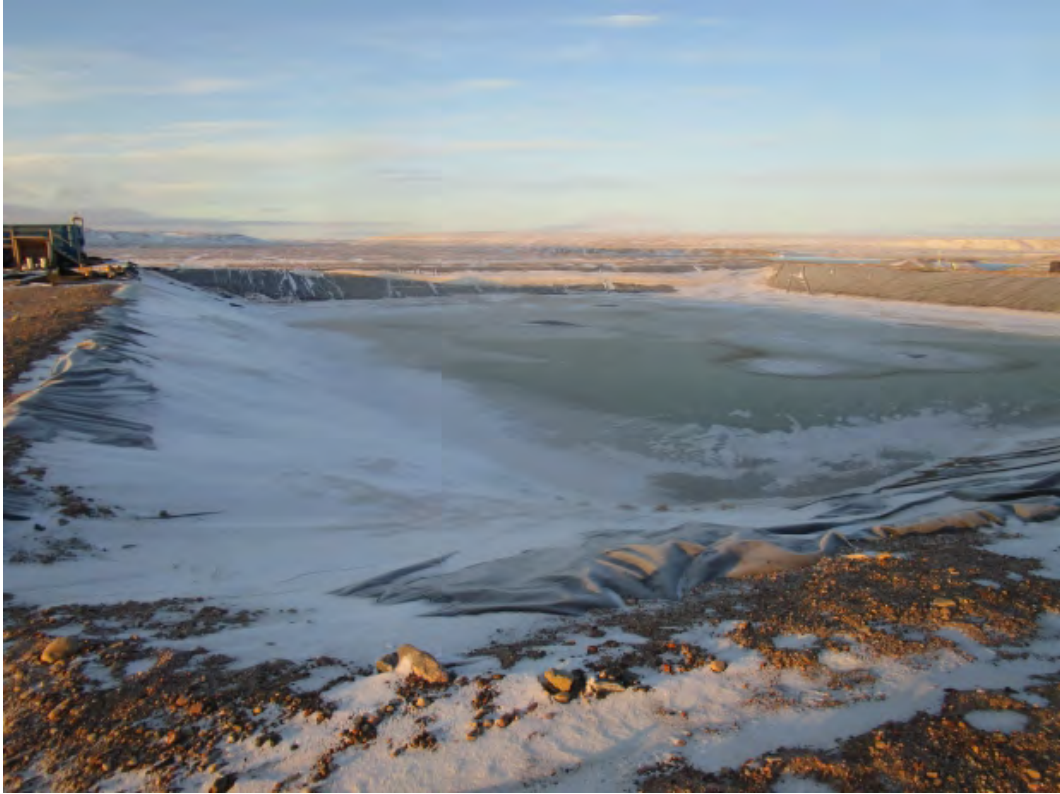
5. PWSP 3

Longitudinal cracking which appeared in the dykes of PWSP #3 due to the melt of permafrost wedges in 2009 has not reoccurred and we consider this structure to be stable in its present condition.

Monitoring points had been set upon the top of the dyke and had been monitored since 2009. Settlements have occurred since that time. These settlements have not led to any stress cracks in the structure. Monitoring of top of berm elevation was discontinued two years ago.

We have no recommendations with respect to this containment facility.

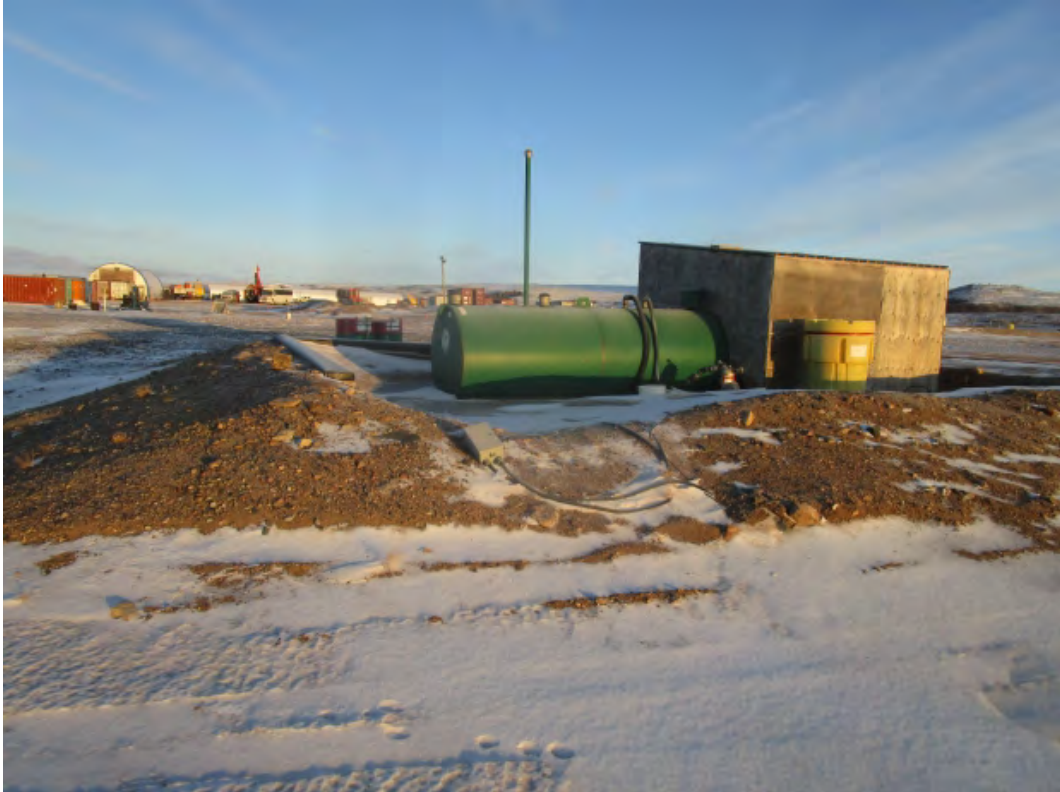
6. Helicopter Fuel Tank Containment.

Our review of the area around the containment at the base of the slopes showed no sign of seepage.

A review of the exterior and the top of the berms showed no sign of cracking or settlement which would indicate stress within the structure.

The structure is considered to be stable in its present condition and contains frozen water that attests to its integrity.

We have no recommendations with respect to this structure.

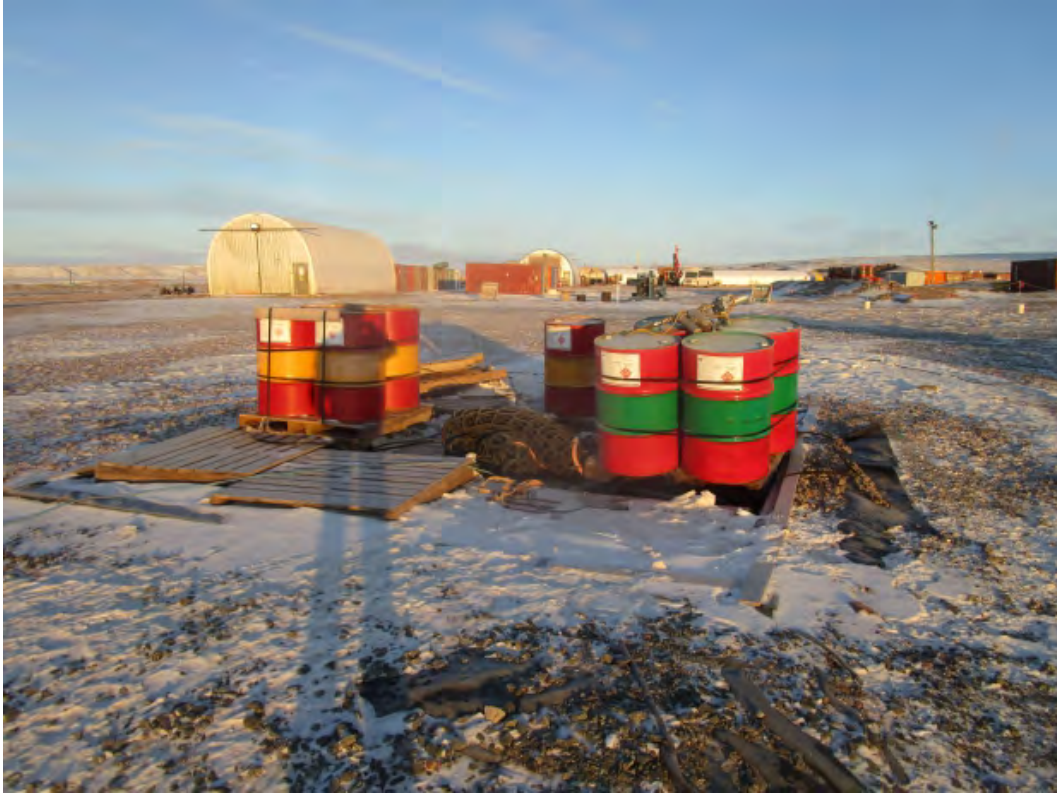
7. Temporary Helicopter Fuel Containment.

As it was the intent of the mine to use fuel that was available in barrels, a temporary cell has once again been constructed with a one piece liner. It measures 16' x 16' x 10' and can readily contain a number of drums as are currently placed in this containment.

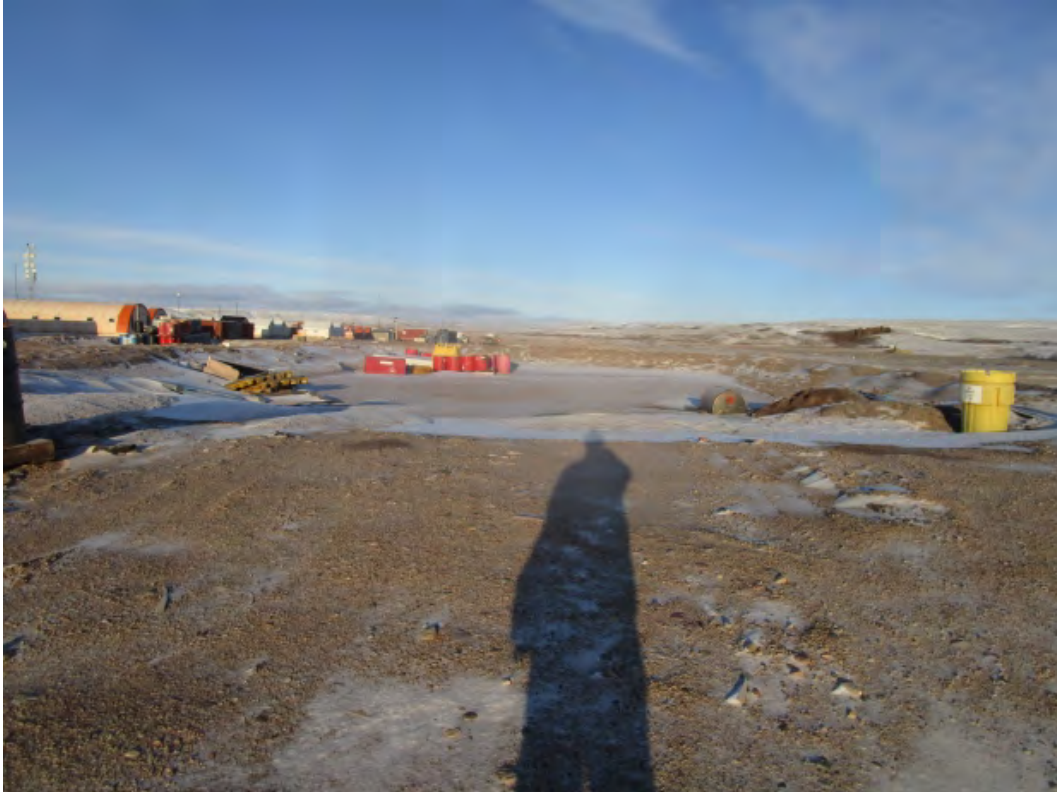
10. Hazardous Waste Storage. (MS-HWB-02)

The structure appears to be stable in its present condition. The frozen water in the cell confirms the integrity of the liner.

There are no recommendations at this time.

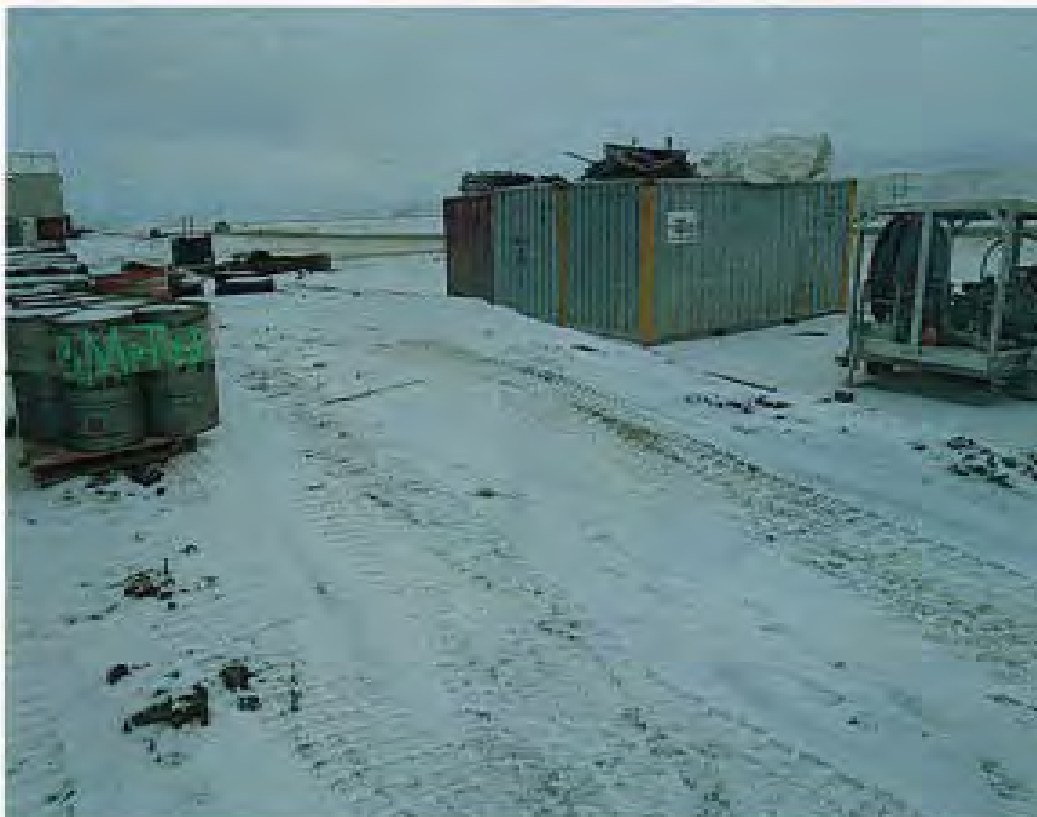
There were 3 locations where the enviroliner was damaged near the top of the dyke, where repairs have taken place.

20. Hazardous Waste Containment (MS-HWB-6).

We have no recommendations with respect to this structure.

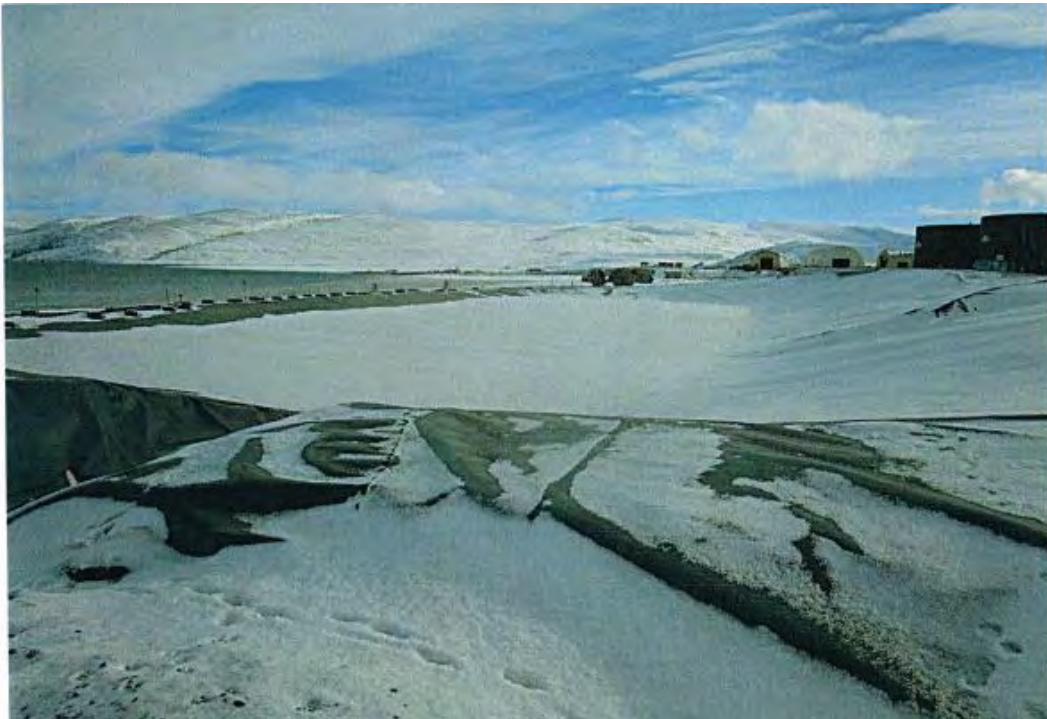
The two inlets to the pond have very recently been upgraded and the enviroliner has been repaired at these locations. This was performed at the end of July, 2017.

We have concerns over the stability of the liner on this pond and recommend the possibility of further tire ballast over the liner which appears possibly subject to wind damage. This shall provide a function for used tires

30. Milne Port Ore Stockpile Sedimentation Pond East (MP-05)

We recommend review of the use of a ballast (possibly tires) on the exposed liner at the dyke to prevent wind uplift.

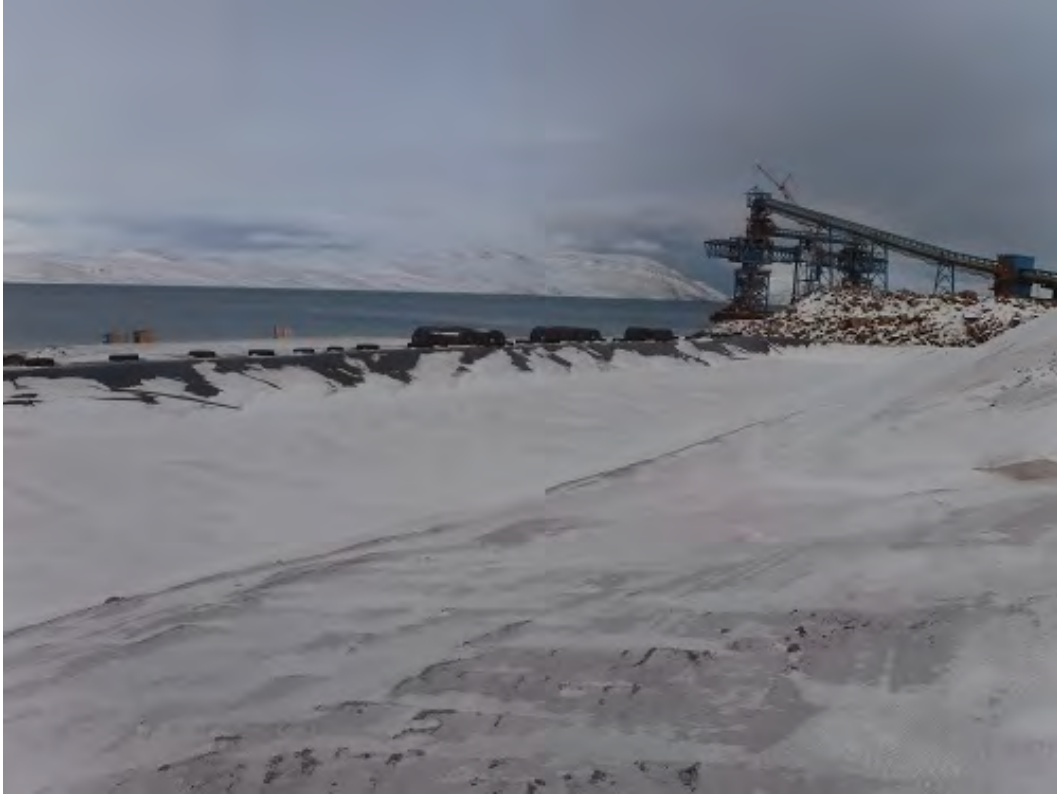
The construction of this sedimentation pond for drainage from the west side of the site is now complete with repairs recommended in our report of last year having been completed.

The inlet where the inlet where possible water infiltration was occurring was addressed at the end of July, 2017, and the inlet has been reconstructed.

We have some concern over the stability of the liner on this pond as we have with the east pond and further recommend that used tire ballast be considered.

31. Milne Port Ore Stockpile Sedimentation Pond West (MP-06)

We have no concerns other than that of possible wind damage to the liner and recommend the use of tires as ballast.

We recommend that the ditch that conducts water from the east side of the pond be reviewed to ensure water is conducted to the pond readily.

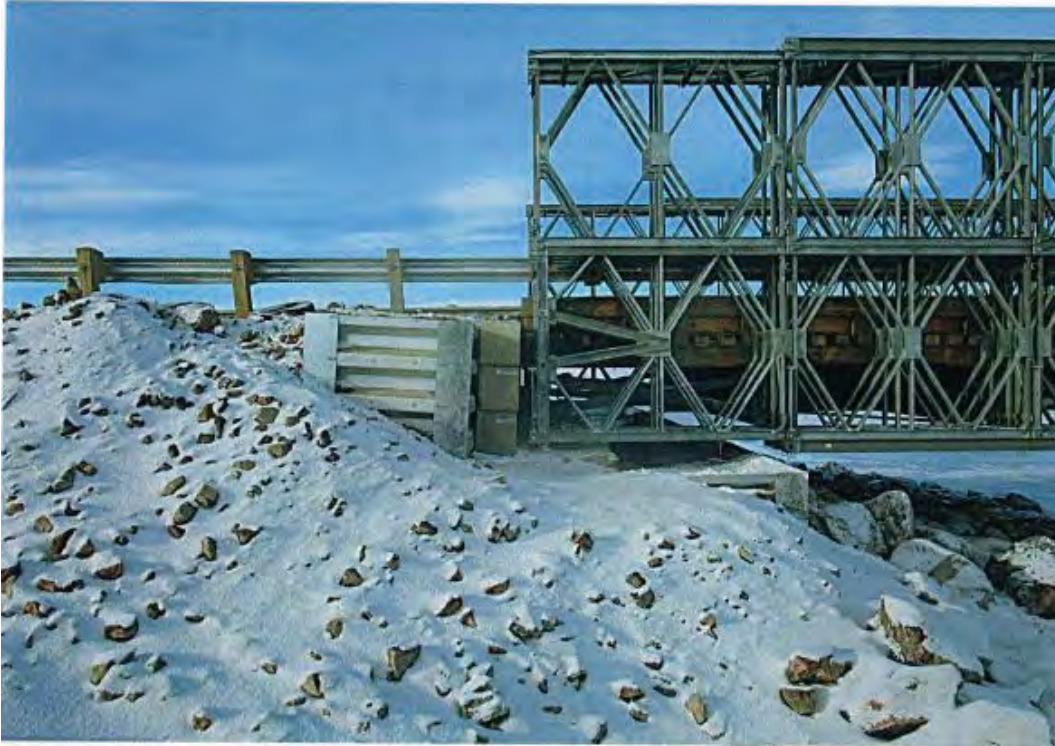
32. Bridge Abutment @ km 97 (Note Space)

I recommend reconstruction of the abutment formed with metal containment utilizing double the length parallel to the road and 50% wider containment.

I recommend that consideration be given to having the trucks come to a full stop at least 50 metres from each end of the bridges. The braking action of the ore haulers does put undue stress upon the road bed which is transferred to the concrete abutments near the top of the abutments.

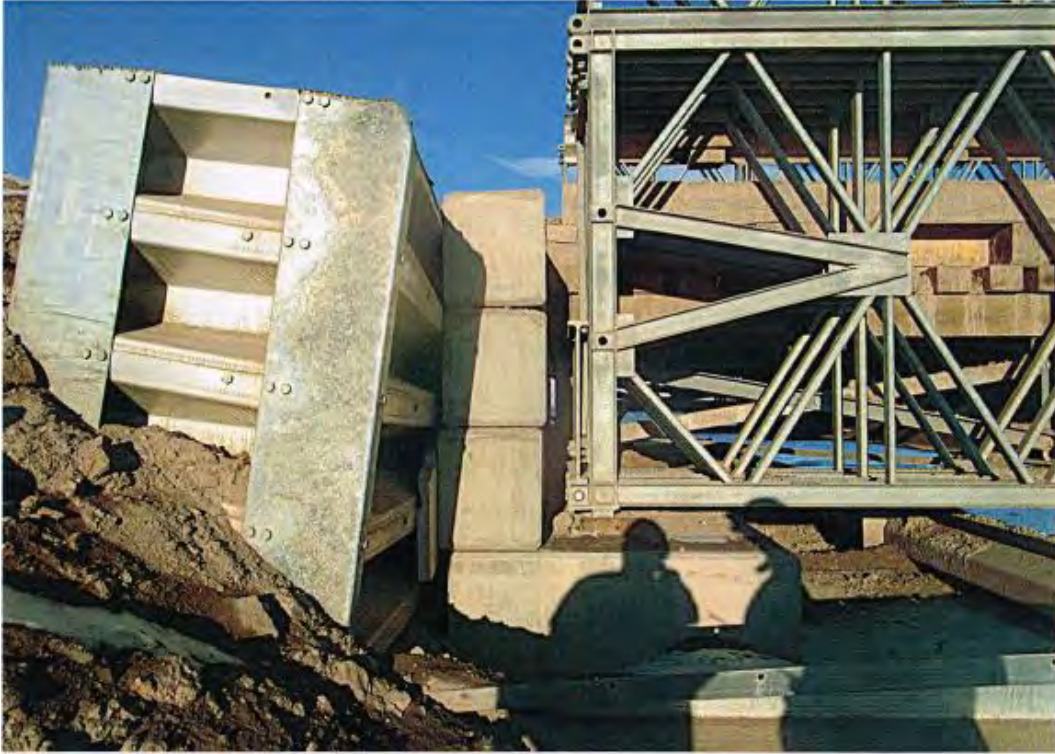
34. Bridge Abutment @ km 80 (Note Space)

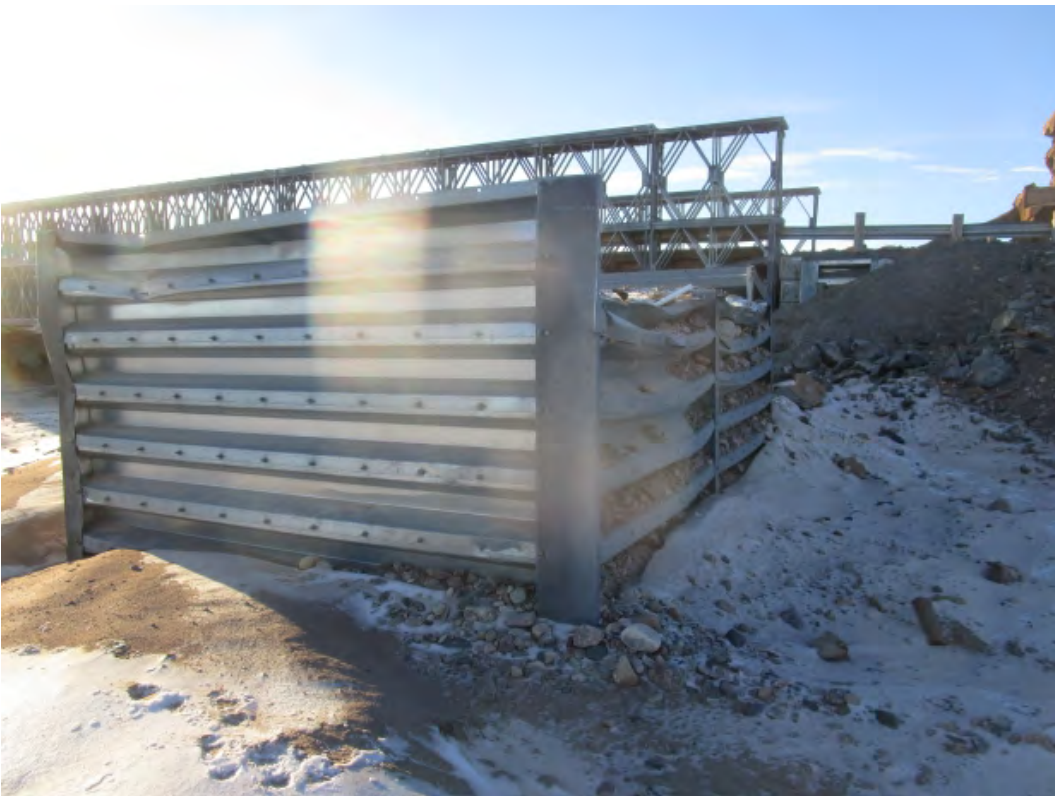
39. Sea can bridge abutments no longer in use. Note there is no deformation.
