BAFFINLAND IRON MINES CORPORATION

ANNUAL GEOTECHNICAL INSPECTIONS

MARY RIVER PROJECT

August 2017

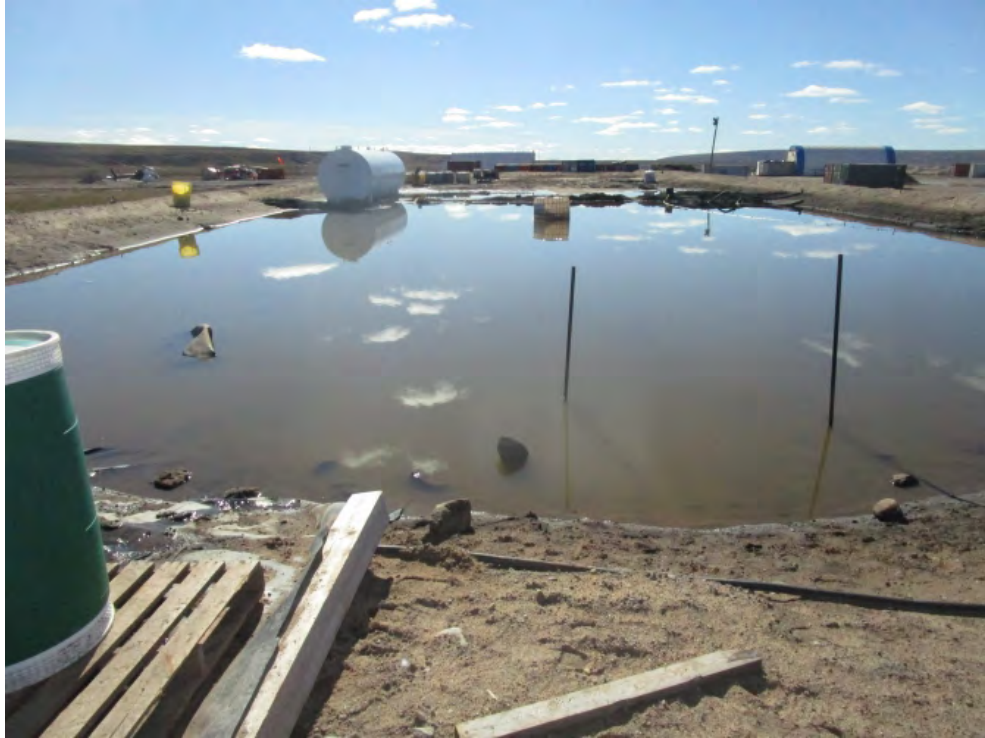
1. Bulk Fuel Storage Facility (MS-HWB-7)

The Bulk Fuel Storage Facility still exists but it is no longer utilized as a bulk fuel storage facility. There are a number of full fuel barrels and lubricant cubes now stored within the berms, as well as a large fuel tank.

At the time of this initial review, water had not been removed from within the containment and water was ponding above the level of the gravel within the bottom of the containment at the north end of the facility.

At the load-out end of the facility there was water ponding within the dykes. At the former fuel unloading area at the north end there is water ponding within the dykes.

The soil structure is considered stable in the present condition and is in conformance with the design basis for the facility.

The presence of water within the structure and at the load-out area is an indication of the integrity of the liner.

We have no recommendations with respect to this containment structure.

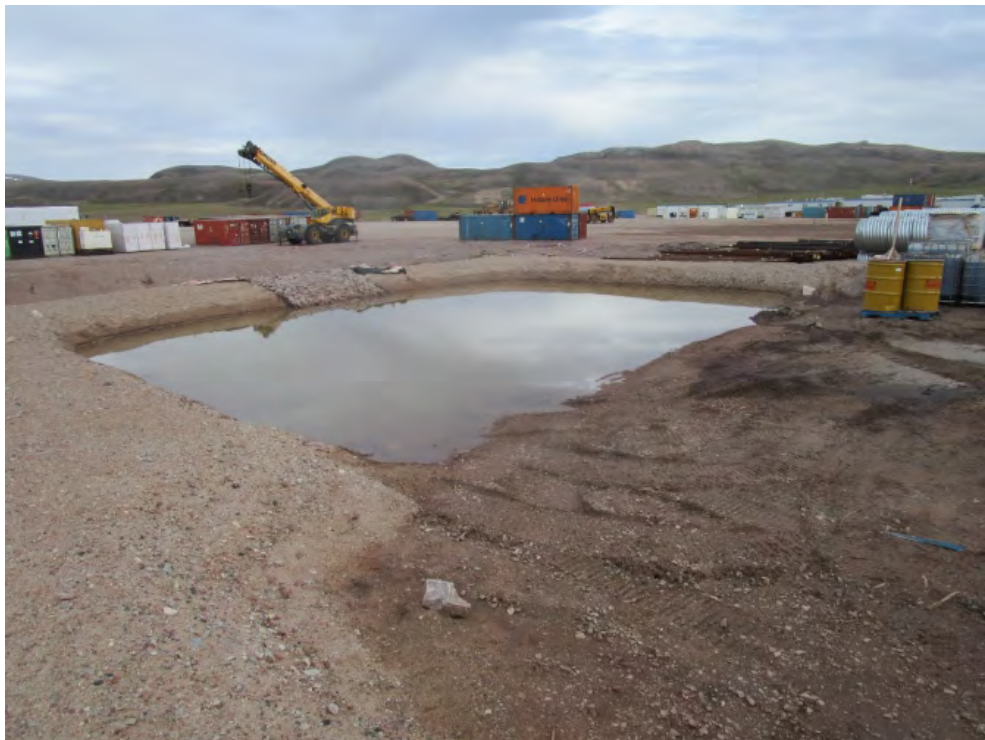
2. Generator Fuel Containment

This particular containment structure is planned to be decommissioned. The fuel bladder that was contained within the dyke has been removed.

There is no indication that the liner is compromised and decommissioning should proceed when the ponding water has been removed and granular cover is either moved to a land farm or other containment. There is water ponding within the structure confirming the integrity of the containment.

The granular fill over the geotextile and liner shall require landfarming with the material from the bulk fuel storage facility.

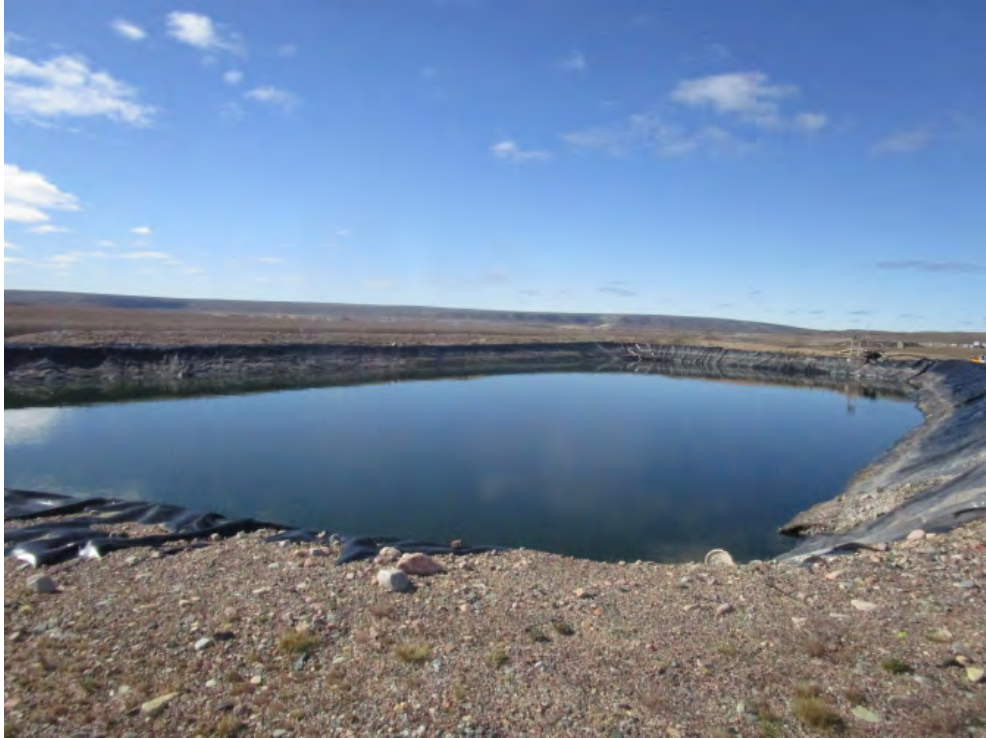
3. PSWP #1

Our review of this area around the pond, at the base of the slopes, showed no sign of seepage and hence we conclude that the liner has been effective in containing sewage and there are no tears or ruptures in the membrane, excepting some minor tears from past activity at the top of the dyke well above the allowable effluent level in the structure in the horizontal portion of the membrane.

A review of the top of the dyke showed no indication of cracking or settlement which would indicate stresses within the structure.

Many of the tears that had occurred in the liner on the top of the dyke have been patched during the period between reviews in 2008 and 2009 and are holding well. As well, there are no signs of weather related deterioration of the liner where it is exposed.

The minor settlements have had little effect on the integrity of the structure.

We have no recommendations with respect to this containment facility.

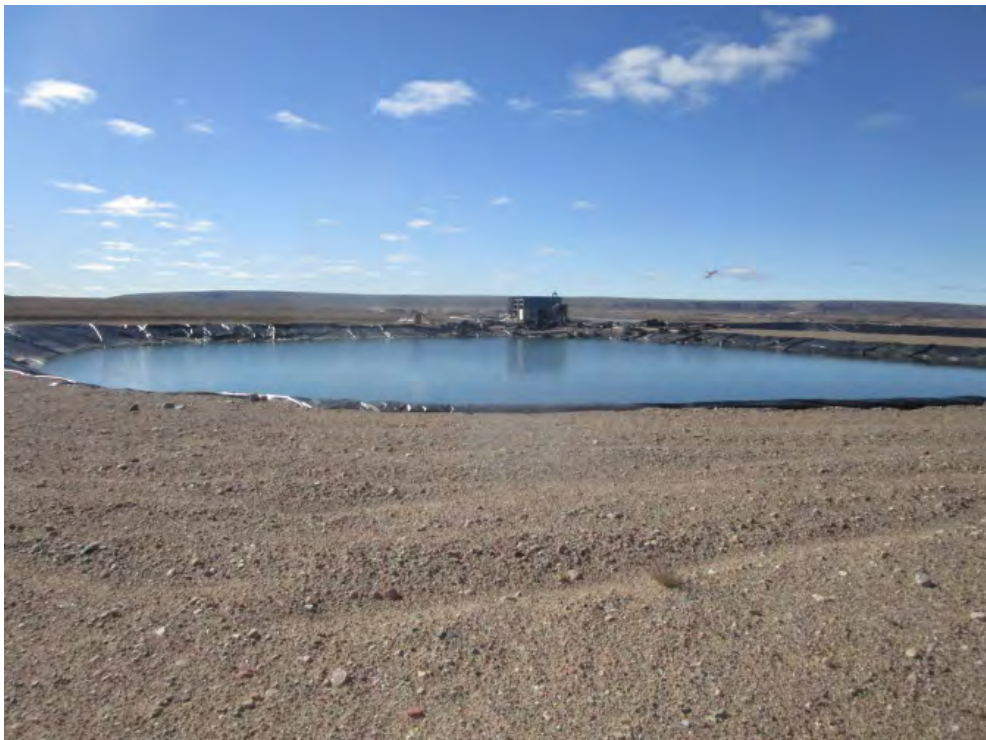
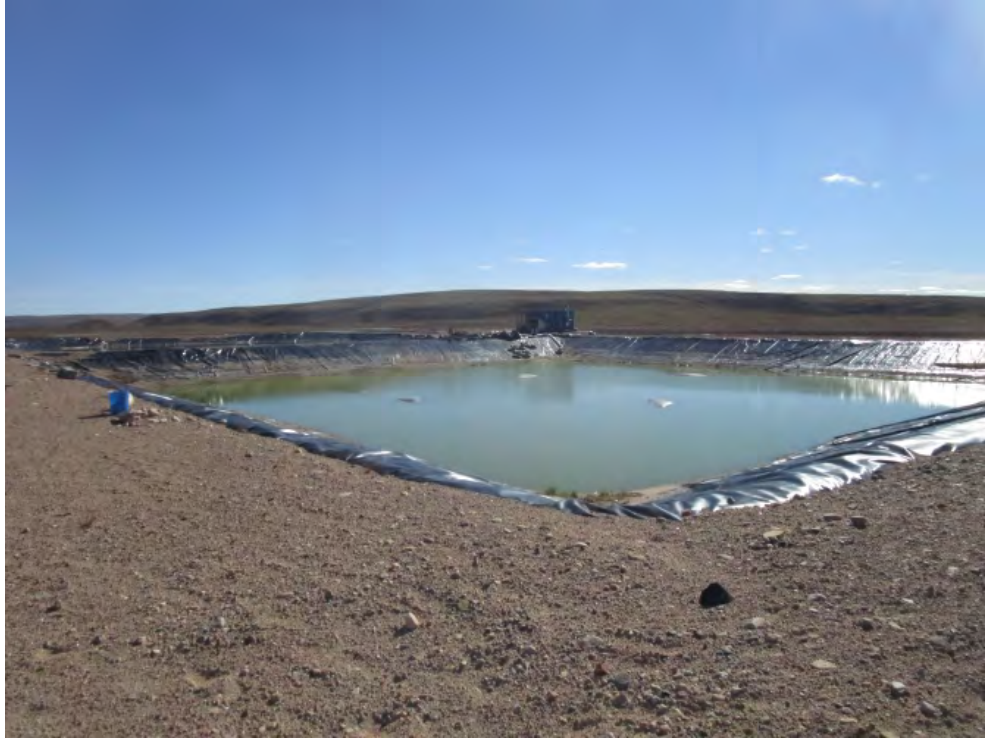
Our review of the area around the pond at the base of the slopes showed no sign of seepage and hence we conclude that the liner has been effective in containing the sewage and there are no tears or ruptures in the membrane.

Longitudinal cracking which appeared in the dykes of PWSP #3 due to the melt of permafrost wedges in 2009 has not reoccurred and we consider this structure to be stable in its present condition.

Monitoring points have been set upon the top of the dyke and have been monitored since 2009. Settlements have occurred since that time. These settlements have not led to any stress cracks in the structure. Monitoring was discontinued two years ago.

The small bubbles that were observed under the liner at the time of the last year's first inspection have returned.

We have no recommendations with respect to this containment facility.

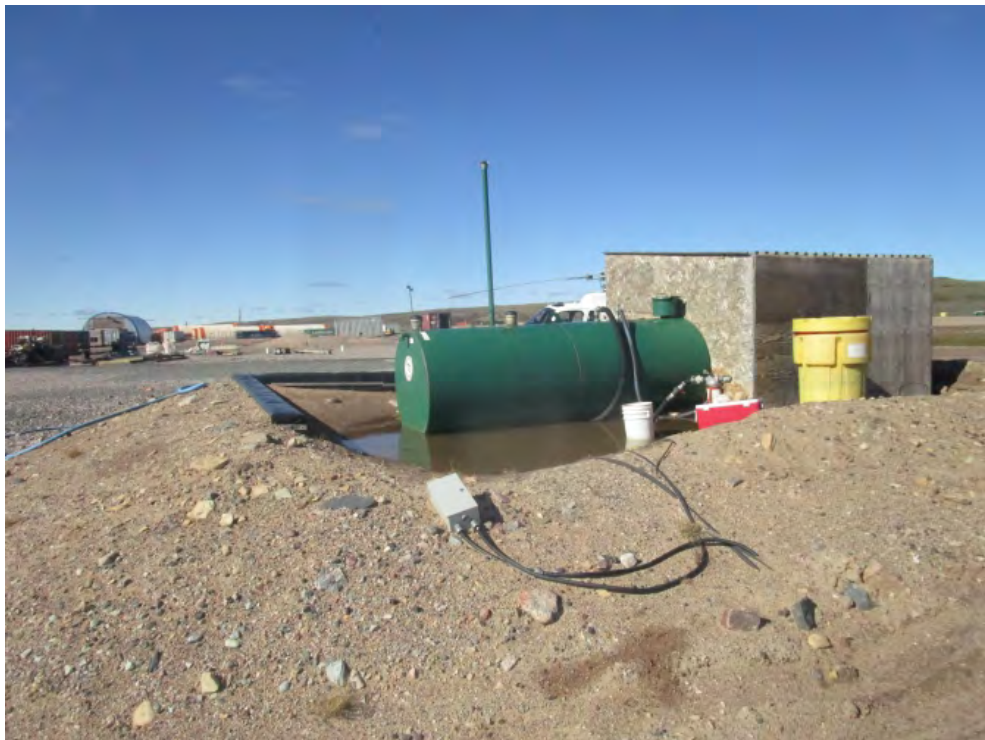
6. Helicopter Fuel Tank Containment

Our review of the area around the pond at the base of the slopes showed no sign of seepage.

A review of the exterior and the top of the berms showed no sign of cracking or settlement which would indicate stress within the structure.

The structure is considered to be stable in its present condition and contains water that attests to its integrity.

We have no recommendations with respect to this structure.

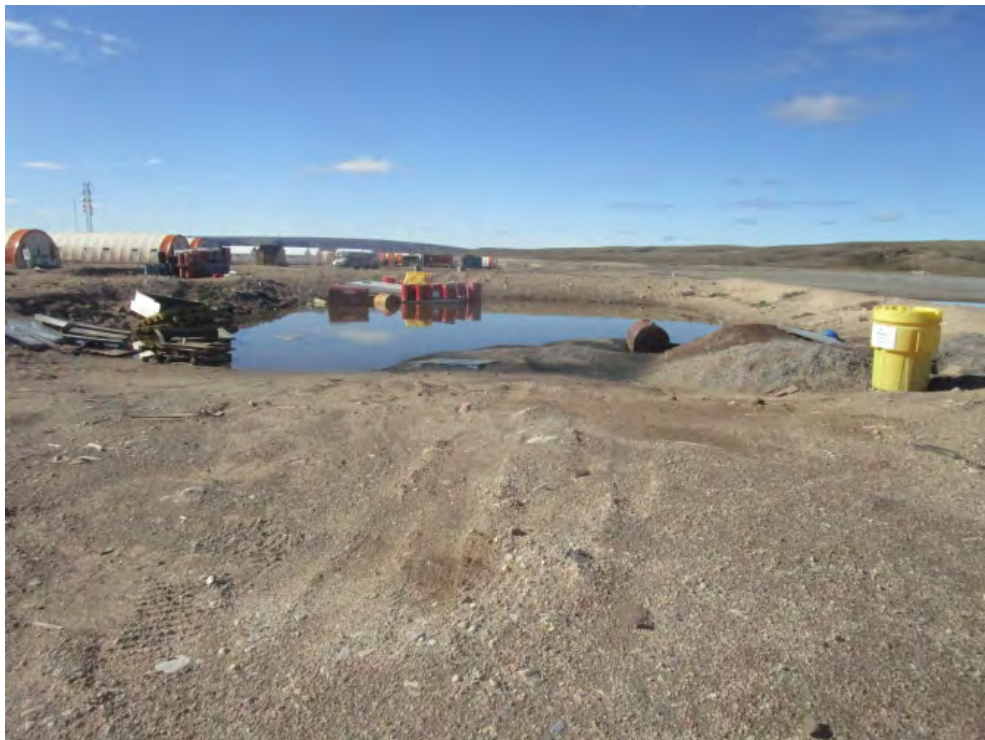
10. Hazardous Waste Storage (MS-HWB-2)

Our review of the area around this cell at the base of the slopes, showed no sign of seepage. There is water ponding in this structure.

The structure appears to be stable in its present condition. The water in the cell confirms the integrity of the liner.

There are no recommendations at this time.

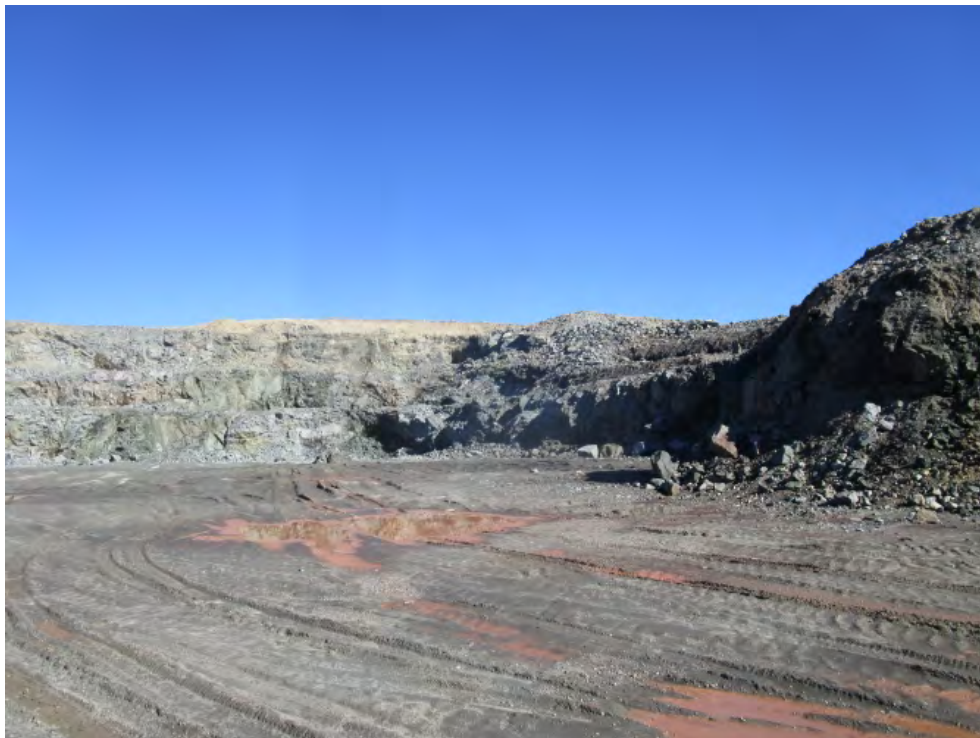
16. Mary River Quarry (QMR2)

The quarry has well defined benches. The quarry faces at the benches are clean except in one end where some subsidences have occurred. This is the fracture zone noted in the last review.

Care must be taken while quarrying in the unstable fracture zone.

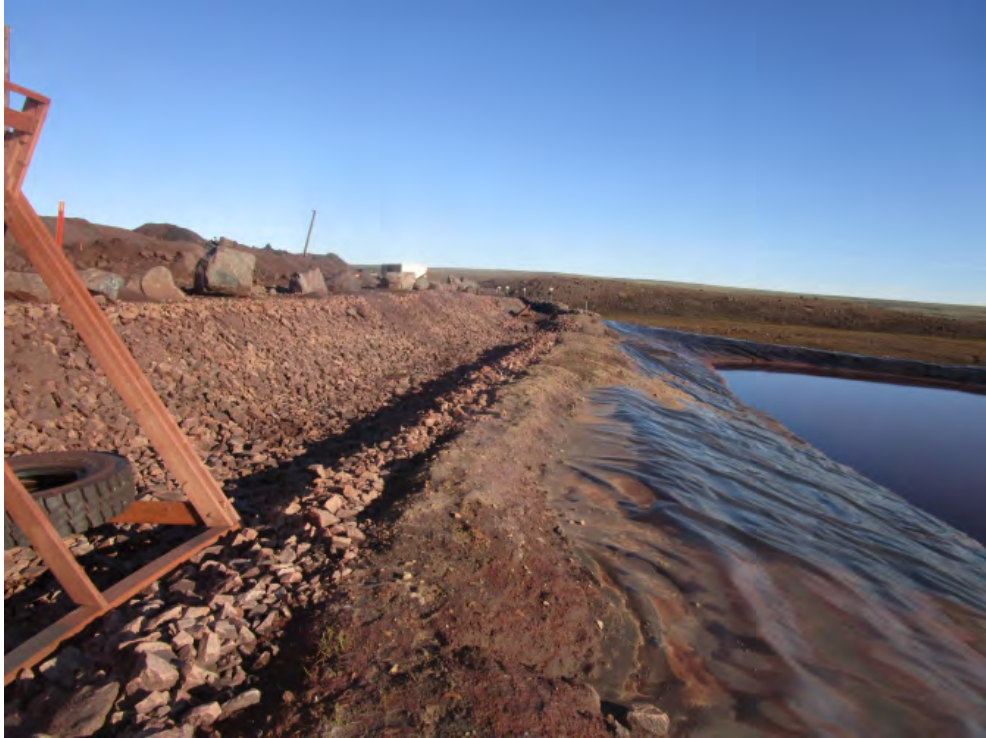
17. Crusher Pad Drainage Containment

Although there was no moisture flowing to the catchment pond, it is evident that the ditches in place and the containment pond are operating as intended. However, there is one low area at the north end where minor drainage bypasses the containment by flowing under the road through a pipe (conduit) used for electrical wires.

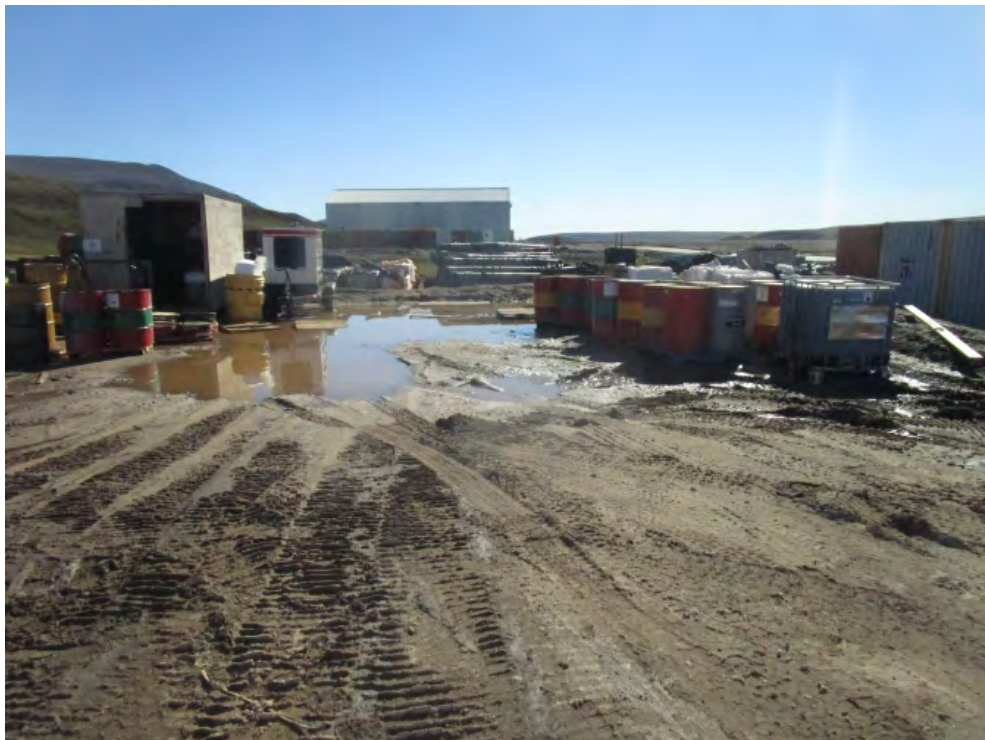
20. Hazardous Waste Containment (MS-HWB-6)

There were 3 locations where the enviroliner is damaged near the top of the dyke.

We have no recommendations with respect to this structure other than making repairs to the damaged enviroliner

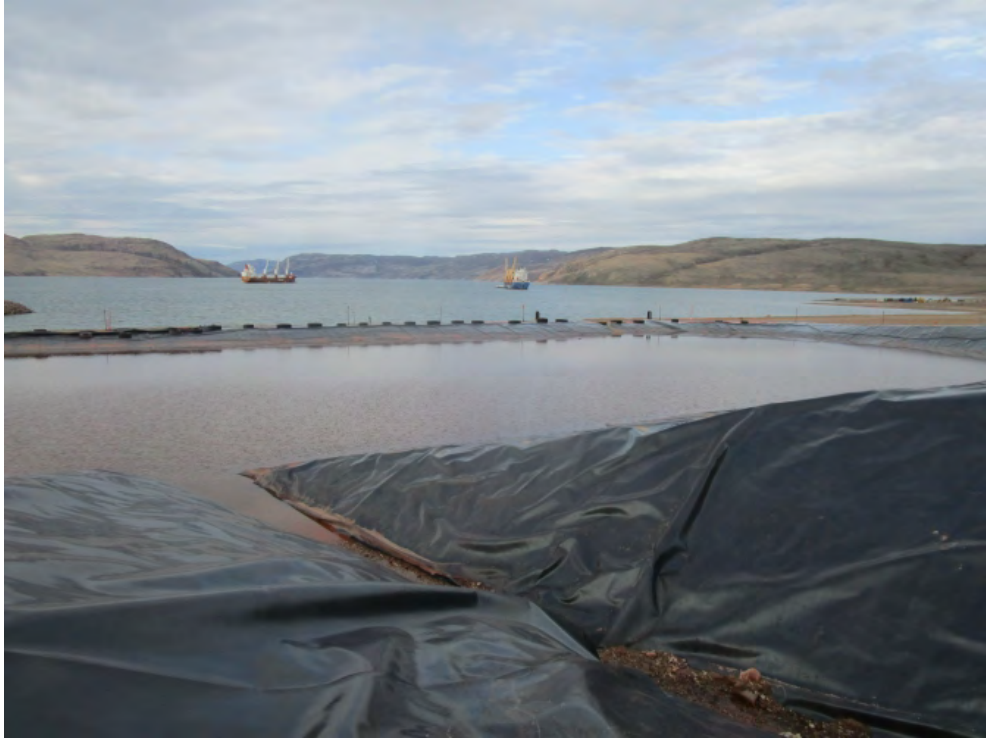
27. Sedimentation Pond East

The two inlets to the pond have very recently been upgraded and the enviroliner has been repaired at these locations.

We have concerns over the stability of the liner on this pond and recommend the possibility of further tire ballast over the liner which appears possibly subject to wind damage. This shall provide a function for used tires.

We recommend review of the use of a ballast (possibly tires) on the exposed liner at the dyke to prevent wind uplift.

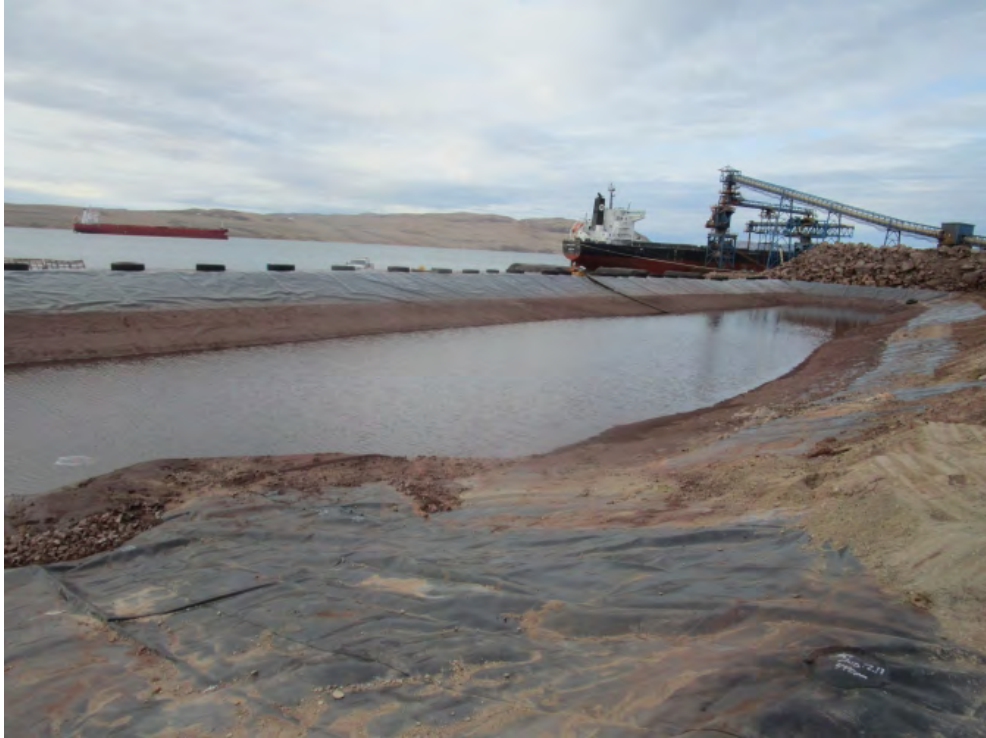
29. Sedimentation Pond West

The construction of this sedimentation pond for drainage from the west side of the site is now complete with repairs recommended in our report of last year having been completed.

We have some concern over the stability of the liner on this pond as we have with the east pond and further recommend that used tire ballast be considered.

We have no concerns other than that of possible wind damage to the liner and recommend the use of tires as ballast.

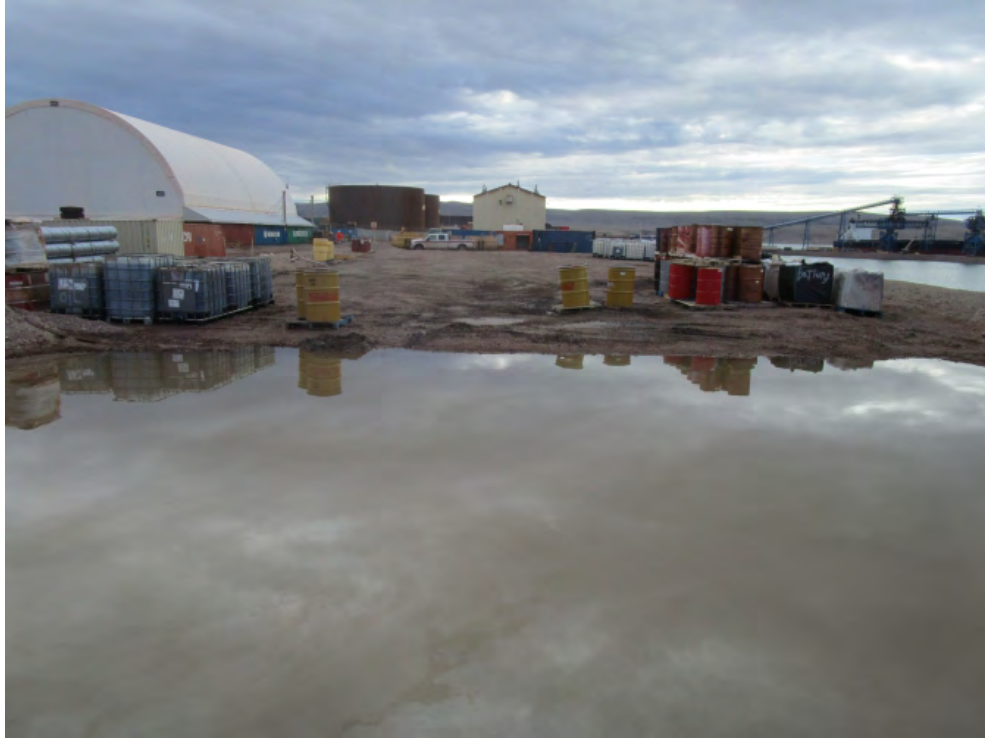
31. Loading Area Contaminated Storage (MP-HWB-1)

Construction appears stable. However there is one exposed tear in the liner at the dyke that requires repair.

We have no recommendations with respect to this structure other than to repair the tear.
