Nunavut Impact Review Board

2022 June Site Visit Report

The Mary River Project

Baffinland Iron Mines Corporation

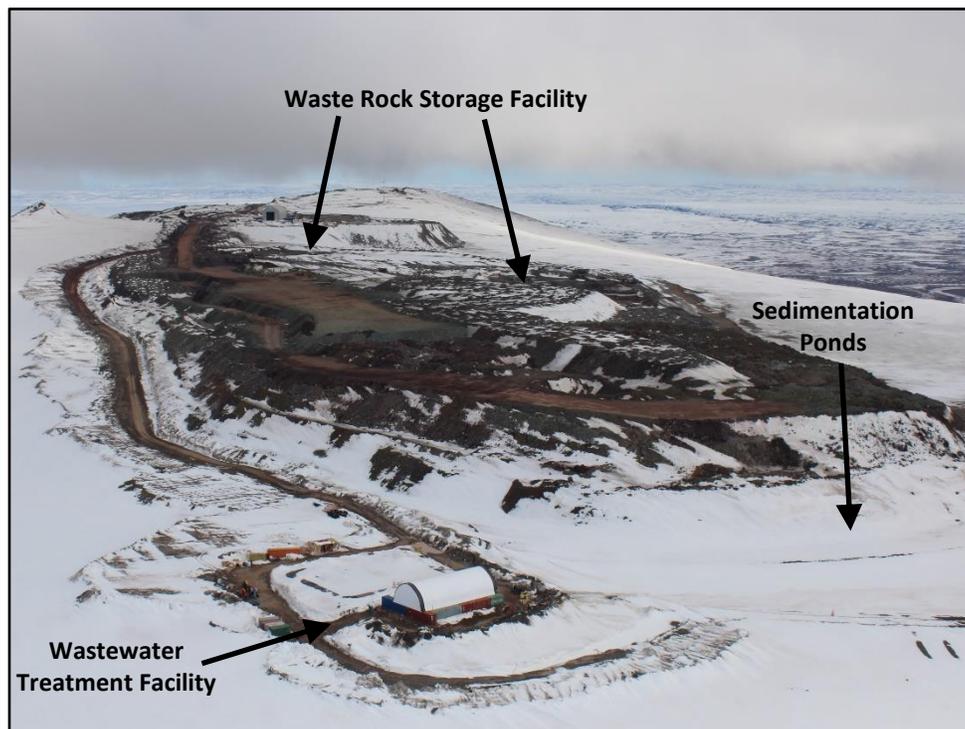
The waste rock storage facility (WRF) is an open area where potentially acid generating rocks are stored (Photo 3). Weather conditions did not allow NIRB staff to obtain good ground level photos of the WRF and sedimentation ponds, but aerial photos were taken via helicopter June 13, 2022. NIRB staff observed that the WRF was beginning to expand as per the *Waste Rock Management Plan* and the NIRB will observe further progression in subsequent site visits.

Photo 3: Waste Rock Storage Pile and Sedimentation Ponds.

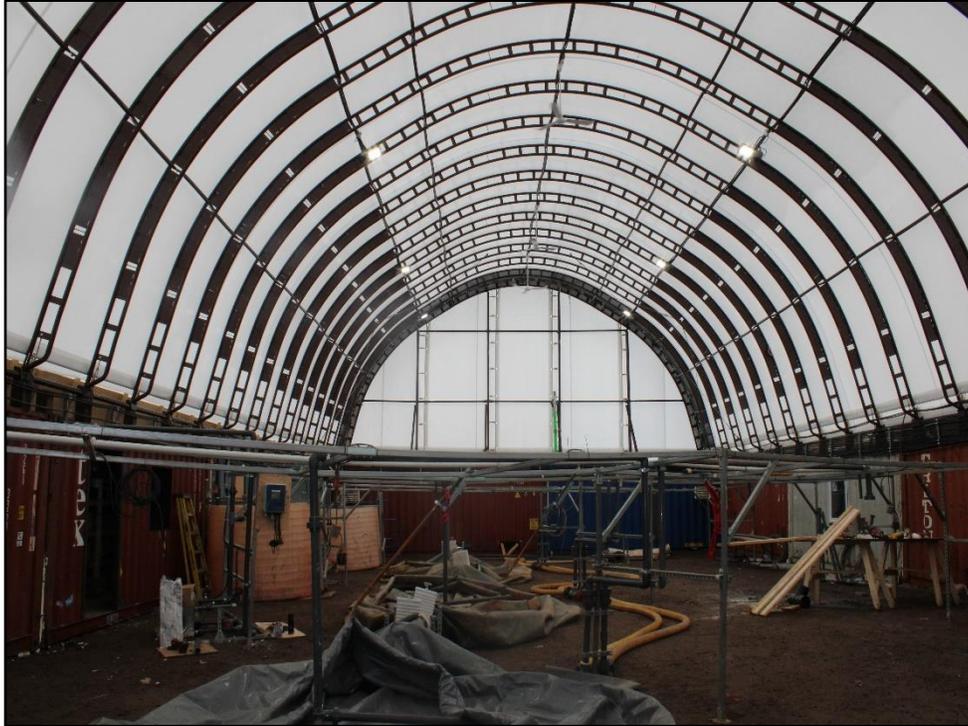
NIRB staff also observed the wastewater treatment facility adjacent to the waste rock sedimentation pond (Photo 4) where wastewater was collected prior to treatment, testing, and discharge to the tundra. The building for this facility was upgraded from a soft-shelled structure to a hard-shelled structure for easier maintenance and operations. This system initially began treating the water in spring 2020 and uses both chemical and physical treatments along with a bladder system to treat the waste rock water.

Photo 4: Wastewater Treatment Facility.

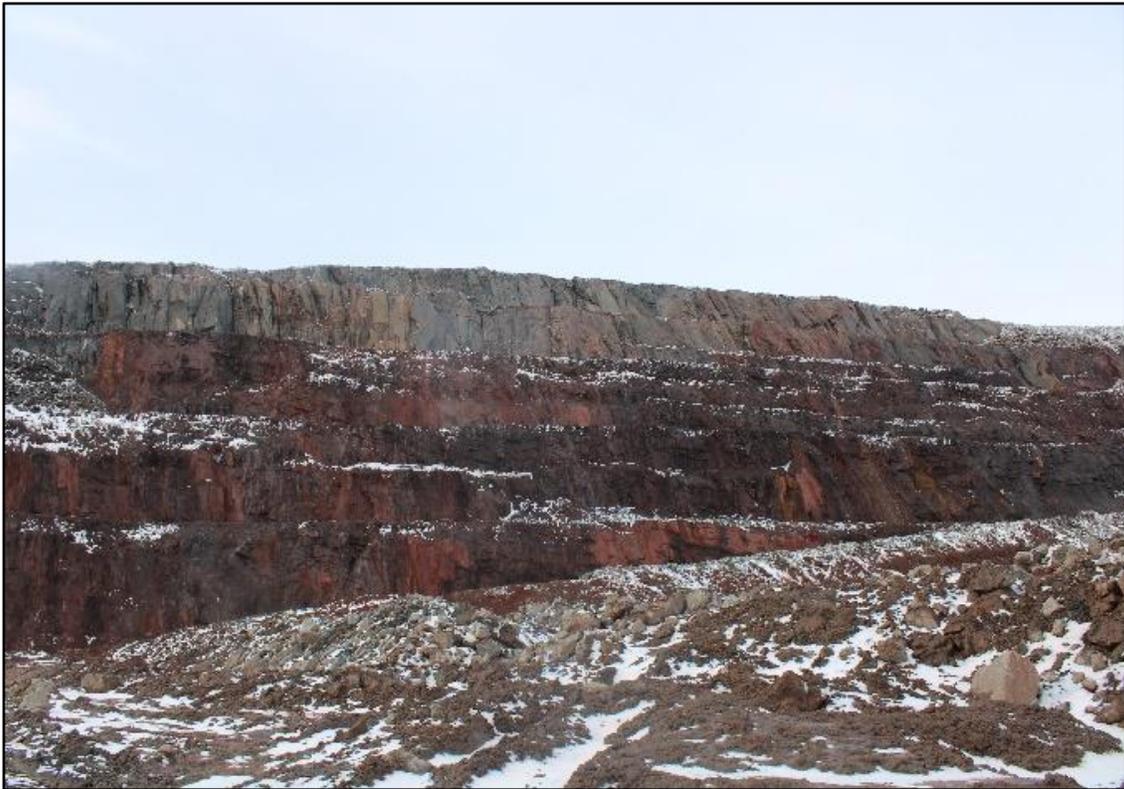
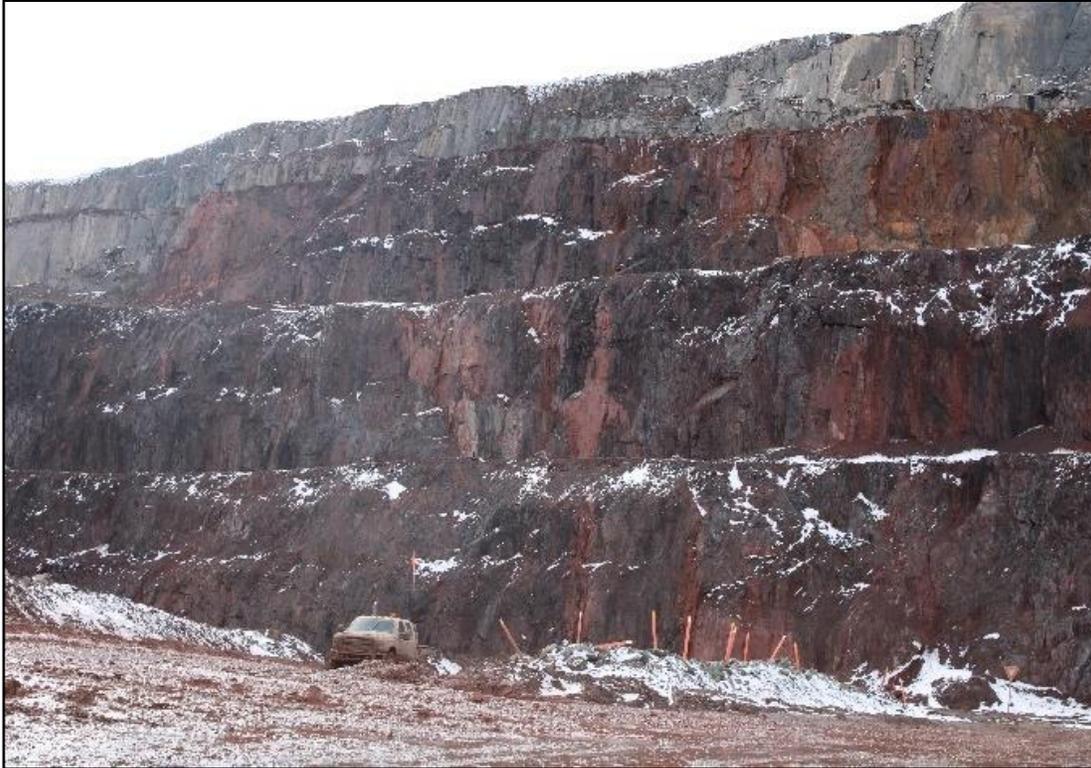
NIRB staff visited the Deposit No.1 pit and noted that ore extraction and mining activities were ongoing. Since the last site visit in 2020, NIRB staff observed the active mining location within the pit had changed. As a result, Baffinland has moved the Mine site haul road to be closer to the active face to ensure safe access and shorter distances for haul trucks to travel.

Photo 6: Deposit No. 1 Mine Pit June 2022.

Photo 7: Deposit No. 1 Mine Pit June 2022 (with truck for scale comparison).

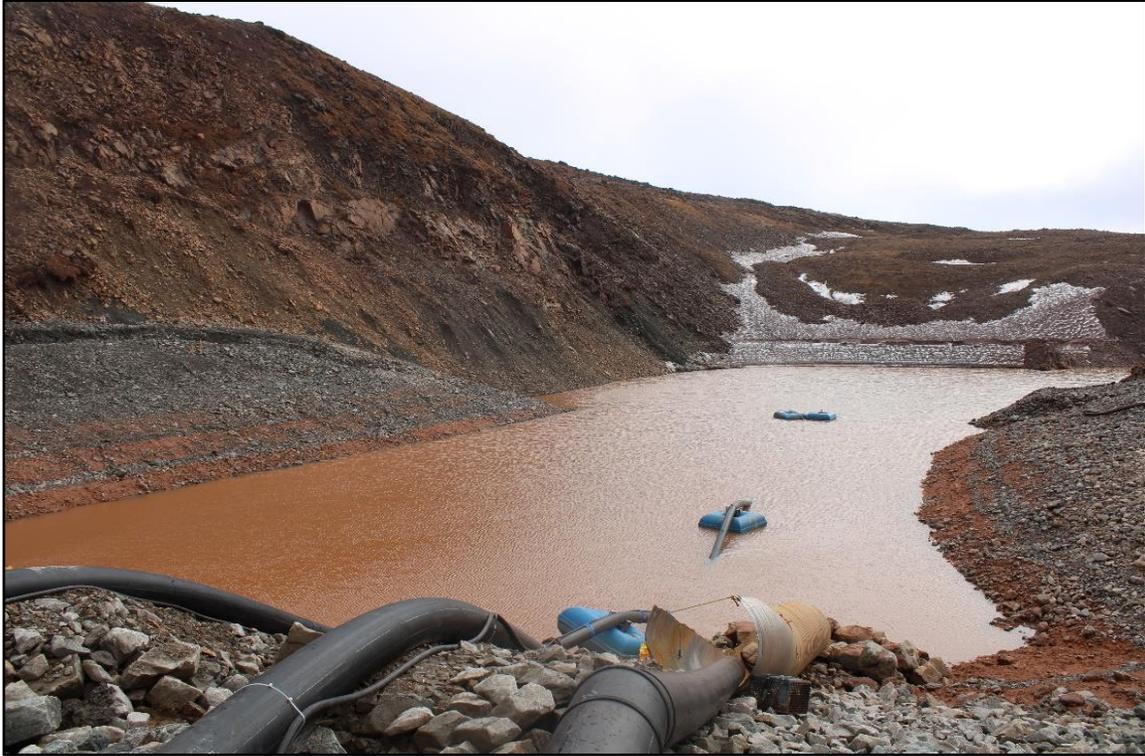
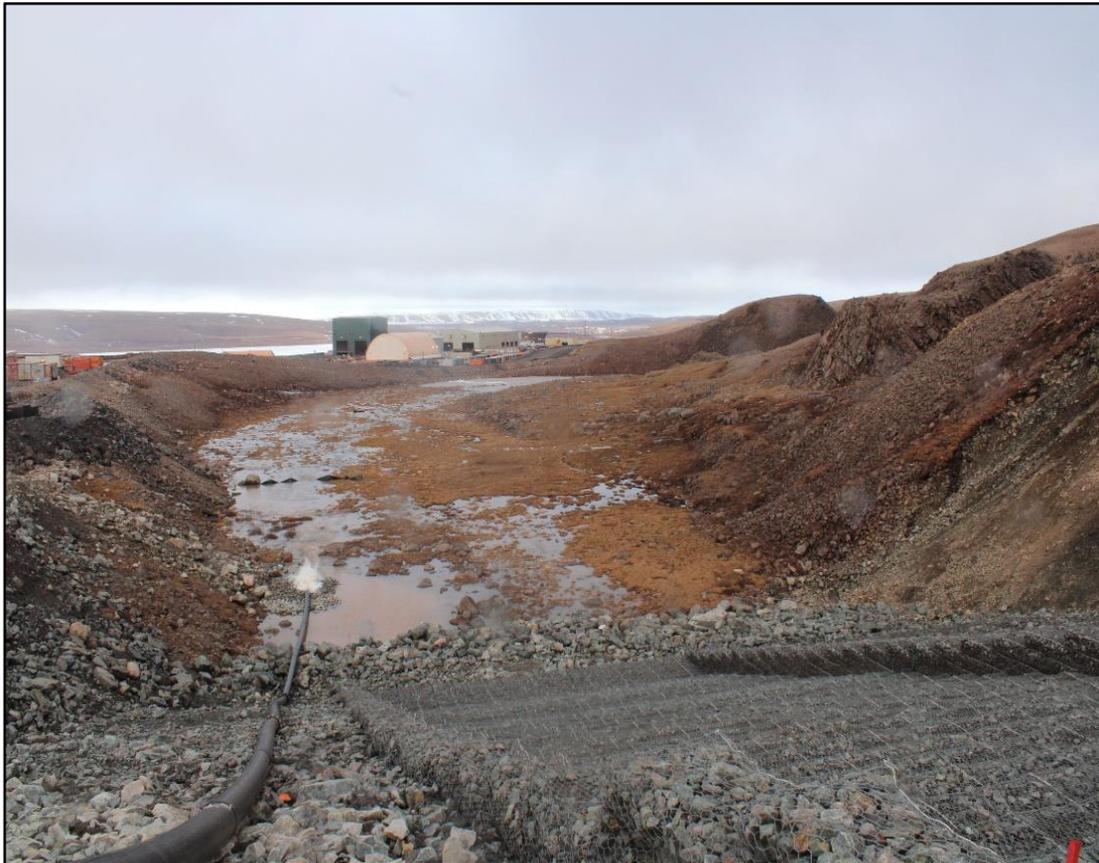
While at Deposit No.1 NIRB staff were able to visit the newly constructed dam located at the base of Deposit No. 1 (Photo 8 & 9). This dam allows for water running down the deposit to be captured in a sedimentation pond where suspended solids in the water can settle prior to the water being pumped with other effluent, after meeting release requirements, into creeks. The dam was completed in 2022 to mitigate any potential accumulation of total suspended solids in run-off water which may lead to impacts on the freshwater environment if left untreated.

Photo 8: Deposit No. 1 Dam Sedimentation Pond

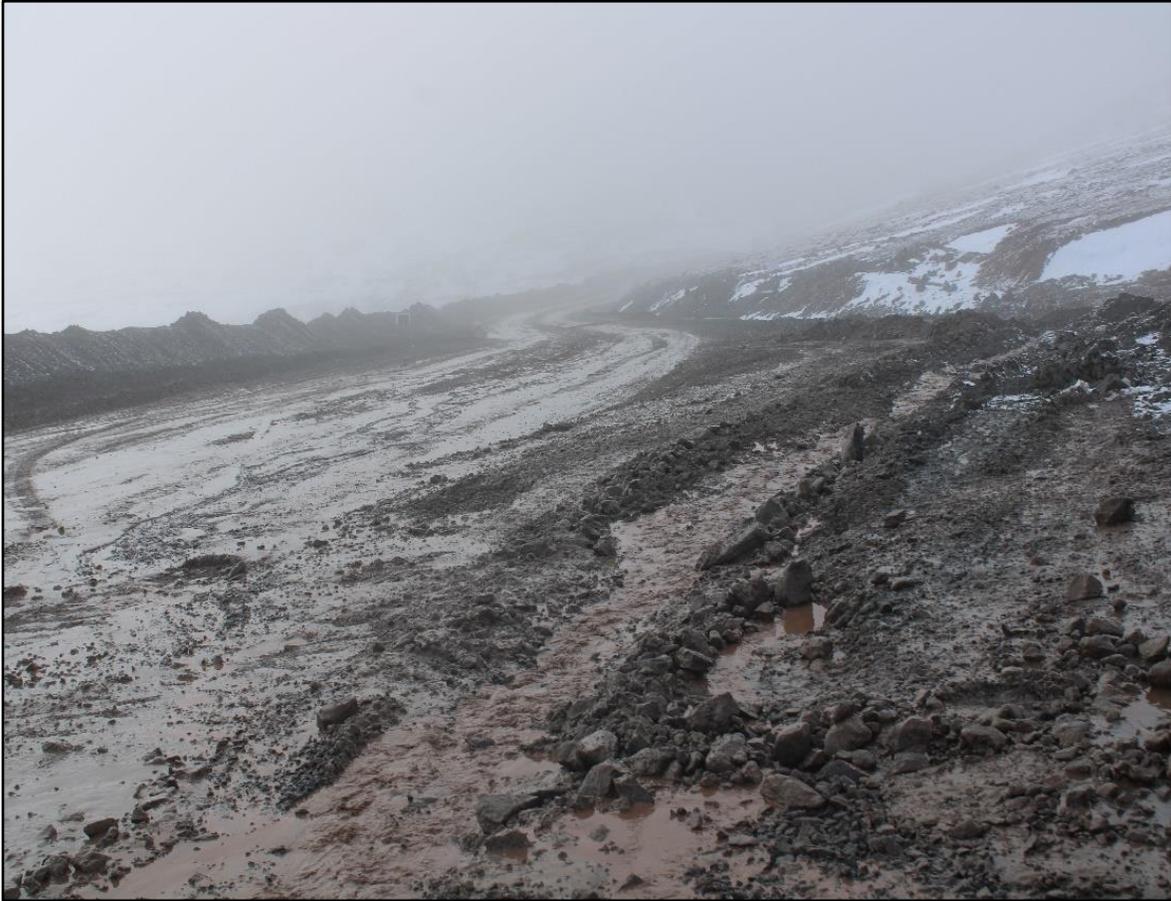
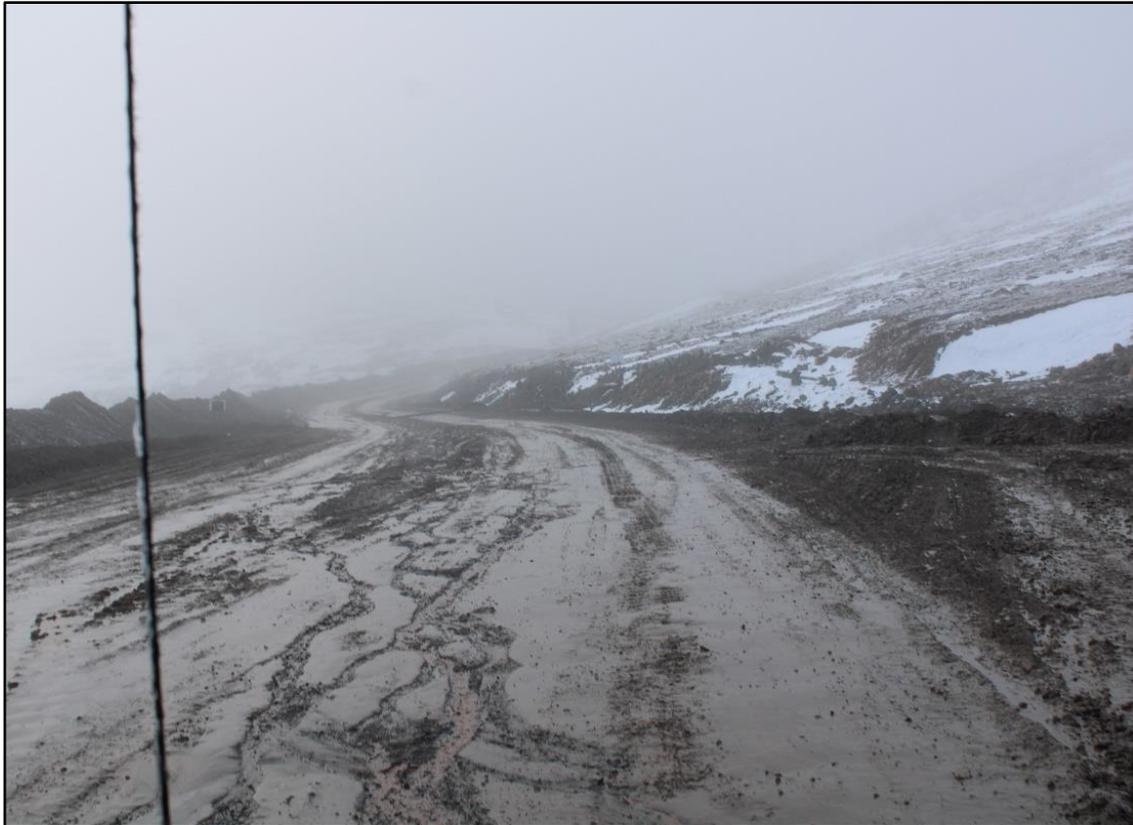
While driving to the deposit, NIRB staff noted that due to the rain even over the past several days, the condition of the Ore Haul Road had deteriorated (Photos 10 & 11). In previous site visits, the road was dry or frozen resulting in a hard packed surface; however, with the rain it had become soft, and Ore Haul trucks were pulled from the road for nearly 24 hours due to dangerous driving conditions. Once the rain stopped, grater operators performed road maintenance to create safe driving conditions and open the road.

Photo 10: Ore Haul Road Conditions During a Rain Event.

Photo 11: Ore Haul Road Conditions During a Heavy Rain Event.

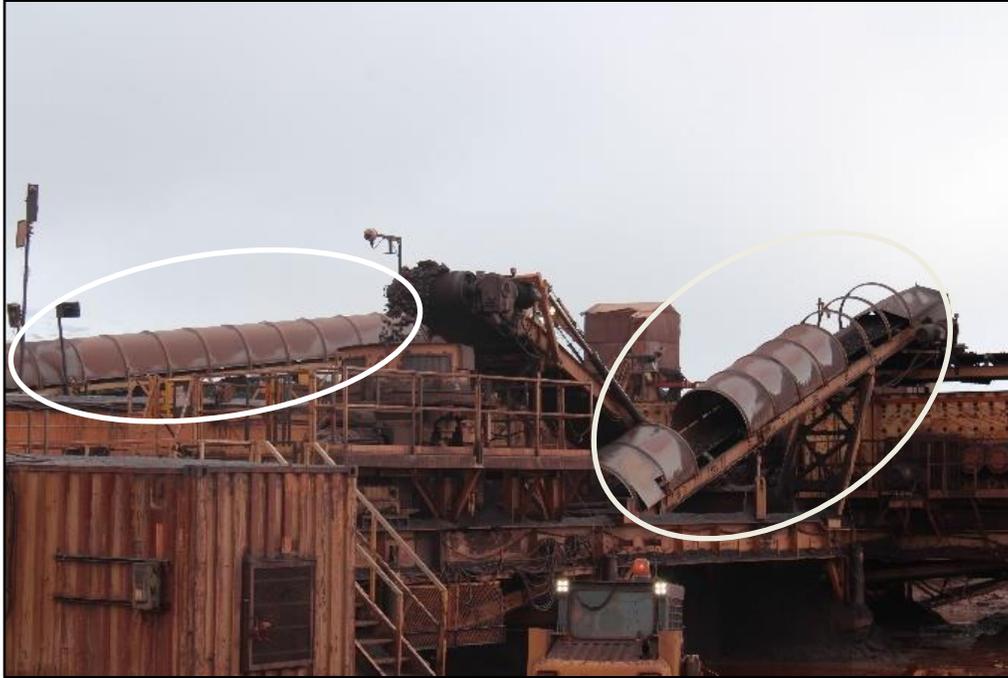
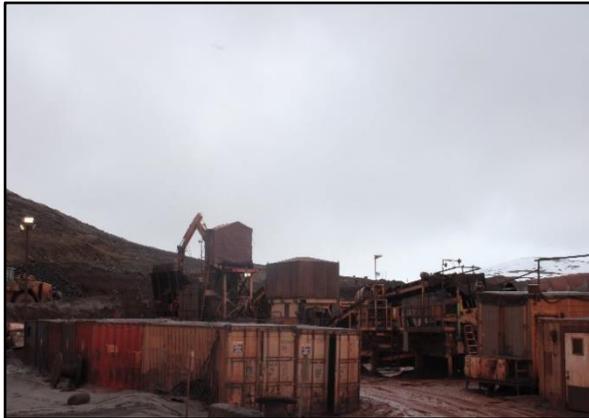
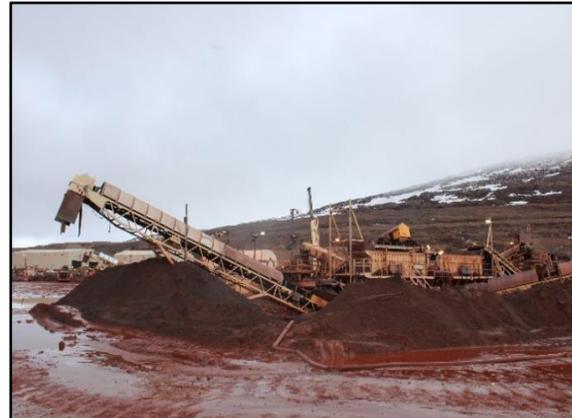
NIRB staff viewed the crusher facility (Photo 12, 13 & 14) by truck due to muddy conditions, to follow-up on the implementation of proper engineering designs and controls as directed by the Board to reduce fugitive dust emissions from the crusher plant. Baffinland stated they had installed additional hoods, shrouds, and bellows across all three (3) crusher systems.

NIRB staff noted a reduction in dust production while the equipment was in operation; however, due to freshet and recent rain events the site overall was subject to wet conditions which would assist in total reduction of fugitive dust emissions for the Project. NIRB staff observed a new sedimentation pond constructed adjacent to the Crusher Plant (Photo 15) where water is actively pumped to allow sediment to settle at the bottom prior to water being released after appropriate testing.

Photo 12: Hoods Present at Crusher Conveyor.

Photo 13: General Crusher Conveyor System Equipment.

Photo 14: Bellows on Crusher Conveyor System.

At the crusher facility, NIRB staff have observed the effectiveness of hoods, shrouds, and bellows to reduce the dust emission from the crusher. These mitigations have had mixed success in the past with Baffinland needing to ensure these mitigations are properly re-installed after maintenance; however, when installed, they are effective at reducing dust.

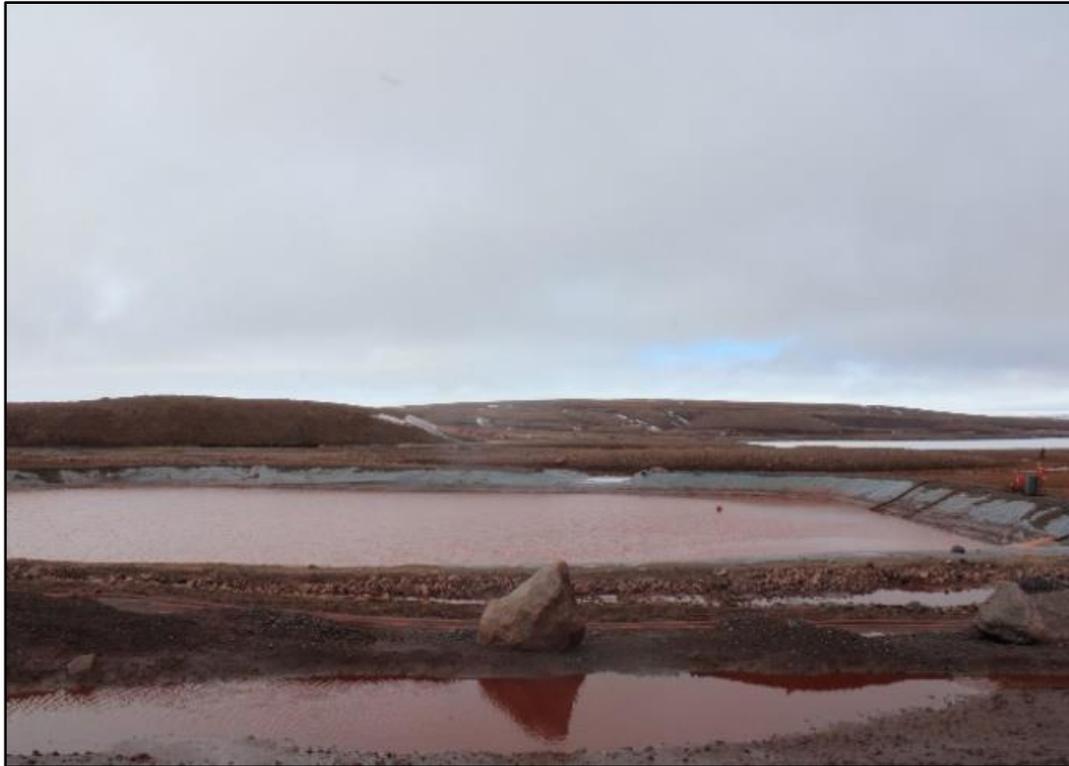
Photo 15: Crusher Facility Sedimentation Pond.

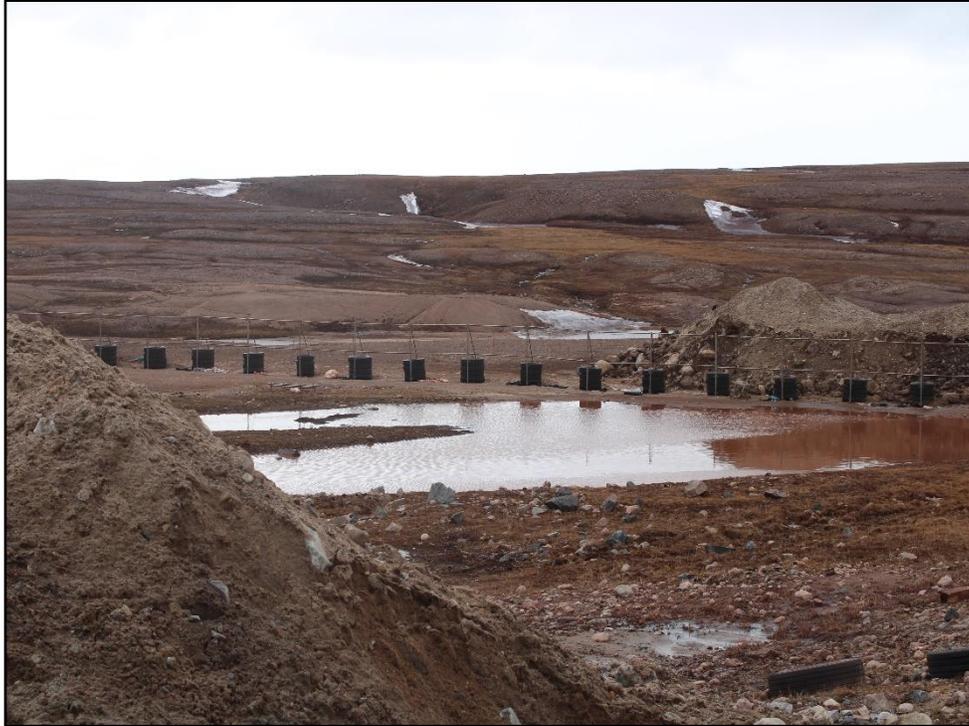
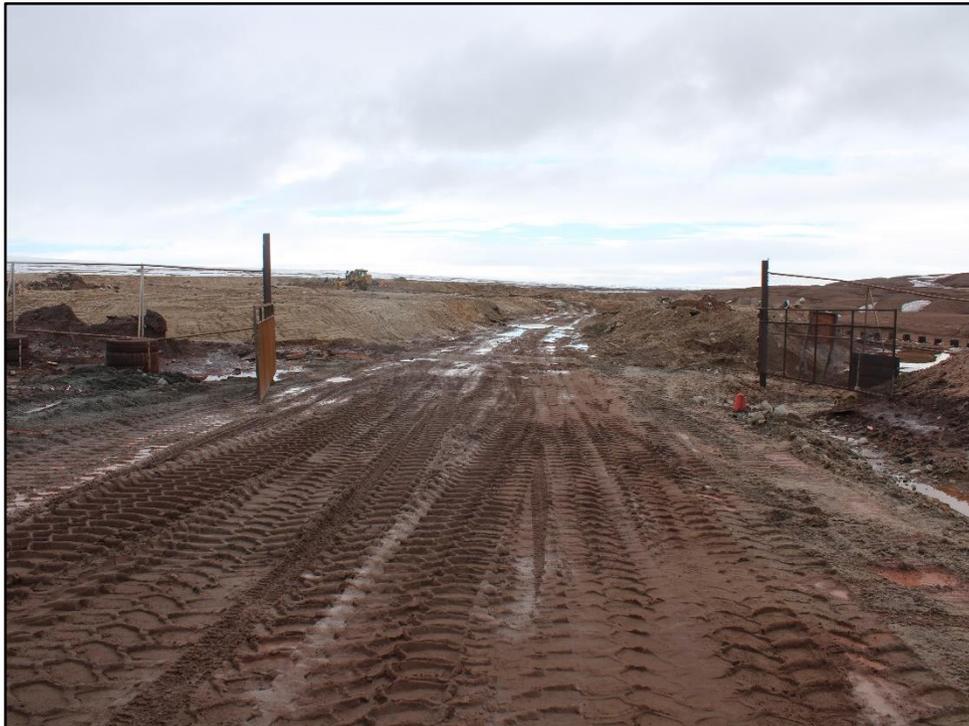
NIRB and Site staff visited the landfill site to view Baffinland's ongoing waste management practices as described in the *Waste Management Plan*. NIRB staff observed that pertaining to Term and Condition 64, Baffinland has maintained the permanent fence around their landfill which can be altered to expand the landfill according to the *Waste Management Plan* as the need arises (Photos 16 & 17). This decreases the risk for waste to be dispersed across the tundra and limits access of animals to the landfill. NIRB staff were satisfied with the status of the fence at the landfill and provided feedback on this progress during the close-out meeting on June 16, 2022.

Photo 16: Fence at Mary River Landfill.

Photo 17: Gate at Mary River Landfill.

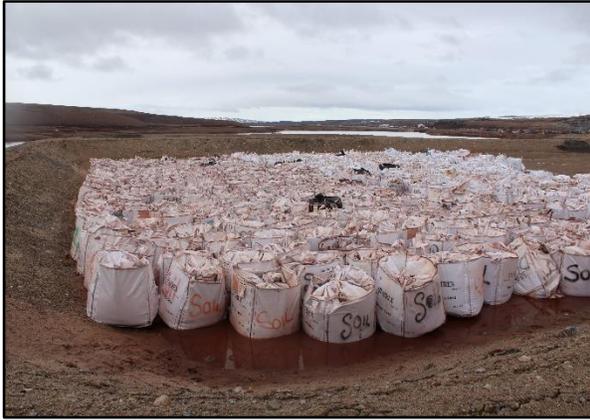
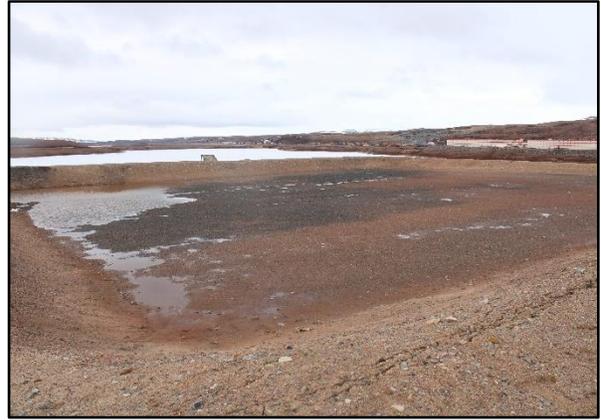
NIRB staff also viewed the landfarm (Photos 18 & 19) which had been discussed with Board staff in February 2020 and was constructed in accordance with plans submitted to the Nunavut Water Board. Baffinland currently has soil and material stored in Cell 1 of the landfill; however, this material remains in quadrex bags until the landfarm becomes fully operational.

Photo 18: Cell 1 of Mary River Landfarm.

Photo 19: Cell 2 of Mary River Landfarm.

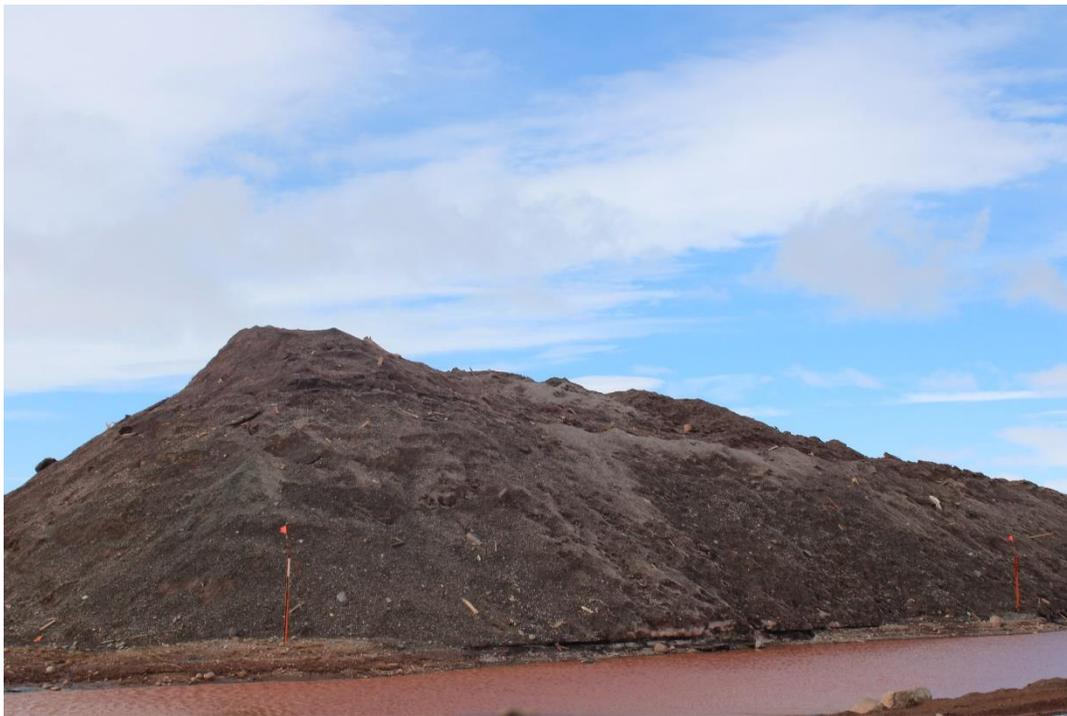
As part of Baffinland snow management, Monitoring Officers noticed piles of snow (Photo 20) which melt during summer months. Most of the piles have some waste mixed with it but NIRB Staff were informed that Baffinland employees have a weekly clean-up around the pile.

Photo 20: Snow Pile Near Weatherhaven Camp

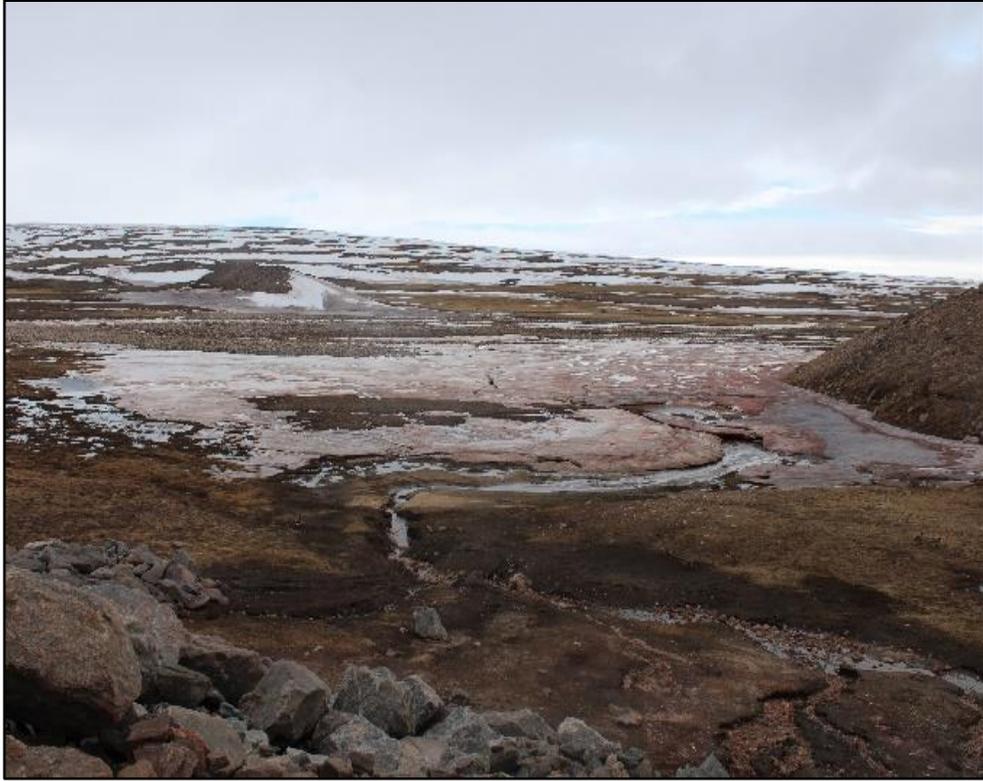
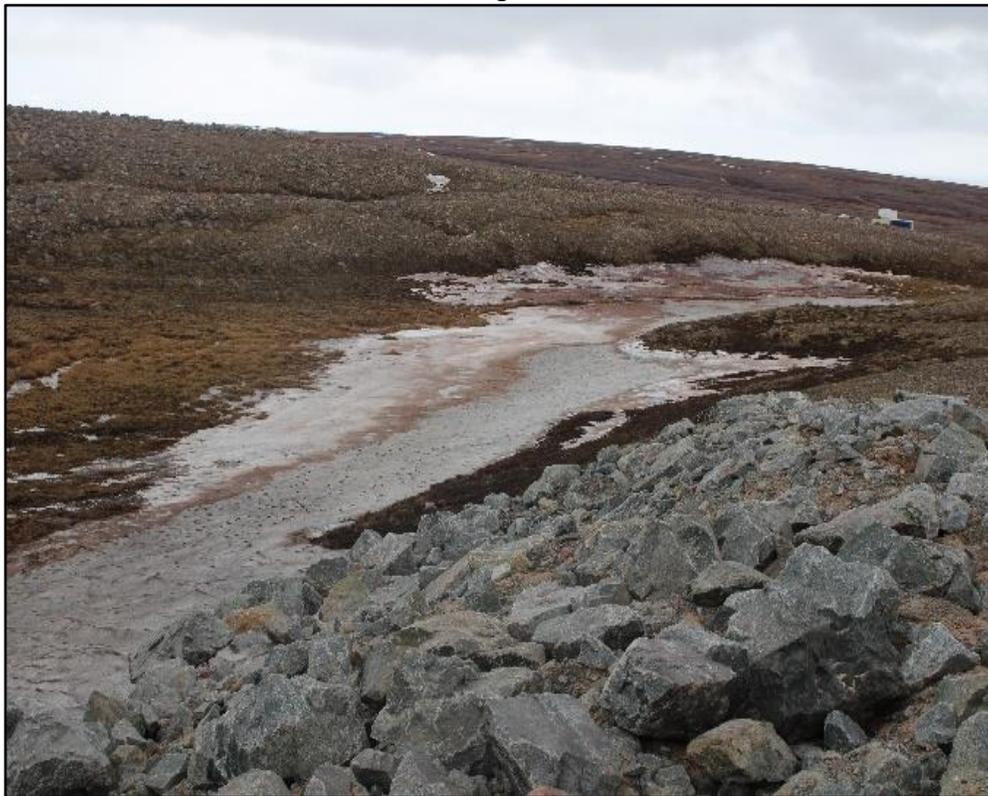
During the NIRB's June 2022 site visit, staff visited the sewage outfall area (Photo 25), where treated wastewater from solid and liquid waste is discharged. In past site visits, NIRB staff noted challenges in maintaining the slope due to erosion and permafrost stability, and Baffinland hired consultants to assess slope stability regularly and apply active management of the slope. During this visit, newly installed ripraps appear to be functioning effectively (Photo 26) in maintaining stability of the area.

Photo 25: Sewage Outfall Area.

Photo 26: Slope and Ripraps of Sewage Outfall Area Embankment.

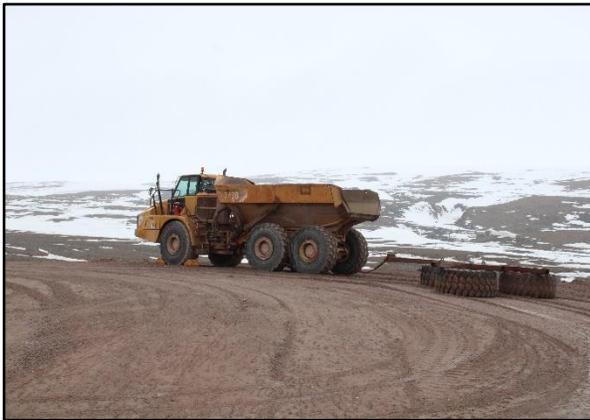
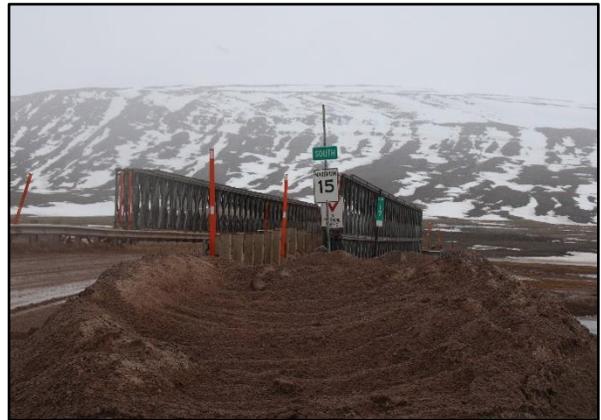
On June 14, 2022, NIRB staff drove along the Tote Road to Milne Port, the day consisted of a steady rain which allowed a firsthand account of the road and water management challenges that Baffinland faces when conditions are wet. During the stops at Milne Port, road conditions became soft, and the road was closed to Ore Haul Trucks due to the excessive weight of these trucks when loaded with ore. The road remained safe and operational for light vehicles (Photo 31); however, conditions were reduced compared to previous site visits. Through discussions with Baffinland staff, NIRB learned that freshet season causes the greatest number of delays and road closures due to the challenges in maintaining the road under wet conditions.

Photo 31: Tote Road Maintenance Activities.

Photo 32: Tote Road Bridge and Resurfacing.

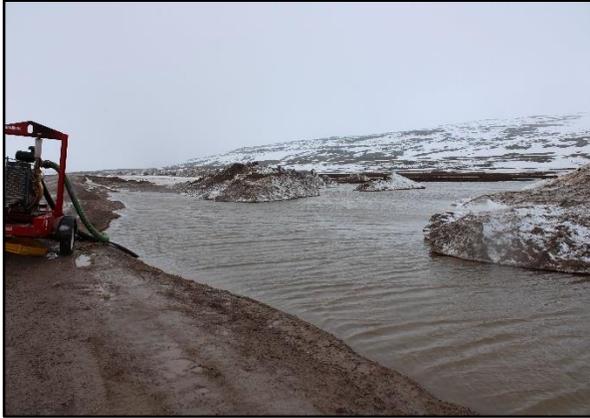
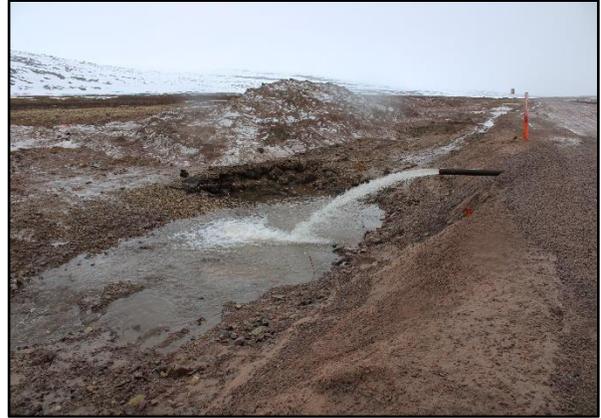
On the return trip, NIRB staff made several stops along the road to observe the condition of emergency shelters (Photo 33), water passage through various culverts (Photos 34 & 35). At culvert CV-059, NIRB staff were able to observe a culvert that was still frozen, blocking the flow of water (Photo 36). As a result, Baffinland staff had installed a temporary diversion to allow water to continue flowing and prevent road washouts (Photo 37). NIRB staff also observed various dust fall stations which were installed at multiple heights (Photo 38 & 39) to reflect discussions from the Terrestrial Environment Working Groups on capturing a better estimate of dust accumulation on ground level.

Photo 36: Culvert CV-059 Along the Tote Road Blocking Water Passage.

Photo 37: Temporary Water Pumping to Continue Flow.

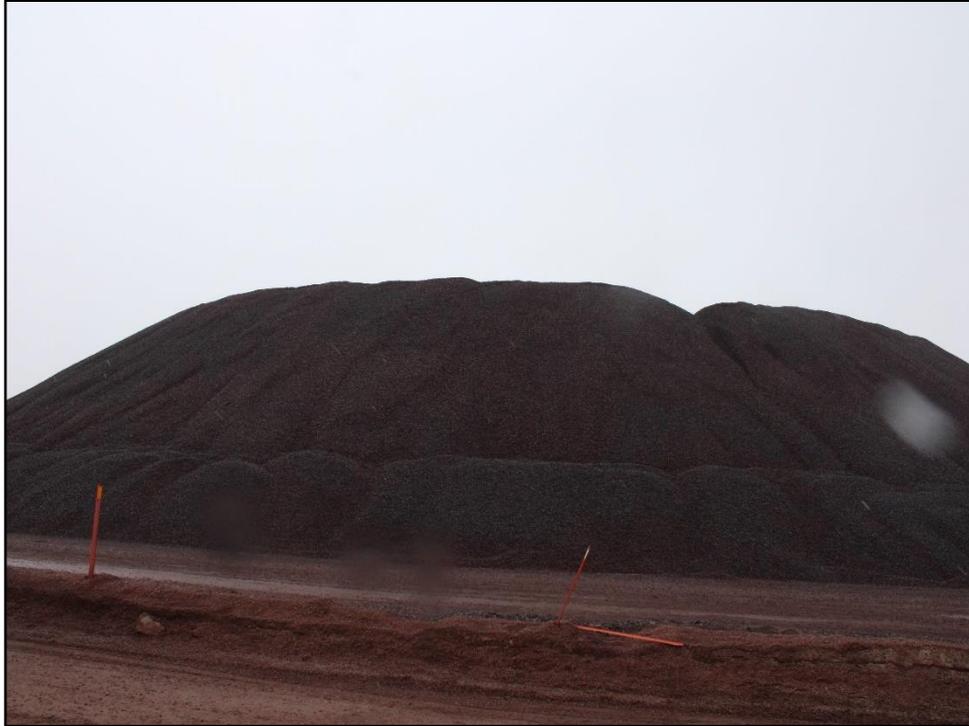
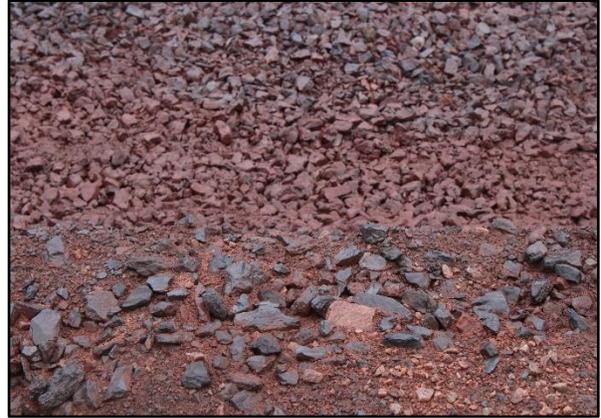
Due to the long-term concern of dust emissions at site, this was discussed with Baffinland staff at the close out meeting. Baffinland confirmed that the dust concerns at site are ongoing and Baffinland is routinely exploring mitigation options to reduce dust production. NIRB staff encouraged Baffinland to focus their mitigation efforts on outstanding areas such as this to minimize the dust emissions into the environment. NIRB staff observed that there is a variation in lump ore being produced (Photo 44).

Photo 41: Ore Stockpile.

Photo 44: Ore Stockpile Lumps Close Up.

At the Ore Stockpile, in the past year, Baffinland has been using *Dust Treat* along the finished faces of the stockpile to help create a crust and stop wind blown dust along the surrounding area. As evidenced in photo 61 and 62, NIRB staff observed dust accumulation along the sea ice near the ore stockpiles and as noted in [section 4.1.2.2](#) of this report, there appears to be continued release of dust while the stockpile is being built using the conveyor. NIRB staff encourage Baffinland to continue exploring mitigation options to reduce dust produced from this source.

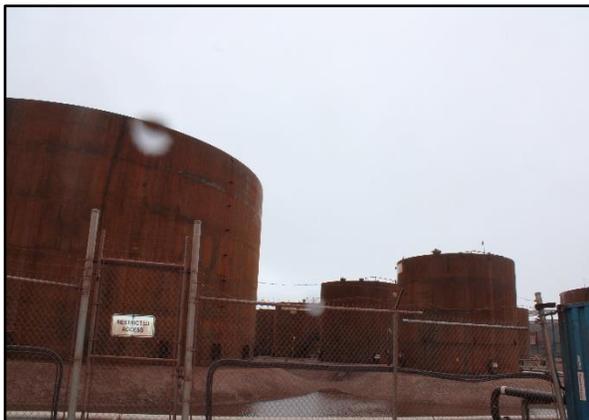
NIRB staff visited the Fuel Tank Farm and noted that the facility appeared to be well maintained and organized (Photo 53); however, there was water ponding in the berm and this is expected during freshet and would be removed once tested. At the same time, the NIRB staff also observed the Hazardous Waste Storage Area (Photo 54). The area is surrounded by a berm, has spill response equipment available and is fully lined in case of any spills. The area is also a fenced and gated to provide control over access to the storage of hazardous waste and to ensure that fluids are stored properly prior to back-hauling.

Photo 53: Milne Port Fuel Tank Farm.

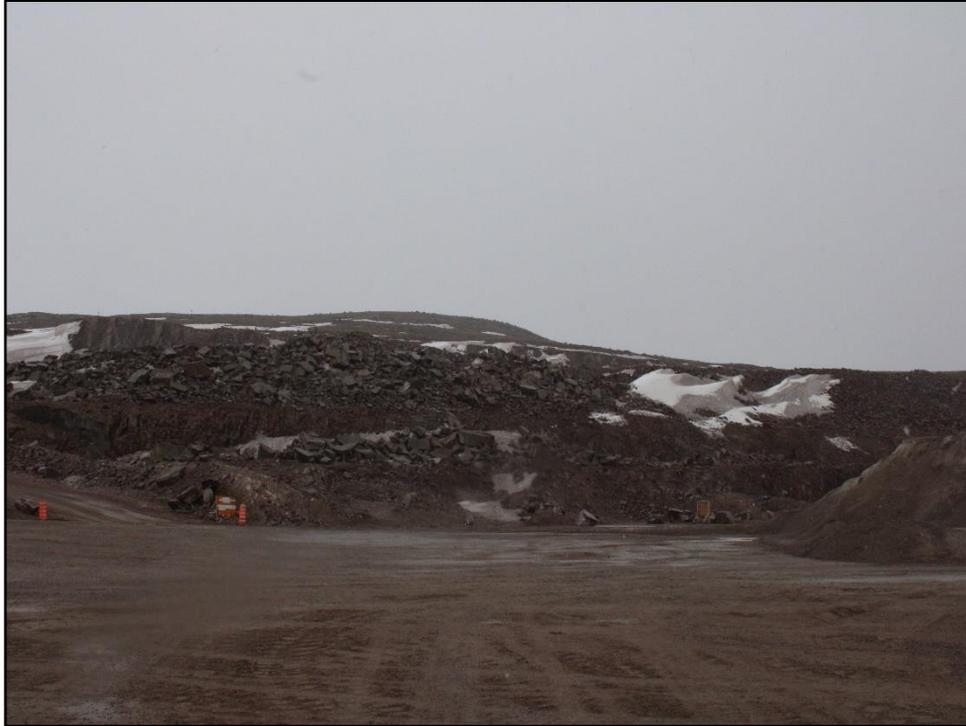
In order to observe the Proponents compliance with Term and Condition 30 of the NIRB's Project Certificate No. 005, NIRB staff visited the quarry at Milne Port (Photo 60). There were no issues of note as they were ramping up for summer use and the equipment had not been fully commissioned for 2022. NIRB staff will observe the area during the summer 2022 site visit.

Photo 60: Milne Port Quarry Site.

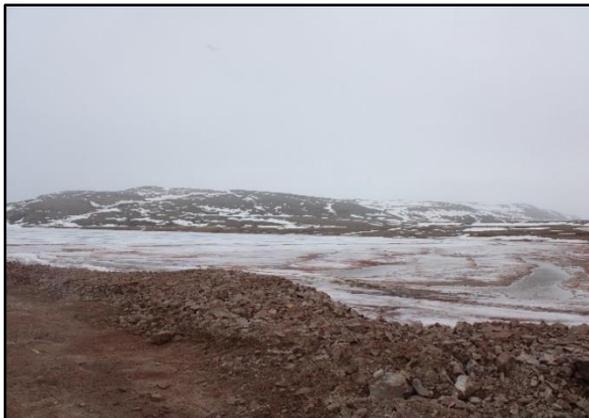
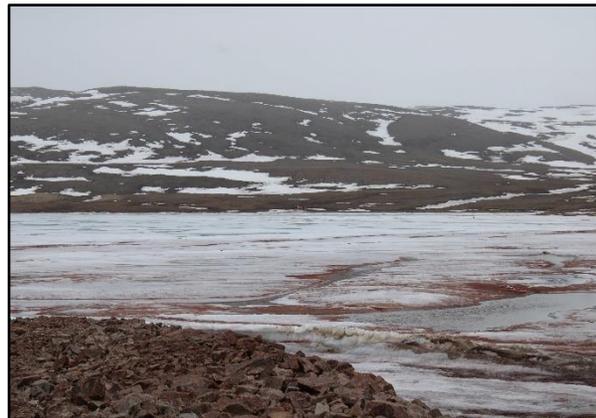
Photo 61: Dust Collecting on Milne Port Sea Ice
(Broad View)

Photo 62: Dust Collecting on Milne Port Sea Ice
(Close-up View)
