Report title: August 2022 Site Visit Report for the Nunavut Impact Review Board's Monitoring of Baffinland Iron Mines Corporation's Mary River Project (NIRB File No. 08MN053).

Project: Mary River Project
Project Location: Qikiqtani (North Baffin) Region, Nunavut

Site visit dates: August 23-25, 2022

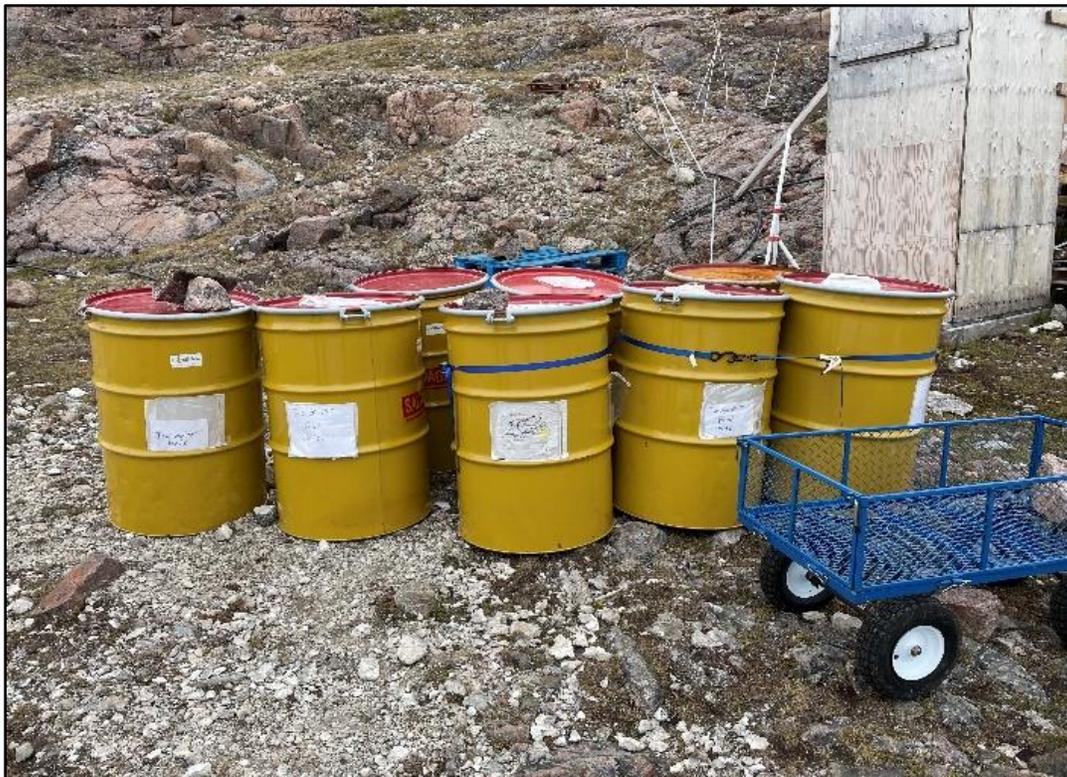
As part of the narwhal monitoring program and related to Term and Condition No. 110, NIRB staff visited the Bruce Head camp (Photo 5 & Photo 6), located nine (9) km north of Milne Port. Baffinland informed NIRB staff that the 28-day program just finished a few days ago, so the Monitoring Officers were unable to take photos of the team at camp and/or observing. Although, NIRB staff were able to see closure of the camp where all waste was stored in barrel (Photo 7) waiting to be transported and disposed at main camp.

Photo 7: Waste Barrels Waiting to be Transported

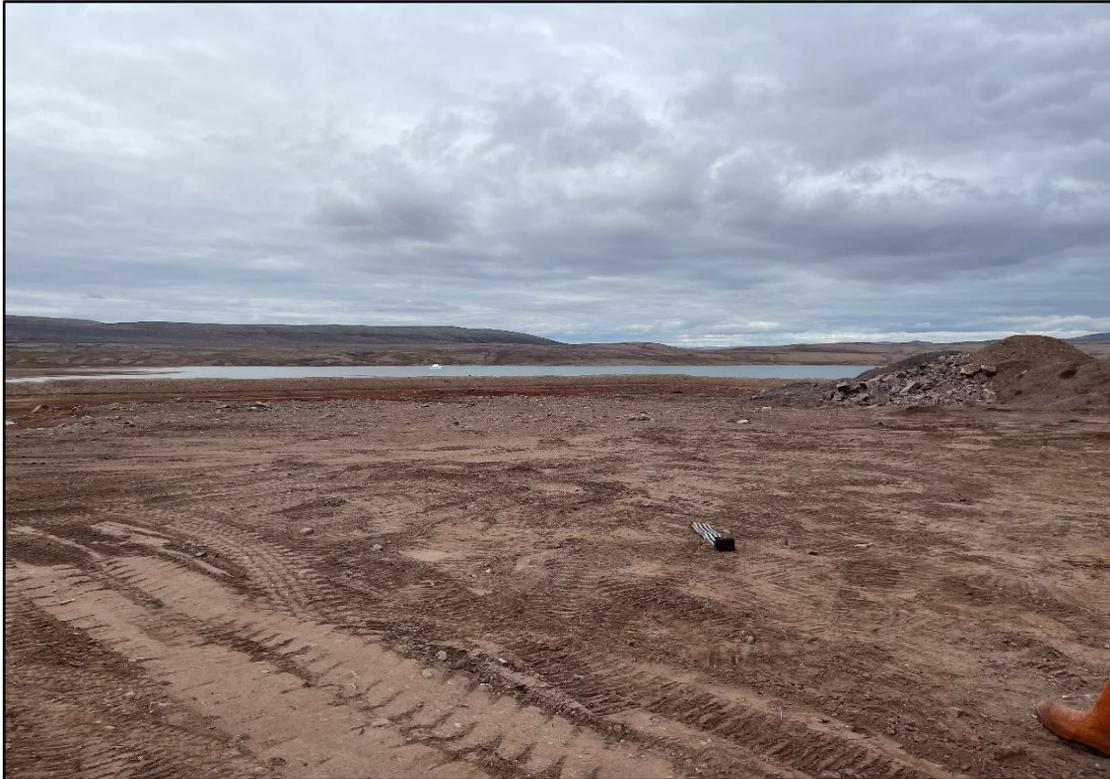
NIRB staff visited the landfarm facility where all contaminated soil and snow is stored and disposed of (Photo 8). As noted in the past, Baffinland stated NIRB staff that the current facility is not operating and has contracted a consultant to review the landfarm and improve the functionality of the area. Monitoring Officers will follow-up during 2023 site visits to observe progress.

Photo 8: Landfarm at Milne Port

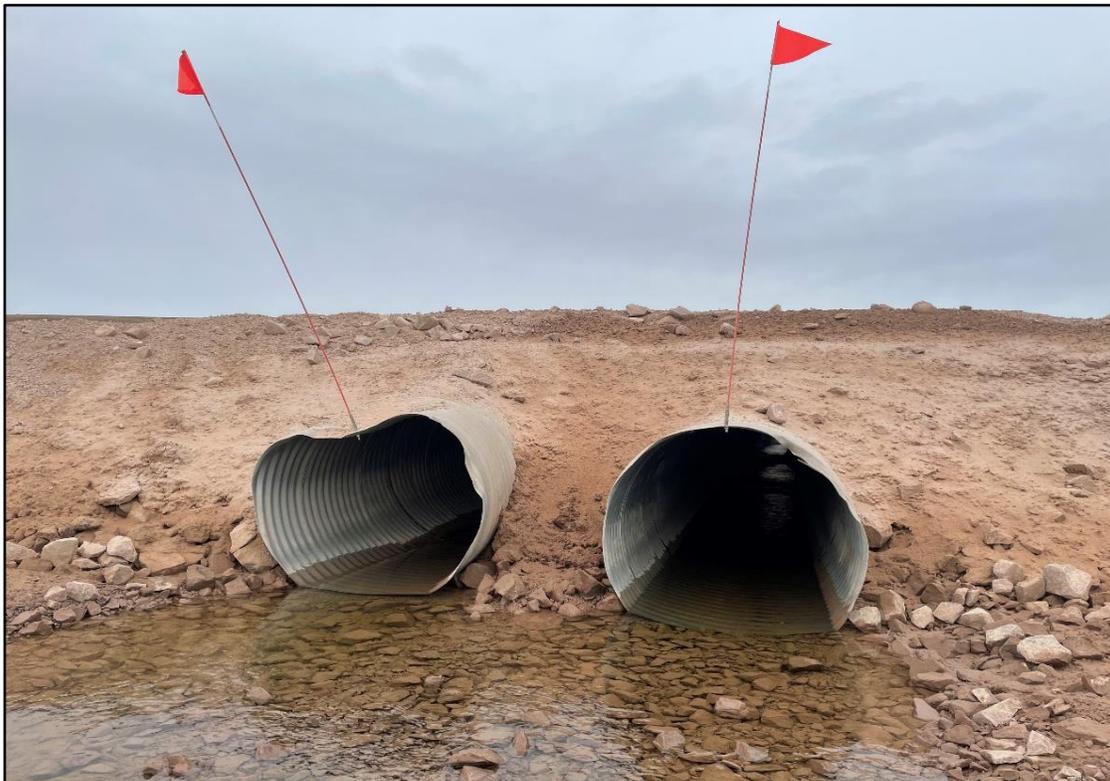
Along the Tote Road, the Project Certificate states through T&C No. 19 that Baffinland is required to maintain fish passage through water crossings. To follow up on the previous site visit in June, the Monitoring Officers returned to culverts previously visited. At culvert CV-104 at KM34 (Photo 17), no issue was noted. In June, the culvert at KM 59.5 (Photo 18) appeared to have blockage and flooding issues. When visited in August, Baffinland had repaired the culvert and there was flow of water again. Baffinland also informed the NIRB that it is working with DFO to further repair damaged culverts noted through DFO's site visits. The culvert BG-29 (Photo 19) is also under review to be repaired. Baffinland committed to following up on the issue in writing and the Monitoring Officers will follow-up in future site visits.

Photo 17: Culvert CV-104 Located at KM34

2	Tote Road	Culvert maintenance and repair plan update.	NIRB requested a timeline/plan regarding when repairs will be made to culverts along the Tote Road.	Baffinland is finalizing a crossing remediation plan for submission to DFO as a requirement of relevant authorizations and the Fisheries Act. The remediation plan will include the methods and timelines to complete work on specified culverts. The details of this plan and work to date will be included in our regular annual reporting cycle.

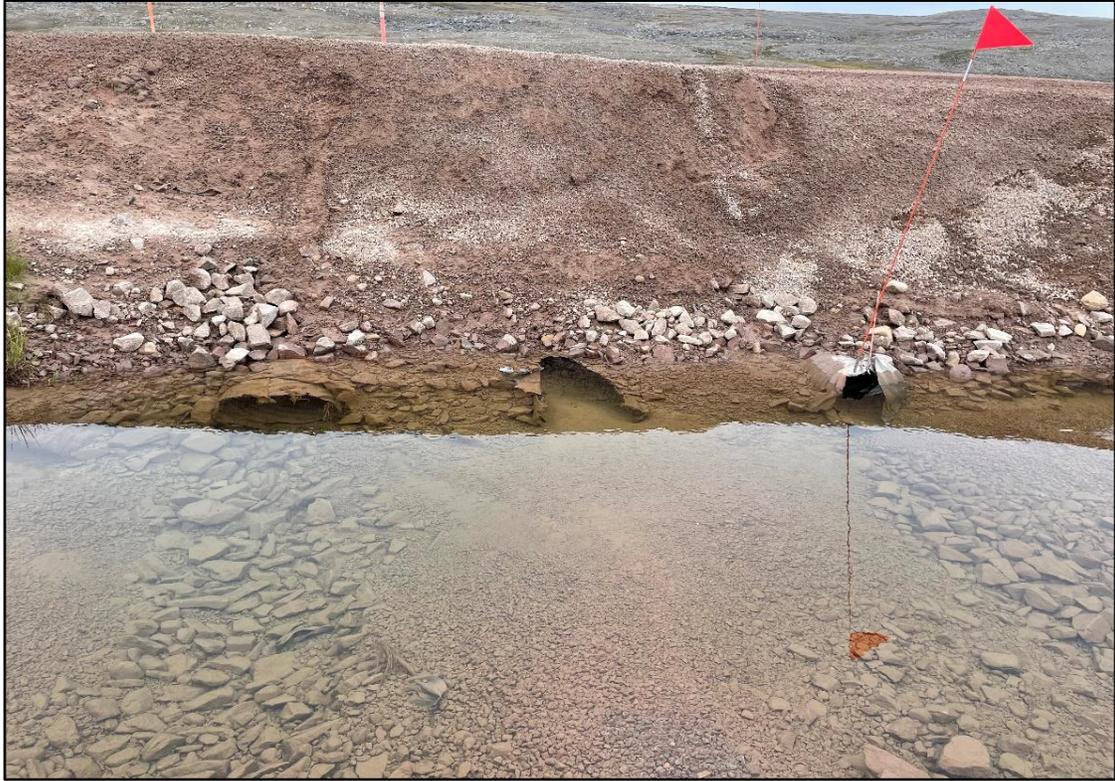
Photo 18: Culvert CV-059 Located at KM59.5

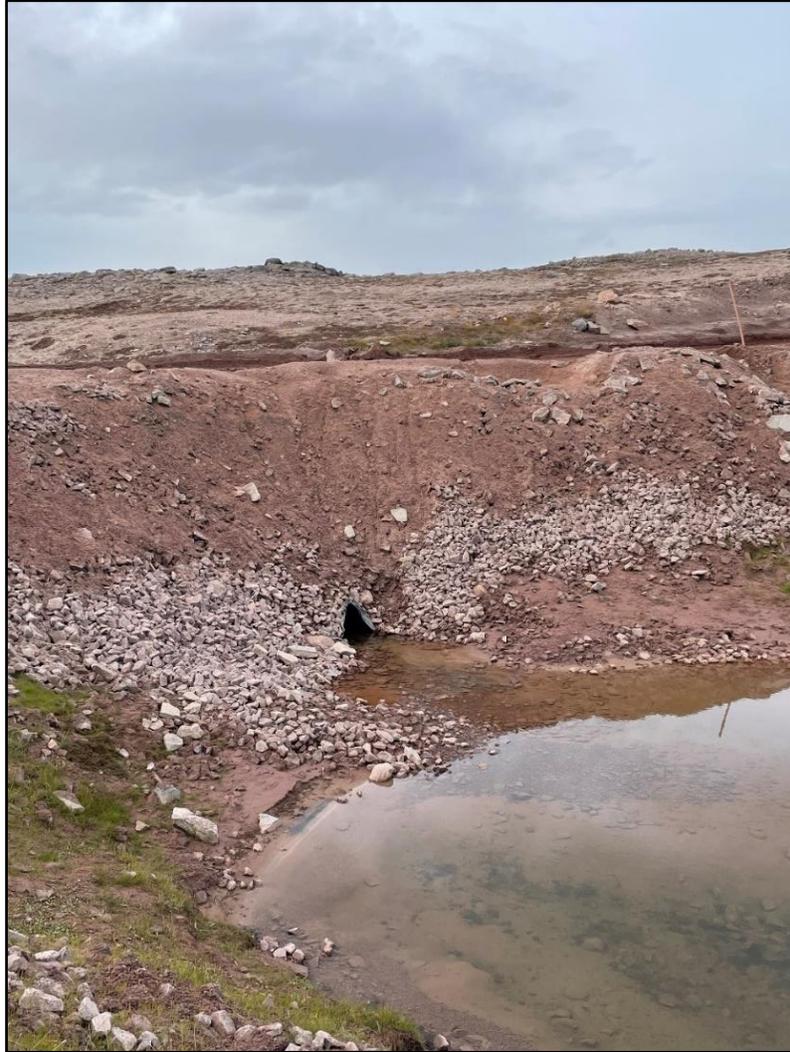
Photo 19: Culvert BG-29 Located at KM84.5

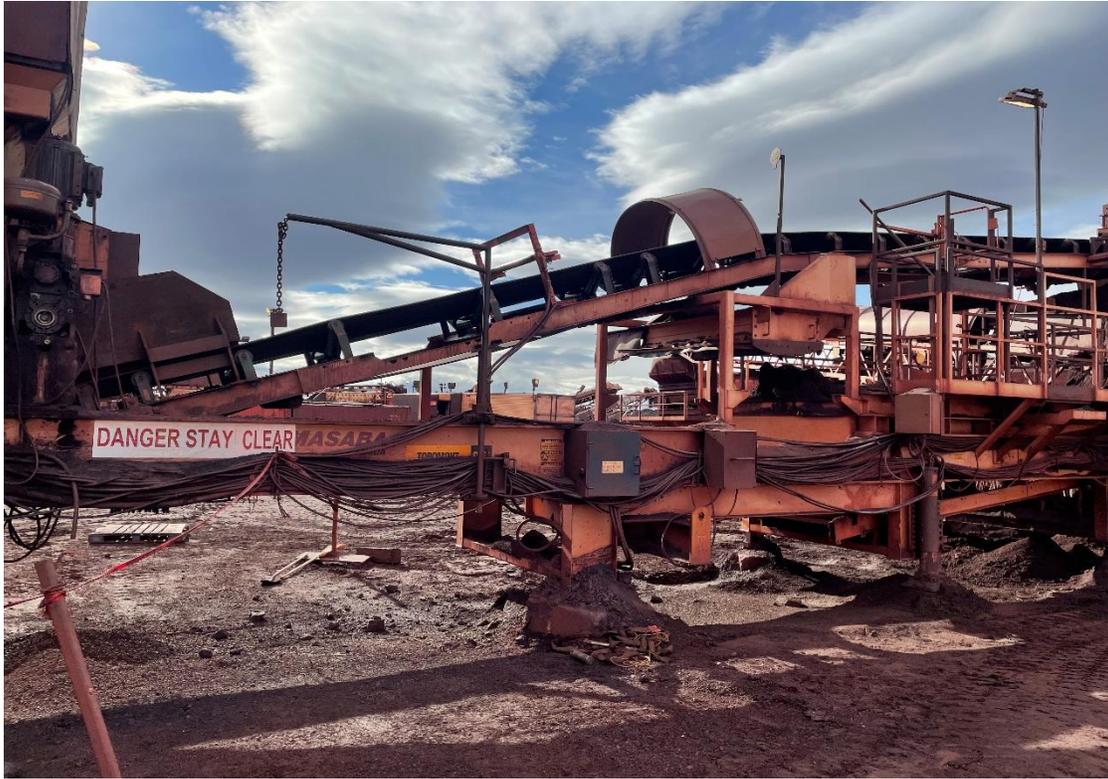
NIRB staff viewed the crusher facility (Photo 29, Photo 30 & Photo 31) by foot. The Monitoring Officers observed the continued dust mitigation applied by Baffinland. On all three (3) crushers facilities hoods, shrouds, and bellows are installed to reduce dust emissions. Baffinland staff also noted the continued maintenance on the crusher equipment generally as well as on the hoods and shrouds. Baffinland stated that due to the need for dust mitigations on the crusher equipment, many of the mitigation designs implemented are constructed on site by repurposing old conveyor belts and other pieces of metal on site.

Photo 31: Conveyor Under Maintenance

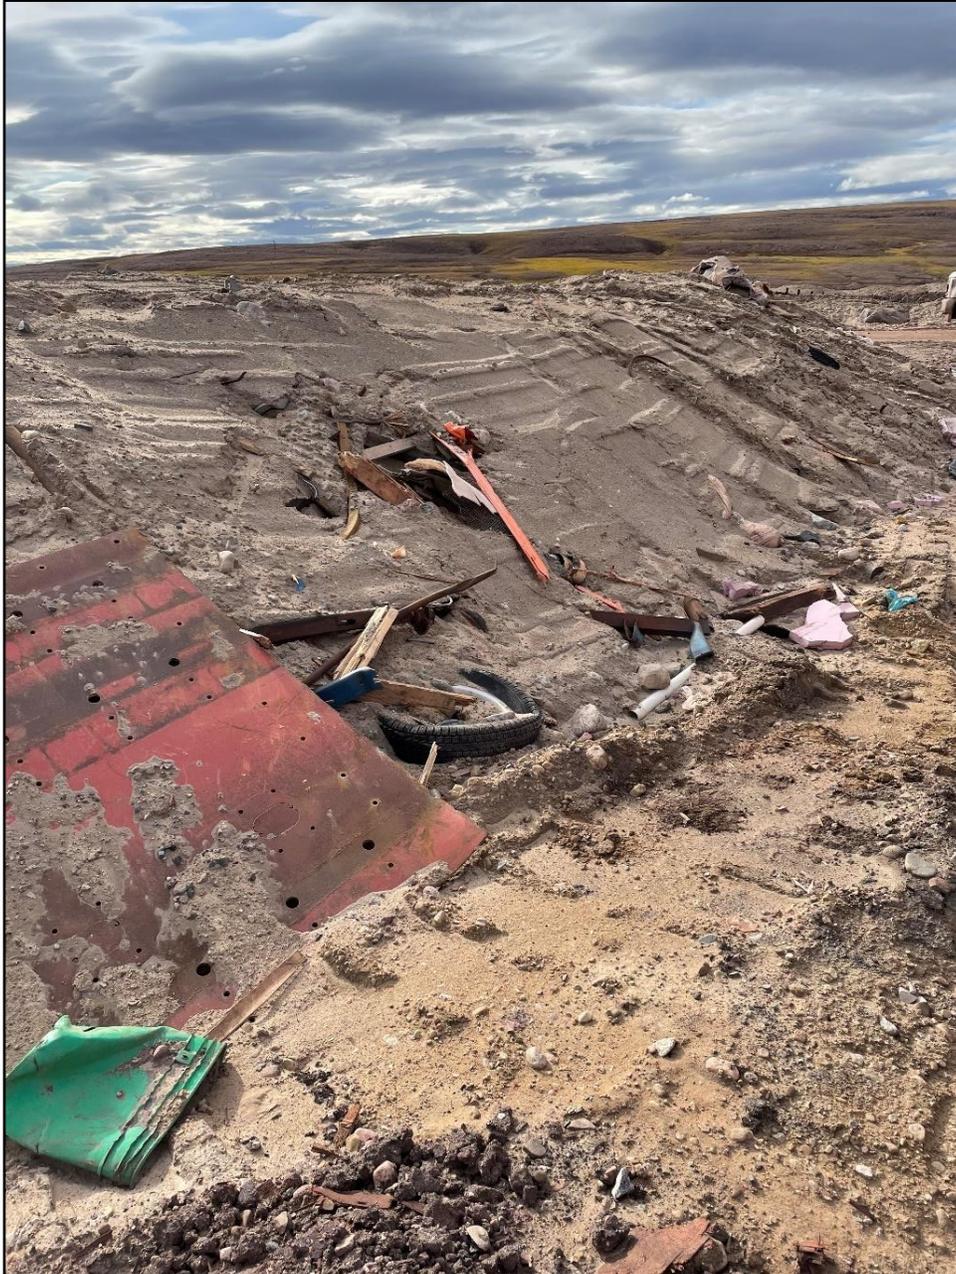
NIRB visited the landfill site to view Baffinland’s ongoing waste management practices as described in the *Waste Management Plan*. NIRB staff observed some tires which are not supposed to be disposed in the landfill ([Photo 32](#) & [Photo 33](#)), this issue was discussed with Baffinland staff at the close out meeting and Baffinland indicated they would review the site and remove any debris not approved for disposal. Fencing around the landfill is well maintained ([Photo 33](#)) as a measure to prevent human-carnivore interactions as required by Term and Condition No. 64.

Photo 32: Buried Tire in the Landfill

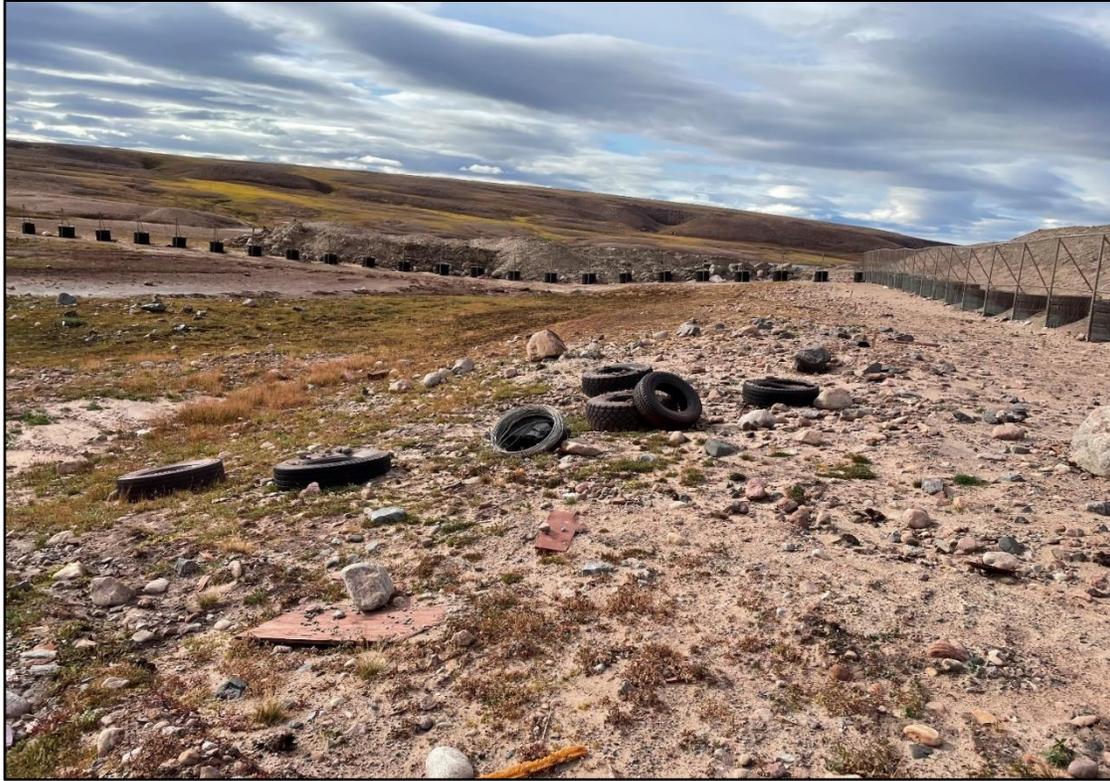
Photo 33: Disposed Tires and Fencing Around the Landfill

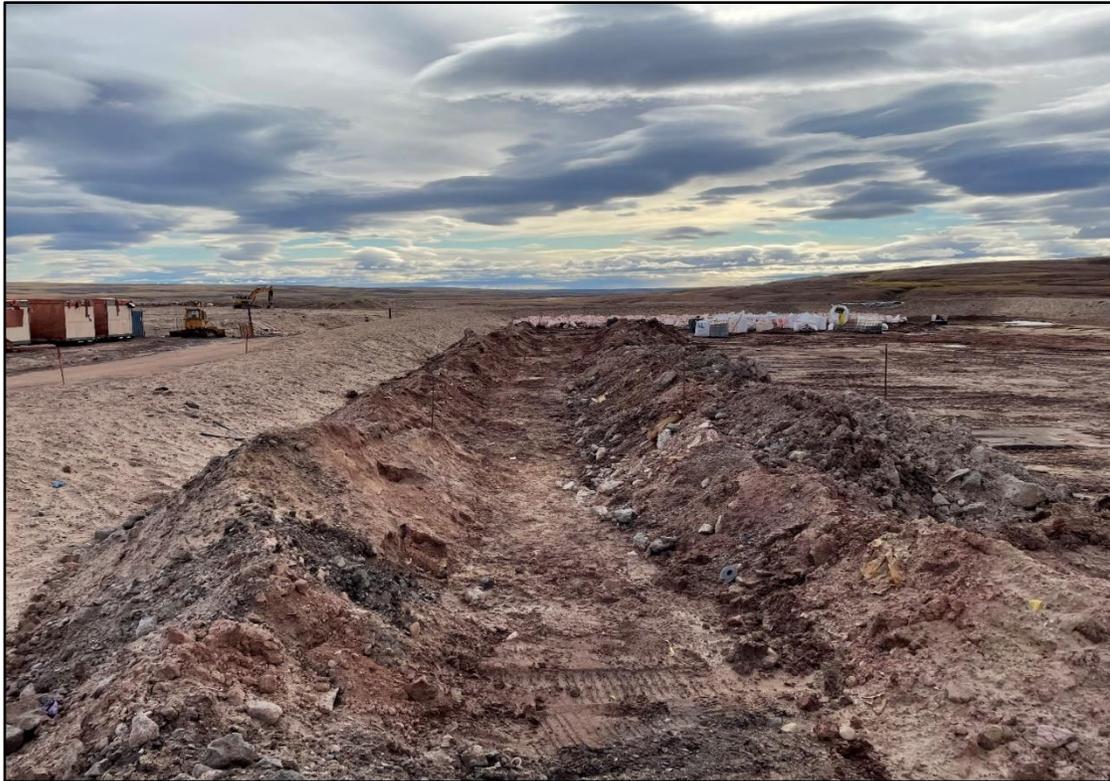
Next to the landfill is the landfarm ([Photo 34](#)) where Baffinland disposed all its contaminated soil and snow from the Mine site. NIRB monitoring officers observed piles of soil which is turned during summer months until contaminants reached an acceptable level for the soil to be disposed in the landfill. Baffinland noted the expected improvements with this landfarm when compared to the one at Milne Port indicating that because this one was new, they would be able to implement the required changes to operation from the beginning rather than after large amounts of contaminated soil had been stored in the landfarm.

Photo 34: Row of Contaminated Soil

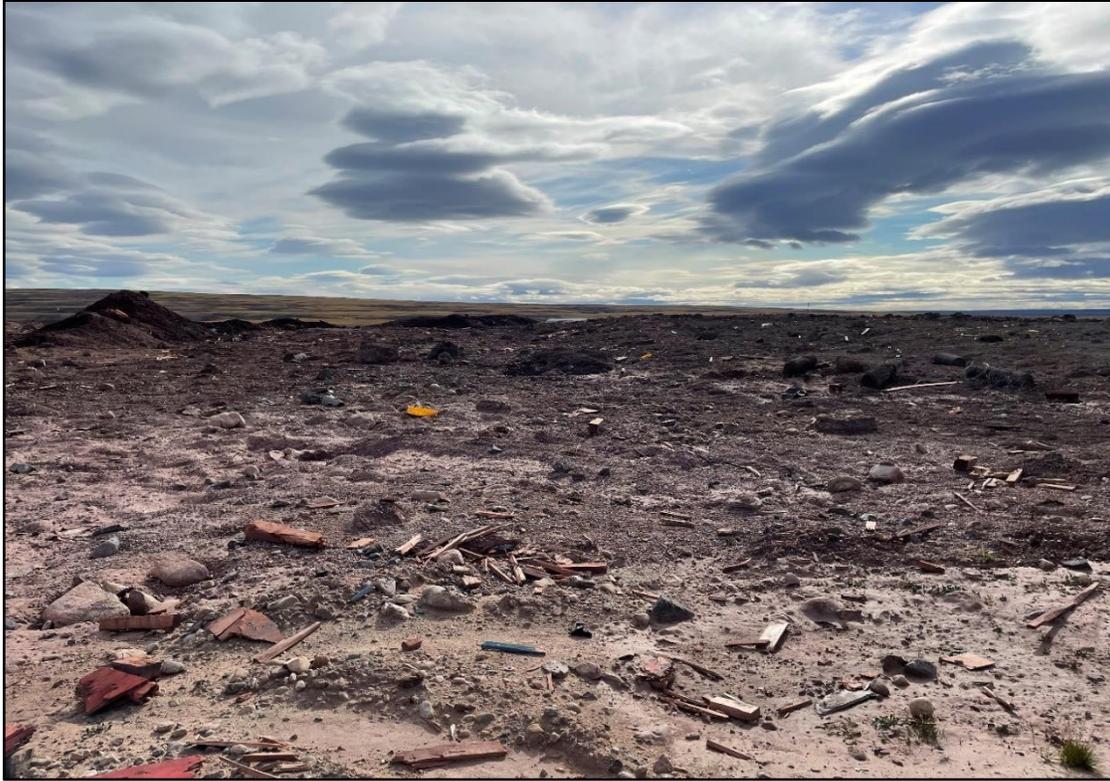
On the road towards the landfill, NIRB staff observed a lot of waste ([Photo 35](#)) in locations where snow was consistently piled through the winter months. As part of Baffinland's *Snow Management Plan*, Baffinland is supposed to clean the area on a regular basis as the snow melts. This concern was discussed with Baffinland, who noted that a clean-up will occur in the following days.

Photo 35: Garbage from Snow Pile

4. As described in Baffinland's *Annual Report* Term and Condition No. 17, on some occasions the Total Suspended Solids was above the discharge criteria. NIRB requested further information on the possible causes of these exceedances.
5. NIRB noted that tires observed within the landfill should be disposed of appropriately ([section 4.1.3.5](#)).
6. NIRB noted to Baffinland that the waste from the snow pile should be cleaned before the next snow ([section 4.1.3.6](#)).

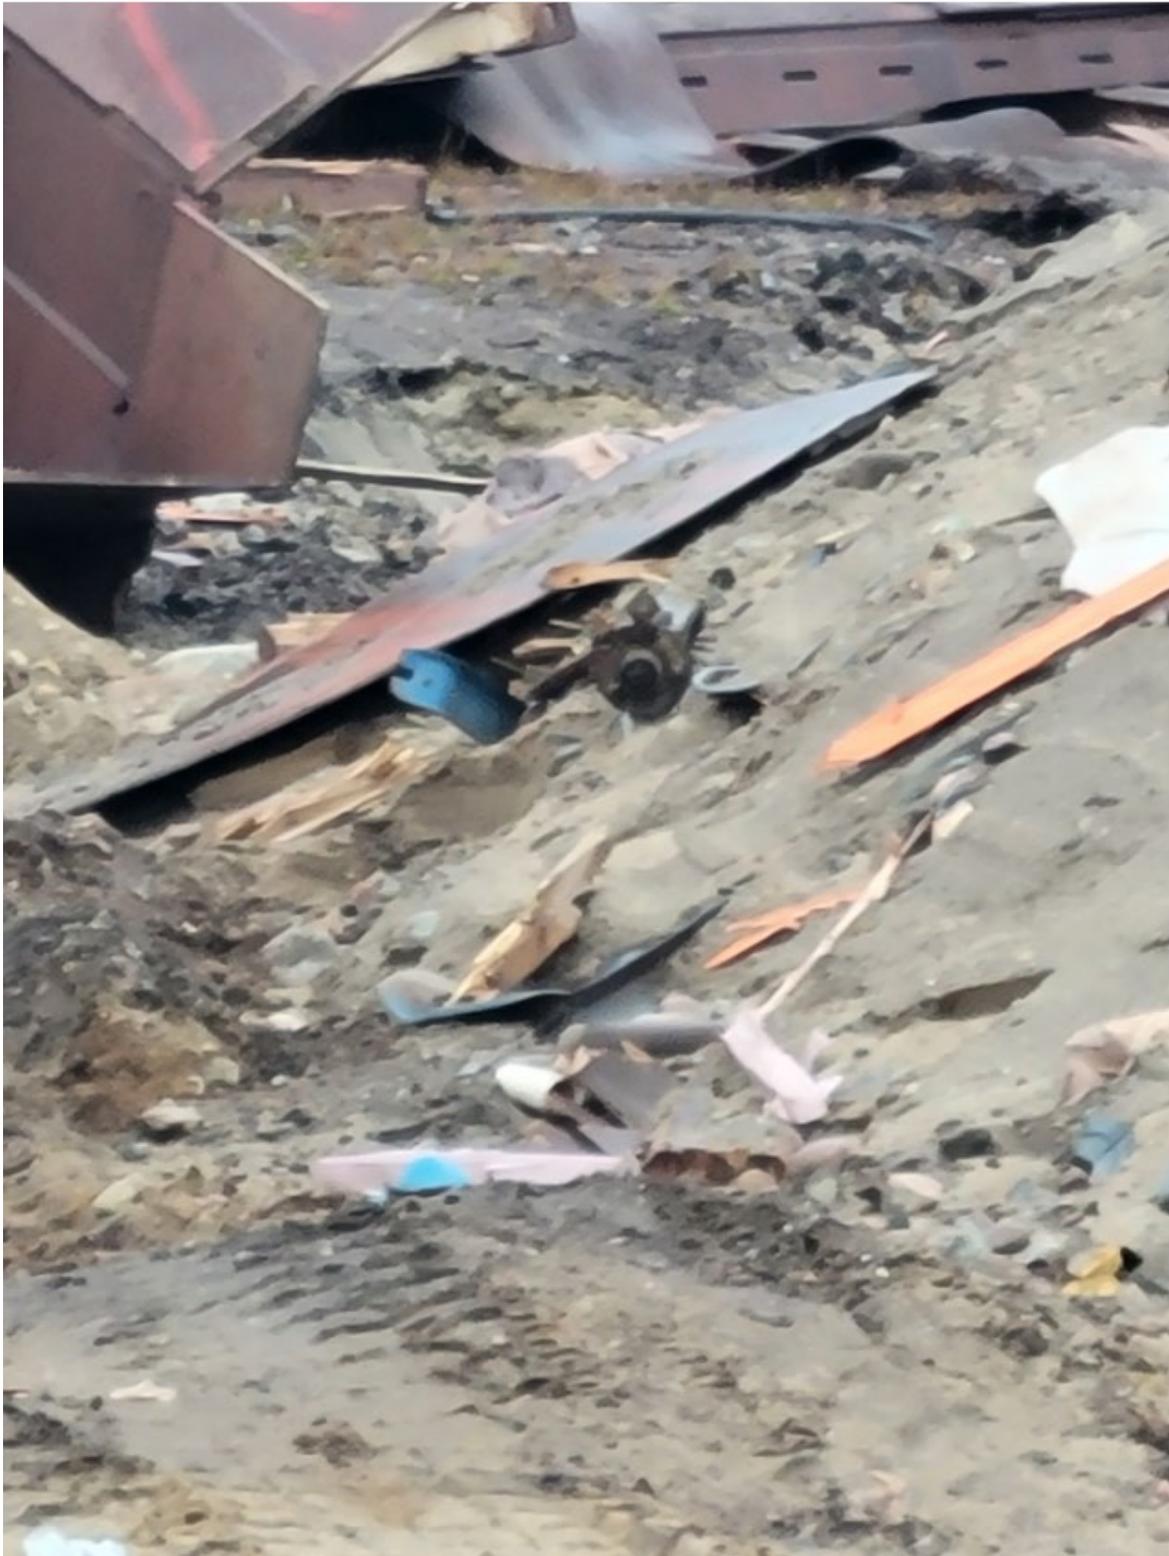
Figure 1. Photo of Landfill area following tire removal

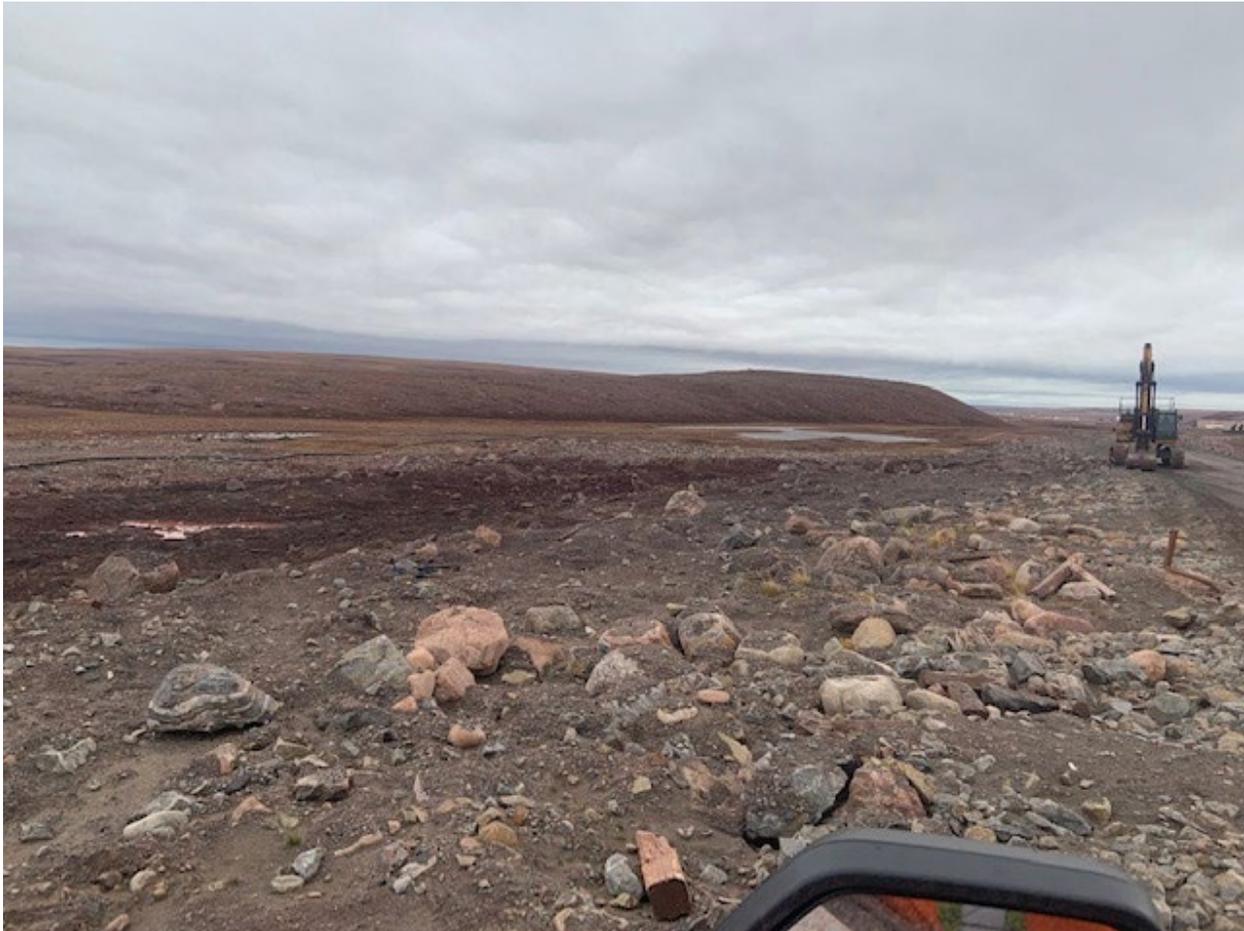
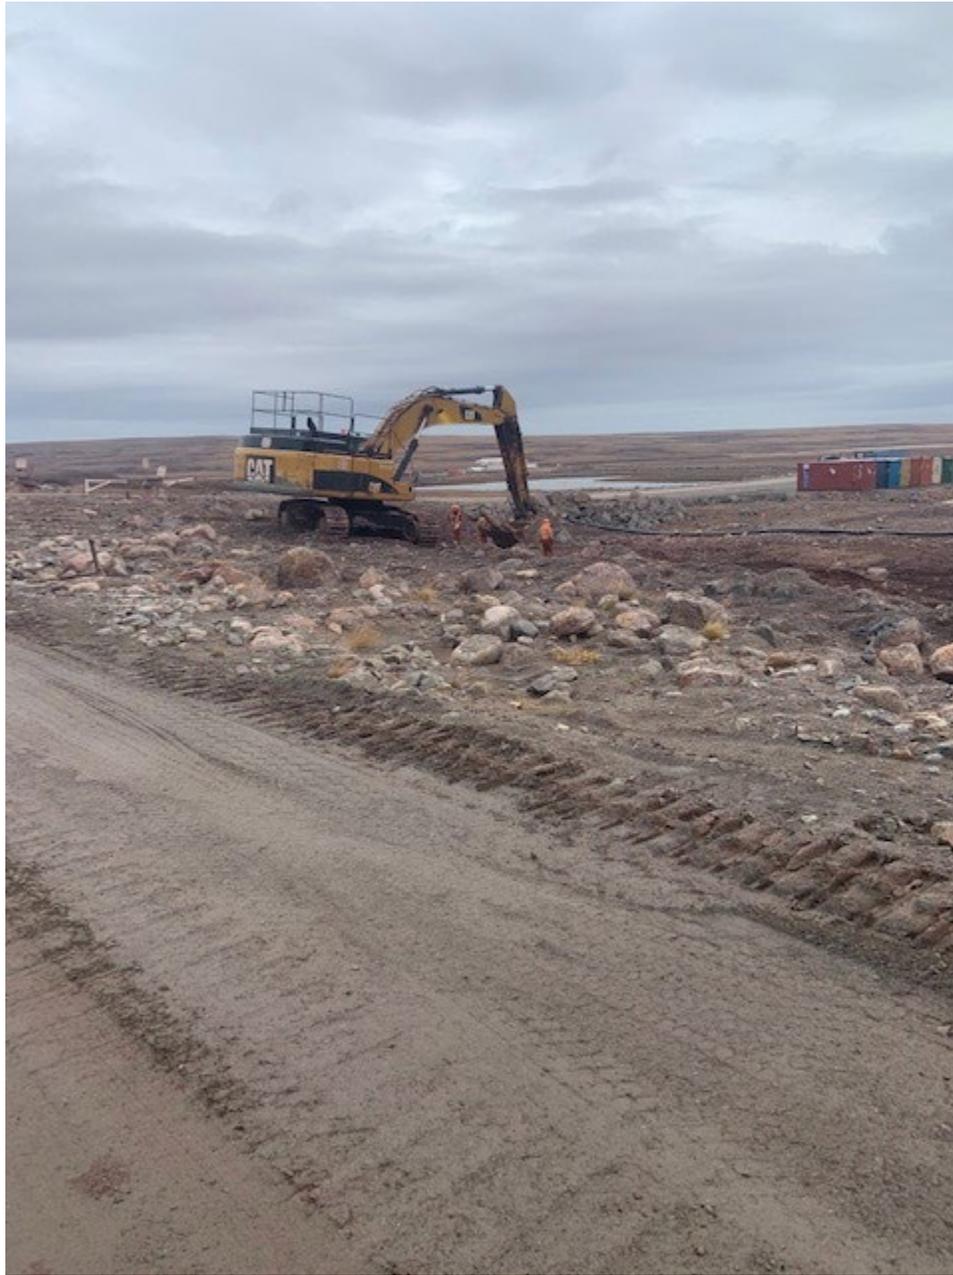
Figure 2. Photo of Snow Dump Area by Dyno – Debris removal ongoing

Figure 3. Photo of Snow Dump Area by Dyno – Debris removal ongoing

Cmt. #	Project Location	Topic	Additional Information	BIM Response
				Additional water sampling conducted for acute toxicity on May 22 at CLT-OUT and SDLT-OUT and June 7th at LDFG-OUT and CLSP-OUT LDFG locations indicated the samples collected were not acutely toxic.
5	Mary River Landfill	Waste Management at the landfill	Presence of partially buried tires in the landfill Action – tires to be removed and an audit of other non-compliant items to be removed.	The area where the tires were found was scanned and the tires removed from the landfill. See Photo 1
6	Mary River Dyno Snow Stockpile	Waste Management at the Dyno Snow Stockpile	Waste and Debris from melting snow stockpile near Dyno.	A combination of excavator and hand-picking was employed once the ground surface was safe for foot access, and all debris from both Dyno snow stockpiles was removed. See Photos 2-4 for after photos.

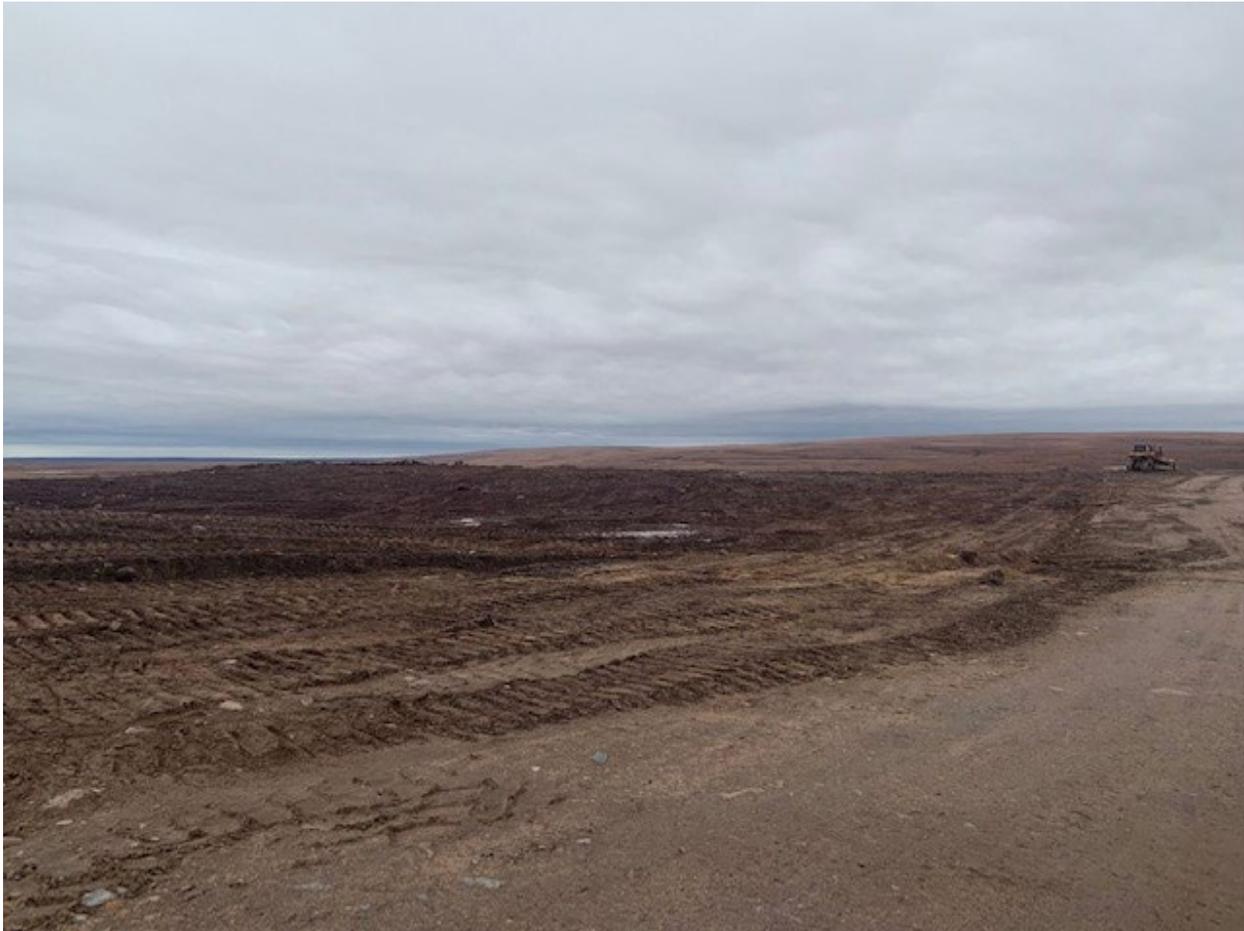
Figure 4. Photo of Snow Dump Area by Dyno – all debris removed
