**RE: 2017 Annual Report for NIRB File No. 17UN025 –Iqaluit Metal Dump**

**Former Iqaluit Metal Dump and Community Landfill –  
Nunavut Impact Review Board (NIRB) 2017 Annual –  
NIRB File No.: 17UN025**

2017 Site Remediation Summary Report – Former Iqaluit Metal Dump and Community Landfill, Iqaluit NU

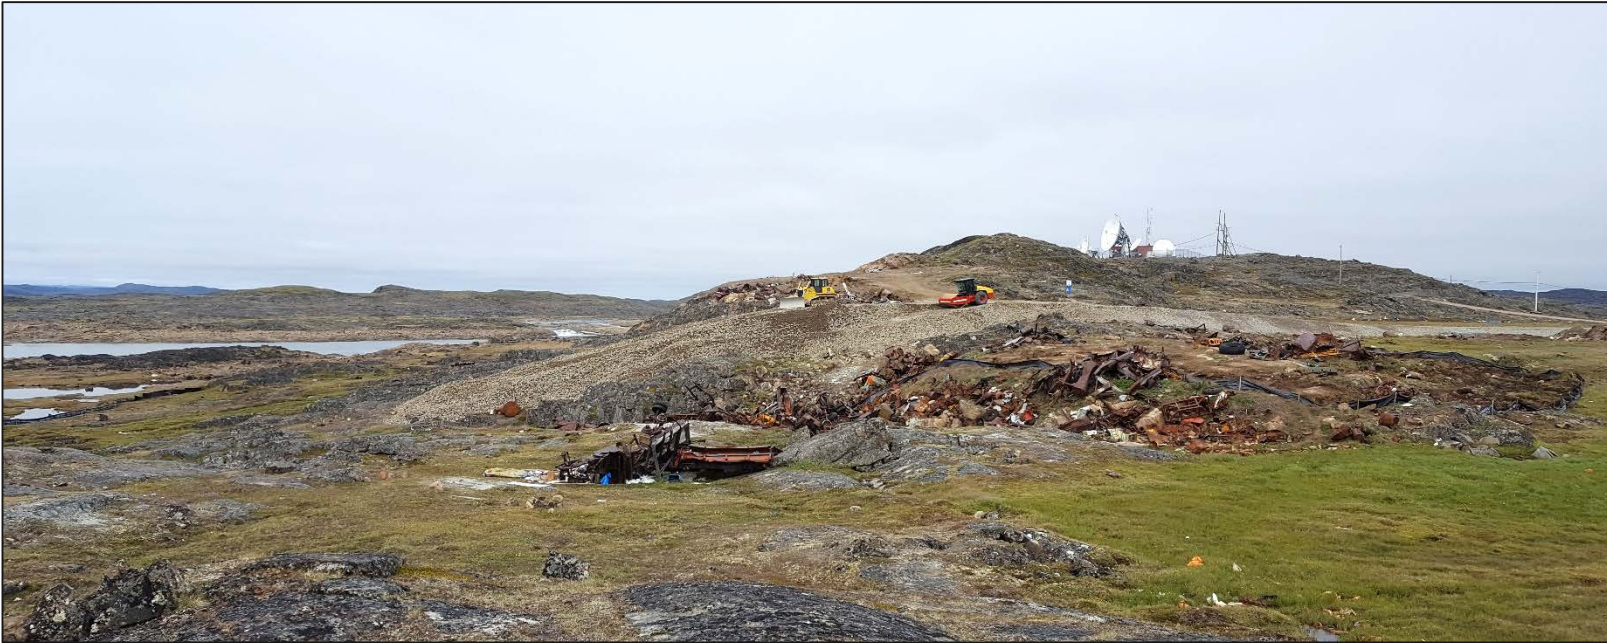
**Photo: 1**  
31 July 2017

Overview of  
southeast of Main  
Landfill prior to  
remediation  
operations

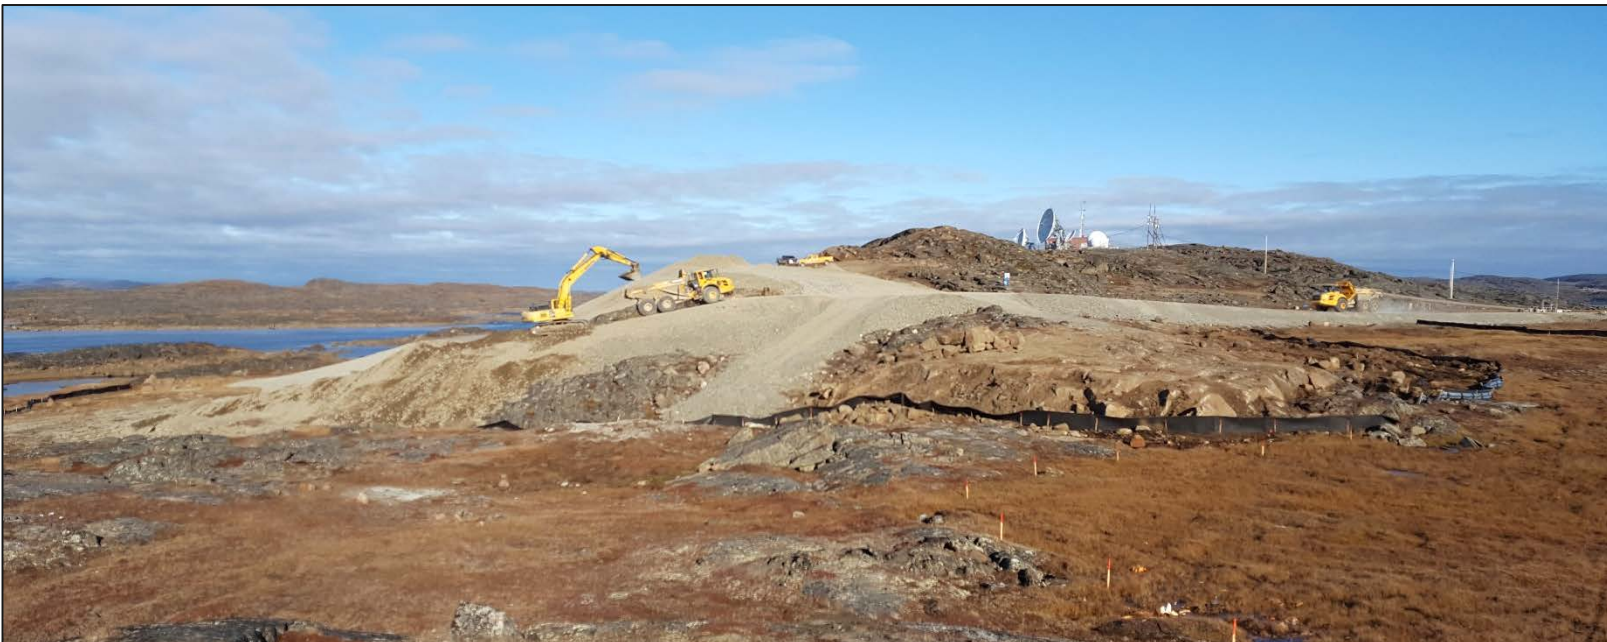
**Photo: 2**  
23 September 2017

Overview of  
southeast of Main  
Landfill, final filling  
and grading  
operations

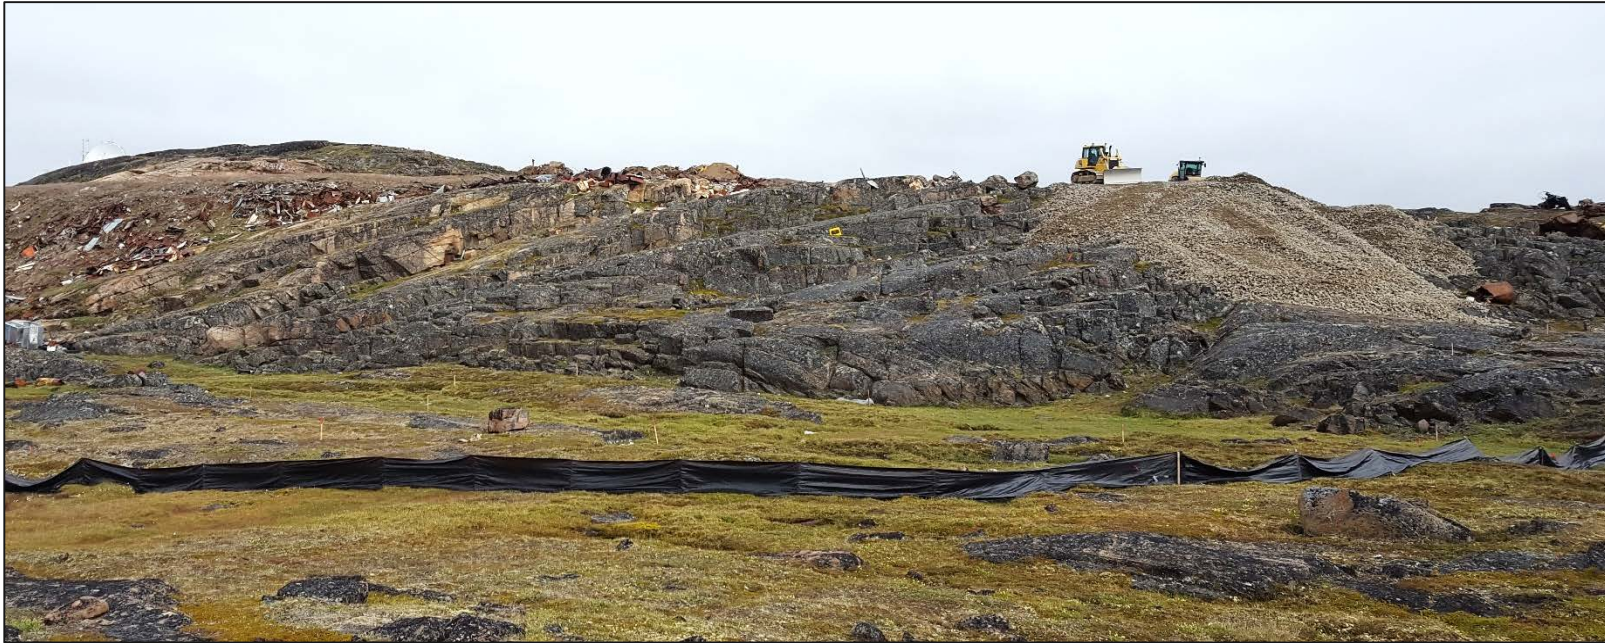
**Photo: 1**  
31 July 2017

Overview of  
southwest of Main  
Landfill prior to  
remediation  
operations

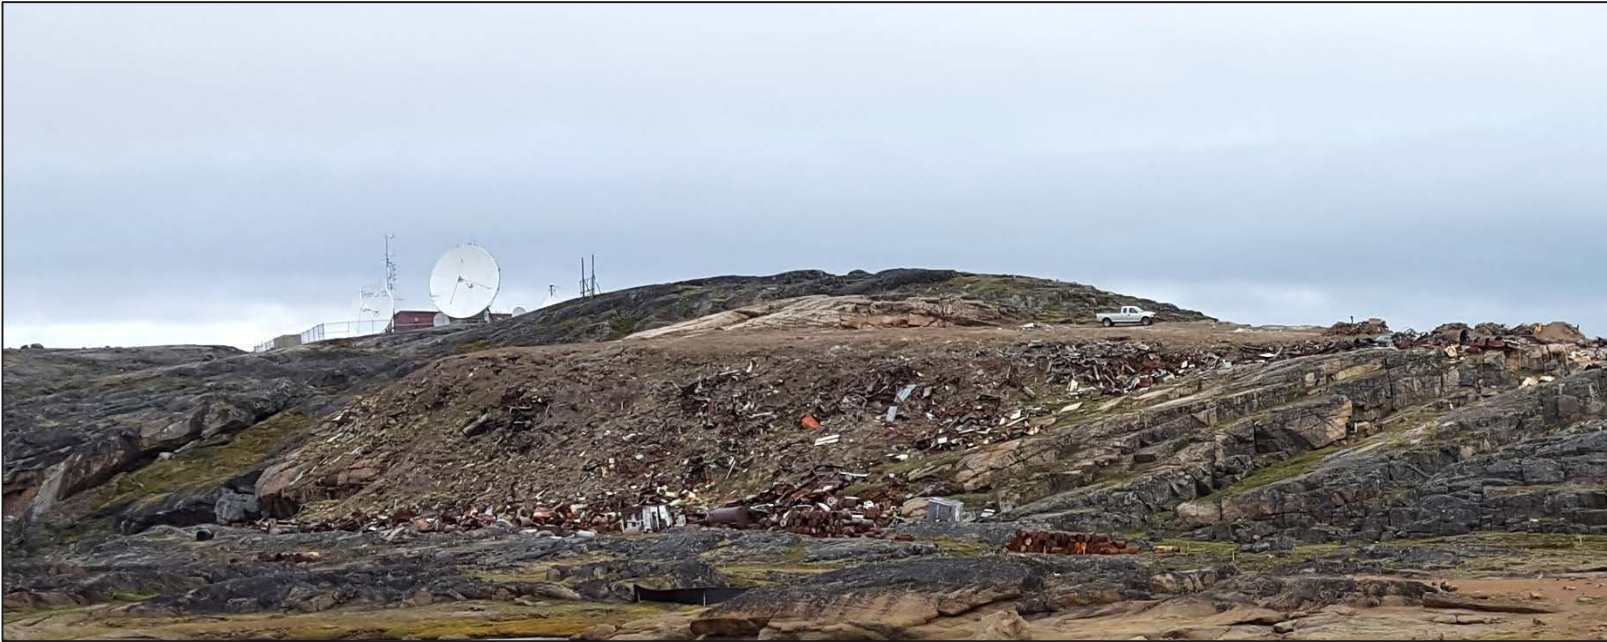
**Photo: 1**  
31 July 2017

Overview of west of  
Main Landfill  
prior to  
remediation  
operations

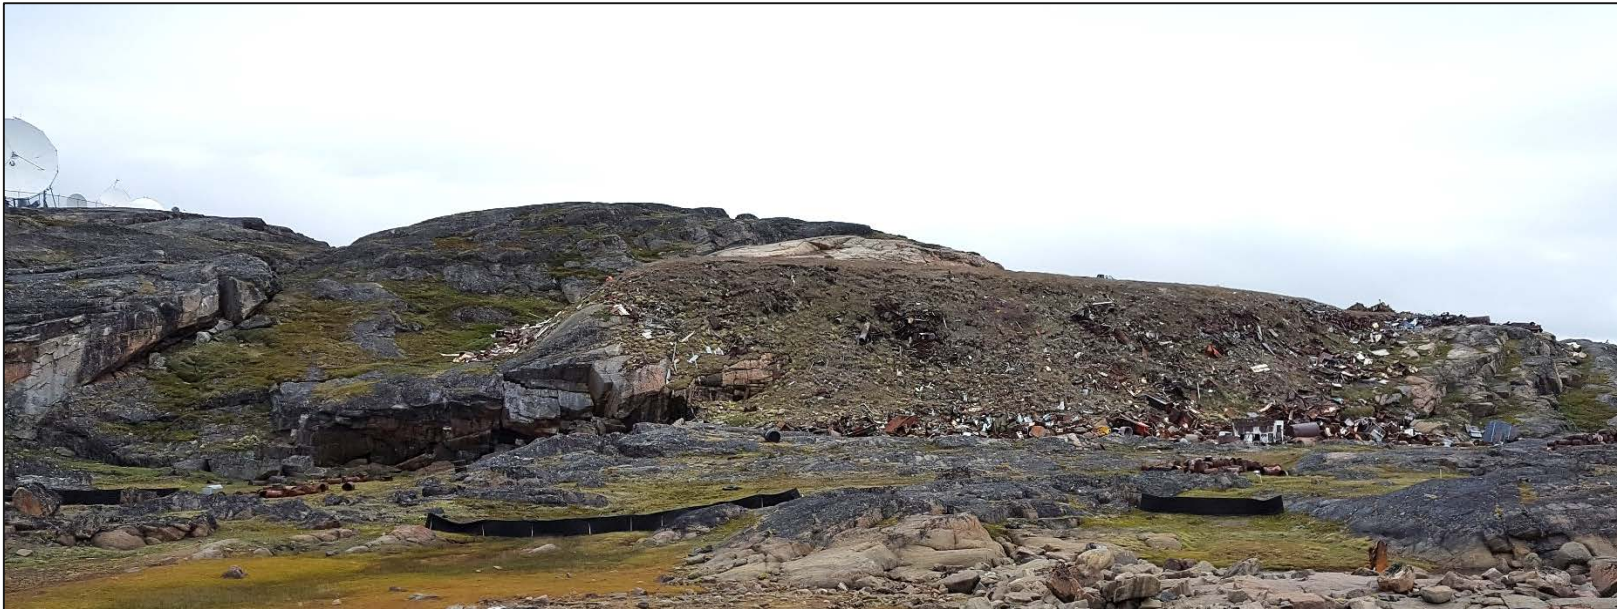
**Photo: 1**  
31 July 2017

Overview of west  
of Main Landfill  
prior to  
remediation  
operations

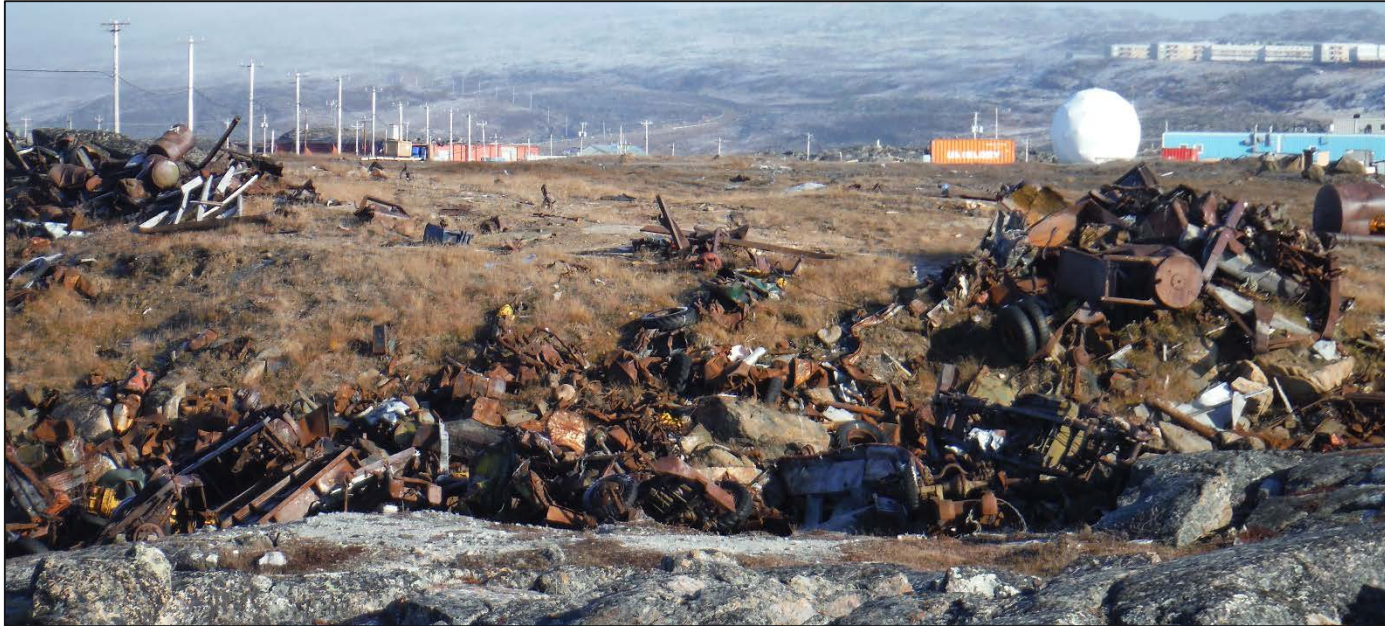
**Photo: 1**  
October 2016

**Description:**  
**(Before)**  
Overview AEC 2  
vehicle dump

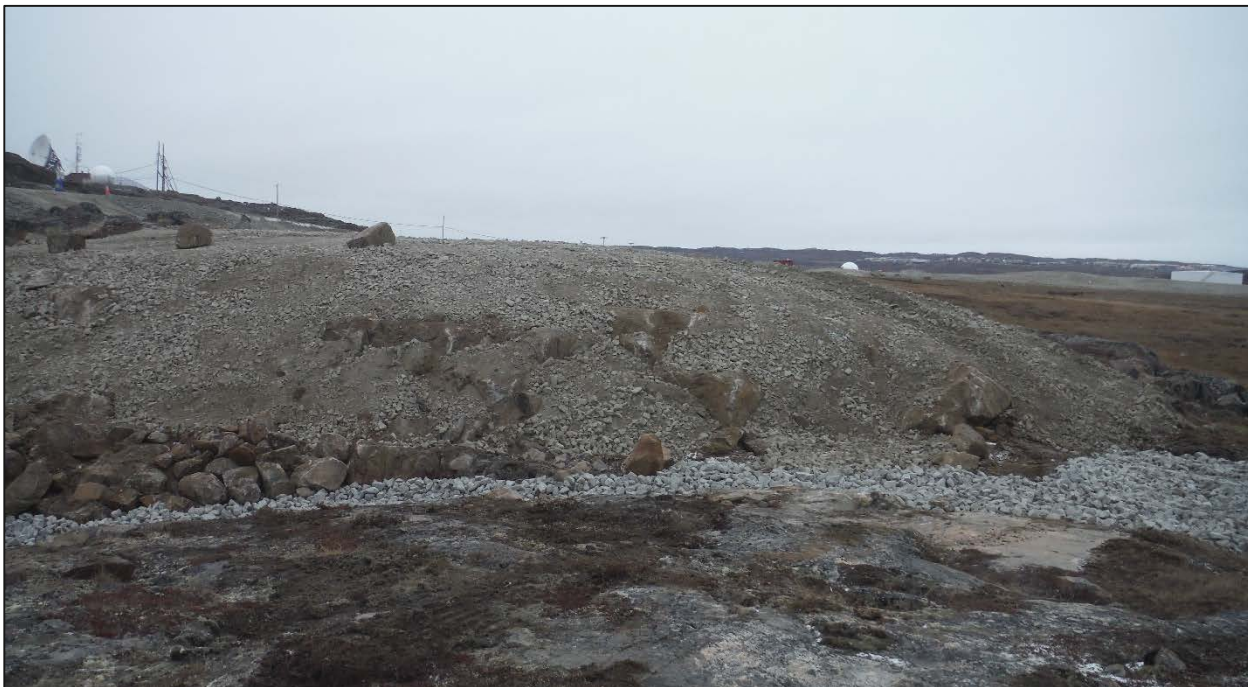
**Photo: 2**  
28 September 2017

**Description:**  
**(After)**  
Overview of AEC 2  
cap

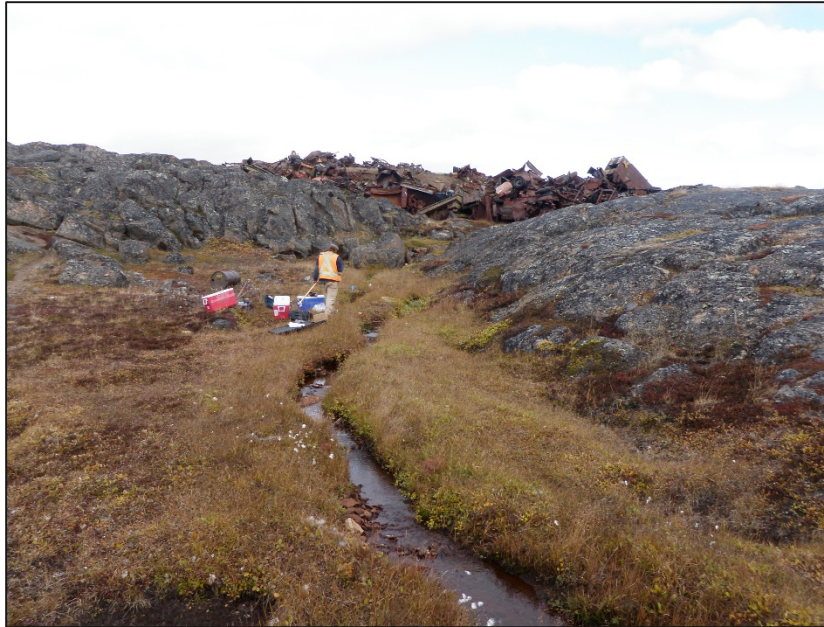
**Photo: 1**  
October 2016

**Description:**  
**(Before)**  
Overview AEC 2  
vehicle dump

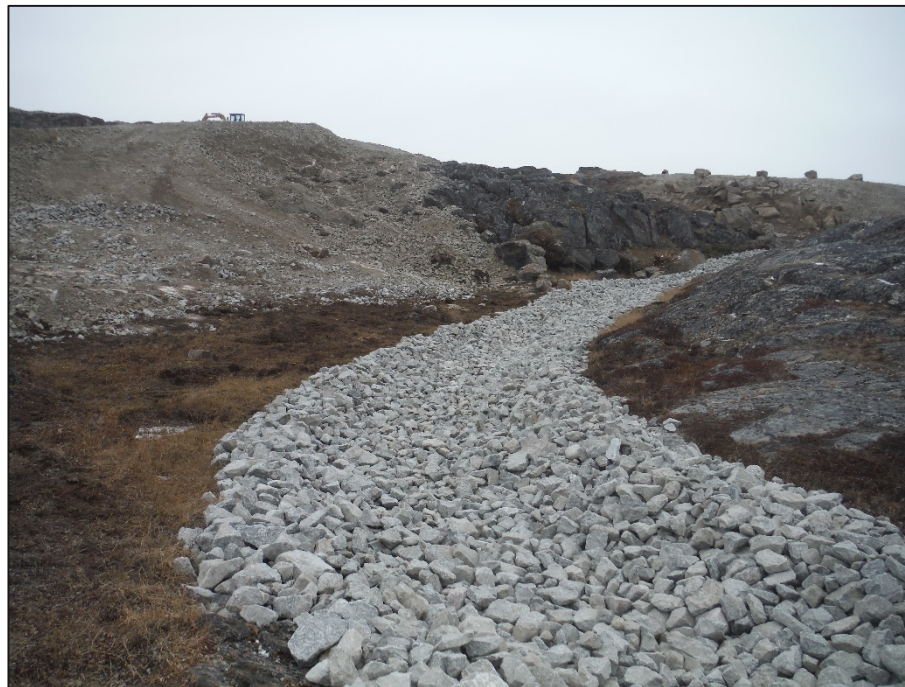
**Photo: 2**  
28 September 2017

**Description:**  
**(After)**  
Overview of AEC 2  
drainage

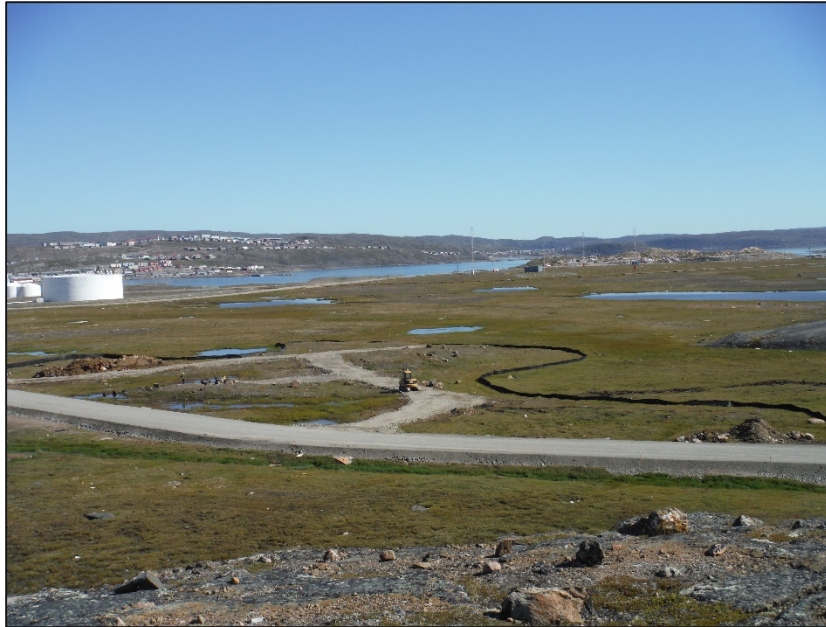
**Photo: 1**  
October 2016

Overview AEC 1

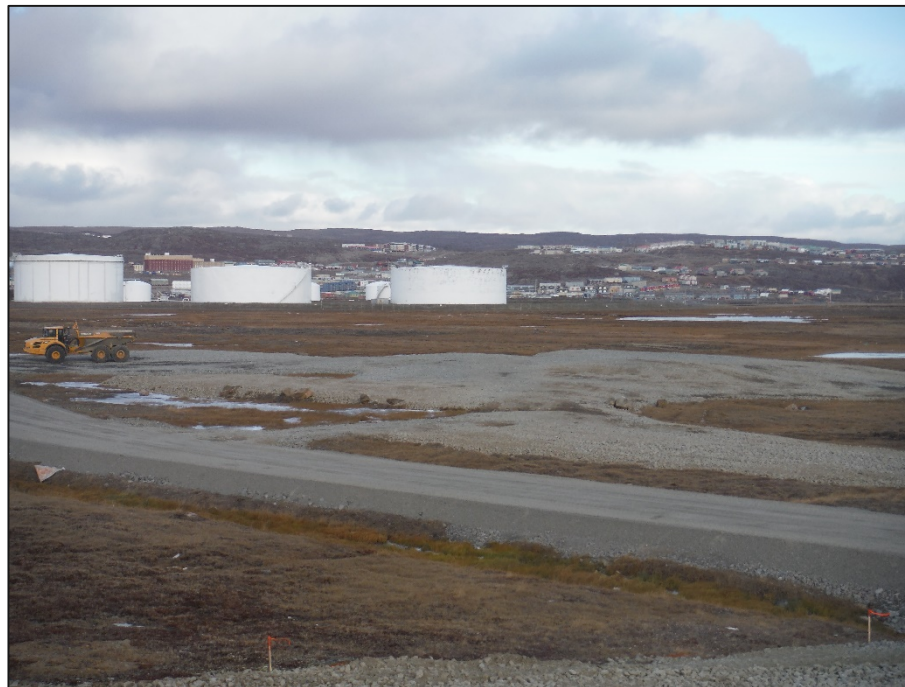
**Photo: 2**  
28 September 2017

Overview of AEC 1  
after capping

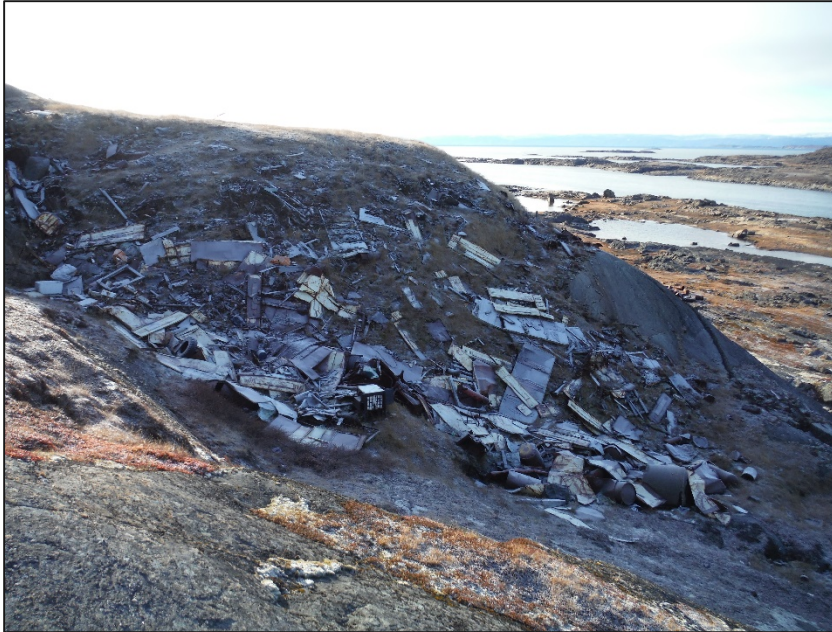
**Photo: 1**  
October 2016

Overview AEC 3,  
north end

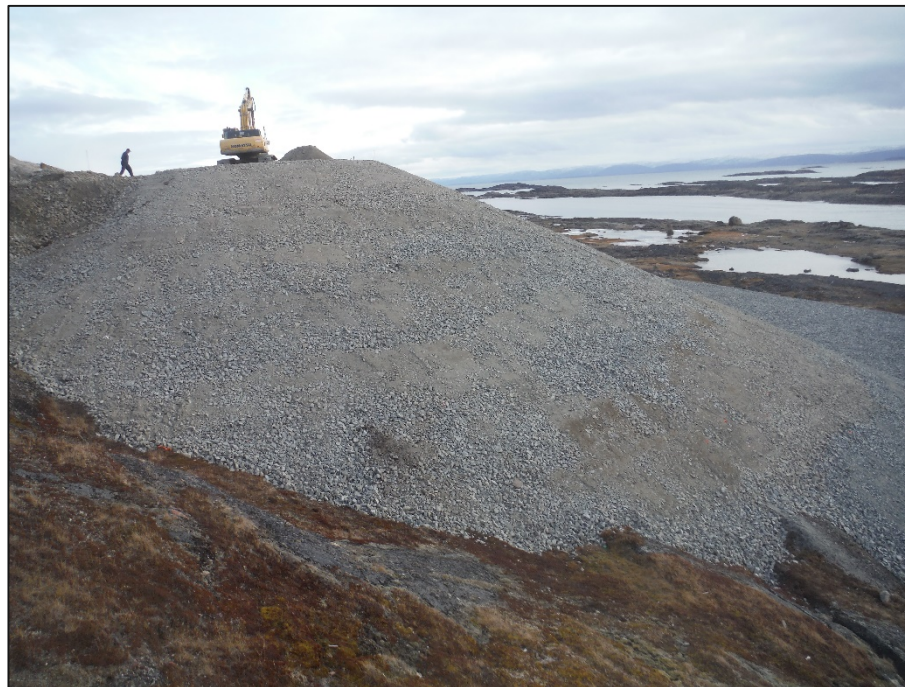
**Photo: 2**  
28 September 2017

Overview of AEC 3  
north end after  
capping

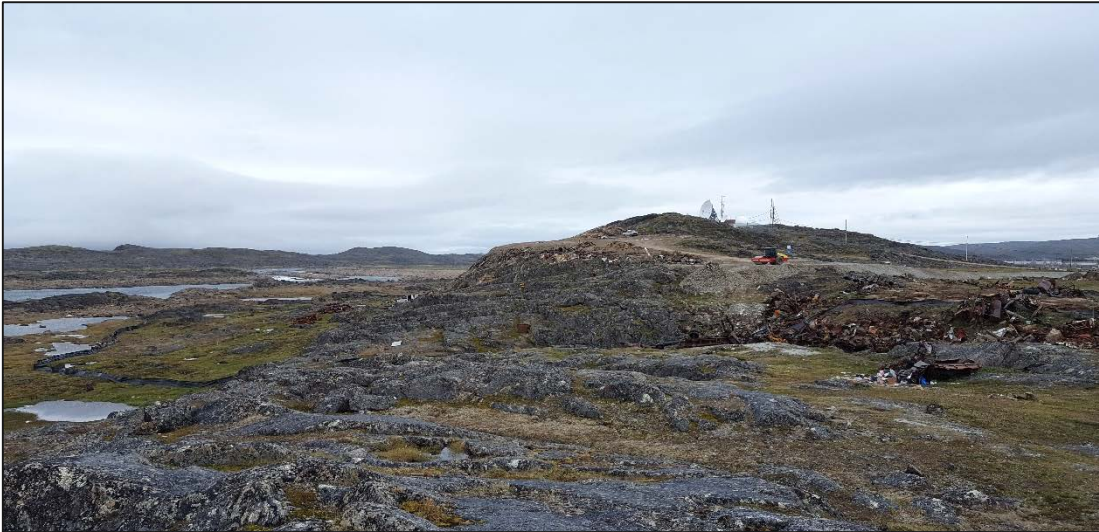
**Photo: 1**

**(Before)** Overview of SE of Main Landfill Prior to Remediation Operations

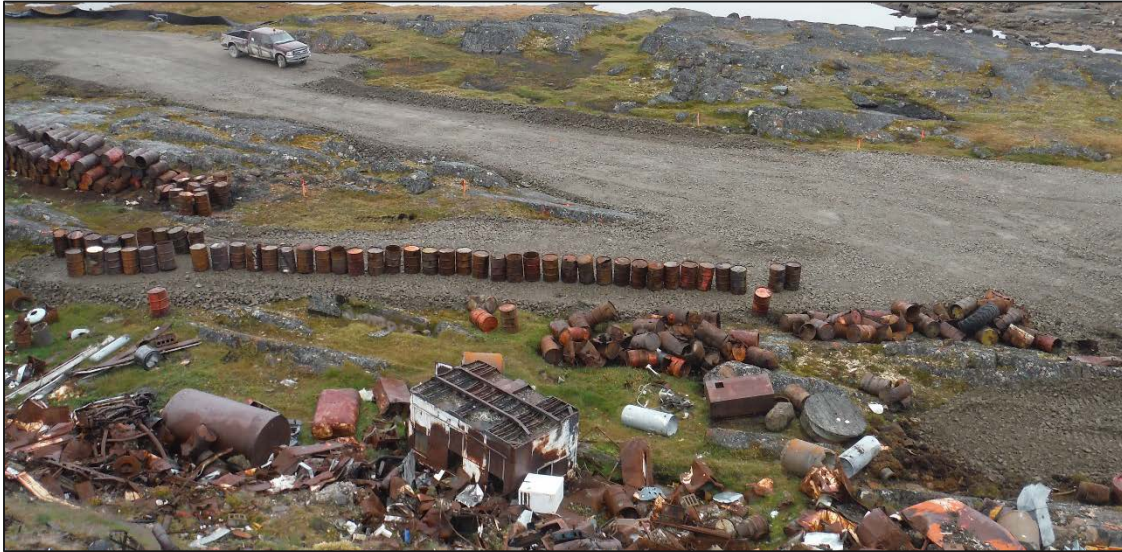
**Photo: 16**

(Before) Drum Sorting

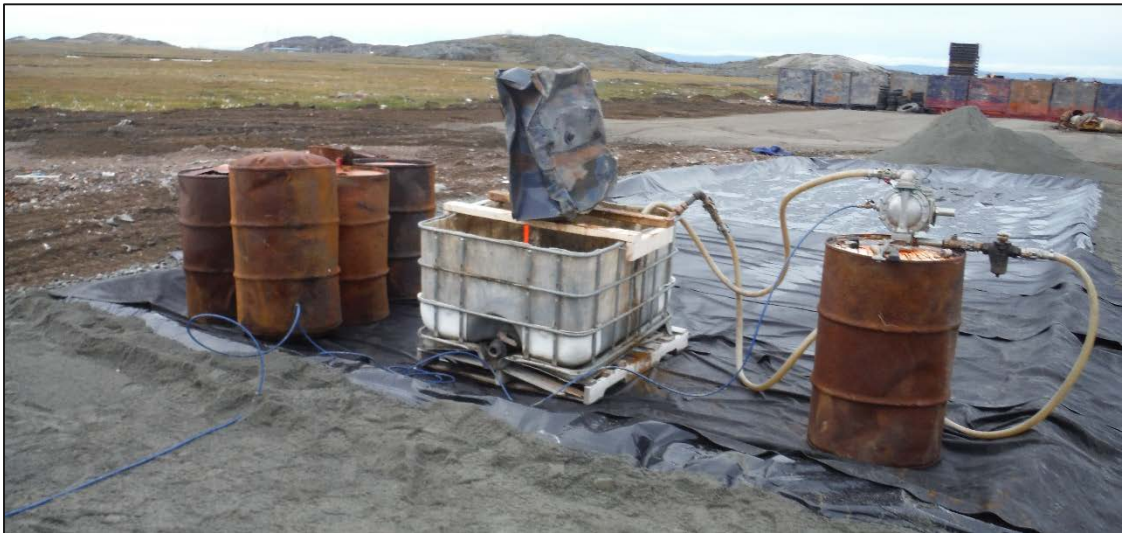
**Photo: 17**

(During) Drum Liquid  
removal staging area

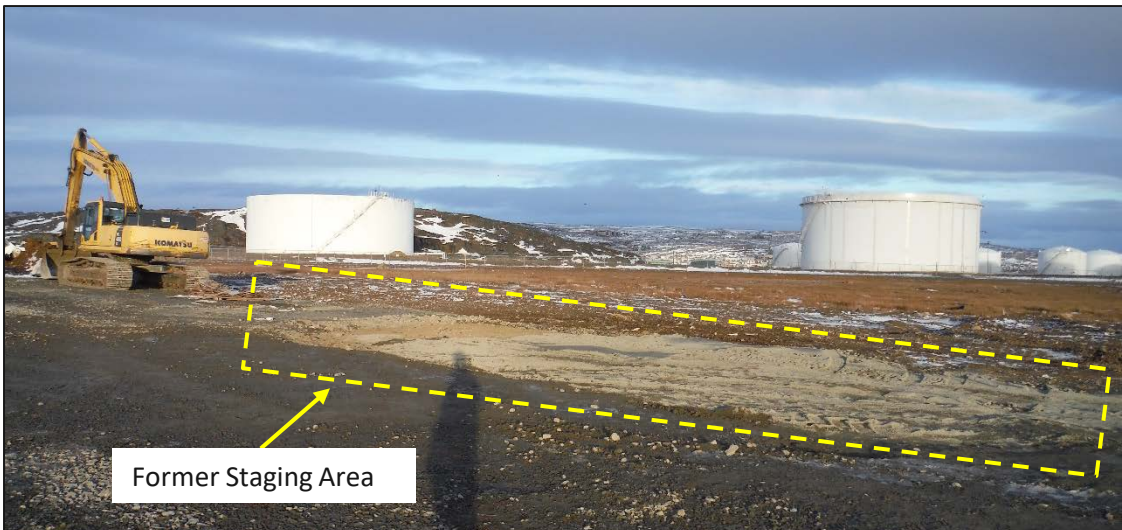
**Photo: 18**

(After) Drum Staging  
Area after liquid  
removal

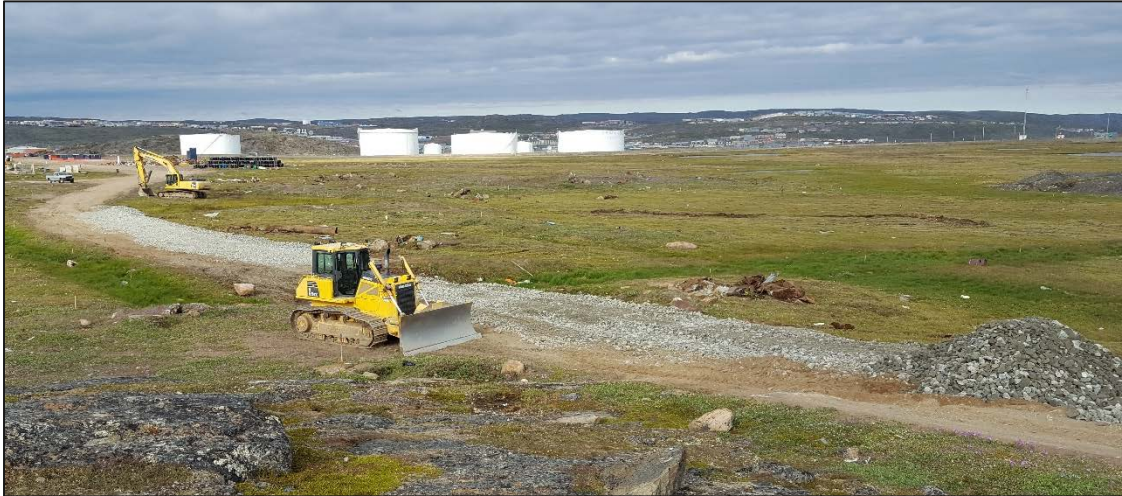
**Photo: 25**

**Description:**  
**(Before)** AEC-1  
Overview, prior to remedial operations

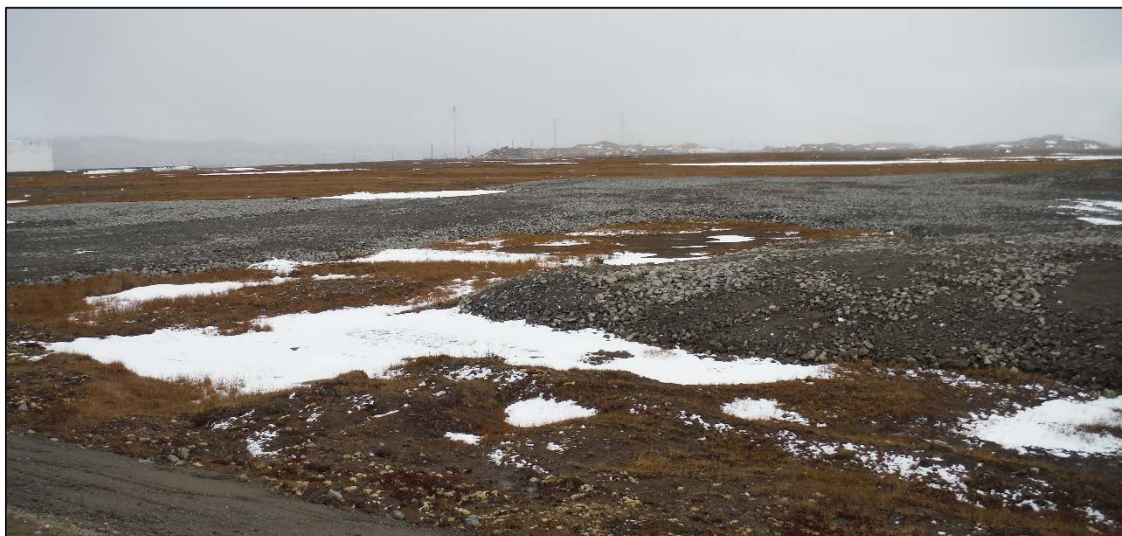
**Photo: 27**

**Description:**  
**(After)** Overview of AEC-1 after final cap and grade

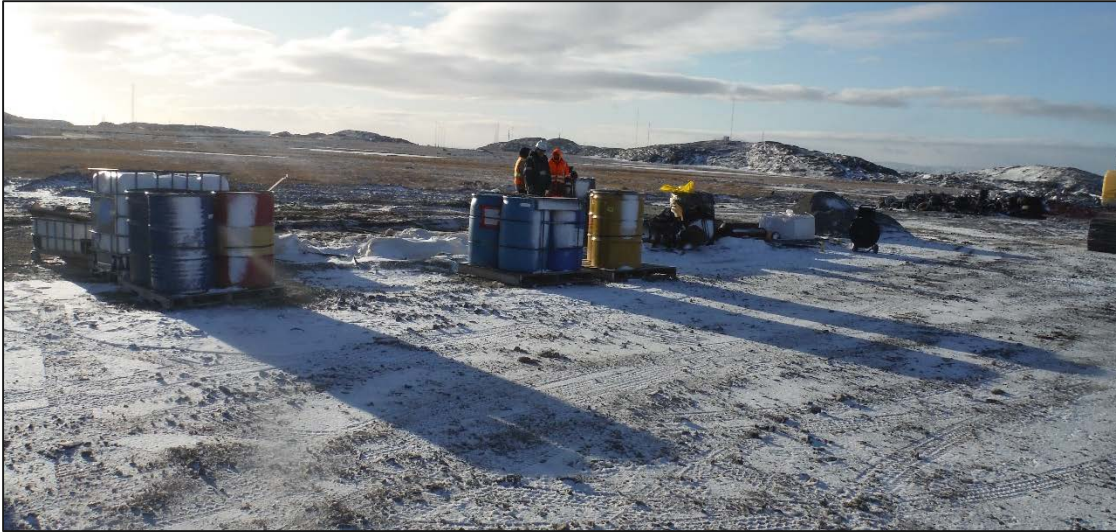
**Photo: 28**

Pallets of various hazardous materials packaged for disposal...

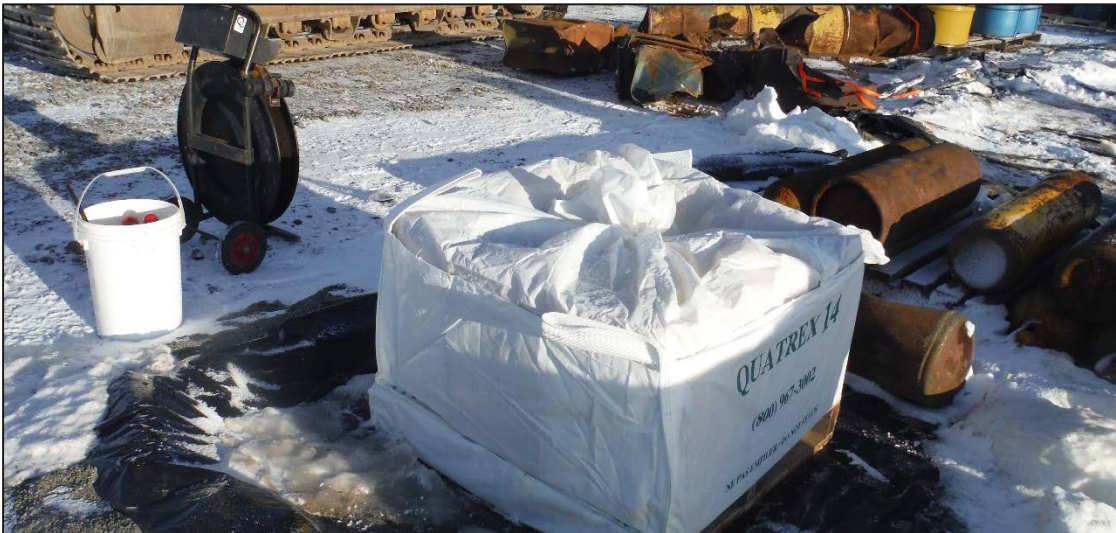
**Photo: 29**

Batteries packaged for disposal

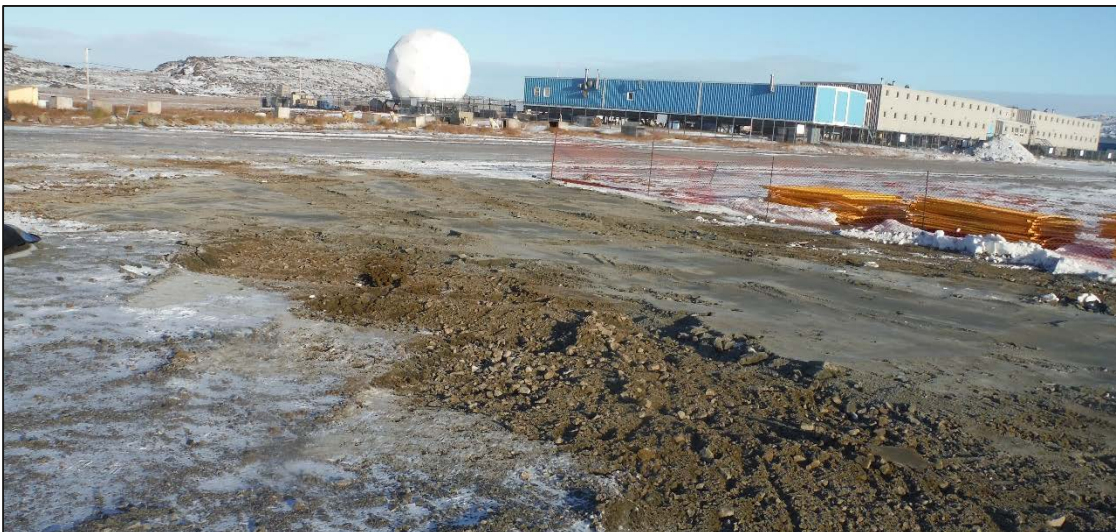
**Photo: 30**

Former area of PHC Impacted Soil post remediation

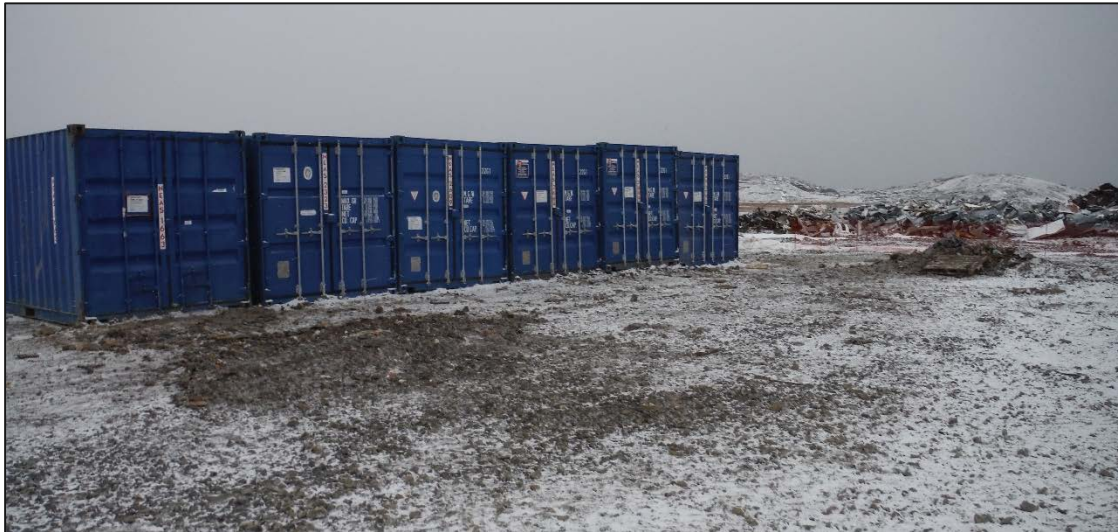
**Photo: 31**

TWA-1, storage containers for hazardous metals

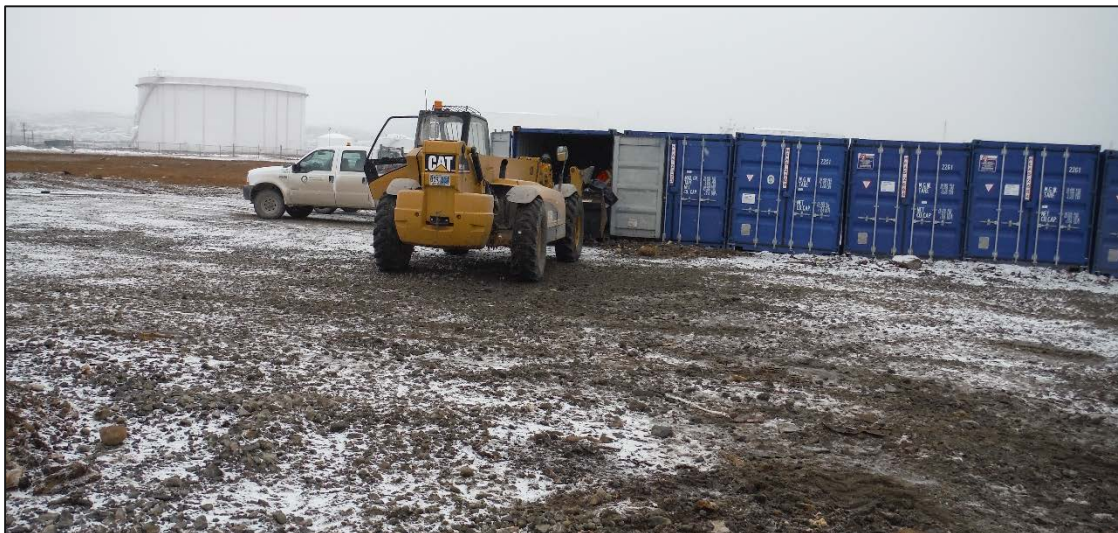
**Photo: 32**

Sea can storage containers being filled with lead containing products and hazardous metal debris

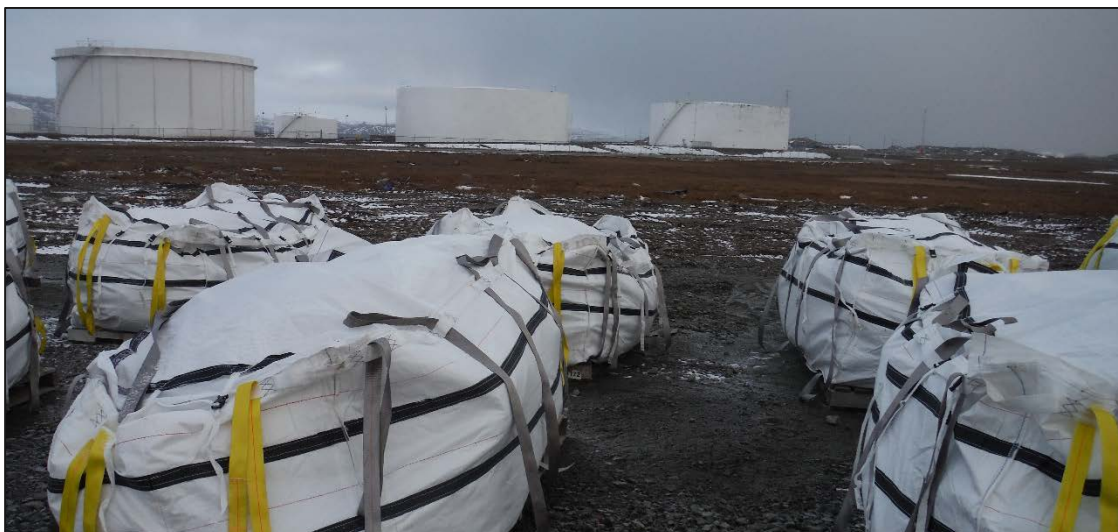
**Photo: 33**

TWA-1 impacted sediment packaged and ready for shipment south
