Nunavut Impact Review Board

Site Visit Report

Meadowbank Gold Mine &

Whale Tail Pit Projects

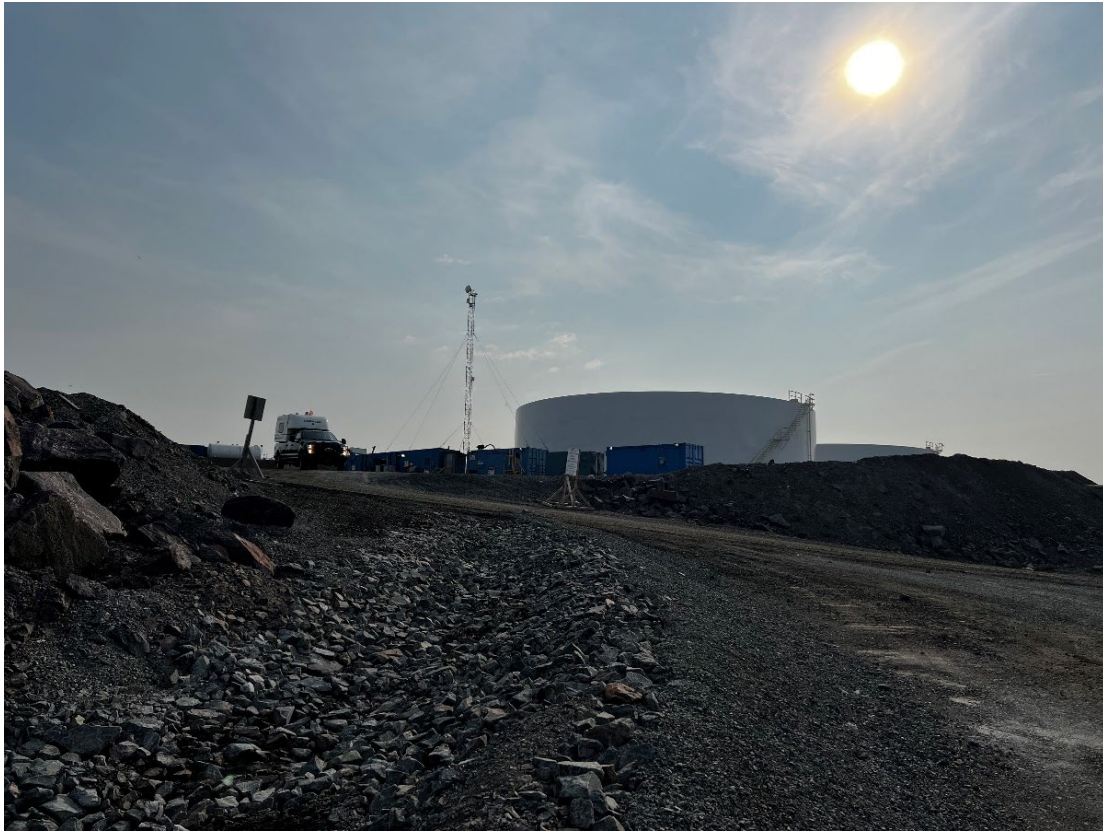
Other		
81	24-hour security at the Baker Lake Facility	24-hour security cameras were observed by NIRB staff at the Baker Lake facilities. The cameras report live feeds to the Meadowbank gatehouse, which is staffed 24 hours per day (Photo 2).

Photo 2: 24-hour security cameras at the Baker Lake Marshalling Facility mounted on a tower. The feeds connect directly to the 24-hour manned gatehouse at kilometre 5 of the AWAR.

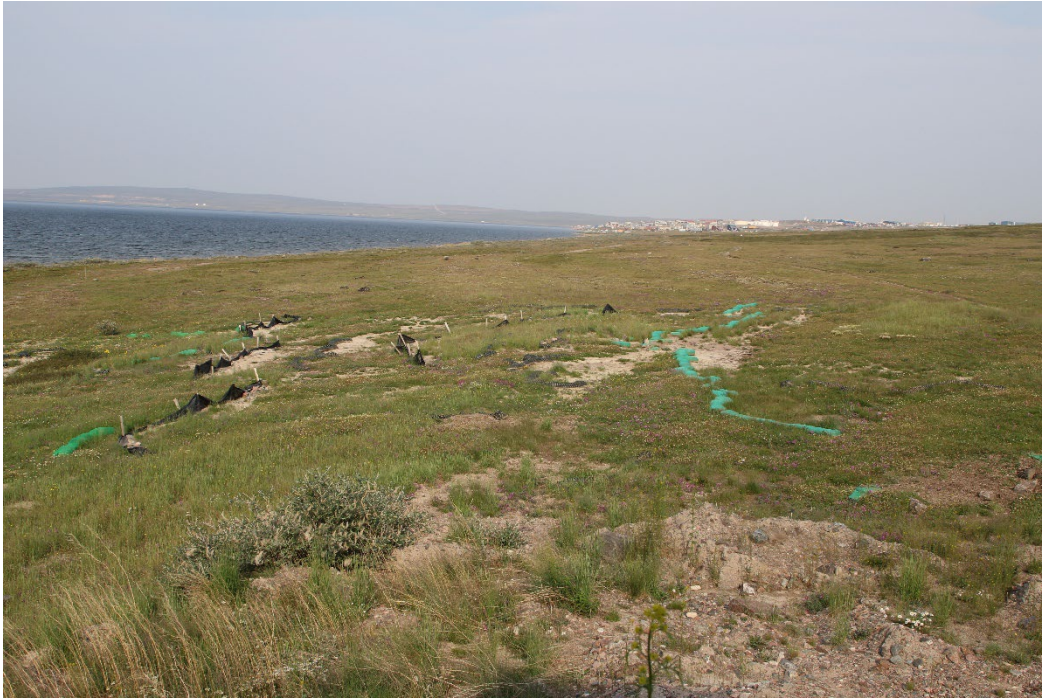
Photo 4: Erosion control fencing at the Baker Lake Laydown Area.

- Re-covering of berm liner in the secondary containment berms at the fuel storage areas at the Baker Lake Marshalling Facility which was noted in 2022 and 2023. Agnico Eagle said they would be repairing in 2024.
- Ensure that sediment fences are in good condition (e.g., Baker Lake Laydown Area) and ready to function in future flood events.

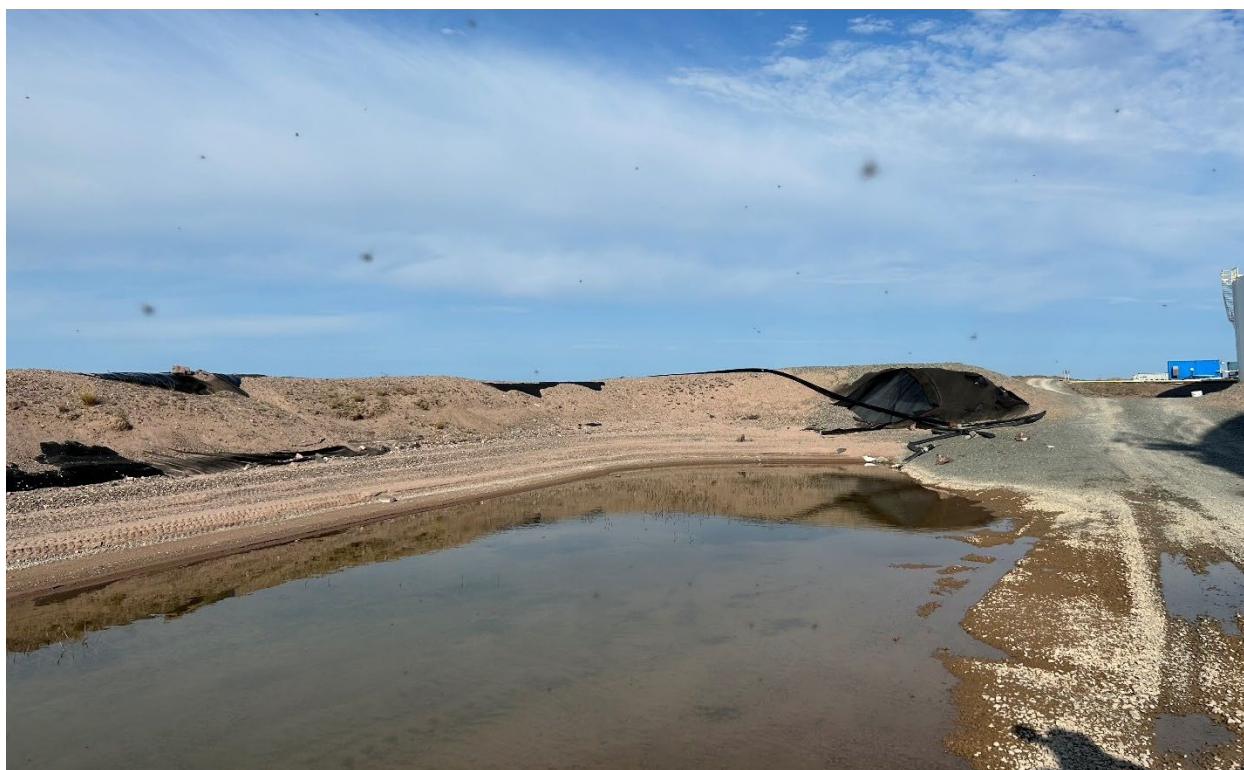
Photo 7: Exposed liner at the Baker Lake Marshalling Facility. Pooled water is pumped out and stored in the Stormwater Management Pond at the Meadowbank Site (2023). Repairs to take place in 2024.

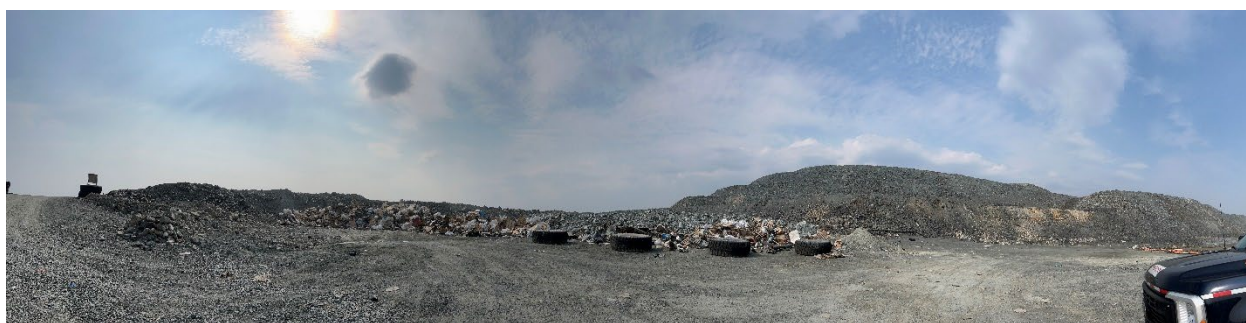
Photo 23: Meadowbank Landfill, it is buried as the waste rock pile increases.

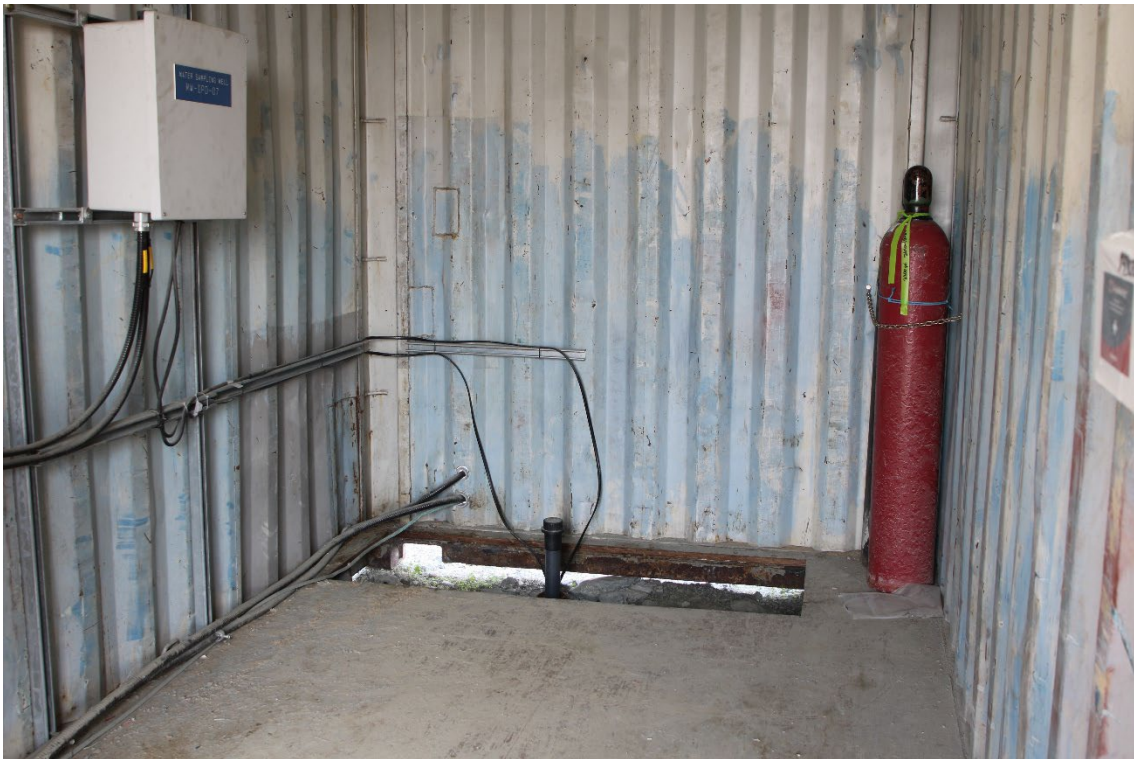
Photo 30: Groundwater well, 1 of 5 onsite.

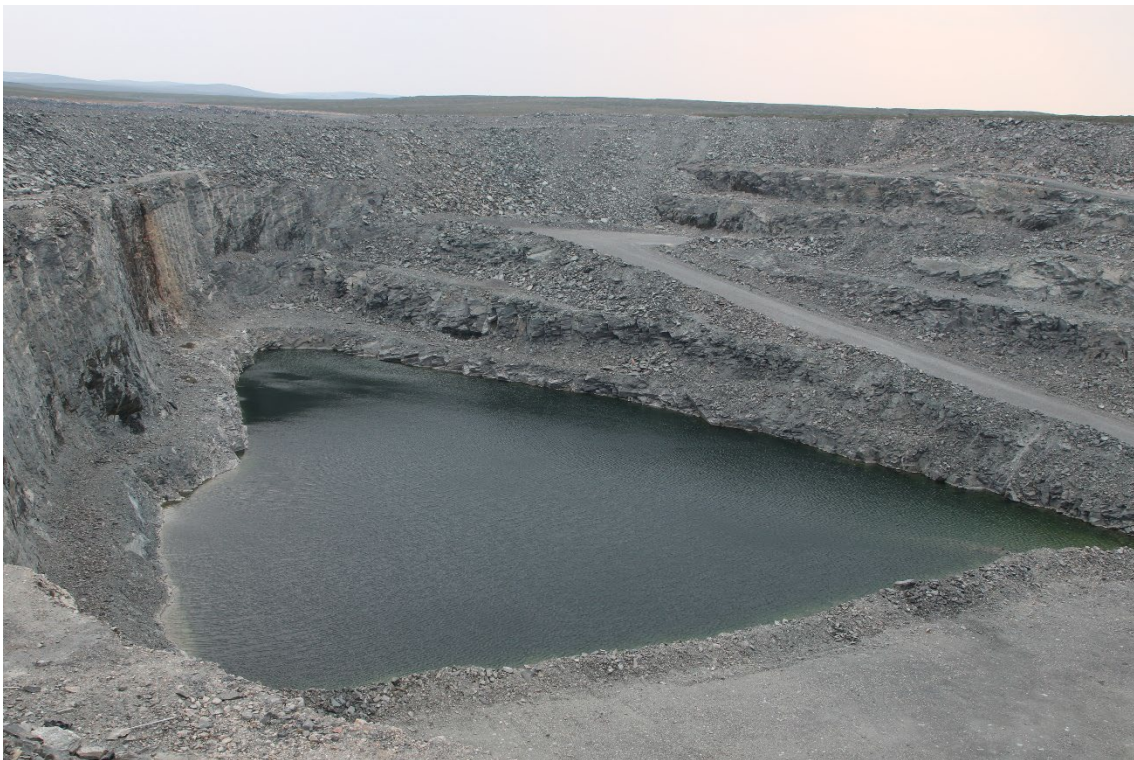
T&C No.*	Topic	Site Observation
36	Raptor Mitigation Measures	Raptor nest was observed on the Whale Tail site during 2024 at Phaser (Photo 34). No Nests were observed by NIRB staff during the 2023 Site Visit. Raptor deterrents were observed at the Baker Lake facilities (Photo 6).
Socio-Economic - General		
		Camp facilities that contribute to Inuit wellbeing onsite include the operational clinic, country food kitchen (Photo 64 and Photo 65), and recreational area (Photo 66). Other facilities such as a gym were also present onsite.
New Terms and Conditions (Amendment 1)		
66	Signage on the AWAR and WTHR	Appropriate signage was noted along both Roads.

Photo 34: Phaser Pit. A peregrine falcon nest that was observed during 2024 site visit.

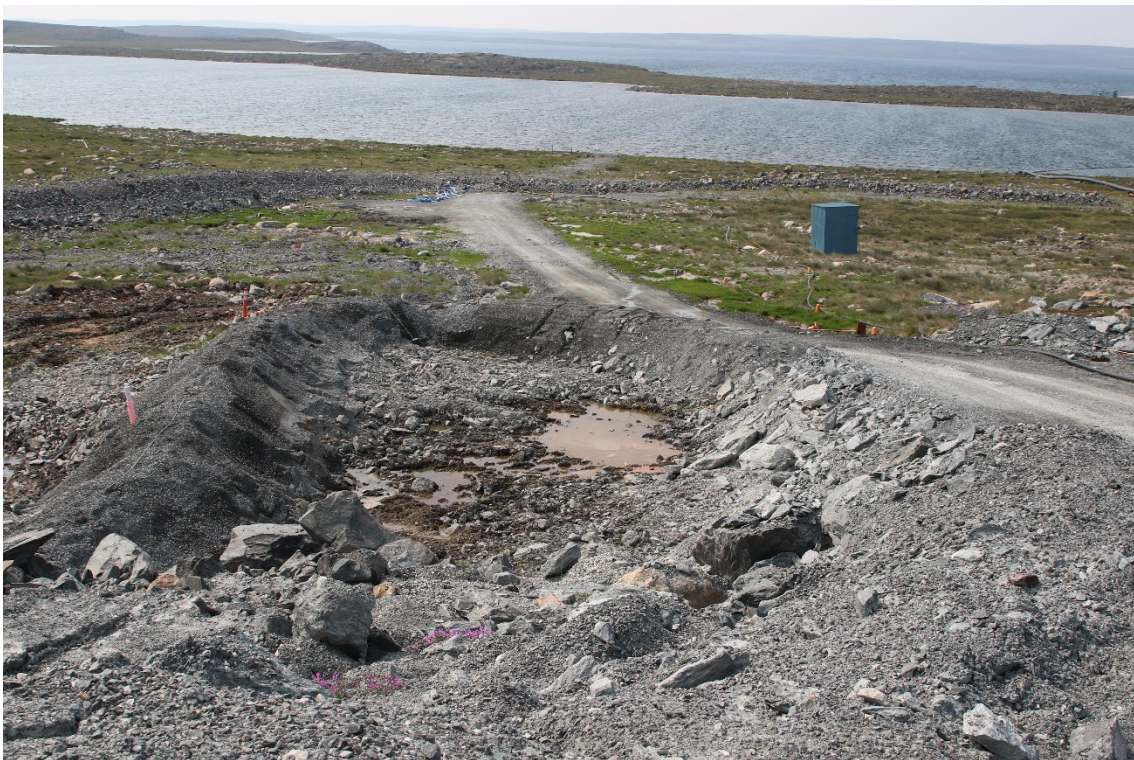
Photo 40: Silt discharge area downslope from Mill, work ongoing.

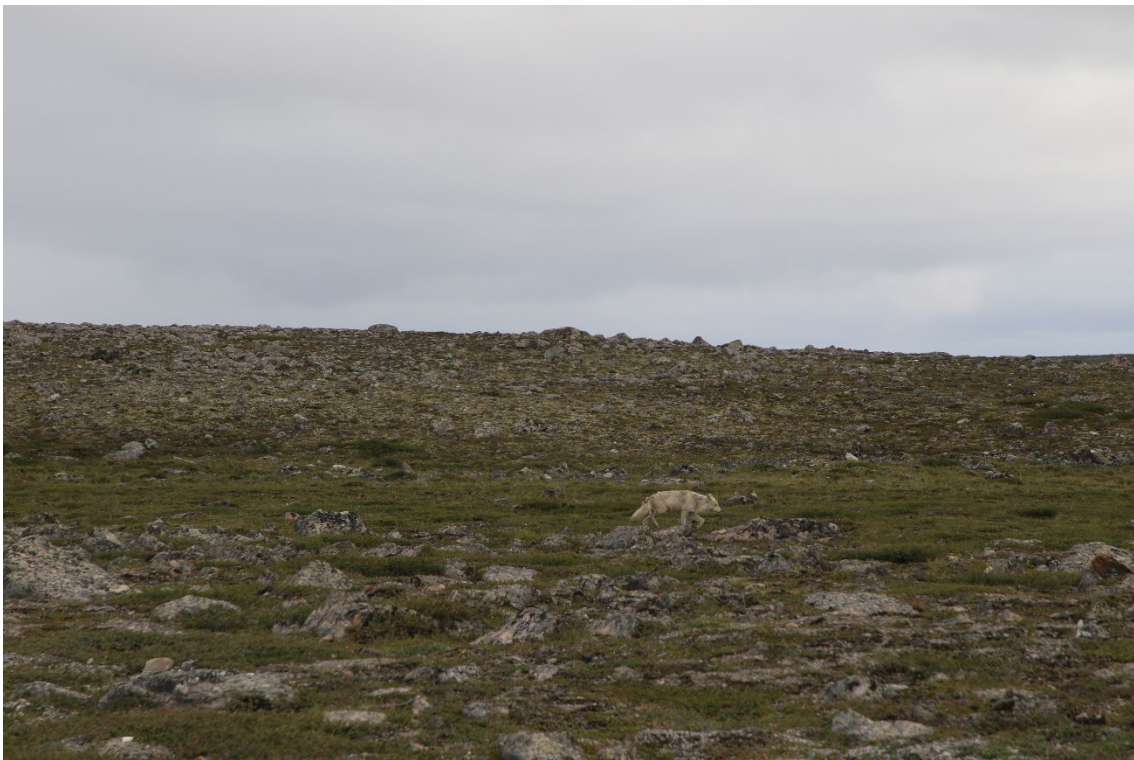
31	Road Traffic Management	Traffic is tracked by Agnico Eagle dispatchers, and all wildlife sightings are reported while staff are using the road in accordance with the Road Access Management Plan (Photo 44).

Photo 44: Amaruq (wolf) on the WTHR.

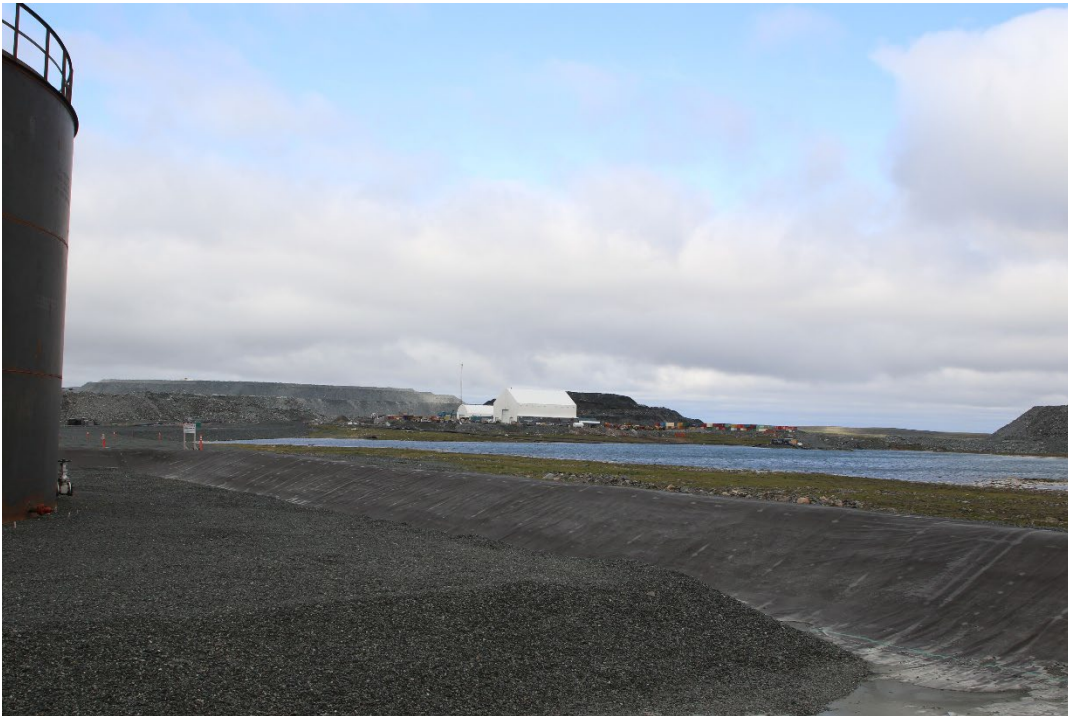
Photo 46: Whale Tail Site tankfarm. A large area of exposed liner is seen in the secondary containment berm.

- Recovering of berm liners in the secondary containment berms at the fuel storage area at Whale Tail similar to 2023, and
- Ensuring all signage is appropriate at site.

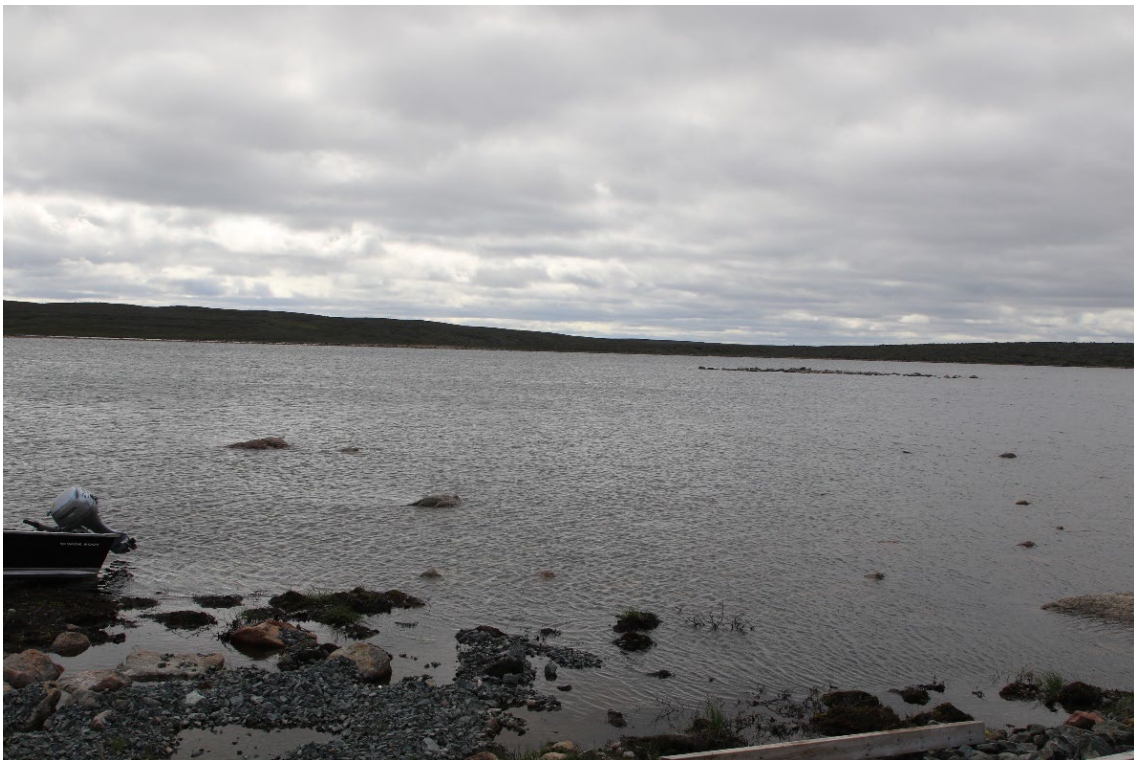
Surface Water Hydrology, Surface Water Quality and Sediment Quality		
17	Surface Water Hydrology	Core Receiving Environment Monitoring Program (CREMP) sample locations were observed at Kangislulik (Mammoth) Lake (Photo 62). Agnico Eagle staff discussed the other samples taken at A20 Lake as well as reference samples taken at Pipe Dream Lake.
Freshwater Aquatic Environment		
20	Setbacks	NIRB staff viewed the locations and has no concerns.
21	Watercourses and fish passage	No issues with fish passage were observed or noted by Agnico Eagle.
Vegetation		
25	Invasive Species	Information is available from the Environment Department in the identification of potential invasive species around the site.
Terrestrial Wildlife		
28	Terrestrial Ecosystem Management Plan (TEMP)	Agnico Eagle staff noted they were working on the updated Terrestrial Ecosystem Management Plan (TEMP) – version 8 with the TAG. Based on the TEMP – version 7, Agnico Eagle followed protocol throughout the site visit. A wolf was also observed by Agnico Eagle staff and reported to other drivers and dispatch per the TEMP – version 7.

Photo 62: Kangislulik Lake (or Mammoth Lake) contains 2 CREMP sample locations – one at each end.
