# WATER LICENCE INSPECTION FORM

<b>Licensee</b>	<b>Licensee Representative</b>
DND-Raytheon	Vincent Millaire
<b>Licence No. / Expiry</b>	<b>Representative's Title</b>
3BC-SHE0919	Environmental Officer
<b>Land / Other Authorizations</b>	<b>Land / Other Authorizations</b>
2 associated Spill Files #16-226 & #17-234	
<b>Date of Inspection</b>	<b>Inspector</b>
July 6, 2017	Baba Pedersen
<b>Activities Inspected</b>	
<input type="checkbox"/> Camp <input type="checkbox"/> Drilling <input type="checkbox"/> Mining <input type="checkbox"/> Construction <input checked="" type="checkbox"/> Reclamation <input checked="" type="checkbox"/> Fuel Storage <input type="checkbox"/> Roads/Hauling <input checked="" type="checkbox"/> Other: Fuel Spills <input checked="" type="checkbox"/> Other: Operational NWS Site

PHOTO LOG

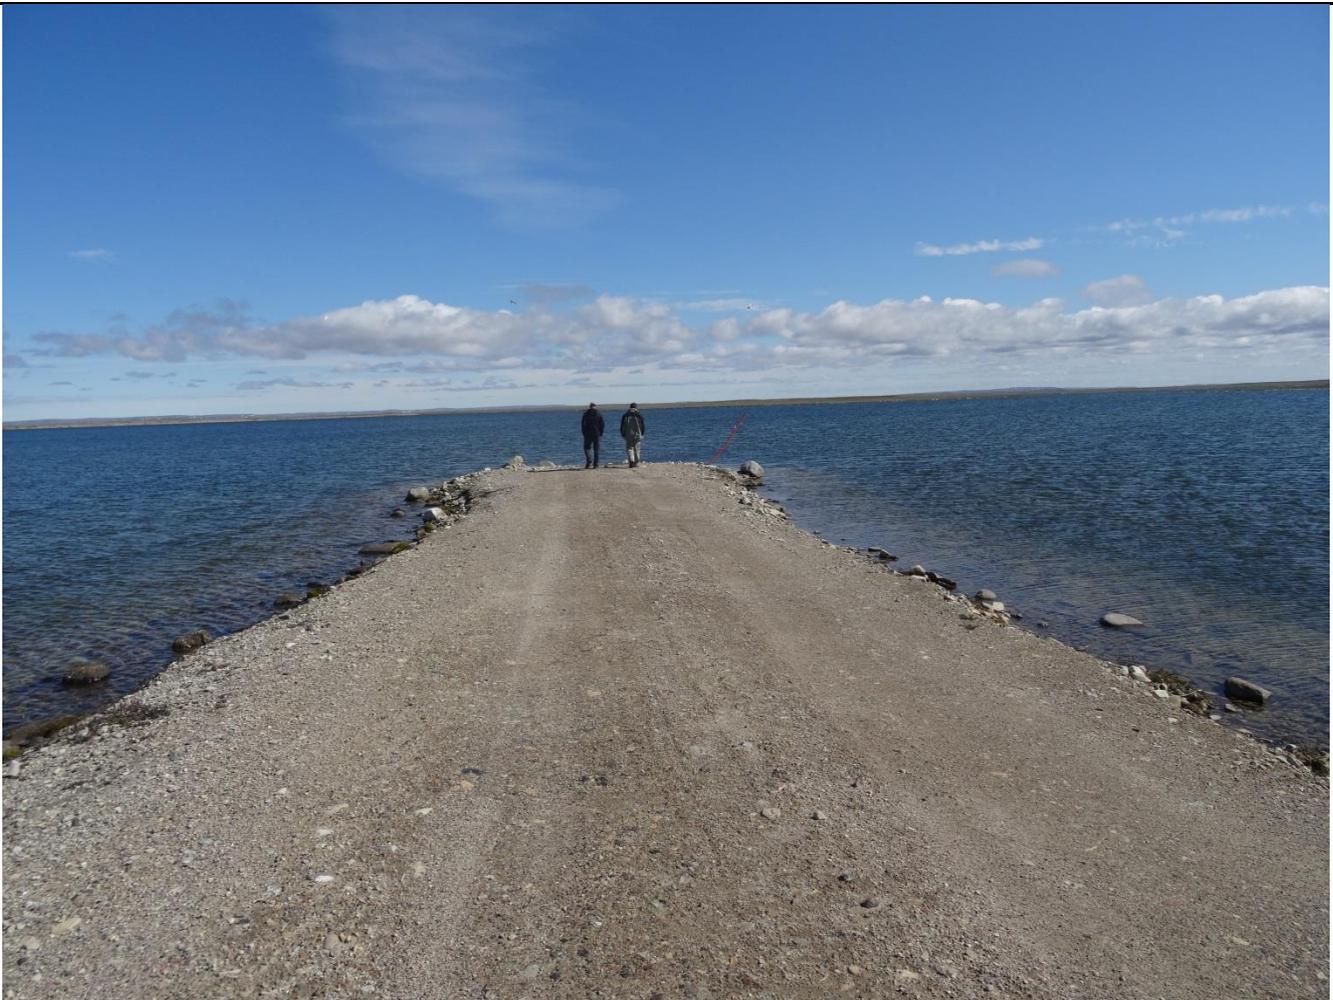
Photo 2

1. There was no Signage to identify and indicate where the Water Source area (Photo 2) was. 2. There was no Signage to Identify and Indicate where the Final Discharge Grey Water Sump (Photos 3 & 4) area was. 3. The Fuel Storage Tanks W22A (Photo 5) and W22C & W22D (Photo 8) were all Secure and well Marked. Both Containment Berms were clean and dry and in good condition with no signs of leakage. 4. All Hazardous Material (Photos 6 & 7) was securely stored in the Warehouse. 5. Spill #16-226 (Photo 9) under the main module has been Cleaned Up satisfactorily. 6. Spill #17-234 (Photo 10) at the Heli Pad has been Cleaned Up satisfactorily.			
<b>SECTION 3</b>	<input type="checkbox"/> <b>Comments</b>	<input type="checkbox"/> <b>Non-Compliance with Act or Licence</b>	<input checked="" type="checkbox"/> <b>Action Required</b>

Description: Water Intake area – showing No Signage

1. Appropriate Signage must be installed in order to indicate and identify where the Water Source Sample area is prior to July 2018. 2. Appropriate Signage must be installed in order to indicate and identify where the Final Discharge Grey Water Sump Sample area is prior to July 2018. 5. I recommend Closure of Spill #16-226. 6. I recommend Closure of Spill #17-234.

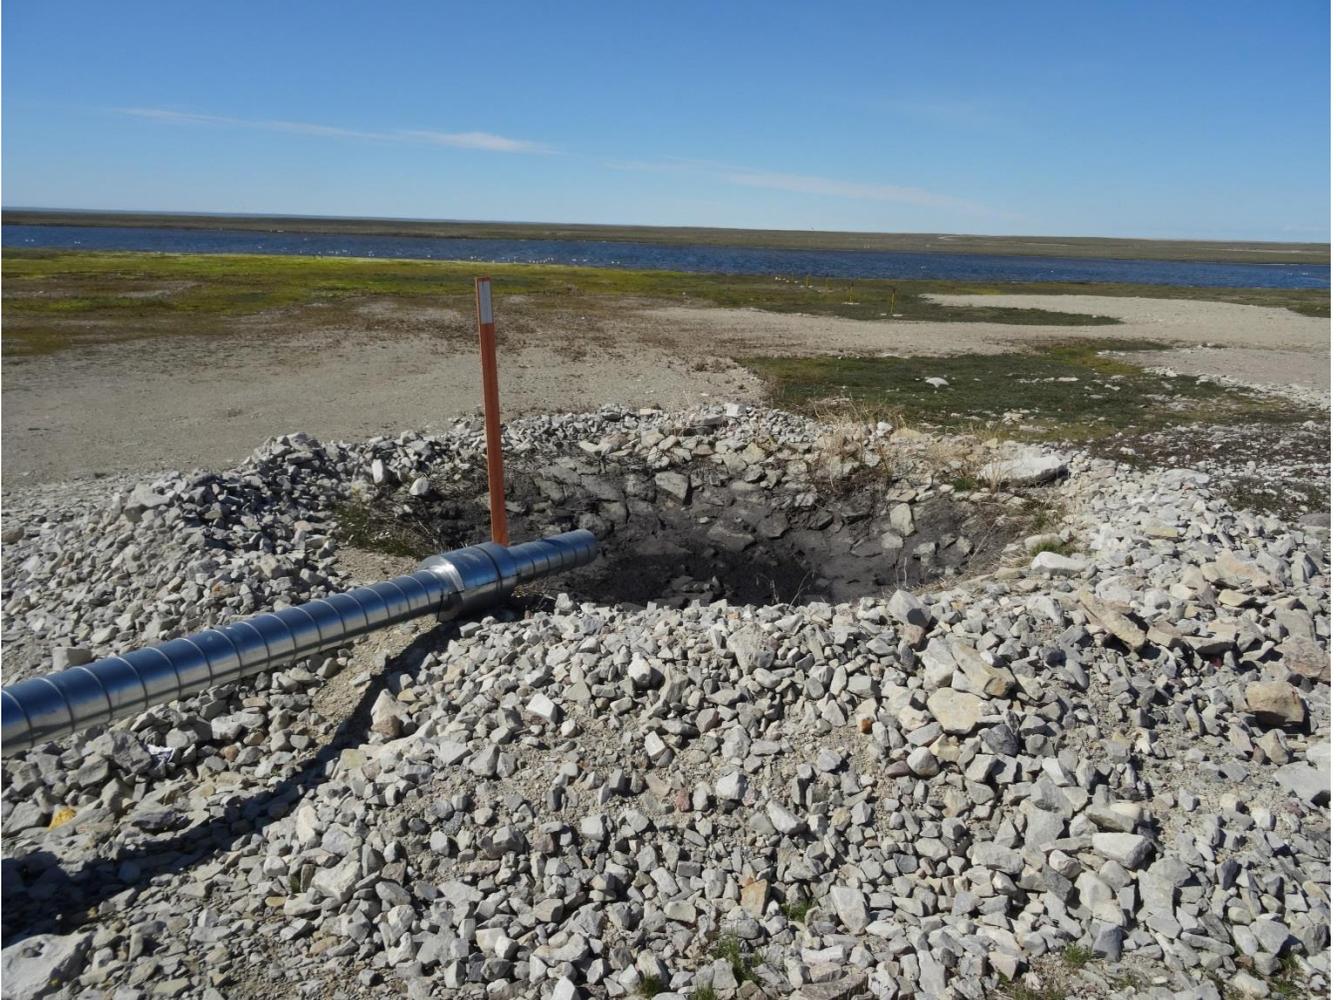
Photo 3

Description: Final Discharge Sump showing No Signage

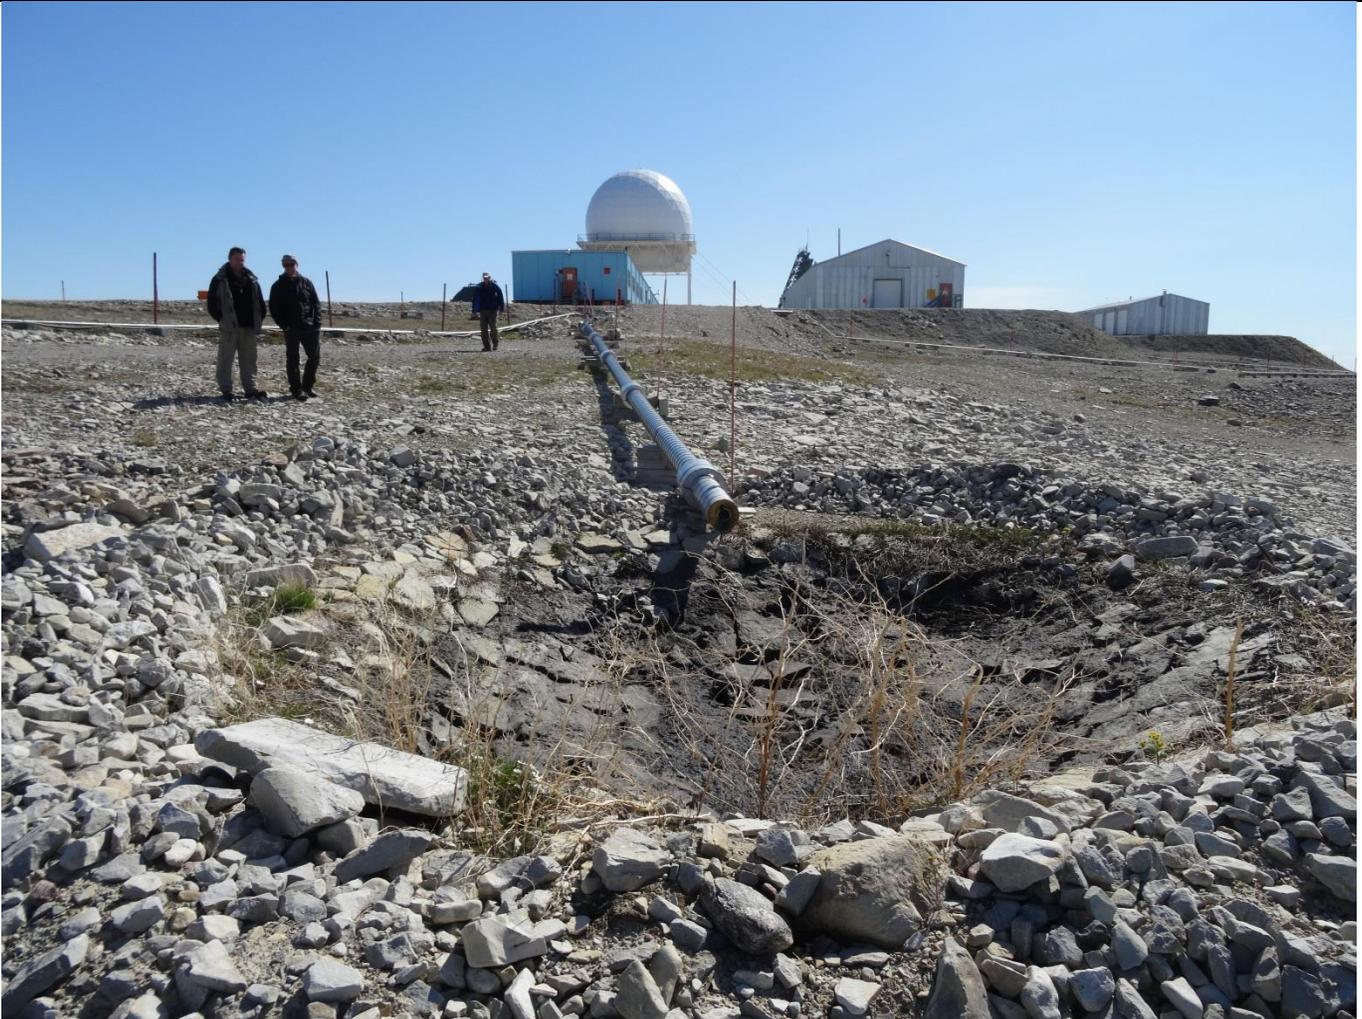
Photo 4

Description: Final Discharge Sump showing No Signage

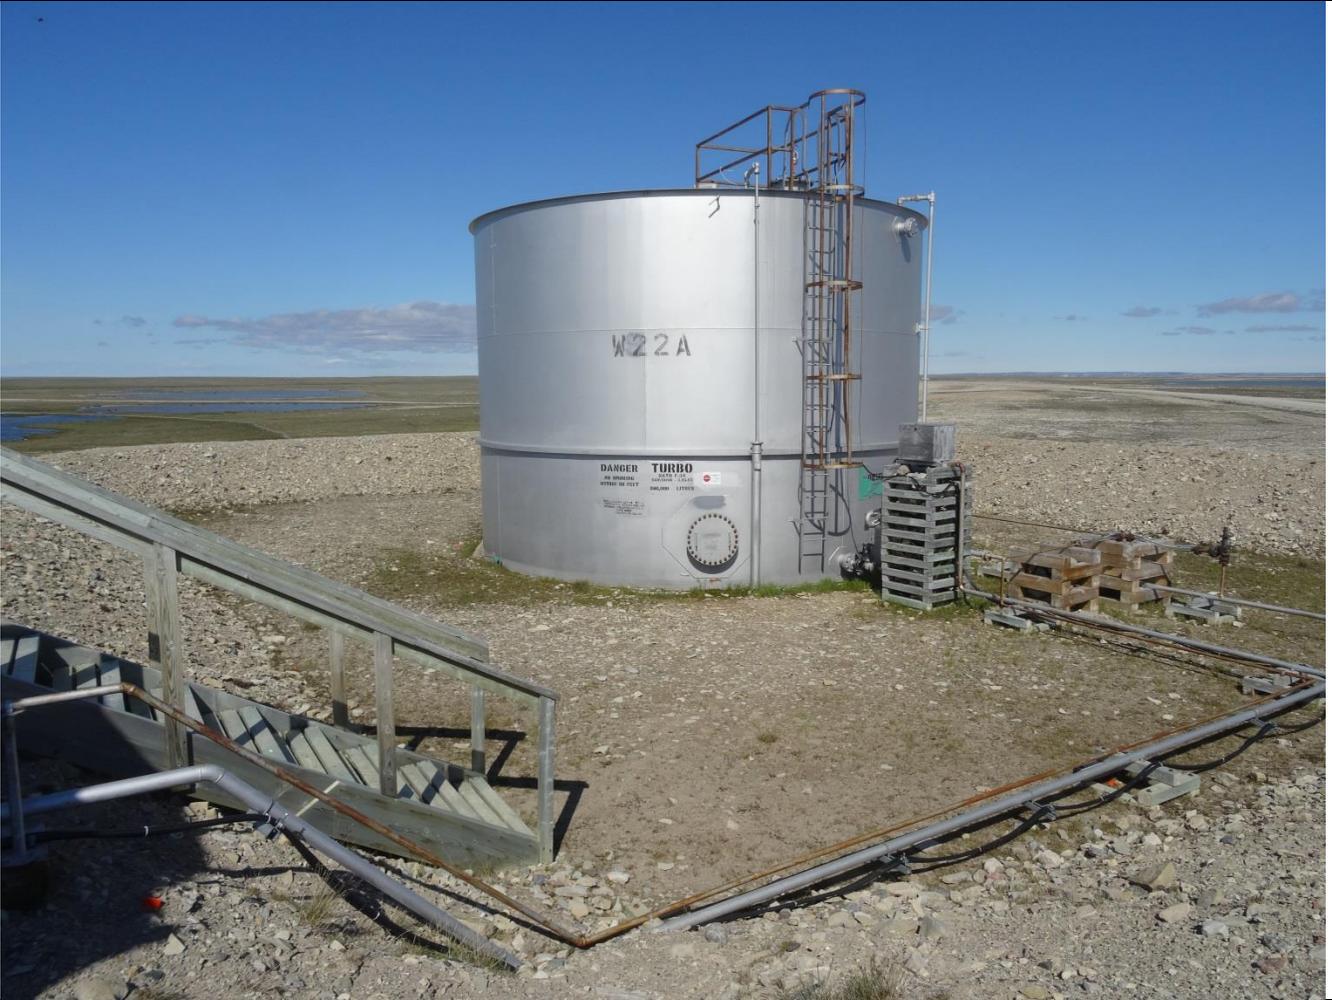
Photo 5

Description: Tank W22A – at NWS Site Area - Well Marked – Berm in Good Condition, Clean and Dry inside

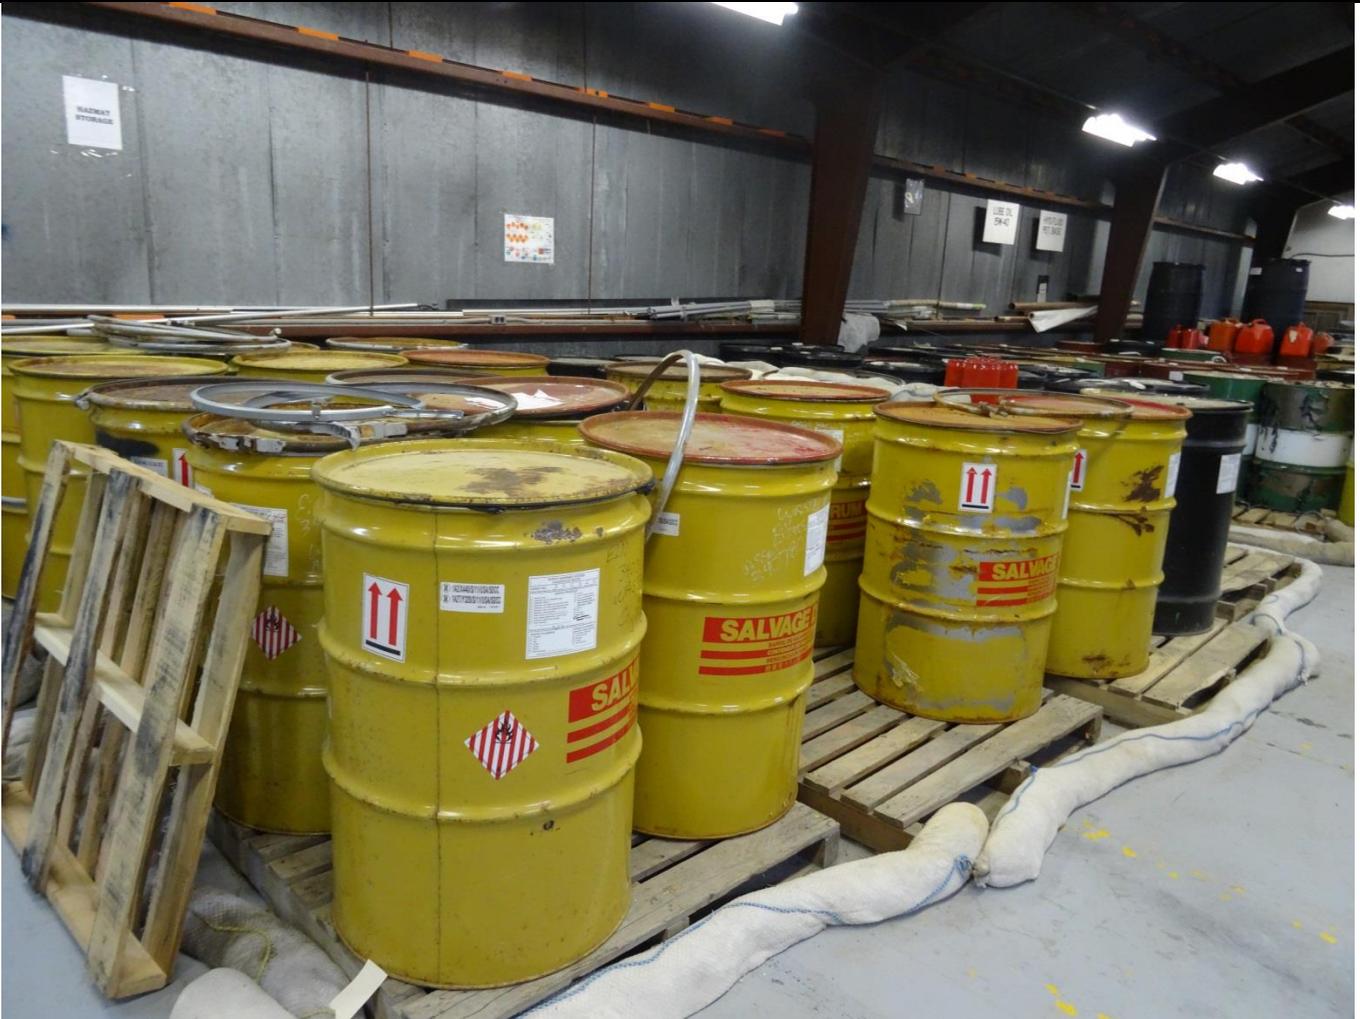
Photo 6

Description: Hazardous Materials Storage inside Warehouse

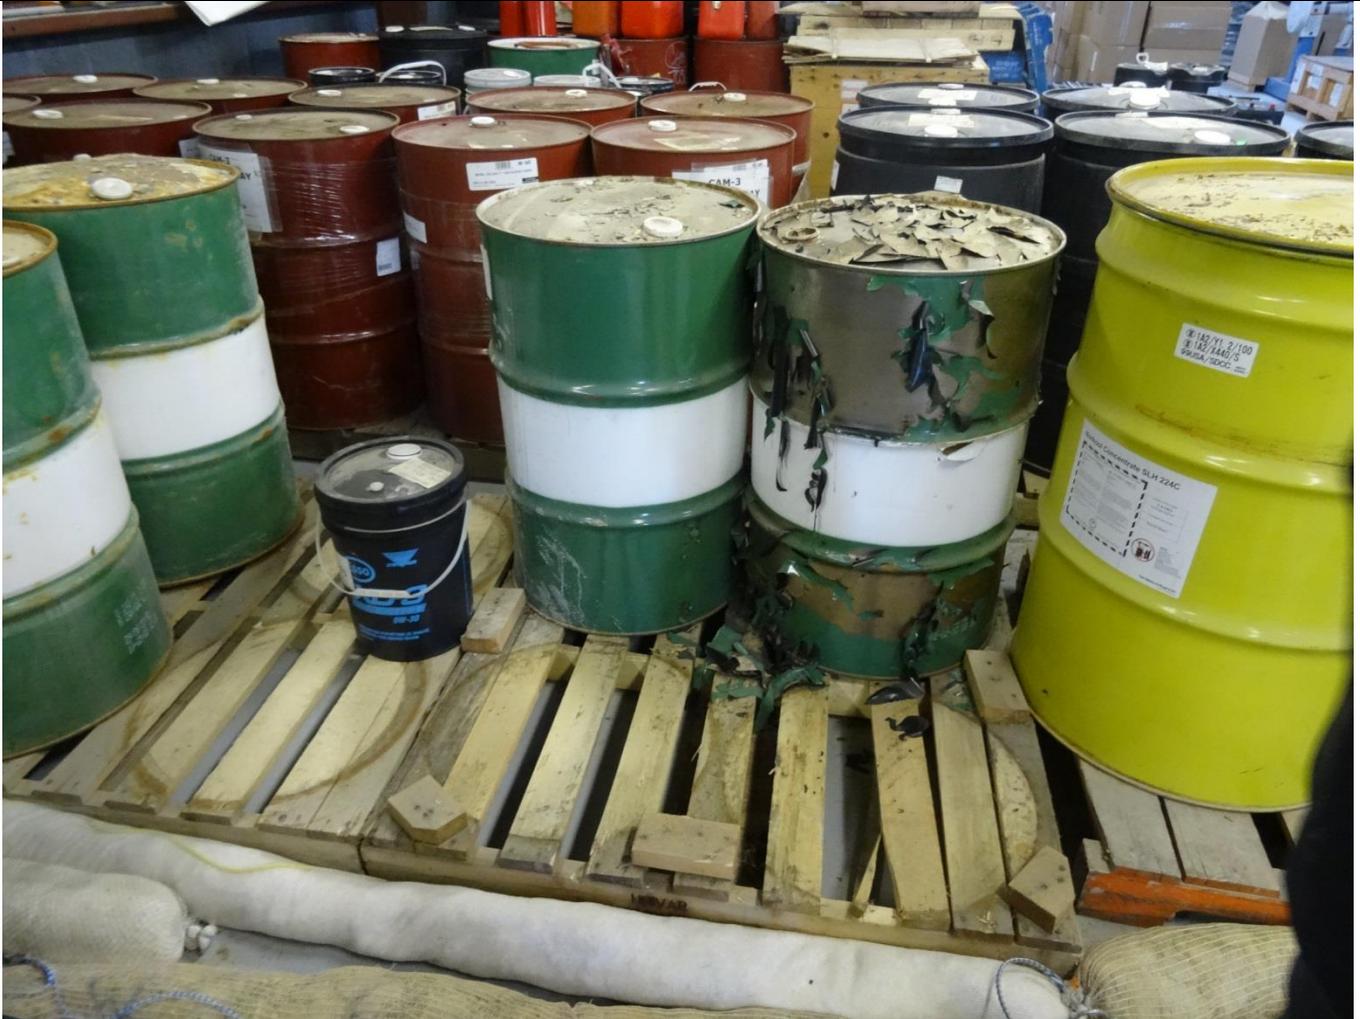
Photo 7

Description: Hazardous Materials Storage inside Warehouse

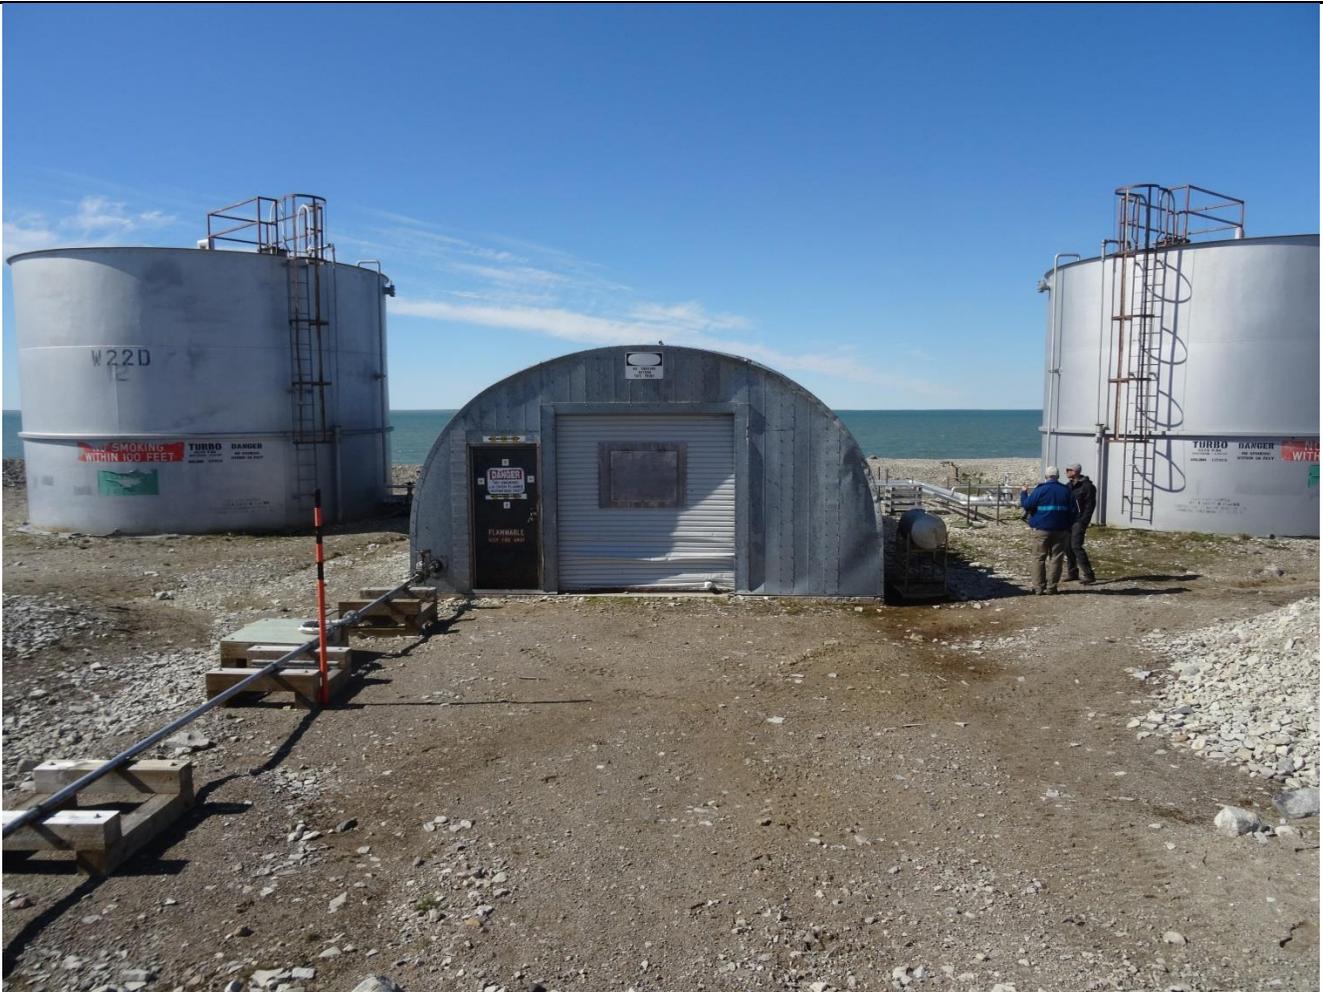
Photo 8

Description: Tanks W22C & W22D- at Beach Area-Well Marked – Berm in Good Condition, Clean and Dry inside

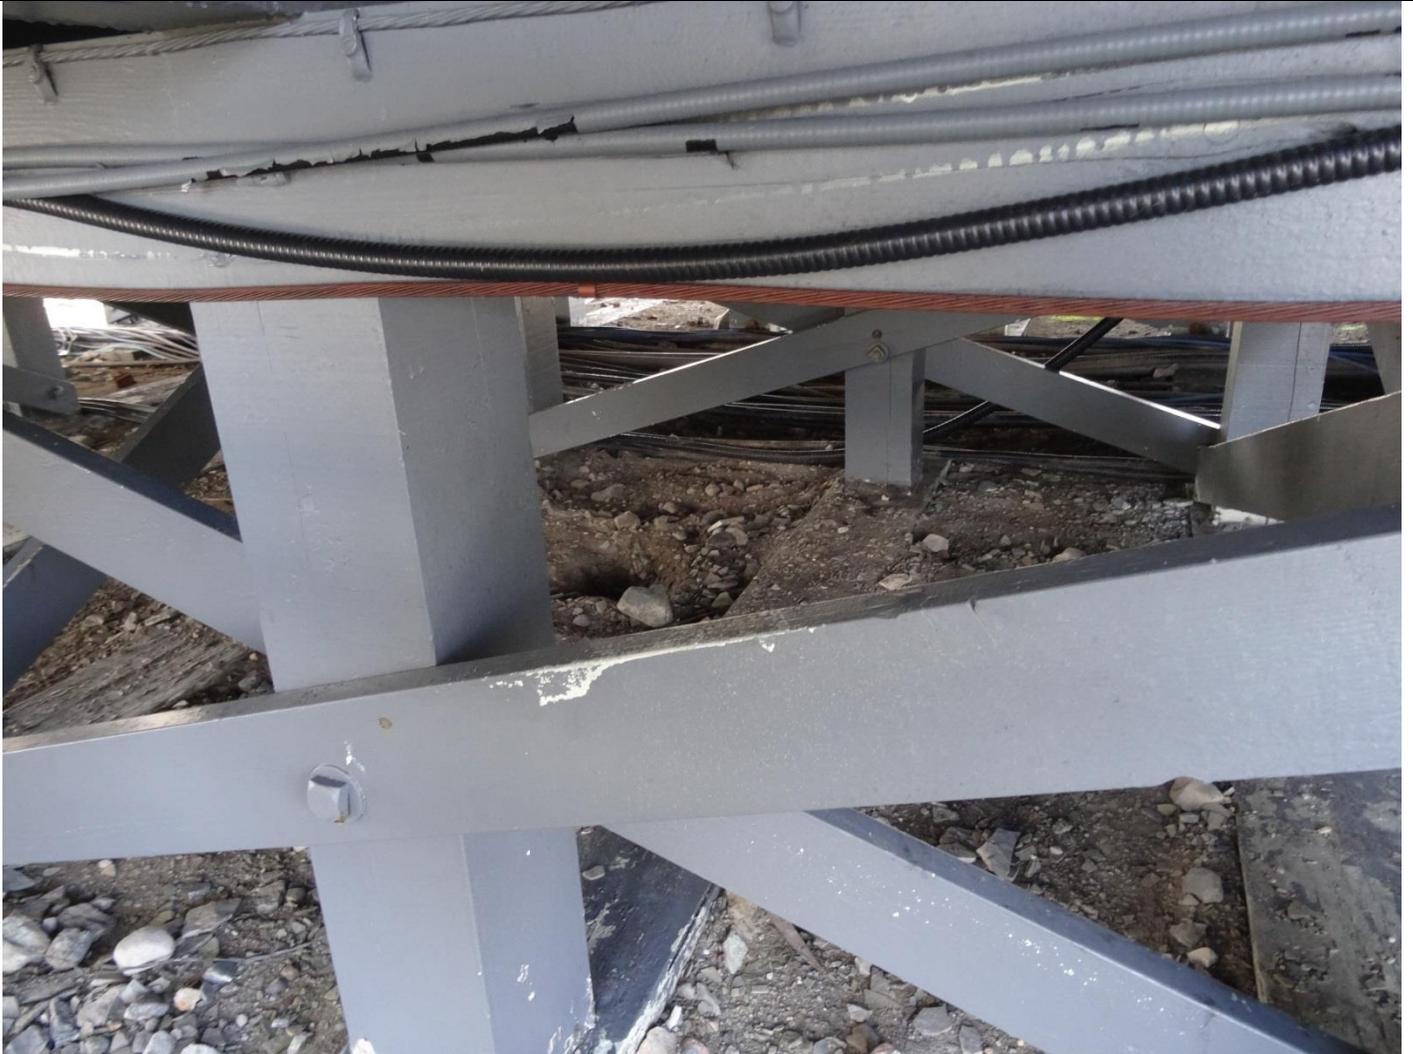
Photo 9

Description: Spill # 16-226 – Under Main Module Building - Cleaned up very nicely, I recommend Closure

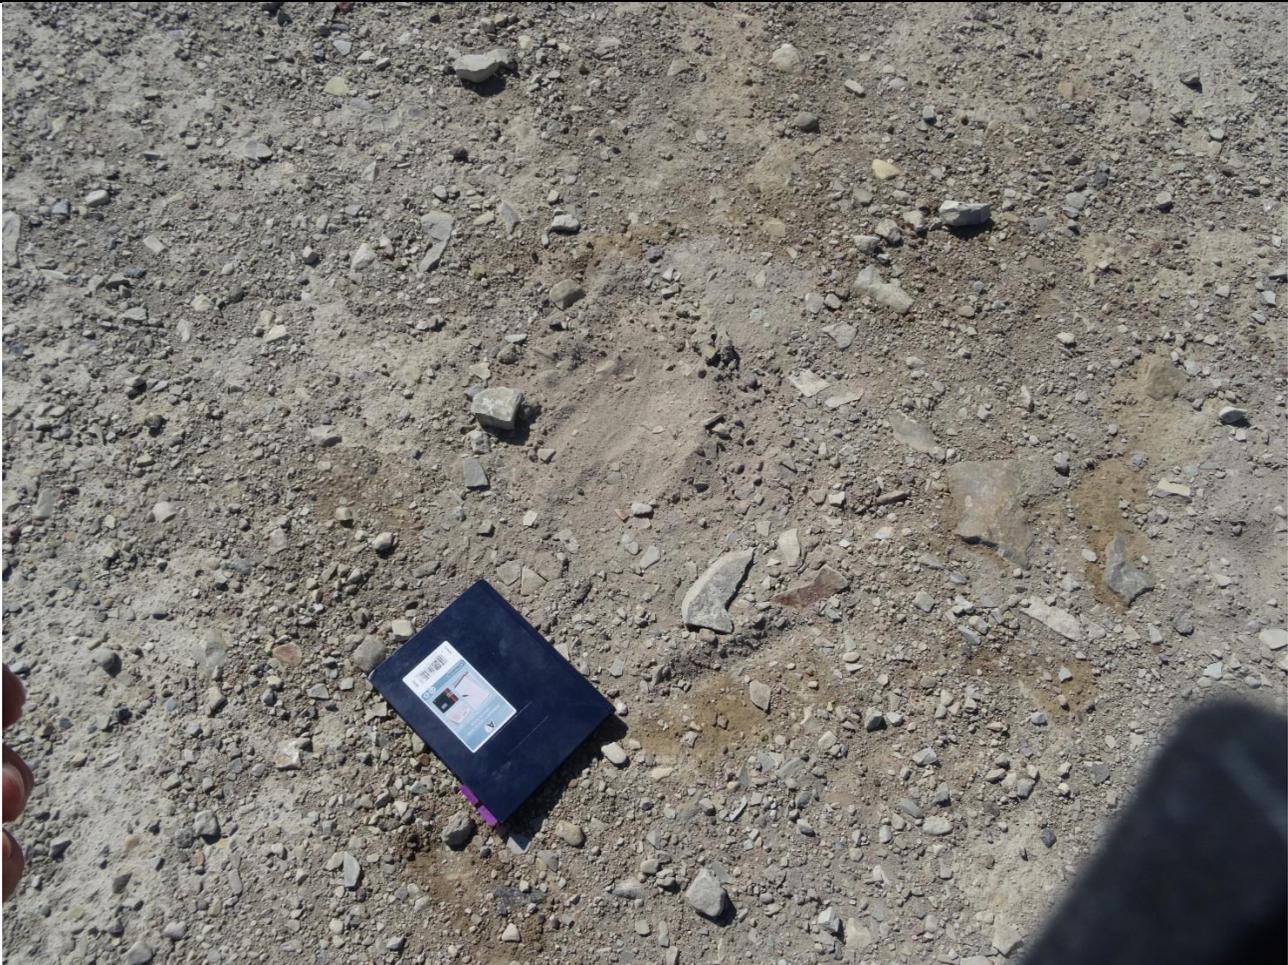
Photo 10

Description: Spill # 17-234 – At Heli Pad - Cleaned up very nicely, I recommend Closure
