Nunavut Impact Review Board

2024 Site Visit Report

**Meliadine Gold Mine Project**

NIRB File No. 11MN034

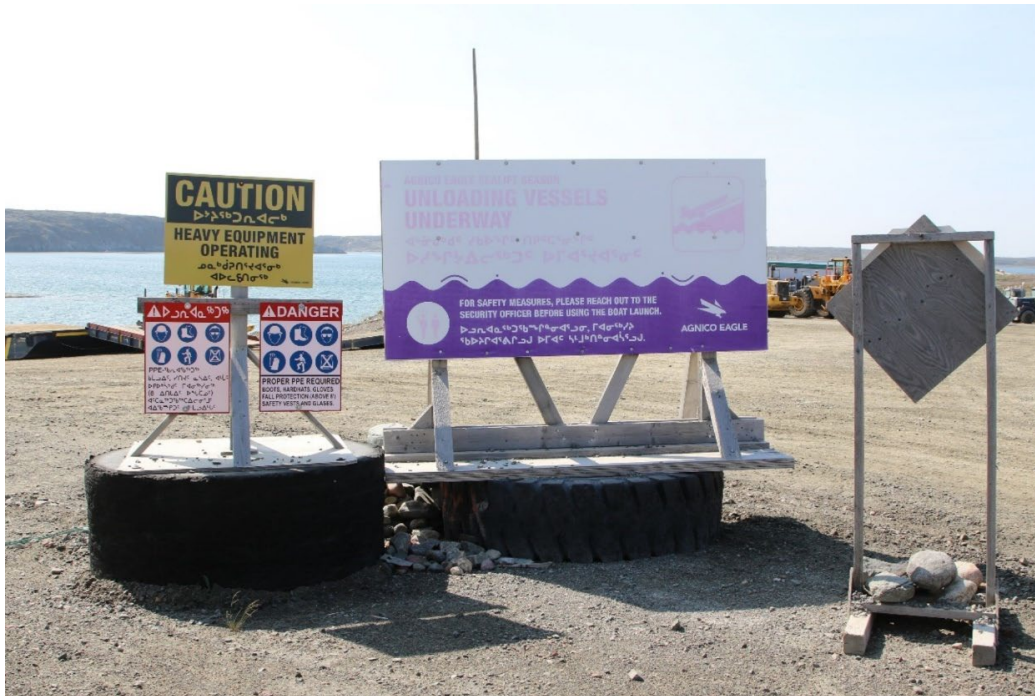
Photo 1: Signage at Laydown Area at Itivia Harbour.

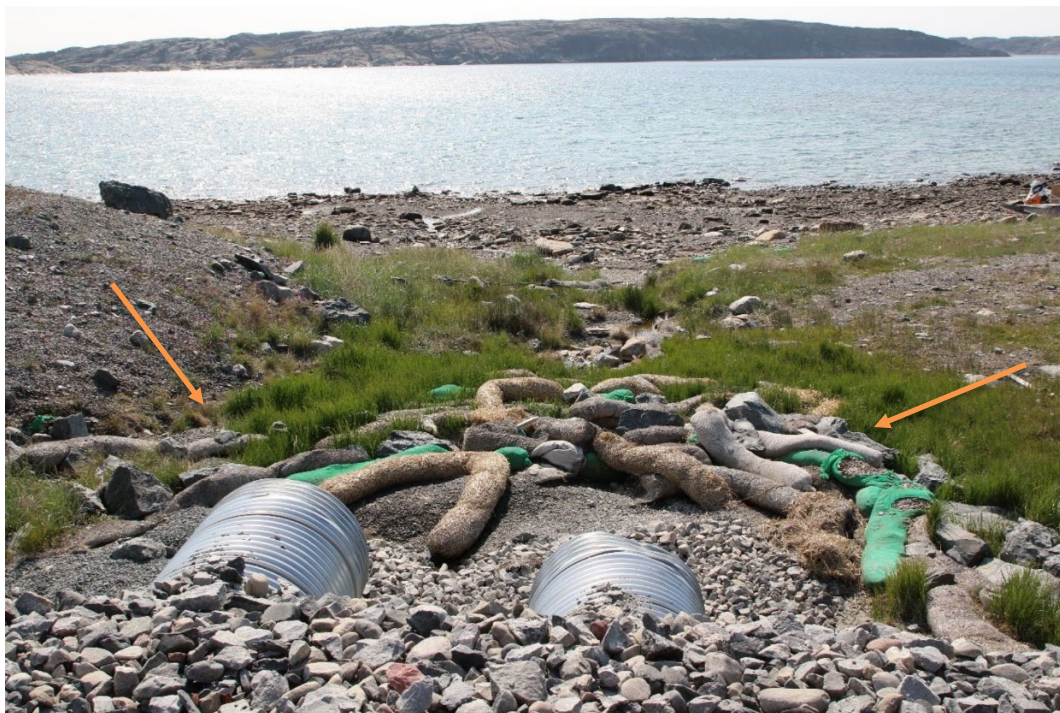
Photo 2: Sediment management at Laydown Area to Itivia Harbour.

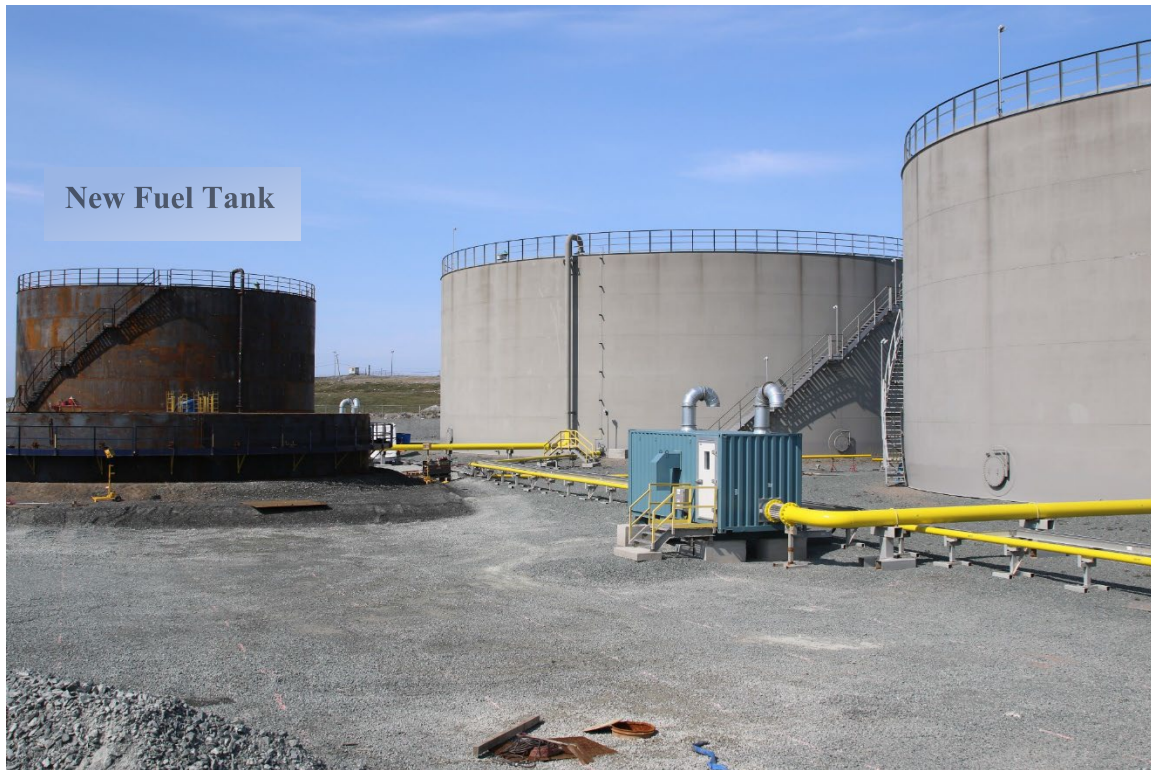
**Photo 3: Fuel tanks at Itivia Harbour within secondary containment.**

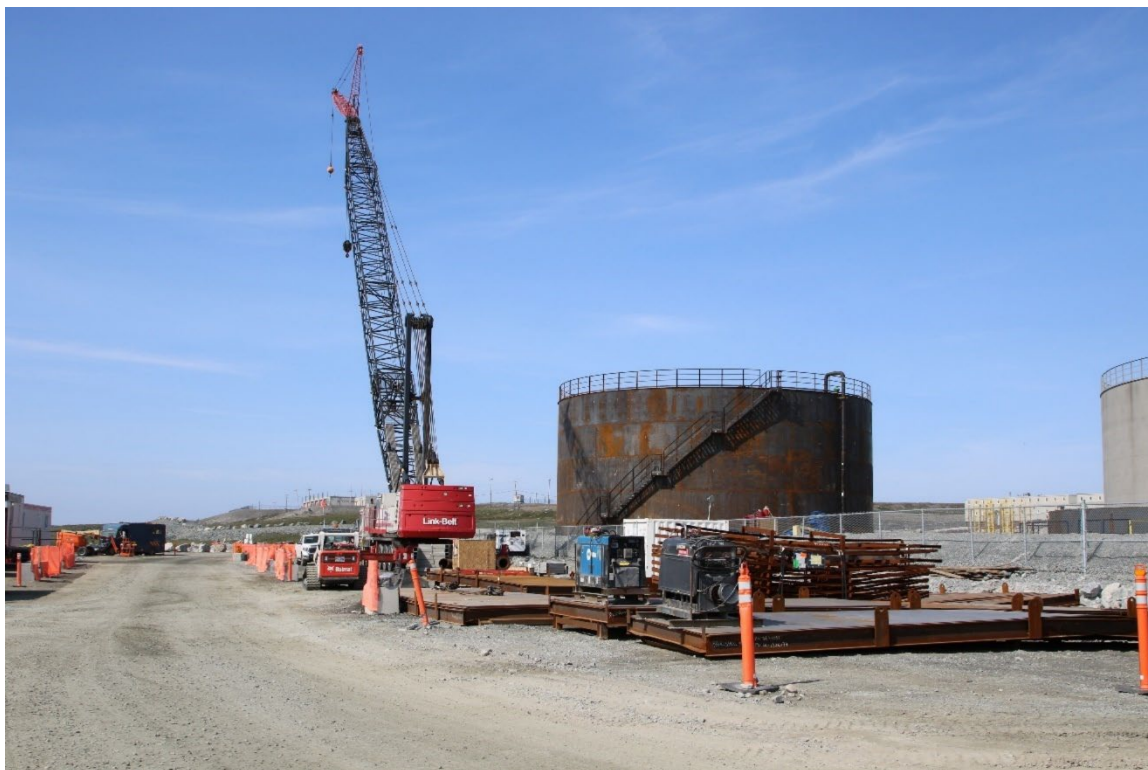
**Photo 4: Construction of new fuel tank at Itivia Harbour.**

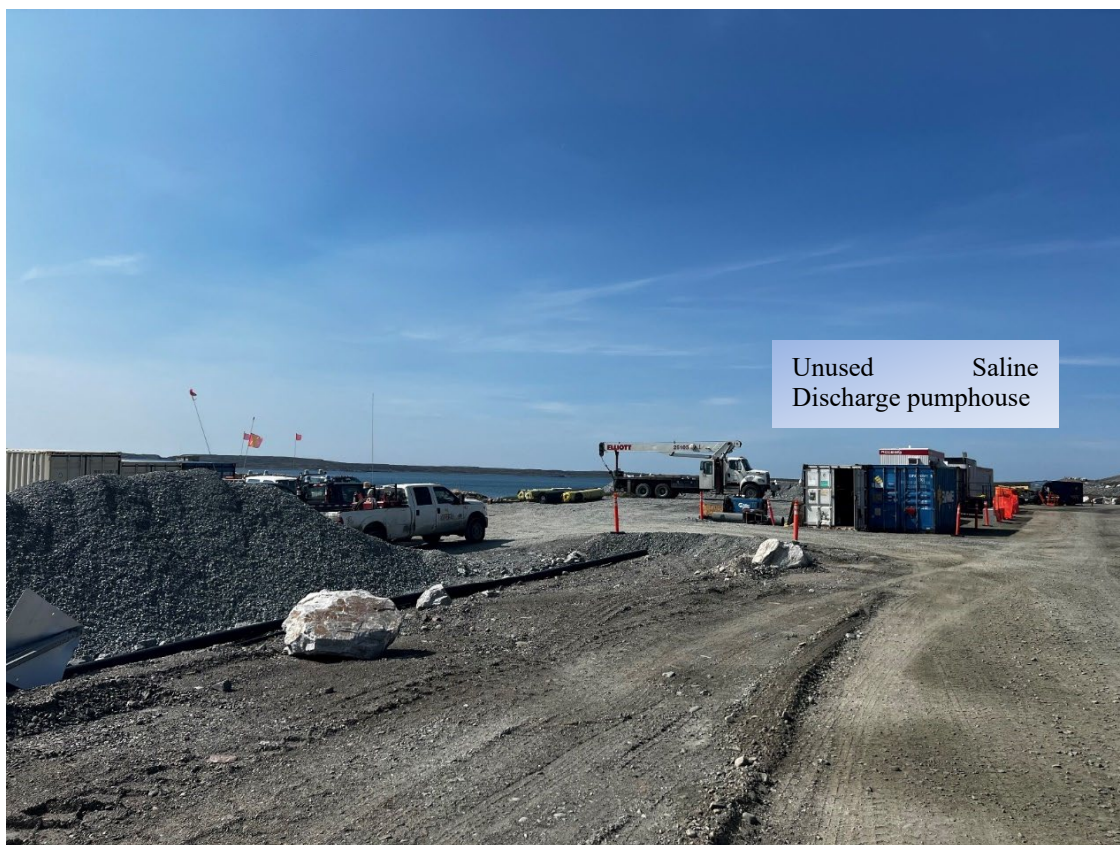
**Photo 5: Saline effluent pumphouse for trucked saline effluent not used in 2024.**

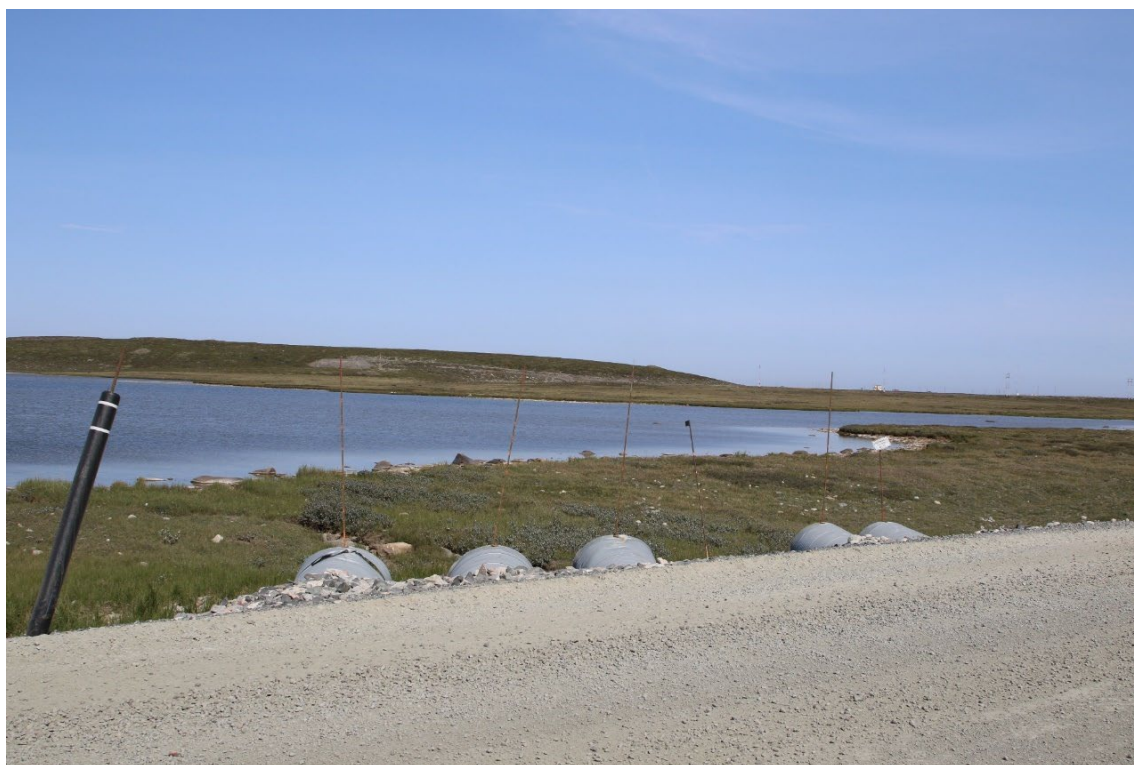
**Photo 6: Culvert #11 along Bypass Road.**

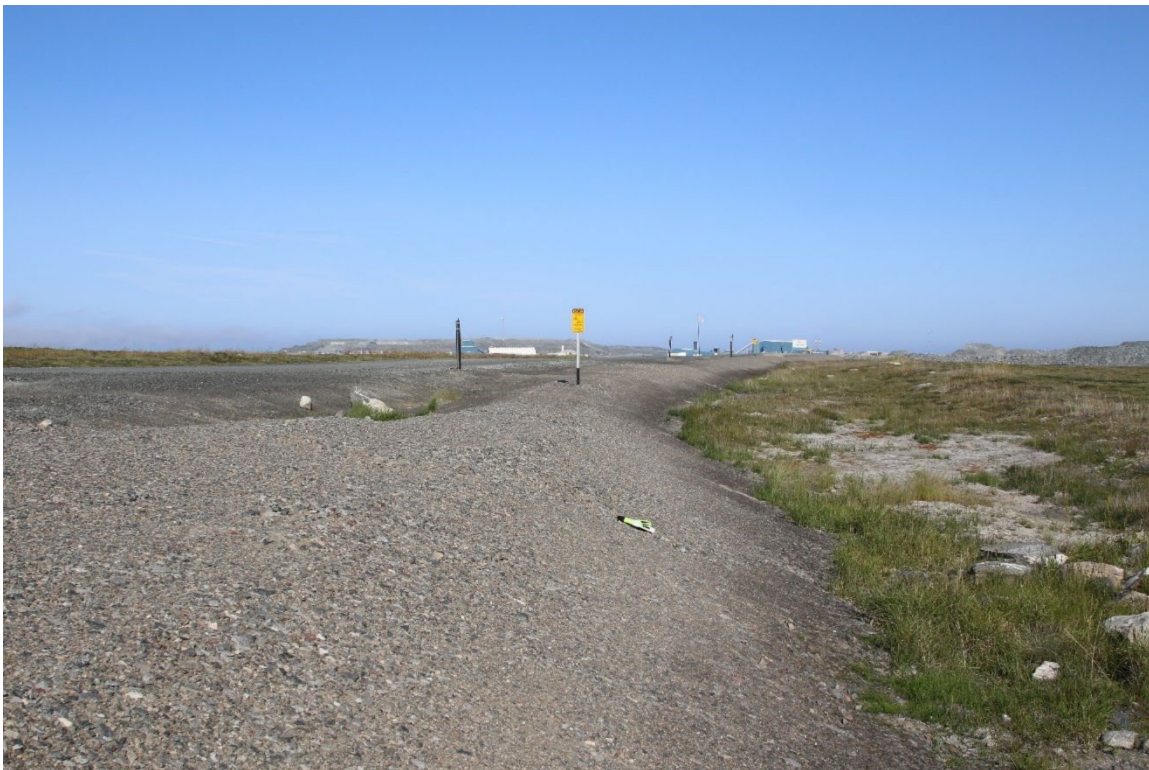
**Photo 8: AWAR and waterline looking west to Mine site.**

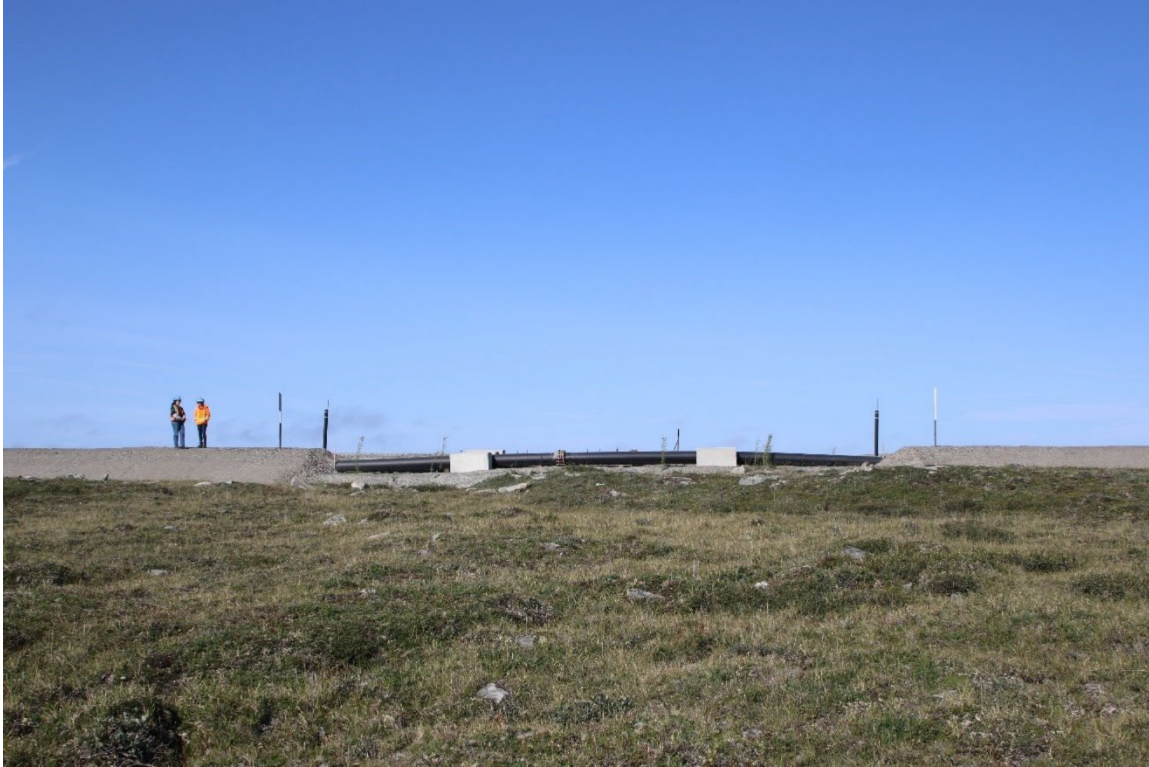
54	Movement of Wildlife	The AWAR is constructed to allow safe passage of caribou.  The NIRB observed a wildlife crossing over a pipeline on site.  Waterlines were being installed along the AWAR. (Photo 9, Photo 10, Photo 18, Photo 19, and Photo 20) Waterlines installation is not yet complete.
Birds and Bird Habitat		
58	Awareness	As a barn swallow had nested in the Paste Plant, Agnico Eagle in 2023 constructed a bird house on site as recommended by Environment and Climate Change Canada. The bird house was moved to the Expo Camp in 2024. (Photo 48)
59	Species at Risk	
62	Protection of nests found with a buffer zone	
Marine Environment		
77	Spill Prevention	As in previous years, spill kits were observed at various locations across the Project, including at road-side quarries, emergency sea cans on the side of the

**Photo 9: Looking south at uncovered waterline from tundra.**

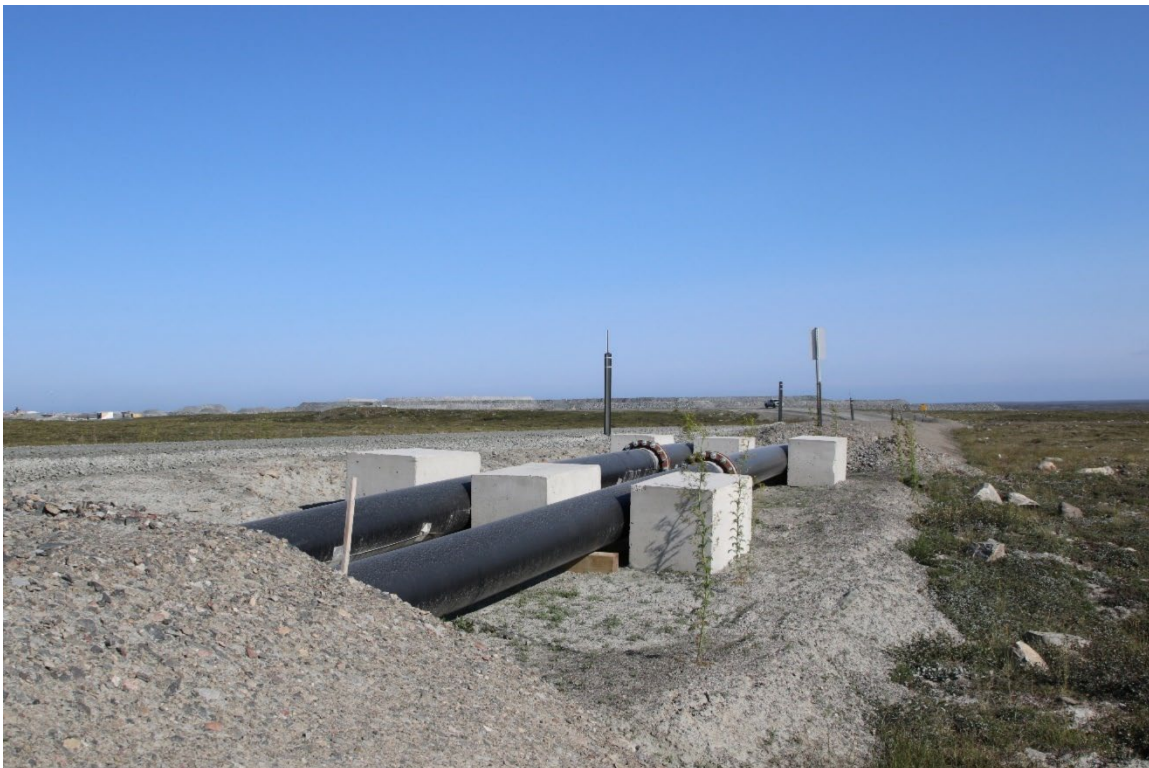
**Photo 10: Looking west at uncovered waterline same location as previous photo.**

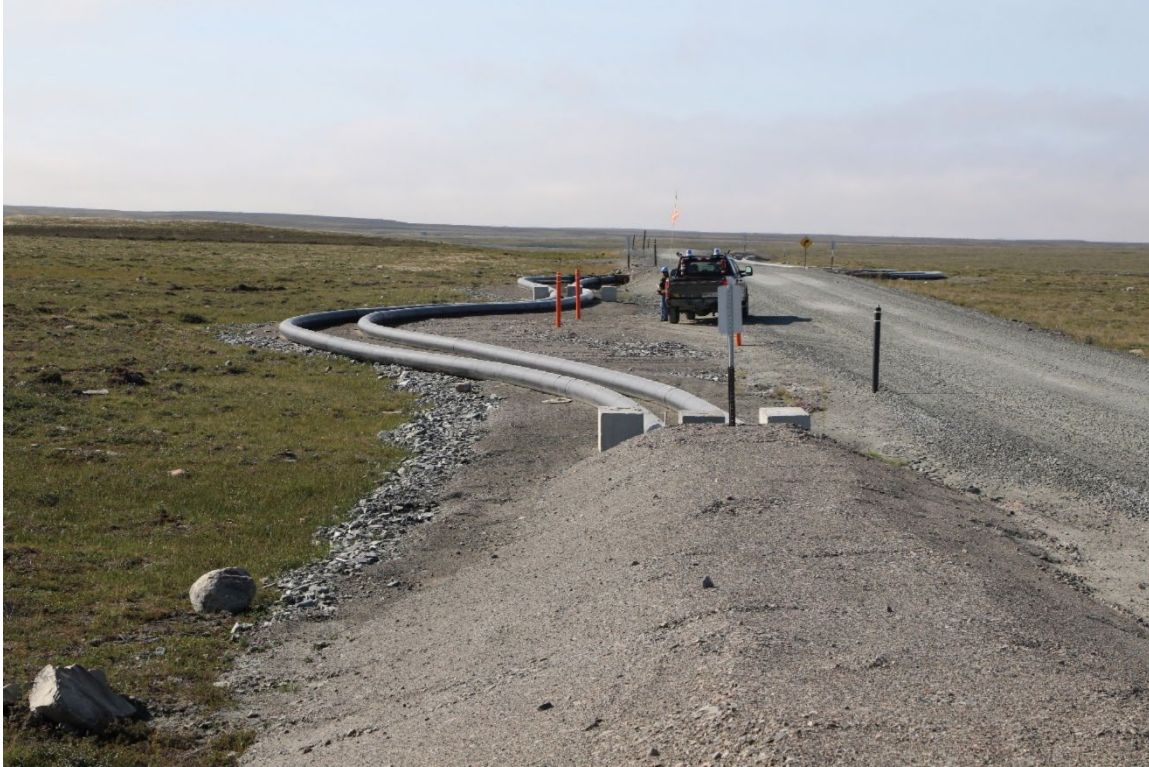
**Photo 11: Looking west at raised waterline and the crossing under the AWAR same location as Photo 9.**

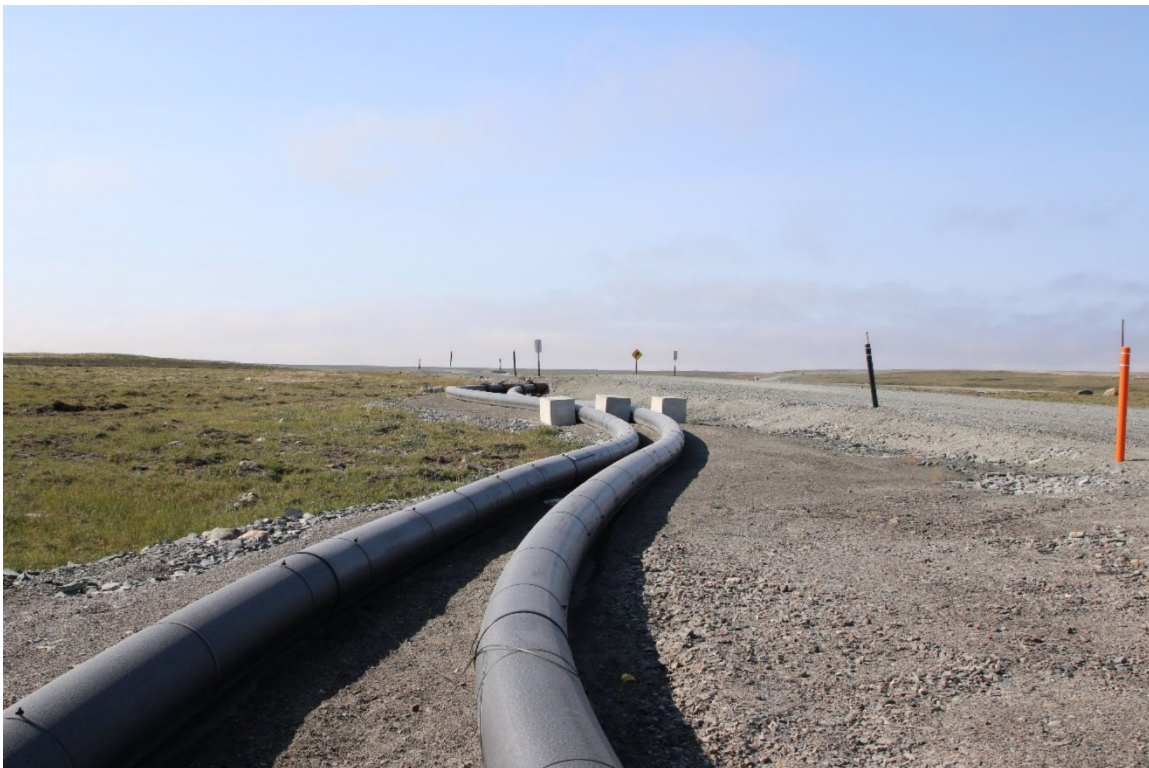
**Photo 12: Waterline crossing under the AWAR from north to south side looking west.**

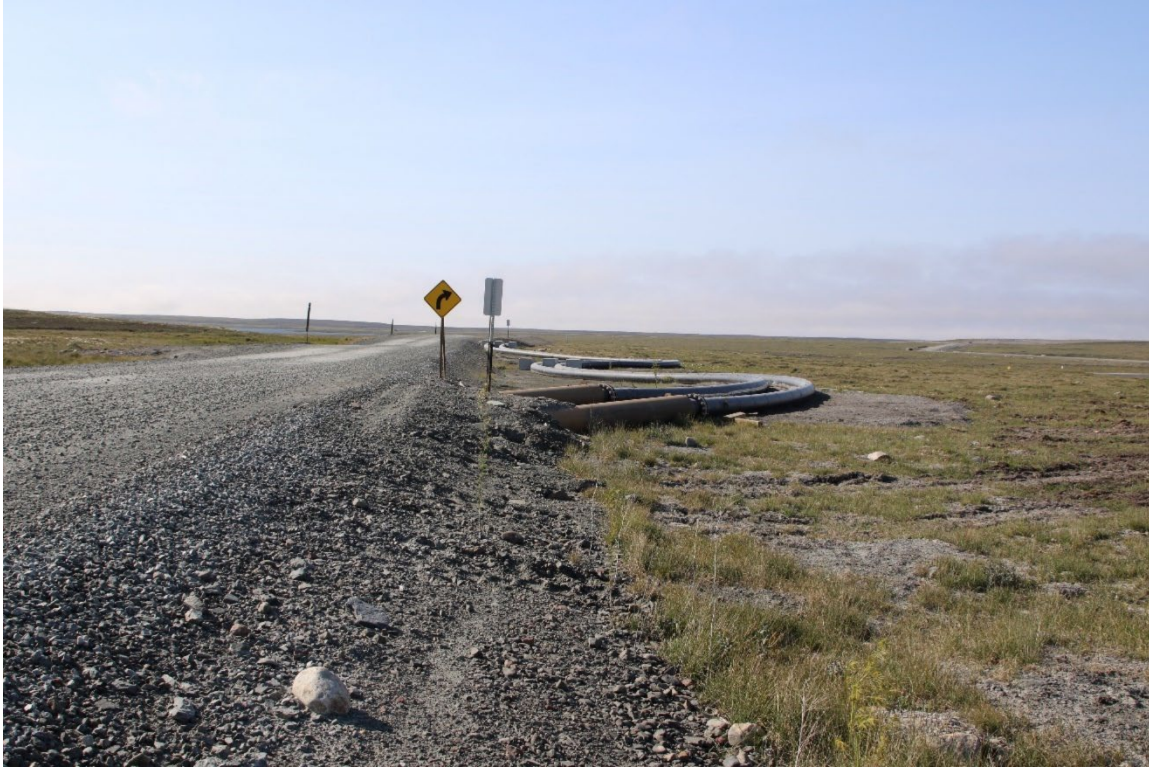
**Photo 13: Uncovered waterline crossing on the south side of AWAR same location as previous photo and waterline crosses under AWAR several times.**

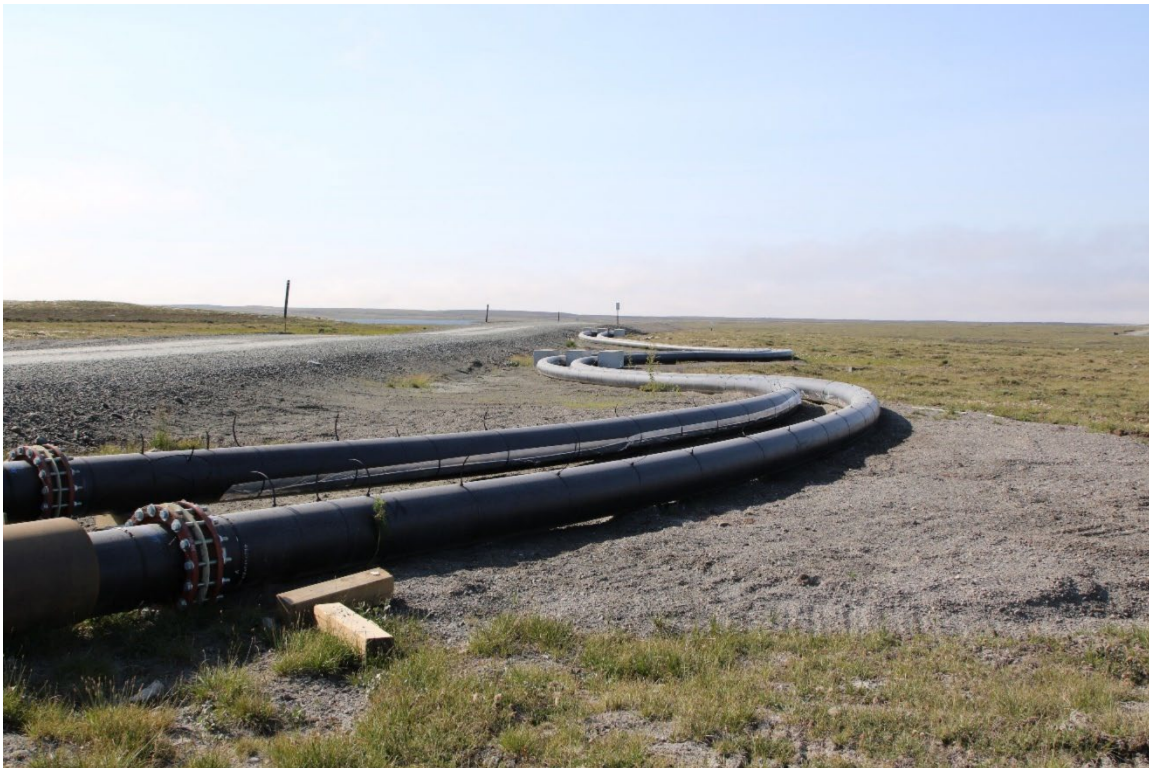
**Photo 14: Uncovered waterline closer view from previous photo.**

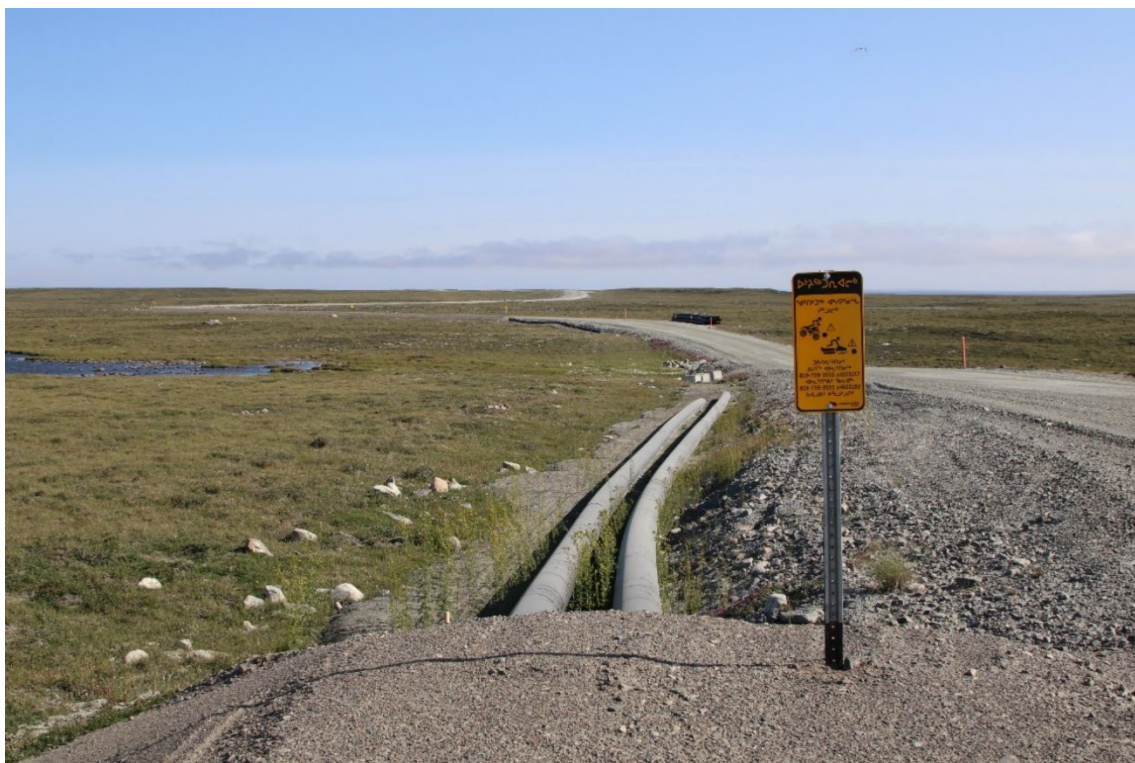
**Photo 15: Section of AWAR awaiting construction on north side, waterline installation pending.**

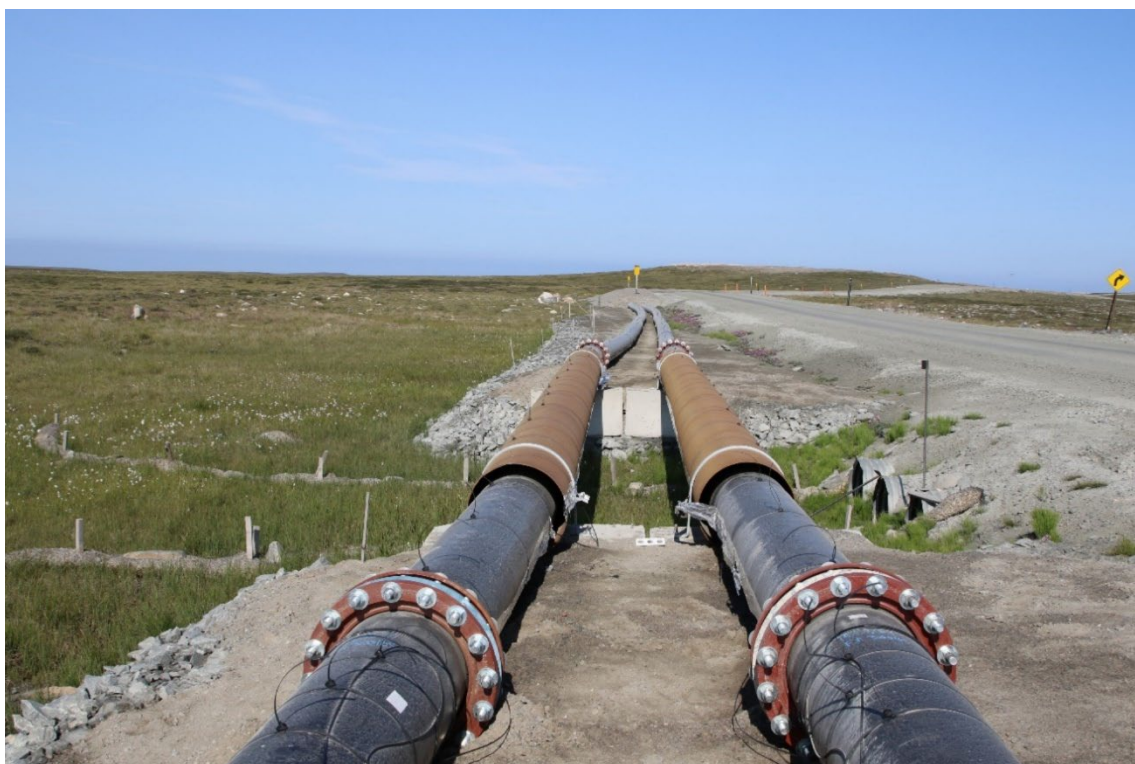
**Photo 16: Suspended waterline to maintain waterflow in the area north side of road, view looking west.**

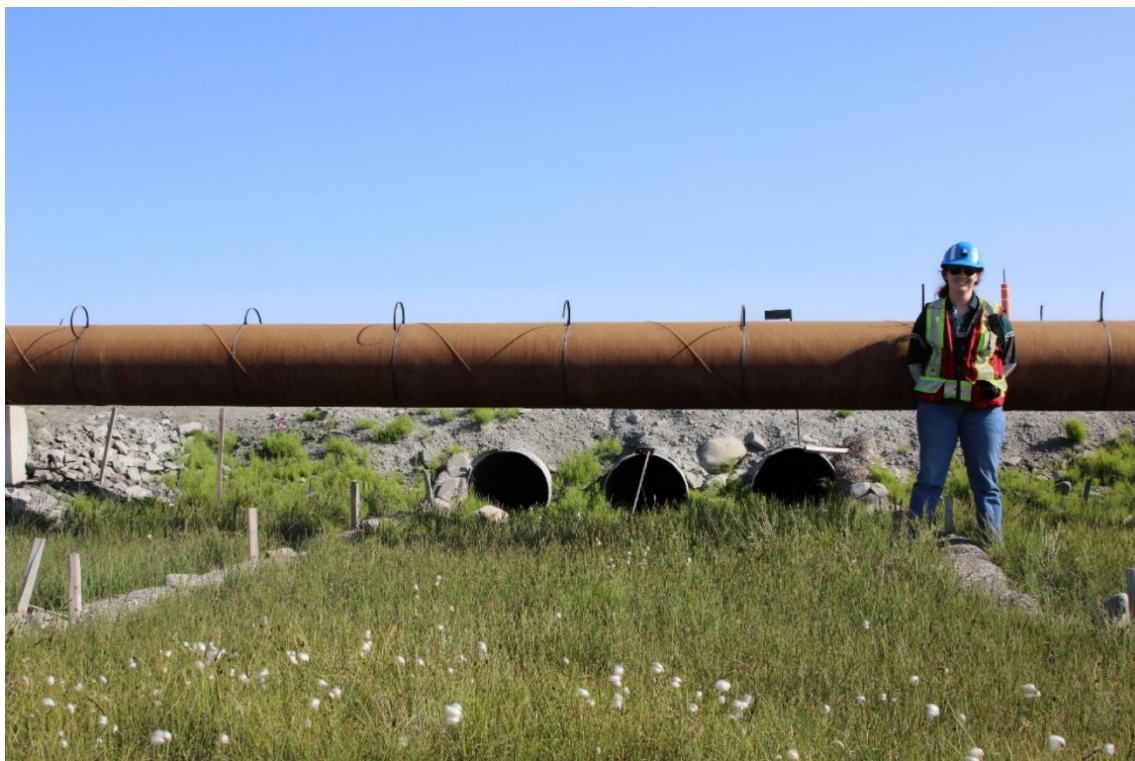
**Photo 17: Suspended waterline to maintain waterflow in the area on south side of AWAR, same location as previous photo.**

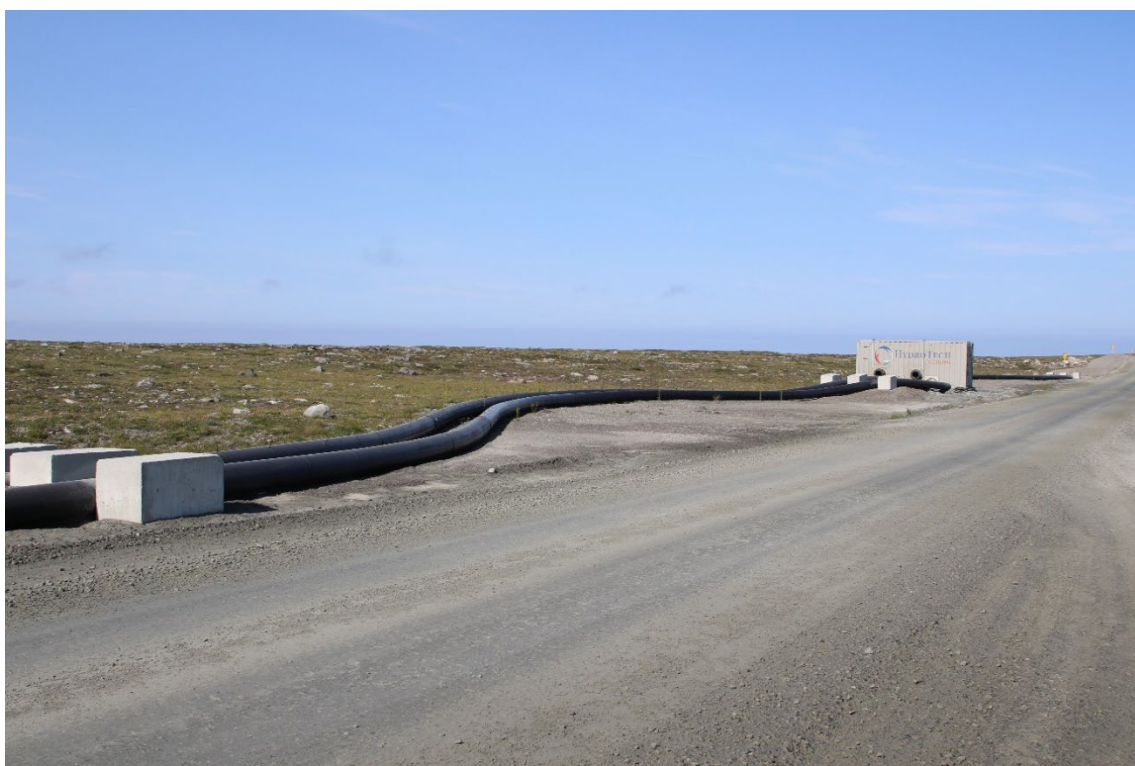
**Photo 18: One of several lift stations along AWAR to help send saline effluent to Itivia Harbour.**

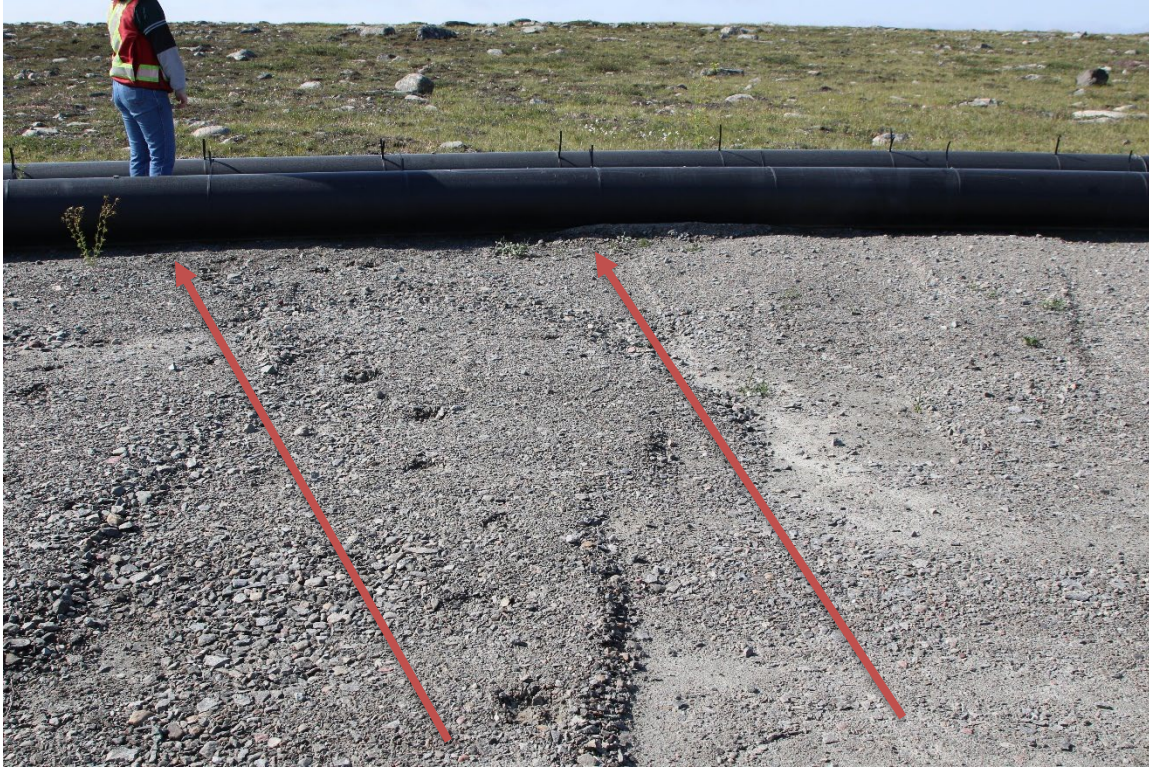
**Photo 19: Caribou track crossing the waterlines by the lift station.**

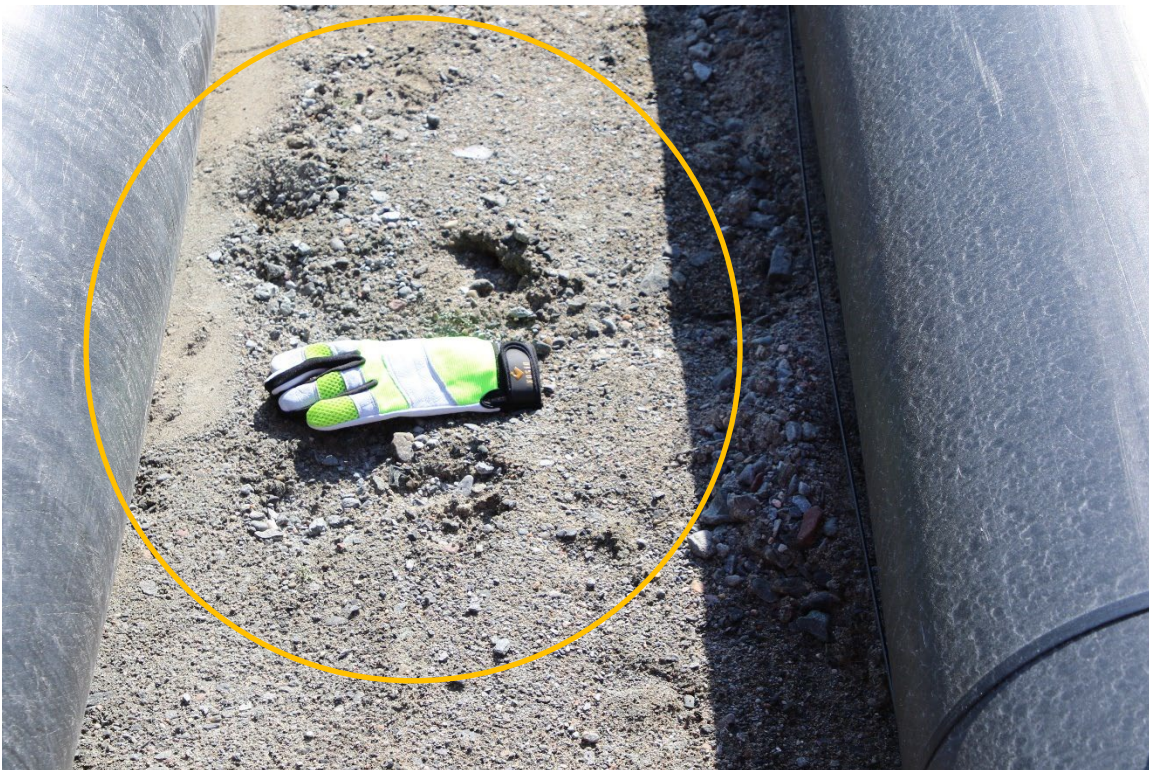
**Photo 20: Caribou tracks between the waterlines by the lift station.**

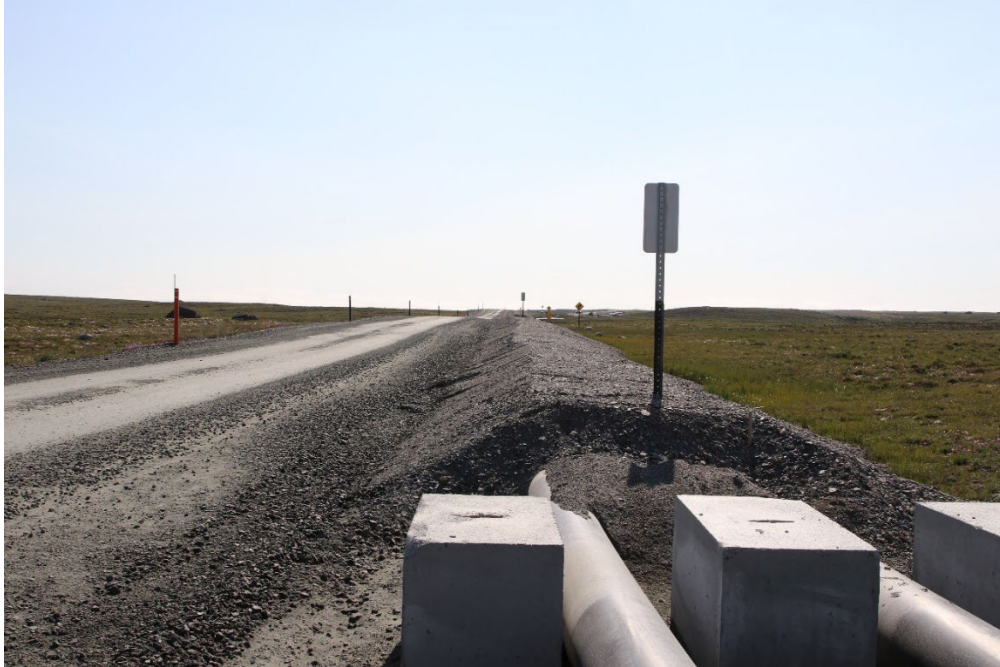
**Photo 21: Raised waterline profile, waterline on south side of AWAR looking east.**

- As the waterline installation has progressed there were several locations and/or lengths along the AWAR where the waterlines are higher than the road. This was not identified as something that may occur during the assessment of the waterlines, and this may cause a hazard to equipment and wildlife that cross during the winter and spring months when the road and waterline infrastructure may become snow covered; and
- Sections of uncovered waterline have cement structures to assist with retaining the waterlines in place were not marked/identified on the tundra. This may be a hazard to anyone who is accessing the land for traditional activities during the winter and spring months. The AWAR was constructed with slopes to allow both humans and wildlife to cross the road with limited difficulty which is now changed with the steeper and higher slopes.

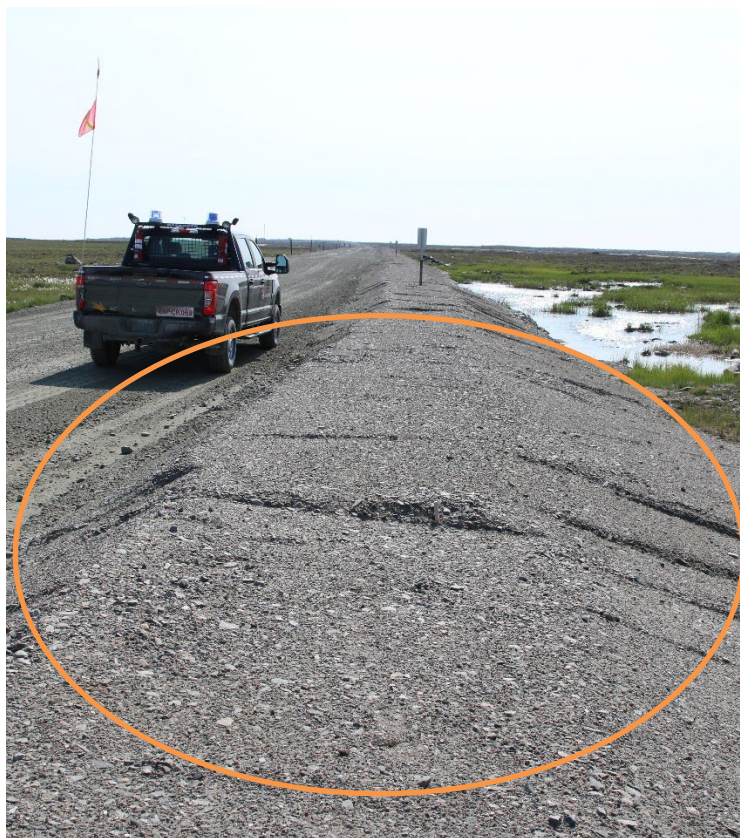
**Photo 22: Raised waterline profile, waterline on south side of AWAR with rills/natural settling looking east.**

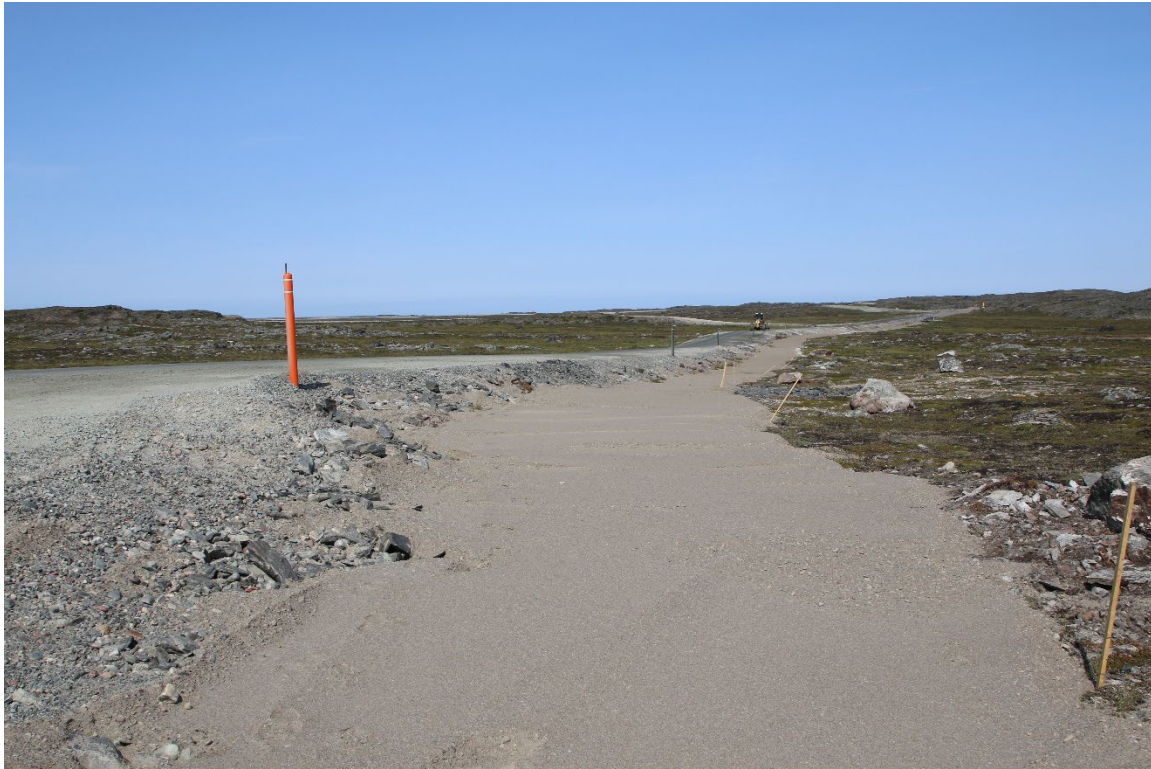
**Photo 23: Installation of bedding for the waterlines, north side AWAR looking west.**

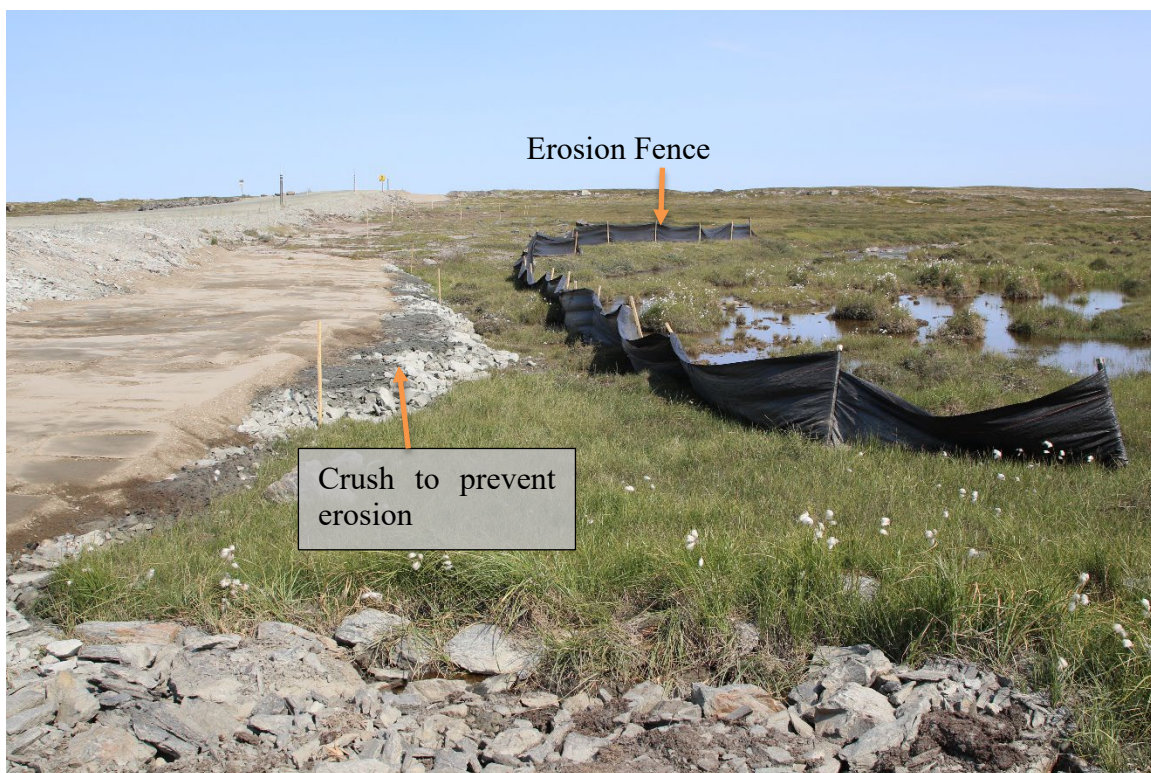
**Photo 24: Erosion mitigation during waterline installation, north side AWAR looking west.**

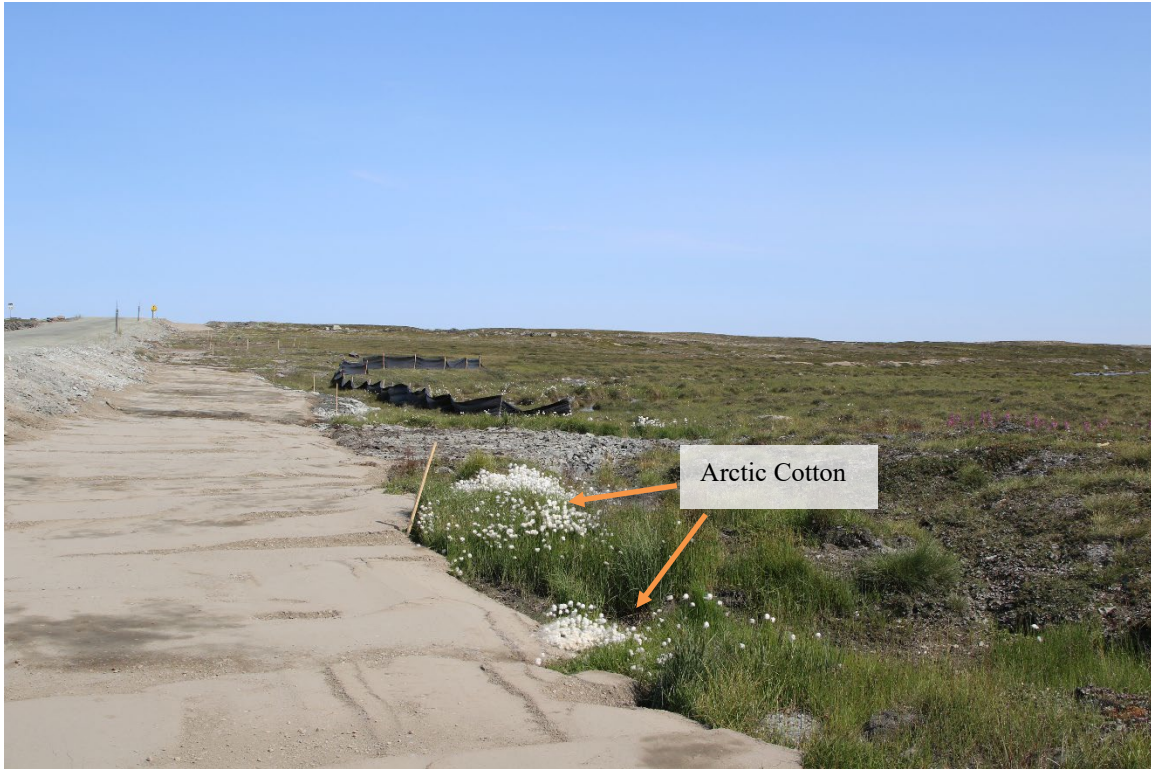
**Photo 25: Erosion Mitigation during waterline installation, north side AWAR looking west. Pam demonstrated how to collect Arctic cotton for Qillaq use.**

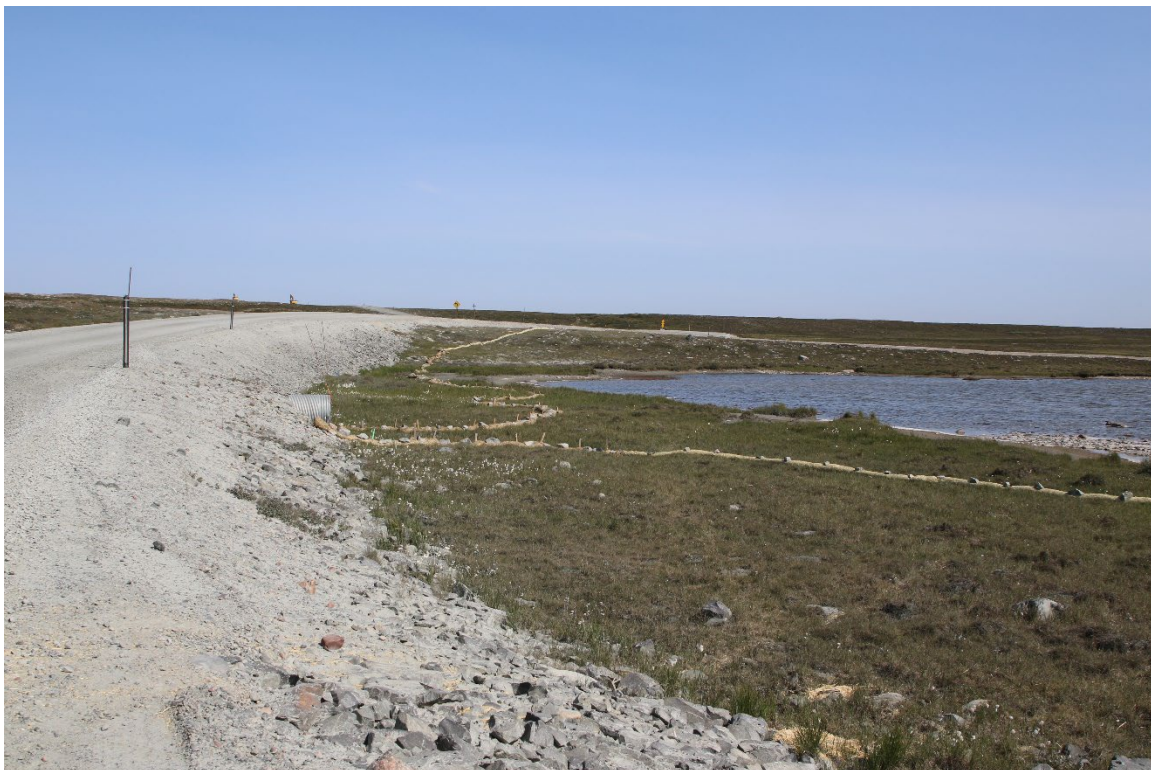
**Photo 26: Erosion mitigation north side of AWAR Culvert 14 looking west.**

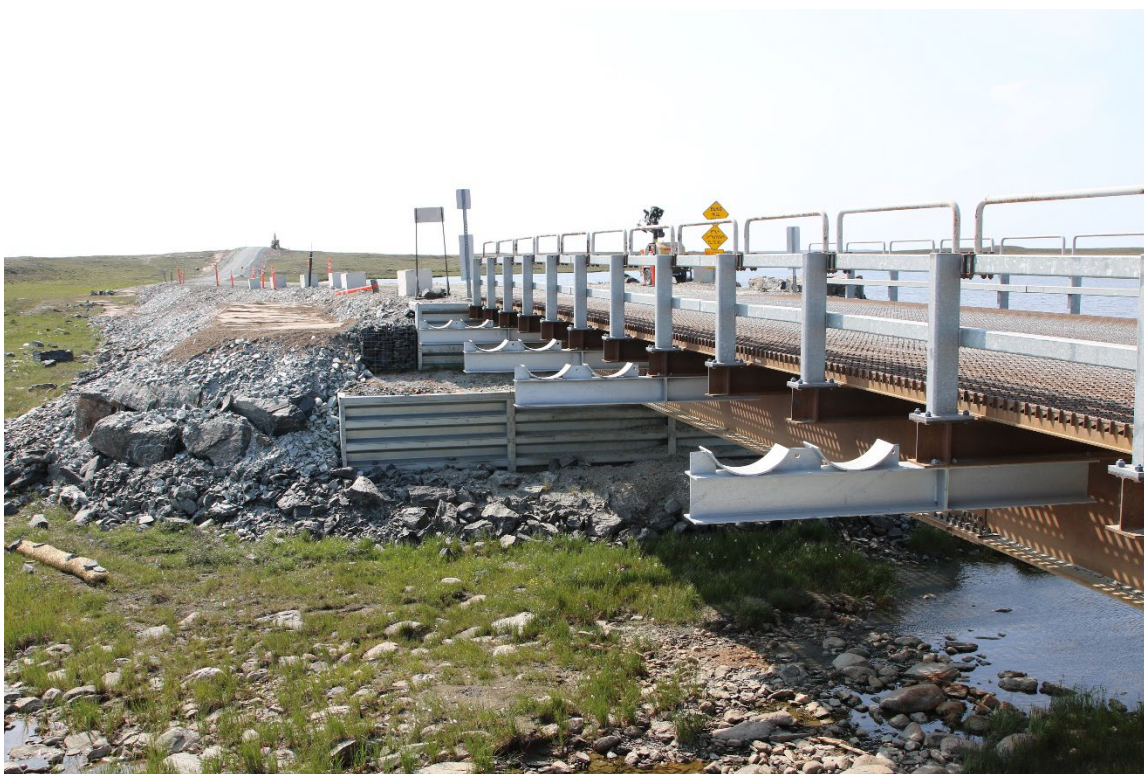
**Photo 27: Example of bridge preparation for waterlines installation, south side looking west.**
