Nunavut Impact Review Board

2024 Site Visit Report

**Meliadine Gold Mine Project**

NIRB File No. 11MN034

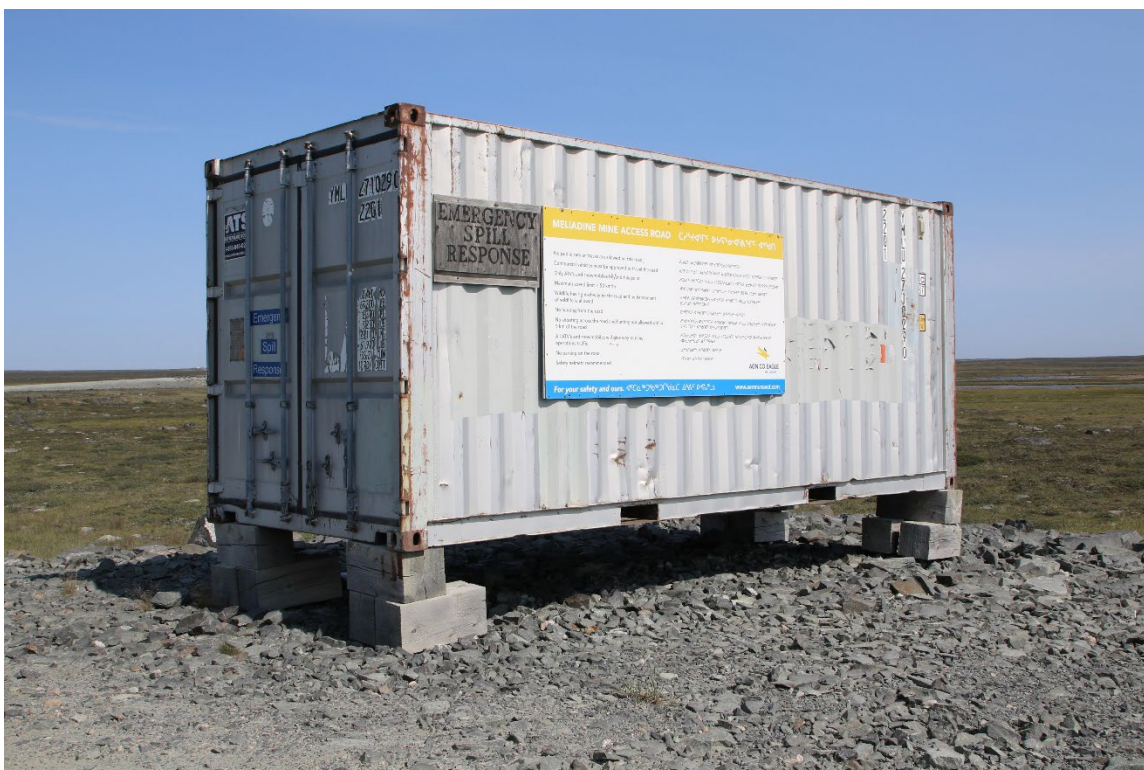
T&C No.*	Topic	Site Observations
		AWAR, and adjacent to fuel storage areas. ( <a href="#">Photo 28</a> )
<b>Accidents and Malfunctions</b>		
125	Measures to protect public and mine traffic on all Project roads including the AWAR.	<ul style="list-style-type: none"> <li>a) The manned gate on the AWAR was operational and recording traffic, including all-terrain vehicles (ATVs). All public traffic is required to check-in with the employee at the gatehouse prior to proceeding on the AWAR.</li> <li>b) The NIRB observed Agnico Eagle calling public ATVs on the radio so other vehicles would know of their presence and location.</li> <li>c) Road signs were posted in English and Inuktitut indicating access and safety requirements of AWAR.</li> <li>d) The NIRB observed speed limit signs along the AWAR.</li> </ul>

**Photo 28: One of the Spill Response seacans located at each water crossing location.**

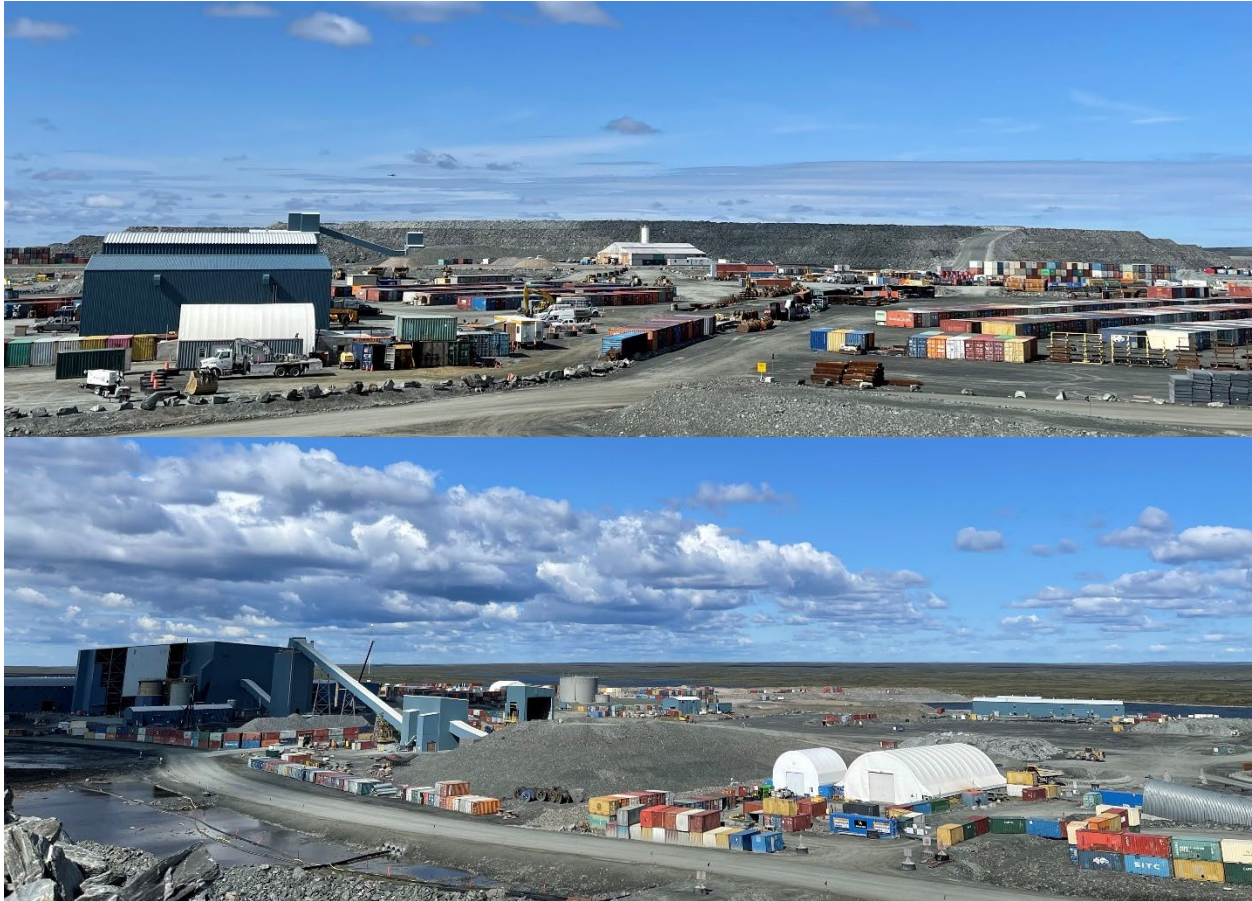
**Photo 29: Overview of Mine Site top photo looking west and bottom looking east.**

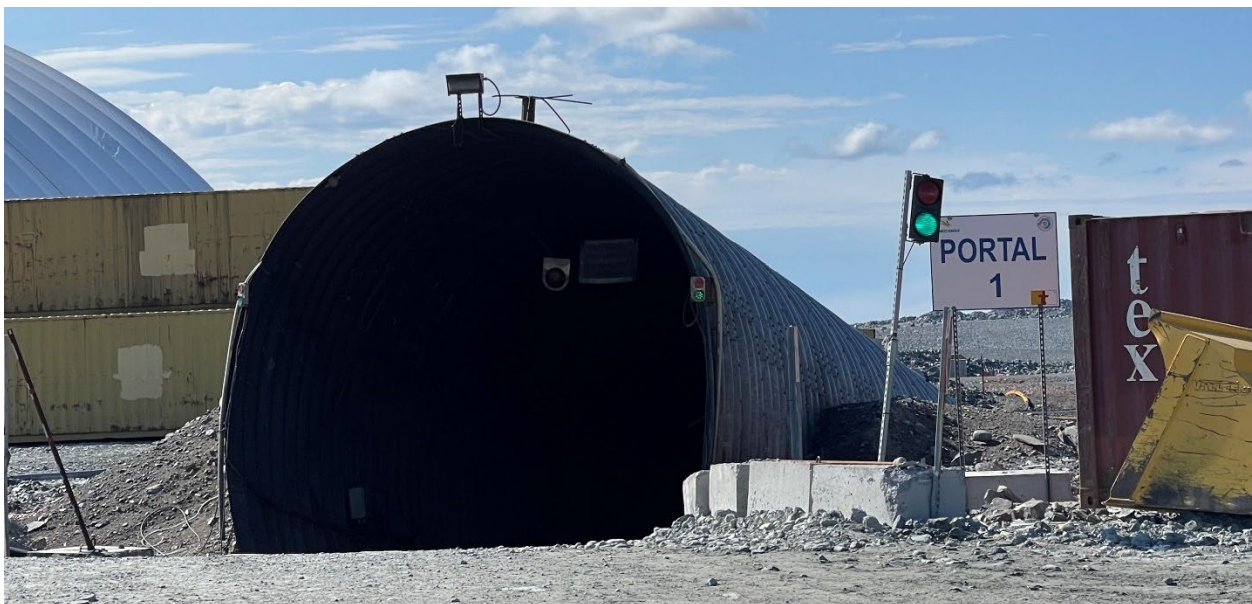
**Photo 30: Portal 1 for Tiriganiaq Underground.**

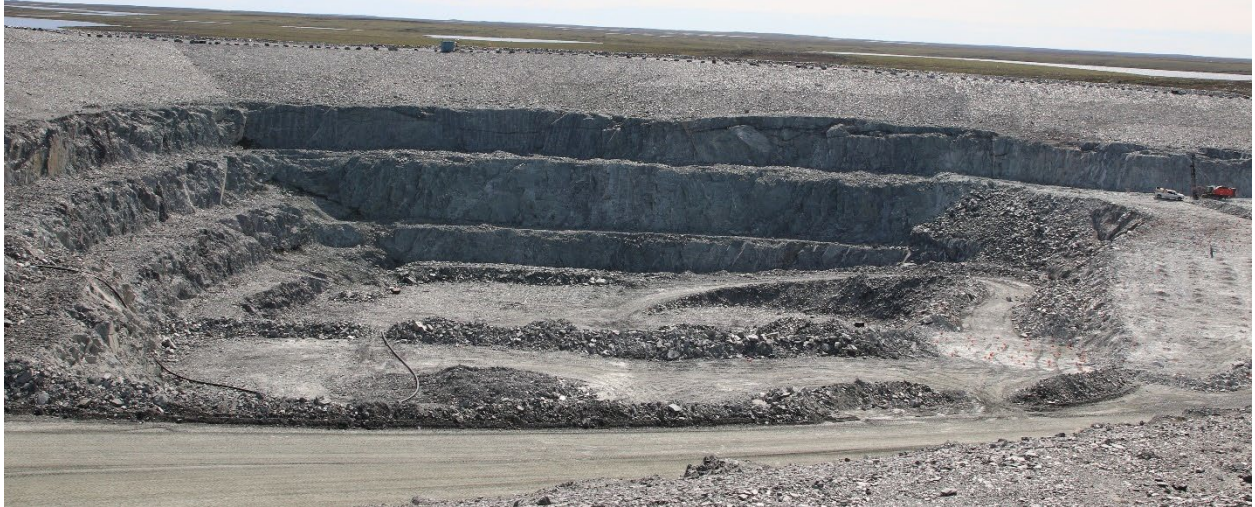
**Photo 31: Tiriganiaq pit 1 – 2022**

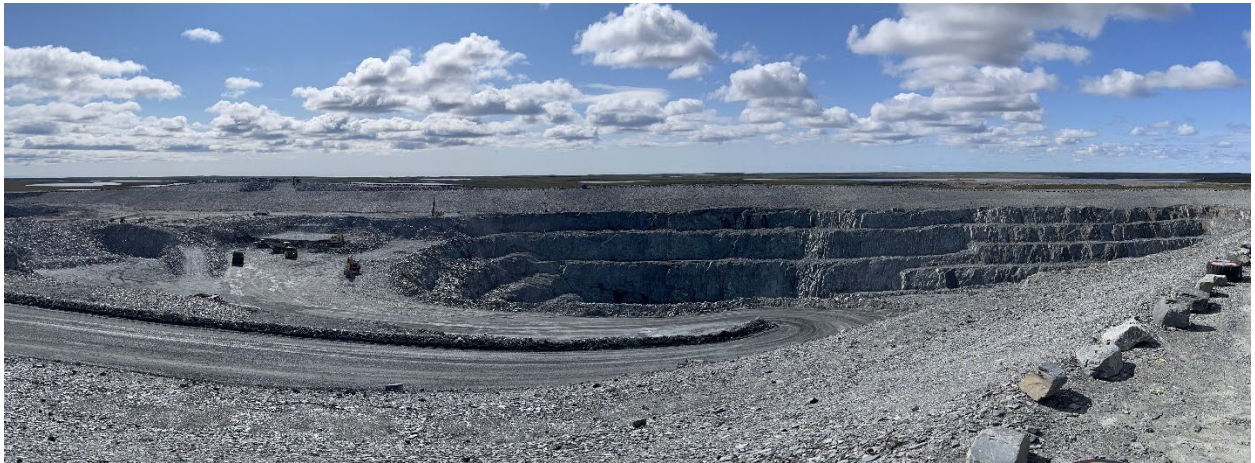
**Photo 32: Tiriganiaq pit 1 – 2023**

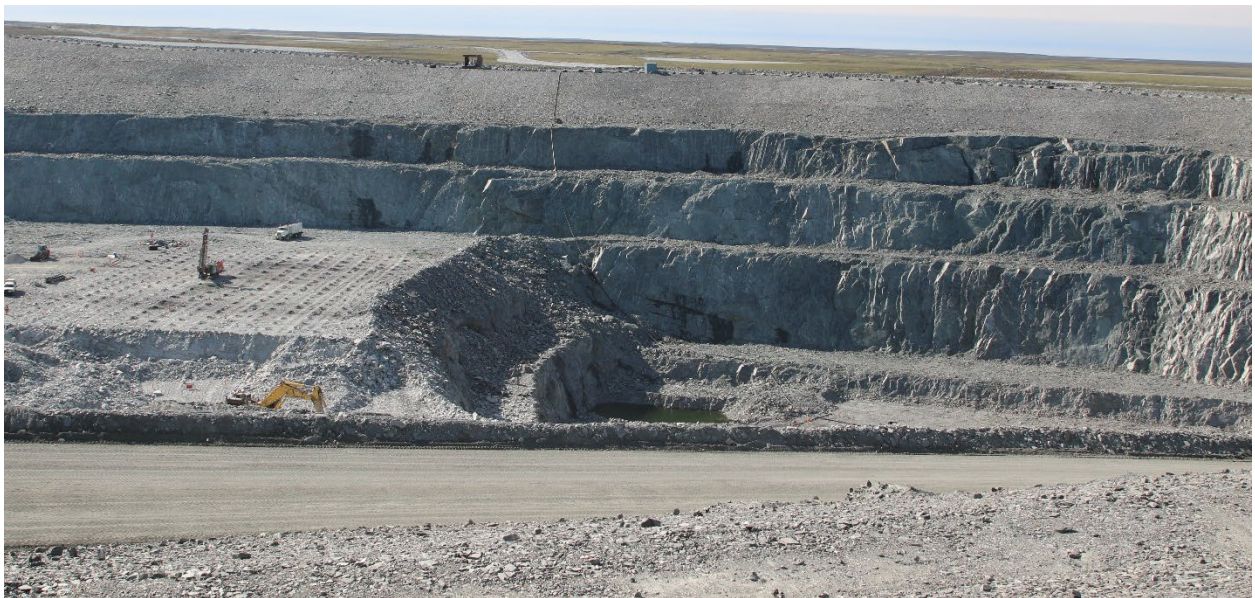
**Photo 33: Tiriganiaq pit 1 – 2024**

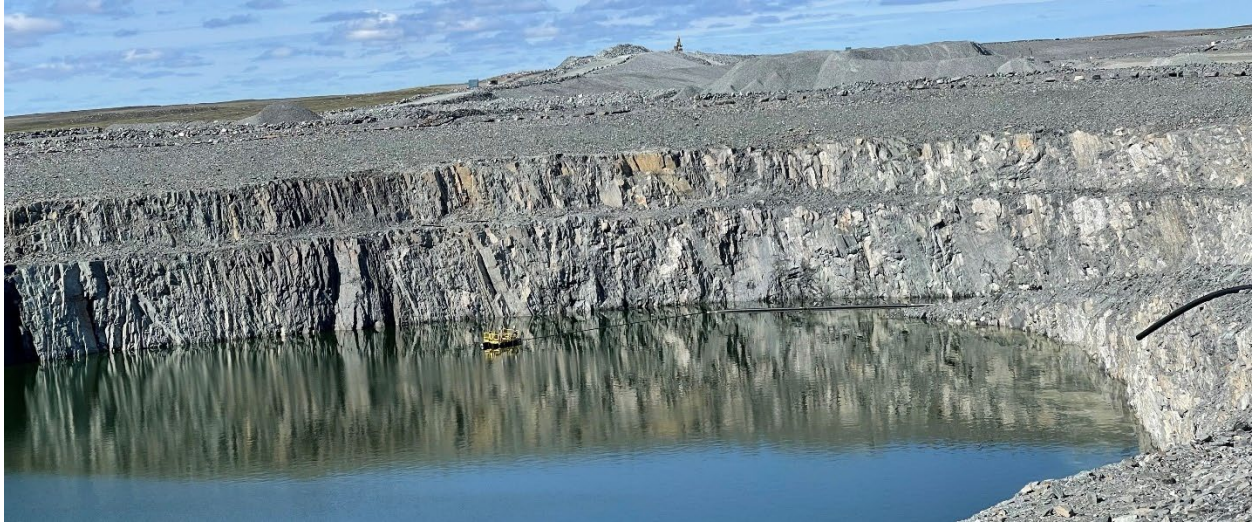
**Photo 34: Tiriganiaq Pit 2 - used for saline effluent storage 2023**

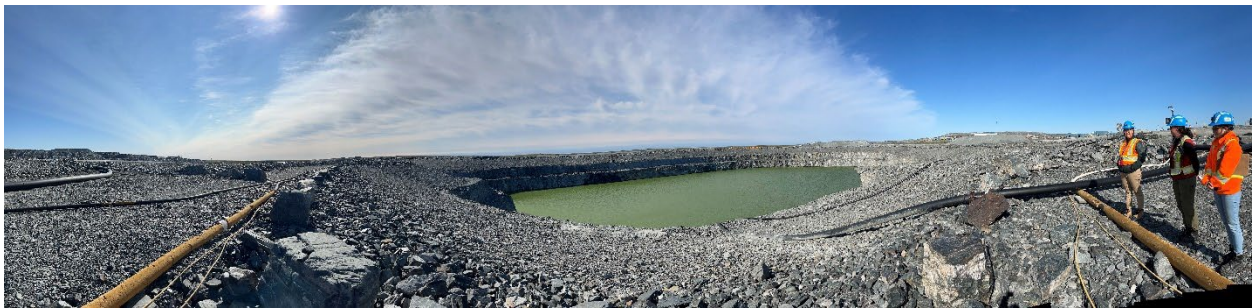
**Photo 35: Tiriganiaq Pit 2 - used for saline effluent storage 2024**

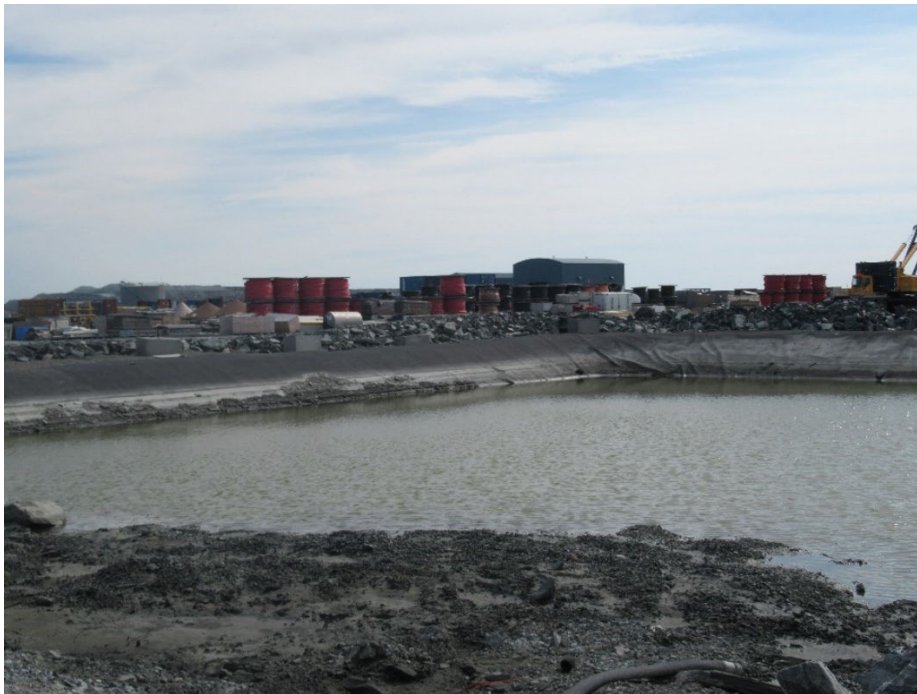
**Photo 36: Saline Pond 3 – not used for saline effluent discharge in 2024; however, it is used for site contact water transferred to CP1 for treatment before release.**

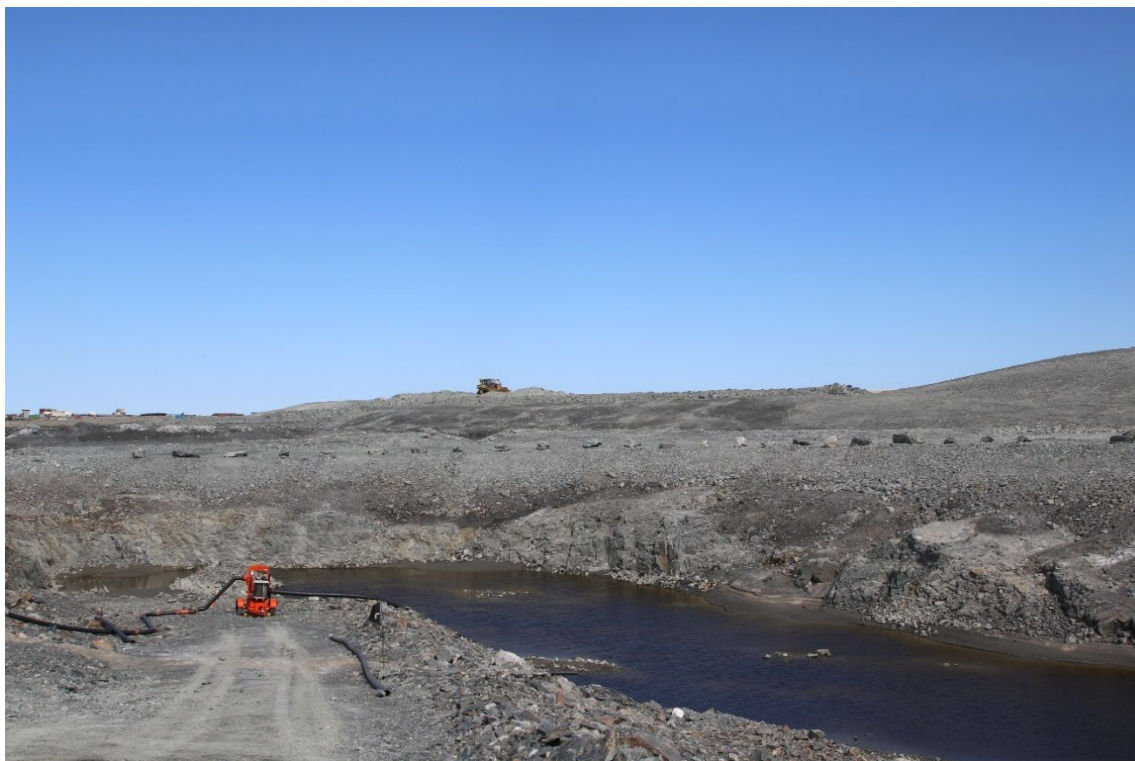
**Photo 37: Containment Pond 3 – one of six (6) containment ponds to collect site contact water.**

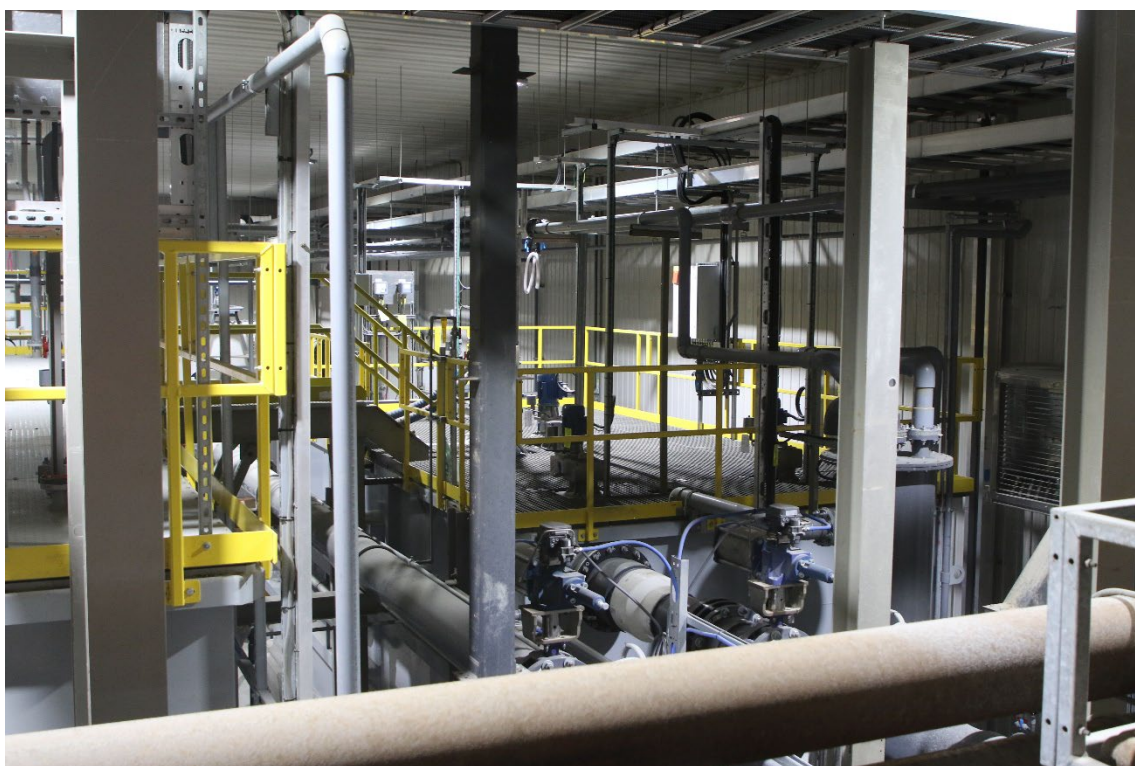
**Photo 38: Water Treatment Complex - contact water is treated to ensure licence parameters are met before discharge into Meliadine Lake.**

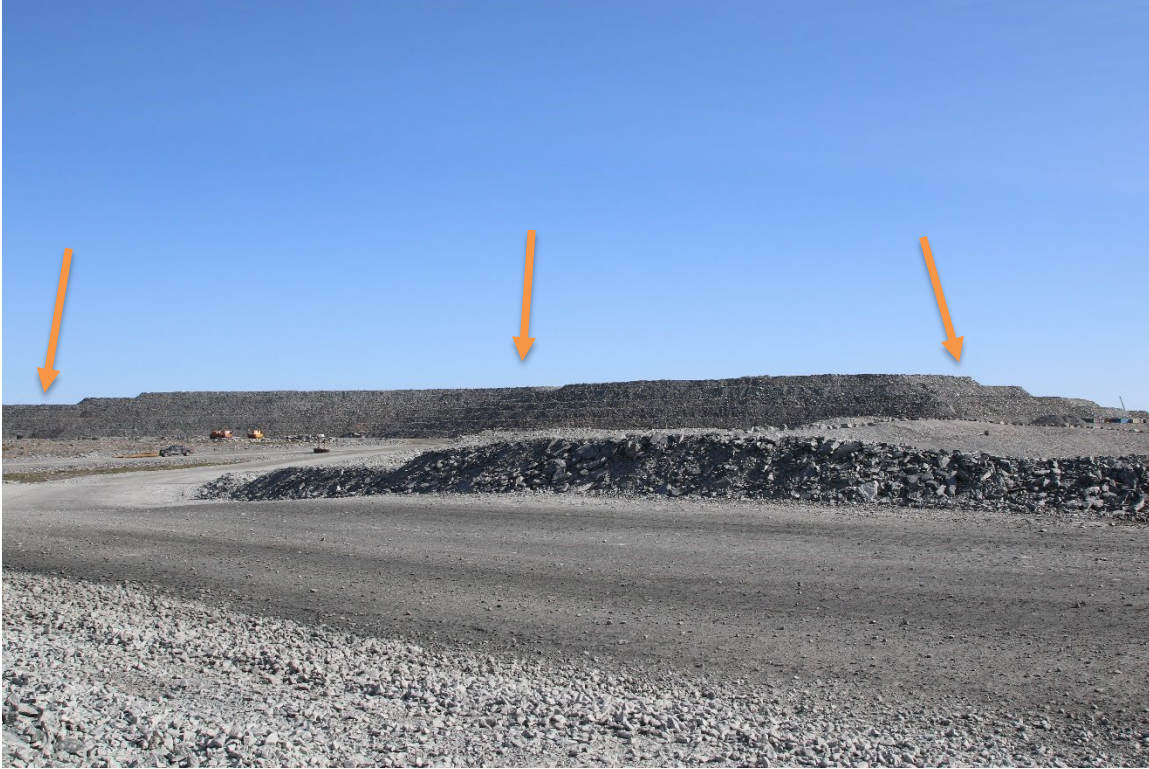
19	Tailings and Waste Rock Monitoring Program	NIRB viewed the facilities and discussed with Agnico Eagle the current program for tailings and waste rock storage and monitoring of these facilities. ( <a href="#">Photo 39</a> )
<b>Hydrogeology and Groundwater</b>		
25	Groundwater Management Plan/Adaptive Management Plan	Agnico Eagle confirmed that saline effluent continues to be pumped to Tiriganiaq 2 for storage and no discharge into Melvin Bay occurred again in 2024. ( <a href="#">photo 35</a> )
<b>Hydrology and Sediment Quality</b>		
28	Sediment and Erosion Management	NIRB observed erosion fences at site and along AWAR. ( <a href="#">Photo 24</a> )
29	Water Infrastructure Monitoring	NIRB observed culverts around site and along the AWAR. ( <a href="#">Photo 6</a> , <a href="#">Photo 16</a> , and <a href="#">Photo 17</a> )

**Photo 39: Waste Rock Storage Facility 1 – one of two (2) waste rock storage facilities on site.**

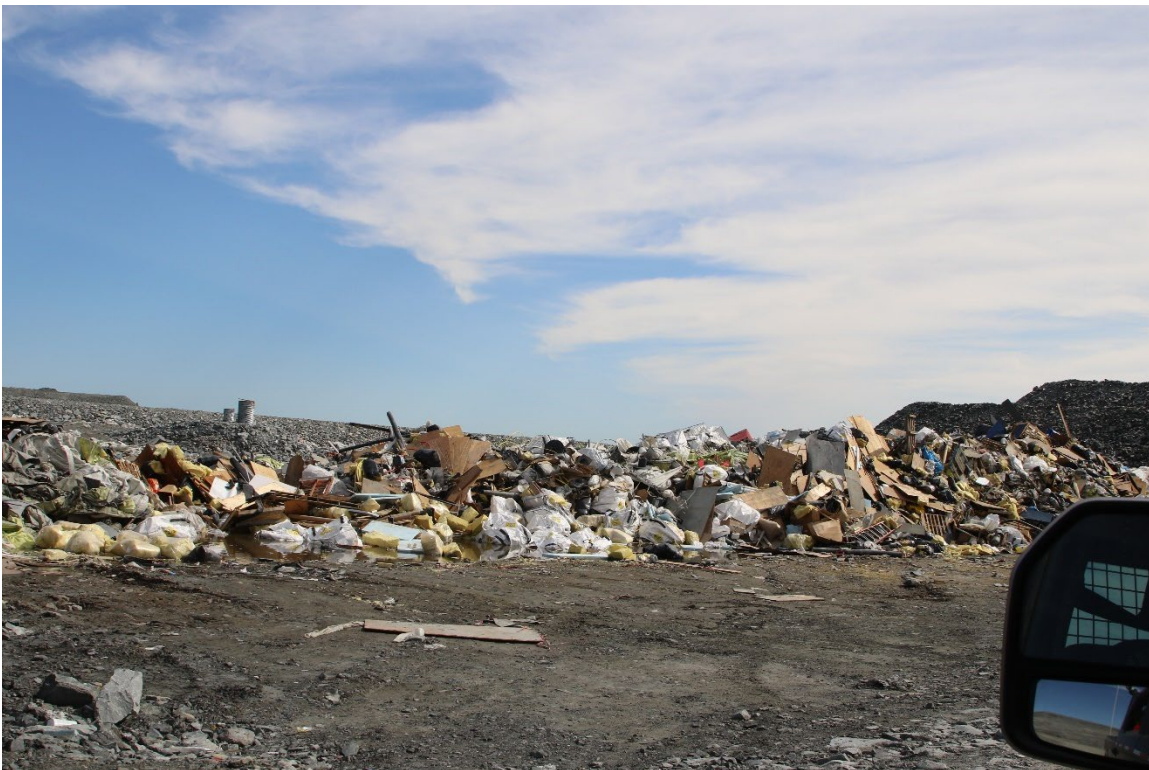
**Photo 40: Landfill - checked to ensure no disposal of food waste.**

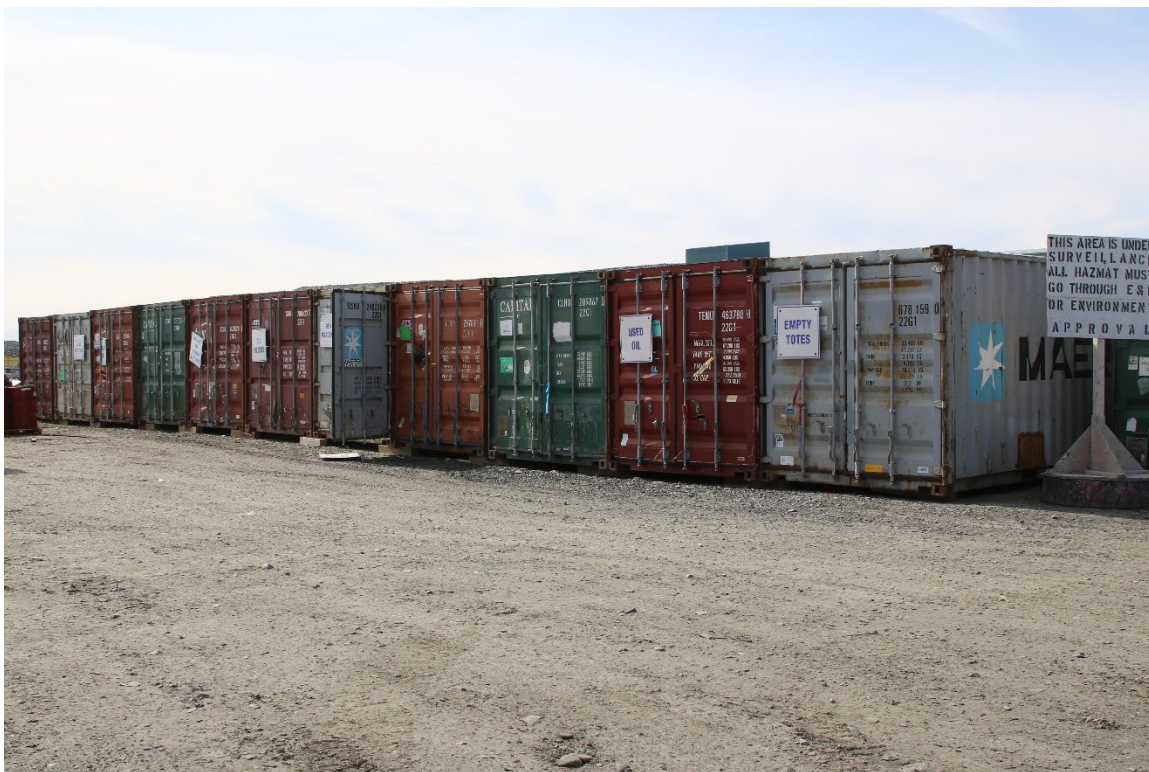
**Photo 41: Hazardous Material Storage Area.**

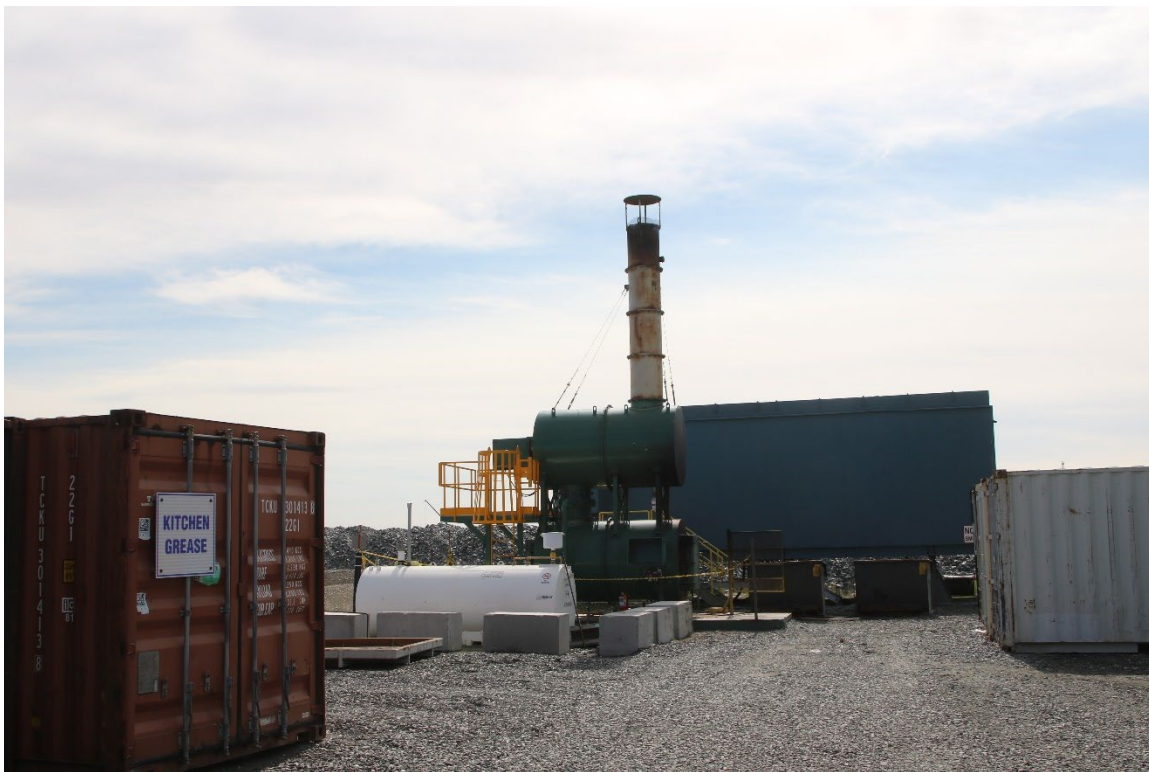
**Photo 42: New Incinerator.**

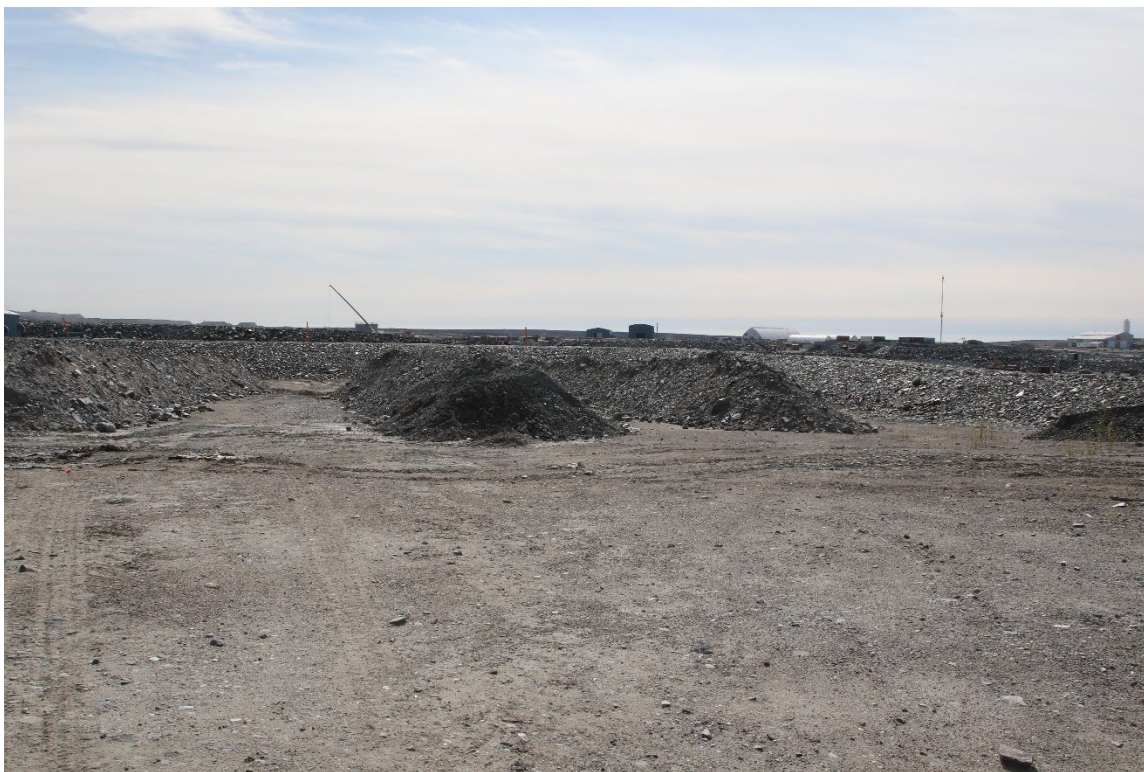
**Photo 43: Landfarm A.**

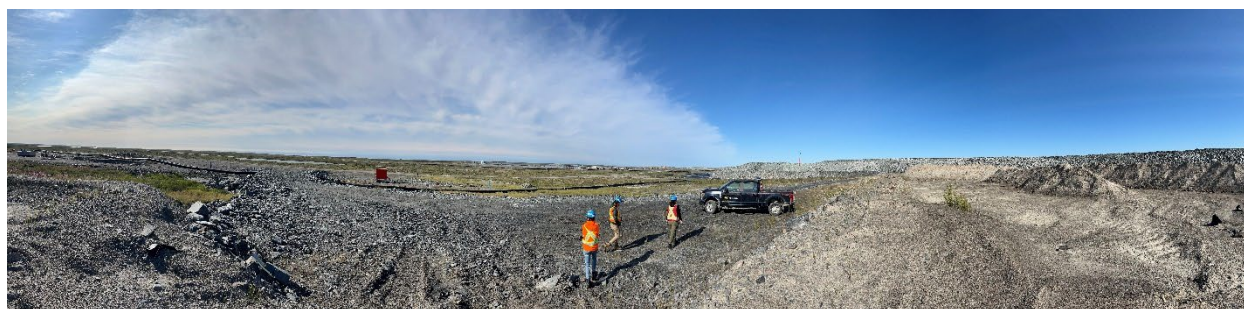
**Photo 44: Landfarm B.**

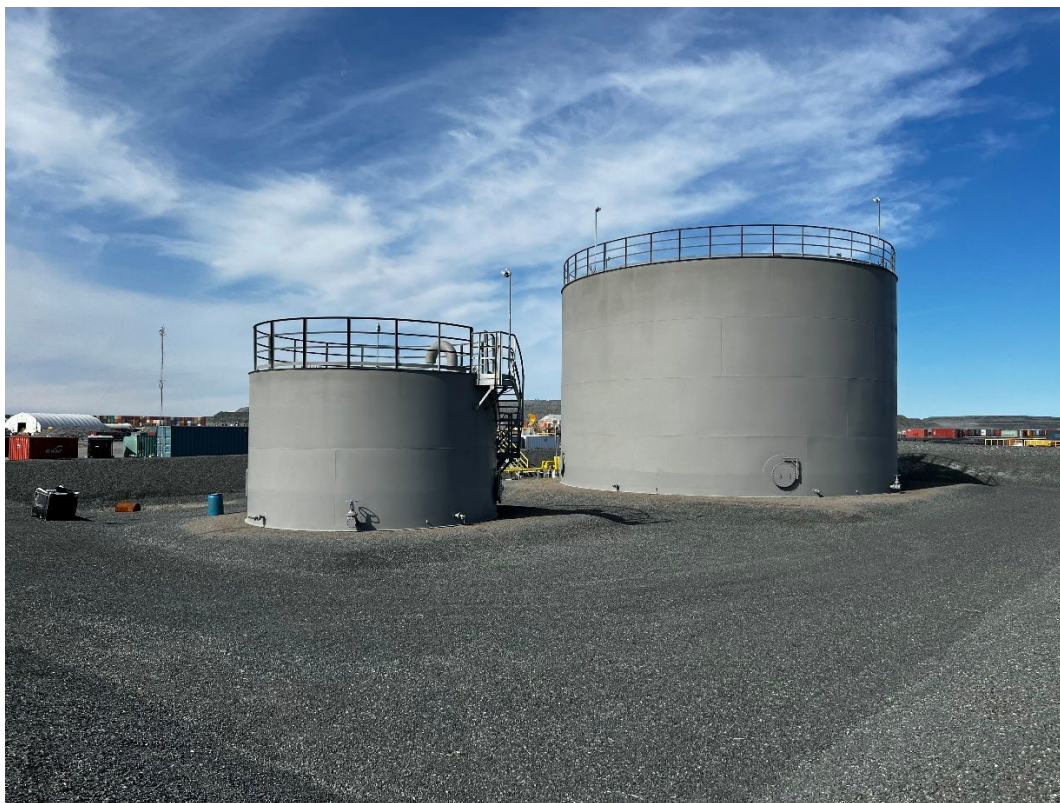
**Photo 45: On-site fuel storage in secondary containment.**

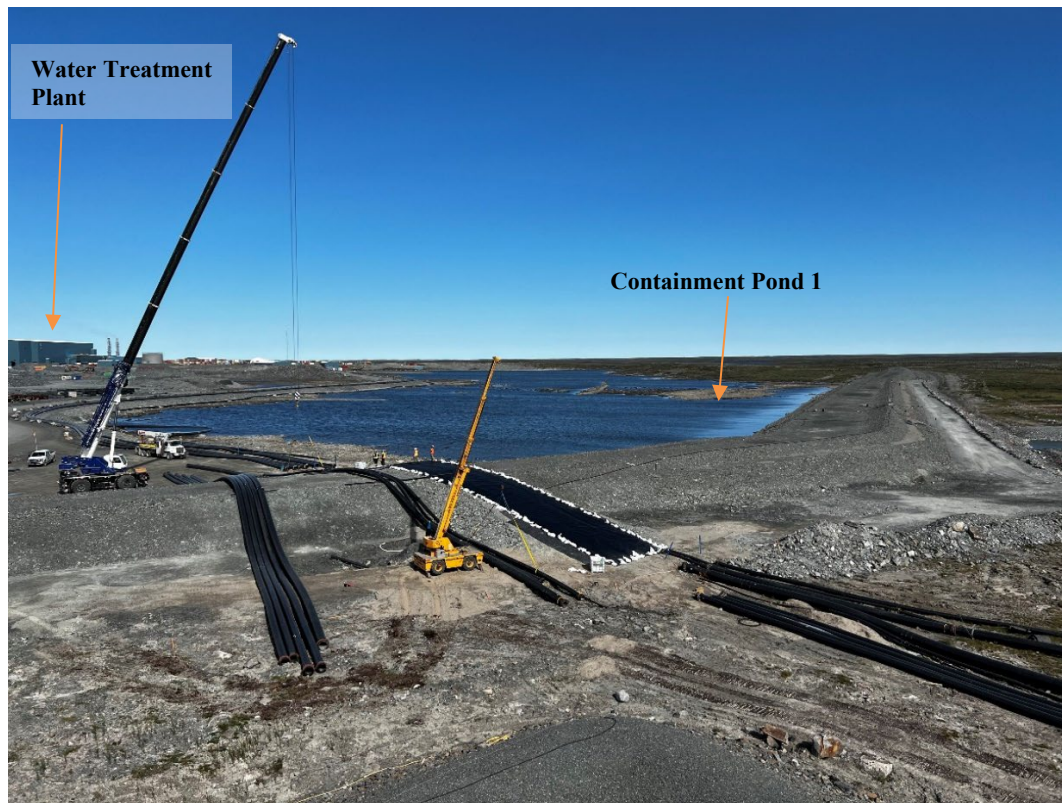
**Photo 46: Waterline crossing over the Containment Pond 1 Berm.**

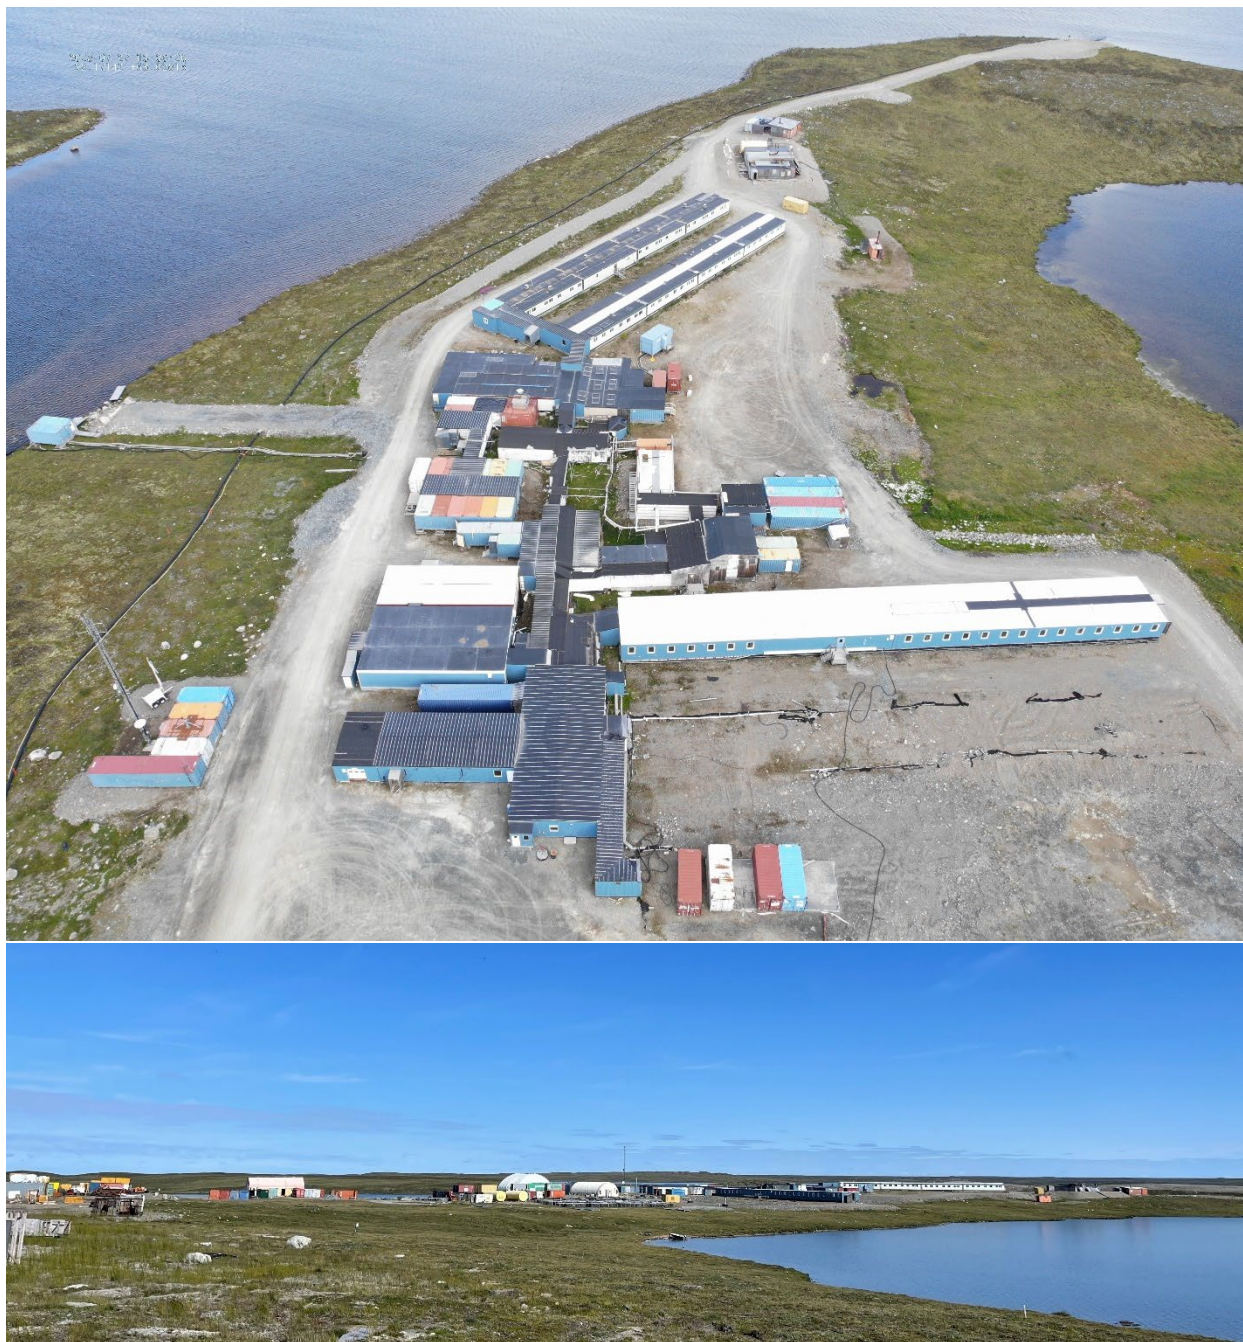
**Photo 47: Exploration Camp. The exploration camp is not in use and has been cleaned up (2023 photos).**

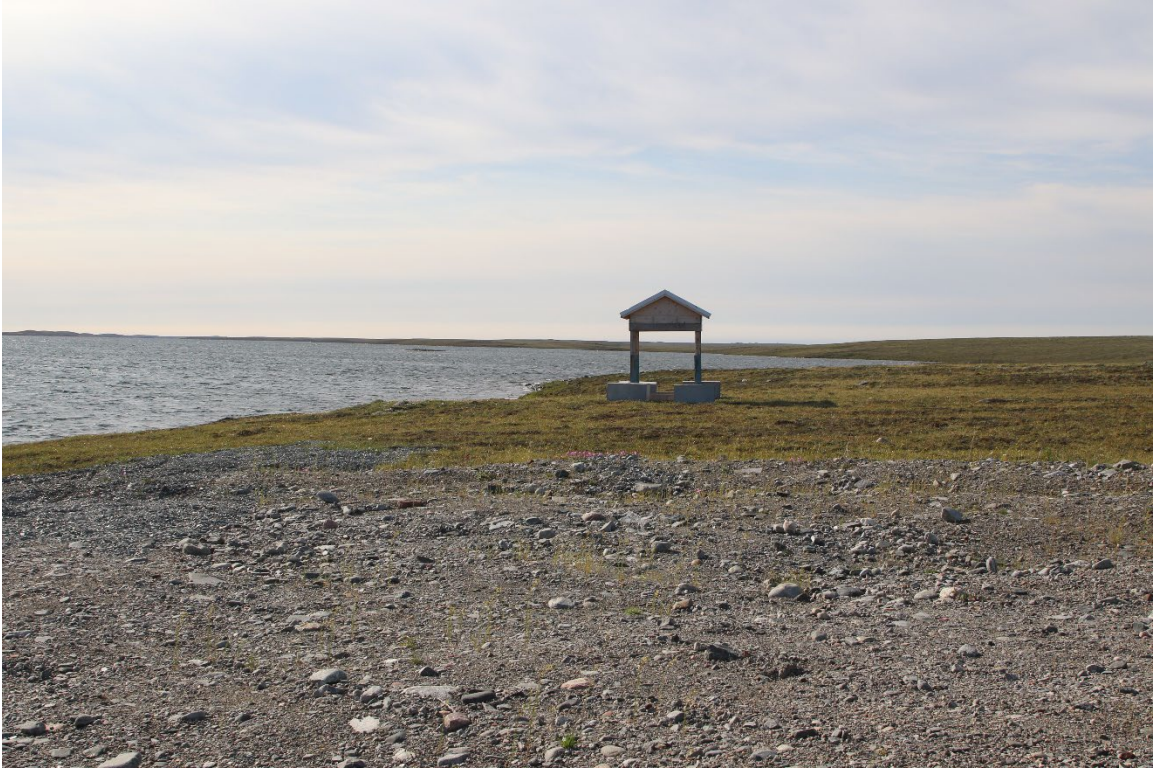
**Photo 48: Bird house for a barn swallow moved from Paste Plant to Exploration Camp.**

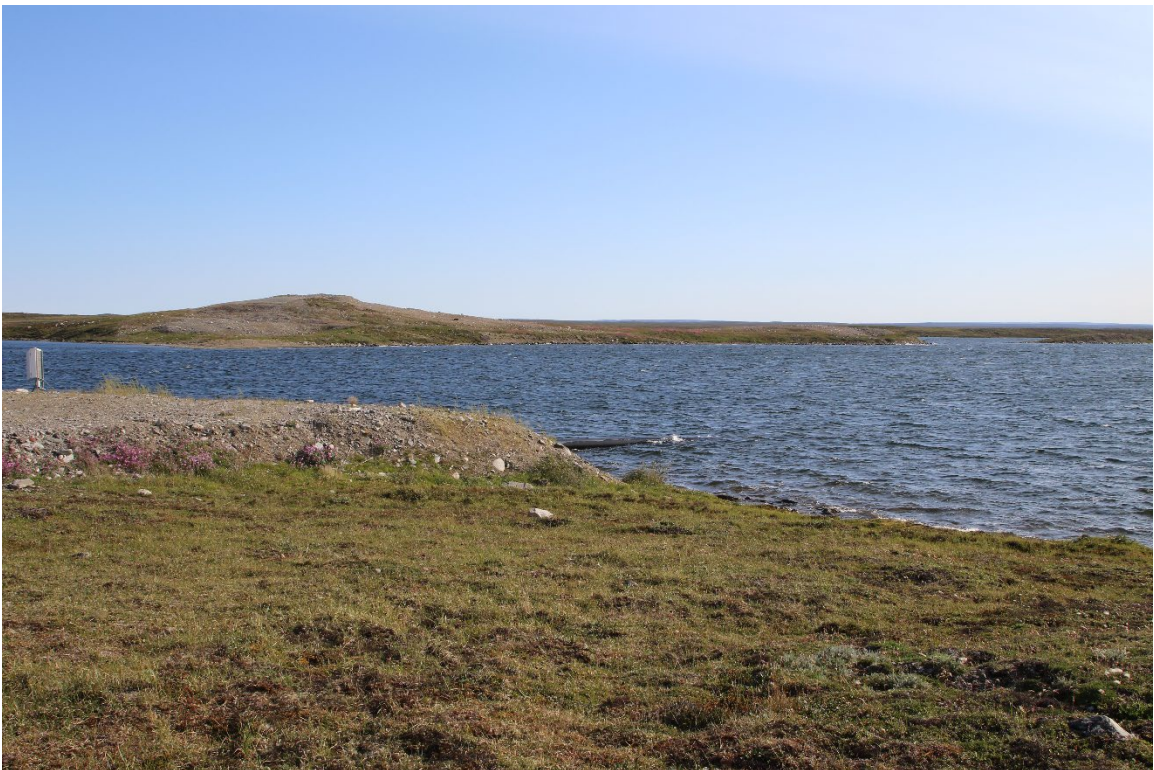
**Photo 49: Treated water discharge into Meliadine Lake by former Exploration Camp.**

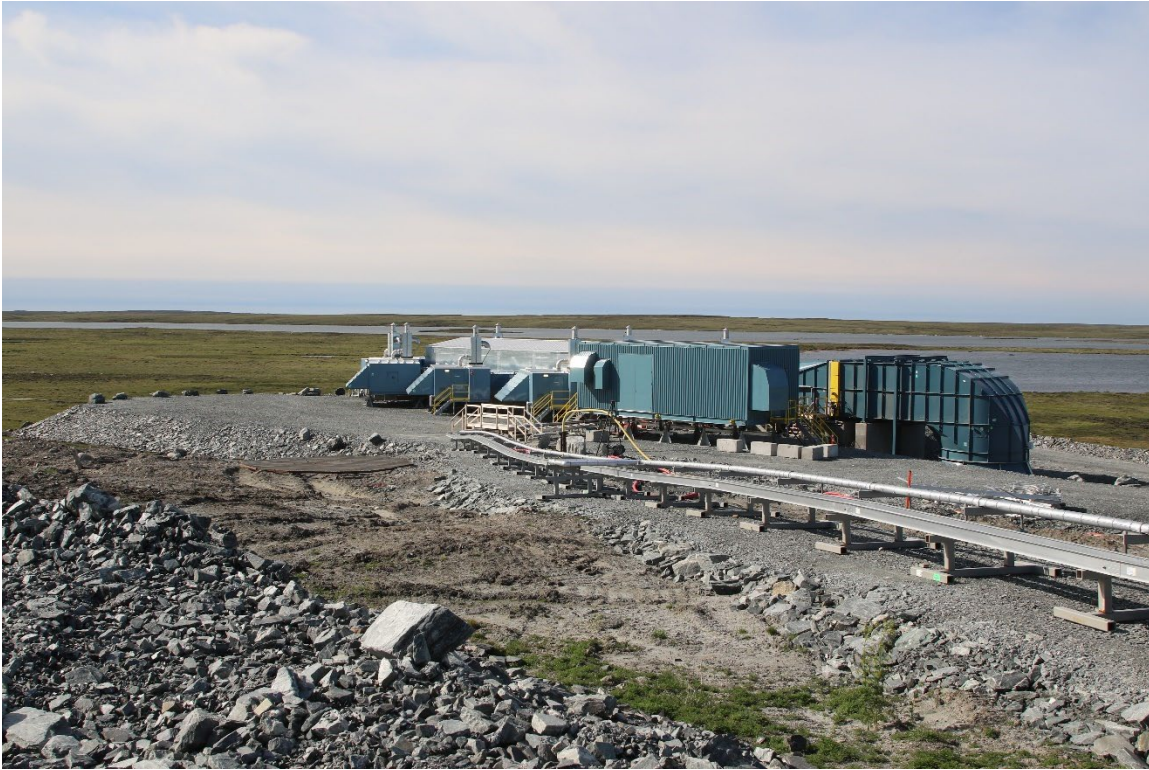
**Photo 50: New Vent Raise south of Tiriganiaq 1, looking southeast.**

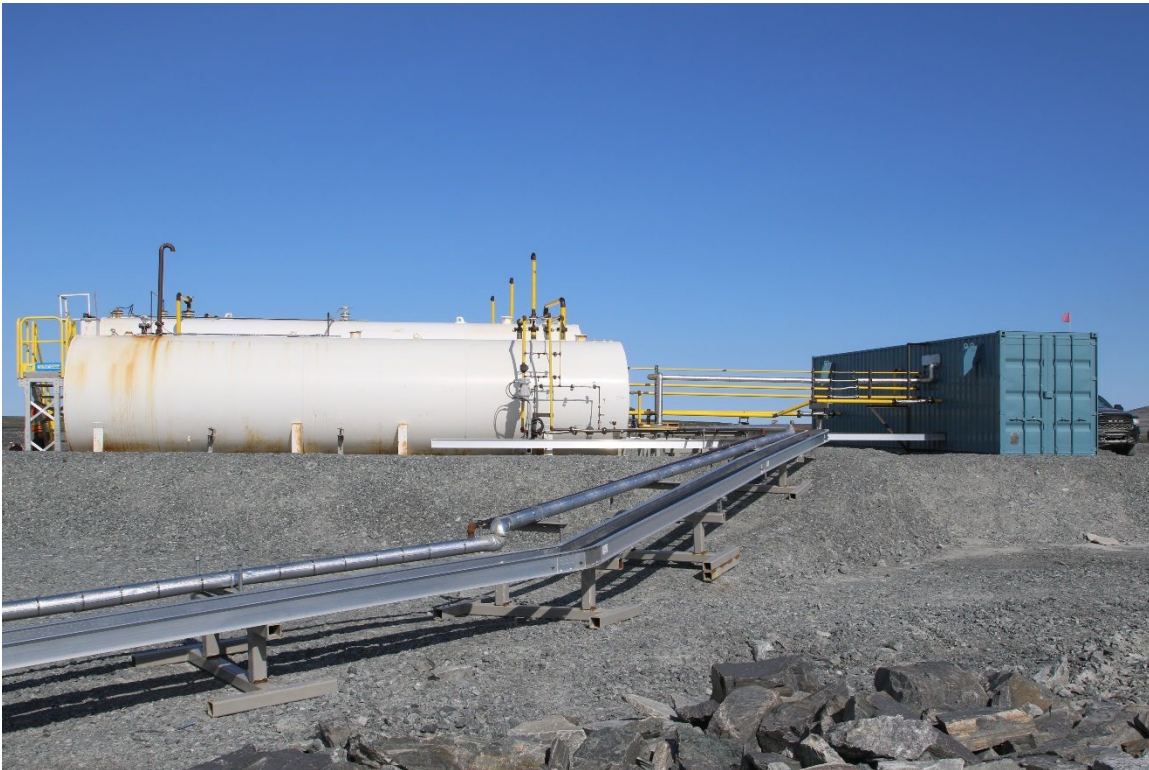
**Photo 51: New Vent Raise south of Tiriganiaq 1, fuel area west of Vent Raise.**

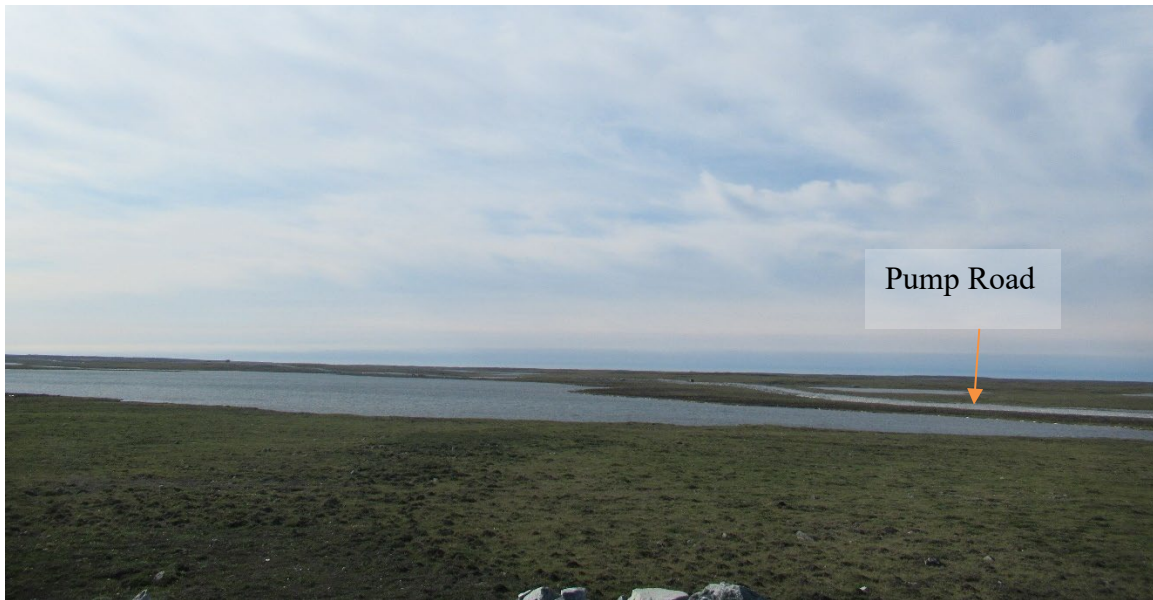
**Photo 52: Looking east to Pump Road from east side of Tiriganiaq 1.**

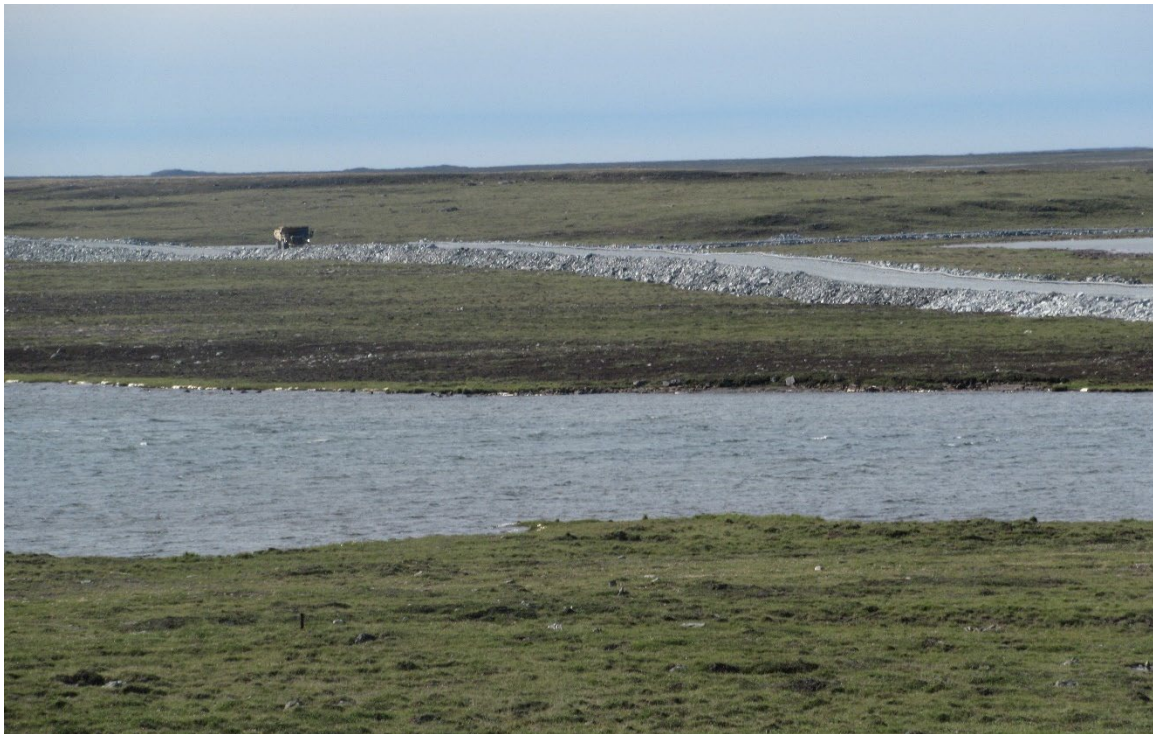
**Photo 53: Equipment on Pump Road moving material, looking east from Tiriganiaq 1.**
