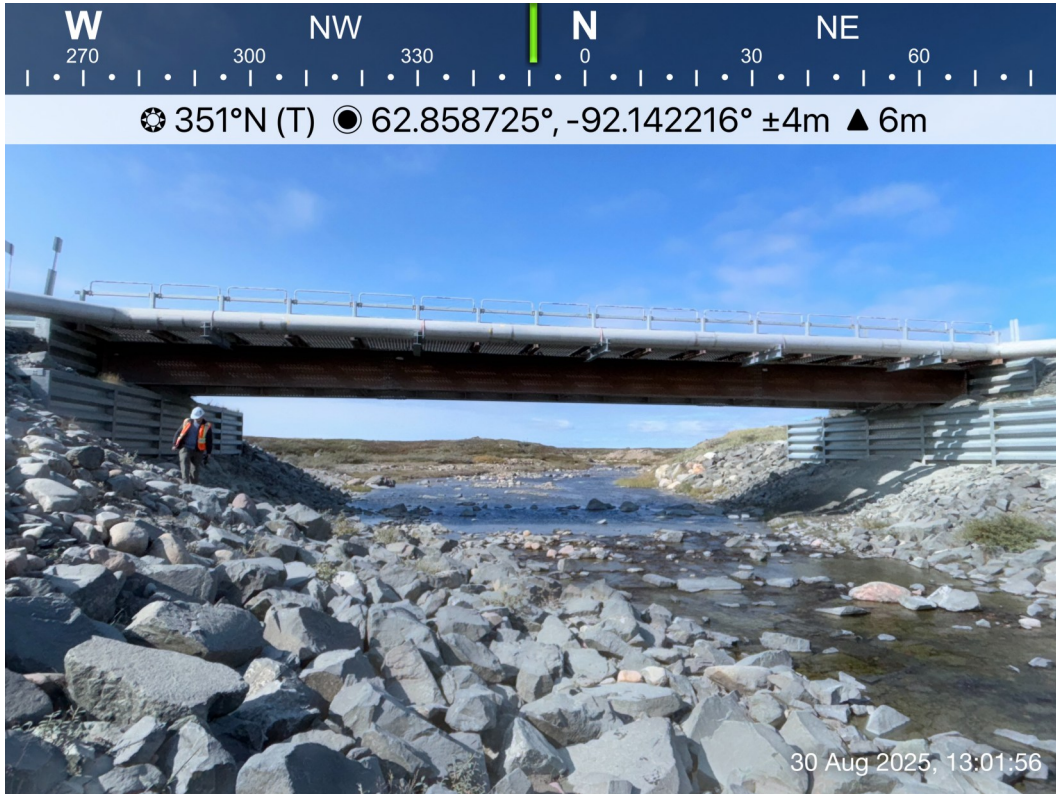
**AWAR Road/
Culvert - Photo 9:** Char River Bridge KM 6.0: Overview.

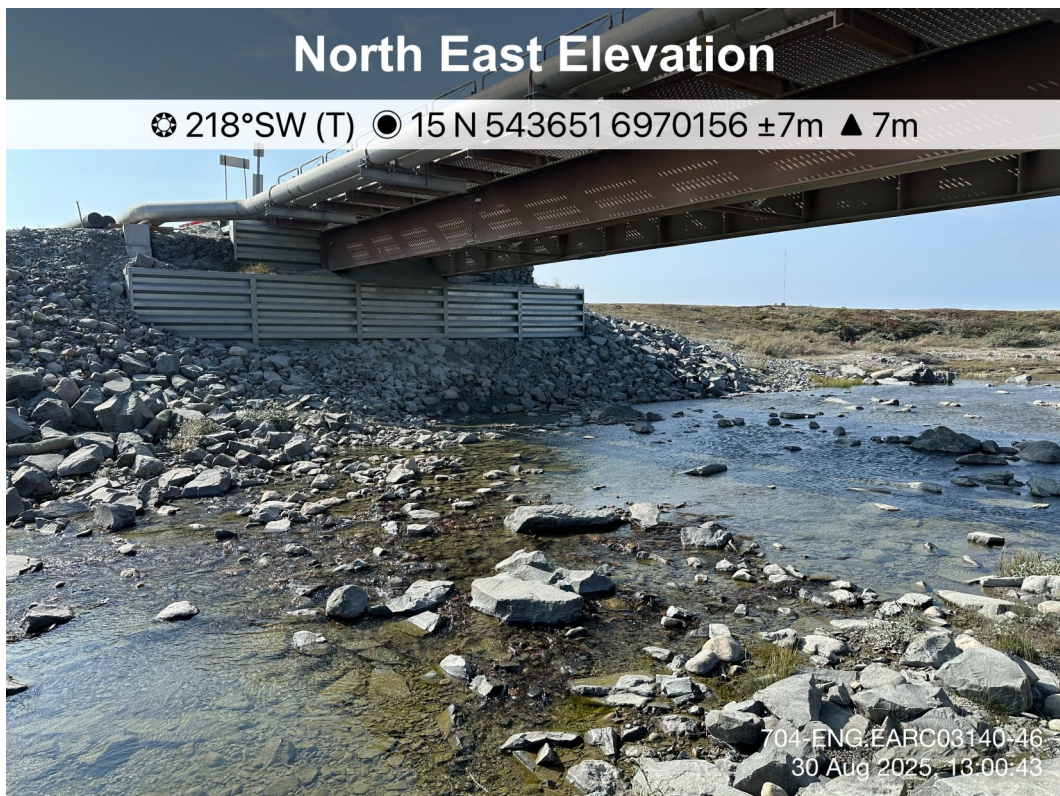
**AWAR Road/
Culvert - Photo 10:** Char River Bridge KM 6.0: South Abutment.

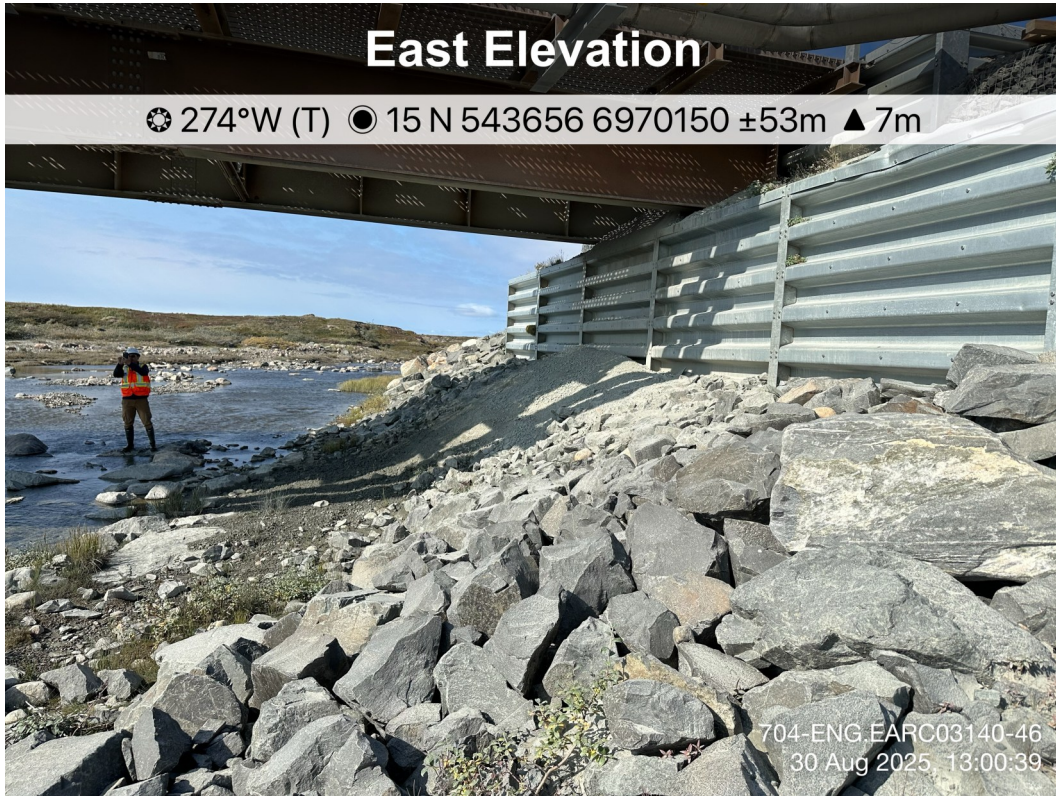
**AWAR Road/
Culvert - Photo 11** Char River Bridge KM 6.0: North Abutment.

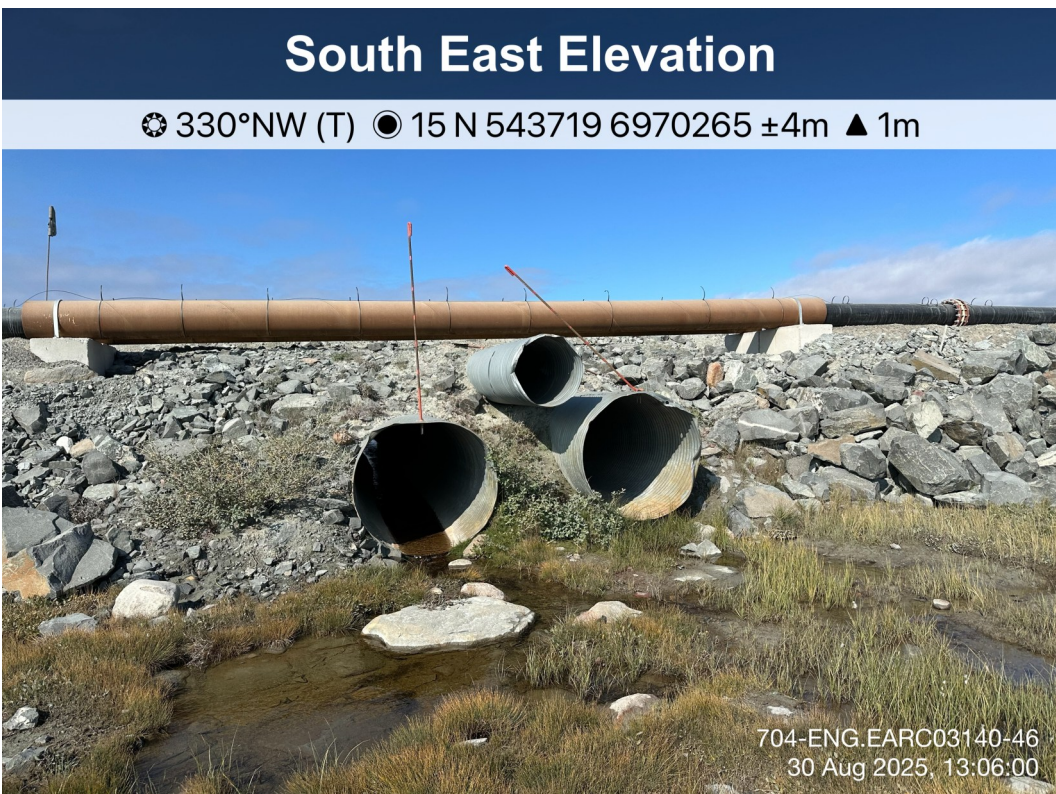
**AWAR Road/
Culvert - Photo 12:** Culvert KM 6.1: Outlet.

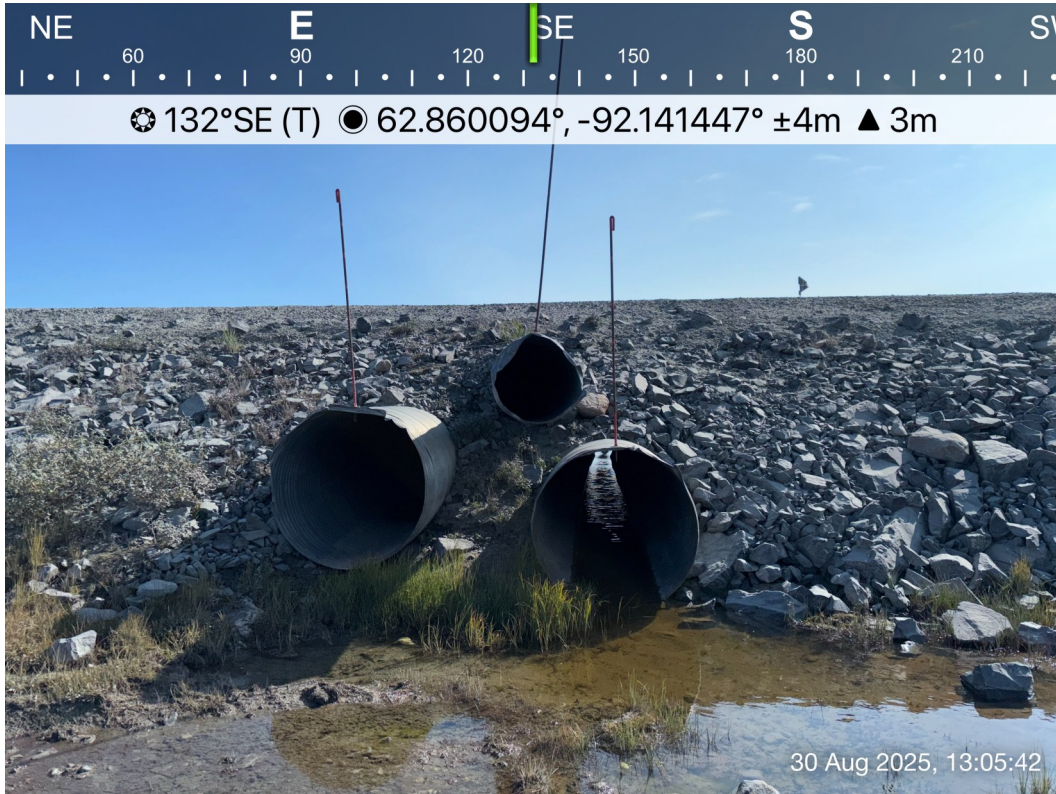
AWAR Road/ Culvert KM 6.1: Inlet.
Culvert - Photo 13

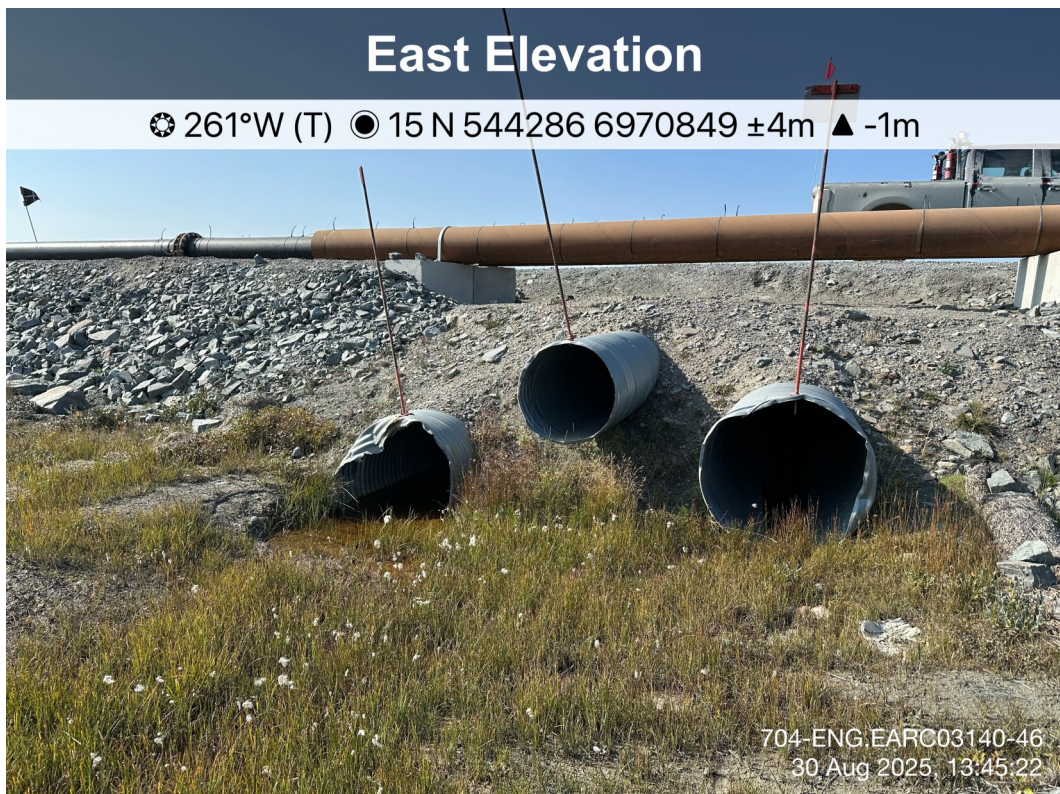
AWAR Road/ Culvert KM 6.9: Outlet.
Culvert - Photo 14:

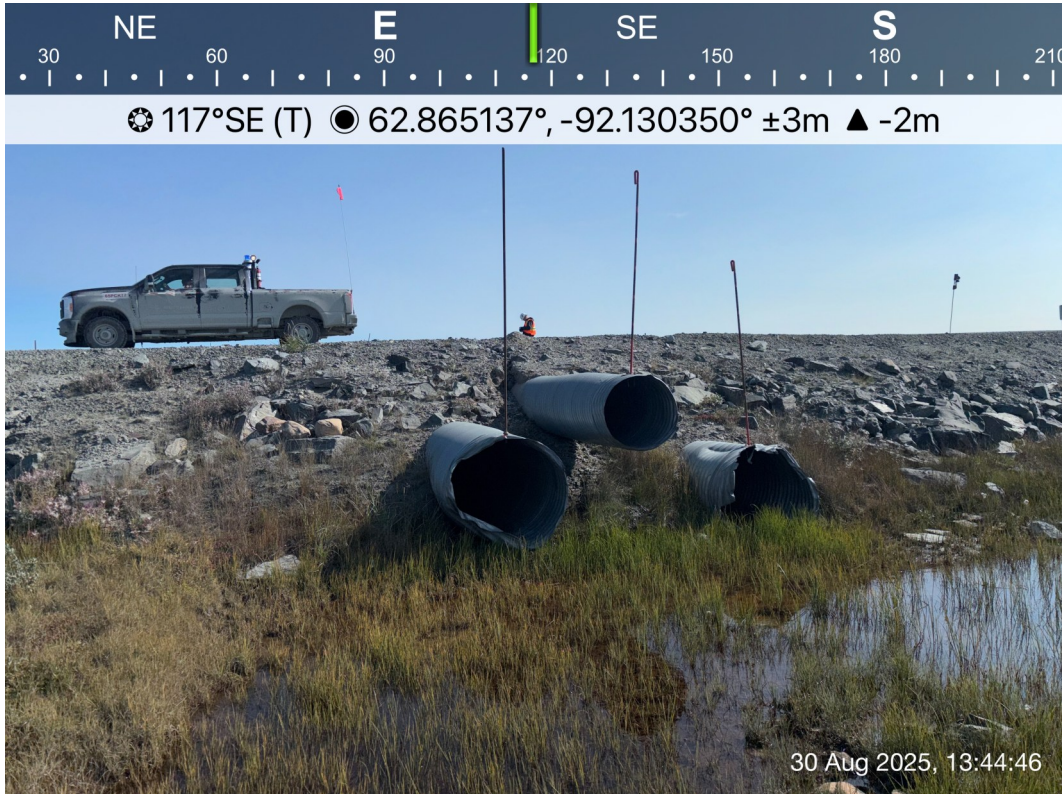
**AWAR Road/
Culvert - Photo 15:** Culvert KM 6.9: Inlet.

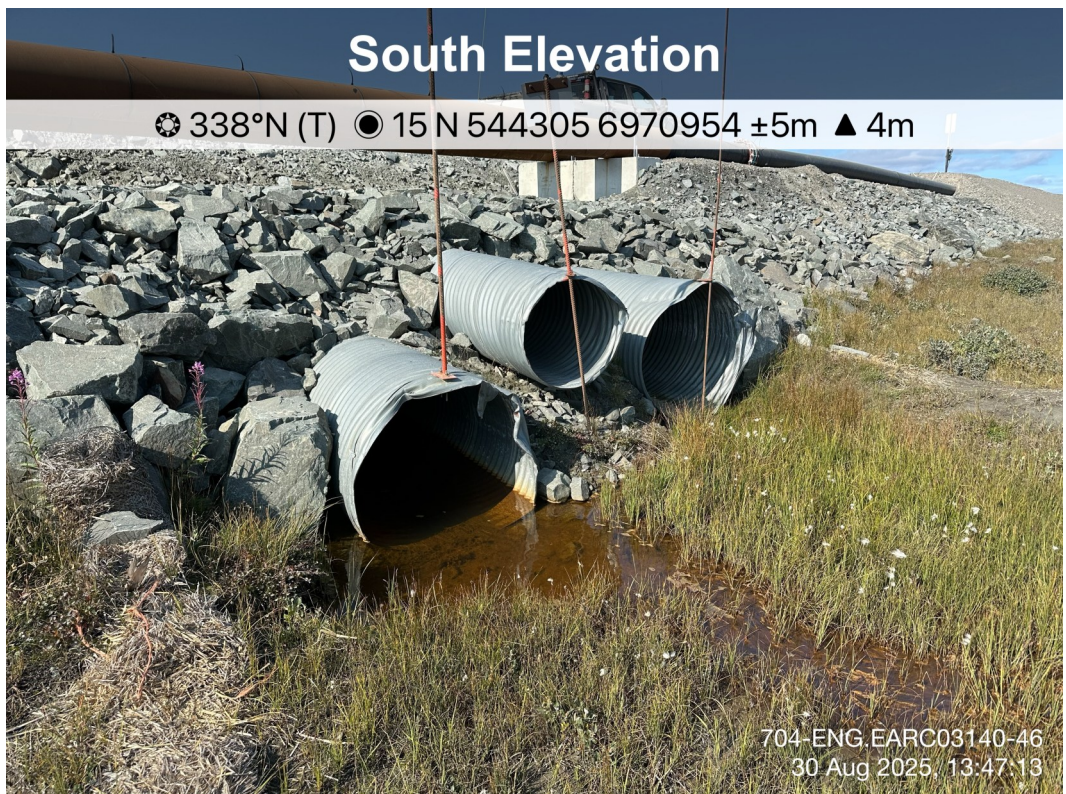
**AWAR Road/
Culvert - Photo 16:** Culvert KM 7.0: Outlet.

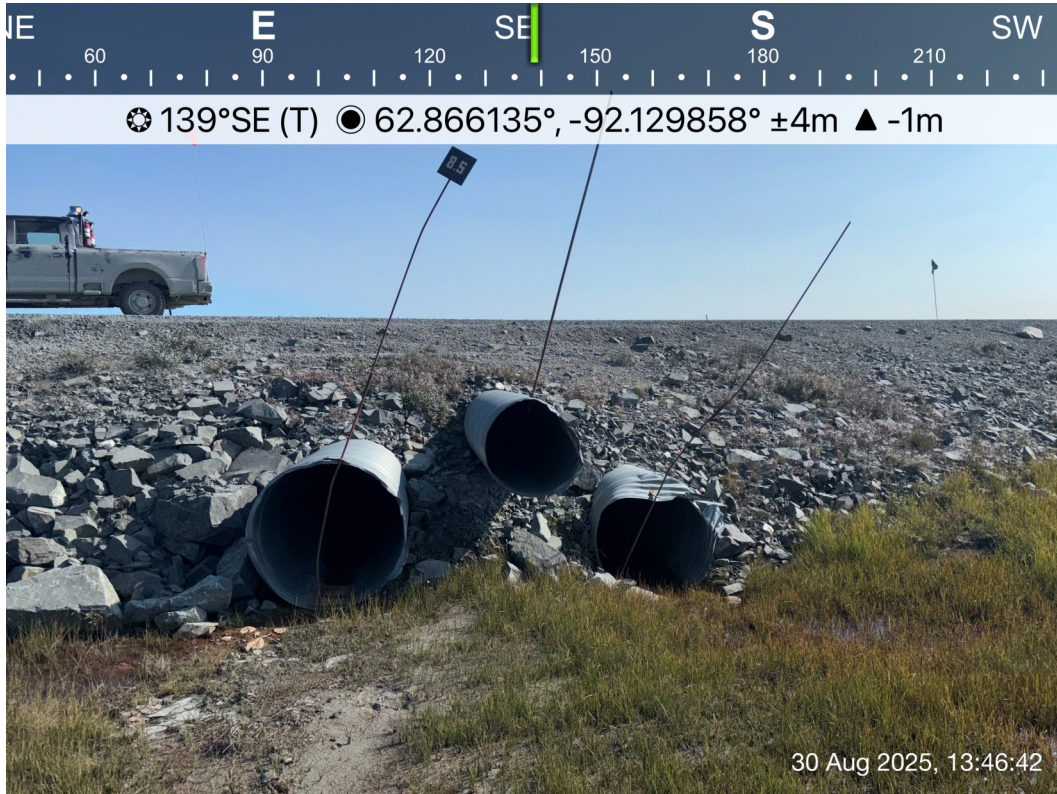
AWAR Road/ Culvert KM 7.0: Inlet.
Culvert - Photo 17:

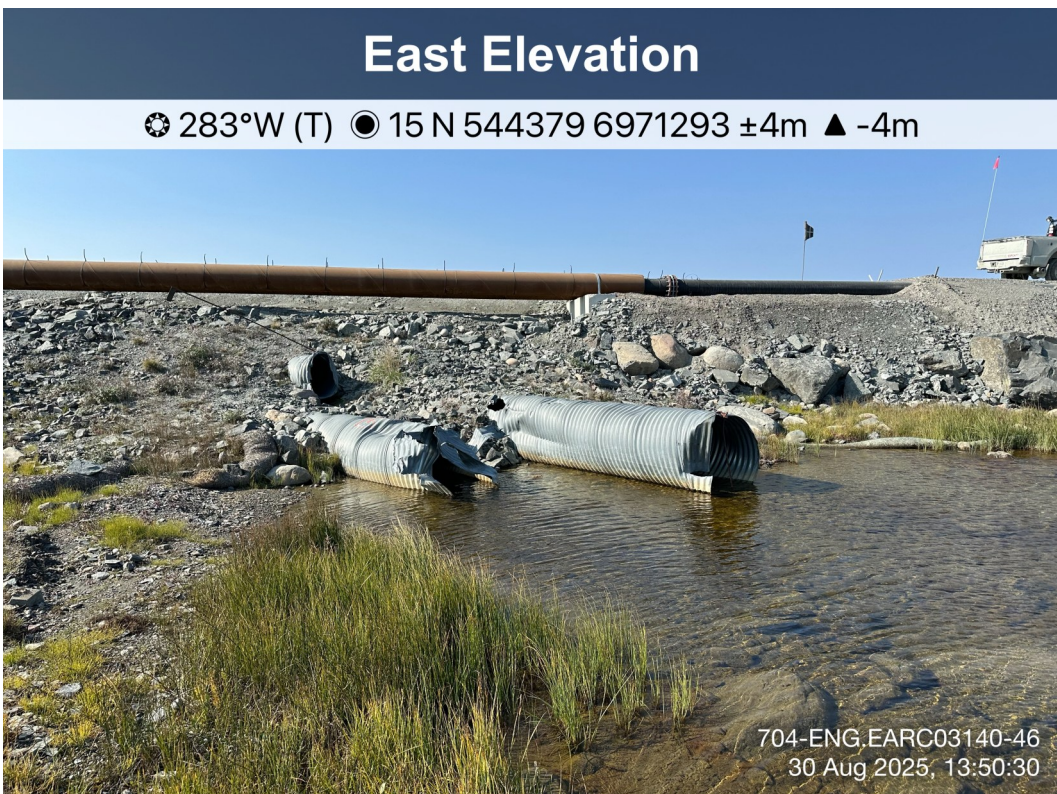
AWAR Road/ Culvert KM 7.35: Outlet.
Culvert - Photo 18:

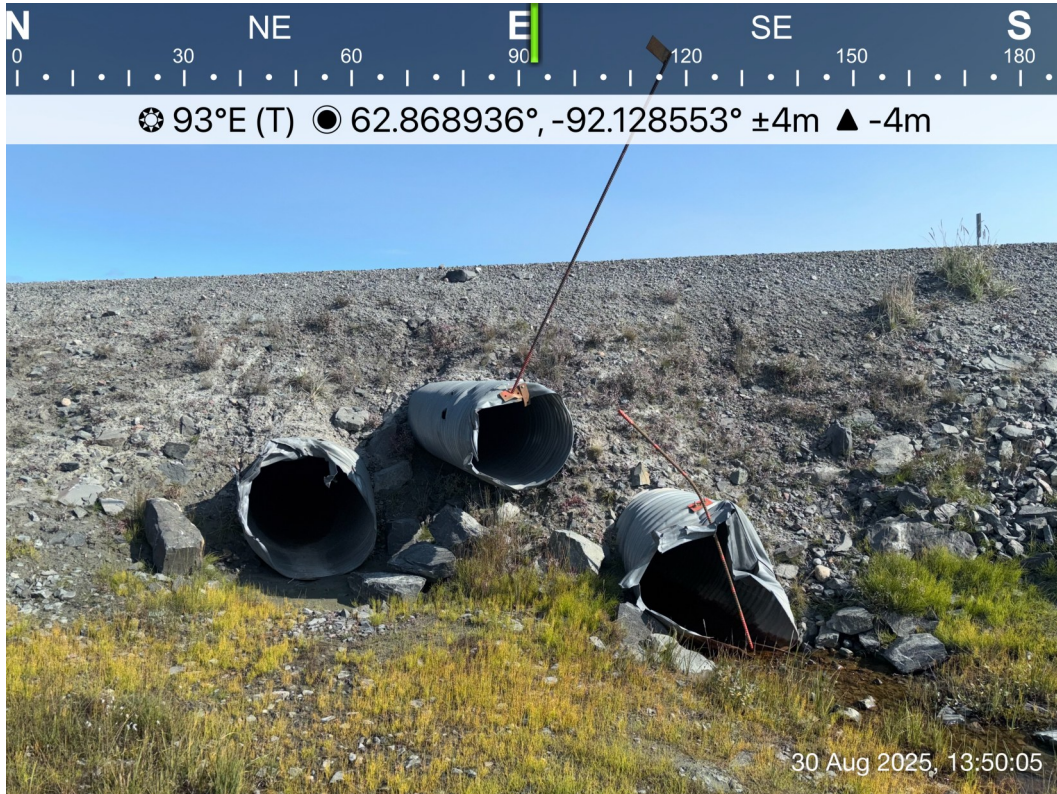
AWAR Road/ Culvert KM 7.35: Inlet.
Culvert - Photo 19:

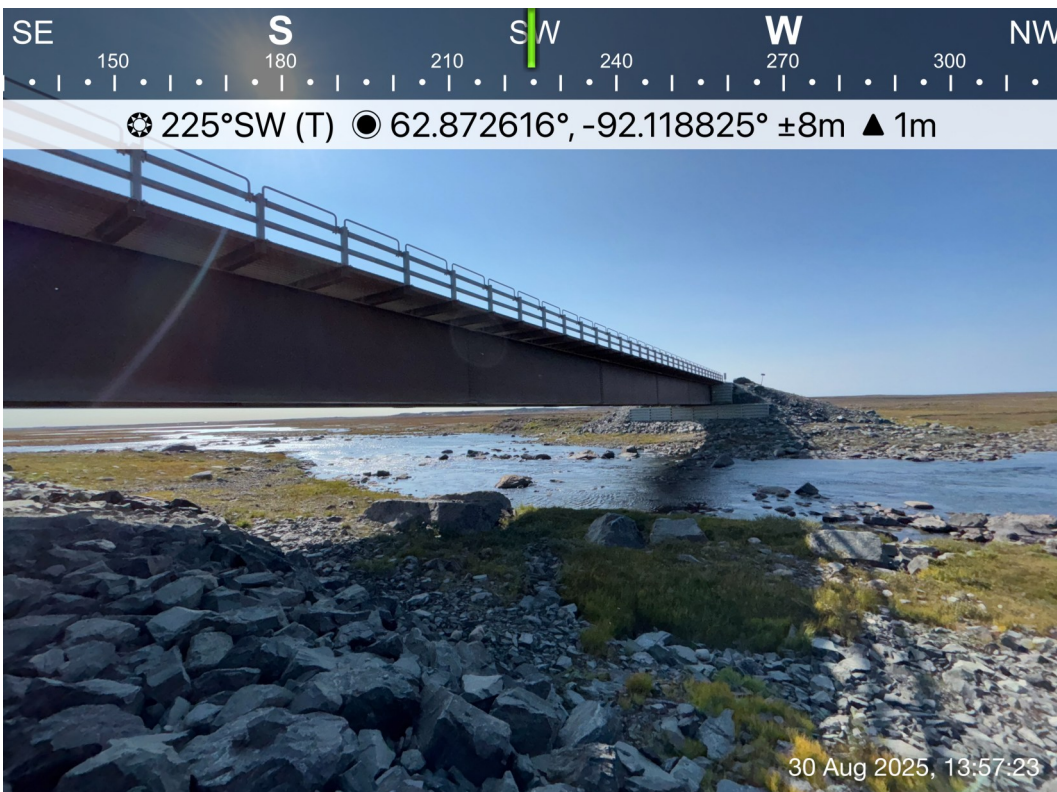
AWAR Road/ Meliadine River Bridge KM 8.0.
Culvert - Photo 20:

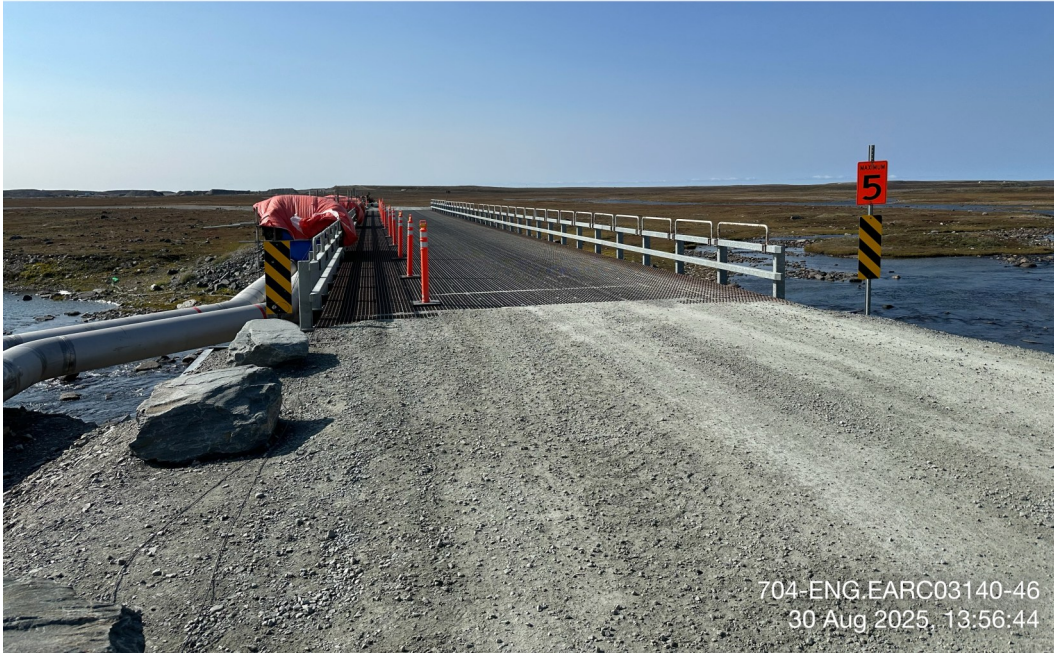
**AWAR Road/
Culvert - Photo 21:** Meliadine River Bridge KM 8.0.

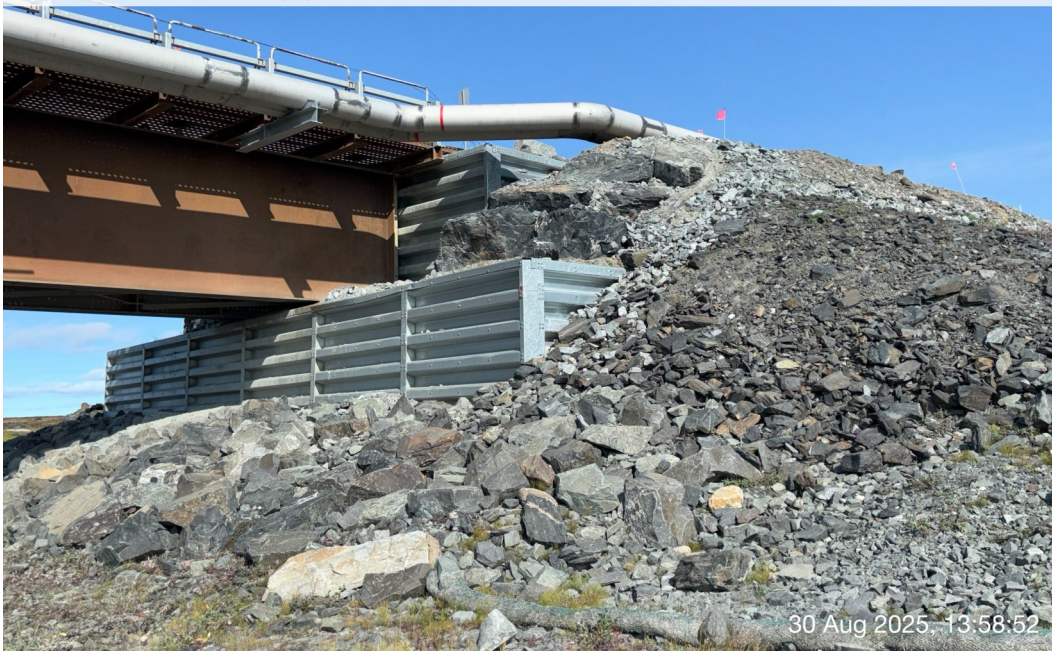
**AWAR Road/
Culvert - Photo 22:** Meliadine River Bridge KM 8.0: East abutment.

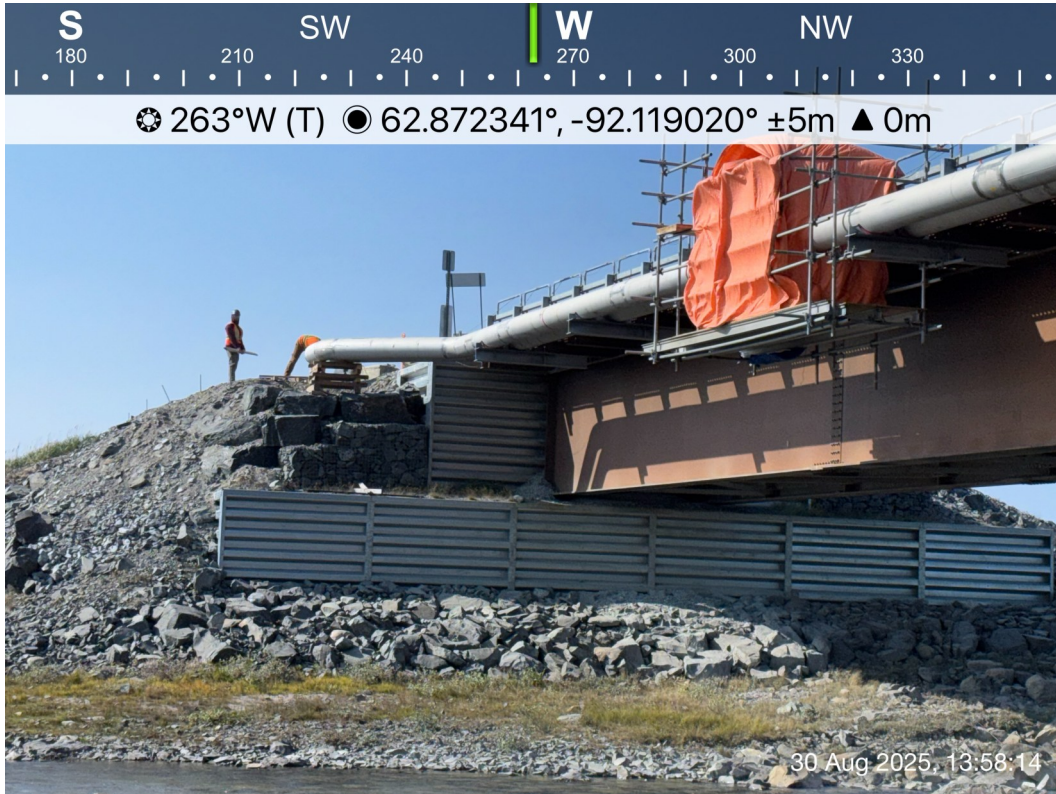
**AWAR Road/
Culvert - Photo 23:** Meliadine River Bridge KM 8.0: West abutment.

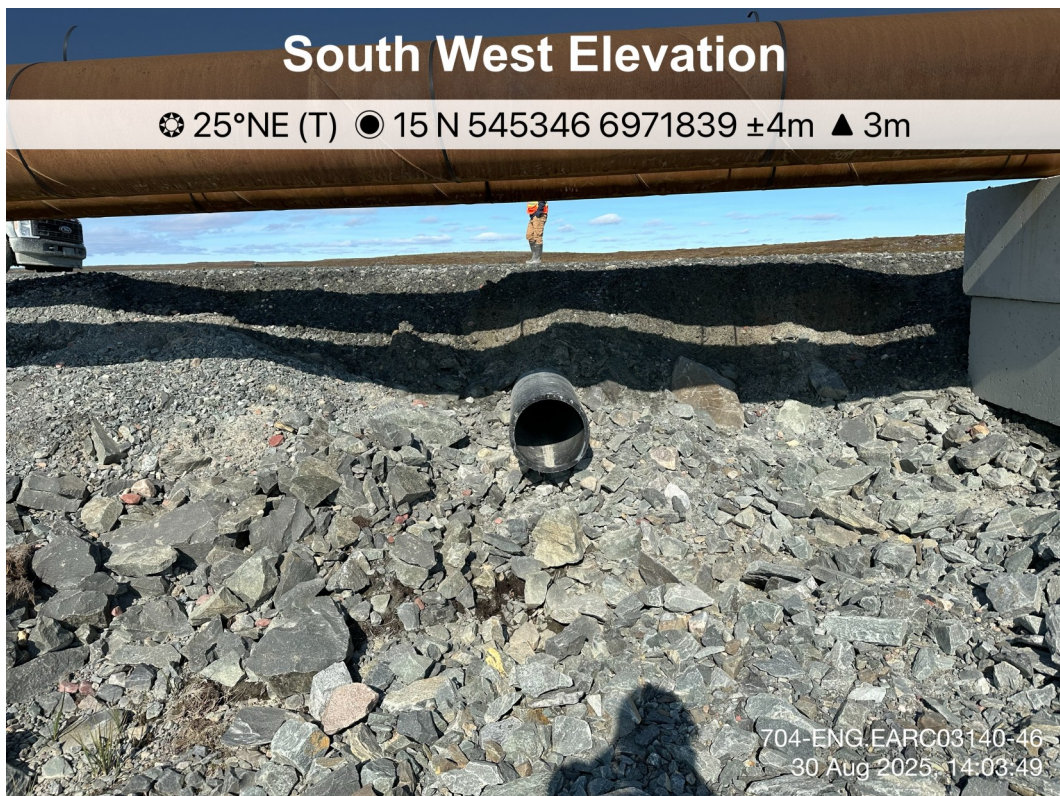
**AWAR Road/
Culvert - Photo 24:** Pipe Sleeve KM 8.7: Outlet.

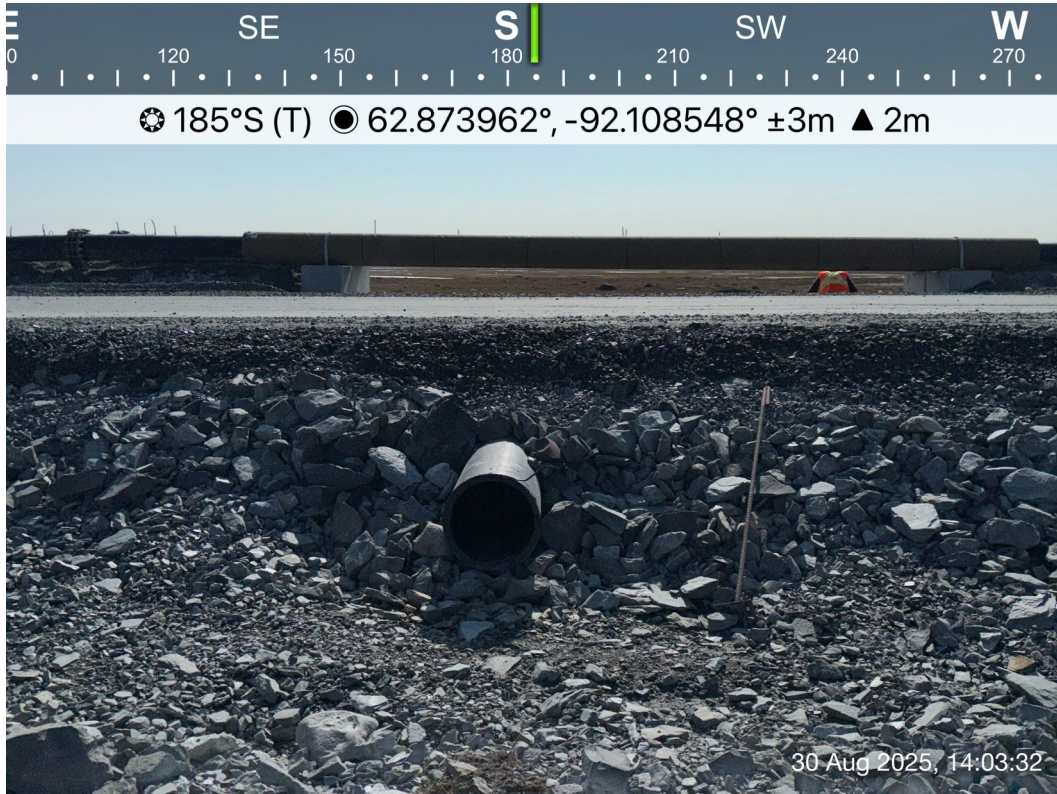
**AWAR Road/
Culvert - Photo 25:** Pipe Sleeve KM 8.7: Inlet.

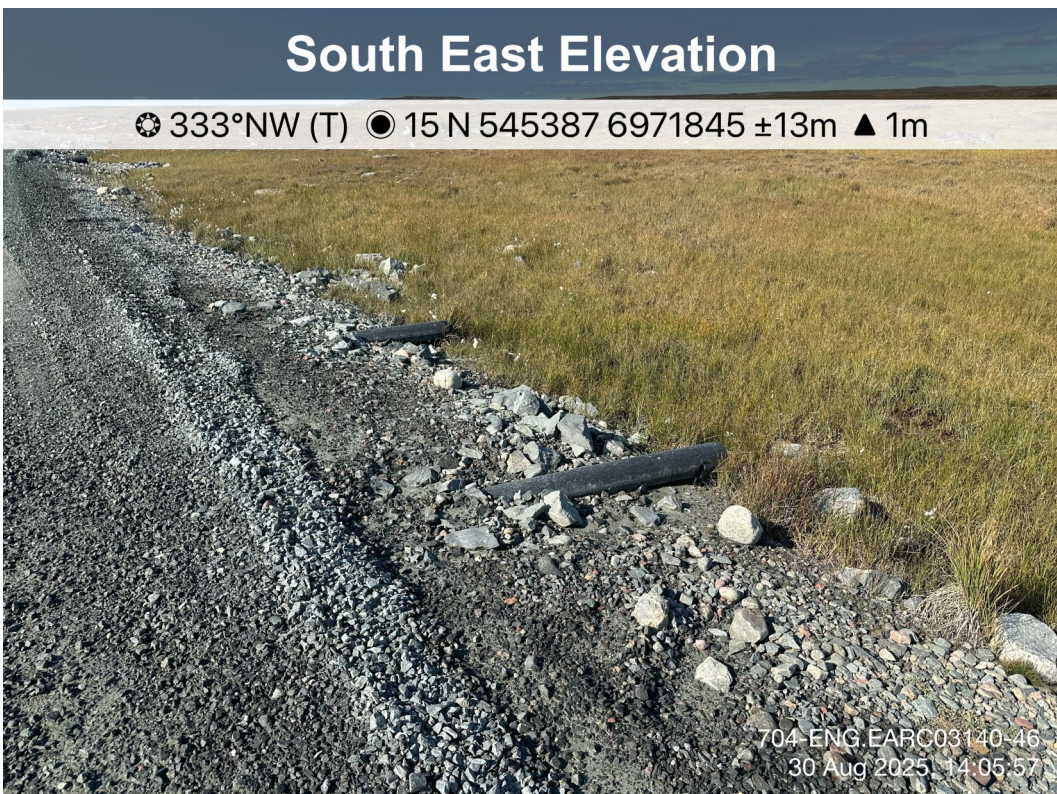
**AWAR Road/
Culvert - Photo 26:** Pipe Sleeve KM 8.8: Inlet.

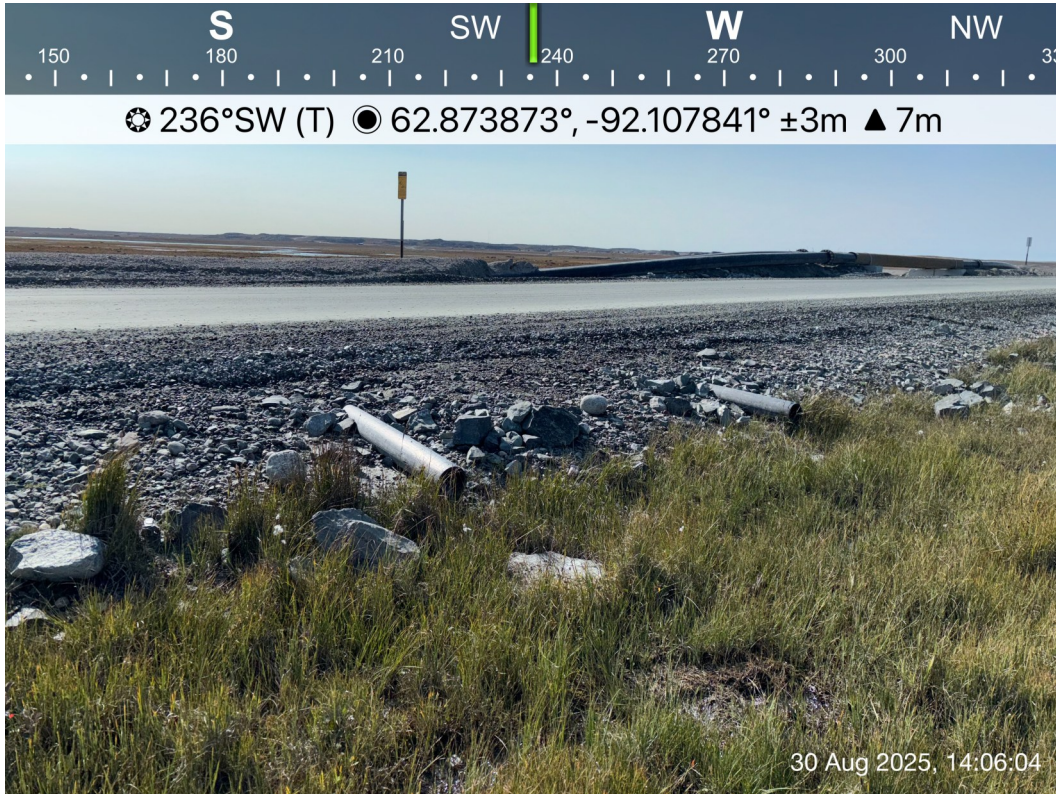
**AWAR Road/
Culvert - Photo 27:** Pipe Sleeve KM 8.8: Inlet.

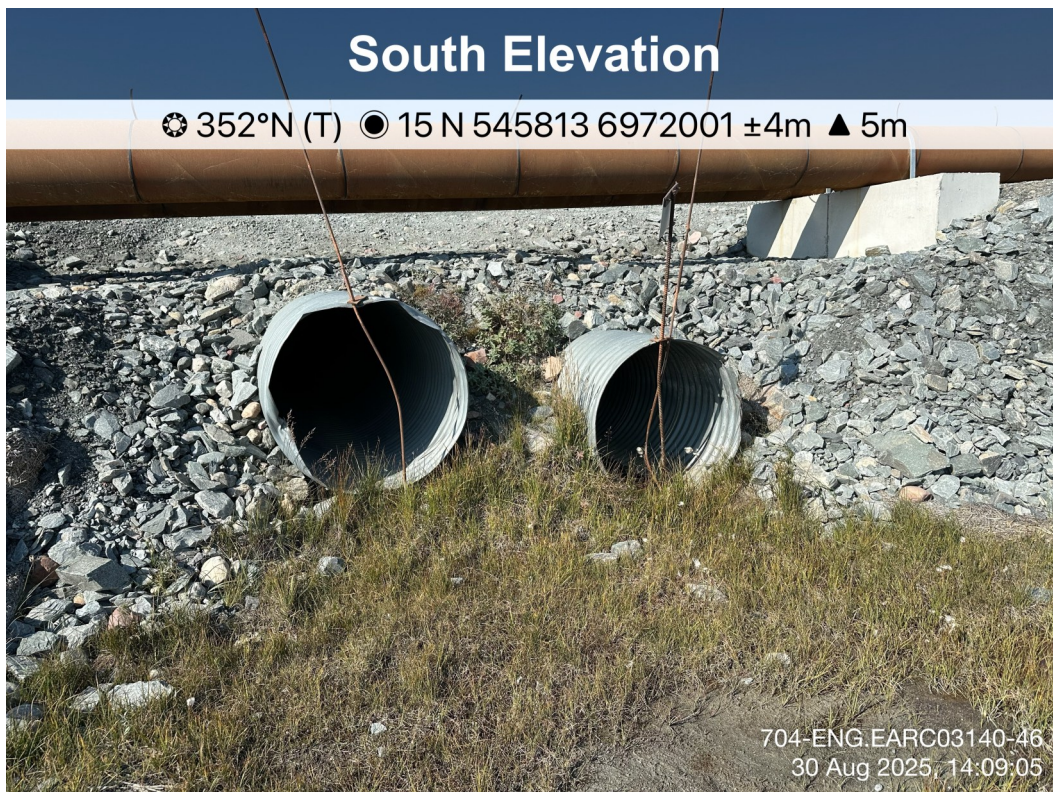
**AWAR Road/
Culvert - Photo 28:** Culvert KM 9.3: Outlet.

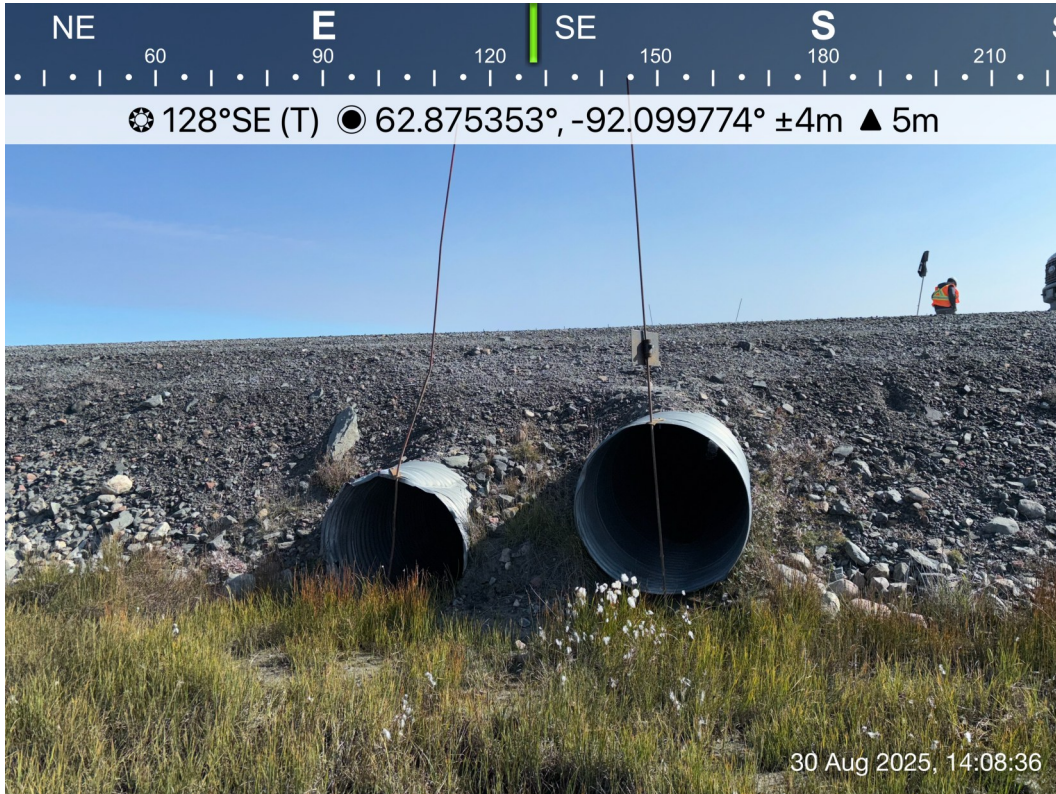
AWAR Road/ Culvert KM 9.3: Inlet.
Culvert - Photo 29:

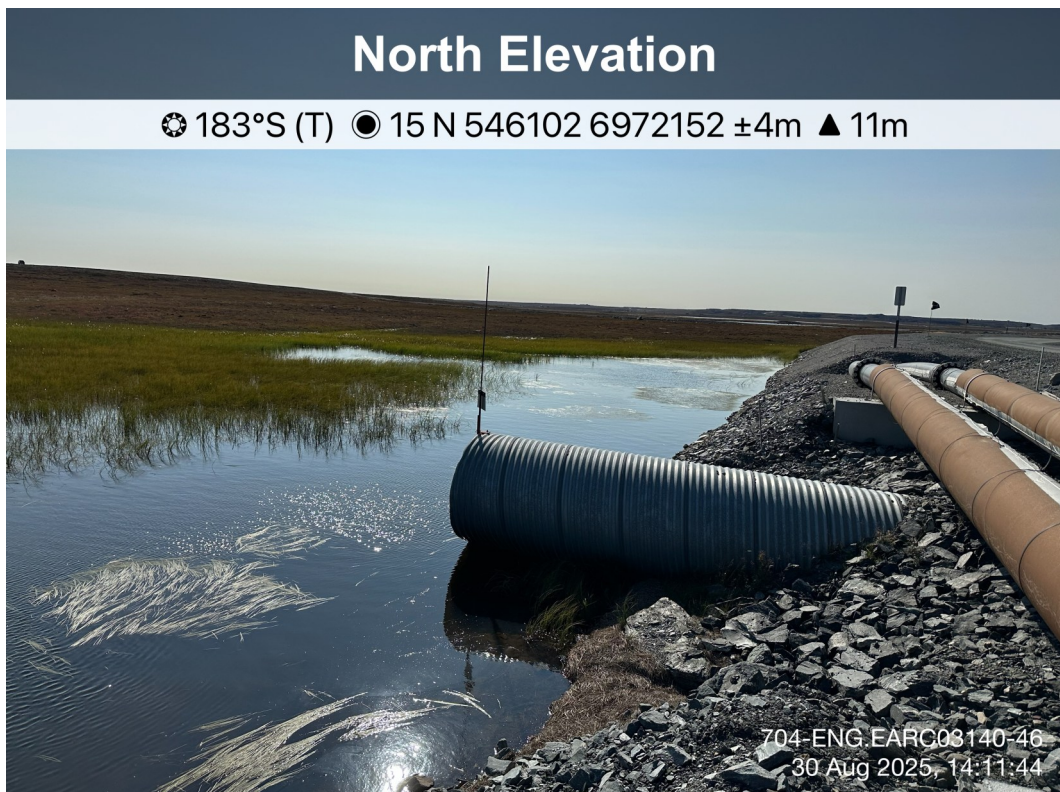
AWAR Road/ Culvert KM 9.6: Inlet.
Culvert - Photo 30:

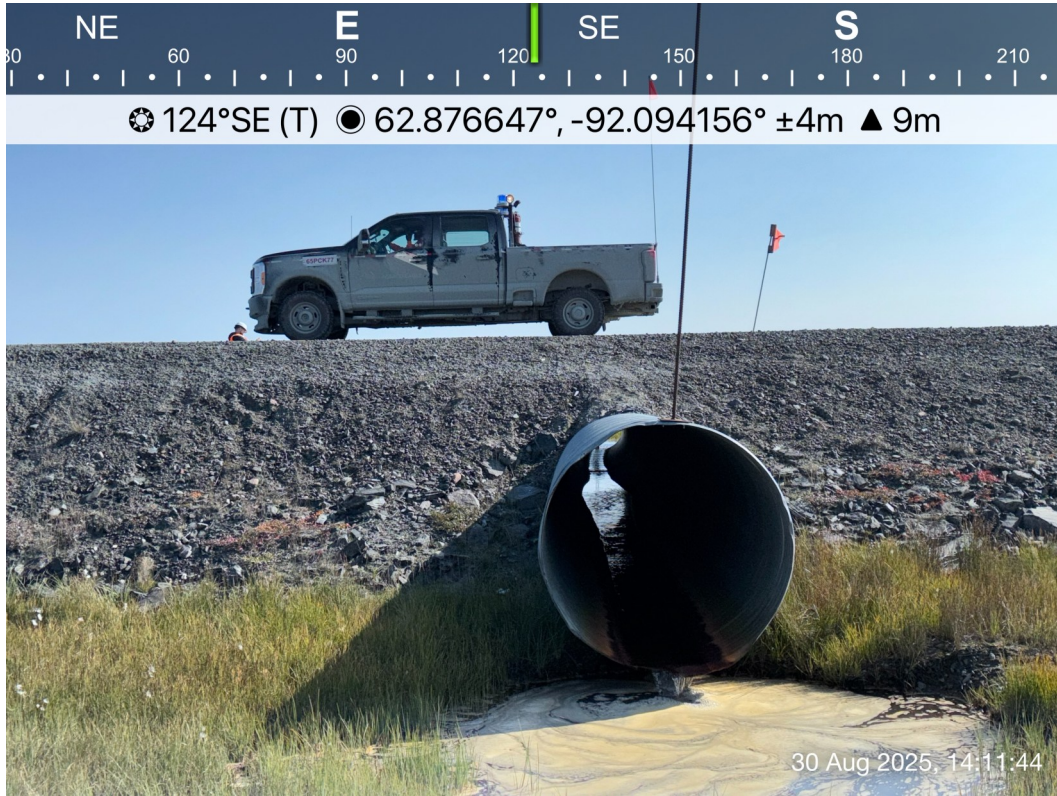
**AWAR Road/
Culvert - Photo 31:** Culvert KM 9.6: Outlet.

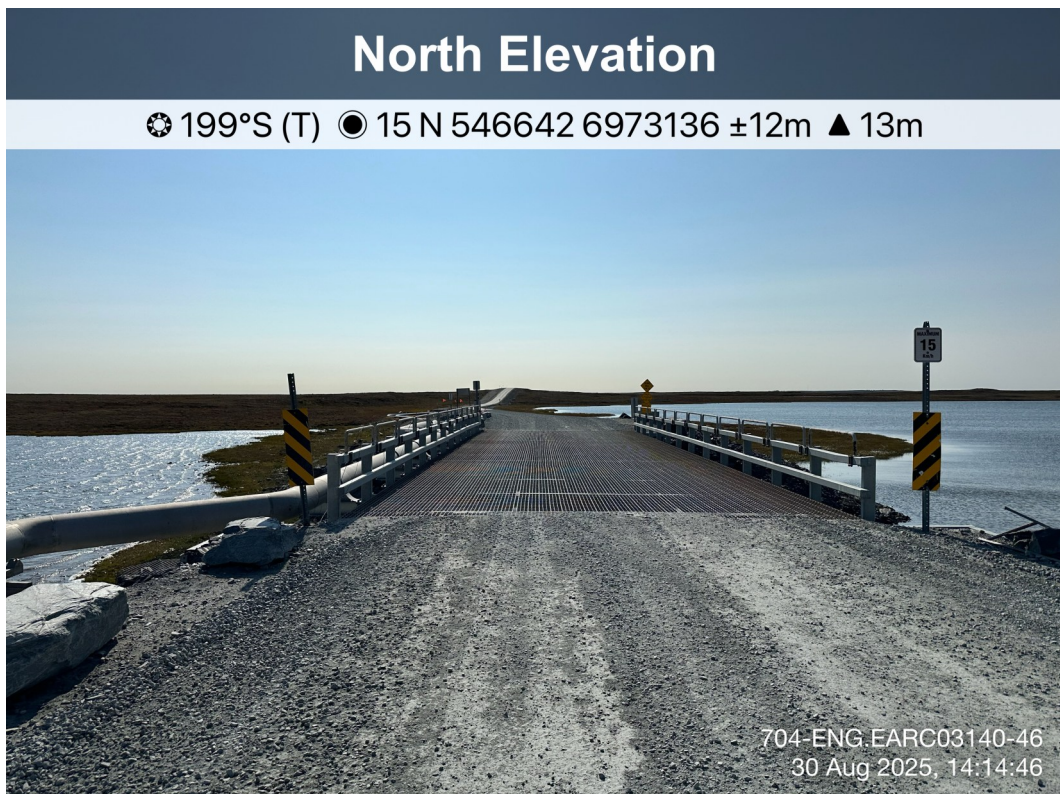
**AWAR Road/
Culvert - Photo 32:** M-5 Bridge KM 10.5.

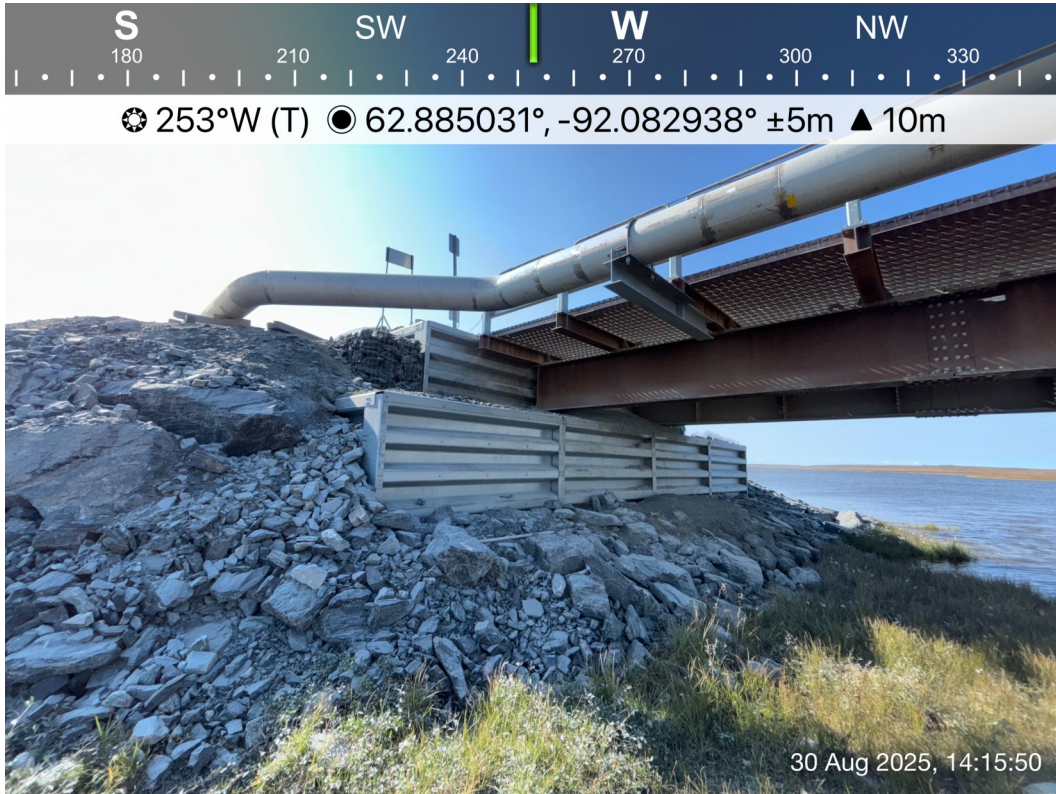
**AWAR Road/
Culvert - Photo 33:** M-5 Bridge KM 10.5: South abutment.

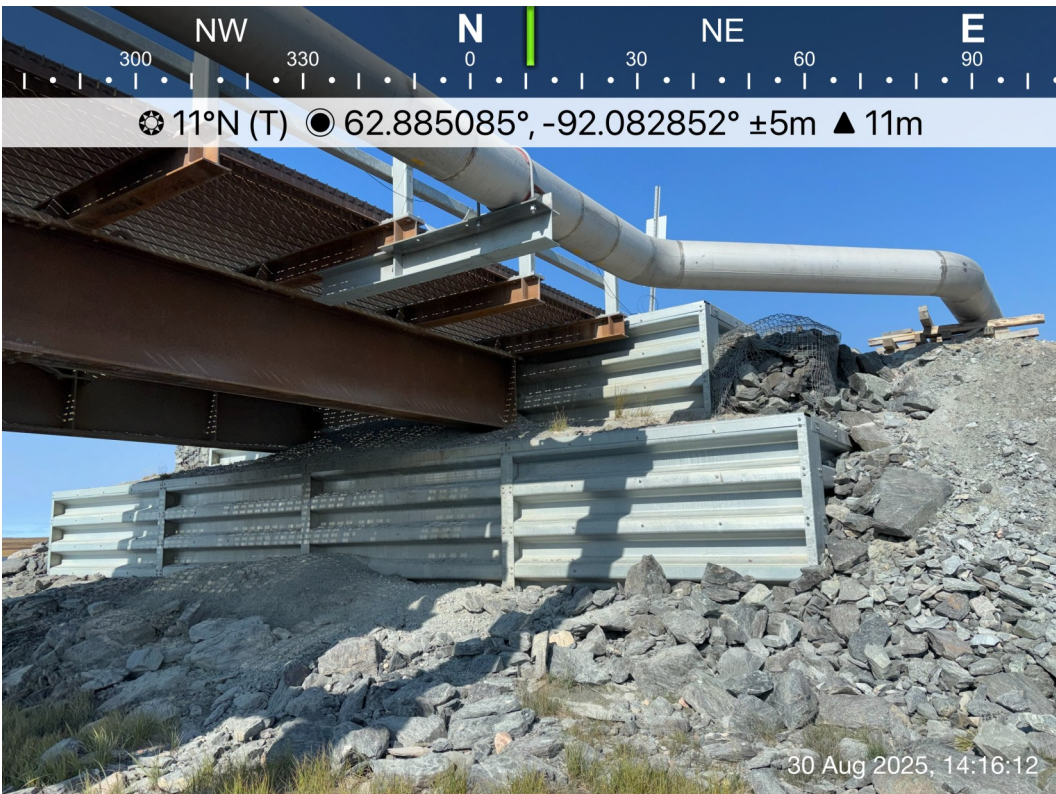
**AWAR Road/
Culvert - Photo 34:** M-5 Bridge KM 10.5: North abutment, damaged gabion basket.

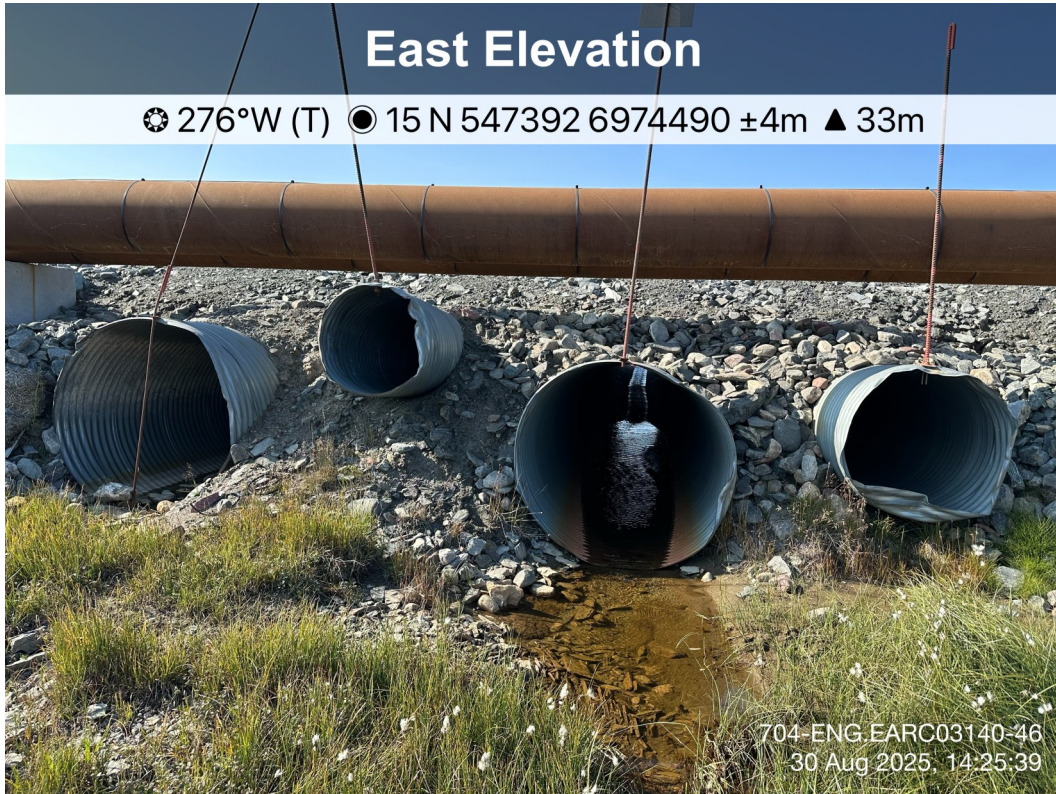
AWAR Road/ Culvert KM 12.2: Inlet.
Culvert - Photo 35:
