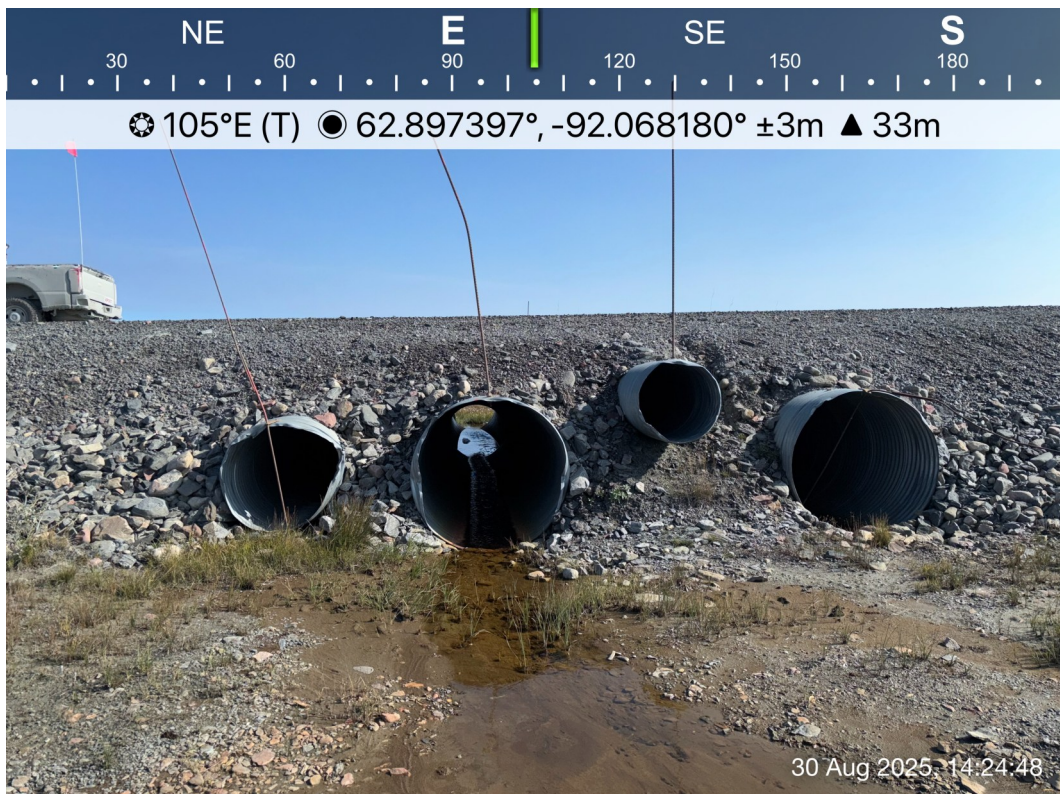
AWAR Road/ Culvert KM 12.2: Outlet.
Culvert - Photo 36:

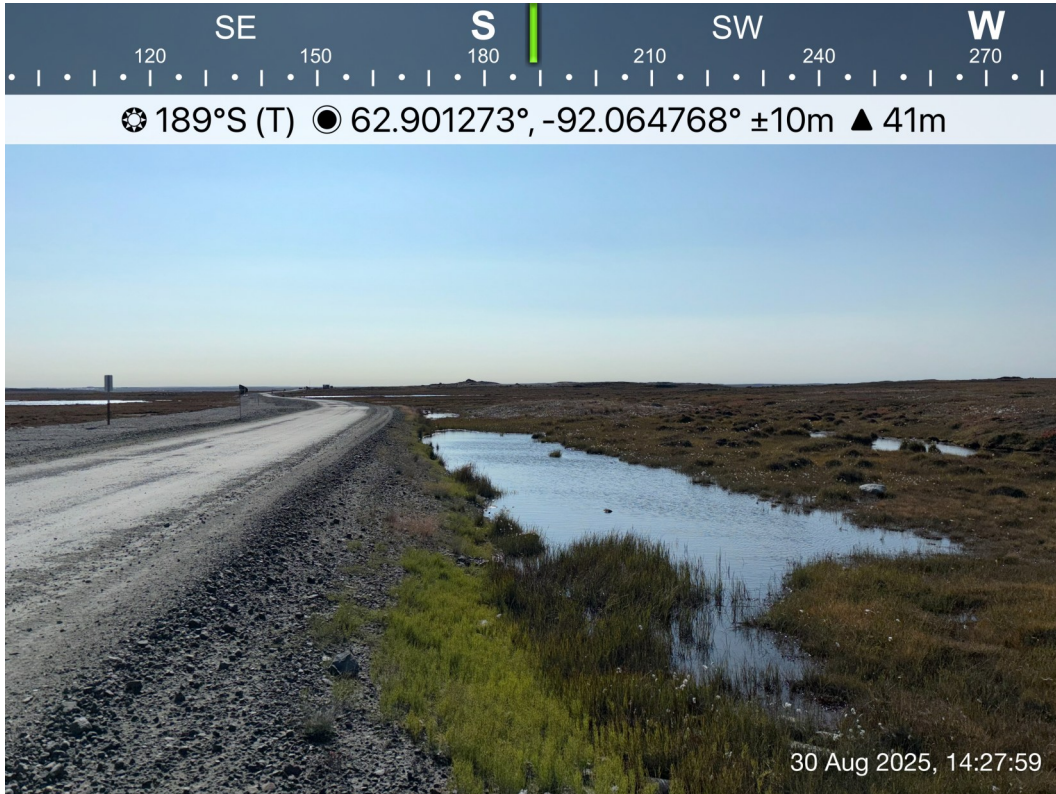
**AWAR Road/
Culvert - Photo 37:** KM 12.6 :No culvert installed, poor drainage condition, no sign of water flow.

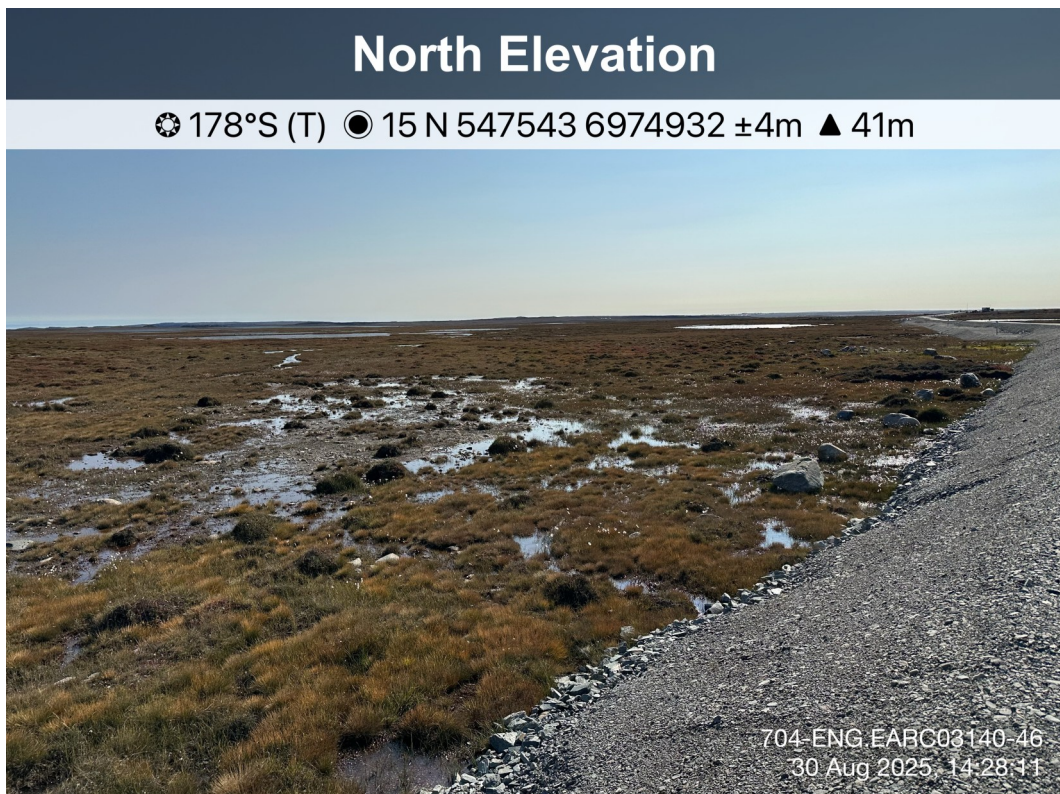
**AWAR Road/
Culvert - Photo 38:** KM 12.6: No culvert installed, poor drainage condition, no sign of water flow.
