WATER LICENCE INSPECTION FORM

Licensee Department of National Defence	Licensee Representative Don Beattie
Licence No. / Expiry 3BC-BAFA0919	Representative's Title Environmental Officer
Land / Other Authorizations	Land / Other Authorizations
Date of Inspection September 3, 2018	Inspector Joseph Monteith
Activities Inspected	
<input type="checkbox"/> Camp <input type="checkbox"/> Drilling <input type="checkbox"/> Mining <input type="checkbox"/> Construction <input type="checkbox"/> Reclamation <input type="checkbox"/> Fuel Storage <input type="checkbox"/> Roads/Hauling <input checked="" type="checkbox"/> Other: Potable Water Source, Solid Waste Facility, Sewage Disposal Facility <input type="checkbox"/> Other:

SECTION 1	<input checked="" type="checkbox"/> Comments (s. __)	<input type="checkbox"/> Non-Compliance with Act or Licence (s. __)	<input type="checkbox"/> Action Required (s. __)
BACKGROUND			
<p>The BAF-3 Long Range Radar Station (BAF-3) is located at an elevation of 366 m above sea level on the southern end of Brevoort Island. (See photo 1). Brevoort Island is 40-km long and 10-km wide. It is found off the east coast of Baffin Island, approximately 250 km Northeast of Iqal

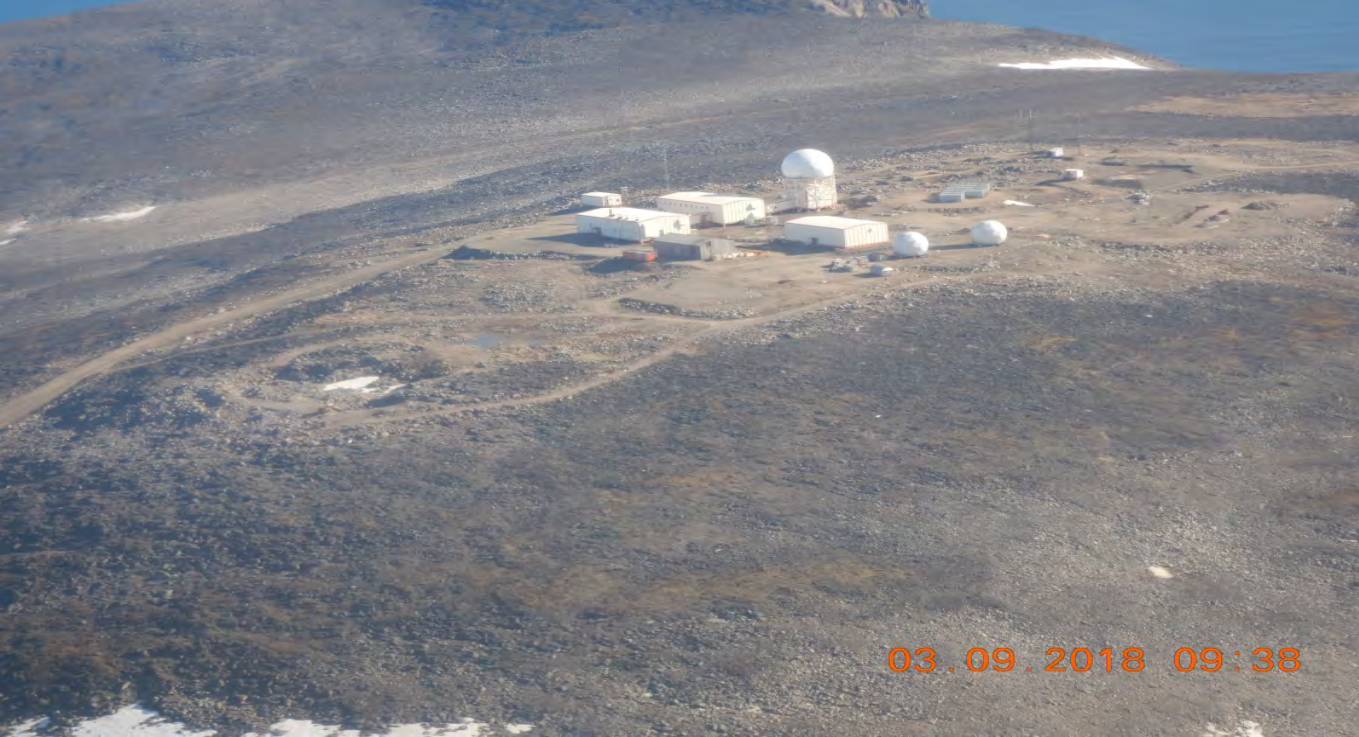
Date	Camera	Inspector
September 3, 2018	Nikon Coolpix	Joseph Monteith
Photo Log #1	Location	
Photo 1	Breevort Island, NU

Description: BAF-3, Breevort Island

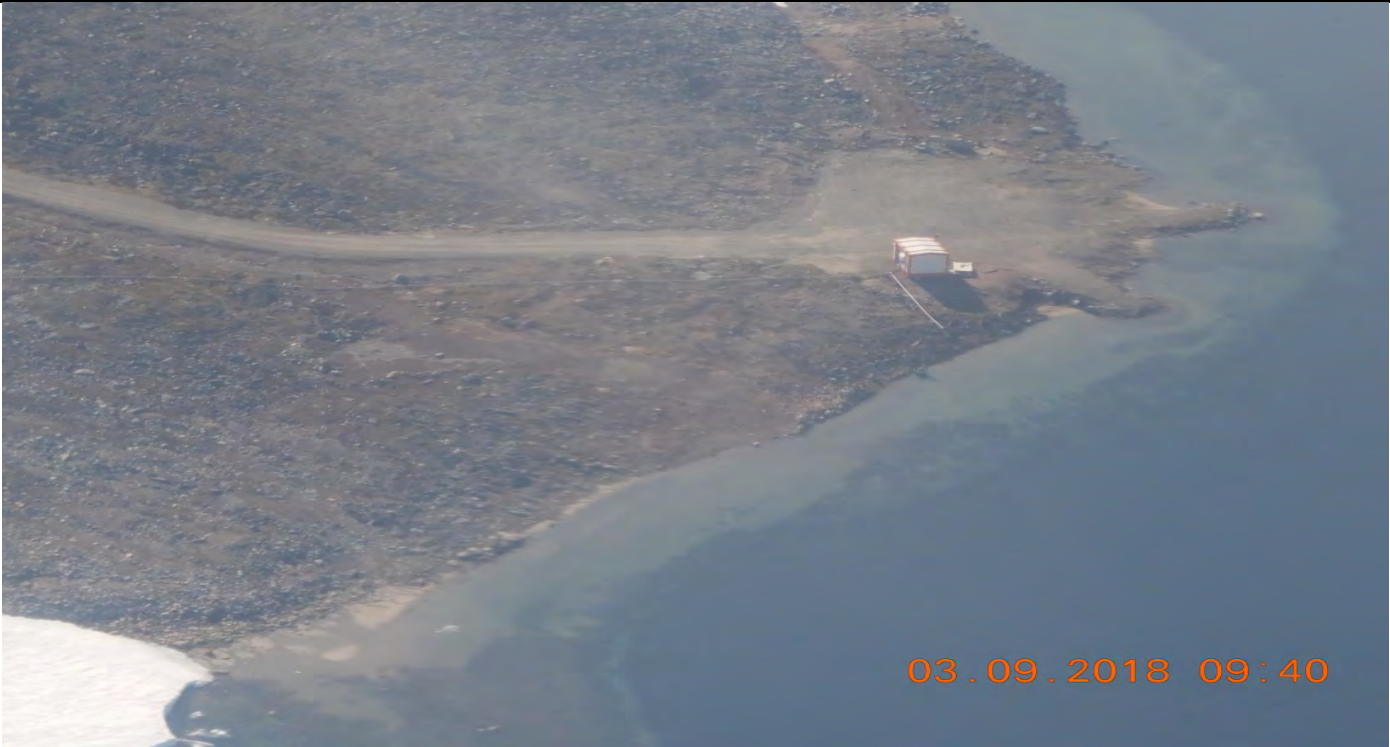
Photo Log	Location
Photo 2	Breevort Island

Description: Pump house recharges pipes which transfers water to the BAF-3 facility.

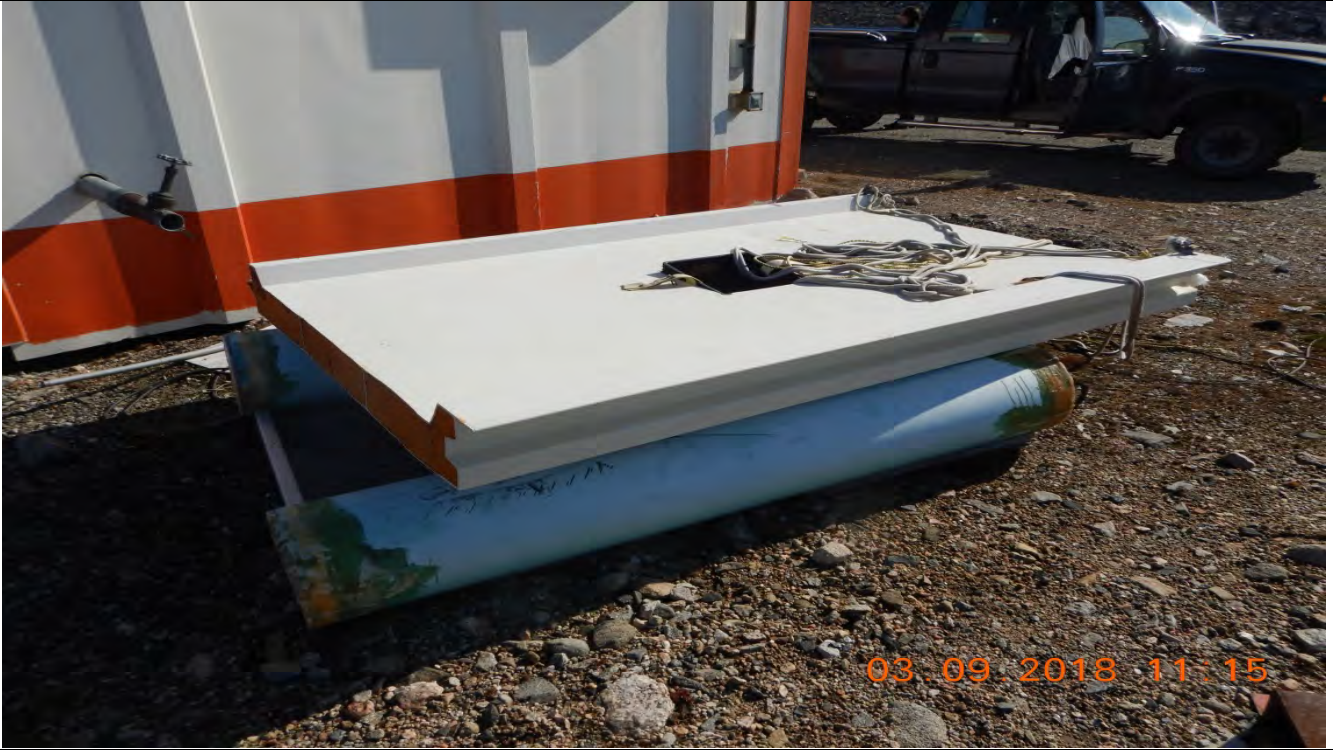
Photo 3

Description: Floating dock with milk carton installed to act as a fish mesh screen when withdrawing from the freshwater source.

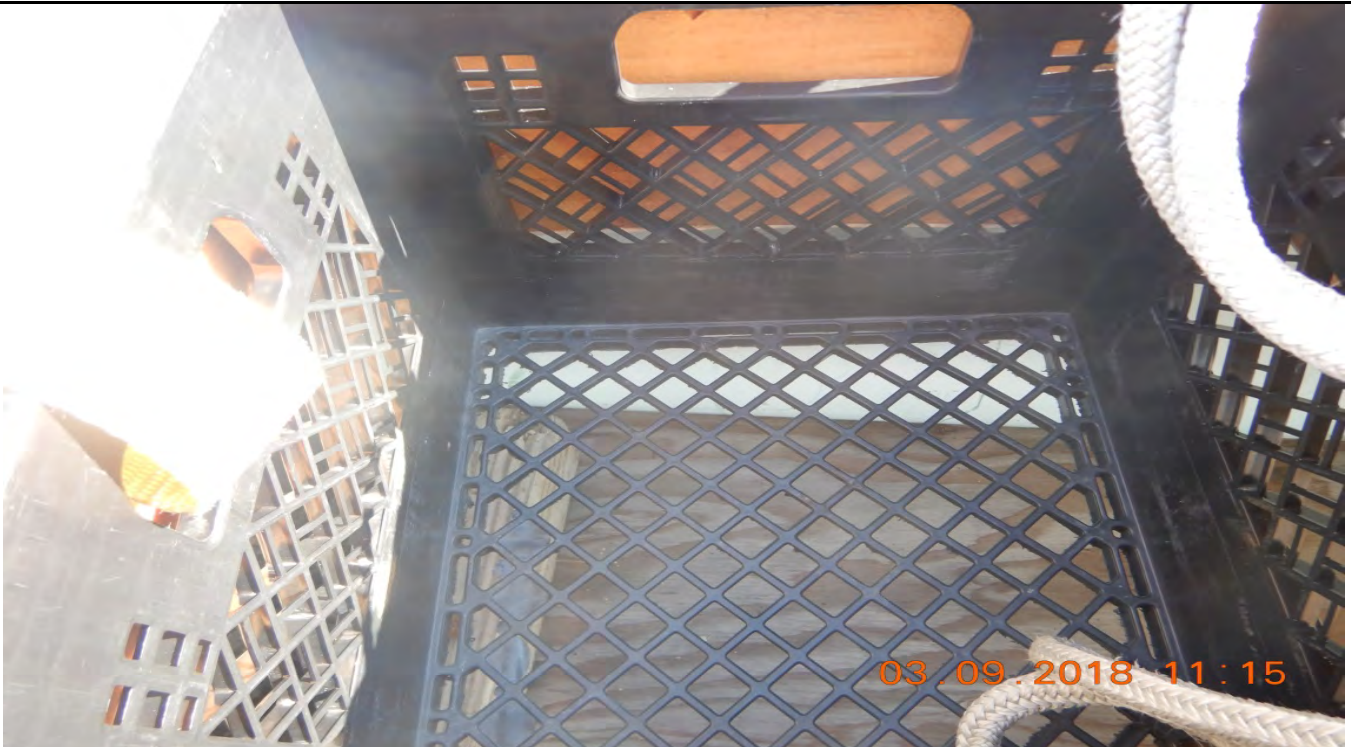
Photo 4

Description: Inside milk crate on floating dock.

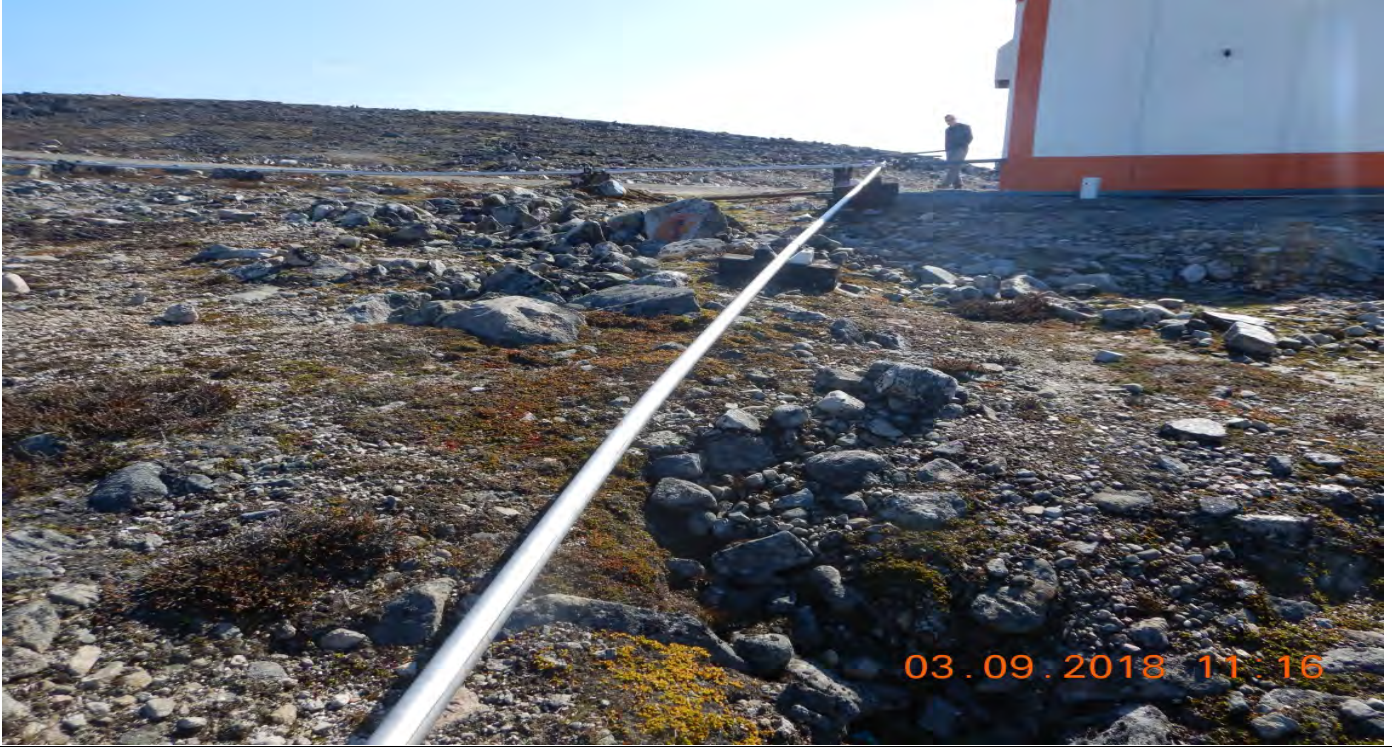
Photo 5

Compliance with General Conditions of the Licence			
<p>On March 28, 2018 a submission of an annual report was uploaded to the Nunavut Water Board ftp website, satisfying the General Requirement.</p>			
Water Use and Related Structures			
<i>Fresh Water Lake</i>			
<ol style="list-style-type: none"> 1. The licensee is authorized to withdrawal 1750 m³ per year 2. All water is withdrawn from Fresh Water Lake (see photo 2). 3. Floating dock with milk crate for fish mesh screen (see photo 3). 4. Intake pipe has a milk crate for a fish mesh screen (see photo 4). 5. Intake pipe to Pump house (see photo 5). 6. Pump house with two water pumps and internal piping (see photo 6).

Description: intake pipe to pump house.

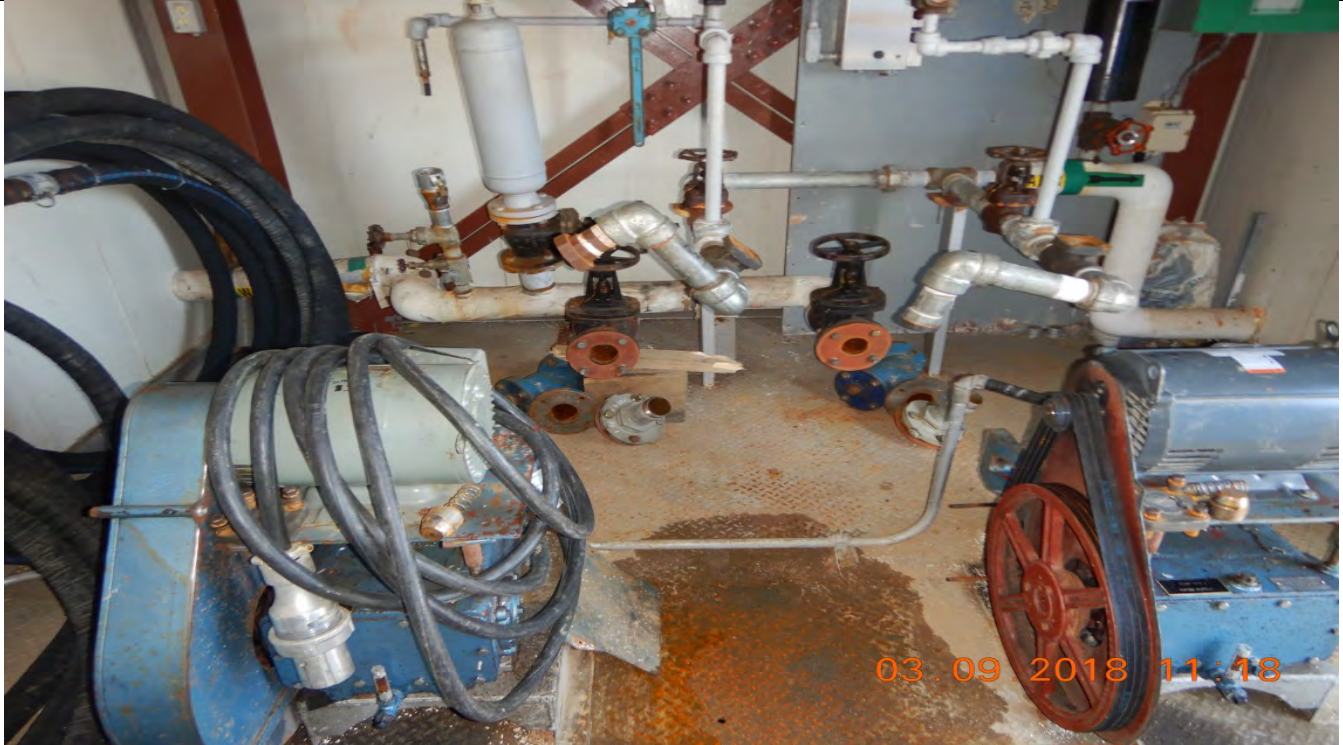
Photo 6

Description: Two water pumps in pump house at potable Fresh Water Lake

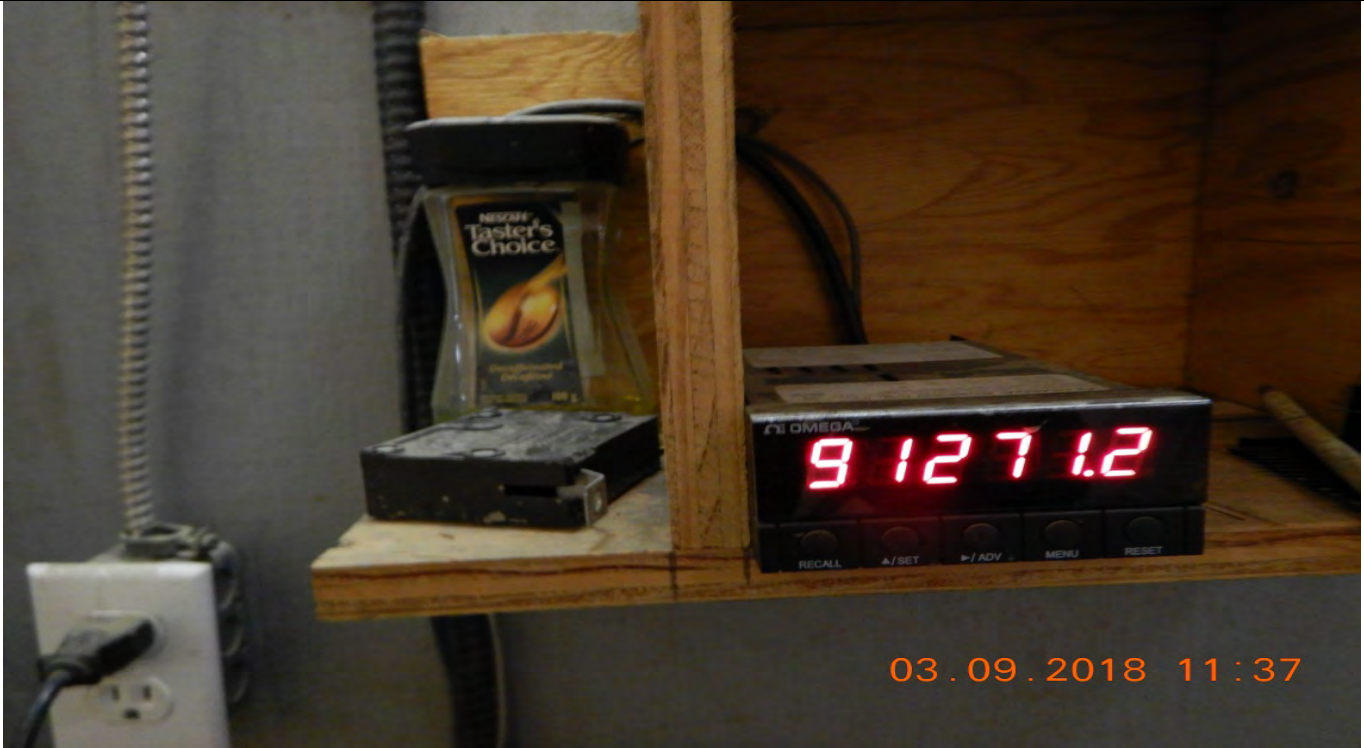
Photo 9

- 7. The Water Storage Building has two 984 m³ Water Storage Tanks (see photo 7 and 8).
- 8. A Water Meter was observed on site, and read 91271.2 Gallons (see photo 9).

Description: Water Storage Tank South. Capacity 984,000

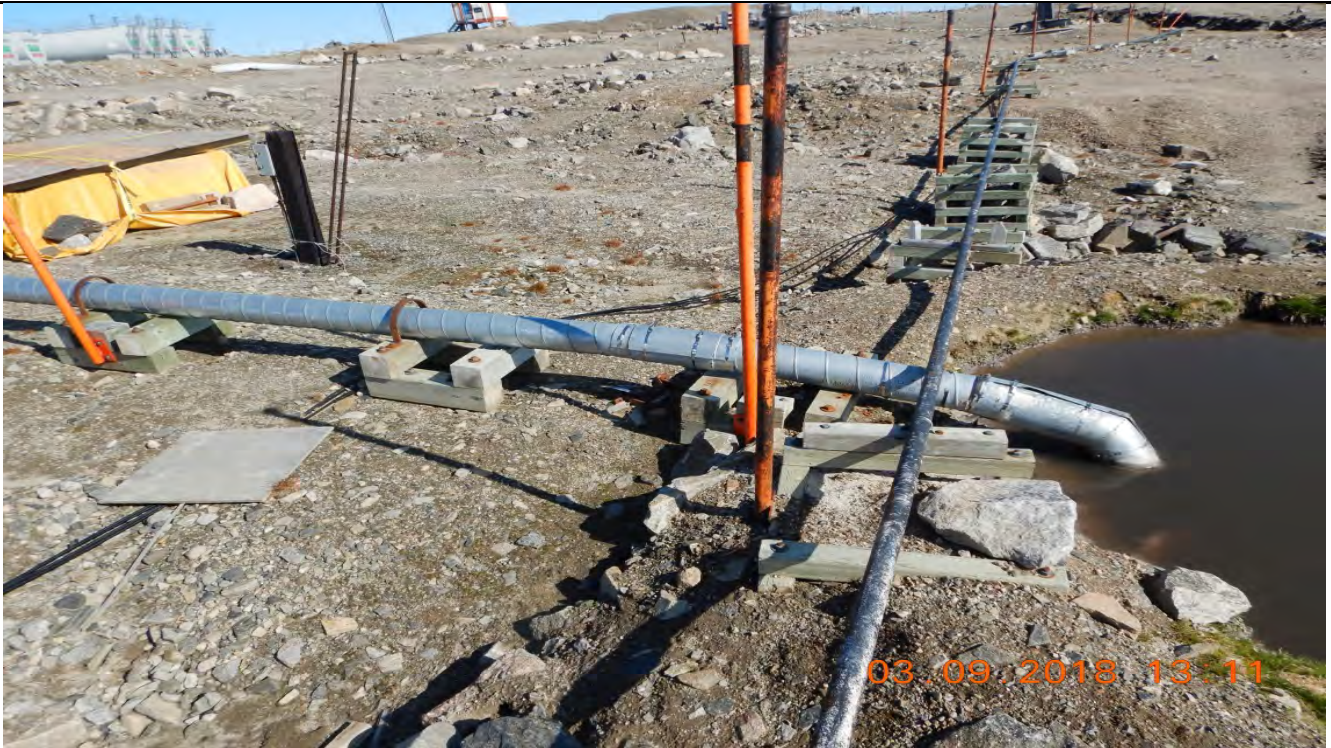
Photo 10

- 9. The Sewage system consists of a septic tank, and an outfall pipe that drops its waste into a sump.
- 10. No observations were made of the septic tank during the inspection.
- 11. The outfall pipe end was below the sewage waste water table in the sump. (See photo 10).
- 12. The Sump pit appeared to be full, and was built up on one side of the wall with rocks. Seepage appears to have leaked through the rocks (See photo 11).

Description: Outtake pipe for sewage

- The Licensee is reminded to remain diligent to prevent wastes from entering water, the environment, and to adhere to the discharge requirements listed in this licence.

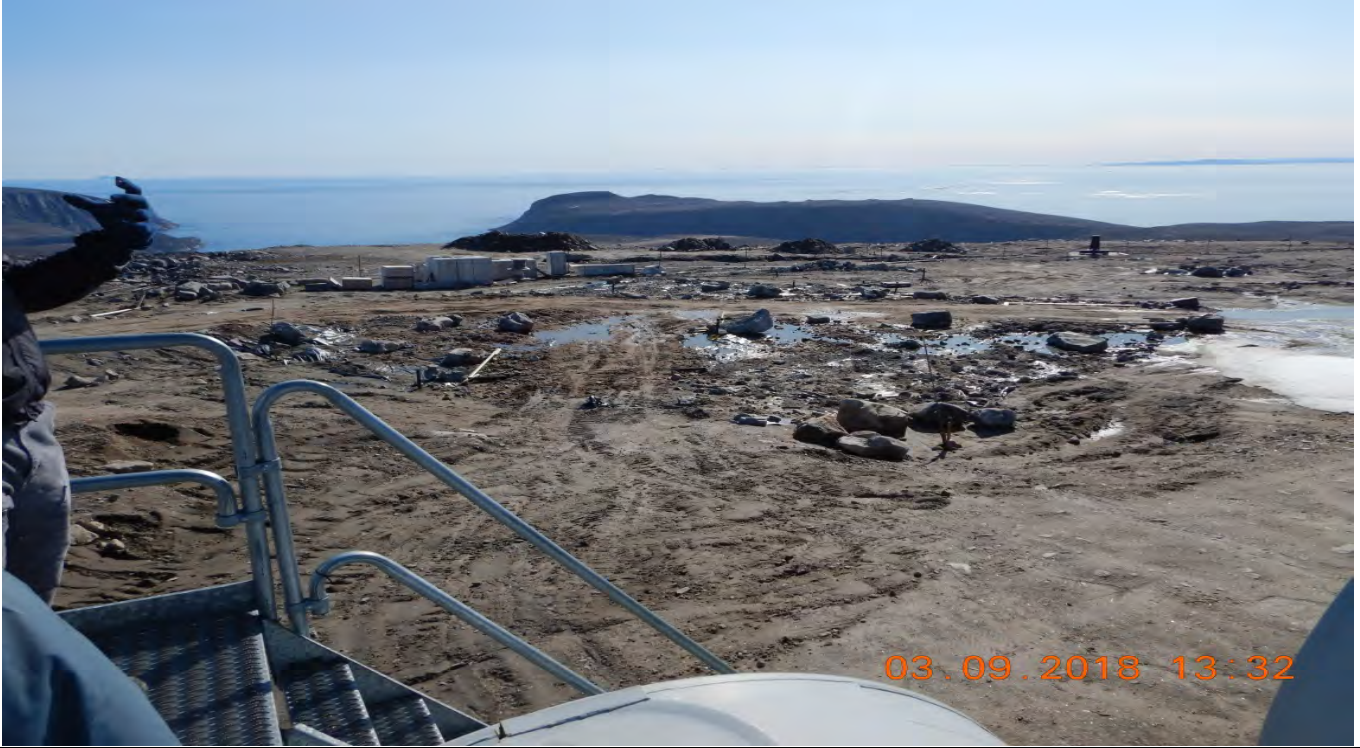
Photo 13

Description: Site of remediation from on top of the storage tank responsible for the spill source.

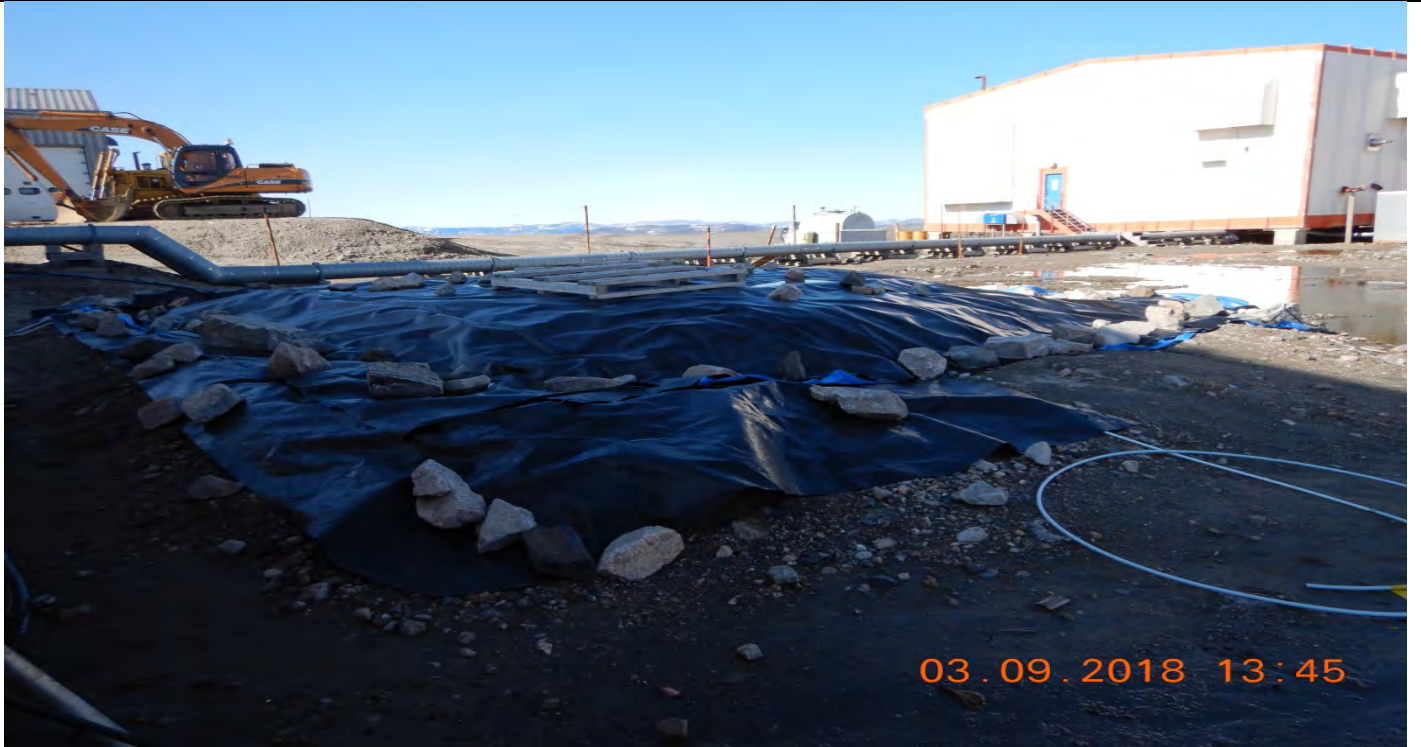
Photo 14

Description: A hydro carbon puffer, creates a negative pressure room, and sucks the hydro carbons out of the soil.

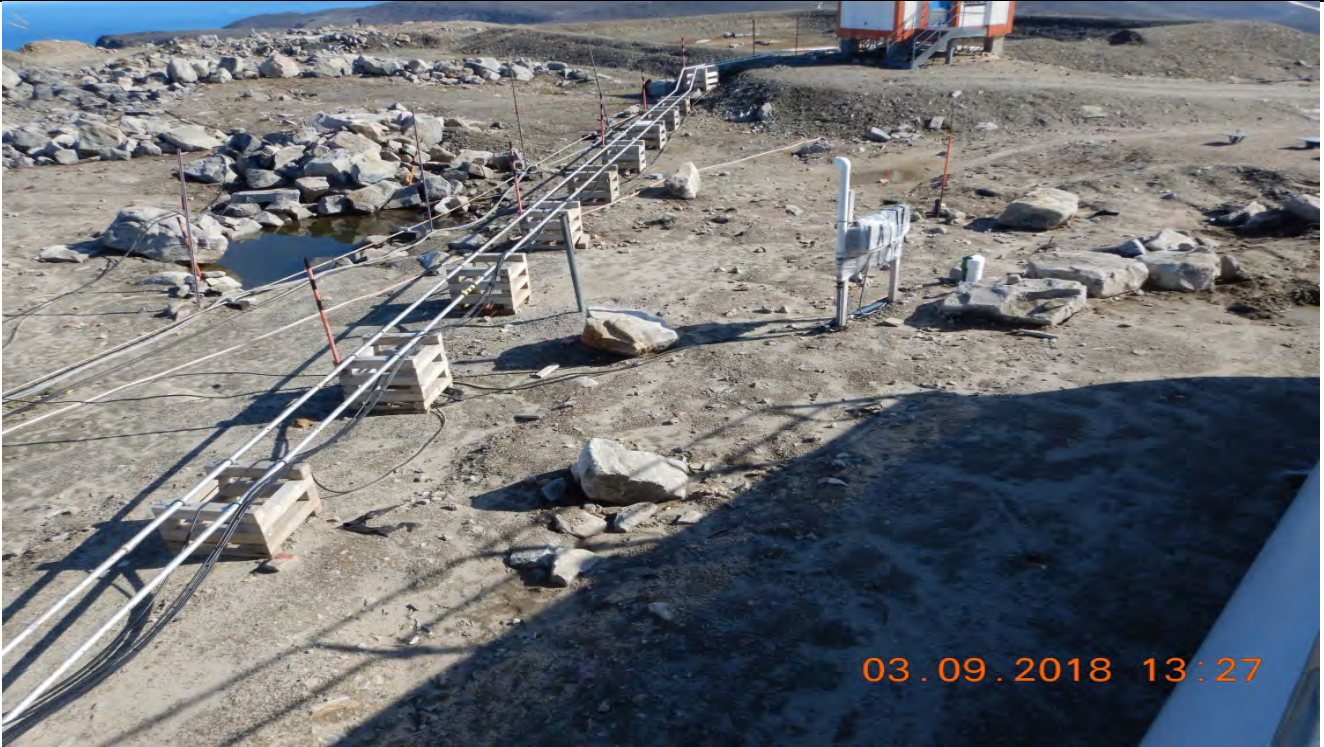
Photo 15

Description: Migration of spill also went north east of the storage tank. The water in the photo is a result of the creation of a trench to capture fuel spill and stop the migration.
