Nunavut Impact Review Board

2024 Site Visit Report for

B2Gold Back River Corp.'s

Back River Gold Mine Project

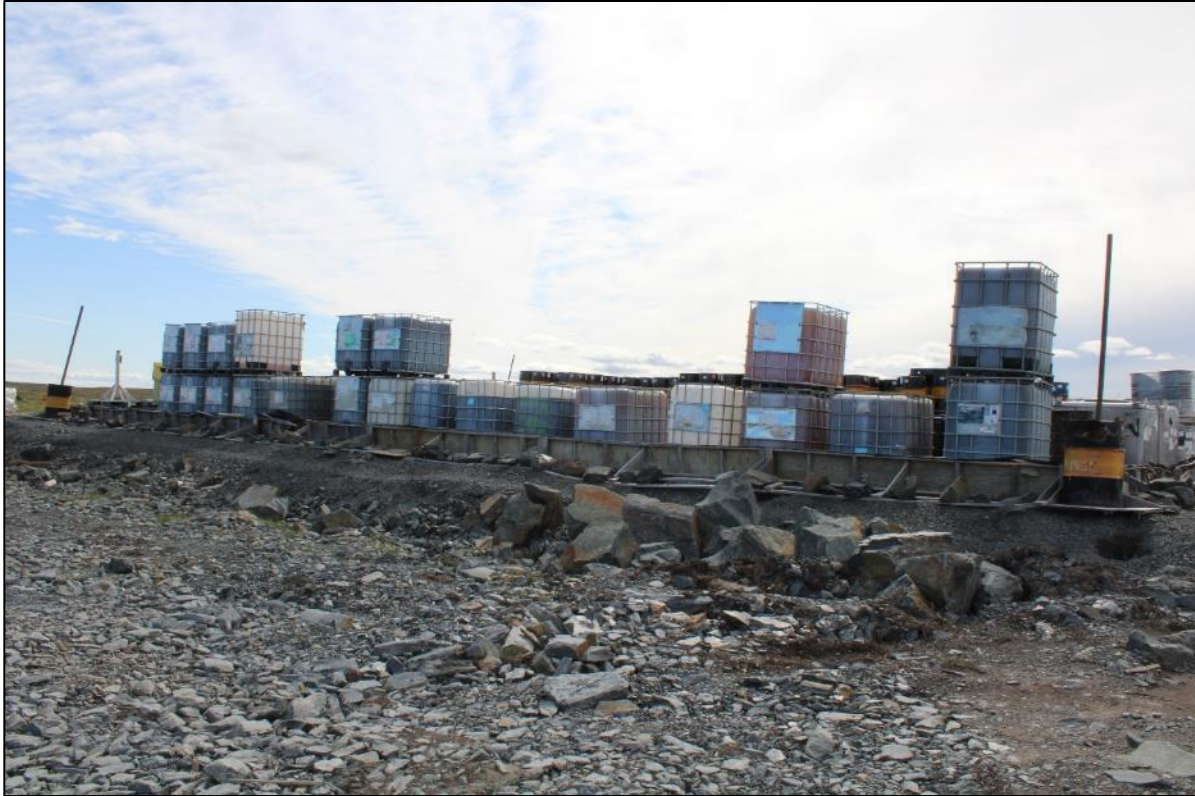
Photo 9: Hazardous Waste Storage.

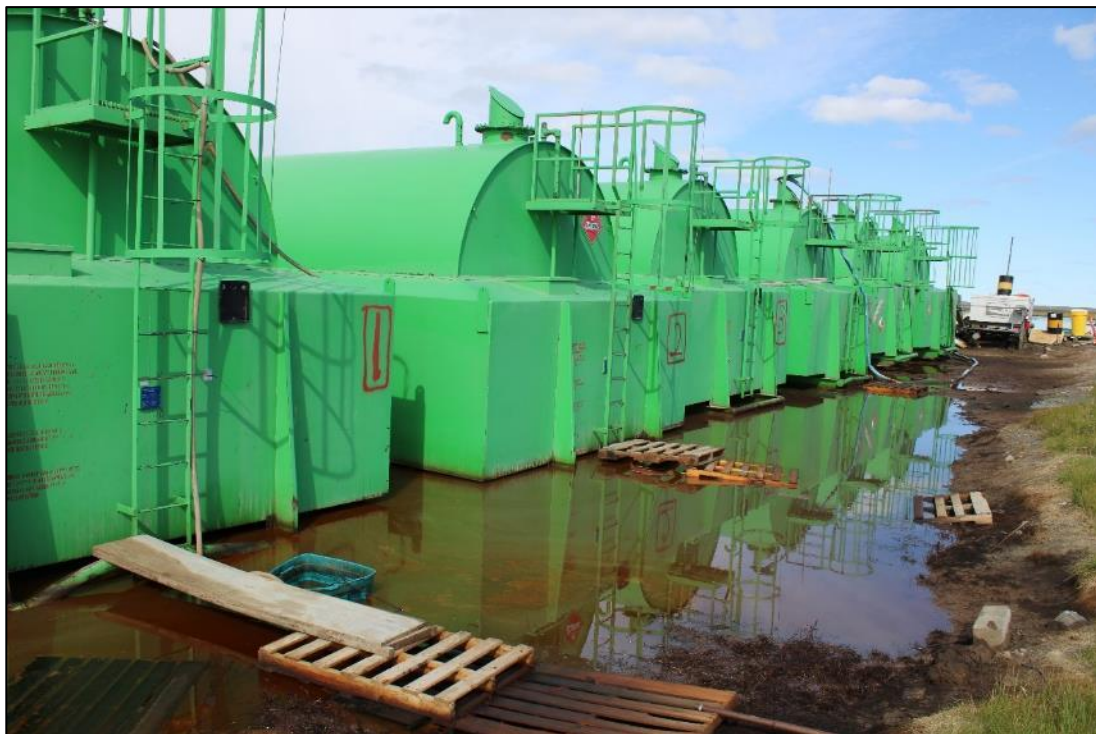
The exploration laydown area is located south of the exploration camp and is composed of maintenance shops, storage buildings, incinerator facilities, drill core storage, the core shack and bulk fuel storage. NIRB staff noted some concerns with contaminated water storage inside the lined fuel storage facility. B2Gold indicated that this water has been tested and they are currently waiting for an oily water separator to arrive for proper treatment. At the close out meeting, it was discussed that this water shouldn't be stored in open containment, even if temporarily and that B2Gold should prioritize resolving this matter and storing the contaminated water in a covered container in the interim.

Photo 12: Contaminated Water Storage Inside the lined Bulk Fuel Storage Area.

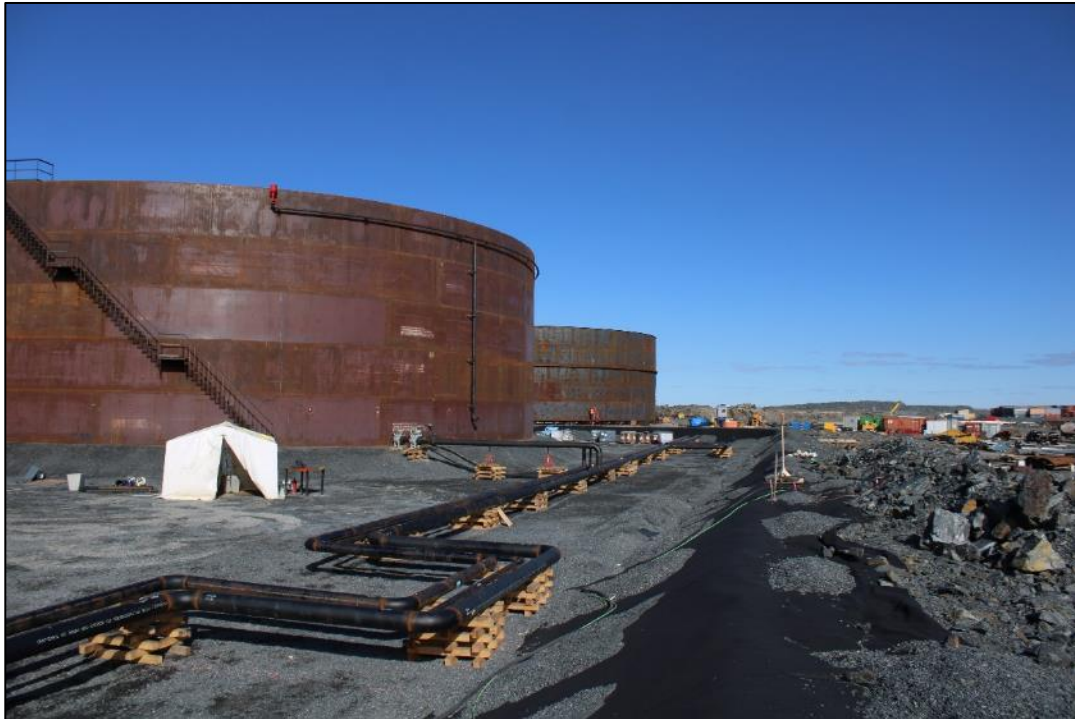
Photo 14: Tankfarm and Berm.

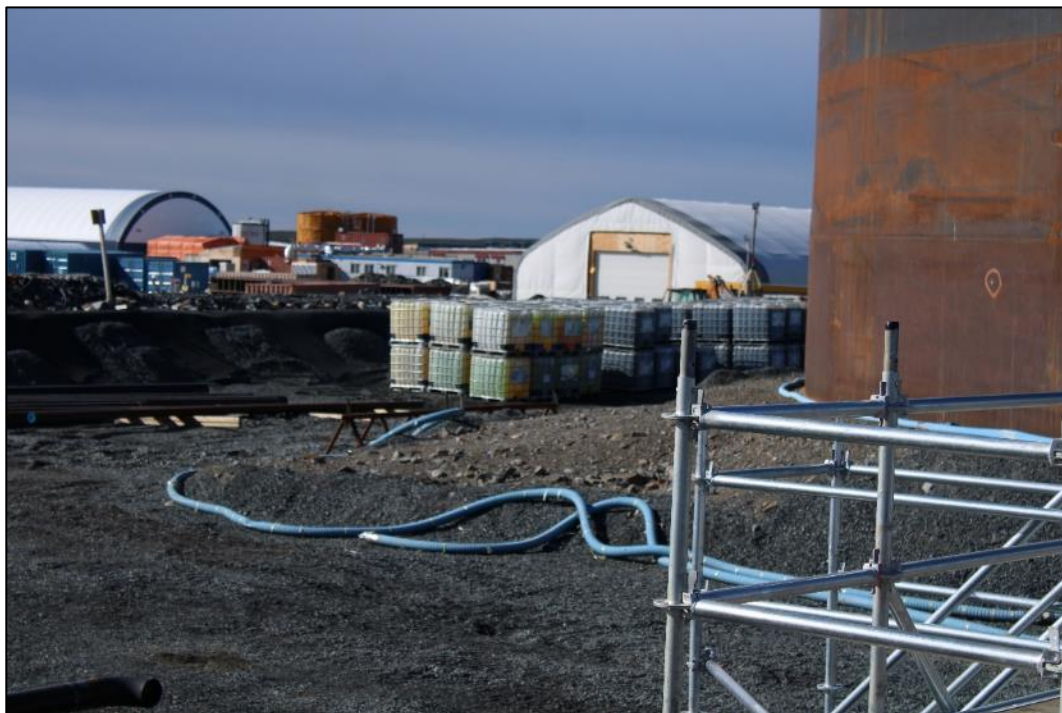
Photo 15: Hazardous Materials Stored inside the Tank Farm Berm.

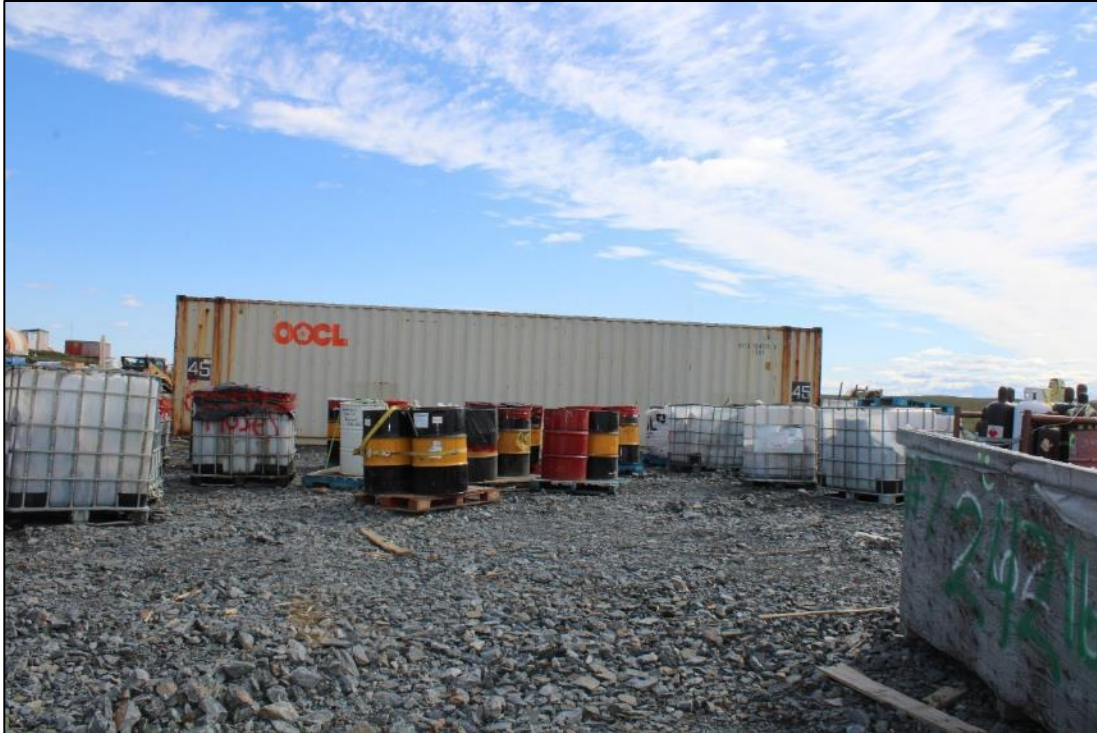
Overall, the bulk diesel fuel and hazardous materials were generally in compliance at Goose Camp. Bulk diesel fuel was contained in double walled tanks within secondary containment. There were some occurrences of fuel barrels being stored outside of secondary containment which was discussed at the close-out meeting. B2Gold staff committed to correcting this immediately.

Photo 16: Hazardous Materials Stored outside of lined containment.

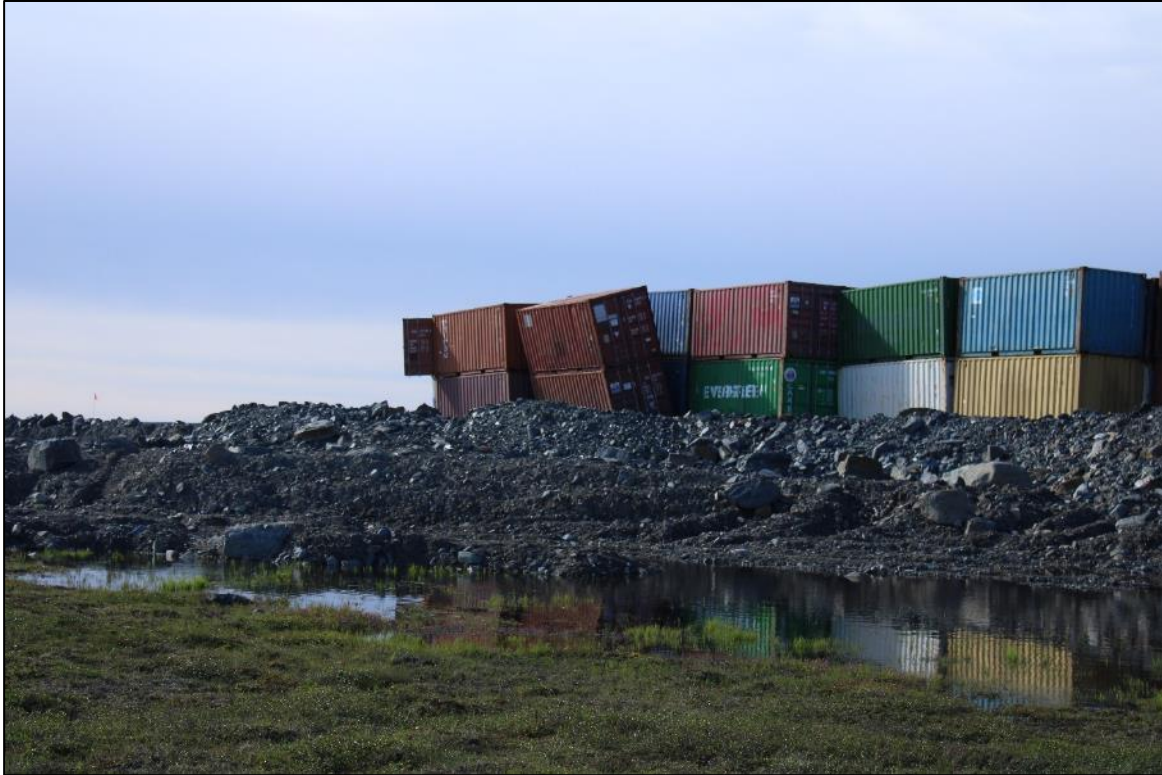
Laydown and storage areas at the Goose Lake Camp were generally tidy; however, there was some minor debris (plastic, wood and metal) on the ground in some laydown areas. This was noted at several different laydown areas, B2Gold noted that this was an ongoing challenge with the mix of staff and contractors on site but that they would continue to work on the practice. NIRB staff also noted a seacan that appeared at risk of tipping over onto the tundra at a Goose Lake Laydown area and B2Gold staff agreed to correct this immediately.

Photo 17: Seacan tipping.

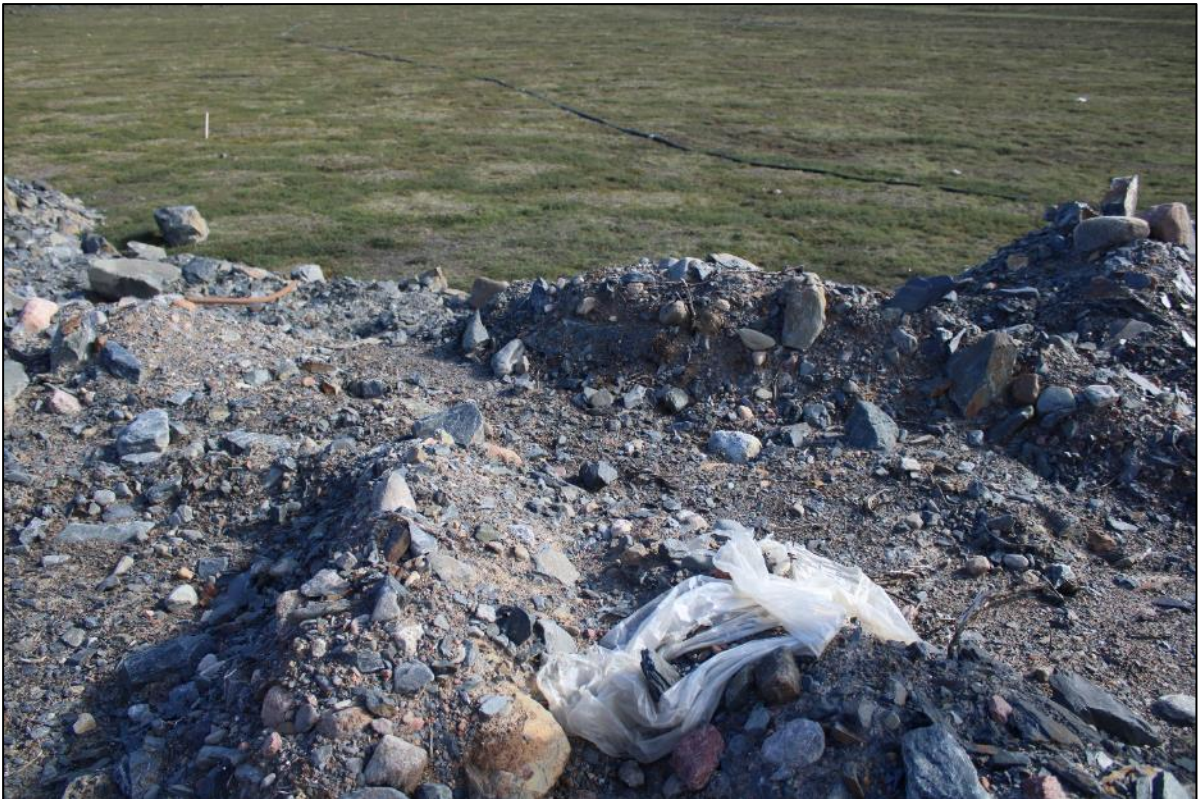
Photo 18: Plastic Debris on the ground in laydown Area.

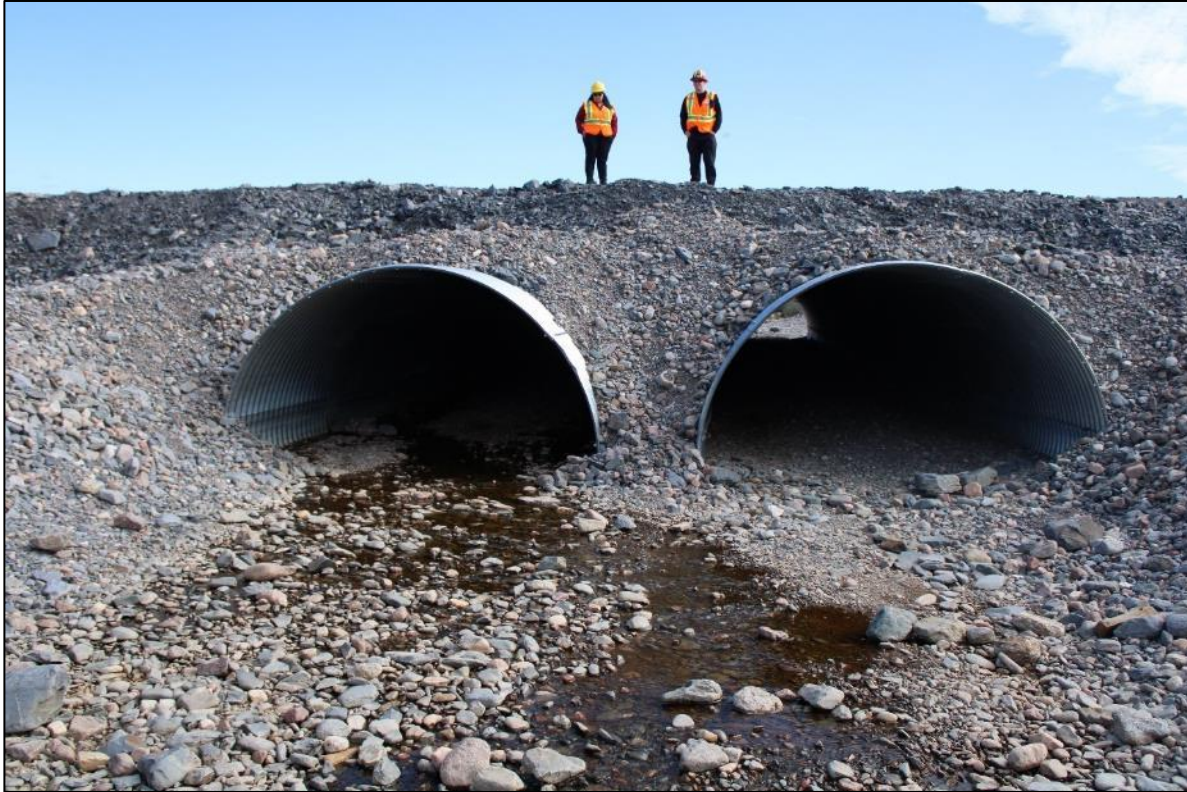
Photo 22: Culverts installed at Rascal Stream Crossing.

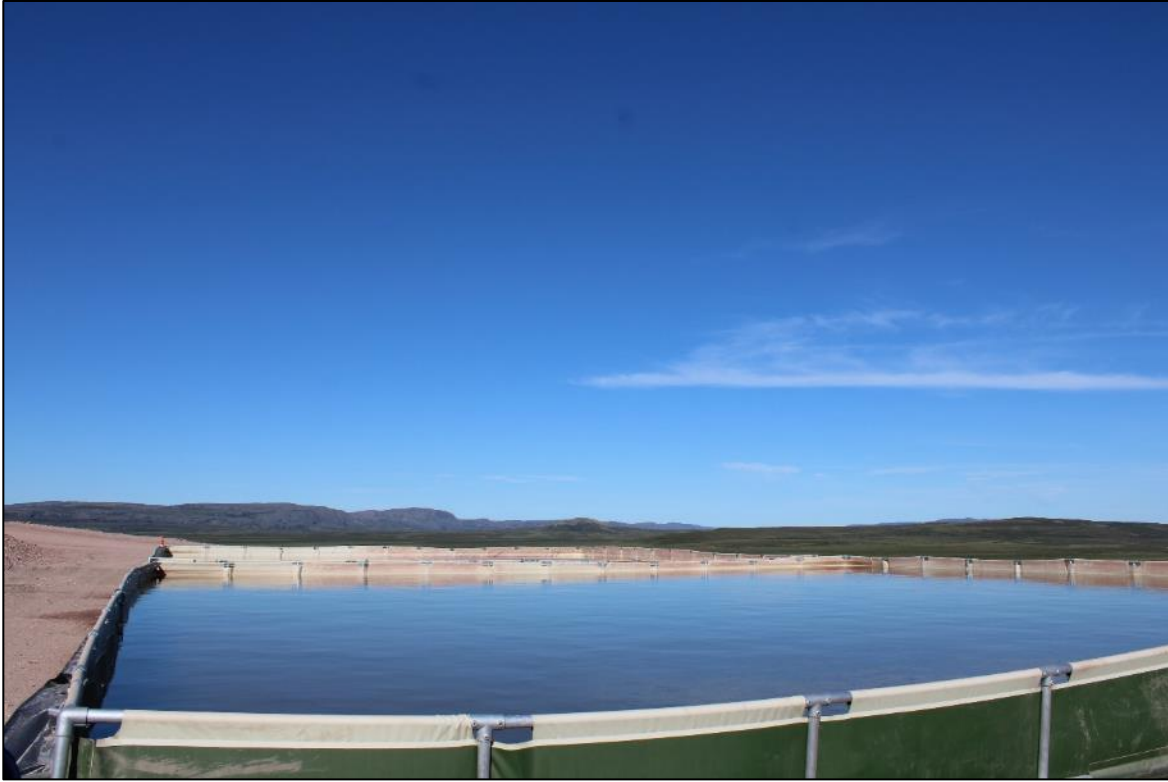
Photo 37: Secondary Containment of Contact Water prior to treatment.
