# Goose & MLA Project Sites – 2025 Annual Geotechnical Inspection

Back River Project, Nunavut, Canada  
B2Gold Back River Corp.

SRK Consulting (Canada) Inc. ■ CAPR004312 ■ March 2026

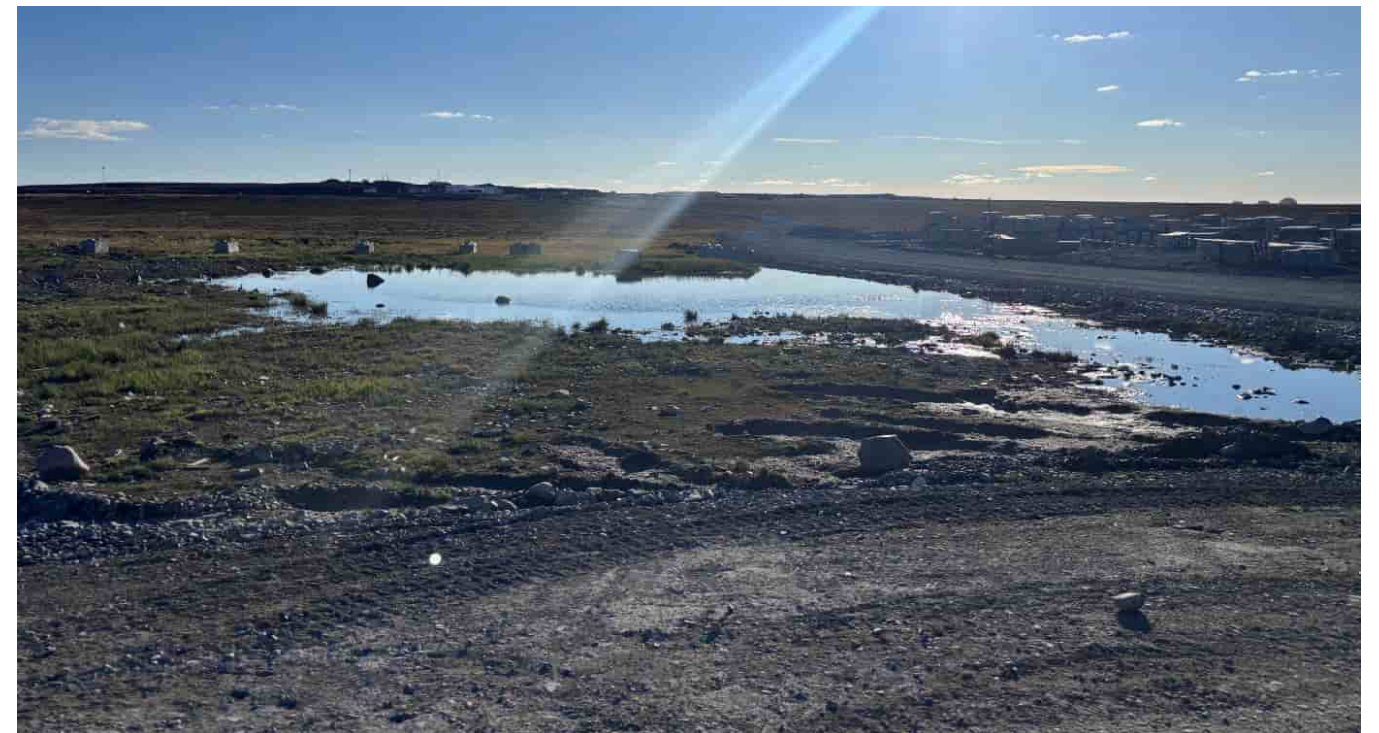
G-2: Exploration camp laydown area looking towards the airstrip access road

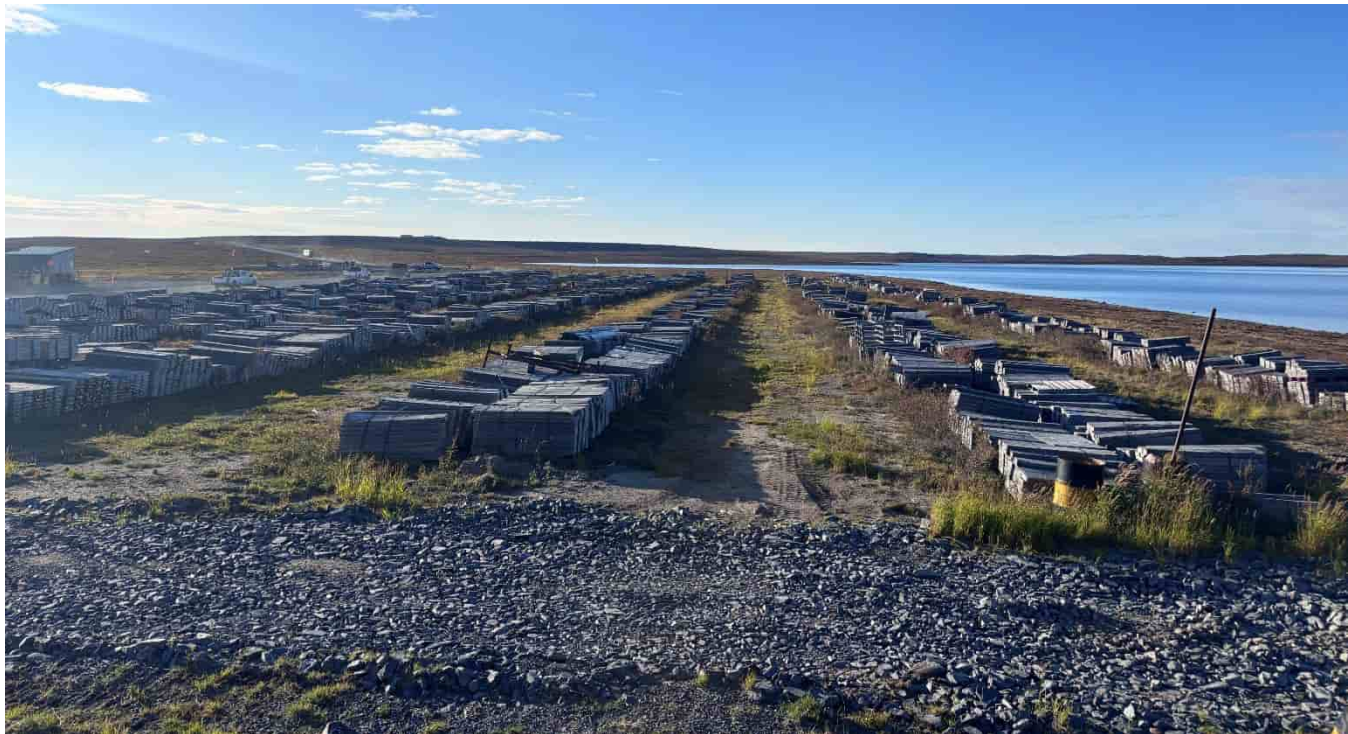
G-15: Exploration camp core storage on degraded tundra, looking NW

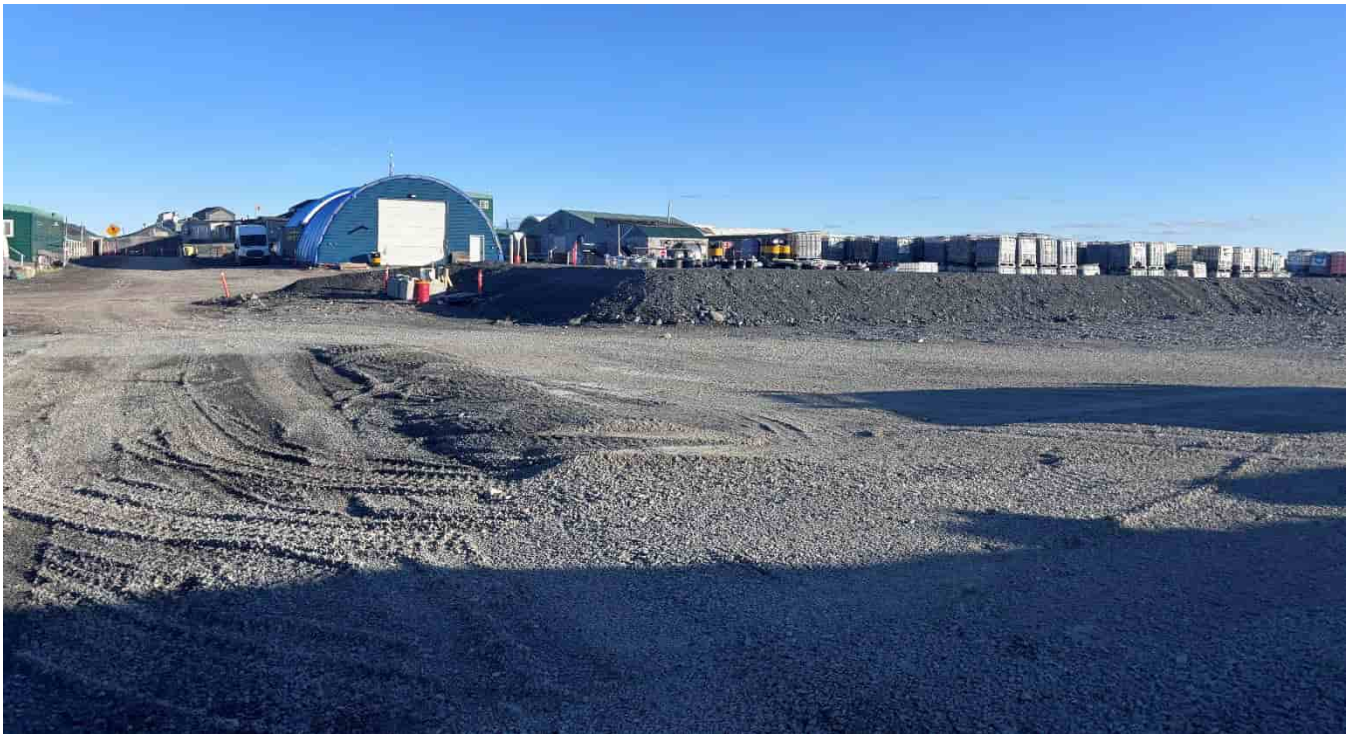
G-16: Exploration camp tote storage and Quonset, looking SE

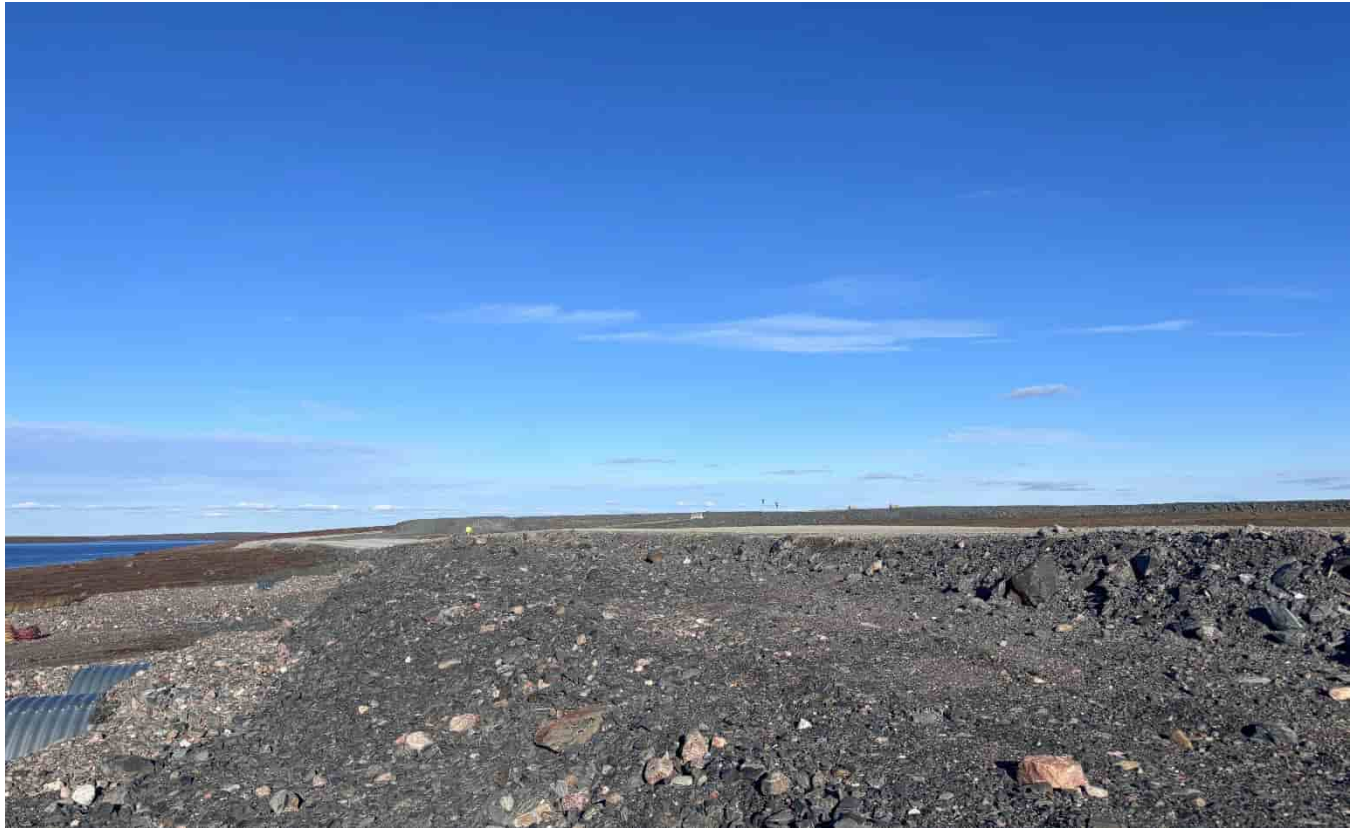
G-25: North side of road rockfill above twin culverts, looking E

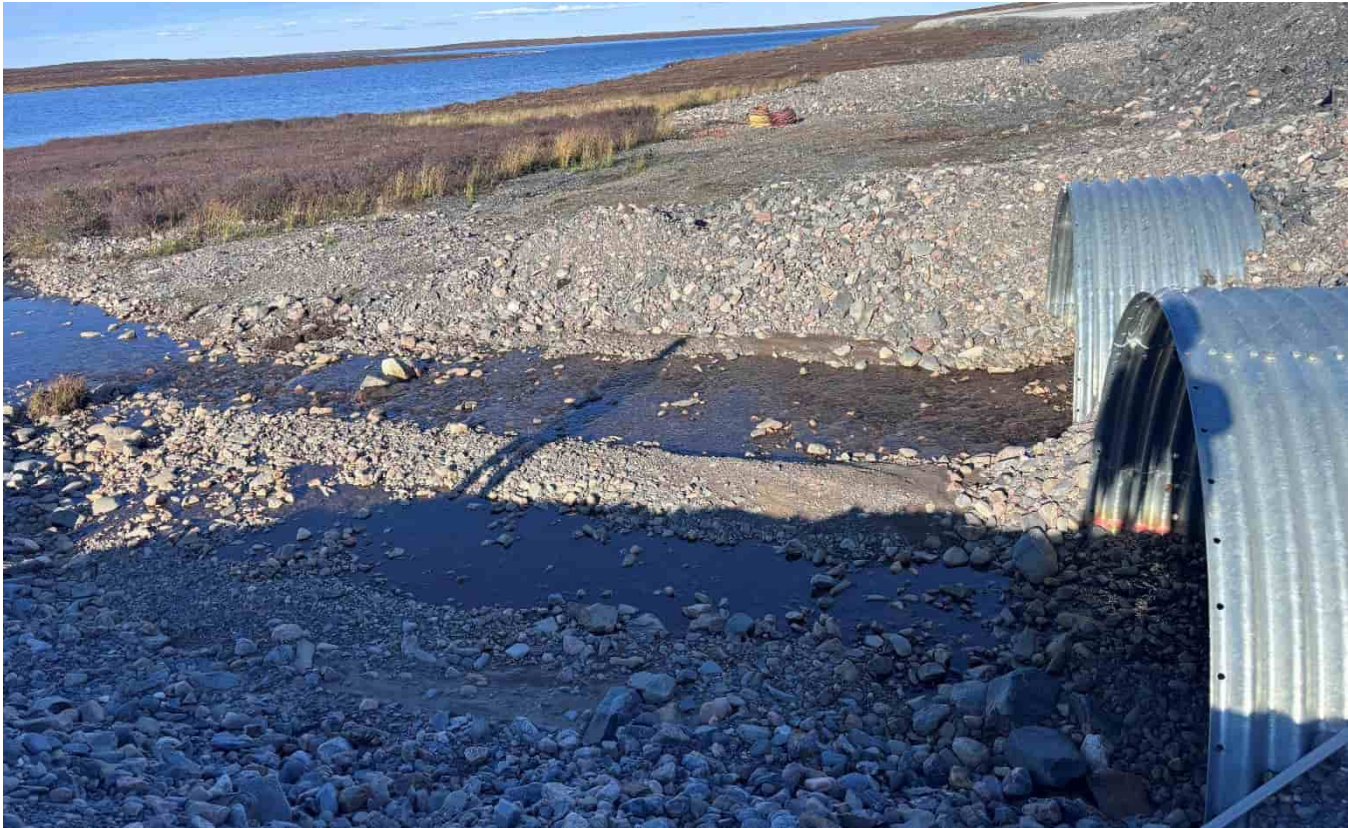
G-26: Downstream (N) side of twin culverts, looking E

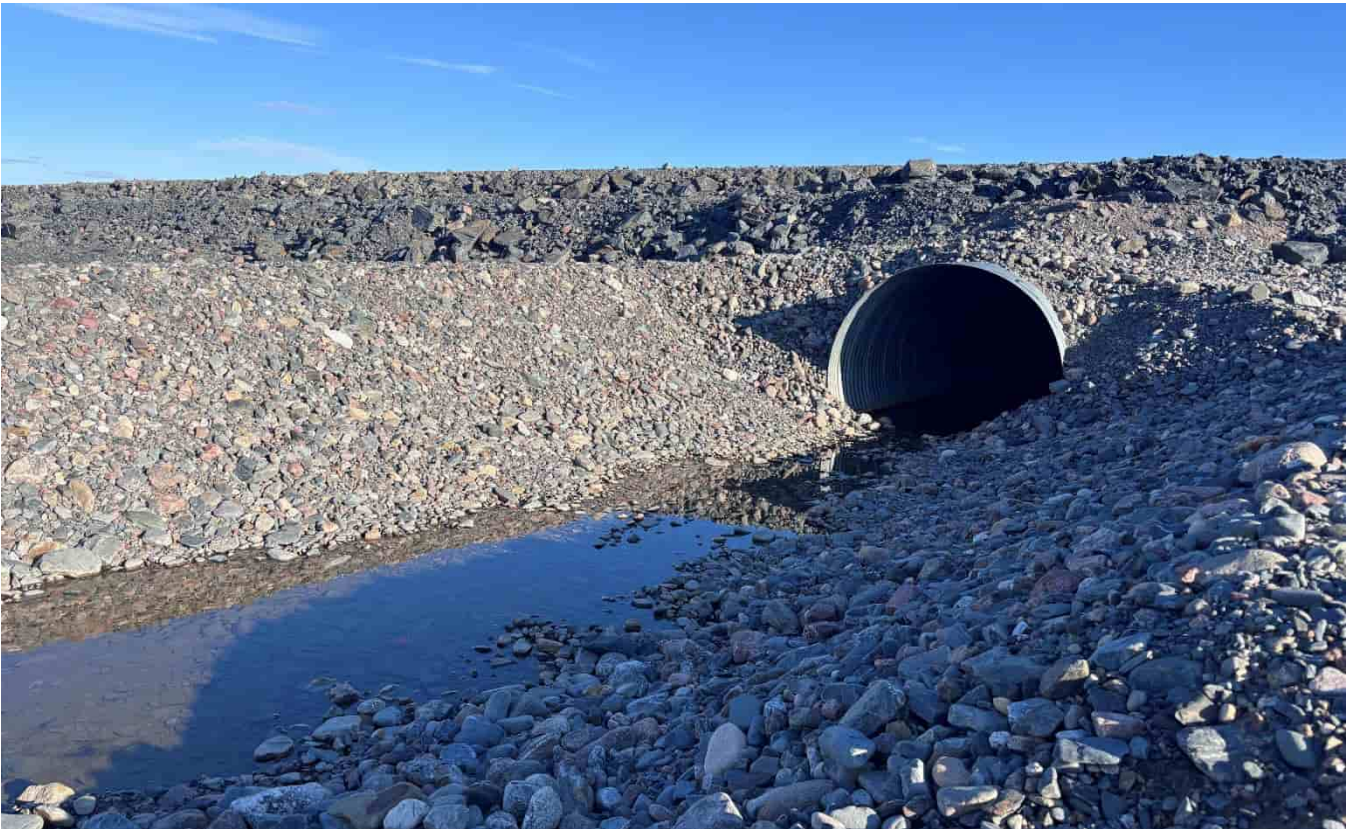
G-27: Downstream (N) side of eastern culvert

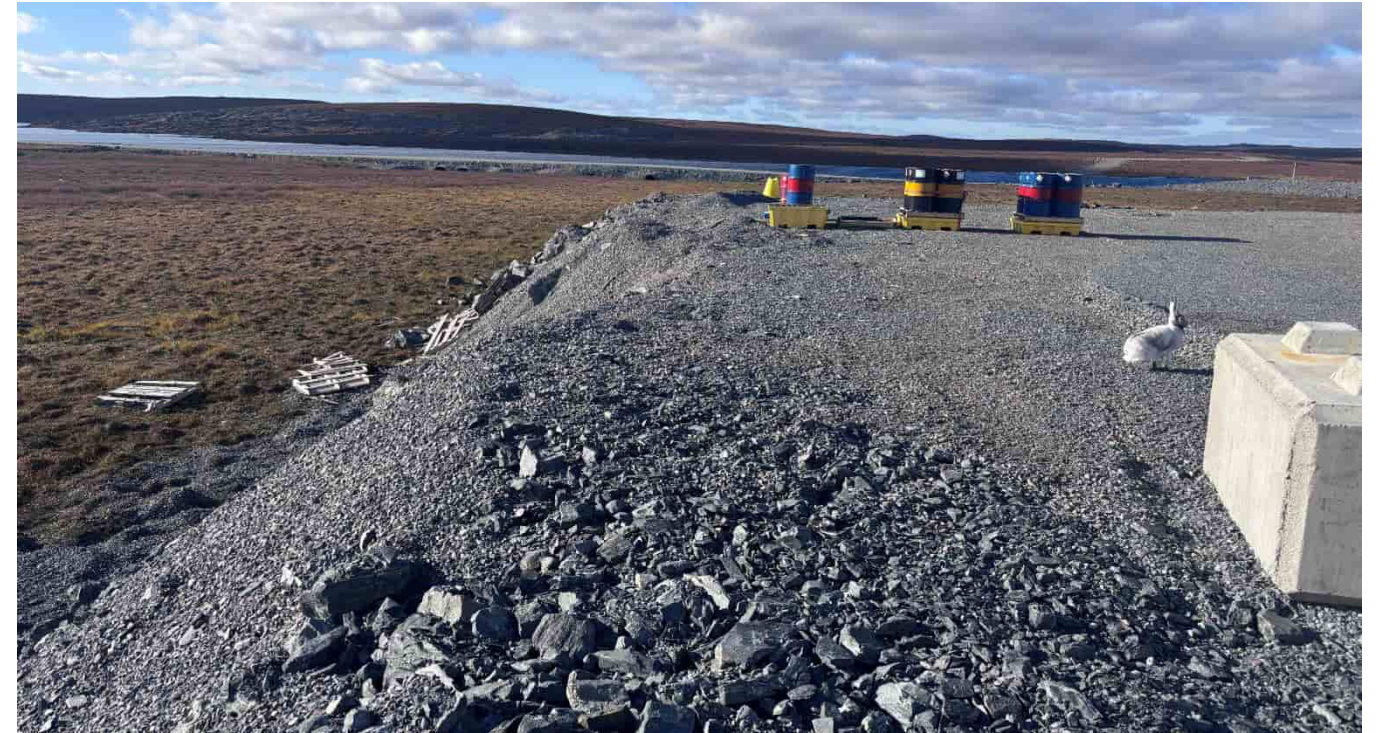
G-33: Slope of SW apron, looking NW

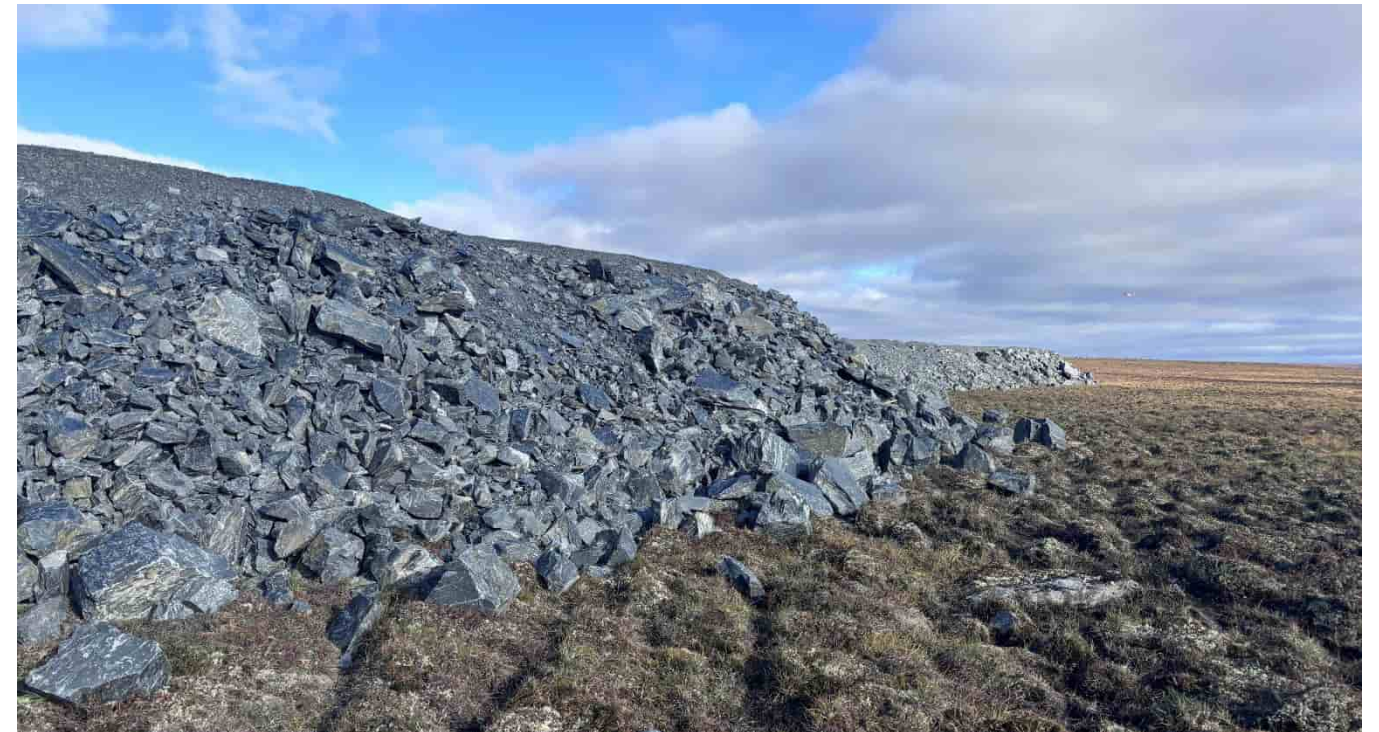
G-35: Slope face of SW apron

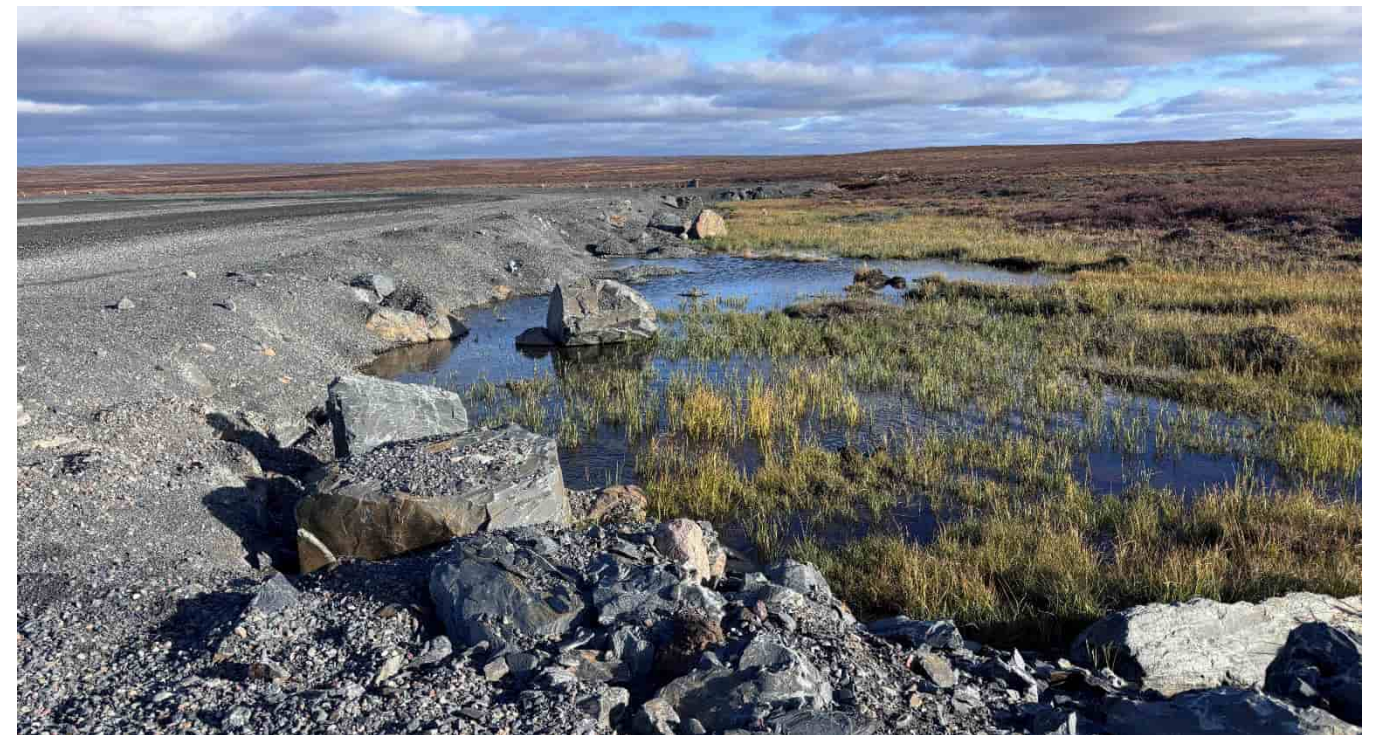
| Infrastructure | Observations | Recommendations and Comments | Recommendation ID |
|---|---|---|---|
| | <ul style="list-style-type: none"> <li>Similar to the 2023 and 2024 inspections, water was observed flowing along the south end of the airstrip and ponding at the toe of the embankment, predominantly at the northeast corner and the south-southwest end near the new airstrip lighting locations. Ponded water and areas of anticipated ice-rich ground were noted adjacent to, and in some locations intersecting, both site airstrips. The new apron constructed on the southeast side of the airstrip (new observation for the 2025 AGI) appears to be impeding surface water flow between the airstrip embankment and the apron pad, resulting in increased water accumulation in this area.</li> </ul> | <ul style="list-style-type: none"> <li>Consideration should be given to redirecting or attempting to move any ponded water away from the toes of the airstrip. Pumping out or removing ponded water at the toes of the airstrip in the fall, before winter freeze-up, would enhance the transfer of cold ambient air and ground heat. This could help mitigate permafrost degradation by reducing thawing rates and slowing the deepening of the active layer. Improved water management of this nature may contribute to a decrease in both short and long-term maintenance activities.</li> <li>These areas should also be considered in more detail as part of the site thermal monitoring plans.</li> </ul> | Carried over from 2024 AGI<br>2024 & 2025-AGI-1 |

G-56: Ponding at SE end of runway, looking SE

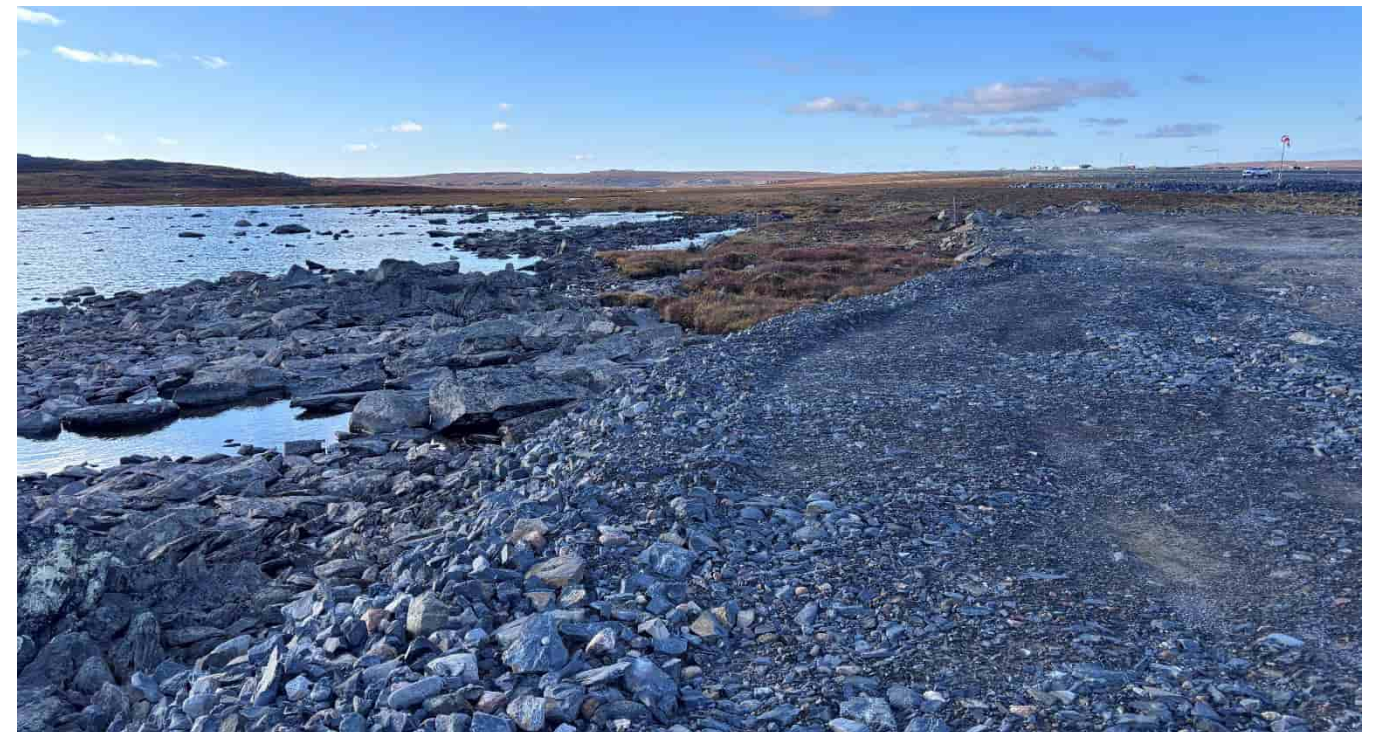
G-58: Pond beside unconstructed 'Rascal Diversion' area, looking NW

- Goose Airstrip – SSE end – The design of the Rascal Diversion Berm should be updated to reflect current site conditions, including the new airstrip lighting pads. It is understood that this is on B2Gold's radar, and they are currently reviewing this with other consultants.

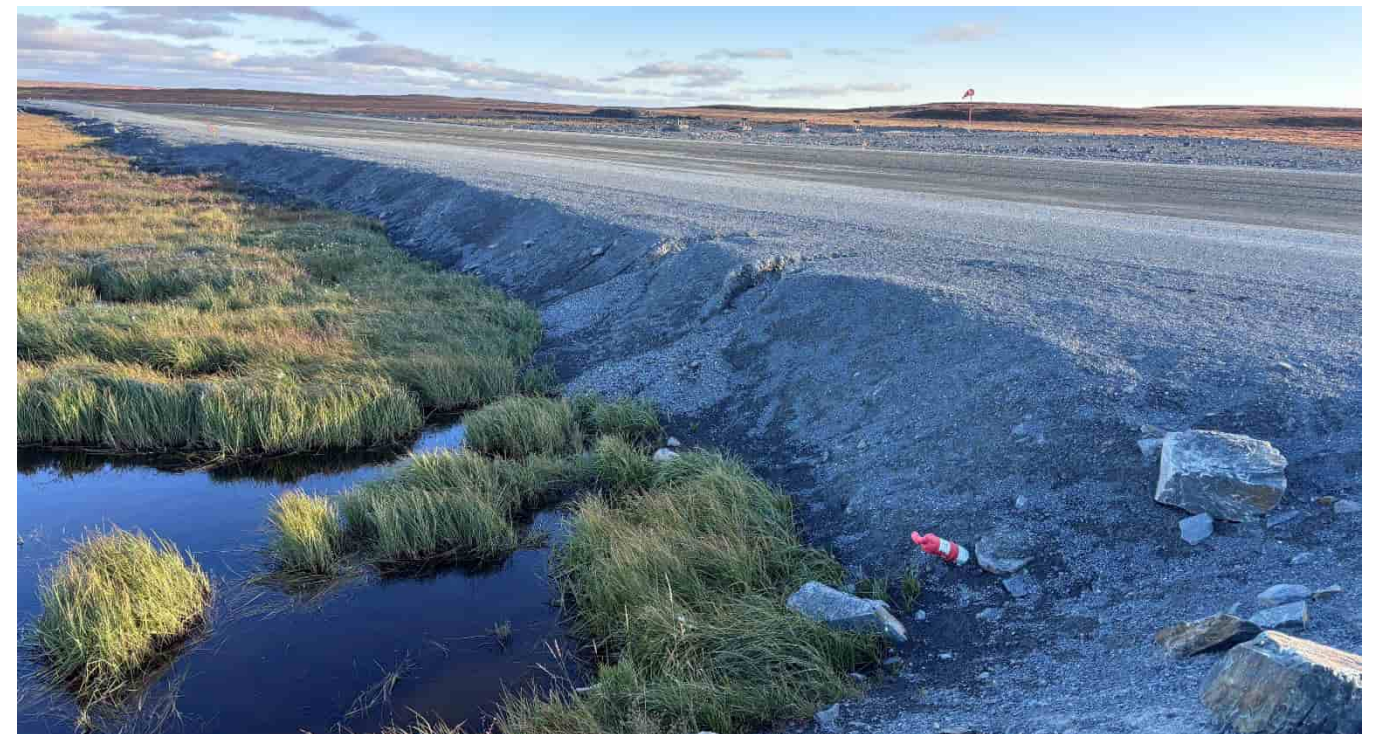
G-66: Erosion pathways and ponding on NE side of runway

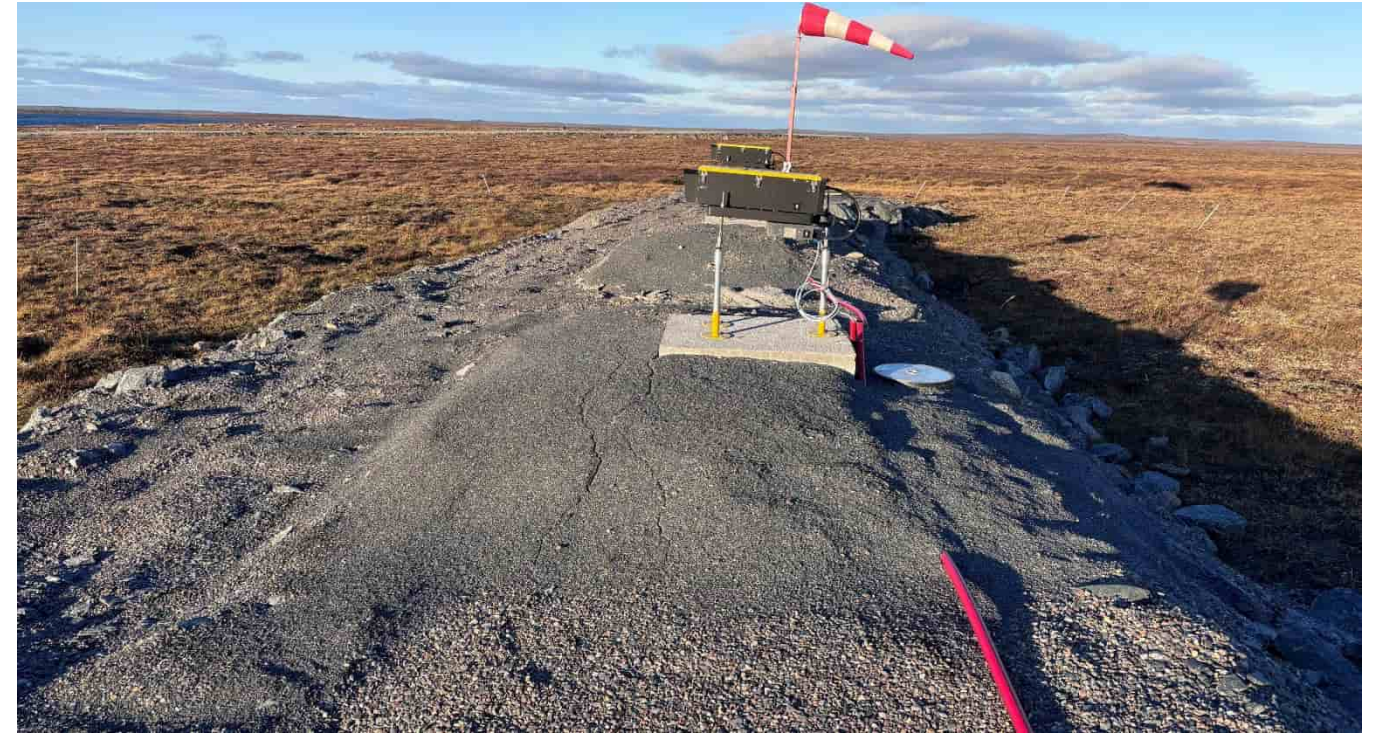
G-76: Unfinished construction of airstrip lights

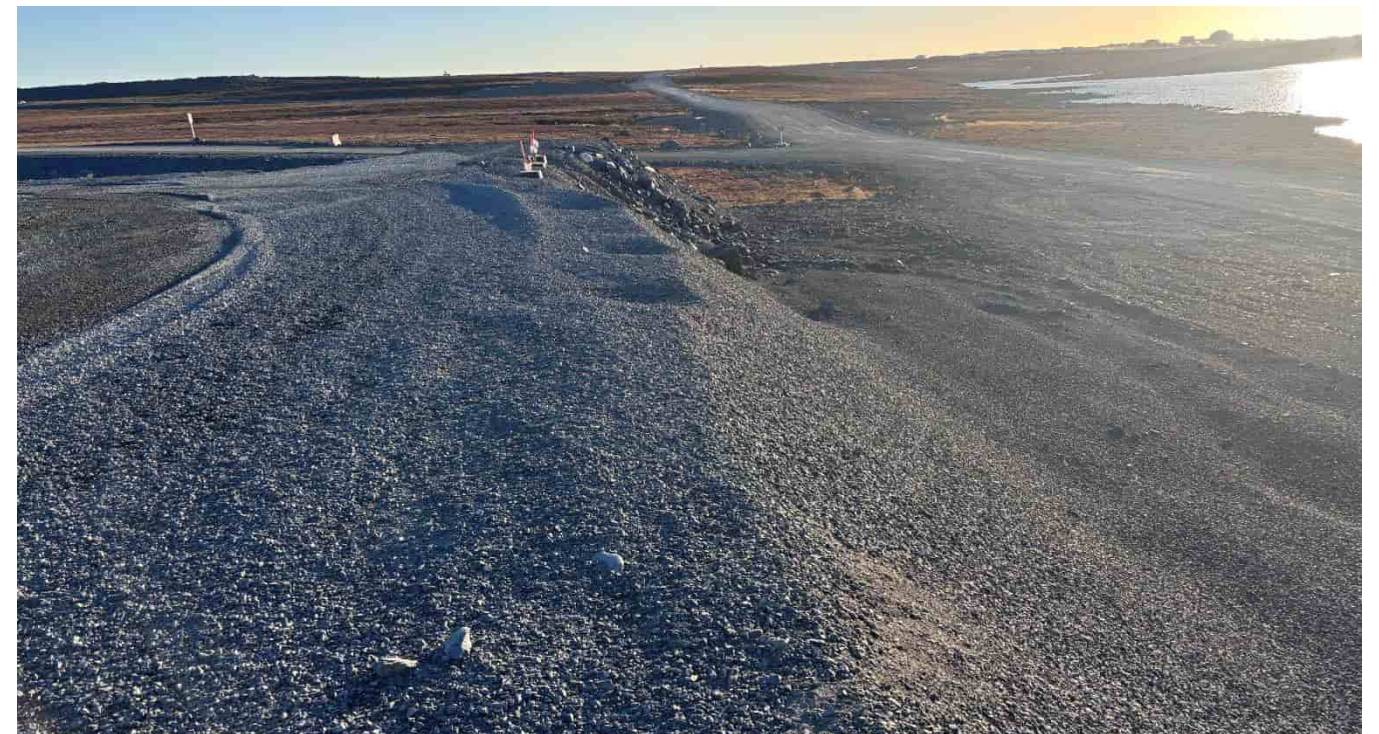
G-78: Slopes between All-Weather Road and NW end of runway

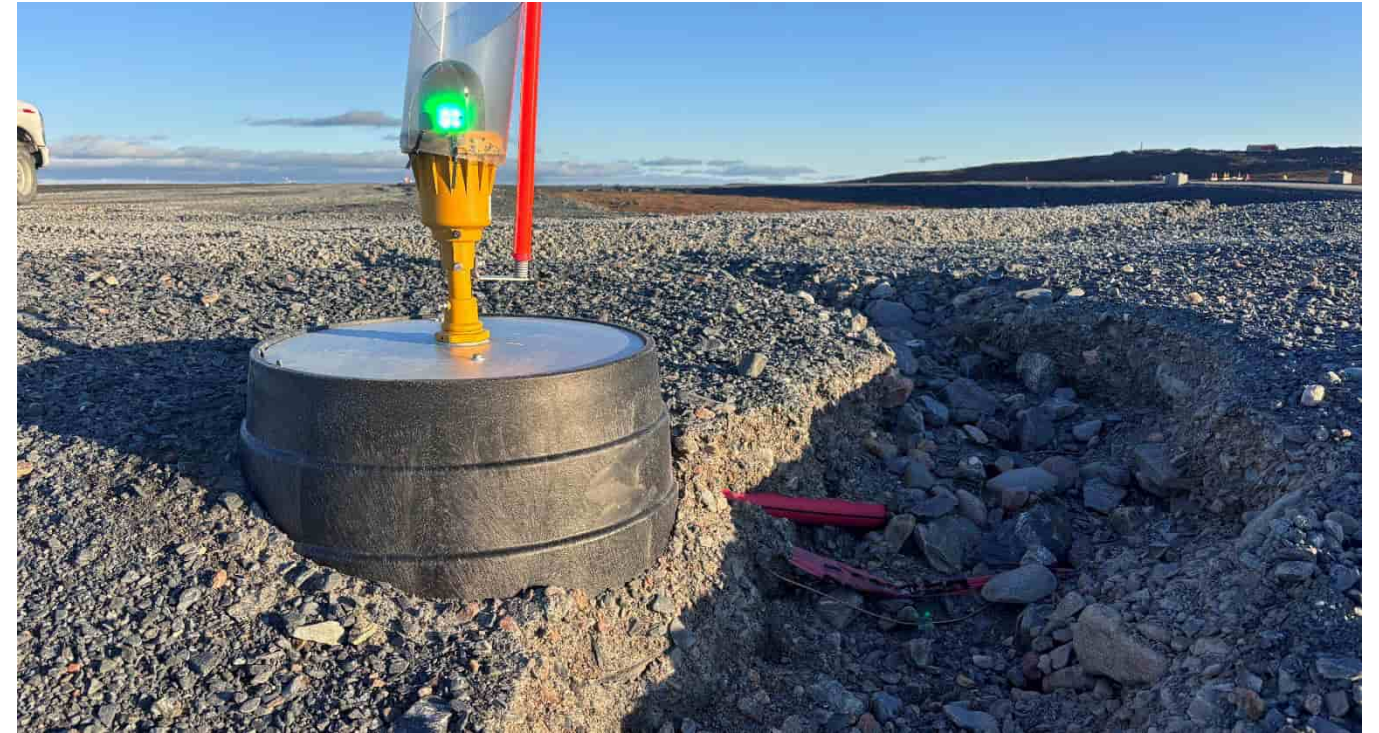
G-80: : Erosion at NW end of runway – exposed cables

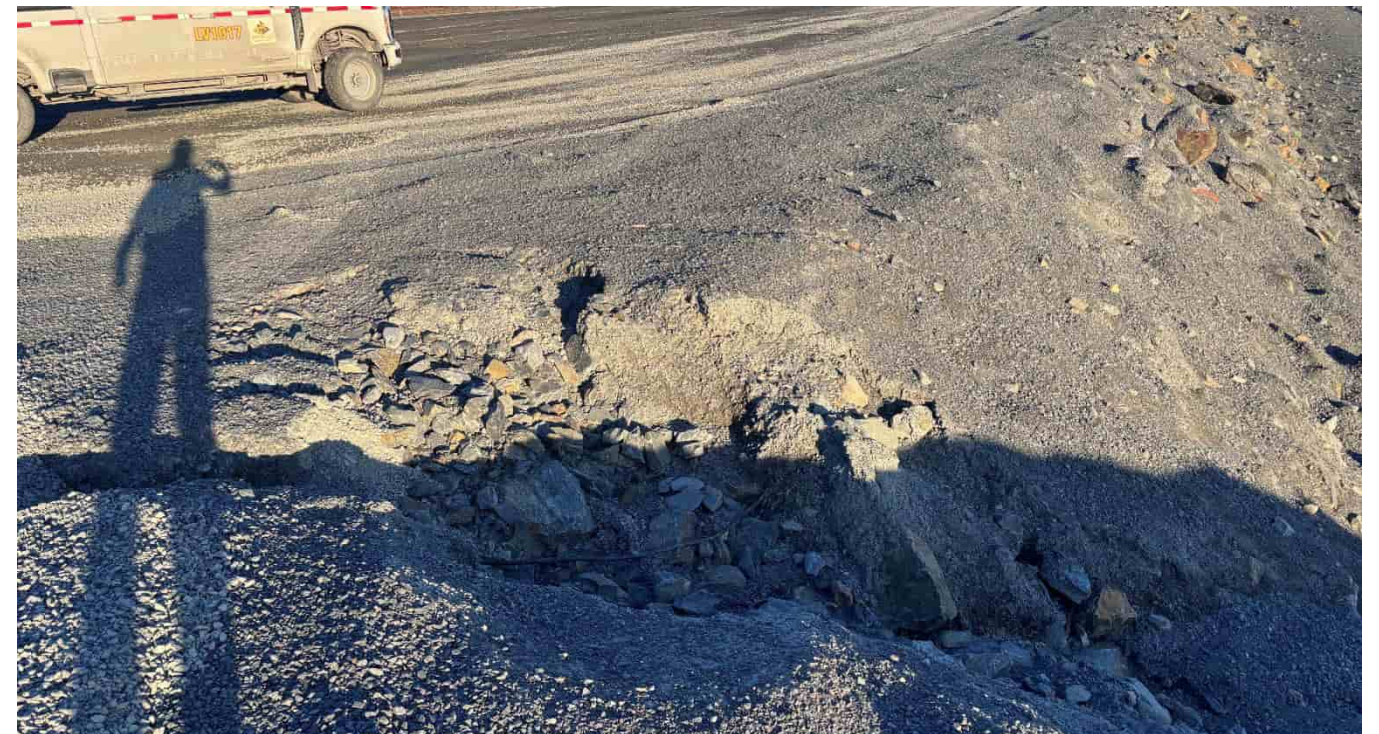
G-82: Erosion pathway at NW end of airstrip

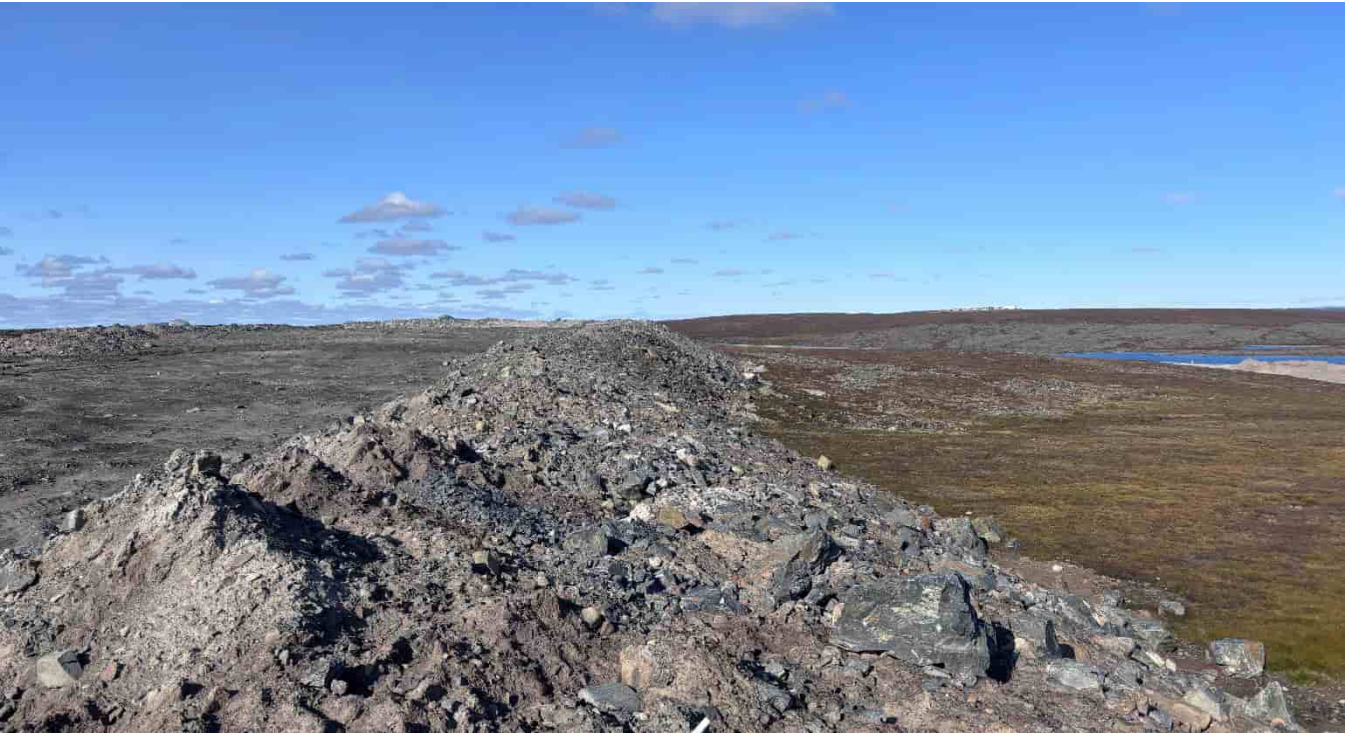
G-127: Echo overburden stockpile – eastern slope, looking N

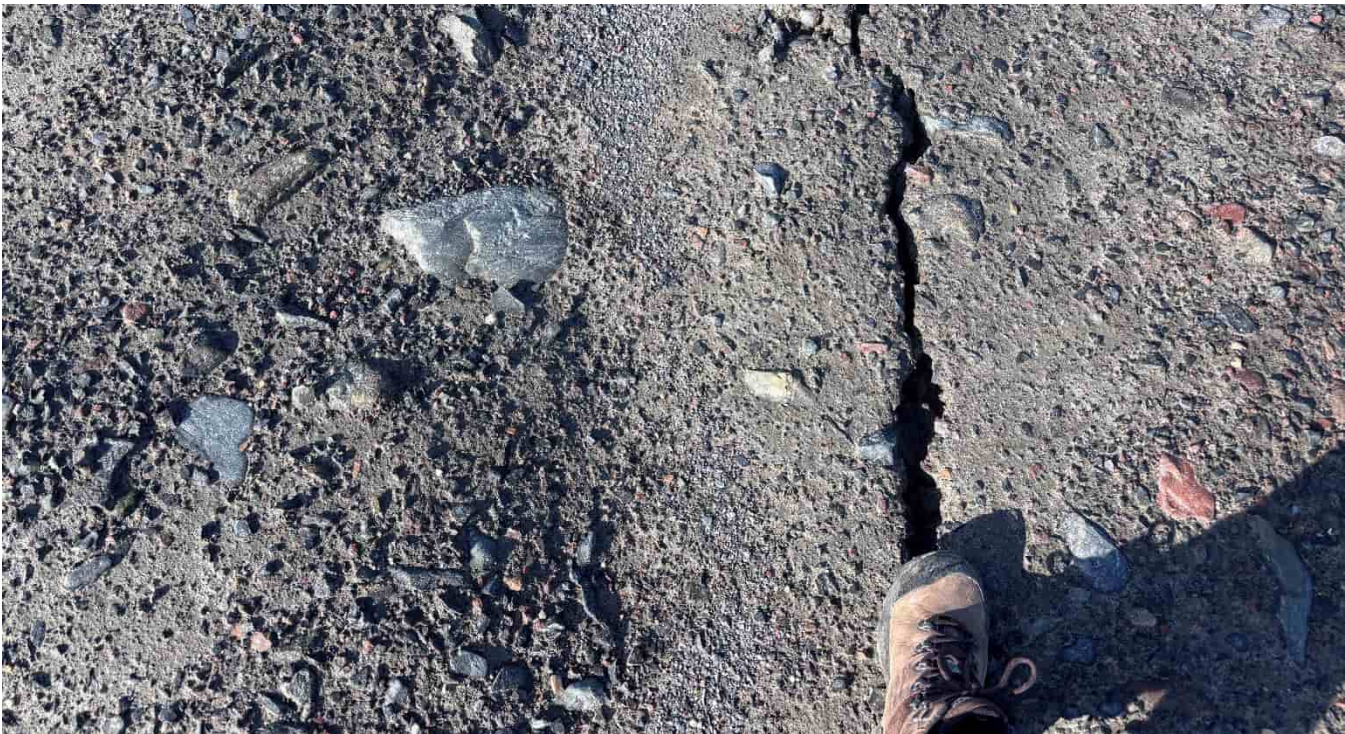
G-129: Tension cracks in overburden stockpile pad (from settlement and melt – no large scale stability concerns)

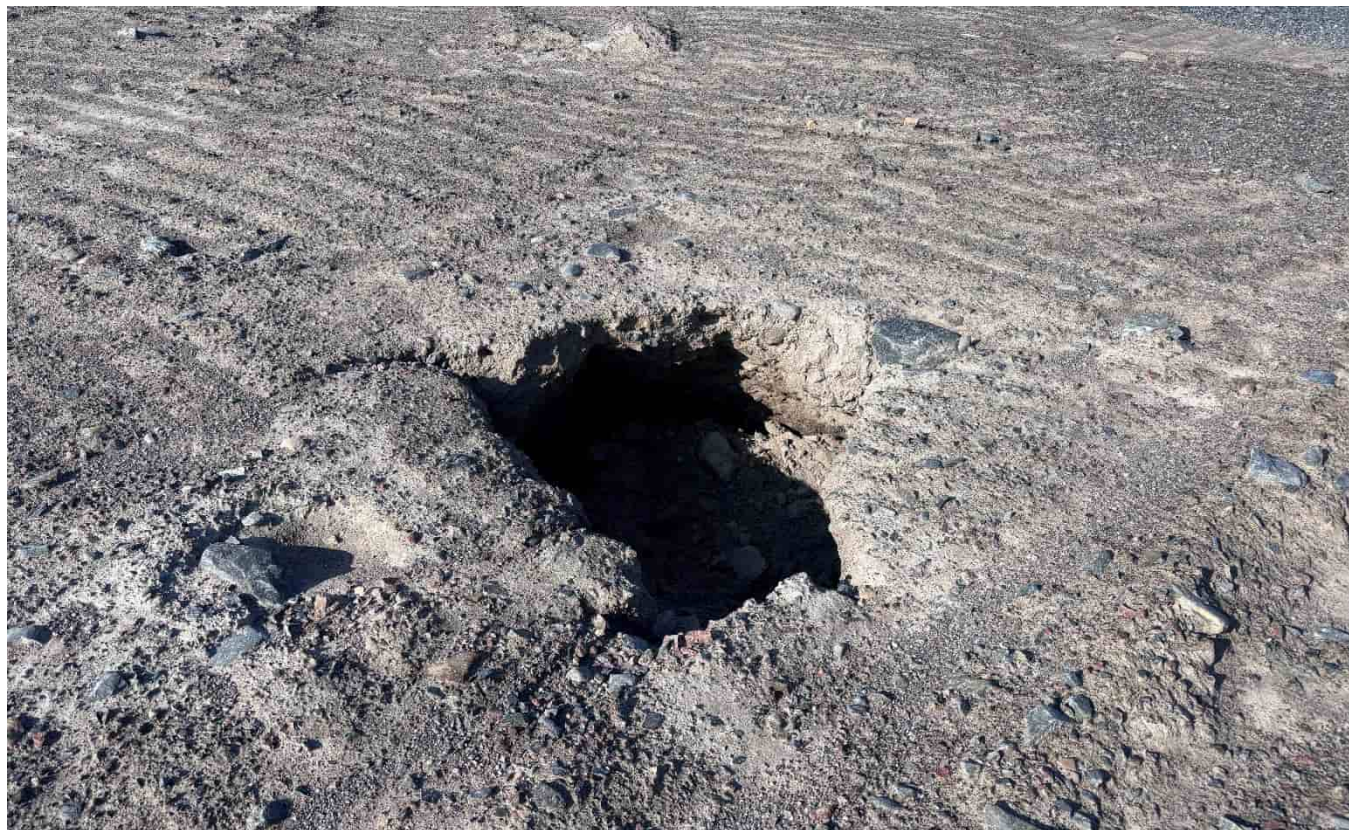
G-131: Example of the sinkhole in eastern side of the overburden stockpile

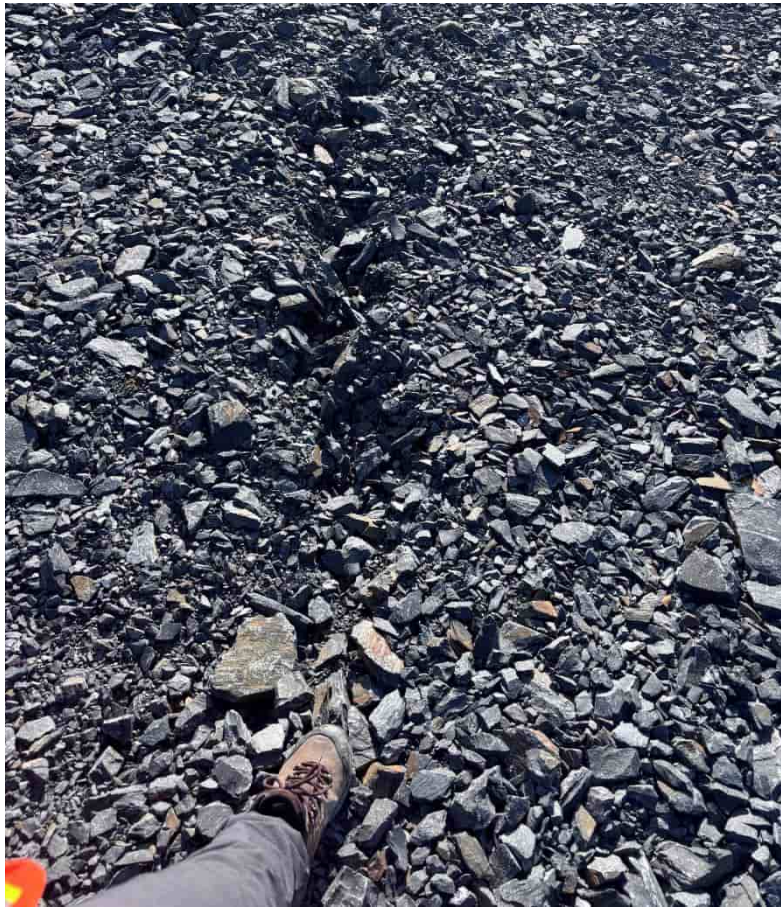
G-140: Tension / settlement crack in diversion

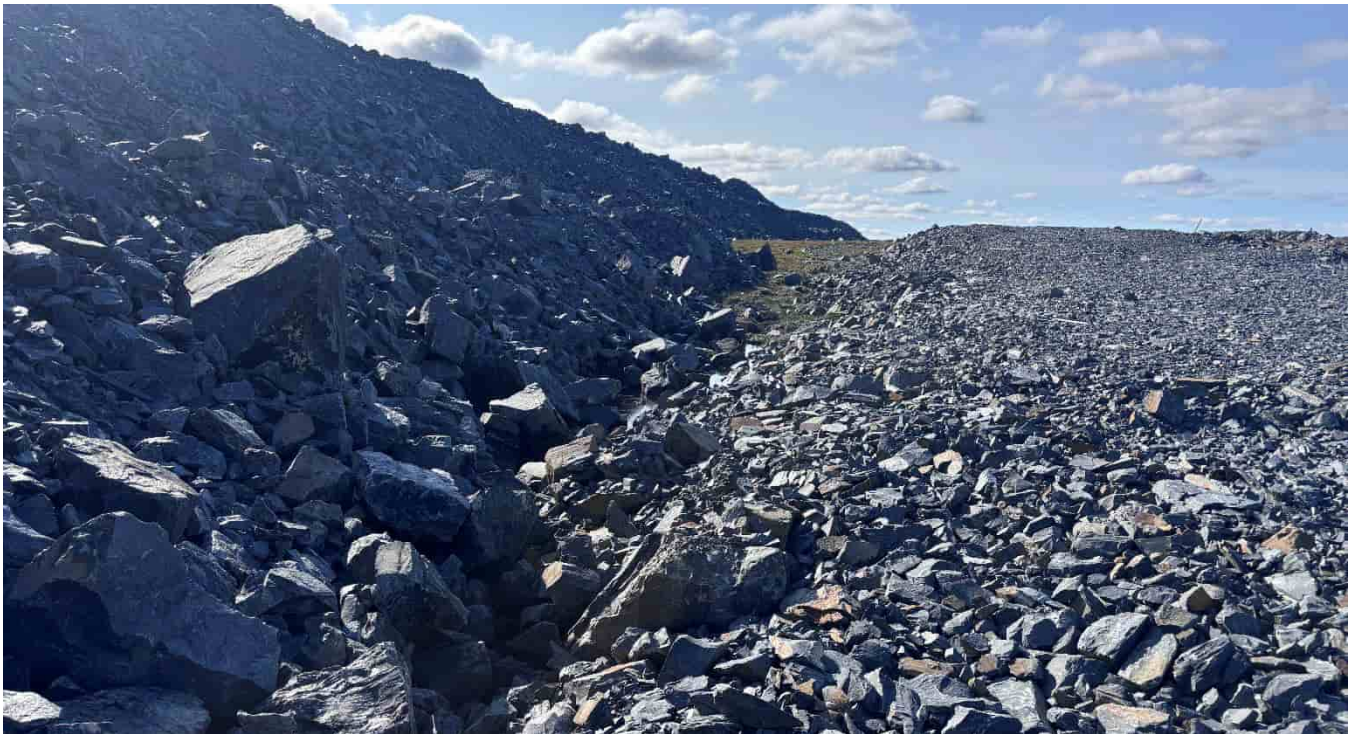
G-141: Diversion, looking SW – dump slopes abutting to diversion

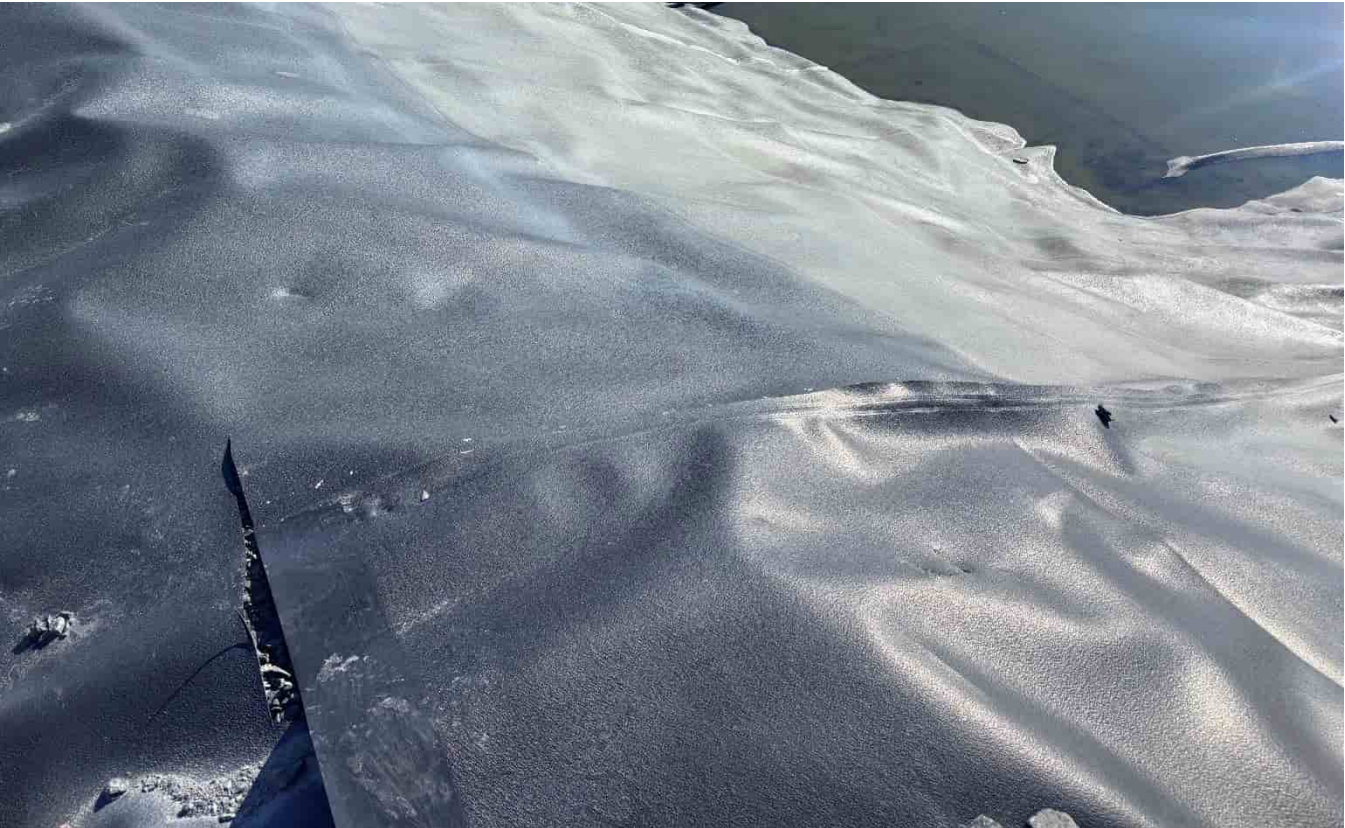
G-151: Treatment pond liner damage above / top of slope

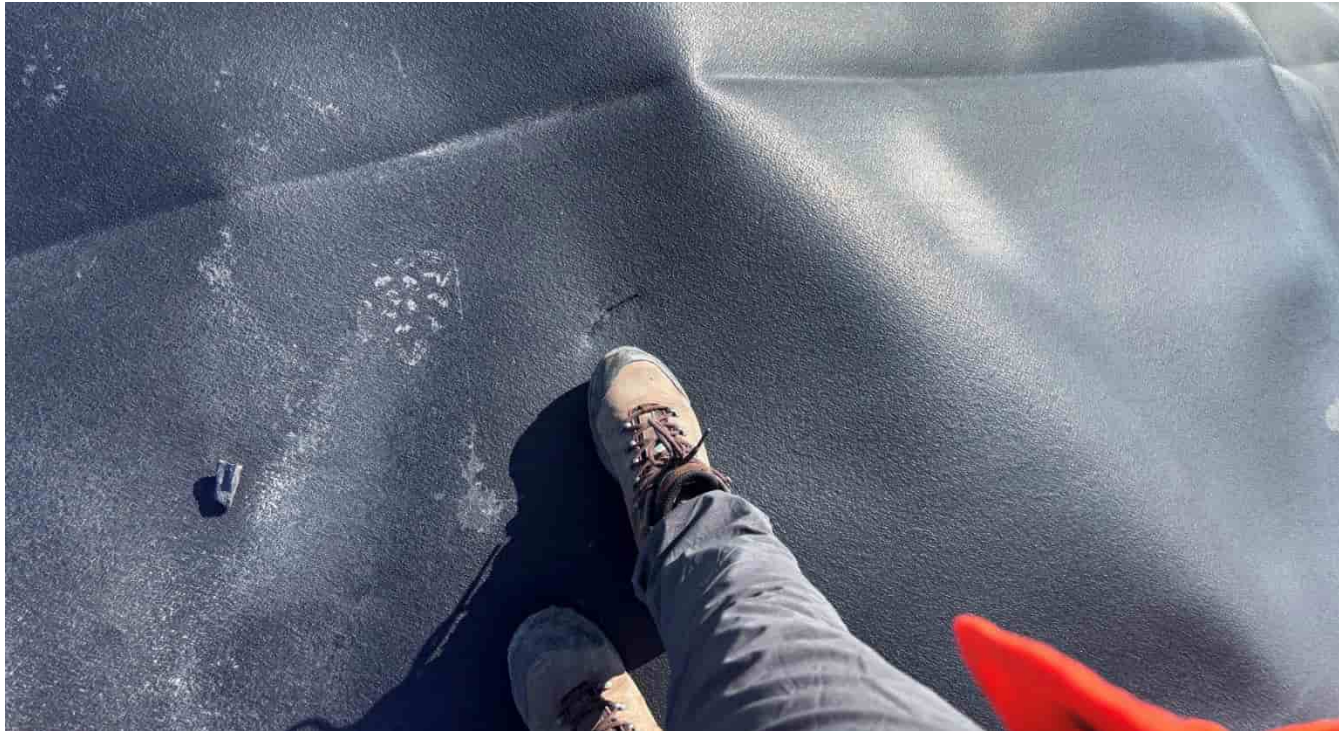
G-152: Exampke liner damage beside southernmost pond
