# Goose & MLA Project Sites – 2025 Annual Geotechnical Inspection

Back River Project, Nunavut, Canada  
B2Gold Back River Corp.

SRK Consulting (Canada) Inc. ■ CAPR004312 ■ March 2026

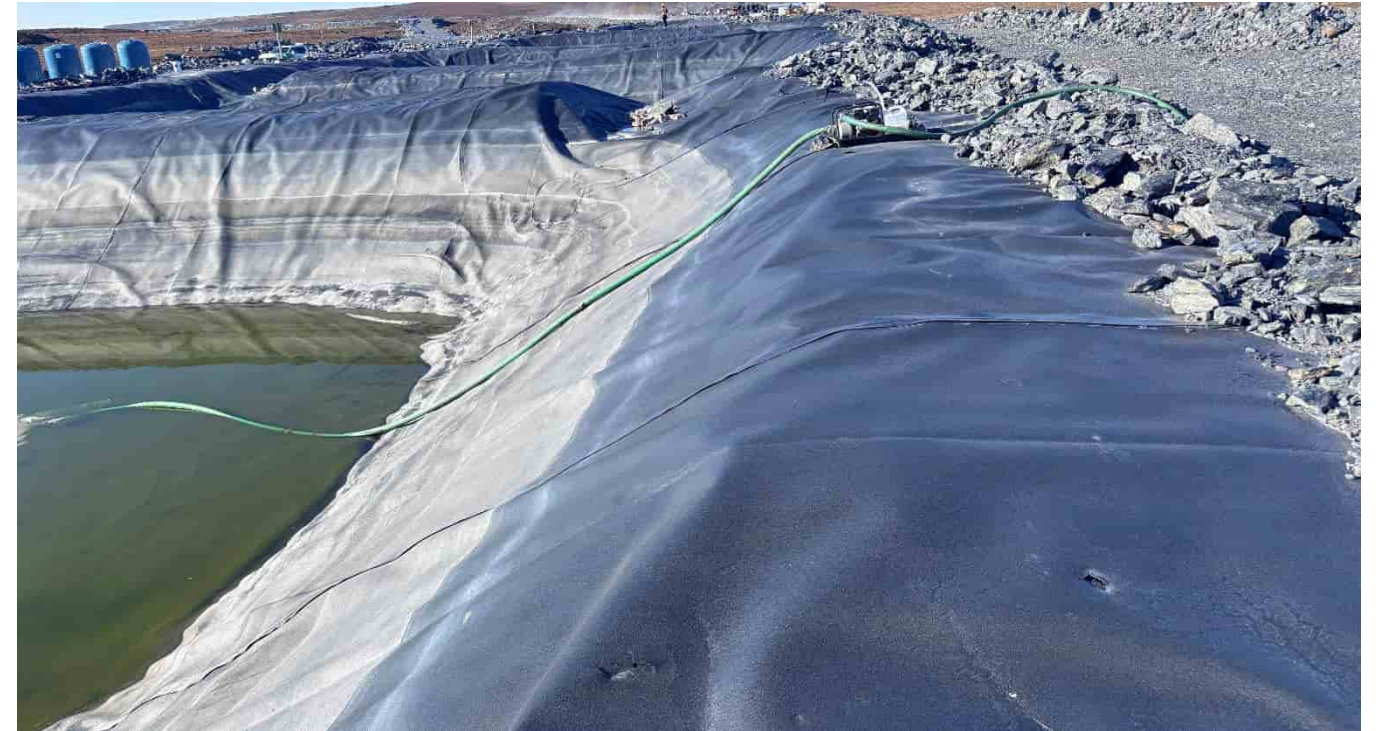
G-153: Treatment pond oversteepened slope and liner damage

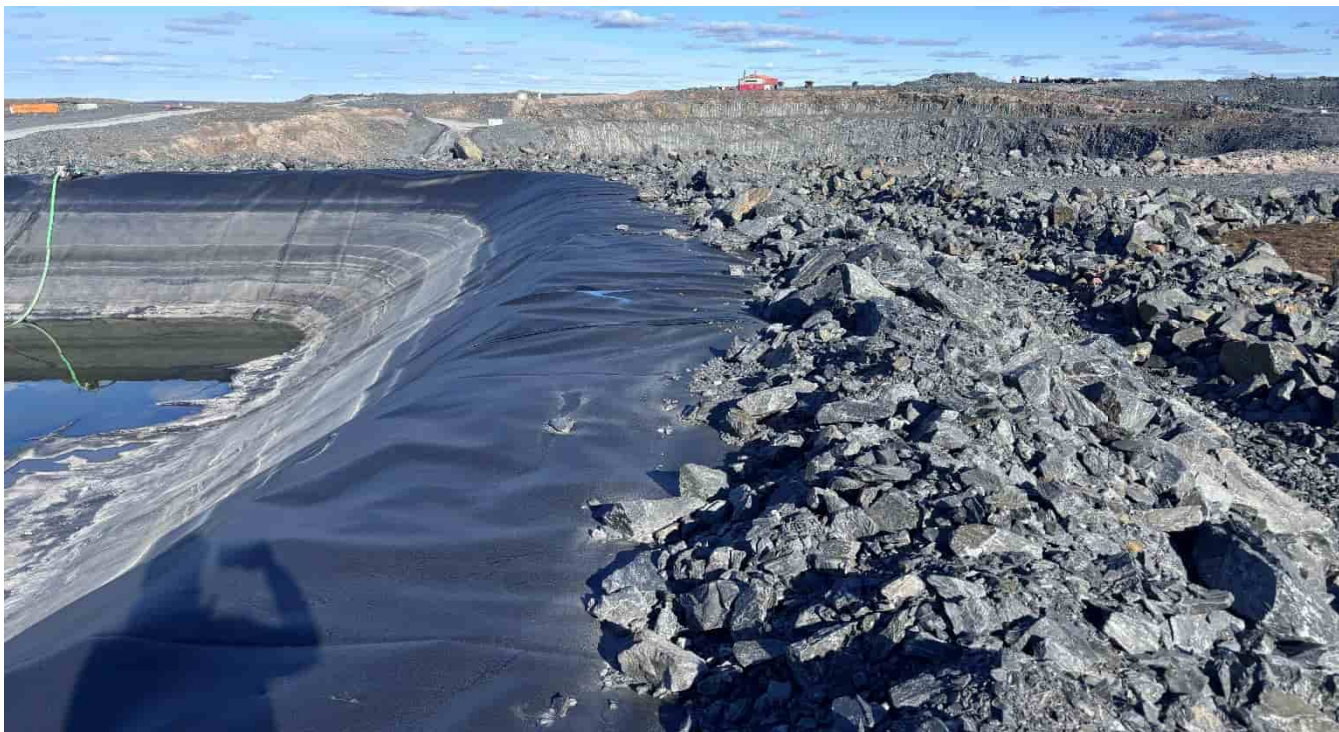
G-154: Coarse over-liner material

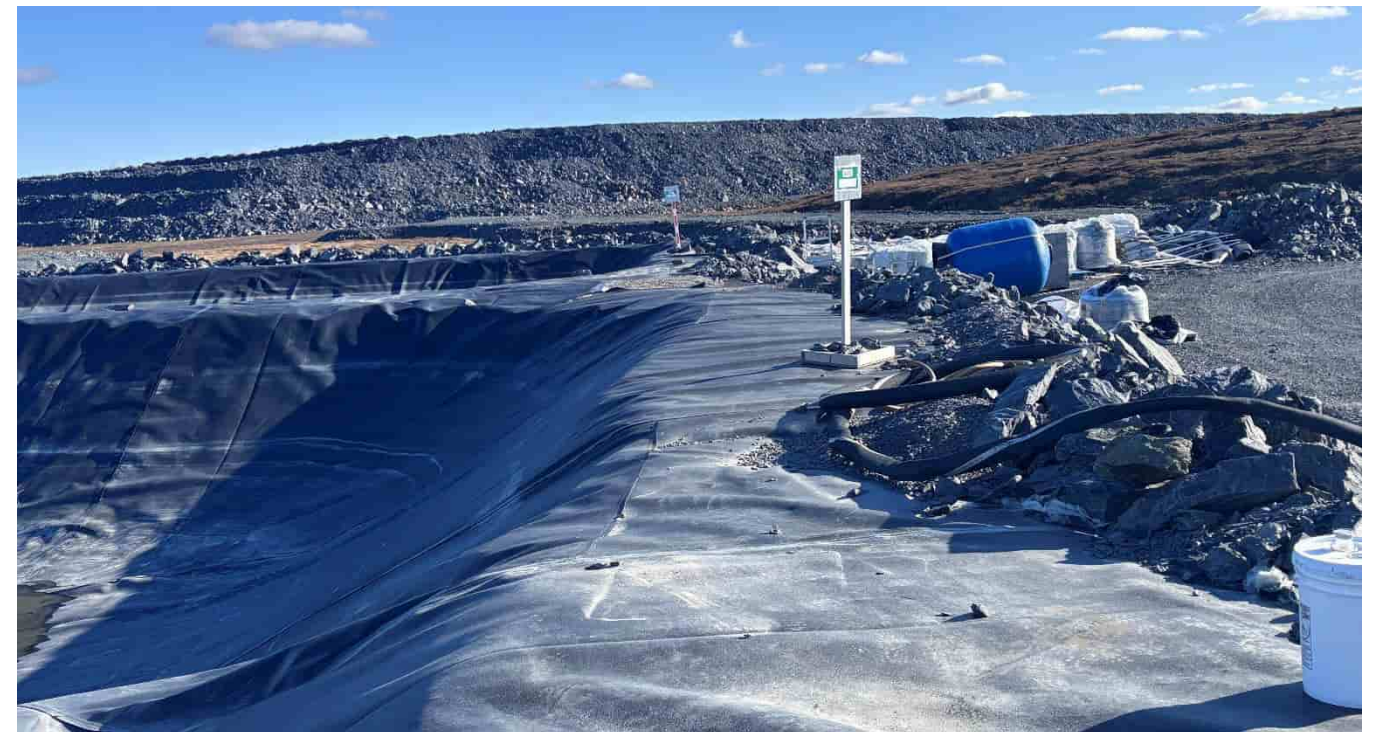
G-155: Coarse over-liner material

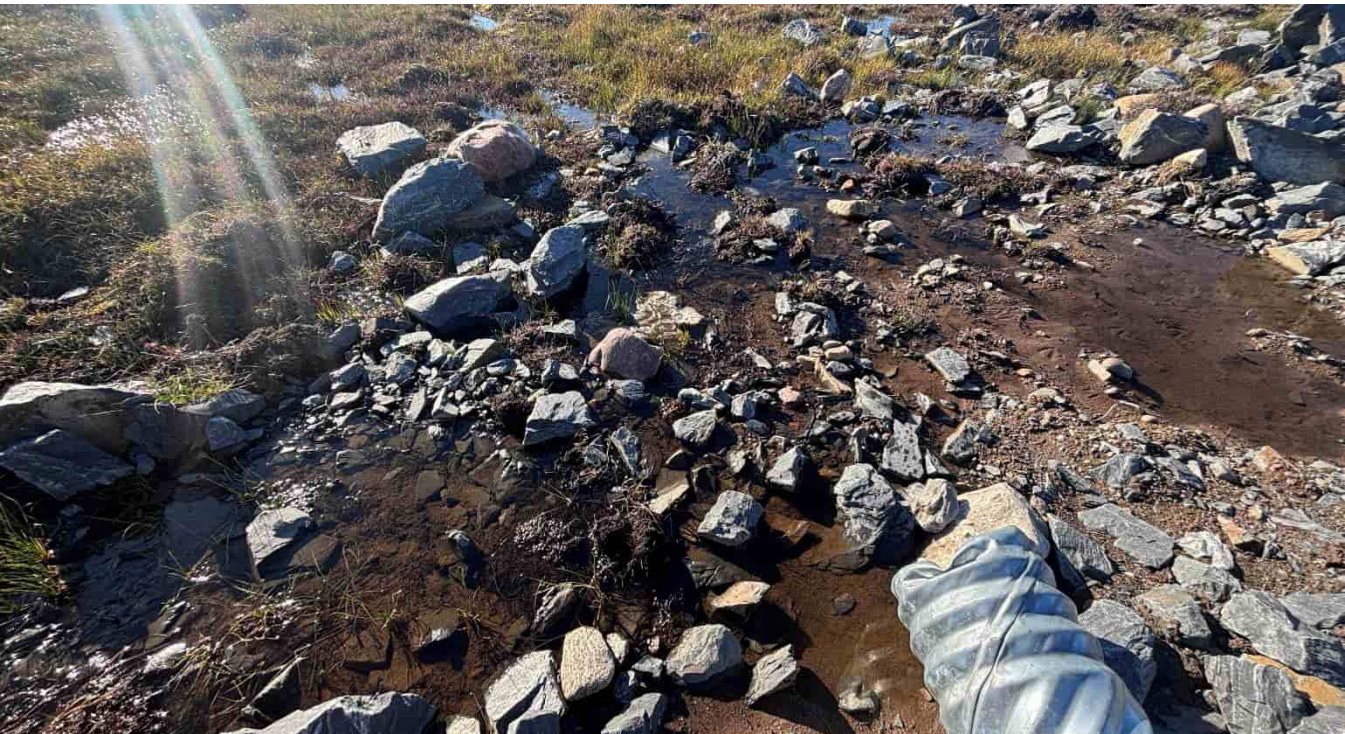
G-159: Downstream of culvert – Some damage to pipe

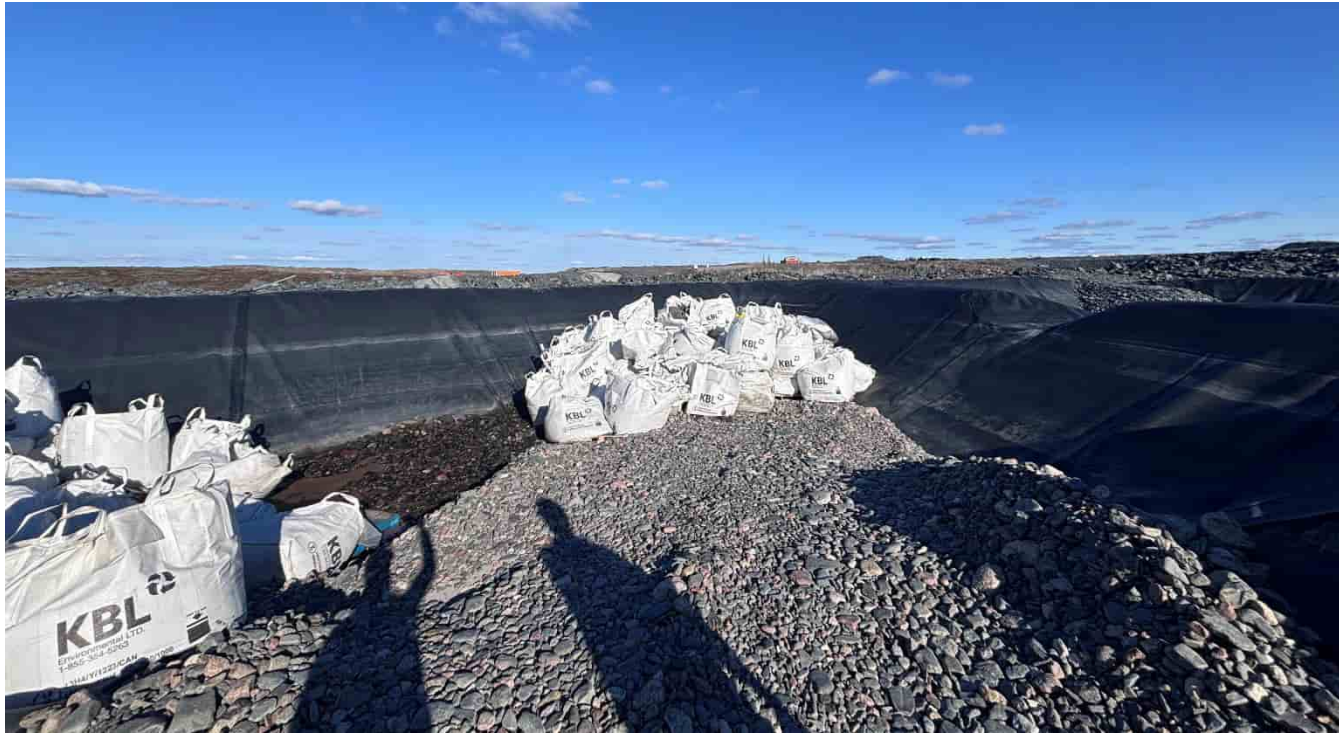
G-160: Northernmost treatment pond with rock over liner

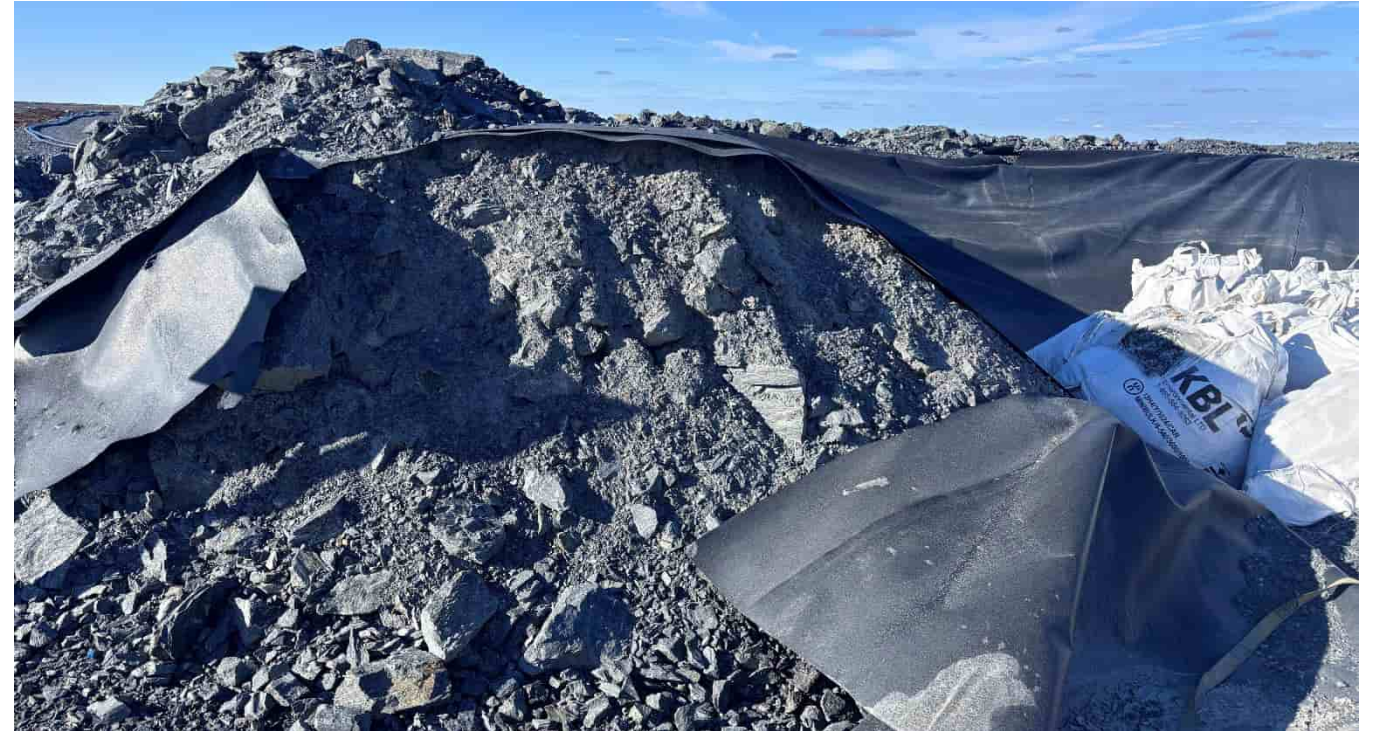
G-161: Inconsistent liner and damage to northernmost pond - low potential containment volume in area

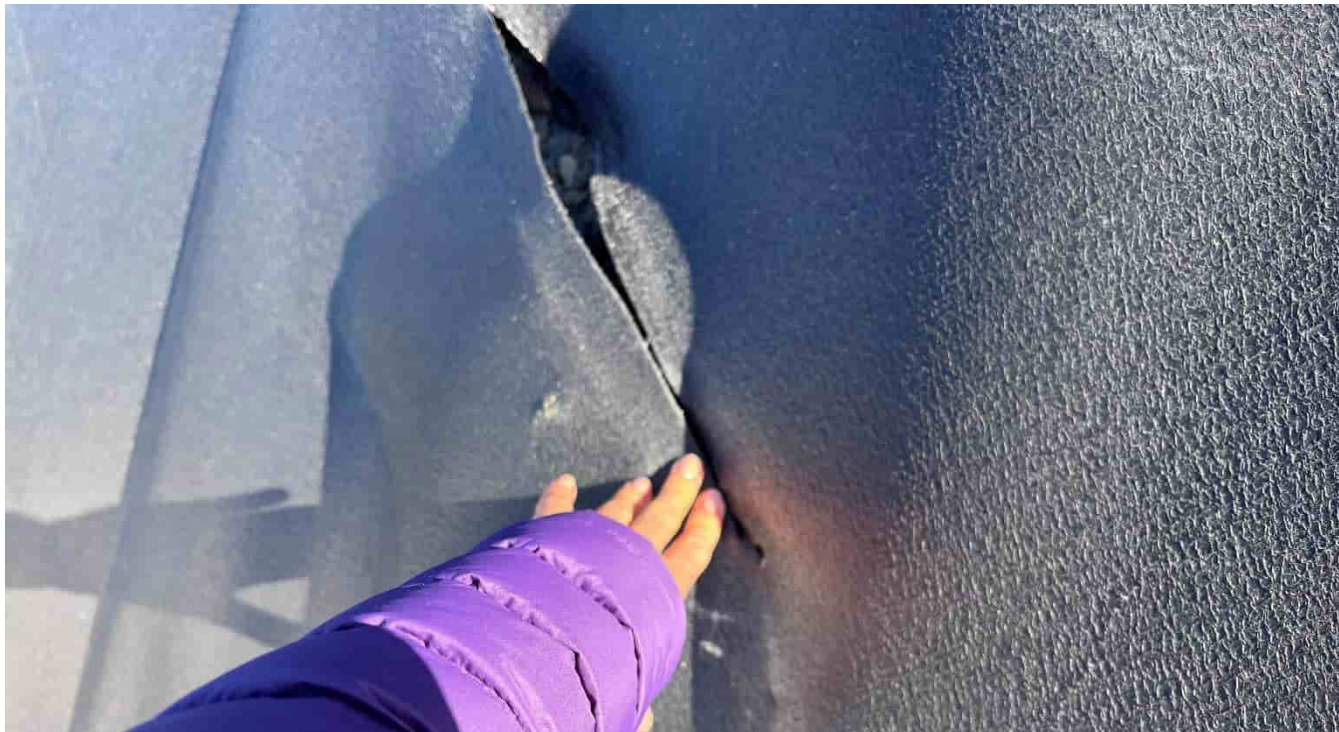
G-162: Liner damage on northernmost pond

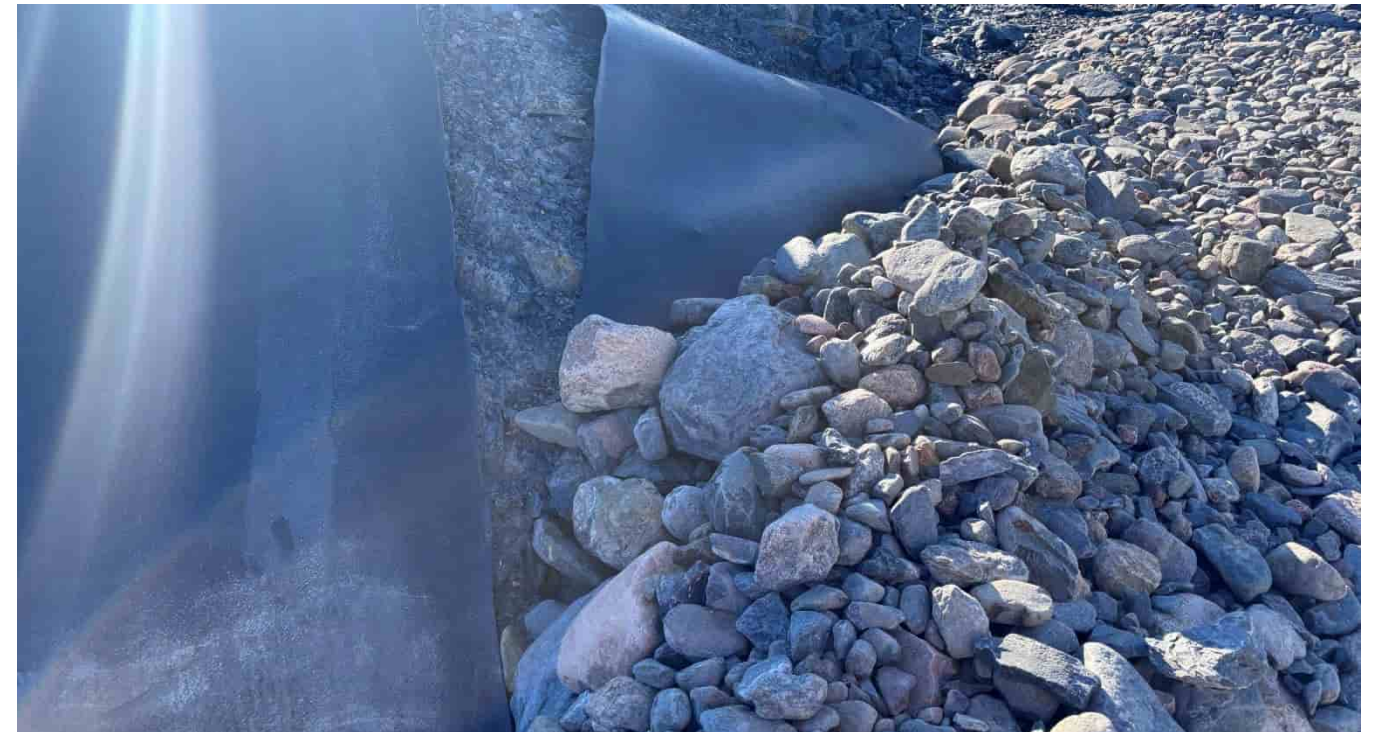
G-163: Inconsistent liner placement underneath rock fill

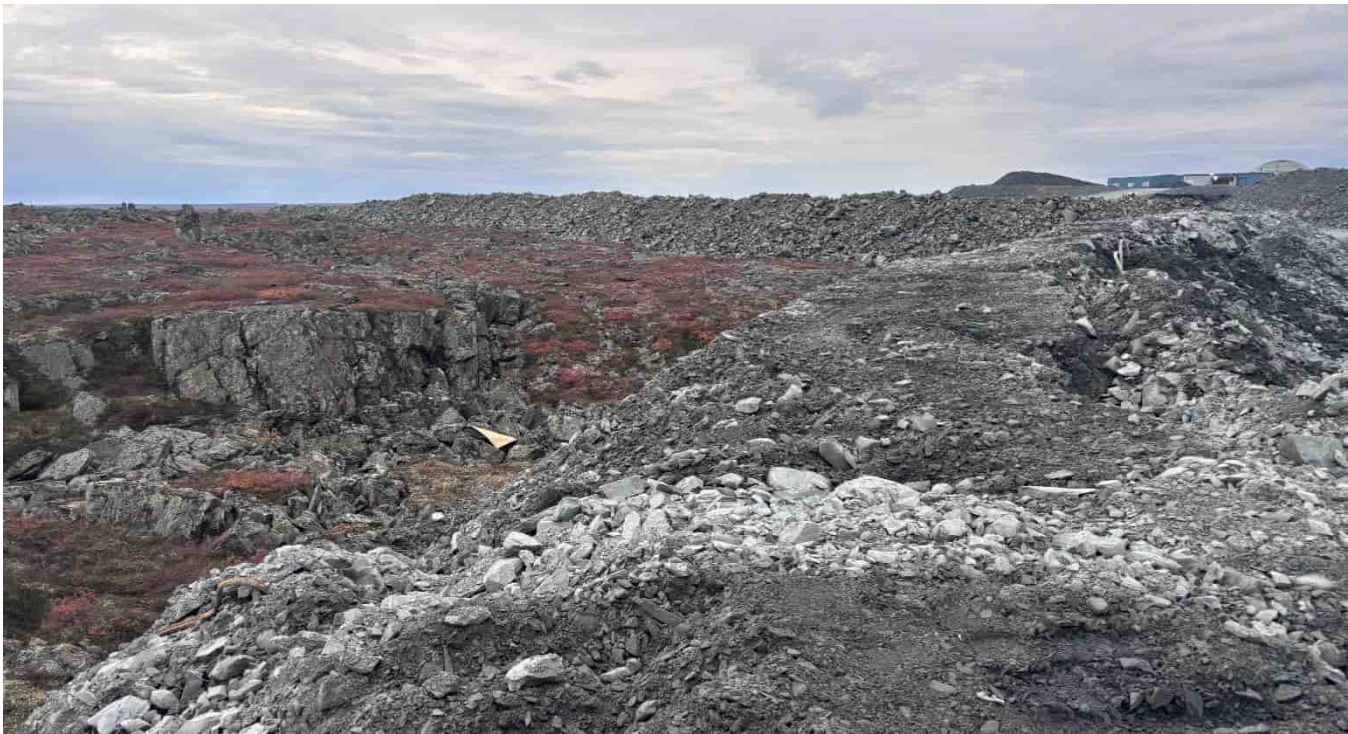
G-226: ROM stockpile SE end – daylighting into tundra

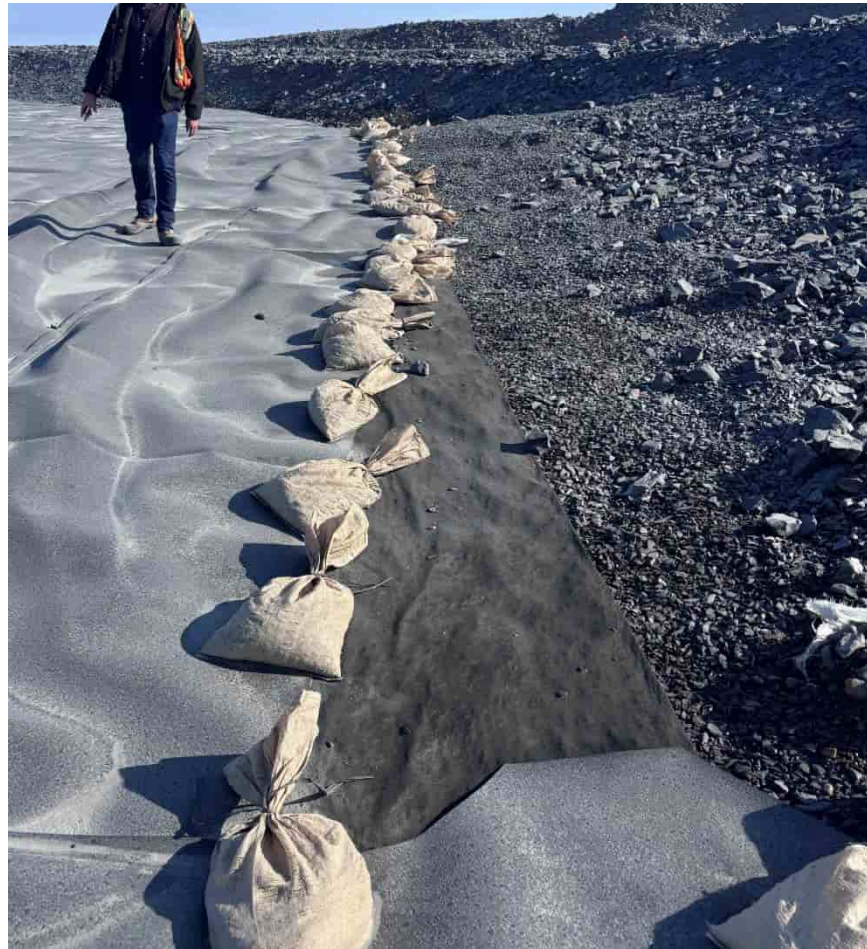
G-233: Typical S edge of liner condition, looking E – liner daylighting / laid ont tundra at this edge

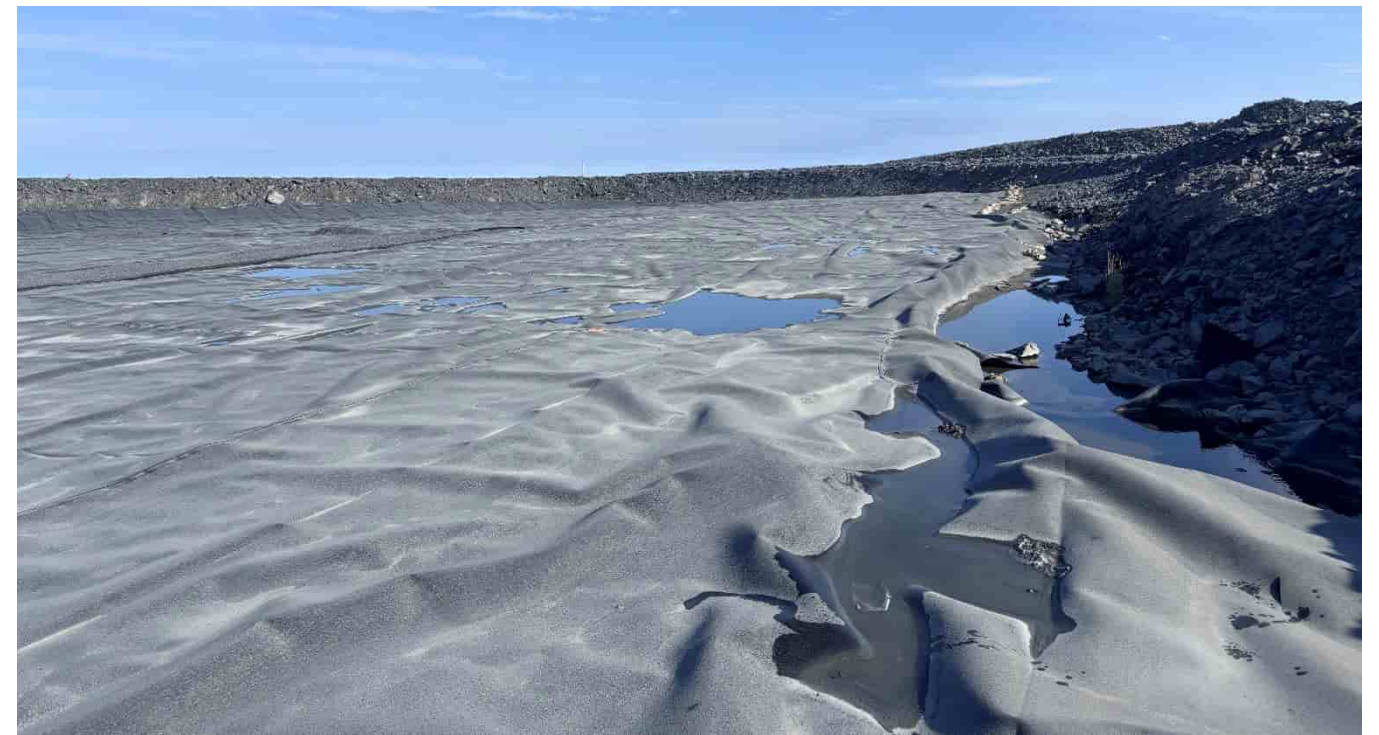
G-234: Ponding water at S edge of pond, looking E – Note varying crest of liner

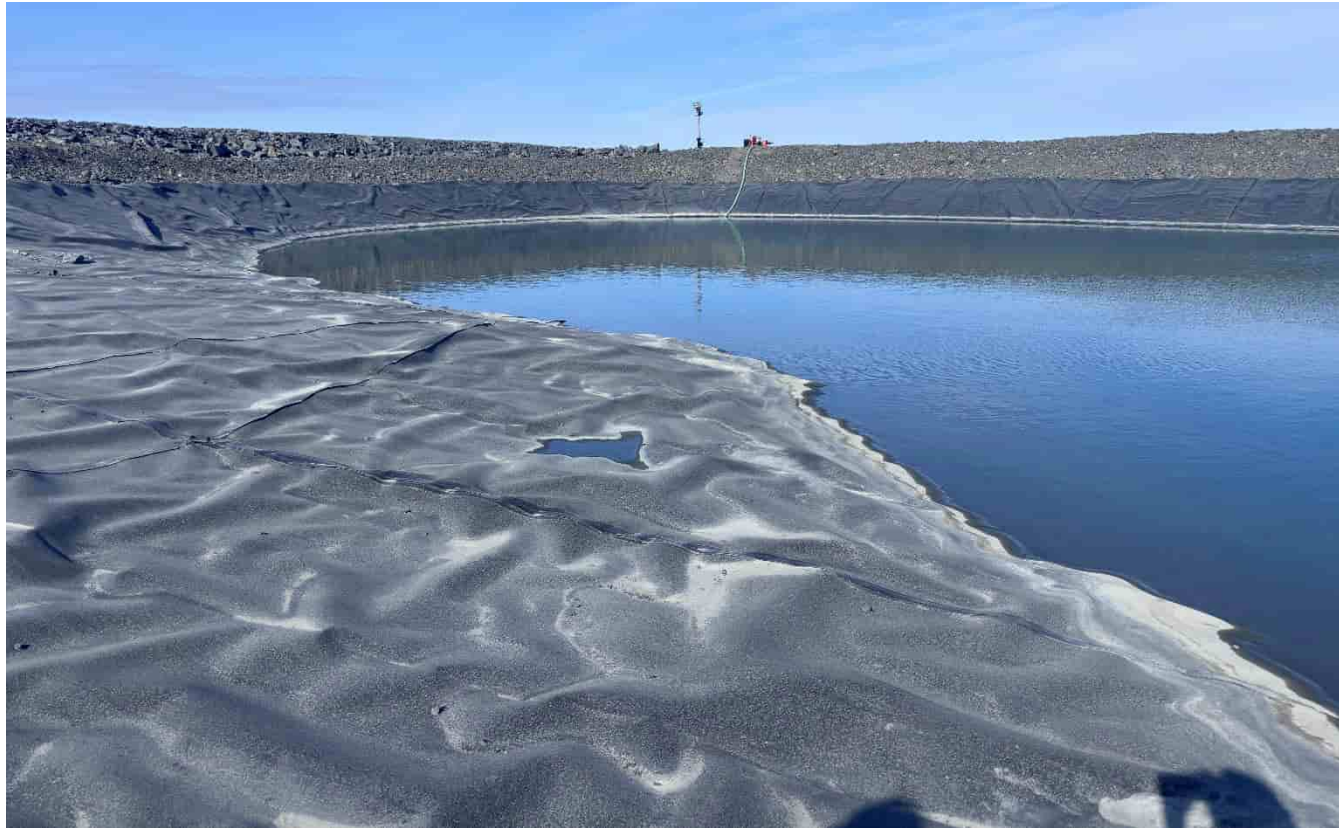
G-236: Edge of main Camp Pad pond at the time of the inspection, looking NW

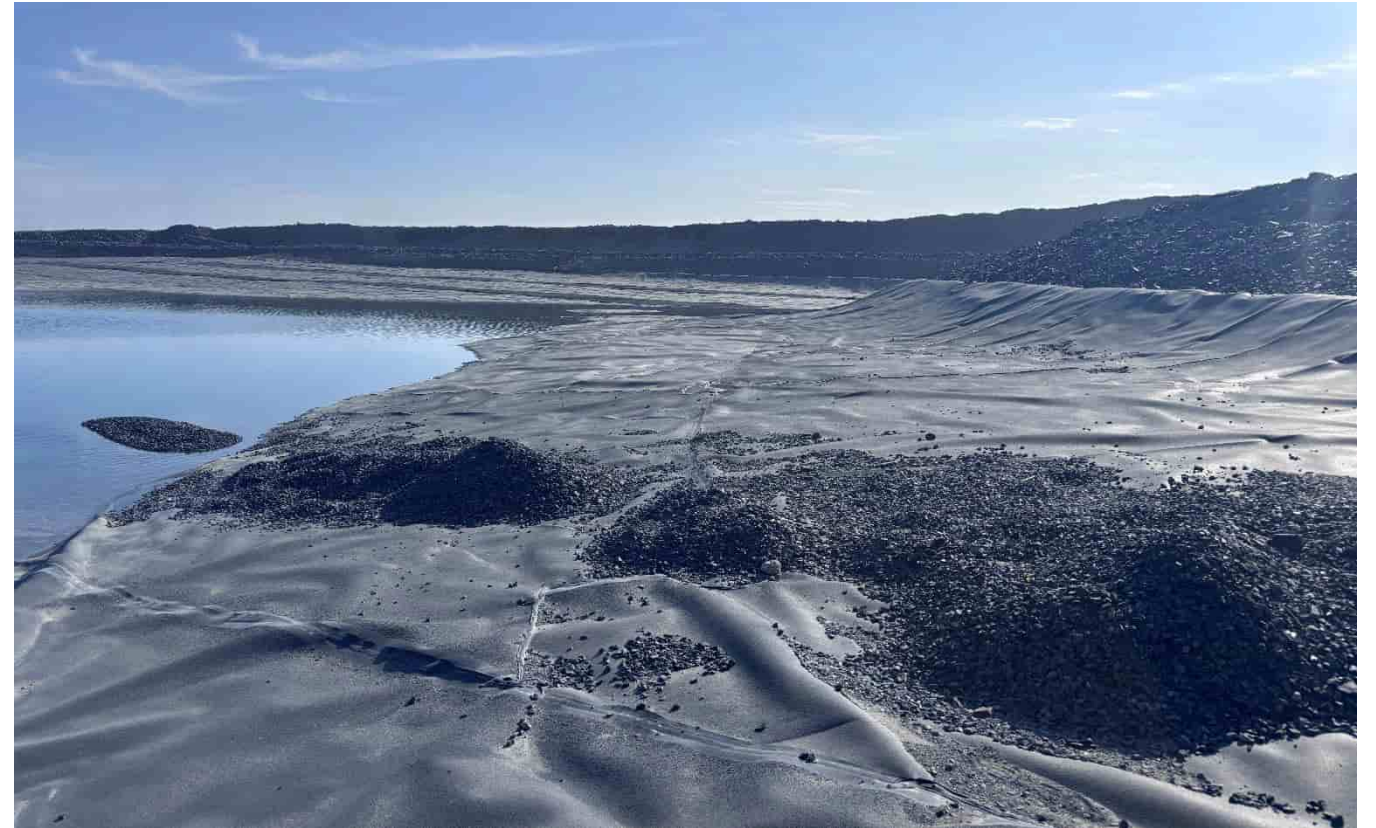
G-237: Rock material directly on liner, looking SE
