| | | 2025 Annual Geotechnical Inspection | | |
| Job No: CAPR004312<br>Filename: Back River_Goose_2025_AGI_Photoslog.pdf | Back River Project | Date:<br>February 2026 | Approved:<br>JBK | Figure:<br>79 |

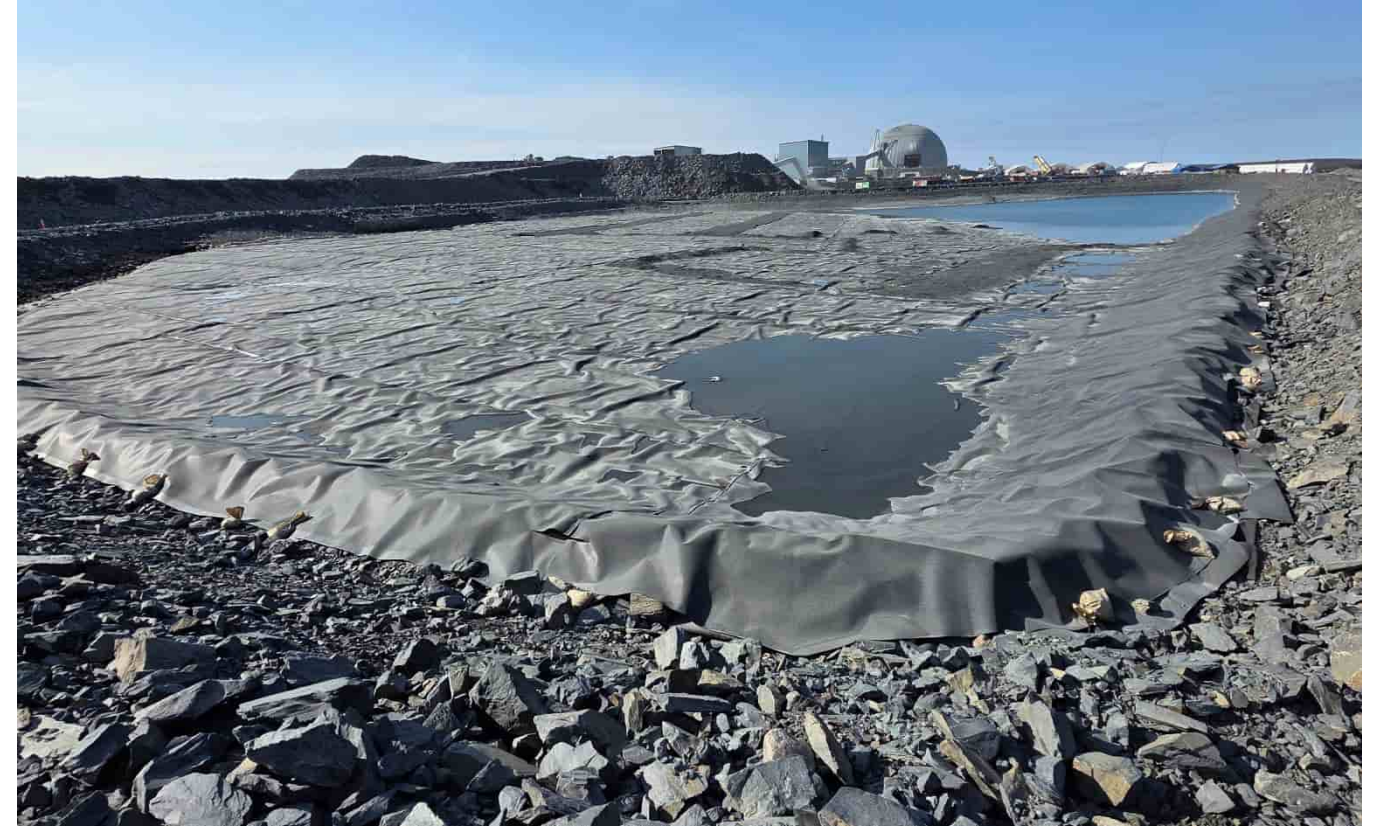
G-239A: Overall pond view from NW corner

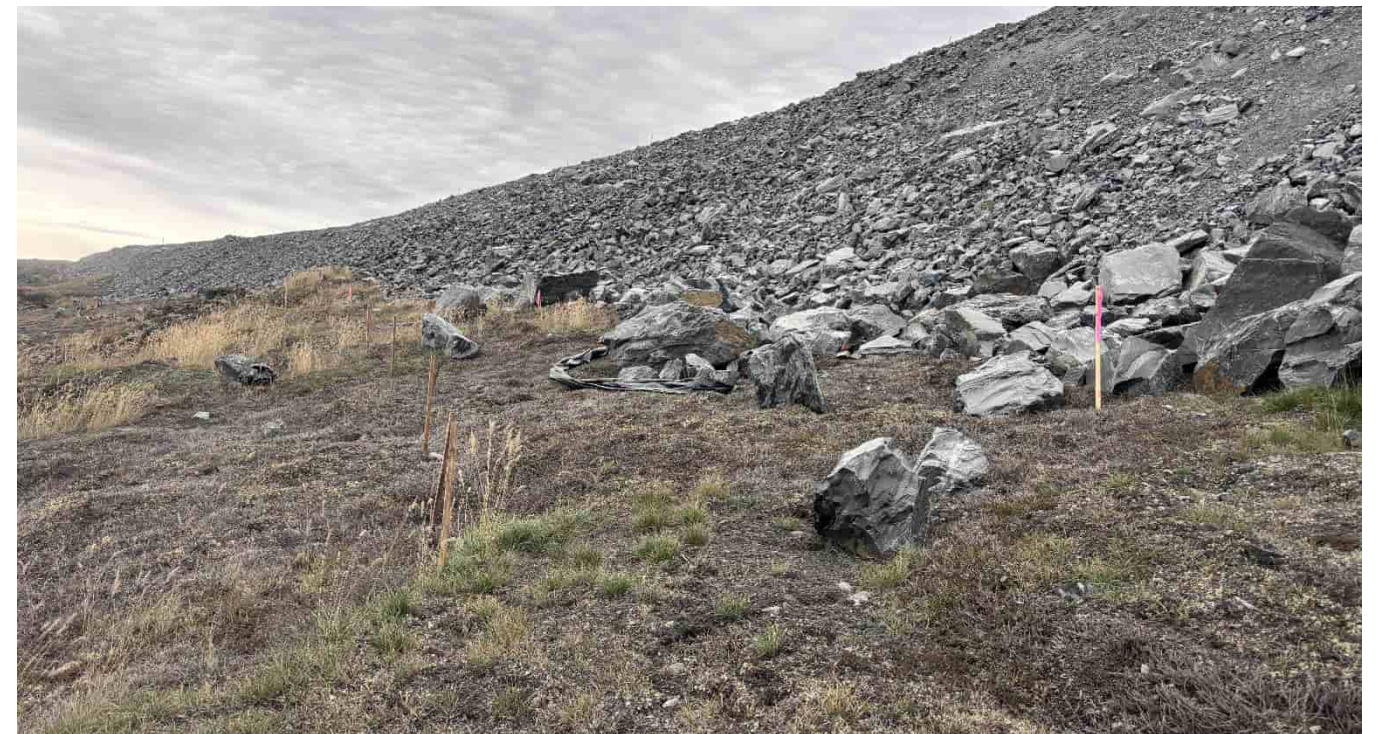
G-251: Downstream slope of All-weather road. Area marked where some drainage through rockfill or slope relaxations and some coarser material roll out previously noted

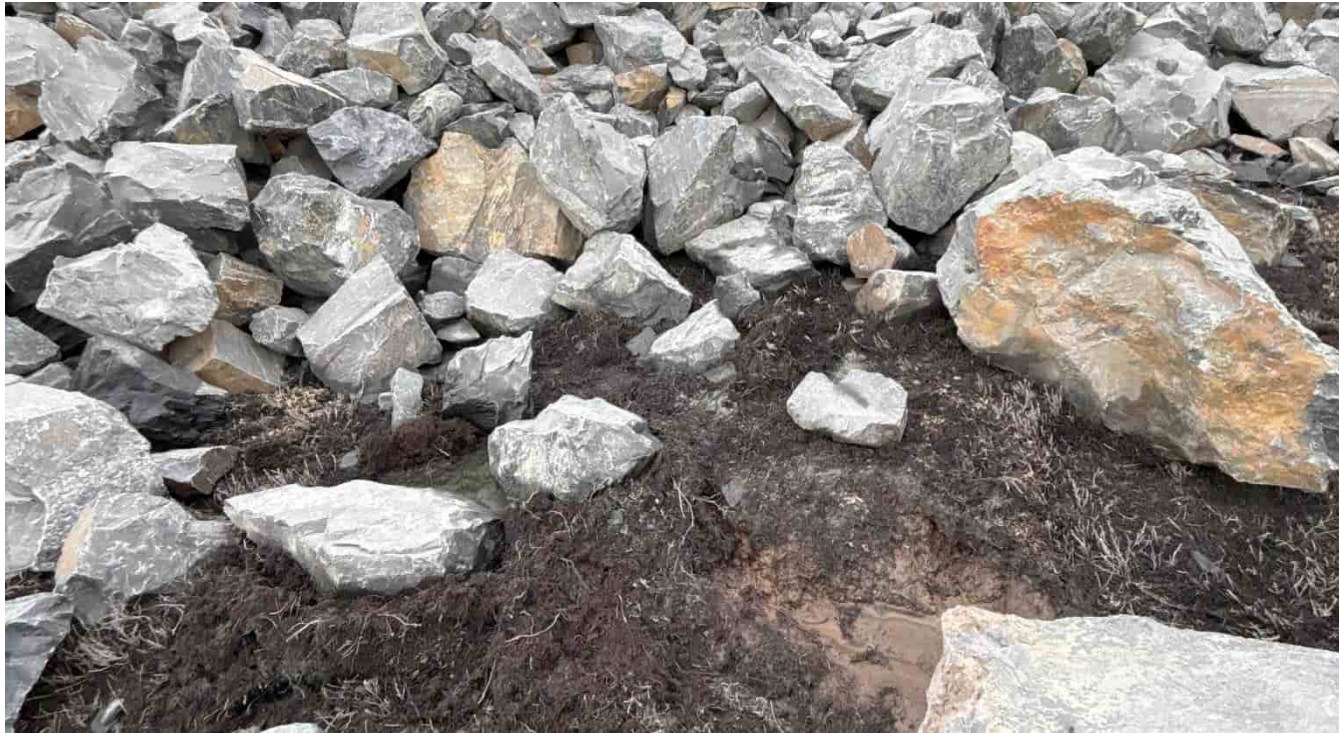
G-252: Damage to tundra due to rockfall from oversteepened slope of All-Weather Road N rockfill – water seepage noted through / below rockfill

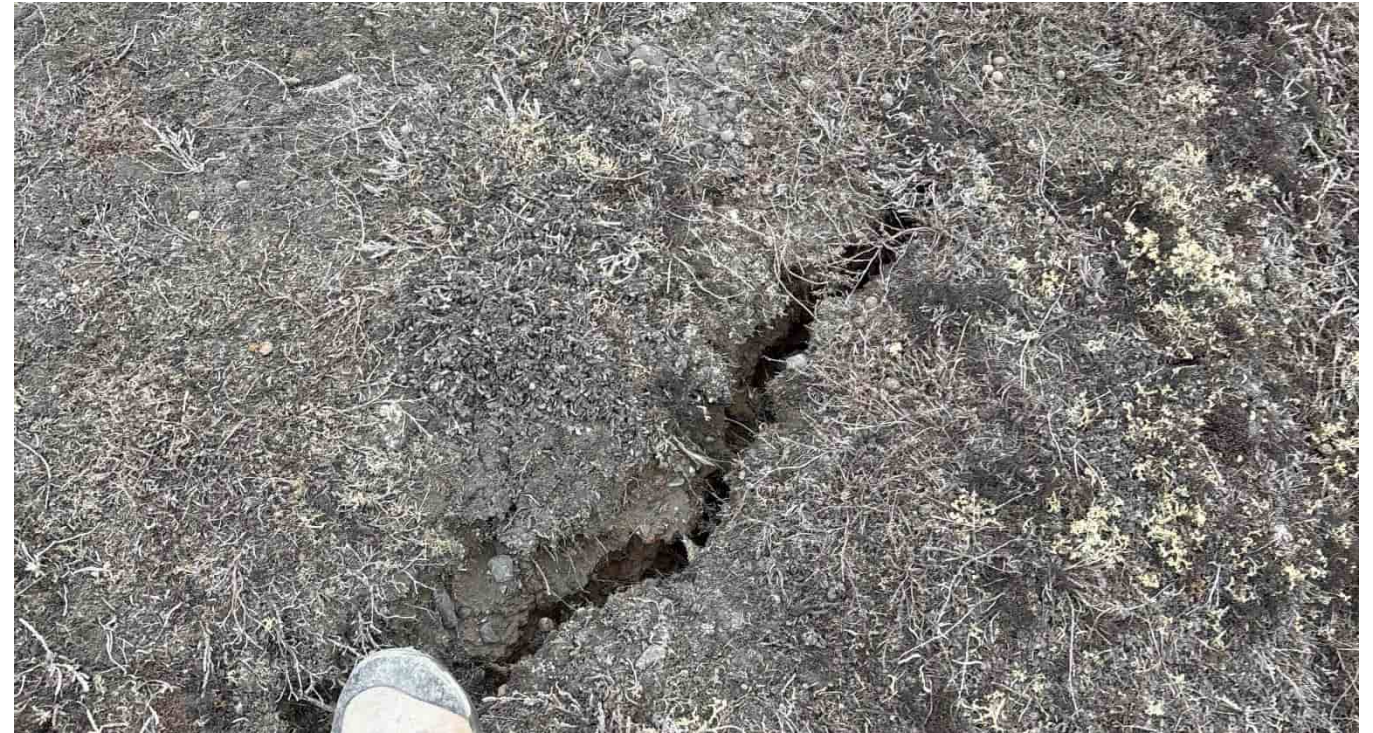
G-253: Tundra near toe of rock fill – settlement to be expected near toes

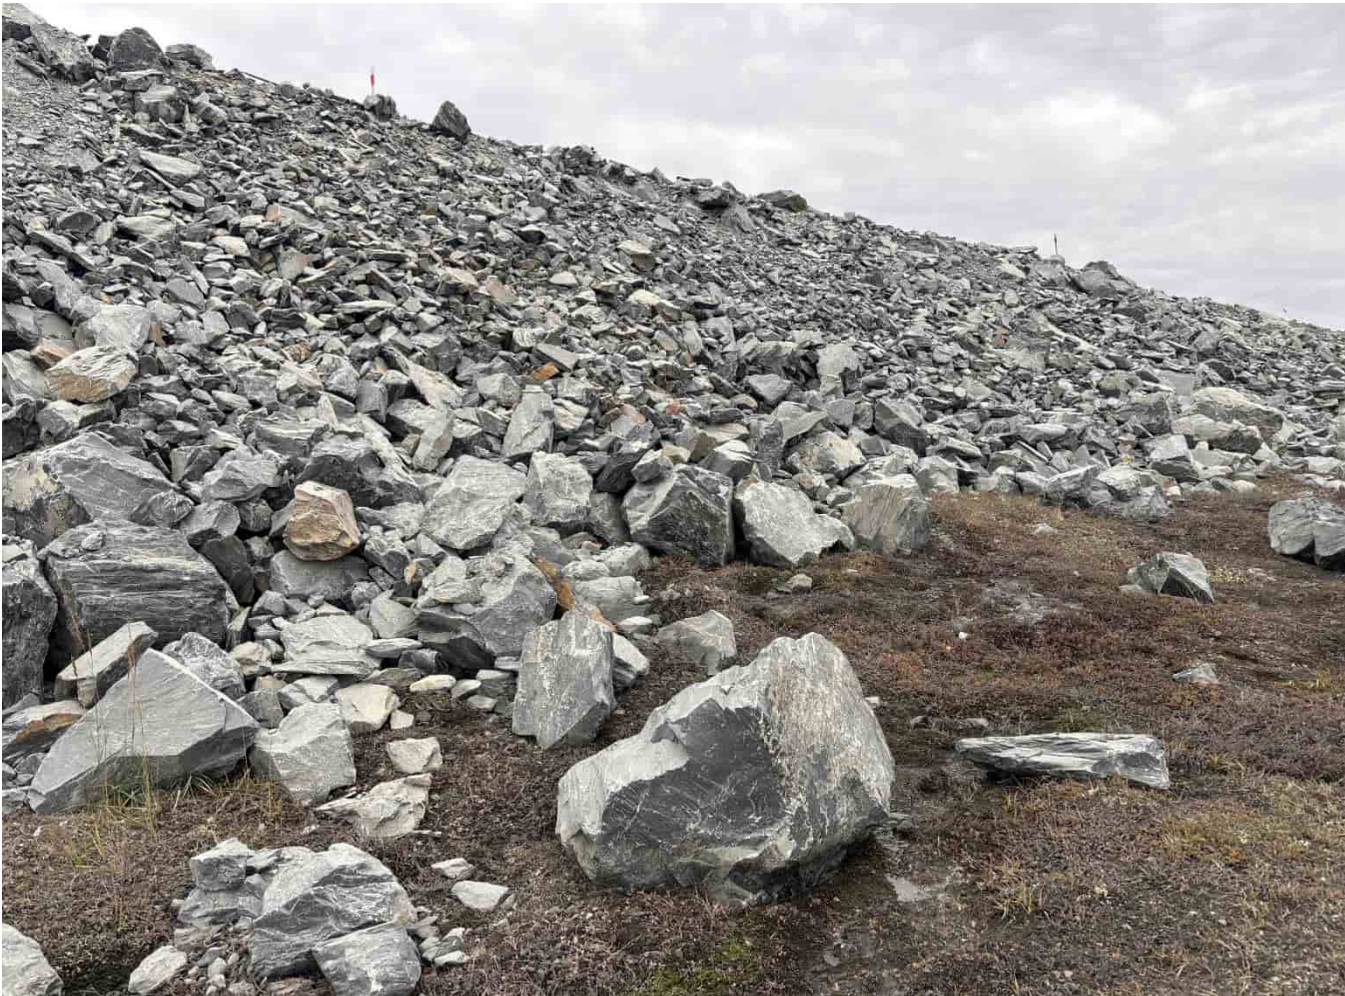
G-257: Water seepage from road rockfill

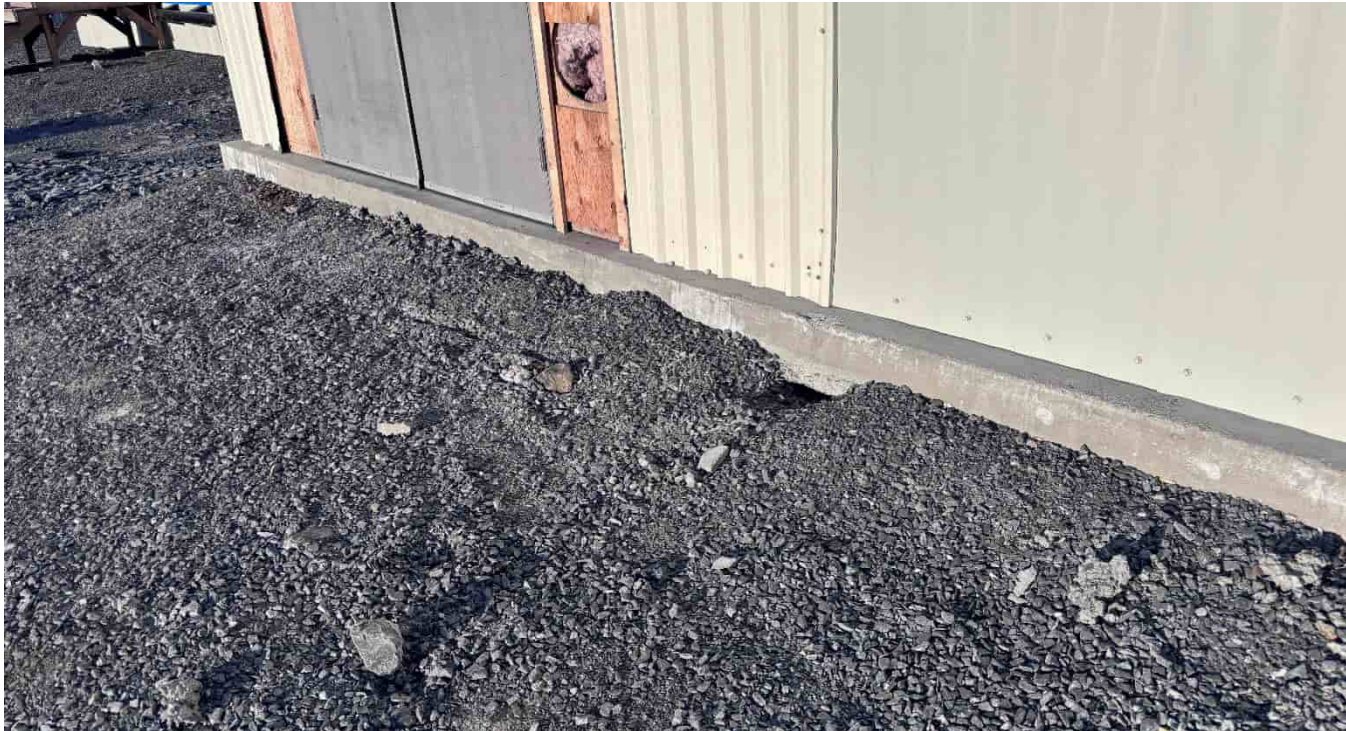
G-270: Surface water flow path / erosion under infrastructure foundation

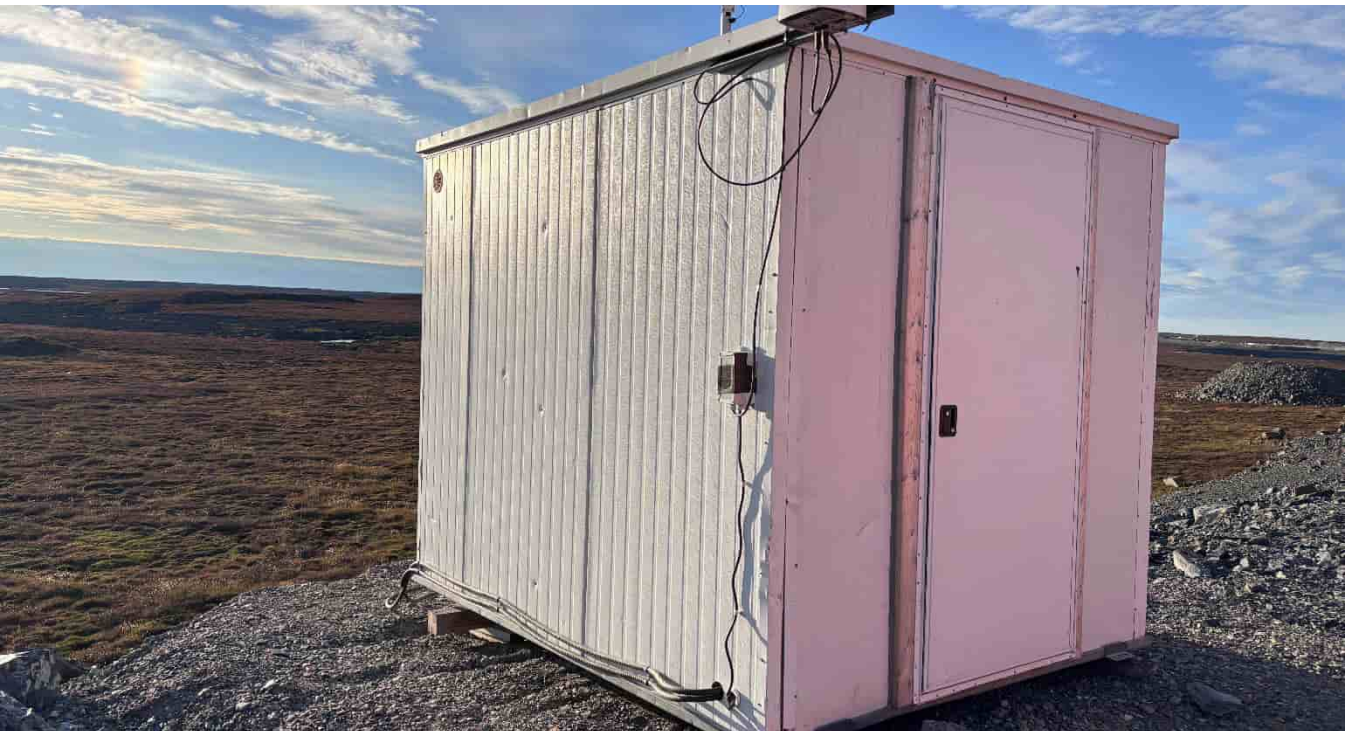
G-272: Storage container close to western pad edge, looking NW – settlement noted in area

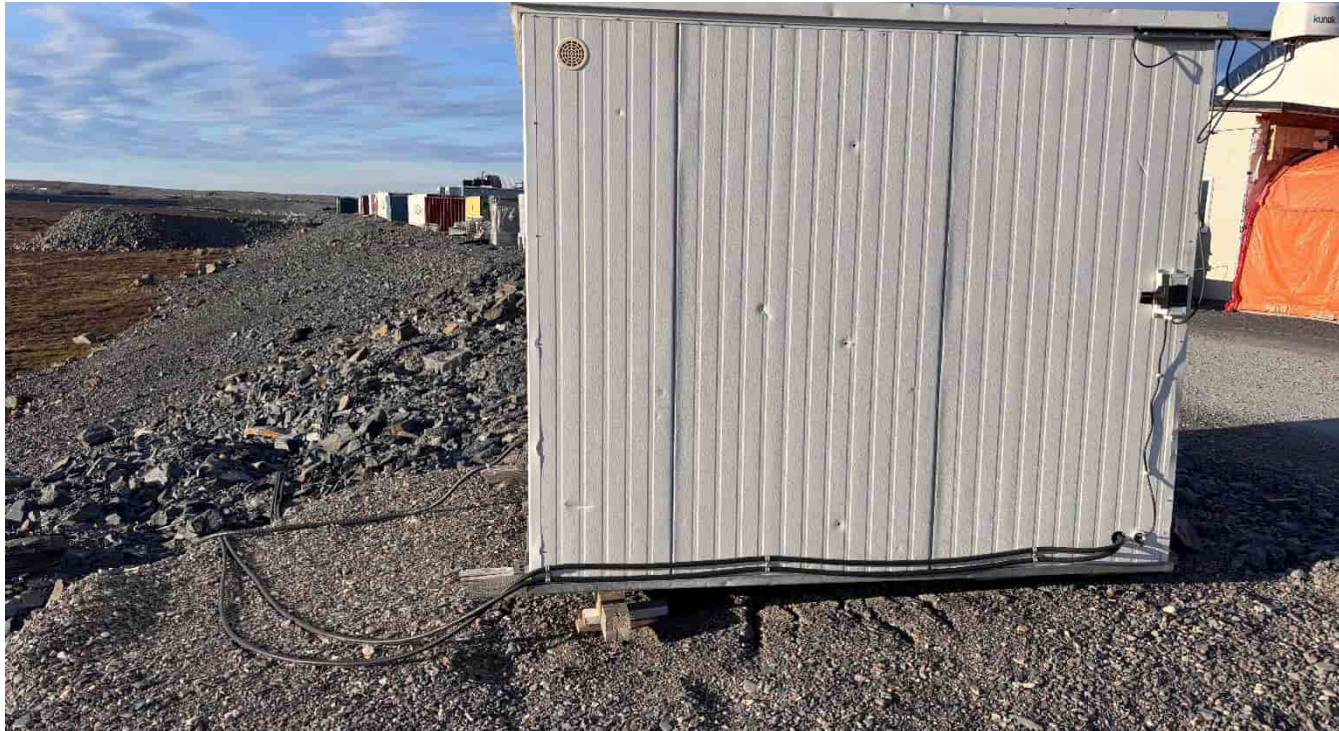
G-273: Storage container close to western pad edge, looking N – settlement and gap beneath container noted

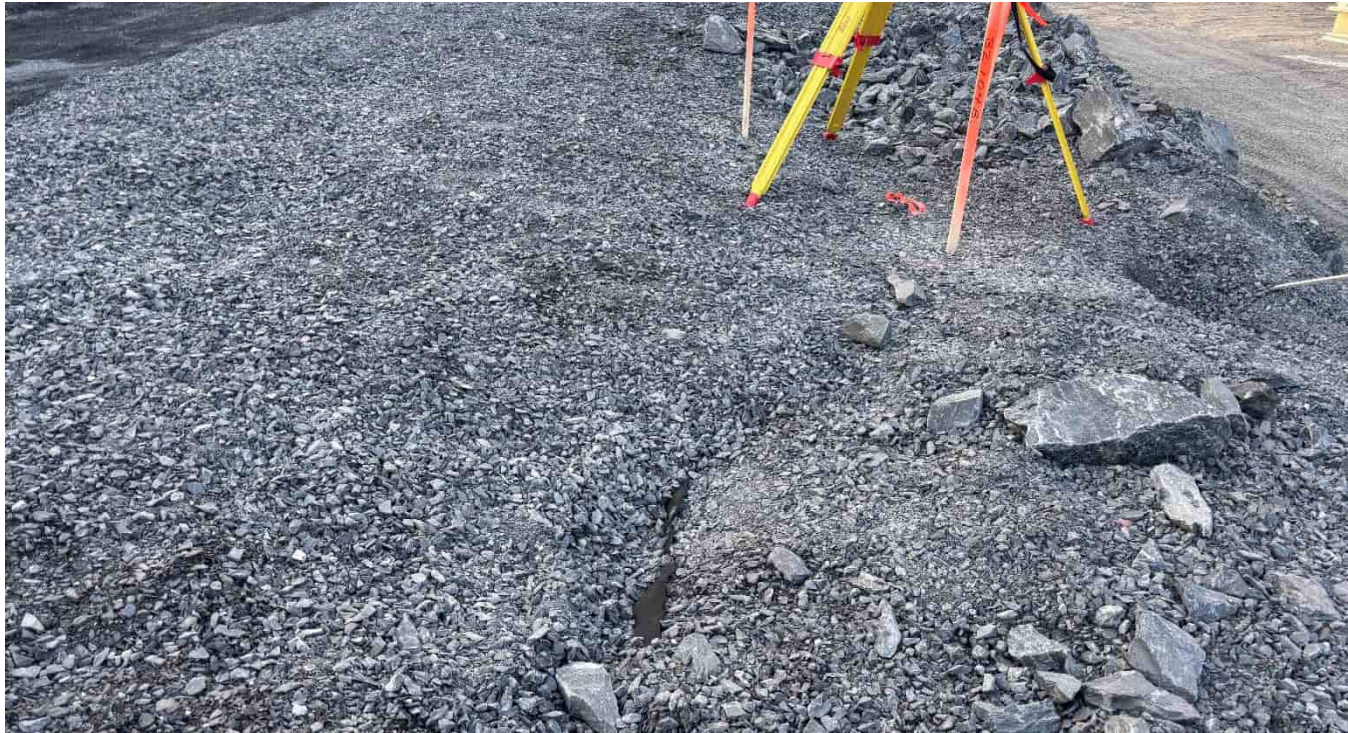
G-330: Exposed liner and degradation to overliner cover tank farm berm

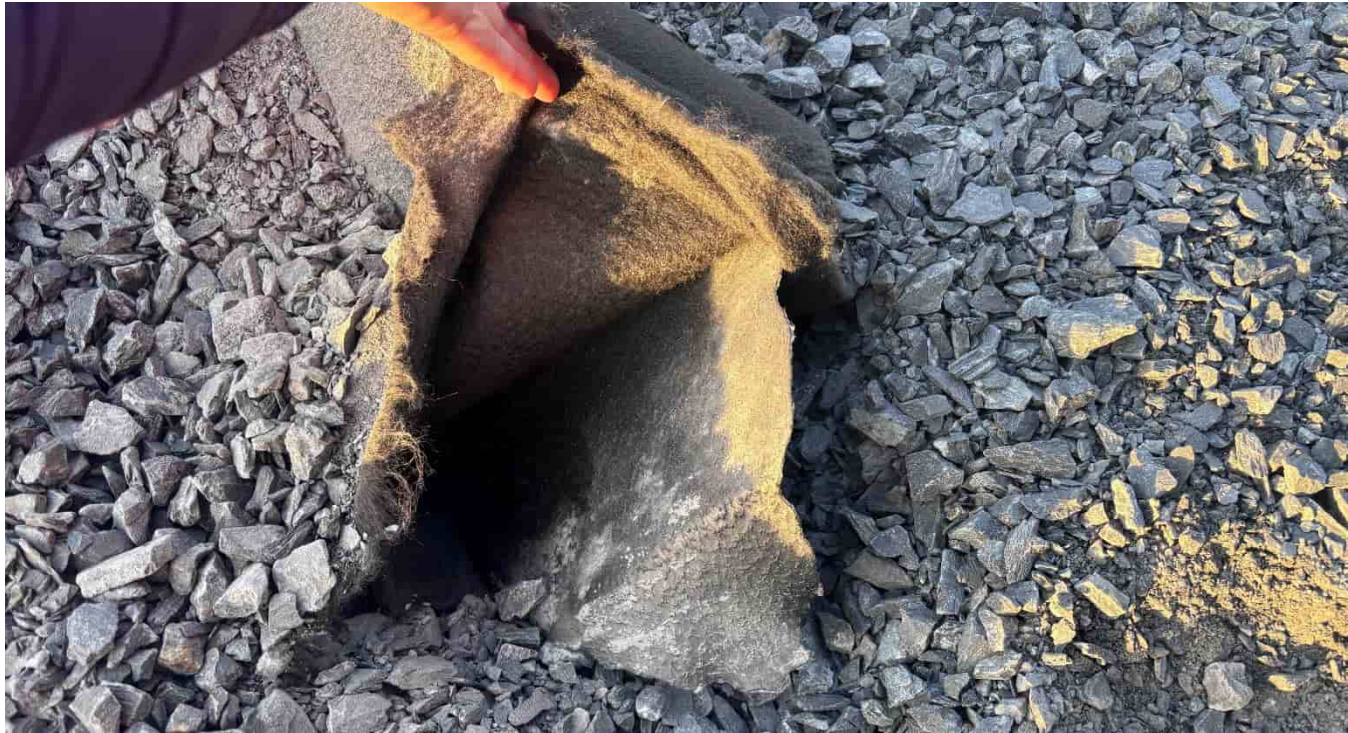
G-334: Exposed and damaged liner on tank farm northern berm slope

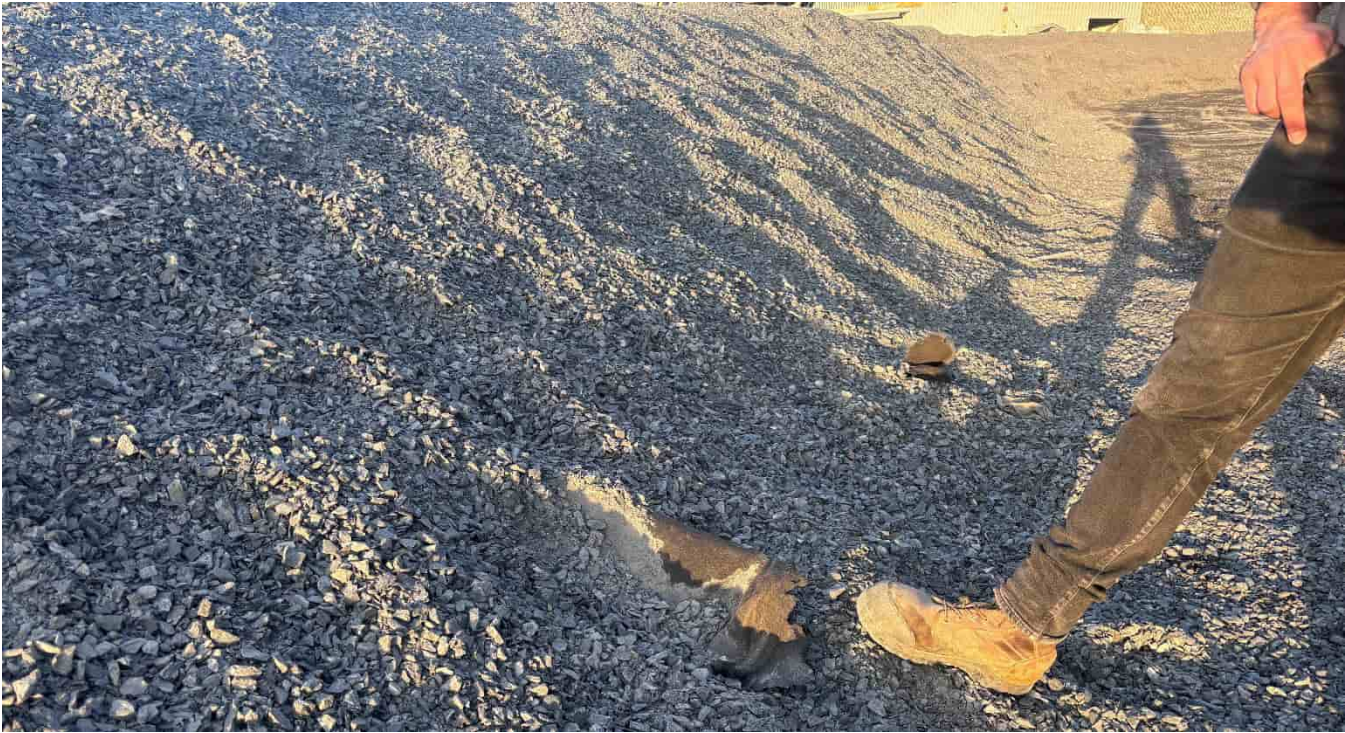
G-335: Exposed and damaged liner on tank farm northern berm slope

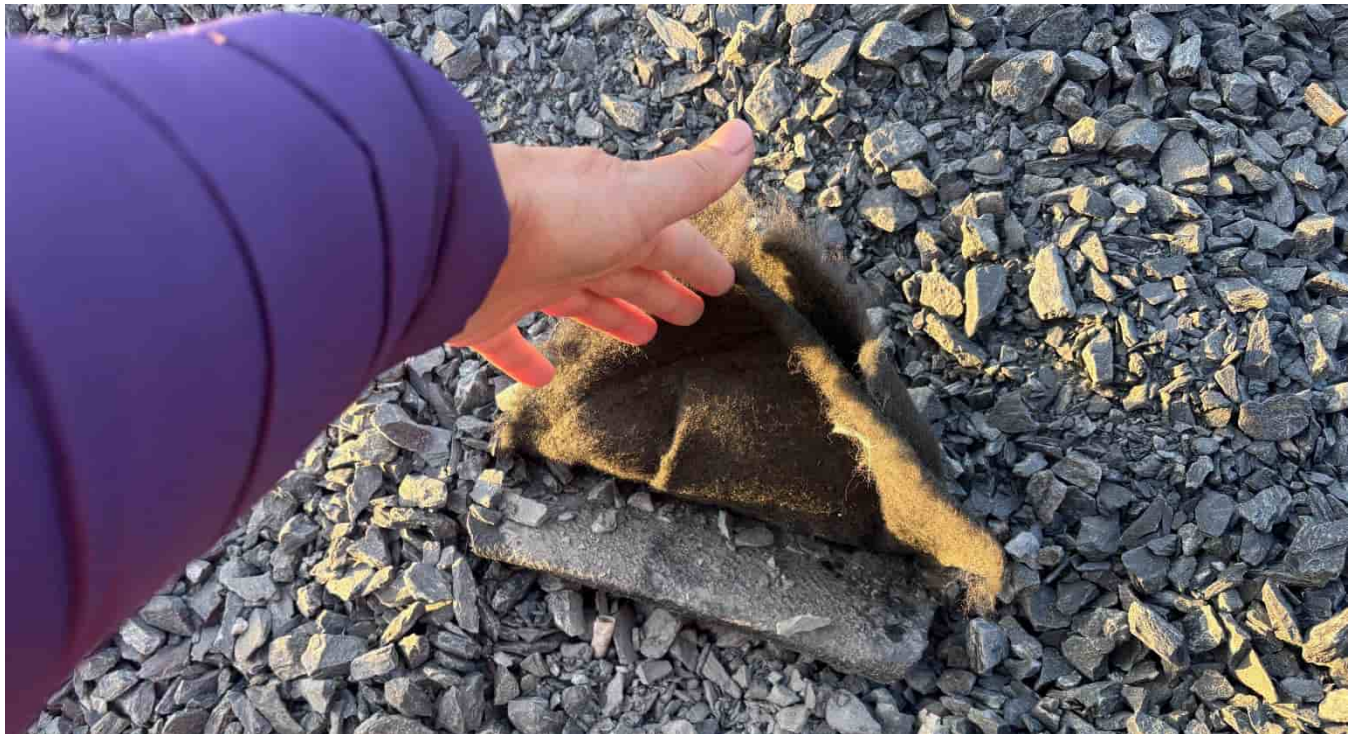
G-336: Exposed and damaged liner on tank farm northern berm slope

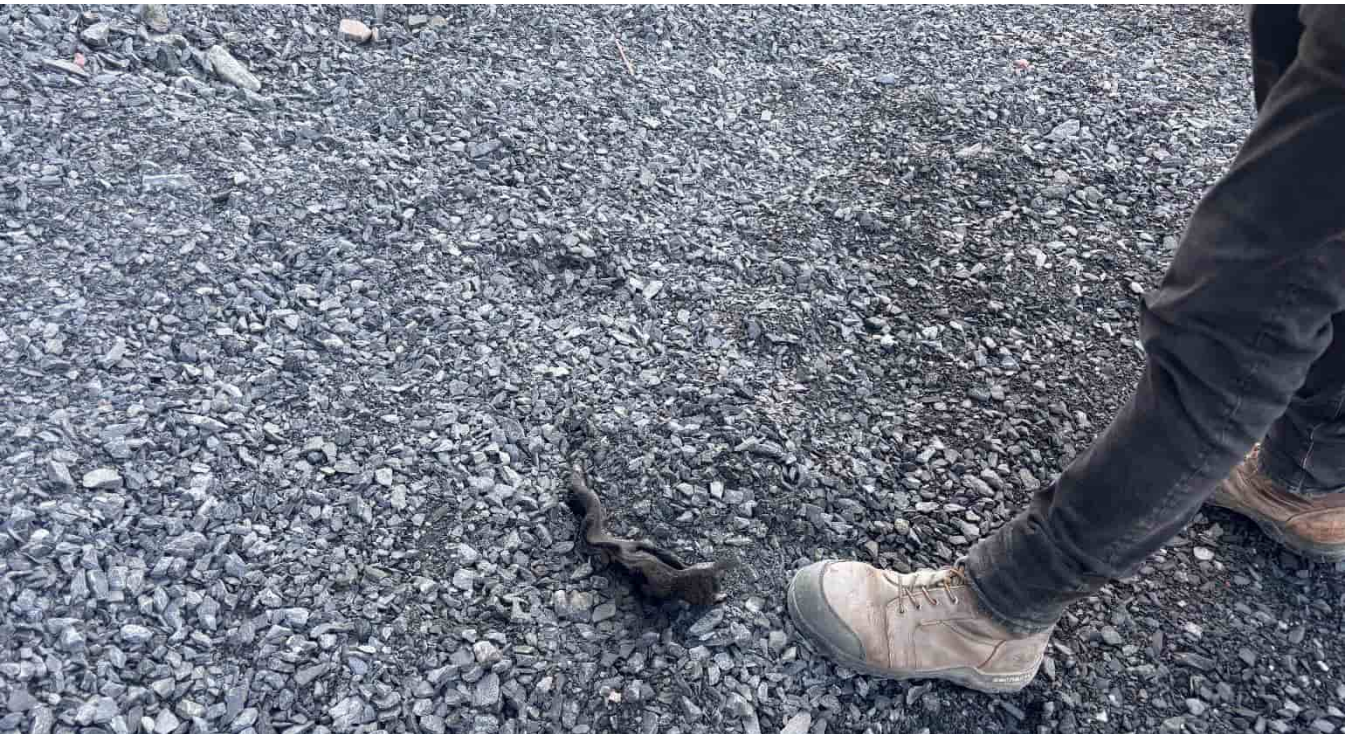
G-337: Exposed and damaged liner on tank farm northern berm slope

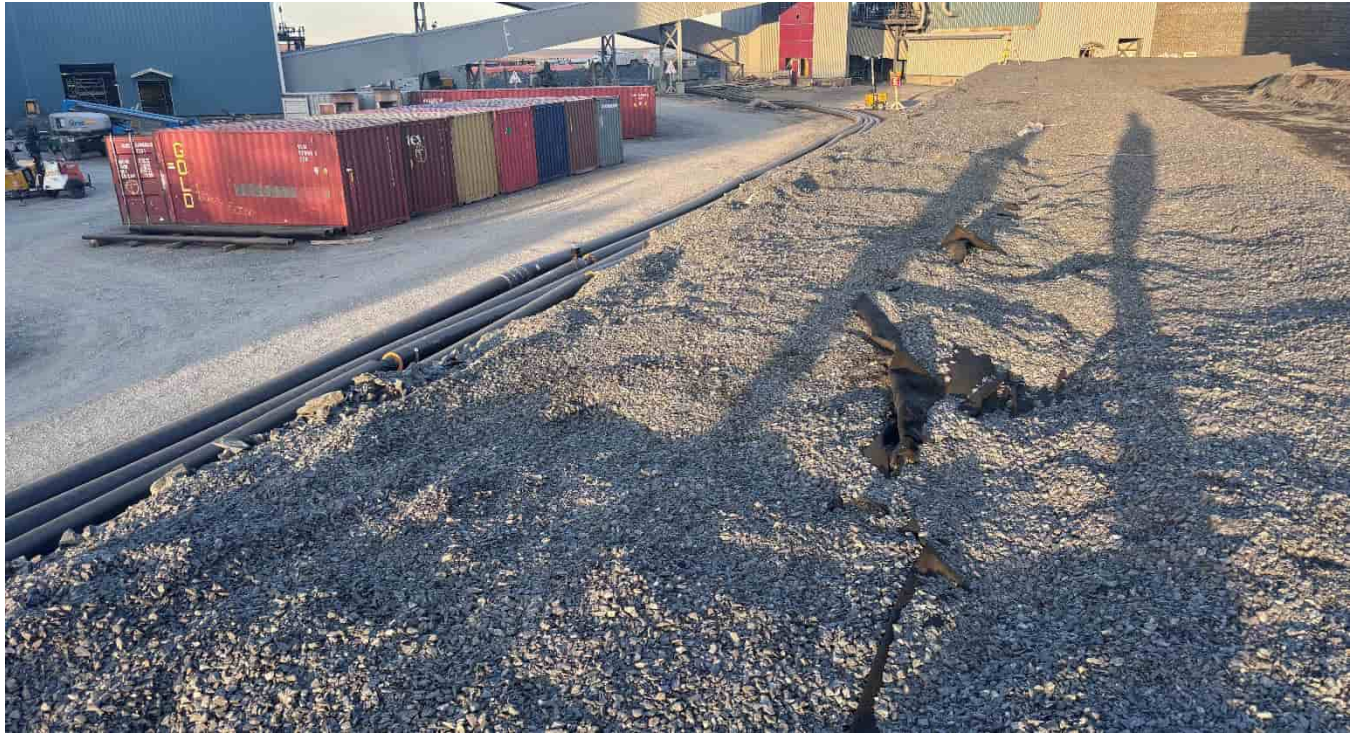
G-338: Exposed liner on northern berm, looking E

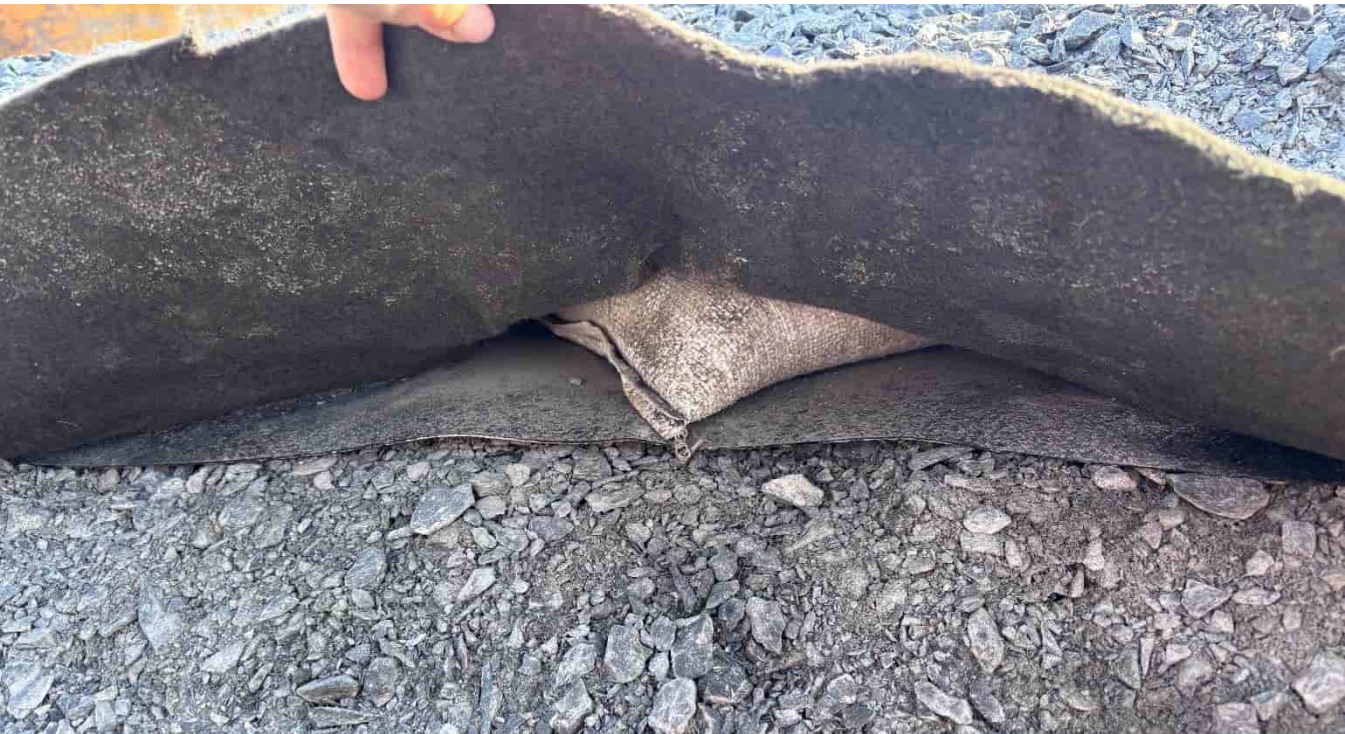
G-357: Sand bag noted below geotextile near crest of berm

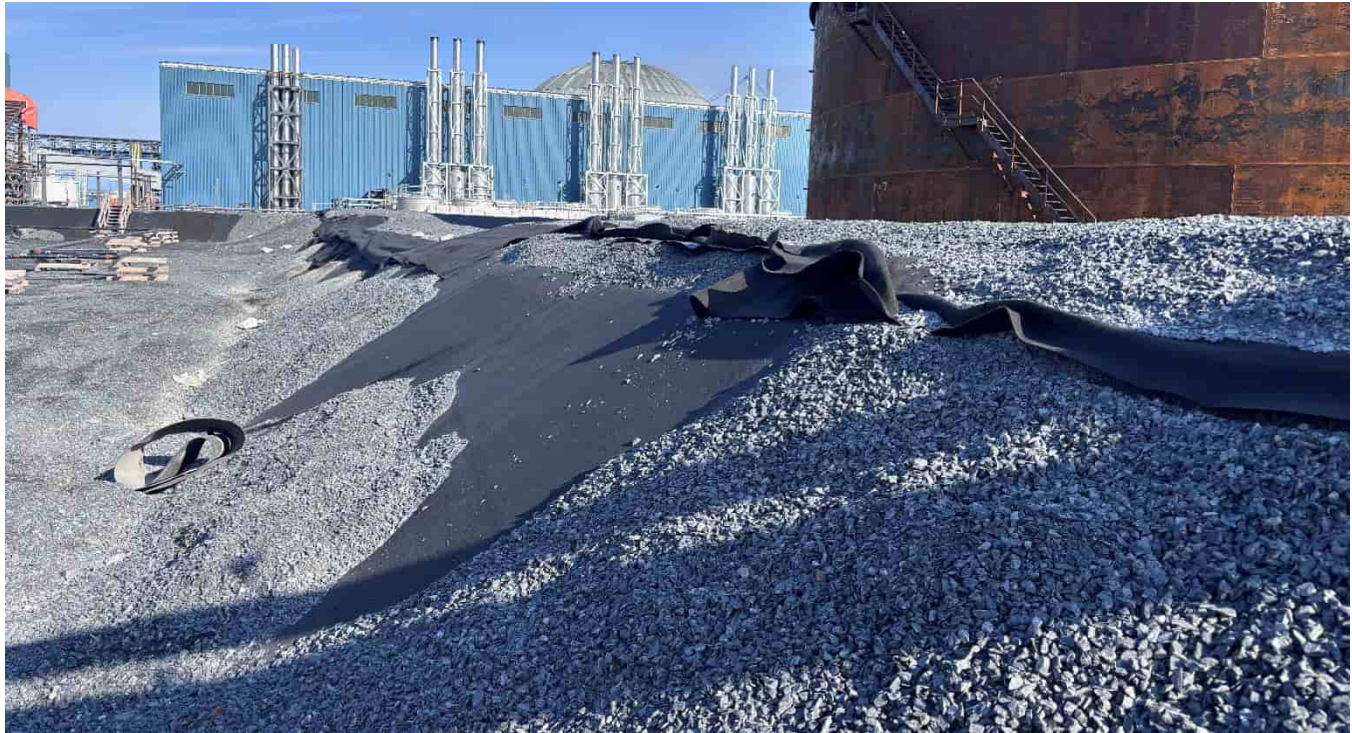
G-358: Exposed liner on slope berm between Tank 2 and Tank 3, looking N

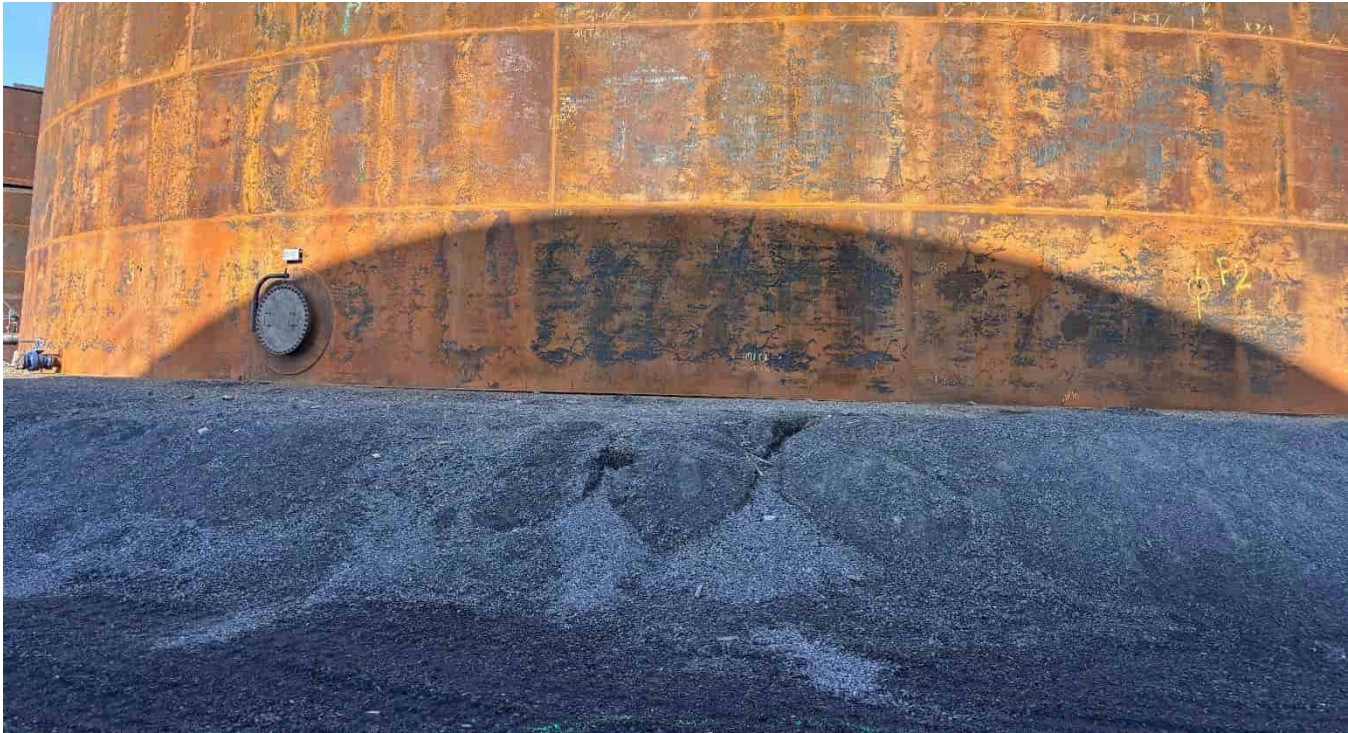
G-366: Erosion pathways starting on on slope beside northeastern tank

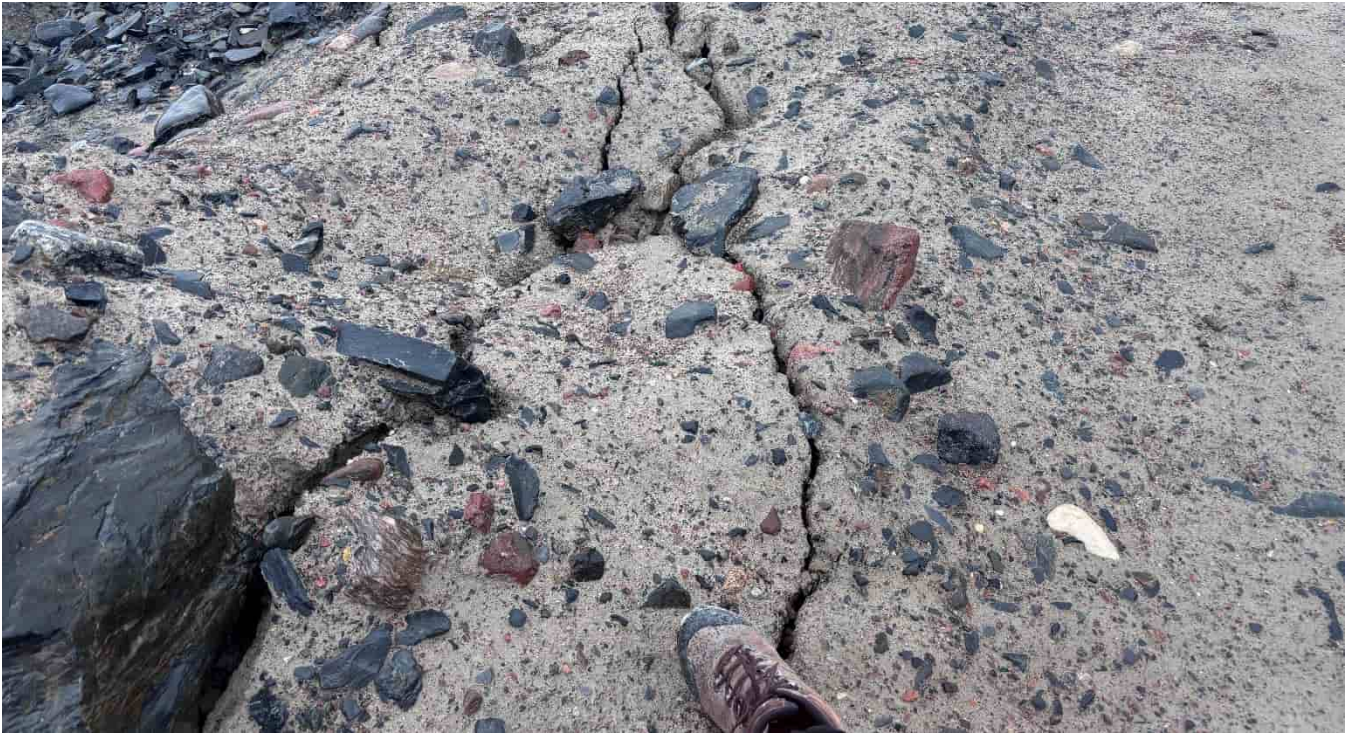
G-399: Example of settlement cracks (expected) in overburden stockpile surface

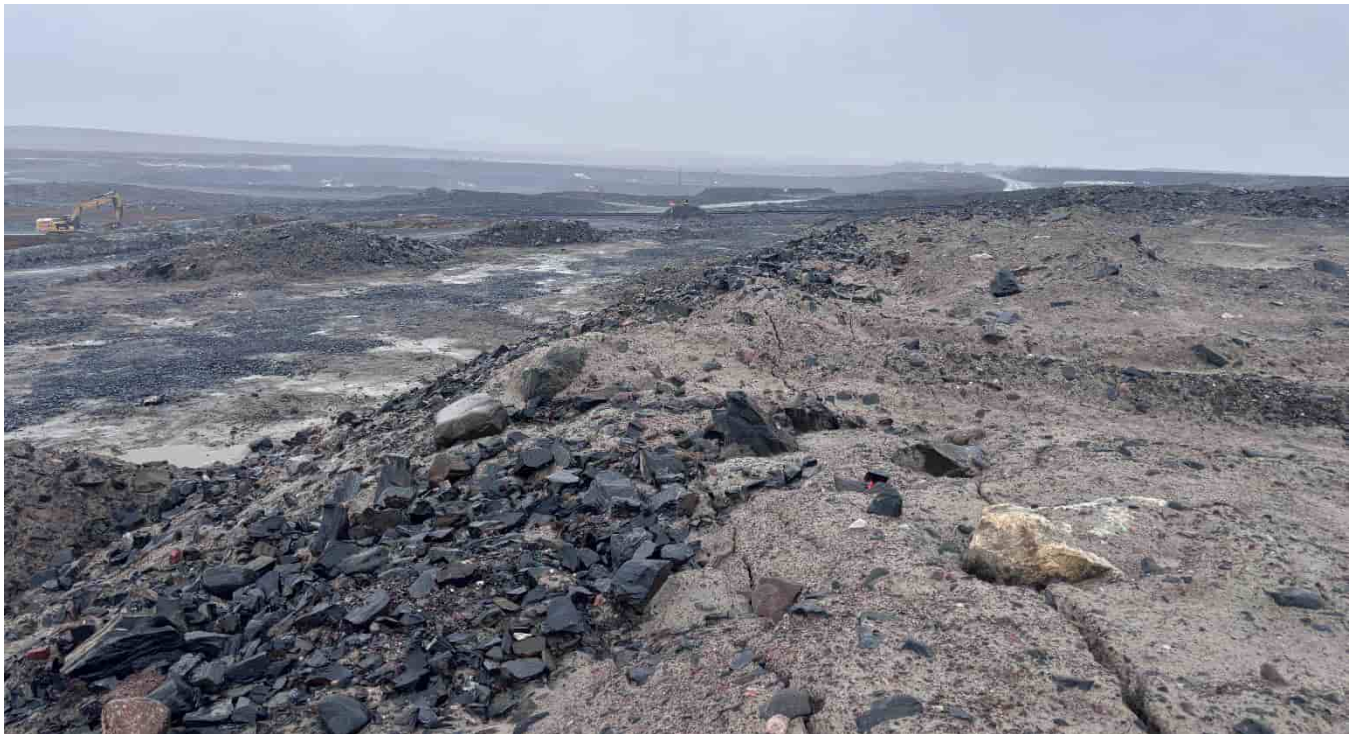
G-400: Stockpile, looking N – cracking closer to top crest near slopes

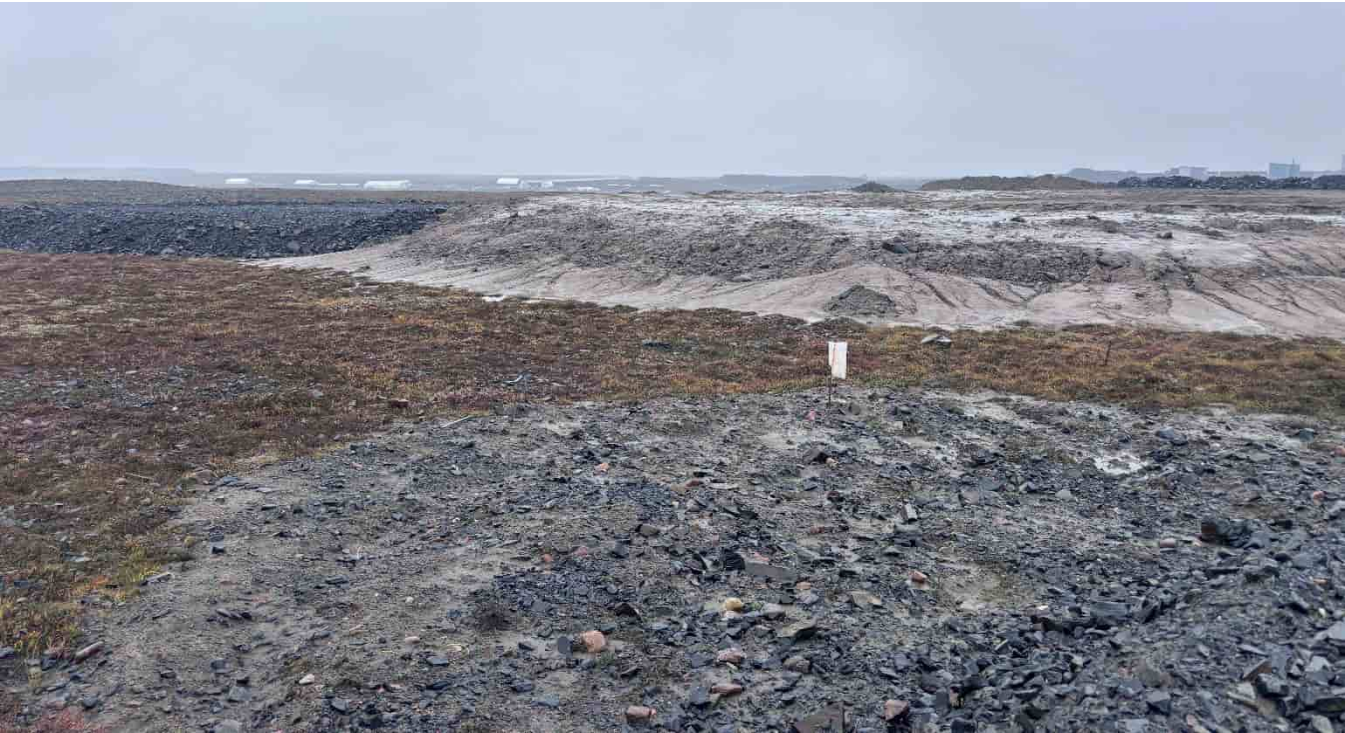
G-407: Overburden stockpile, looking S from road – some erosion from surface water noted on slopes

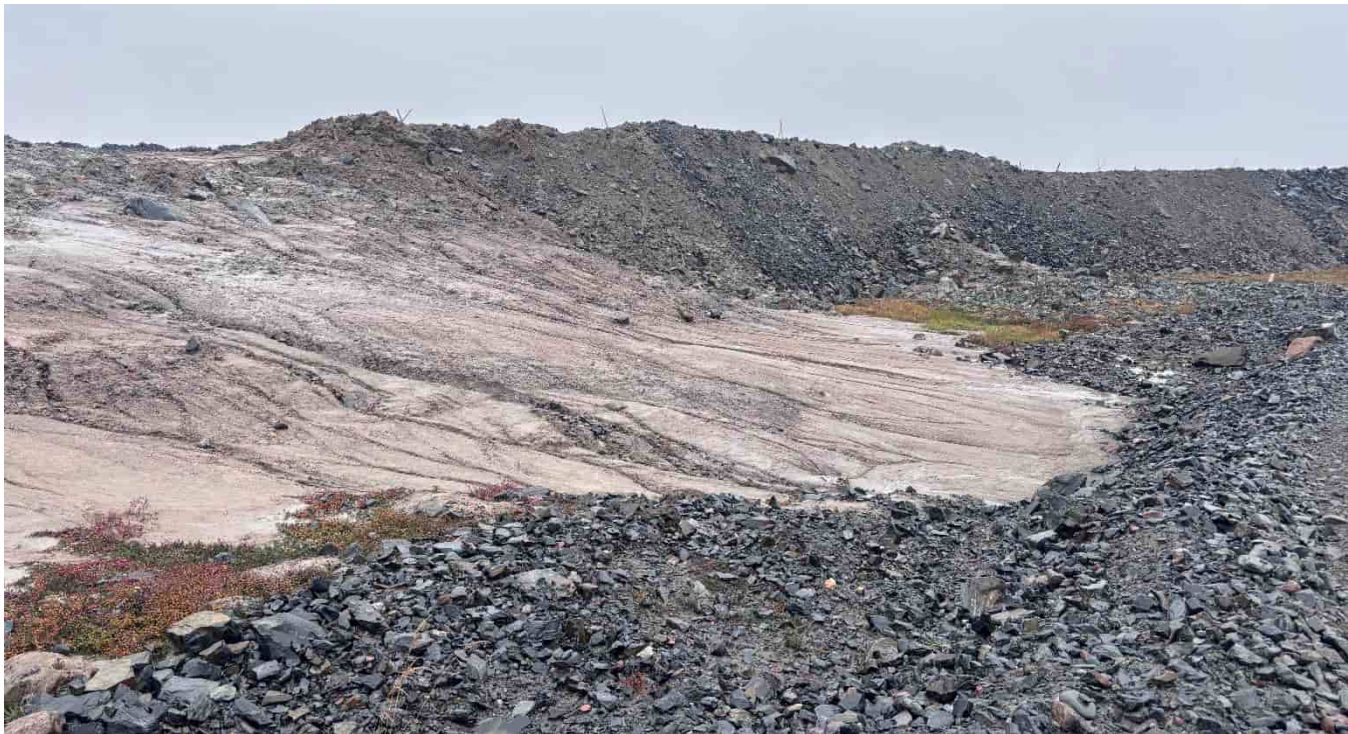
G-408: Stockpile beside road corner and northern pad slope thaw and erosion of overburden material (expected with this type of material when left exposes)

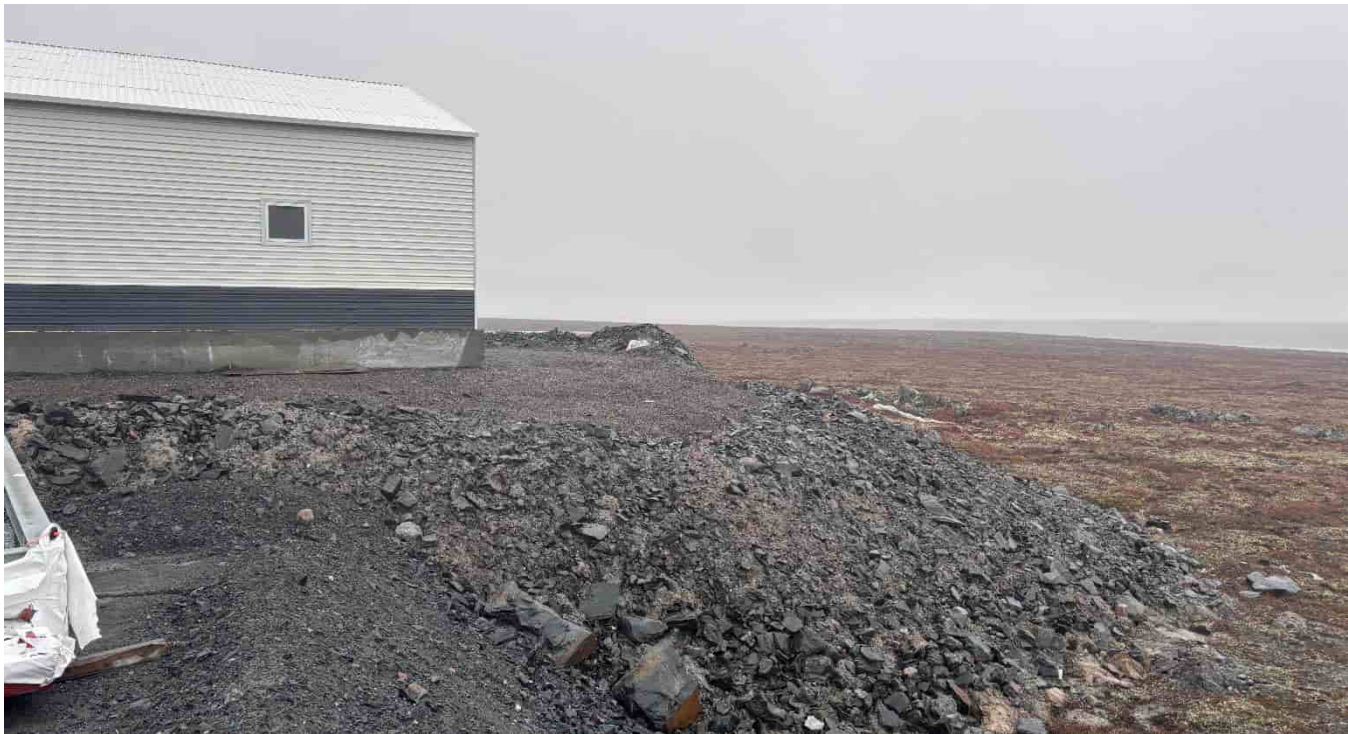
G-439: Settlement of pad near building, looking N
