| | | 2025 Annual Geotechnical Inspection | | |
| Job No: CAPR004312<br>Filename: Back River_Goose_2025_AGI_Photoslog.pdf | Back River Project | Date:<br>February 2026 | Approved:<br>JBK | Figure:<br>79 |

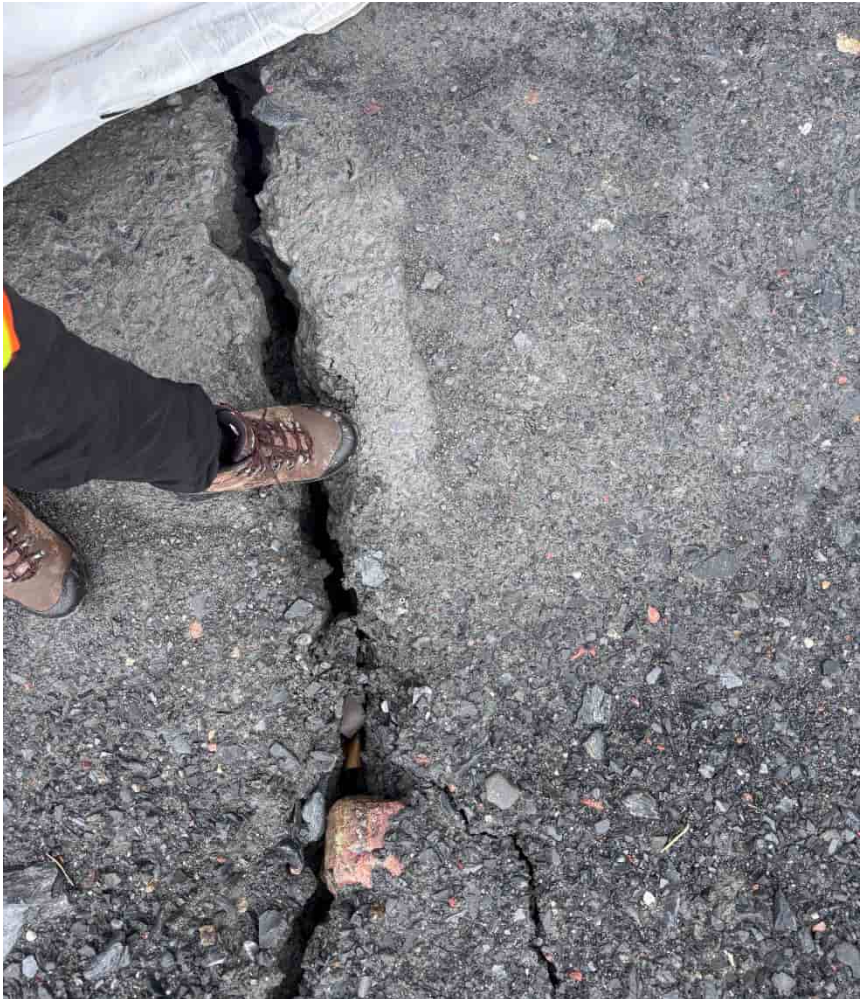
G-438: Large tension crack near building foundation
