| | | 2025 Annual Geotechnical Inspection | | |
| | | Primary Pond Dam | | |
| Job No: CAPR004312<br>Filename: Back River_Goose_2025_AGI_PhotoLog.pdf | Back River Project | Date:<br>February 2026 | Approved:<br>JBK | Figure:<br>159 |

## **Appendix B      Photolog from 2025 Site Visit – MLA**

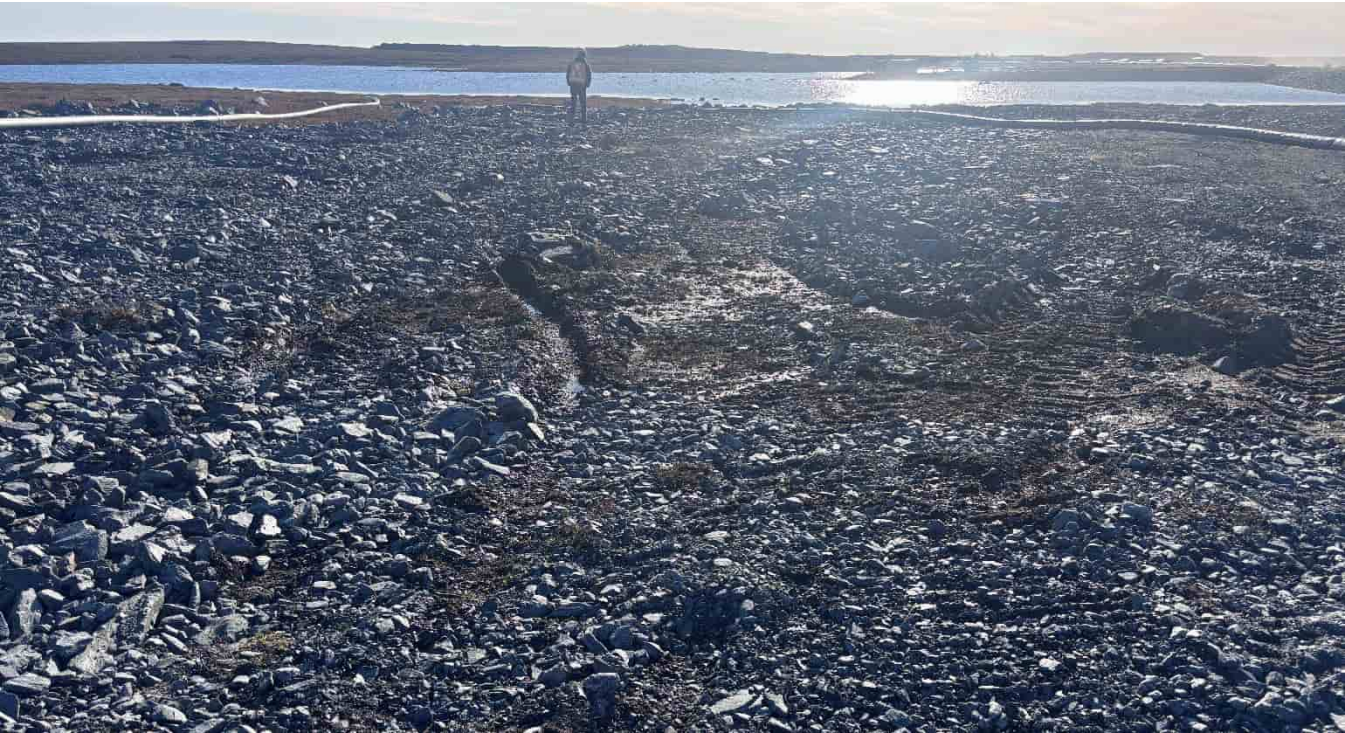
G-462: Pipeline pad north of Primary Pond

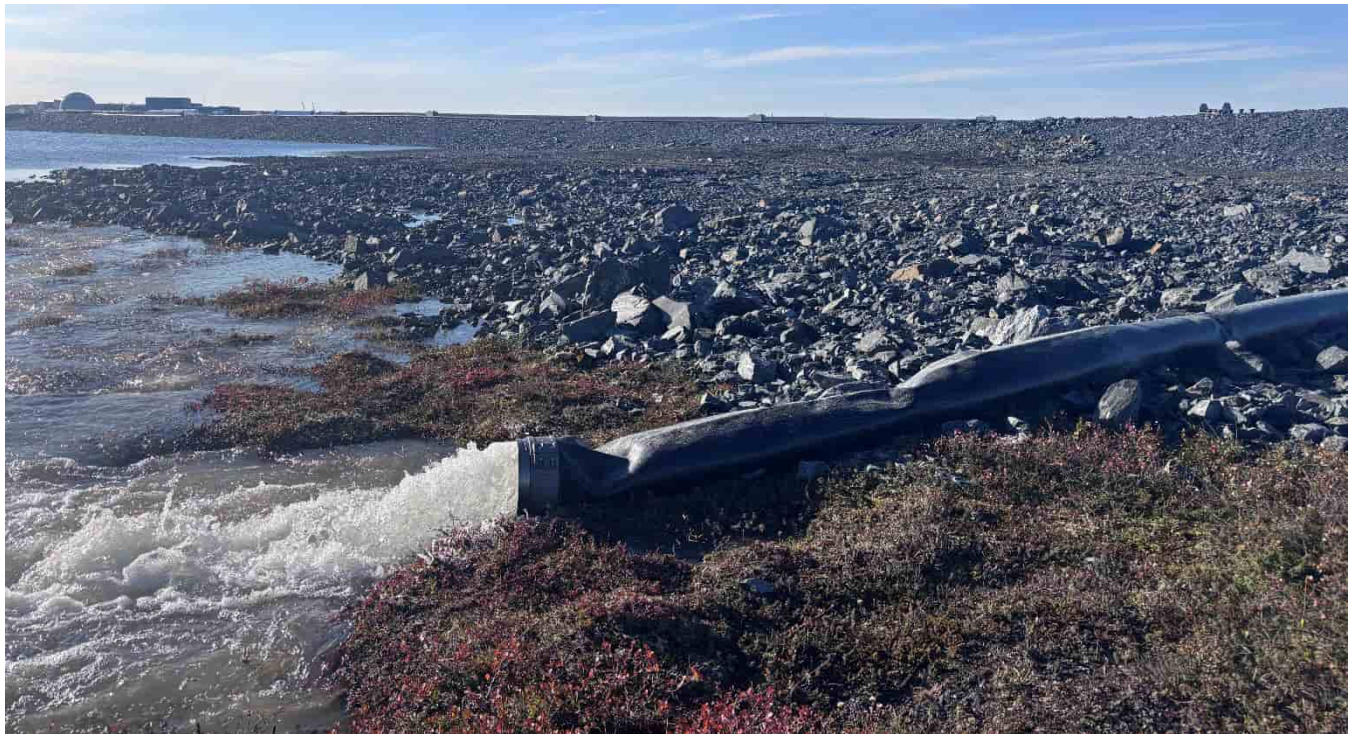
G-463: View SE towards Primary Pond, some disturbance to tundra noted downstream of dam in aerea

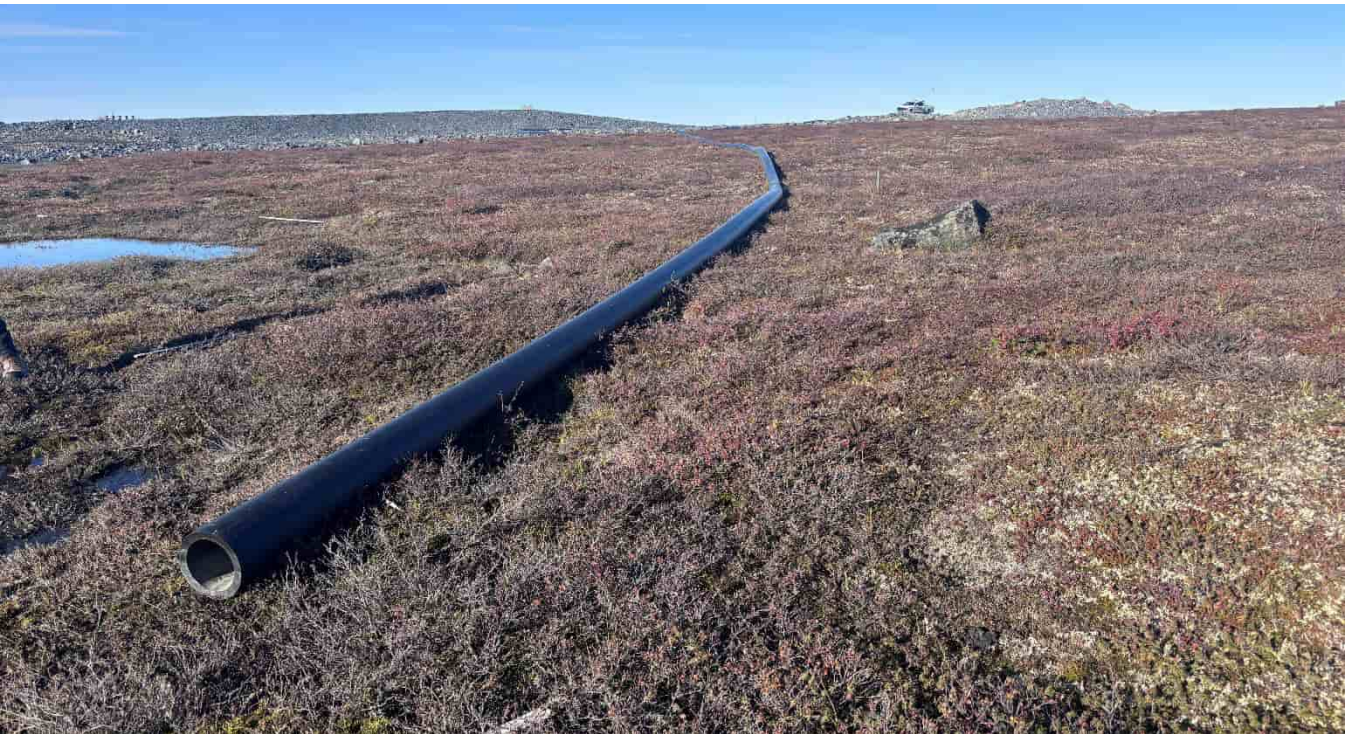
G-464: Discharge into N side of primary pond at unfavourable locations (in terms of increased potential for thermal degradation within pond footprint), looking SW (this was corrected / moved)

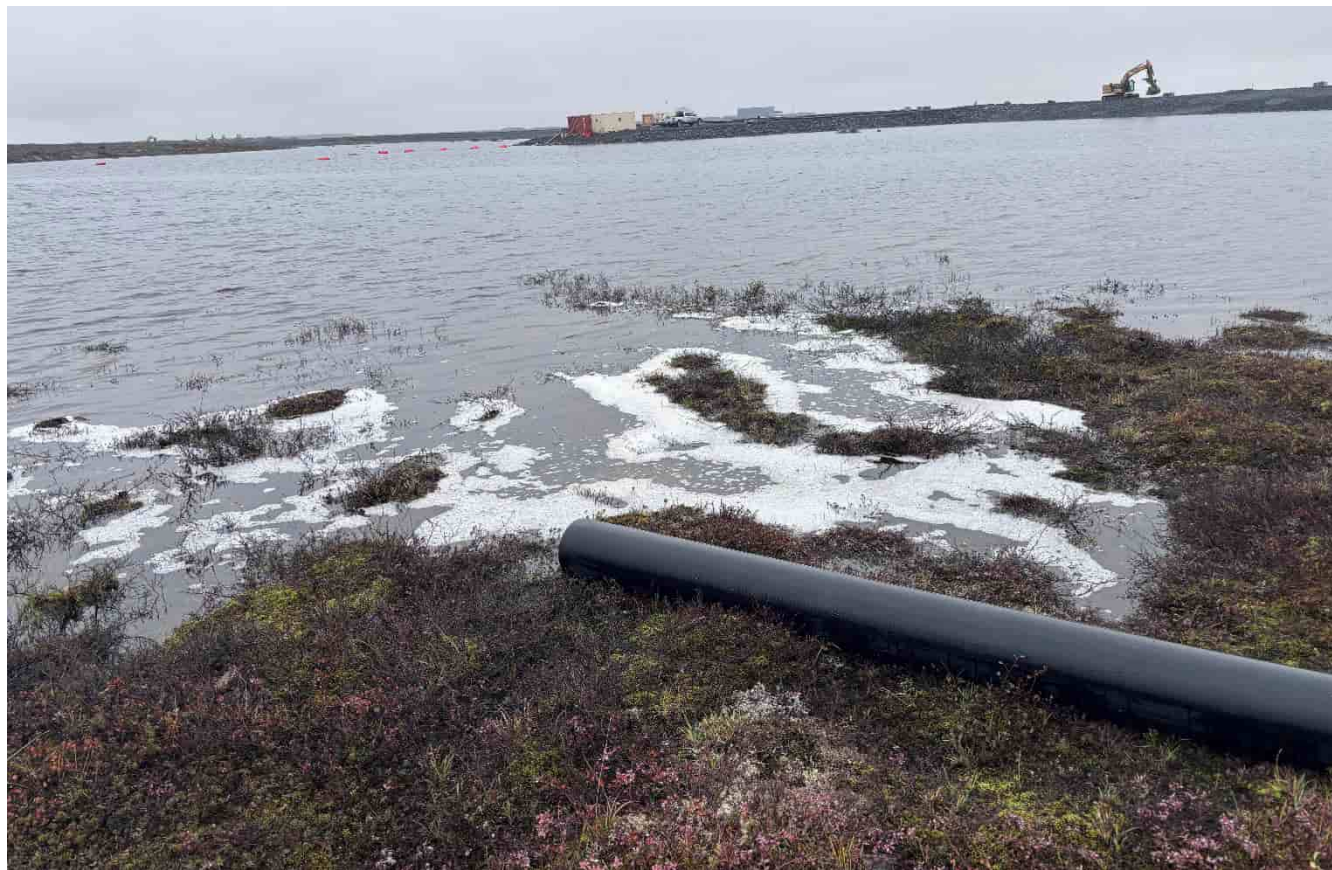
G-481: Discharge point the N of Primary Pond : Note that the disturbed area was backfilled with the low permeability material and the discharge point was moved while SRK was on site.

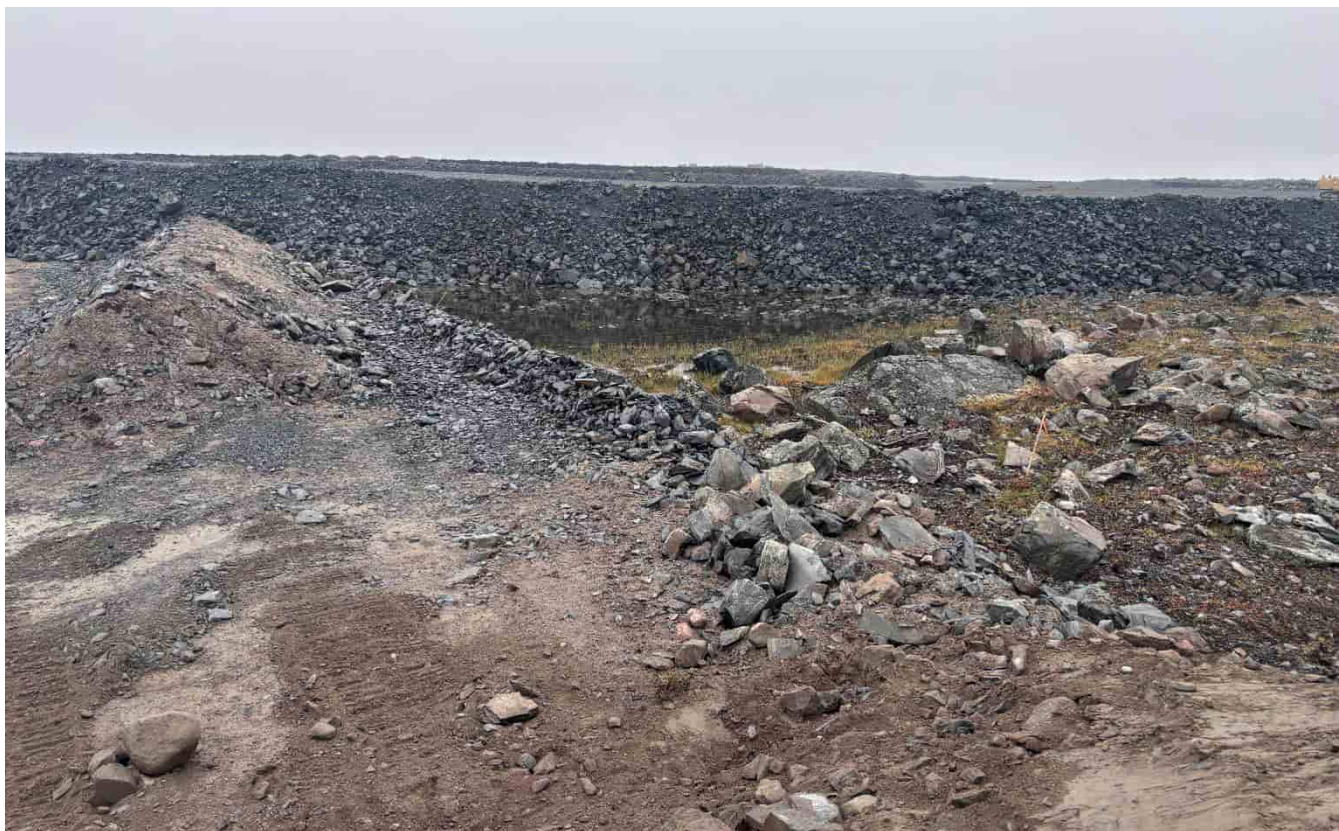
G-487: Ponding water beside overburden fill at Umwelt WRSA. The ponded water was filled to minimize future ponding in area.

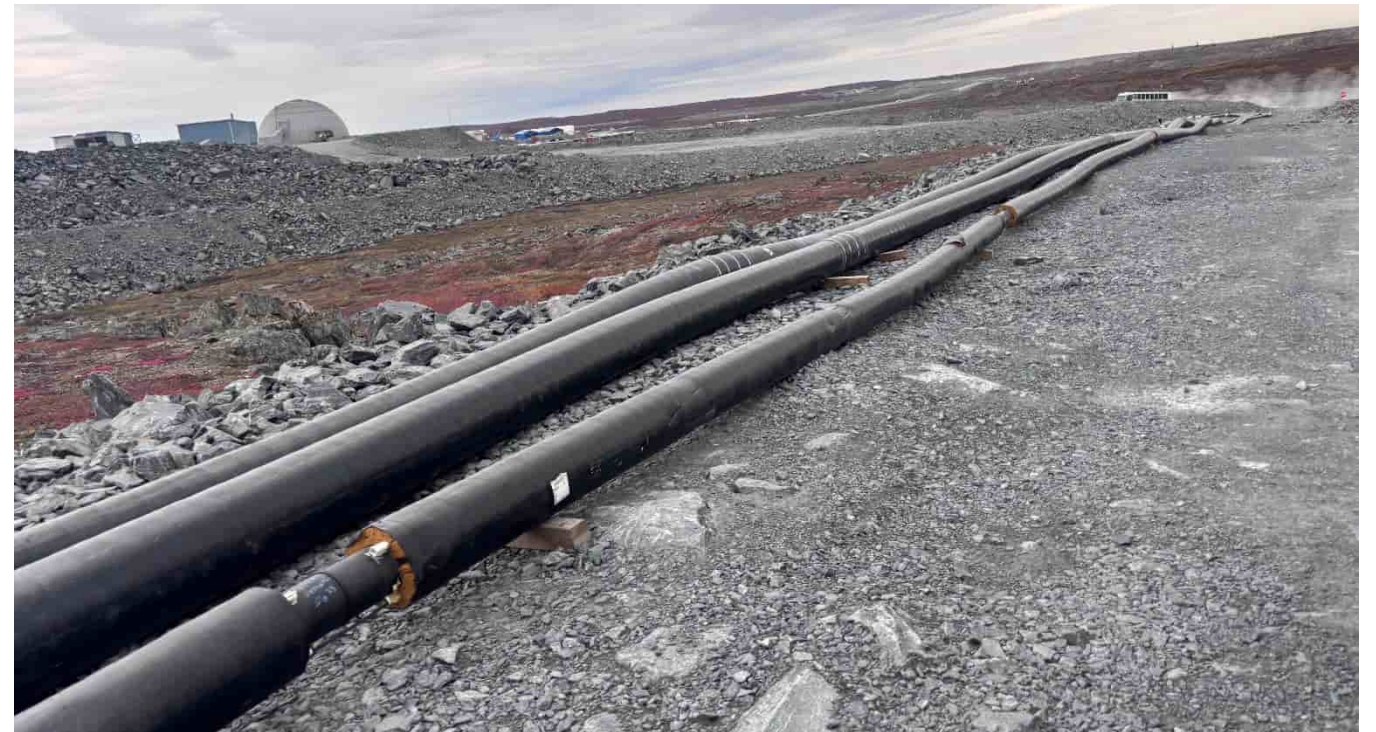
G-509: Depression in tailings pipeline road, piping suspended in smaller sections

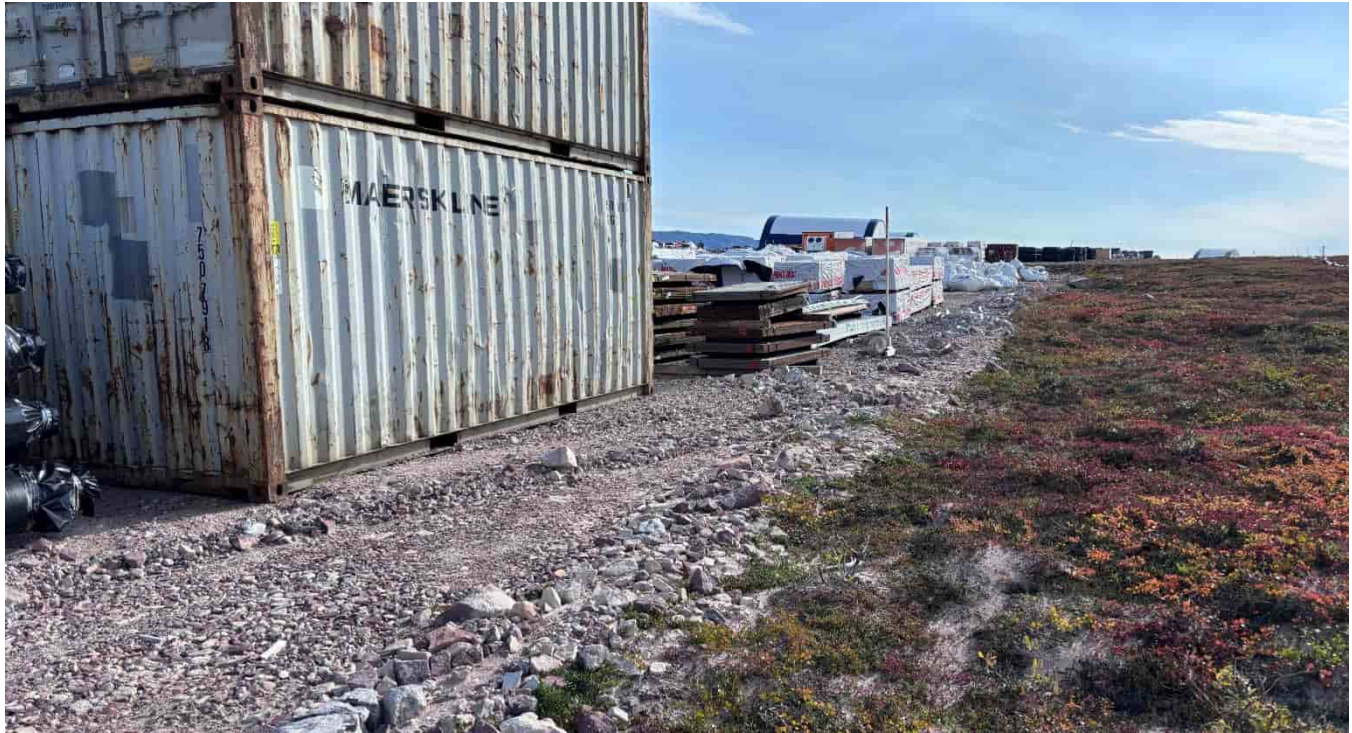
M-5: Laydown area beside airstrip – Note thickness of pad is too thin

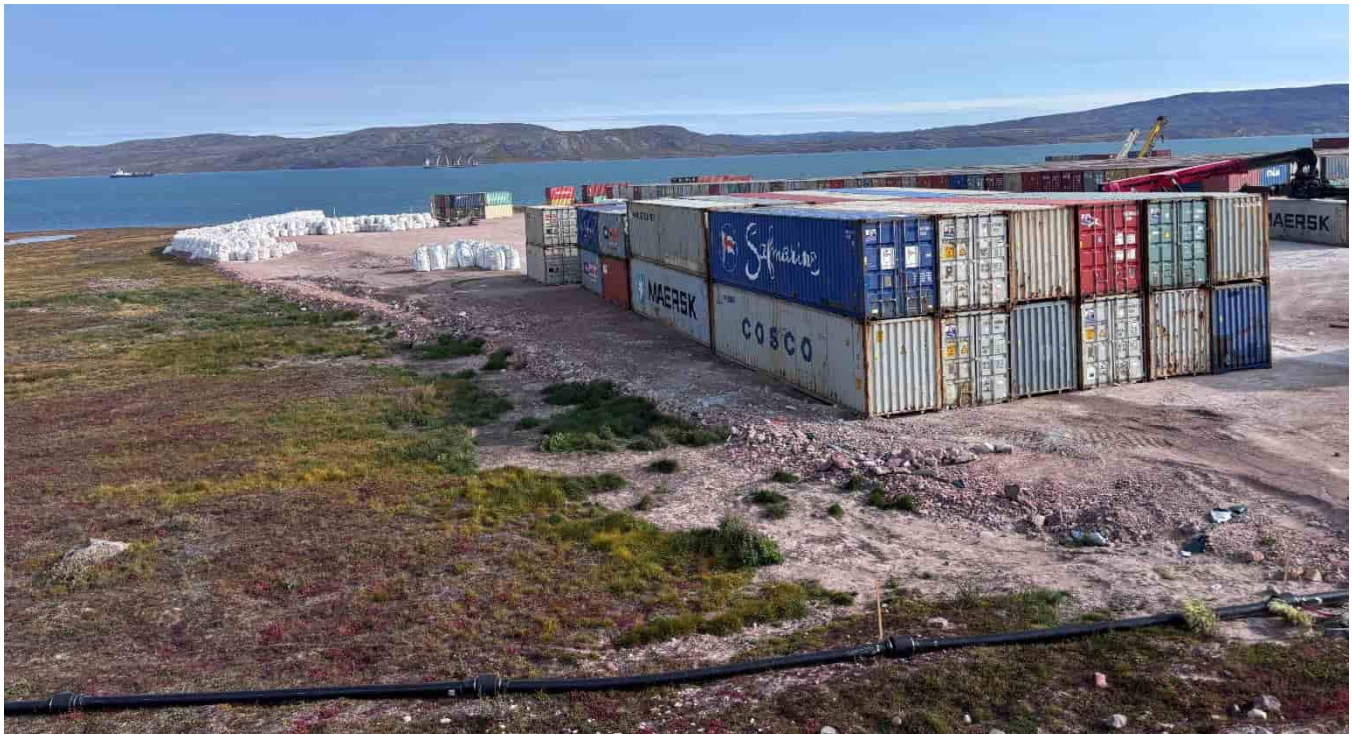
M-7: Northern side of pad, looking E from airstrip. Pipe on tundra

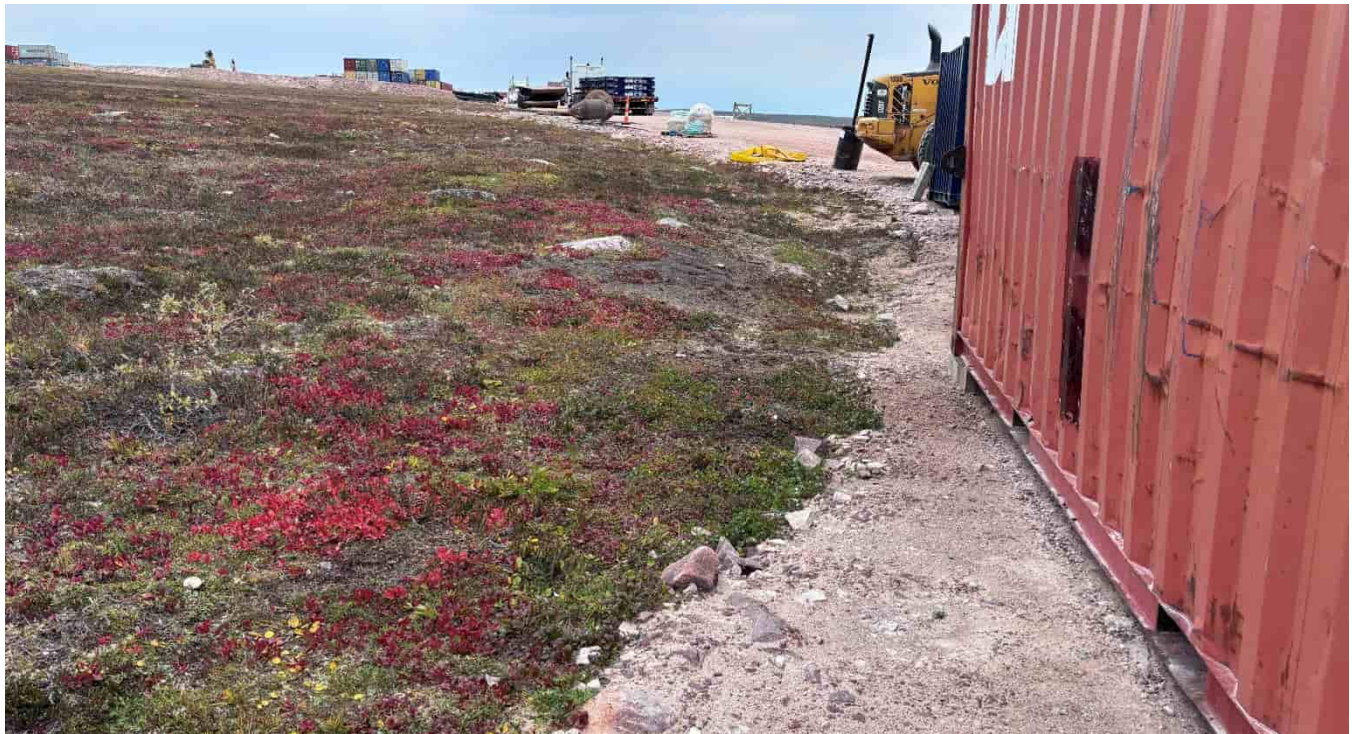
M-19: Shoreline pad – seacan near edge of thin pad

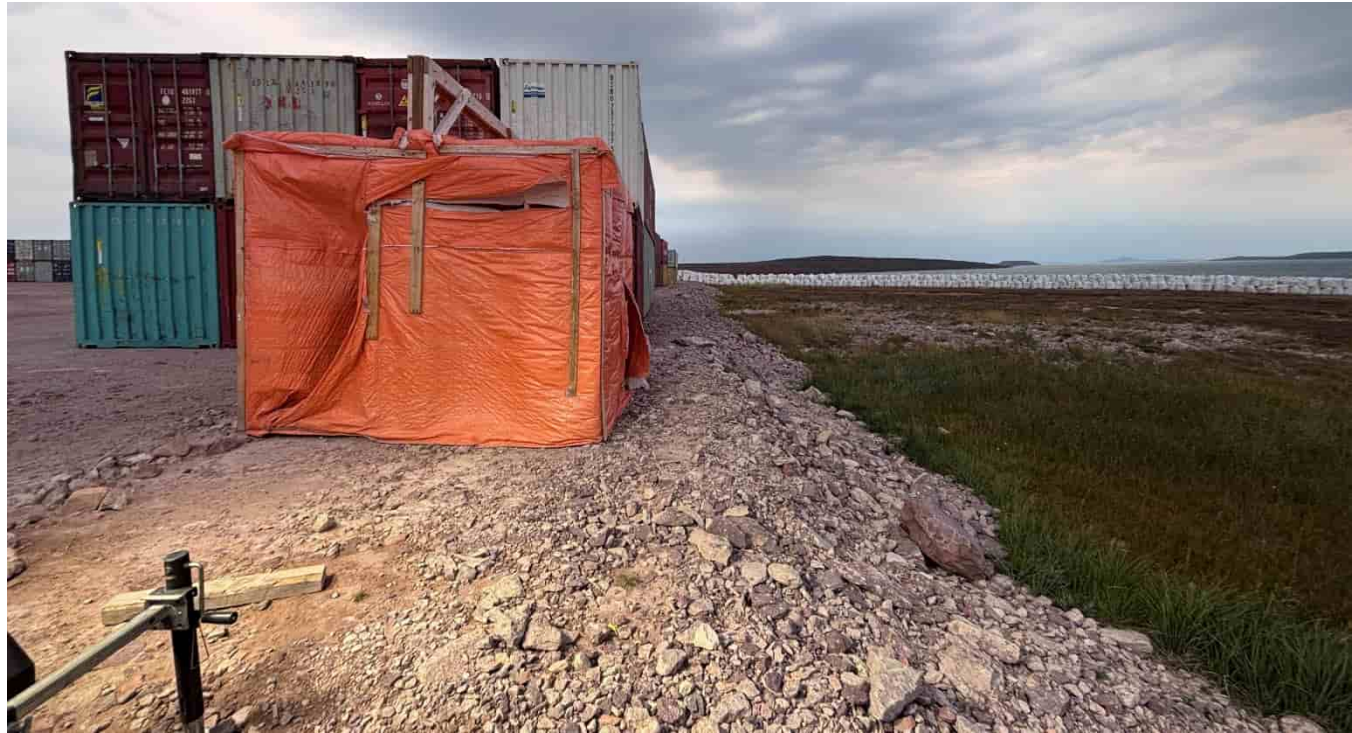
M-26: Stacked seacans beside pad slope

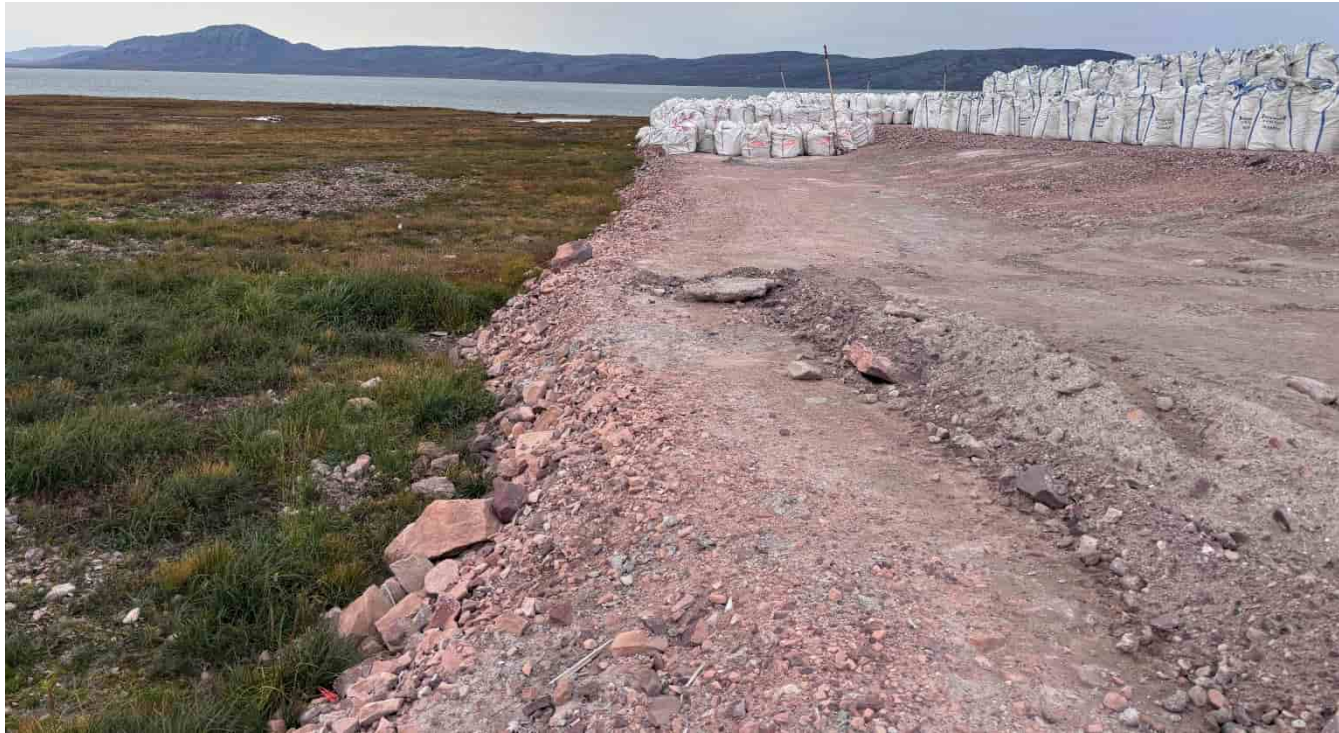
M-32: Damage to pad on northern side

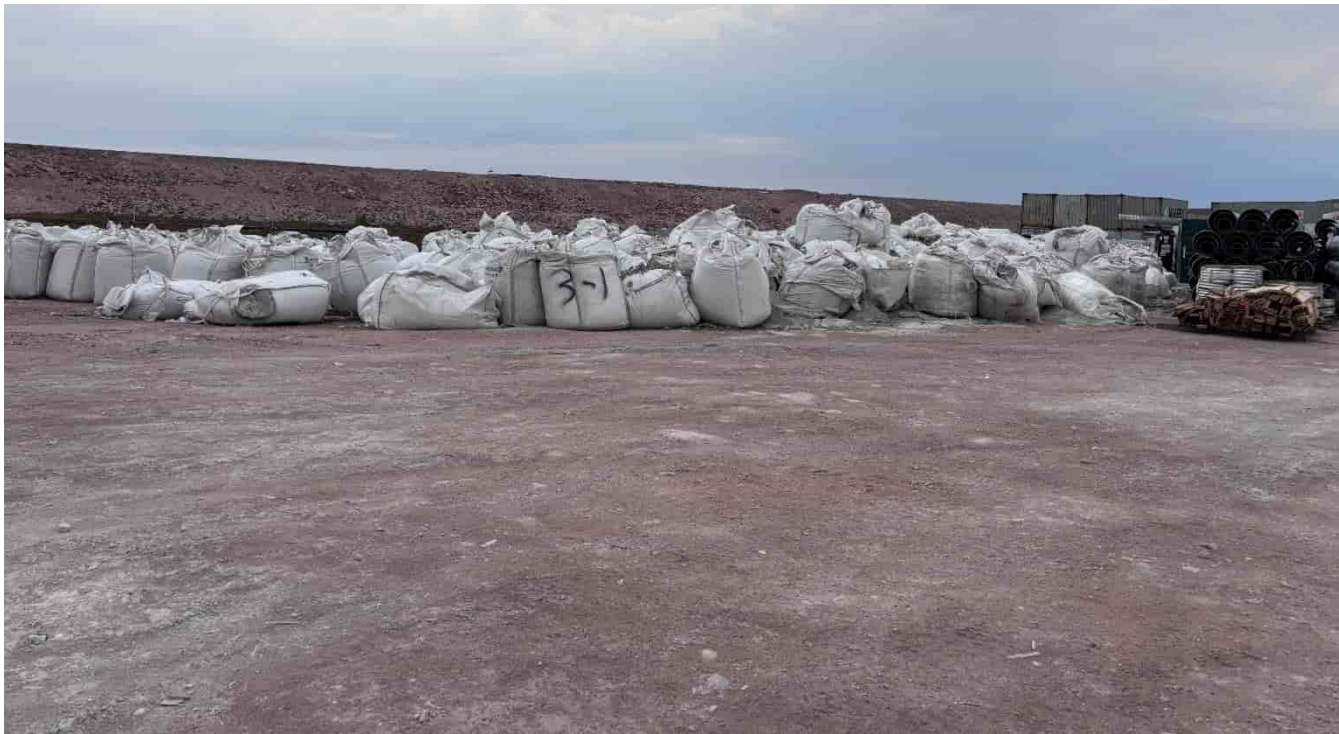
M-34: Broken bags on W side of pad

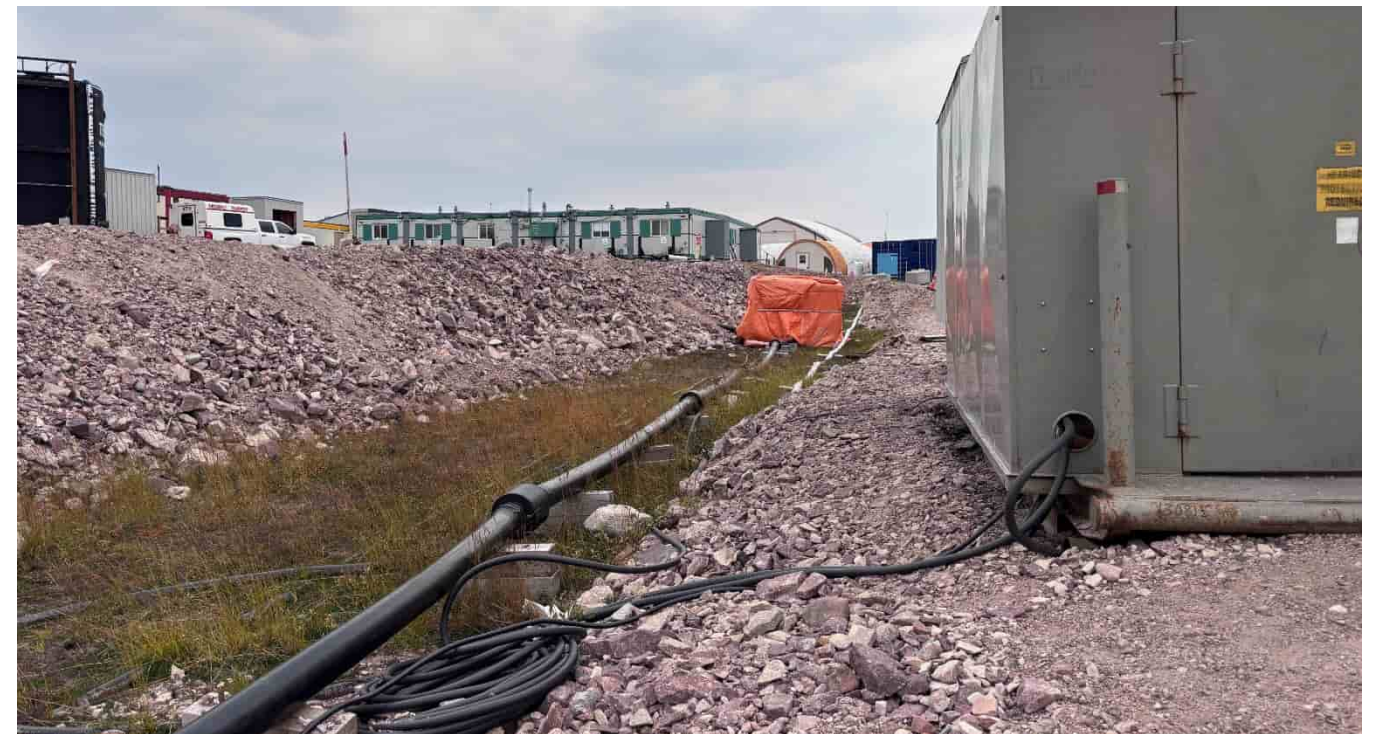
M-39: Pipe between camp pad and freight storage pad, looking SW

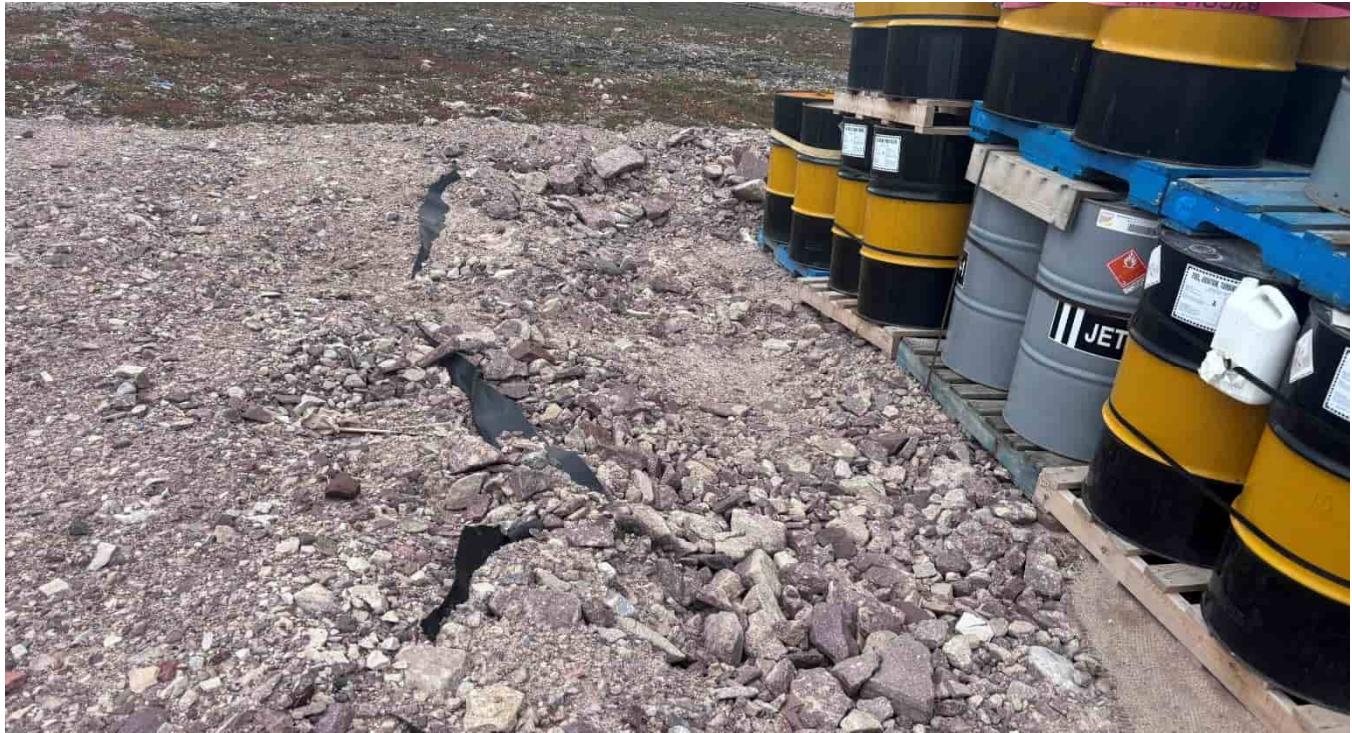
M-42: Temporary fuel storage – Note exposed liner

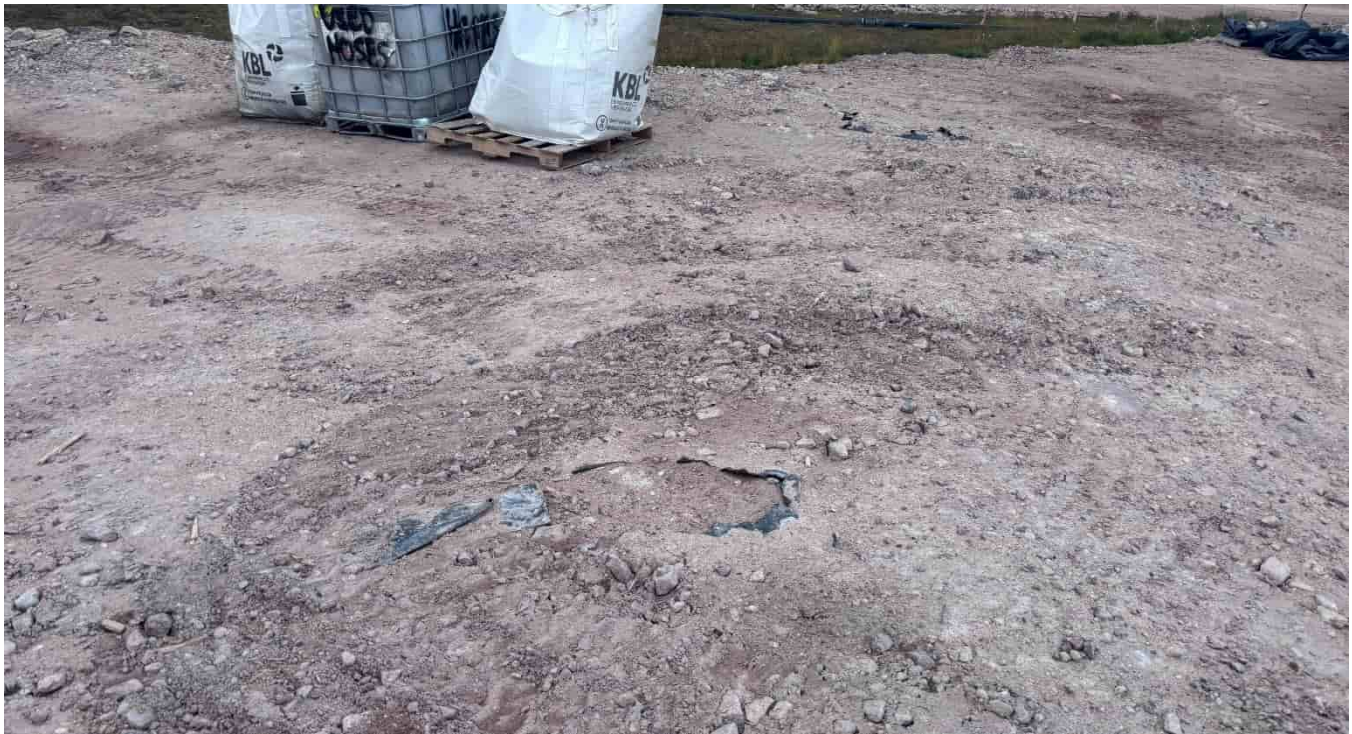
M-44: Temporary fuel storage - Damaged liner

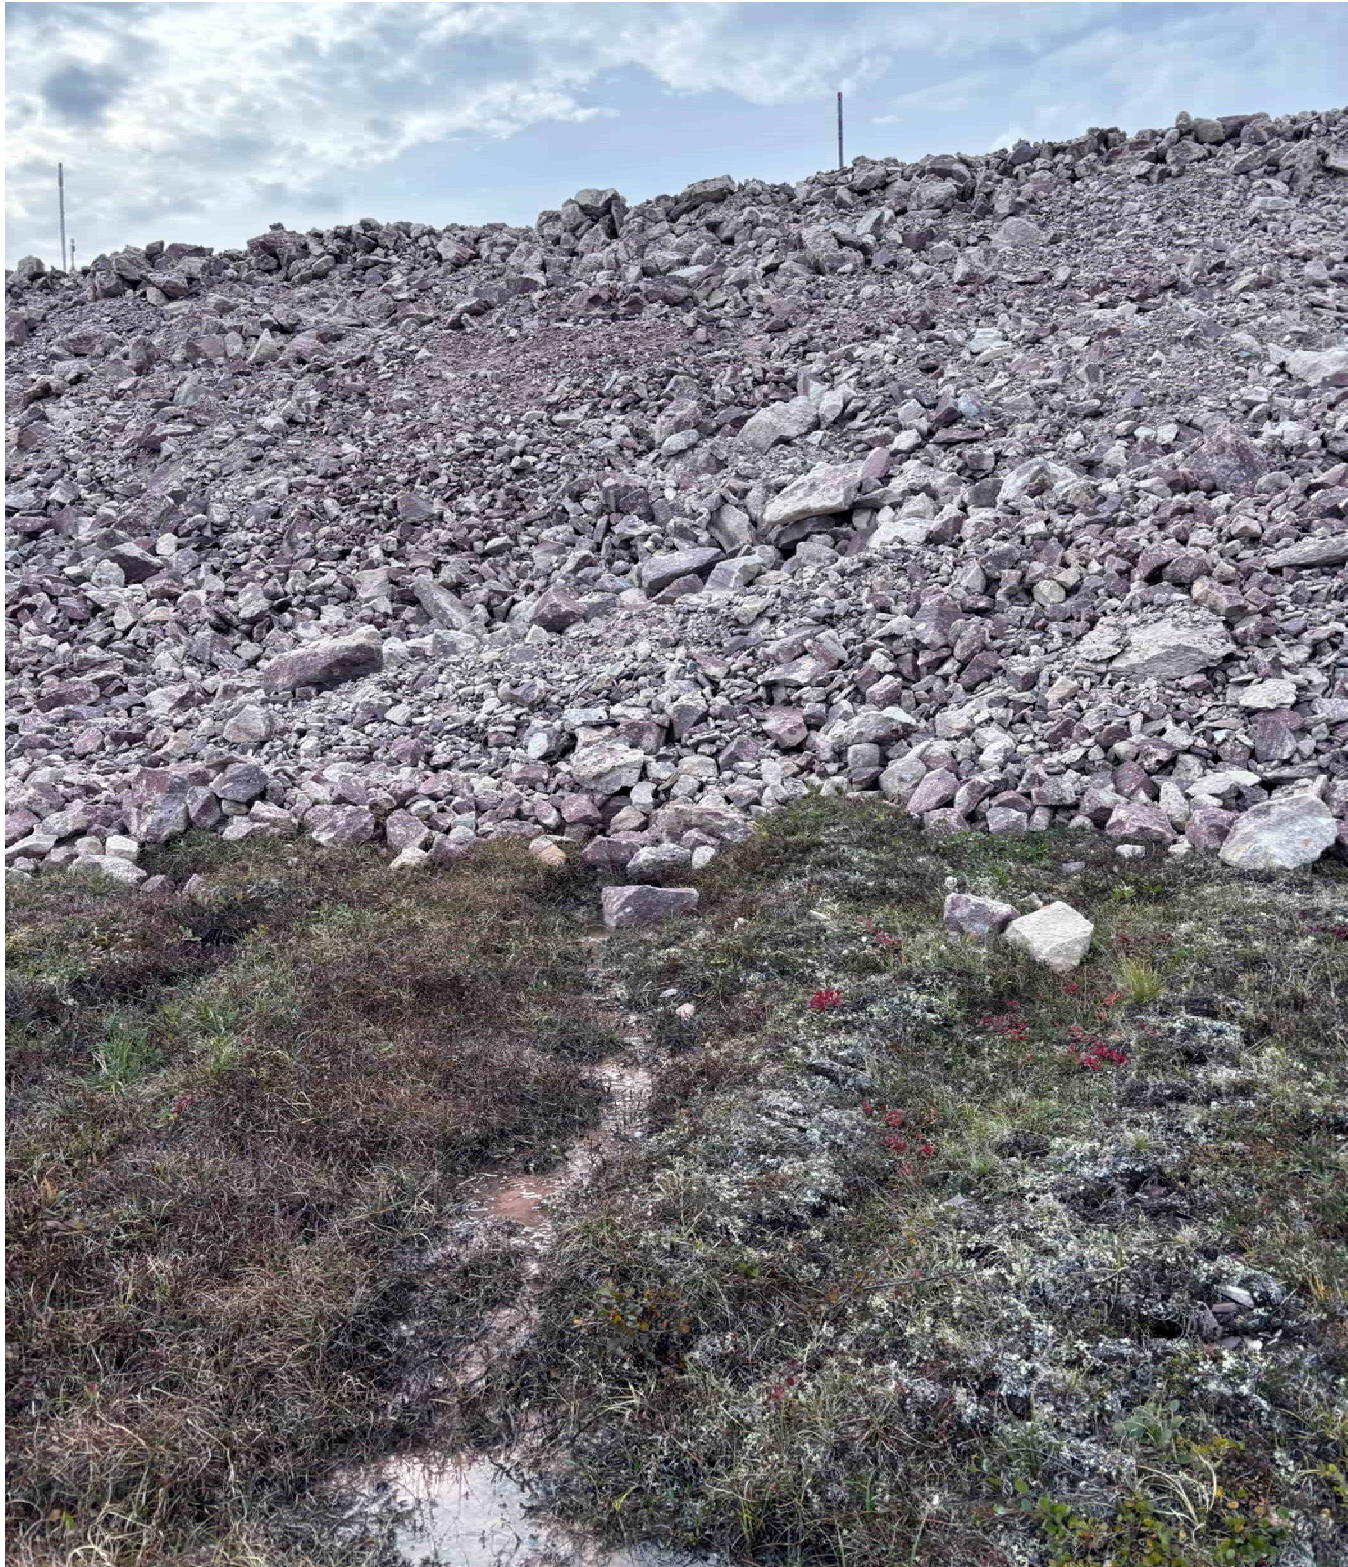
M-50: Water seepage from eastern pad slope

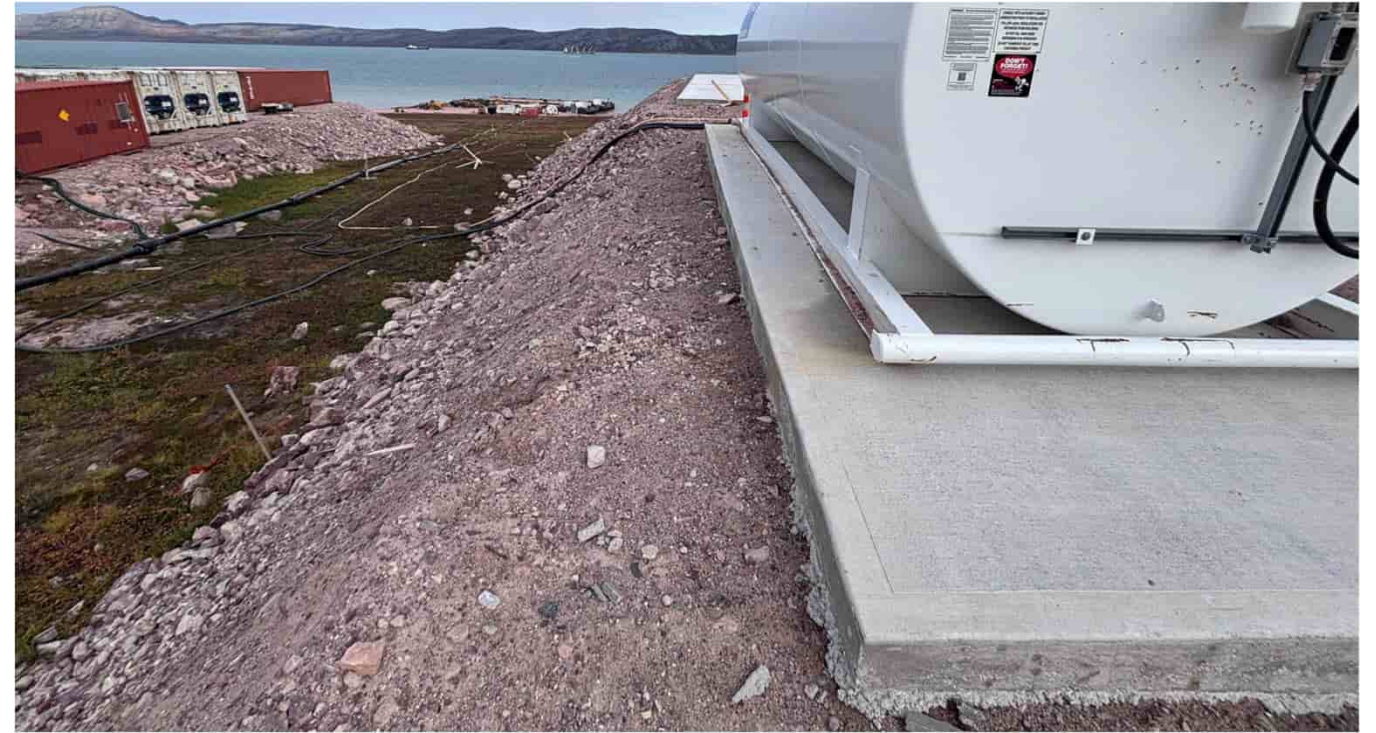
M-57: Concrete slab is located <1m from the crest of the pad, looking N

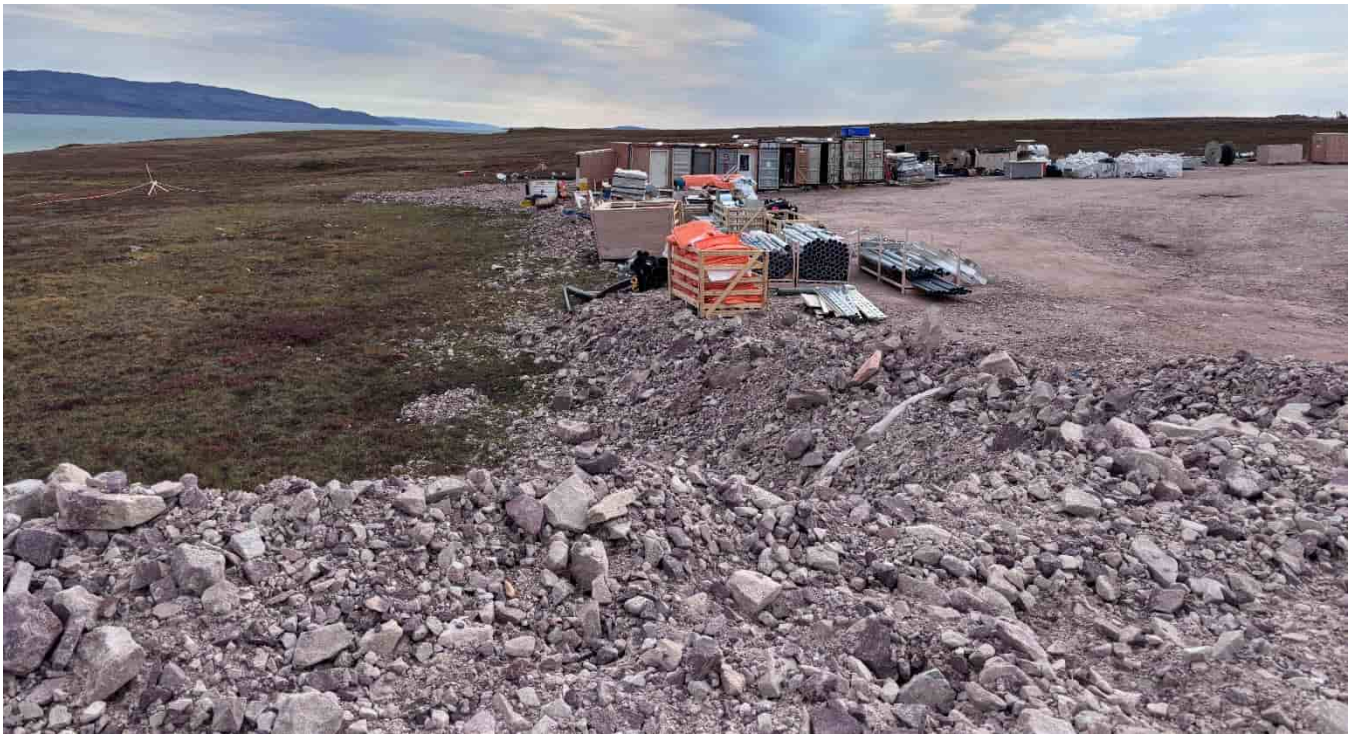
M-62: Undefined edge of slope beside laydown at SE corner of pad
