| | | 2025 Annual Geotechnical Inspection | | |
| | | MLA Airstrip | | |
| Job No: CAPR004312<br>Filename: Back River_MLA_2025_AGI_Photos.pdf | Back River Project | Date:<br>February 2026 | Approved:<br>JBK | Figure:<br>36 |

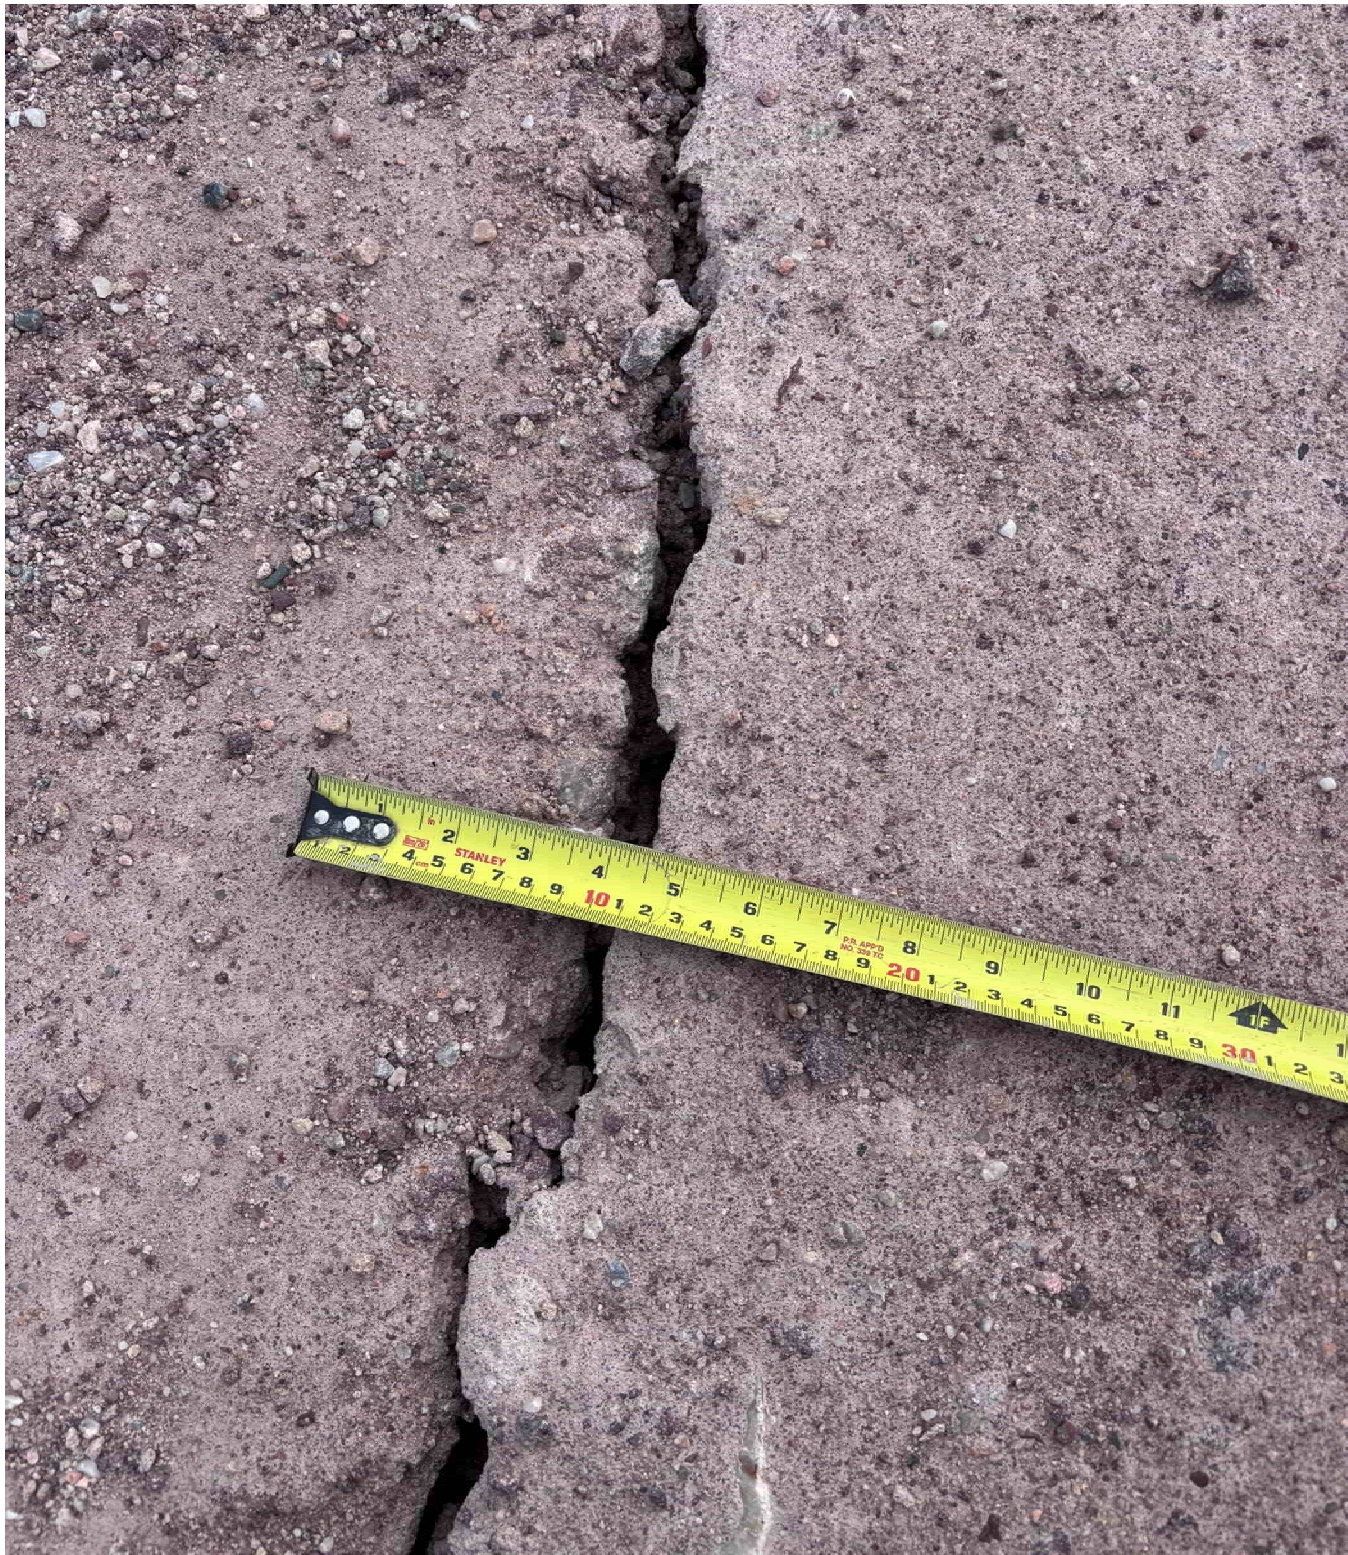
M-104: Tension crack in airstrip surface

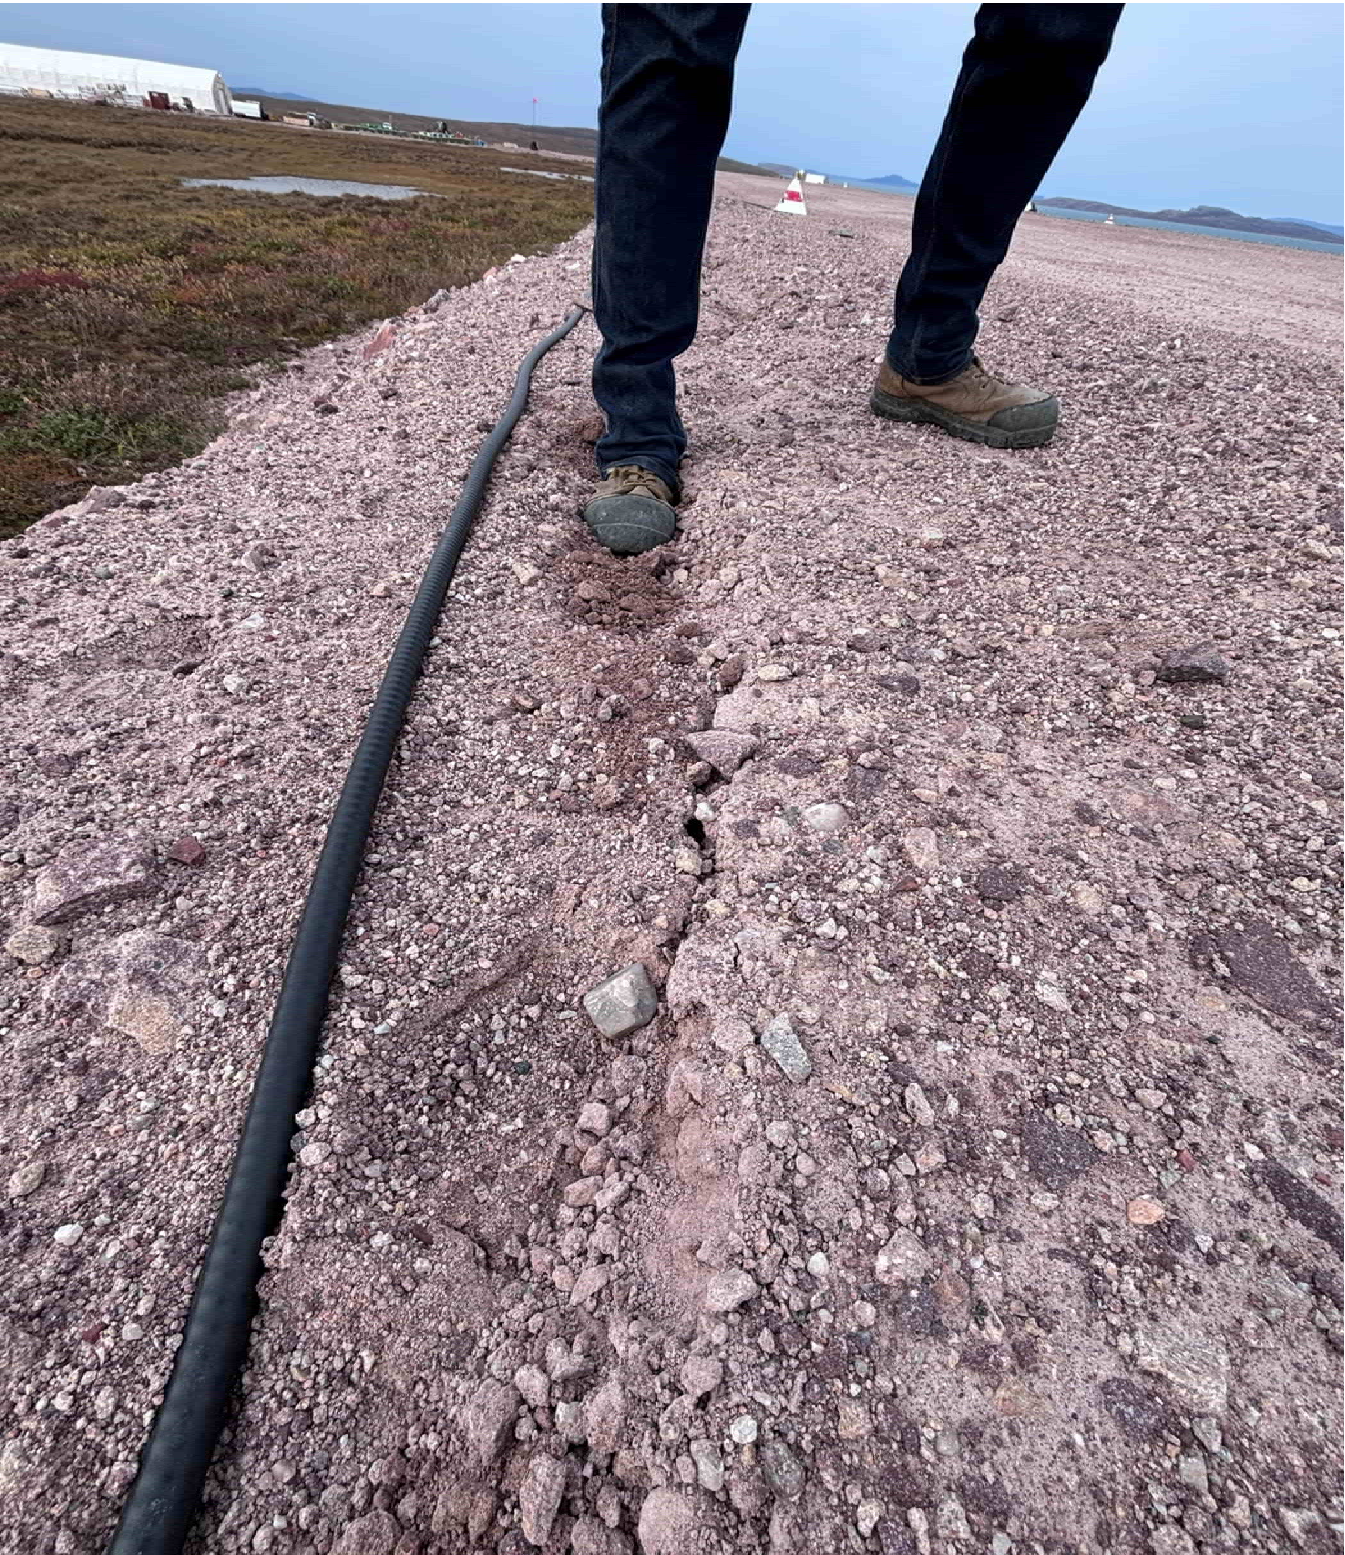
M-105: Settlement of western embankment at SE end of airstrip

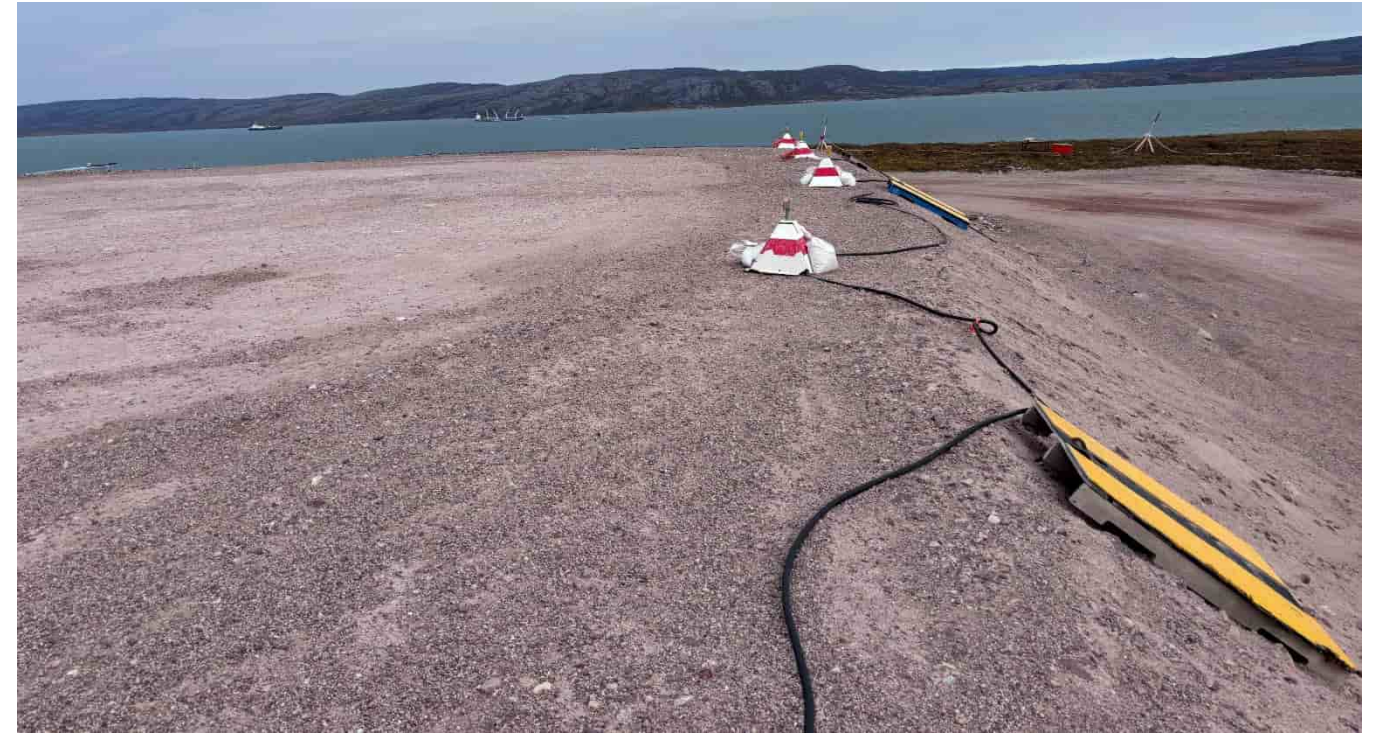
M-107: Slope at SE end of airstrip

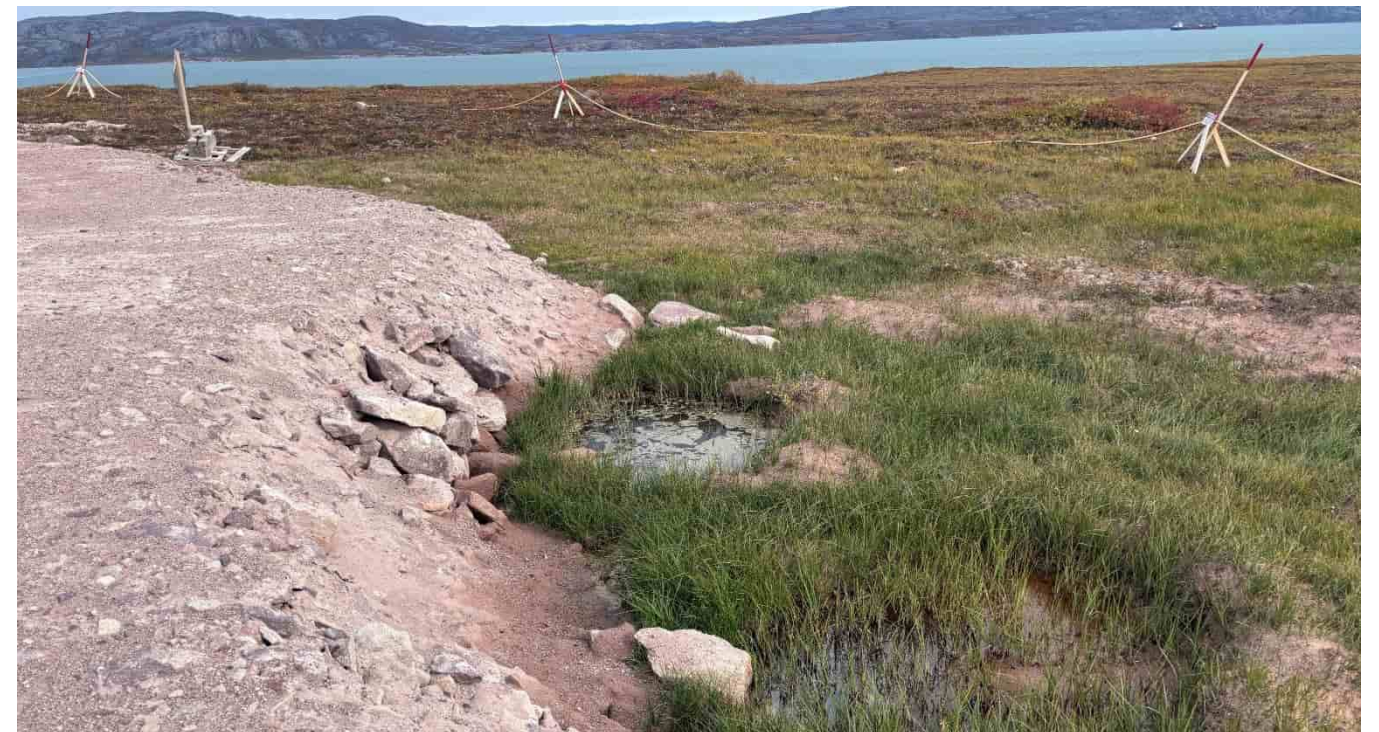
M-109: Ponding at SE end of airstrip

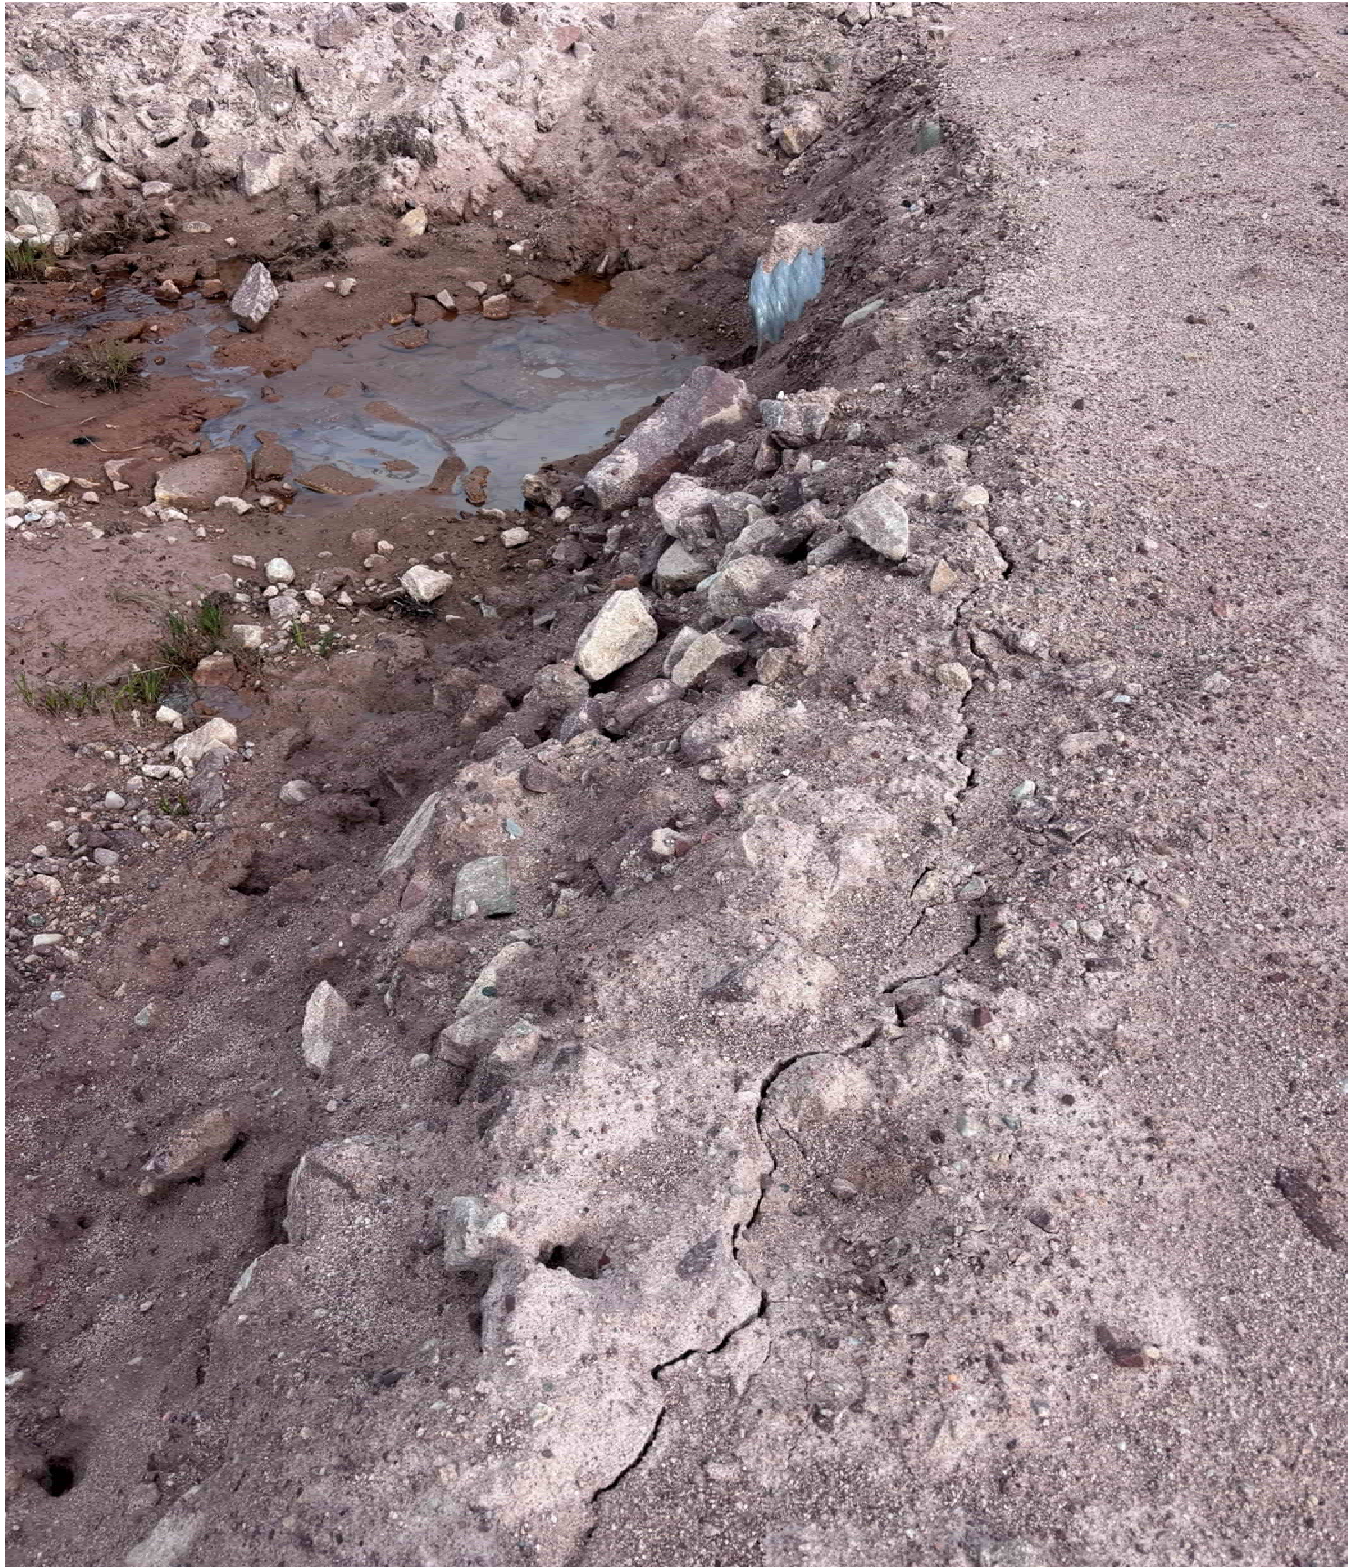
M-111: Tension crack in airstrip access road embankment, beside culvert inlet under road

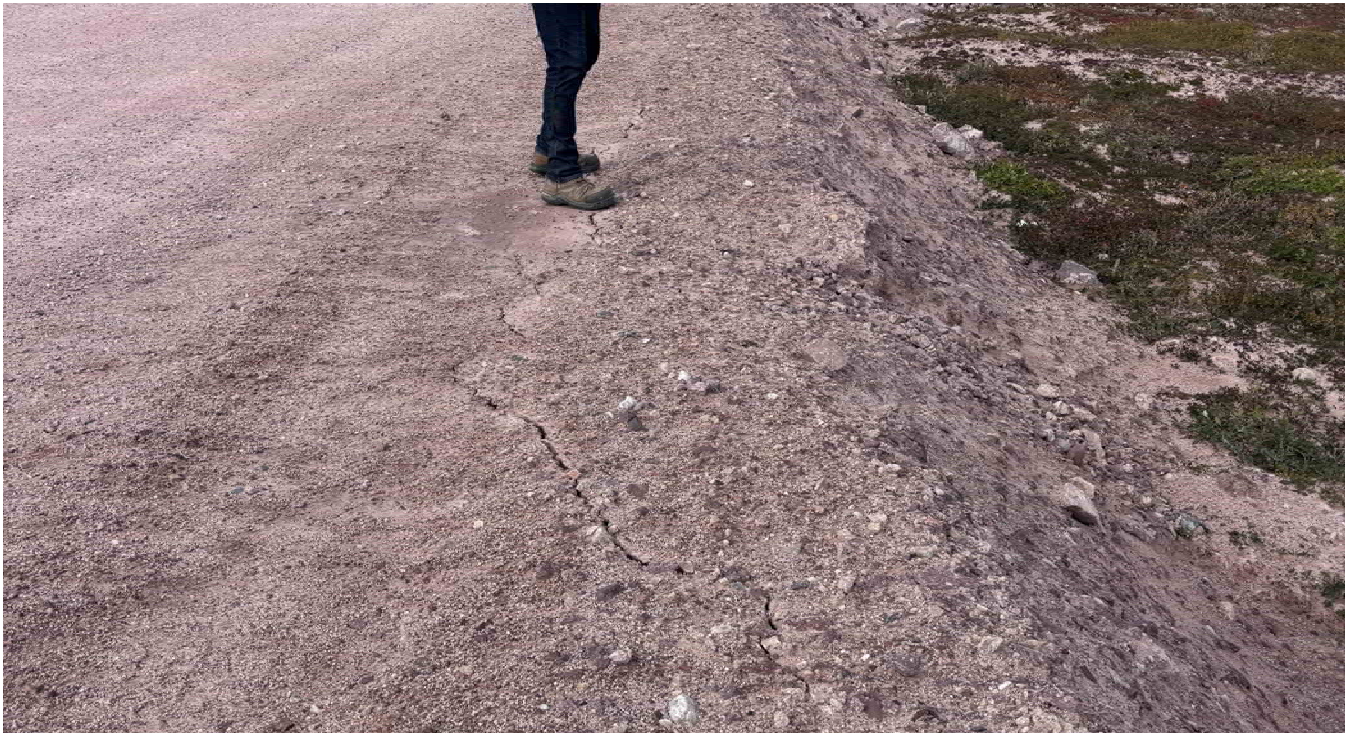
M-114: Tension crack in access road embankment, looking NW

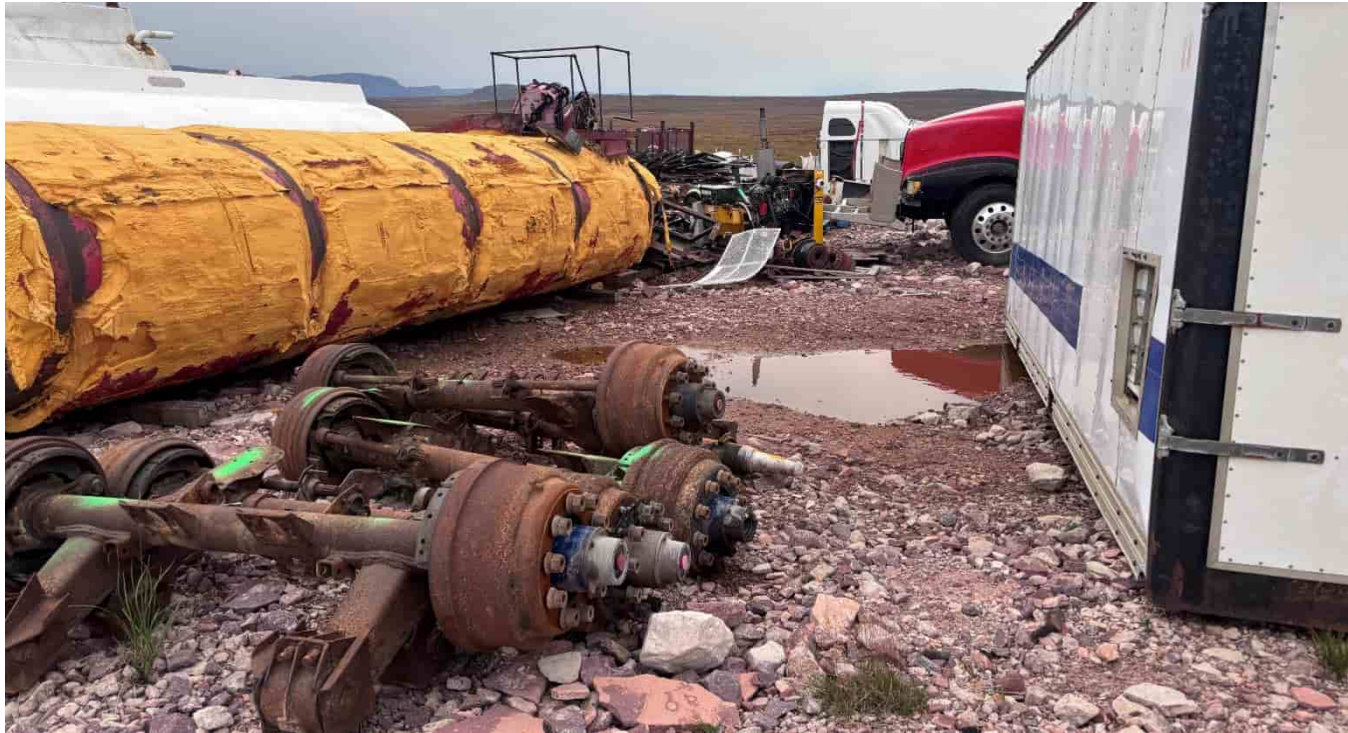
M-122: Ponding underneath seacan in laydown area

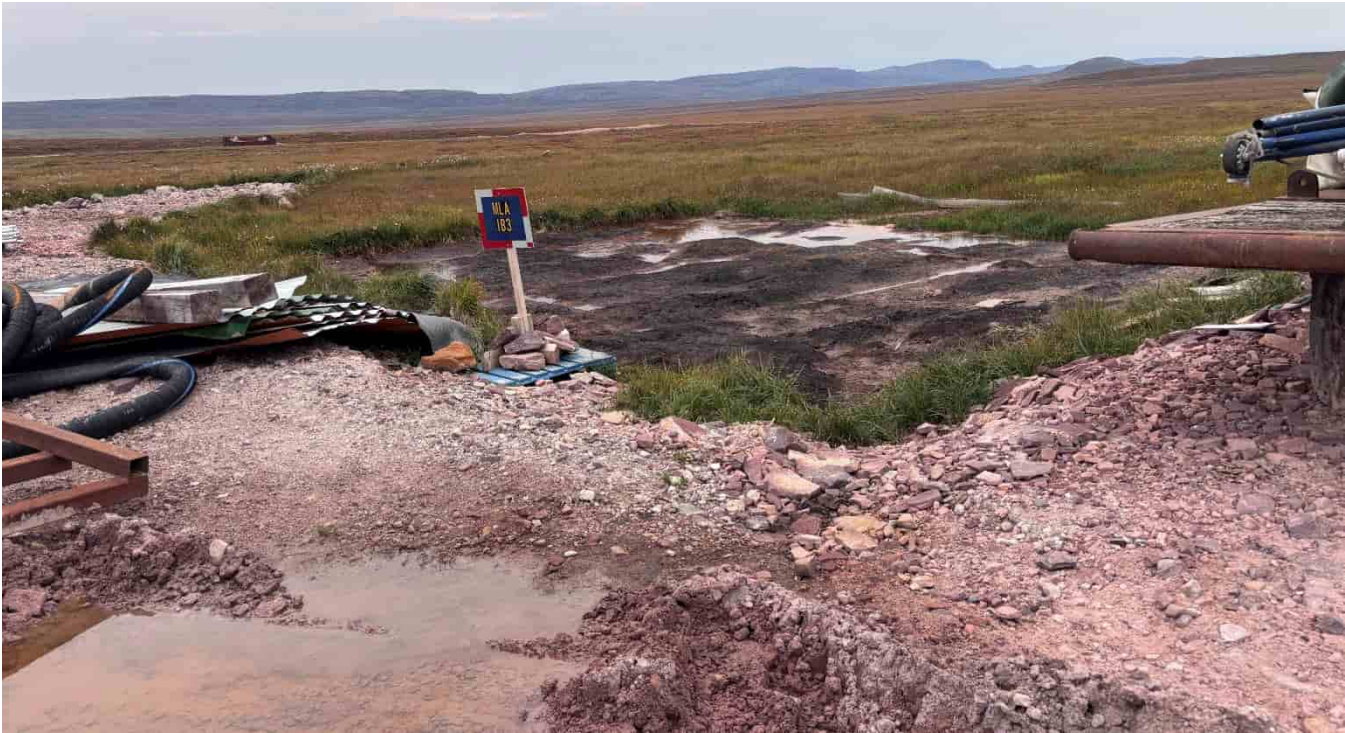
M-123: Ponding in laydown area

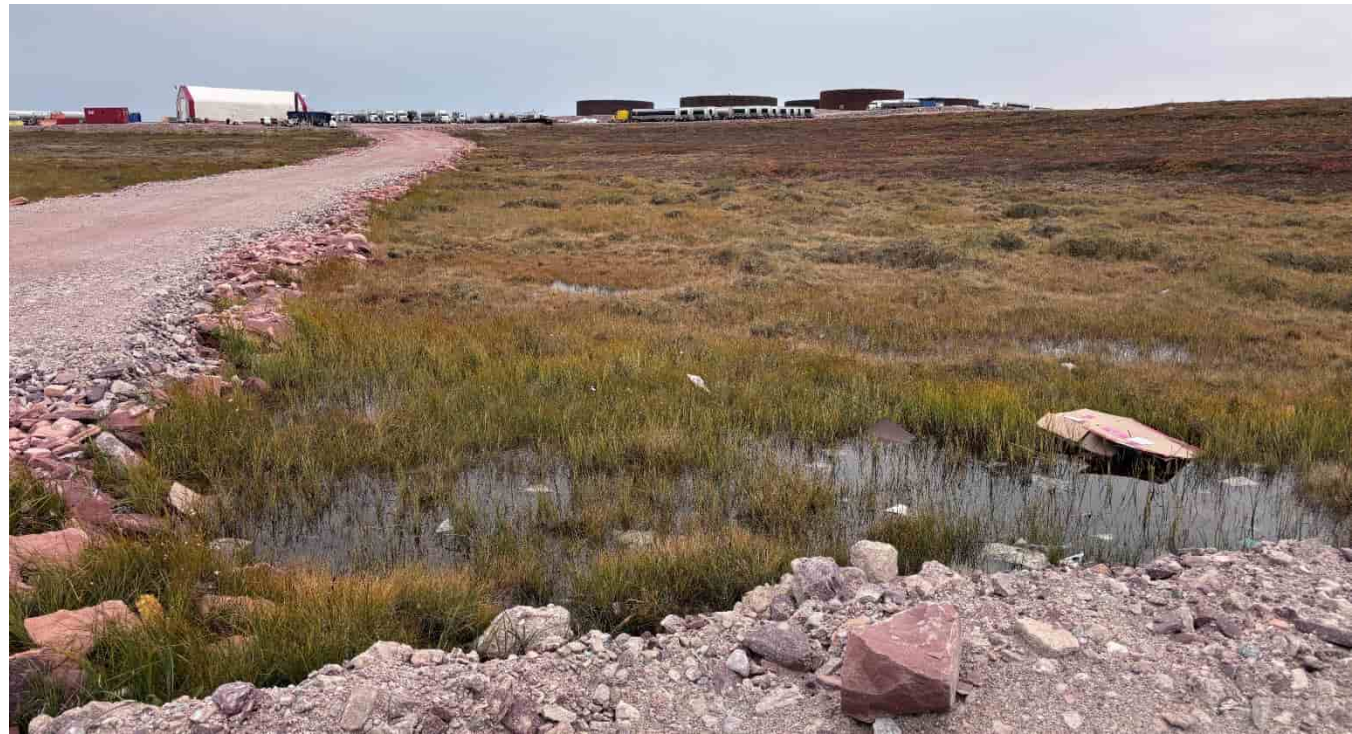
M-129: Ponding beside former explosives storage access road, looking SE

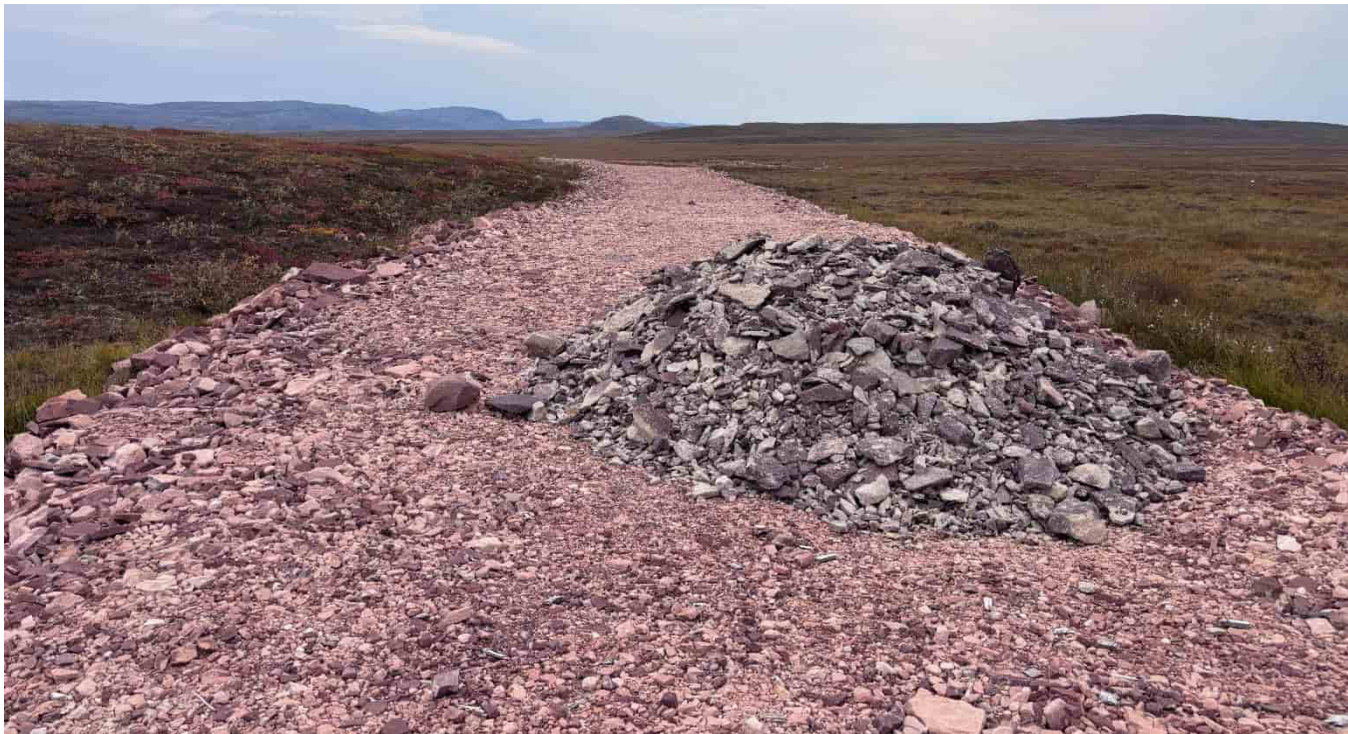
M-132: Rock pile on road

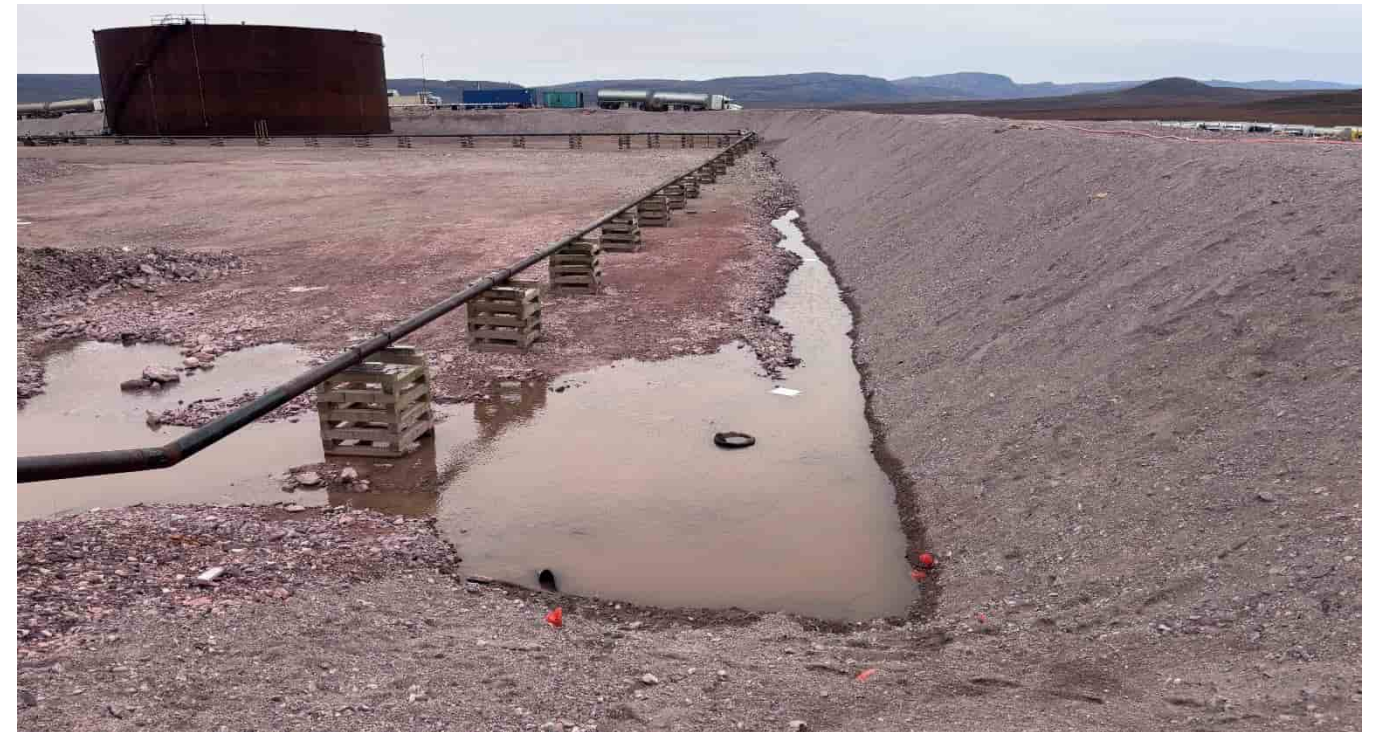
M-140: Ponding water along toe of berm at NE corner of tank farm

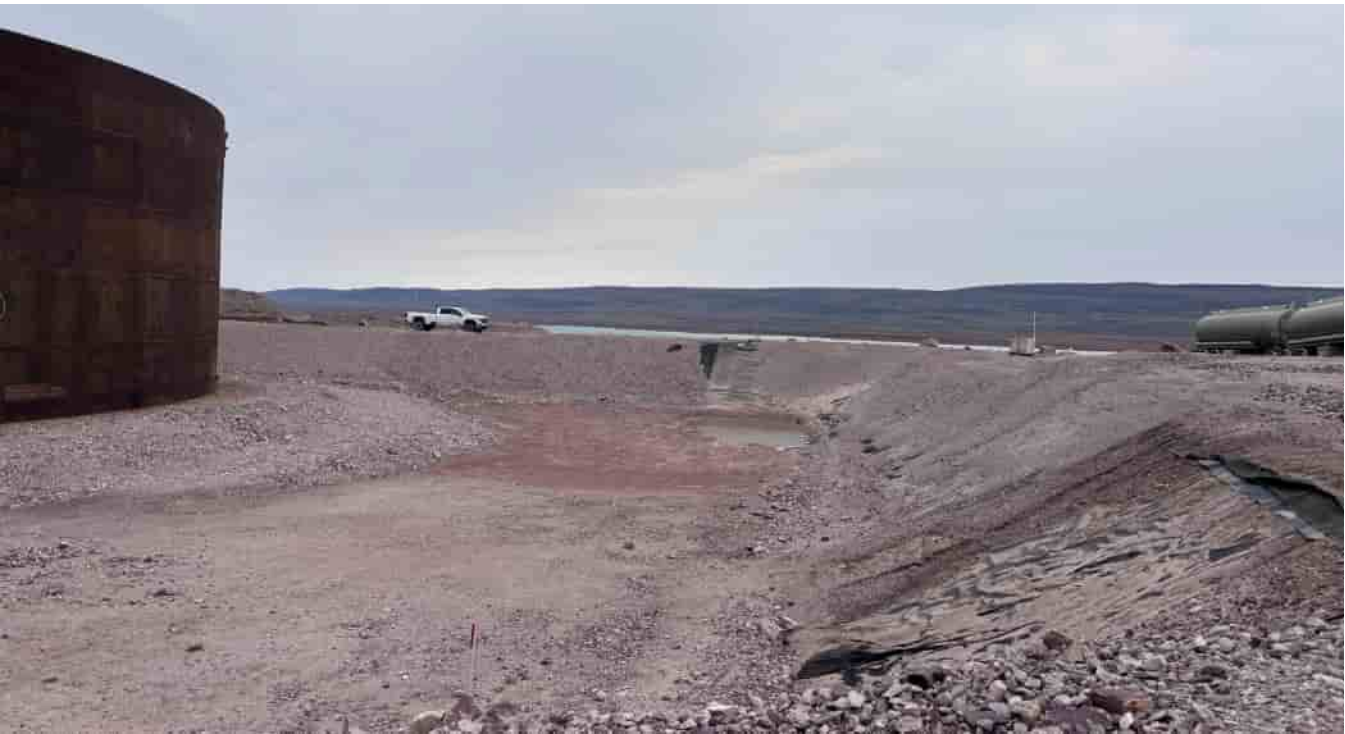
M-148: SW corner of the tank farm. Note areas with exposed liner

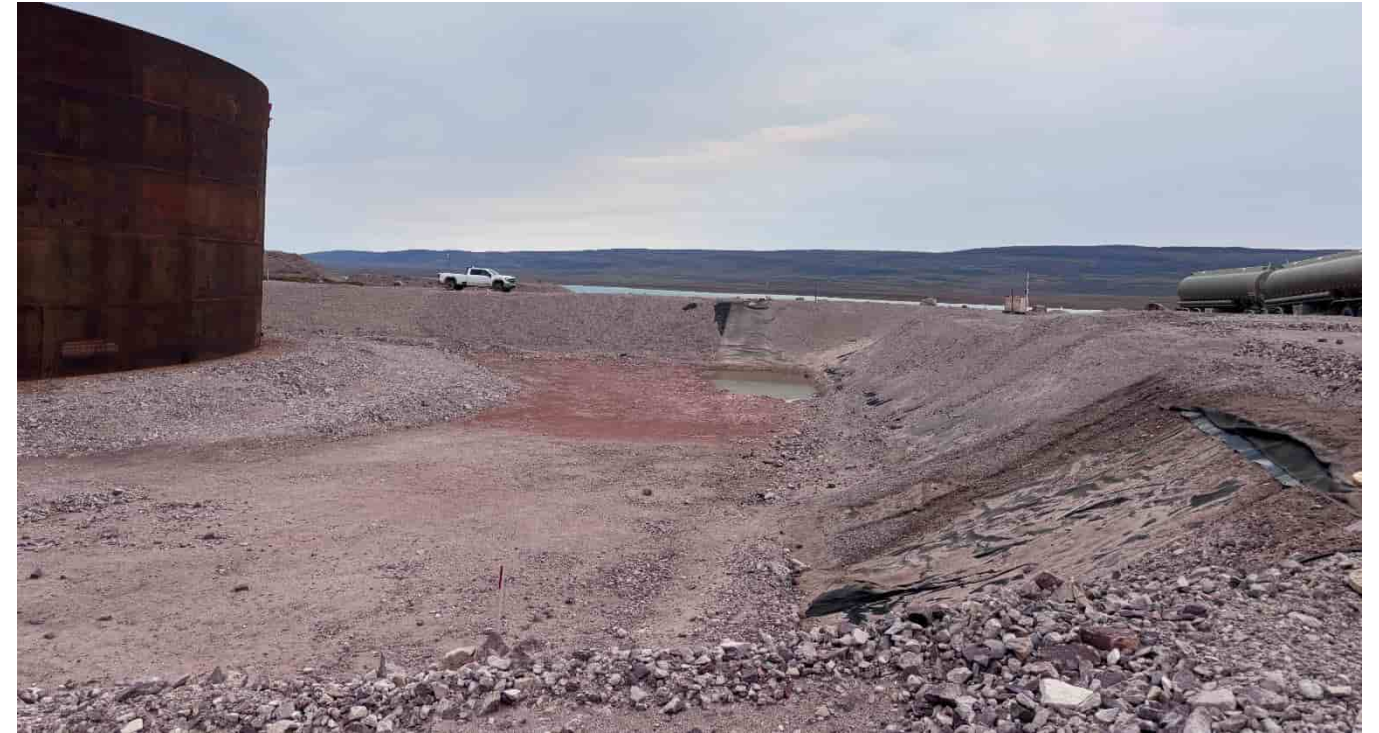
M-150: Western berm, looking S – Note exposed liner

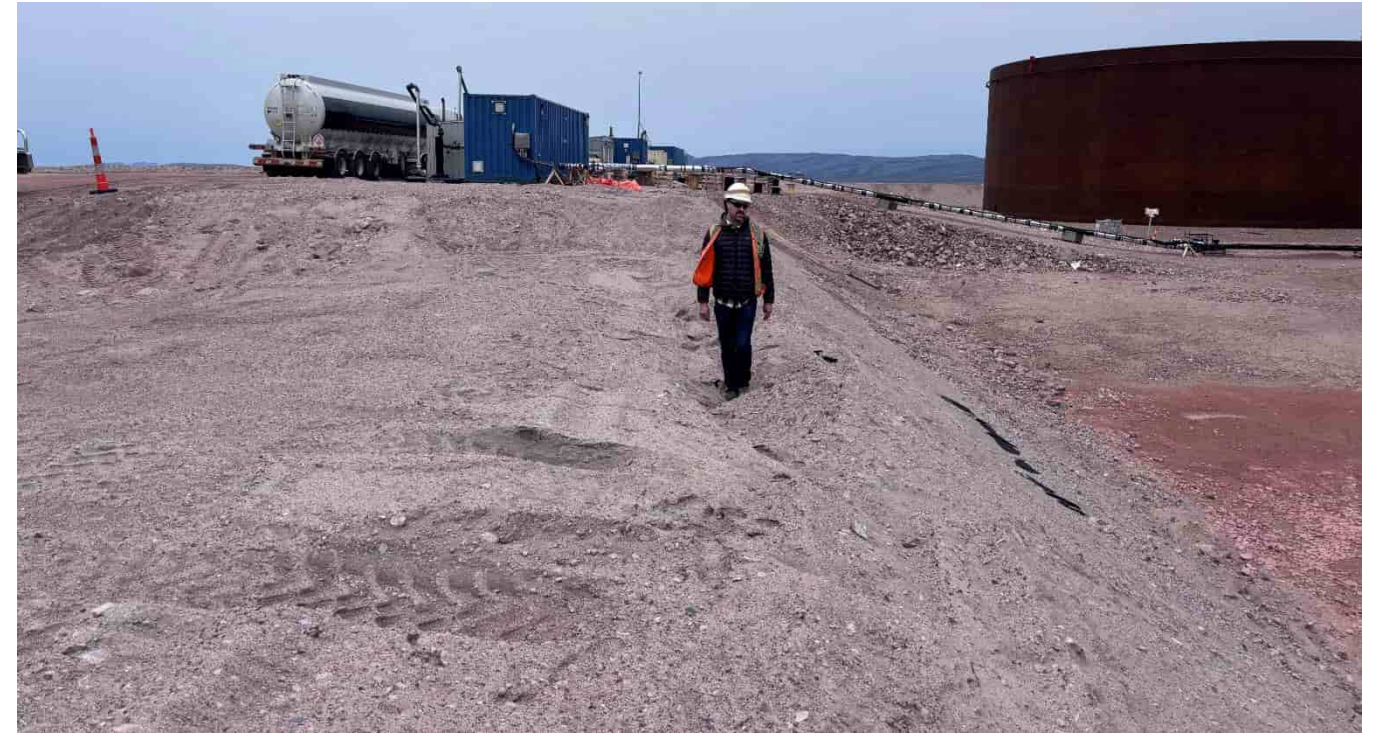
M-154: Sluffing of the fill material at SW corner of tank farm

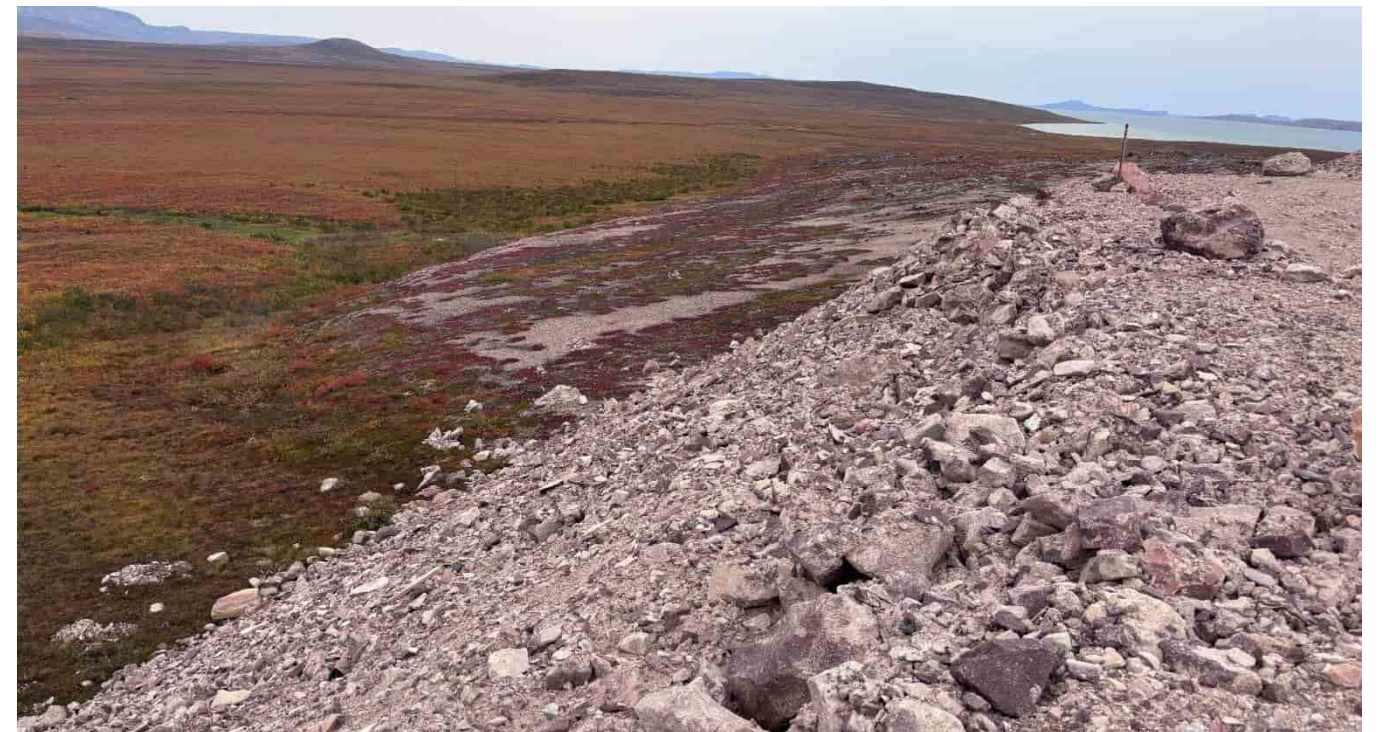
M-156: Tank farm pad slope at SW corner – Note oversteepened slope

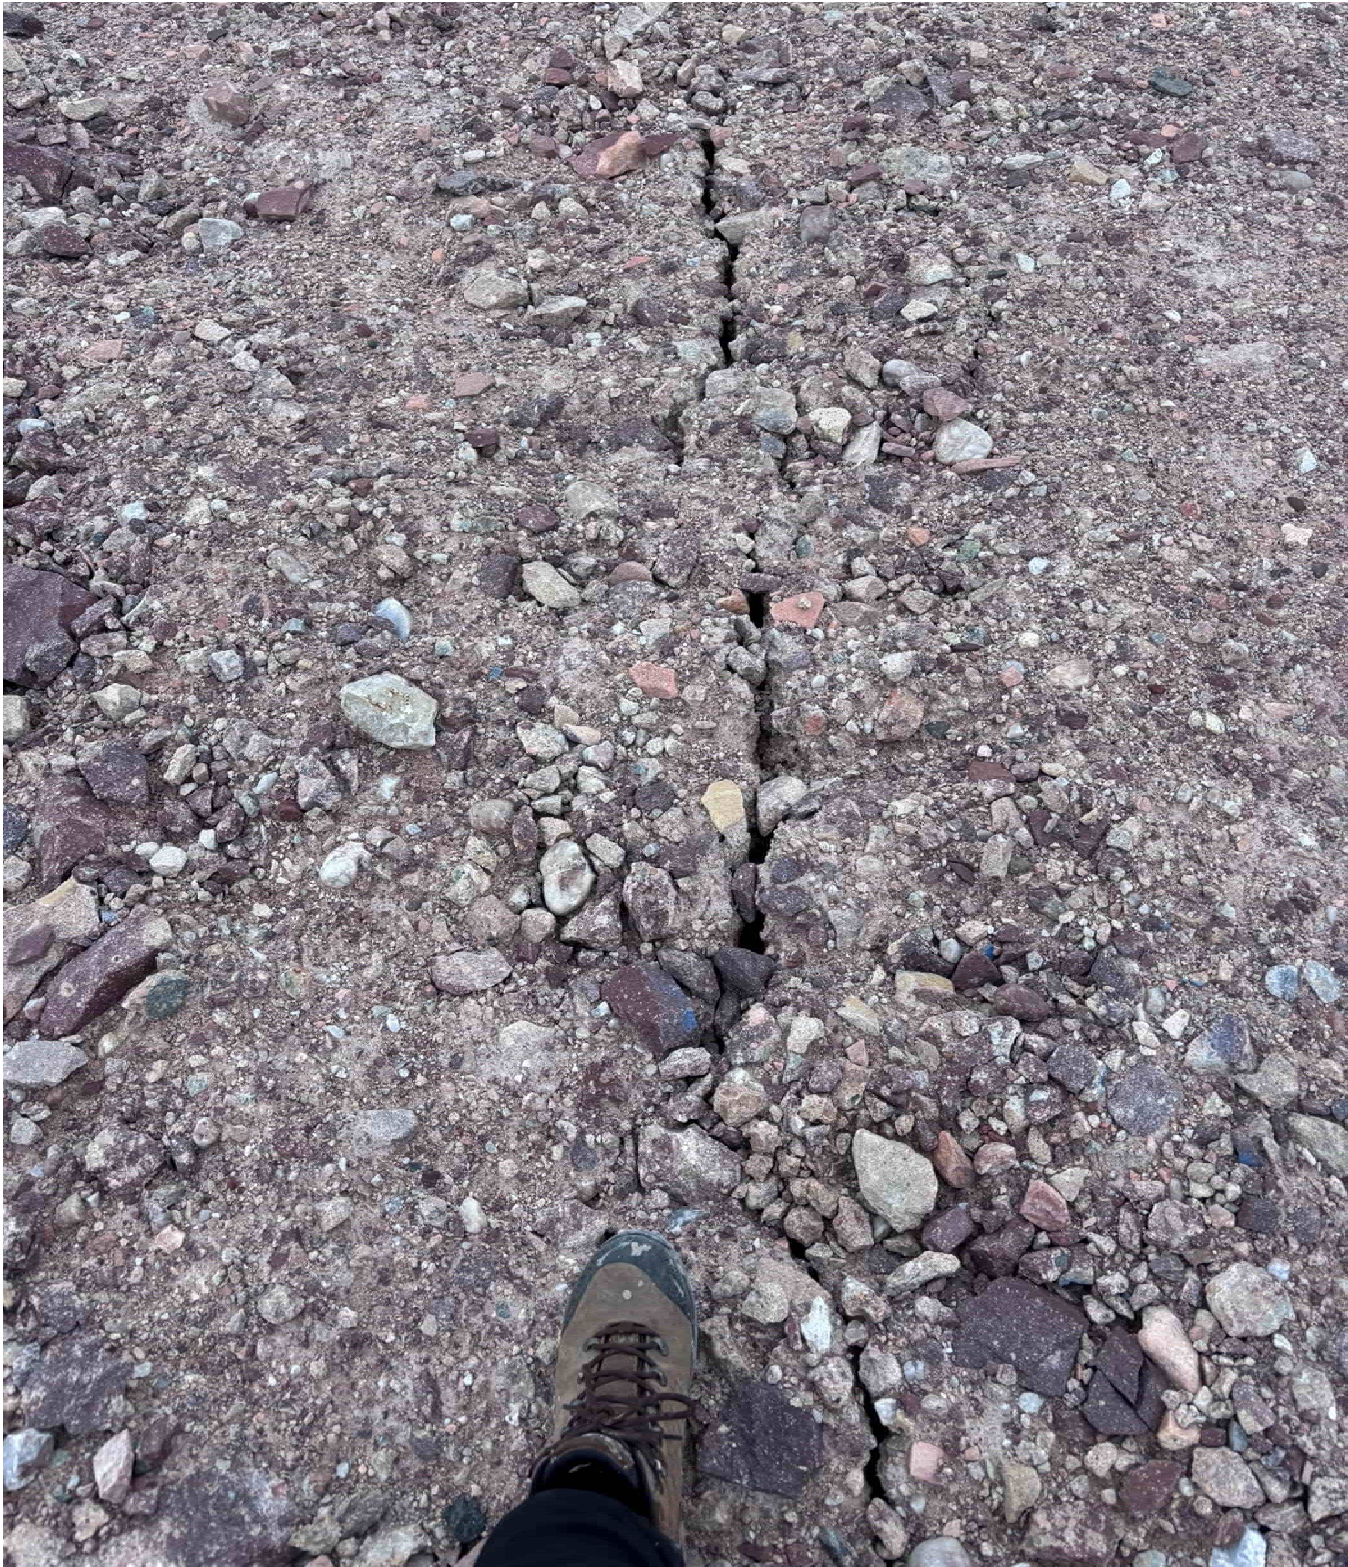
M-159: Fireball Pad - Typical tension crack above western pad slope

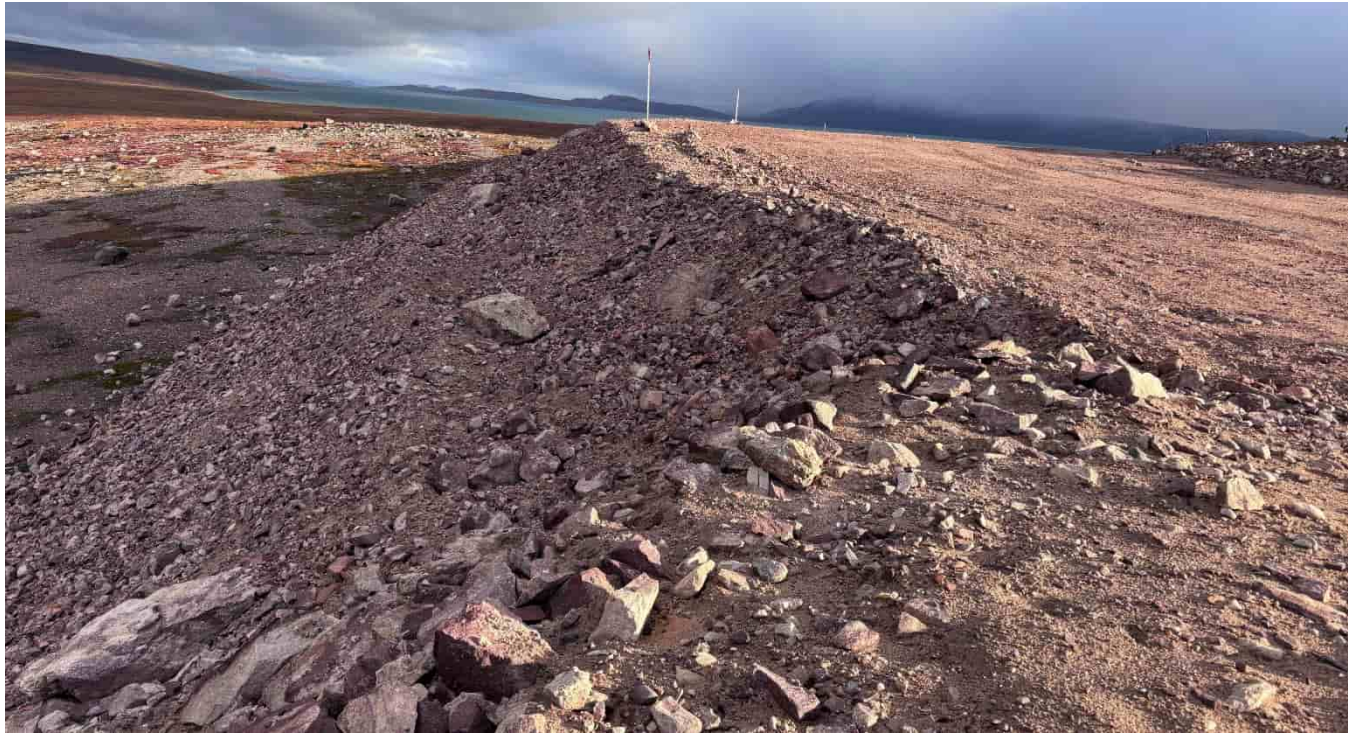
M-167: Oversteepened road embankment, looking N

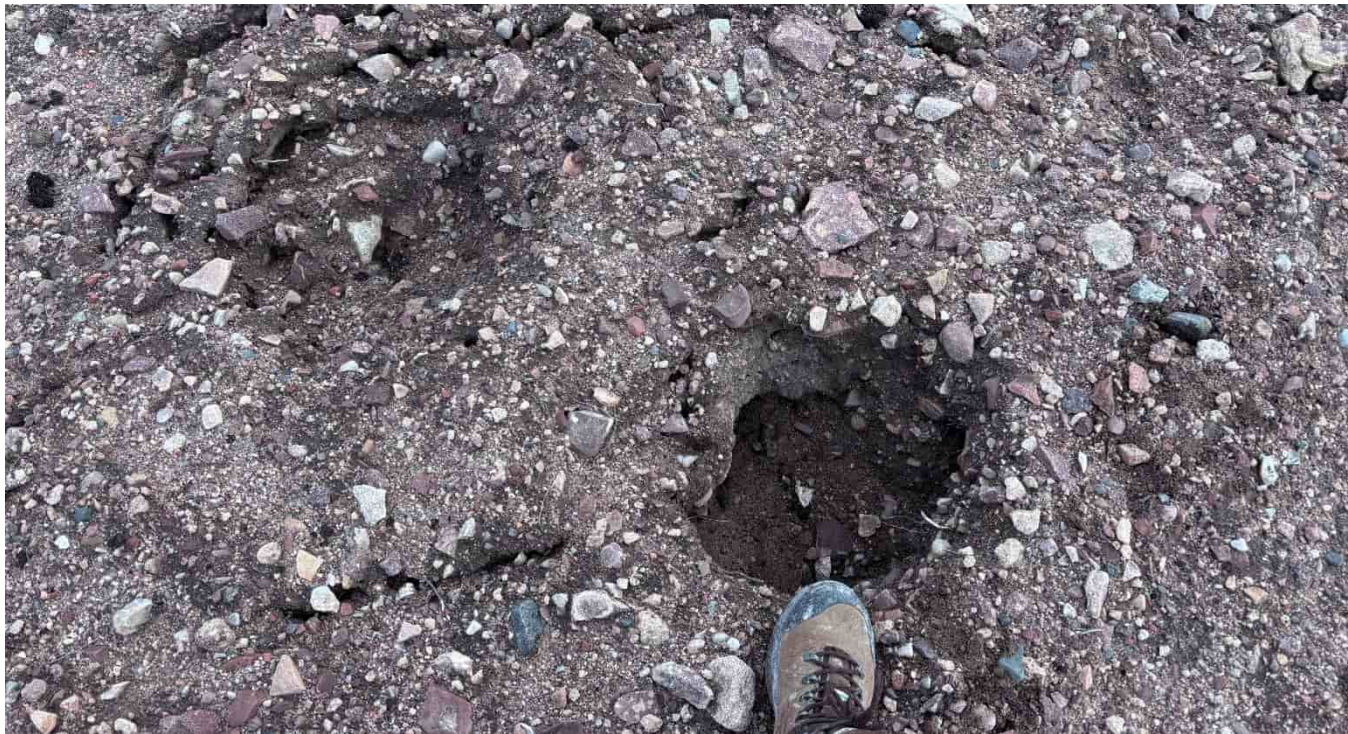
M-169: Sinkhole in southern berm
