| | | 2025 Annual Geotechnical Inspection | | |
| | | MLA Airstrip | | |
| Job No: CAPR004312<br>Filename: Back River_MLA_2025_AGI_Photos.pdf | Back River Project | Date:<br>February 2026 | Approved:<br>JBK | Figure:<br>36 |

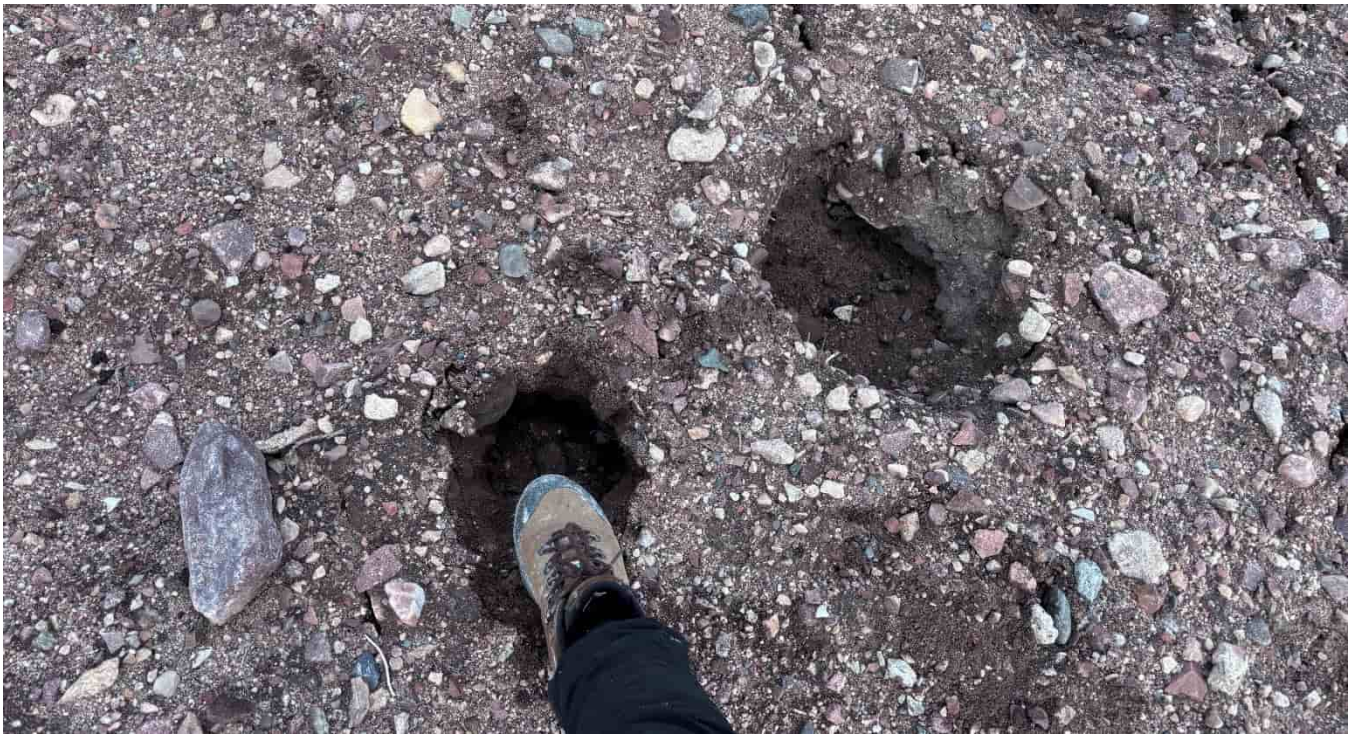
M-170: Sinkholes in southern berm

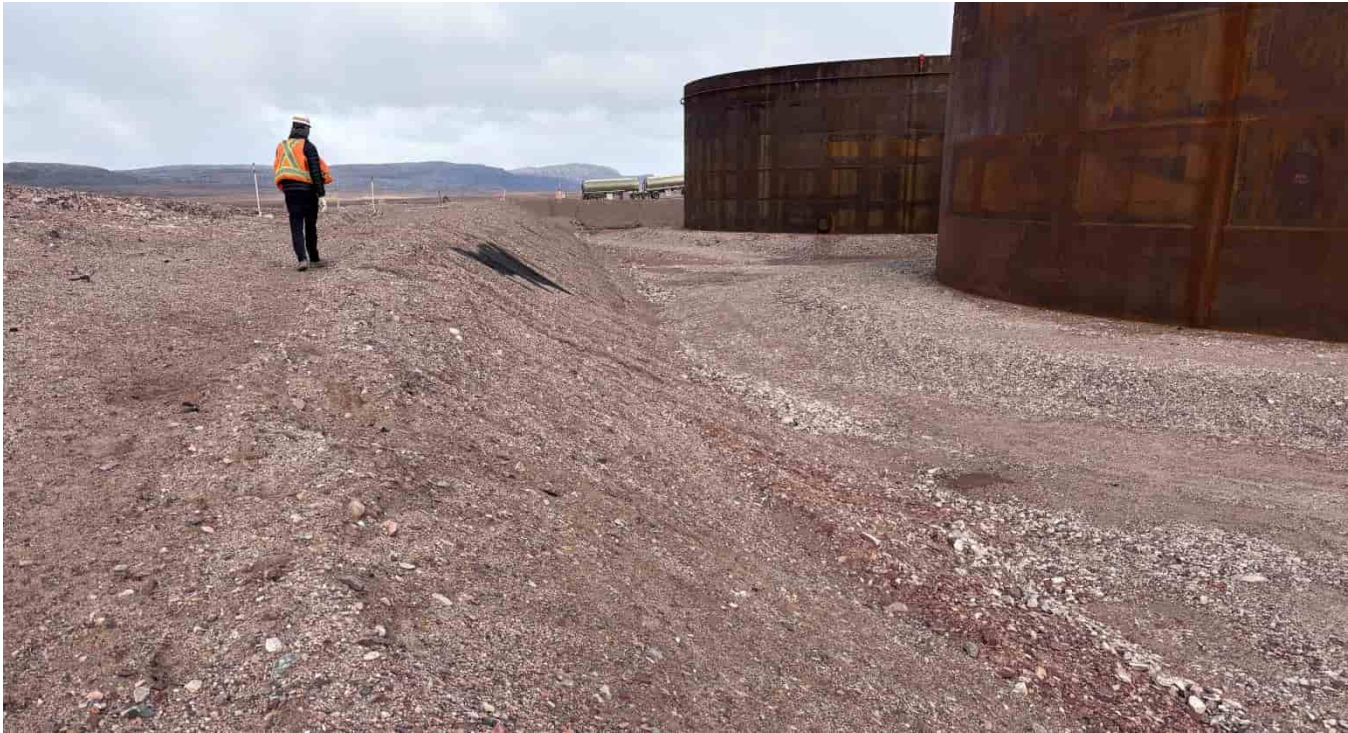
M-172: Exposed liner on southern berm

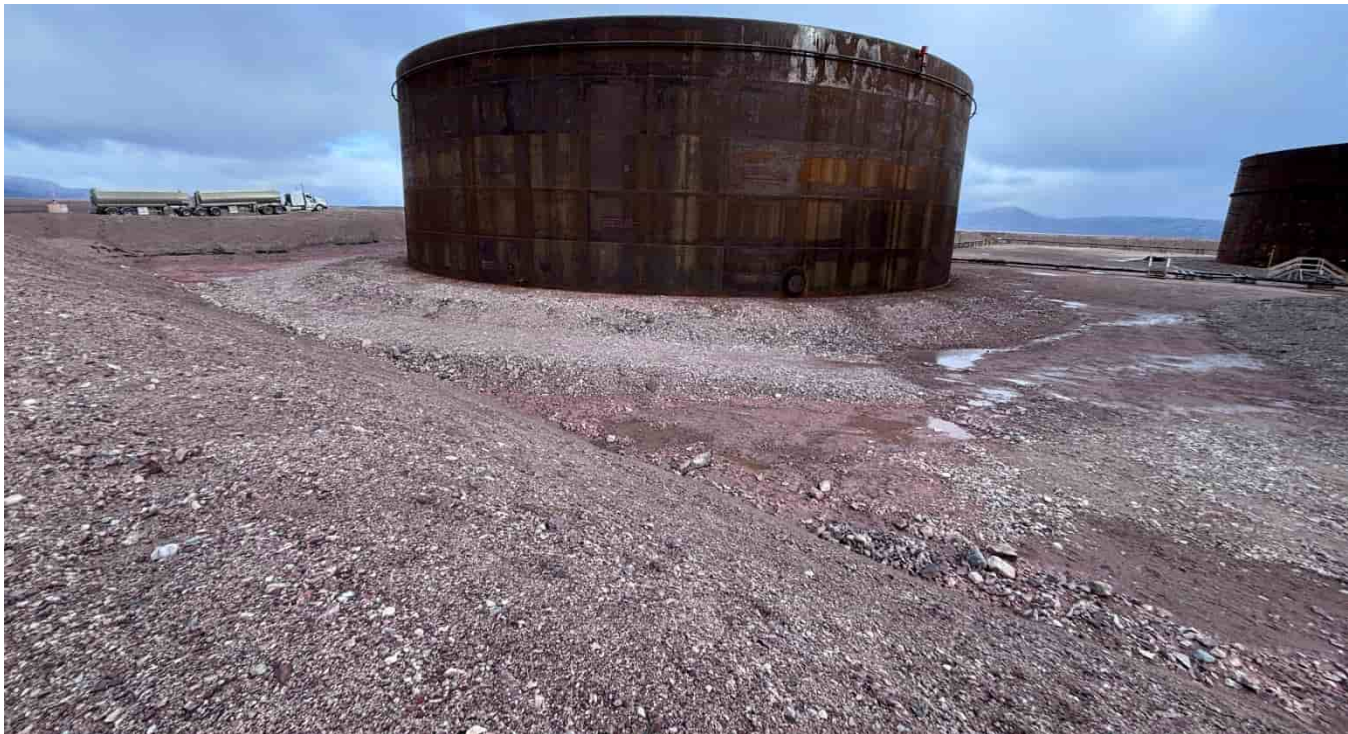
M-173: Ponding water between tanks, looking NW

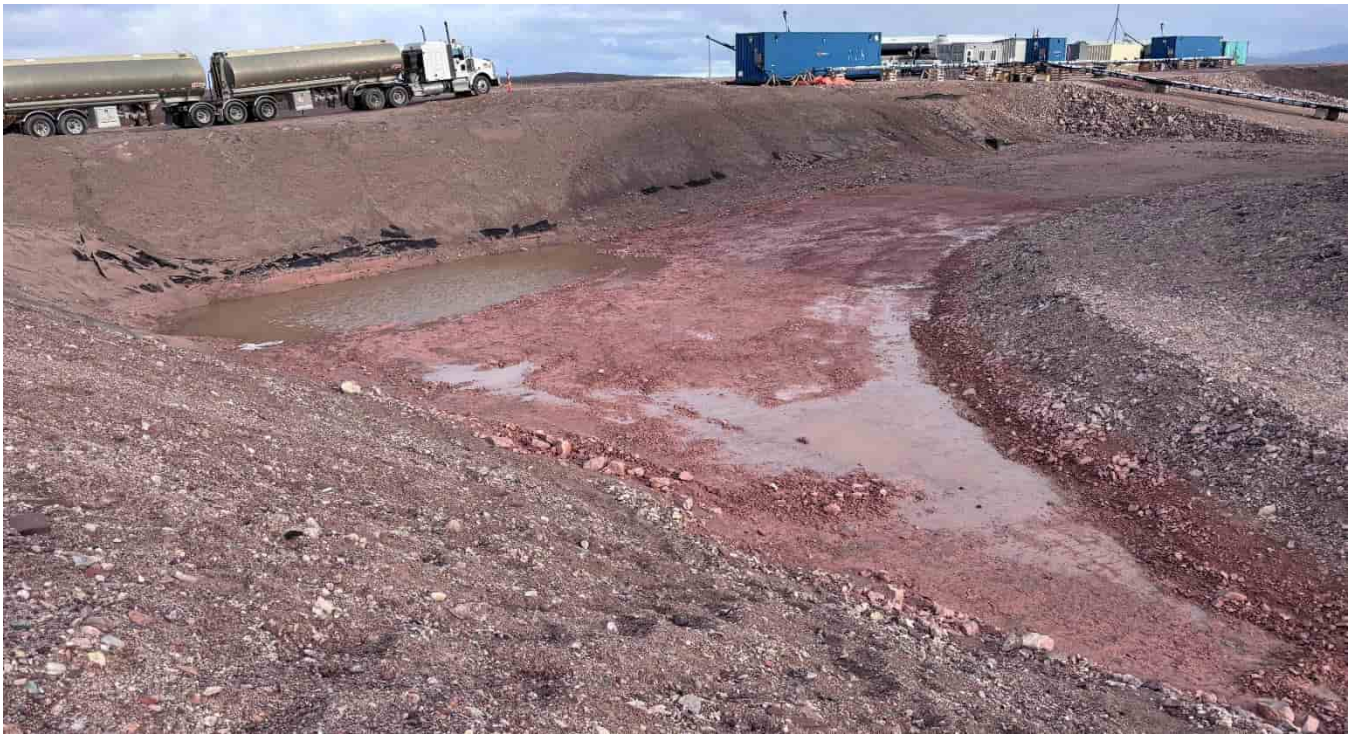
M-174: Ponding water and exposed liner below fireball

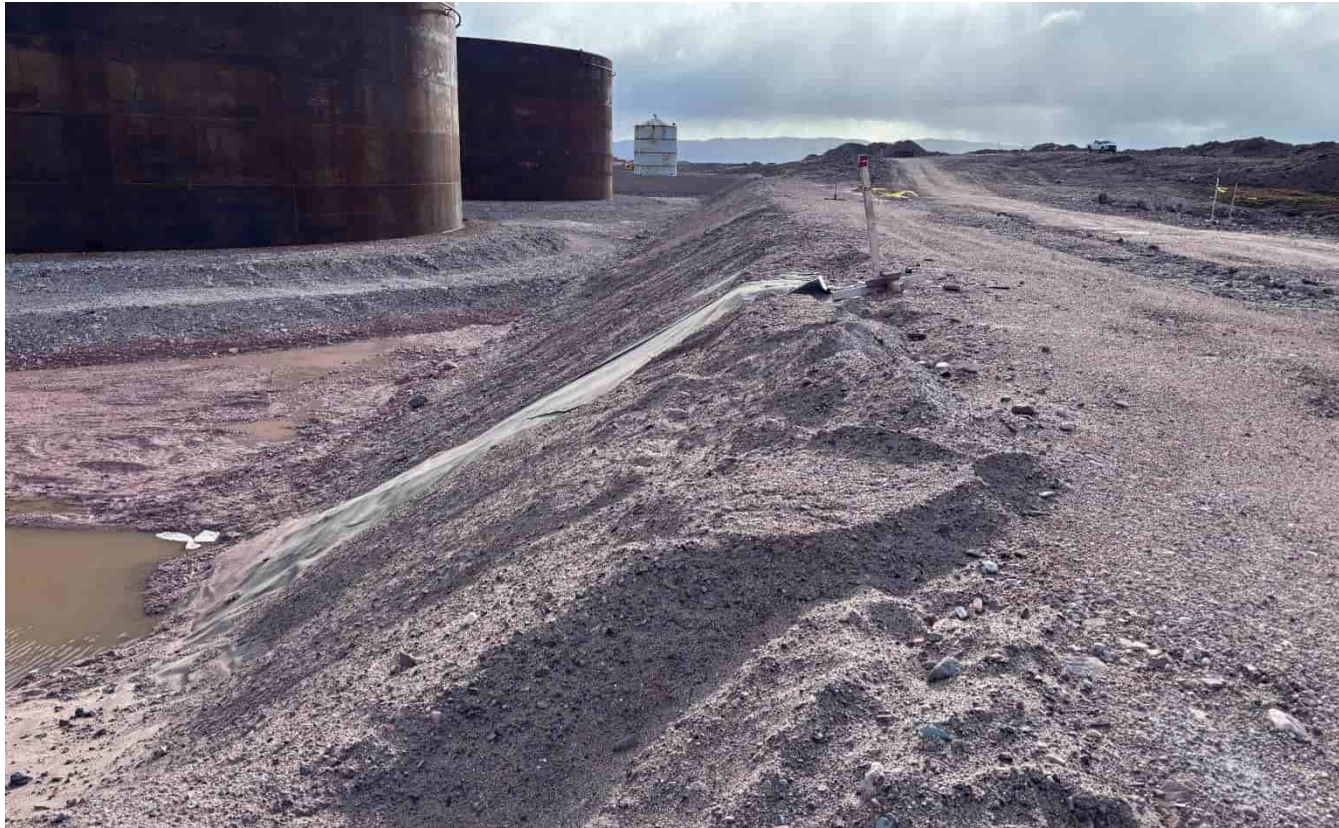
M-175: Ponding water below southern berm, looking E

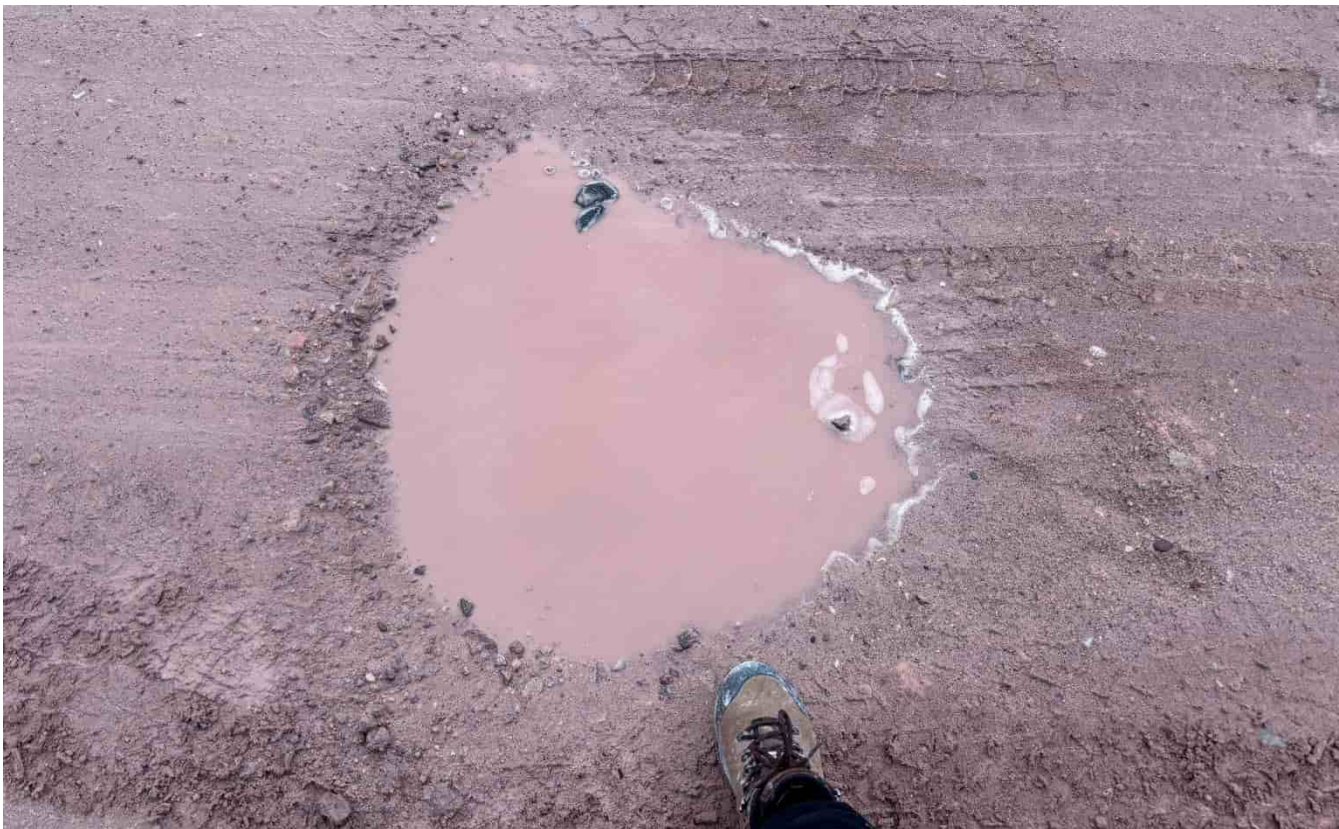
M-177: Typical size of ponding water on fireball pad

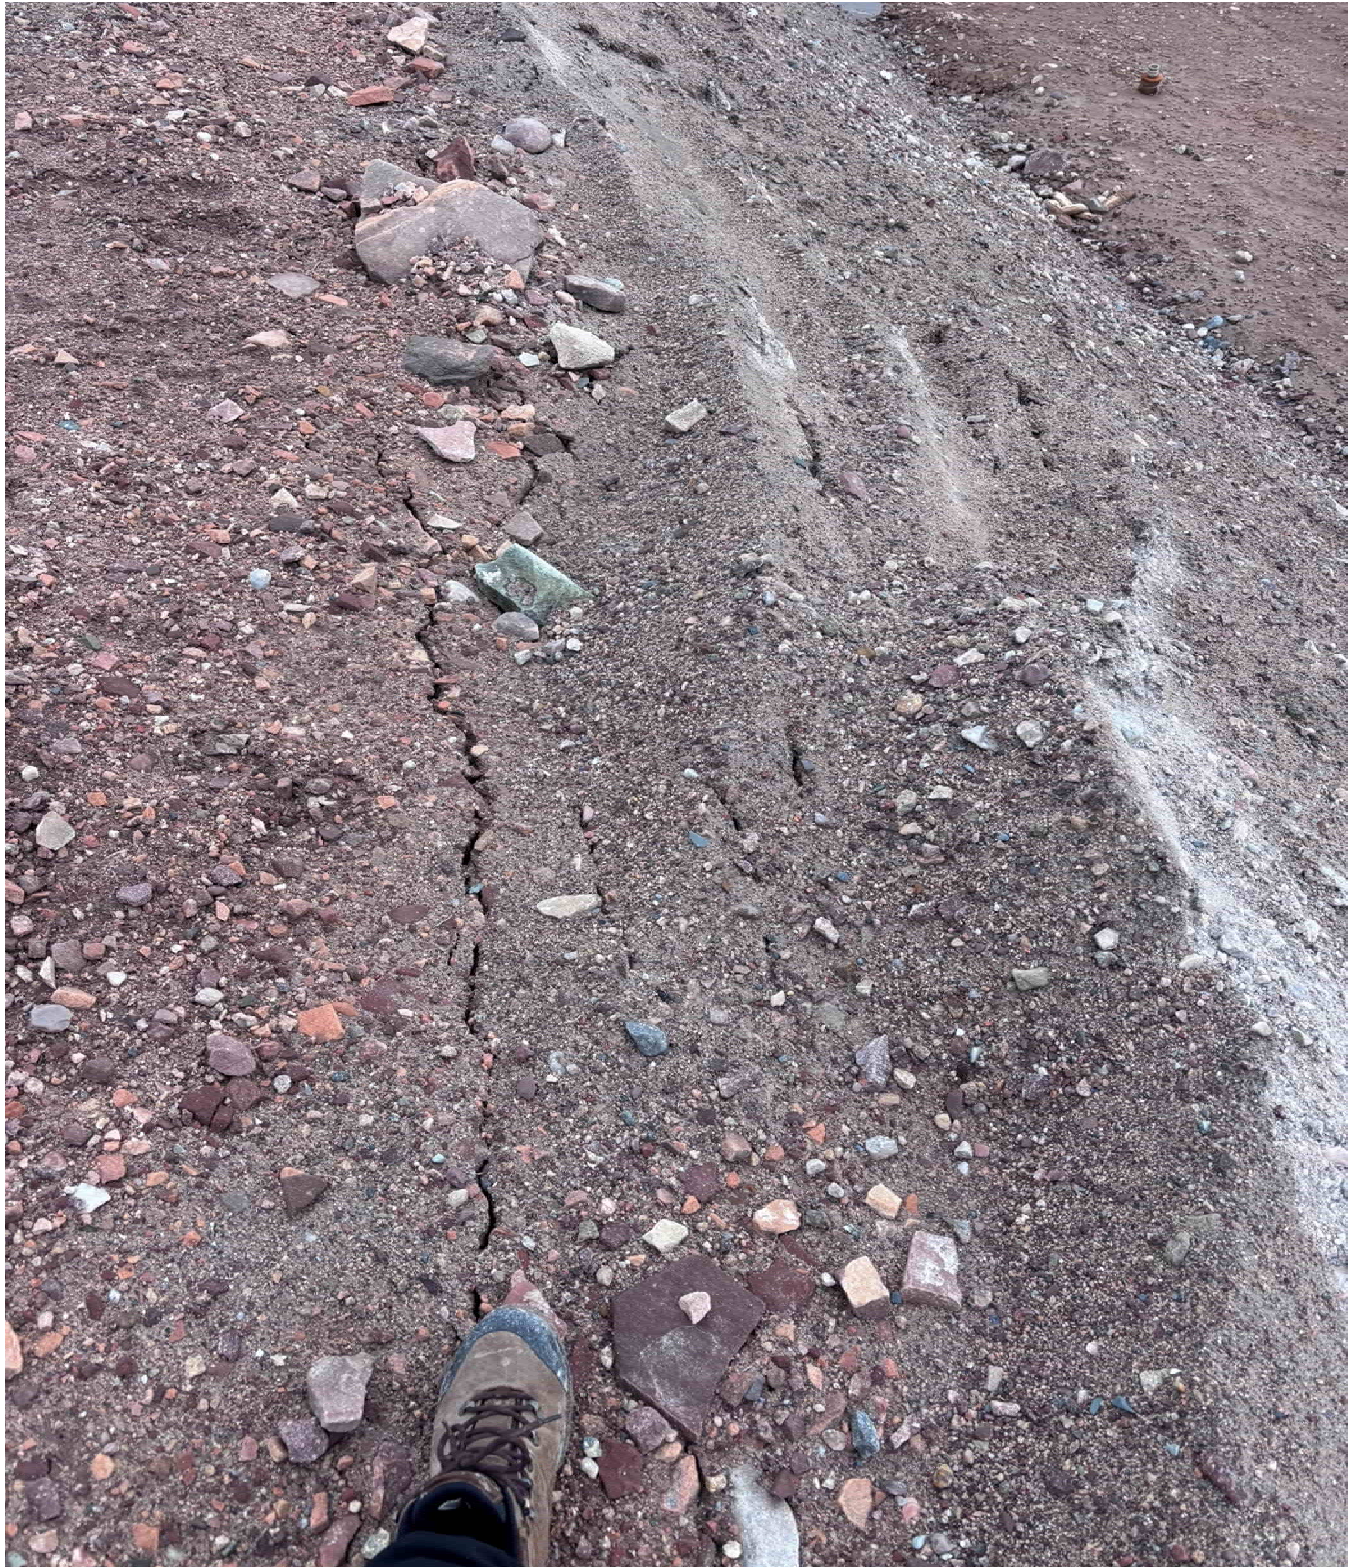
M-179: Tension cracks - crest of western berm

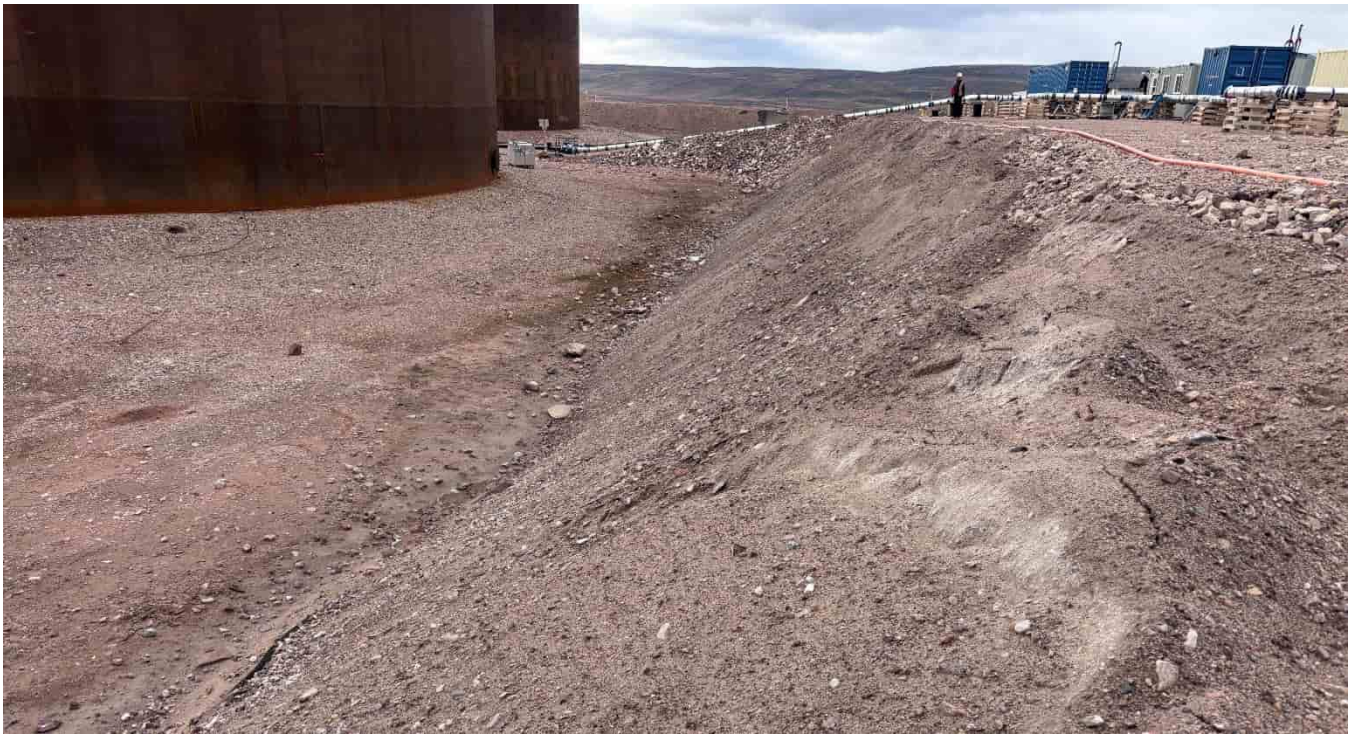
M-180: Erosion of slope below fireball

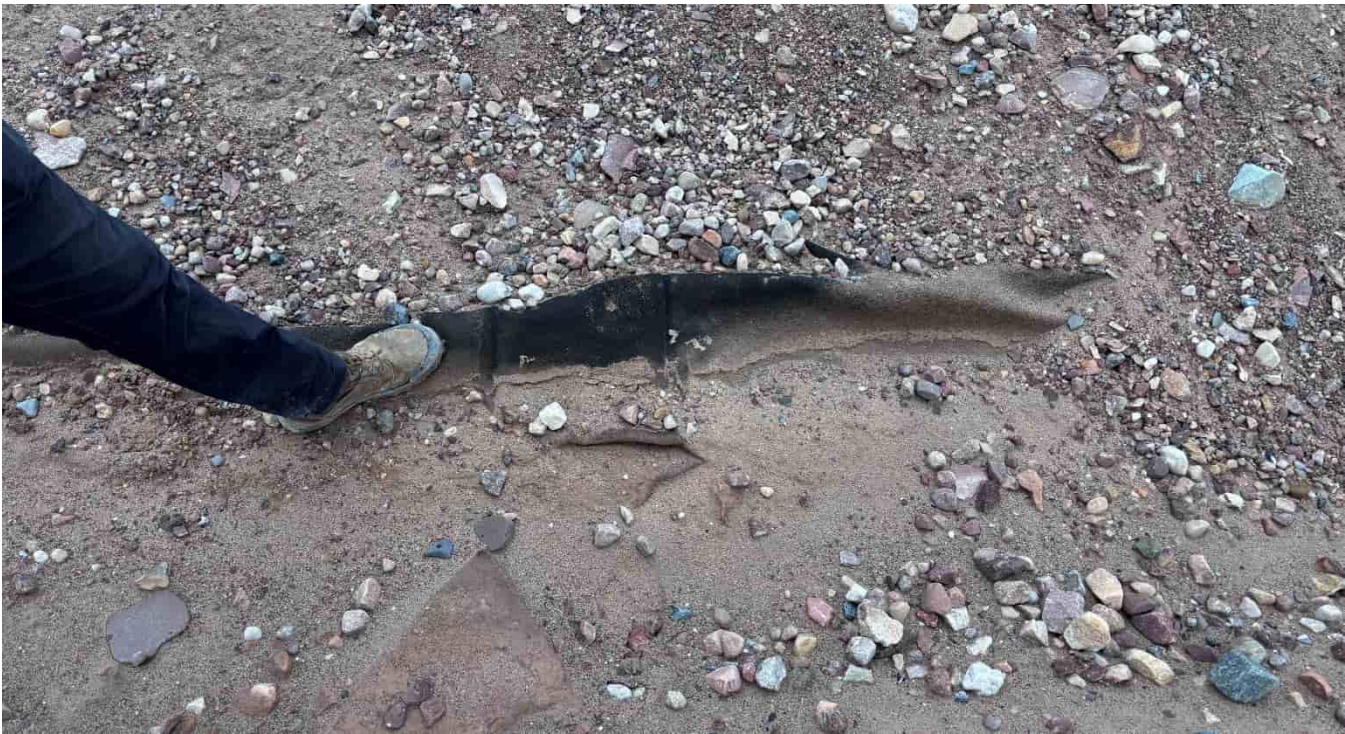
M-184: Exposed liner on slope between fireball and tank farm
