## BACK RIVER OFFSETTING OPTION

# Nulahugyuk Creek Habitat Remediation

**Submitted to:**  
Sabina Gold & Silver Corp.

Report Number: Doc 009-1545534.4000 Ver 0

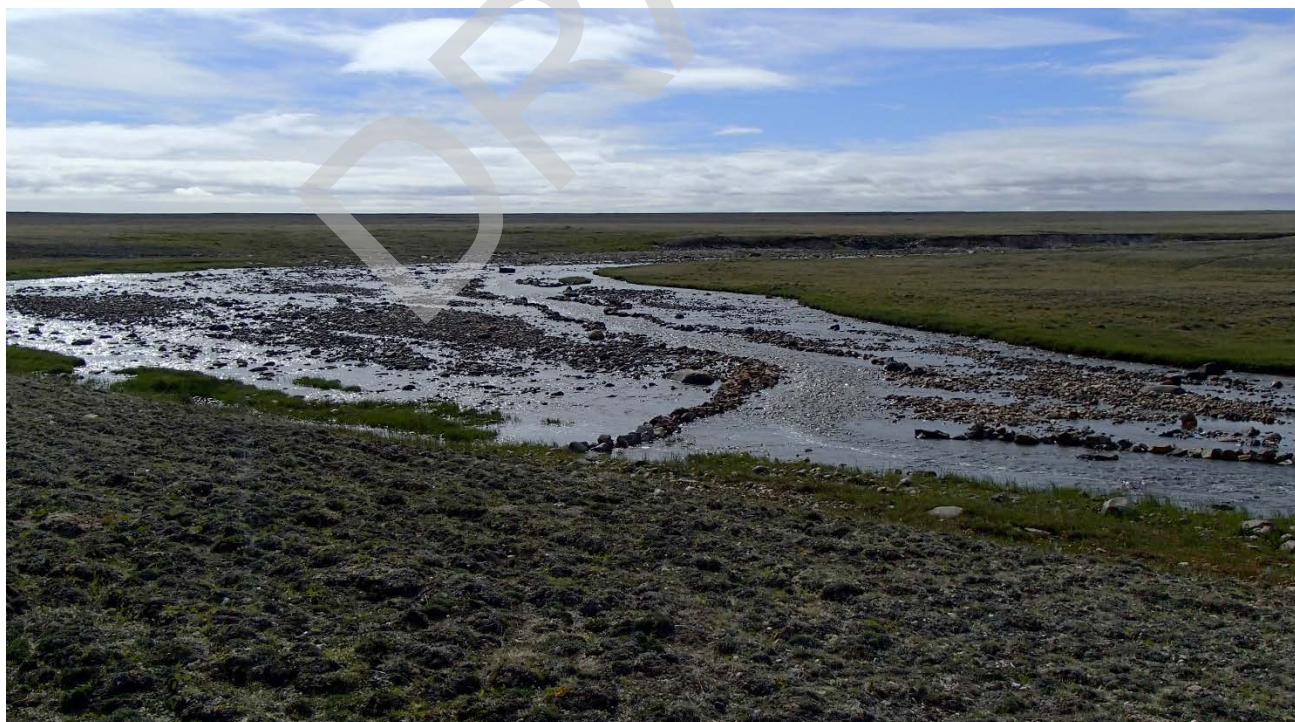
Photo 4-6: Upstream view from elevated RDB showing low-flow channel and weirs constructed during remediation at Site 1. 18 July 2016.

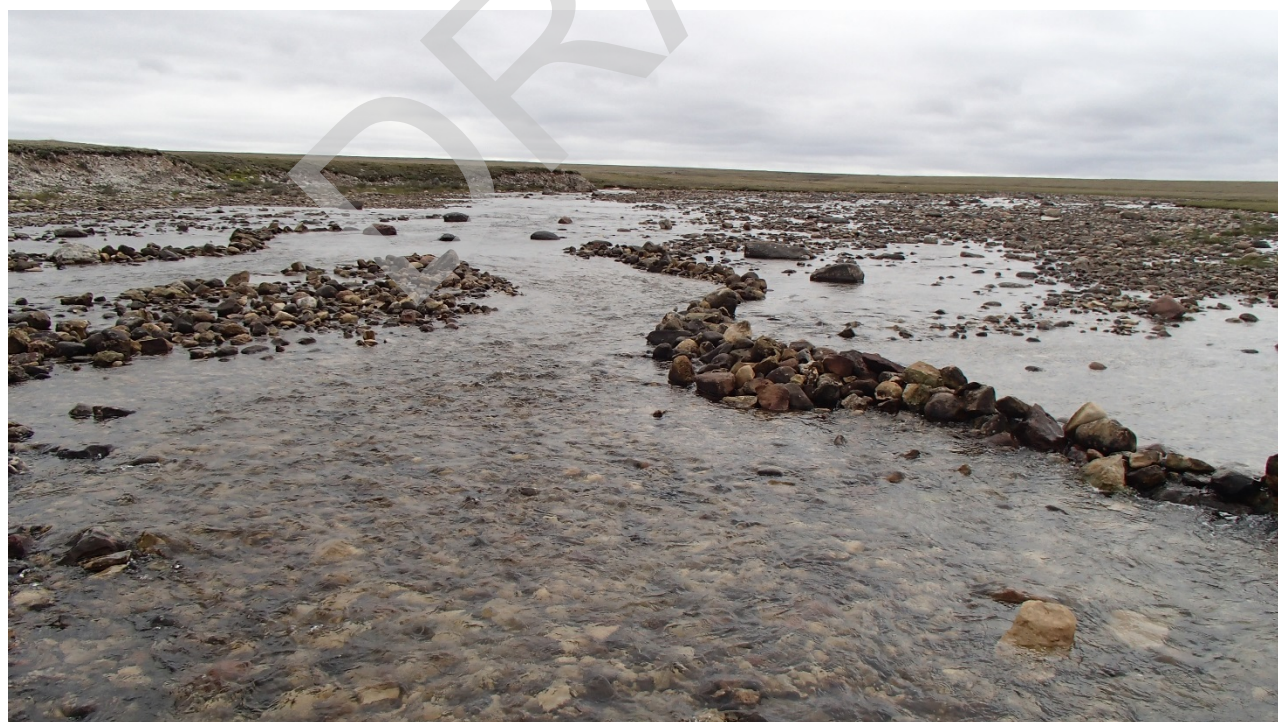
*Photo 4-8: Upstream view of low-flow channel A including upstream extent of low-flow channel B (top-left) at Site 2. 18 July 2016.*

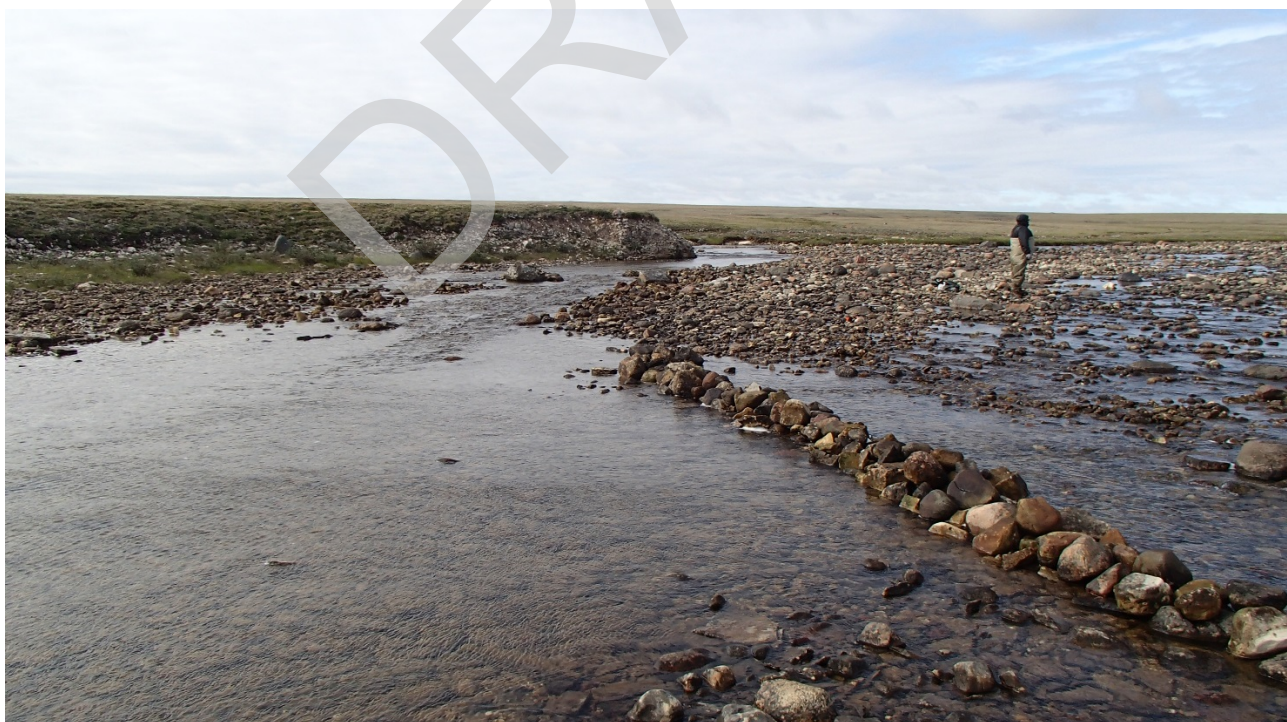
*Photo 4-10: Upstream view of low-flow channel A and Weir A at Site 3 post-remediation. Note the directional weir facilitating fish passage towards the channel and away from problem area. 19 July 2016.*

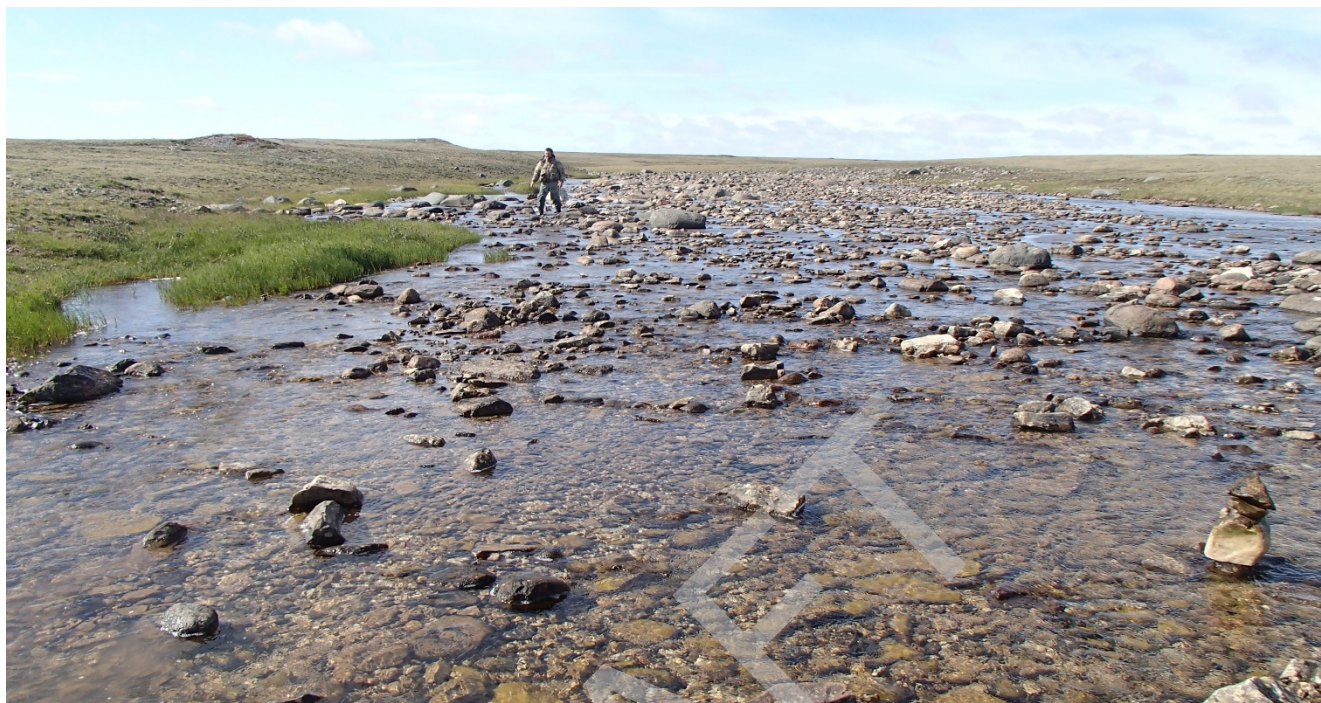
*Photo 4-11: Upstream view of the RDB from the downstream extent of Site 4 prior to remediation. Note the lack of discernible channel across the creek. 19 July 2016.*

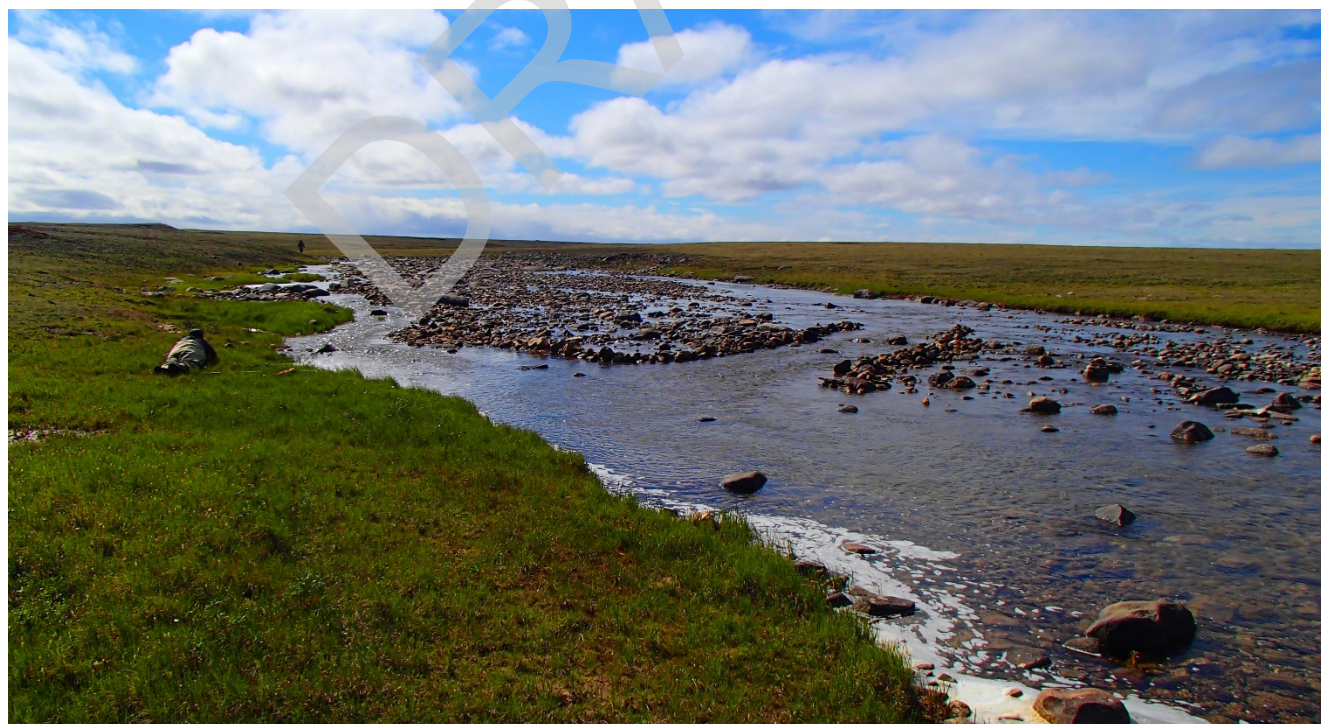
*Photo 4-12: Upstream view of low-flow channels A and B constructed at Site 4. 19 July 2016.*

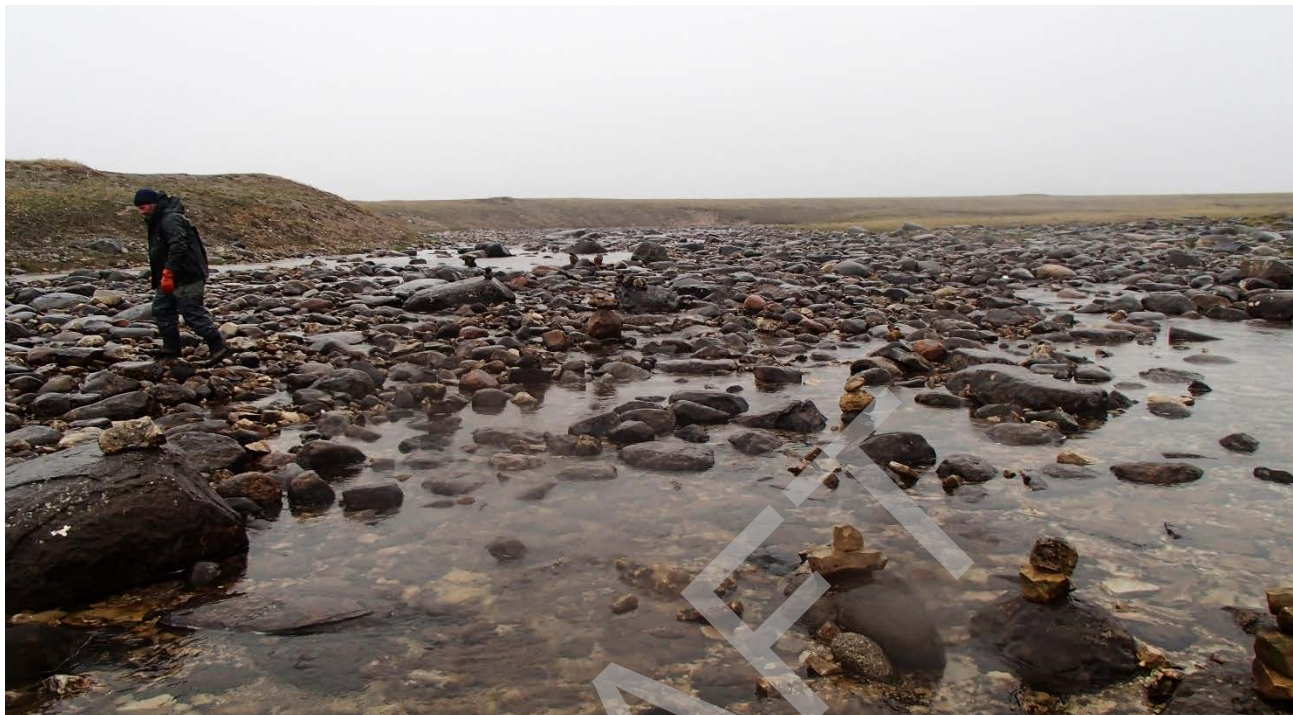
*Photo 4-13: Upstream view of problem area from the downstream extent of Site 4 prior to remediation. Note the lack of discernible channel. 20 July 2016.*

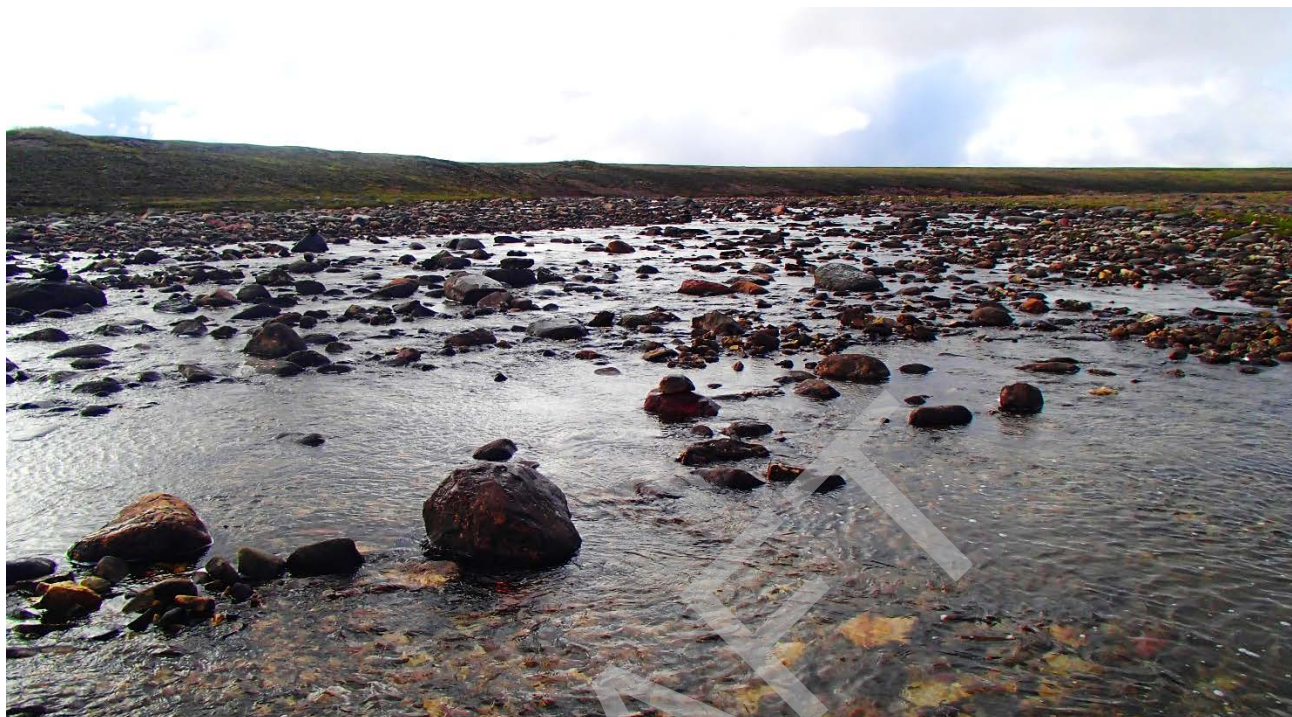
*Photo 4-15: Upstream view of the problem area from the downstream extent of Site 6 prior to remediation. Note the lack of a discernible channel. 21 July 2016.*

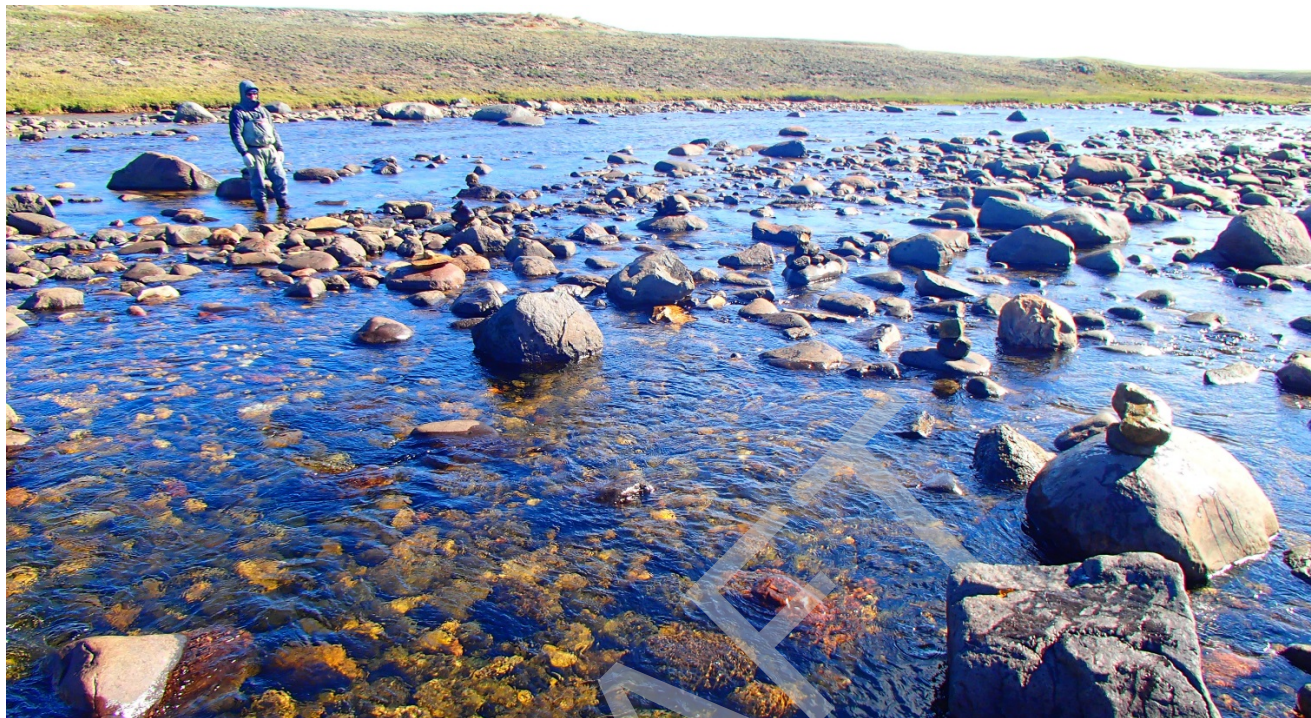
*Photo 4-17: Downstream view of the location of low-flow channel B from the upstream extent of Site 7 prior to remediation. Note the absence of a continuous channel connecting to the pool along the LDB at the downstream extent. July 24, 2016.*

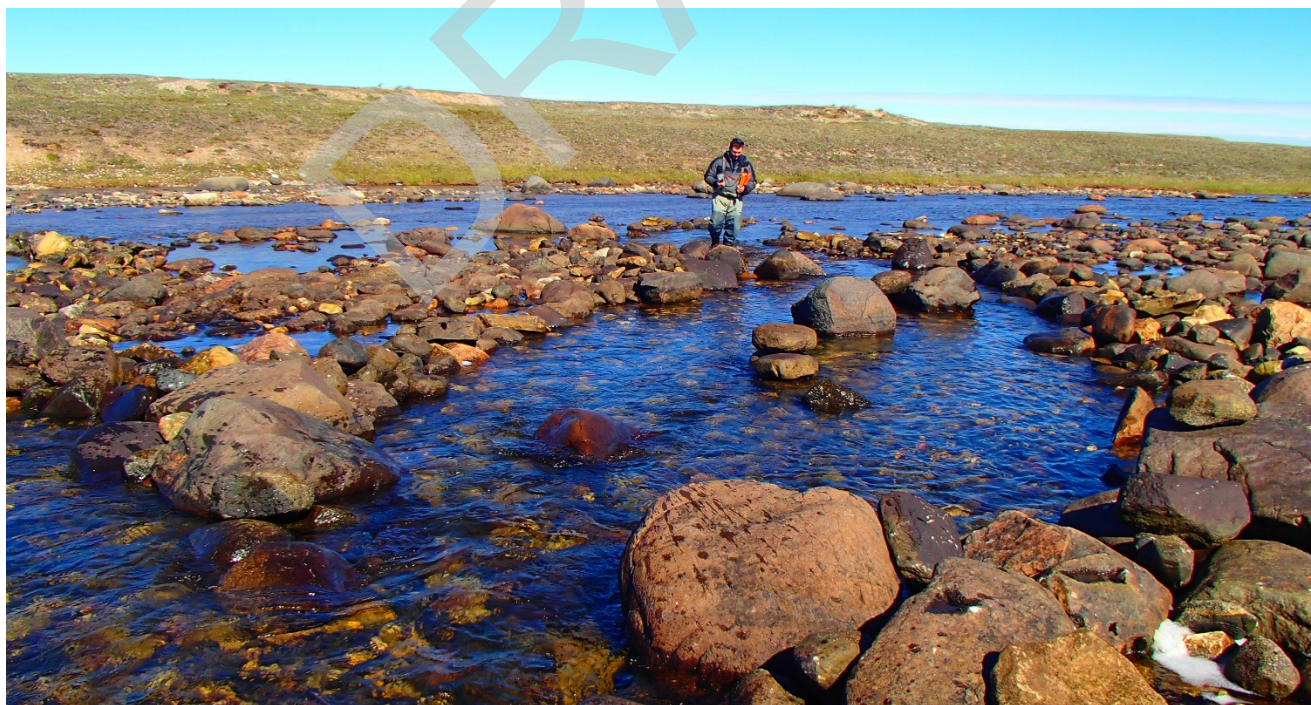
*Photo 4-18: Downstream view of low-flow channel B from the upstream extent of Site 7 post-remediation. Note connectivity with the pool along the LDB at the downstream extent. 24 July 2016.*

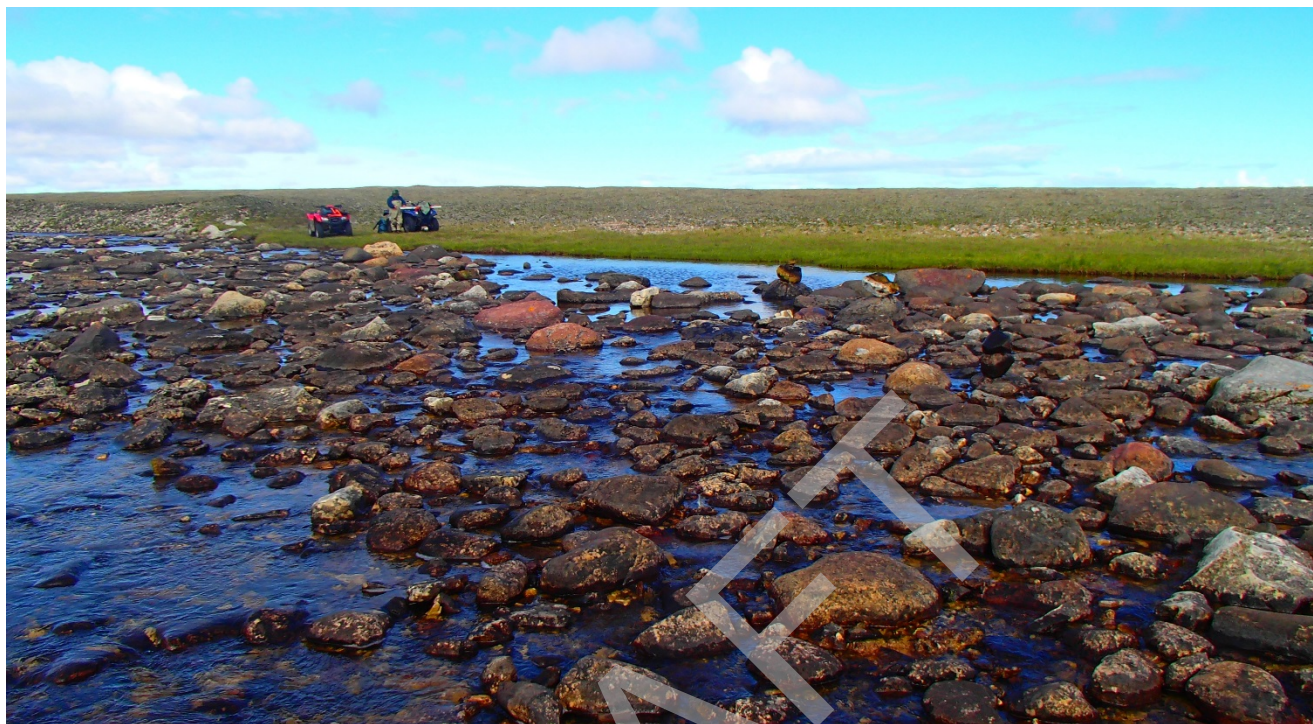
*Photo 4-19: Upstream view of the problem area facing the LDB at Site 8 prior to remediation. Note the absence of a continuous migratory channel across centre of creek. 23 July 2016.*

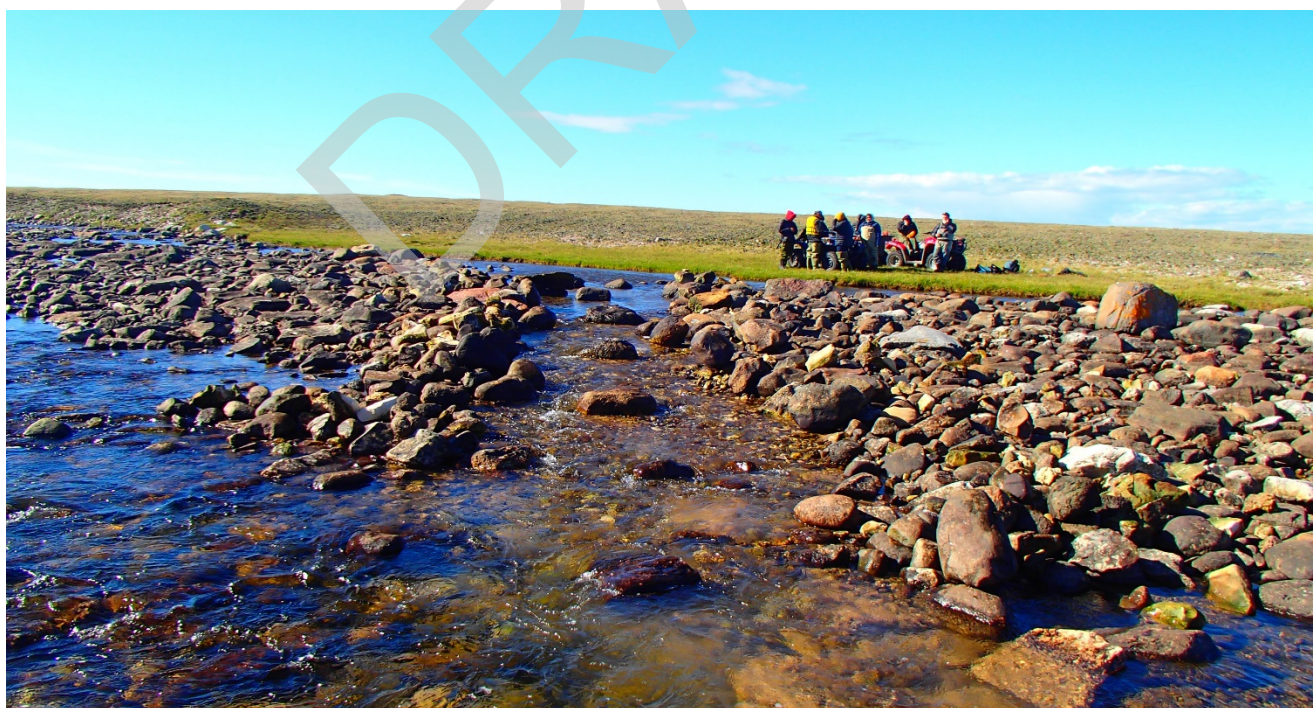
*Photo 4-20: Upstream view of the low-flow channel constructed at Site 8. Note the large boulders left in the low-flow channel to act as velocity breaks and cover for fish. 23 July 2016.*

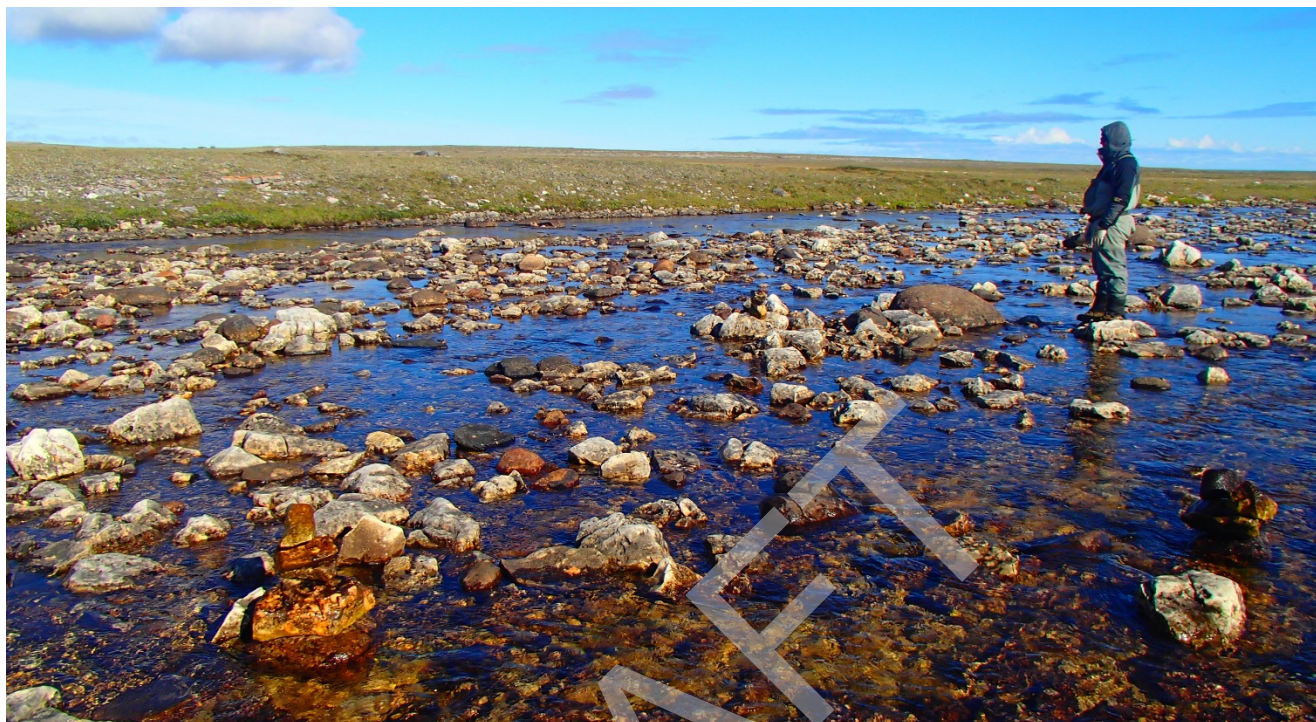
*Photo 4-21: Downstream view of the problem area, facing the LDB at Site 9 prior to remediation. Note the absence of a continuous migratory channel across centre of creek. 23 July 2016.*

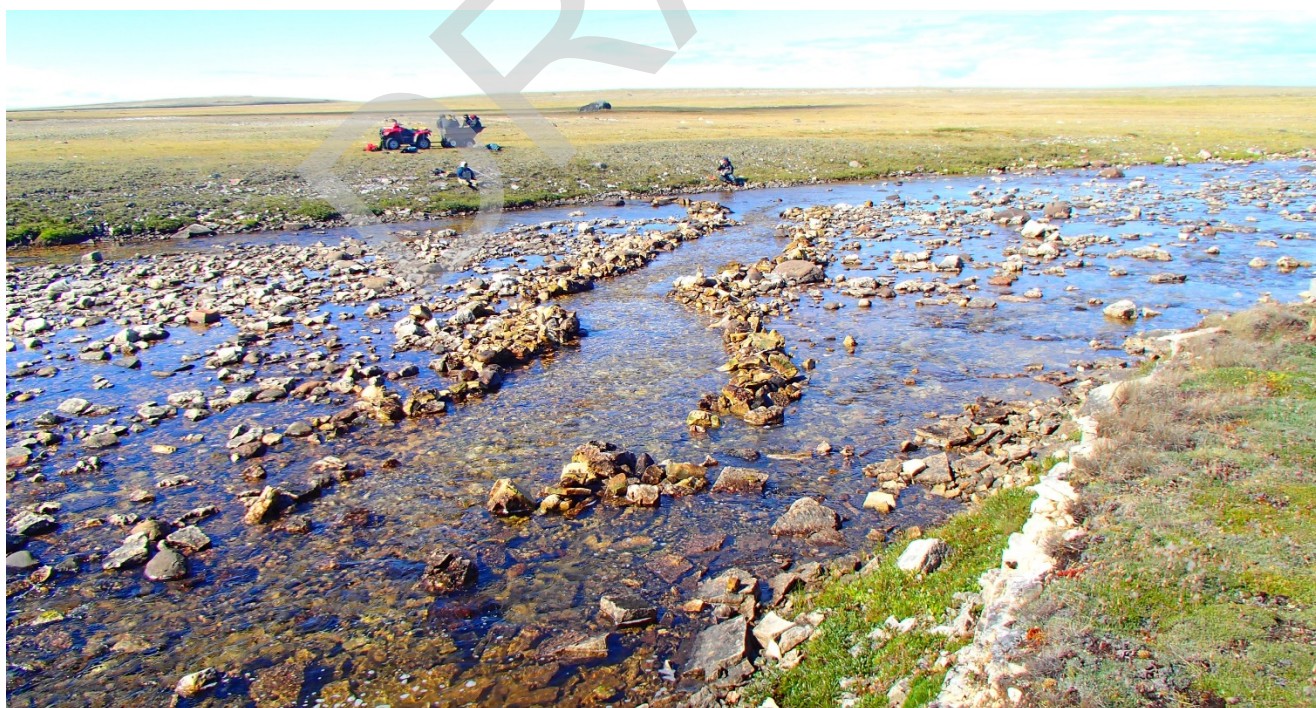
*Photo 4-22: Downstream view from above the RDB of the low-flow channel constructed at Site 8. 23 July 2016.*

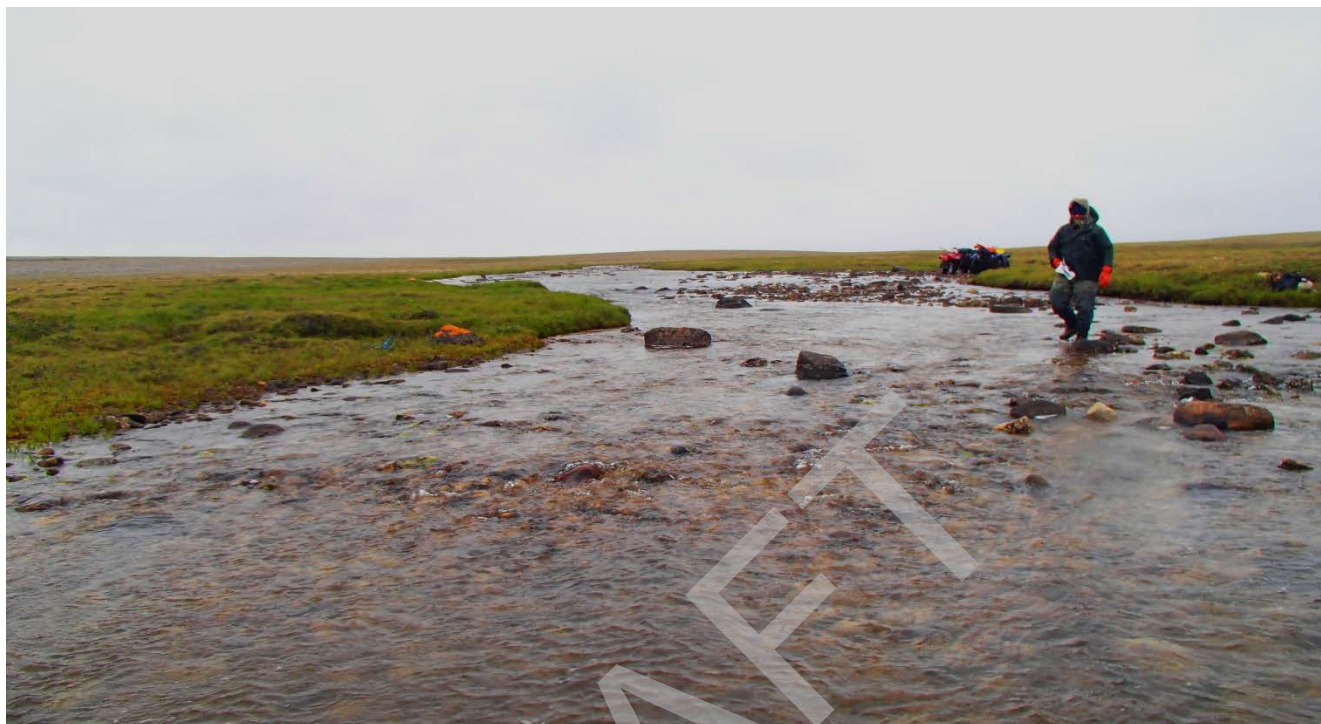
*Photo 4-23: Upstream view of problem area at Site 10 prior to remediation. Note the dispersed flows across the creek. 22 July 2016.*

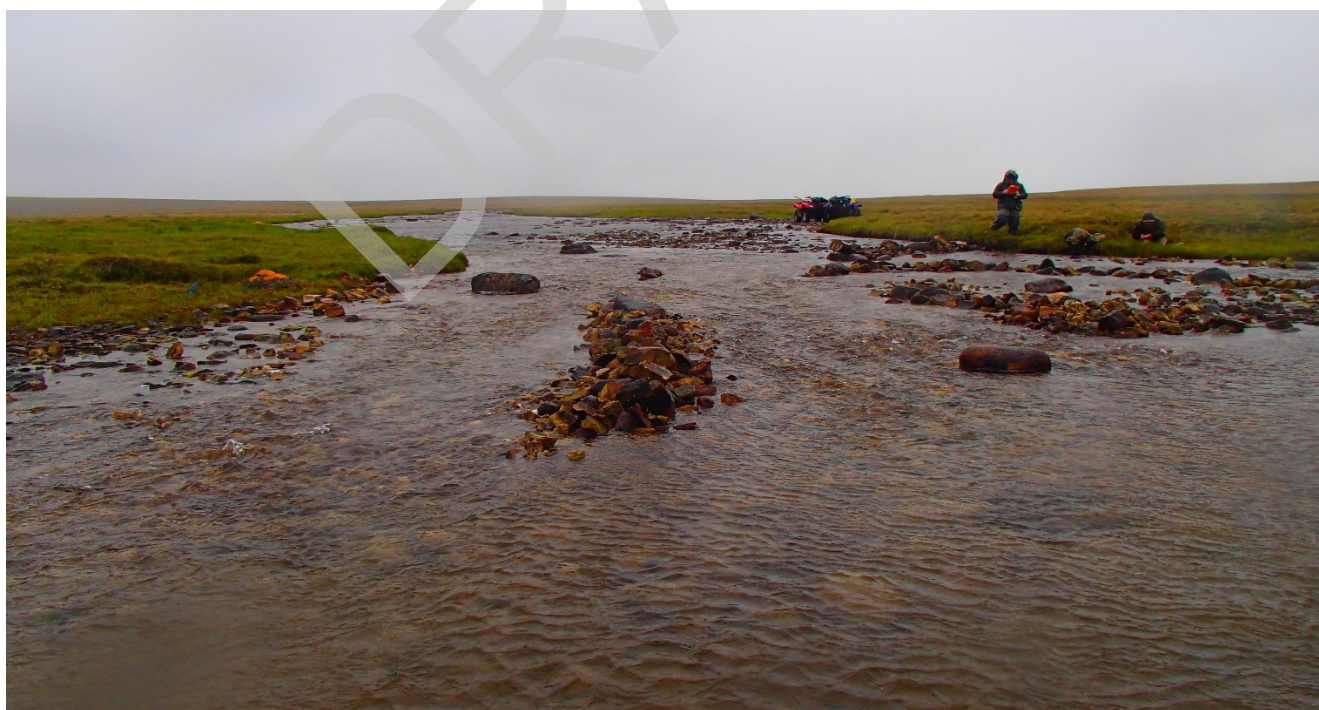
*Photo 4-24: Upstream view of low-flow channel A and B constructed at Site 10. Note that the channel provides fish passage beyond the pond (in foreground). 22 July 2016.*

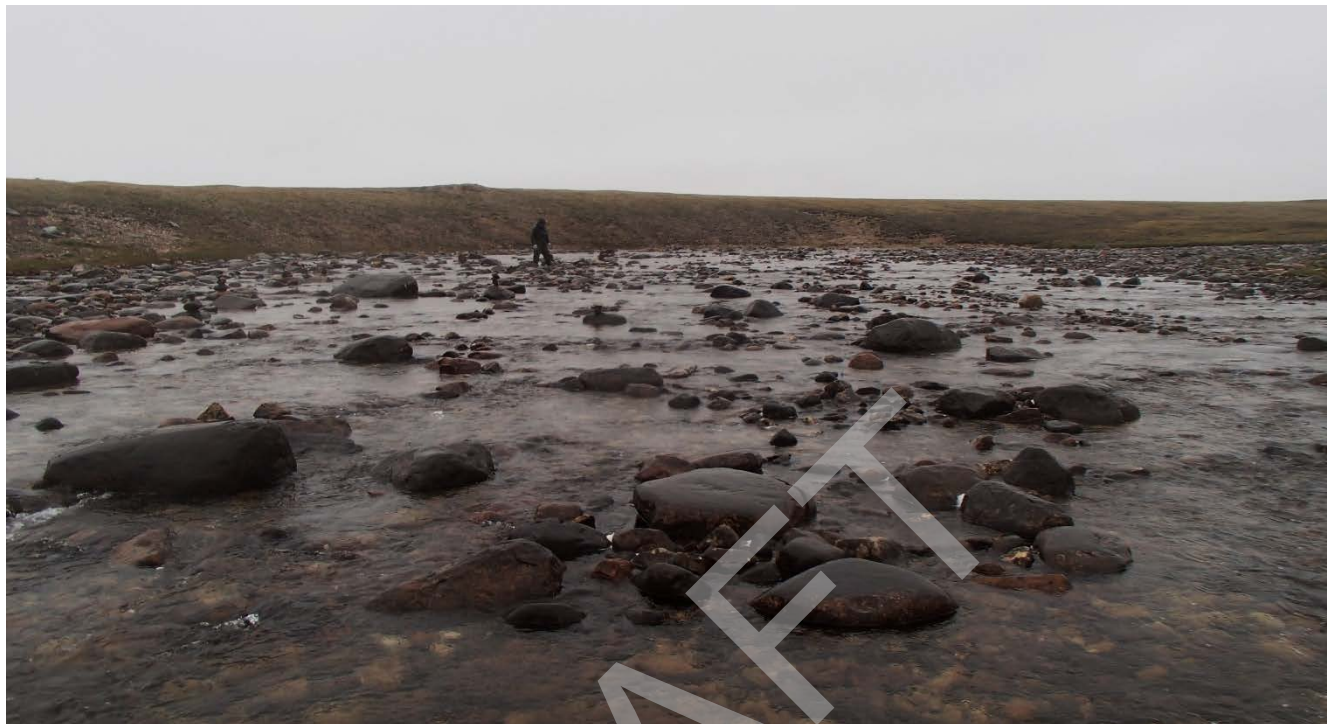
*Photo 4-25: Upstream view of problem area from downstream extent of Site 11 prior to remediation, note dispersed flows across creek. 20 July 2016.*

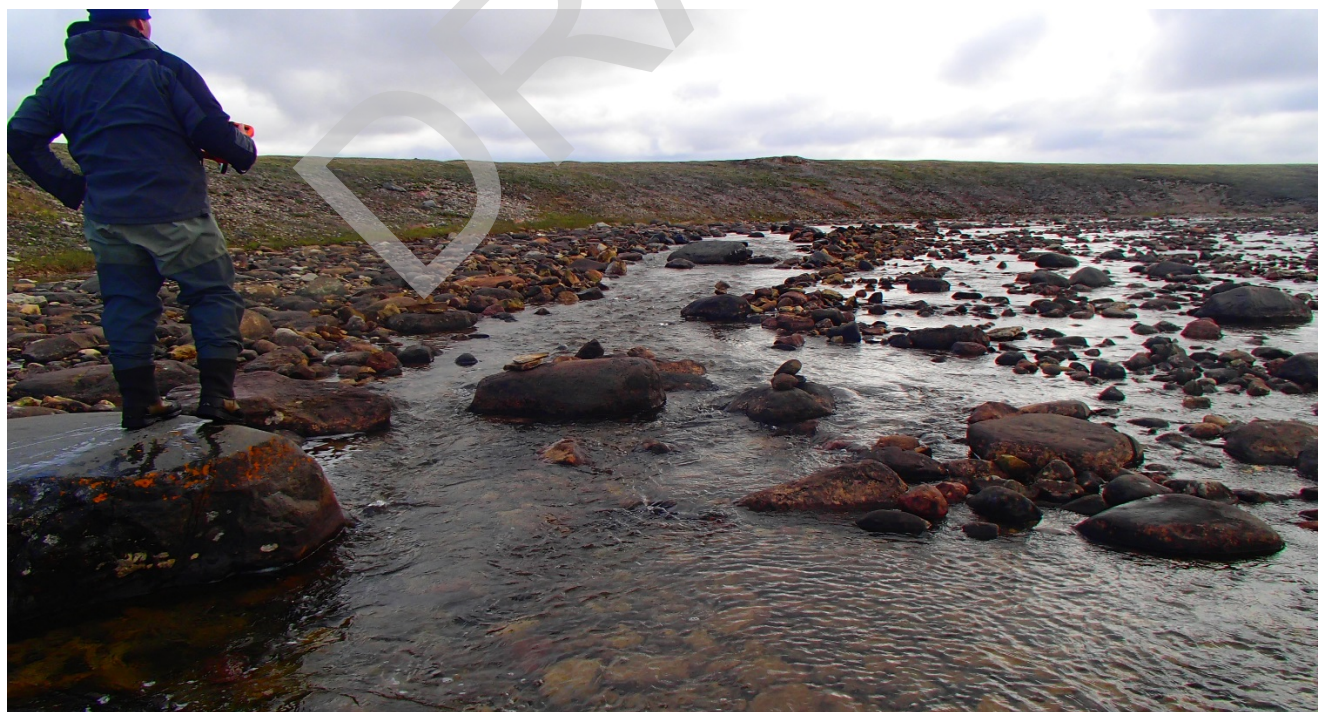
*Photo 4-26: Upstream view of low-flow channel at Site 11 post-remediation, note that the channel provides fish passage along the RDB of creek. 20 July 2016.*

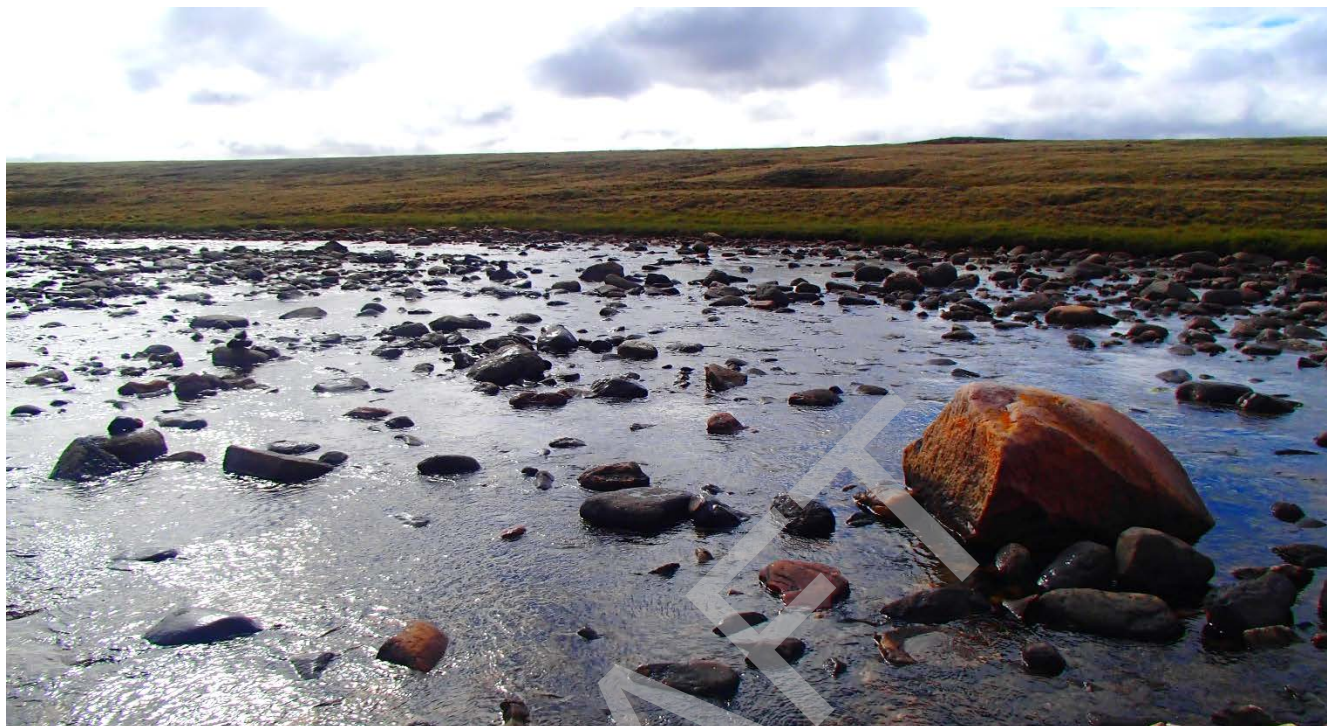
The problem area was within a stream section approximately 33 m wide, located downstream of a sharp bend in the river, and was characterized by run habitat and a dominance of cobble/boulder substrates. Flows were dispersed across the centre of creek, with some flow concentrated along the LDB of channel at the upstream extent and near the RDB at the downstream extent. Run habitat suitable for fish passage was noted along the LDB and RDB. There was no continuous unobstructed route for fish passage upstream along the RDB and towards the centre of the creek due to lack of depth, and the presence of a boulder garden with several sections of dry streambed. Site 12 was ranked as a risk level 1-lowest priority for remediation. See Photo 4-27 and Photo 56 in Appendix A.

Photo 4-27: downstream view of problem area looking towards RDB at Site 12 prior to remediation, note dispersed flows across creek. 21 July 2016

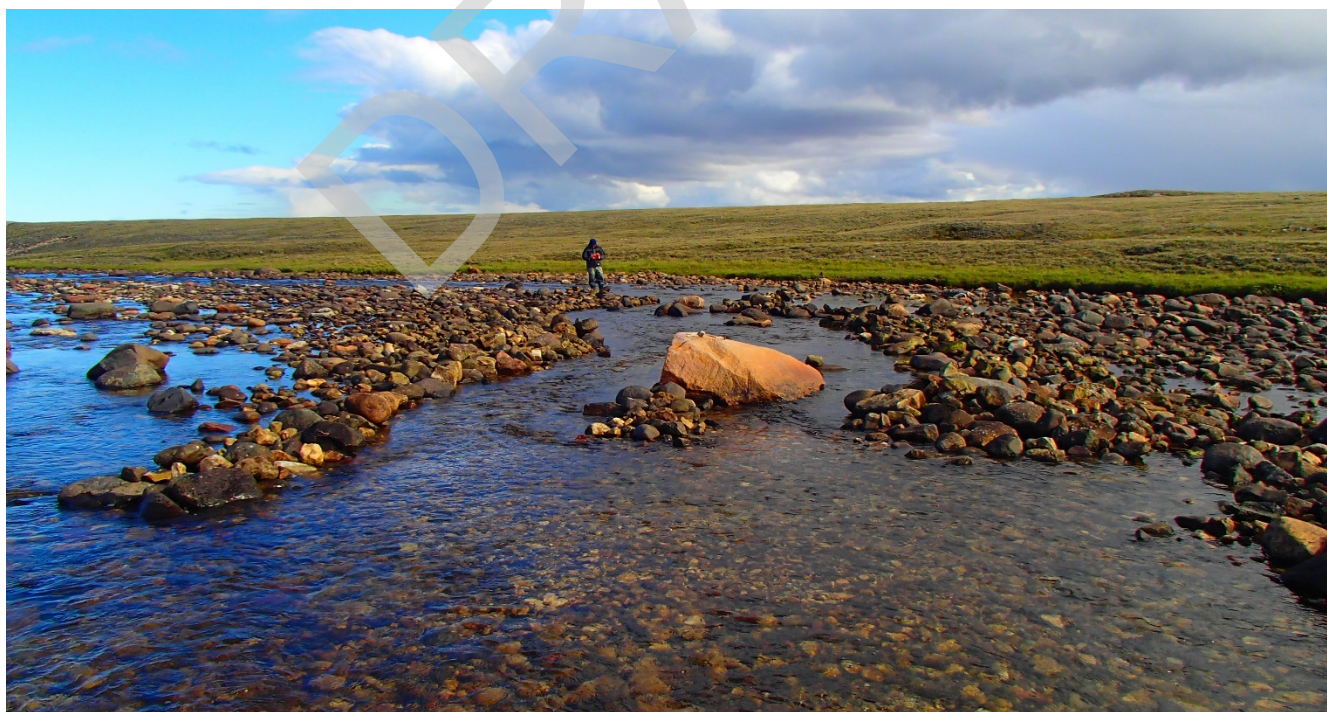
Photo 4-28: Downstream view of the low-flow channel constructed at Site 12 post-remediation, note that the channel provides fish passage across the creek. 21 July 2016.

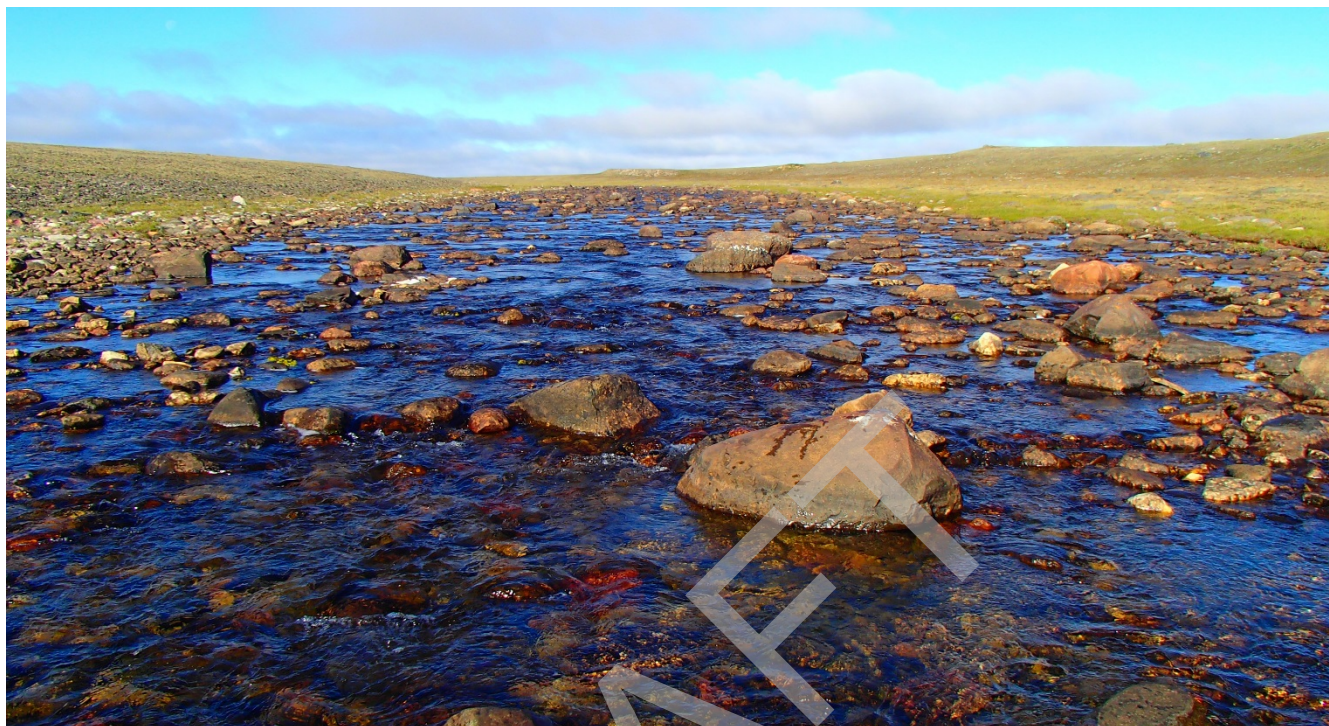
*The problem area was within a stream section approximately 29 m wide, located upstream of a sharp bend in the creek and was characterized by run/riffle habitat and cobble/boulder substrates. Remediation Site 7 was located 30 m downstream of this problem area. A thalweg along the RDB may be suitable for fish passage under flow conditions; however, a rock barrier present in low-flow conditions may impede upstream passage. Site 13 was ranked as a risk level 1-lowest priority for remediation. See Photo 4-29.*

*Prior to remediation, fish passage was likely impeded by a barrier of cobble and boulder under low-flow conditions. After substrate manipulation, several small migratory routes were established. It is expected that remediation efforts at this site will facilitate upstream movements of fish.*

*Photo 4-29: Upstream view of rock barrier impeding fish passage under low-flow conditions at Site 13 prior to remediation. 24 July 2016.*

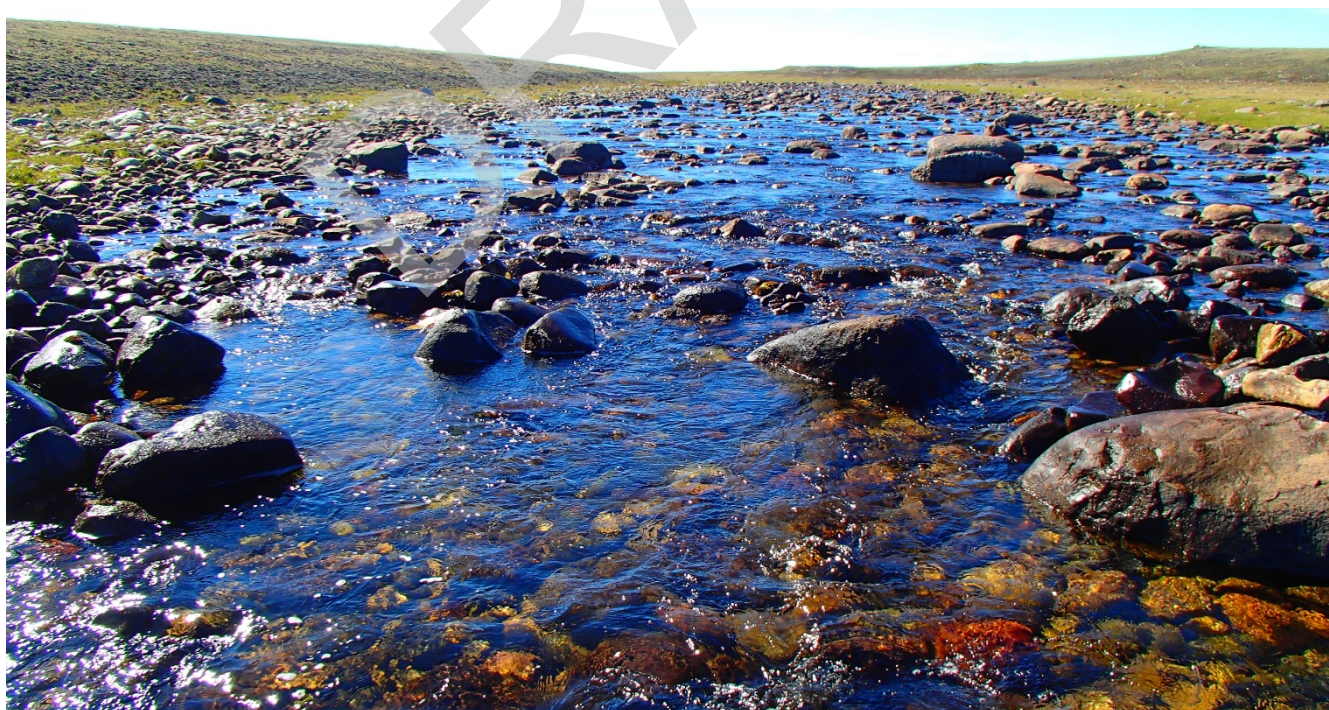
*Photo 4-30: Upstream view of Site 13 post-remediation. Note several small channels available to facilitate upstream migration. 24 July 2016.*

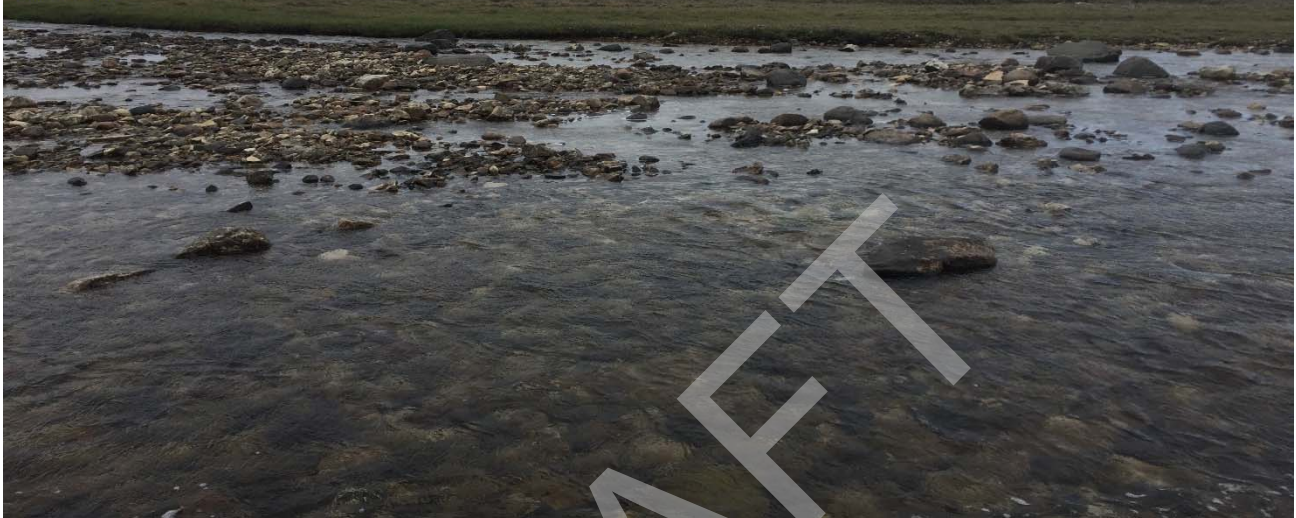
*Photo 11: Facing the LDB at the downstream extent of Site 1 pre-remediation. Note the presence of dispersed, low-flow conditions and cobble/ boulder bars. 18 July 2016.*

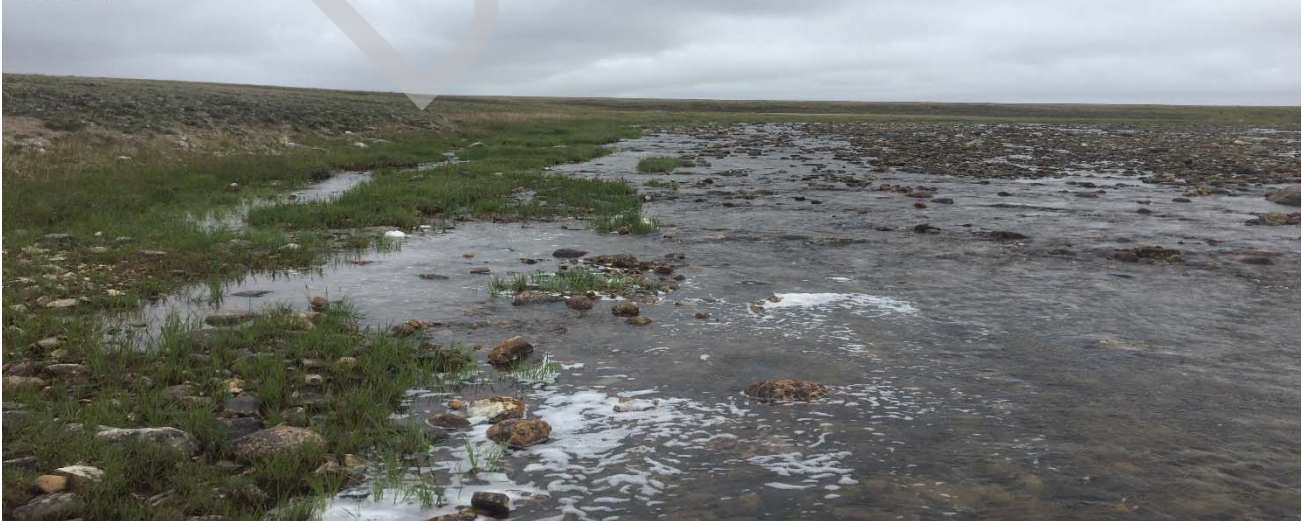
*Photo 12: Facing upstream along the RDB at site 1 pre-remediation, showing diminishing flows and exposed streambed further upstream. 18 July 2016.*
