## BACK RIVER OFFSETTING OPTION

# Nulahugyuk Creek Habitat Remediation

**Submitted to:**  
Sabina Gold & Silver Corp.

Report Number: Doc 009-1545534.4000 Ver 0

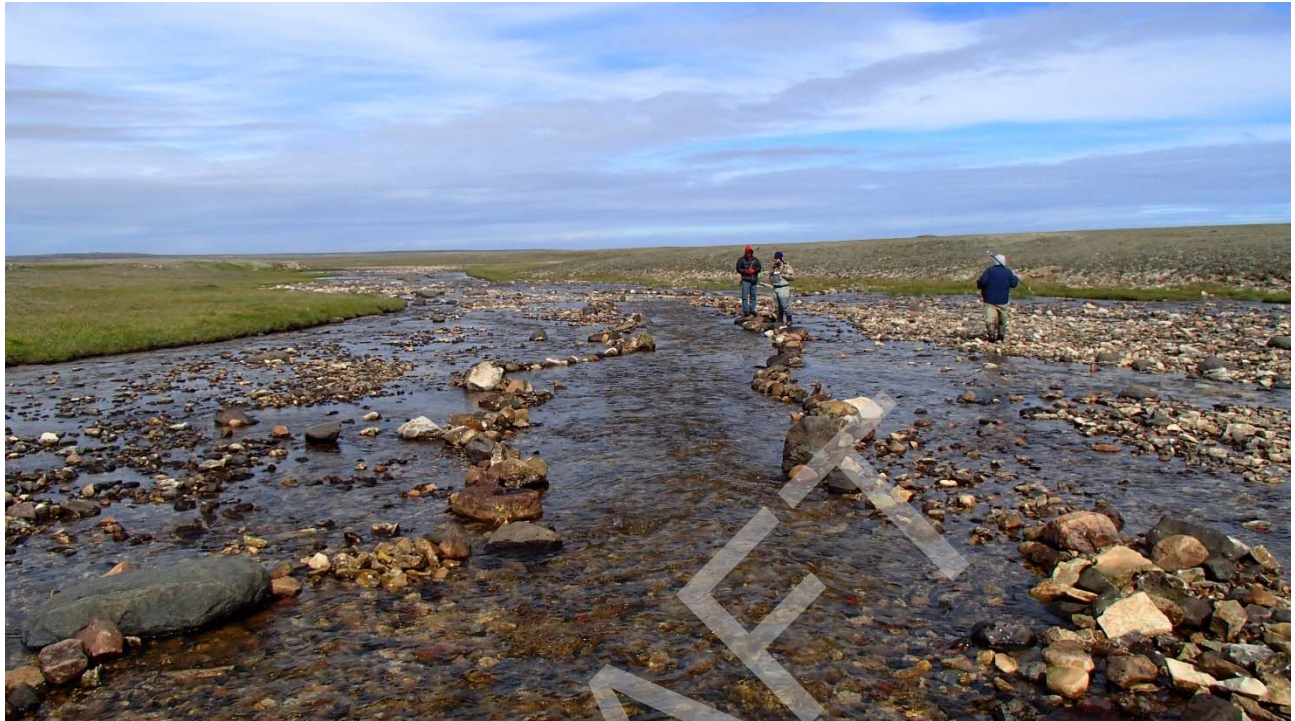
*Photo 13: Facing downstream at the upstream extent of Site1. Note the meander along the boundaries of the low-flow channel resulting in velocity breaks (i.e., refugia). 18 July 2016.*

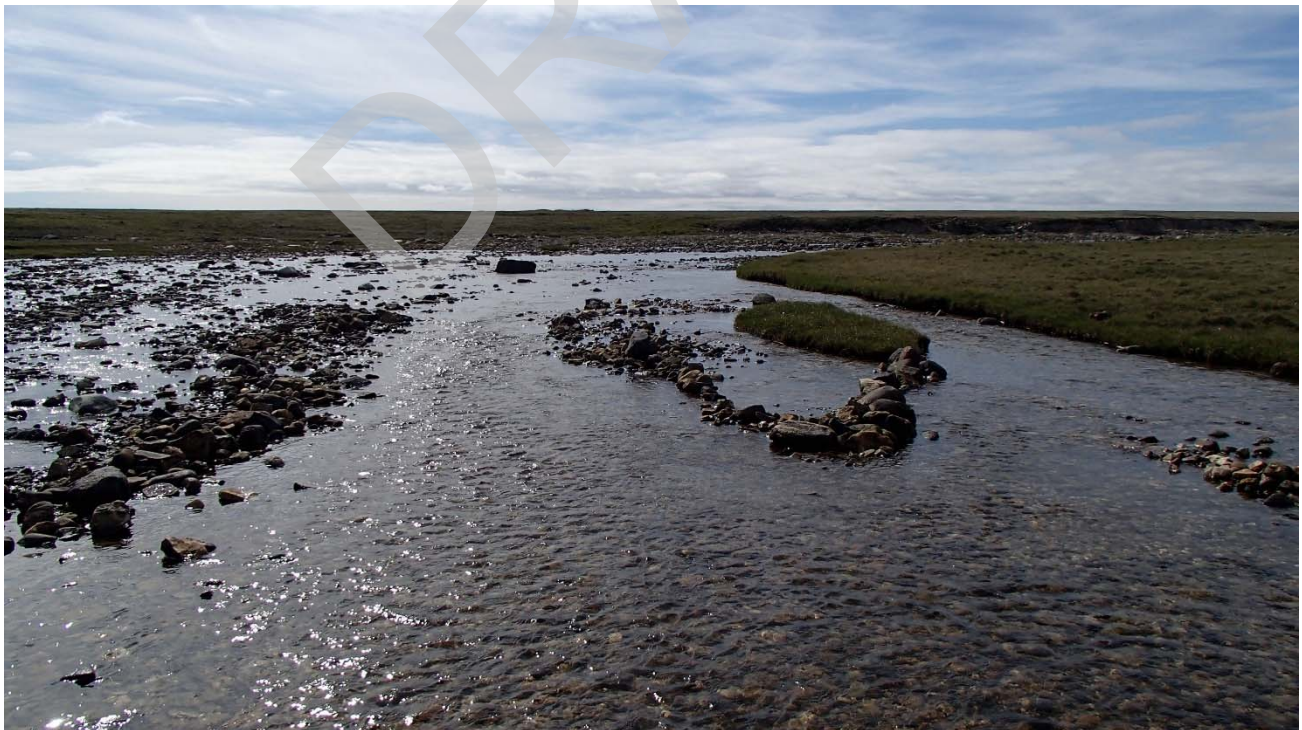
*Photo 14: Facing upstream at the upper extent of Site 1 post-remediation. Note the opening along the LDB boundary to allow for fish passage in either direction around the island. 18 July 2016.*

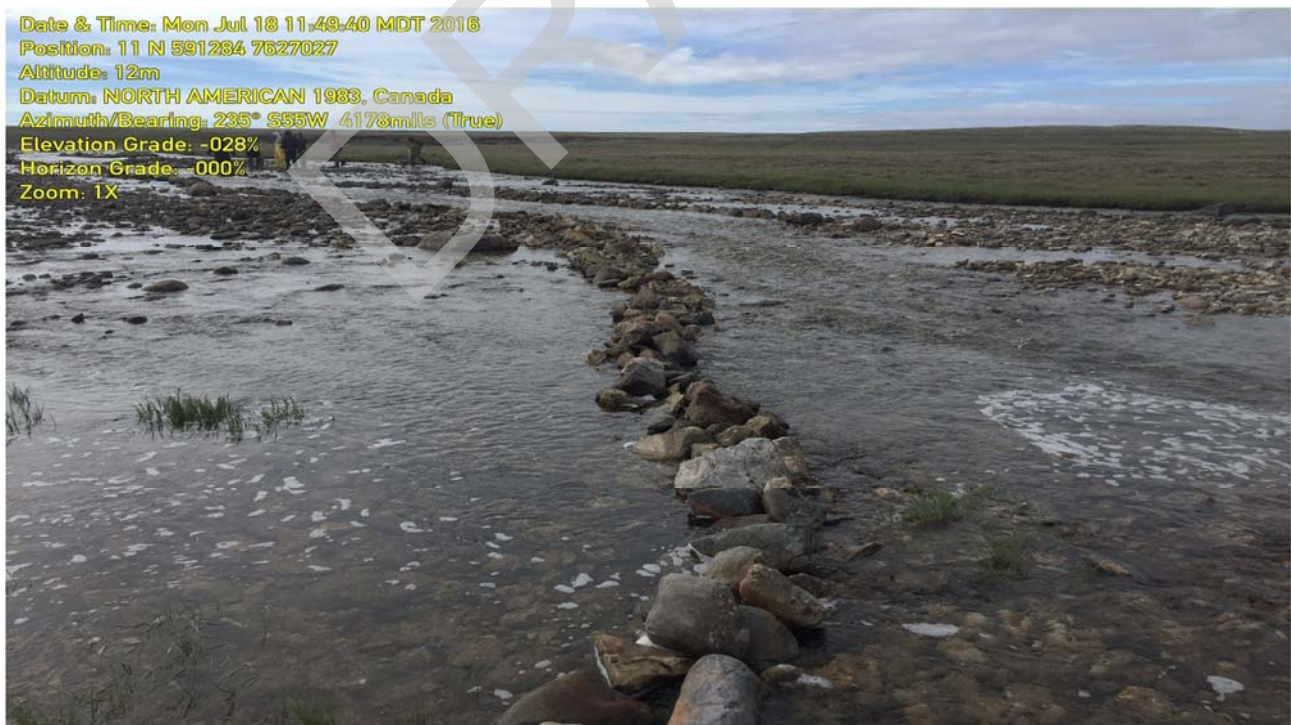
Photo 16: Directional weir B as viewed from the RDB at Site 1, guiding fish away from potential barriers further upstream. 18 July 2016.

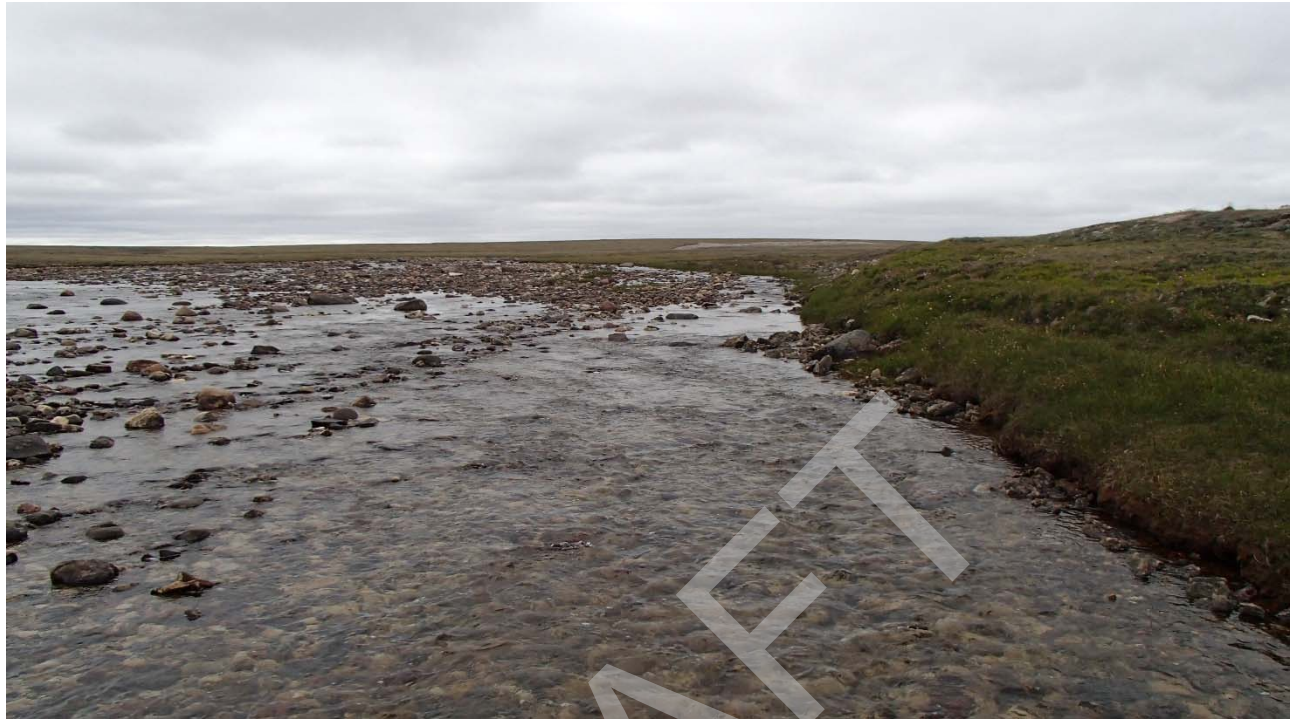
*Photo 17: Facing upstream along the LDB at the downstream extent of Site 2 prior to remediation. Note the barriers to fish passage upstream along the LDB. 18 July 2016.*

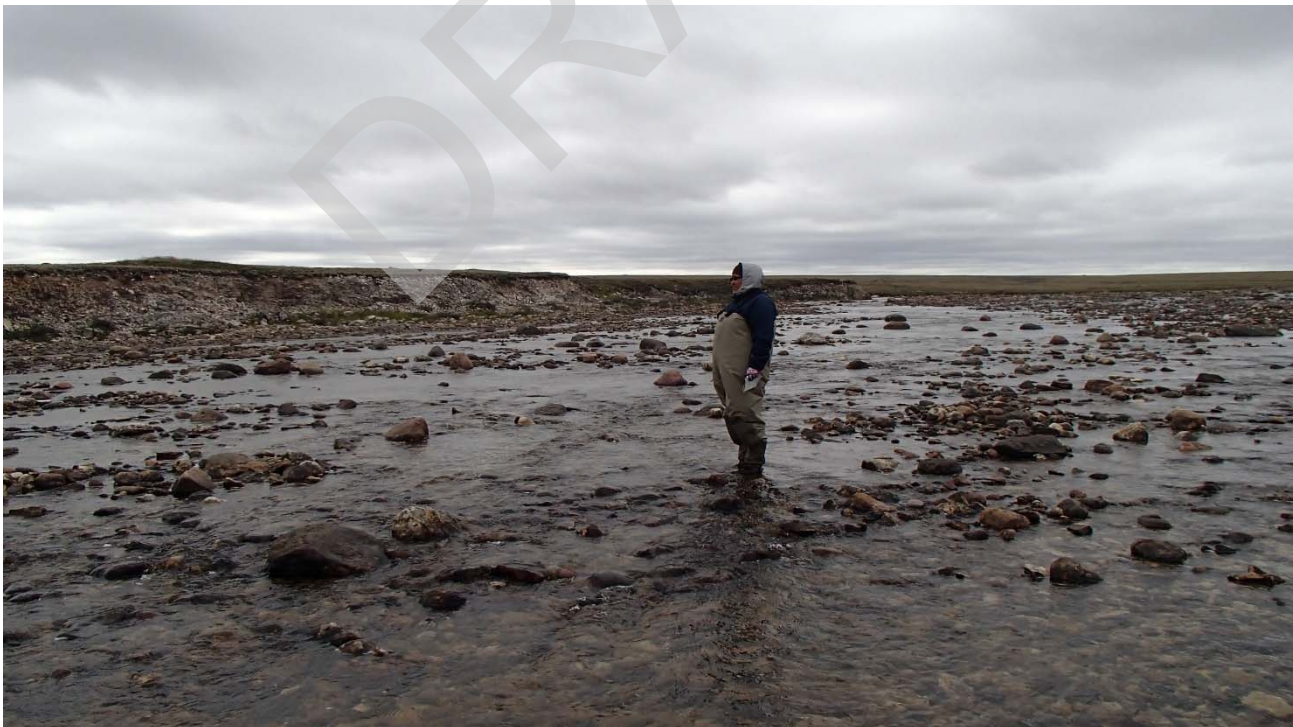
*Photo 18: Upstream view of Site 2 prior to remediation. Note the exposed substrate located directly behind the local field assistant. 18 July 2016.*

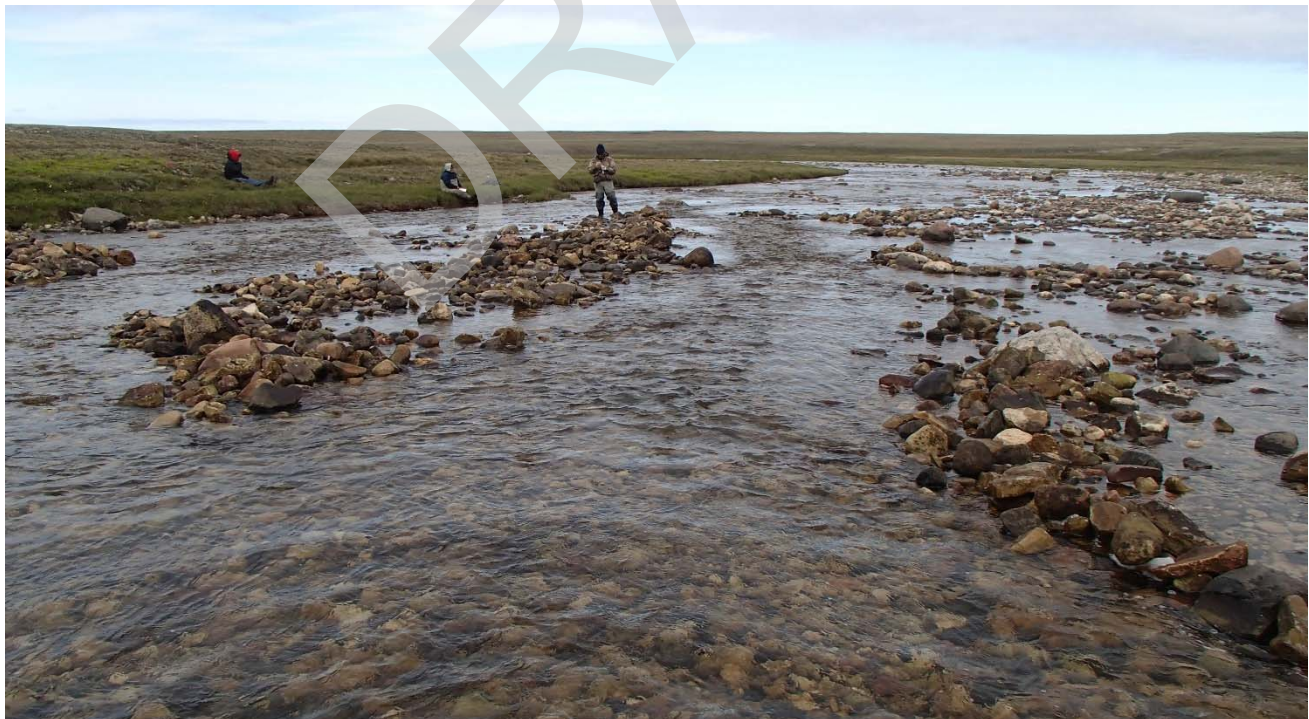
*Photo 20: Downstream view of low-flow channels constructed at Site 2. Note the natural cobble bar which was utilized to separate the two channels. 18 July 2016*

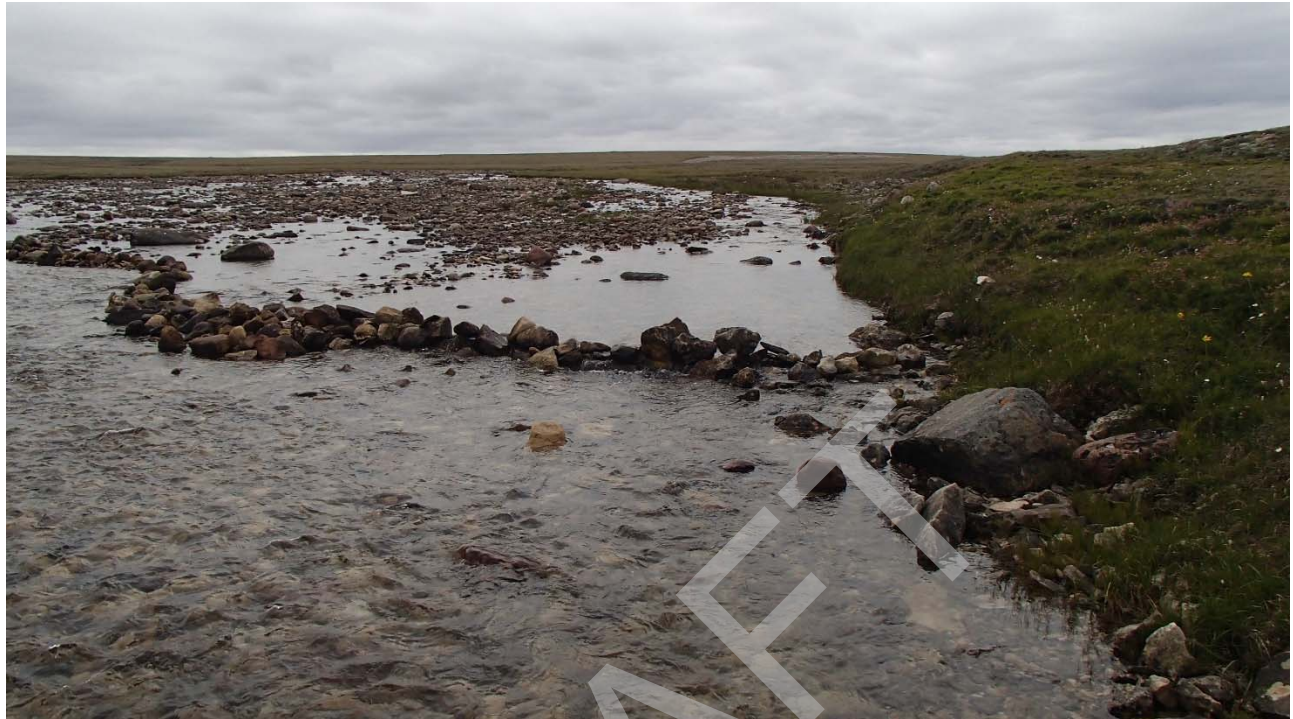
*Photo 21: Upstream view of weir A constructed at Site 2 to direct fish passage away from the LDB where flows diminish further upstream. 18 July 2016.*

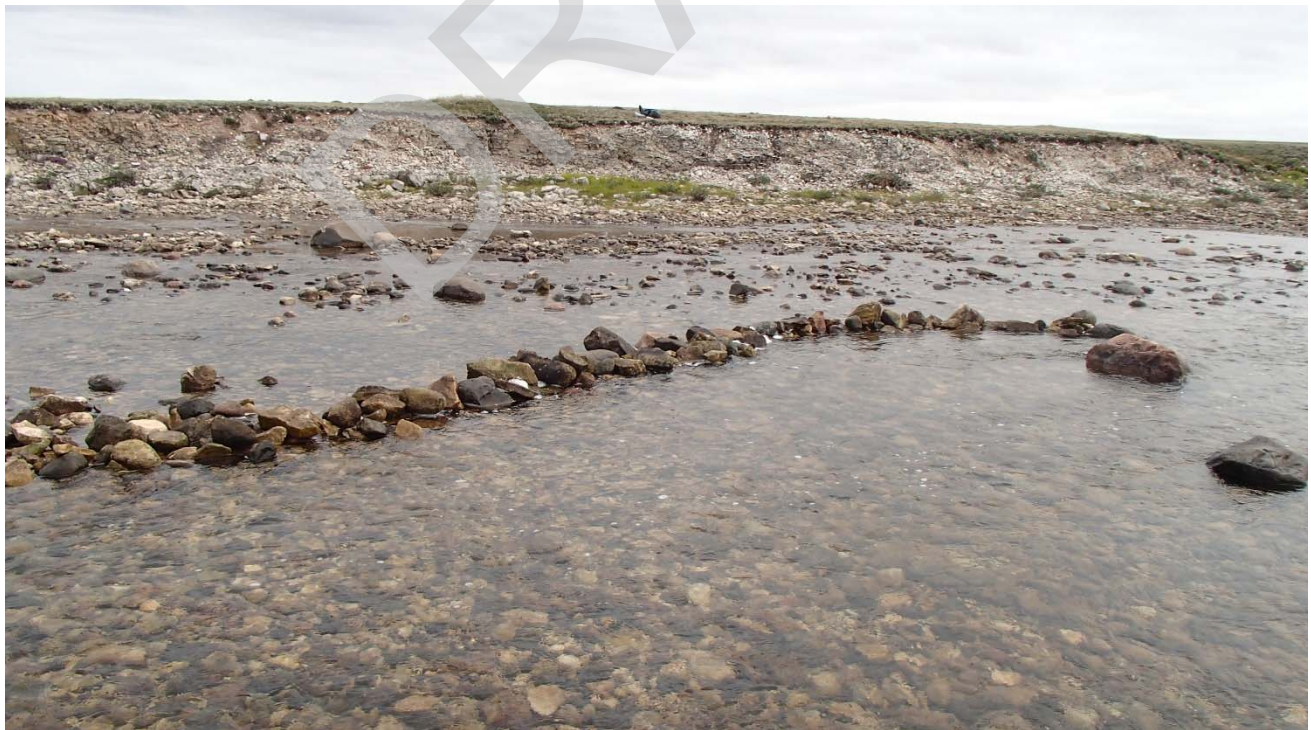
*Photo 22: Directional weir B at the upstream extent of low-flow channel B at Site 2, constructed to direct flows towards the low-flow channel. 18 July 2016.*

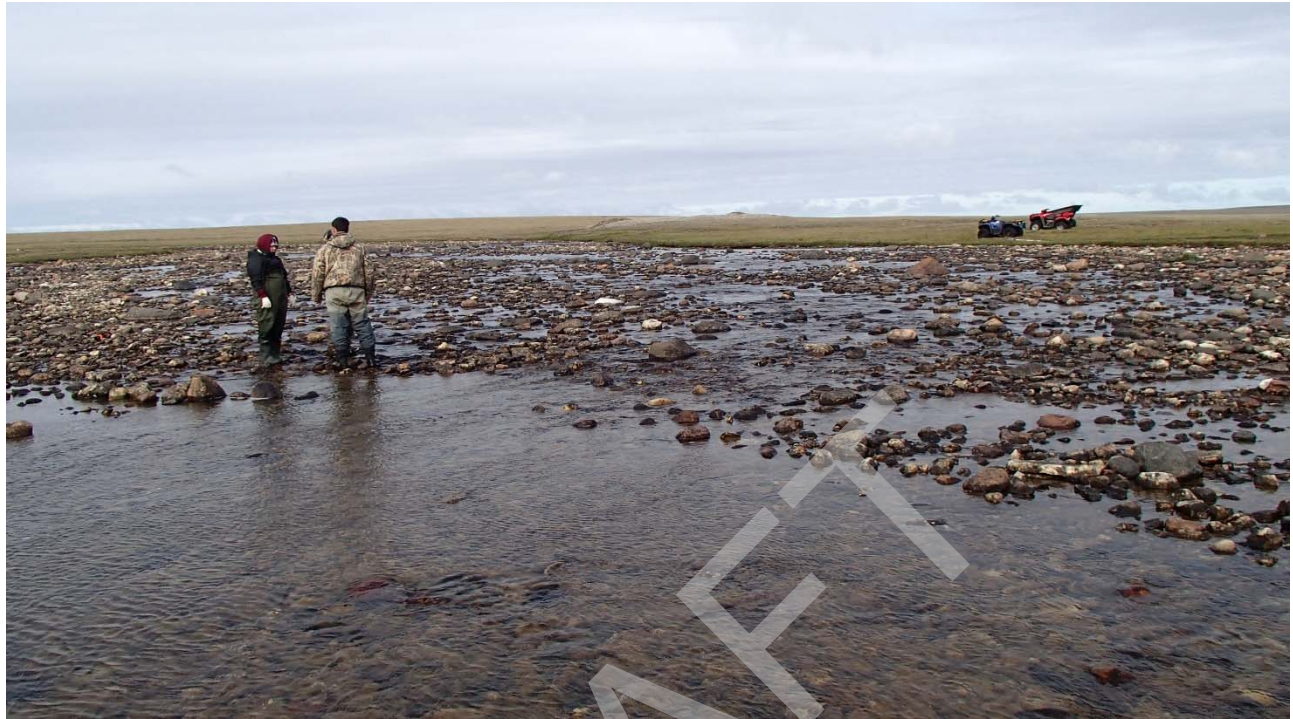
*Photo 23: Upstream view of Site 3 prior to remediation showing dispersed flow with no clearly defined thalweg. 19 July 2016.*

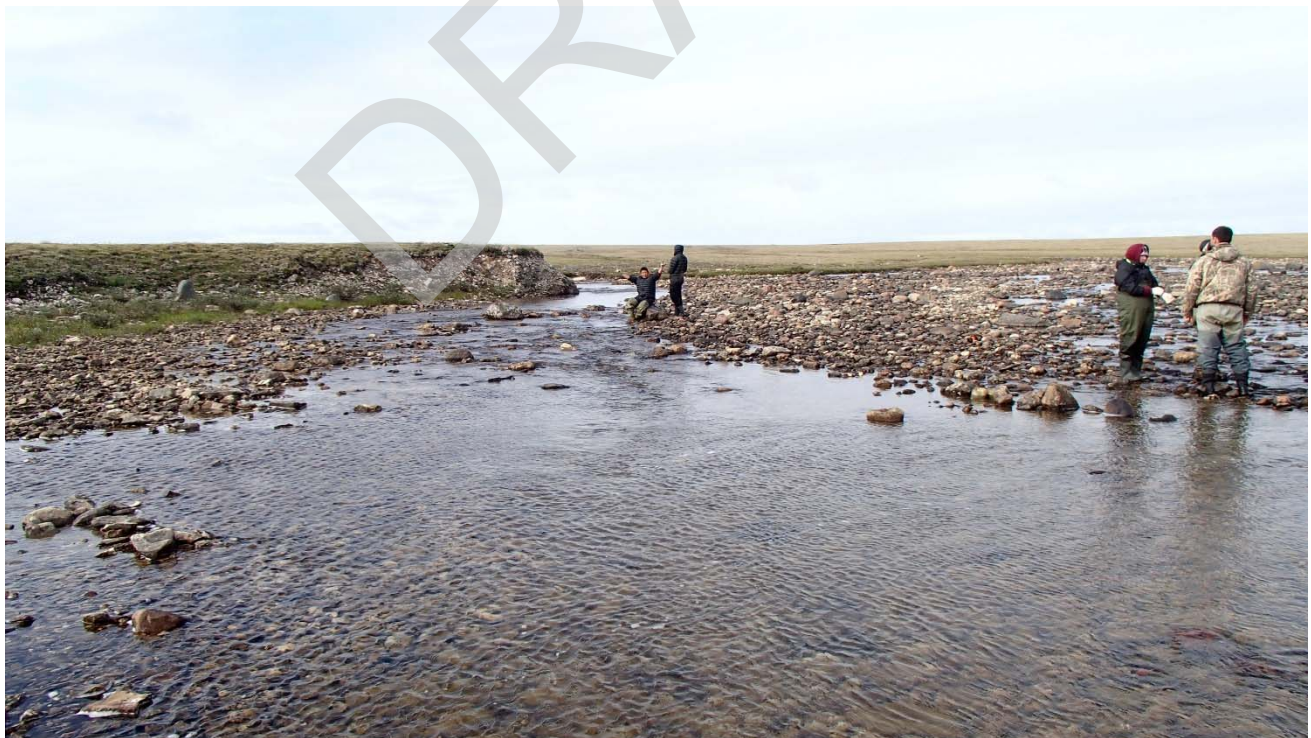
*Photo 24: Upstream view of Site 3 prior to remediation showing the clearly defined thalweg present along the RDB. 19 July 2016.*

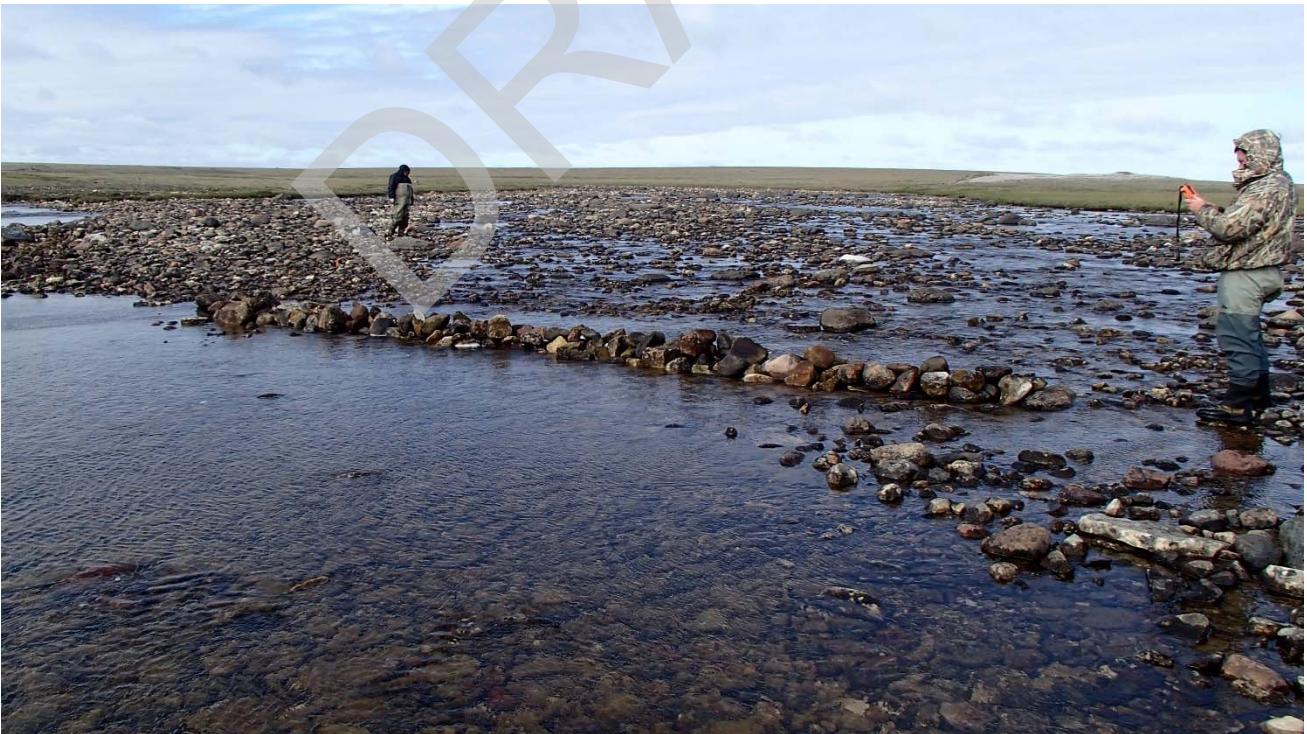
*Photo 26: Upstream view of weir A constructed at Site 3 to deter fish migration along the LDB where stranding is likely. 19 July 2016*

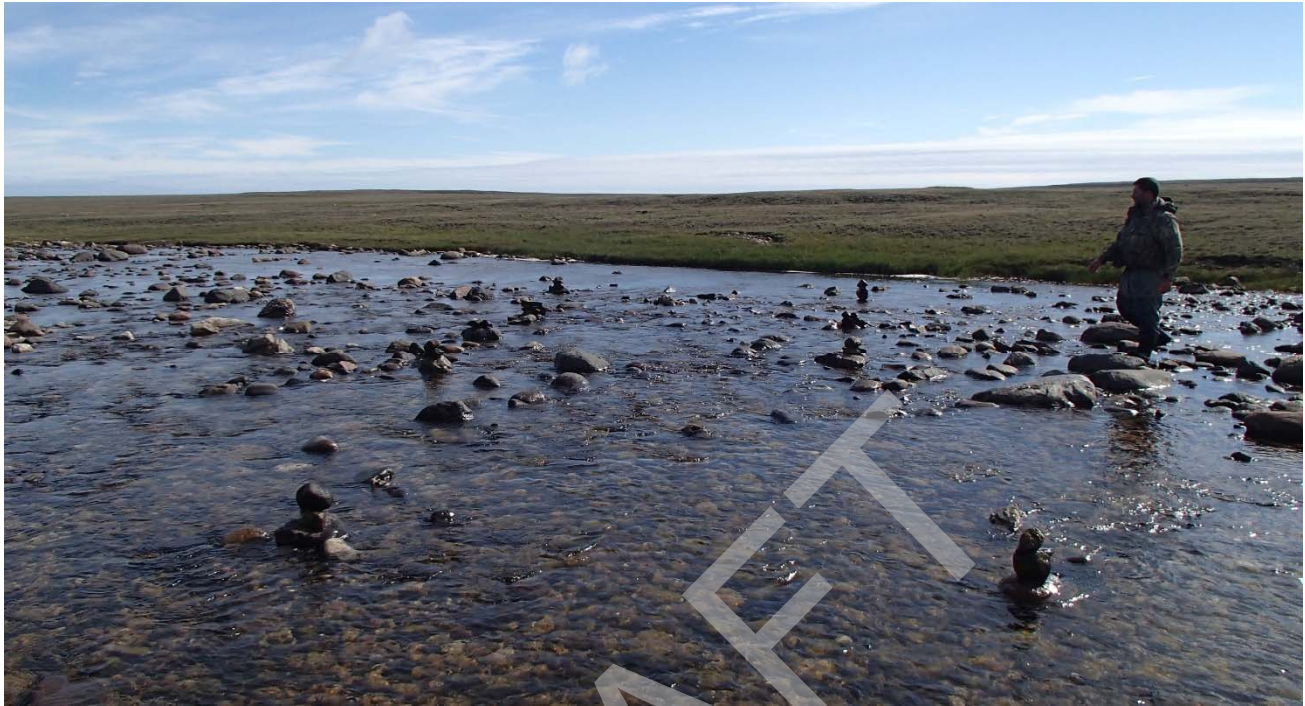
*Photo 27: Downstream view of Site 4 prior to remediation, showing dispersed flow with no clearly defined thalweg. 19 July 2016.*

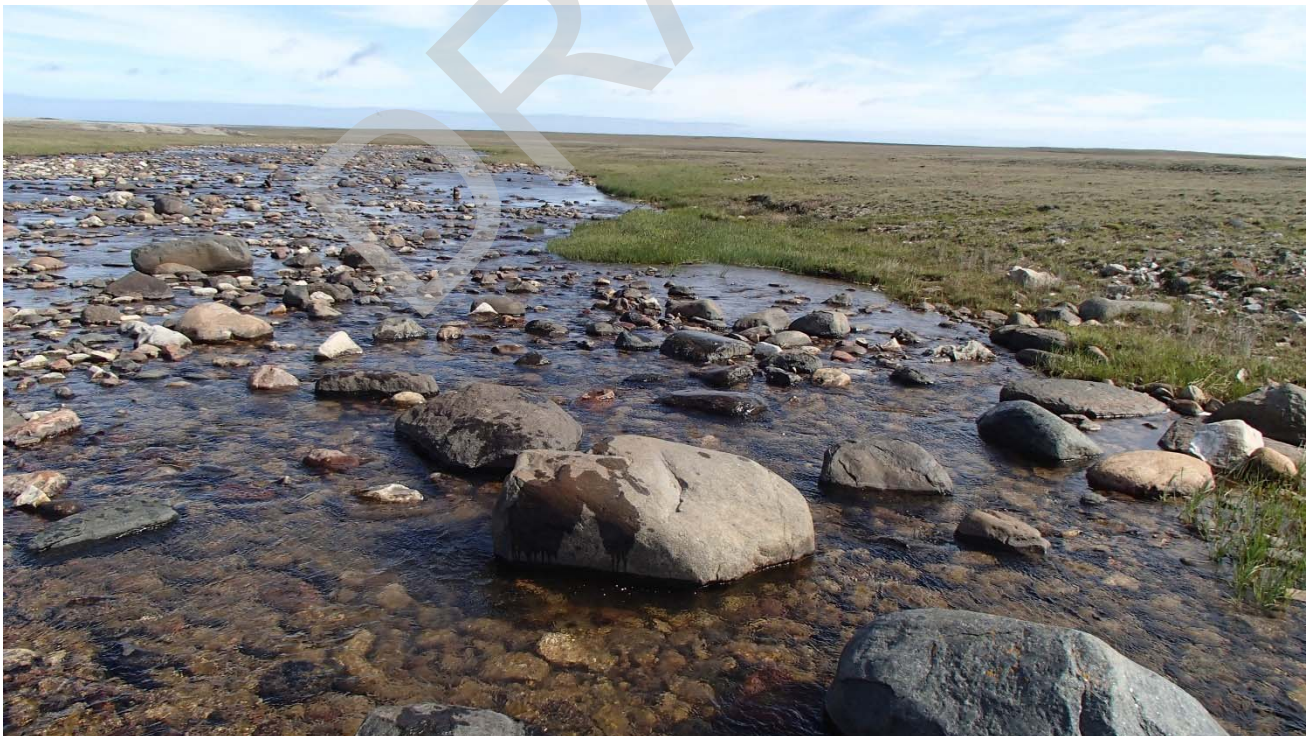
*Photo 28: Downstream view from the upstream extent of Site 4 prior to remediation. Note the dispersed flow and lack of a clearly defined thalweg. 19 July 2016.*

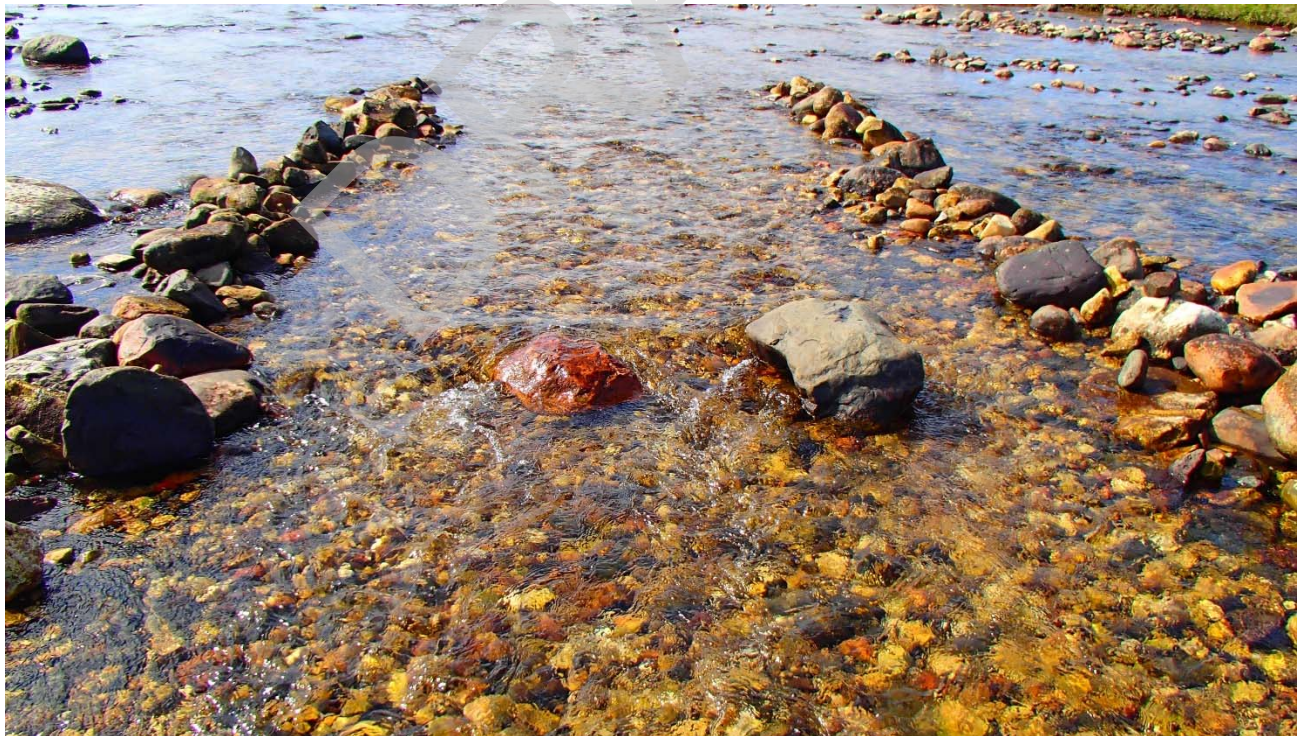
*Photo 32: Upstream view of low-flow channel B constructed at Site 4, showing boulders placed within the channel to provide cover for migratory fish. 19 July 2016.*

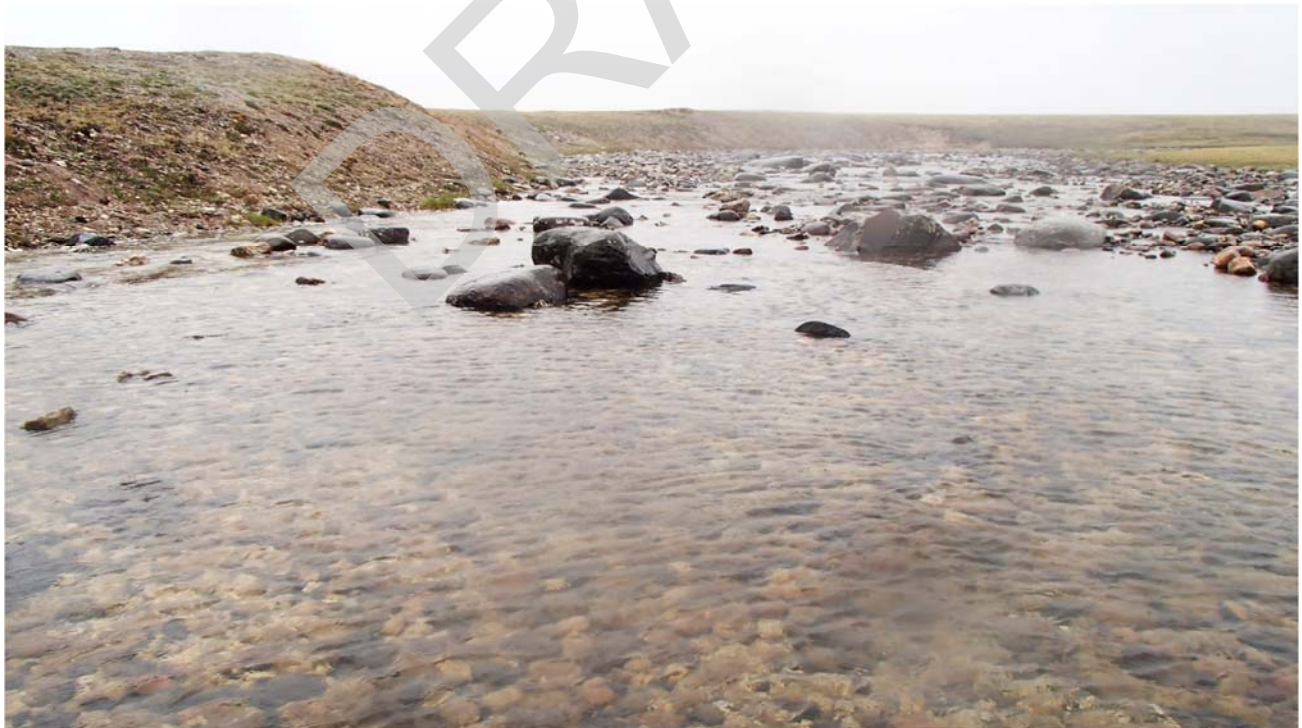
*Photo 34: Upstream view of the pool at the upstream extent of Site 5, showing suitable refuge for migratory fish during periods of low flow. 20 July 2016.*

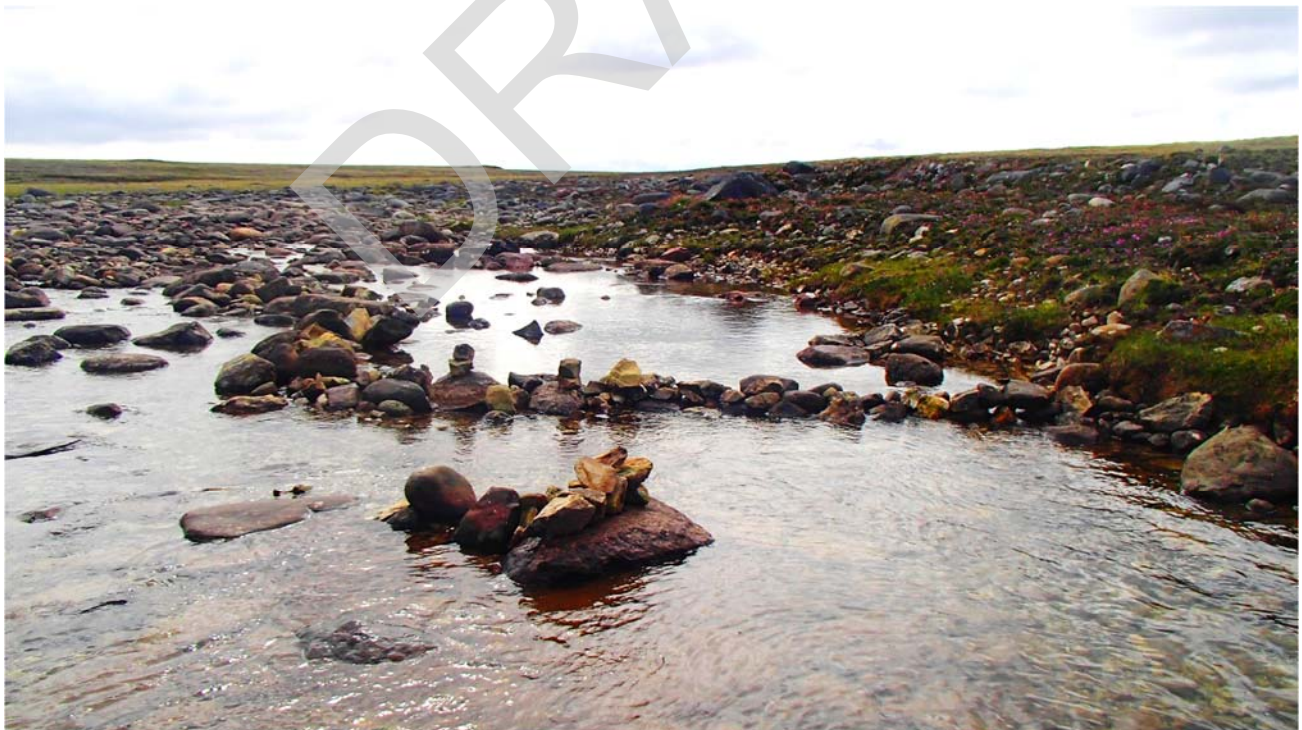
*Photo 36: Upstream view of the directional weir at Site 5 to direct fish away from dry sections of the LDB. 20 July 2016.*

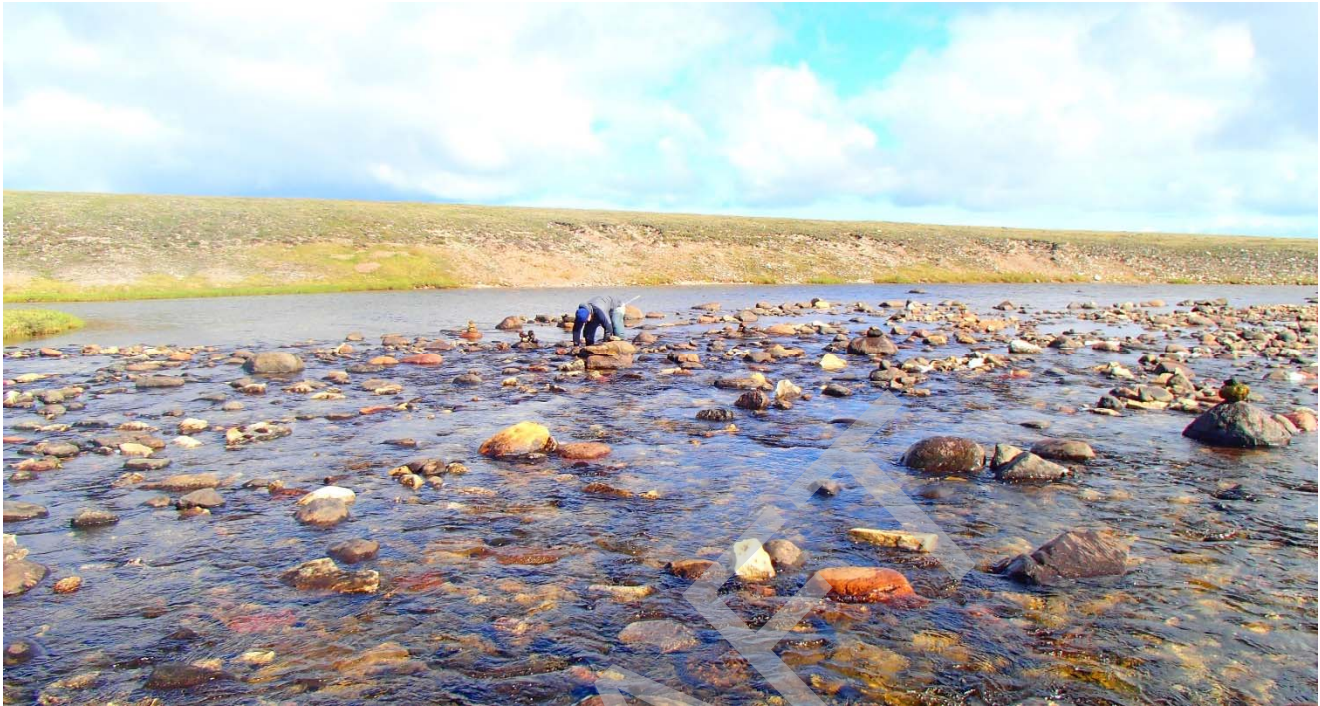
*Photo 37: Downstream view of Site 6 prior to remediation. Note the lack of a discernible channel connecting the large pool at the downstream extent of the problem area. 21 July 2016.*

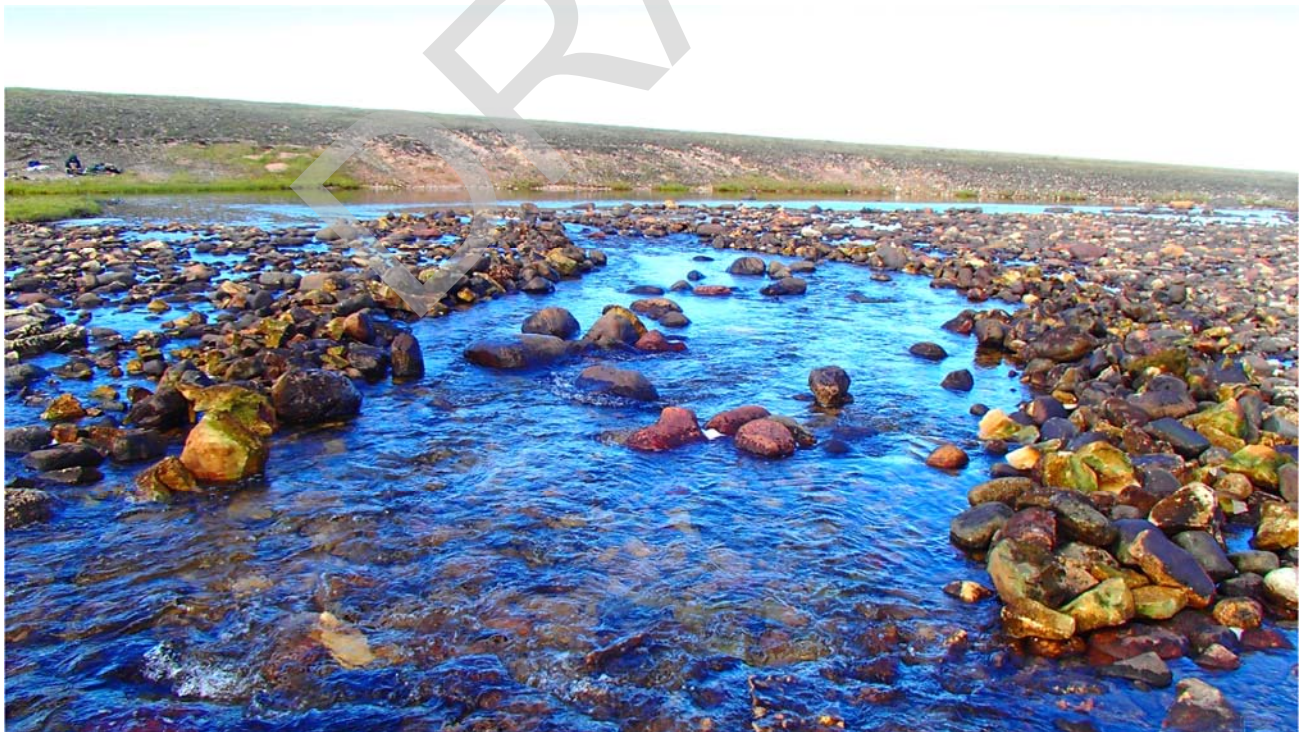
*Photo 38: Downstream view of the low-flow channel at Site 6. This low-flow channel provides passage from the large pool located at the downstream extent of Site 6 to upstream locations. 21 July 2016.*

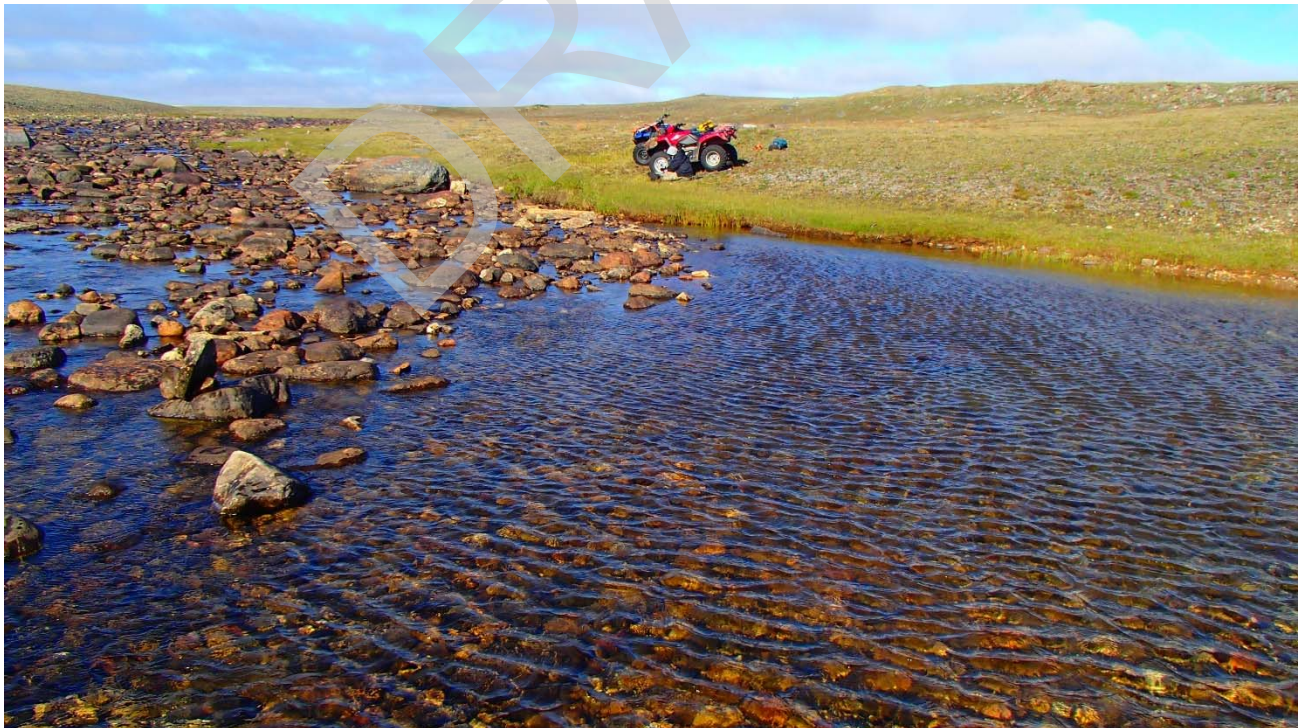
*Photo 40: Upstream view from the pool located along the LDB at the downstream extent of Site 7 prior to remediation. Note the absence of an unobstructed path for fish along the LDB. 24 July 2016.*

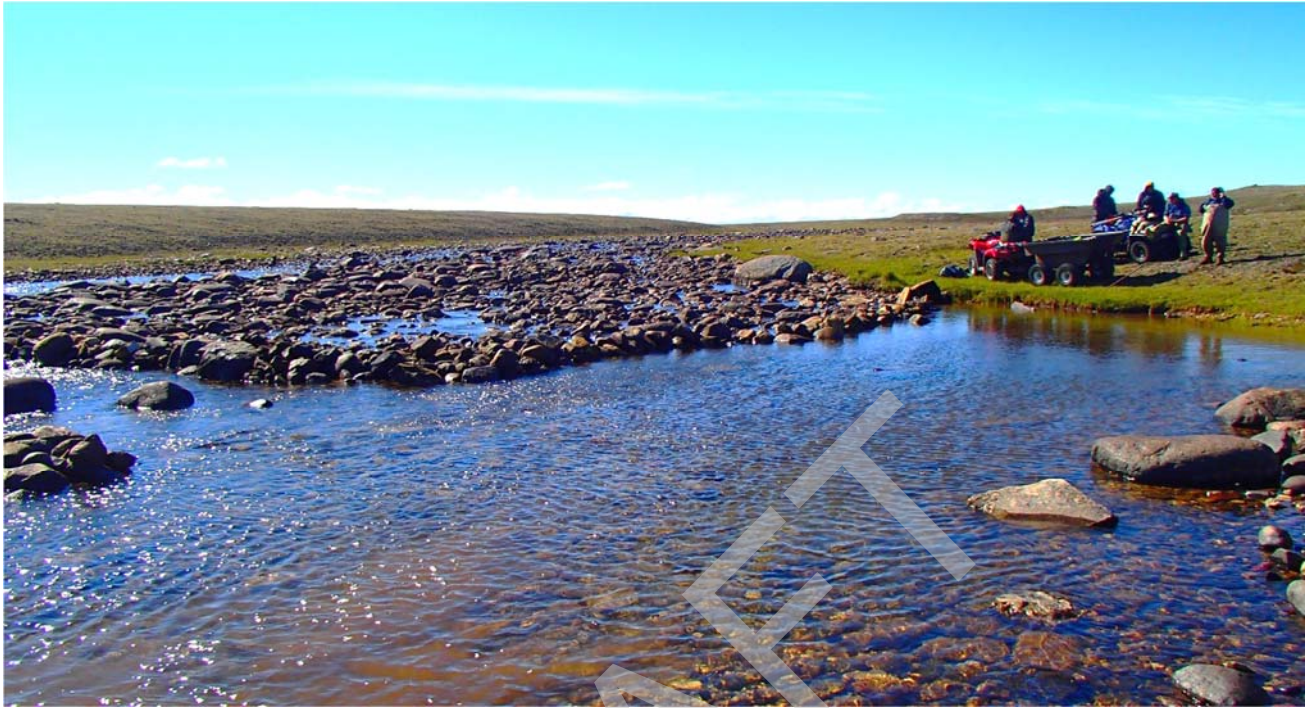
*Photo 43: Upstream view from the pool along the LDB at the downstream extent of Site 7 post- remediation. Note weir A directing migratory passage towards the low-flow channels and away from the problem area along the LDB. 24 July 2016.*

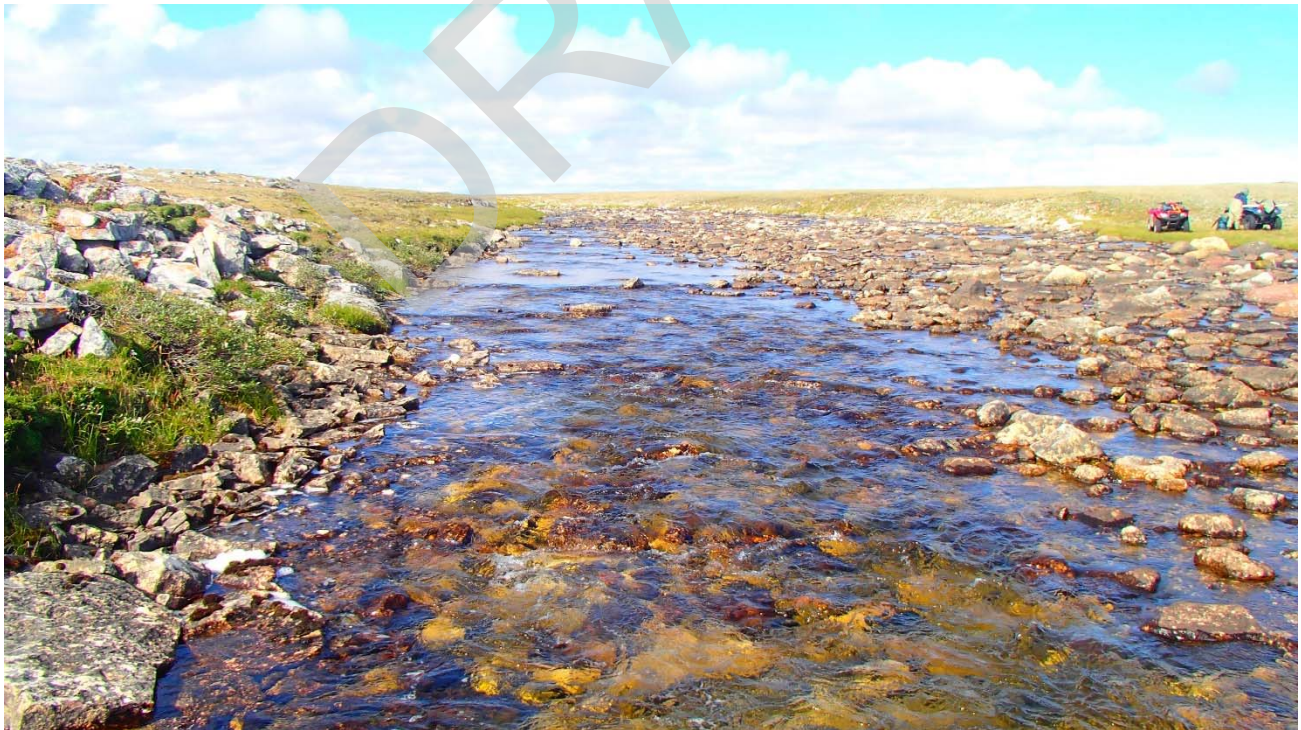
*Photo 44: Upstream view of concentrated flow along the RDB of Site 8 prior to remediation. Note the suitable conditions for fish passage along the RDB but with no connectivity to flows along the LDB. 23 July 2016.*

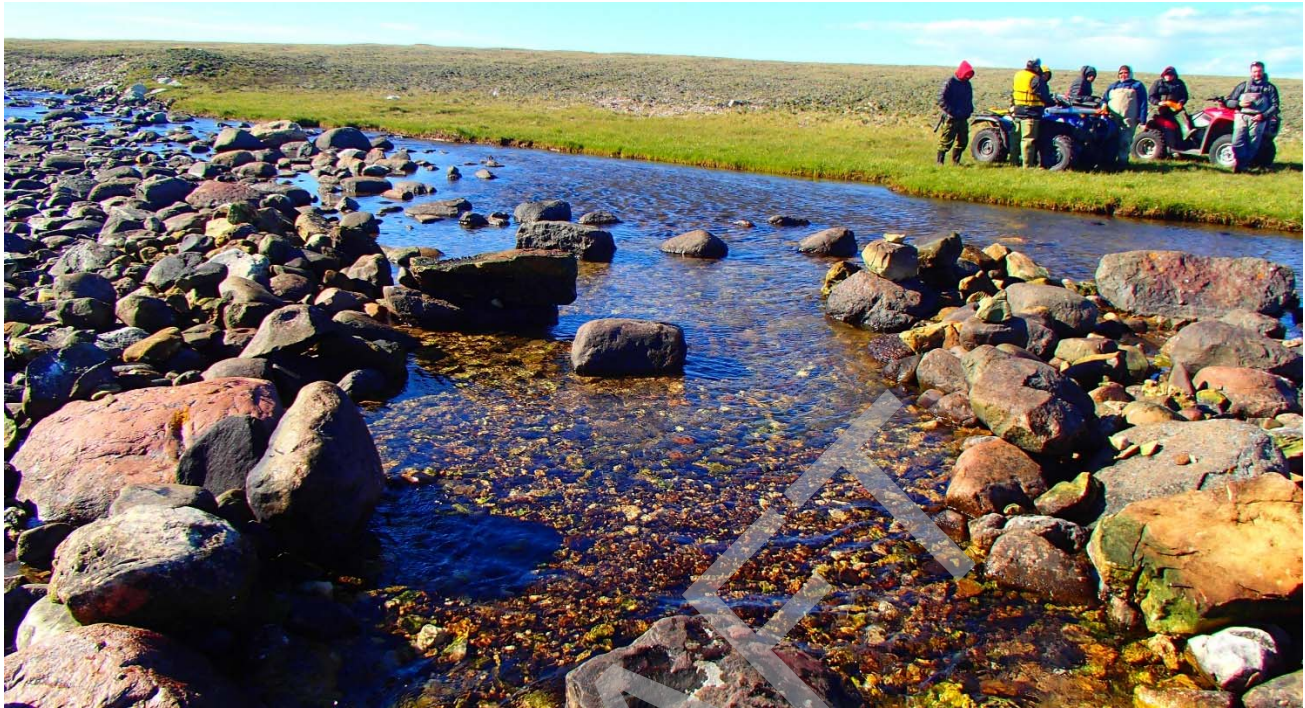
Due to the presence of a clear thalweg along the RDB, the low-flow channel at Site 8 was constructed to provide an alternative passage across the centre of creek (Photo 45 to 46 in Appendix A). The low-flow channel connected to a small pool with suitable flows for fish passage along the LDB. (Photo 45 in Appendix A). Some large boulders were left within the constructed channel to provide refugia for migratory fish (Photo 4-20). Due to the availability of large boulders, the boundaries of the low-flow channel are well armoured and are expected to withstand spring freshet flow conditions.

*Photo 45: Upstream view from centre of the low-flow channel at Site 8. Note the connectivity with the concentrated flow and pool along LDB. 23 July 2016.*

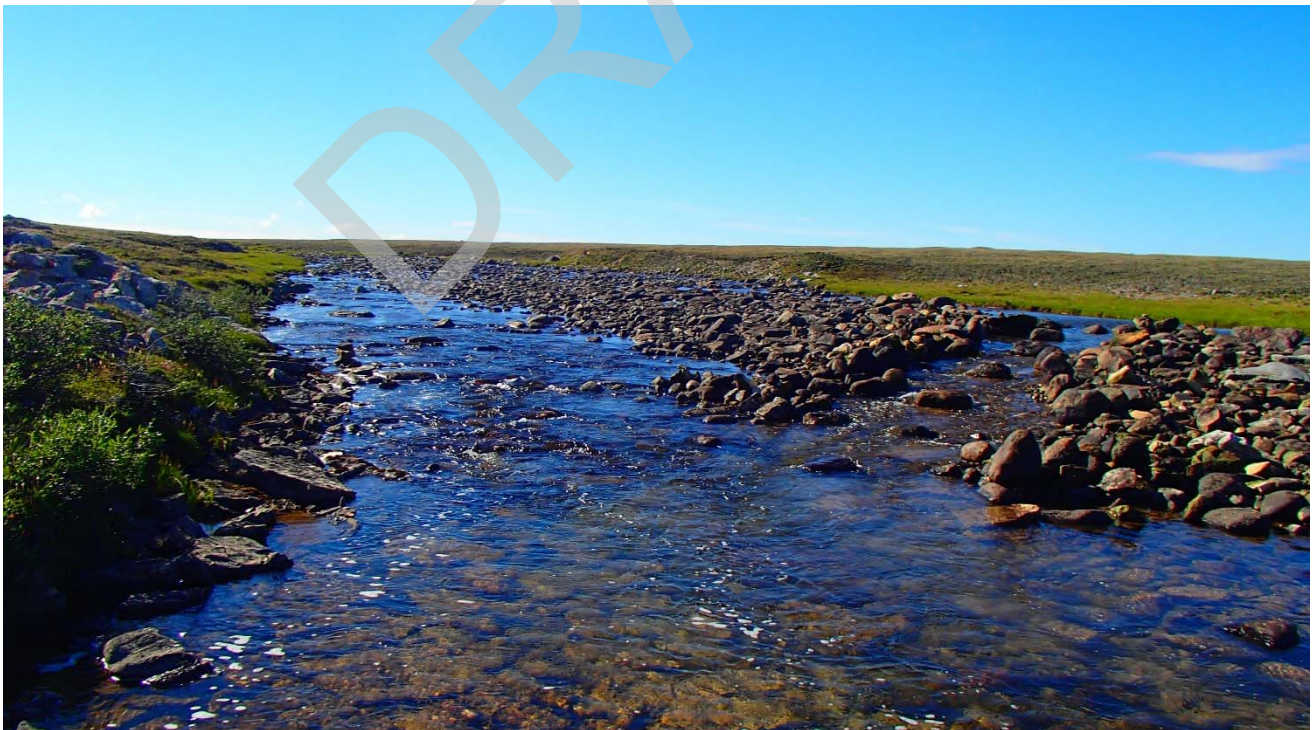
*Photo 46: Upstream view of the low-flow channel at Site 8. The channel provides passage across the creek towards the LDB, with the natural thalweg along the RDB still accessible. 23 July 2016.*
