## BACK RIVER OFFSETTING OPTION

# Nulahugyuk Creek Habitat Remediation

**Submitted to:**  
Sabina Gold & Silver Corp.

Report Number: Doc 009-1545534.4000 Ver 0

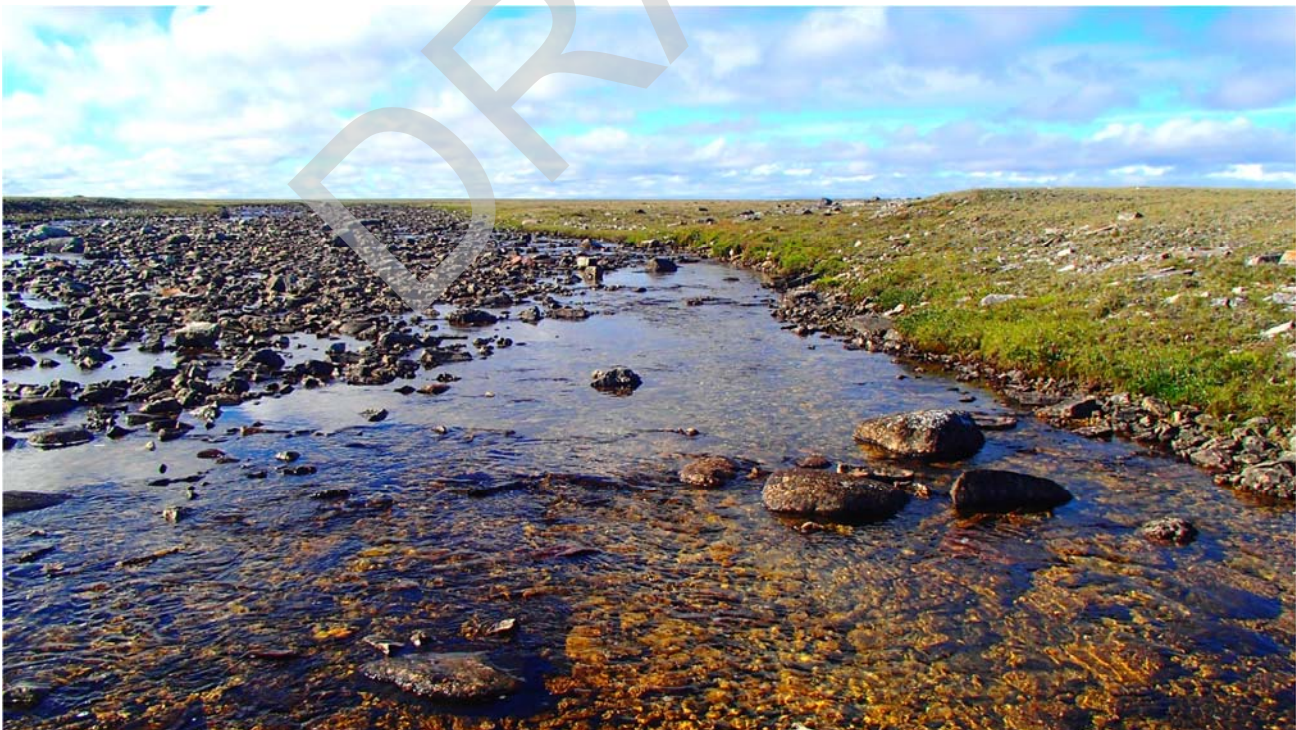
*Photo 48: Upstream view from the downstream extent of Site 9 prior to remediation. Photograph shows diminishing flows and dry streambed upstream along the LDB. 23 July 2016.*

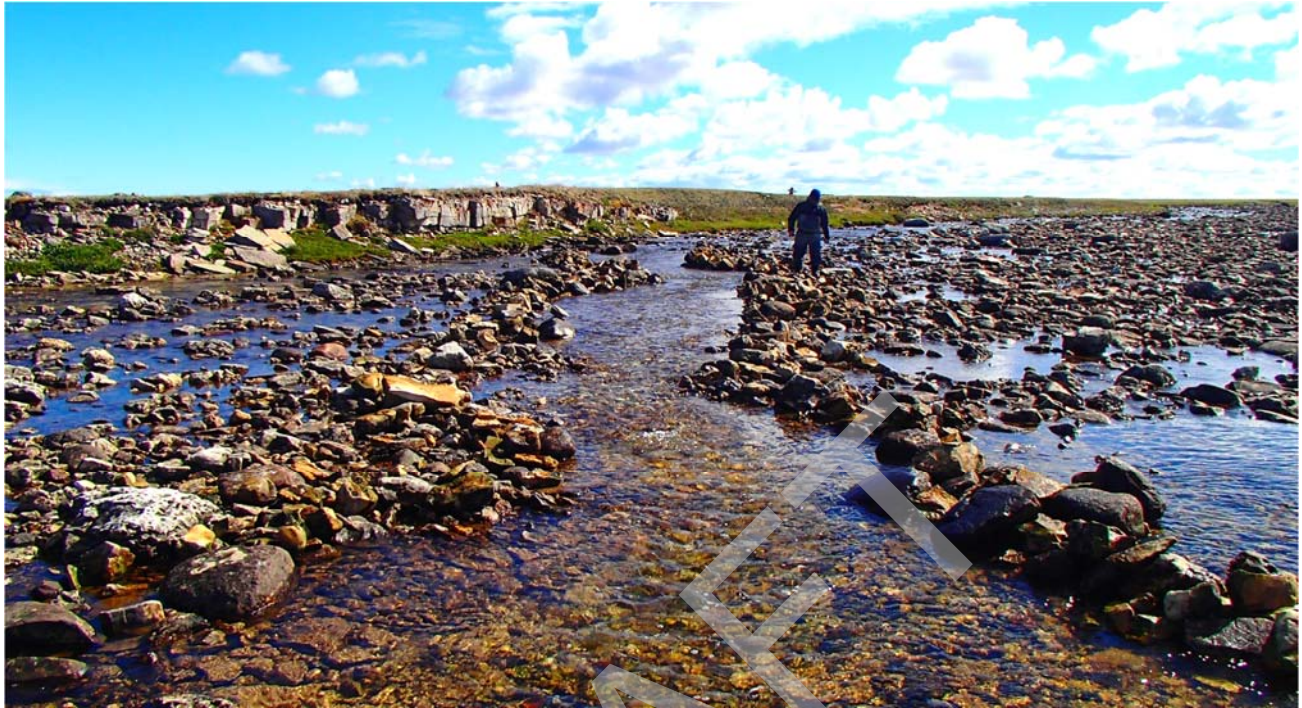
*Photo 49: Upstream view of the low-flow channel constructed at Site 9, which created a clear route towards flows along the RDB. 23 July 2016.*

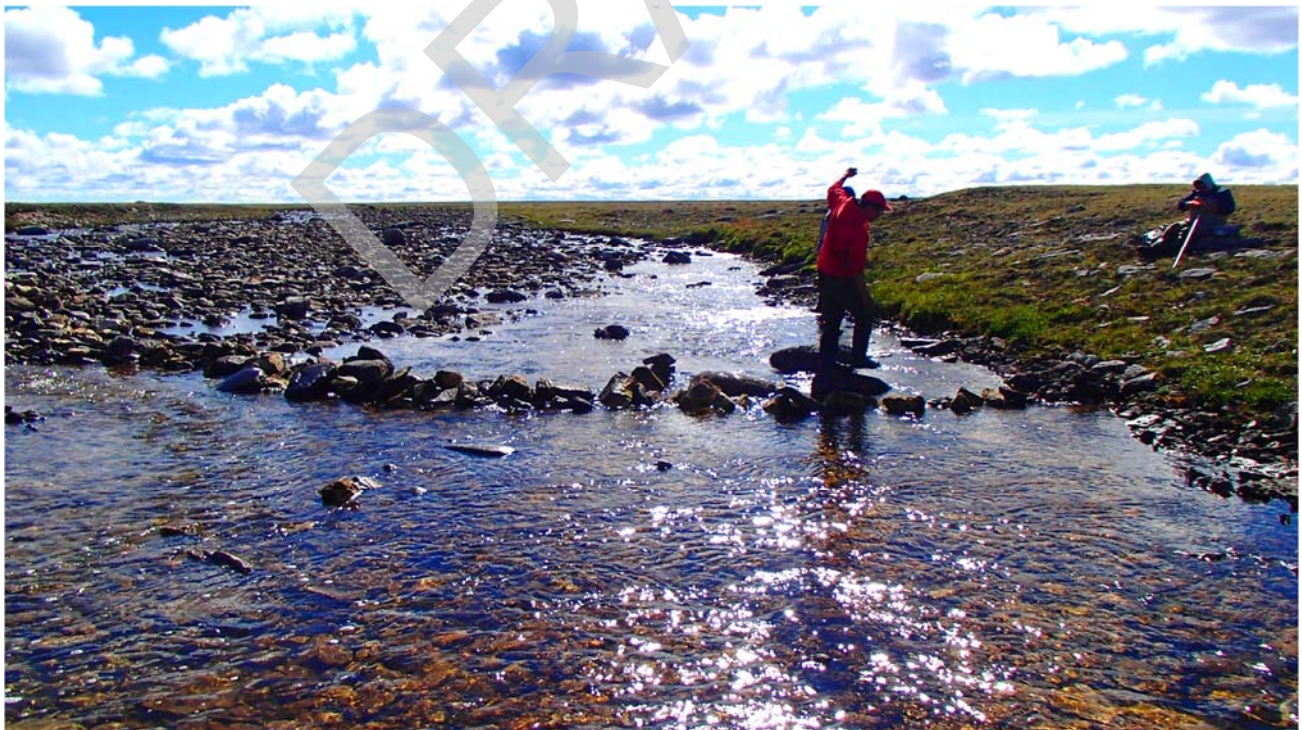
*Photo 50: Upstream view from the downstream extent of Site 9 post-remediation. Photograph shows the directional weir constructed to deter passage along the LDB and to direct migration towards the low-flow channel. 23 July 2016.*

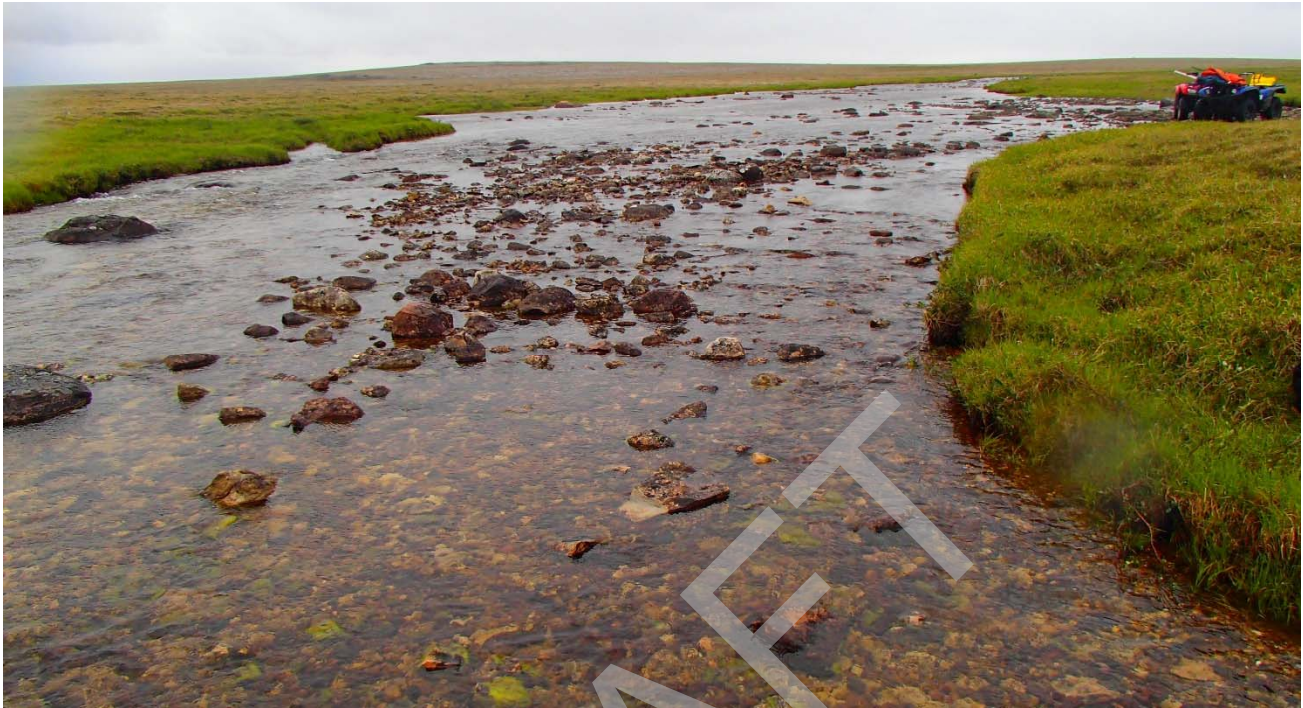
*Photo 51: Upstream view of Site 10 prior to remediation. Note the dispersed flow and cobble bars. 22 July 2016.*

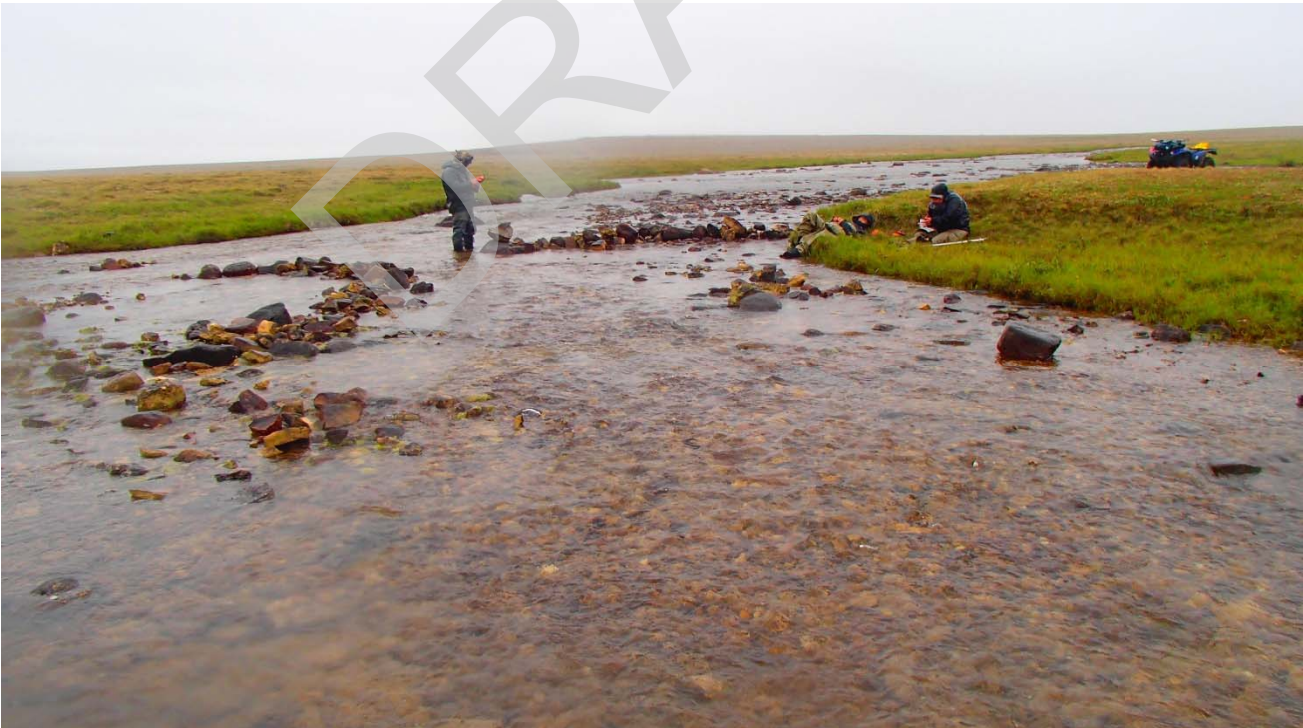
*Photo 52: Upstream view of low-flow channel C and weir A constructed at Site 10. The channel provides passage toward the thalweg and the weir directs fish towards the RDB. 22 July 2016.*

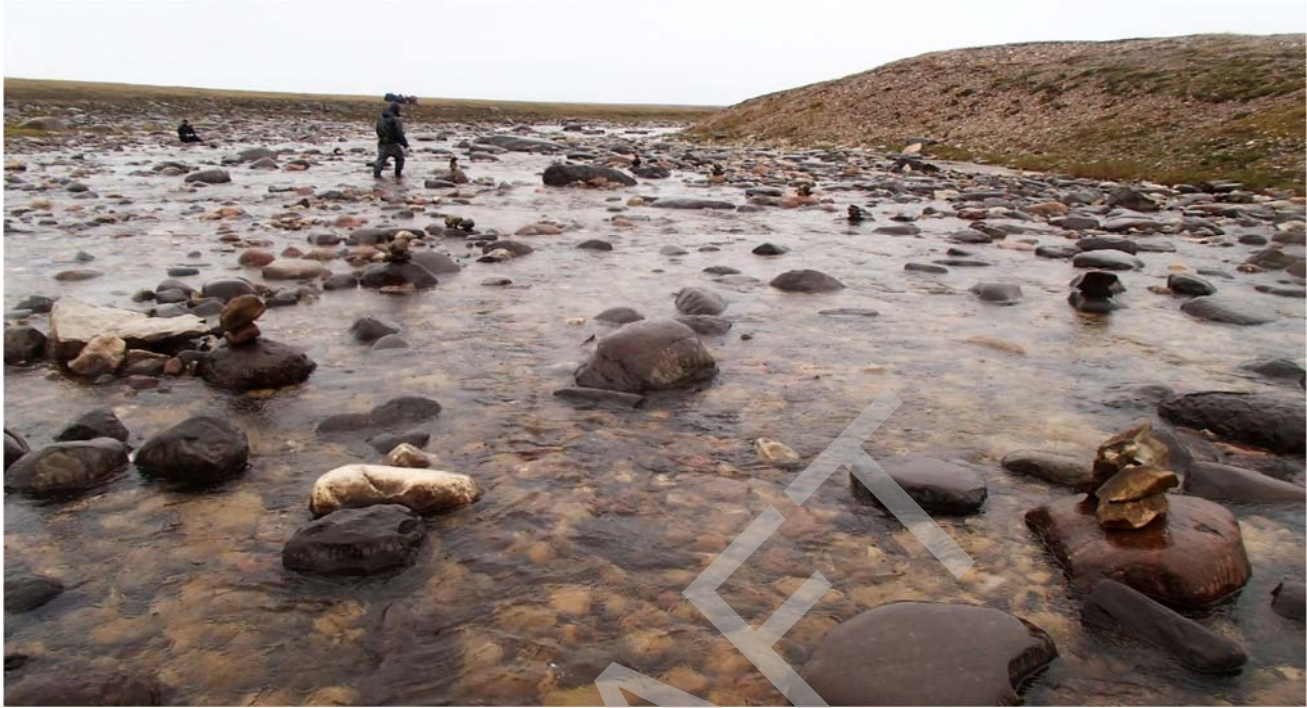
*Photo 53: Downstream view of Site 11 prior to remediation. Note the dispersed flow and lack of clear migratory routes for fish. 20 July 2016.*

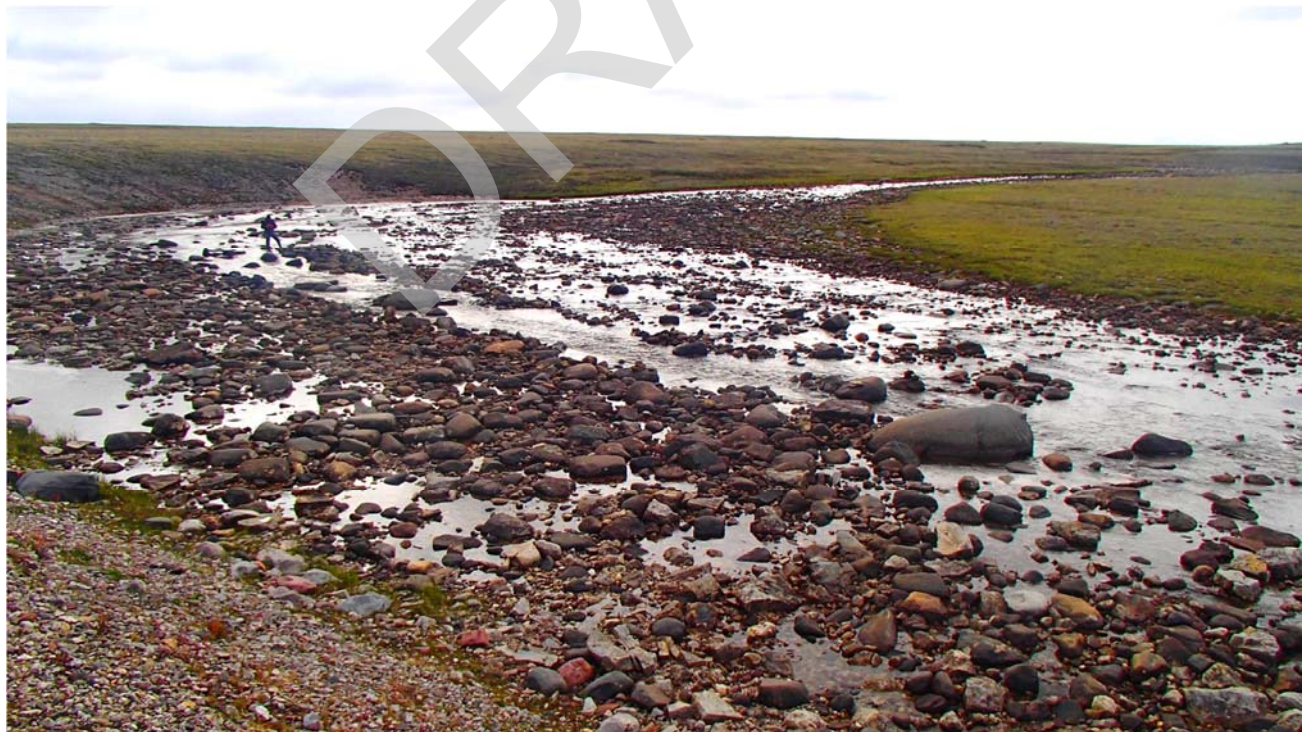
The low-flow channel at Site 11 was constructed within the centre of the creek where flows were concentrated. The channel connected a small pool at the downstream extent to a deep run habitat unit at the upstream extent (Photo 54 in Appendix A; Photo 4-26). Some boulders were too large to be relocated and were left within the constructed channel to provide refugia for migratory fish (Photo 55 in Appendix A). Due to the availability of large boulders, the boundaries of the low-flow channel are well armoured and are expected to withstand spring freshet flow conditions.

*Photo 54: Upstream view from above the RDB of the low-flow channel constructed at Site 11. The low-flow channel provides an unobstructed path for fish through the centre of creek. 20 July 2016.*

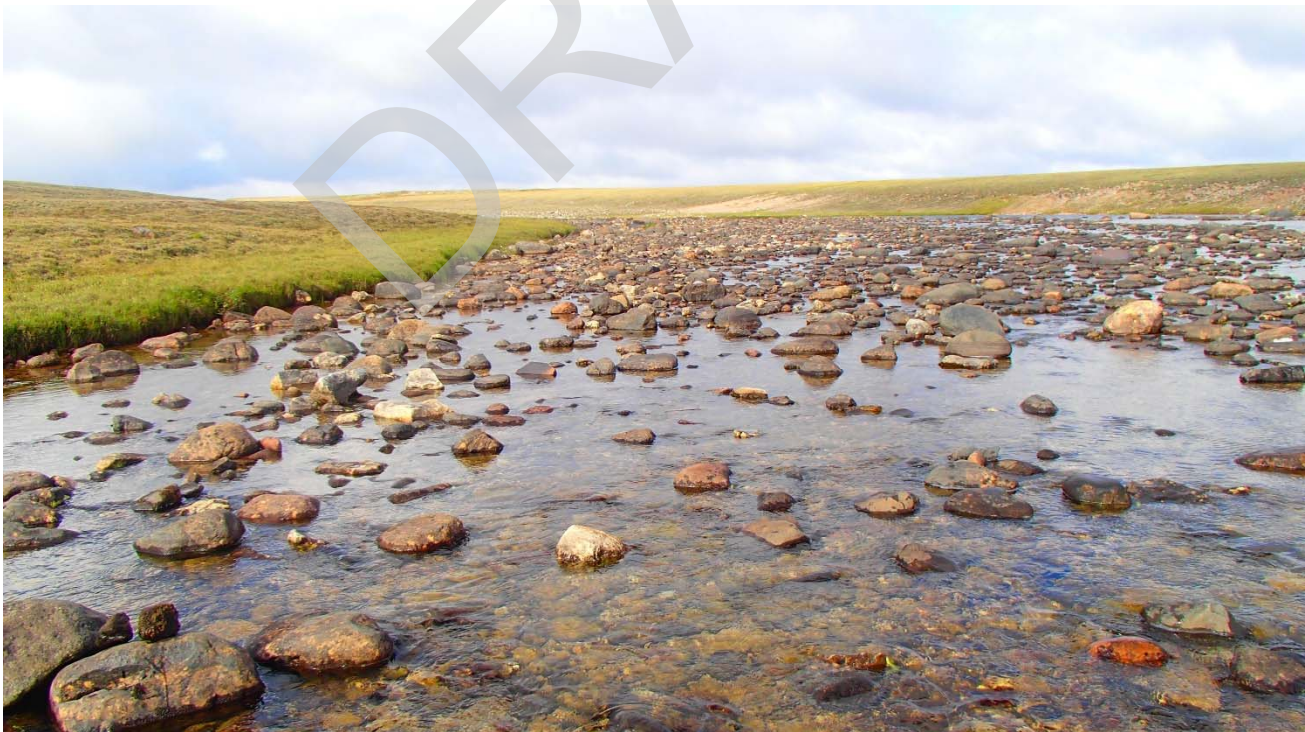
The problem area was within a stream section approximately 33 m wide, located downstream of a sharp bend in the river, and was characterized by run habitat and a dominance of cobble/boulder substrates. Flows were dispersed across the centre of creek, with some flow concentrated along the LDB of channel at the upstream extent and near the RDB at the downstream extent. Run habitat suitable for fish passage was noted along the LDB and RDB. There was no continuous unobstructed route for fish passage upstream along the RDB and towards the centre of the creek due to lack of depth, and the presence of a boulder garden with several sections of dry streambed. Site 12 was ranked as a risk level 1-lowest priority for remediation. See Photo 4-27 and Photo 56 in Appendix A.

*Photo 56: Upstream view of Site 12 prior to remediation. Note the absence of an unobstructed path for fish along the RDB. 21 July 2016.*

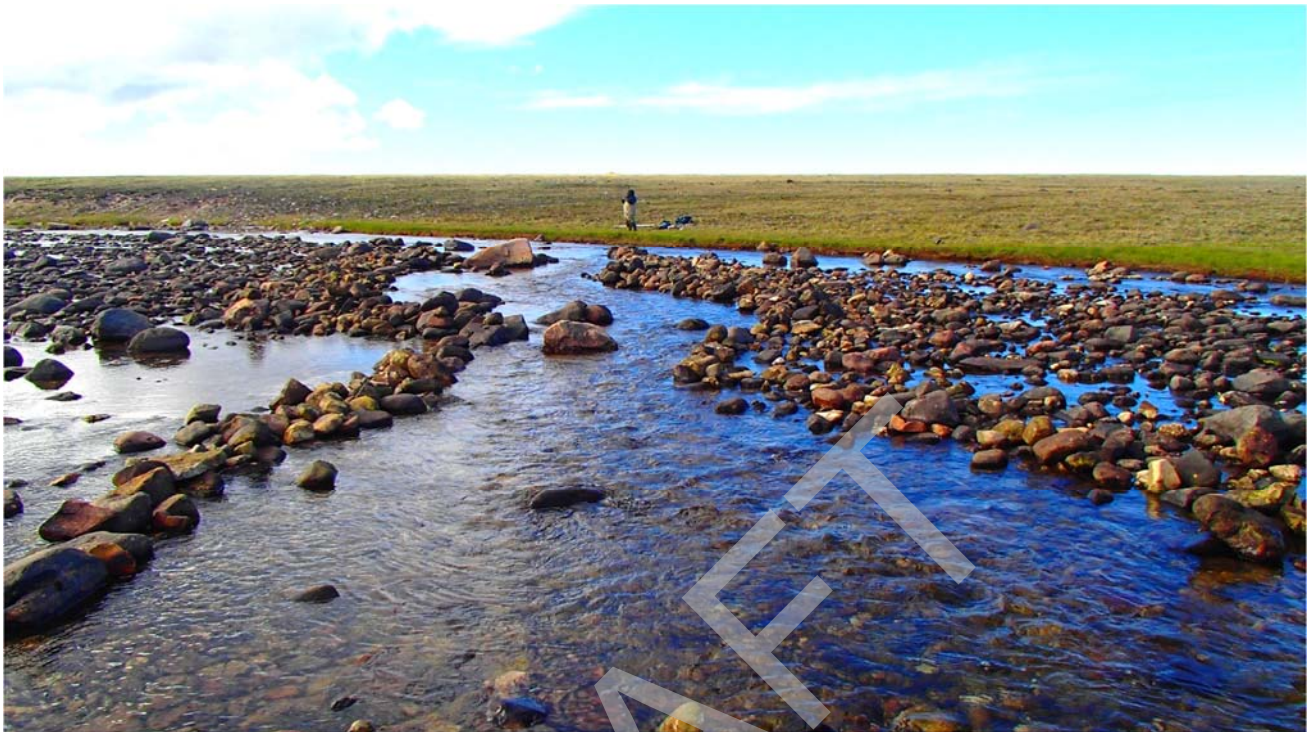
*Photo 57: Upstream view of the low-flow channel constructed at Site 12, connecting suitable habitats to the LDB. Note the large boulders left within the channel to act as cover for migratory fish. 21 July 2016.*

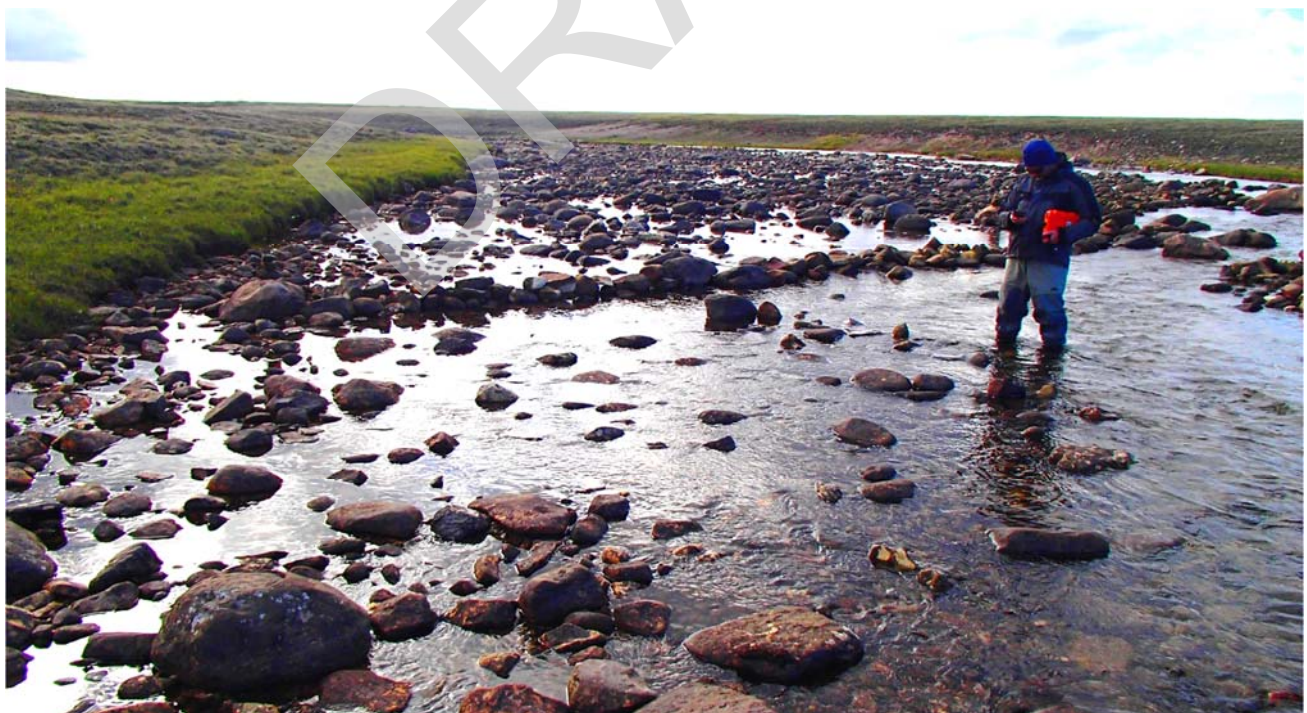
*Photo 58: Upstream view of weir A constructed at Site 12 to direct fish towards the constructed low-flow channel and away from the dry streambed along the RDB. 21 July 2016.*
