**DATE** December 20, 2017**PROJECT No.** 1776921\_023\_TM\_RevA**TO** Matthew Pickard  
Sabina Gold & Silver Corp.**CC** Merle Keefe, Dionne Filiatrault, Jen Range**FROM** Cam Stevens and Ashley Eckford**EMAIL** cestevens@golder.com**2017 BERNARD HARBOUR REMEDIATION SITE INSPECTION**

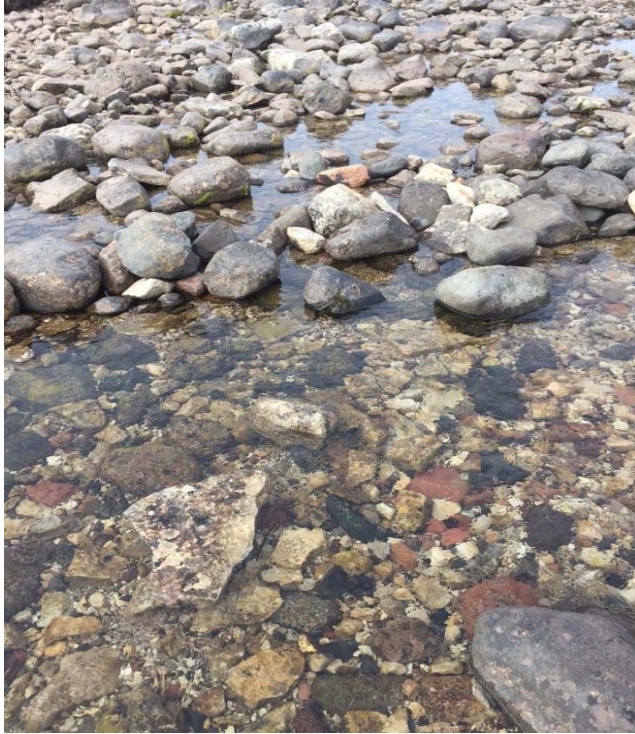
The photos below are examples of the pre- and post-remediation efforts of displaced directional weirs that were repaired during the field program. At Site 12, (Photos 1 and 2; Photos 35 and 36 in Appendix A) boulders were displaced from a directional weir that blocked access to the shallow right downstream bank and directed fish passage towards the low-flow channel. Repair efforts repositioned the boulders and strengthened the weir to restore its function. A similar repair was completed at Site 1 where boulders were displaced from a directional weir (Photos 3 and 4; Photos 1 and 2 in Appendix A). The boulders were repositioned into the weir to better direct fish passage into the low-flow channel and away from the shallow right downstream bank.

**Photo 1:** Upstream View of the Directional Weir at Site 12, Pre-Remediation, 26 July 2017

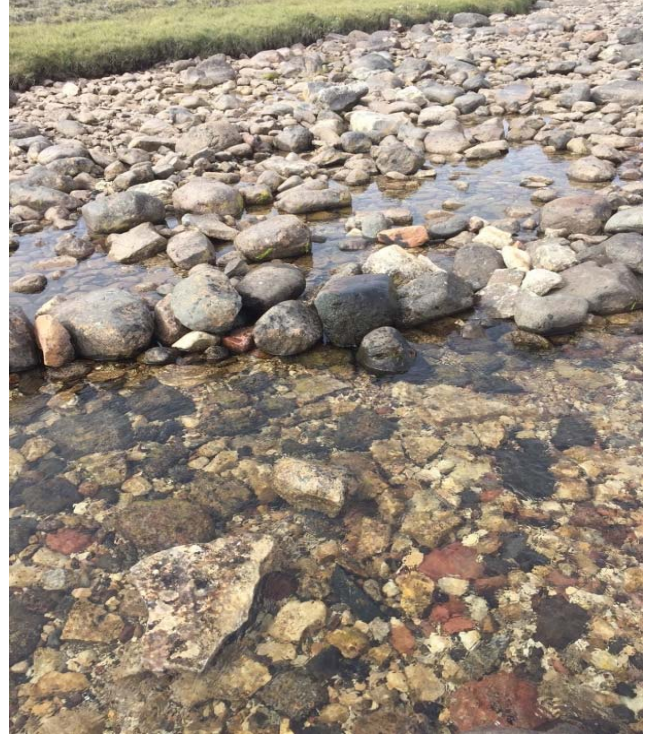
**Photo 2:** Upstream View of the Directional Weir at Site 12, Post-Remediation, 26 July 2017

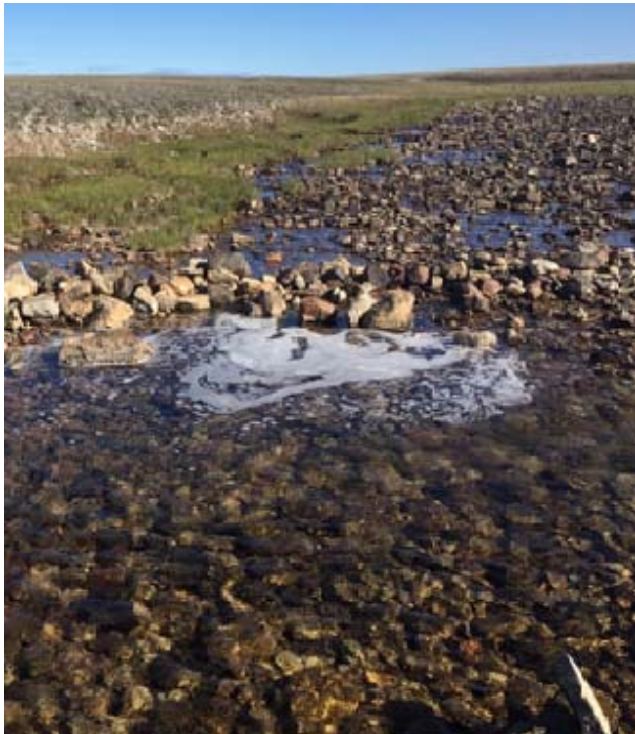
**Photo 3:** Upstream View of the Directional Weir A at Site 1, Pre-Remediation, 26 July 2017

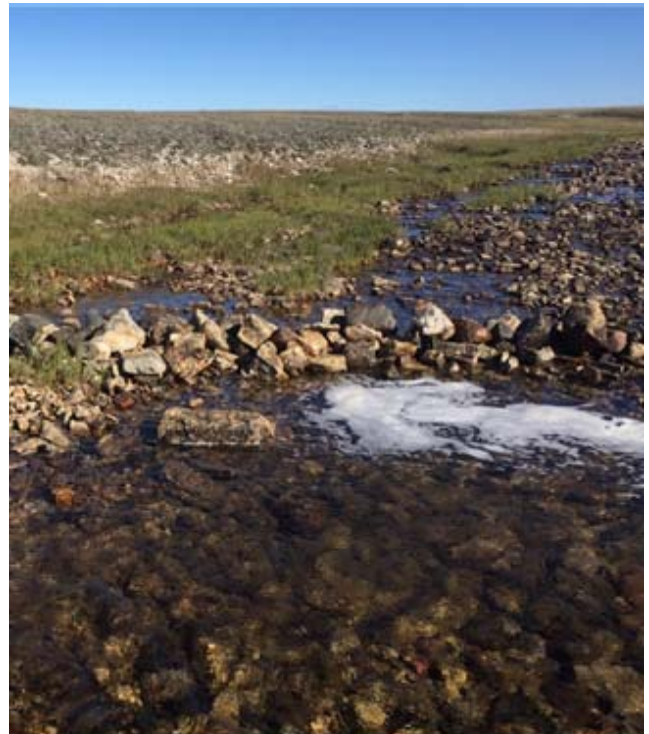
**Photo 4:** Upstream View of the Directional Weir A at Site 1, Post-Remediation, 26 July 2017

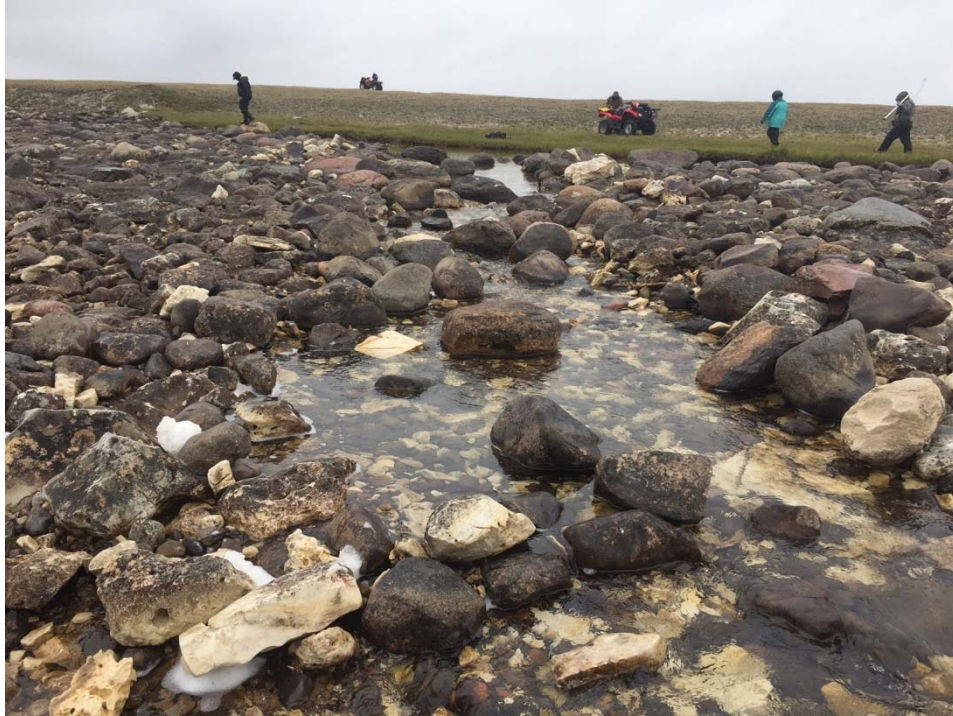
A summary of recommended repairs for displaced sections that could not be addressed are listed in Table 6. An example of a low-flow channel requiring remediation is Site 8 (Photo 5; Photo 23 in Appendix A). Although some boulders were intentionally placed in the channel during construction as refugia for migrating fish, spring flows displaced more boulders into the thalweg. At low water levels (as shown in Photo 6), navigating the channel may be difficult for migrating fish if the channel is not repaired. An example of a site requiring the construction of a new directional weir is Site 11. A directional weir constructed from the left downstream bank to the mouth of the low-flow channel is recommended to direct fish passage into the low-flow channel and away from the shallow left downstream bank where stranding may occur (Photo 6; Photo 32 in Appendix A).

**Photo 5:** Low-flow Channel (Upstream View) at Site 8 Requires Removal of Displaced Boulders, 26 July 2017

| Site | Structure | Recommended Repairs and Improvements | Photos (Appendix A) |
|---|---|---|---|
| 8 | Low-flow Channel | Boulders were intentionally left in the low-flow channel at Site 8 during 2016 construction as refugia for migrating fish. Upon inspection, some boulders appeared to be displaced (Photo 23, Appendix A) which could provide challenges to upstream migrating fish at low water levels. It was recommended that some small boulders be removed from the low-flow channel. | 22, 23 |

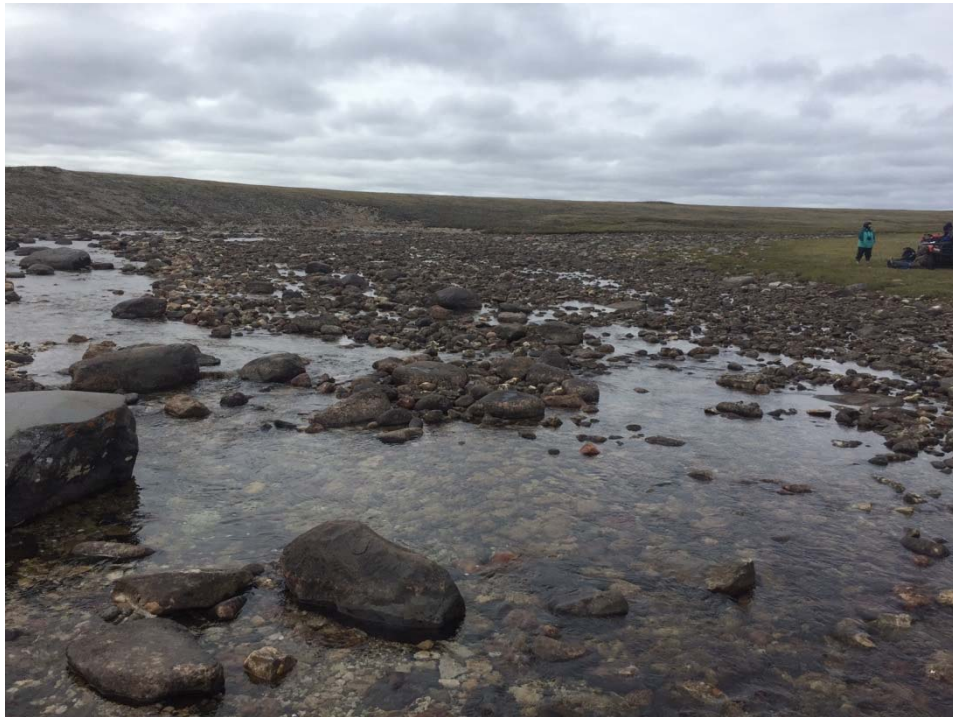
**Photo 6:** Upstream View of Proposed Directional Weir Location at Site 11, 26 July 2017

| Site | Structure | Recommended Repairs and Improvements | Photos (Appendix A) |
|---|---|---|---|
| 11 | Low-flow Channel | The left downstream bank of the low-flow channel underwent some displacement. There is potential for upstream migrating fish to access the shallow left side of the creek. The construction of a weir from the bottom end of the low-flow channel to the left downstream bank of the creek would direct fish passage into the channel and block access to the shallow area where stranding may occur (Photo 32, Appendix A). | 32 |

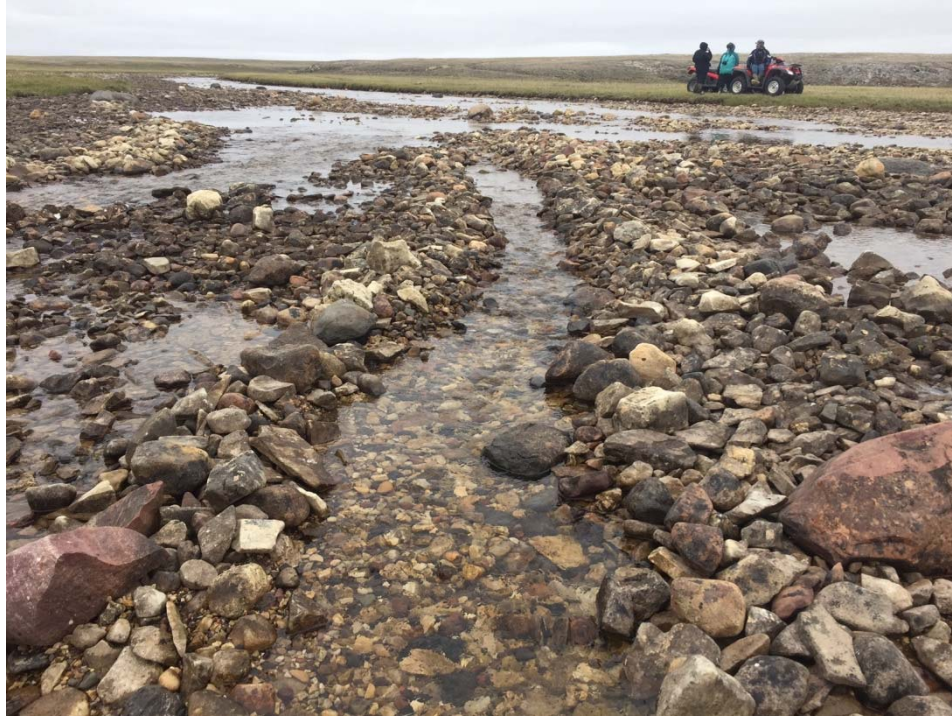
**Photo 7:** Low-Flow Channel B (Upstream View) at Project 1 where Improvements are Recommended, 27 July 2017

| Project | Structure | Recommended Repairs and Improvements | Photos (Appendix A) |
|---|---|---|---|
| | Low-flow Channel B | The upstream section of the low-flow channel does not have sufficient flow for fish passage. The channel should be cleared of rocks in the blocked section to allow fish passage. | 41, 42 |

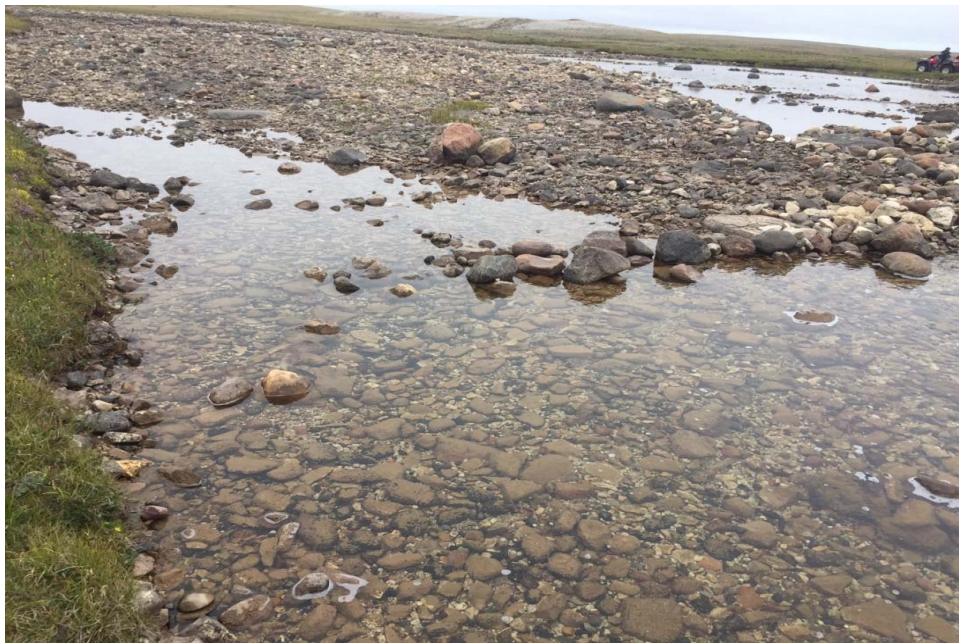
An example of a directional weir requiring repair is Project 3. A directional weir constructed from the right downstream bank to the mouth of the low-flow channel was blown out from high spring flows (Photo 8; Photo 46 in Appendix A). Without the weir in place, fish may travel up the right downstream bank at higher water levels and get stranded in the shallow boulder garden. It is recommended that the weir be rebuilt with larger boulders and secured to block access to the shallow area upstream and direct fish passage into the low-flow channel.

**Photo 8:** Blown out Directional Weir (Upstream View) at 2012 Project 3, 27 July 2017

| Project | Structure | Recommended Repairs and Improvements | Photos (Appendix A) |
|---|---|---|---|
| 3 | Directional Weir | The directional weir was blown out from high spring flow and needs repair. Fish may get trapped up the shallow right downstream bank in higher water levels. | 46 |

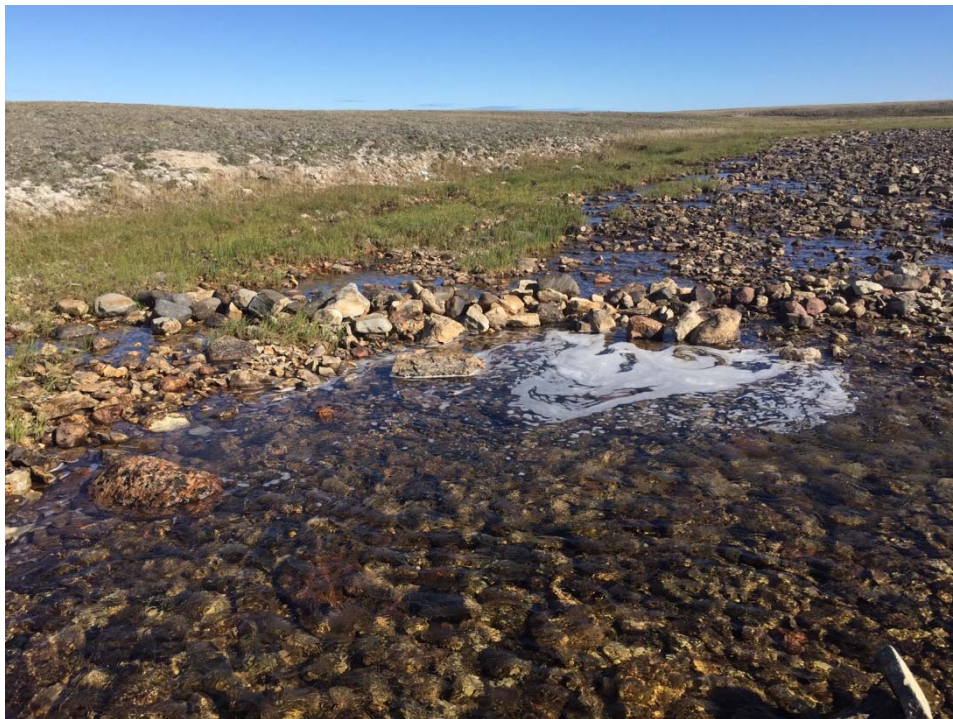
| Site | Structure | Percent Displaced | Repairs | Photos (Appendix A) |
|---|---|---|---|---|
| 1 | Directional Weir A | 5 | A few small boulders were out of place from the directional weir constructed to guide fish into the low-flow channel. They were easily placed back into the weir. | Pre-repair – 1<br>Post-repair – 2 |

*Photo 1: Upstream view of Directional Weir A pre-repair at Site 1. 26 July 2017.*

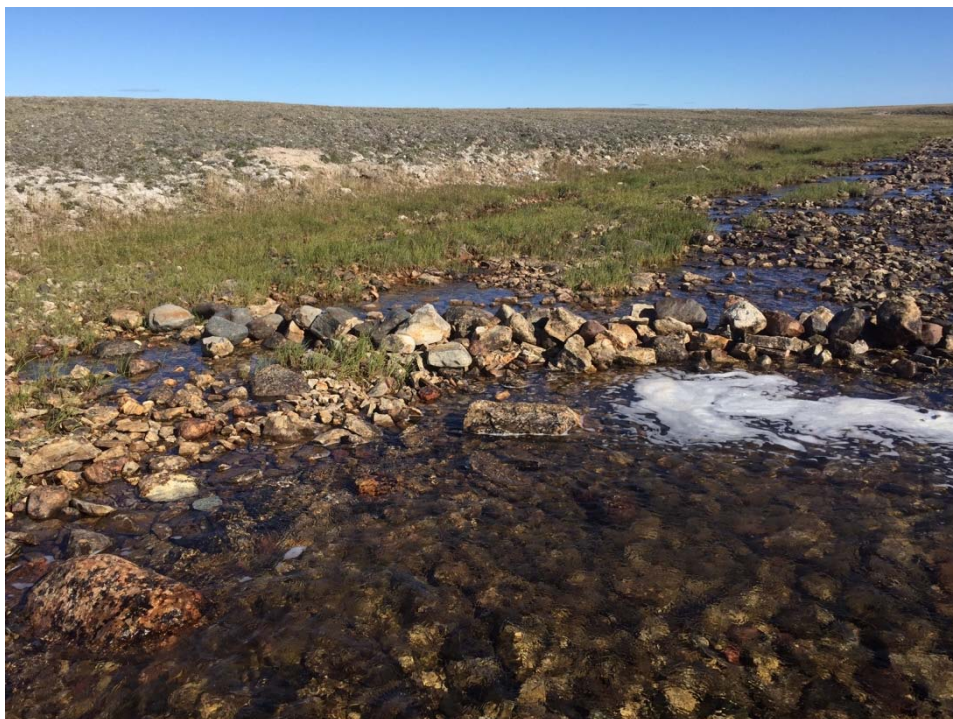
*Photo 2: Upstream view of Directional Weir A post-repair at Site 1. 26 July 2017.*

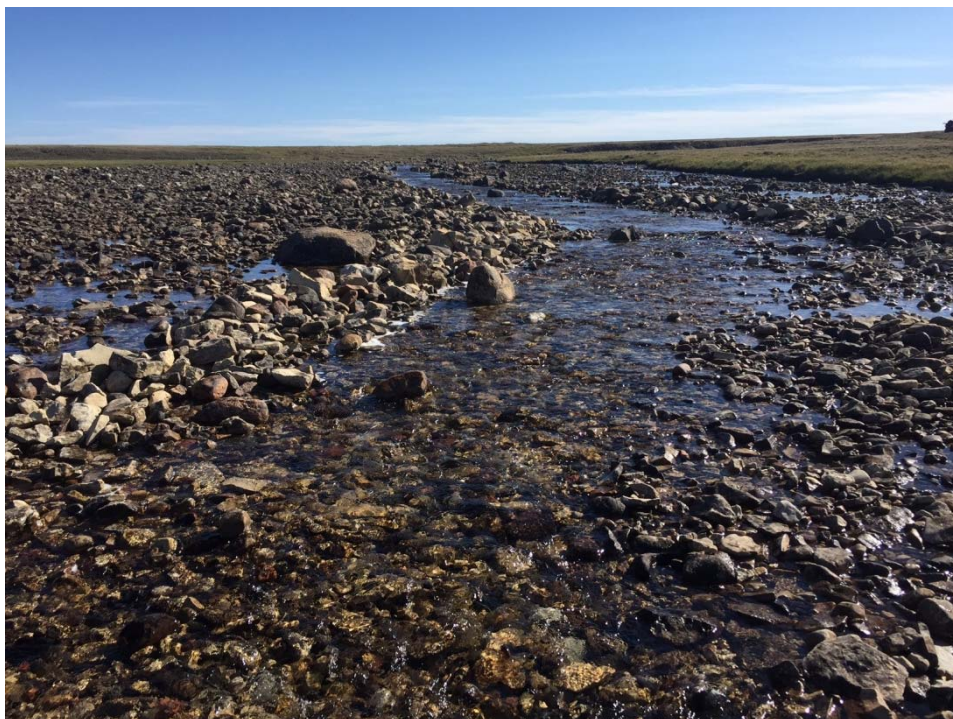
*Photo 4: Upstream view of Low-flow Channel at Site 1. 26 July 2017.*

| Site | Structure | Recommended Repairs and Improvements | Photos (Appendix A) |
|---|---|---|---|
| 1 | Low-flow Channel | Upon inspection, the low-flow channel at Site 1 was intact (Photo 4, Appendix A) but it is recommended that the left downstream bank of the channel near the weir be fortified with rocks and small boulders to enhance its effectiveness. | 3, 4 |

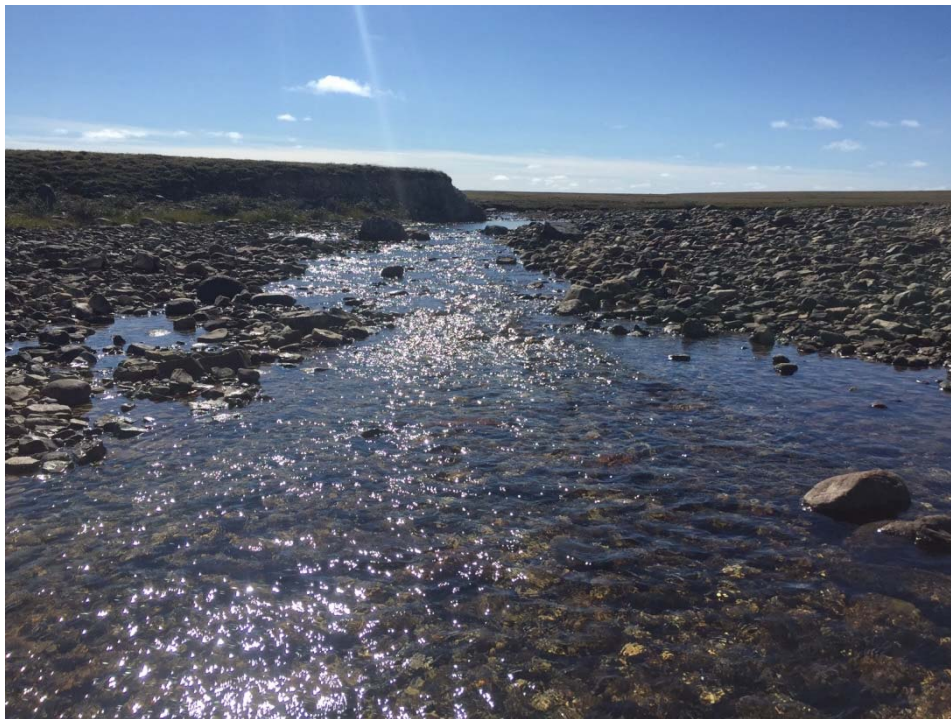
*Photo 9: Upstream view of Low-flow Channel at Site 3. 26 July 2017.*

| Site | Structure | Recommended Repairs and Improvements | Photos (Appendix A) |
|---|---|---|---|
| 3 | Low-flow Channel | The displaced boulders in the centre of the channel should be removed, and the banks of the low-flow channels should be reinforced where needed. | 9 |

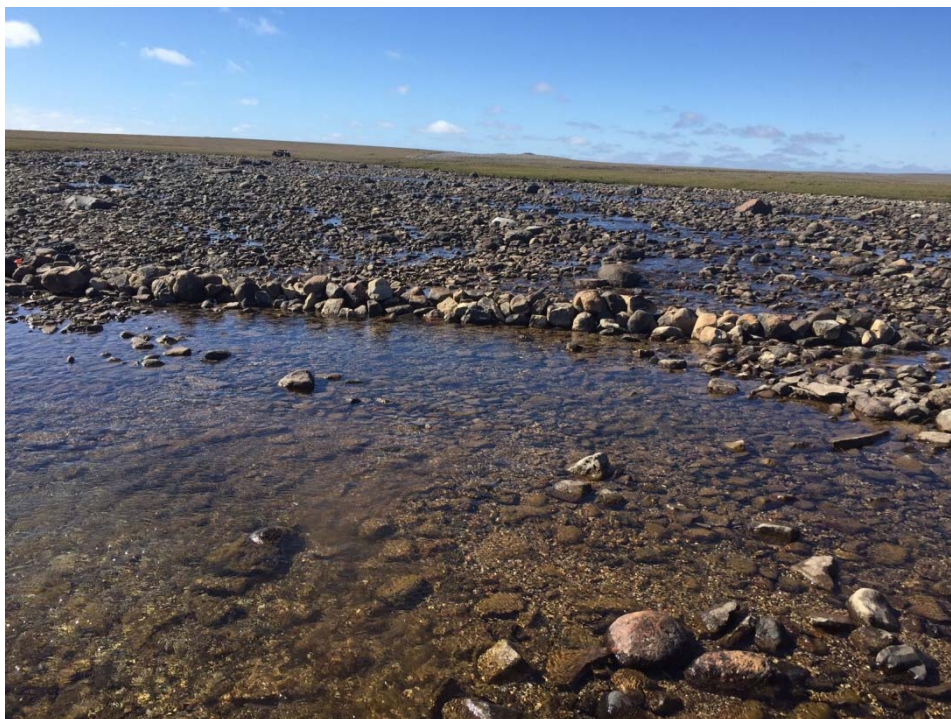
*Photo 10: Upstream view of Directional Weir at Site 3. 26 July 2017.*

| Site | Structure | Recommended Repairs and Improvements | Photos (Appendix A) |
|---|---|---|---|
| | Directional Weir | The directional weir is intact and stable (Photo 10, Appendix A), but future activities could extend it to the left downstream bank to ensure fish cannot migrate up the shallow left bank of the creek. | 10 |

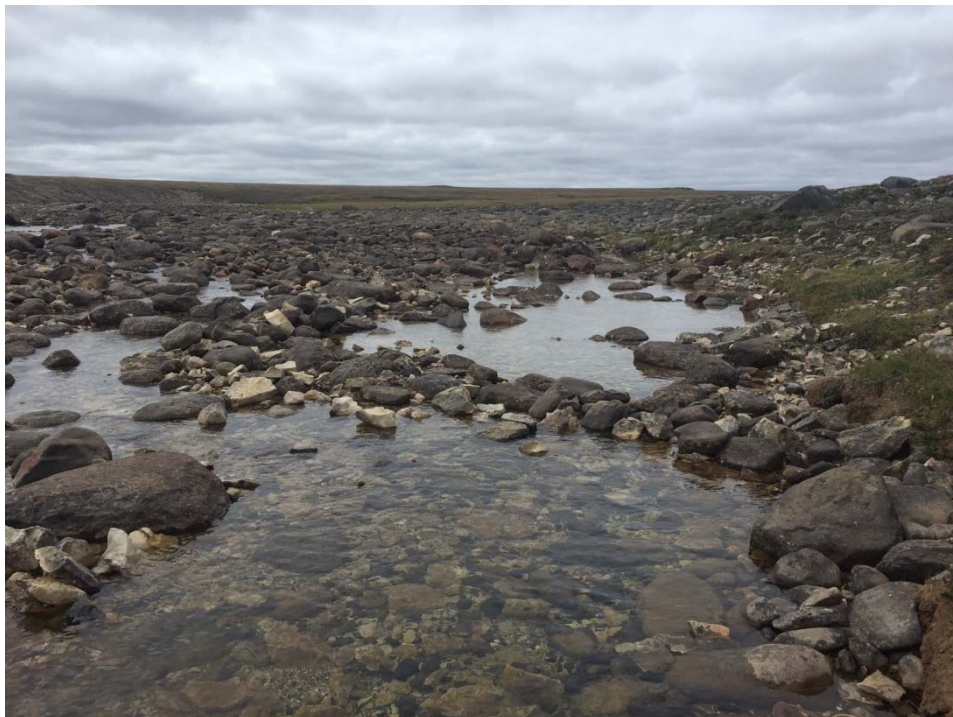
| Site | Structure | Percent Displaced | Repairs | Photos (Appendix A) |
|---|---|---|---|---|
| 5 | Directional Weir | 20 | Displaced boulders in the directional weir resulted in a gap large enough to allow fish to travel up the left downstream bank where they would become trapped further upstream. The boulders were replaced once again blocking access to the shallow area. | Pre-repair – 15<br>Post-repair – 16 |

*Photo 15: Upstream view of Directional Weir pre-repair at Site 5. 26 July 2017.*

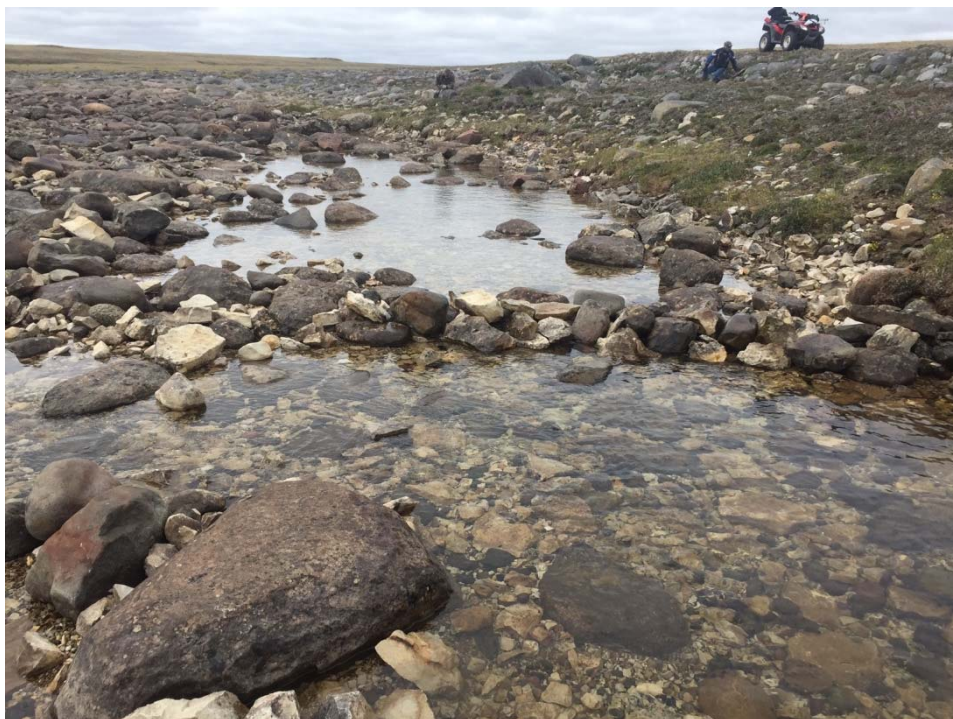
*Photo 16: Upstream view of Directional Weir post-repair at Site 5. 26 July 2017.*

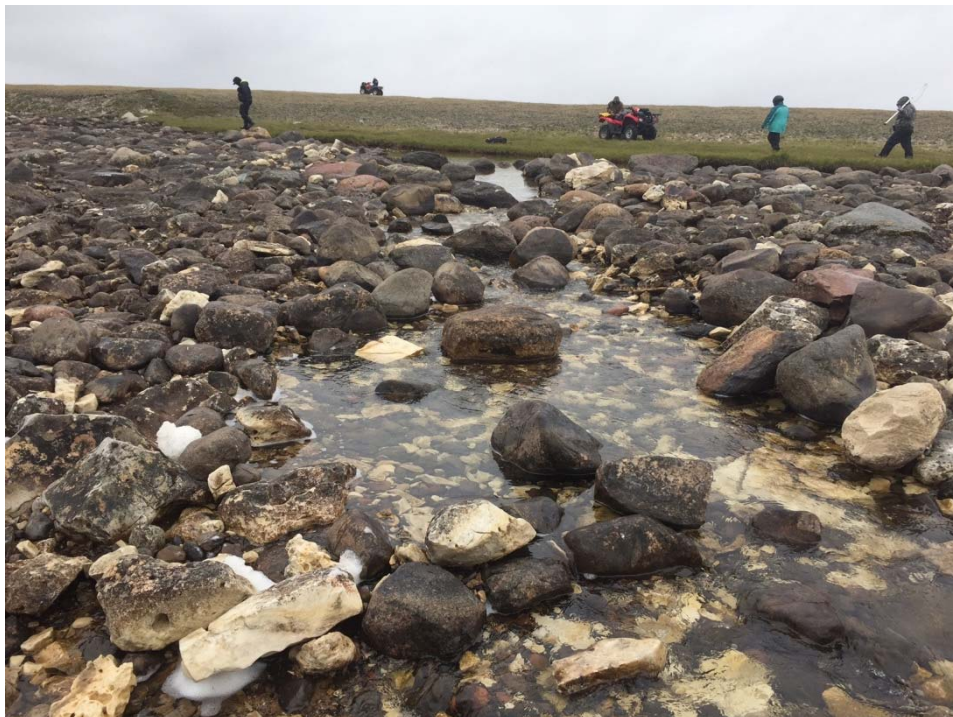
*Photo 23: Upstream view of Low-flow Channel at Site 8. 25 July 2017.*

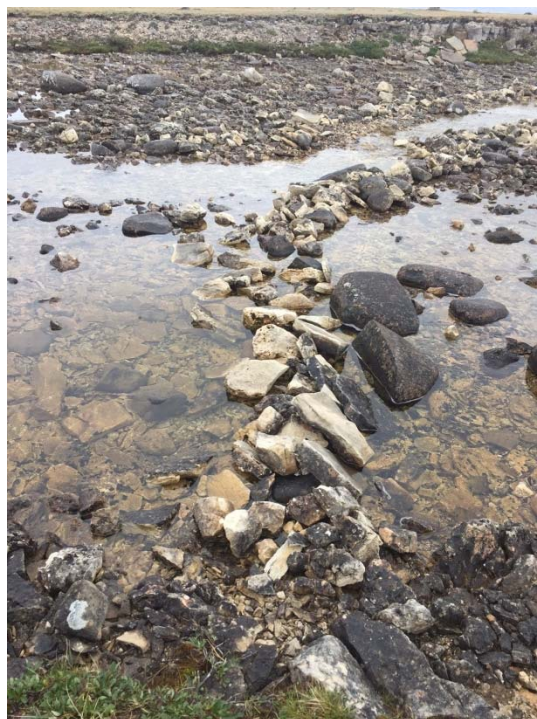
| Site | Structure | Percent Displaced | Repairs | Photos (Appendix A) |
|---|---|---|---|---|
| 9 | Directional Weir | 5 | Several boulders were displaced in the directional weir which blocks access to the shallow left downstream bank. The boulders were easily moved back into place. | Post-repair – 26 |

*Photo 26: Upstream view of Directional Weir at Site 9. 25 July 2017.*

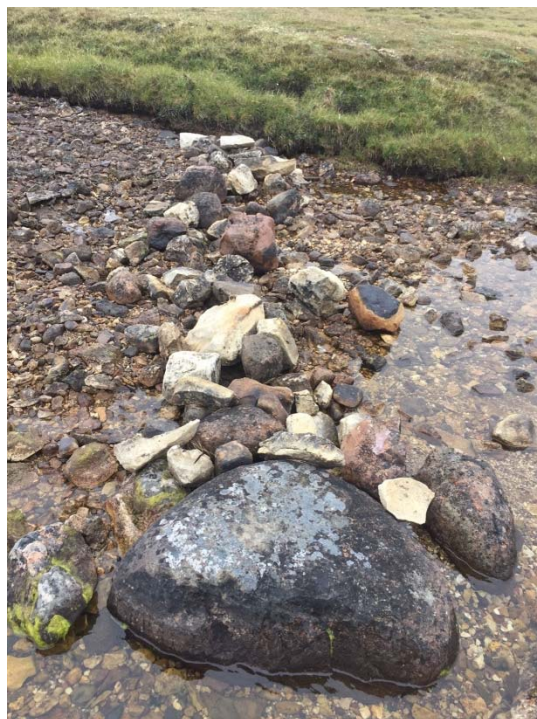
| Site | Structure | Percent Displaced | Repairs | Photos (Appendix A) |
|---|---|---|---|---|
| 10 | Directional Weir | 2 | A few small boulders were displaced from the weir but easily replaced to block access along the shallow left downstream bank. During construction in 2016 the weirs susceptibility to displacement was noted due to a lack of large boulders in the area. | Pre-repair – 30 |

*Photo 30: Upstream view of Directional Weir at Site 10. 25 July 2017.*

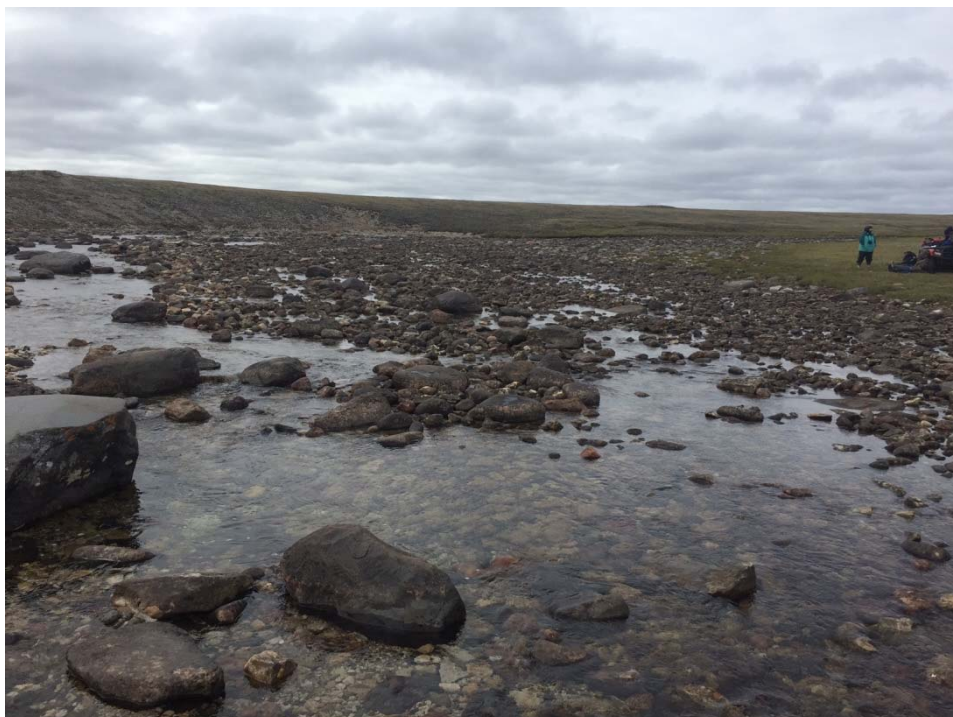
*Photo 32: Upstream view of proposed Directional Weir location at Site 11. 26 July 2017.*

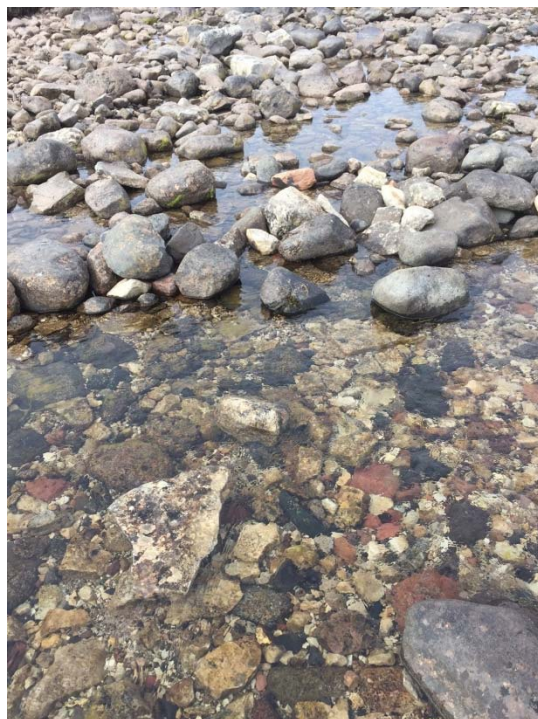
| Site | Structure | Percent Displaced | Repairs | Photos (Appendix A) |
|---|---|---|---|---|
| 12 | Directional Weir | 2 | A few boulders were displaced in the directional weir but easily replaced to once again block access to the shallow right downstream bank and direct fish passage into the low-flow channel. | Pre-repair – 35<br>Post-repair – 36 |

*Photo 35: Upstream view of Directional Weir pre-repair at Site 12. 26 July 2017.*

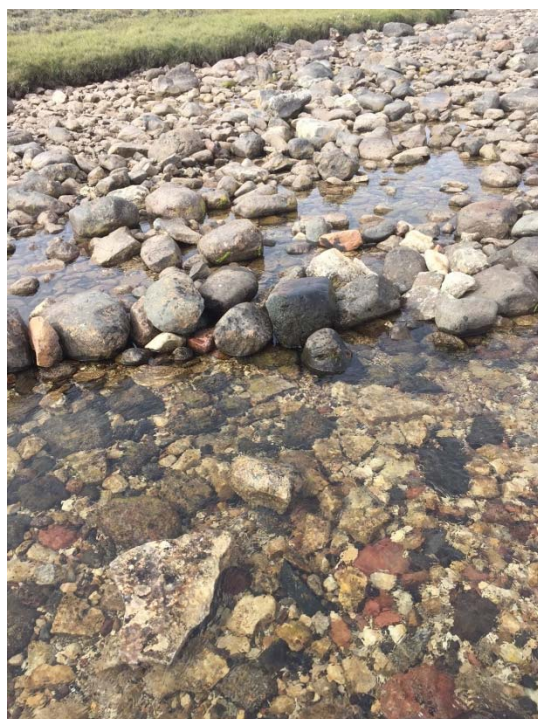
*Photo 36: Upstream view of Directional Weir post-repair at Site 12. 26 July 2017.*

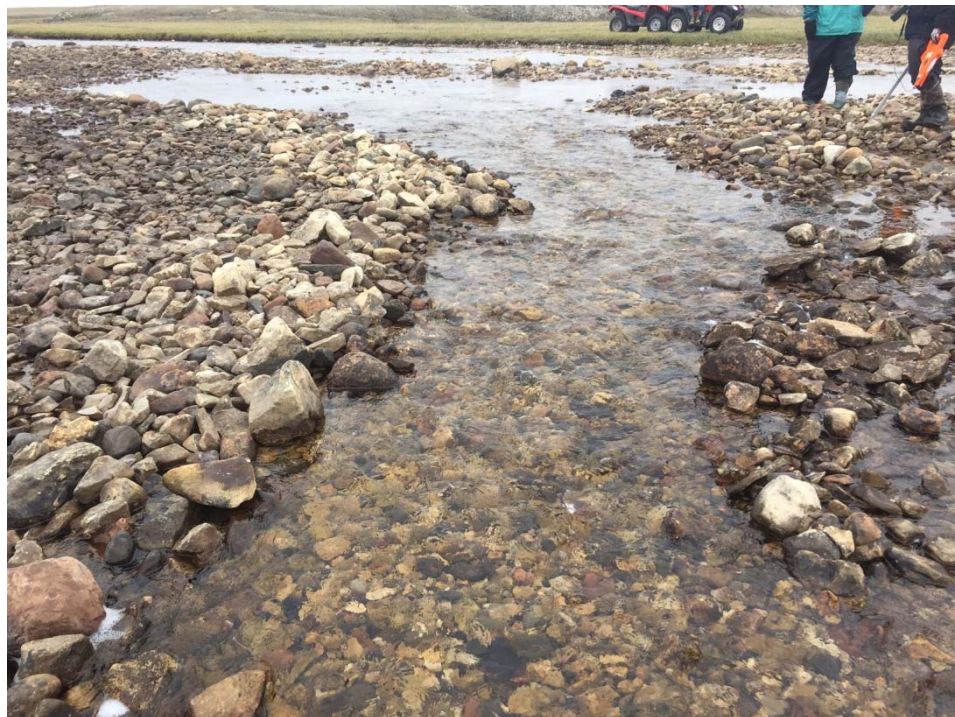
*Photo 39: Upstream view of Low-flow Channel A at 2012 Project 1. 27 July 2017.*

| Project | Structure | Recommended Repairs and Improvements | Photos (Appendix A) |
|---|---|---|---|
| 1 | Low-flow Channel A | The left downstream bank of the low-flow channel could use fortification with boulders. The flow is sufficient for fish passage but the channel could be more defined. | 39 |

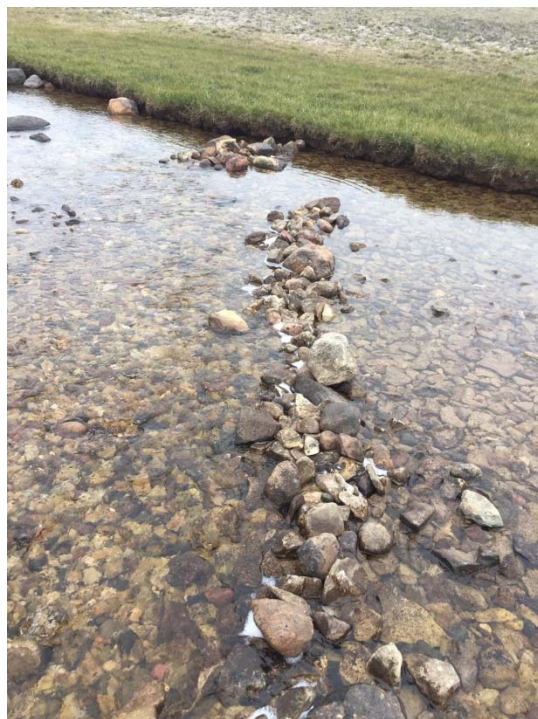
*Photo 40: Downstream view of Directional Weir at 2012 Project 1. 27 July 2017.*

| Project | Structure | Recommended Repairs and Improvements | Photos (Appendix A) |
|---|---|---|---|
| | Directional Weir | A large section of the directional weir was displaced, creating an opening to allow fish to travel up the shallow right downstream bank of the creek where stranding may occur. This is recommended as a high priority remediation for the future. | 40 |

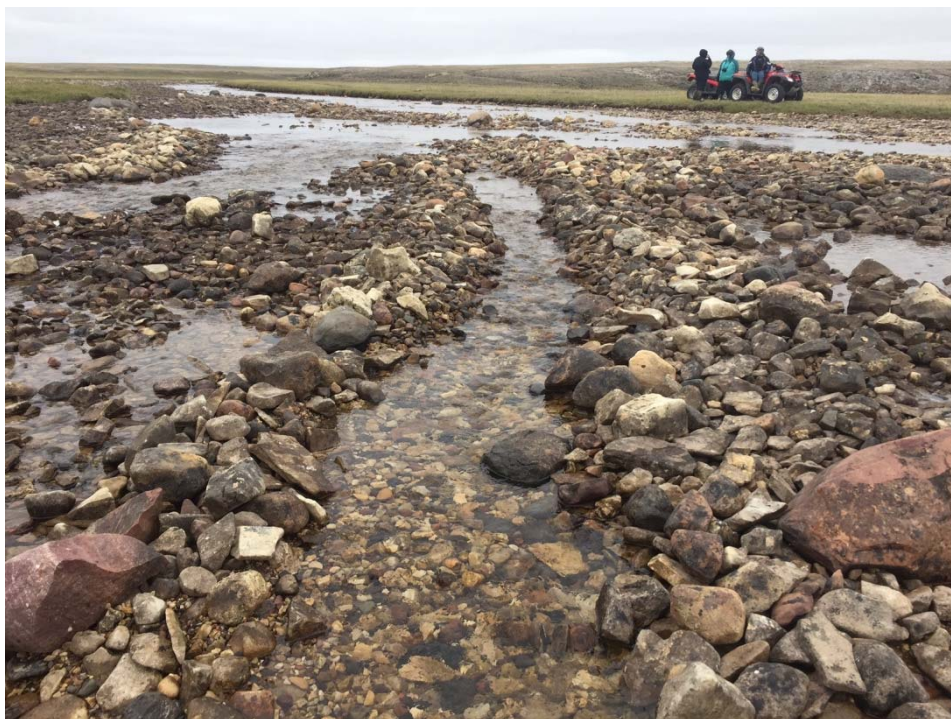
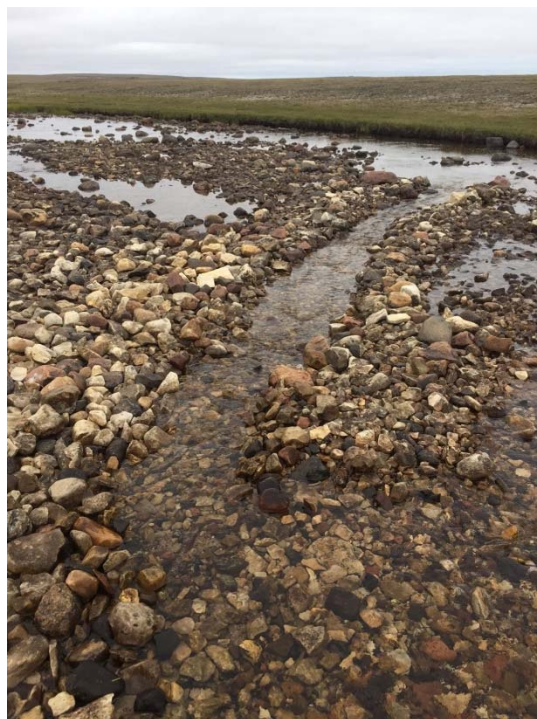
*Photo 41: Upstream view of Low-flow Channel B pre-repair at 2012 Project 1. 27 July 2017.*

*Photo 42: Downstream view of Low-flow Channel B post-repair at 2012 Project 1. 27 July 2017.*

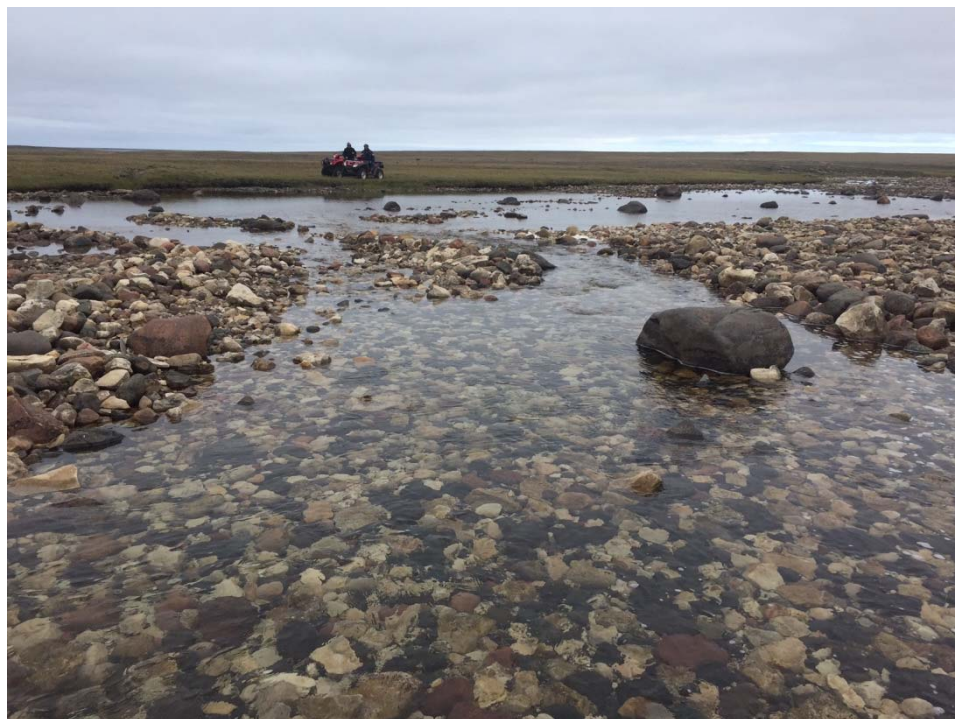
*Photo 43: Downstream view of Low-flow Channels A and B at 2012 Project 2. 27 July 2017.*

| Project | Structure | Recommended Repairs and Improvements | Photos (Appendix A) |
|---|---|---|---|
| 2 | Low-flow Channel B | The low-flow channel could be cleared of boulders as passage for fish could be difficult in low-flow. | 43 |

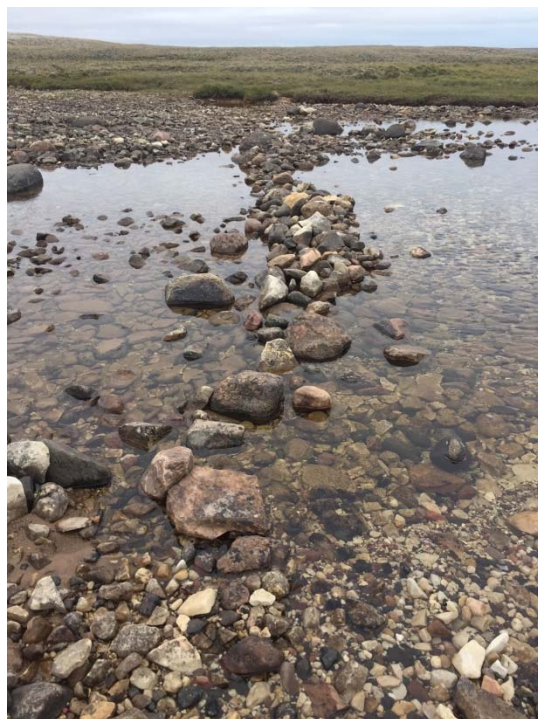
*Photo 44: Downstream view of Directional Weir at 2012 Project 2. 27 July 2017.*

| Project | Structure | Recommended Repairs and Improvements | Photos (Appendix A) |
|---|---|---|---|
| | Directional Weir | The directional weir could benefit from fortification with boulders to the banks edge and to the low-flow channel. | 44 |

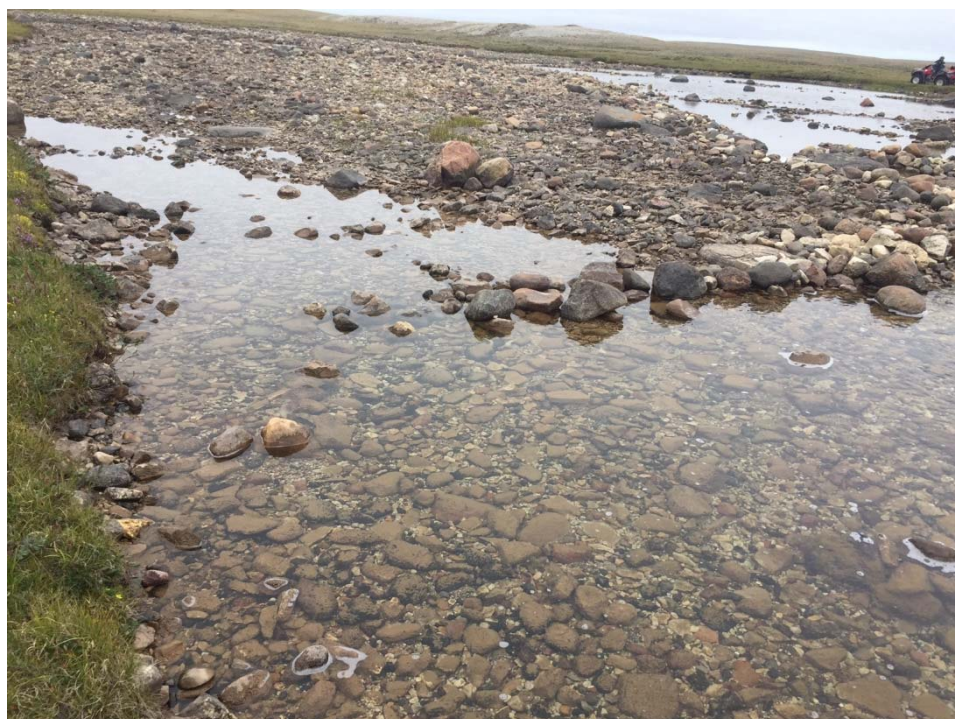
*Photo 46: Blown out Directional Weir at 2012 Project 3 requiring remediation. 27 July 2017.*

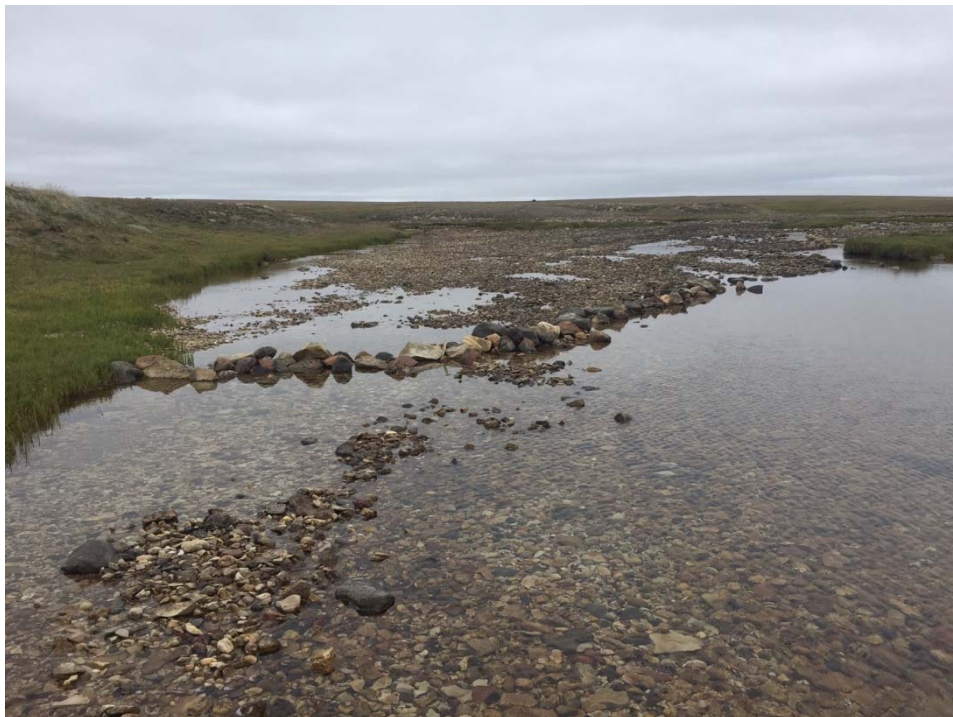
*Photo 51: Upstream view of Directional Weir A at 1212 Project 5. 27 July 2017.*

| Project | Structure | Recommended Repairs and Improvements | Photos (Appendix A) |
|---|---|---|---|
| 5 | Directional Weir A | The directional weir could use fortifying to ensure fish cannot access the shallow right downstream bank where stranding may occur. | 51 |
