## **BERNARD HARBOUR TECHNICAL MEMORANDUM**

**Project No.** 1787890-045-TM-Rev0

### **2018 BERNARD HARBOUR OFFSETTING MEASURE INSPECTION**

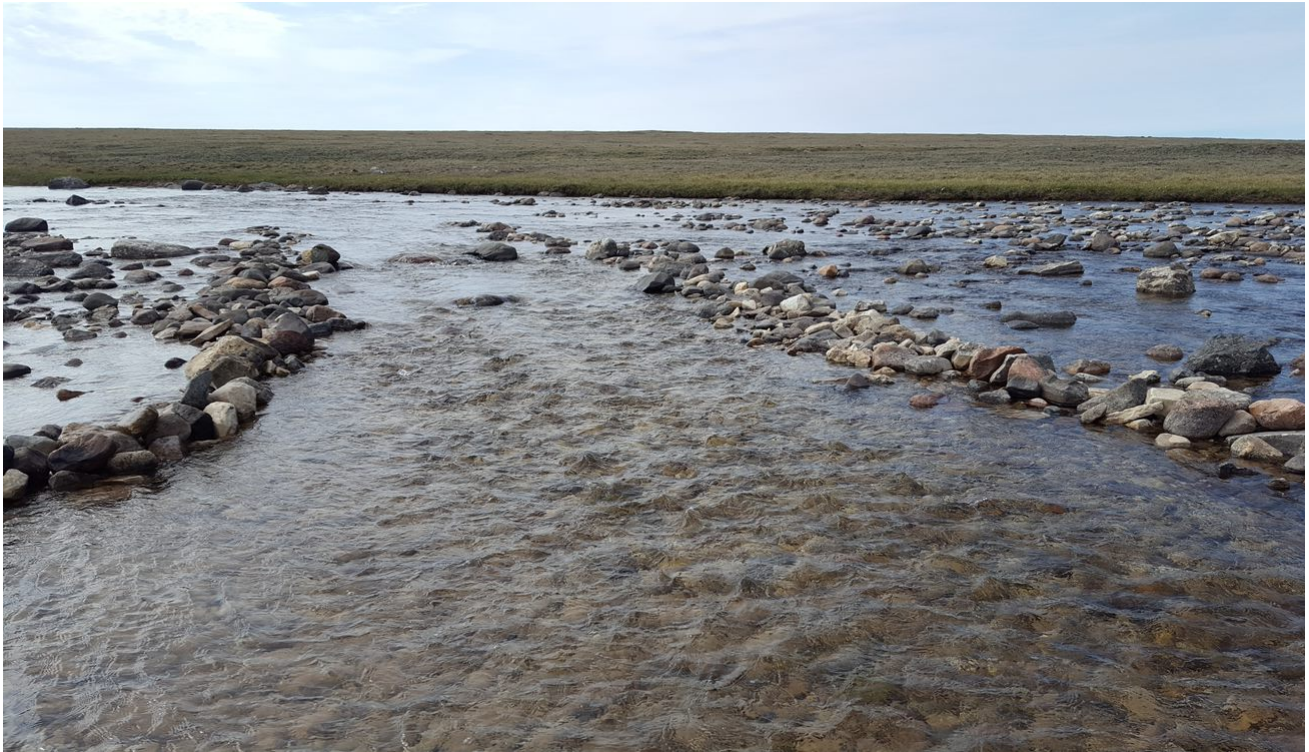
Discharge measurements were collected approximately 500 m upstream from the mouth of Nulahugyuk Creek (UTM 590514 7627609) using a Swoffer velocity meter. Flows of 0.755 m<sup>3</sup>/s were recorded on 24 July, flows of 0.578 m<sup>3</sup>/s were recorded on July 25, and flows of 0.547 m<sup>3</sup>/s were recorded on 26 July. Amanda Dumond (HTO Manager) noted that spring arrived late in 2018 and the field crew observed large ice flows that remained in the Dolphin and Union Strait on the travel out to Nulahugyuk Creek, in addition to snow still present throughout the study area upon arrival to Bernard Harbour. A late spring melt of snow and ice may provide an explanation for the higher flows observed in late July when compared to flows observed during previous visits in July (2015 to 2017) (Table 1). On average, the measured flow in Nulahugyuk Creek in 2018 was about nine times higher than the flow observed in 2016, about three times higher than the flow observed in 2016 and about one and a half times higher than the flow observed in 2015 (Table 1). Throughout the field program, water levels were observed to be higher than those compared to photographs from the 2017 field memo (see comparison of Photo 1 and Photo 2). Depths within the low-flow channels at the time of the inspections were, on average, 0.19 m ( $\pm 1$  SD 0.07), and deemed sufficient for passage of adult Arctic Char (Table 2). Of note, the higher water levels during the 2018 field program offered an opportunity to see whether the remediation structures are effective at higher flows, specifically whether the weirs and channel boundaries required additional stabilization and height to effectively function for fish.

**Photo 1: Upstream View of Low-flow Channel B at Site 4, 24 July 2018**

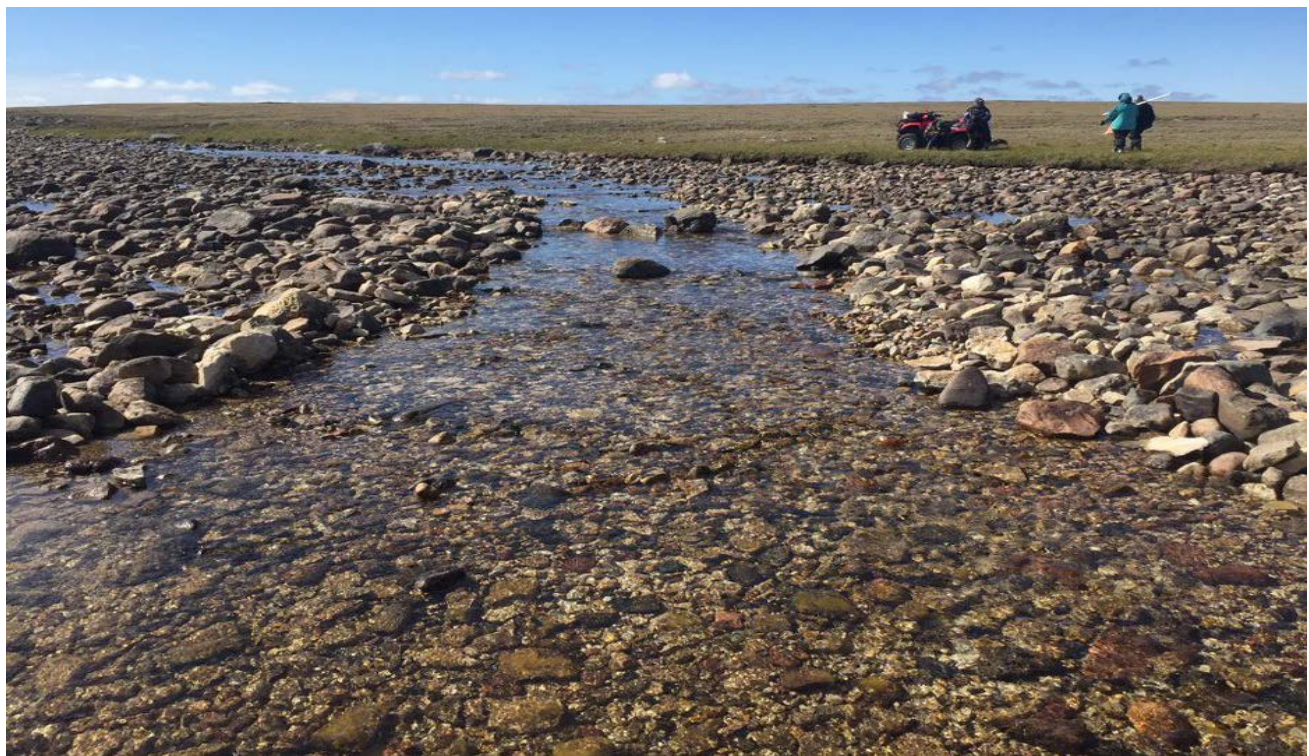
**Photo 2: Upstream View of Low-flow Channel B at Site 4, 26 July 2017**

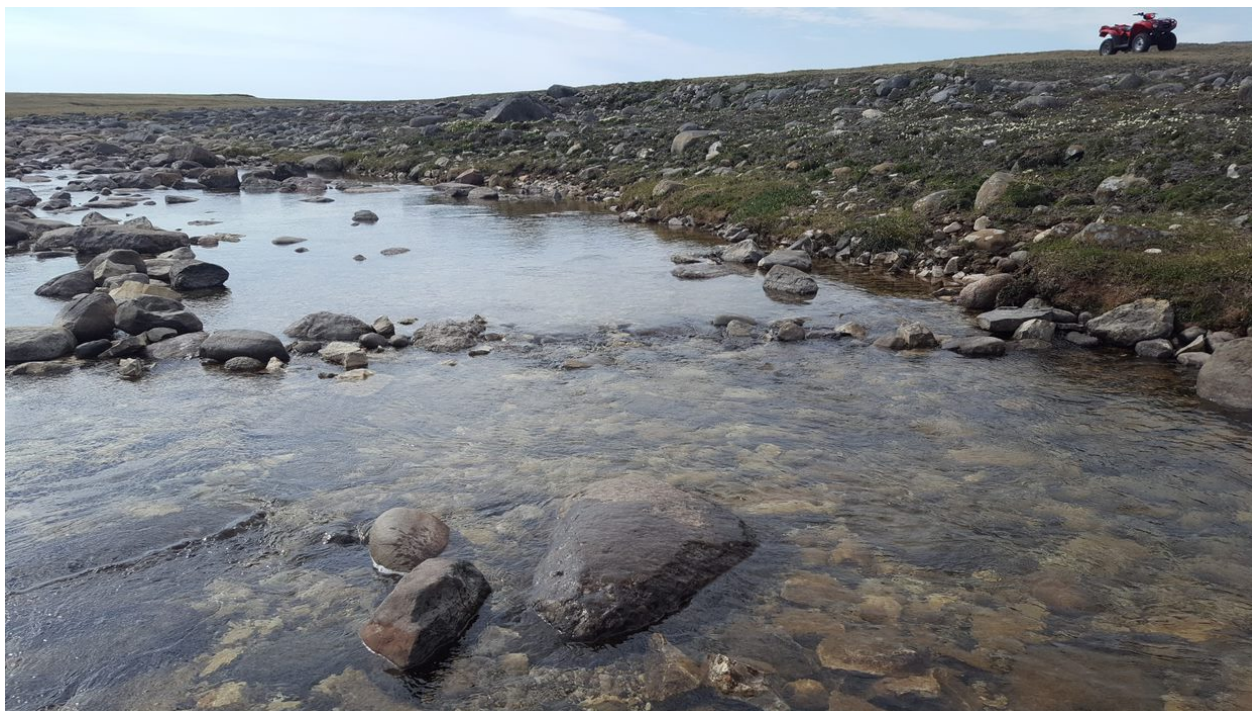
The below photos are examples of the pre- and post-modification efforts. At Site 5 (Photos 3 and 4; also see Photos 16 and 17 in Appendix A), the directional weir was no longer functional at current water levels, and access to shallow water would have been possible by migrating fish. Improvement efforts used additional boulders to increase the height of the directional weir structure such that the weir functions were restored as intended. An example of a low-flow channel repair includes work completed at Site 6 where boulders were displaced from one section of the low-flow channel edge (or bank) (Photos 5 and 6; also see Photos 18 and 19 in Appendix A). Repairs to the bank of a low-flow channel are expected to prevent fish from accessing adjacent shallow habitats, while augmenting flows for fish passage through the unobstructed path of the channel.

**Photo 3: Upstream View of Directional Weir, Pre-Adjustment at Site 5, 24 July 2018**

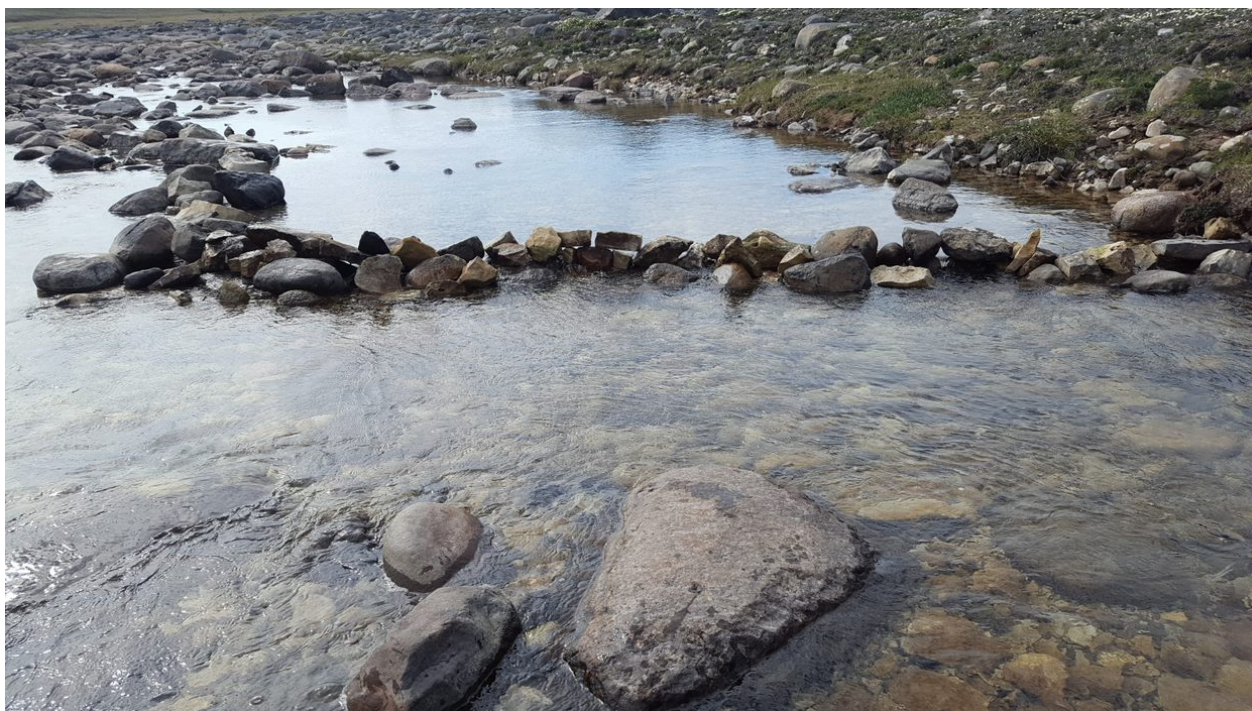
**Photo 4: Upstream View of Directional Weir, Post-Adjustment, at Site 5, 24 July 2018**

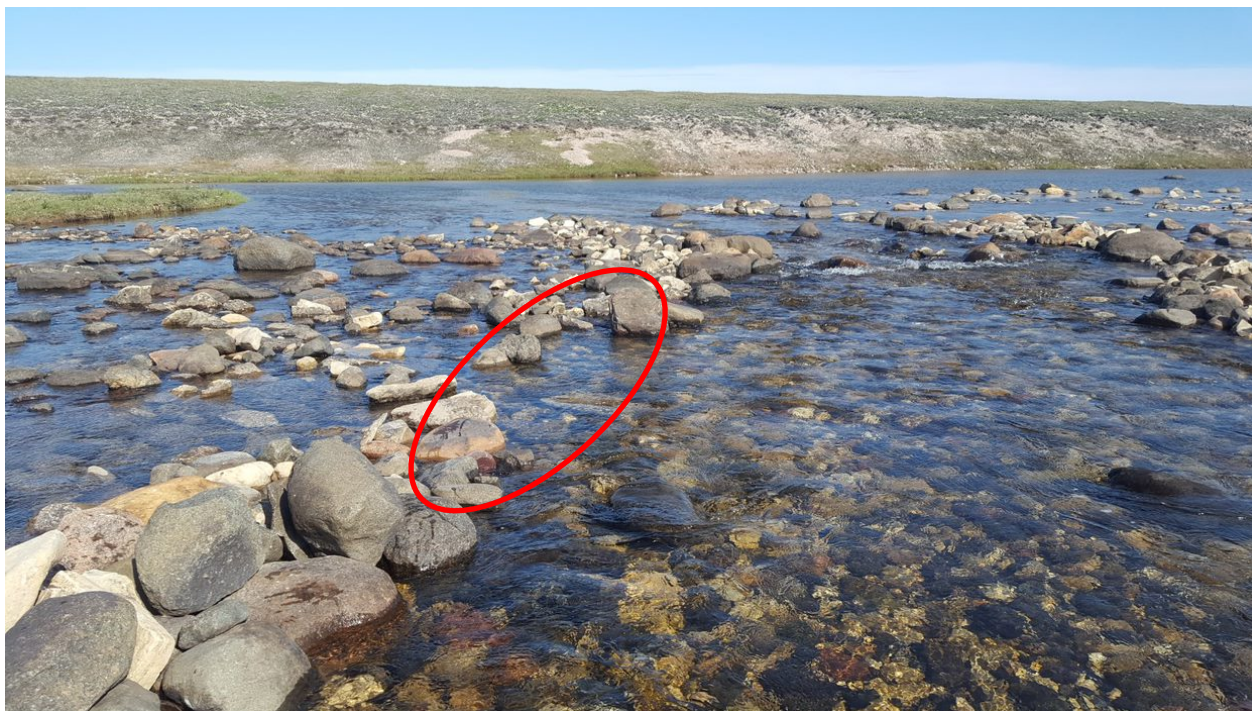
**Photo 5: Downstream View of Low-flow Channel, Pre-Repair, at Site 6, 24 July 2018**

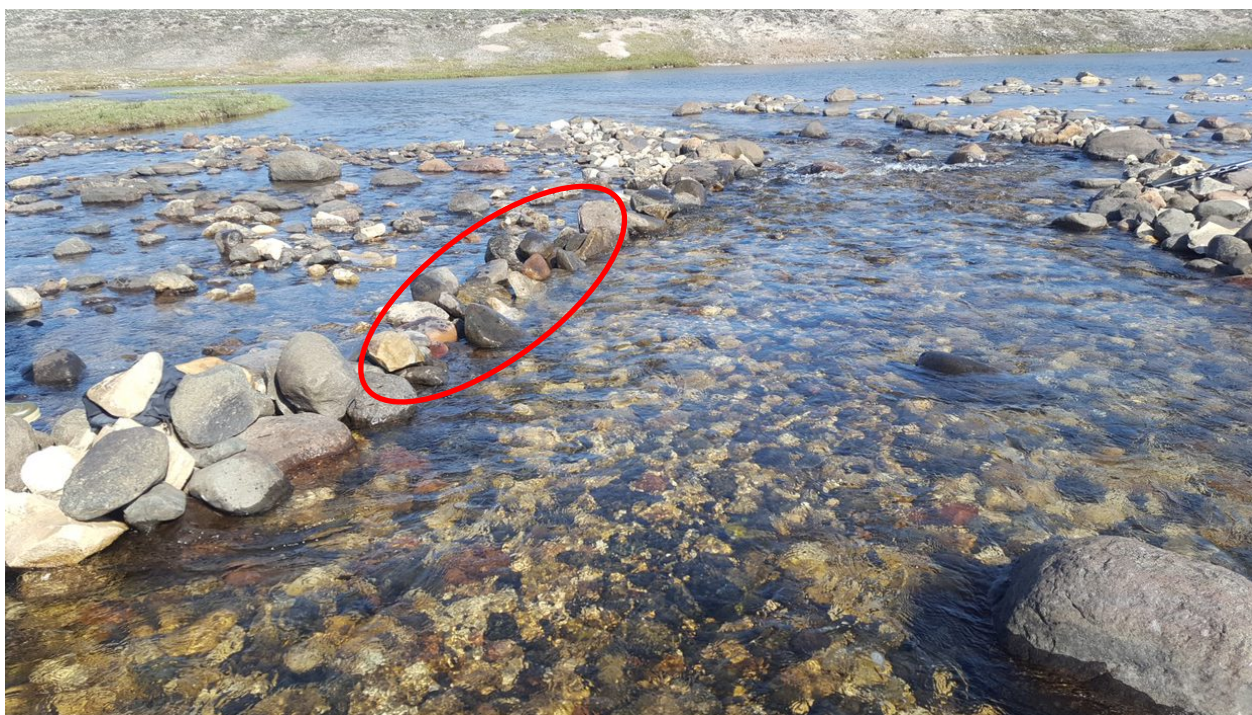
**Photo 6: Downstream View of Low-flow Channel, Post-Repair, at Site 6, 24 July 2018**

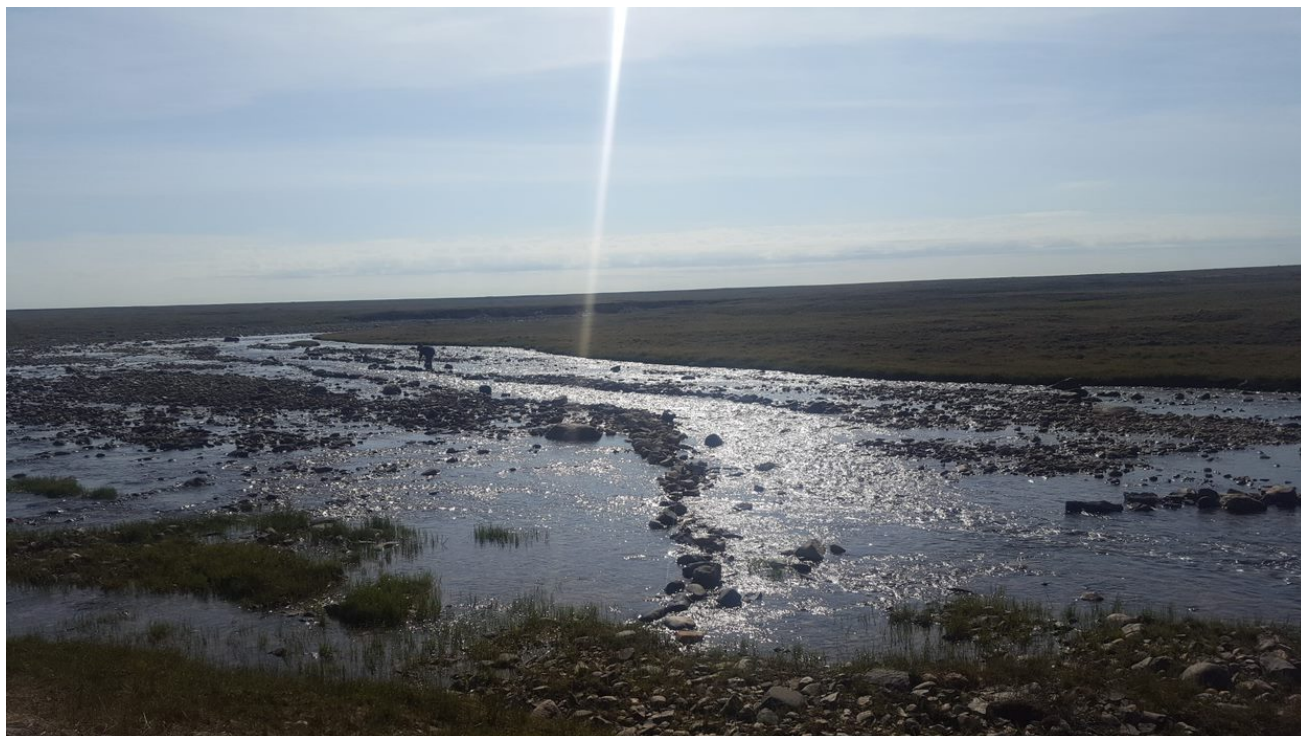
| Site | Structure | Length of Structure (m) | Percent Affected (%) | Repaired | Further Remediation Recommended | Photos (Appendix A) |
|---|---|---|---|---|---|---|
| 1 | Low-flow Channel | 110 | 5 | Yes | No | 1 |

*Photo A1: Upstream View of the Low-flow channel at Site 1 Pre-Repair on 25 July 2018*

| Site | Structure | Percent Affected | Repairs and Improvements | Photos (Appendix A) |
|---|---|---|---|---|
| 1 | Low-flow Channel | 5 | A few boulders were out of place along the length of low-flow channel. They were repositioned to ensure no gaps were present. | Pre-repair - 1 |

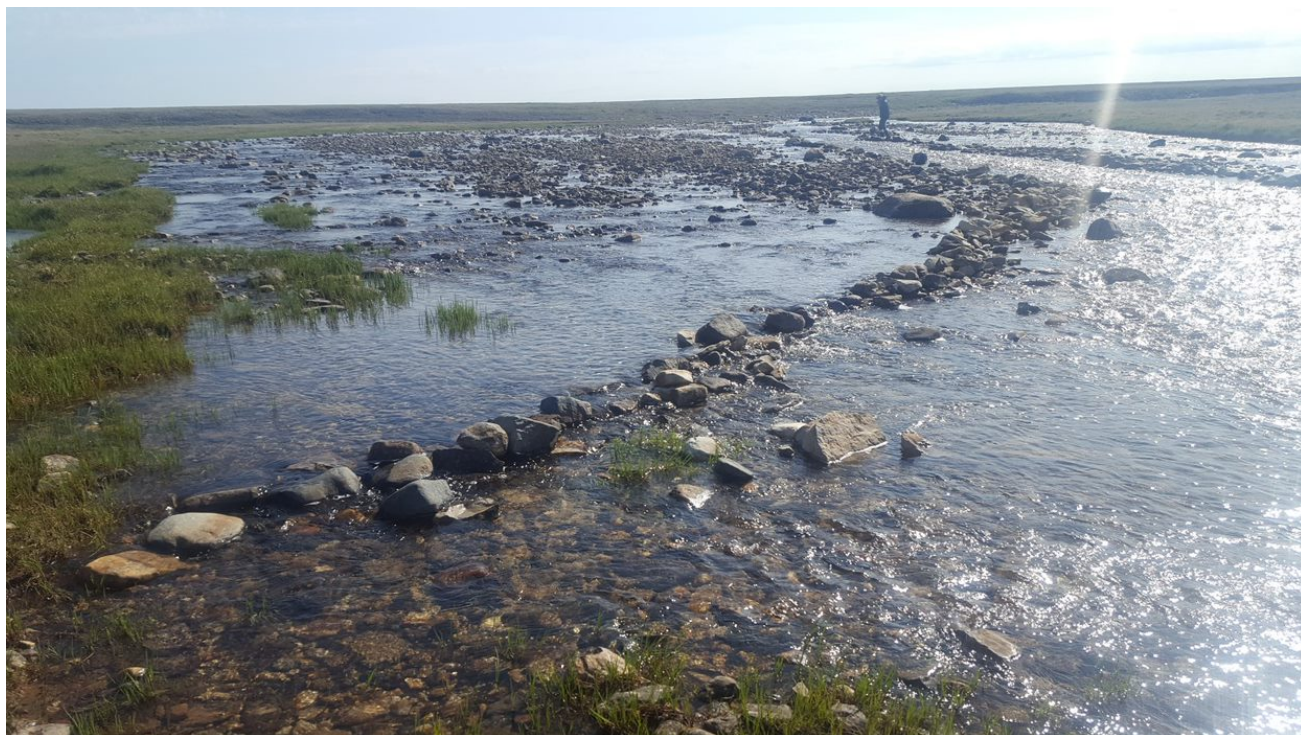
| Site | Structure | Length of Structure (m) | Percent Affected (%) | Repaired | Further Remediation Recommended | Photos (Appendix A) |
|---|---|---|---|---|---|---|
| | Directional Weir A | 15 | 30 | Yes | No | 2 |

*Photo A2: Upstream View of Directional Weir A Pre-Repair at Site 1 on 25 July 2018*

| Site | Structure | Percent Affected | Repairs and Improvements | Photos (Appendix A) |
|---|---|---|---|---|
| | Directional Weir A | 30 | A few boulders were out of place from the directional weir constructed to guide fish into the low-flow channel. They were placed back into the weir and the weir height was increased to accommodate the elevated water level. | Pre-repair – 2 |

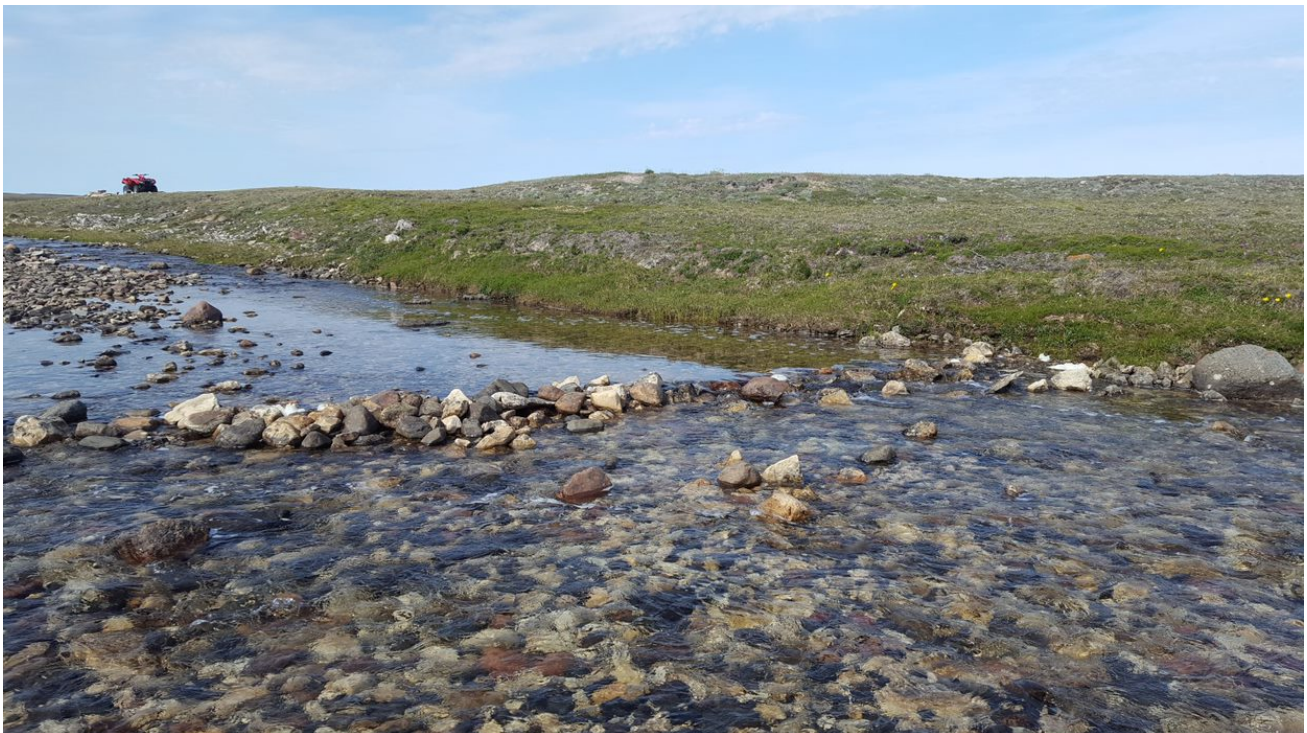
| Site | Structure | Length of Structure (m) | Percent Affected (%) | Repaired | Further Remediation Recommended | Photos (Appendix A) |
|---|---|---|---|---|---|---|
| | Augmentation Weir | 12 | 50 | Yes | No | 6,7 |

*Photo A6: Downstream View of Augmentation Weir, Pre-Repair, at Site 2 on 25 July 2018*

| Site | Structure | Percent Affected | Repairs and Improvements | Photos (Appendix A) |
|---|---|---|---|---|
| 2 | Augmentation Weir | 50 | Displaced boulders in the flow augmentation weir resulted in several gaps. The boulders were repositioned, and the overall weir height increased to accommodate the elevated water level | Pre-repair – 6<br>Post-repair – 7 |

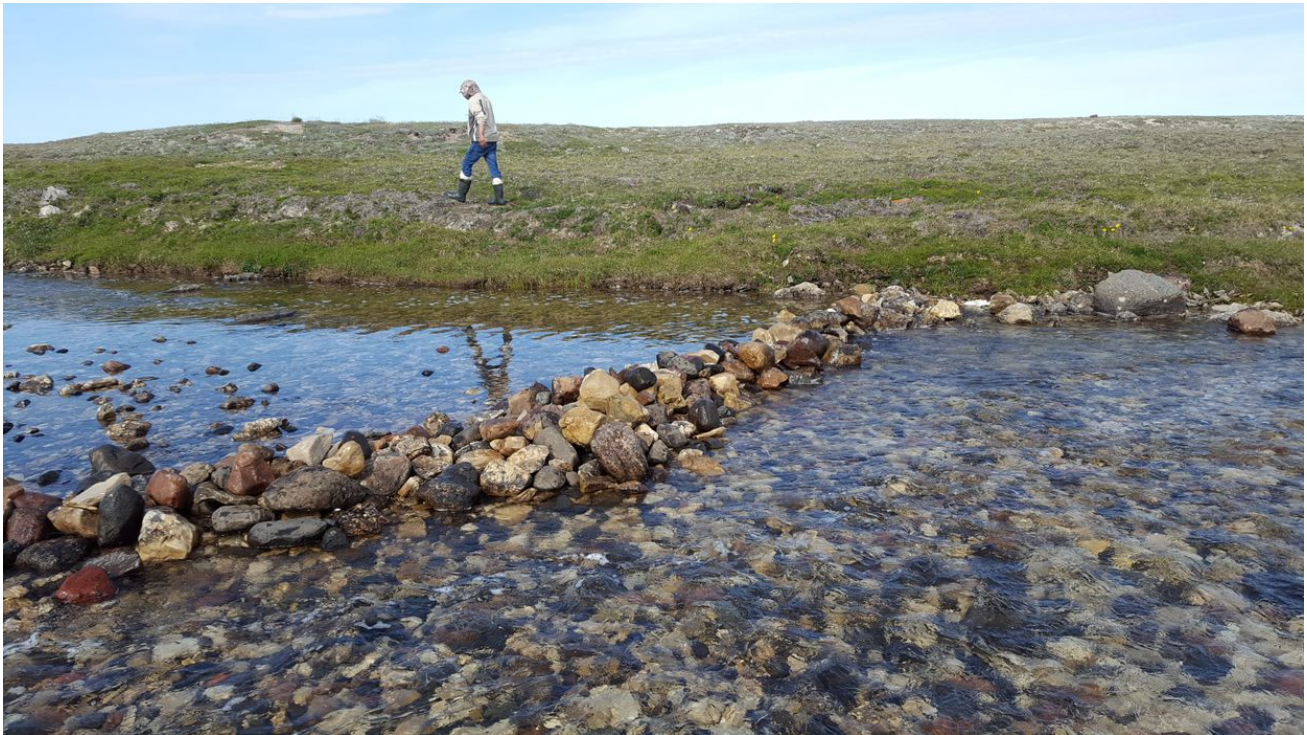
*Photo A7: Downstream View of Augmentation Weir, Post-Repair, at Site 2 on 25 July 2018*

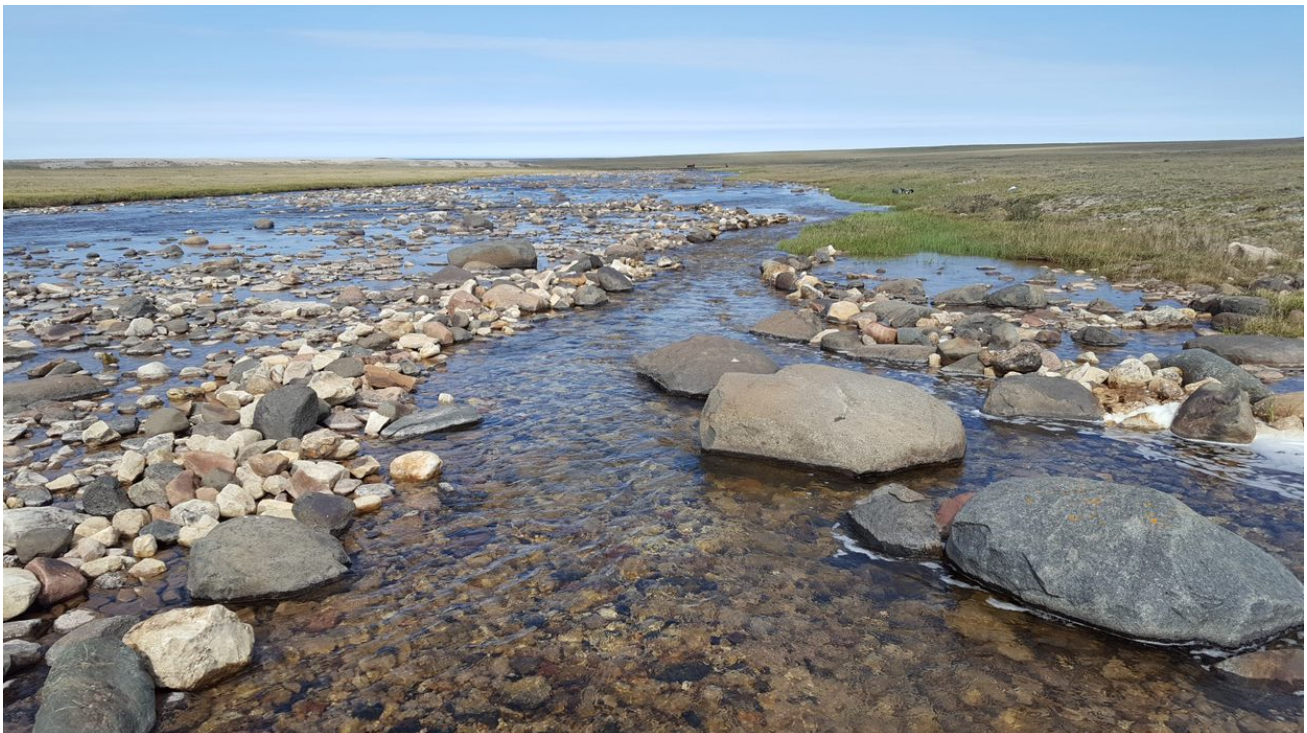
| Site | Structure | Length of Structure (m) | Percent Affected (%) | Repaired | Further Remediation Recommended | Photos (Appendix A) |
|---|---|---|---|---|---|---|
| 4 | Low-flow Channel A | 22 | 10 | Yes | No | 10 |

*Photo A10: Downstream View of Low-flow Channel A, Pre-Repair, at Site 4 on 24 July 2018*

| Site | Structure | Percent Affected | Repairs and Improvements | Photos (Appendix A) |
|---|---|---|---|---|
| 4 | Low-flow Channel A | 10 | Several boulders were displaced in the directional weir and low-flow channel A at the confluence with low-flow channel B. The boulders were moved back into place and the overall weir and channel bank height increased to accommodate the elevated water level. | Pre-repair – 12<br>Post-repair – 11, 13 |

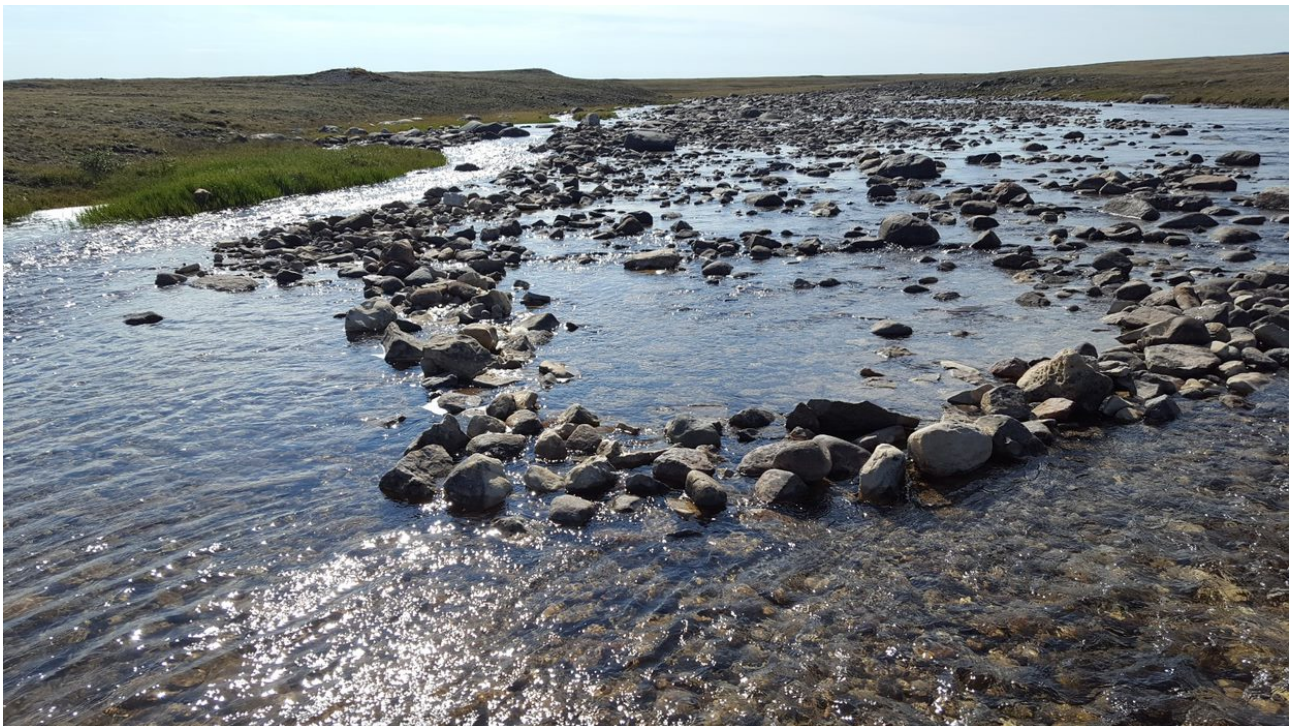
| Site | Structure | Length of Structure (m) | Percent Affected (%) | Repaired | Further Remediation Recommended | Photos (Appendix A) |
|---|---|---|---|---|---|---|
| | Directional Weir | 10 | 50 | Yes | No | 12, 13 |

*Photo A12: Upstream View of Directional Weir at the confluence of Low-flow Channel A and Low-flow Channel B, Pre-Repair, at Site 4 on 24 July 2018*

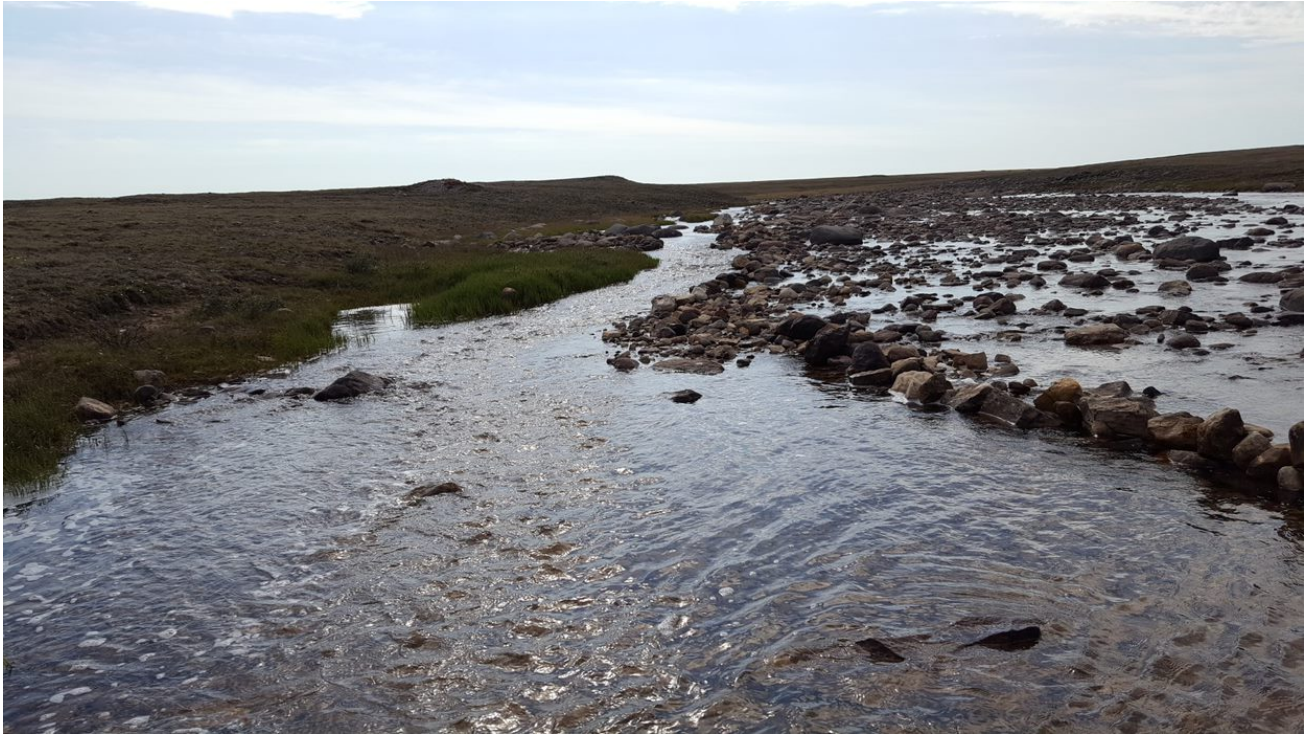
*Photo A13: Upstream View of Low-flow Channel A and Directional Weir, Post-Repair, at Site 4 on 24 July 2018*

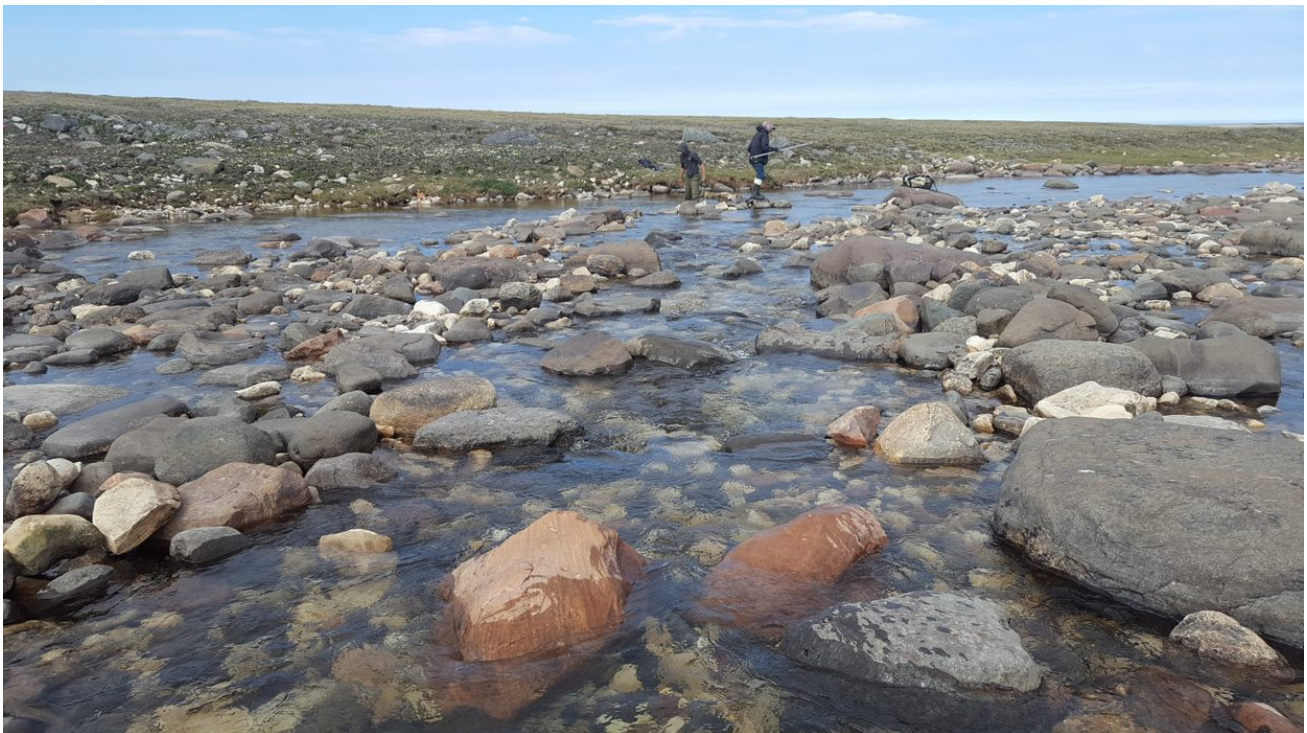
*Photo A14: Downstream View of Low-flow Channel at Site 5 on 24 July 2018*

| Site | Structure | Percent Affected | Repairs and Improvements | Photos (Appendix A) |
|---|---|---|---|---|
| 5 | Low-Flow Channel | N/A | Several large boulders installed to provide refugia for migrating fish were out of position, creating high velocities; downstream boulders were adjusted to create low-velocities paths to the channel. | Pre-repair – 14<br>Post-repair - 15 |

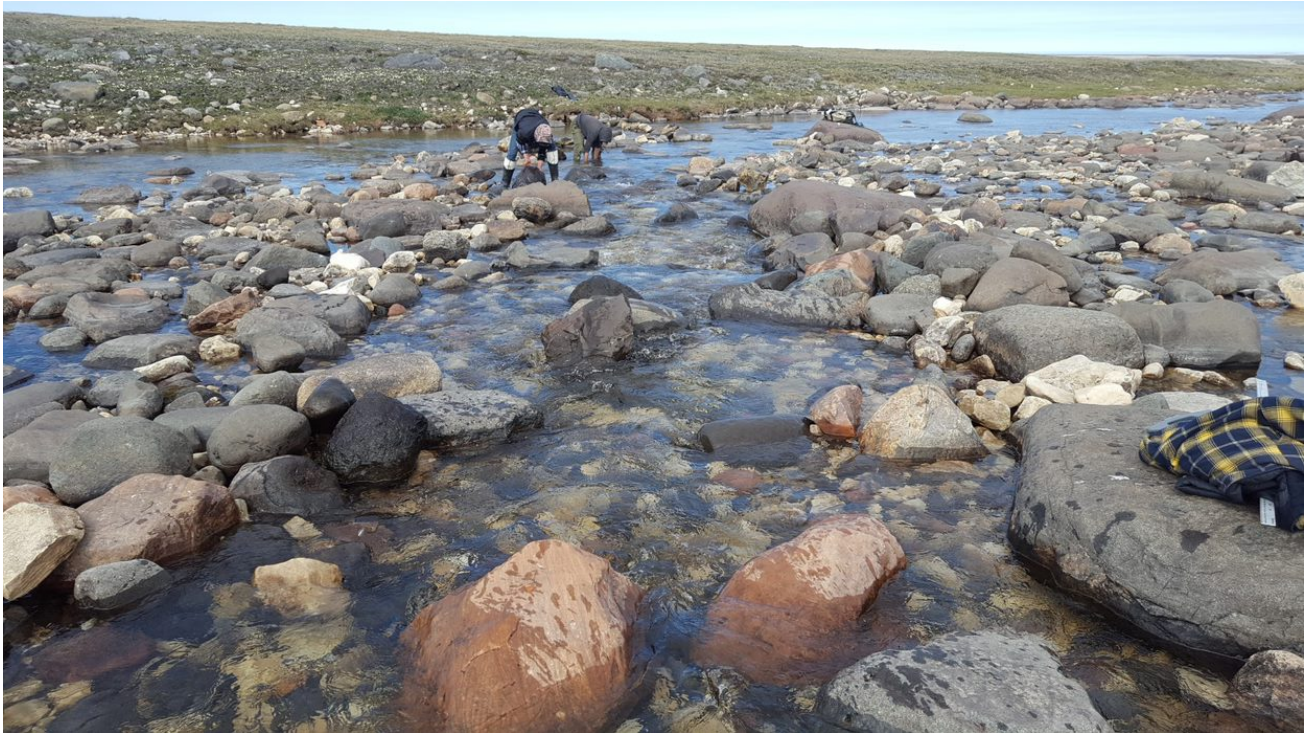
*Photo A15: Downstream View of Low-flow Channel at Site 5 on 24 July 2018*

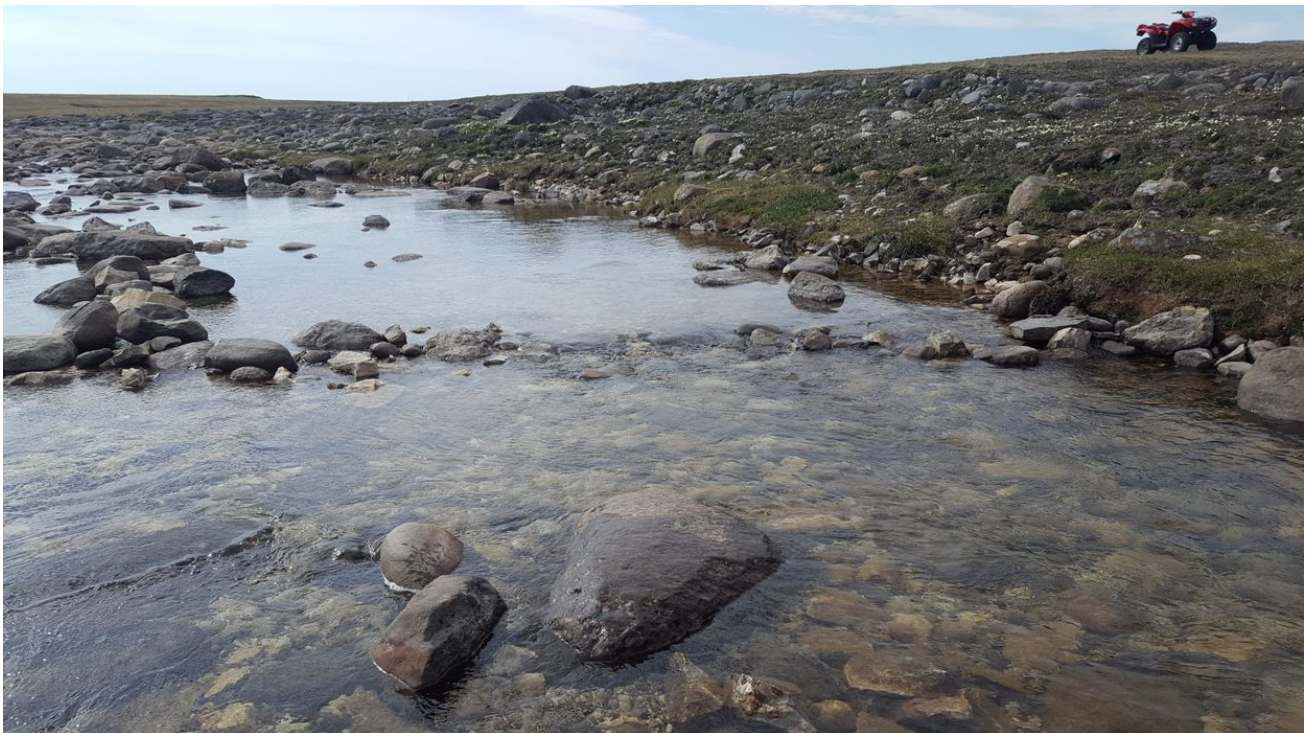
| Site | Structure | Length of Structure (m) | Percent Affected (%) | Repaired | Further Remediation Recommended | Photos (Appendix A) |
|---|---|---|---|---|---|---|
| | Directional Weir | 5 | 100* | Yes | No | 16, 17 |

*Photo A16: Upstream View of Directional Weir, Pre-Improvement, at Site 5 on 24 July 2018*

| Site | Structure | Percent Affected | Repairs and Improvements | Photos (Appendix A) |
|---|---|---|---|---|
| | Directional Weir | 100 | The weir was completely submerged at the time of the field program due to elevated water depths. The length of the weir was built up using boulders so it continued to be functional in blocking fish passage to shallower waters. | Pre-repair – 16<br>Post-repair - 17 |

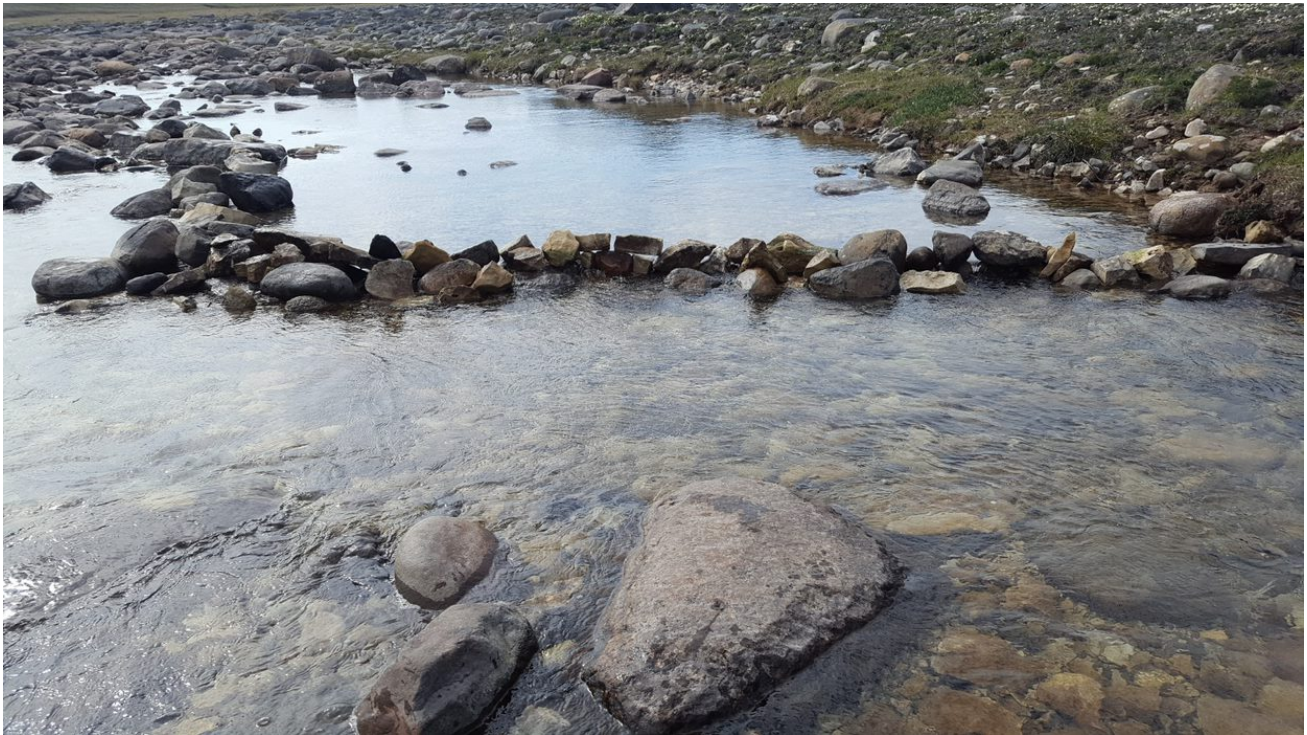
*Photo A17: Upstream View of Directional Weir, Pre-Improvement, at Site 5 on 24 July 2018*

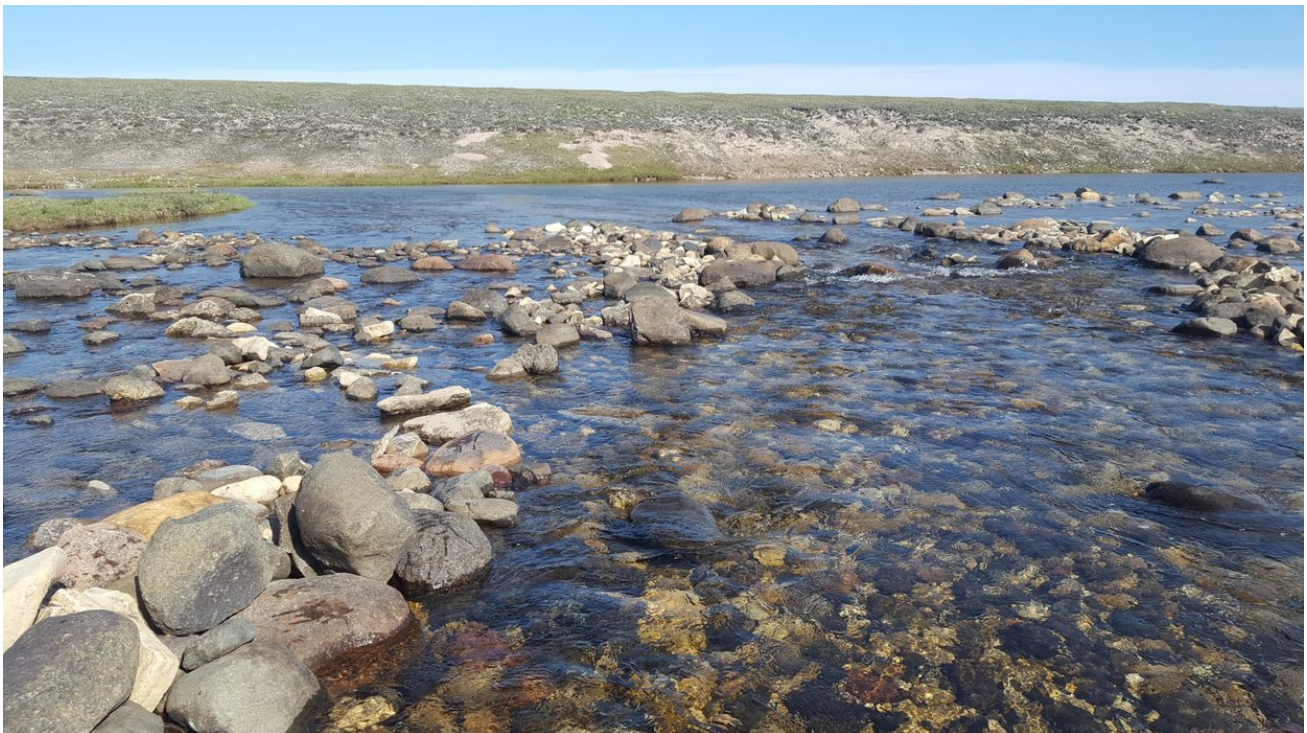
| Site | Structure | Length of Structure (m) | Percent Affected (%) | Repaired | Further Remediation Recommended | Photos (Appendix A) |
|---|---|---|---|---|---|---|
| 6 | Low-flow Channel | 30 | 10 | Yes | No | 18, 19 |

*Photo A18: Downstream View of Low-flow Channel, Pre-Repair, at Site 6 on 24 July 2018*

| Site | Structure | Percent Affected | Repairs and Improvements | Photos (Appendix A) |
|---|---|---|---|---|
| 6 | Low-flow Channel | 10 | An approximate 5 m section of the left downstream side of the low-flow channel was displaced, leaving a gap through which fish would be able to access shallower water. Boulders were used to re-build the gap. | Pre-repair – 18<br>Post-repair – 19 |

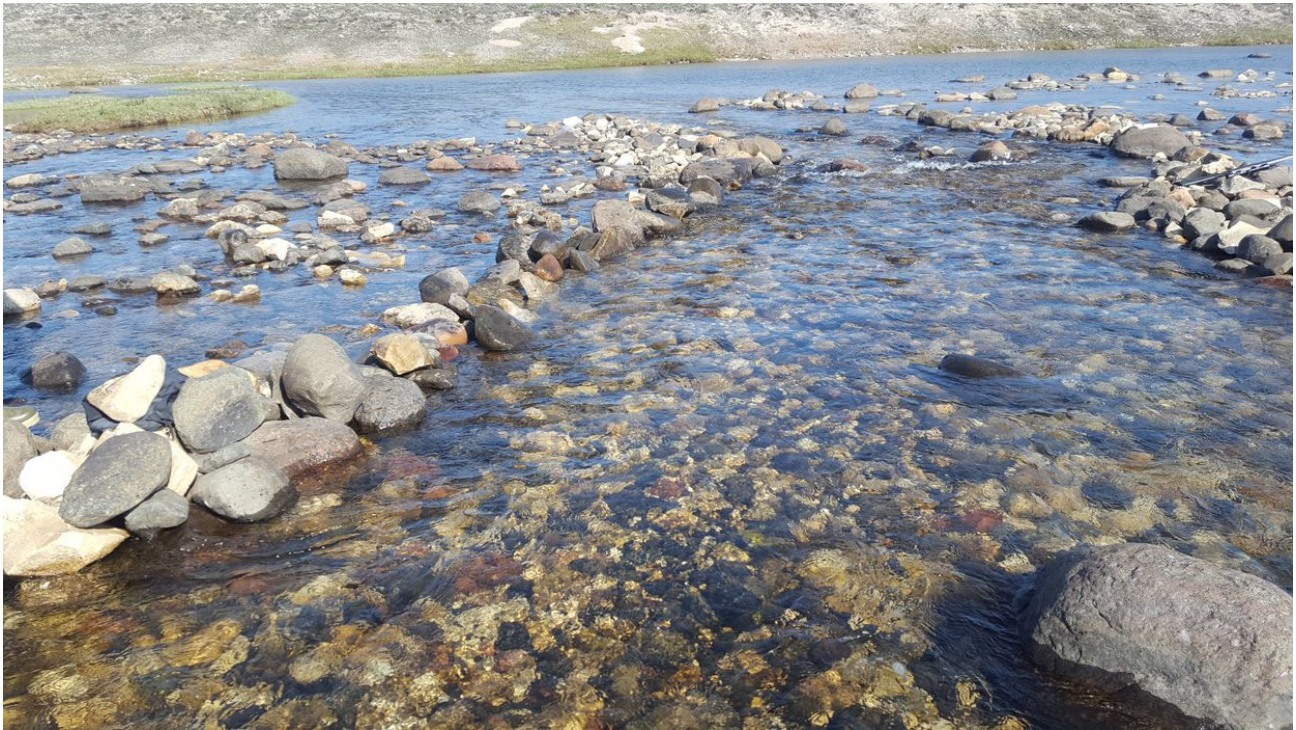
*Photo A19: Downstream View of Low-flow Channel, Post-Repair, at Site 6 on 24 July 2018*

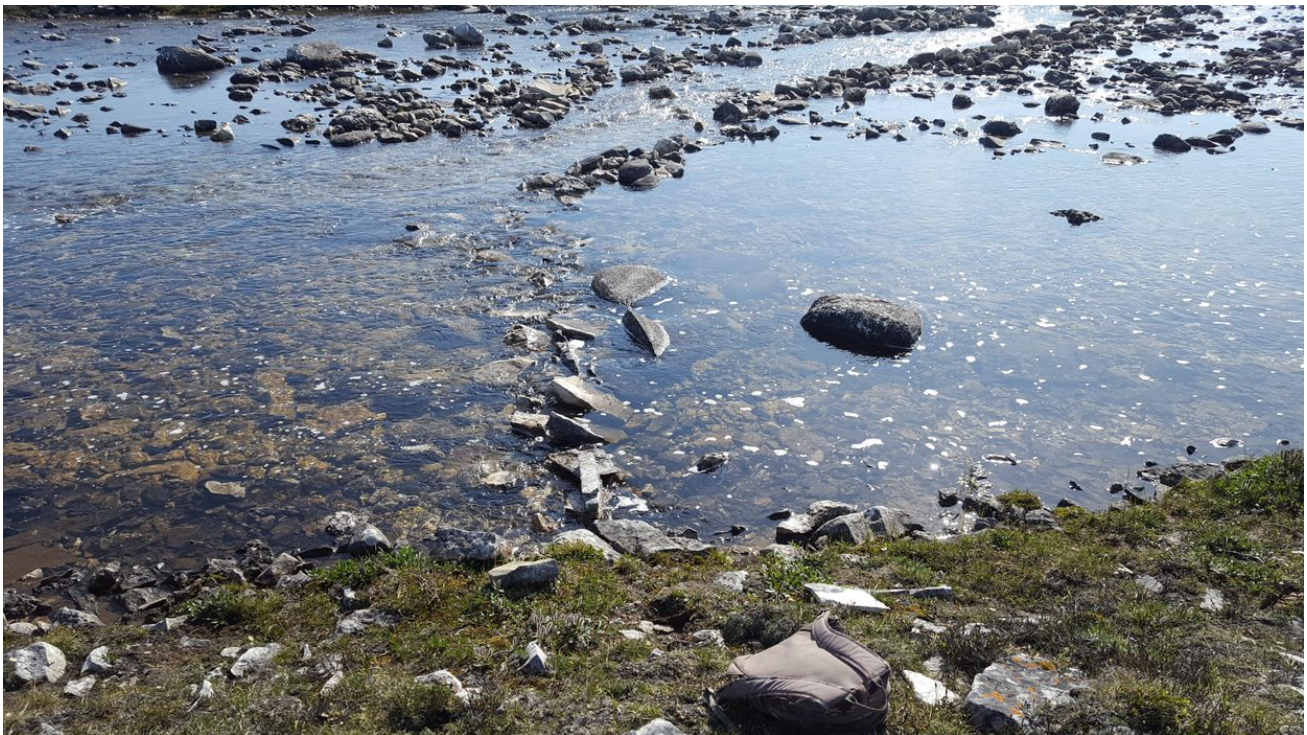
| Site | Structure | Length of Structure (m) | Percent Affected (%) | Repaired | Further Remediation Recommended | Photos (Appendix A) |
|---|---|---|---|---|---|---|
| | Directional Weir | 7 | 80* | Yes | No | 24, 25 |

*Photo A24: View from Left Downstream Bank of Directional Weir, Pre-Improvement, at Site 9 on 25 July 2018*

| Site | Structure | Percent Affected | Repairs and Improvements | Photos (Appendix A) |
|---|---|---|---|---|
| 9 | Directional Weir | 80 | The weir was partially submerged at the time of the field program due to the elevated water depths. The length of the weir was built up using boulders and cobble, so it continued to be functional in blocking fish passage to shallower waters. | Pre-repair – 24<br>Post-repair – 25 |

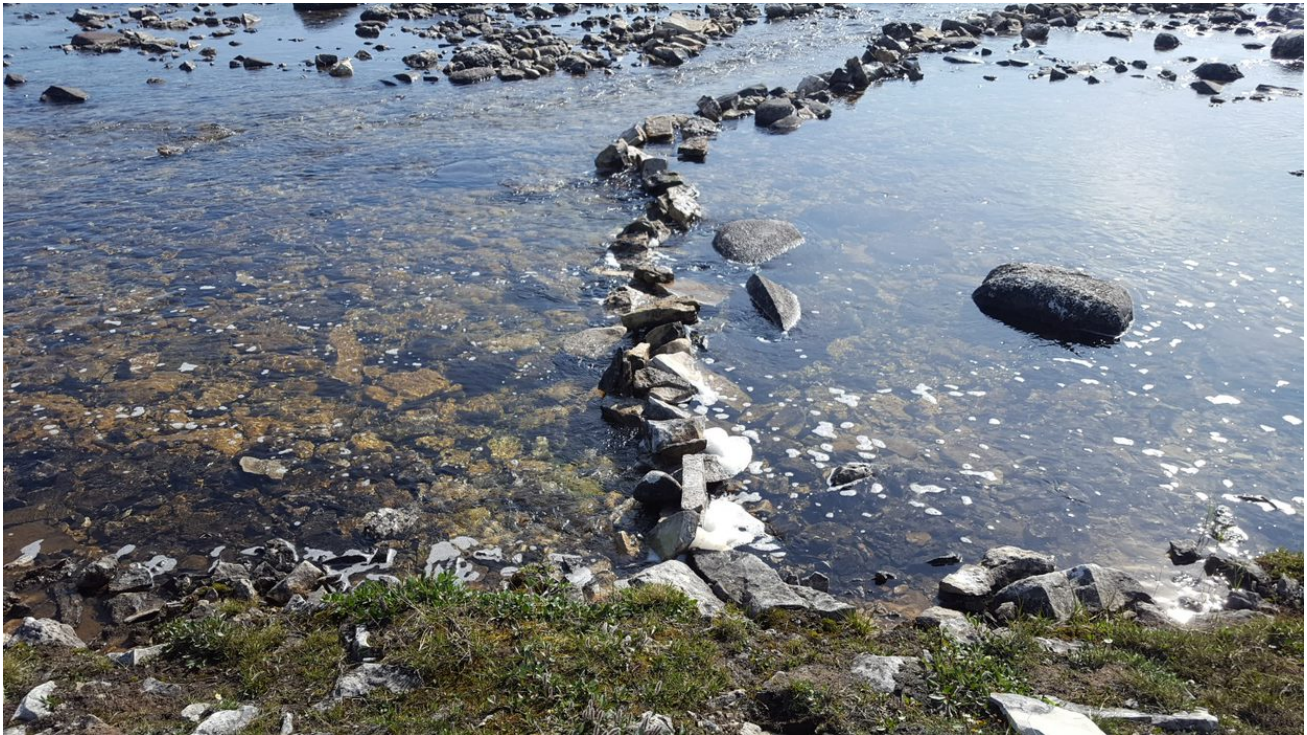
*Photo A25: View from Left Downstream Bank of Directional Weir, Post-Improvement, at Site 9 on 25 July 2018*
