## **BERNARD HARBOUR TECHNICAL MEMORANDUM**

**Project No.** 1787890-045-TM-Rev0

### **2018 BERNARD HARBOUR OFFSETTING MEASURE INSPECTION**

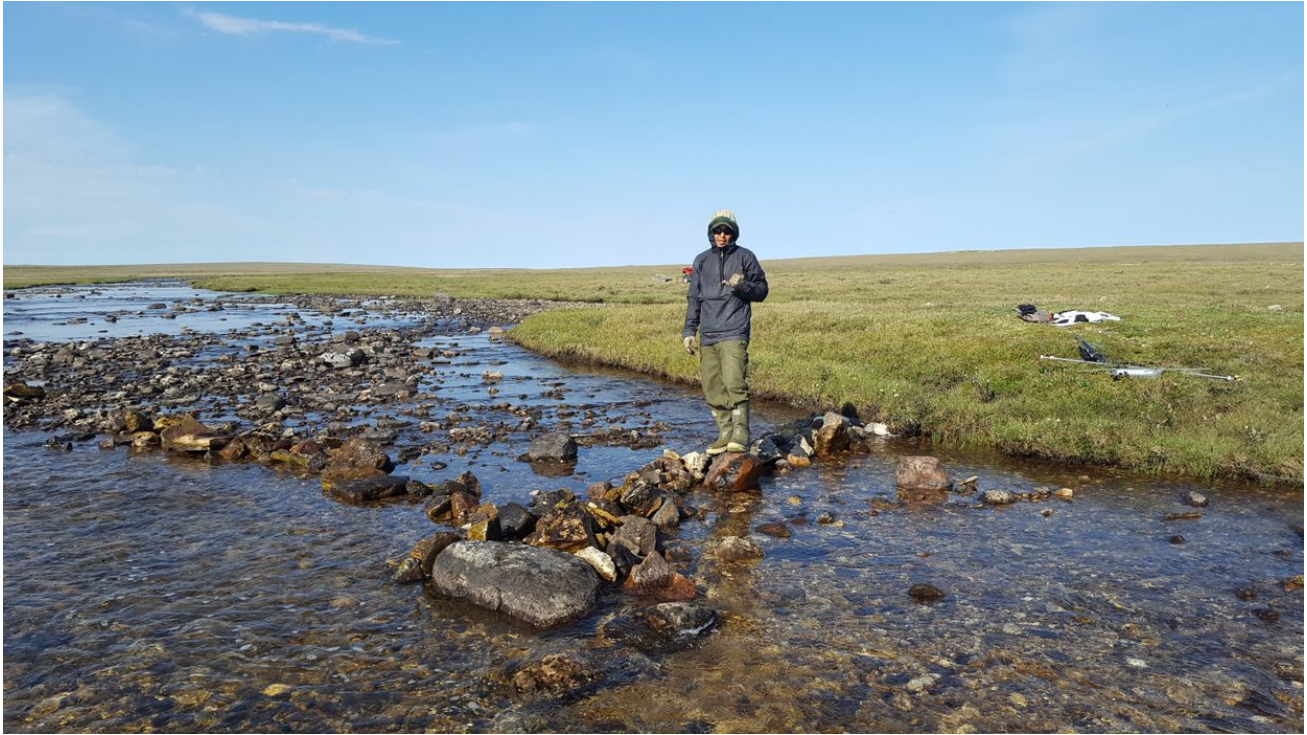
| Site | Structure | Length of Structure (m) | Percent Affected (%) | Repaired | Further Remediation Recommended | Photos (Appendix A) |
|---|---|---|---|---|---|---|
| | Directional Weir | 8 | 5 | Yes | No | 29 |

*Photo A29: Upstream View of Directional Weir, Post-Repair, with assistant Adrian at Site 10 on 25 July 2018*

| Site | Structure | Percent Affected | Repairs and Improvements | Photos (Appendix A) |
|---|---|---|---|---|
| 10 | Directional Weir | 5 | The weir was partially submerged at the time of the field program due to the elevated water depths. The length of the weir was built up using boulders and cobble so it continued to be functional in blocking fish passage to shallower waters. | Post-repair – 29 |

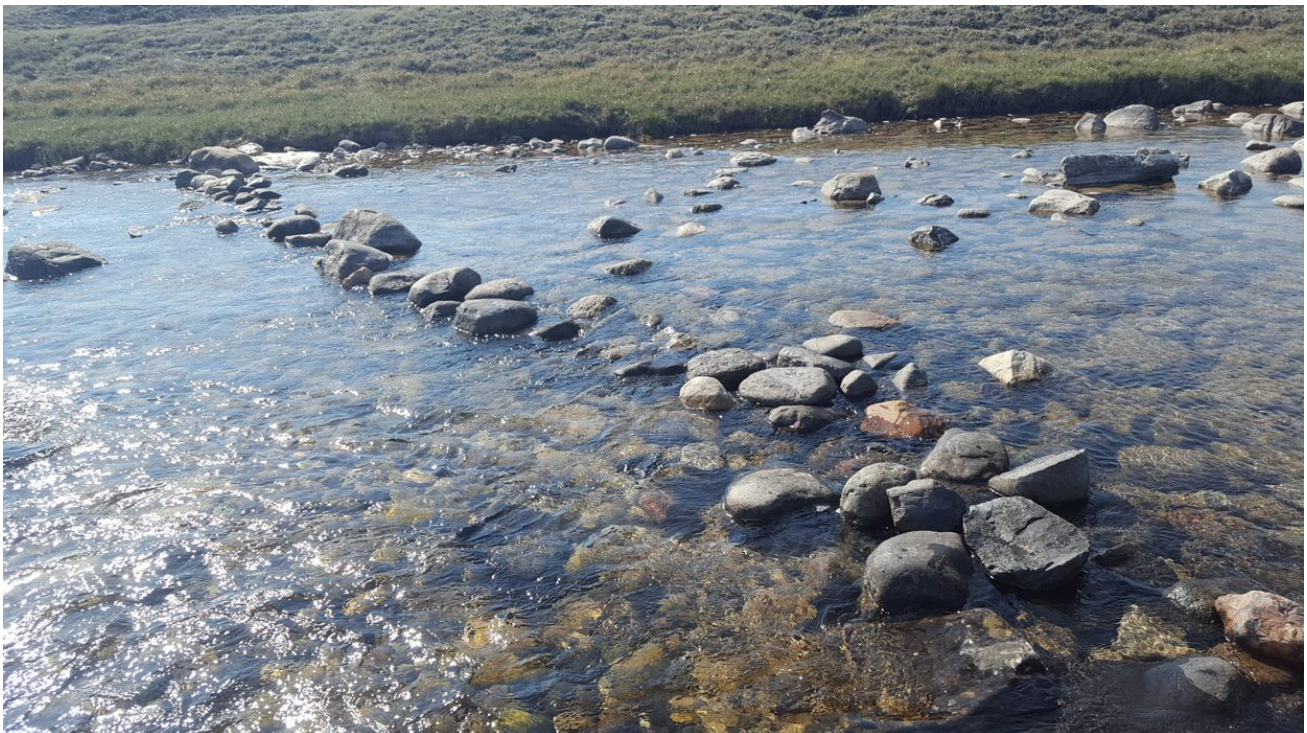
| Site | Structure | Length of Structure (m) | Percent Affected (%) | Repaired | Further Remediation Recommended | Photos (Appendix A) |
|---|---|---|---|---|---|---|
| | Directional Weir | 10 | 50 | Yes | No | 32, 33 |

*Photo A32: Downstream View of Directional Weir, Pre-Repair/Improvement, at Site 12 on 24 July 2018*

| Site | Structure | Percent Affected | Repairs and Improvements | Photos (Appendix A) |
|---|---|---|---|---|
| 12 | Directional Weir | 50 | A few boulders were out of place from the directional weir constructed to guide fish into the low-flow channel. They were placed back into the weir and the weir height was increased to accommodate the elevated water level. | Pre-repair – 32<br>Post-repair – 33 |

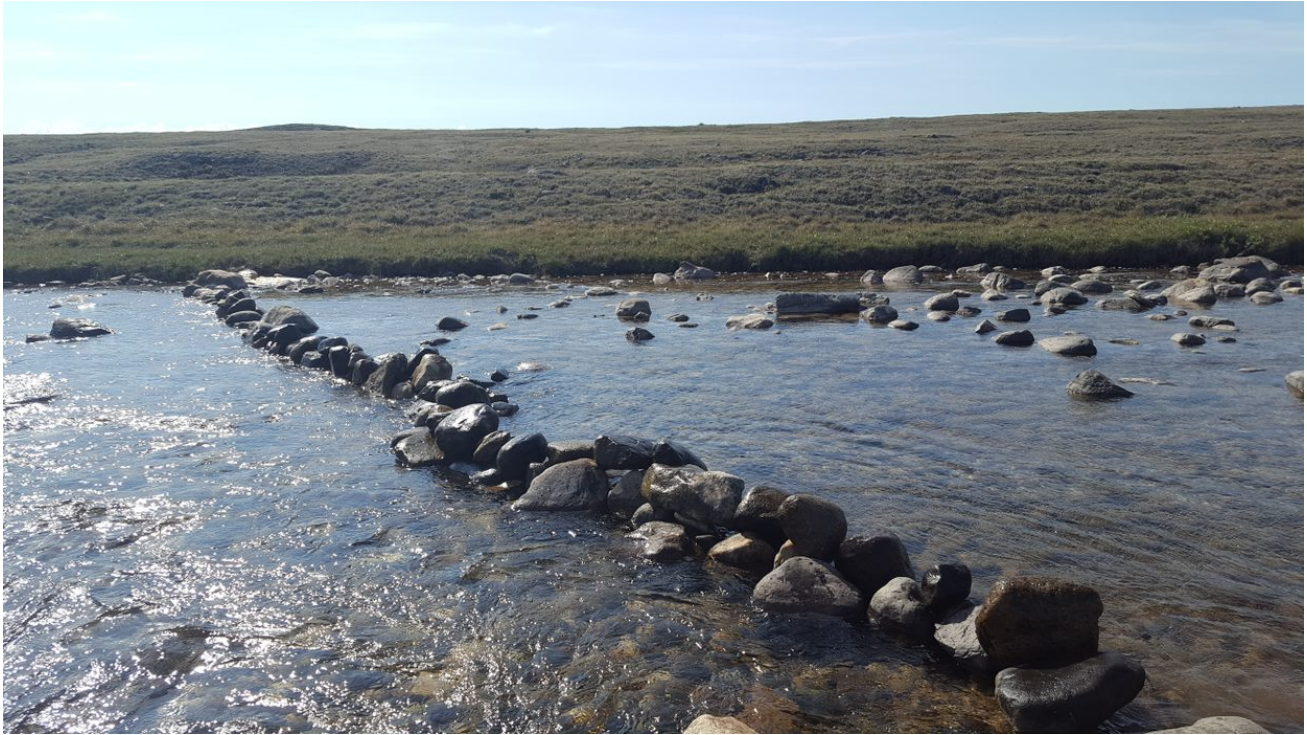
*Photo A33: Downstream View of Directional Weir, Post-Repair/Improvement, at Site 12 on 24 July 2018*

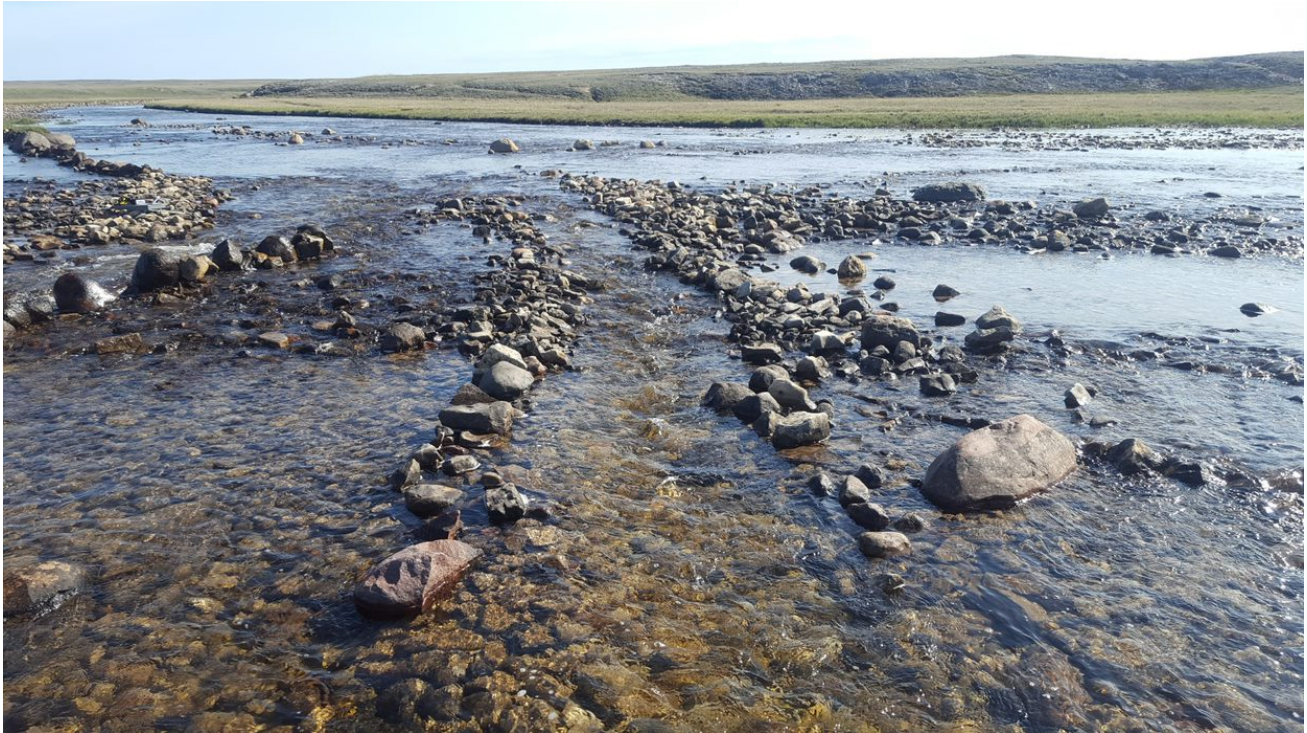
*Photo A35: Upstream View of Low-flow Channel B at 2012 Project 1, Depths Allows for Fish Passage, 25 July 2018*

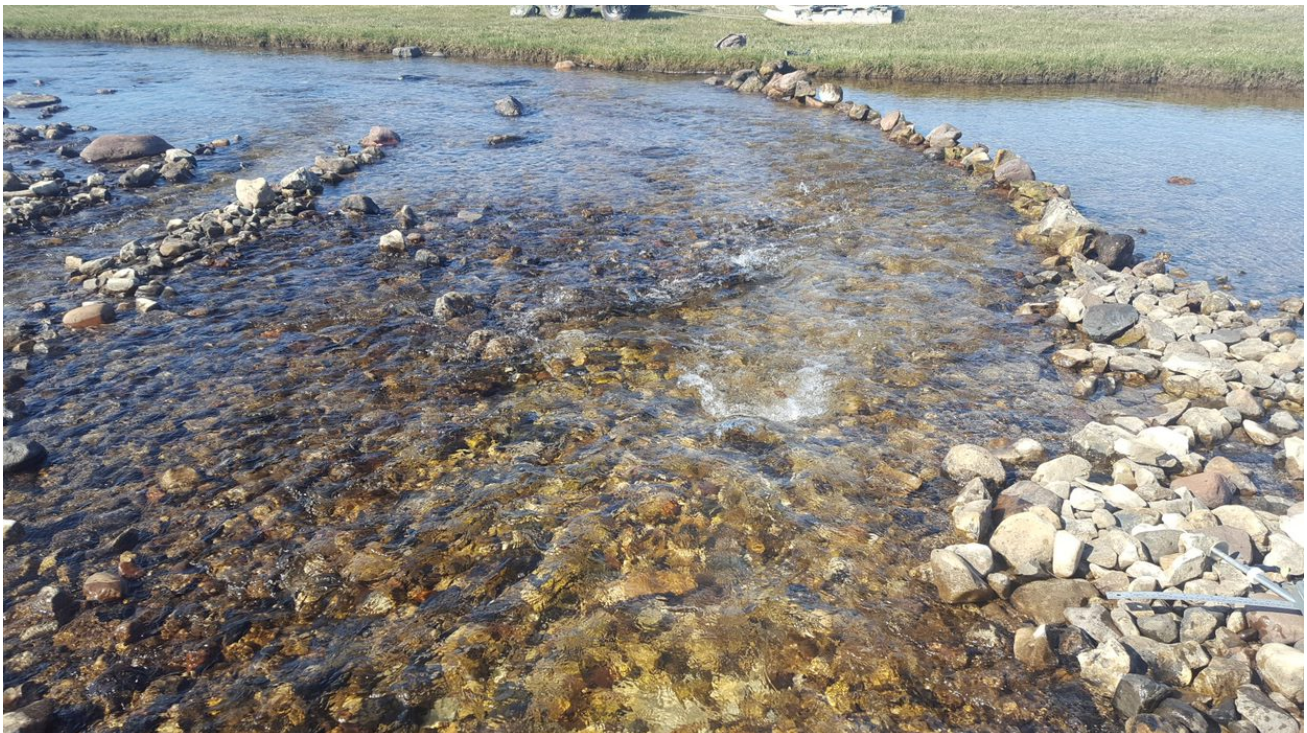
| Project | Structure | Length of Structure (m) | Percent Affected (%) | Repairs Recommended in Golder 2017 | Repaired or Improved | Photos (Appendix A) |
|---|---|---|---|---|---|---|
| | Low-flow Channel A | 28 | 100 | Yes | Yes | 36, 37 |

*Photo A36: Downstream View of Low-flow Channel A, Pre-Repair, at 2012 Project 1, 25 July 2018*

| Site | Structure | Percent (%) Displaced | Repairs and Improvements | Photos (Appendix A) |
|---|---|---|---|---|
| 1 | Low-flow Channel A | 100 | Boulders and cobble were placed to better define the left downstream bank of the low-flow channel. | Pre-repair – 35, 36<br>Post-repair - 37 |

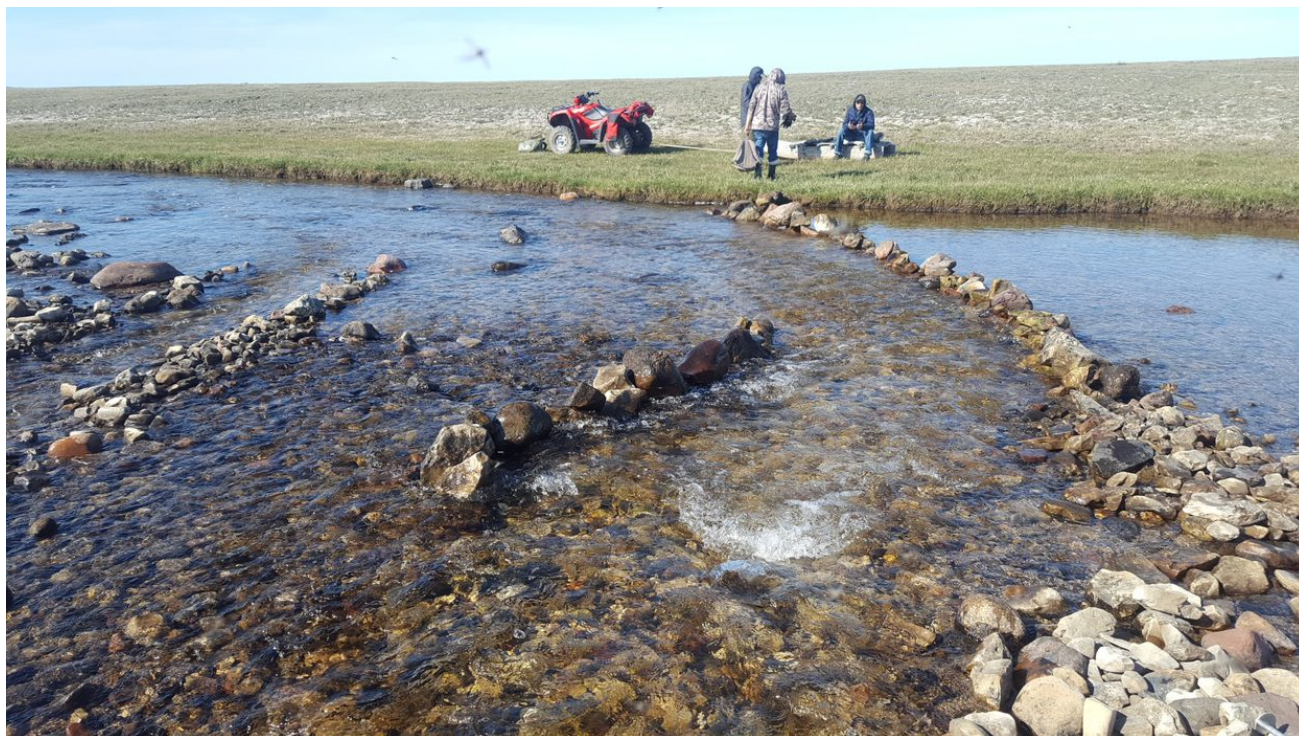
*Photo A37: Downstream View of Low-flow Channel A, Post-Repair, at 2012 Project 1, 25 July 2018*

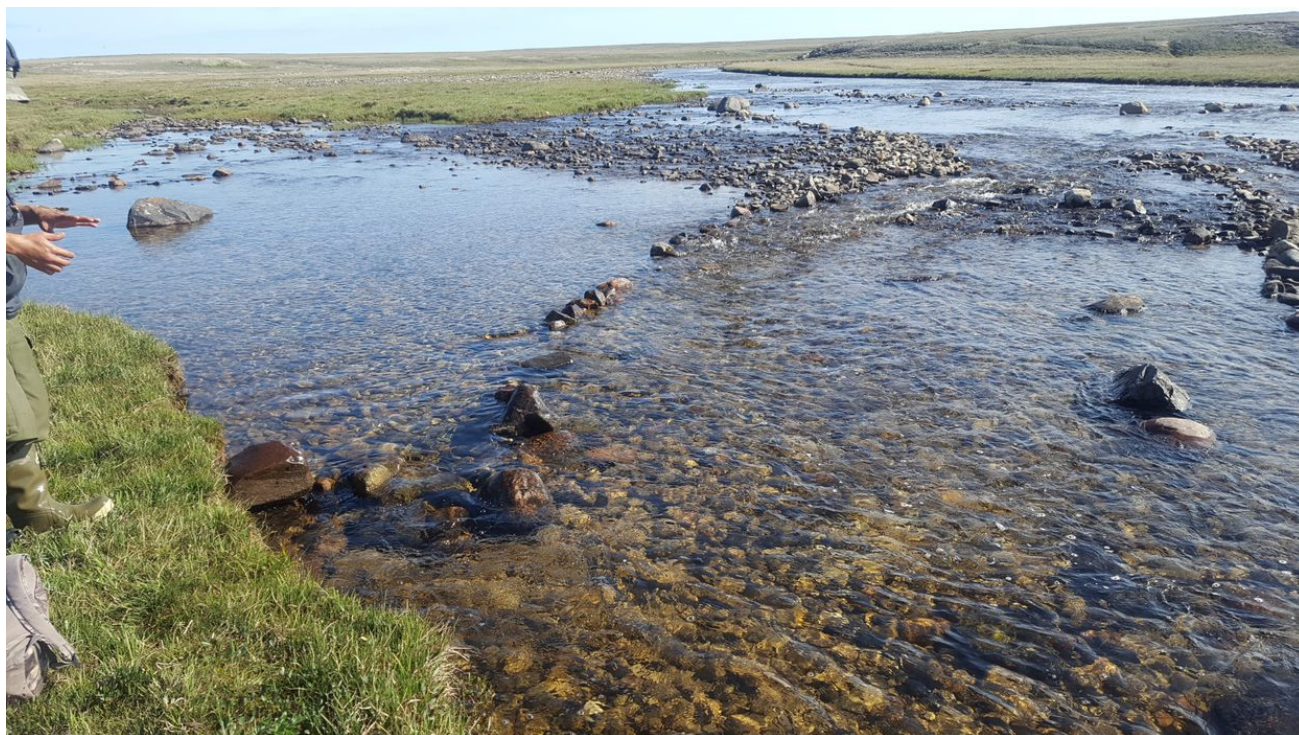
| Project | Structure | Length of Structure (m) | Percent Affected (%) | Repairs Recommended in Golder 2017 | Repaired or Improved | Photos (Appendix A) |
|---|---|---|---|---|---|---|
| | Directional Weir | 9 | 50 | Yes | Yes | 38, 39 |

*Photo A38: View from Right Downstream Bank of Directional Weir, Pre-Repair, at 2012 Project 1, 25 July 2018*

| Site | Structure | Percent (%) Displaced | Repairs and Improvements | Photos (Appendix A) |
|---|---|---|---|---|
| | Directional Weir A | 50 | A large section of the directional weir was replaced and fortified with boulders and cobble, blocking fish passage to the shallow right downstream bank of the creek where stranding might have occurred. | Pre-repair – 38<br>Post-repair - 39 |

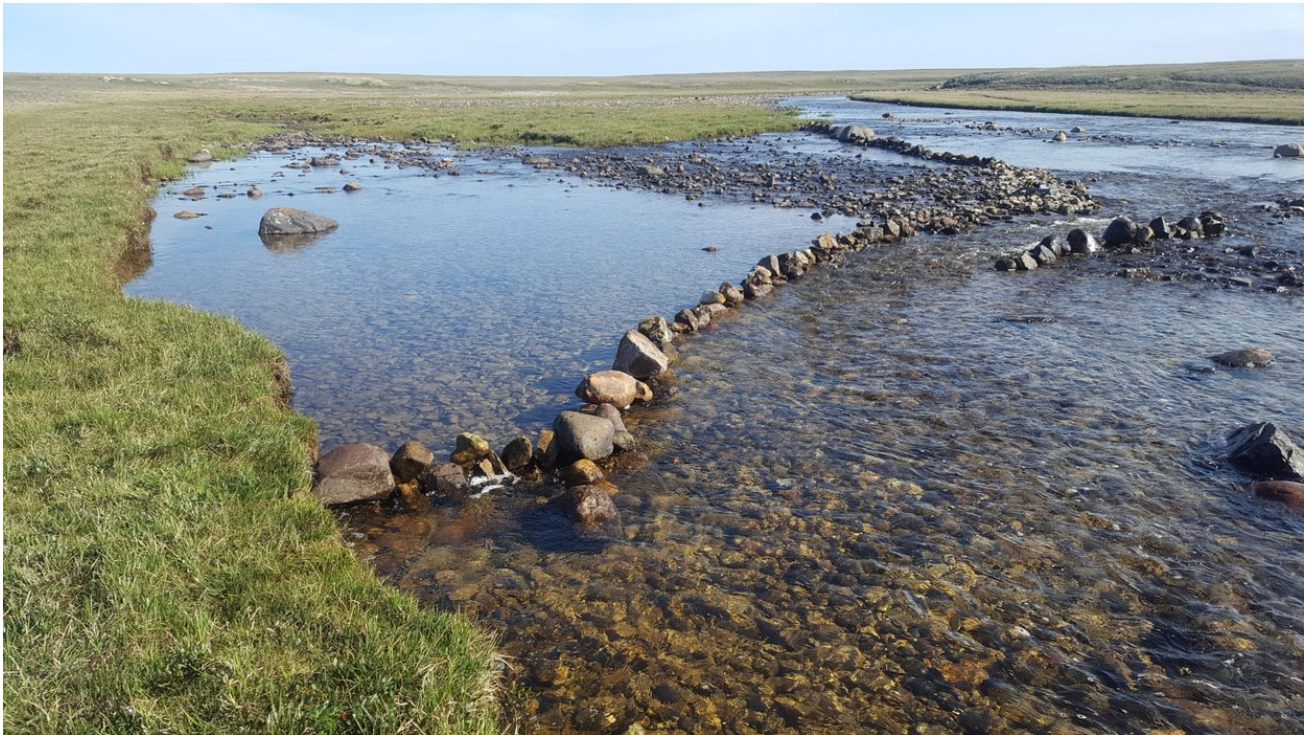
*Photo A39: View from Right Downstream Bank of Directional Weir, Post-Repair, at 2012 Project 1, 25 July 2018*

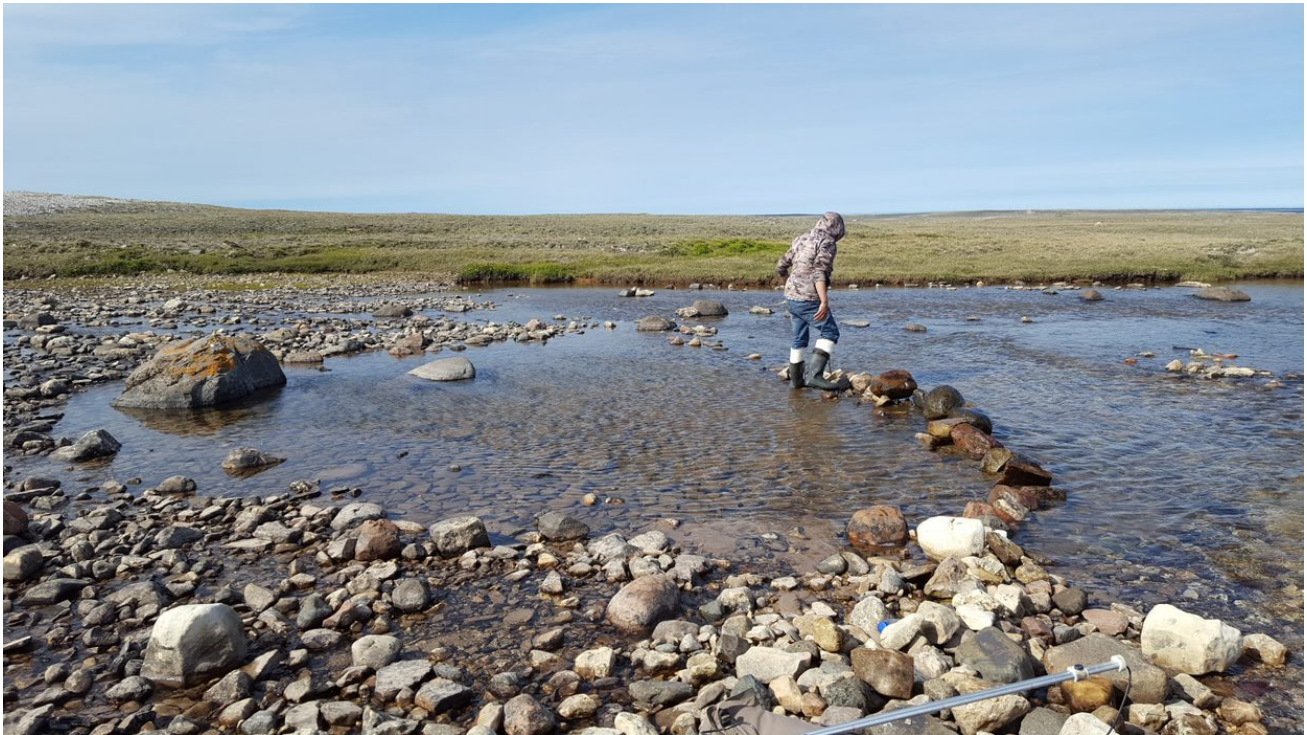
| Project | Structure | Length of Structure (m) | Percent Affected (%) | Repairs Recommended in Golder 2017 | Repaired or Improved | Photos (Appendix A) |
|---|---|---|---|---|---|---|
| | Directional Weir | 15 | 90 | Yes | Yes | 41, 42 |

*Photo A41: Downstream View of Directional Weir, Pre-Repair, at 2012 Project 2, 24 July 2018*

| Site | Structure | Percent (%) Displaced | Repairs and Improvements | Photos (Appendix A) |
|---|---|---|---|---|
| 2 | Directional Weir | 90 | Part of the weir was rebuilt to prevent access to shallower water where stranding might have occurred and to ensure utilization of the low-flow channels. | Pre-repair – 41<br>Post-repair – 42 |

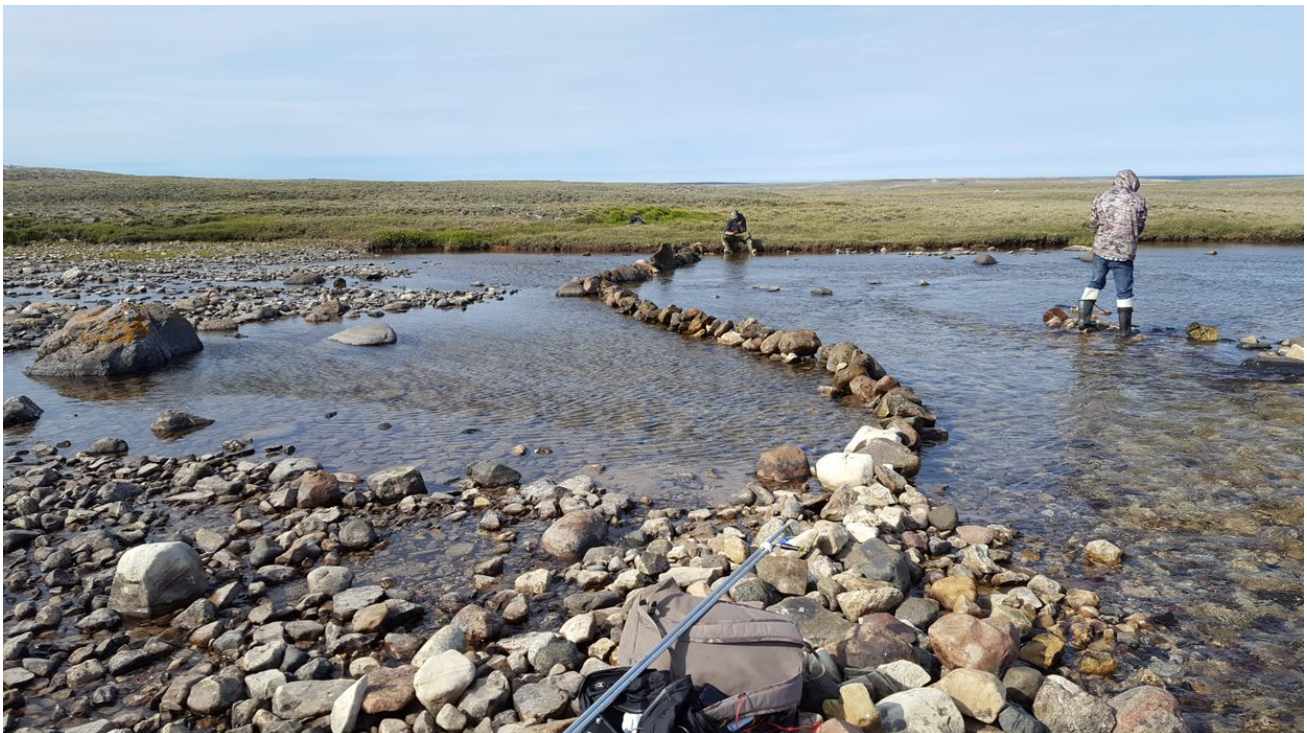
*Photo A42: Downstream View of Directional Weir, Post-Repair, at 2012 Project 2, 24 July 2018*

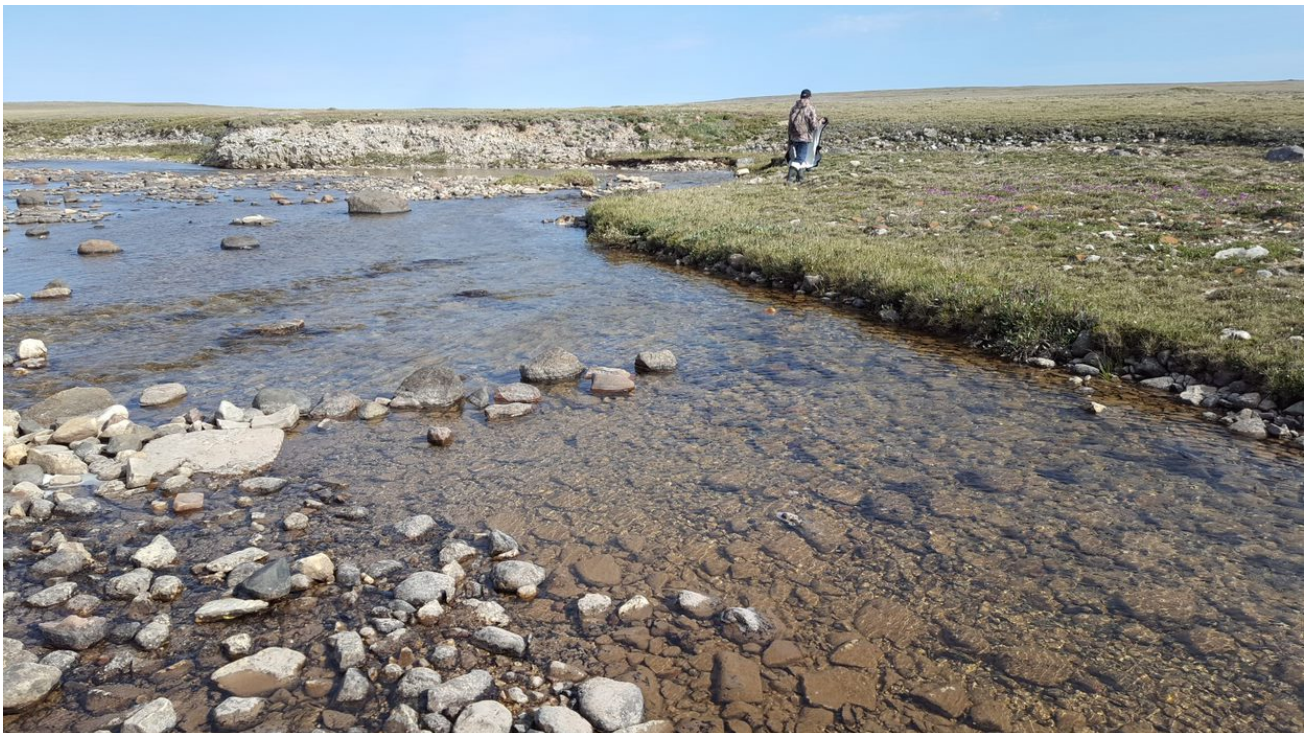
| Project | Structure | Length of Structure (m) | Percent Affected (%) | Repairs Recommended in Golder 2017 | Repaired or Improved | Photos (Appendix A) |
|---|---|---|---|---|---|---|
| | Directional Weir | 5 | 90 | Yes | Yes | 44, 45 |

*Photo A44: Downstream View of Directional Weir, Pre-Repair, at 2012 Project 3, 24 July 2018*

| Site | Structure | Percent (%) Displaced | Repairs and Improvements | Photos (Appendix A) |
|---|---|---|---|---|
| 3 | Directional Weir | 90 | The directional weir was re-built and extended to the right downstream bank to prevent fish access to shallow waters where stranding might have occurred. | Pre-repair – 44<br>Post-repair – 45 |

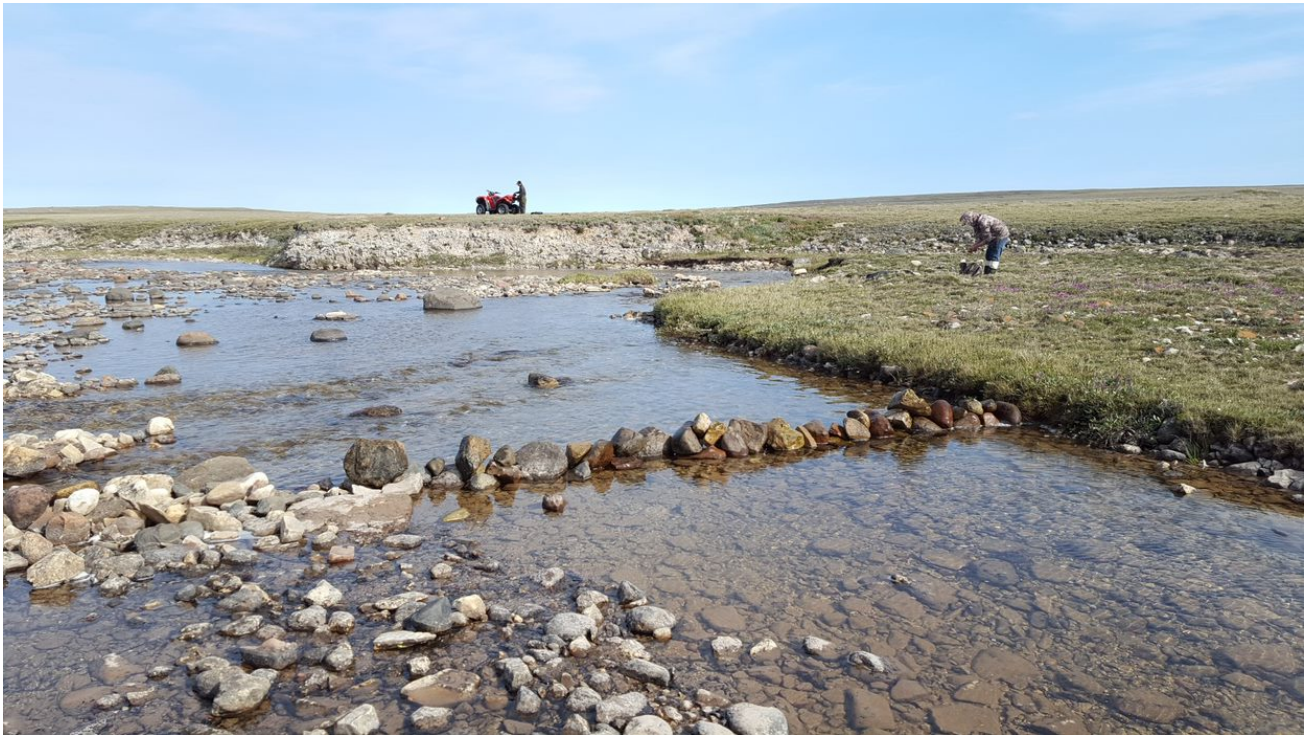
*Photo A45: Downstream View of Directional Weir, Post-Repair, at 2012 Project 3, 24 July 2018*

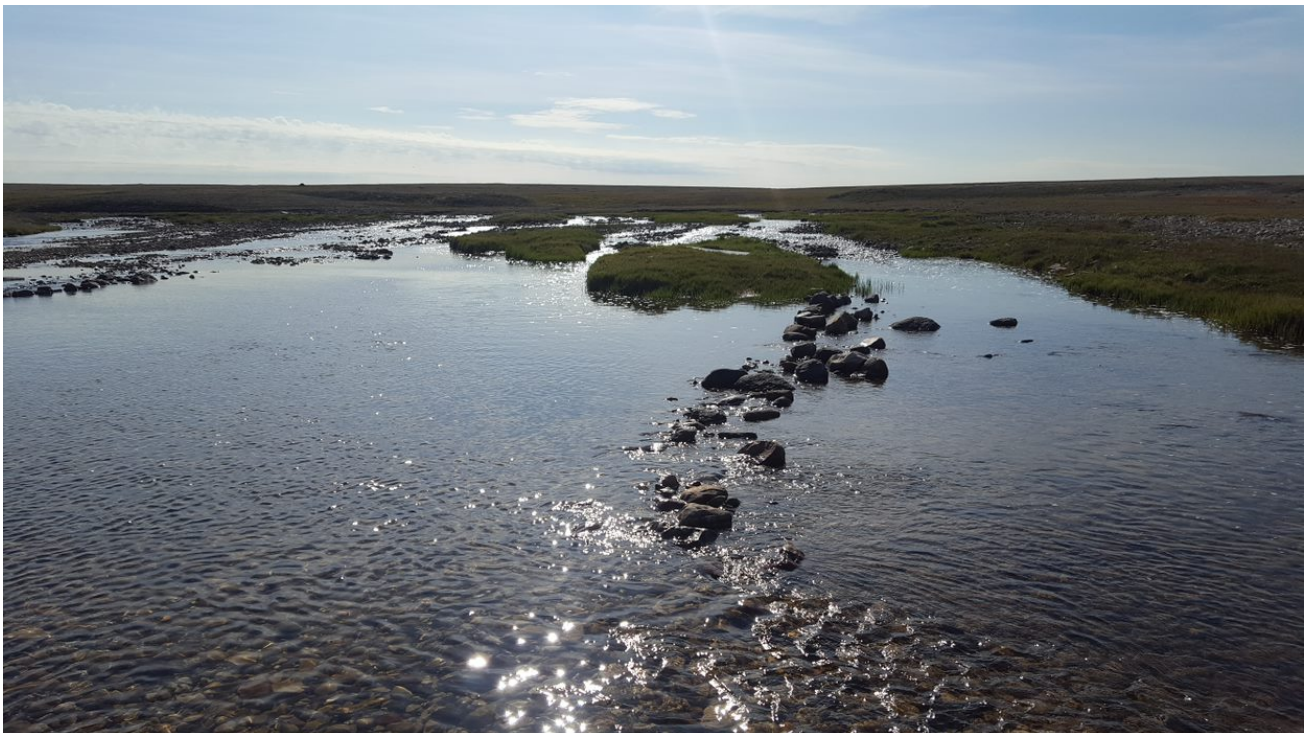
| Project | Structure | Length of Structure (m) | Percent Affected (%) | Repairs Recommended in Golder 2017 | Repaired or Improved | Photos (Appendix A) |
|---|---|---|---|---|---|---|
| | Directional Weir B | 15 | 30 | No | Yes | 50, 51 |

*Photo A50: Upstream View of Directional Weir B, Pre-Repair, at 2012 Project 5, 25 July 2018*

| Site | Structure | Percent (%) Displaced | Repairs and Improvements | Photos (Appendix A) |
|---|---|---|---|---|
| 5 | Directional Weir B | 30 | No repairs were indicated in the 2017 report; however, a portion of the directional weir was built up and fortified to prevent access to the shallow left downstream side of the creek where stranding might have occurred. | Pre-repair – 50<br>Post-repair – 51 |

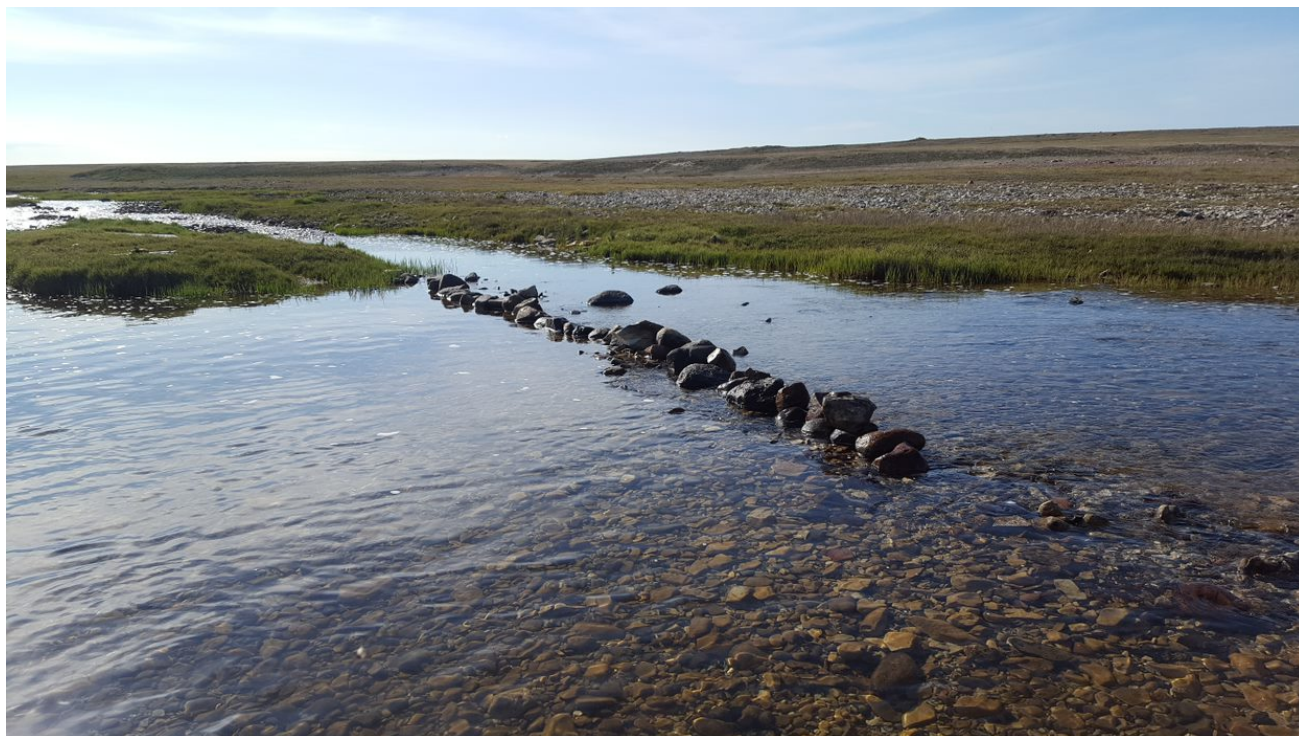
*Photo A51: Upstream View of Directional Weir B, Pre-Repair, at 2012 Project 5, 25 July 2018*
