### 3. OBSERVATIONS AT SITE

From March 23 to 25, 2026, NIRB staff conducted a site visit to the Goose Property Area, travelled the Winter Ice Road (WIR), and visited the Marine Laydown Area (MLA) of the Back River Project, accompanied by B2Gold Nunavut's environment team. The purpose of the visit was to review construction progress, environmental management practices, and compliance with Project Certificate No. 007, Amendment 01. During the visit, NIRB staff observed ongoing construction, commissioning, and operational activities and held discussions with B2Gold Nunavut personnel regarding environmental monitoring, mitigation measures, and adherence to Project Certificate requirements ([Table 1](#))

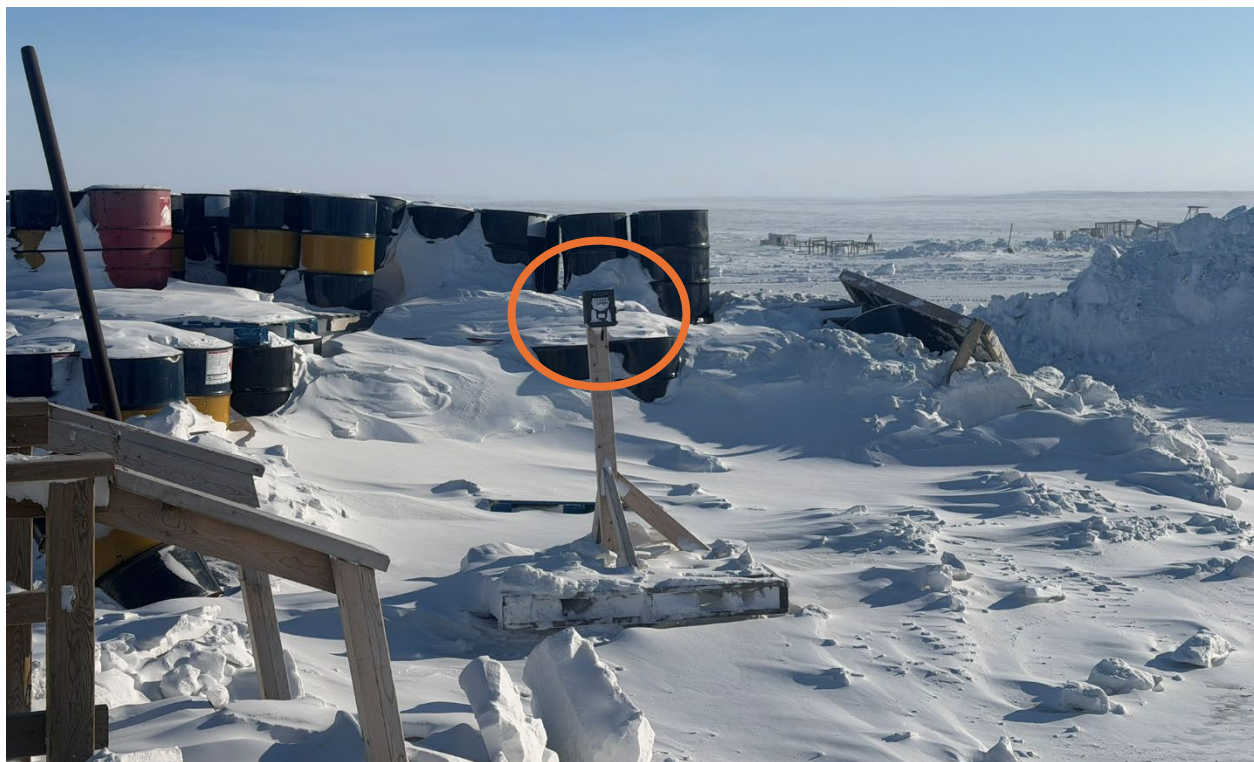
| | | wildlife camera located at the Goose Exploration Camp incinerator was observed to be obstructed by accumulated snow at the time of the visit ( <a href="#">Photo 10</a> ). |

**Photo 10: Wildlife monitoring camera located east of incinerators (camera housing appeared obstructed by accumulated snow)**

- A wildlife monitoring camera located near the incinerator buildings at the Goose Exploration Camp was observed to be obstructed by accumulated snow at the time of the site visit. While B2Gold Nunavut confirmed that wildlife cameras are inspected on a biweekly basis, additional inspections following significant snowfall or wind events, or more frequent checks during winter months, would help ensure continued camera functionality and effective wildlife monitoring ([Photo 10](#)).

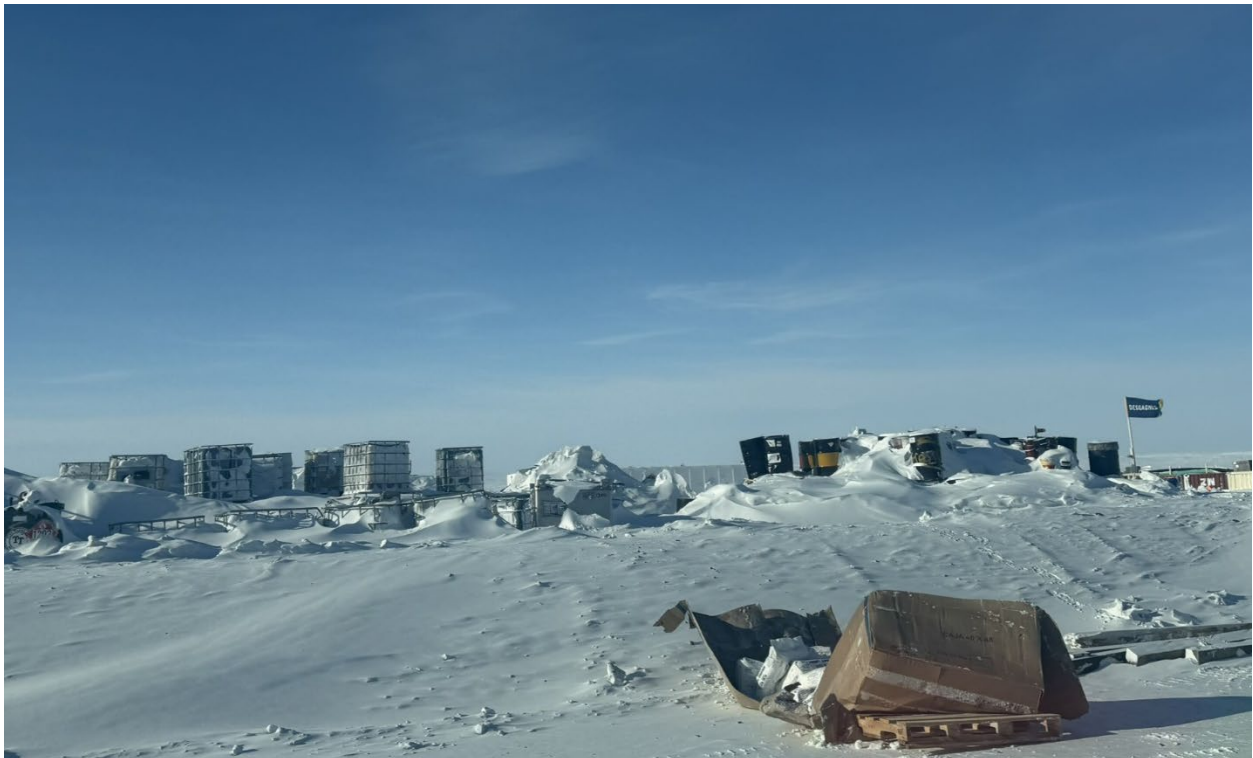
**Photo 14: Debris including damaged box and bulk bags on the snow surface east of HAZMAT containment**

- At the Goose Exploration Camp, several areas appeared unorganized, with debris including damaged boxes and bulk bags observed on the snow surface east of the HAZMAT containment area ([Photo 14](#)). Unsecured mega bags, totes, and other containers were also observed near the settling pond area ([Photo 19](#)), posing a potential wildlife entrapment hazard.

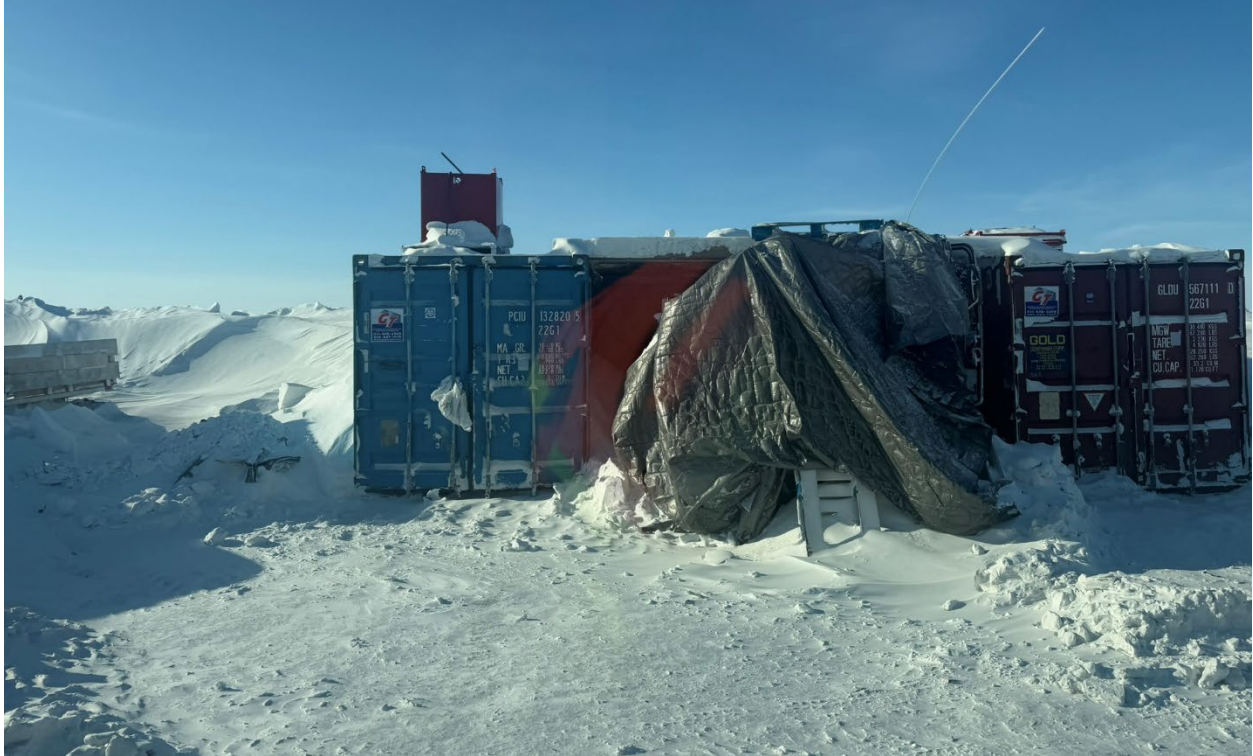
**Photo 17: Improperly secured seacans east of the air traffic control unit**

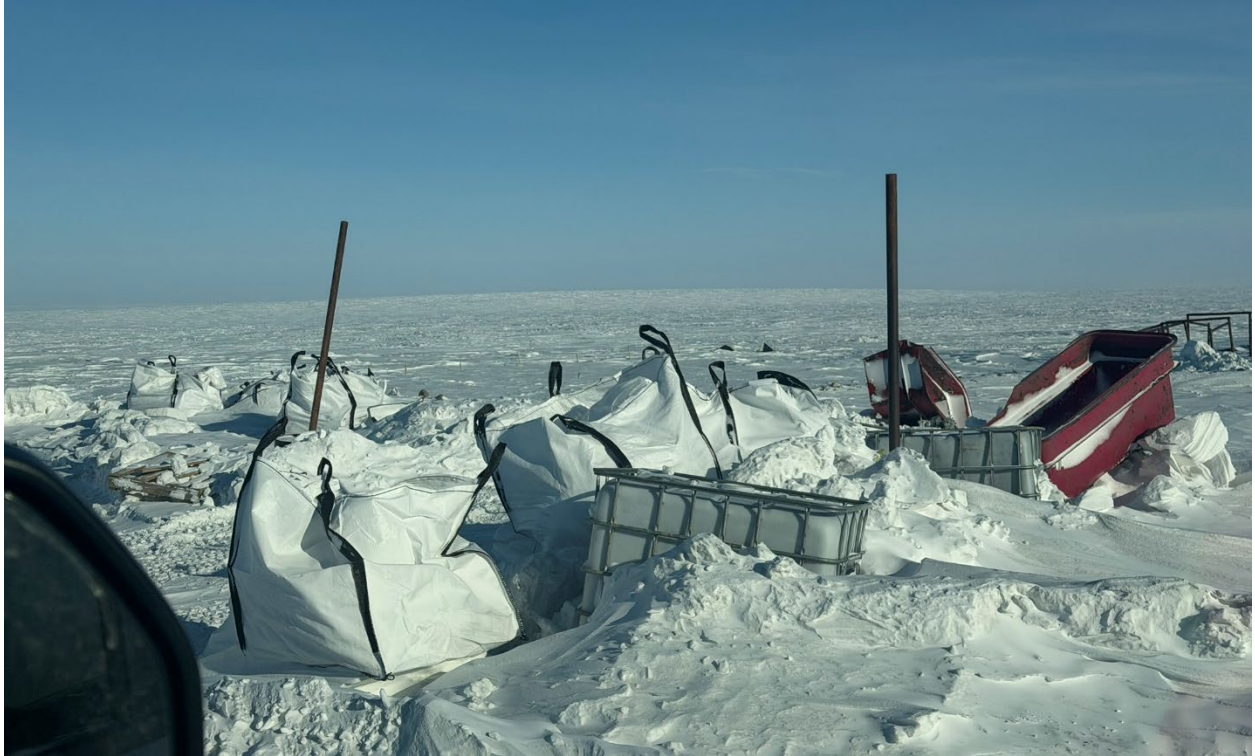
**Photo 19: Unsecured mega bags, totes, and containers near the settling pond posing a potential wildlife entrapment hazard**

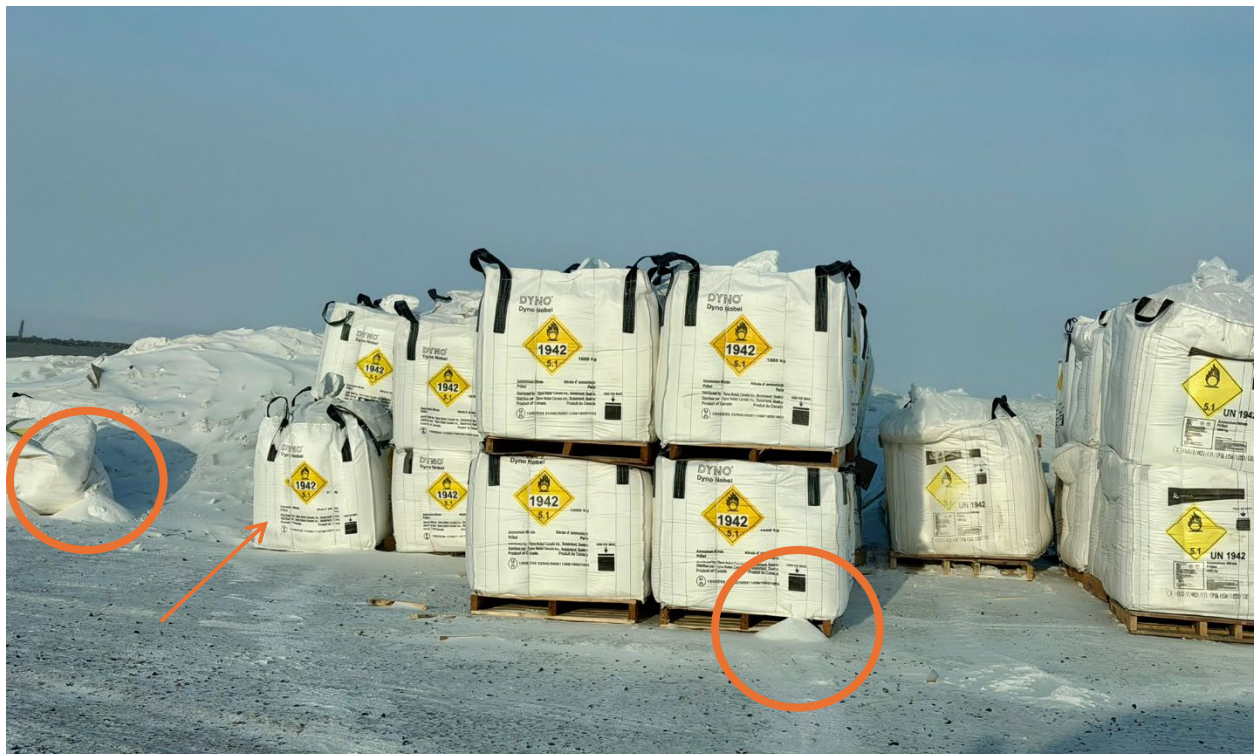
Photo 55: Storage and staging of Ammonium Nitrate (AN) bulk bags at the blasting area<sup>9</sup>

<sup>9</sup> During the site visit, a puncture was observed on a bulk bag containing prilled ammonium nitrate, with active discharge onto the snow-covered ground surface. The damage was considered consistent with mechanical impact. B2Gold Nunavut staff were notified, and corrective actions were taken, including cleanup of the

released material (see Follow-Up section). Bulk bags were also observed to be placed directly on the ground surface, increasing the potential risk of material loss and environmental release.

At the Blasting Area, a punctured bulk bag containing prilled ammonium nitrate was observed, with active discharge onto the snow-covered ground surface (Photo 55). The damage was attributed to mechanical impact during material handling. Corrective actions included securing the damaged bag, transferring remaining material into a waste mega bag, and shoveling and sweeping the affected area.

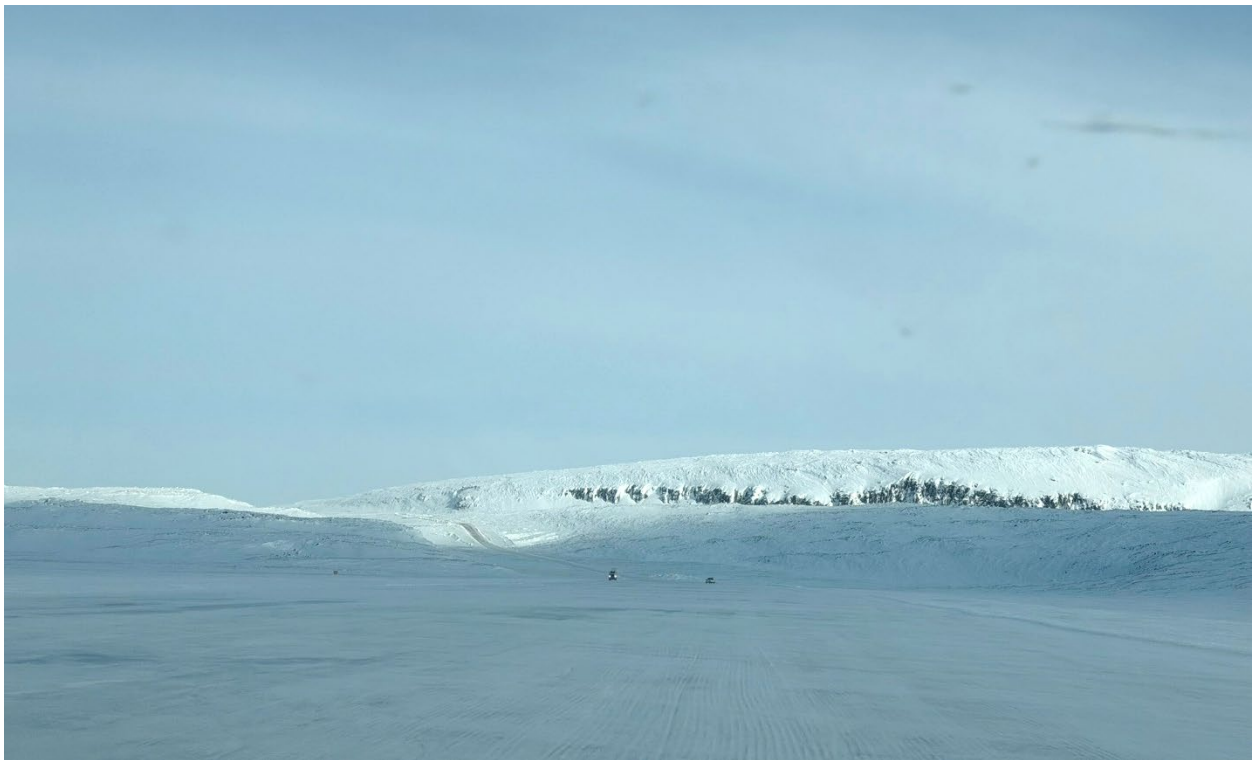
**Photo 87: Lake between Portages 13 and 14 (~ Km 50)**

- On wide lake sections of the Winter Ice Road, including the lakes between Portages 10 and 12 ([Photo 85 and Photo 87](#)), Portages 13 and 14, Bathurst Lake ([Photo 99](#)), and the ice road extending onto sea ice toward the Arctic Ocean at Bathurst Inlet ([Photo 106, Photo 107, Photo 110, and Photo 111](#)), clear road boundaries and delineators were not consistently observed. The installation of delineators would improve driver guidance during low visibility conditions such as nighttime travel or wind and snow events, and would help ensure vehicles remain within the designated corridor, particularly given that ice strength is greatest along the center of the road.

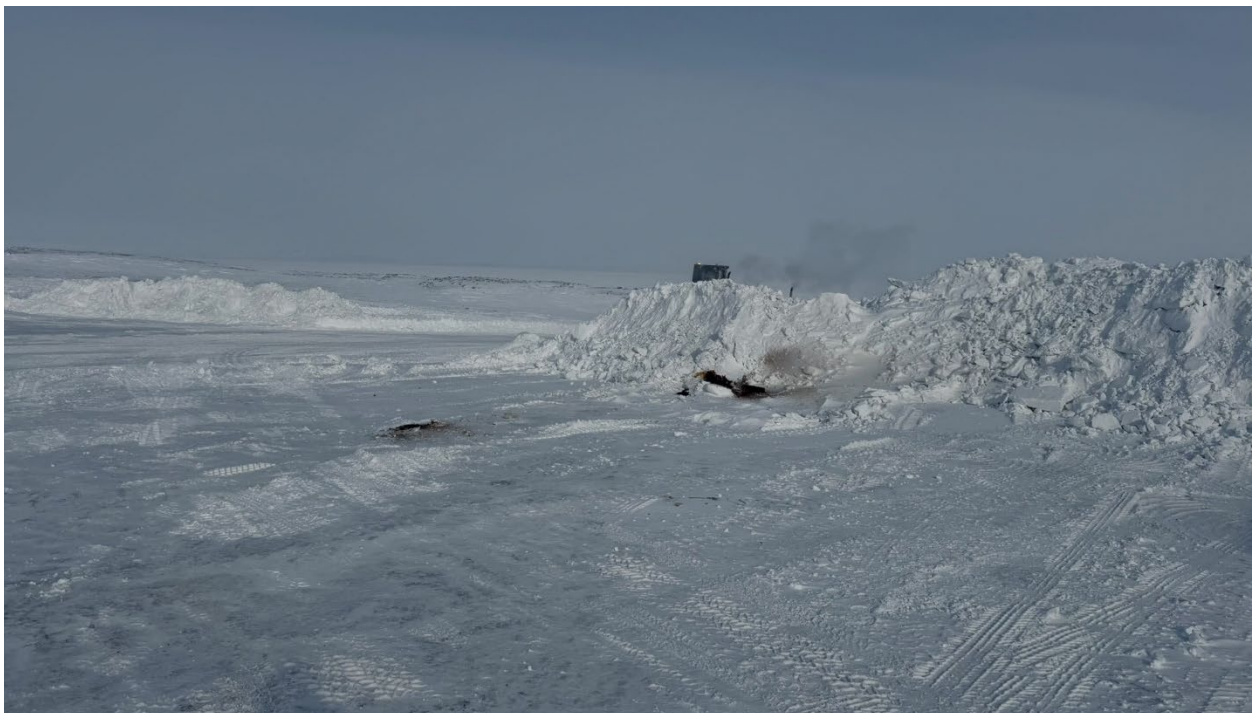
**Photo 97: Hydraulic fluid or oil spill, northern end of MLA Forward Camp<sup>13</sup>**

<sup>13</sup> During the site visit, a spill was observed, evidenced by brown discoloration of the snow. The material appeared consistent with hydraulic fluid or oil. B2Gold Nunavut staff were notified, and cleanup actions were completed (see Follow-Up Section).

At the MLA Forward Camp, a small oil or hydraulic fluid spill was observed on snow (Photo 97 and Photo 98), later determined to have originated from a crew bus. Contaminated snow was shoveled, collected in a bag, and disposed of appropriately.

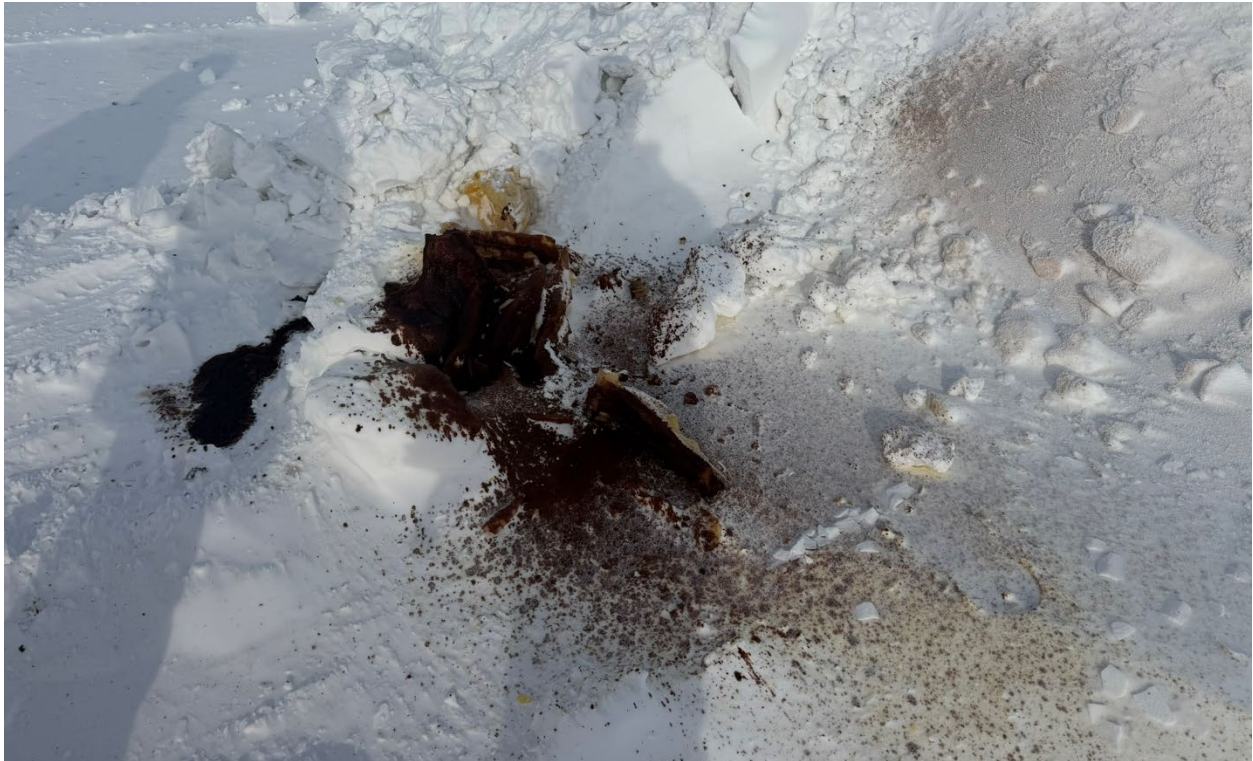
**Photo 98: Close-up: Hydraulic fluid or oil spill, northern end of MLA Forward Camp**

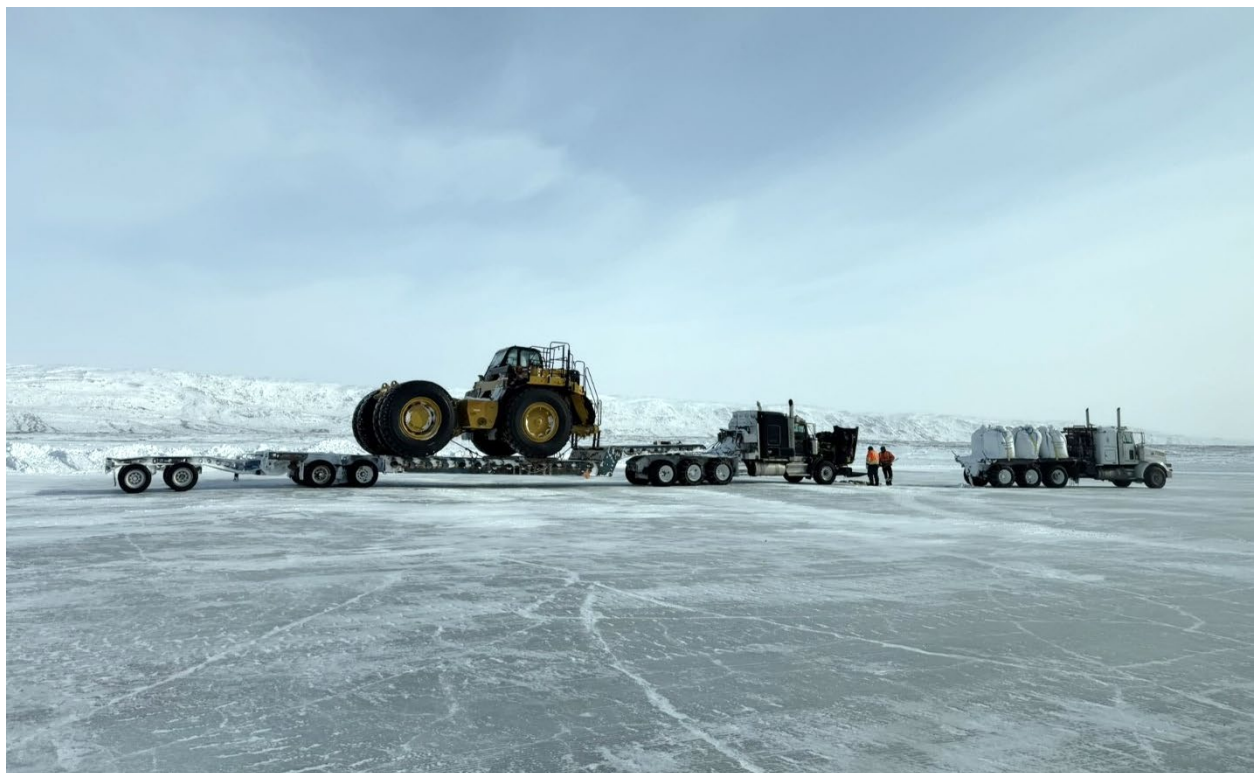
**Photo 105: Disabled equipment truck on sea ice, facing east**

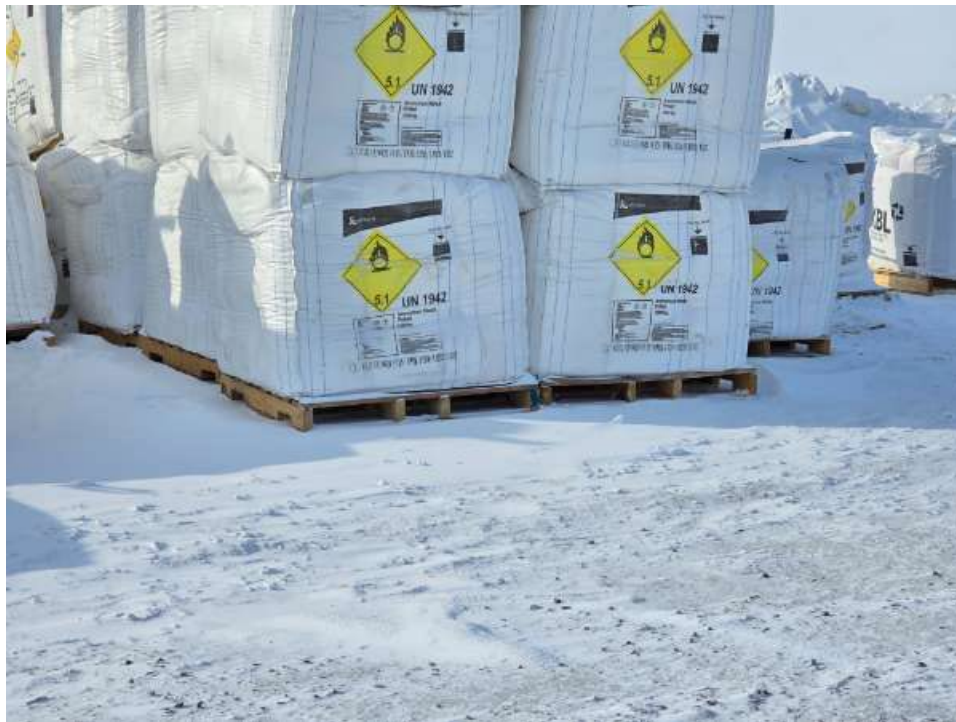
On March 28, Macoura Kone, Manager, Environment, B2Gold Nunavut, provided internal spill reports to the NIRB, including post-cleanup photographs confirming that corrective actions were completed (Photo 141 and 142).

**Photo 141: Ammonium nitrate (AN) spill area following cleanup, photo extracted from the internal spill report**
