# TOTE ROAD CV-225

BAFFINLAND IRON MINES  
MARY RIVER PROJECT

### **Erosion and Sediment Controls implemented in 2023**

# 2023 TOTE ROAD CULVERT EROSION AND SEDIMENTATION CONTROL IMPLEMENTATION SUMMARY

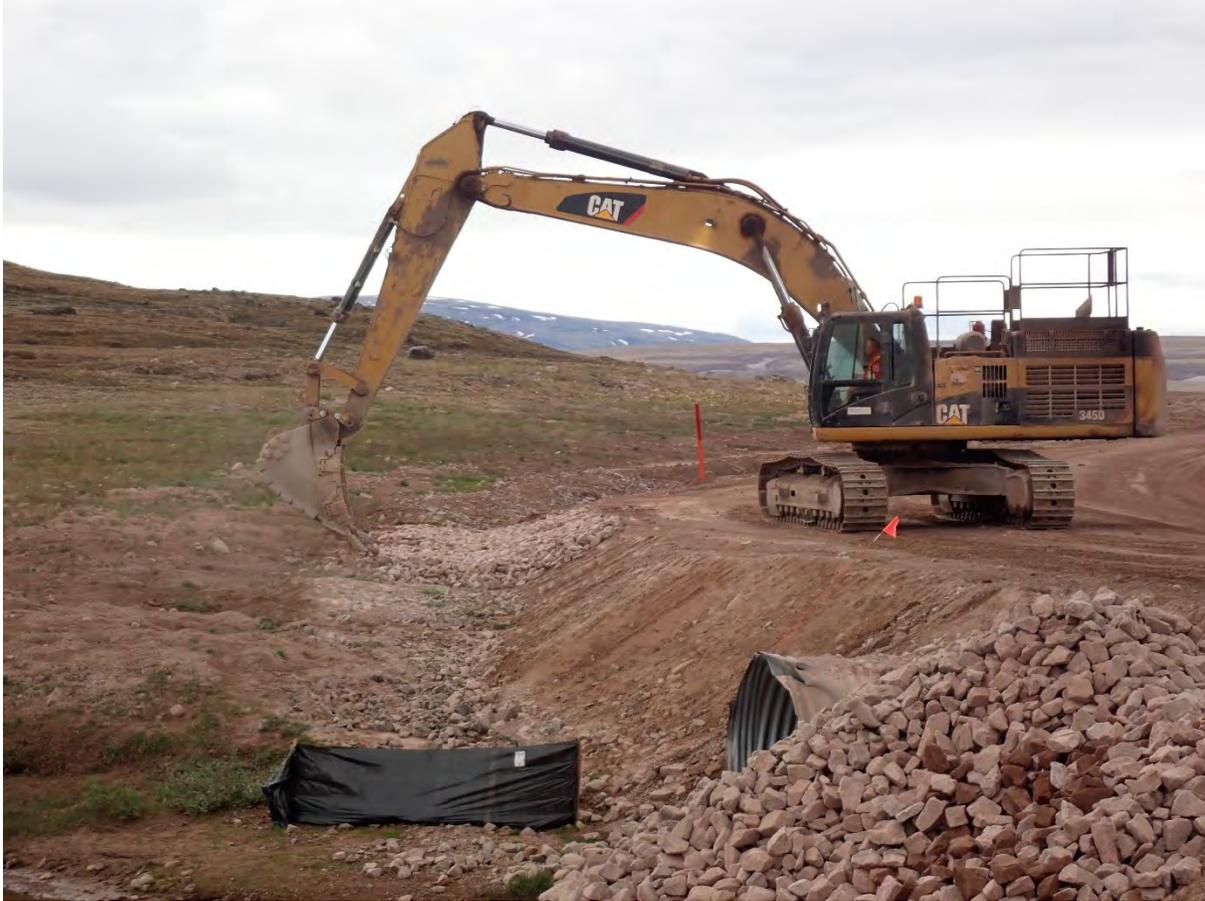
Excavator lining swale in the upstream south swale at BG-04 with rip-rap stone
