Nunavut Impact Review Board

April 2024 Site Visit Report

The Mary River Project

NIRB File No. 08MN053

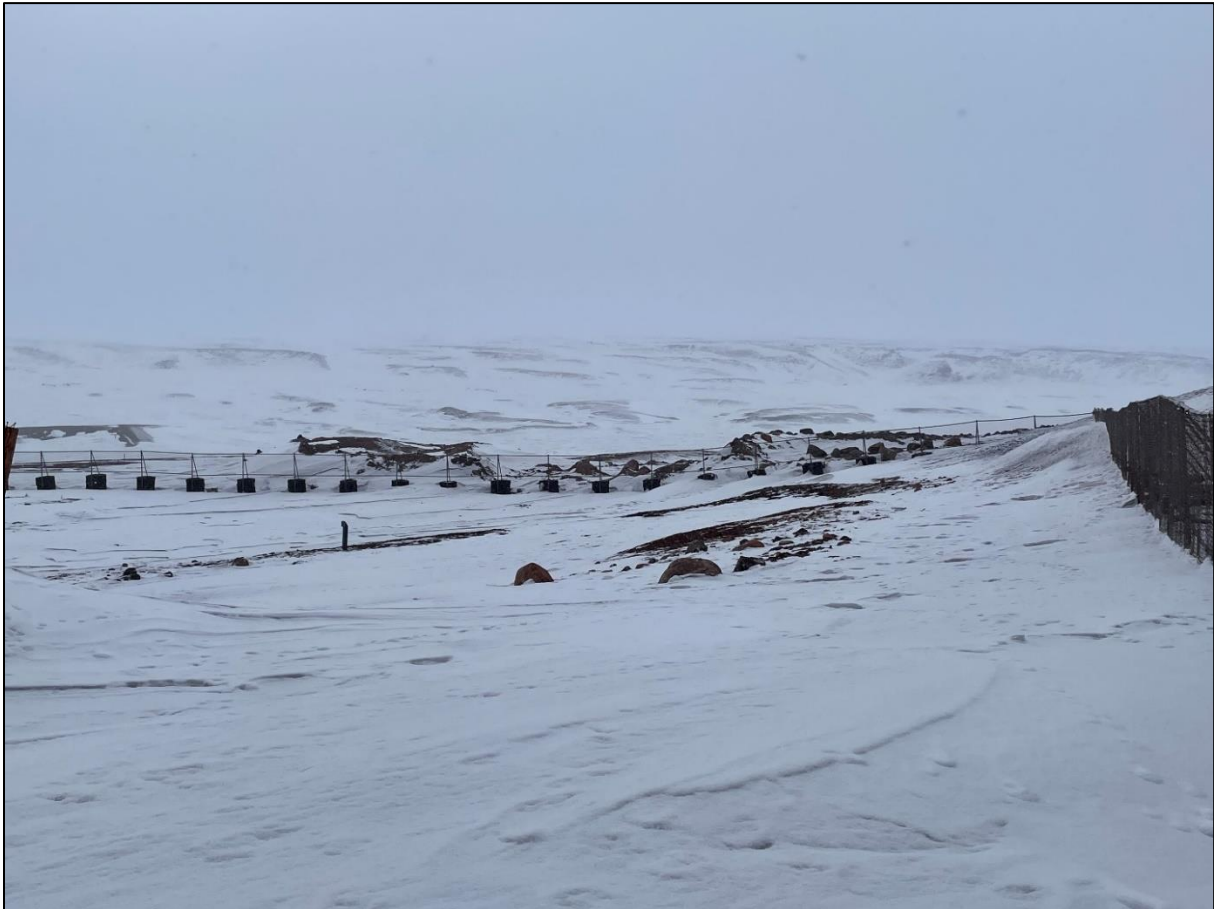
- The landfill is operational with the fencing intact and ongoing management activities are in place with a gate to limit access;
- The crusher facility has storage containers for replacement parts and was actively trialing dust suppression along the conveyor system to further reduce dust at the crusher;

Photo 3: Fence Surrounding the Landfill at Mine Site.

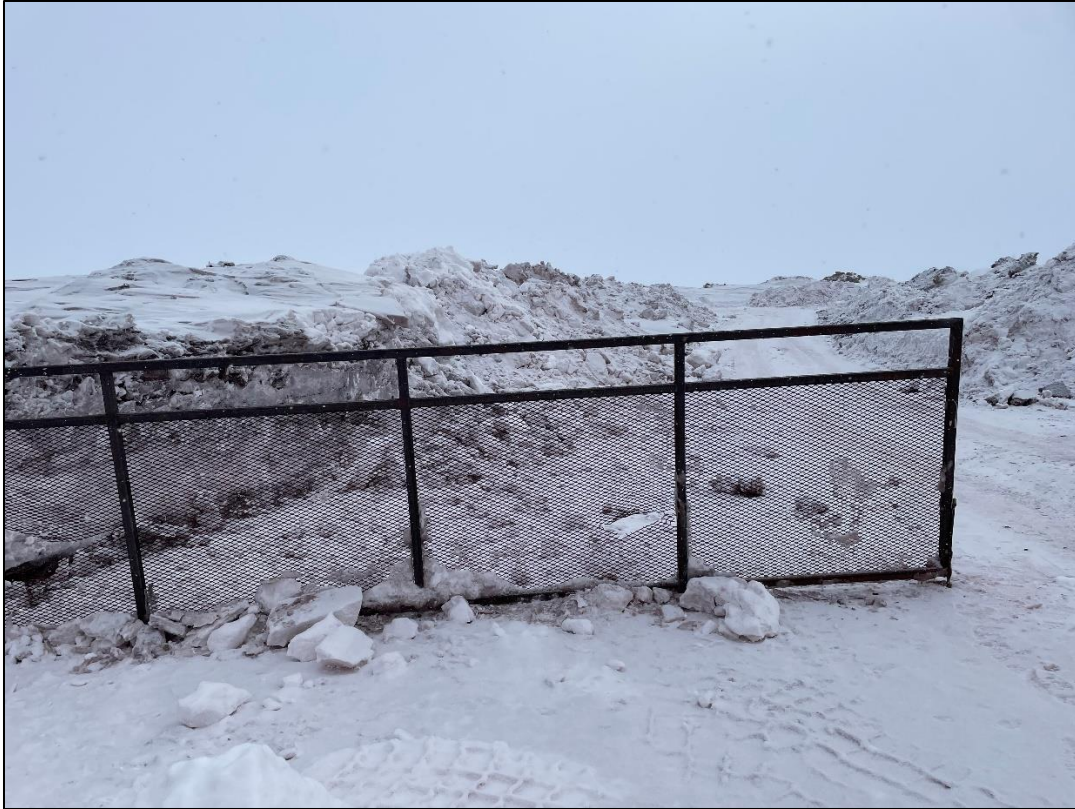
Photo 4: Landfill Entrance Gate.

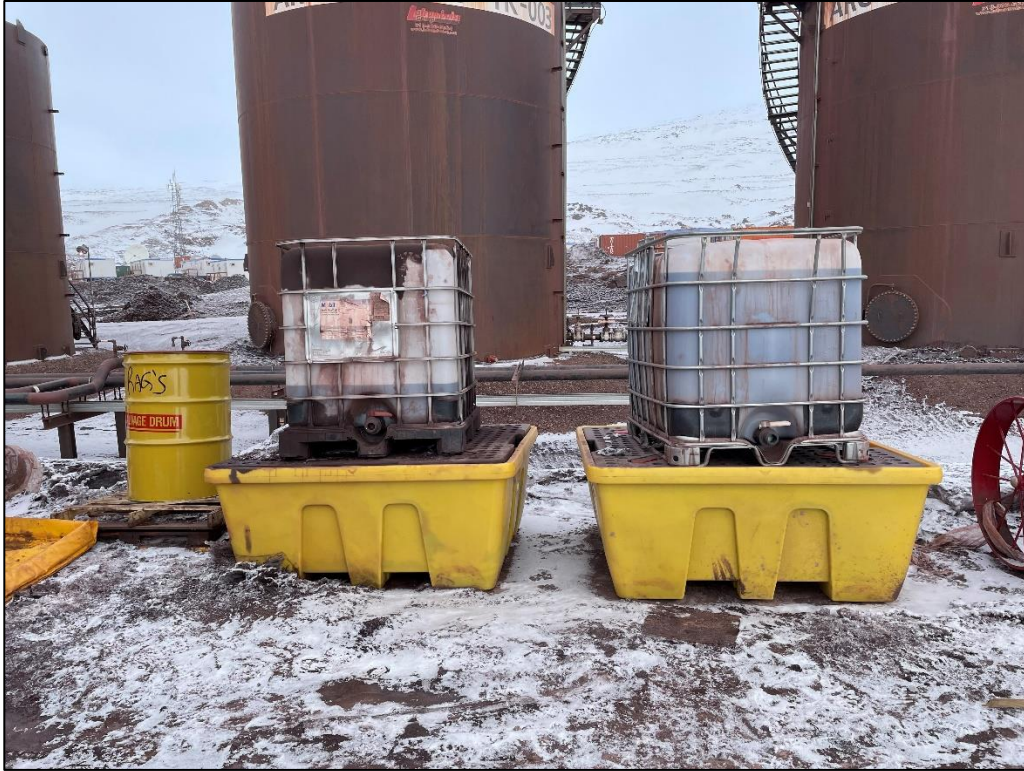
- Camp accommodations appear well organized and maintained;
- The tank farm is clean and organized with secondary containment both under the entire area as well as under specific drip points for fuel filling and storage;

Photo 9: Mine Site Fuel Tank Farm and Secondary Containment for oil storage.

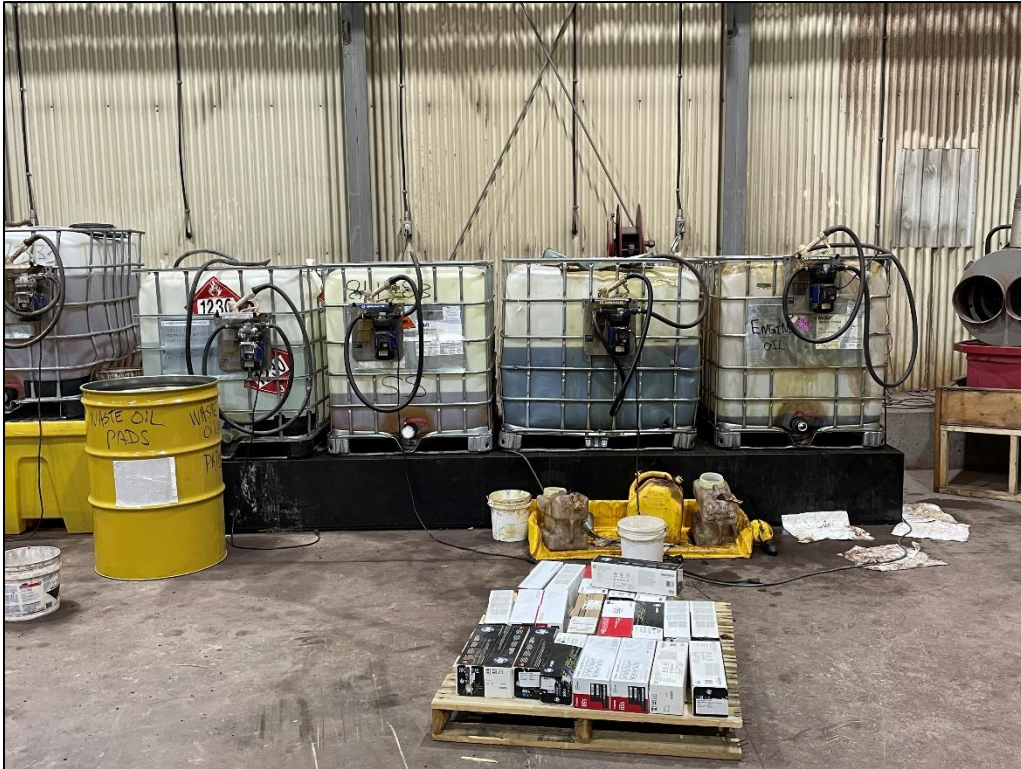
- The crusher facility also has active air monitors in place to measure dust production at the crusher in addition to the passive sample collectors;
- The incinerator facility is well organized and clean with appropriate labelling secondary containment around fluid dispensers;

Photo 11: Secondary Containment for Fluid Dispensing Station inside the Incinerator Facility.

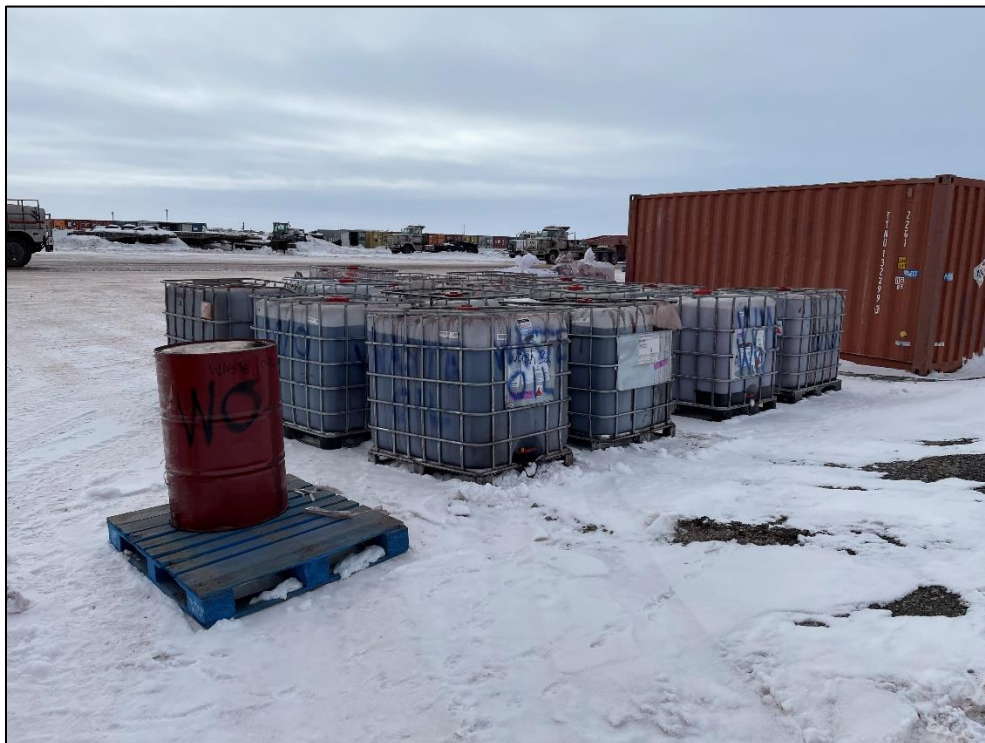
- Hazardous Waste was stored outside the lined area outside the incinerator facility which was noted to Baffinland Staff; and
- Staff observed various orientation materials and cultural poster Boards around Sailivik camp to help staff be more familiar with Inuit culture and activities.

Photo 15: Hazardous Waste Storage Outside of the Lined Area¹.

¹ After discussing the storage of hazardous waste outside of a properly lined facility with Baffinland, they corrected the situation by moving the waste oil to the appropriate storage location prior to NIRB's departure from site.

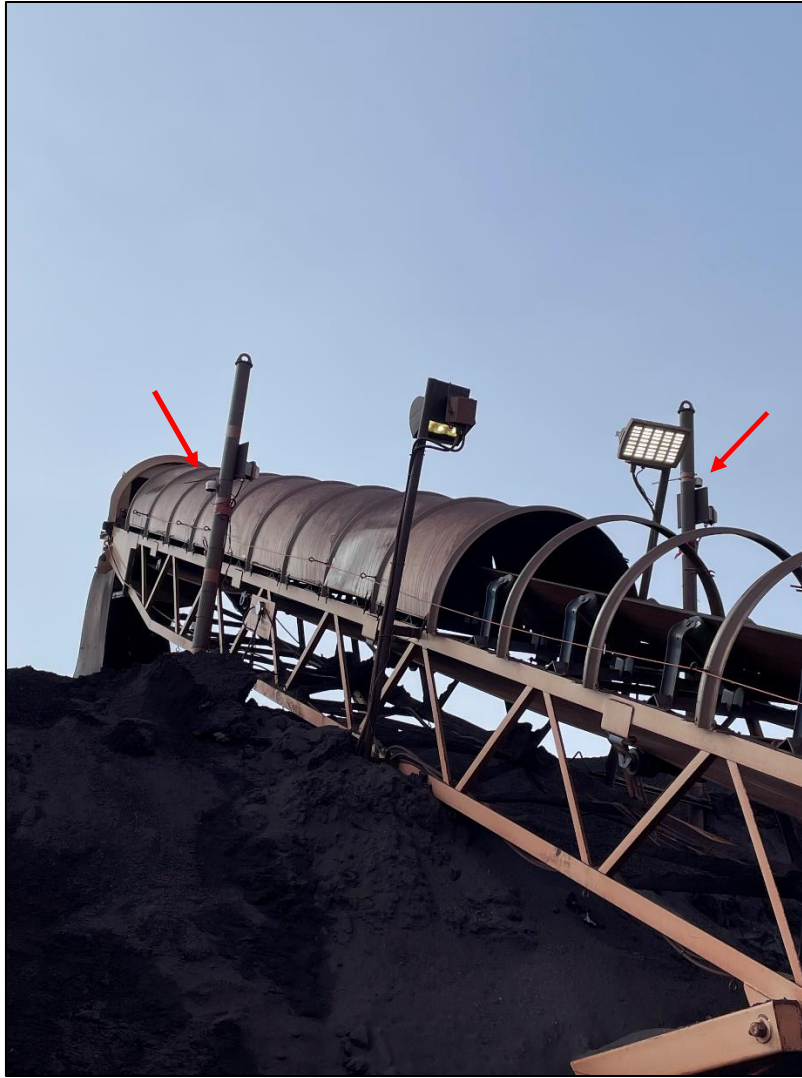
T&C No.	Topic	Site Observation
		<p>installed across the site including at the crusher facility (Photo 16).</p> <p>Baffinland is also trialing liquid dust suppressant along the crusher conveyor system (Photos 19, 20 & 21) in an effort to coat the ore in dust suppressant earlier in the production chain. This is in addition to the hoods, shrouds and bellows along the crushing equipment as well as lowering the drop height (Photos 17). Collectively, all of these chemical and mechanical mitigations should help reduce the dust produces from the crusher facility.</p>
11	Incinerator	<p>All food waste is incinerated from the kitchen including cardboard that stored food. NIRB Staff visited the Incinerator facility at the Mine Site; it was clean and well organized (Photo 11 & 12).</p>
Hydrology and Hydrogeology		
17	Prevent impacts to water bodies from effluent	<p>Related to Terms and Conditions 24 and 46</p> <p>The KM 105 Dam, Settling Pond and Effluent Testing Station was constructed in 2022 to help manage effluent from the Mine Haul Road and Deposit (Photos 31, 32, 33, 34 & 35).</p>

Photo 16: Hoods and Shrouds along the Crusher Conveyor with Active Air Sampler to Measure Dust Production (Arrows).

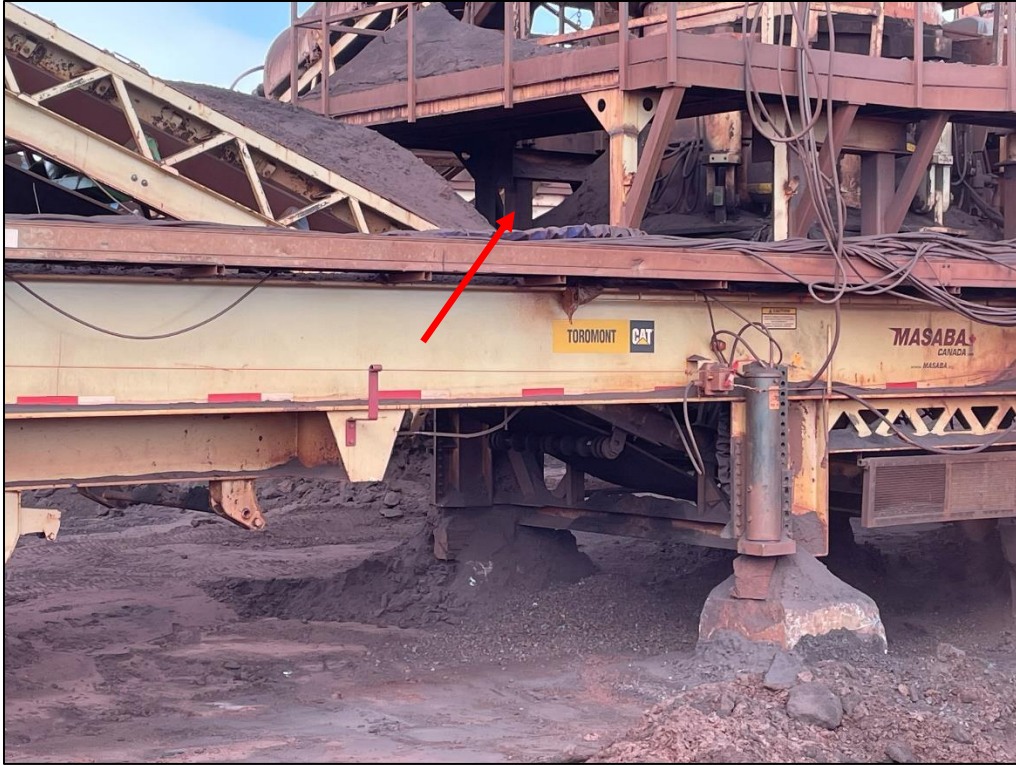
Photo 19: Liquid Dust Suppressant Application Trial Area (Arrow) at the Crusher Facility.

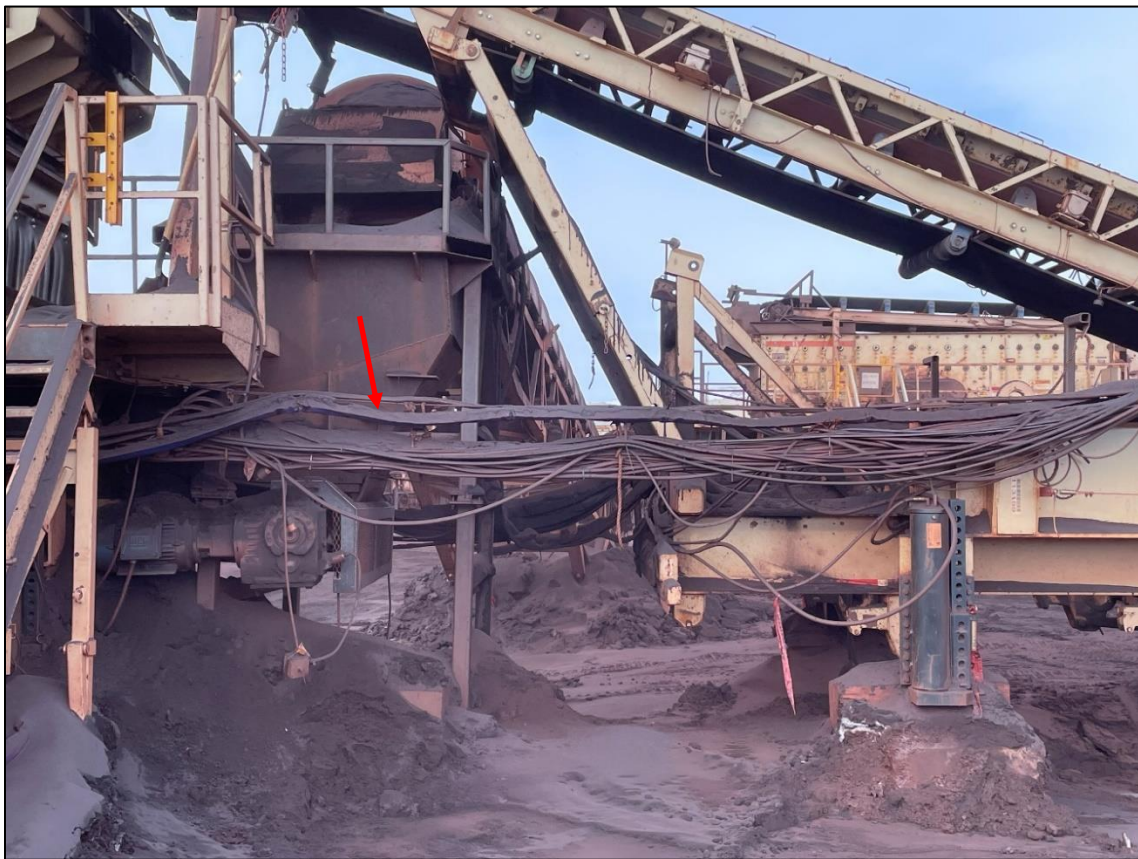
Photo 20: Heat Traced Pipe for Delivery of Dust Suppressant (Arrow).

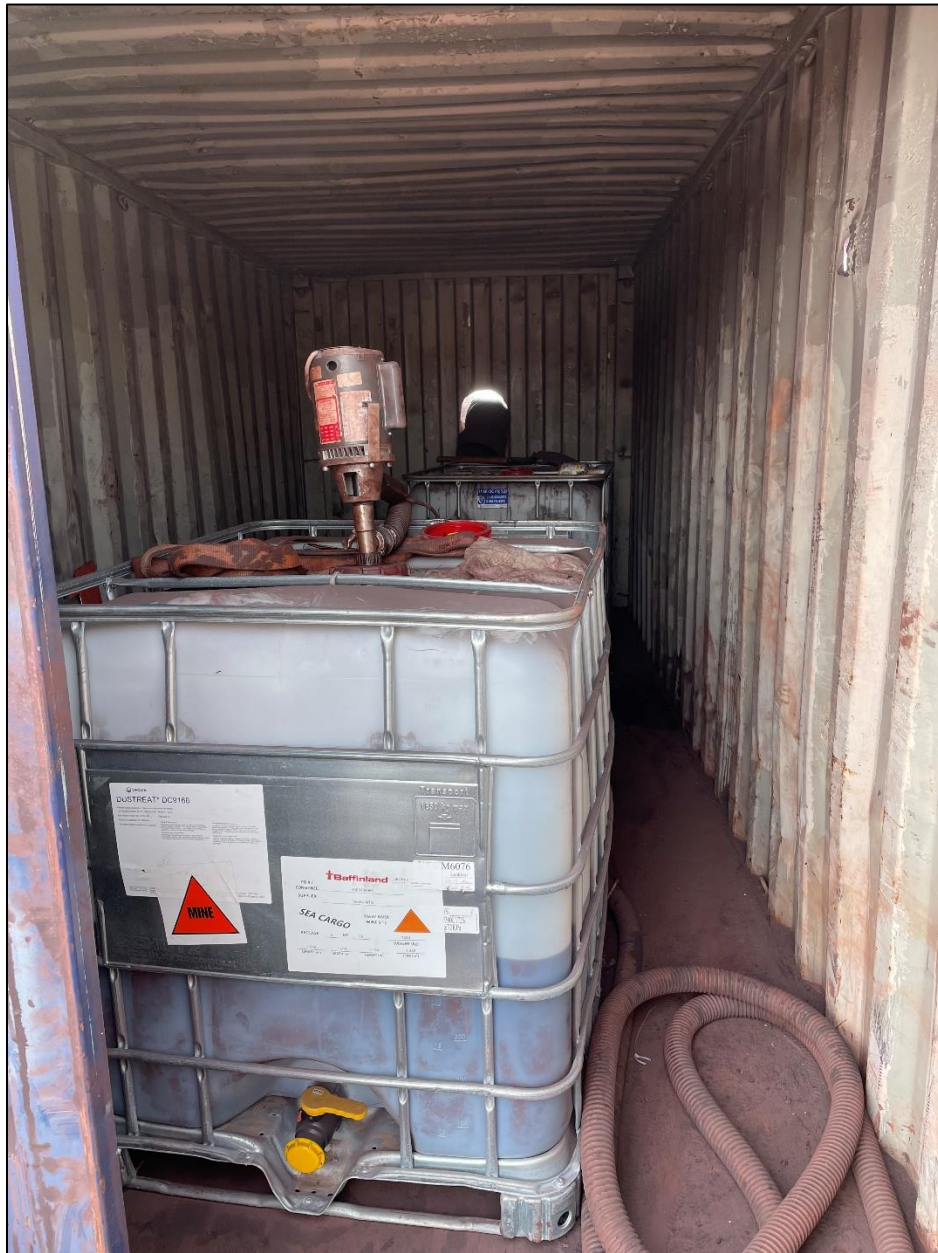
Photo 21: Liquid Dust Suppressant Stored in a Heated Seacan next to the Crusher.

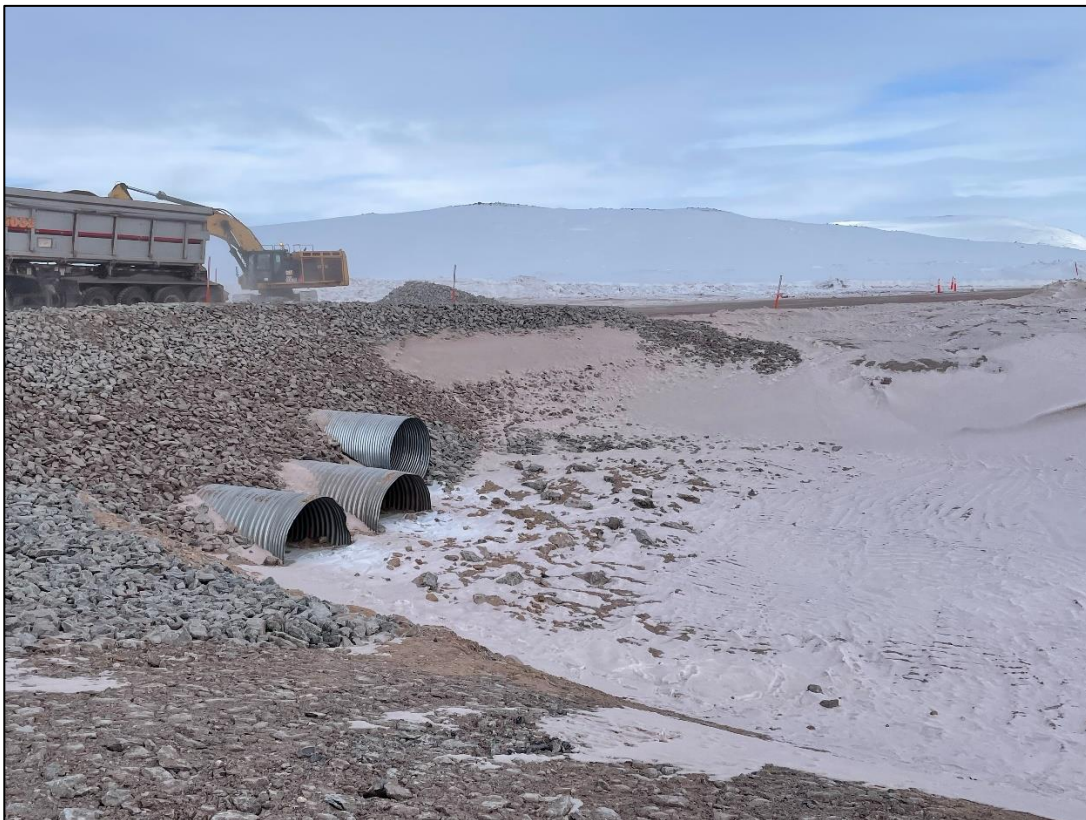
19	Mitigate impacts to natural water flow	<p>Several culverts and ditches were observed along the Tote Road with riprap being installed in order to better control the flow of water during freshet. Some of the culverts observed were also being repaired in response to the Order from the Department of Fisheries and Oceans Canada in 2022 (Photos 40, 41 & 42).</p>
Landforms, Geology and Geomorphology, Soils and Permafrost		
26	Erosion Management	<p>Related to Term and Condition 43</p> <p>NIRB staff observed riprap along the tote road to control water and prevent erosion (Photo 41 & 42).</p>
28	Permafrost monitoring	<p>NIRB staff observed the monitoring that is occurring at site for various dam structures and other large site infrastructure.</p>
Freshwater Aquatic Environment including Biota and Habitat		
46	Freshwater Aquatic Environment – Drainage	<p>Baffinland has either appropriate drainage and/or lined berms for fuel storage and maintenance facility areas, sewage, wastewater, and/or other facilities responsible for site generated water or site contact water (Photos 31, 32, 33, 34 & 35).</p>

Photo 40: Completed Culvert Repair on the West side of the Tote Road.

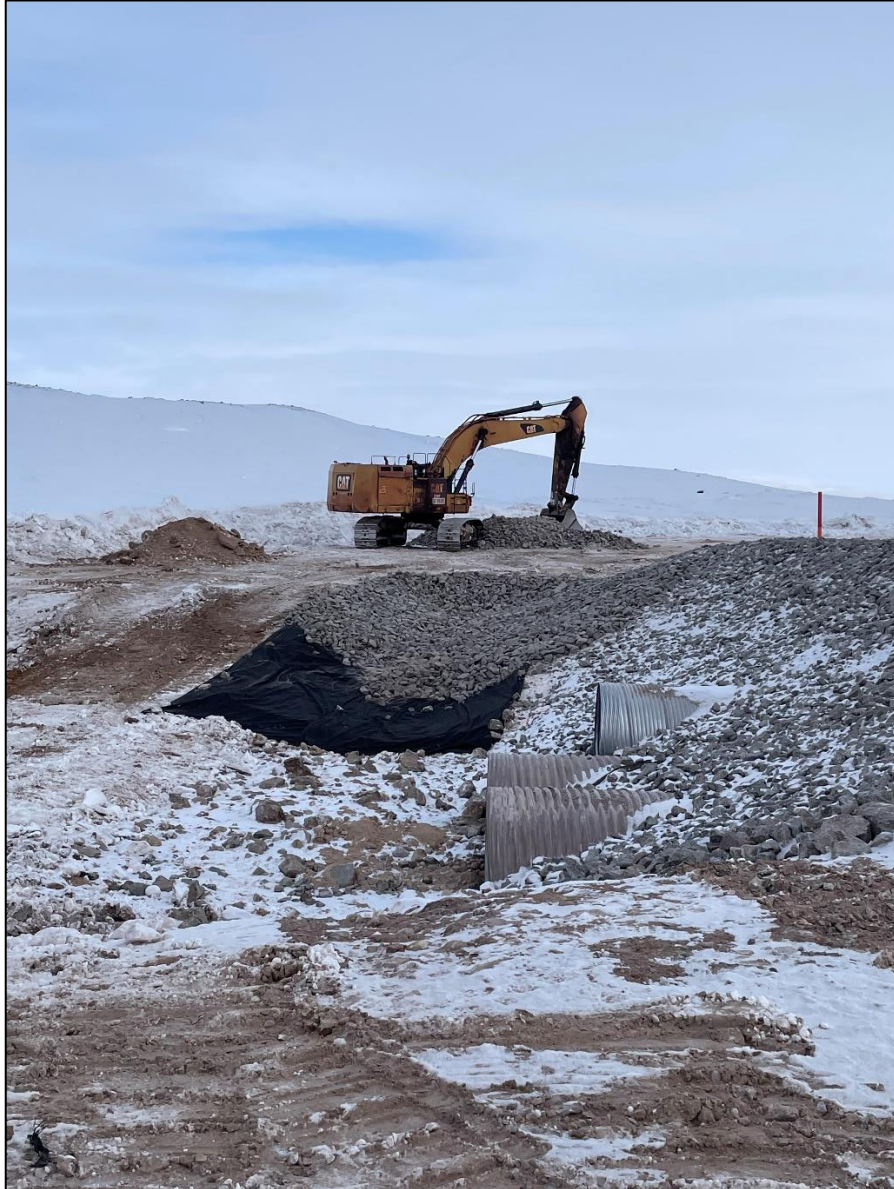
Photo 41: Installation of riprap in Completing Culvert Repair on the East Side of the Tote Road.

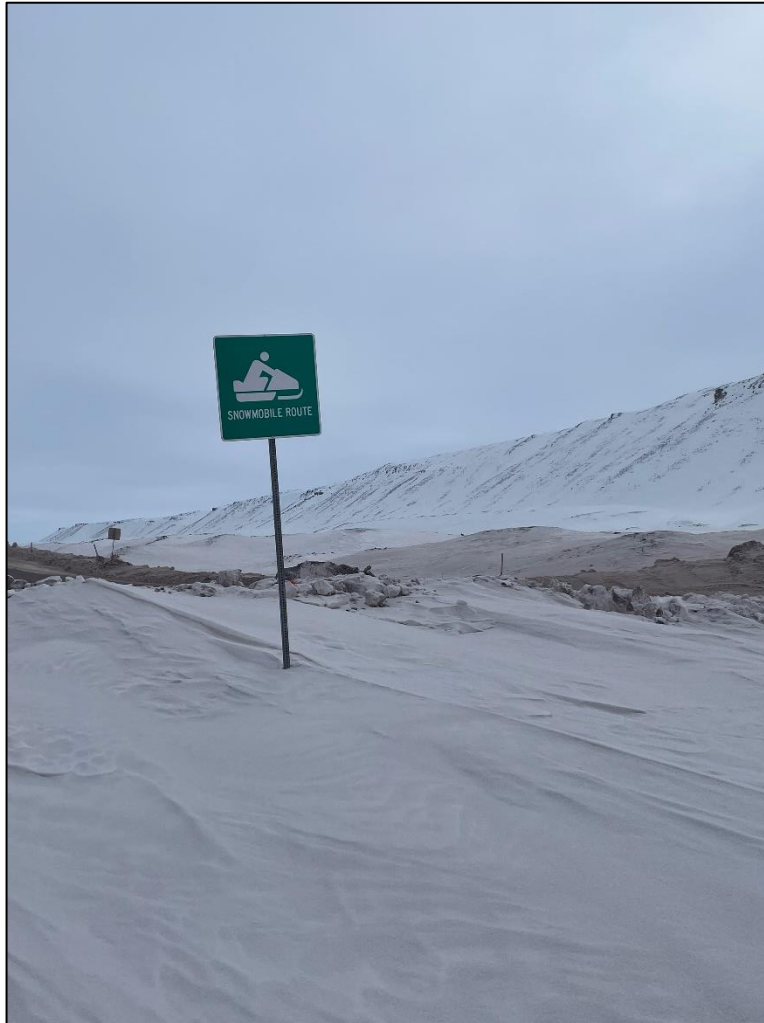
- Dust monitoring was being completed along the Tote Road;
- Emergency Shelters and halfway stop are operational;
- Riprap continues to be installed to help control water flow along the road; and
- Snowmobile crossing at KM 90 was clear of obstruction but could be leveled off better to make for clear access.

Photo 43: East Side of Snowmobile Crossing at KM 90.

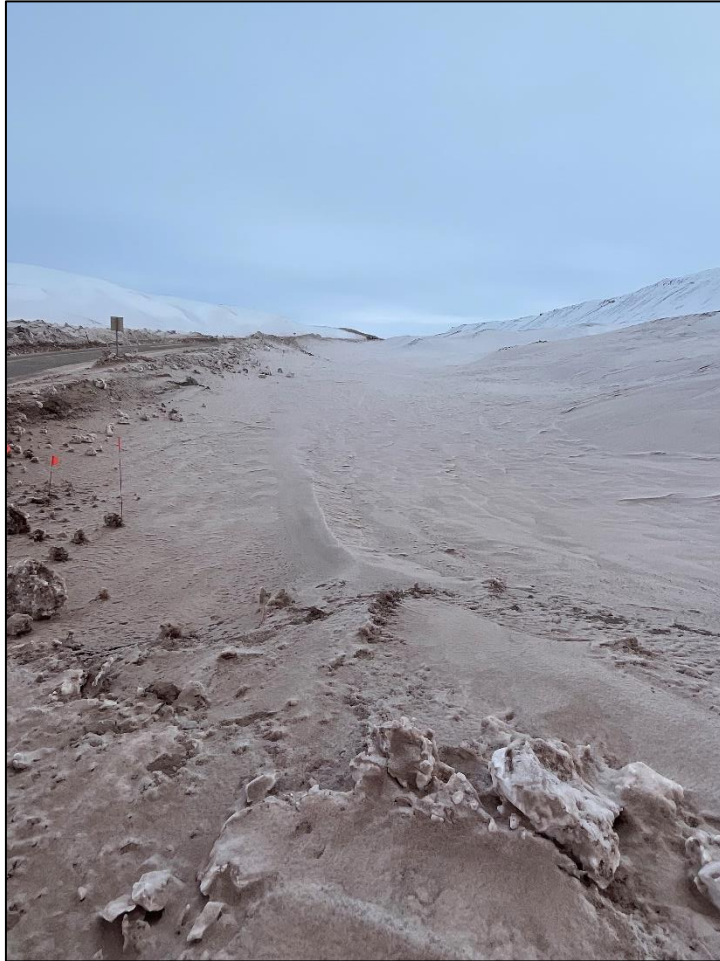
Photo 44: West Side of Snowmobile Crossing at KM 90.
