Nunavut Impact Review Board

2024 Site Visit Report for

Mary River Iron Ore Mine Project

January 2025

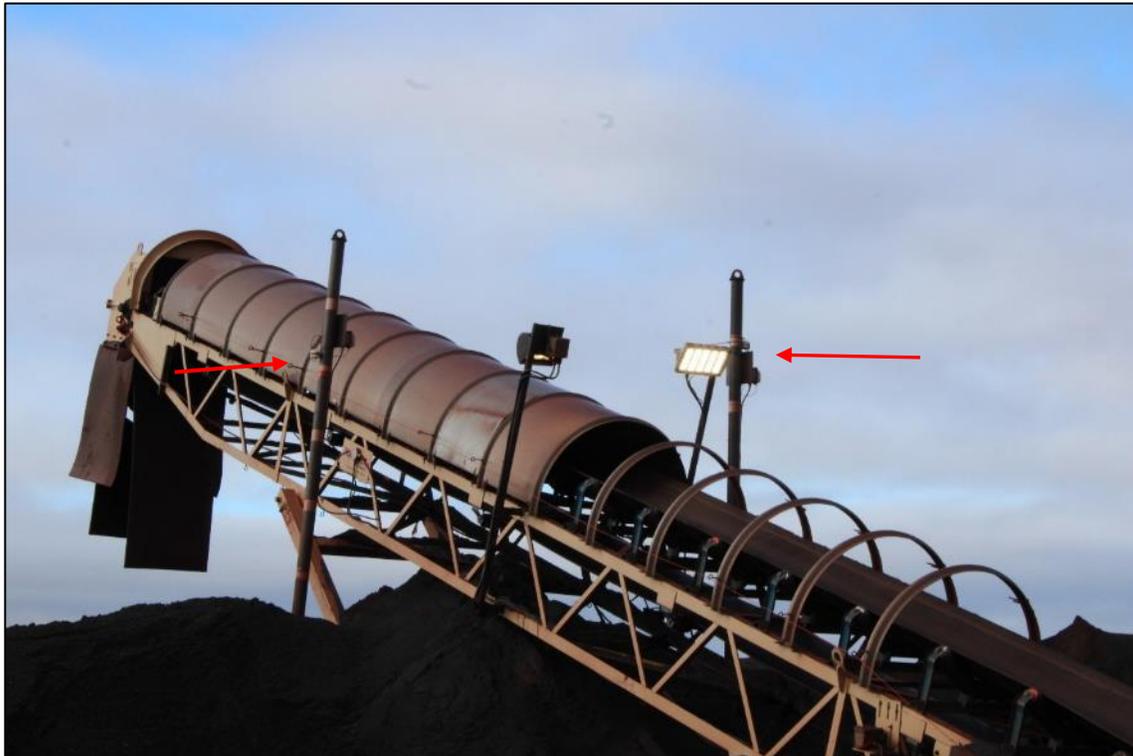
The crusher facility located at the Mine Site has organized storage containers for replacement parts and during the NIRB site visit, Baffinland was conducting liquid dust suppression trials along the conveyor system to further reduce fugitive dust at the crusher. These trials consisted of a dust suppressant storage and pumping station, as well as several dispensers placed along the conveyor system for application. The crusher facility also has active air monitors in place to measure dust production at the crusher to determine the effectiveness of dust suppression at various points along the material supply chain.

Photo 10: Hoods and Shrouds along the Crusher Conveyor with Active Air Sampler to Measure Dust Production (Arrows pointing to air samplers).

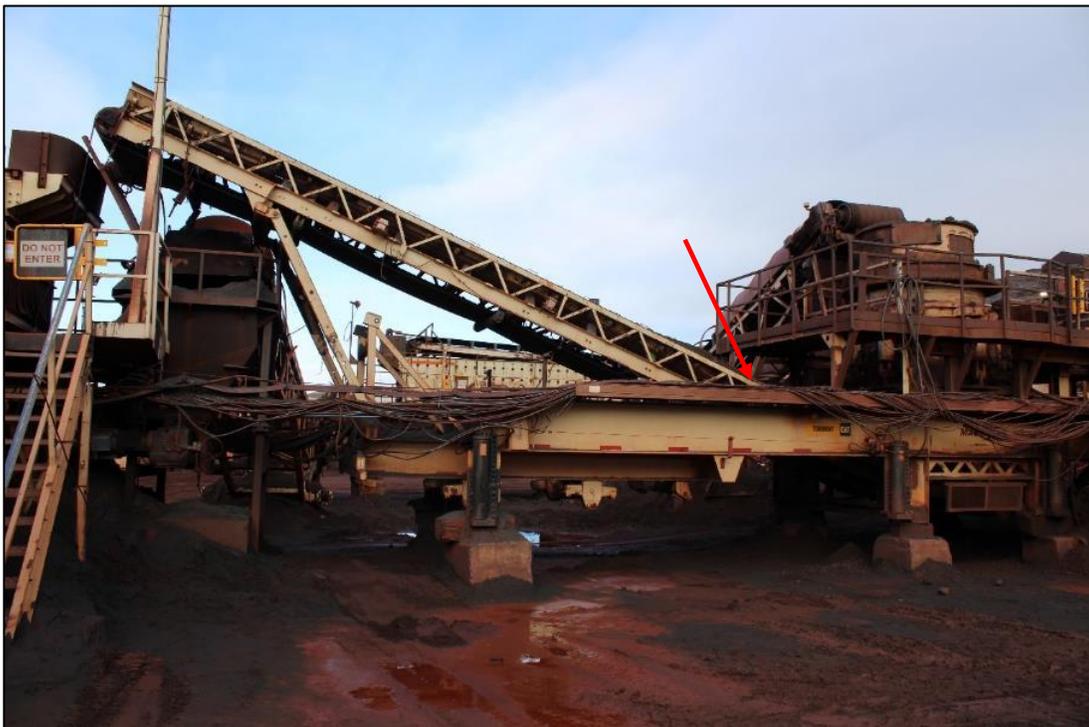
Photo 12: Liquid Dust Suppressant Application Trial Area (Arrow) at the Crusher Facility.

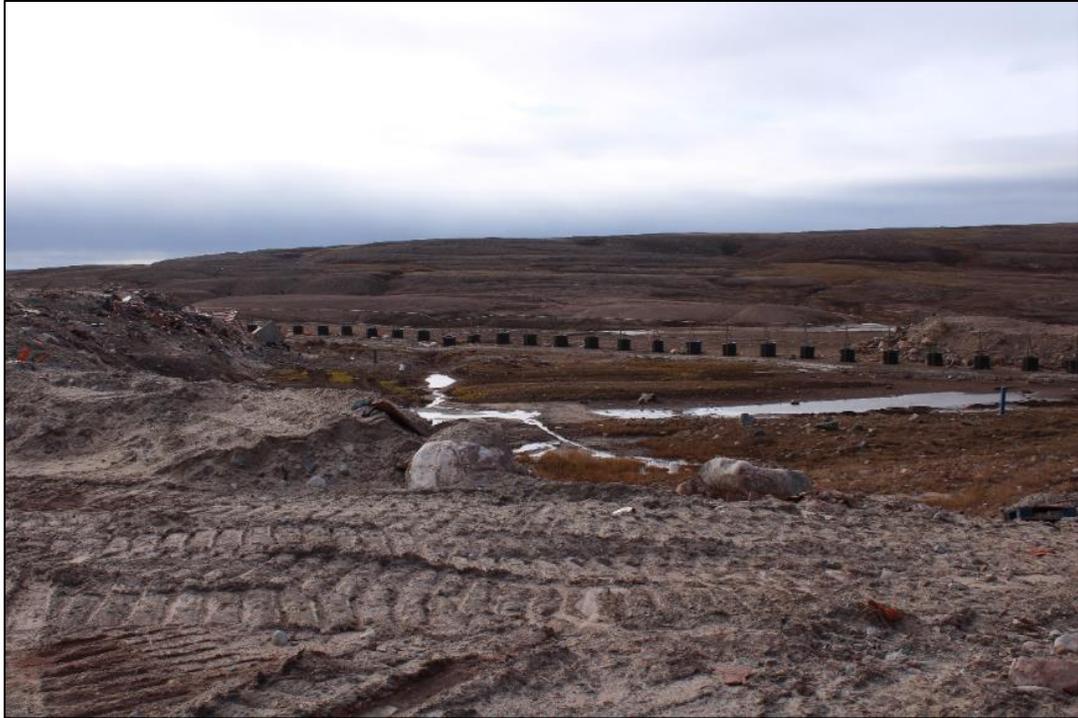
Baffinland constructed the landfill fence in 2019 after discussion with NIRB during site visits and the Nunavut Water Board through updates to the Waste Management Plan. The fence was constructed while making use of excess waste tires that had accumulated from the Haul trucks along the Tote Road. During several site visits since 2019, NIRB has noted that the landfill had been well maintained and used according to the Waste Management Plan. However, during this visit, NIRB staff noted that there was debris piled outside of the landfill and that the gate had been damaged and was no longer controlling access to the landfill. This was discussed with Baffinland staff at the closeout meeting and it was noted that it would be rectified.

Photo 29: Fence Surrounding the Landfill at Mine Site.

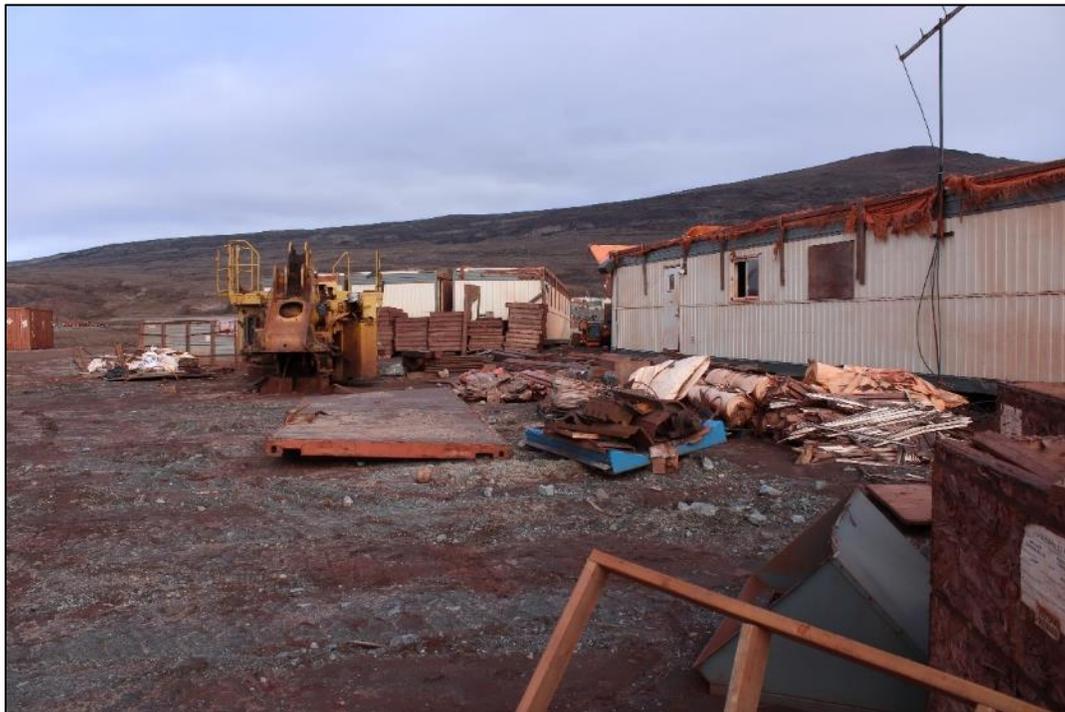
Photo 30: Debris Waiting for Sorting Outside Landfill Facility.

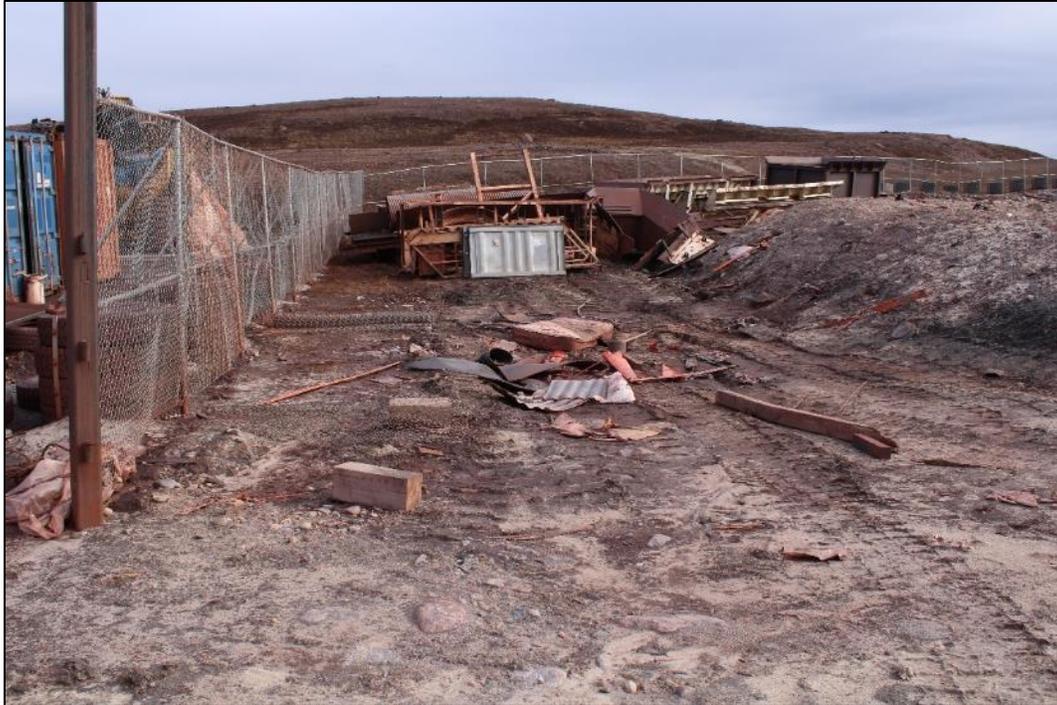
Photo 31: Broken Landfill Entrance Gate.

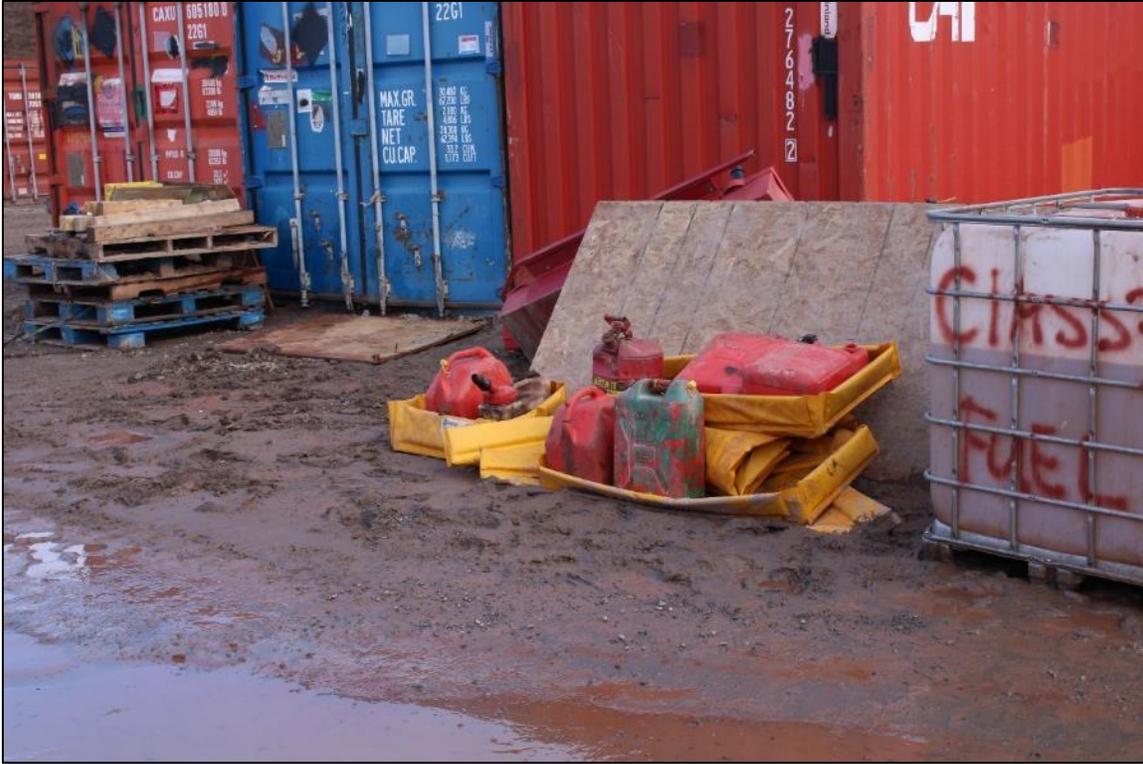
NIRB staff were toured around the waste management facilities at the Mine site and noted that the waste management practices appear to be operating in compliance with the Waste Management Plan and that there were adequate measures in place for waste separation and sorting. When observing the hazardous waste storage area, NIRB staff noted that there were several waste oil totes and fuel barrels stored outside of the secondary containment berm. NIRB staff discussed this with Baffinland along with the recurrence of it since the previous site visit in April 2024. Baffinland staff noted that there were approved plans to expand the berm size and sorting area for their hazardous waste at the Mine site and it was agreed that they would be prioritizing this in the coming months to ensure that all hazardous material is stored in secondary containment.

Photo 40: Hazardous Waste Storage Area with Secondary Containment Incorrectly Installed.

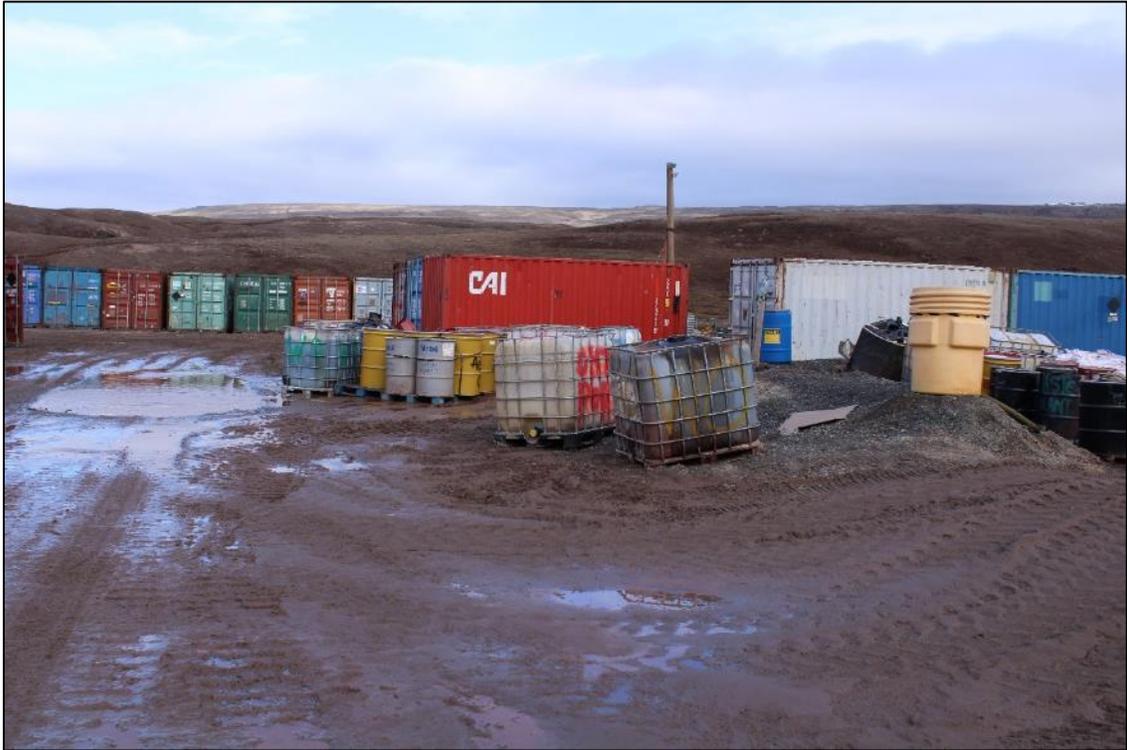
Photo 41: Hazardous Waste Storage Outside of the Lined Area

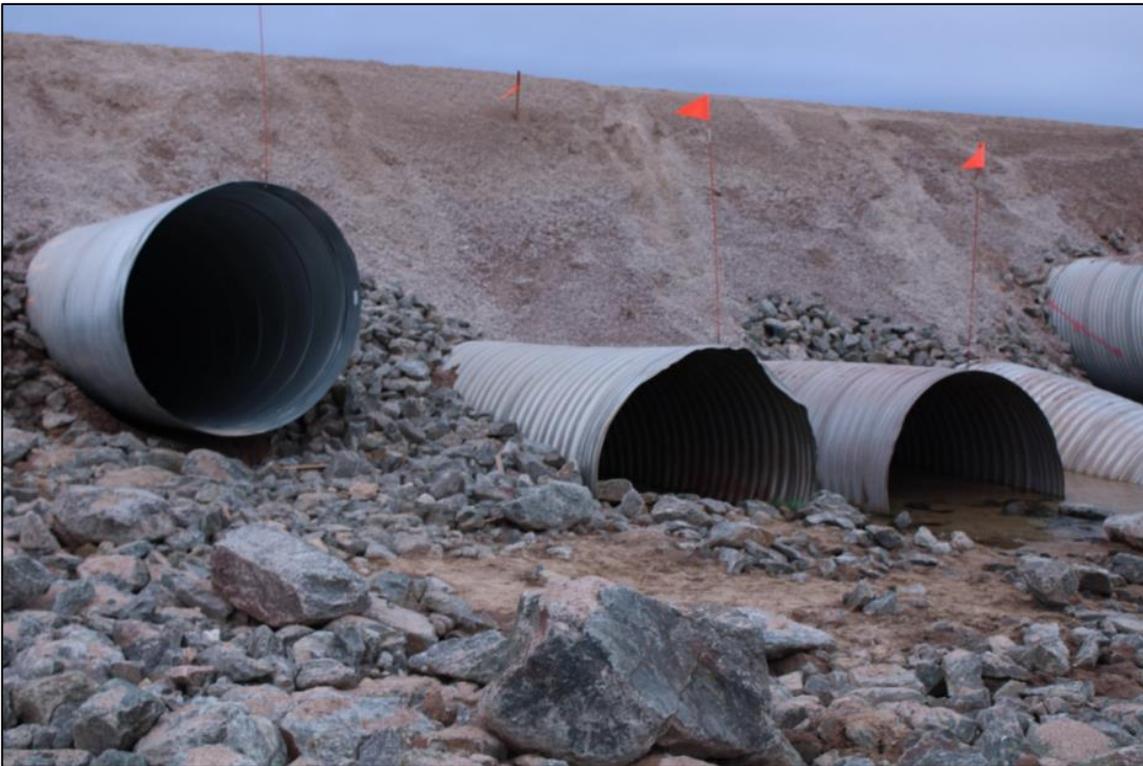
On September 19, 2024, NIRB staff drove along the Tote Road, stopping at several culverts to observe remediation work that was underway due to the Fisheries and Ocean Canada order. Baffinland noted that seven (7) of the ten (10) culverts under Fisheries and Oceans Canada order had been replaced with three (3) of the repaired culverts needing to be re-evaluated and modified due to the culverts collapsing. NIRB staff also observed ongoing Dust Monitoring station as well as new dust fall monitoring stations installed as part of joint study being completed with Natural Resources Canada (NRCan) to evaluate the effectiveness of a new dust collector.

Photo 42: Culvert Repair at KM 80 that Failed.

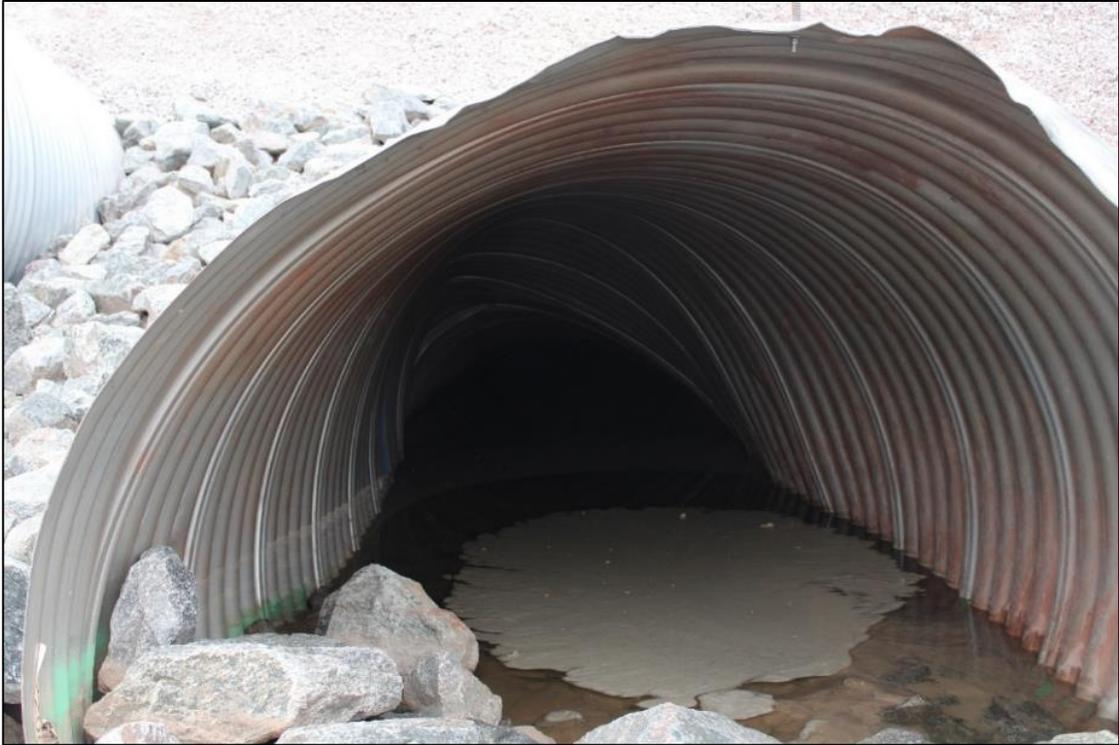
Photo 43: Blocked Culvert at KM 80.

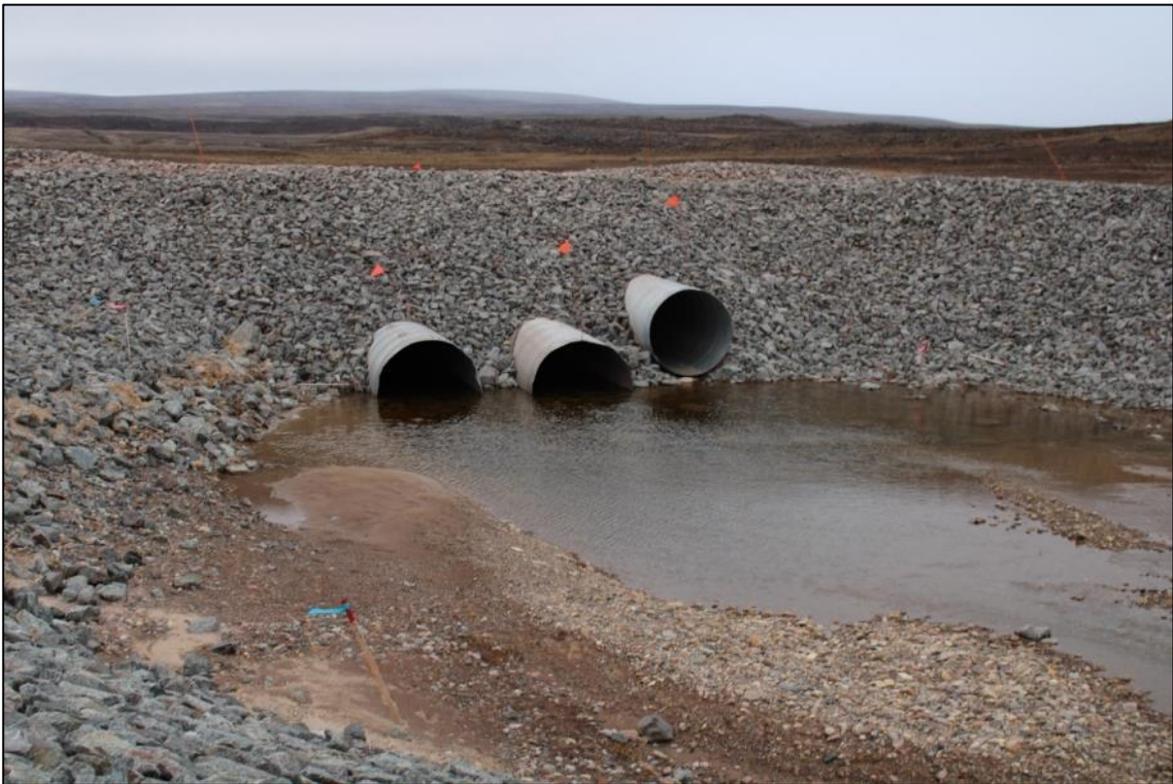
Photo 44: Culvert at KM 90 that was Successfully Replaced.

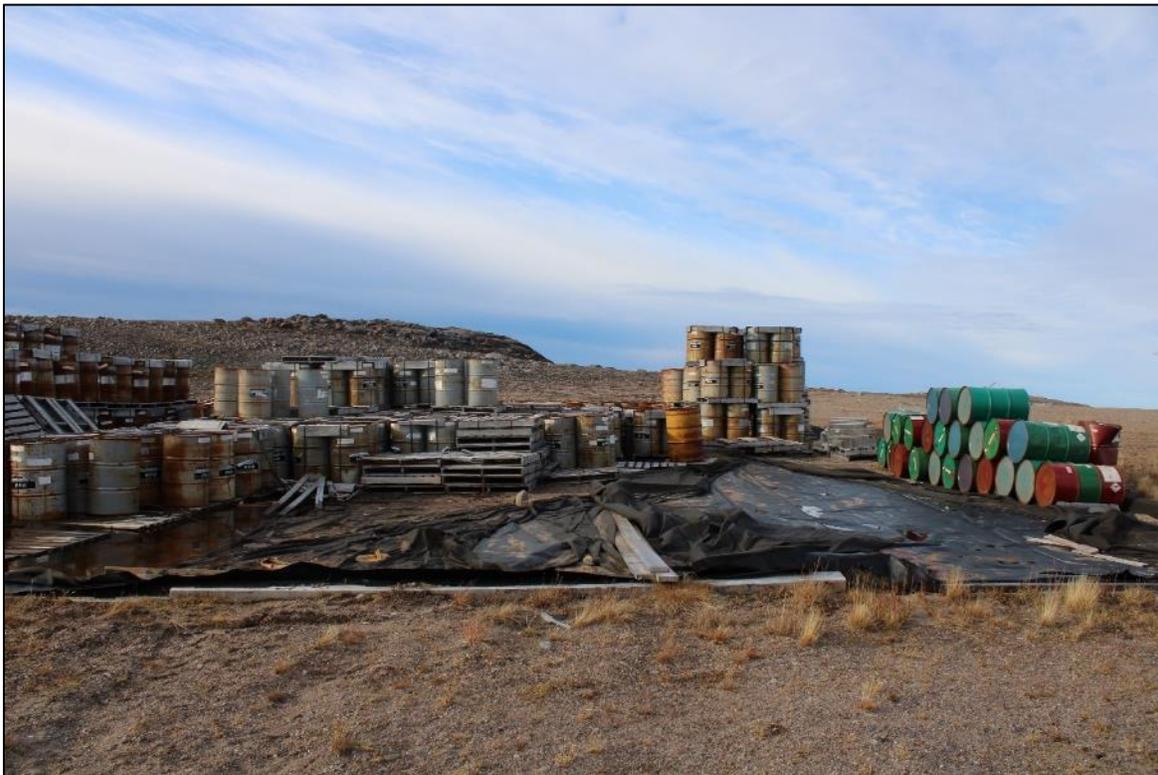
The NIRB staff were taken to Steensby Inlet via Helicopter and noted that the site had been in limited use during the 2024 season. However, NIRB staff noted some garbage accumulation around the infrastructure. It was discussed that it would be beneficial for Baffinland to place burn barrels and garbage disposal areas as well as advertise this to the communities in an effort to reduce waste being deposited at the site by land users. Additionally, there was a substantial amount of fuel stored at Steensby Inlet, although this fuel was in secondary containment, the containment was in poor condition and no longer served the intended purpose. Baffinland indicated that they would be prioritizing this fuel to be back hauled in 2025 as activities at Steensby begin to pick up.

Photo 63: Fuel Storage and Damaged Secondary Containment.

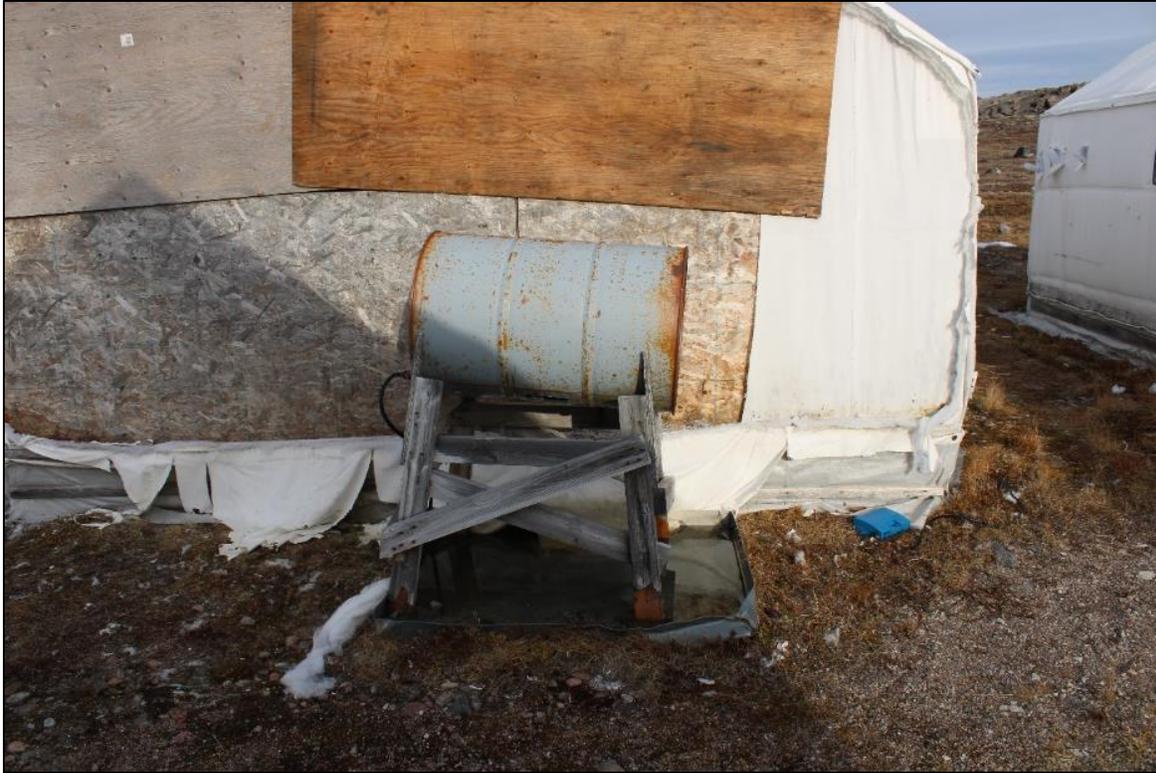
Photo 64: Damaged Secondary Containment on camp Fuel Barrel.

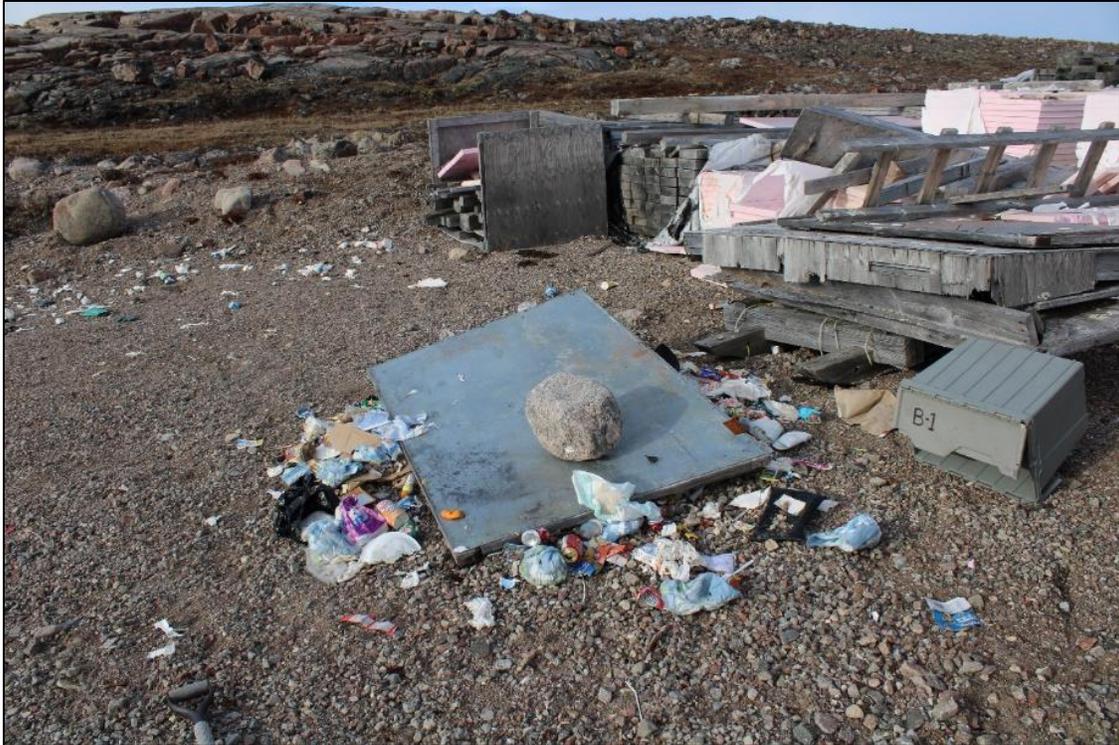
Photo 66: Garbage near the Shore at Steensby Inlet Camp.
