Nunavut Impact Review Board

2025 Site Visit Report

Mary River Project

Report Title: 2025 Site Visit Report Mary River Project

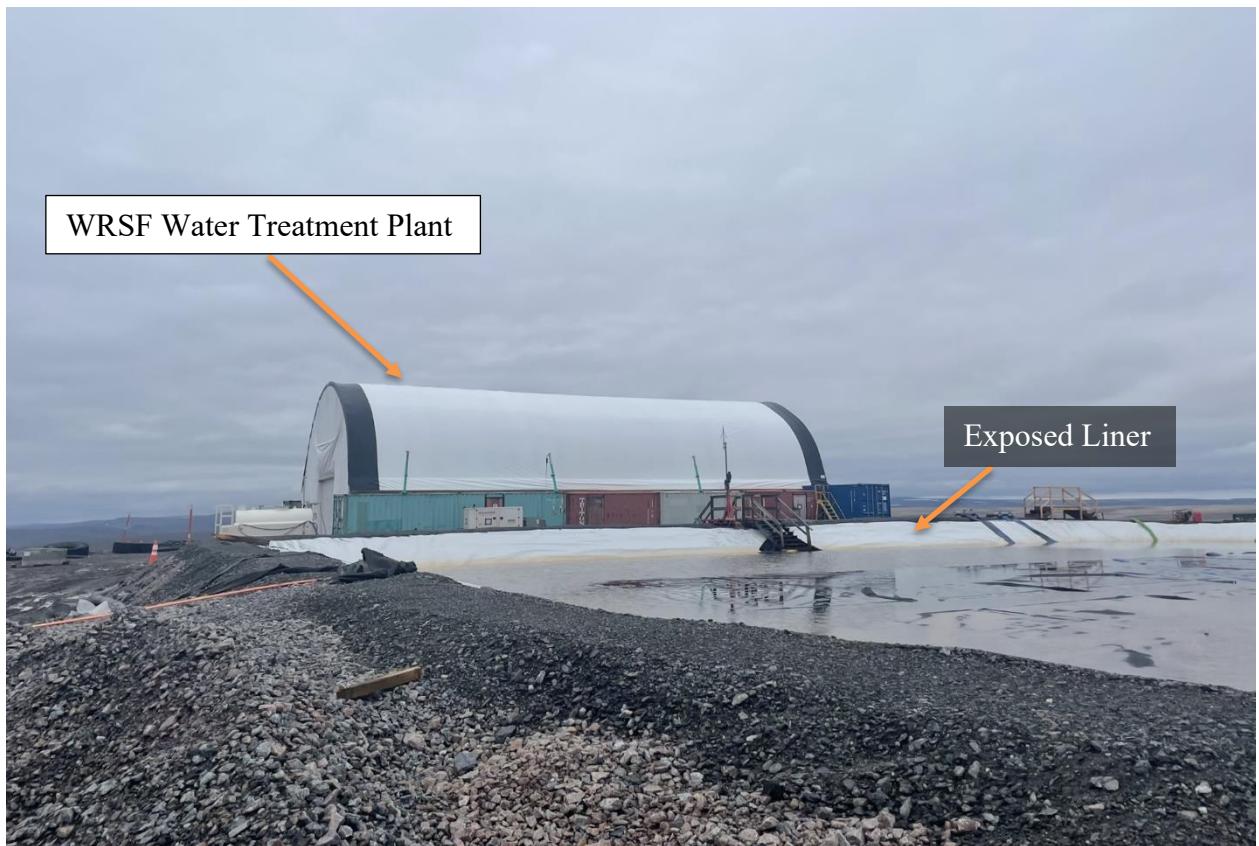
Photo 7: Lined Treatment Cell (Geotube Pond) next to the WRSF Water Treatment Plant

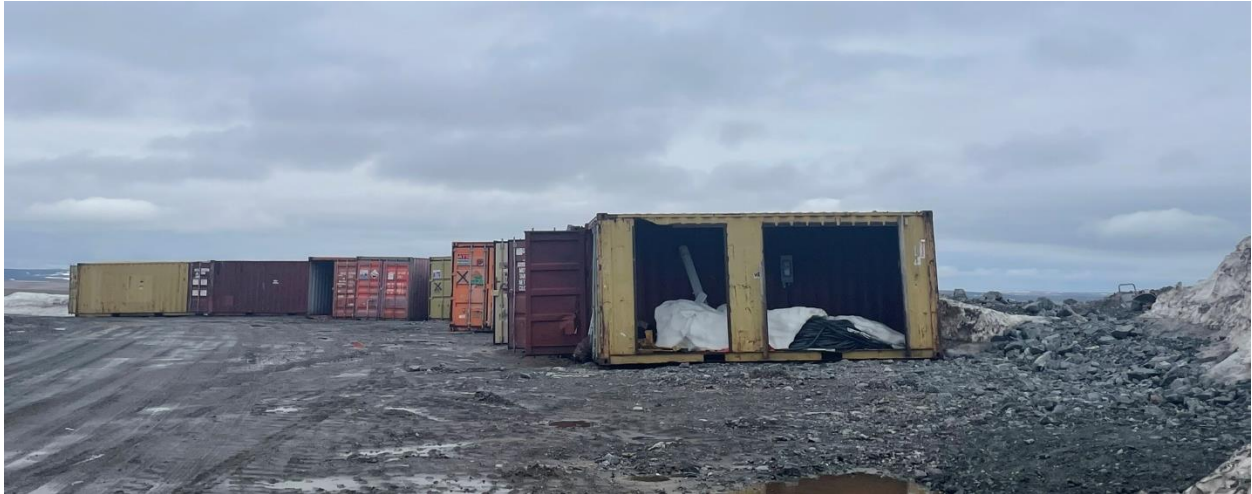
Photo 8: Seacans adjacent to the Geotube Pond observed to be unsecured

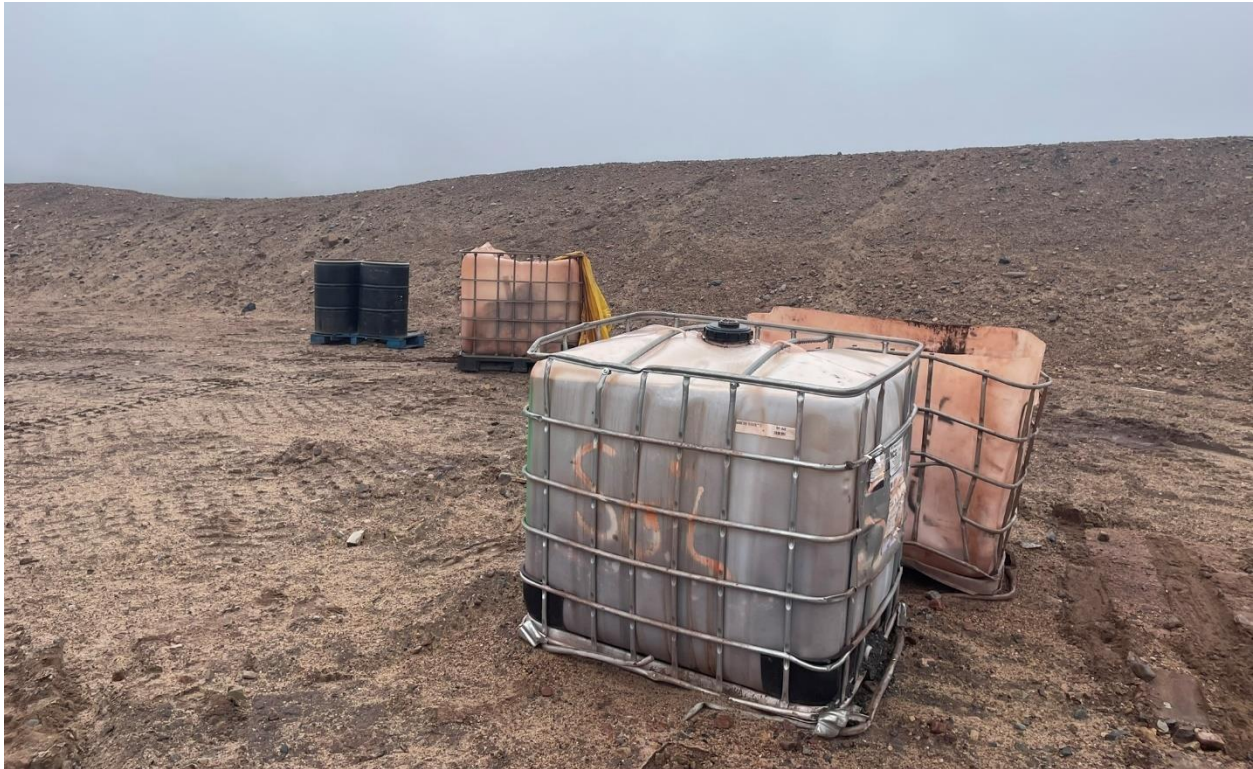
Photo 27: Uncontained Hazardous Material at New Monitoring Well Site

- Totes containing hazardous waste was observed stored outside of secondary containment. Baffinland staff acknowledged the issue and committed to corrective action. NIRB expects this to be closely monitored moving forward.

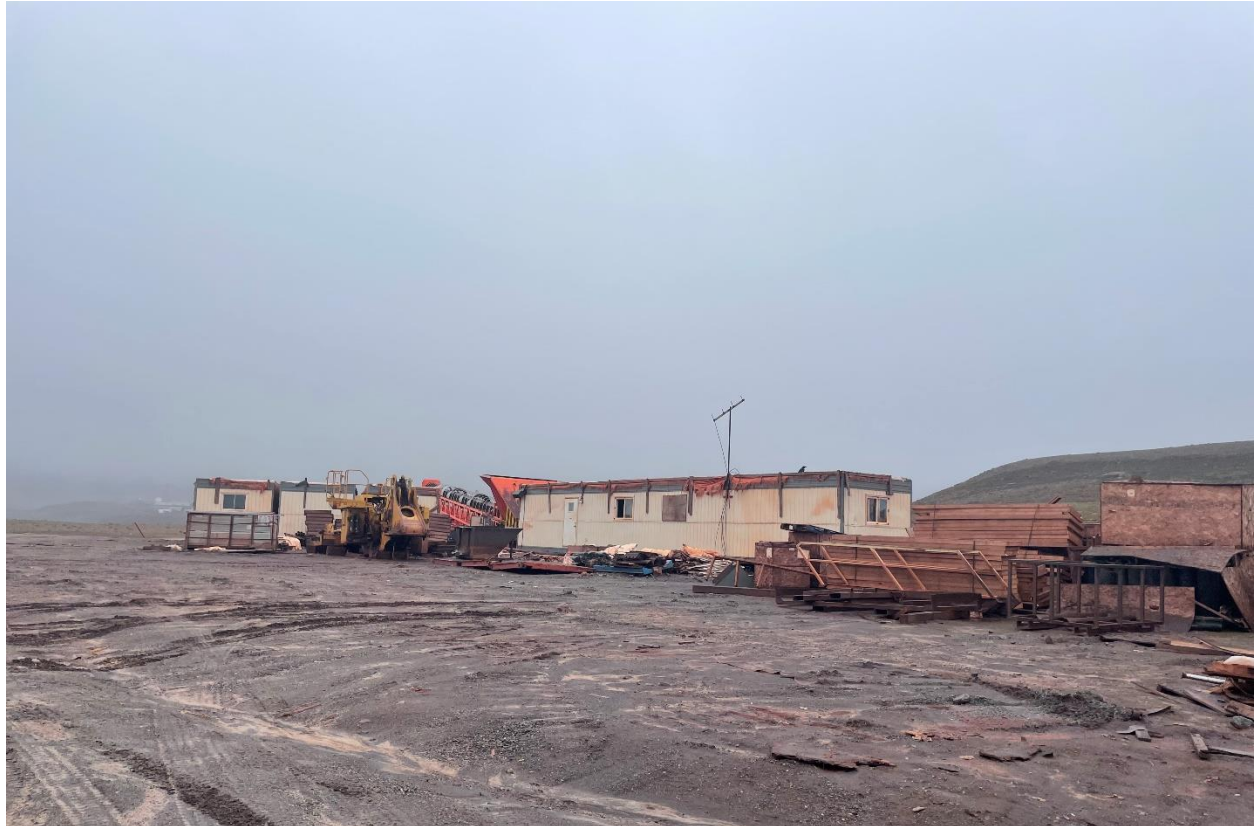
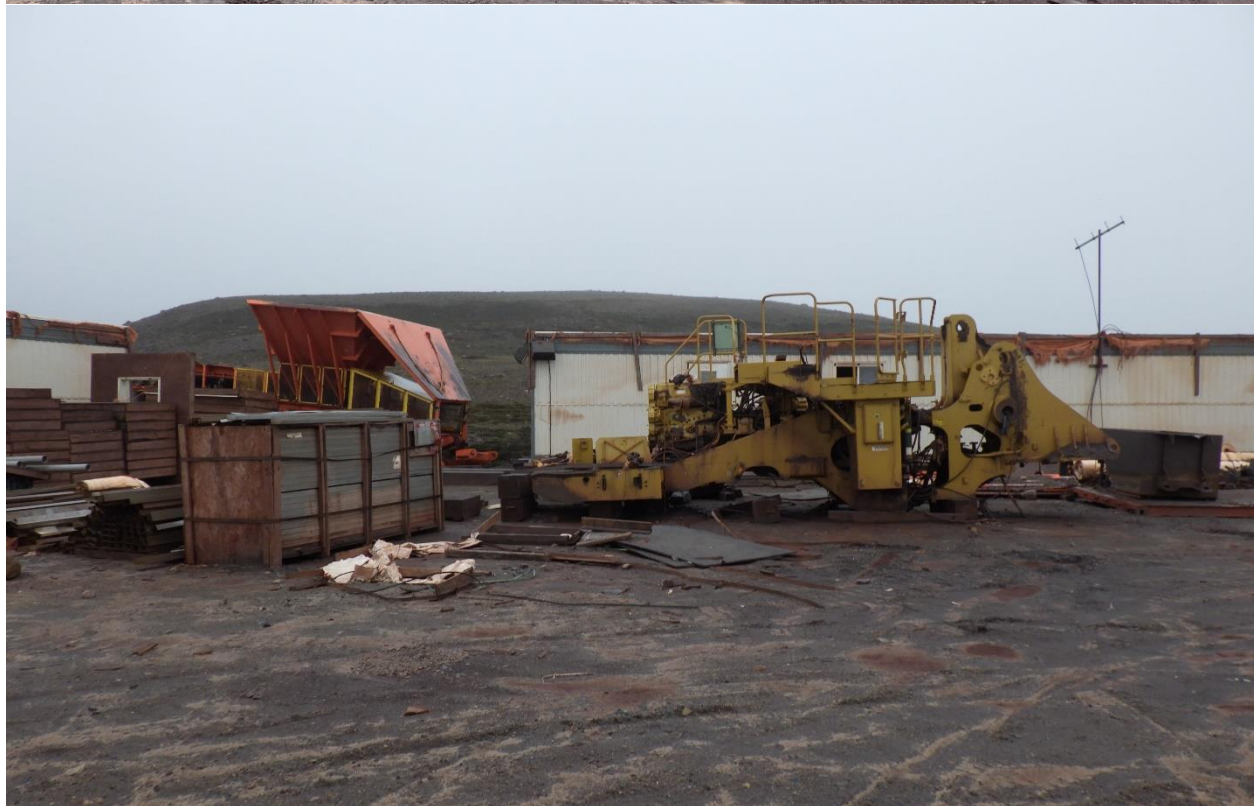
Photo 30: Building materials and equipment debris, mostly metal, outside Landfill gate

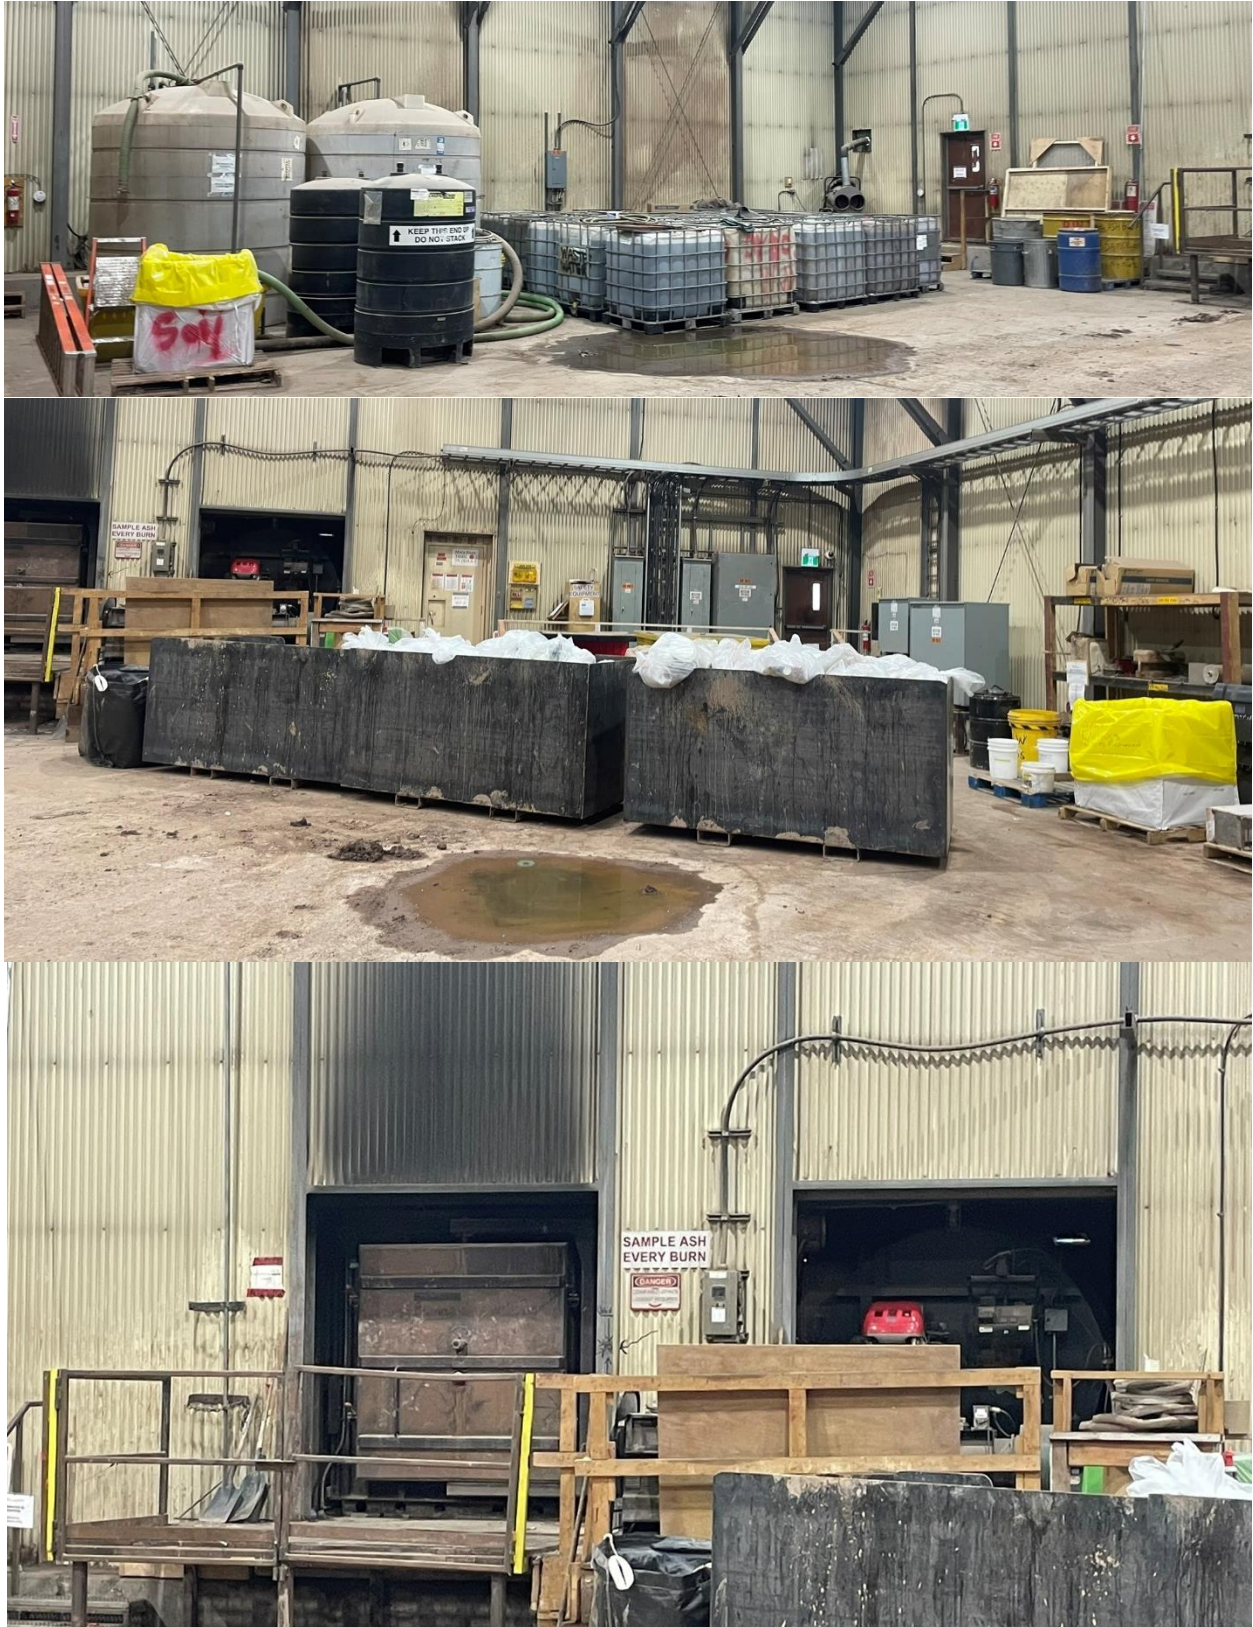
T&C	Topic	Site Observations
11	Incinerator	All food waste is incinerated from the kitchen including cardboard that stored food. NIRB Staff visited the Incinerator facility at the Mine Site; it was clean and well organized (Photo 34).
Hydrology and Hydrogeology		
17 (related to 24 and 46)	Prevent impacts to water bodies from effluent	The KM 105 Dam, Settling Pond and Effluent Testing Station was constructed in 2022 to help manage effluent from the Mine Haul Road and Deposit (Photo 18 and Photo 19).
19	Mitigate impacts to natural water flow	<p>Several culverts and ditches were observed along the Tote Road with riprap being installed in order to better control the flow of water during freshet. Some of the culverts observed were also being repaired in response to the Order from the Department of Fisheries and Oceans Canada (Photo 45, Photo 47, Photo 48, Photo 49, Photo 58, and Photo 60).</p> <p>While at the culverts at KM 80, it was noted that the road surface was spongy when walking on it, indicating a potential void. Baffinland personnel accompanying NIRB staff immediately requested site staff to investigate (Photo 50). Following the NIRB visit, it was later determined that the culvert pipes had all collapsed in the beneath the road. See the <i>CV-216 By-Pass Culvert Crossing Design Brief</i> Appendix A prepared by Nunami Stantec for Baffinland and submitted to the Nunavut Water Board (NIRB File No. 357441) for photos.</p>

Photo 34: Mary River Incinerator Building

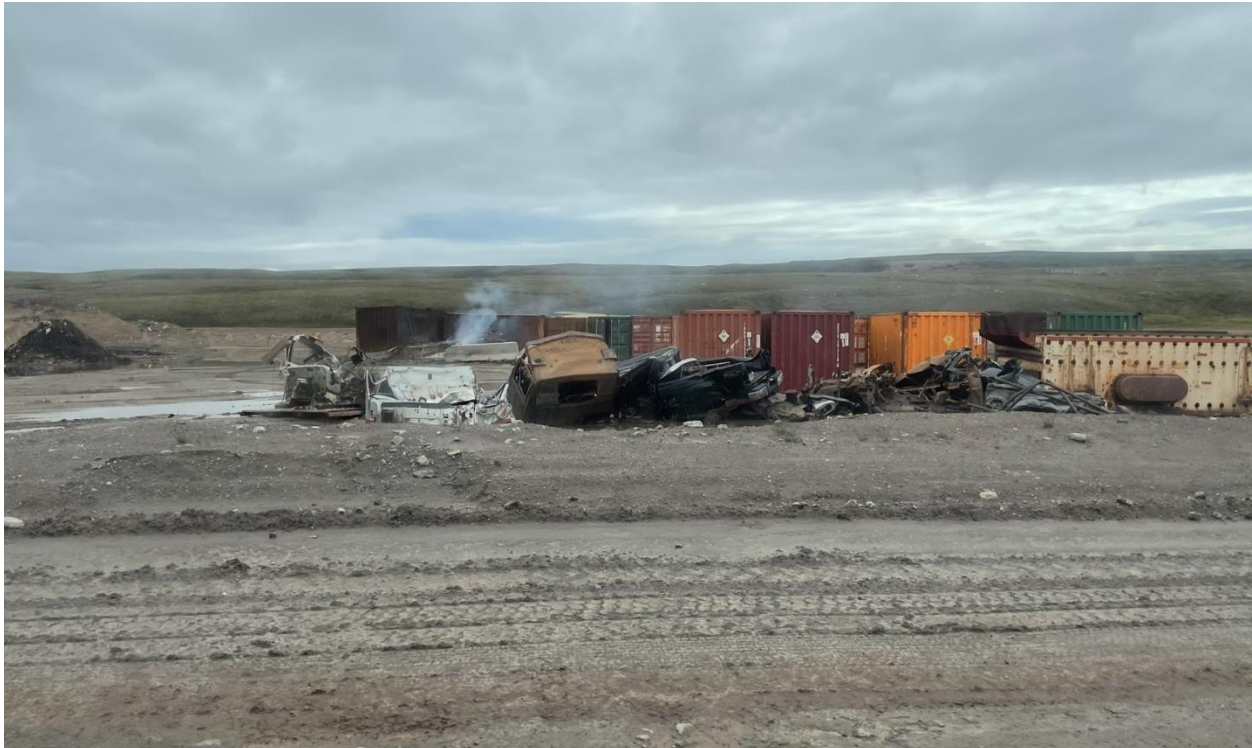
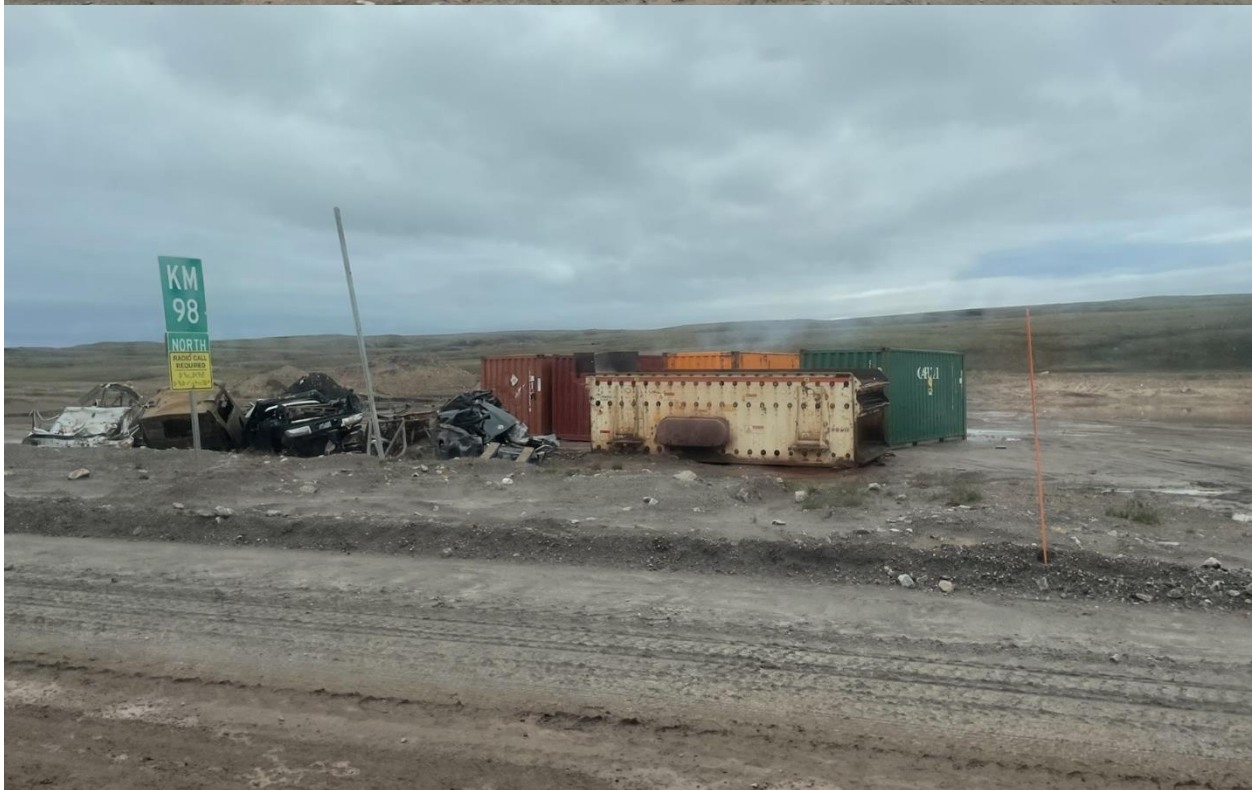
Photo 43: Open air burning of waste at KM 98

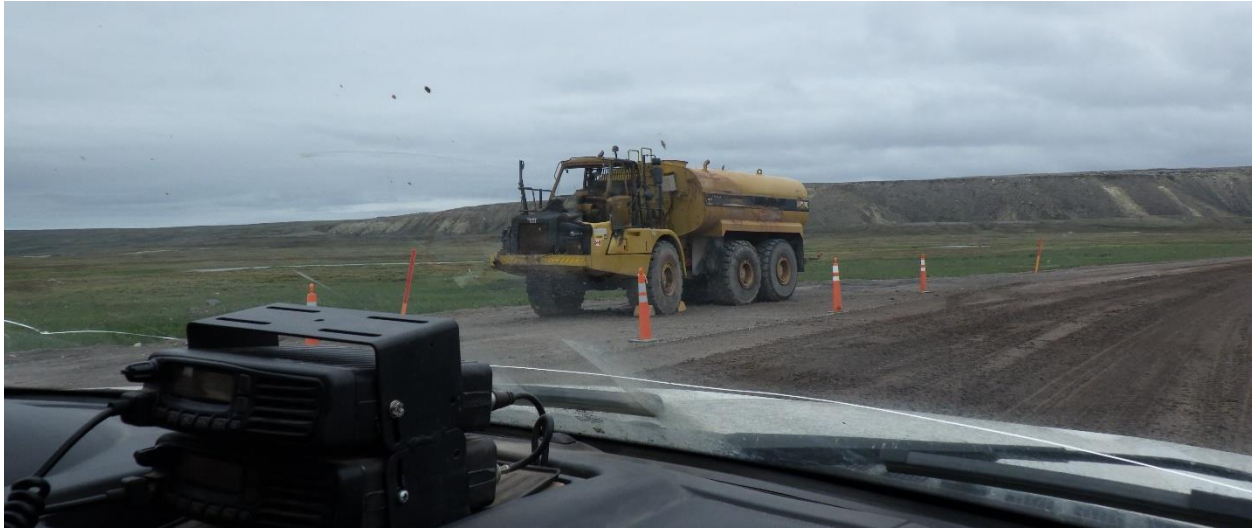
Photo 44: Fire-damaged Tanker on Tote Road. Staff reported the fire was due to an electrical failure

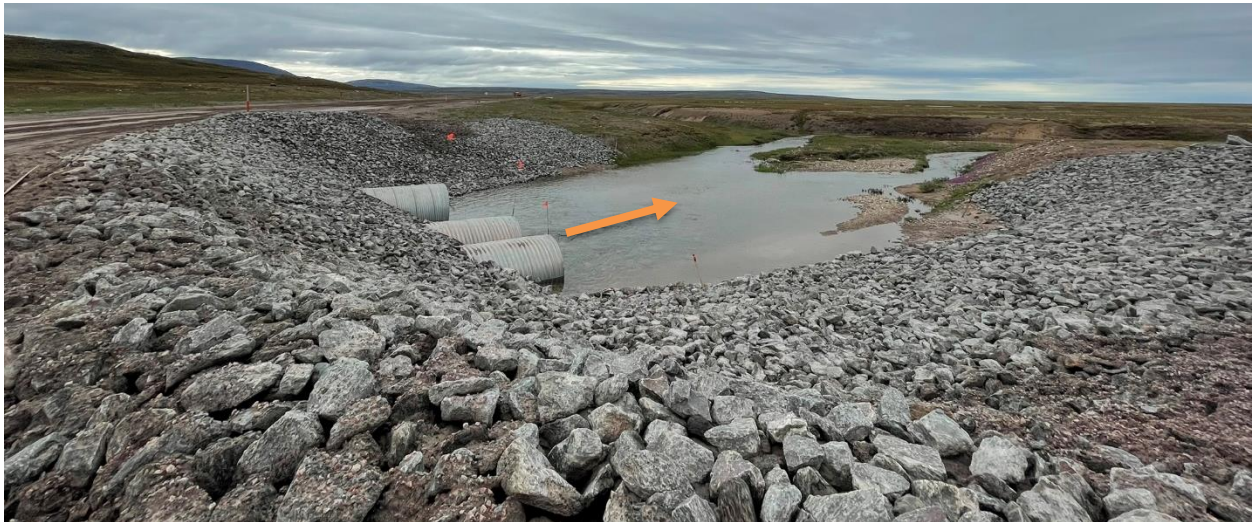
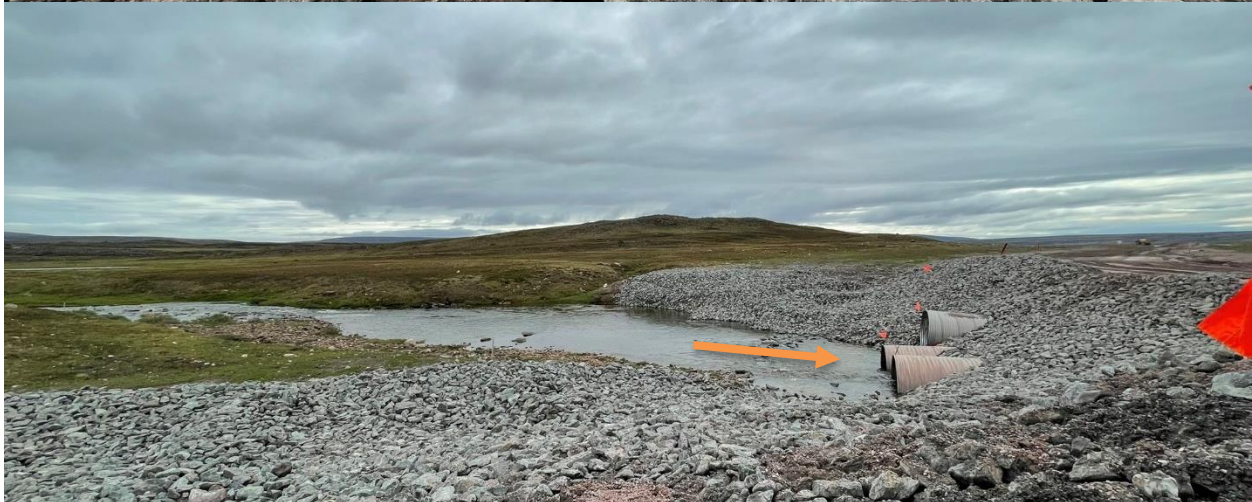
Photo 45: KM94 culverts observed to be clear and functional

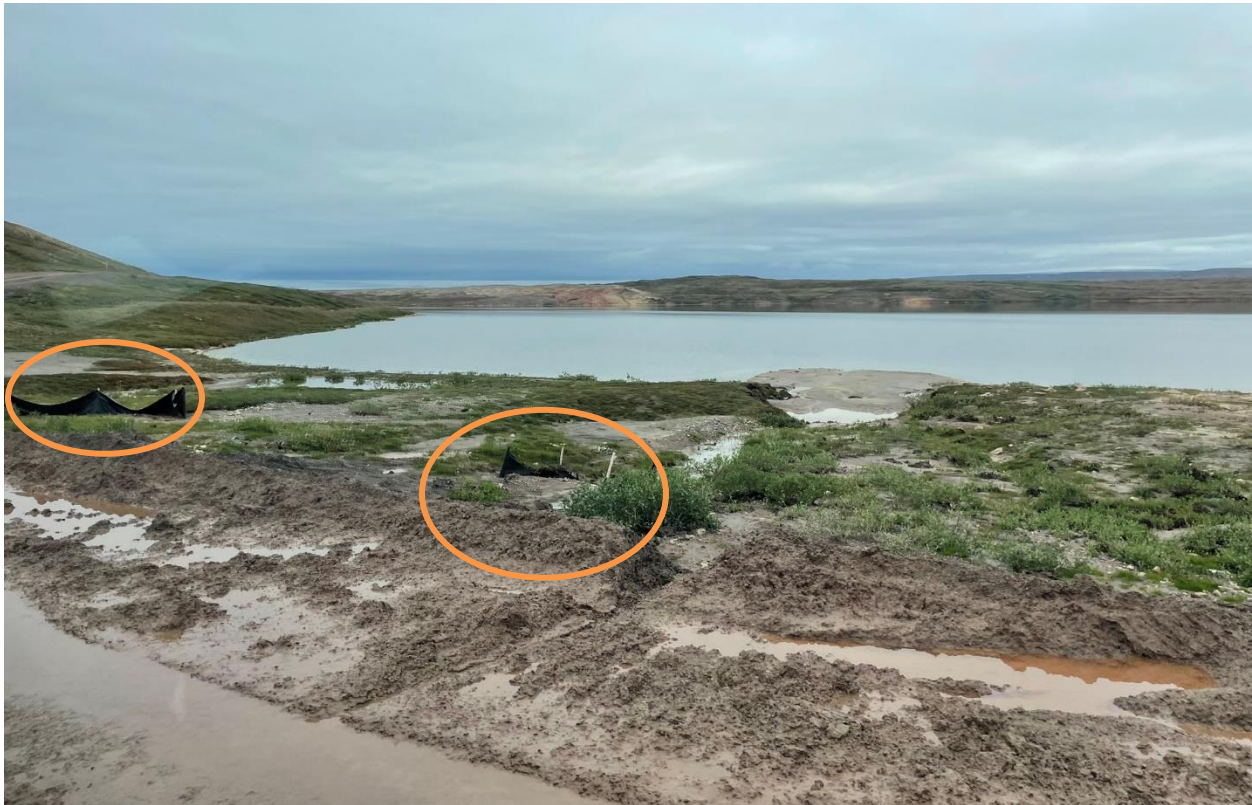
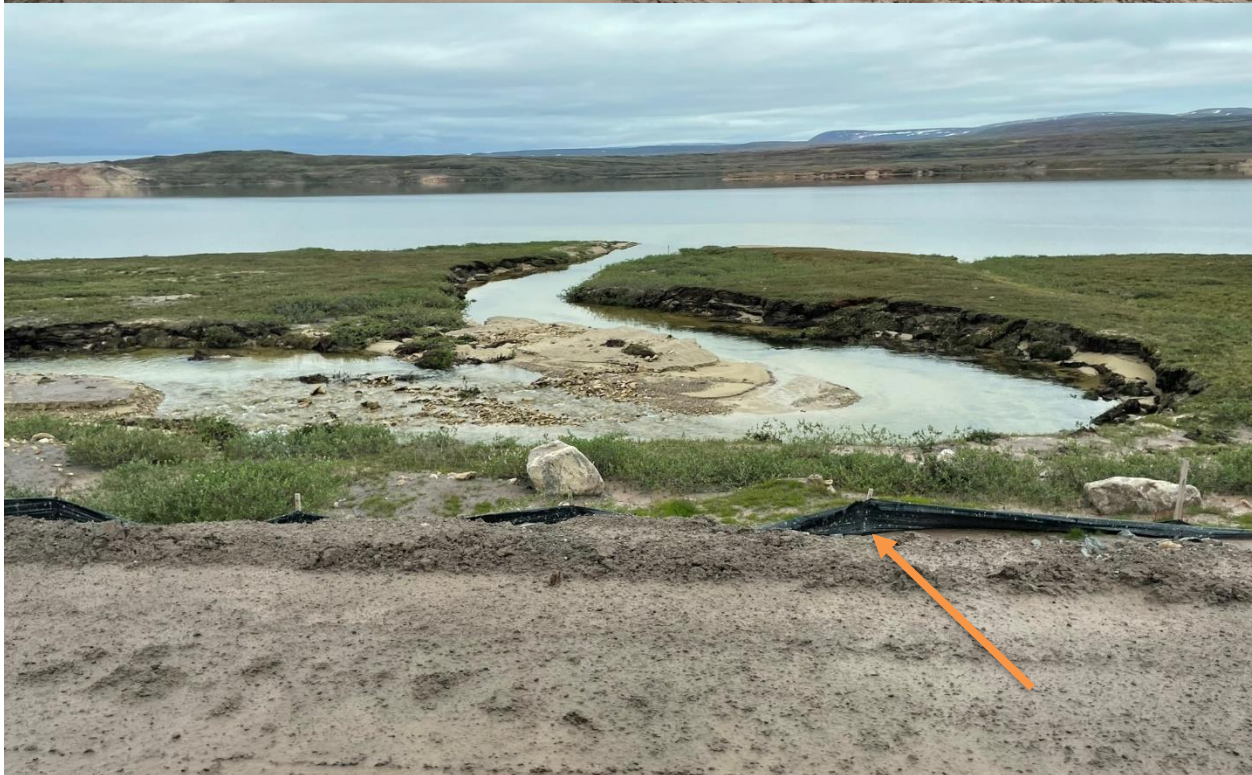
Photo 46: Erosion fence with silt build-up and deterioration at KM 89. Note extreme mudiness of the Tote Road.

- Silt curtains were found deteriorated at multiple locations along the Tote Road, and in some cases were full of sediment, reducing their effectiveness in controlling runoff and protecting nearby water bodies.

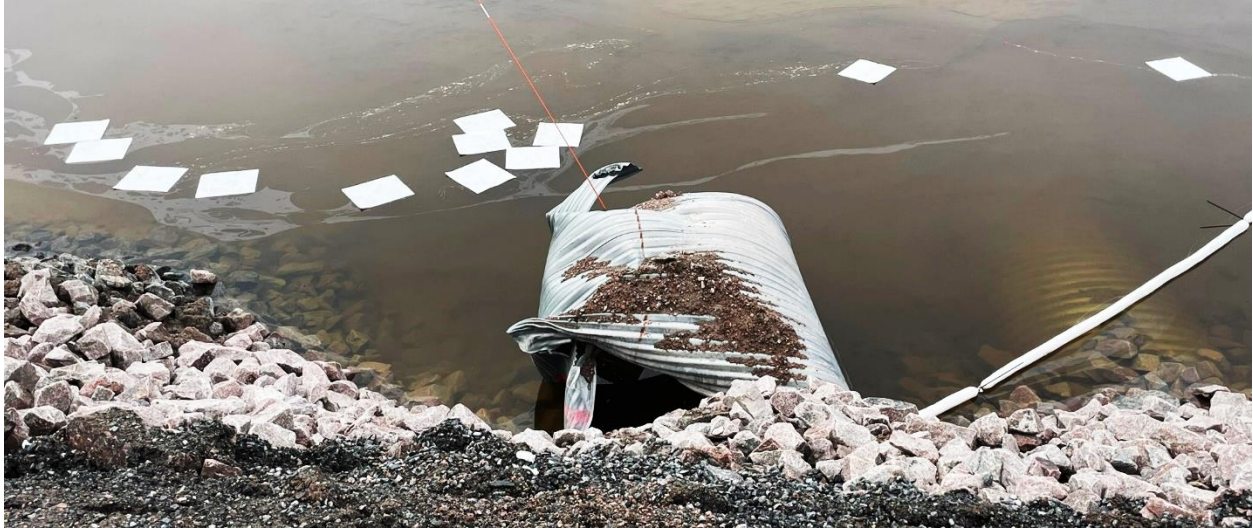
Photo 48: Culvert Inlet at KM80 (Looking South) requiring Replacement; hydraulic fluid spill observed.

A hydraulic fluid leak at KM80 had not yet been completely cleaned up, with hydrocarbon sheen observed on both sides of the road outside of containment booms. Absorption pads were also observed scattered in the water on both sides of the road, inside and outside of the containment booms. Baffinland environmental staff found that a spill kit container on scene had been left open, likely allowing wind to pick up and scatter the pads. The container was closed preventing further wind-blown scattering.

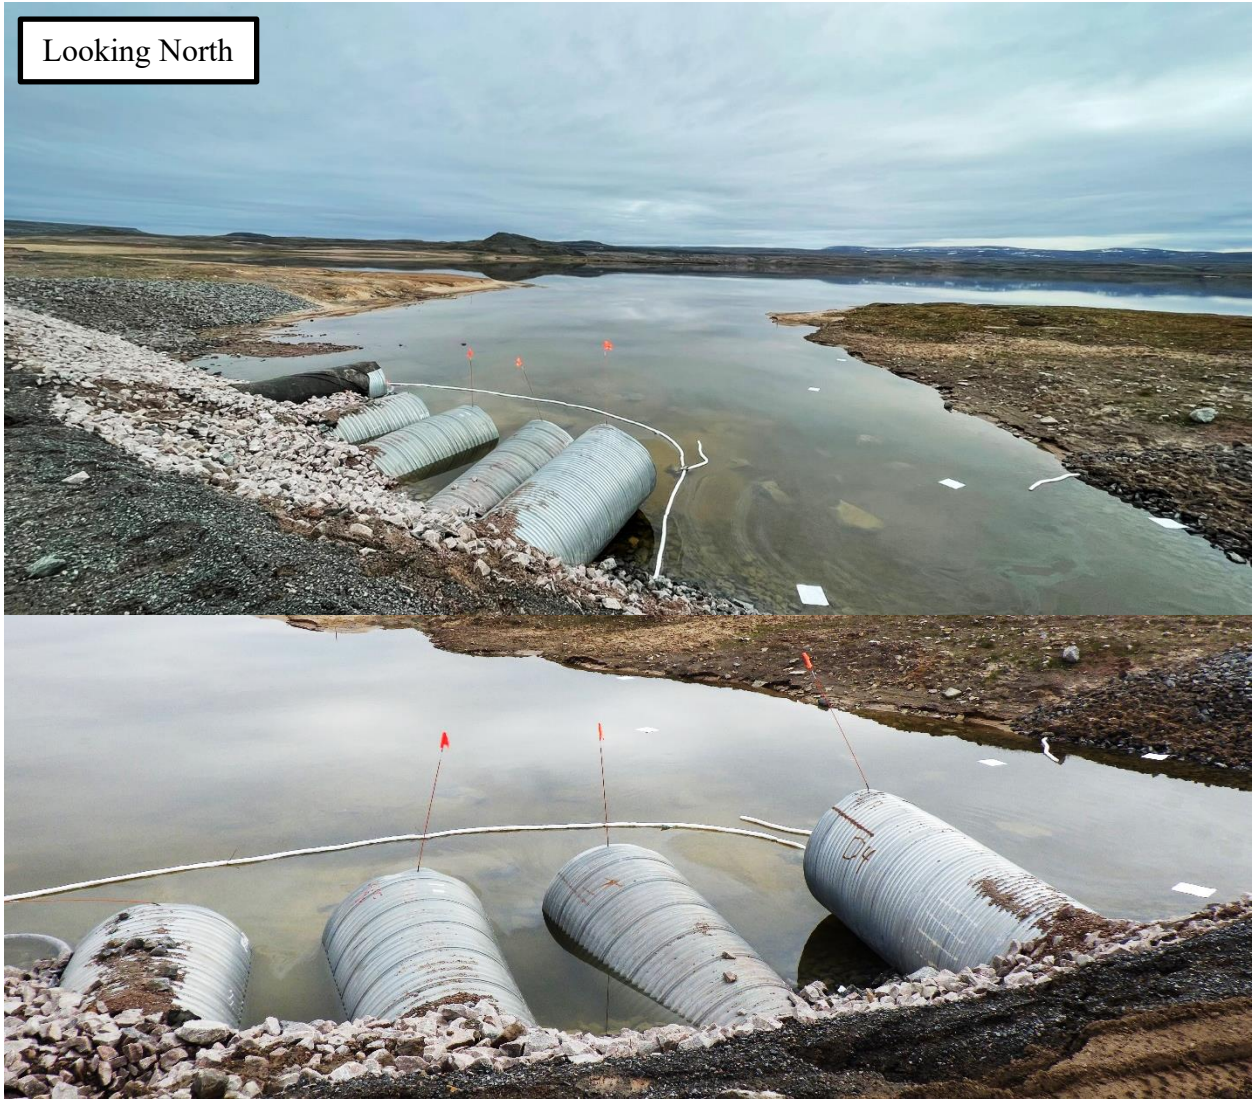
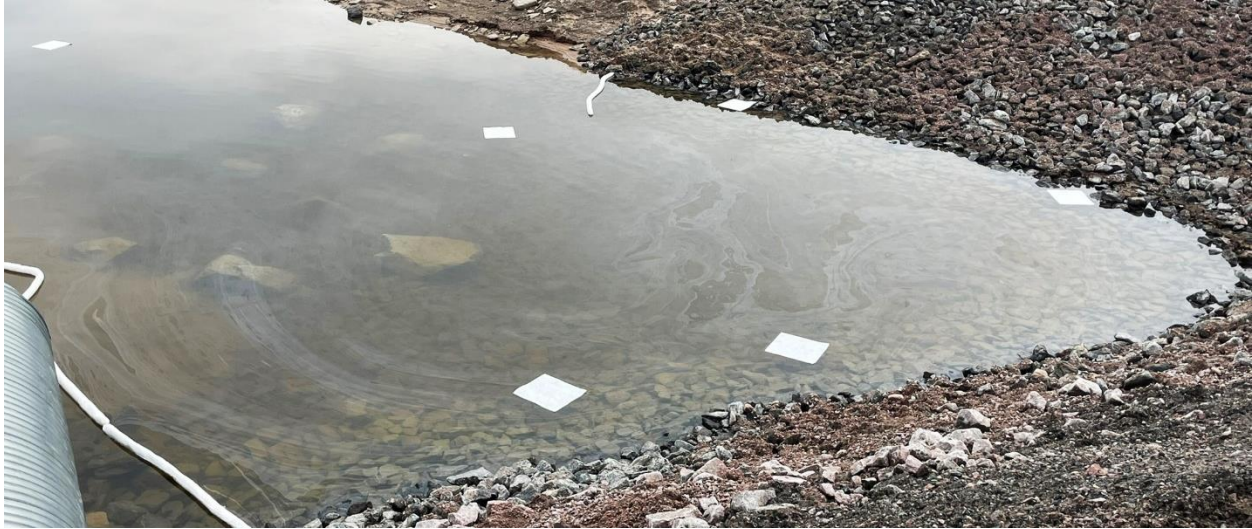
Photo 49: Culvert Outlet at KM80 (looking north) with hydraulic fluid spill

While inspecting the culvert, water levels on both sides of the road prevented NIRB staff from observing the interior of the culverts. While walking on the road above the culverts, NIRB staff noted that the road surface was soft and spongy, with air and water being forced to the surface when pressure was applied, indicating a possible void beneath the road surface. This was brought to the attention of Baffinland staff and they immediately called for the road maintenance personnel to inspect the site.

The week following the NIRB site visit, it was confirmed that all the culverts had collapsed in the middle below the road. See the *CV-216 By-Pass Culvert Crossing Design Brief Appendix A* prepared by Nunami Stantec for Baffinland and submitted to the Nunavut Water Board (NIRB File No. 357441) for photos and additional information.

- Collapsed culverts at KM 80 of the Tote Road, which were not known at the time of the visit, require urgent, and long-term repair. This, along with ongoing road maintenance challenges following the 2024 rainfall event and soft road conditions north of the mine site, raises concerns about the long-term viability of the road for heavy ore transport.

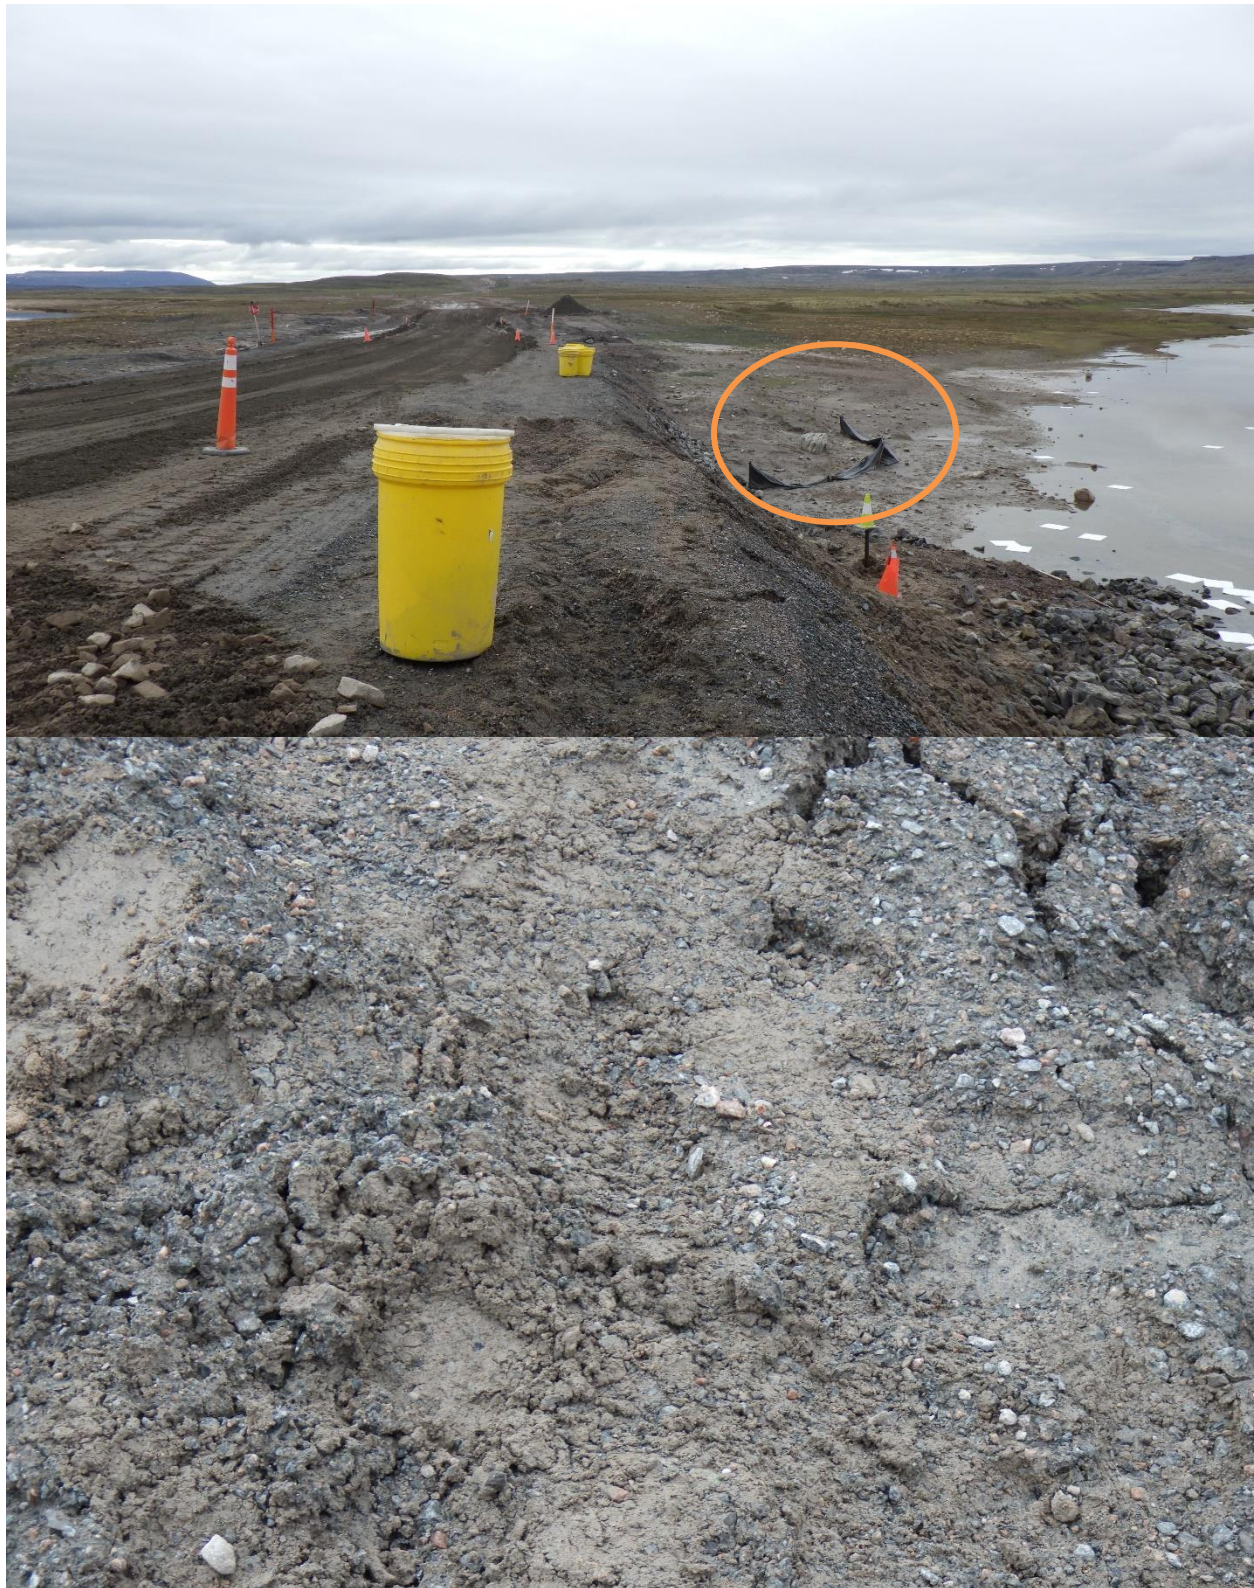
Photo 50: Road Surface at KM80 showing a soft, spongy surface

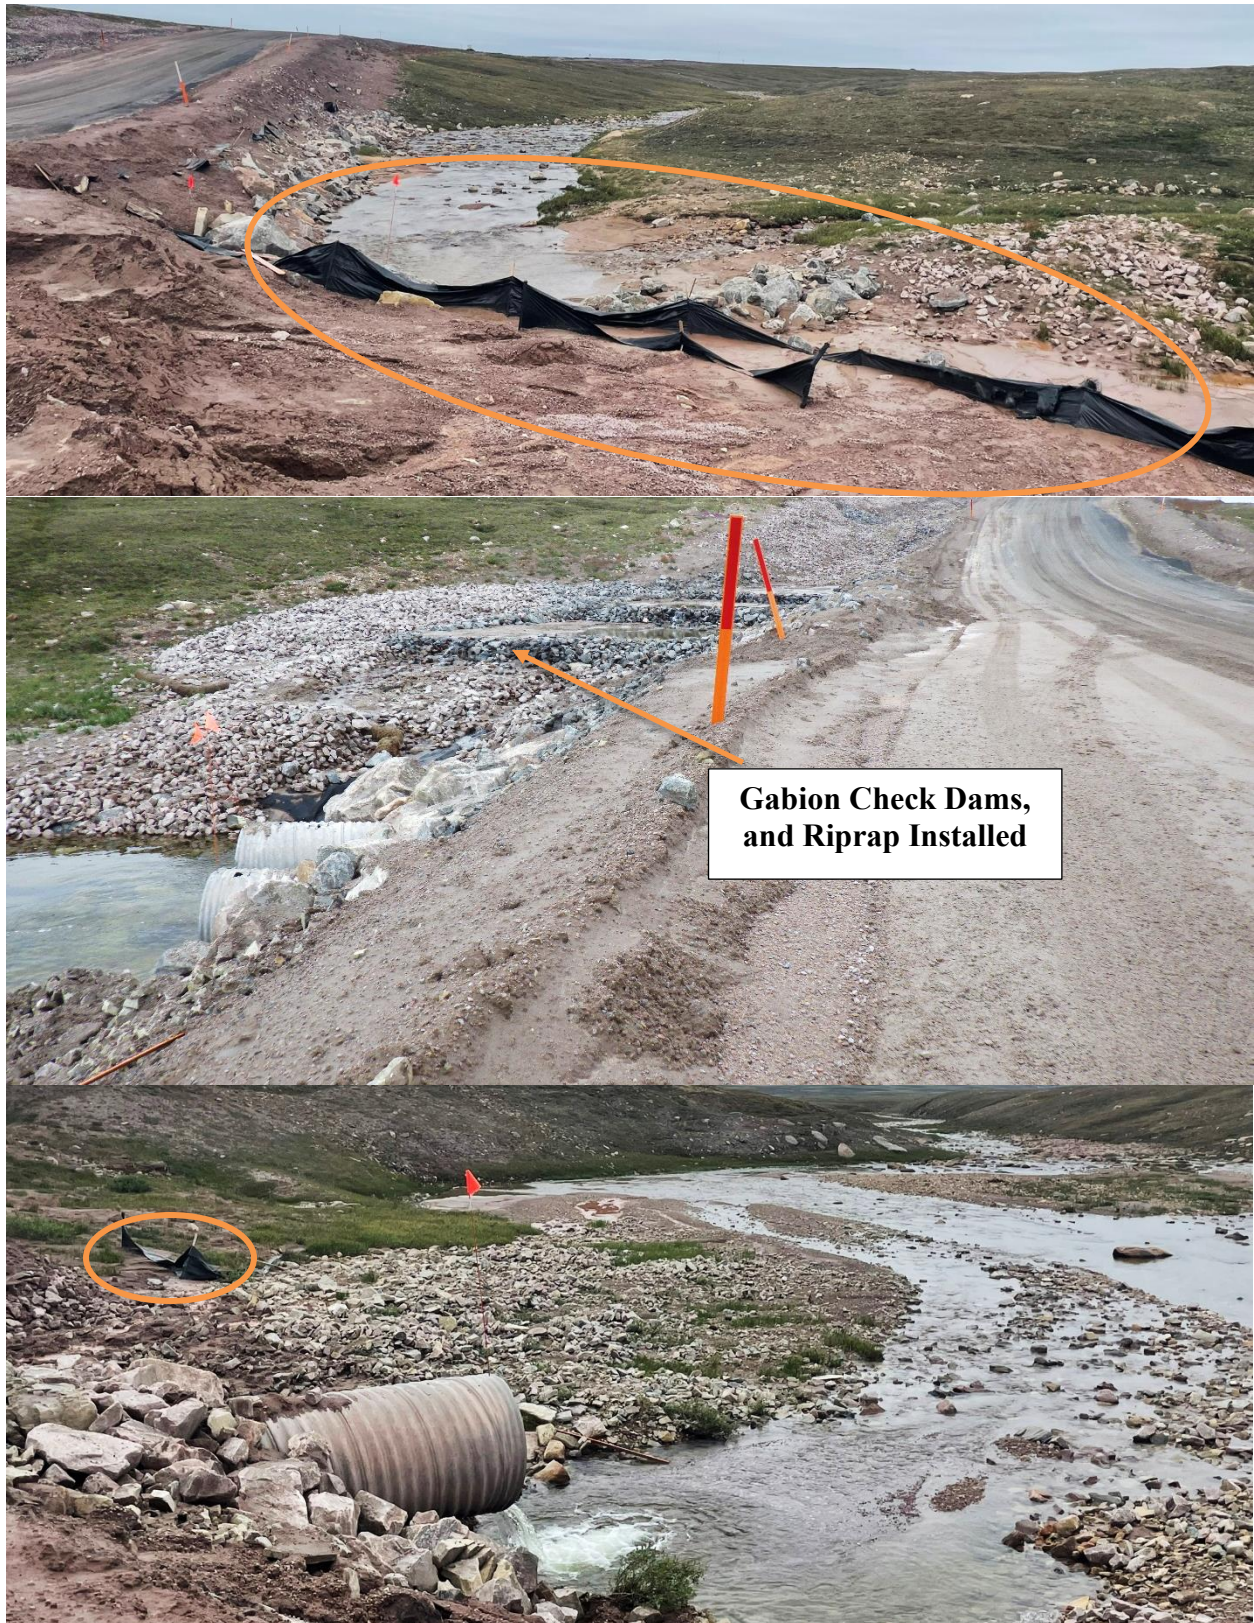
Photo 56: Functioning culvert with adjacent silt fence in poor condition: sagging and sediment buildup noted

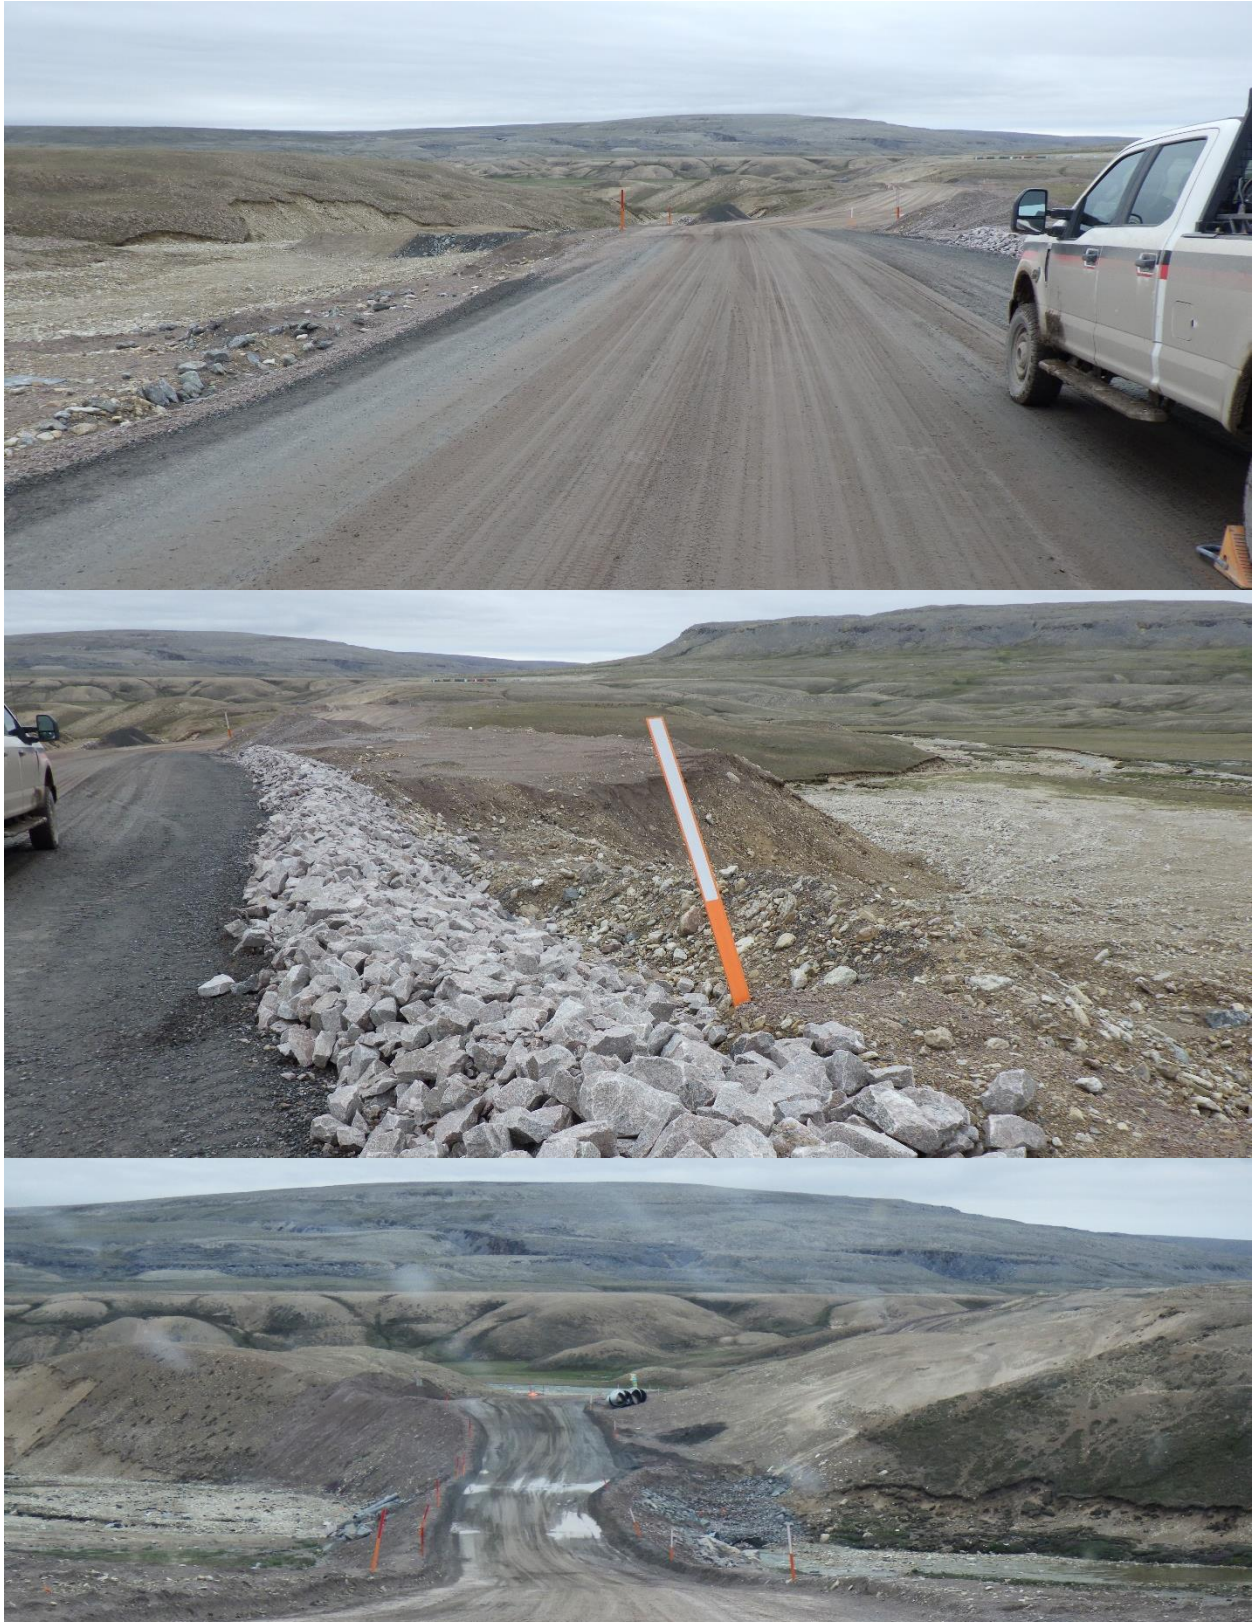
Photo 57: Area of September 2024 Washout After >1:1000-Year Rainfall Event; culverts replaced through Emergency Remediation
