Nunavut Impact Review Board

2025 Site Visit Report

Mary River Project

Report Title: 2025 Site Visit Report Mary River Project

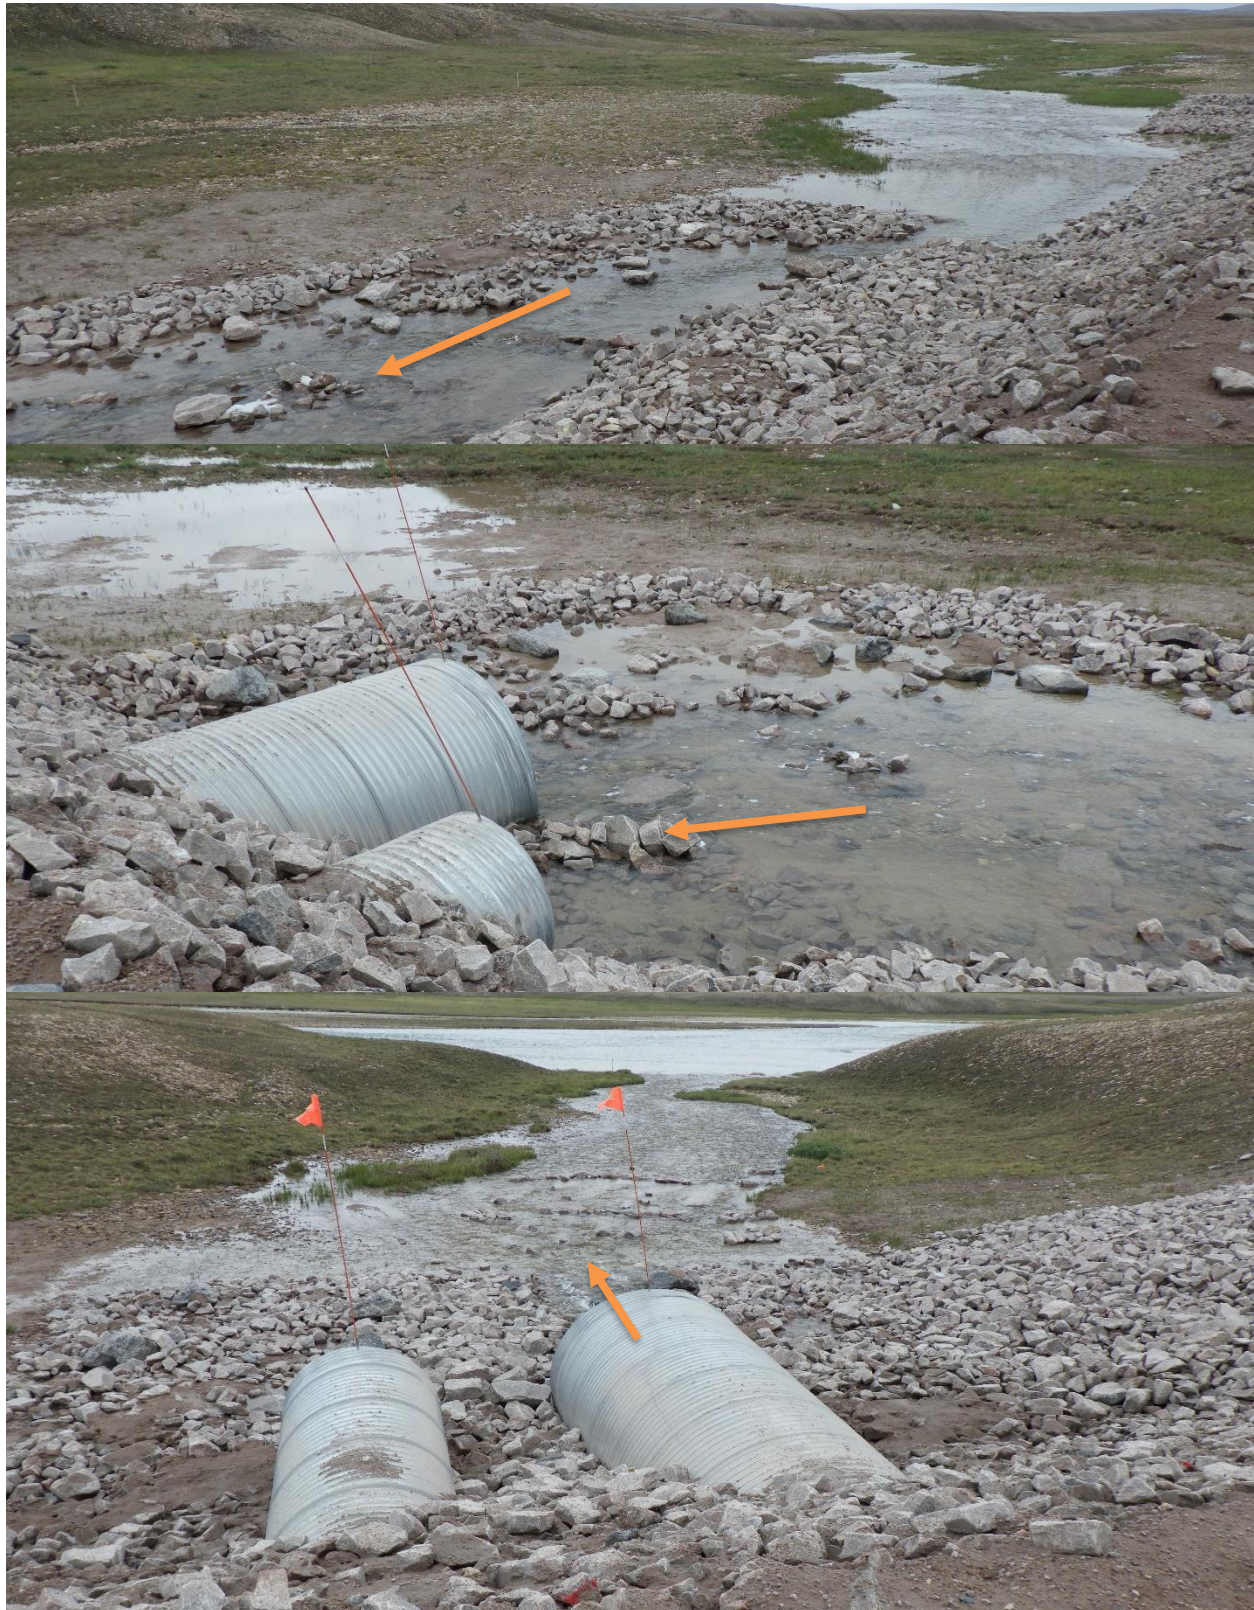
Photo 58: Culverts at KM 36 in good condition

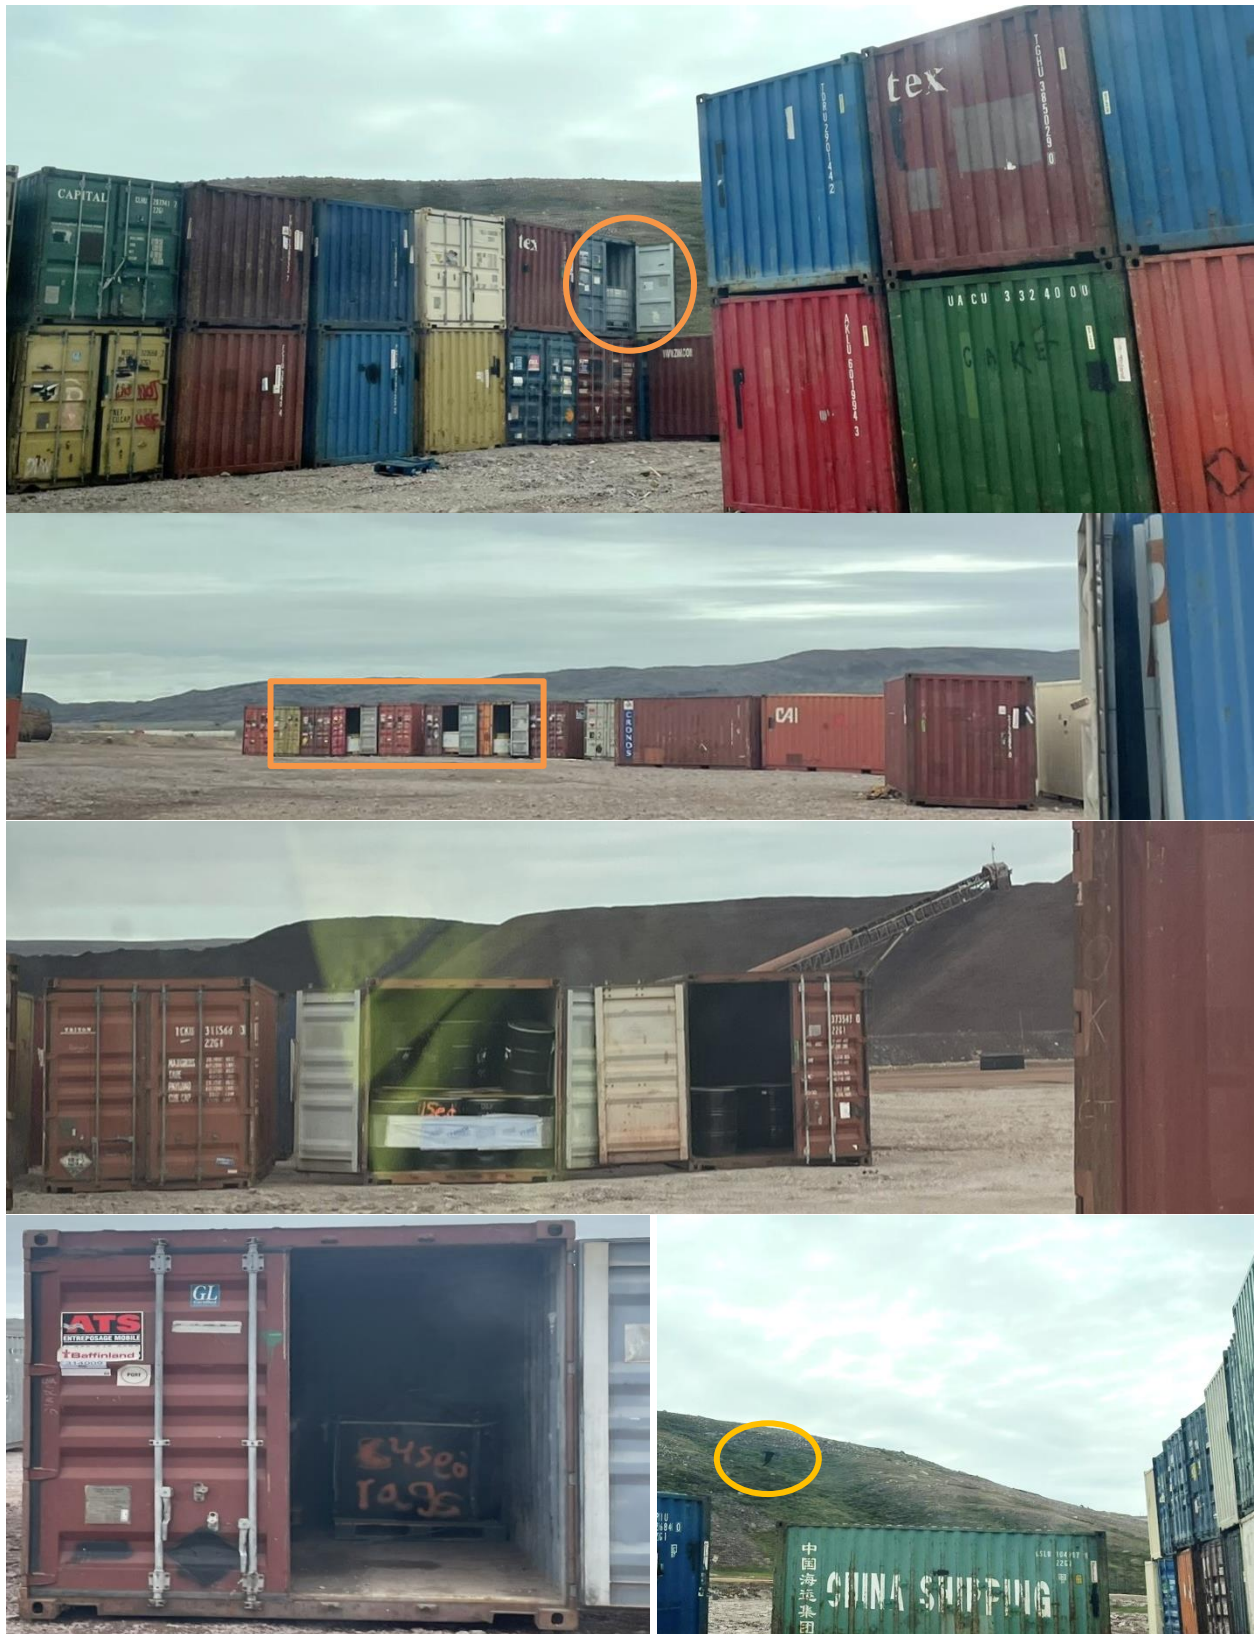
Photo 66: Laydown Pad north of Landfarm; several open seacans contained barrels and used rugs, with ravens observed flying in and out

- Seacans containing potentially hazardous materials were observed with doors open at the Milne Port site, with ravens flying in and out. This poses both environmental and wildlife risks and indicates a need for improved seacan management.
