From April 30 to May 2, 2026, NIRB staff conducted a spring site visit to Baffinland Iron Mines Corporation’s Mary River Project, including the Mine Site, Tote Road, and Milne Port, accompanied by Baffinland environmental staff. The visit focused on observing site activities, environmental management practices, and implementation of Project Certificate requirements. During the visit, NIRB staff observed ongoing operational activities and held discussions with the Proponent regarding environmental monitoring, mitigation measures, and adherence to Project Certificate requirements (Table 1).

3.1. Mine Site

3.2. Tote Road

3.3. Milne Port

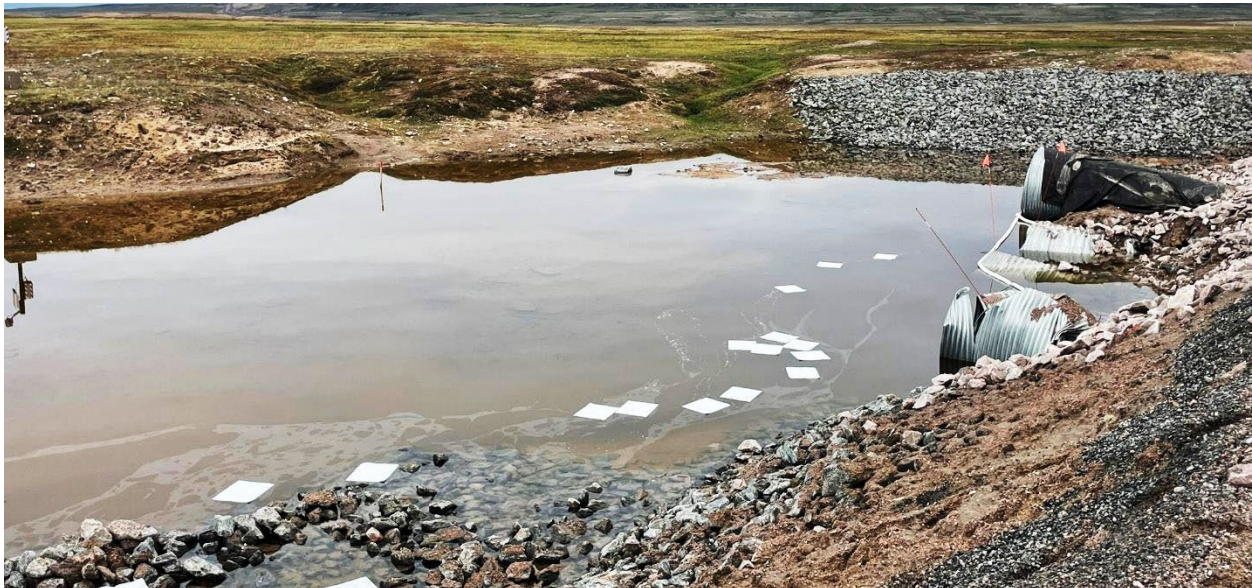
As noted in the 2025 NIRB site visit report (NIRB File No. 357398), concerns were identified at the KM 80 culvert crossing where high-water levels prevented observation of the culvert interior. The road surface above the culverts was observed to be soft and spongy, with water and air forced to the surface under pressure, indicating a potential void beneath the road. Following the site visit, it was confirmed that the culverts had collapsed beneath the road. Additional details and supporting information are provided in the CV-216 By-Pass Culvert Crossing Design Brief, Appendix A, submitted to the Nunavut Water Board (NIRB File No. 357441).

Photo 1: Culvert Inlet at KM80, hydraulic fluid spill observed (Source: 2025 NIRB Site Visit Report)

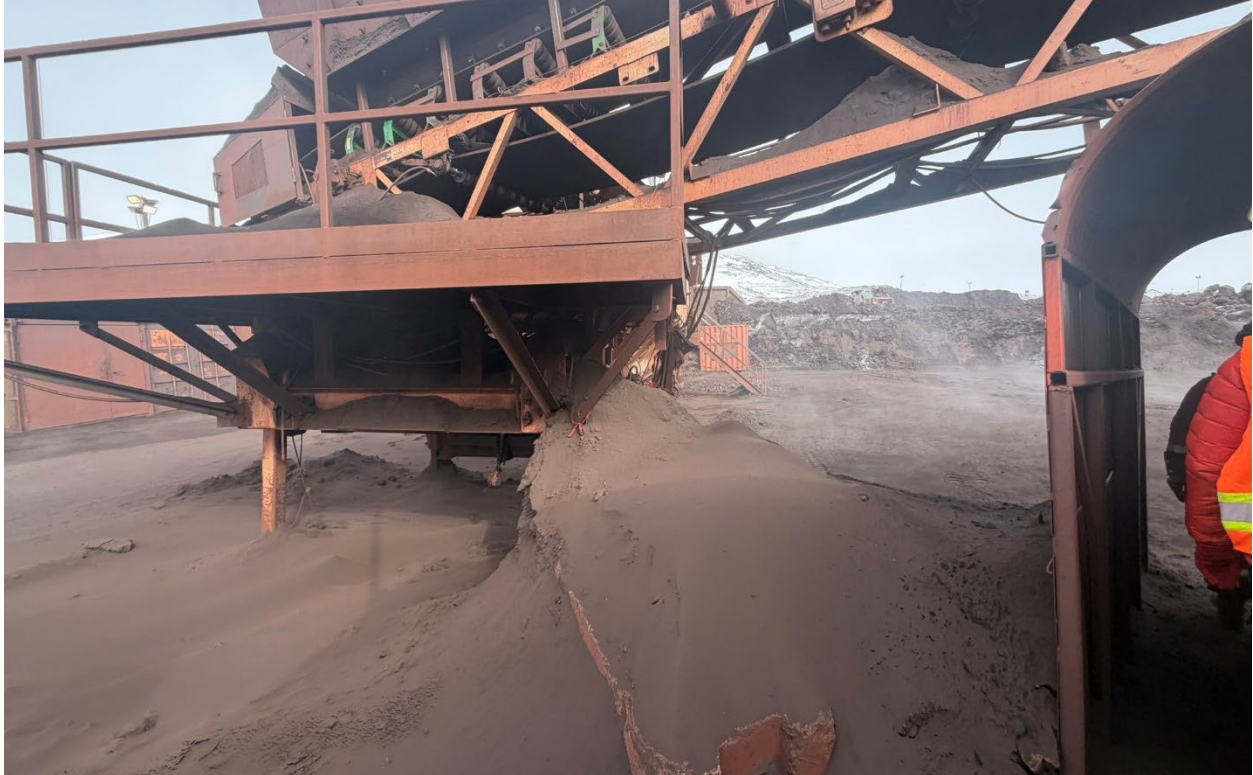
⁴ The crusher facility consists of three (3) units (Crushers A, B, and C) used for primary ore size reduction, with conveyors transferring material to the adjacent stockpile area for temporary storage. Dust control measures, including dust suppressant application, skirting at conveyor outlets, and the use of shrouds, were observed throughout the crusher facility.

Photo 16: Accumulation of fine ore dust beneath crusher A conveyors, likely due to vibration-induced spillage

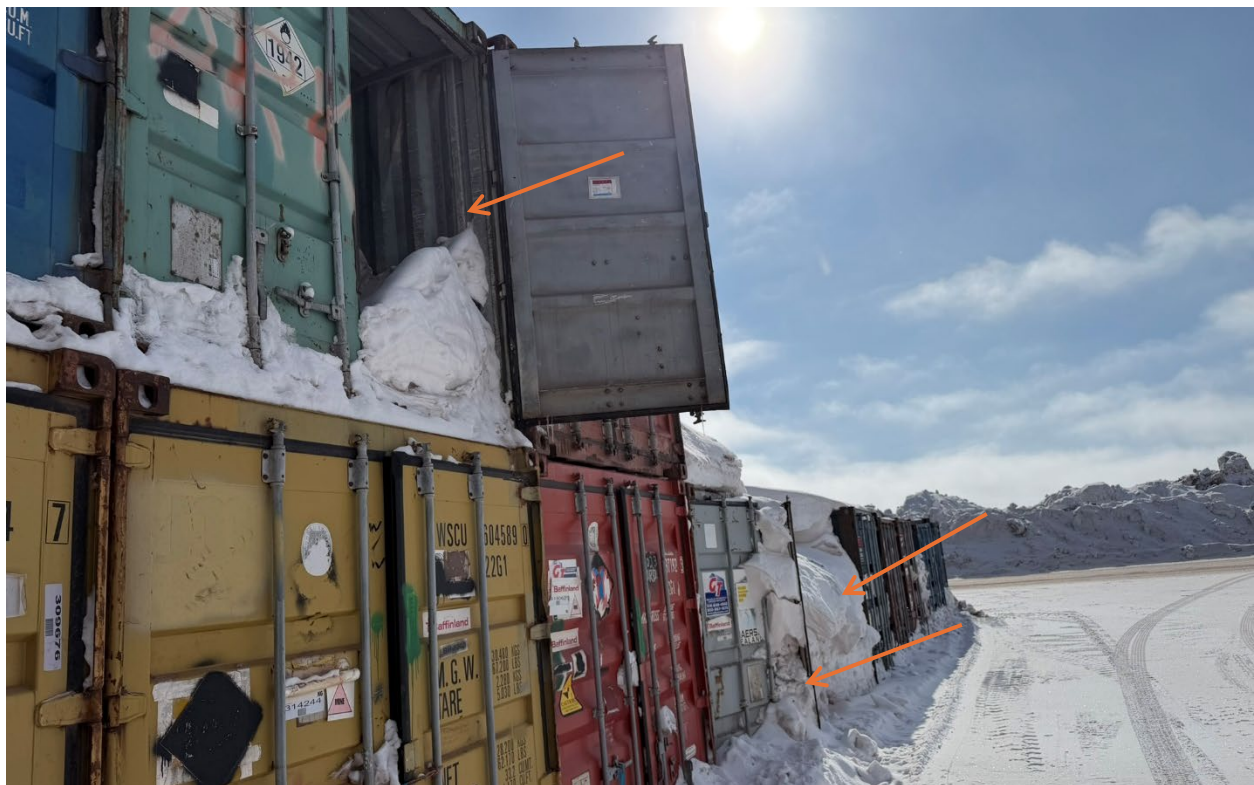
Photo 25: Unsecured seacans in front of the incinerator building

Ensure seacans are fully closed, secured and maintained in good condition. Implement routine inspections and remove unused units where feasible.

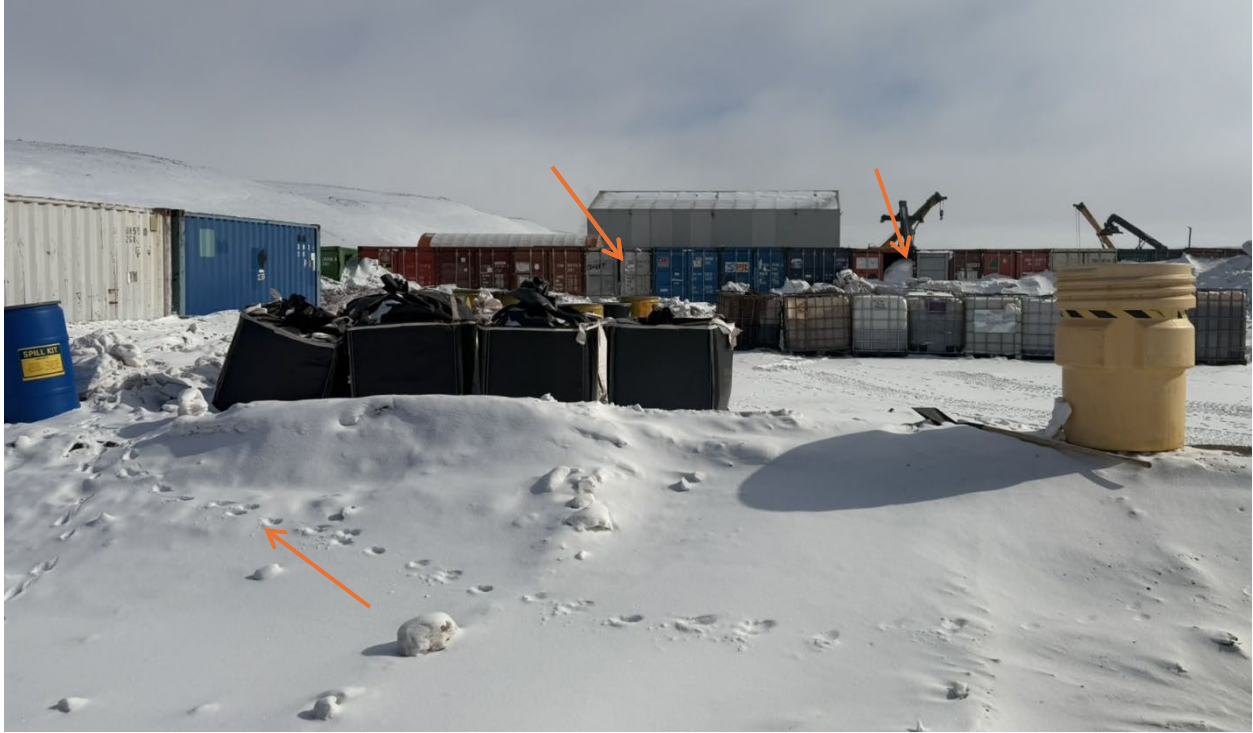
Photo 28: Hazardous waste berm with visible wildlife snow tracks; unsecured sea cans in background

Wildlife presence in and around waste management areas including the incinerator complex, hazardous waste berm, landfill, and landfarm cells suggests that current containment and deterrence measures are not fully effective. These conditions create potential pathways for wildlife attraction, ingestion, contamination exposure, and habituation, which are inconsistent with the intent of applicable Project Certificate requirements related to waste management and terrestrial wildlife protection.

Strengthen containment and deterrence measures at the incinerator area, hazardous waste berm, landfill, and landfarm. Eliminate access pathways and monitor wildlife activity.

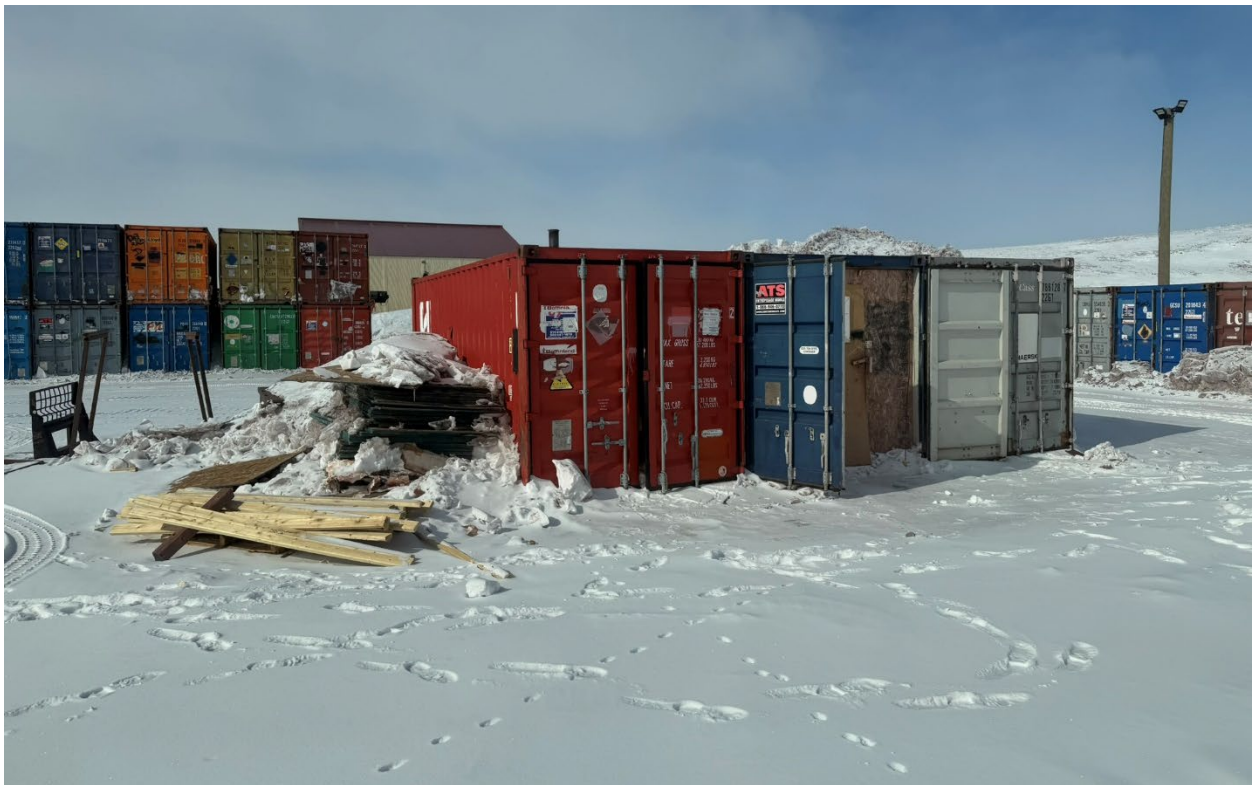
Photo 29: Seacans adjacent to hazardous waste berm, some unsecured, with human and wildlife tracks present

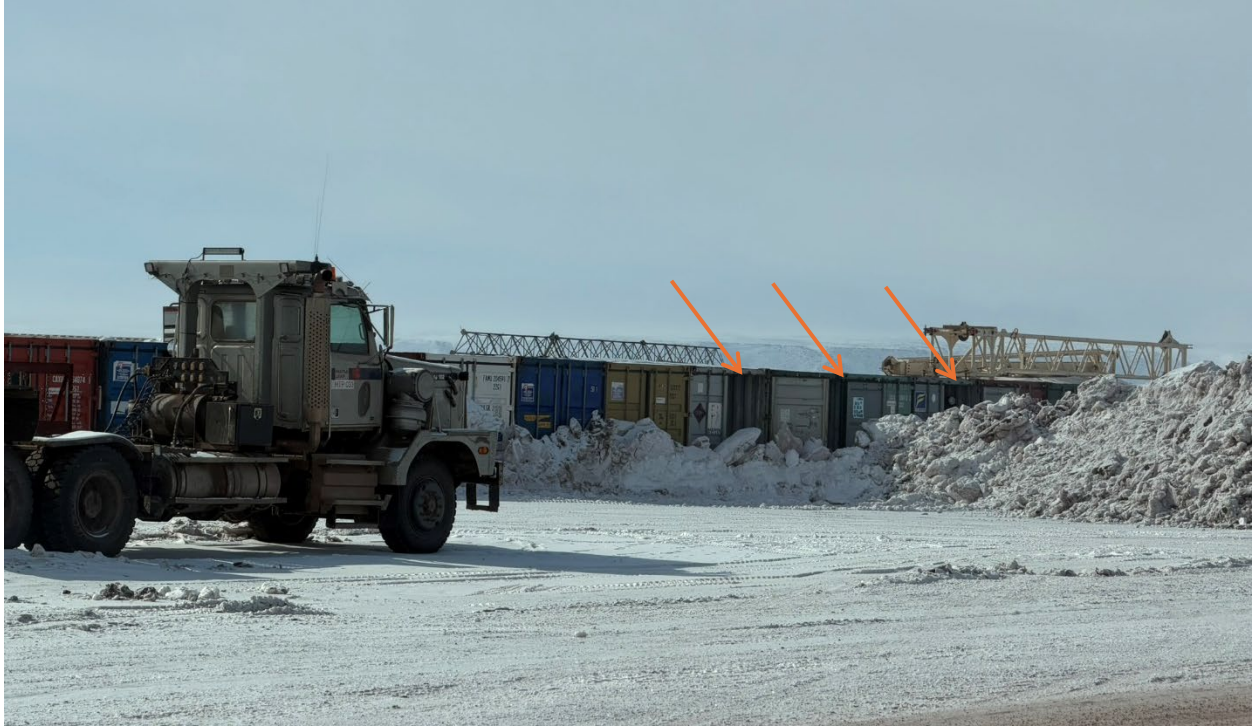
Photo 30: Seacans south of the incinerator building, with multiple units unsecured

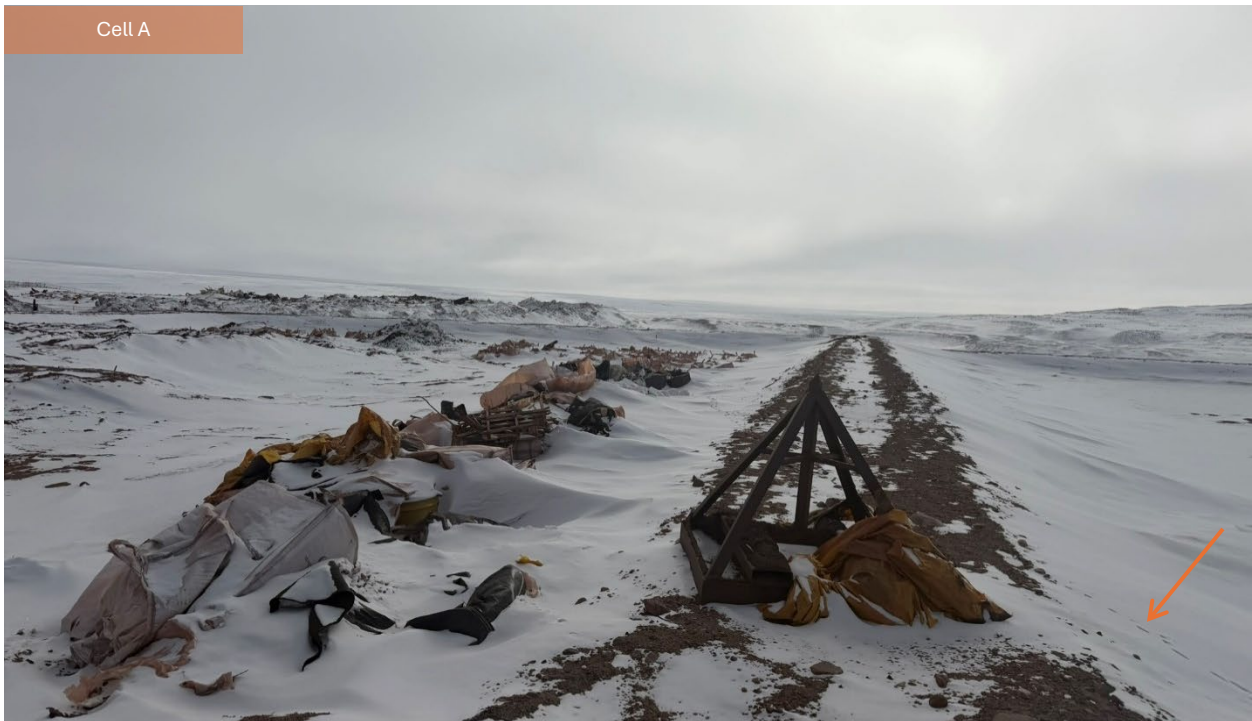
Photo 35: Landfarm cells with visible wildlife snow tracks

⁶ The landfill is used for the disposal of inert solid waste, and the landfarm is a designated facility for the treatment and management of hydrocarbon-contaminated soils; wildlife snow tracks were observed, indicating potential wildlife use.

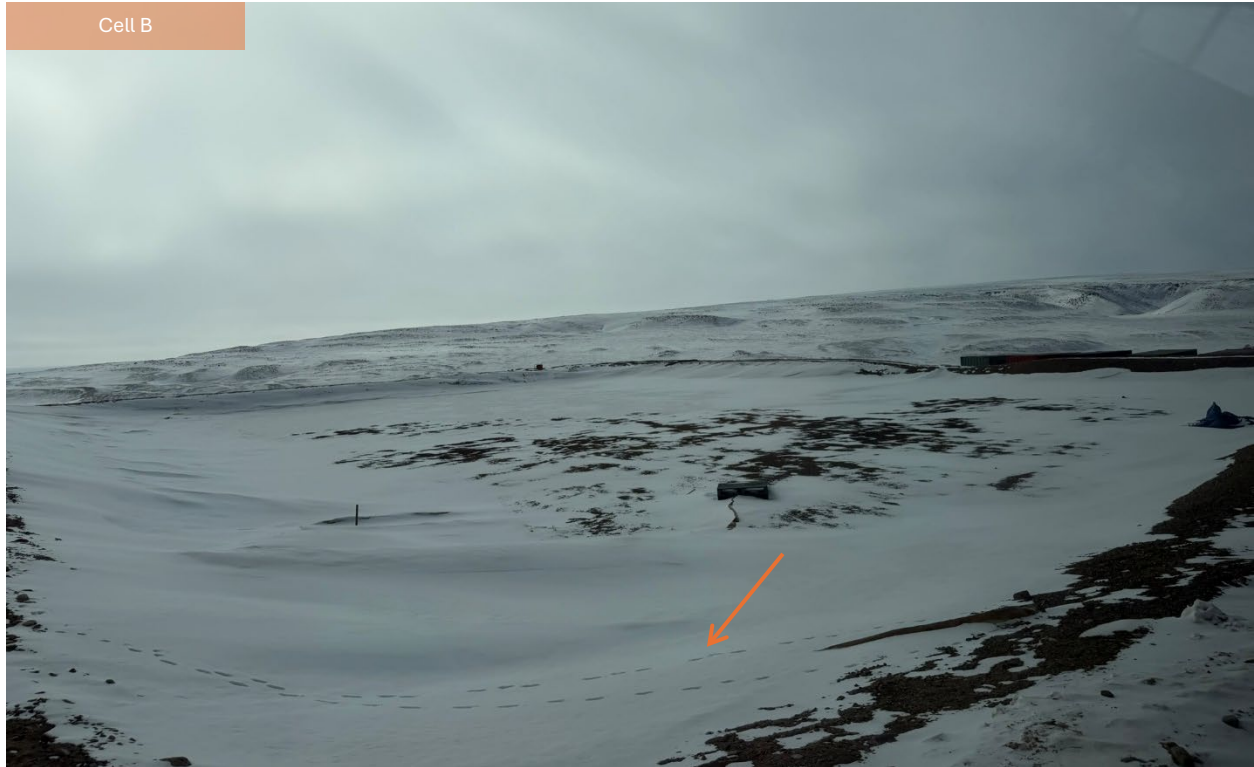
Photo 36: Landfarm cells with visible wildlife snow tracks

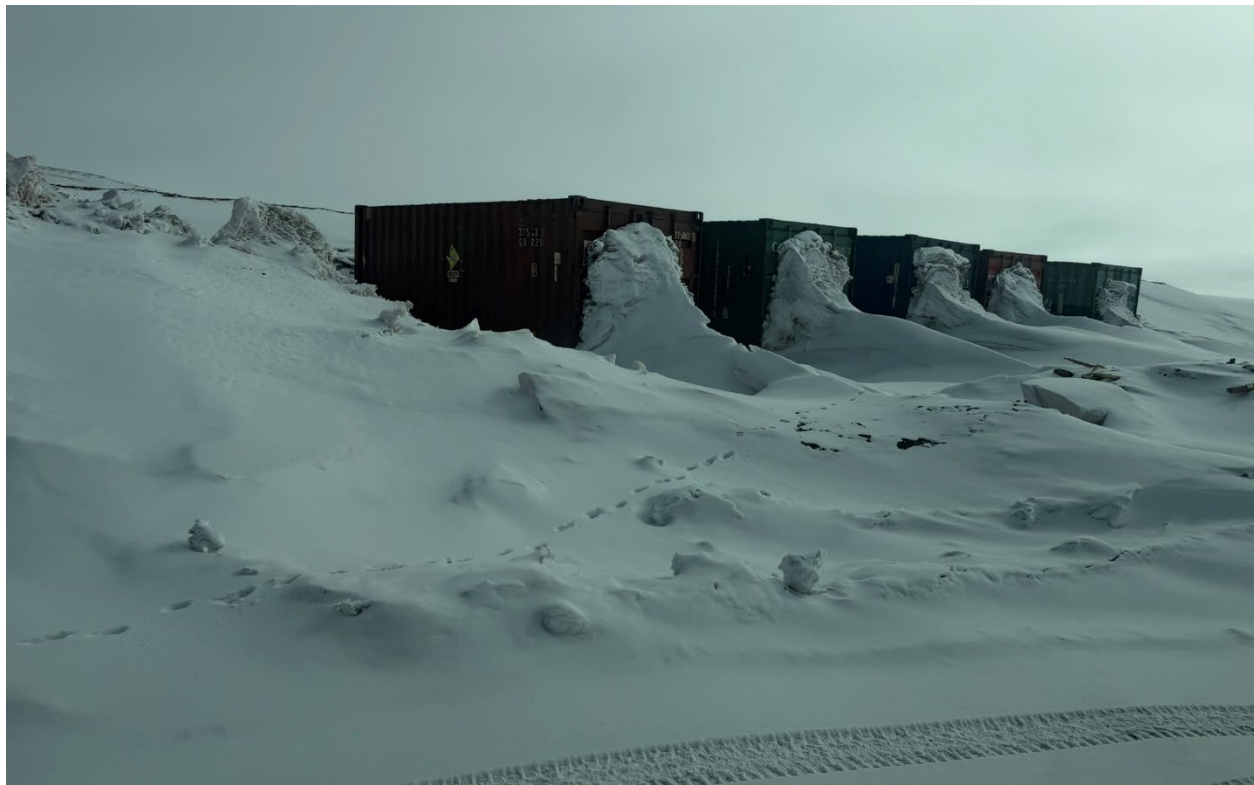
Photo 37: Seacans adjacent to landfill area, with snow tracks observed

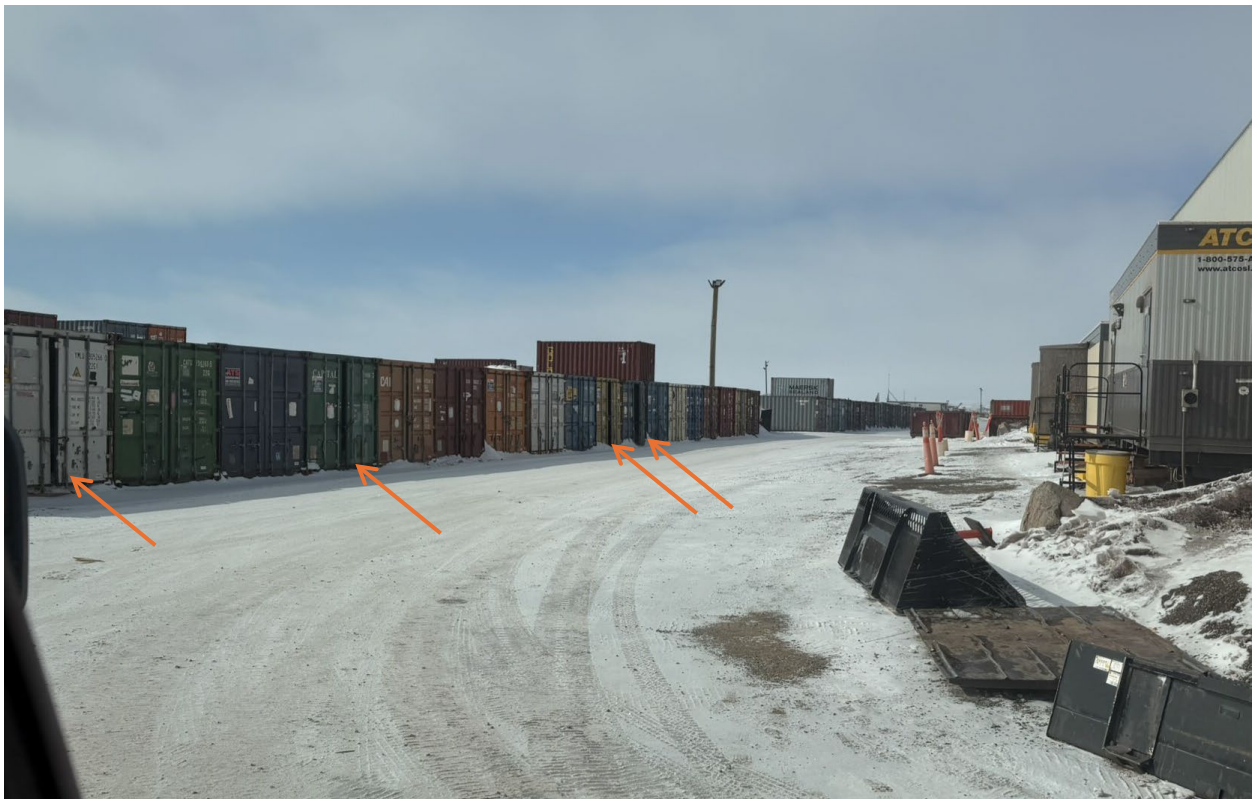
Photo 39: Seacans in warehouse area, with multiple units partially open

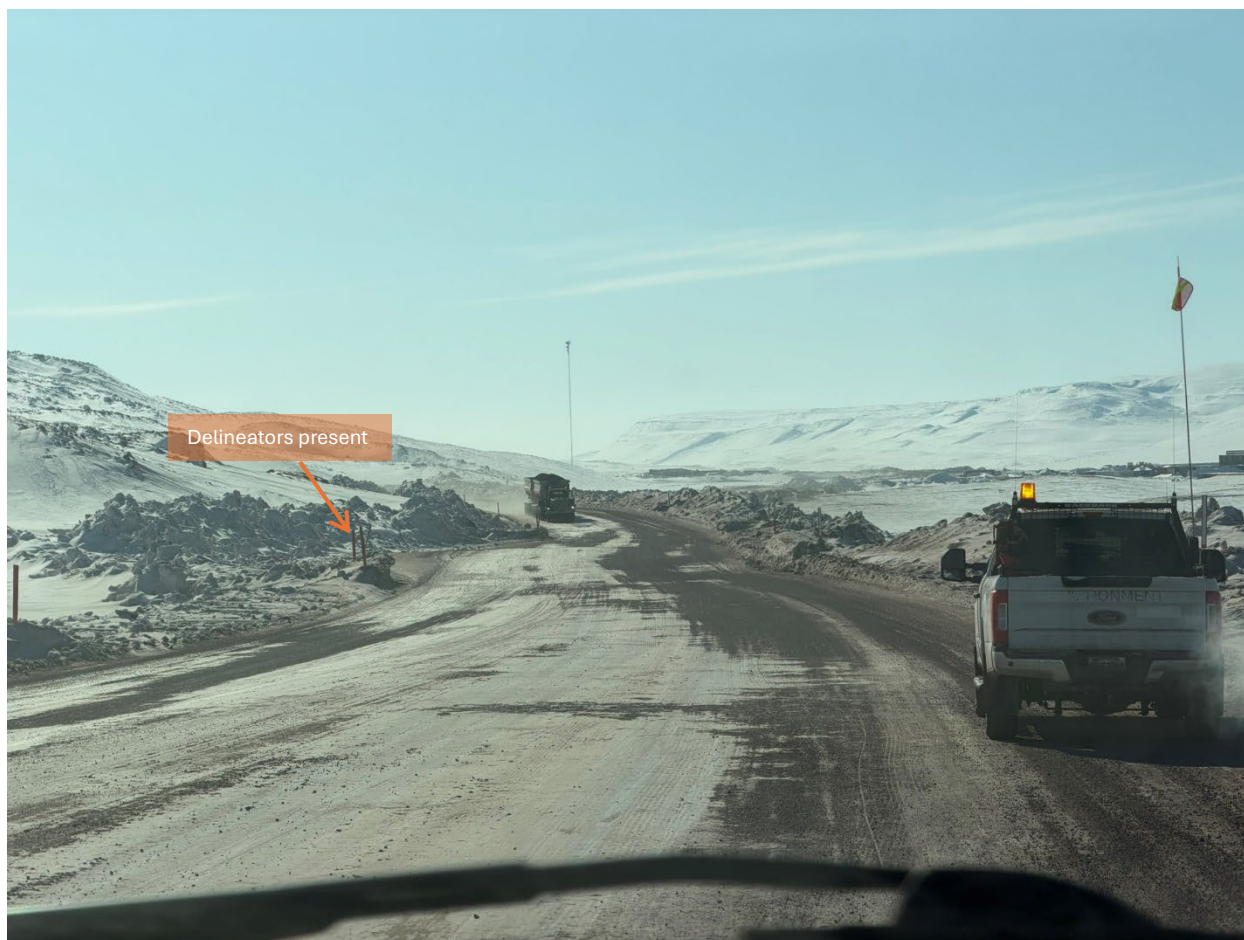
Photo 48: Overview of the Tote Road (southbound) with ore haul truck; localized dust deposition observed on adjacent snow surfaces, diminishing with increasing distance from the road

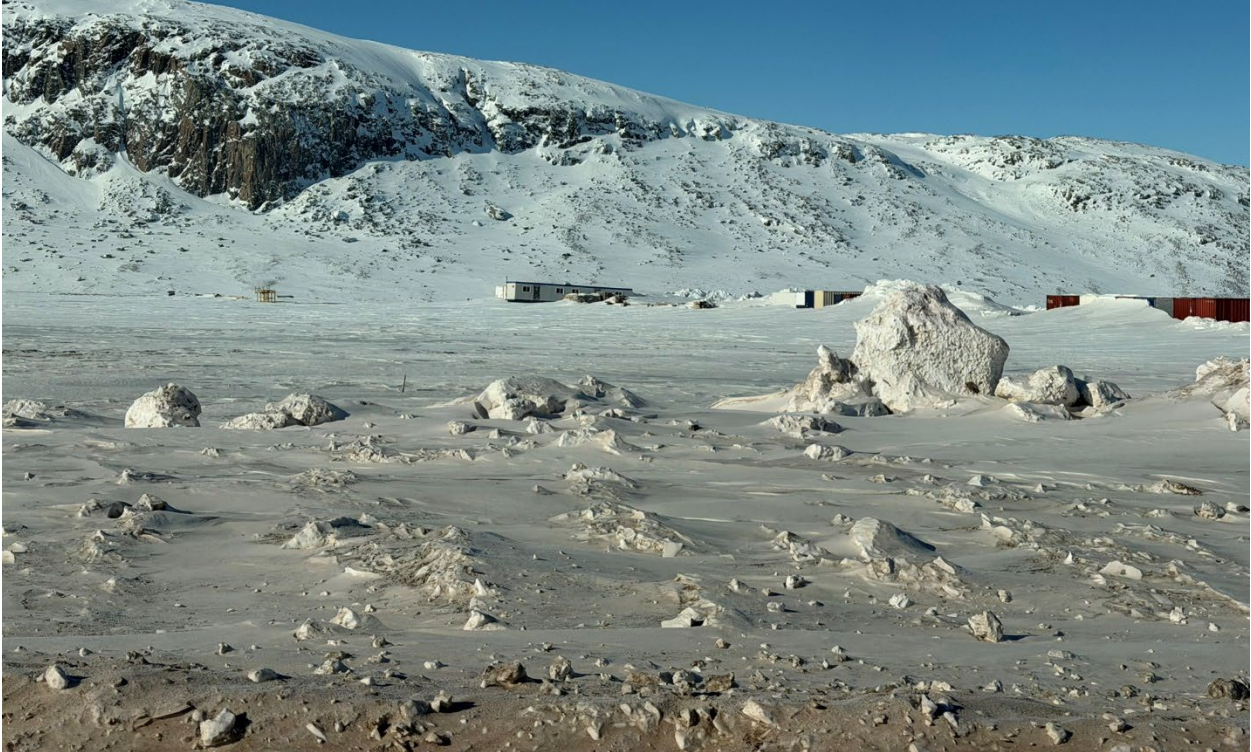
Photo 49: At KM 4, west-facing view from the Tote Road, showing decreasing dust deposition

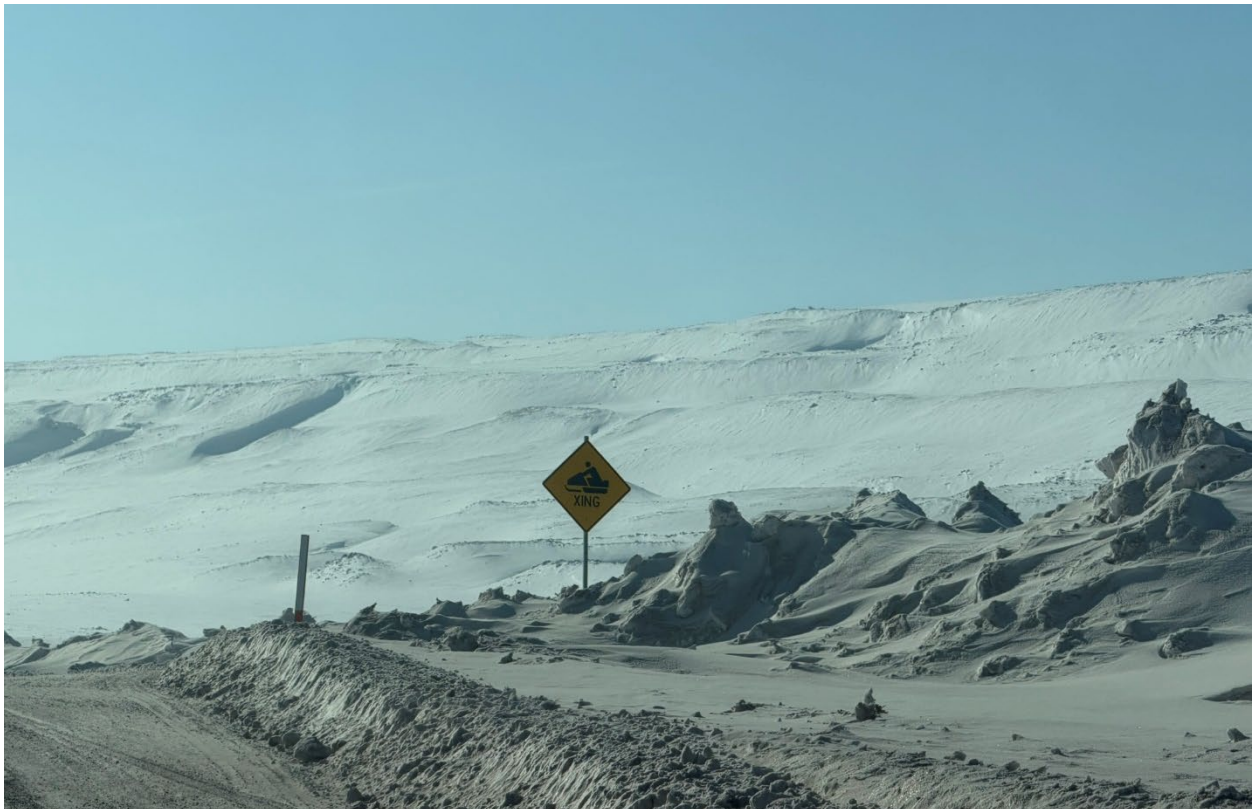
Photo 52: Close-up view of the crossing signage and adjacent steep, uneven berms blocking safe entry

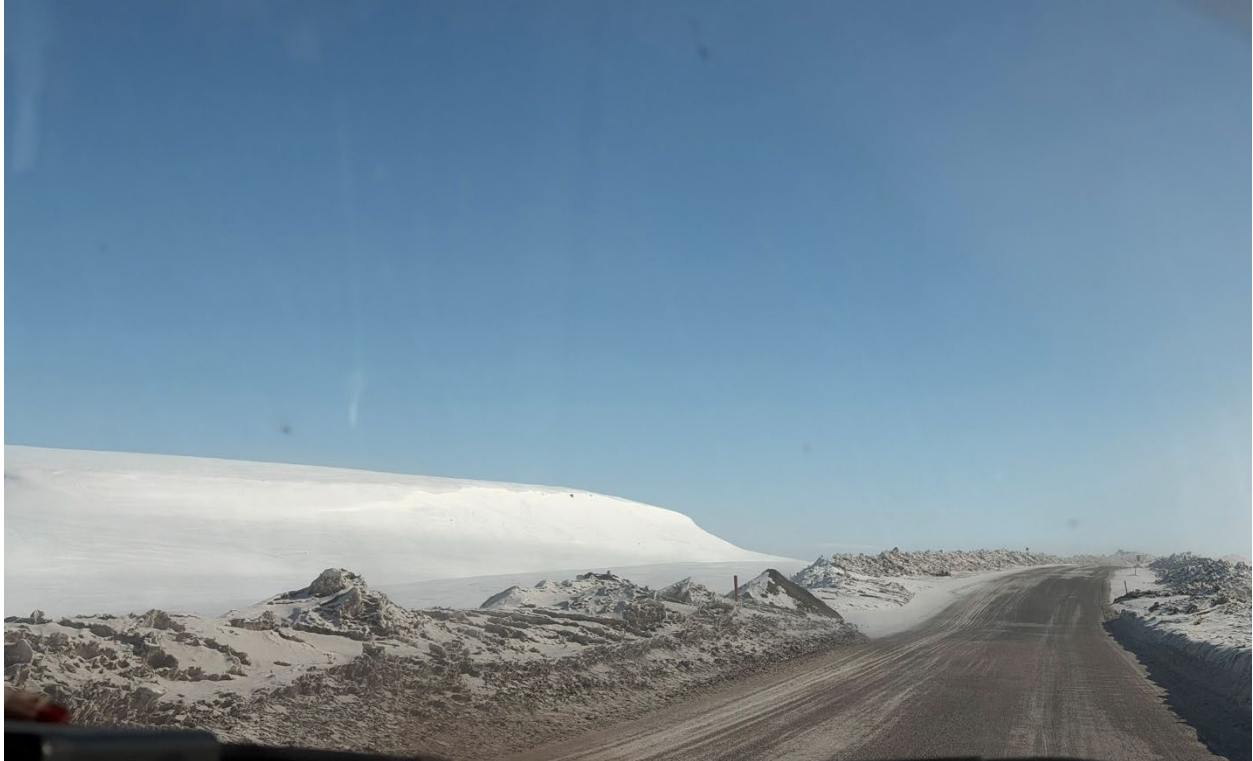
Photo 65: Dust conditions at KM 70, showing localized deposition

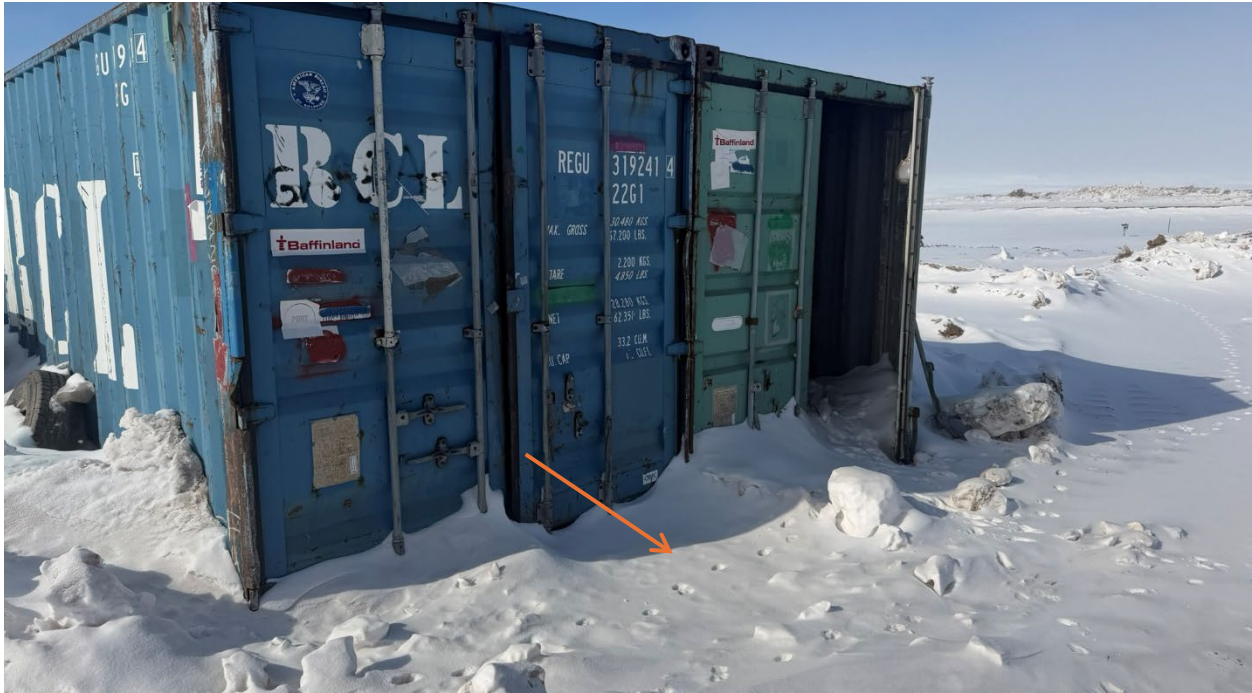
Photo 67: Unsecured seacan units adjacent to the KM 80 bridge, with wildlife tracks observed entering the unit, indicating use by wildlife and presenting potential hazards to both wildlife and personnel

Along the Tote Road, similar concerns were noted at the KM 80 crossing and by-pass road, where unsecured seacans and observed wildlife activity indicate continued access to materials. In addition, concrete jersey barriers installed as part of the recent culvert replacement works were observed to be insufficiently supported on sloped surfaces, creating a potential risk of instability, particularly during spring melt and high-flow conditions.

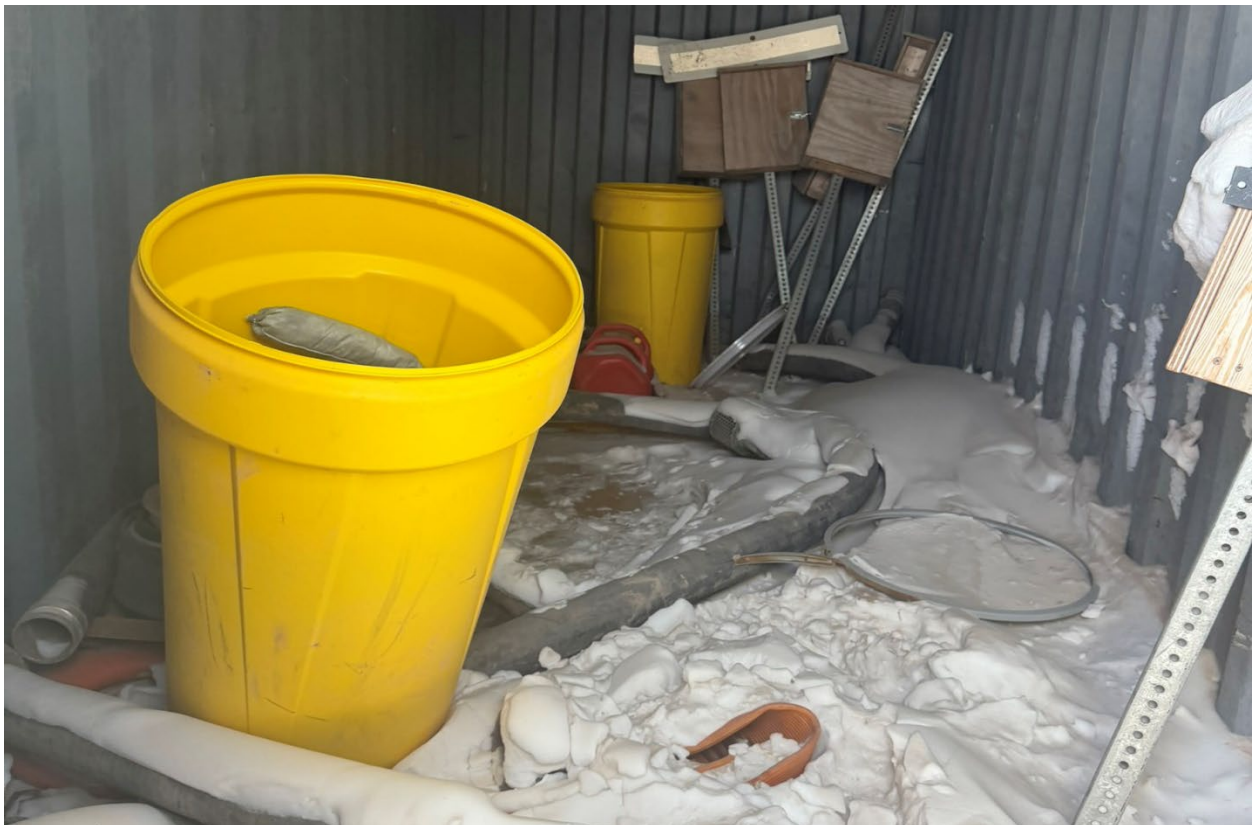
Photo 68: Interior of unsecured seacan units at KM 80 crossing, containing debris, equipment, signage, spill kits, and fuel containers

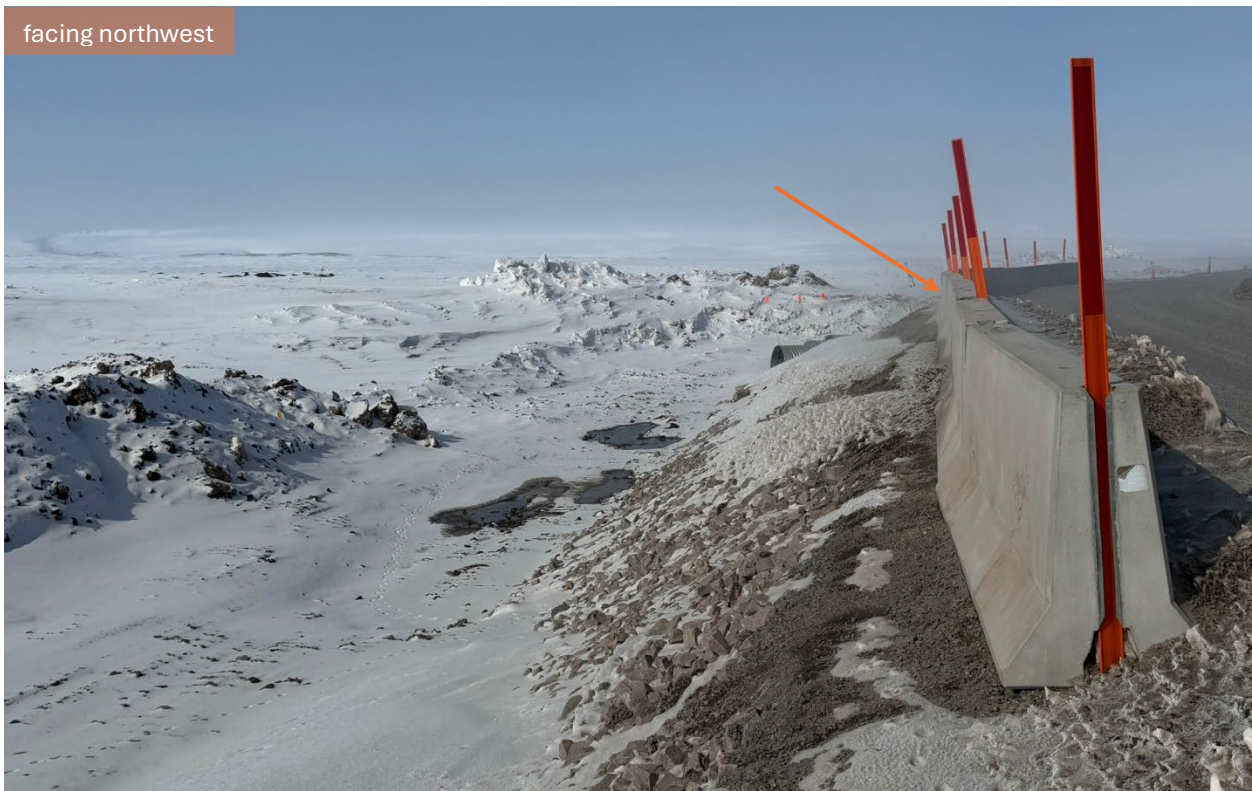
In response, Baffinland constructed a by-pass road and installed three new culverts under an Emergency Fisheries Act Authorization issued by Fisheries and Oceans Canada. At the time of the 2026 site visit, the by-pass road and new culvert installation were complete (Photo 69, Photo 70, Photo 71, and Photo 72). Concrete jersey barriers placed along the shoulder crest appear to be insufficiently supported on the sloped surface, creating a potential instability concern (Photo 72).

Photo 72: Concrete jersey barriers installed along both shoulders of the new by-pass road⁸

⁸ Unstable placement of concrete jersey barriers observed on the shoulder crest. Due to inadequate seating on the slope, there is a risk of downslope toppling. Failure threatens to crush or block the underlying culvert, resulting in seasonal meltwater pooling, slope erosion, and roadway washout. Stabilization or barrier setback could be required.

Assess and stabilize concrete jersey barriers along the by-pass Road if needed. Ensure proper placement to reduce the risk of movement, culvert blockage, or road damage.
