GJOA HAVEN, NU

Investigation of Prospective Granular Borrow
Sources

January 2025

Prepared by:
Nunami Stantec Limited

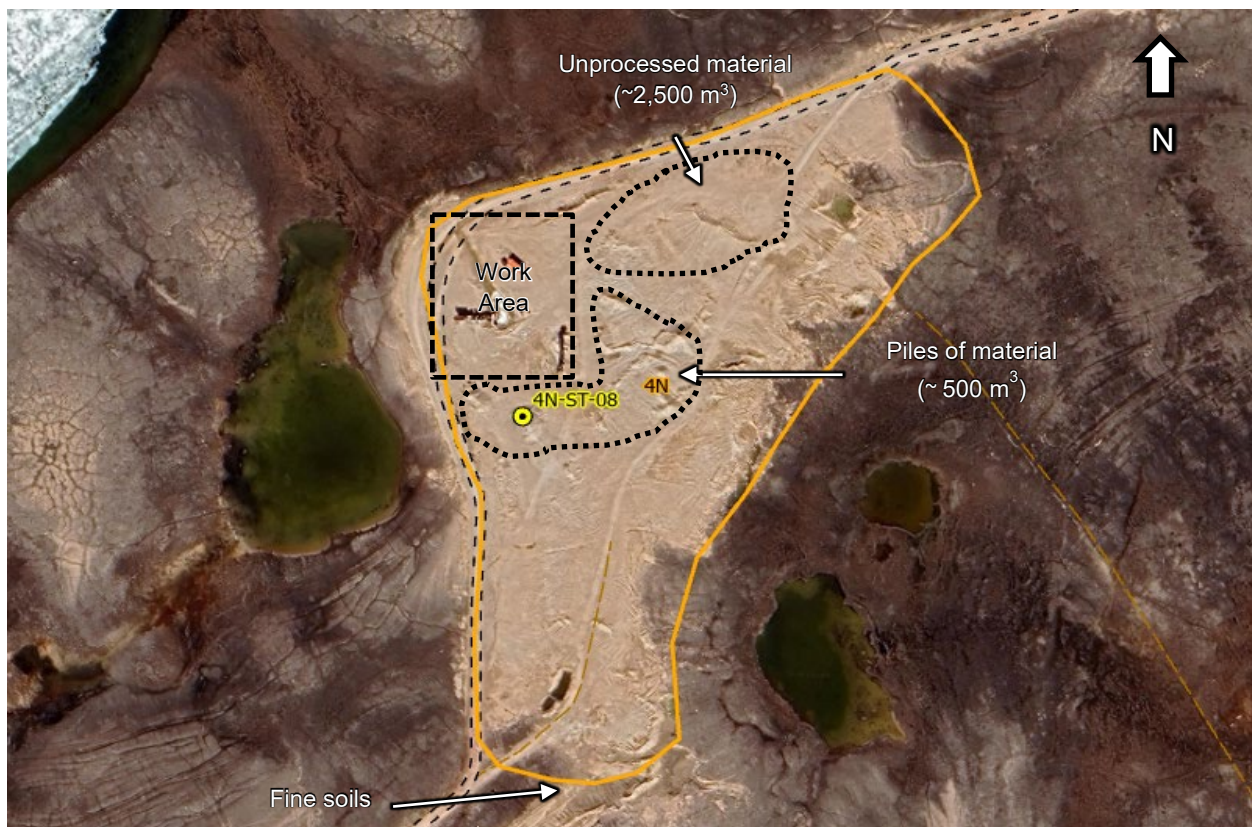
Figure 3 Remaining Volume Estimate – Existing Quarry Site 4N

Although the Hamlet noted that quarry site 4N is near depletion, it is expected that additional granular material is available in the northern portion of the deposit (accounting for a volume of 2,500 m³). Some material is also available from piles and unprocessed material (accounting for a volume of 500 m³).

In total, it is estimated that quarry site 4N (**Figure 3**) contains approximately 3,000 m³ of remaining granular material.

- As of July 2024, borrow extraction and processing is being conducted at the quarry site 4N. It is recommended that the Hamlet process the remaining 3,000 m³ of materials, then relocate its equipment to quarry site GH-101.

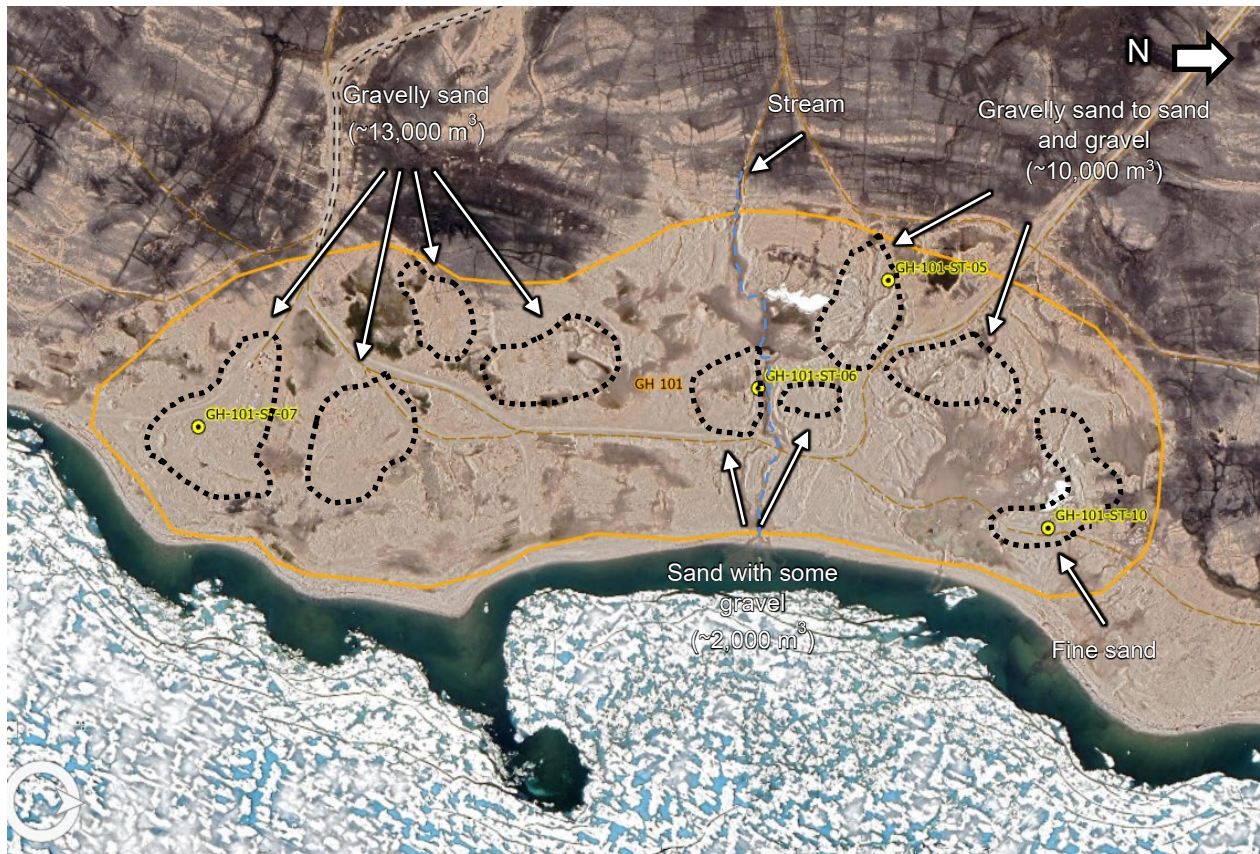
Figure 4 Remaining Volume Estimate – Existing Quarry Site GH-101

Although the Hamlet noted that quarry site GH-101 is near depletion, it is expected that additional granular material is available from the site. Remaining material is available from piles and unprocessed material. It is estimated that the existing quarry site GH-101 (**Figure 4**) may contain up to 25,000 m³ of remaining granular material ranging from sand with some gravel and traces of fine particles to gravelly sand with traces of fine particles; cobbles (<1%) also occur.

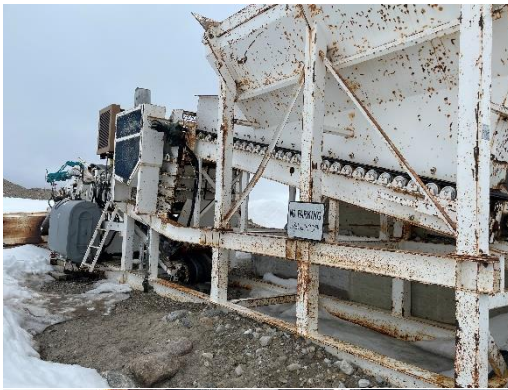
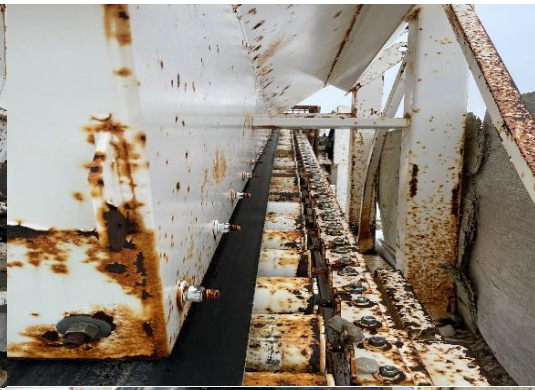
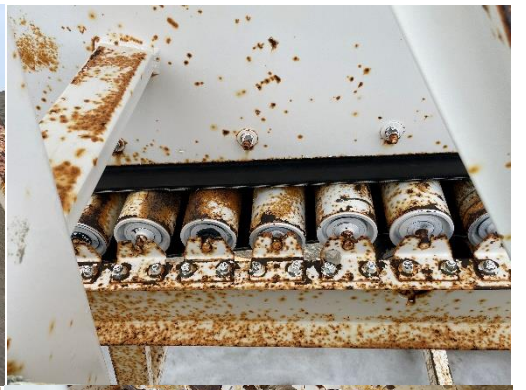
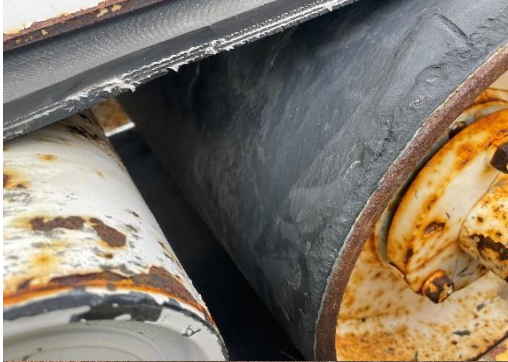
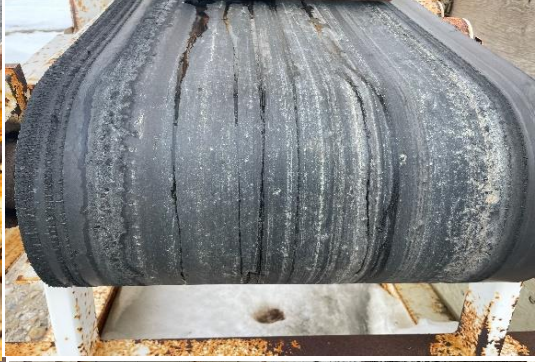
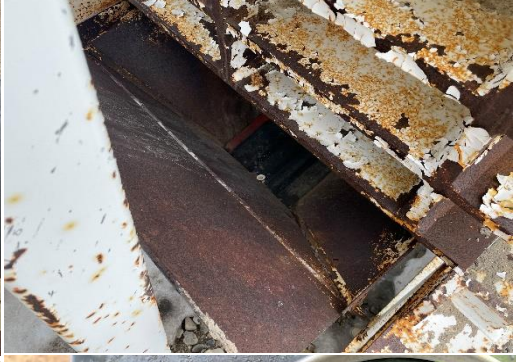
SHEET METAL	X	Good to fair					
ENGINE HOOD	X	N/A		X	CONVEYOR FRAME	Good	
STEPS, HAND RAILS	X	Good to fair		X	CONVEYOR BELTS	Feed coneyor will need to be replaced	
CATWALKS	X	Good		X	HOPPER WALLS	Fair	
PAINTWORK	X	Some surface rust		X	CHASSIS	Surface rust	
HYDRAULICS							
HYDRAULIC CYLINDERS	X	Good					
HOSES & LINES	X	Good to Fair			CONVEYOR MOTOR	Good	
CONTROLS & VALVES	X	Main push/pull valve need to be repair			VIBRATORS	Good	
FUNCTIONAL TEST	X	Worked as it should			CRUSHER ADJUSTMENT	Good	
CONVEYORS	X	Both conveyor operated as it should			DRIVE TRAIN	Good	
MAGNETIC SEPERATOR	N/A				CONVEYOR FOLDERS	N/A	
FEEDER HOPPER		Good			BREAKER CLUTCH	Good	
JAW CRUSHER		Good					
TOGGLE & MECHANICAL		Good			JAW WEAR	Will need to be flipped	
WALL LINERS		Good to Fair			PALTFORMS	Good	
SCREENER		Good to fair			VIBRATOR	Good	
Visible issues							
Discharge belt will need replacement							
Impact roller # 7,8,9 will need replacement

Tail pulley will need repair or replacement							
Stationary Jaw liner plate will need to be flipped							
Hydraulic detent control valve very stiff will need replacement							
Main drive belt should be replaced and adjusted to OEM specs							
Hydraulic cooler fan will need to repaired or replaced							
Vibrating screen drive belts cracked and worn, will need to be replaced							
Battery will need replacement							
Screen media should be replaced							
Comments							
Overall crusher in good shape, will need minor repairs and a complete service. Oil, filter and lube.

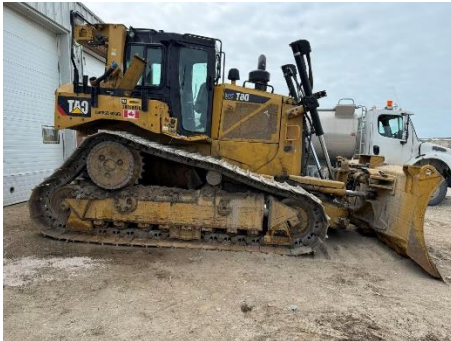
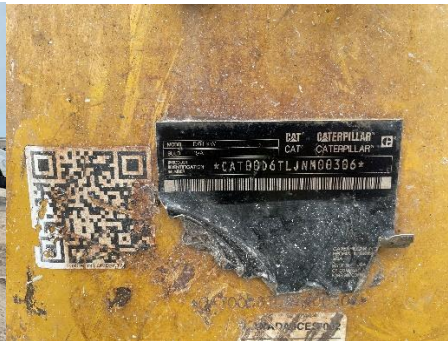
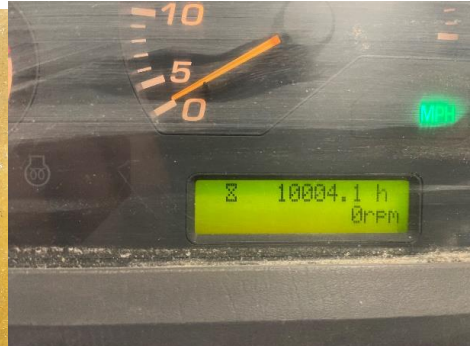
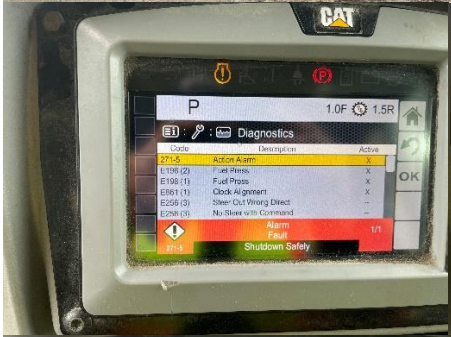
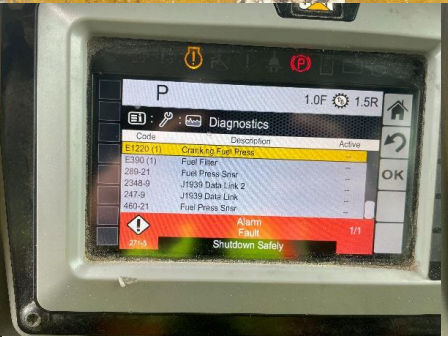
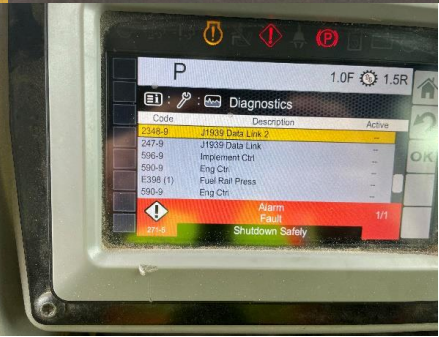
Dozer Inspection Condition Inspection

PAINTWORK		Good to fair	
HYDRAULICS							
HOSES & LINES		Fair(tube on rear of dozer is leaking)		TILT CYLINDER		Good	
LIFT CYLINDERS		Good		ANGLE CYLINDER		Good	
				RIPPER CYLINDER		N/A	
FUNCTIONAL TEST / PLAY LOCALIZATION							
PINS PUSH FRAME		Fair		PUMP NOISE		None at time of inspection	
PINS BLADE		Fair		ELECTRICS		Some repair needed	
PINS RIPPER		N/A		TRANSMISSION		Good	
EQUALIZER BAR		Further inspection required		BRAKE/CLUTCHES		Further inspection required	
STALL TEST		Failed as fuel code in system		STEERING		Fair	
BLADE CONDITION AND TYPE		STRAIGHT		ANGLE(PAT)		X	
		PIVOT PINS		TRUNIONS		U SHAPE	
		SKIN		CUTTING EDGE		X	
						SIDE ARMS	
U/C		RIGHT SIDE		LEFT SIDE			
BUSHINGS						TRACK SHOE WIDTH	
SHOES		10%		10%		ROTATING BUSHING	
REAR IDLER		40%		40%			
CARRIER ROLLER		40%		40%		CAT SYSTEM ONE	
SPROCKETS		40%		40%			
LINKS		40%		40%			
CANON CONDITION		Fair		Fair			
VISIBLE ISSUES							
Hydraulic oil tube replacement

Battery replacement							
Diagnostic code investigation							
CAT TA2 inspection							
Undercarriage needs replacement							
COMMENTS							
Overall the dozer is in fair condition, will need repair and diagnostics to bring up to standards. Has potential to be a good machine.
