Non-Hazardous Landfill, Construction Report, Ulu Gold Project Interim Report Draft

SRK Consulting (Canada) Inc.
1CB041.000
September 2022

Project No: 1CB041.000

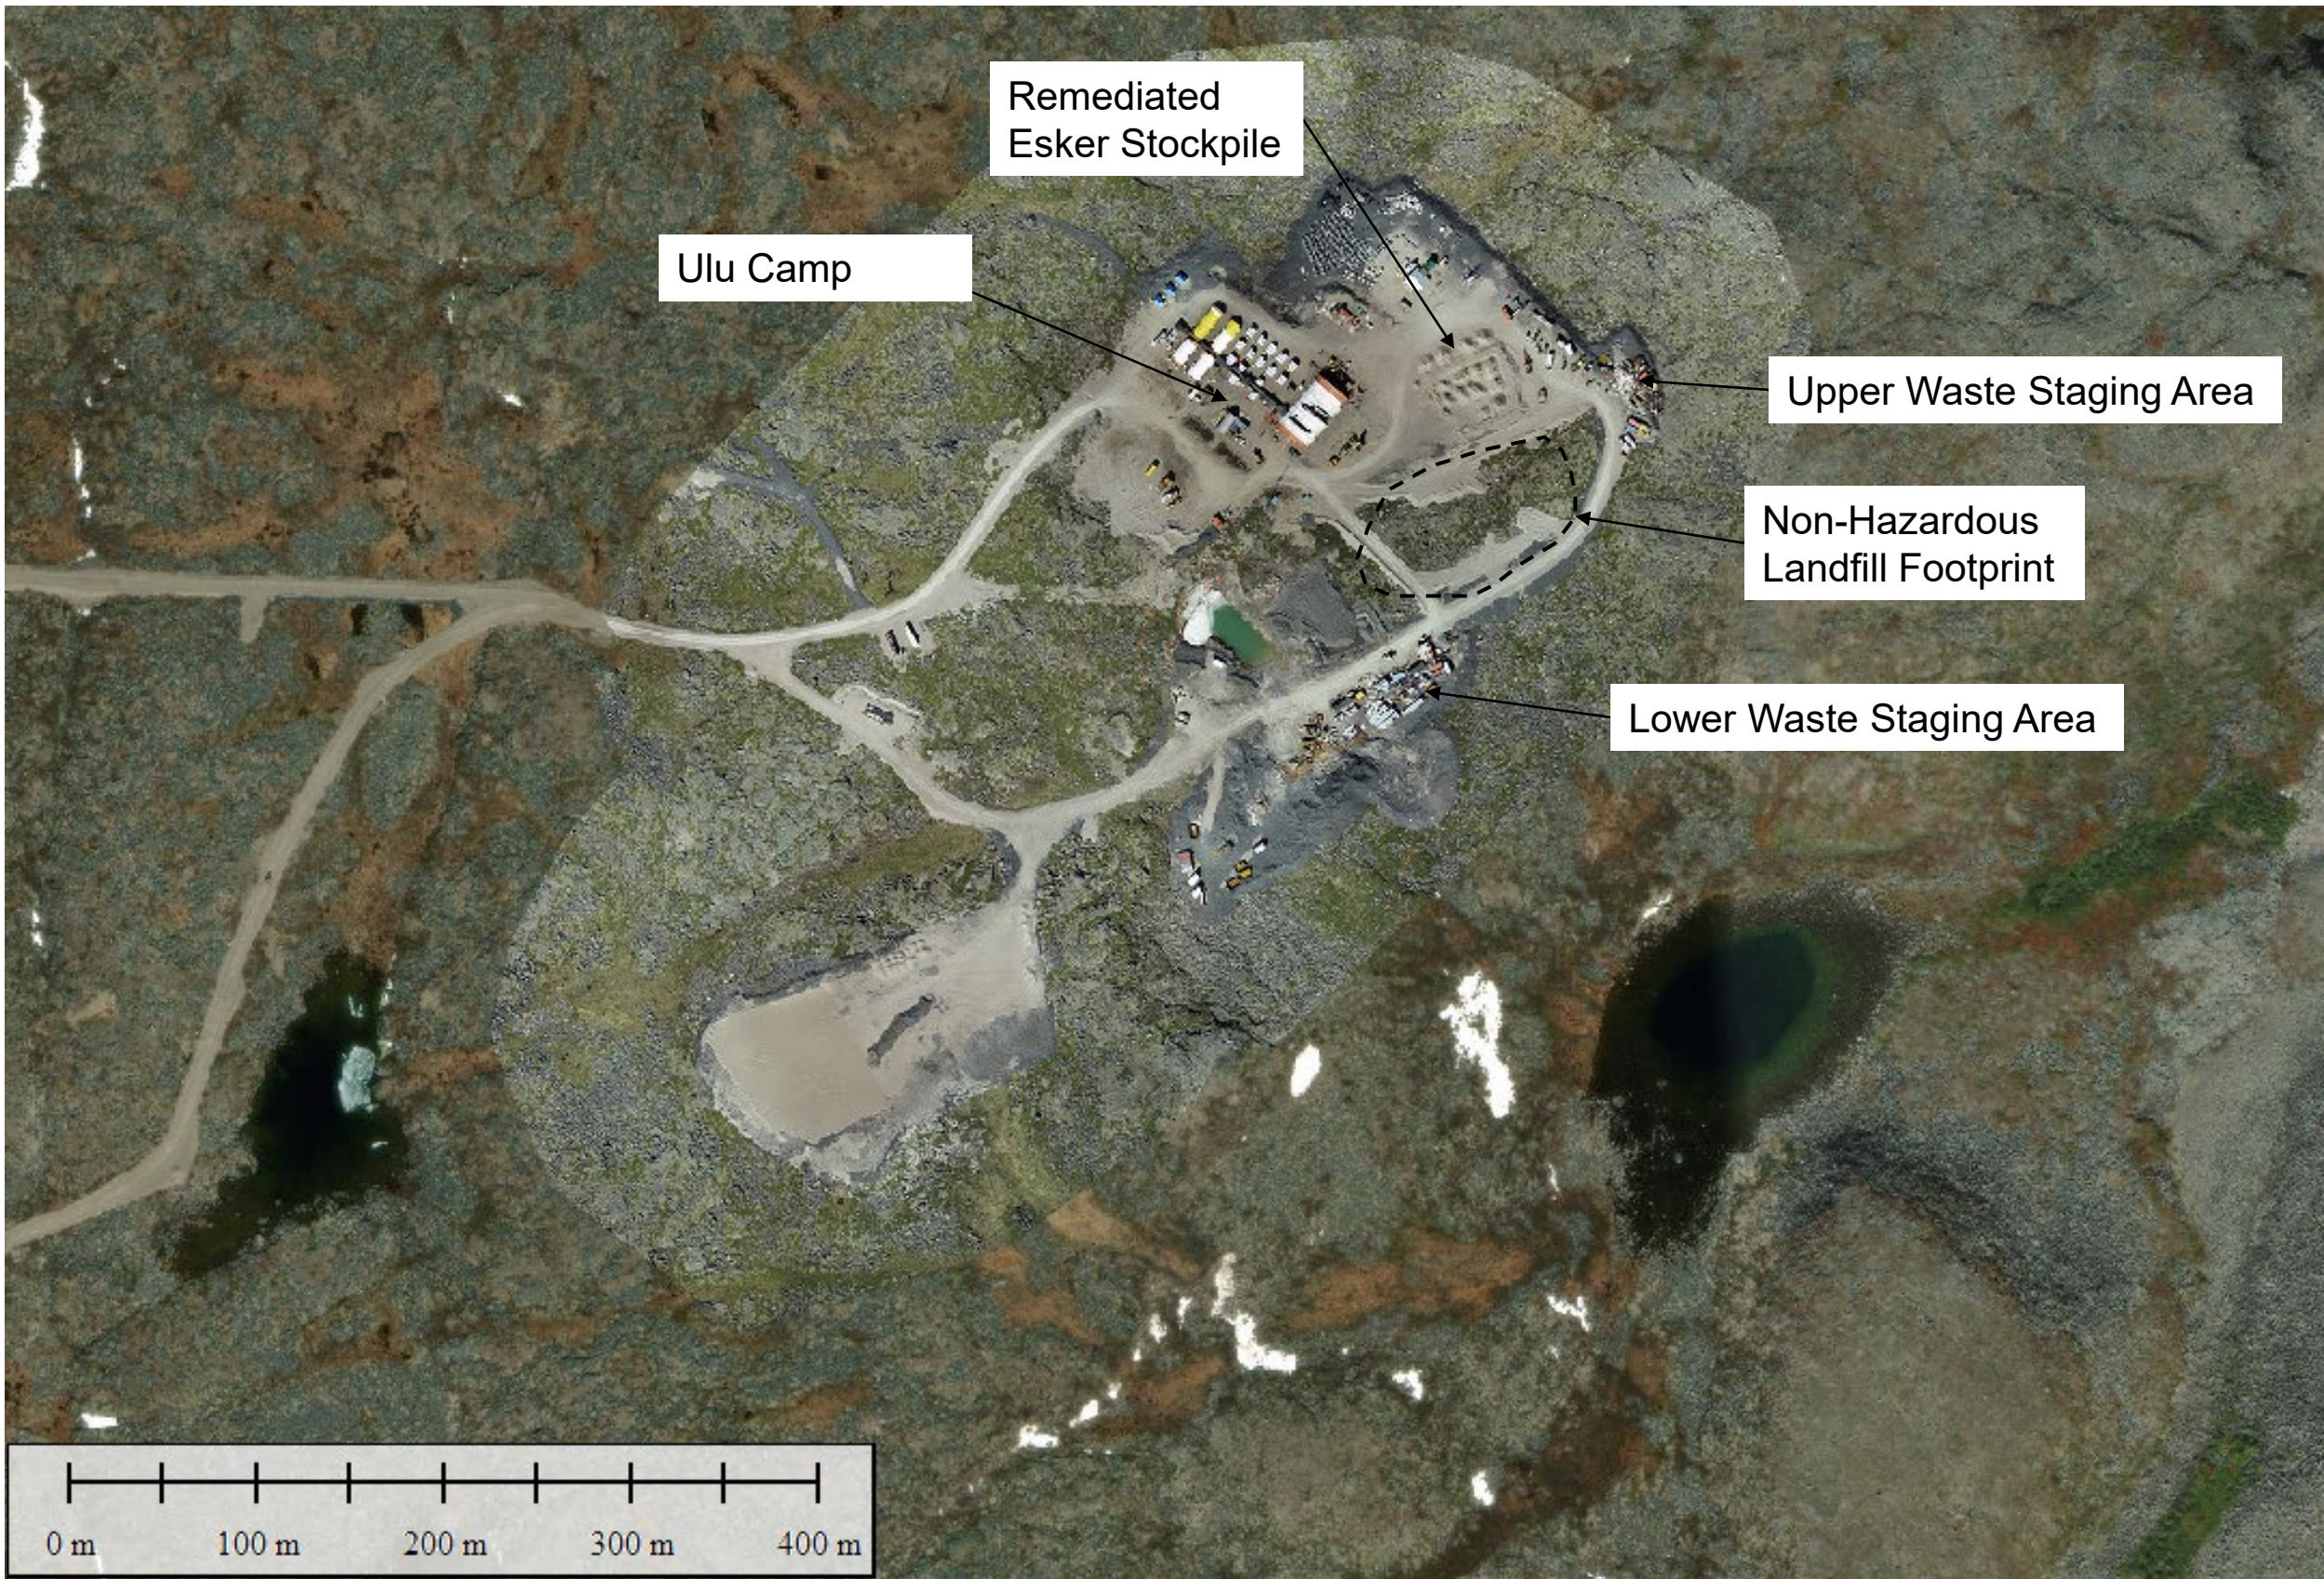
Job No: CAPR001821 Filename: Ulu_Landfill_Figures_DG.pptx	  Ulu Gold Project	Non-Hazardous Landfill		
		Ulu Camp Overview		
		Date: September 2022	Approved: DG	Figure: 3-1

The waste material was consolidated and sorted in the upper and lower staging areas, see Figure 3-1. Staging included the consolidation of loose waste within available seacans and cut tanks for transport into the landfill area. Placement within the landfill was generally done by front end loader, excavator and pushed/pull but the bulldozer.

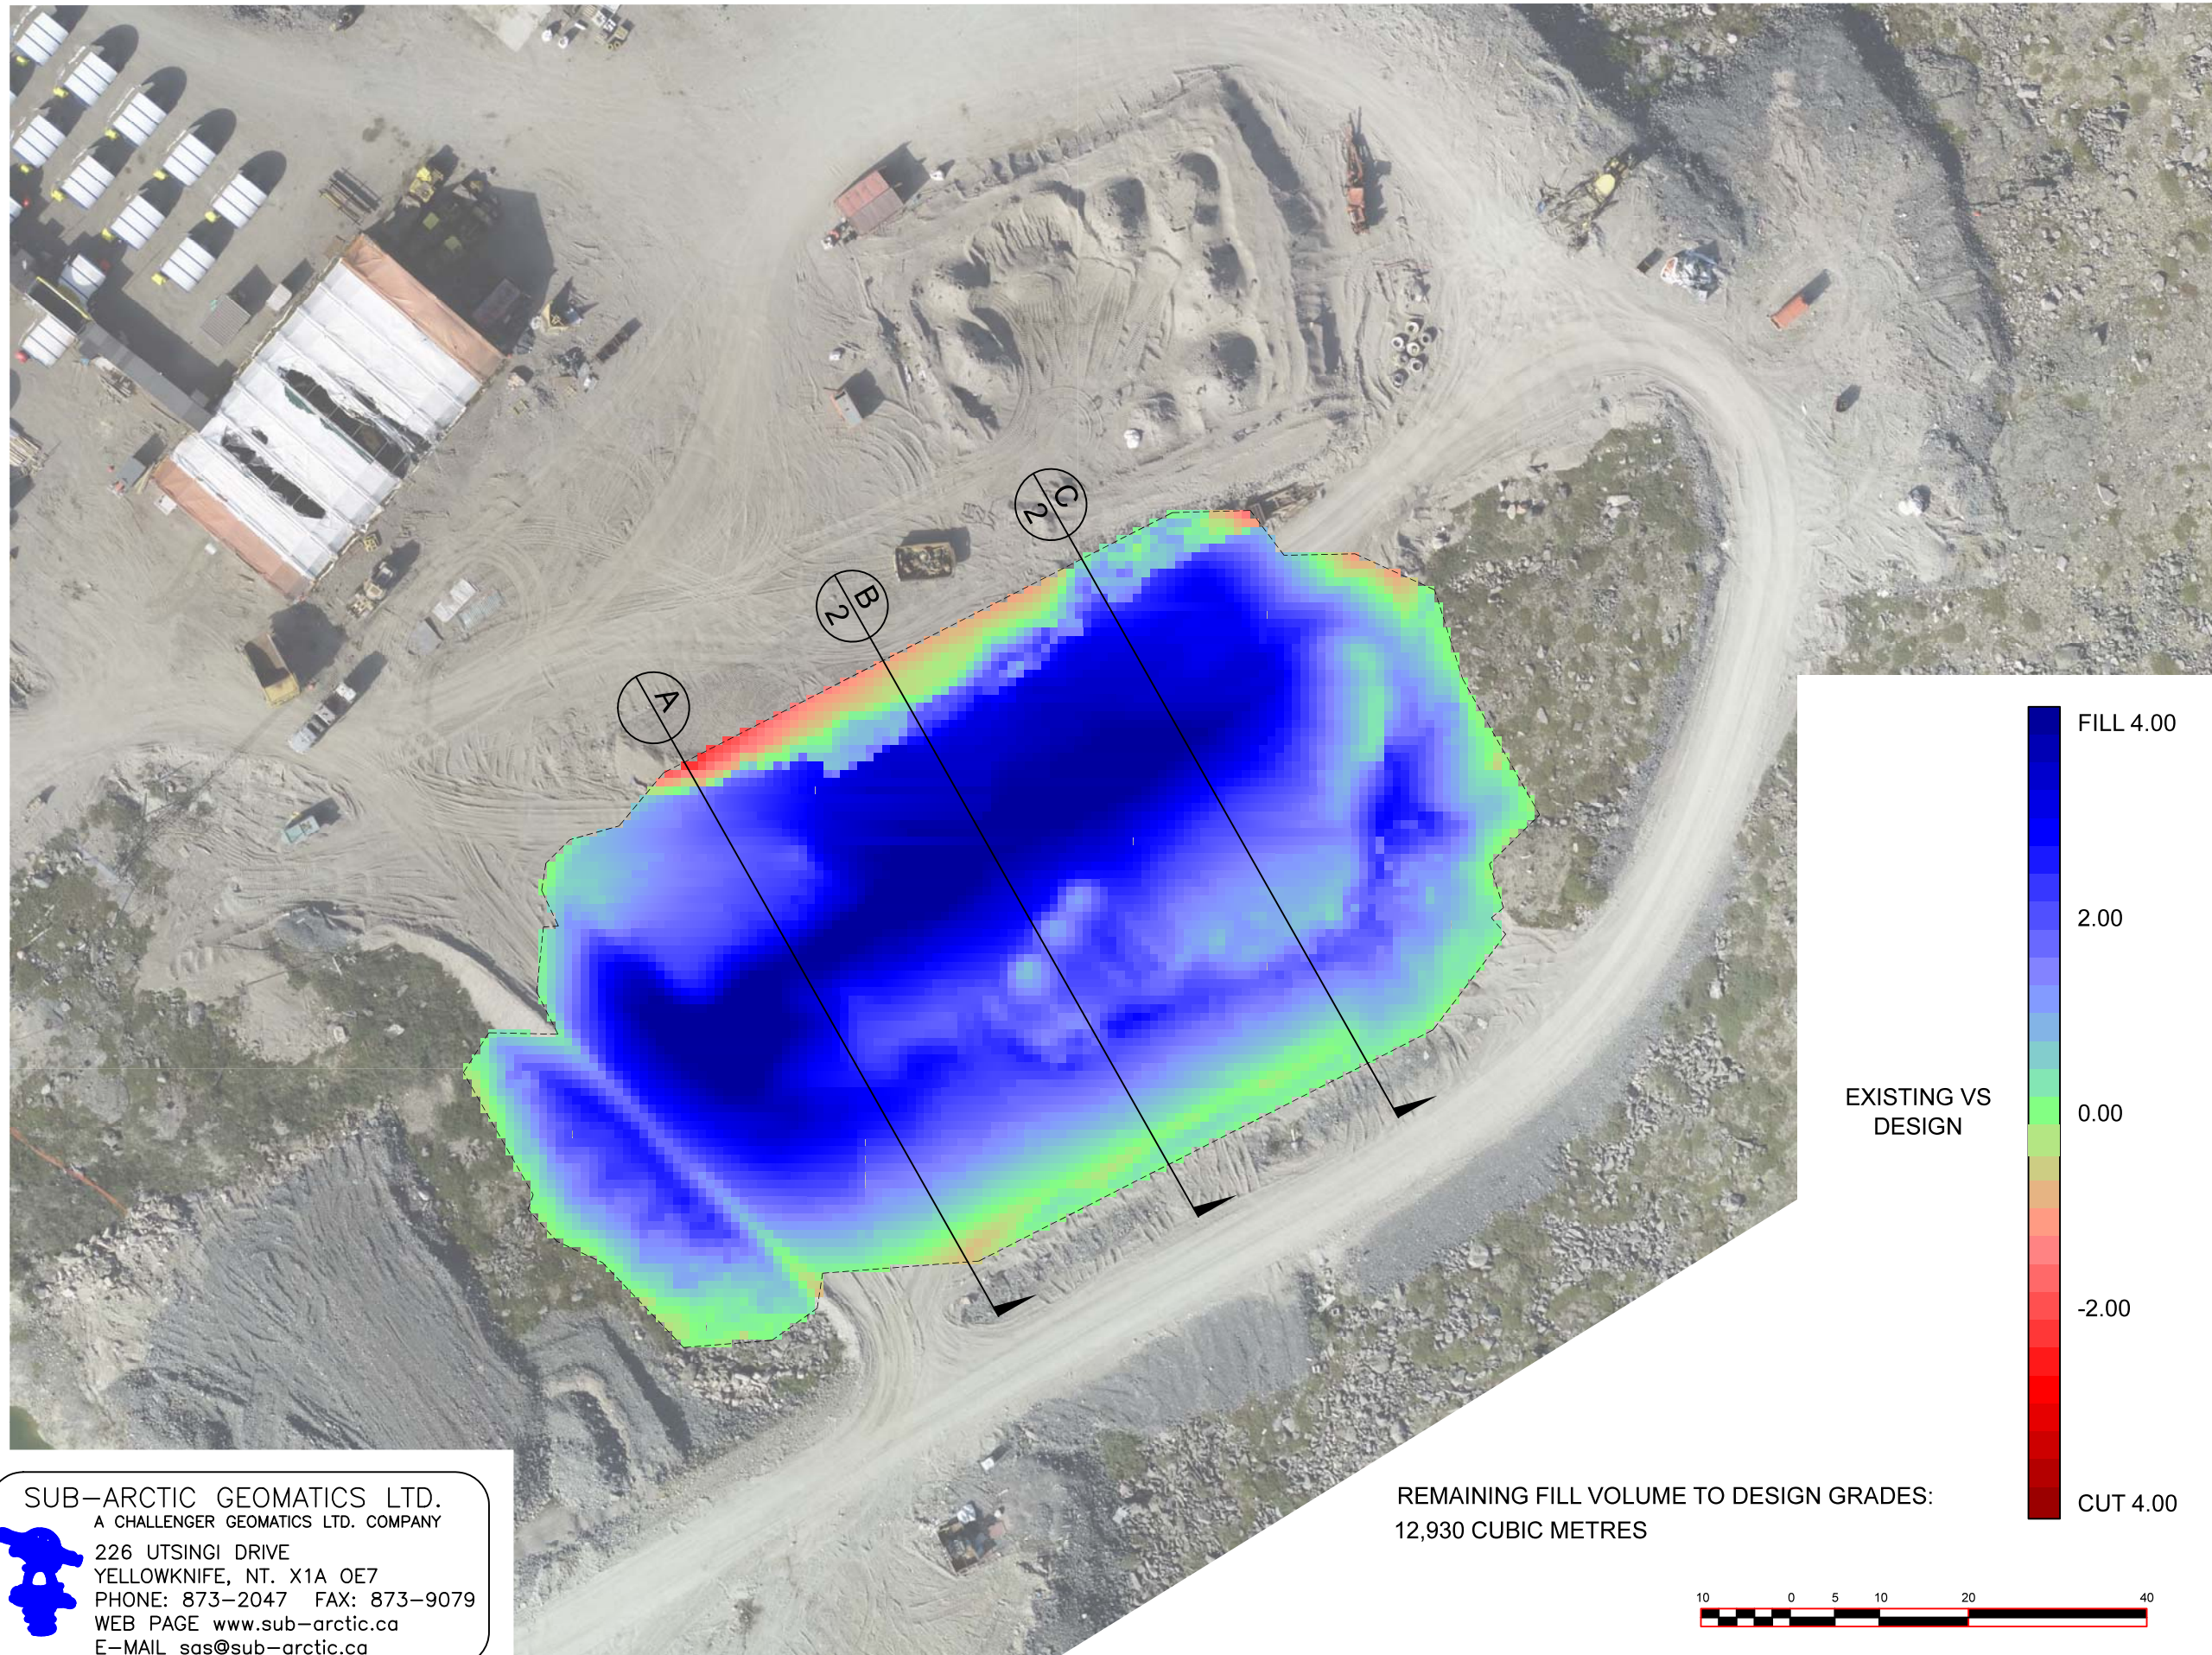
REMAINING FILL VOLUME TO DESIGN GRADES:
12,930 CUBIC METRES

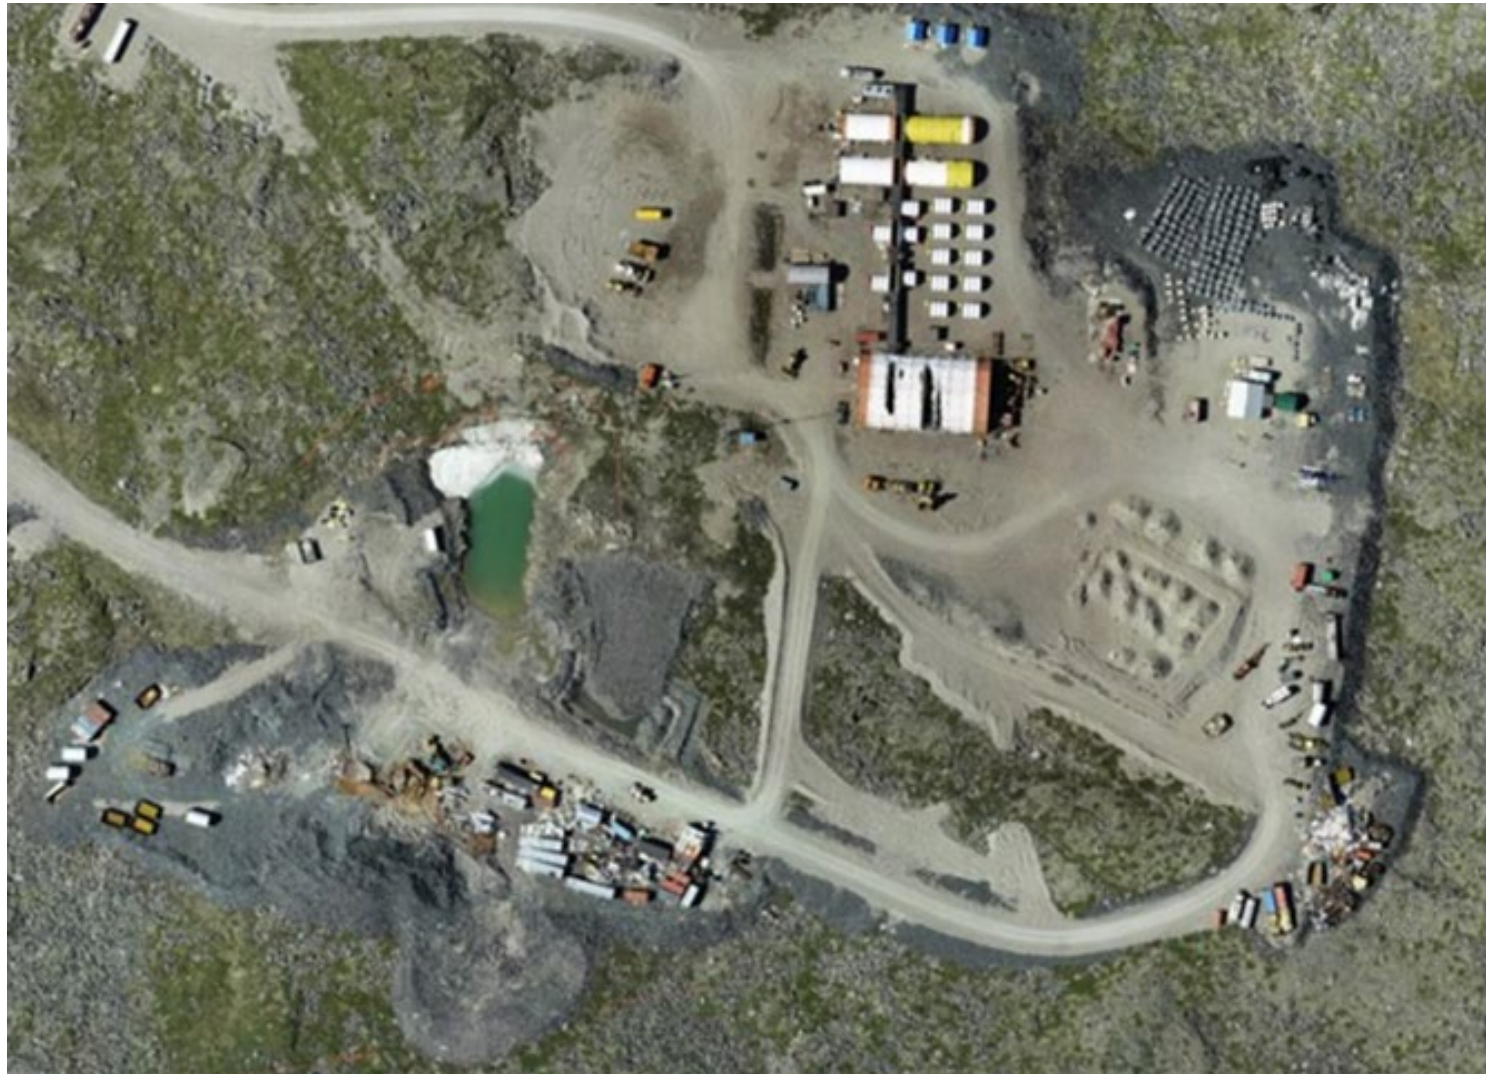
The beginning of the 2021 field season

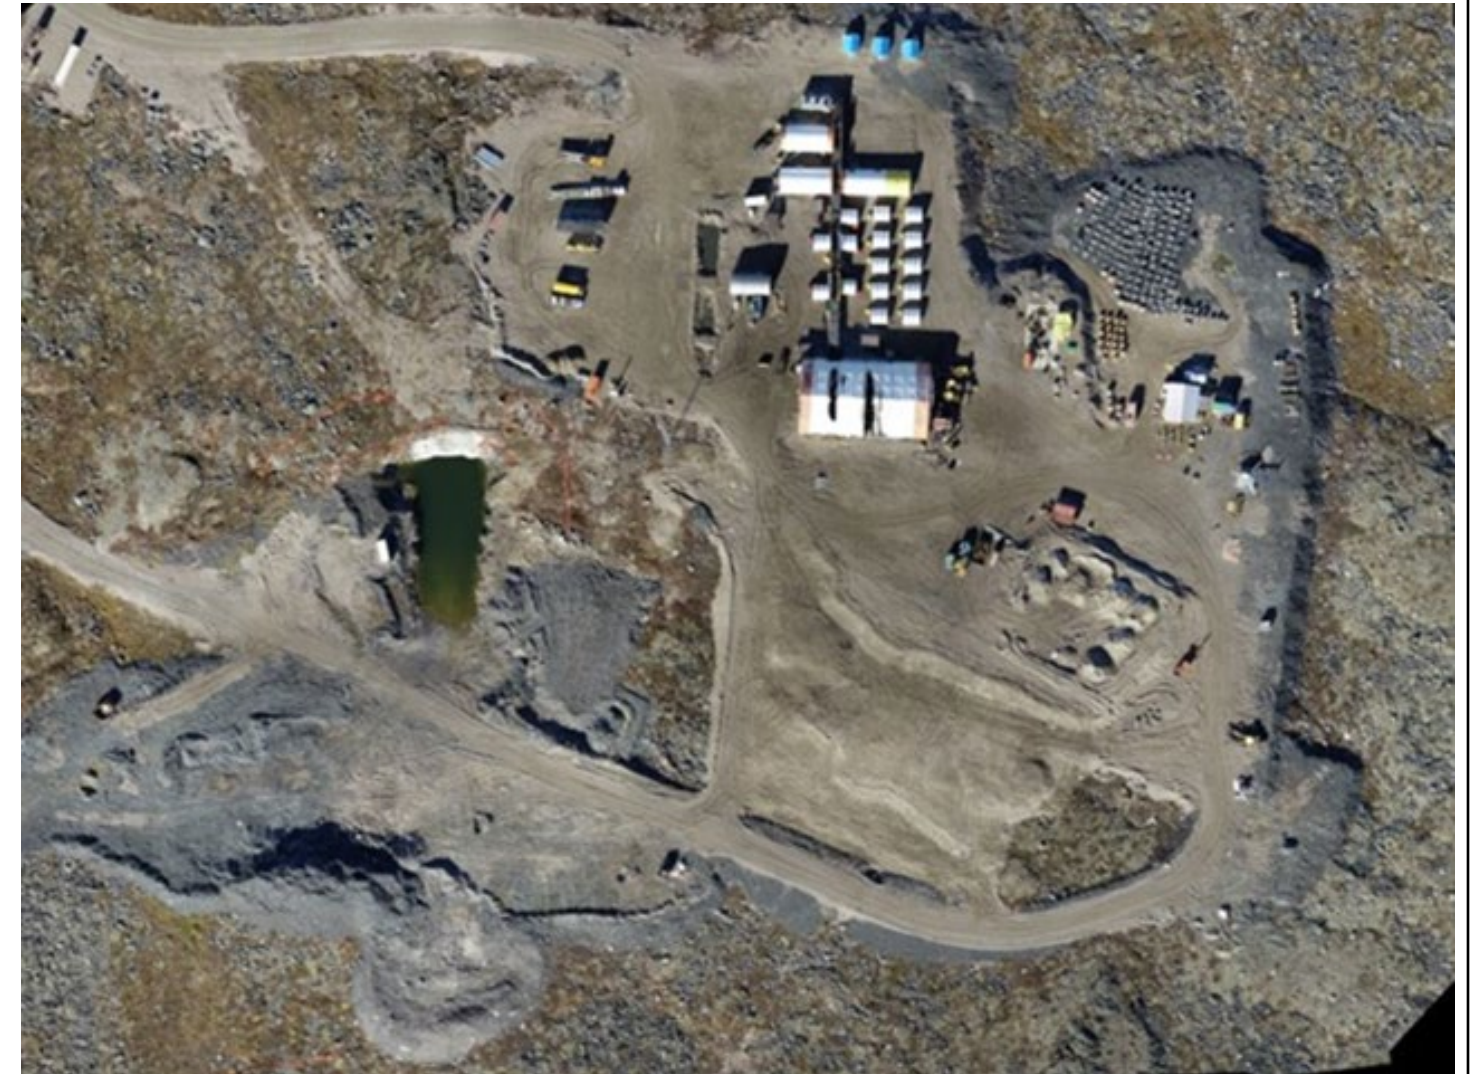
The end of the 2021 field season

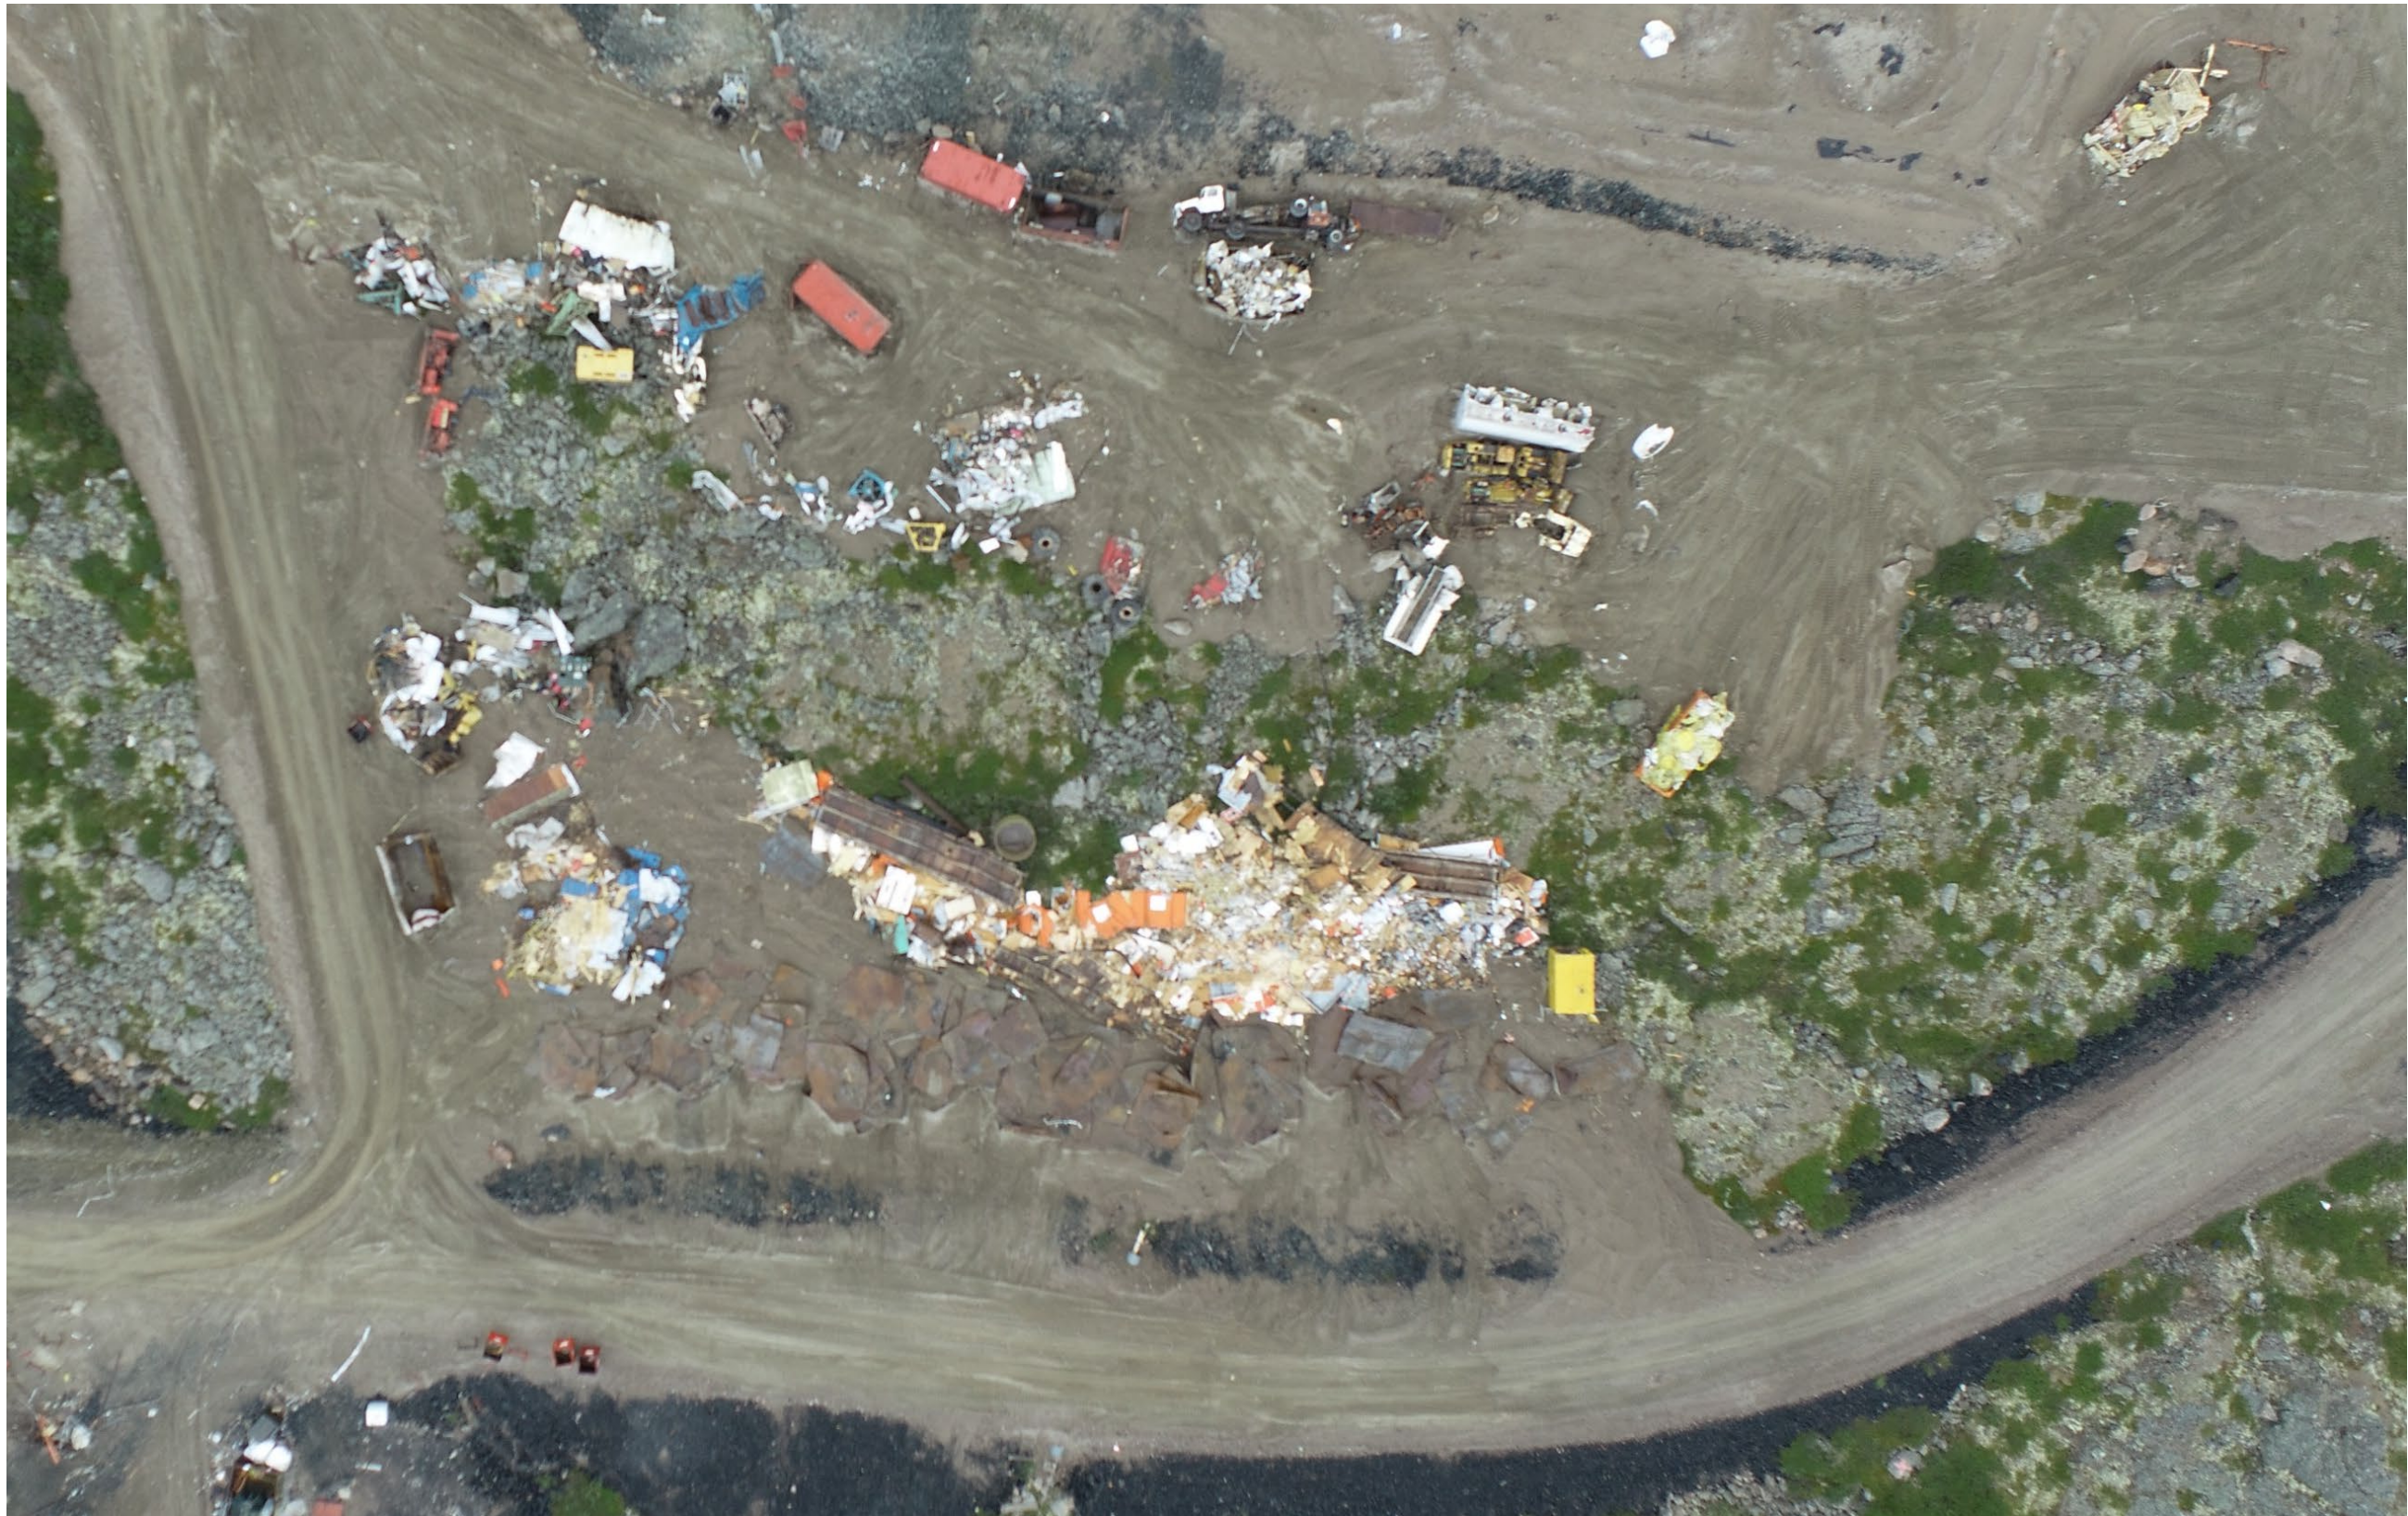
Progress overview on July 27, 2021

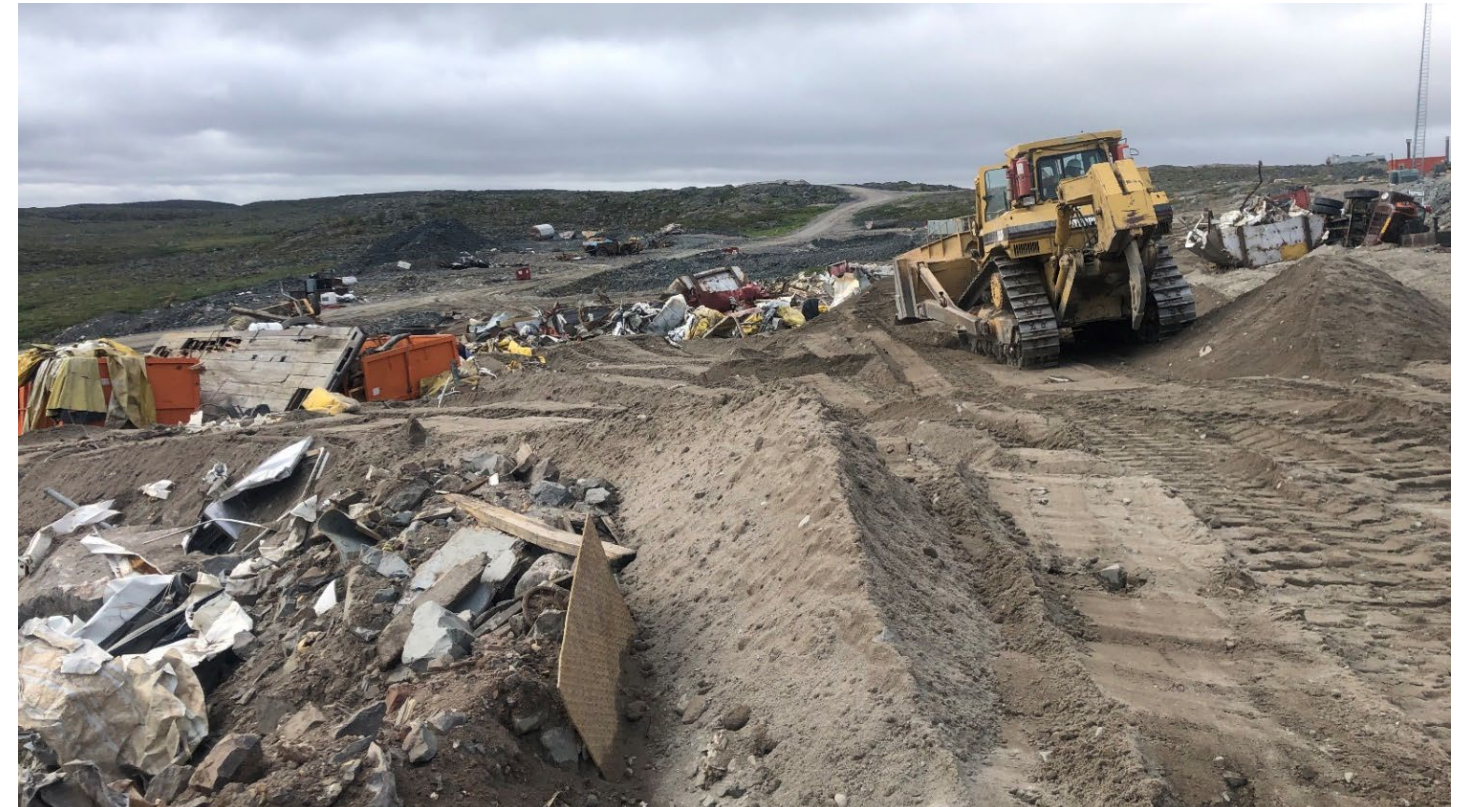
The east side of the site facing west, esker placement within voids and wind cover on August 3, 2021

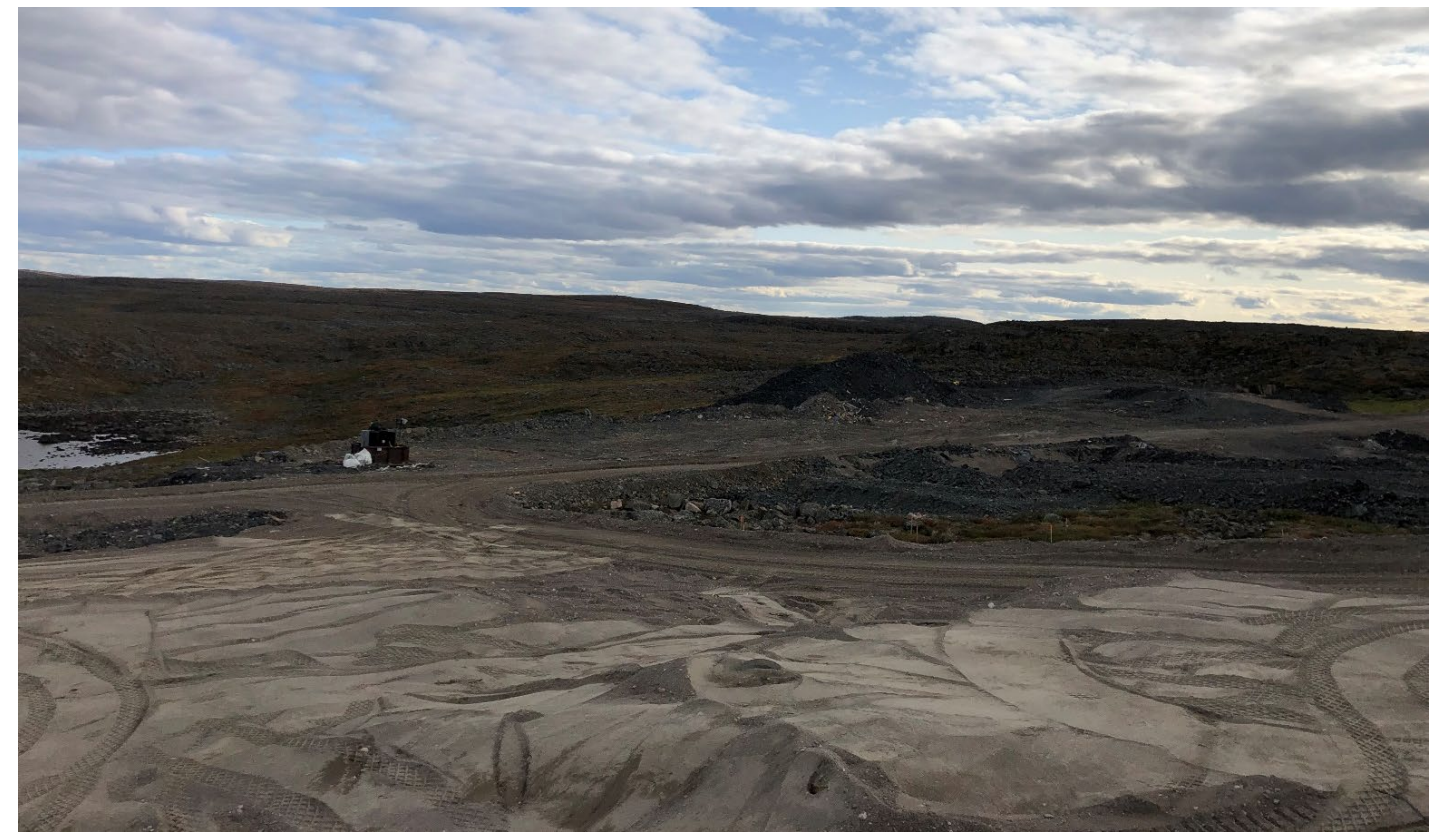
The north side of the site facing southwest with interim cover compaction on August 19, 2021

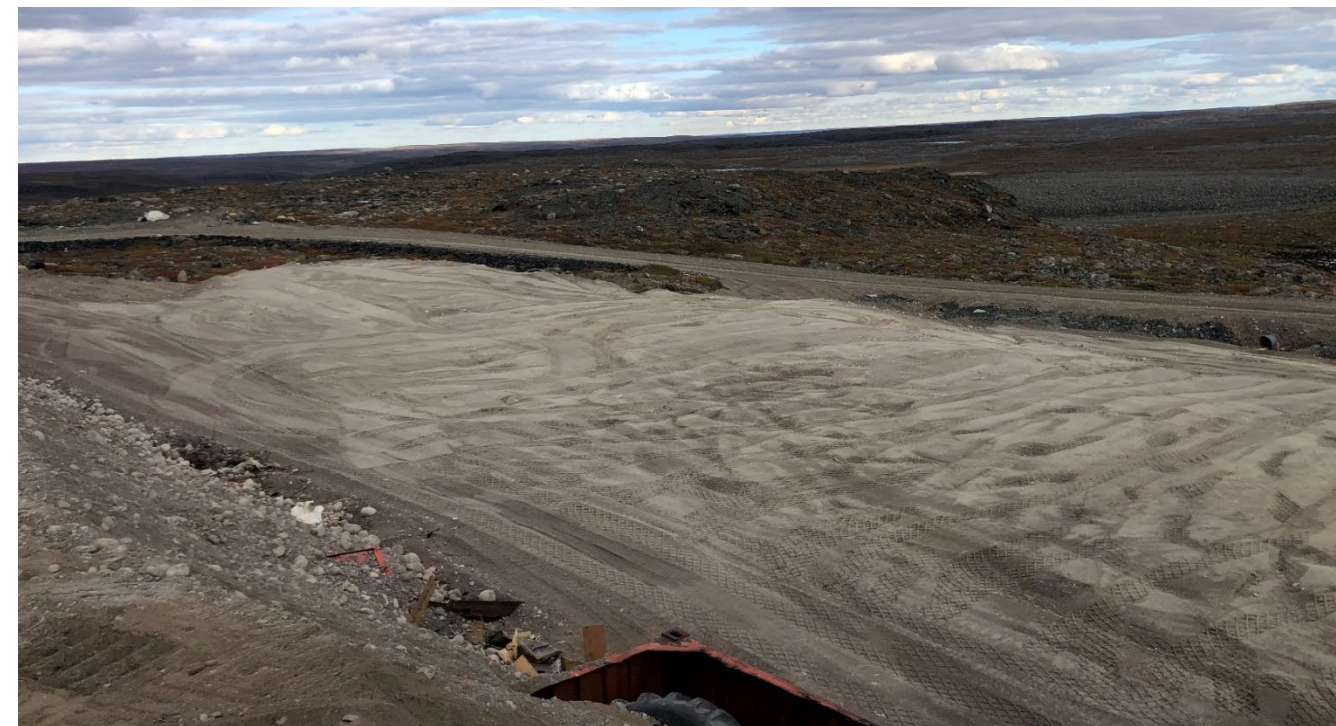
The north side of the site facing southeast with interim cover compaction on August 19, 2021
